MISSOURI DEPARTMENT OF NATURAL RESOURCES
STATE HISTORIC PRESERVATION OFFICE, P.O. Box 176, Jefferson City, MO 65102
ARCHITECTURAL/HISTORIC INVENTORY FORM

1. SURVEY NO. BO-AS-009-0001		2. SURVEY NAME: Rocheport Historic District	
3. COUNTY: Boone		4. ADDRESS (STREET NO.)	STREET (NAME) Katy Trail
5. CITY: Rocheport	VICINITY: <input checked="" type="checkbox"/>	6. UTM: / /	LAT: LONG: T: 48W R: 15W S: 1

8. HISTORIC NAME (IF KNOWN): M.K.&T. Railroad tunnel		9. PRESENT/OTHER NAME (IF KNOWN): Katy trail tunnel	
10. OWNERSHIP: <input type="checkbox"/> PRIVATE <input checked="" type="checkbox"/> PUBLIC		11A. HISTORIC USE (IF KNOWN): railroad tunnel	11B. CURRENT USE: Katy Trail tunnel
HISTORICAL INFORMATION

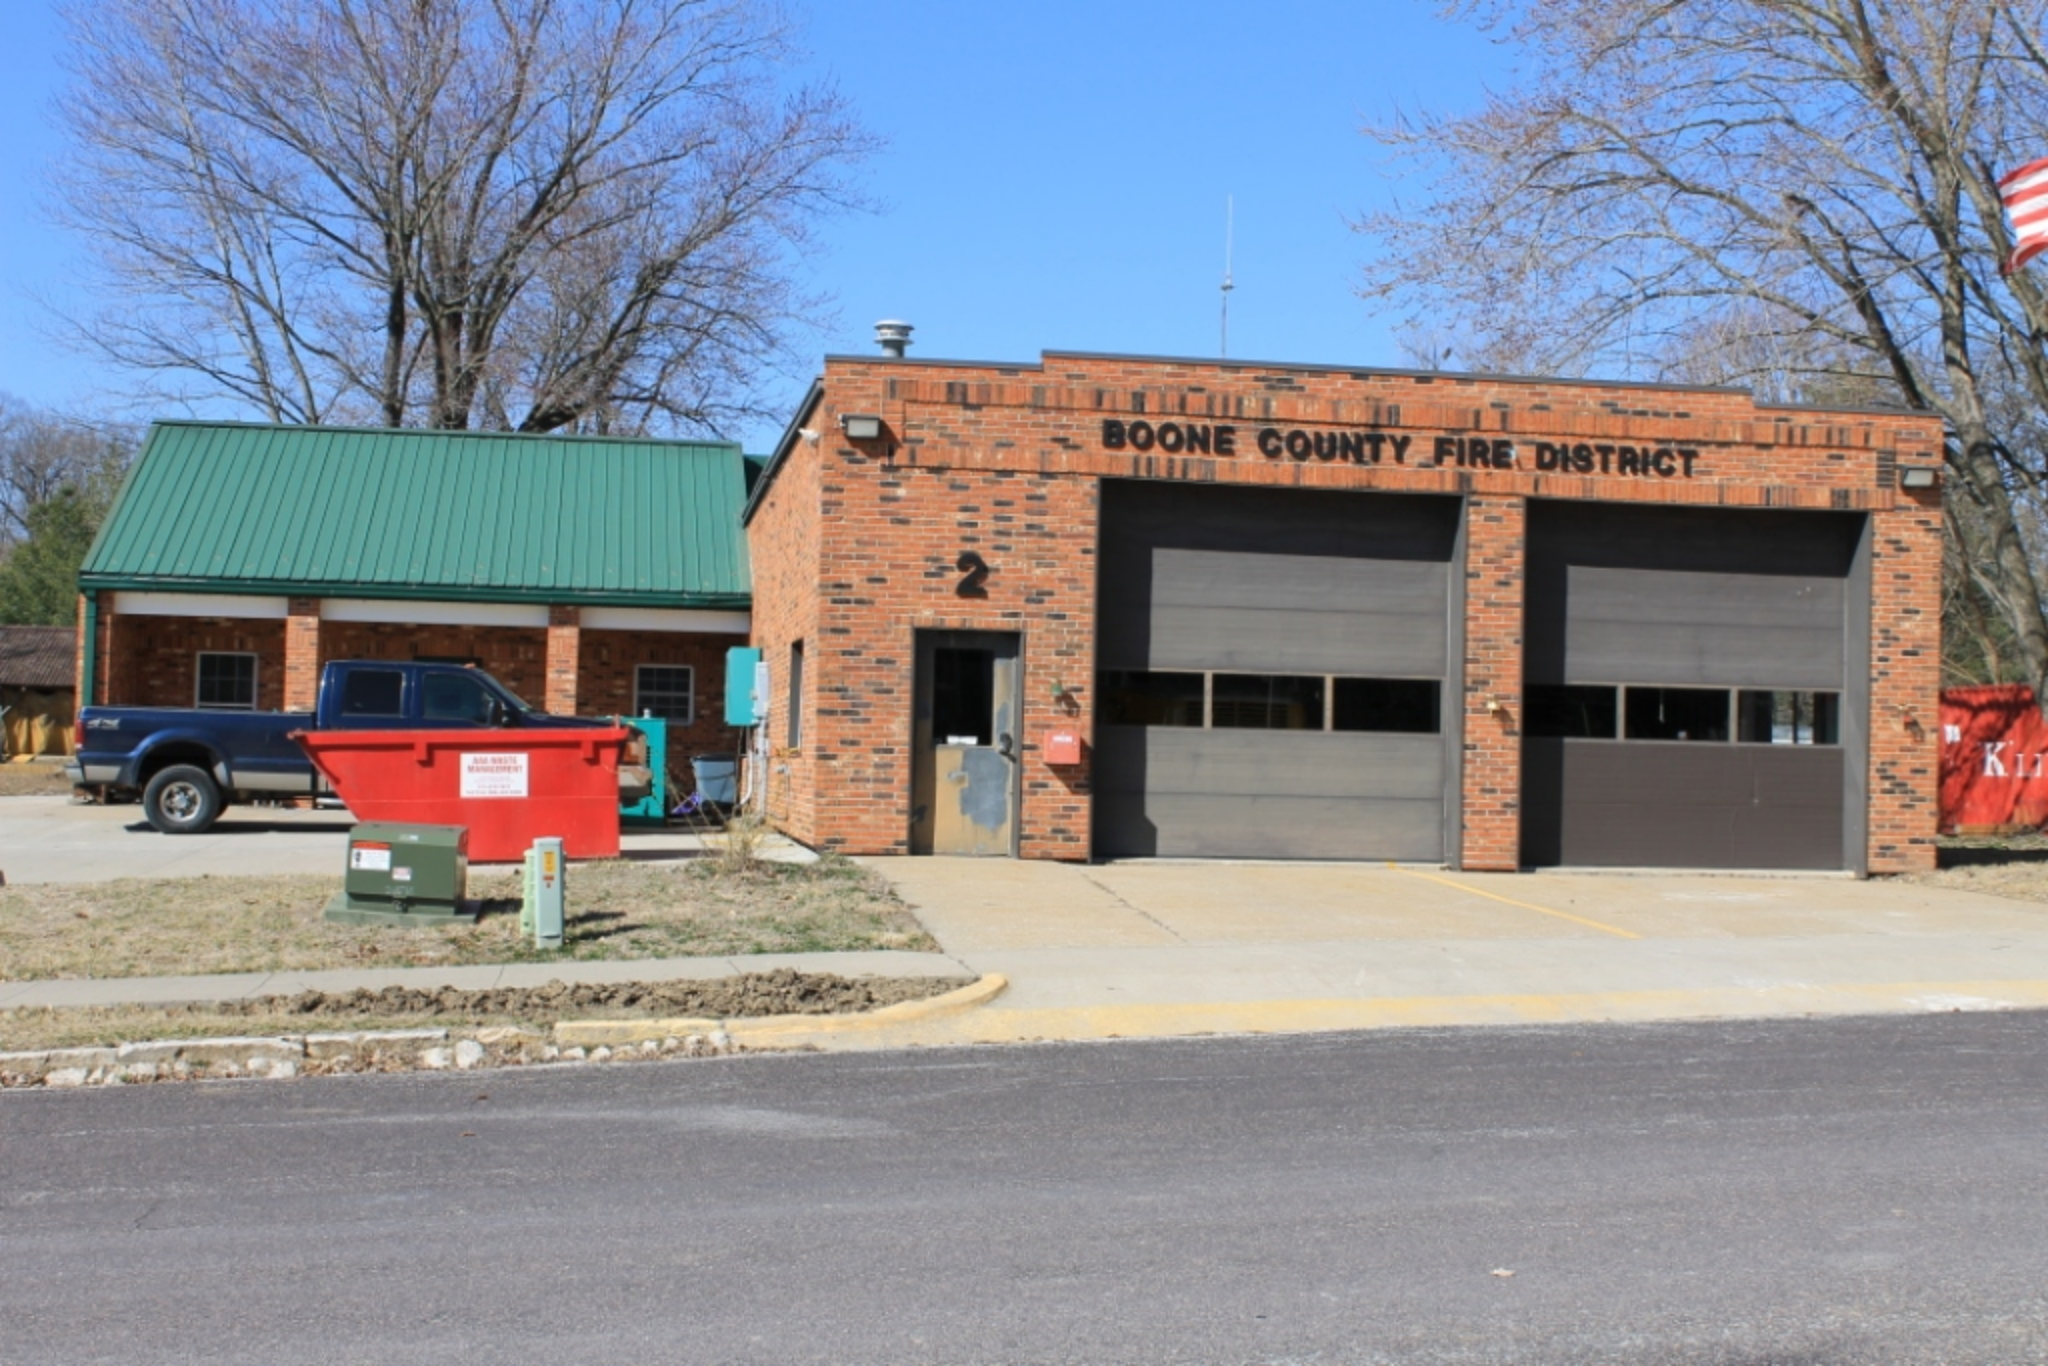
This one-story massed plan building is built of a type and color of brick that coordinates well with the other business buildings along Central Street. The building has two wings. The left wing is a gable roofed wing with an overhanging roof that creates a porch supported by brick pillars. The roof of this portion of the building is covered with metal. The right wing of the building is a tall, flat roofed garage. The front (west) facade of the building has five bays. The left bay, which is in the gable roofed wing of the building, contains a one-over-one single hung window. The next bay, which is also in the gable roofed wing, contains a door. The next bay, also in the gable roofed wing, contains a one-over-one window. The next bay is in the flat roofed wing of the building; this bay contains a walk out door. The two rightmost bays each contain a tall overhead garage door that allows passage of the fire fighting equipment housed there.

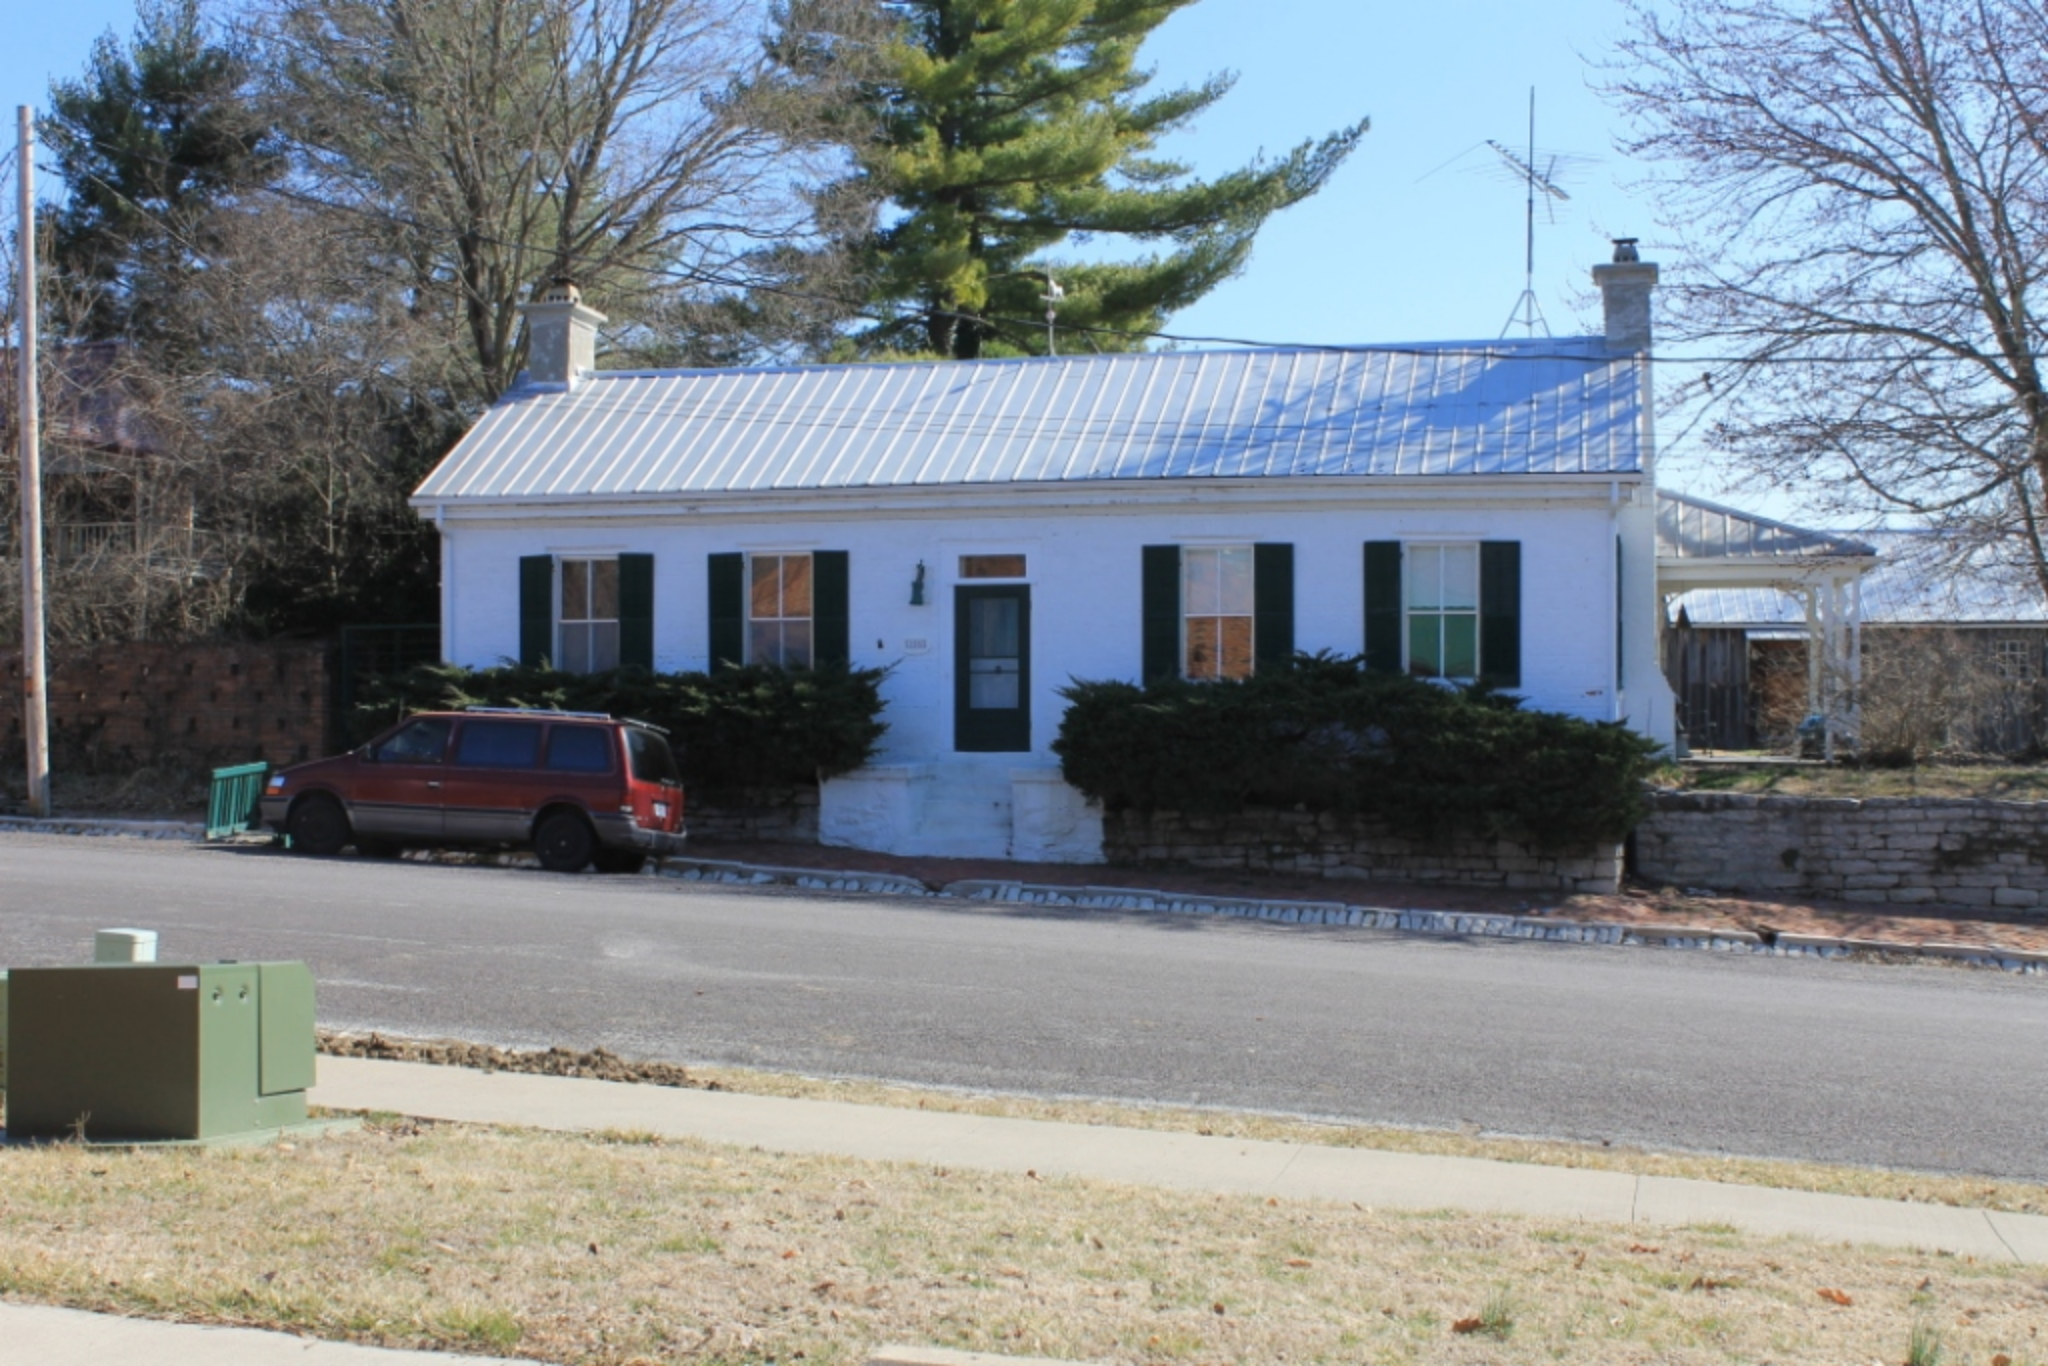
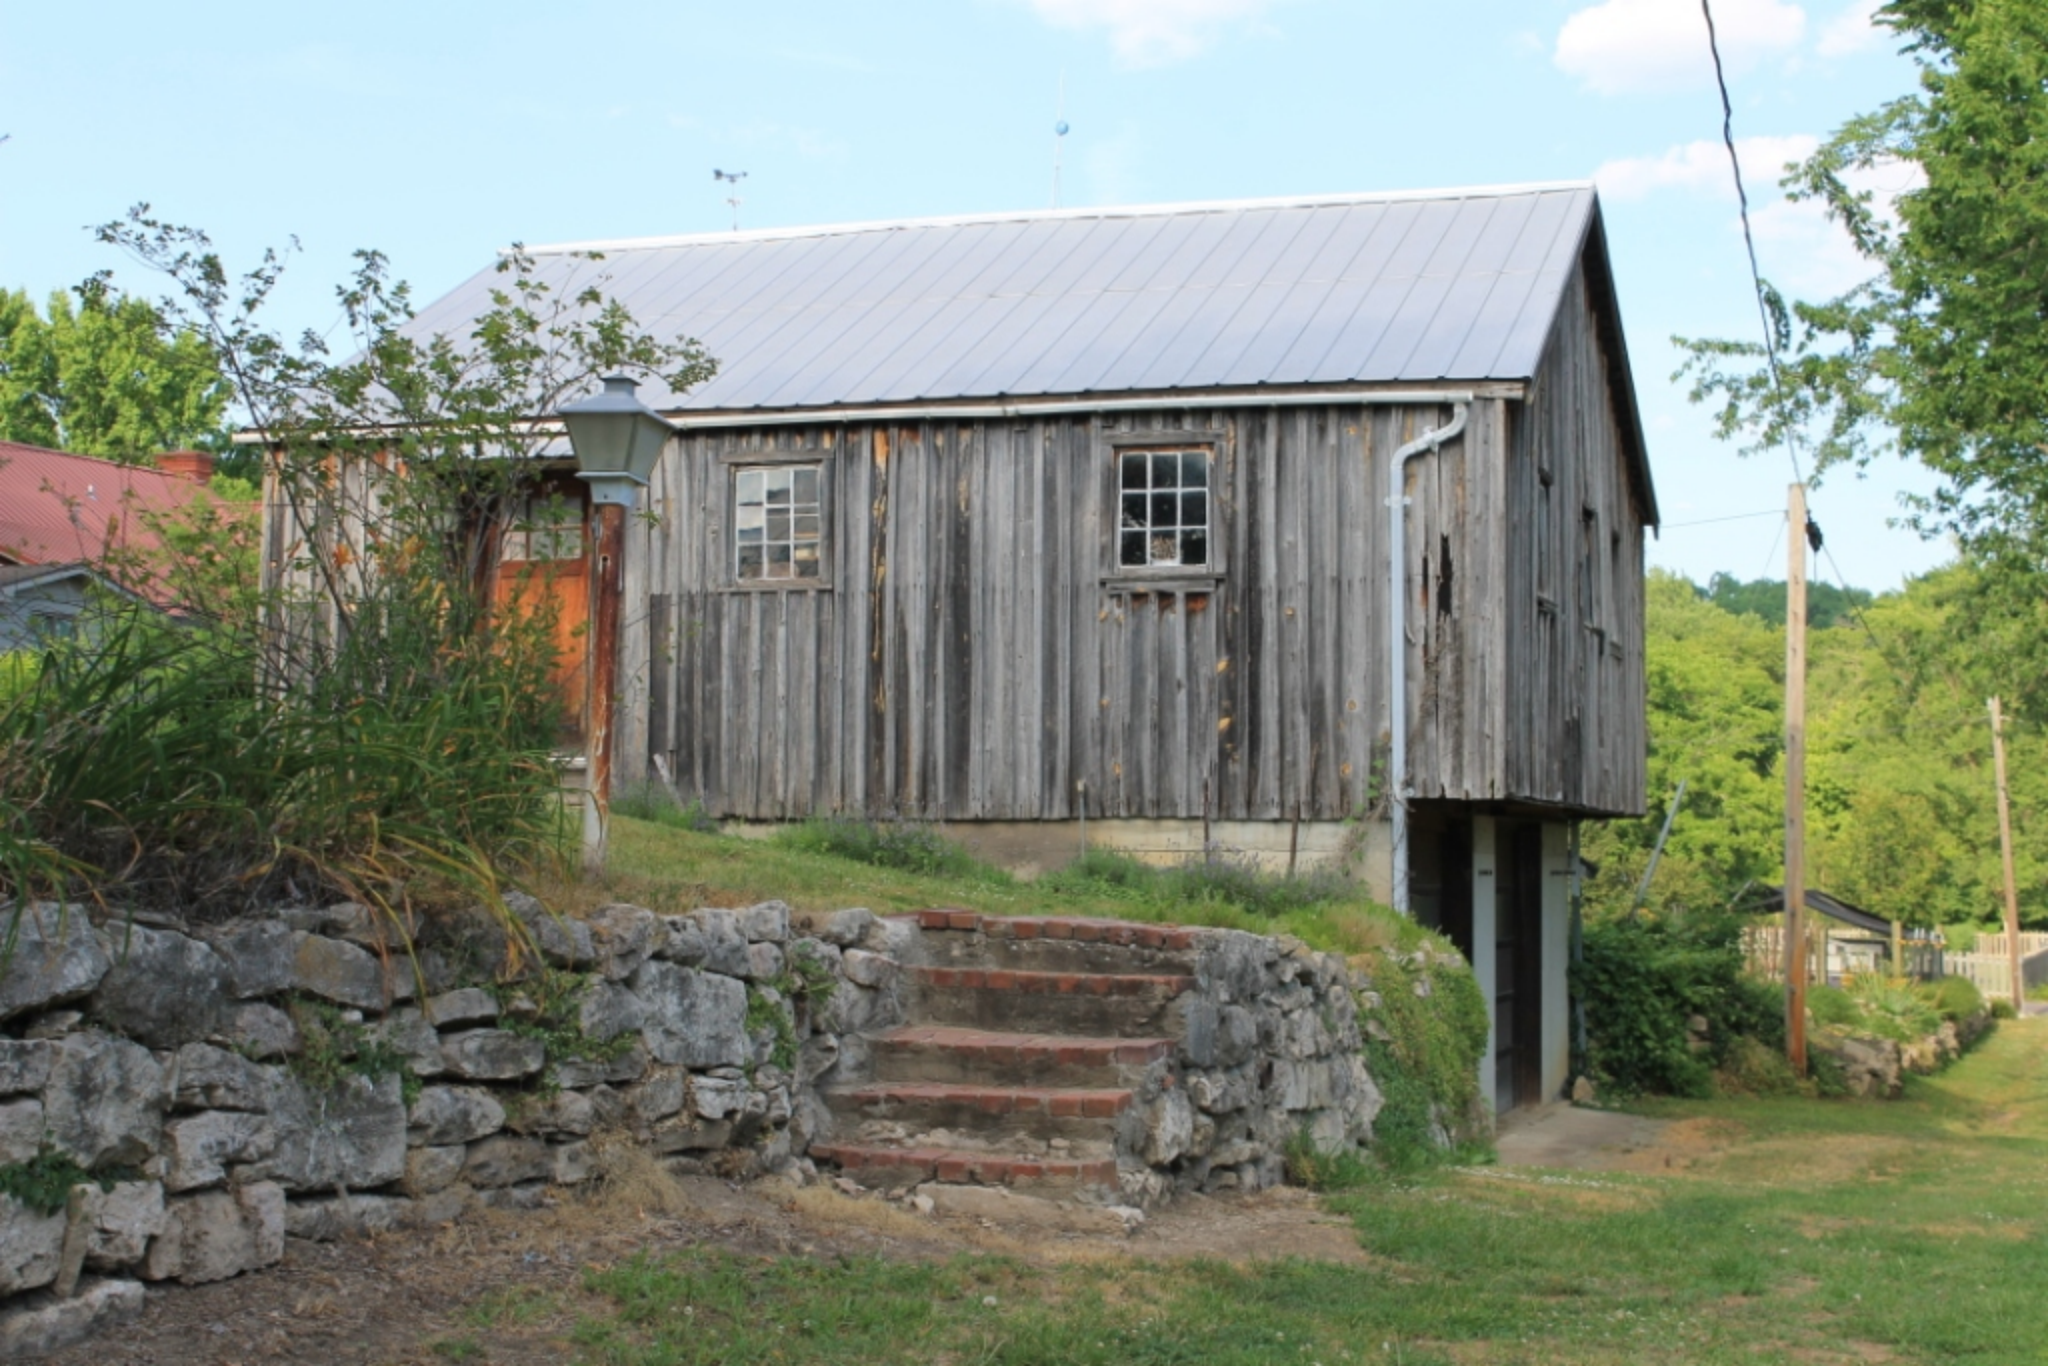
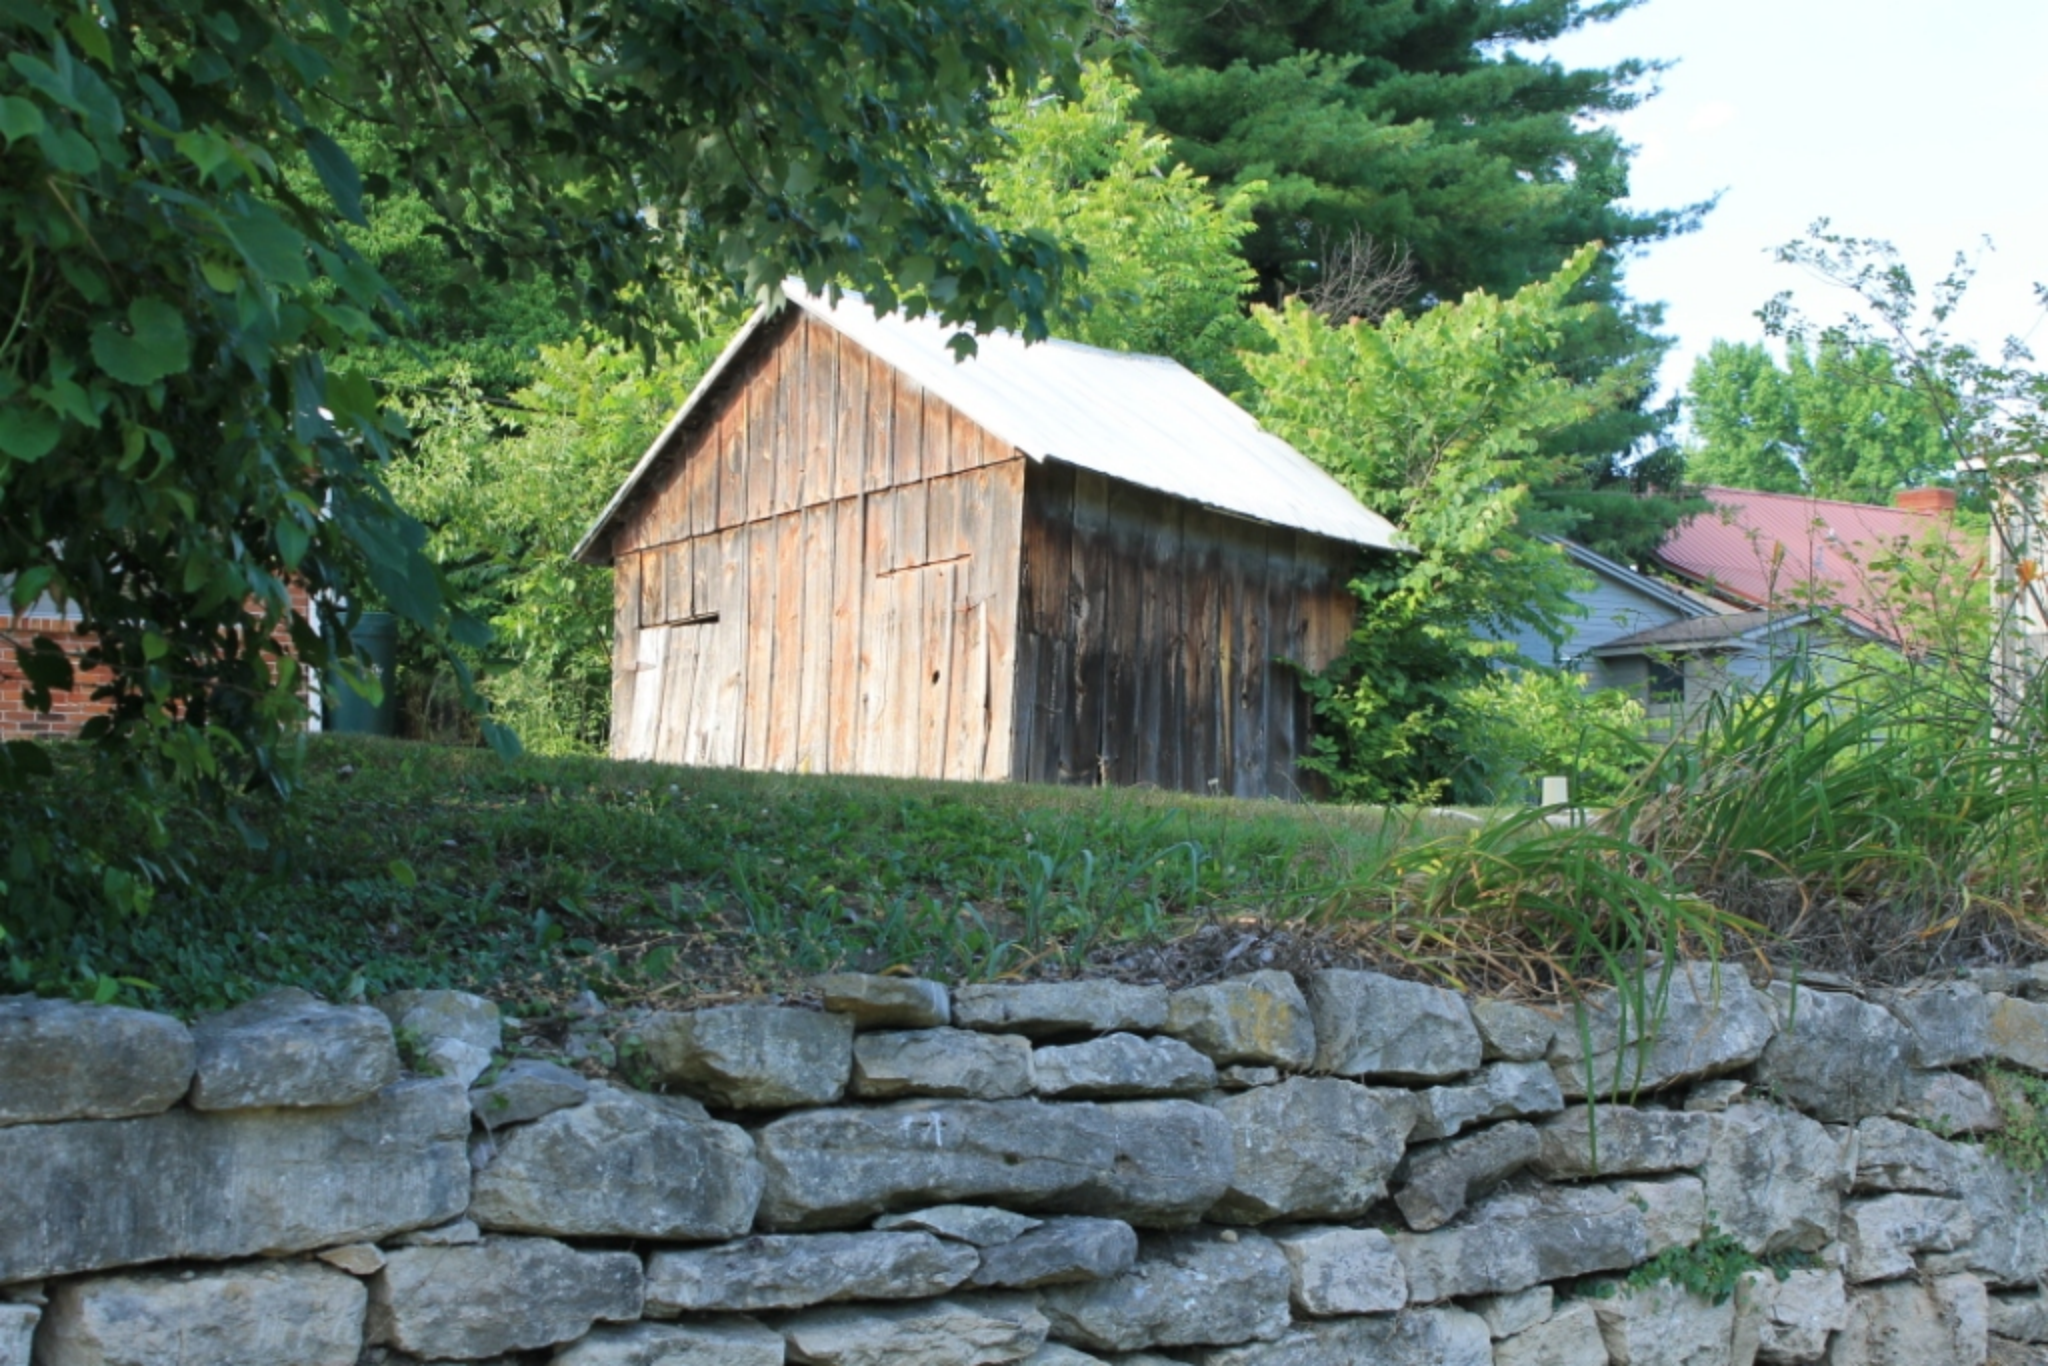
This one-story, brick, Federal style, L shaped building has a low gable metal roof covered in metal. A hipped roof porch is at the south end of the building. The porch is supported by sawn wood posts that replicate the original posts. The front (east) facade has five bays. The two left bays each contain a two-over-two single hung window. The center bay contains a paneled door with a fixed pane window; the door is covered with a modern glass and metal storm door. A single fixed pane transom is above the door. The door opens onto a stoop. The two right bays each contain a two-over-two single hung window. The windows have black shutters. The building has an interior corbelled chimney on each end.

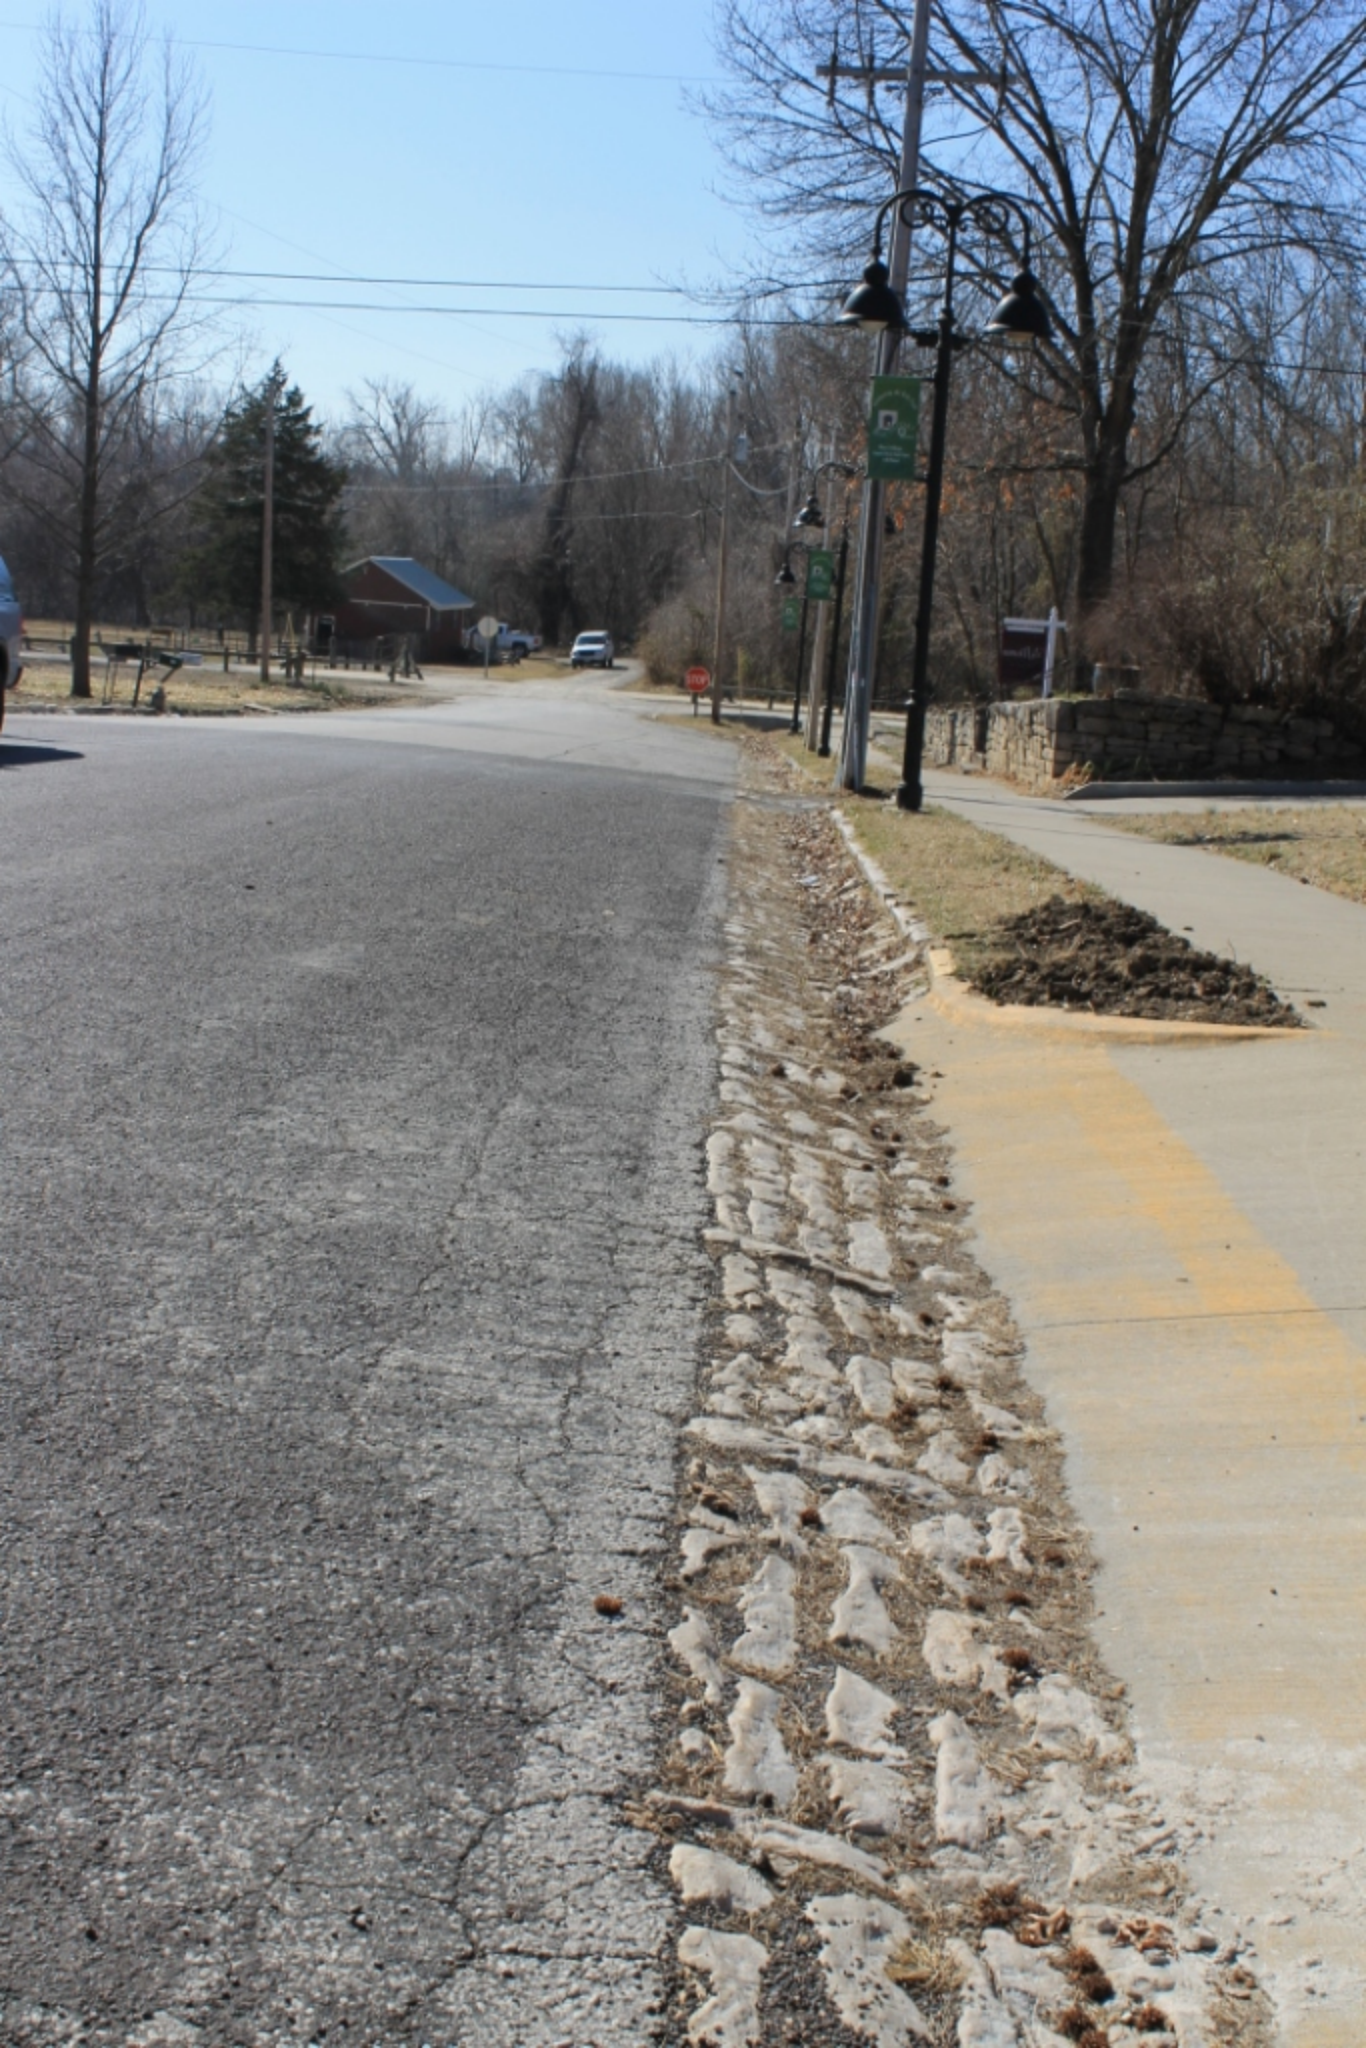
The stone curb and gutter consists of rectangular stones set horizontally to form a curb at the edge of the lawn or sidewalk. A row of rectangular stones set vertically under the curb stones forms the wall of the ditch of the gutter. Several rows of stones set horizontally line the gutter and reach to the street level.

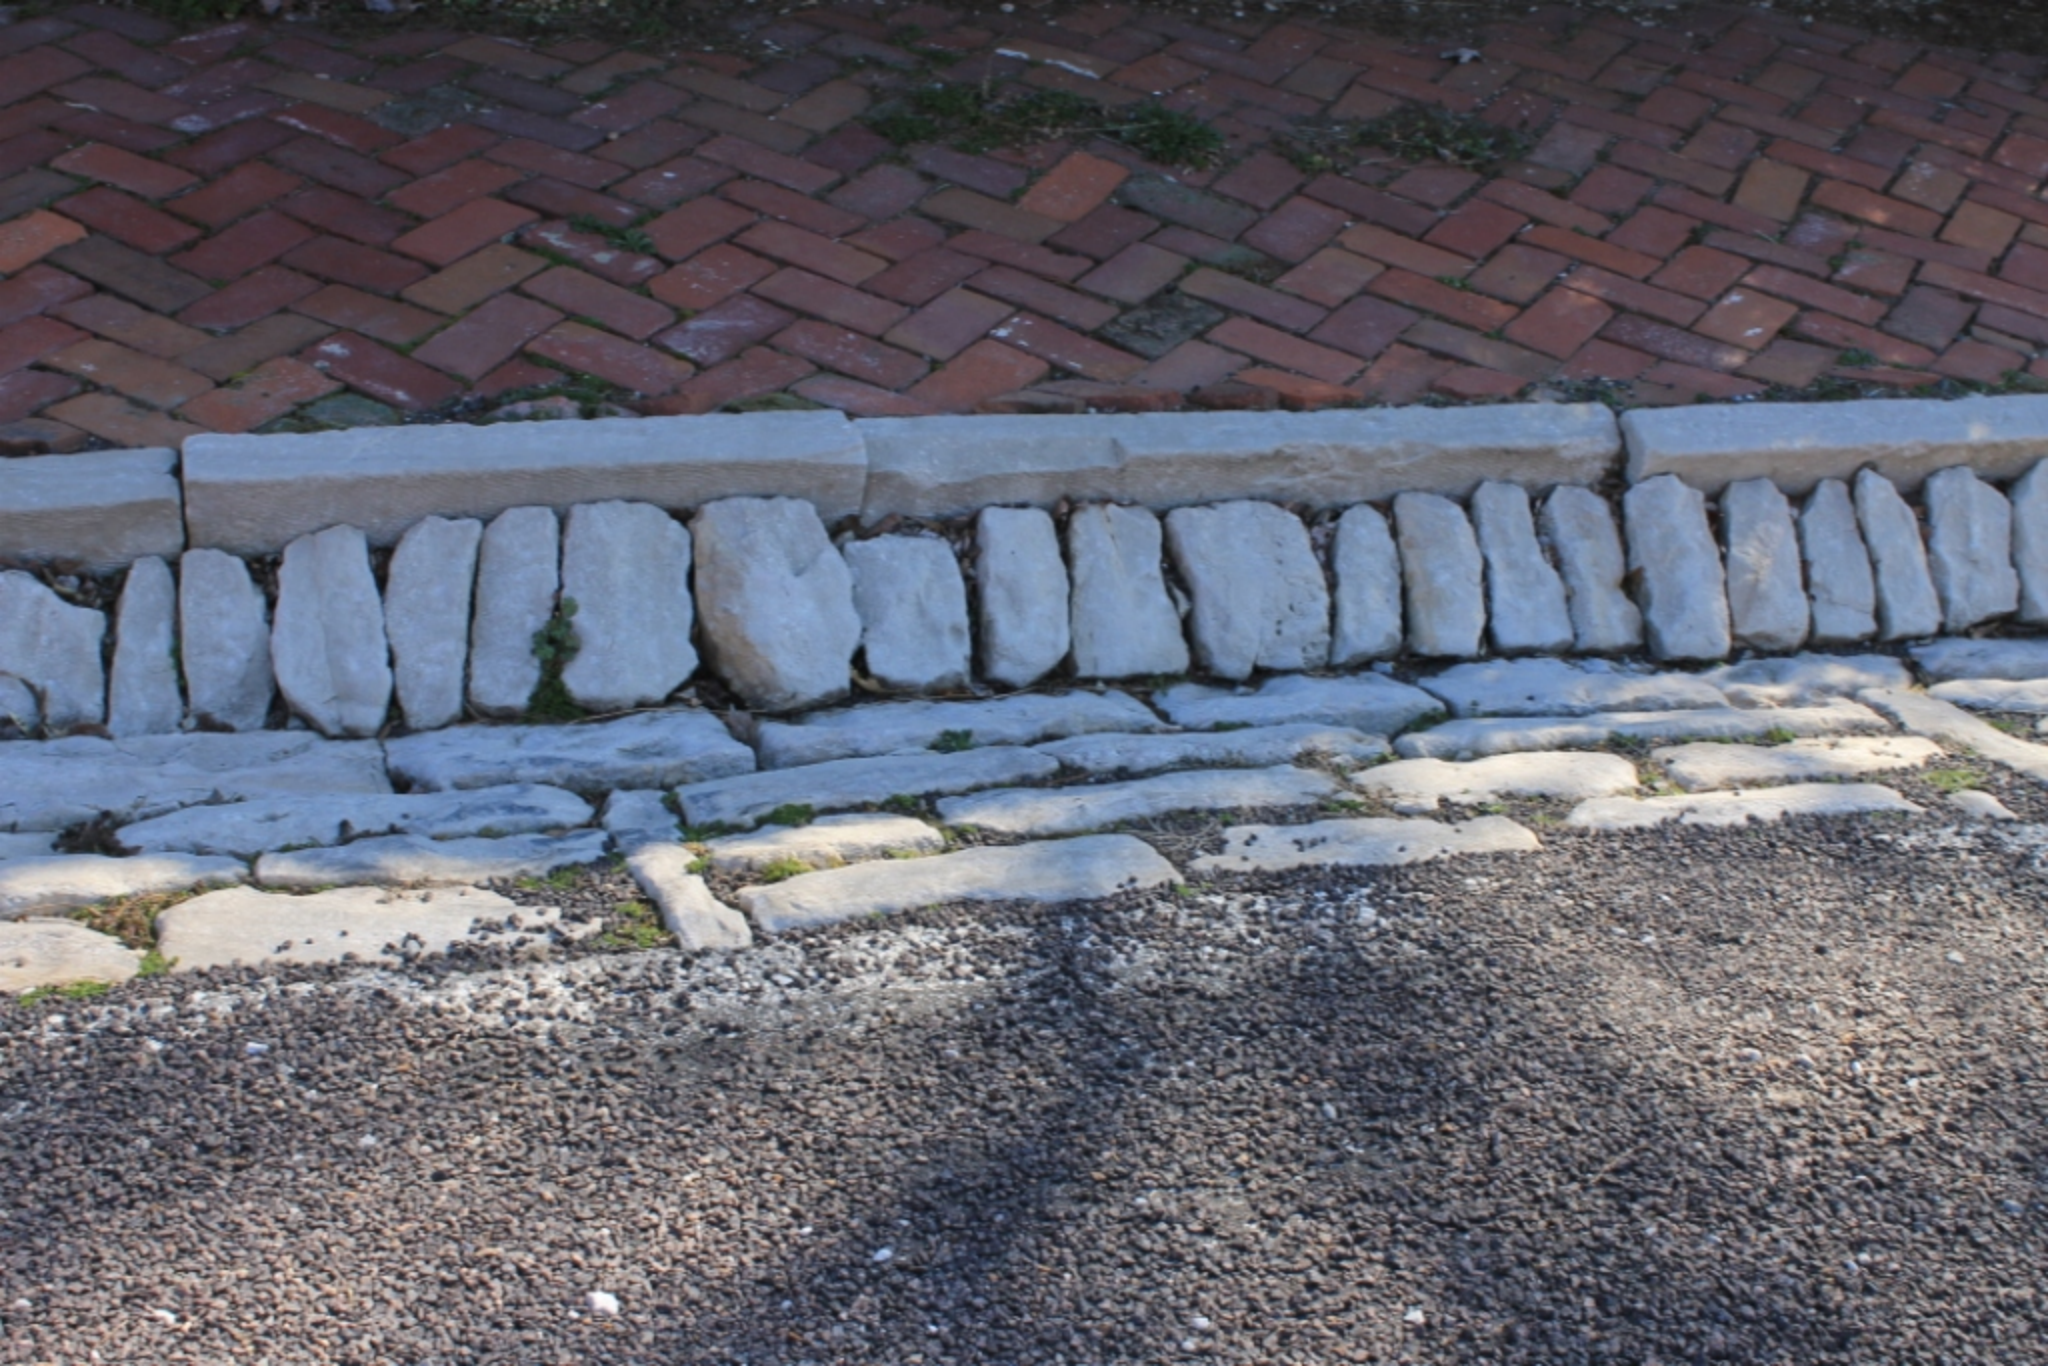
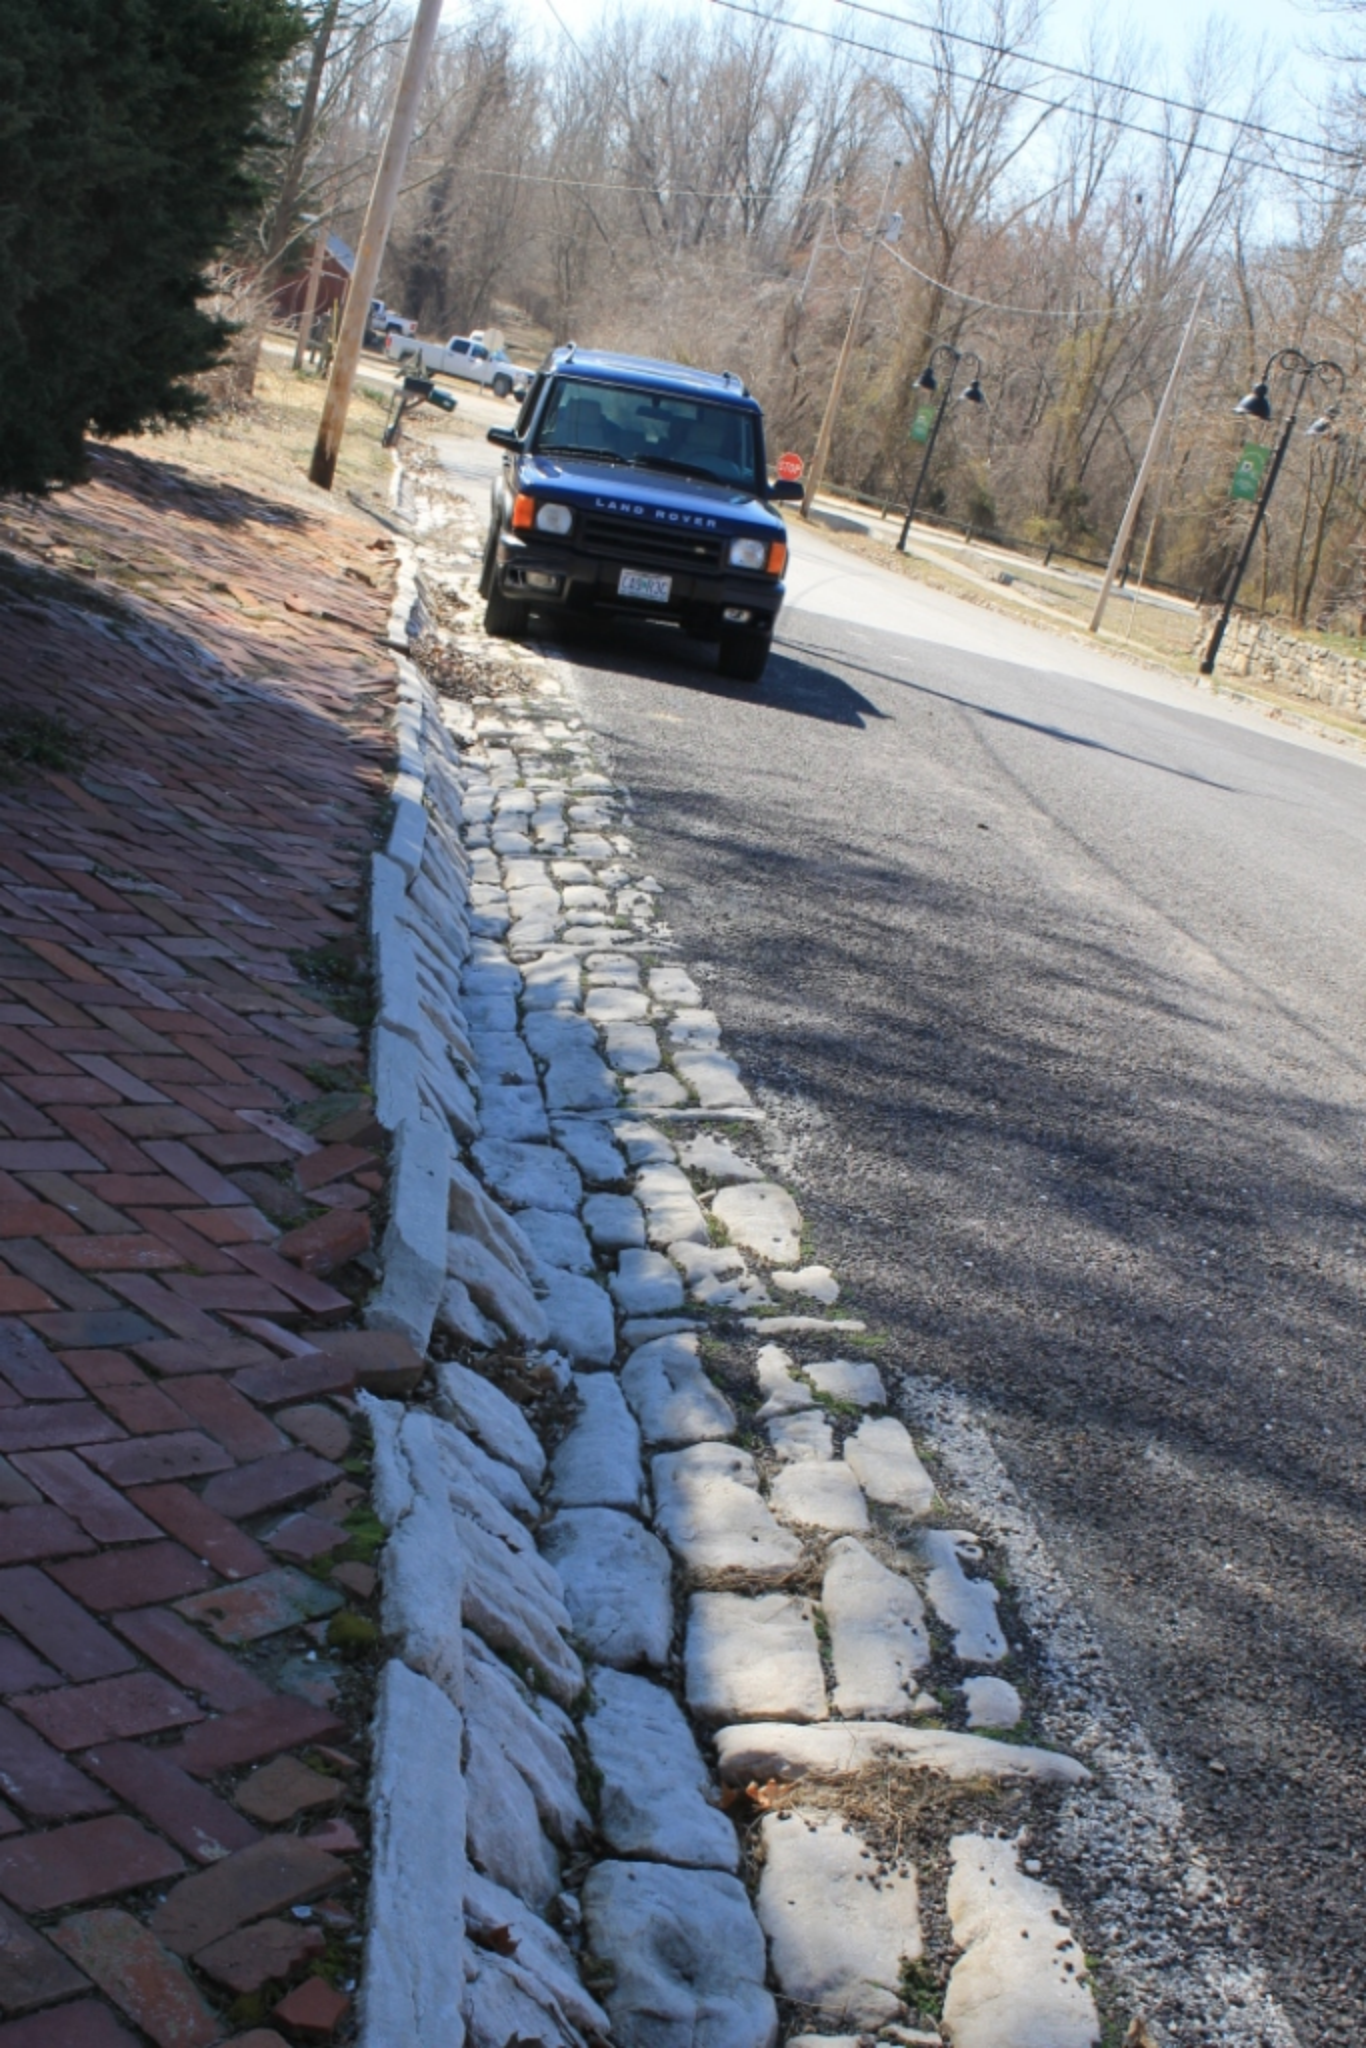
The stone curb and gutter consists of several rows of stones. A row of rectangular stones set horizontally against the sidewalk or lawn forms a curb. A row of rectangular stones set vertically and angled down toward the street forms the wall of the ditch part of the gutter. Four to five rows of rectangular stones laid horizontally between the vertical stones and the street complete the gutter.
