MISSOURI DEPARTMENT OF NATURAL RESOURCES
STATE HISTORIC PRESERVATION OFFICE, P.O. Box 176, Jefferson City, MO 65102
ARCHITECTURAL/HISTORIC INVENTORY FORM

1. SURVEY NO. BO-AS-009-0001		2. SURVEY NAME: Rocheport Historic District	
3. COUNTY: Boone		4. ADDRESS (STREET NO.)	STREET (NAME) Katy Trail
5. CITY: Rocheport	VICINITY: <input checked="" type="checkbox"/>	6. UTM: / /	LAT: LONG: T: 48W R: 15W S: 1

8. HISTORIC NAME (IF KNOWN): M.K.&T. Railroad tunnel		9. PRESENT/OTHER NAME (IF KNOWN): Katy trail tunnel	
10. OWNERSHIP: <input type="checkbox"/> PRIVATE <input checked="" type="checkbox"/> PUBLIC		11A. HISTORIC USE (IF KNOWN): railroad tunnel	11B. CURRENT USE: Katy Trail tunnel
HISTORICAL INFORMATION

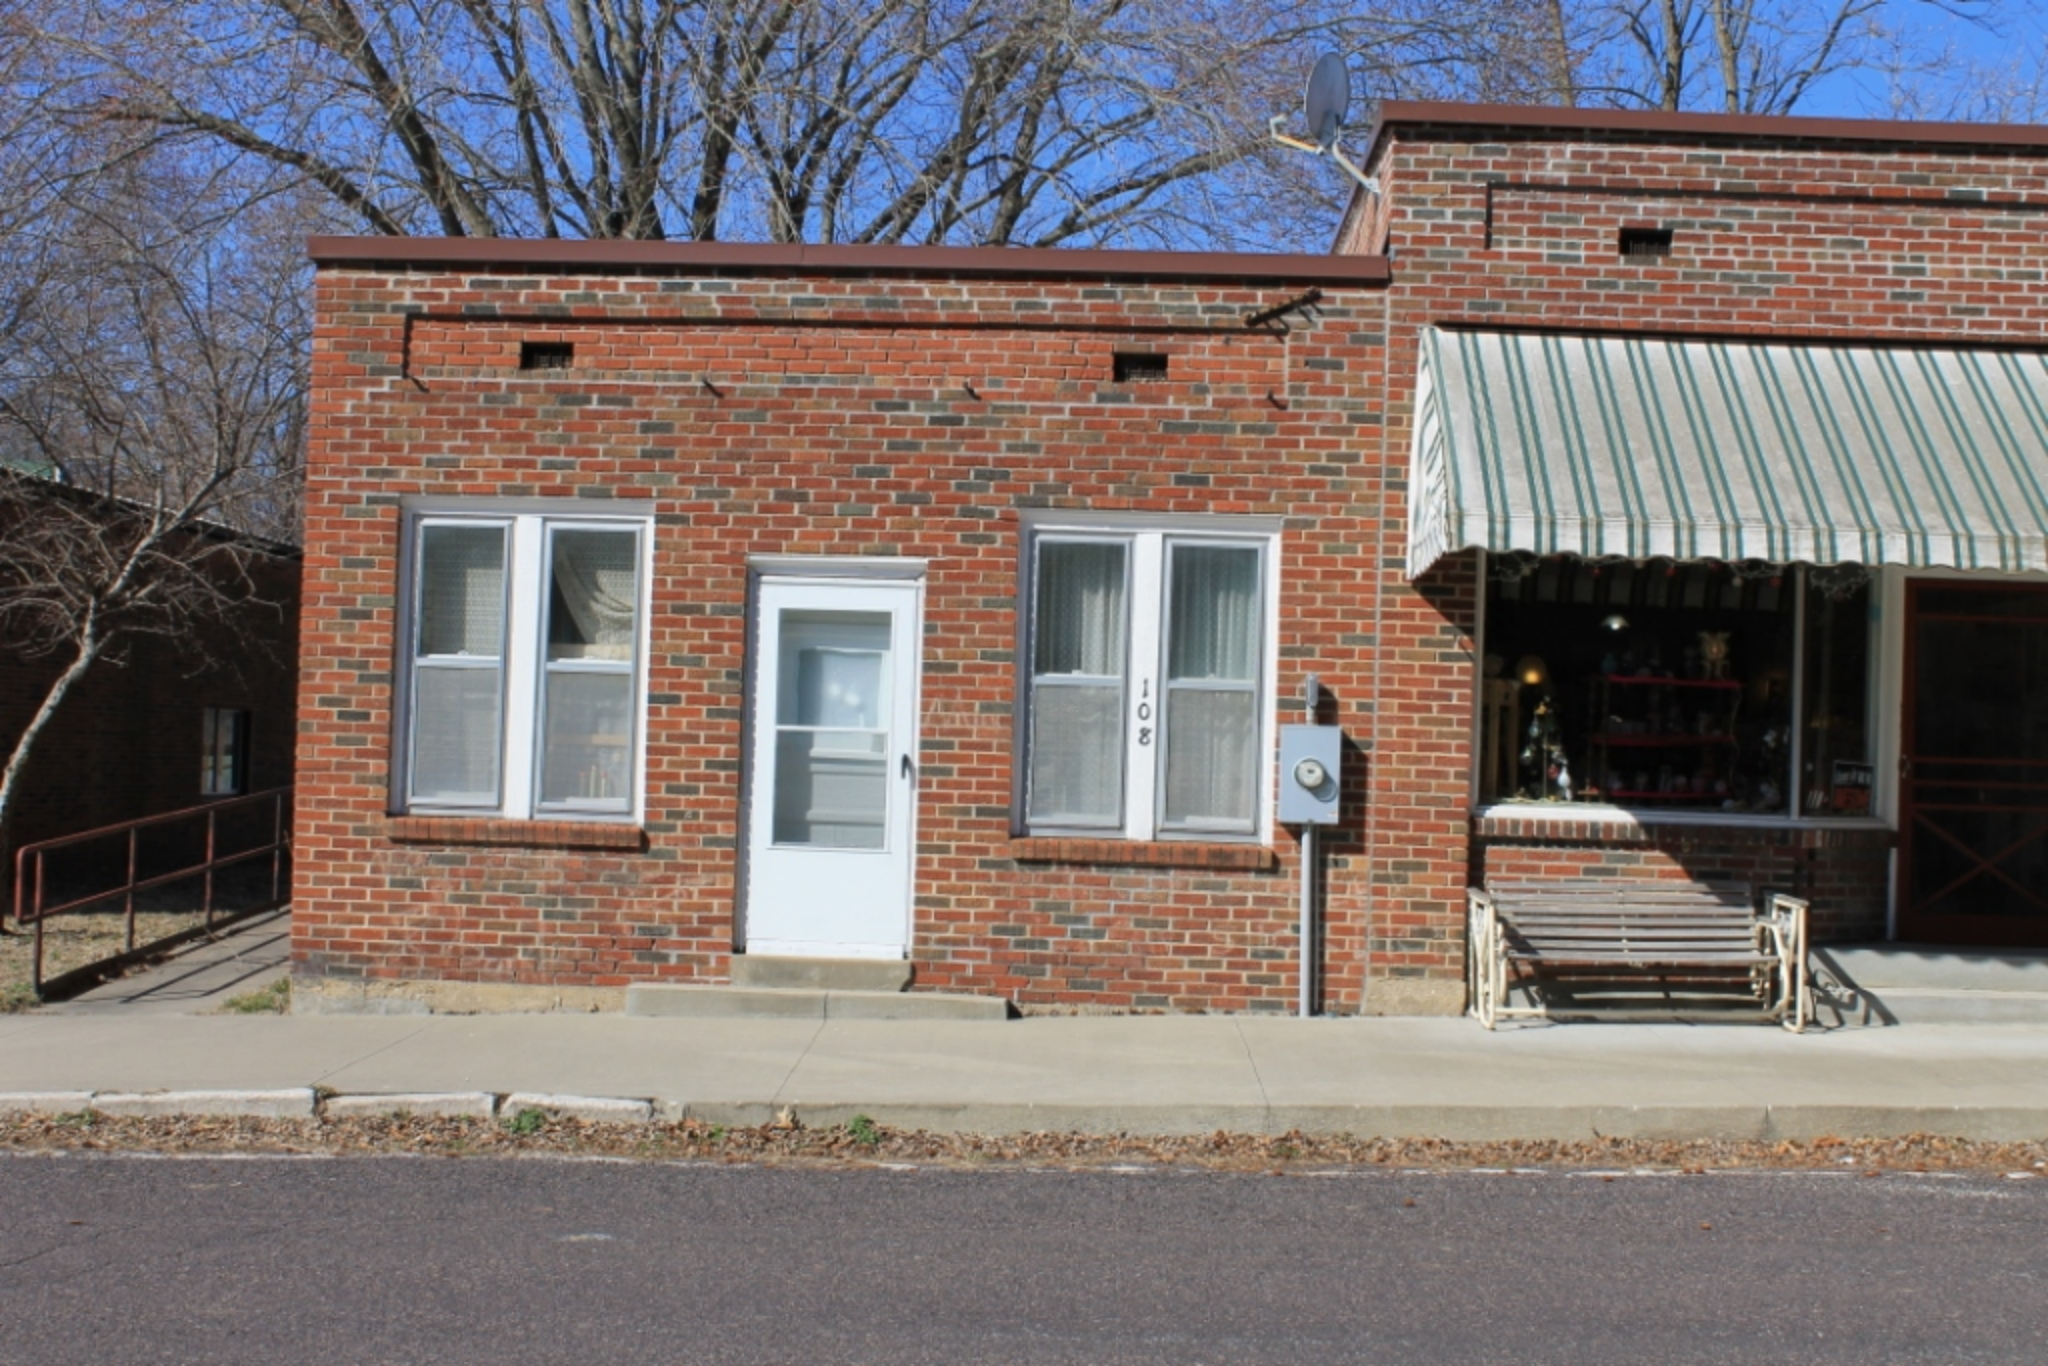
The Leslie Burroughs Barber Shop/City Hall building is a small, one-story, square-shaped, brick building with a slightly sloped shed roof. The roof is covered in asphalt. The front (east) facade has three bays. The left bay contains a pair of one-over-one single hung windows covered with modern metal storm windows. The center bay contains a paneled door with a fixed pane window in the upper portion and a modern glass and metal storm door. The door opens onto a one step high platform that forms a sort of stoop. The right bay contains a pair of one-over-one single hung windows covered with modern metal storm windows. The windows have brick sills. Extending across the center of the facade above the bays is an inset brick panel.

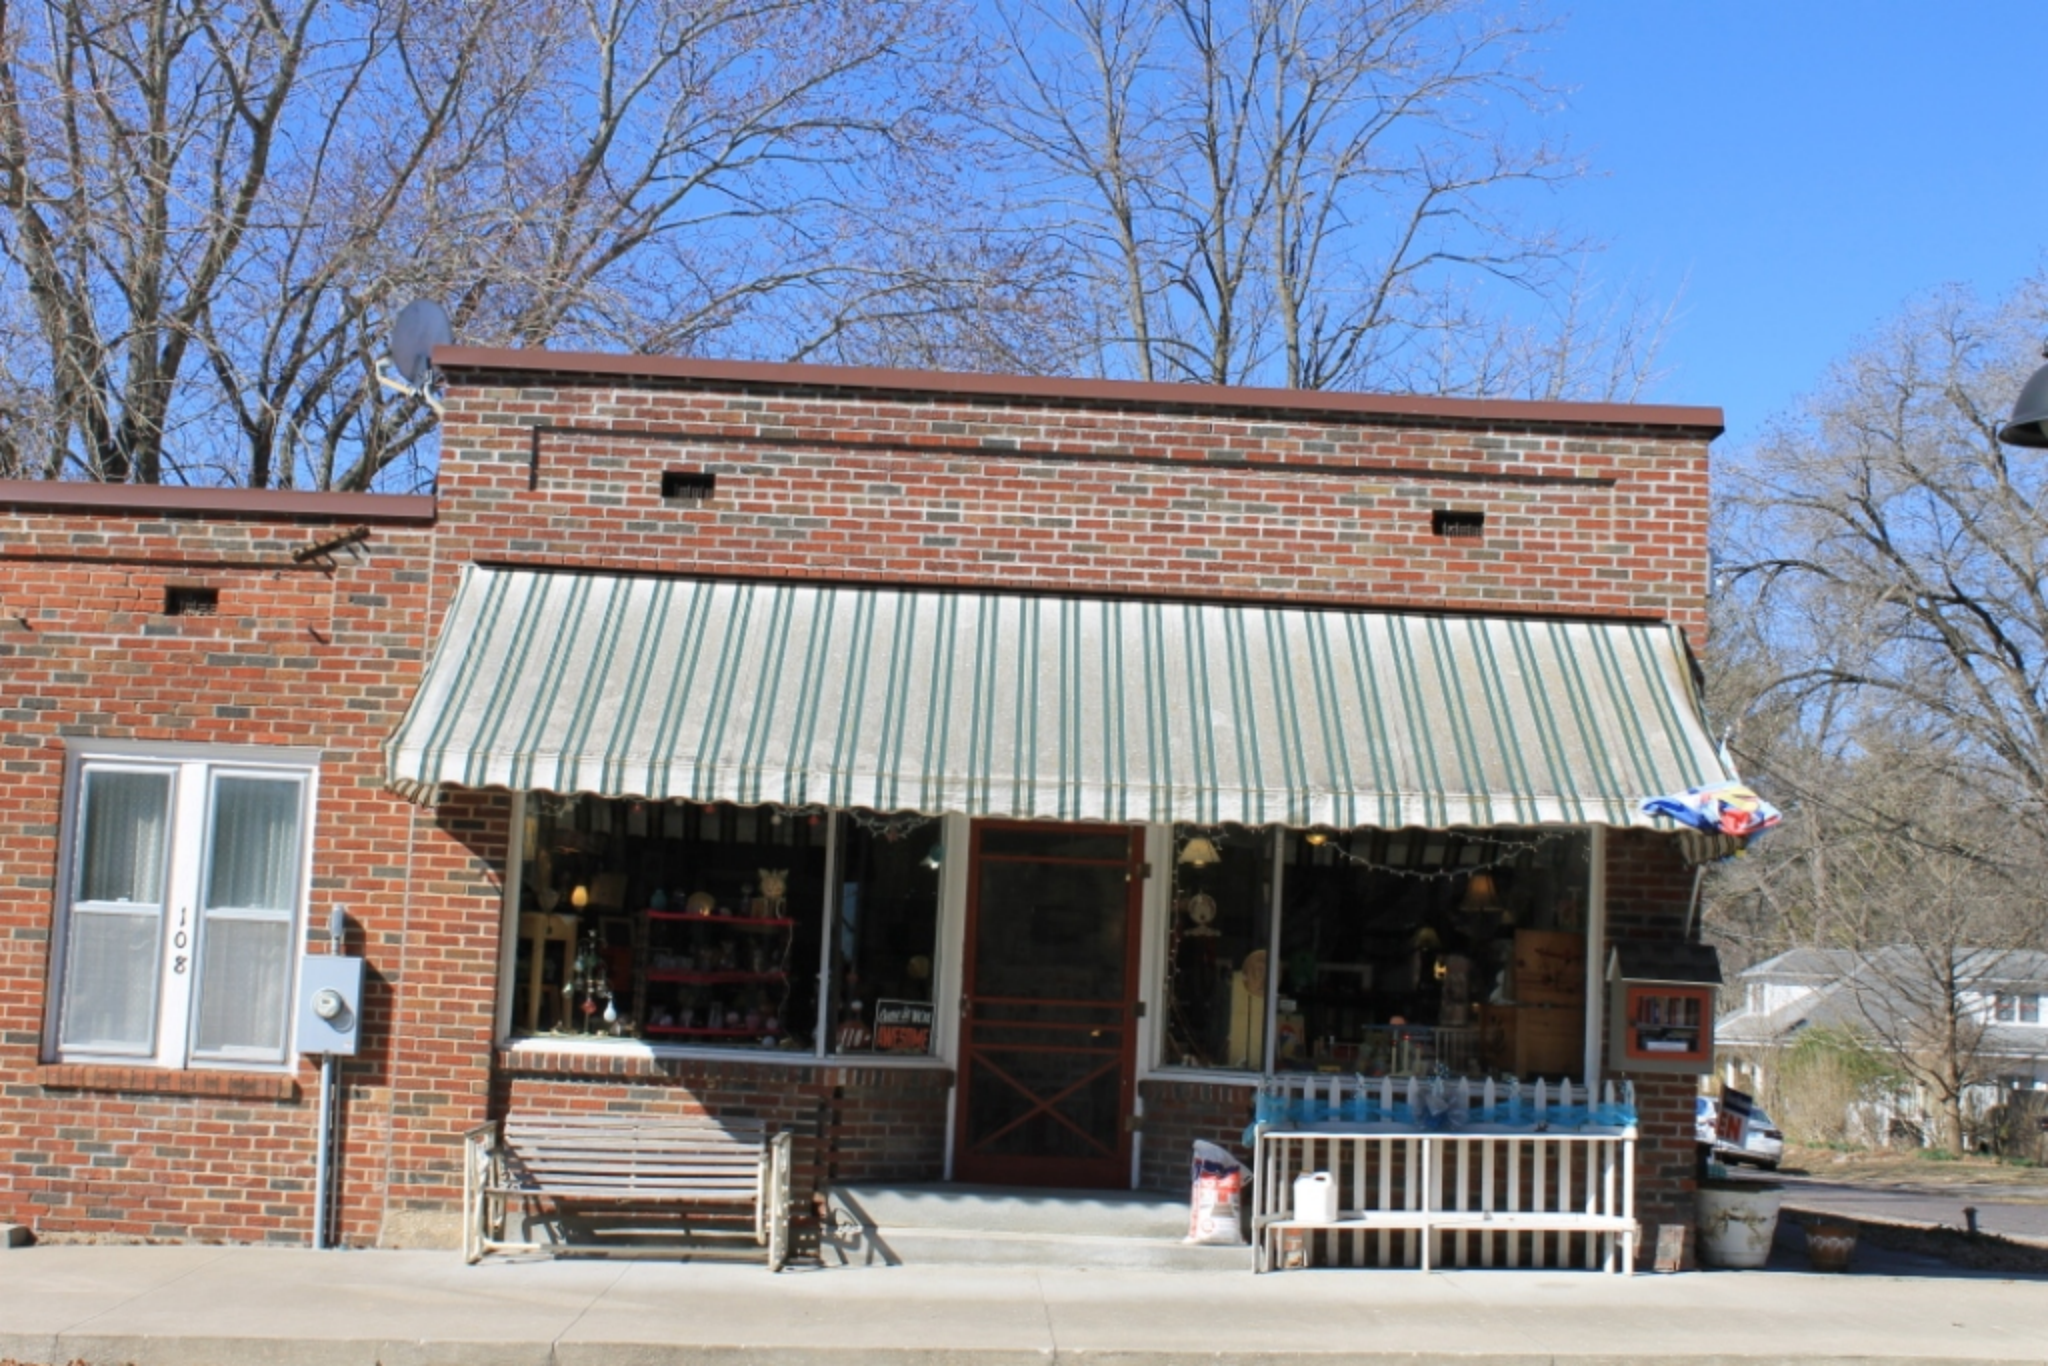
This brick store building has a typical early twentieth century store front. The (east) facade storefront has five bays. The left bay contains a plate glass window above a brick bulkhead. The next bay contains a plate glass window above a brick bulkhead that angles from the window to its left toward the center bay. The center bay contains a recessed glass door. The next bay contains a plate glass window above a brick bulkhead that angles right toward the far right bay, which contains a plate glass window above a brick bulkhead. Two concrete steps lead from the sidewalk to the entry door. An awning extends across the front facade of the building. At the top of the building is an inset brick panel. Toward the rear of the side (north) facade of the building are two bays. The left bay contains a door; the right bay contains a one-over-one single hung window.

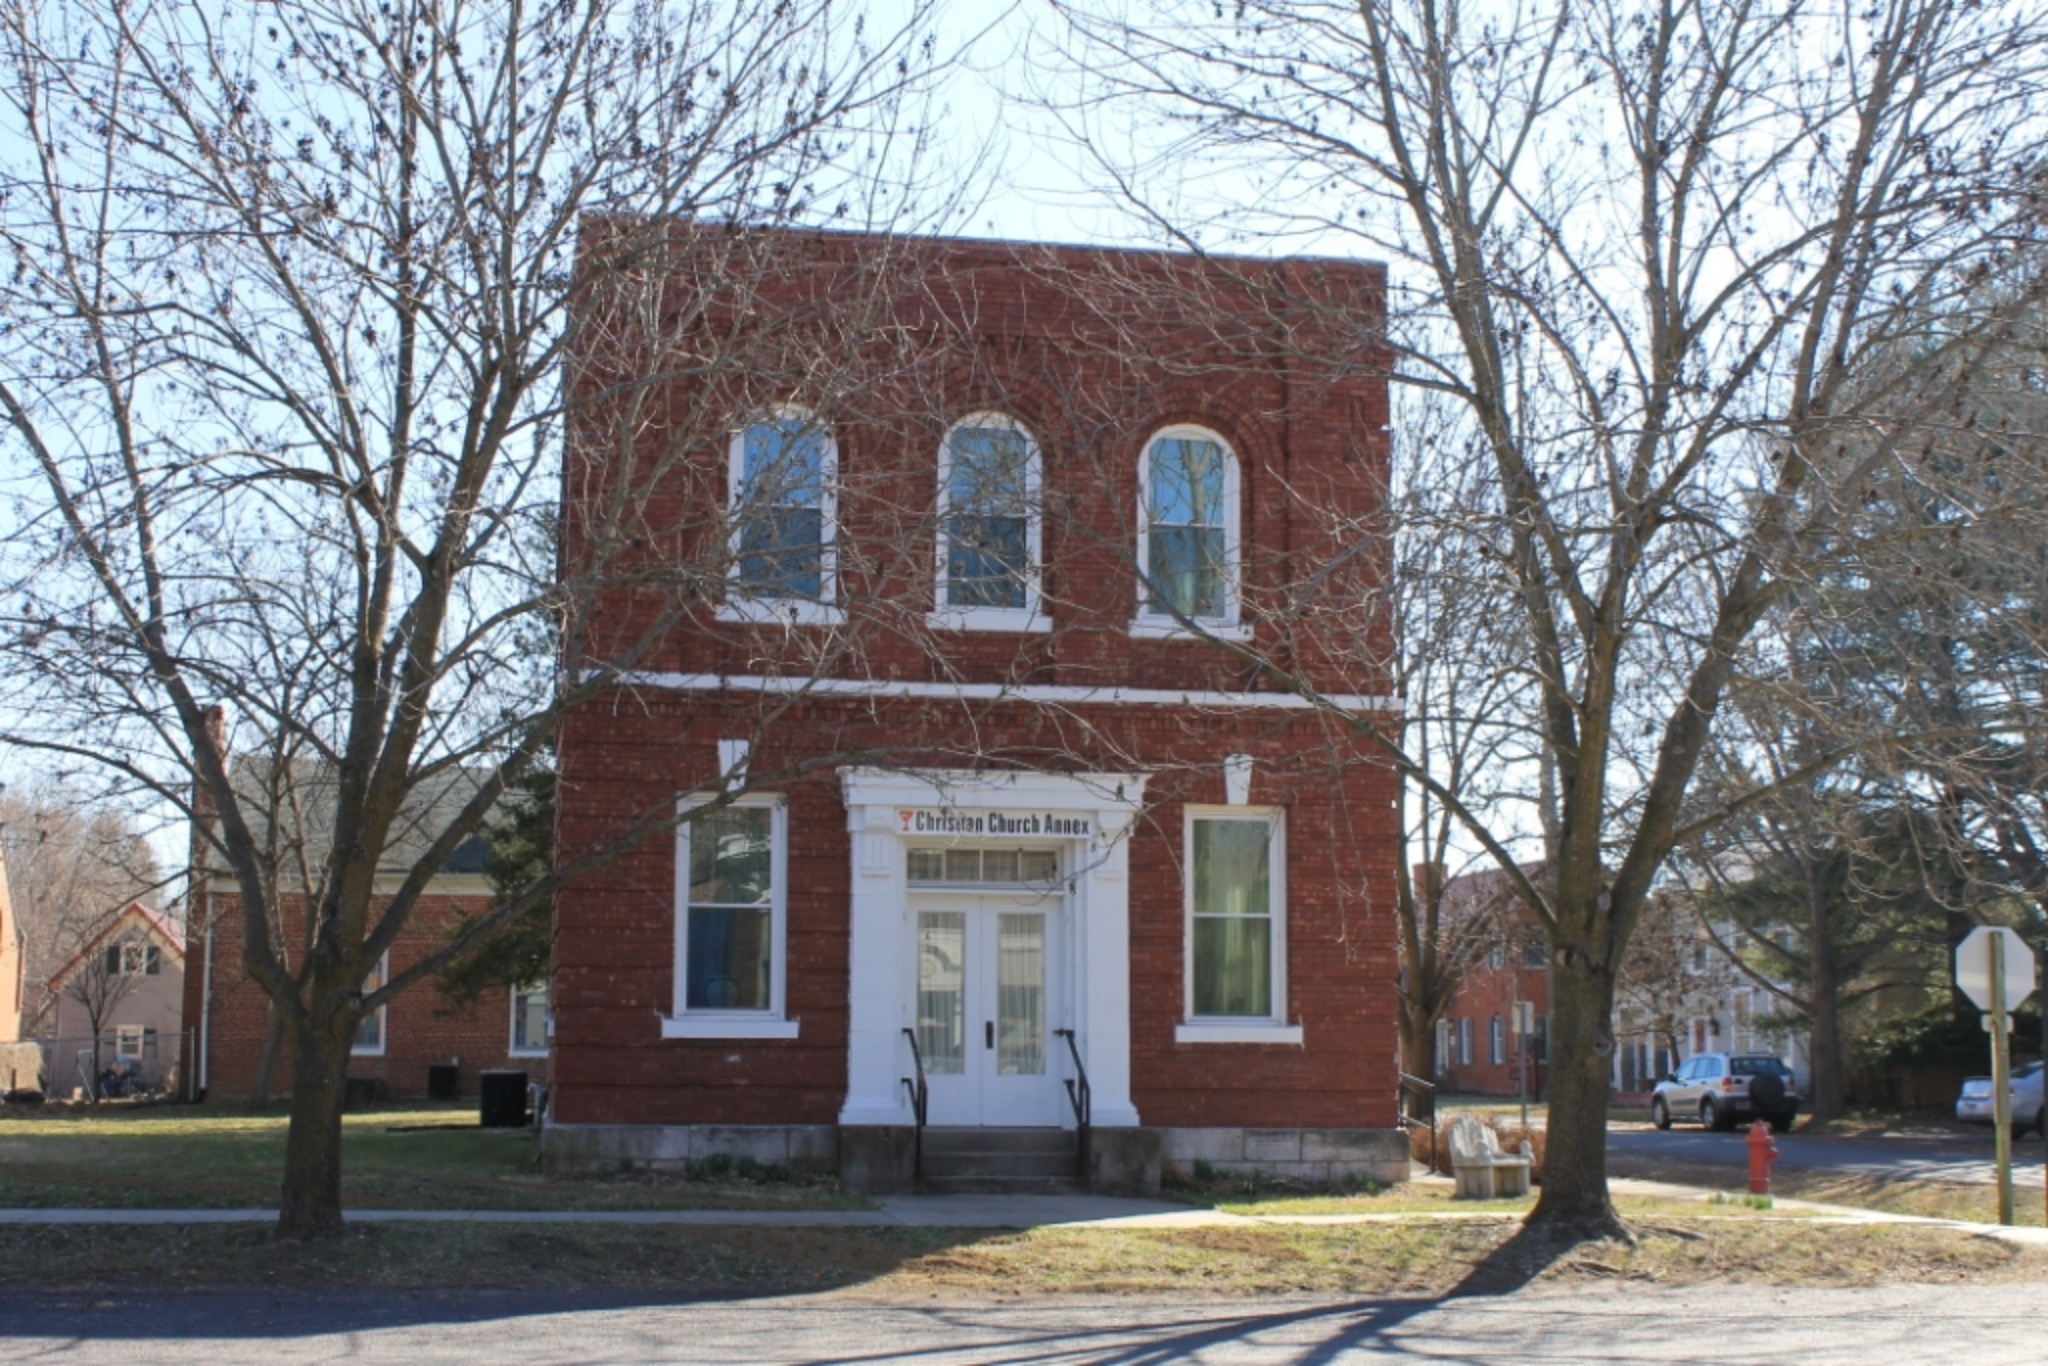
The temple plan brick commercial building sits on a low stone foundation. All the rectangular windows have stone sills and keystones. A stone string course atop two rows of diagonally laid brick and a row of brick dentils surrounds the building. The front facade has three bays. The left bay contains a rectangular 1 x 1 wooden window topped with keystone and voussoirs. The center bay contains a recessed entryway with stone pilasters and corbelled cornice. The entry consists of a pair of doors with large panes of glass and a four light transom. The right bay contains a rectangular 1 x 1 wooden window topped with a keystone and voussoirs. The second story has three bays with round arched 1 x 1 windows. The round arches of these bays are surrounded with three rows of row lock bricks that extend to the side of the windows and down the walls between the windows. These windows have stone sills. The side (south) facade has seven bays. On the first story, each of the three left bays each contains a 1 x 1 wooden window, next is a bay containing a door with a transom, then two bays each containing a 1 x 1 wooden window, and a bay containing a door with a transom. The second story has seven bays. The bays on either end contain rectangular windows topped with soldier courses and having stone sills; the five center bays have round arched openings accented with three courses of projecting brick above them. Bricks laid in decorative patterns highlight the south facade.

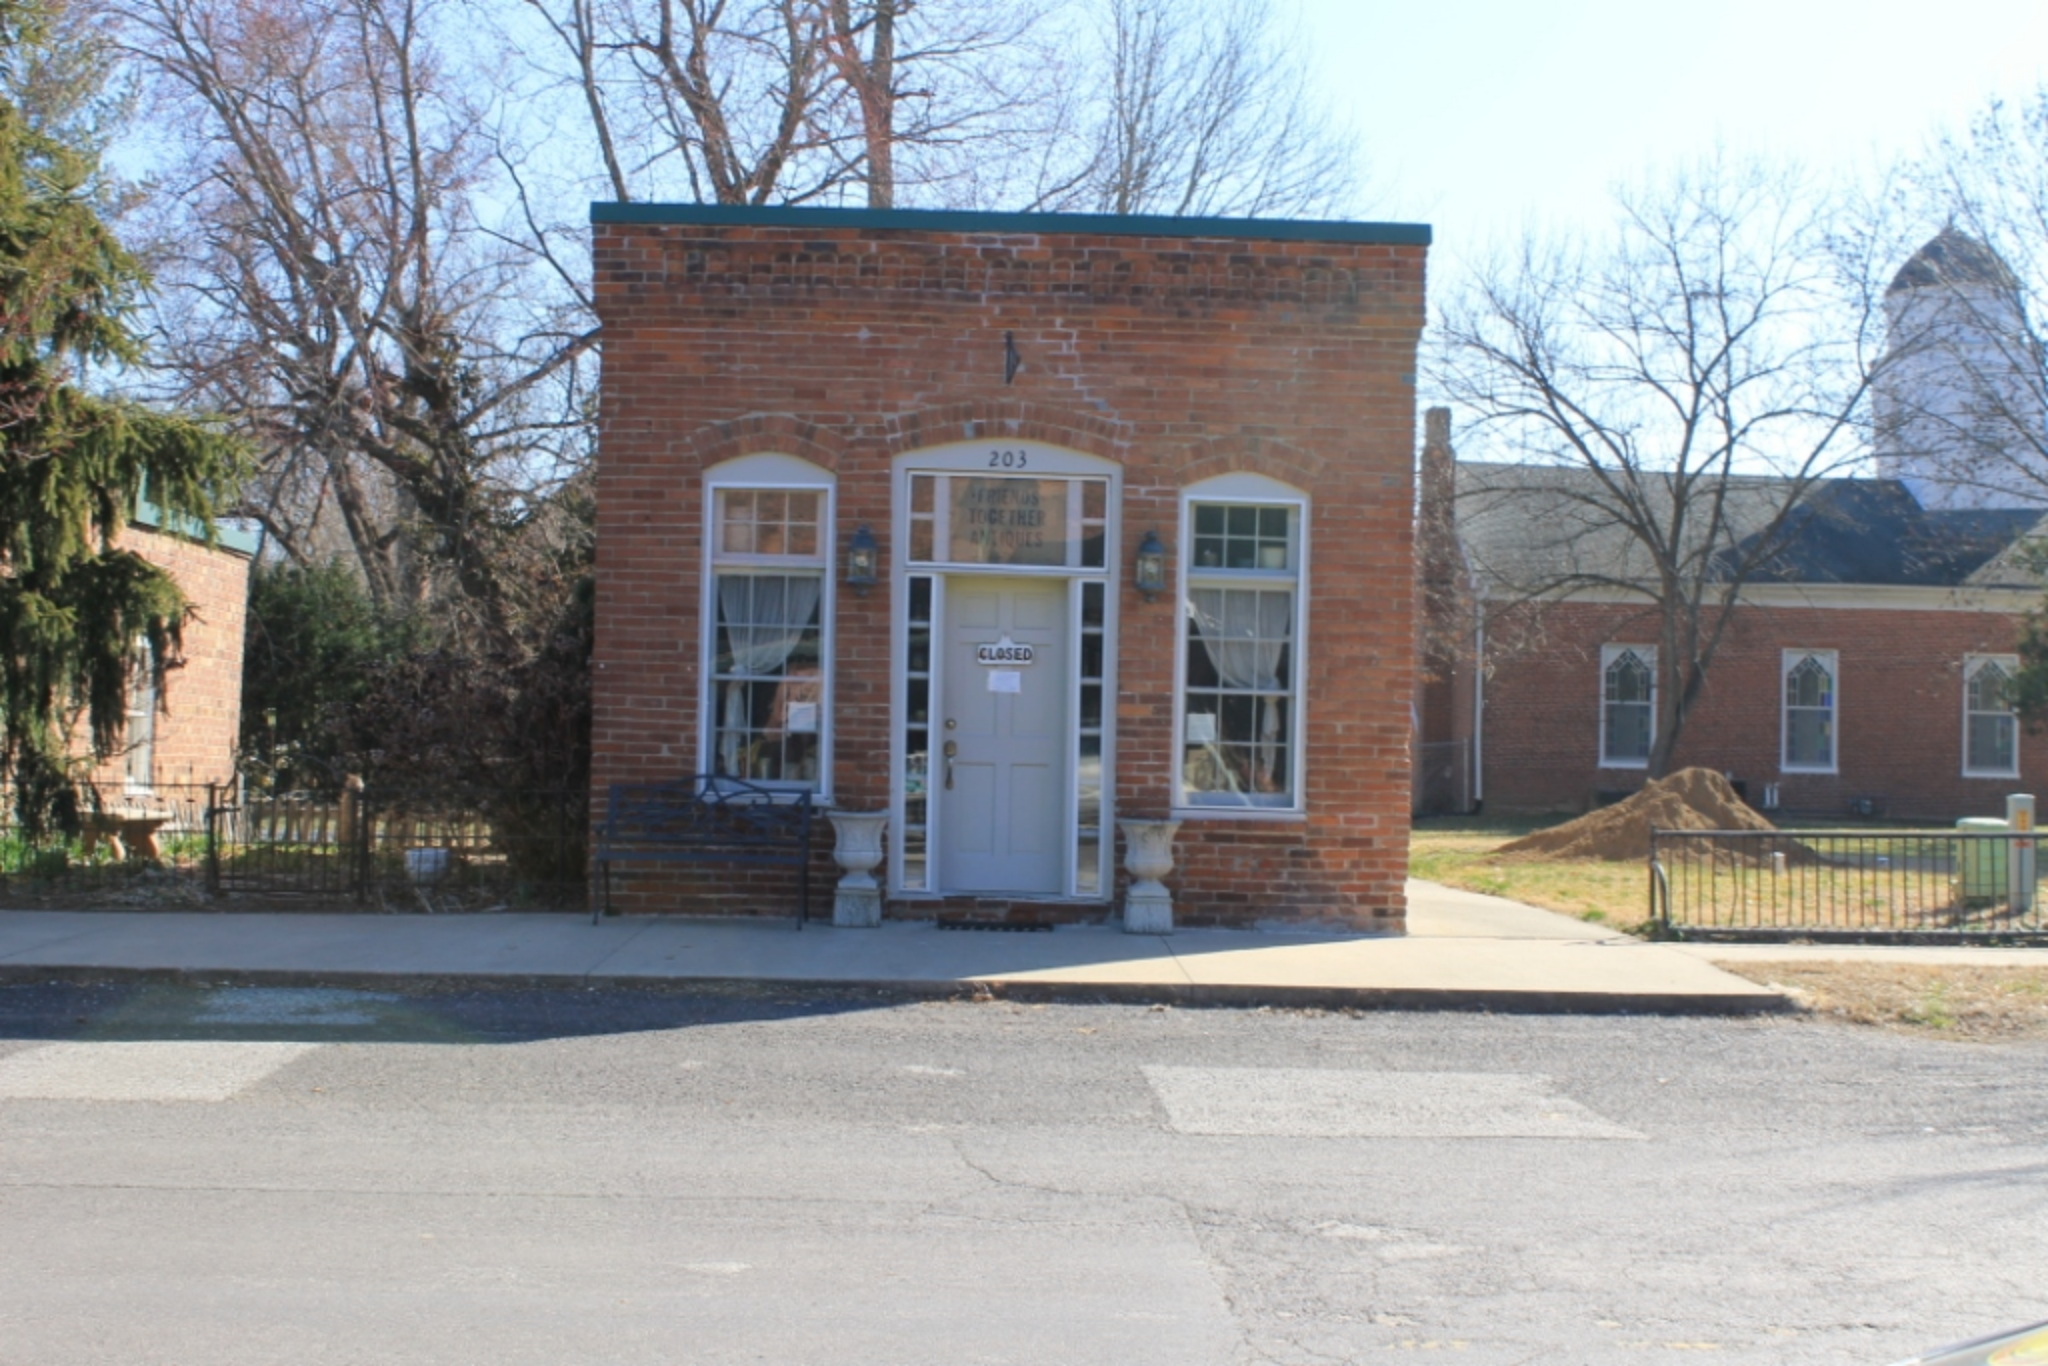
The one-story brick store building has a slightly sloped roof covered in asphalt. It has a metal cap or flashing at the roof line. Below the metal cap or flashing are two rows of stretcher bricks. Under the stretcher bricks are three rows of diagonally laid brick that form a sort of projecting cornice. The front (west) facade of the building has three bays. The left bay contains a six-over-six-over six wooden window. The center bay contains a doorway with five paned sidelights and a five-paned transom consisting of a large central pane flanked by two panes one over the other. The transom and sidelights are covered with modern storm windows. The right bay contains a six-over-six-over-six wooden window.

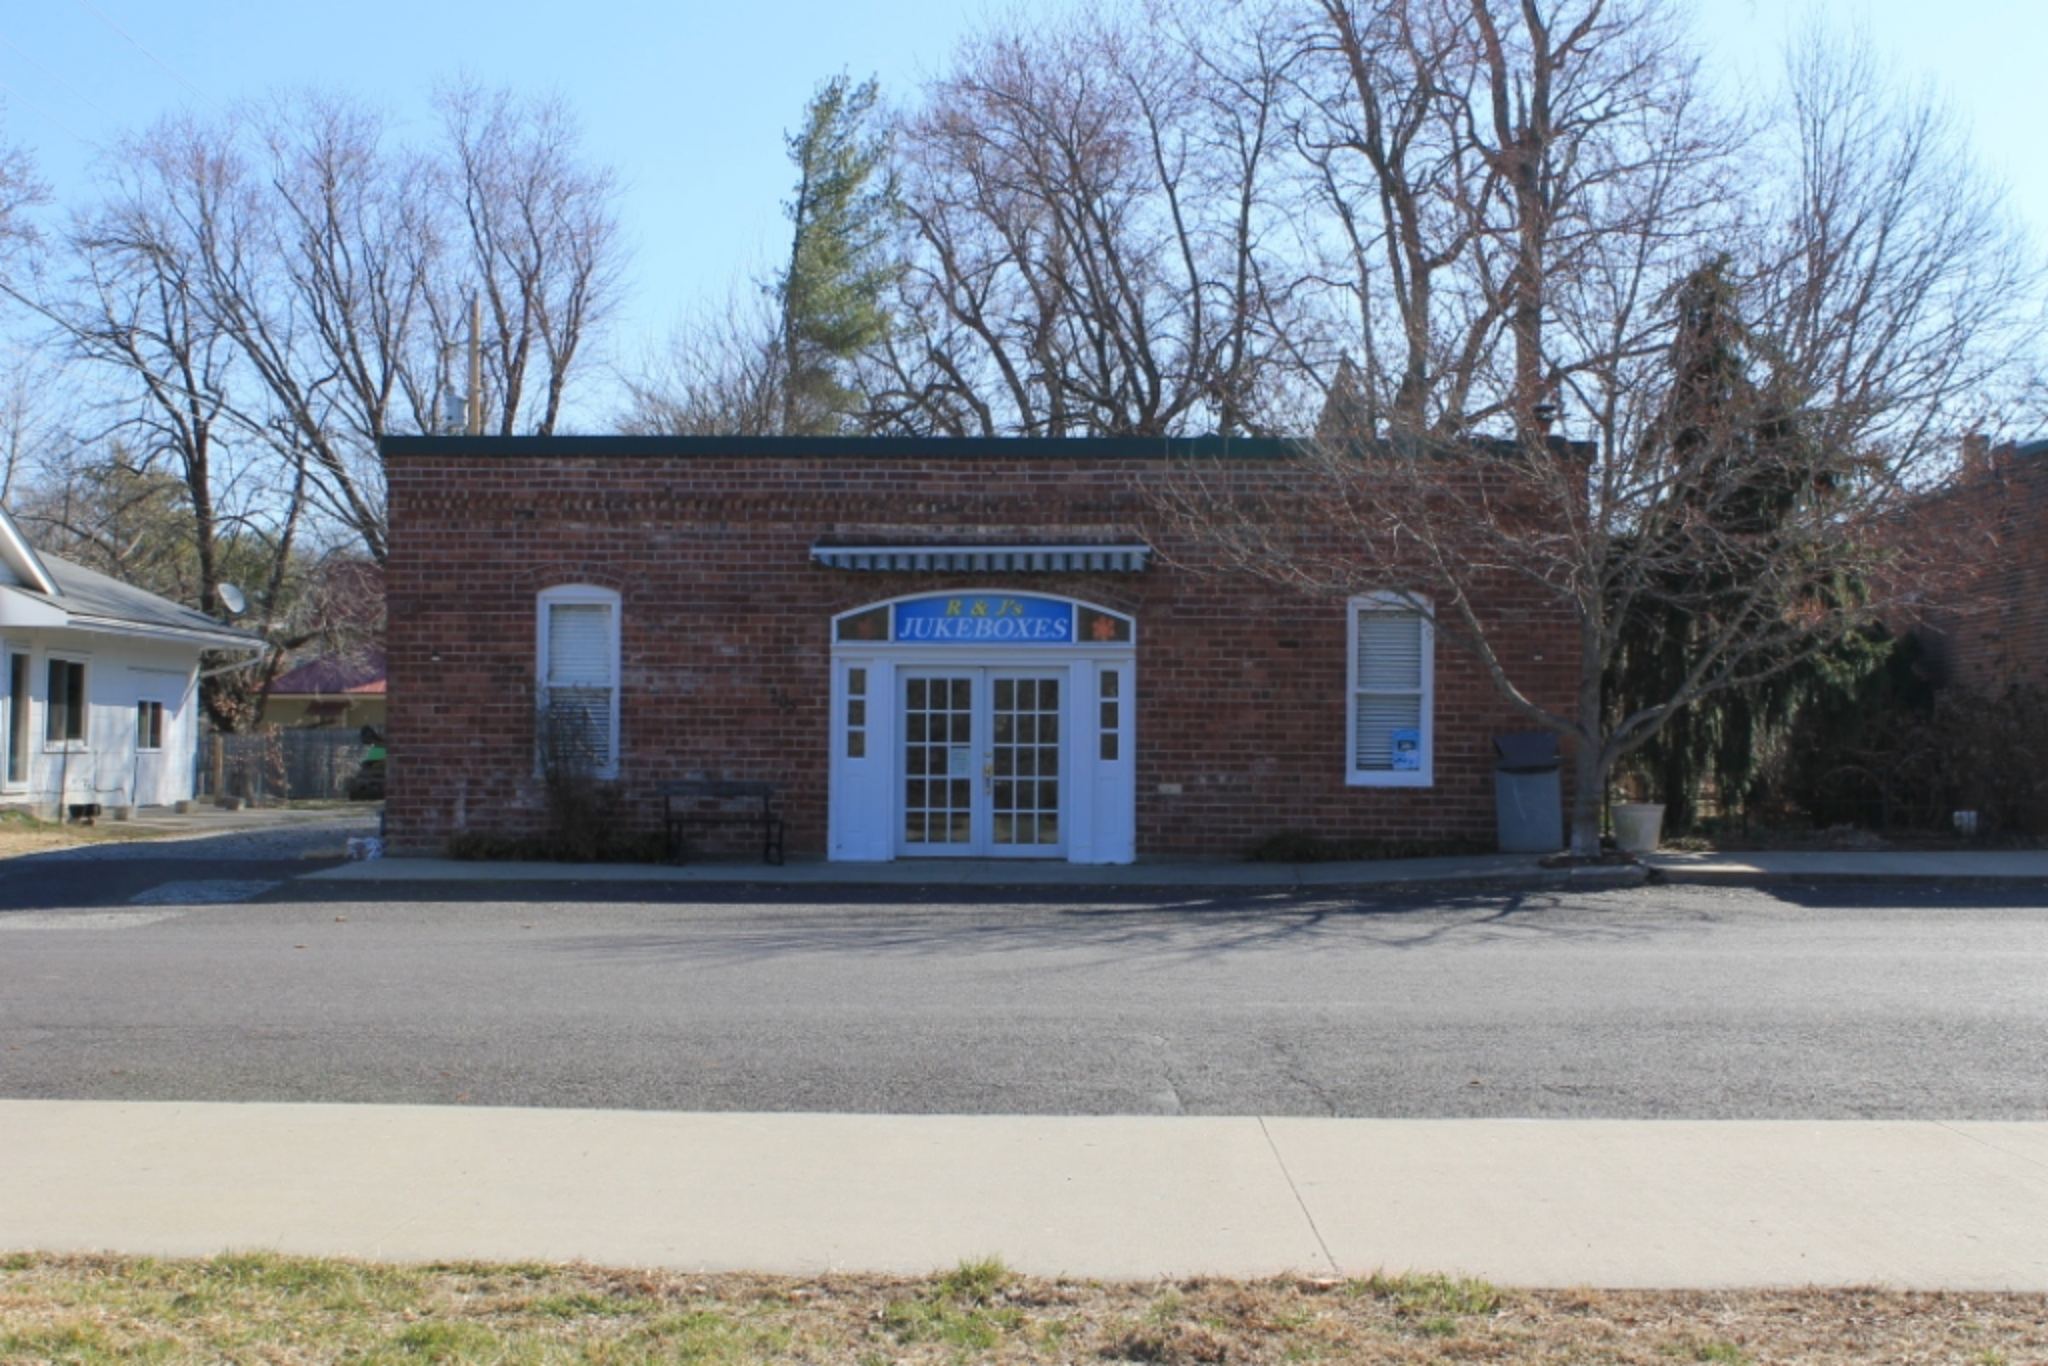
This one-story, vault plan brick commercial building has slightly sloped roof covered in asphalt. The roof line is clad in a narrow band of metal flashing. A row of header bricks and two rows of brick inset diagonally across the front form something of a cornice. The building has three bays. The left bay contains a rectangular one-over-one single hung window set into a segmental arched opening. The center bay contains a large doorway with double doors, each with fifteen panes; sidelights with three panes above wooden panels flank the door. Above the door is a segmental arched transom with three panes; the name of the current store is placed in the center pane. The right bay contains a rectangular one-over-one single hung window set into a segmental arched opening.

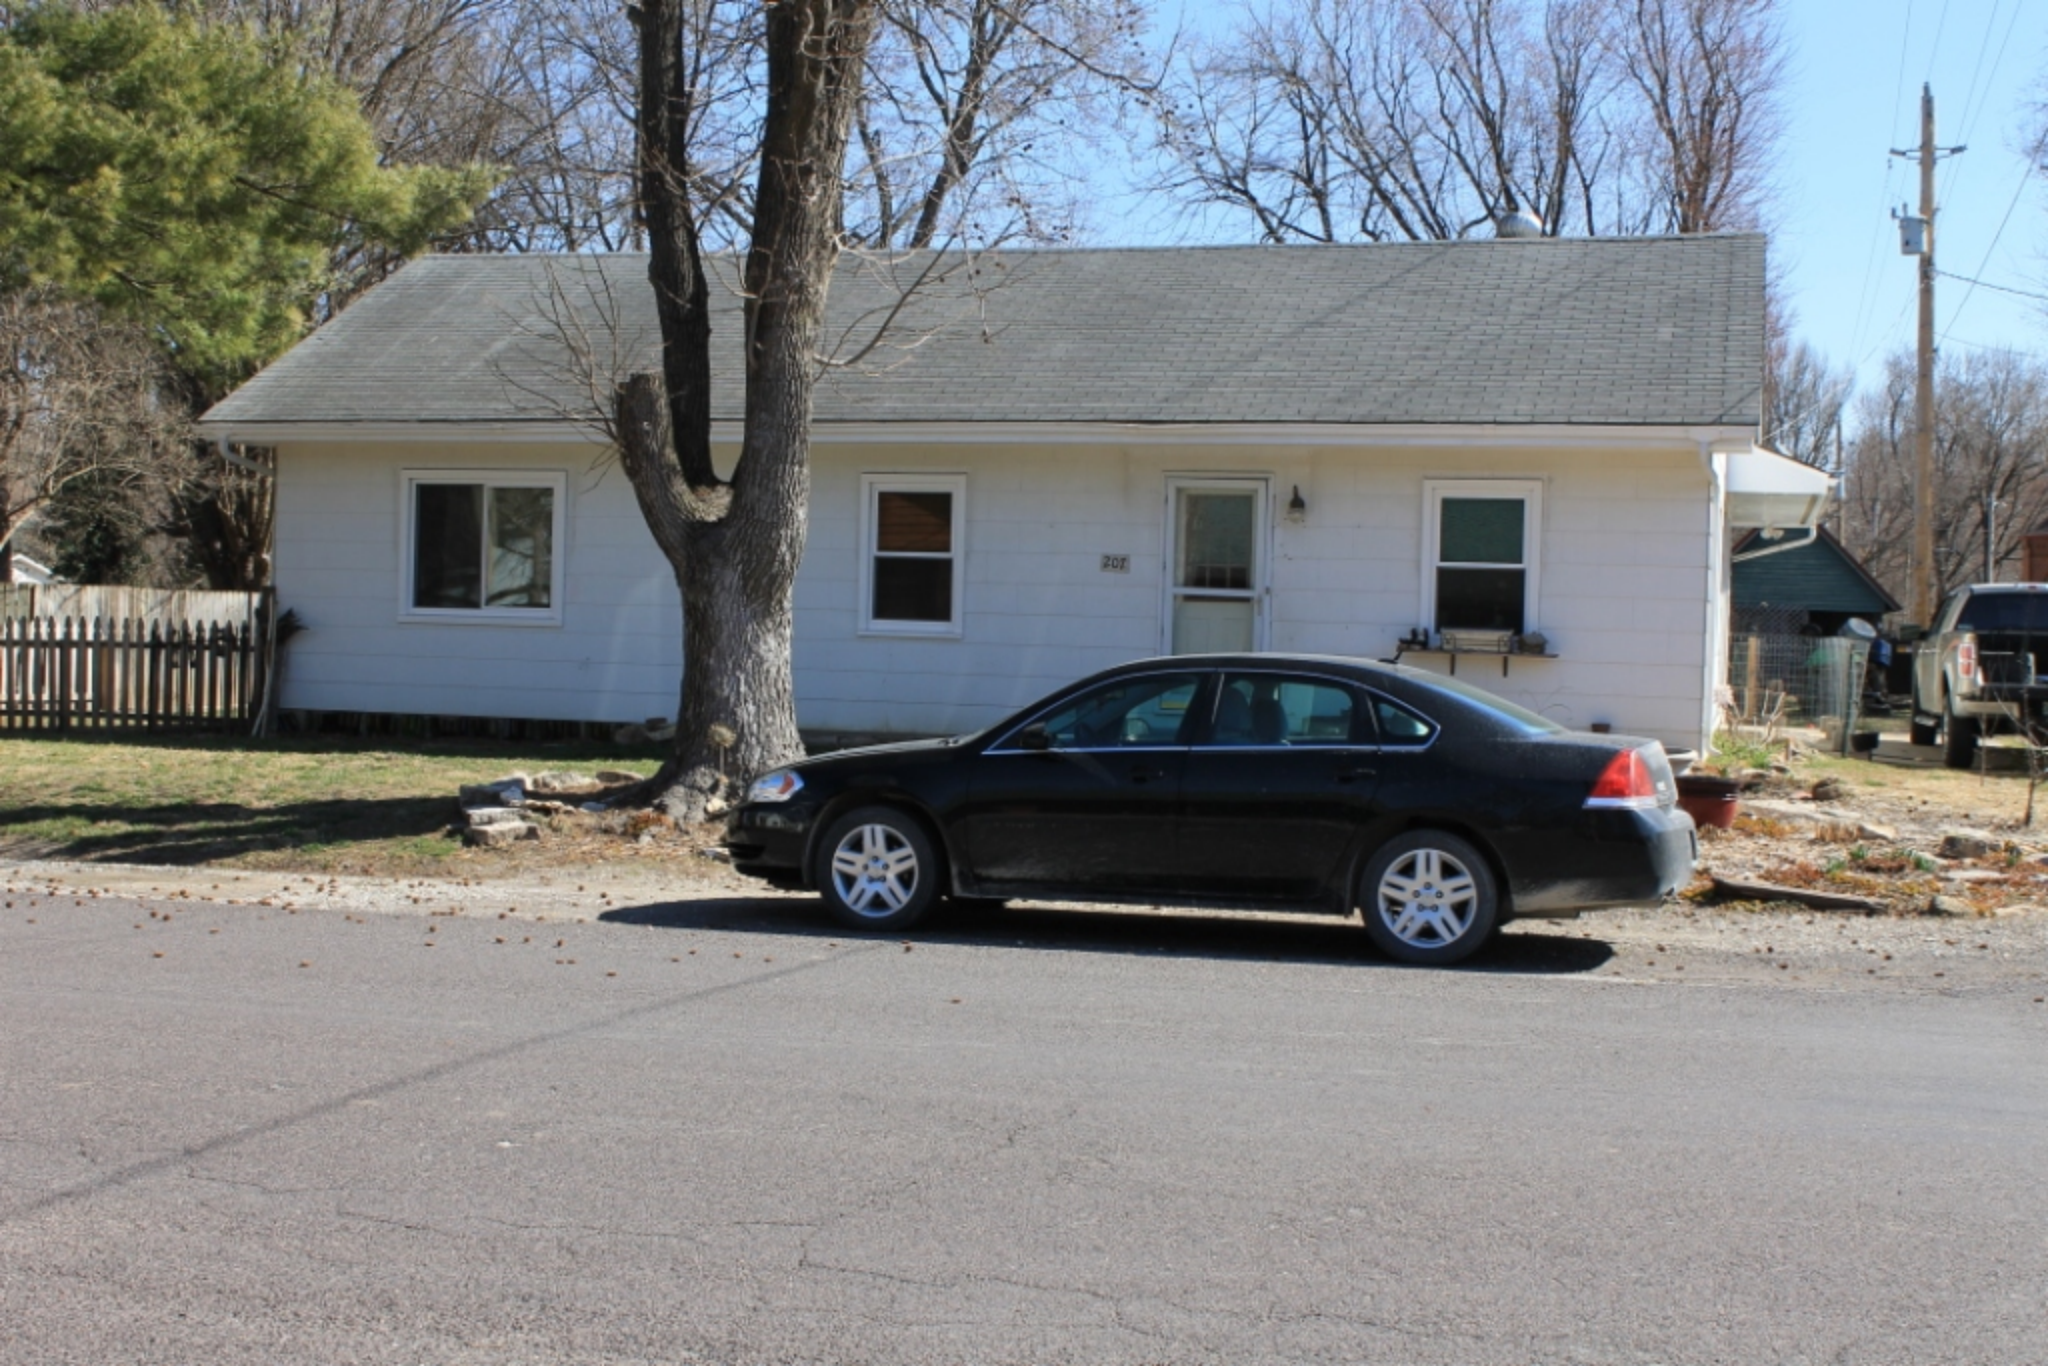
This one story, massed plan side gable, frame house is clad in asbestos shingles. The medium gabled roof is covered in asphalt shingles. The front (west) facade has four bays. The bay on the left contains a two vertical pane sliding window. The next bay contains a one-over-one vinyl window. The next bay contains a paneled wooden door with a nine pane window above the panels. The door is covered with a modern glass and metal storm door. The rightmost bay contains a one-over-one vinyl window.
