MISSOURI DEPARTMENT OF NATURAL RESOURCES
STATE HISTORIC PRESERVATION OFFICE, P.O. Box 176, Jefferson City, MO 65102
ARCHITECTURAL/HISTORIC INVENTORY FORM

1. SURVEY NO. BO-AS-009-0001		2. SURVEY NAME: Rocheport Historic District	
3. COUNTY: Boone		4. ADDRESS (STREET NO.)	STREET (NAME) Katy Trail
5. CITY: Rocheport	VICINITY: <input checked="" type="checkbox"/>	6. UTM: / /	LAT: LONG: T: 48W R: 15W S: 1

8. HISTORIC NAME (IF KNOWN): M.K.&T. Railroad tunnel		9. PRESENT/OTHER NAME (IF KNOWN): Katy trail tunnel	
10. OWNERSHIP: <input type="checkbox"/> PRIVATE <input checked="" type="checkbox"/> PUBLIC		11A. HISTORIC USE (IF KNOWN): railroad tunnel	11B. CURRENT USE: Katy Trail tunnel
HISTORICAL INFORMATION

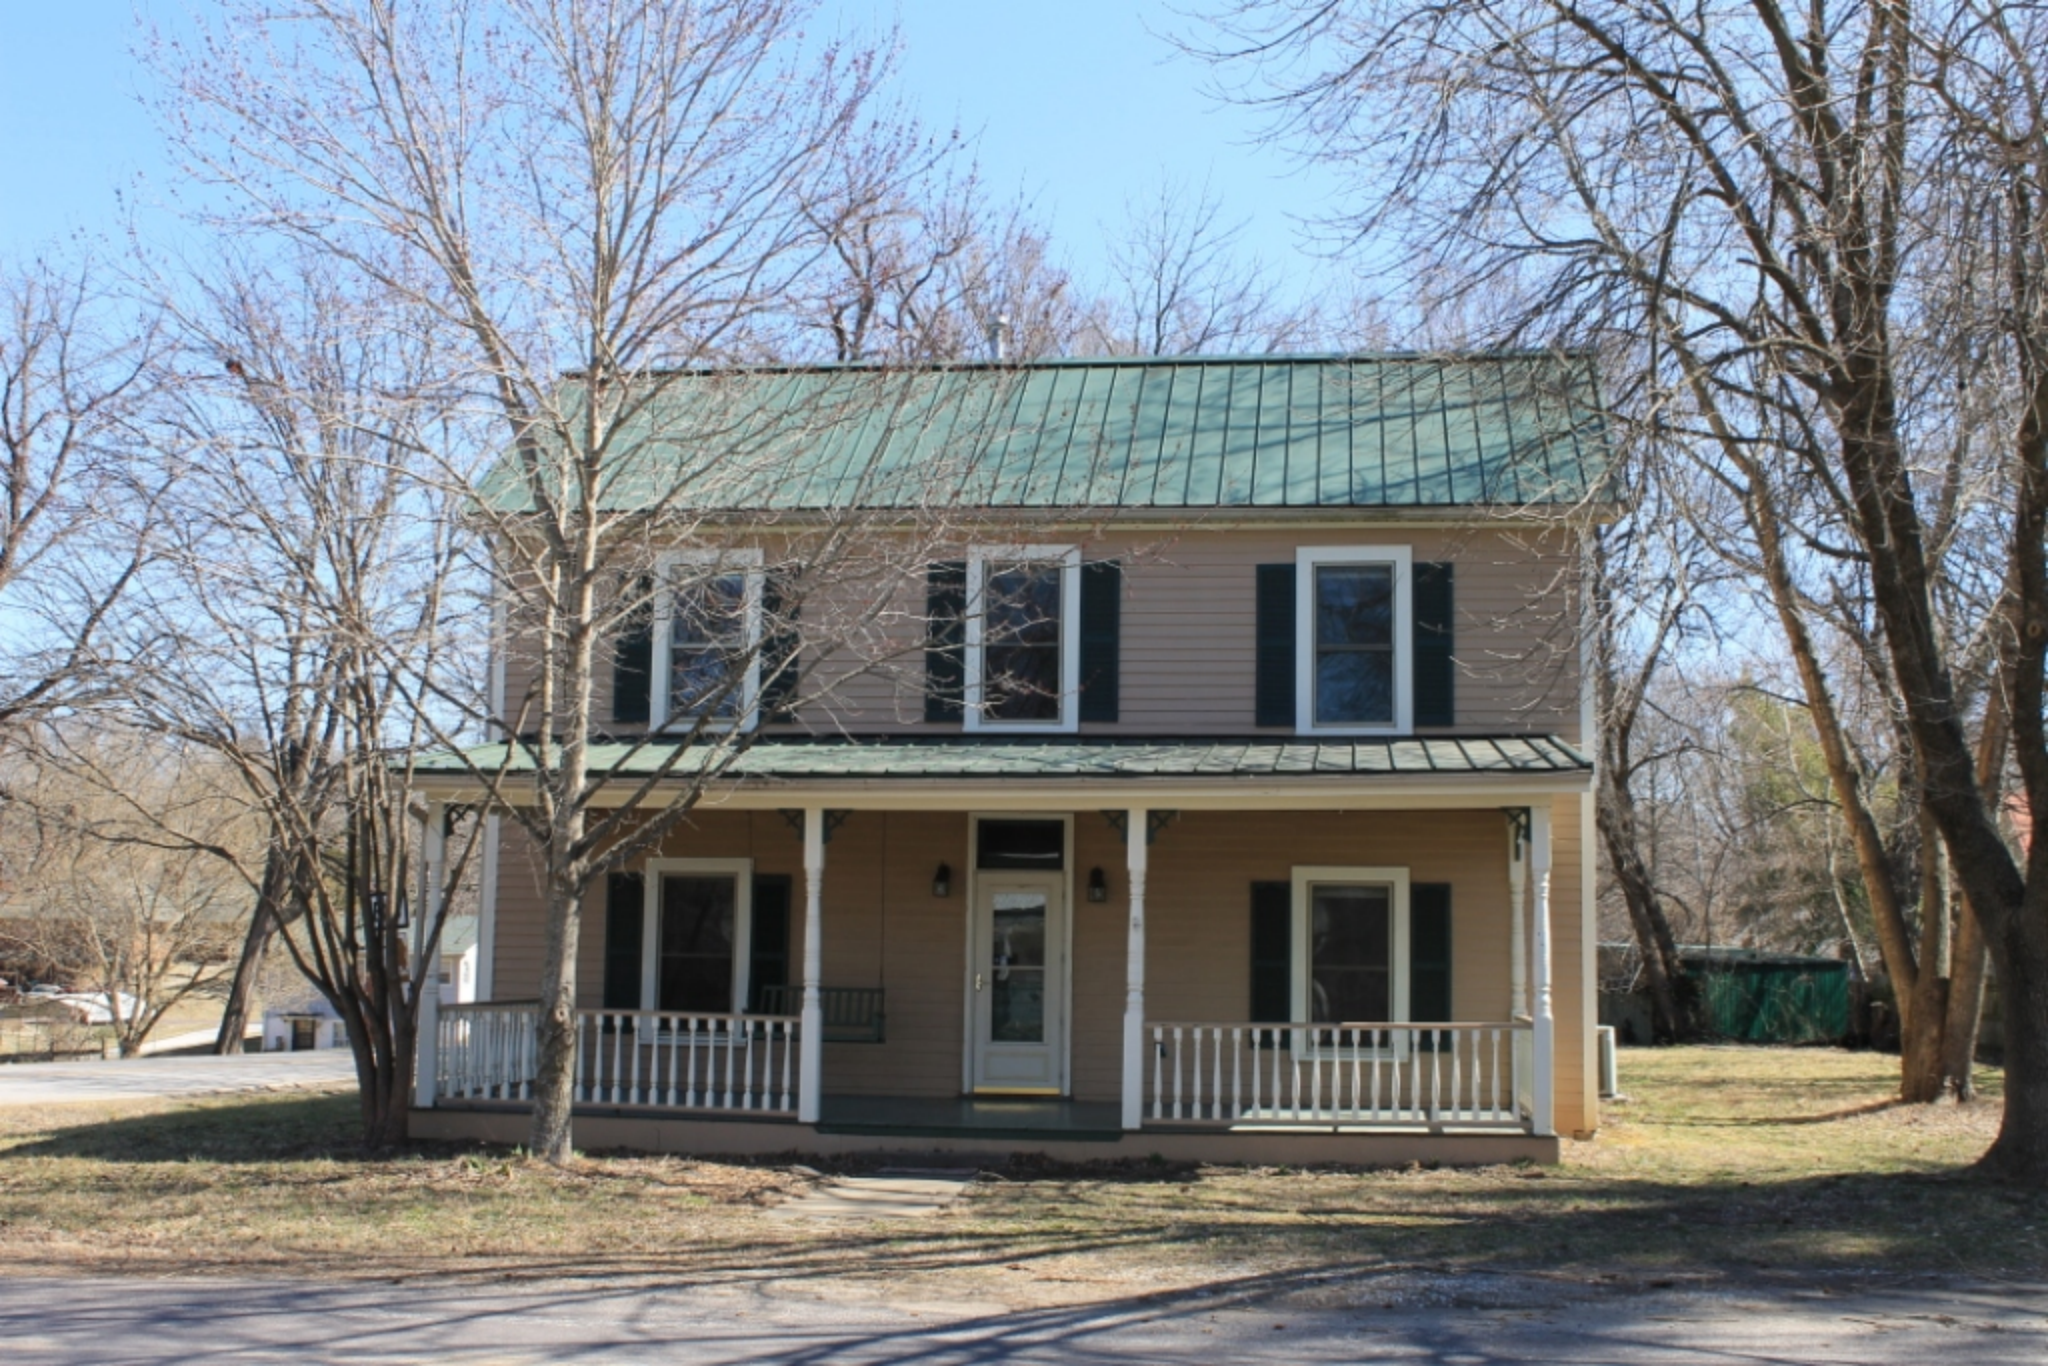
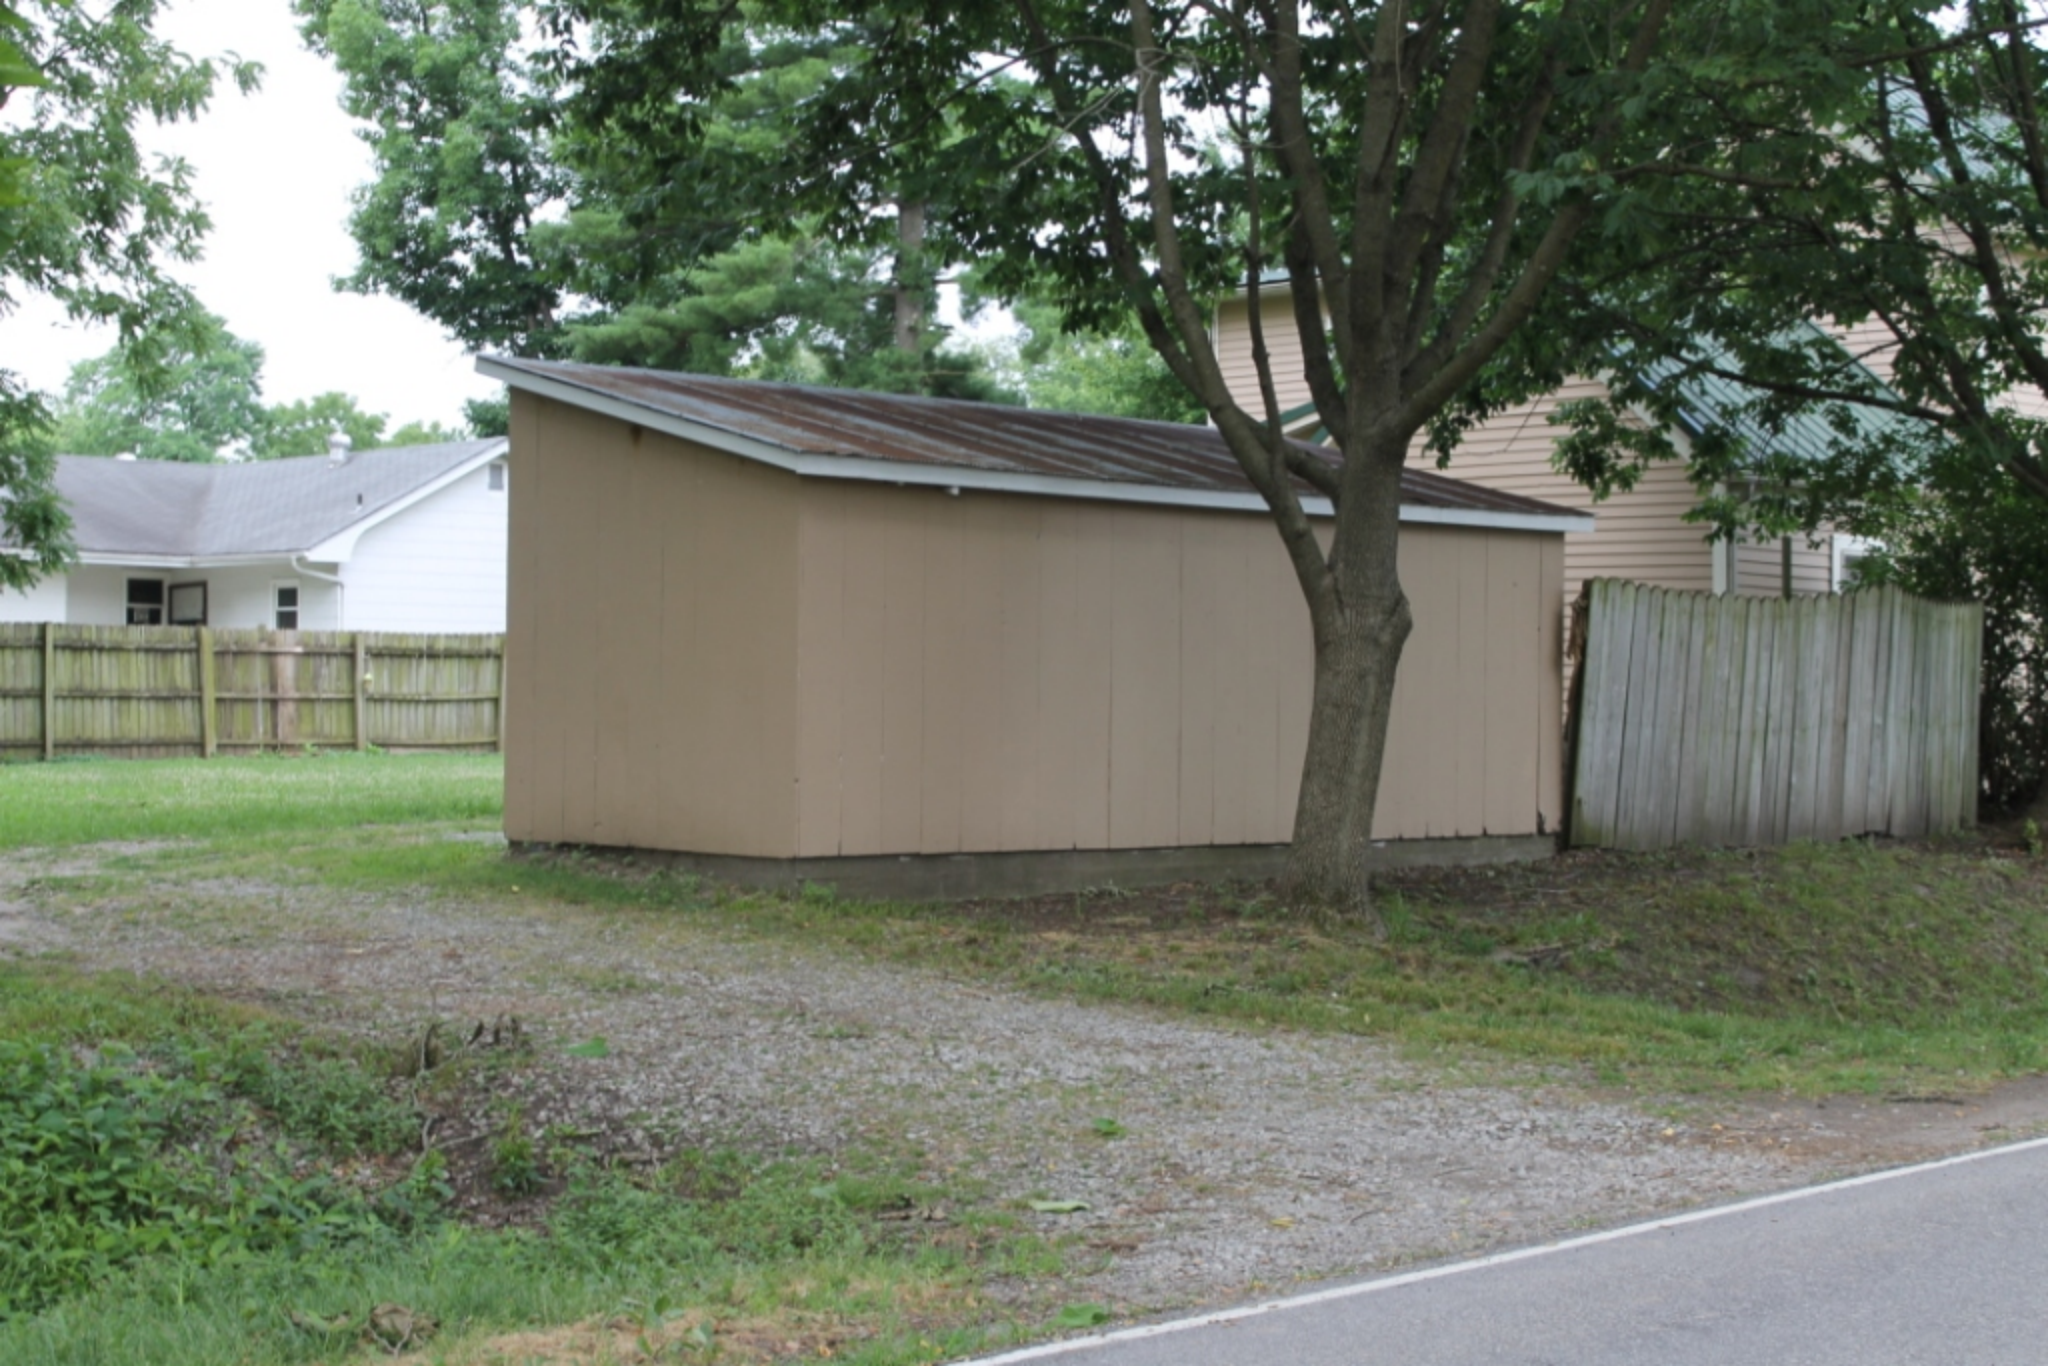
This two story, hall and parlor plan, frame building has a metal medium gable roof on the main block of the house and a metal cross gable roof on the rear wing. The house is now clad in vinyl siding. The lines of the roofs suggest a number of additions. According to a 1973 photograph, the rear wing had a one story enclosed porch on the rear. This has been replaced with a two story addition that extends the cross gable wing on the rear. The first story of the front (west) facade of the house has three bays. The left bay contains a one-over-one vinyl window. The center bay contains a door with a single paned transom; the door is covered with a modern metal and glass storm door. The right bay contains a one-over-one vinyl window. The second story of the front (west) facade has three bays, each containing a one-over-one vinyl window placed above the bays on the first story. A railing surrounds the one-story veranda that runs the length of the house; turned posts support the flat roof of the veranda. The corners of the posts are accented with sawn corner brackets.

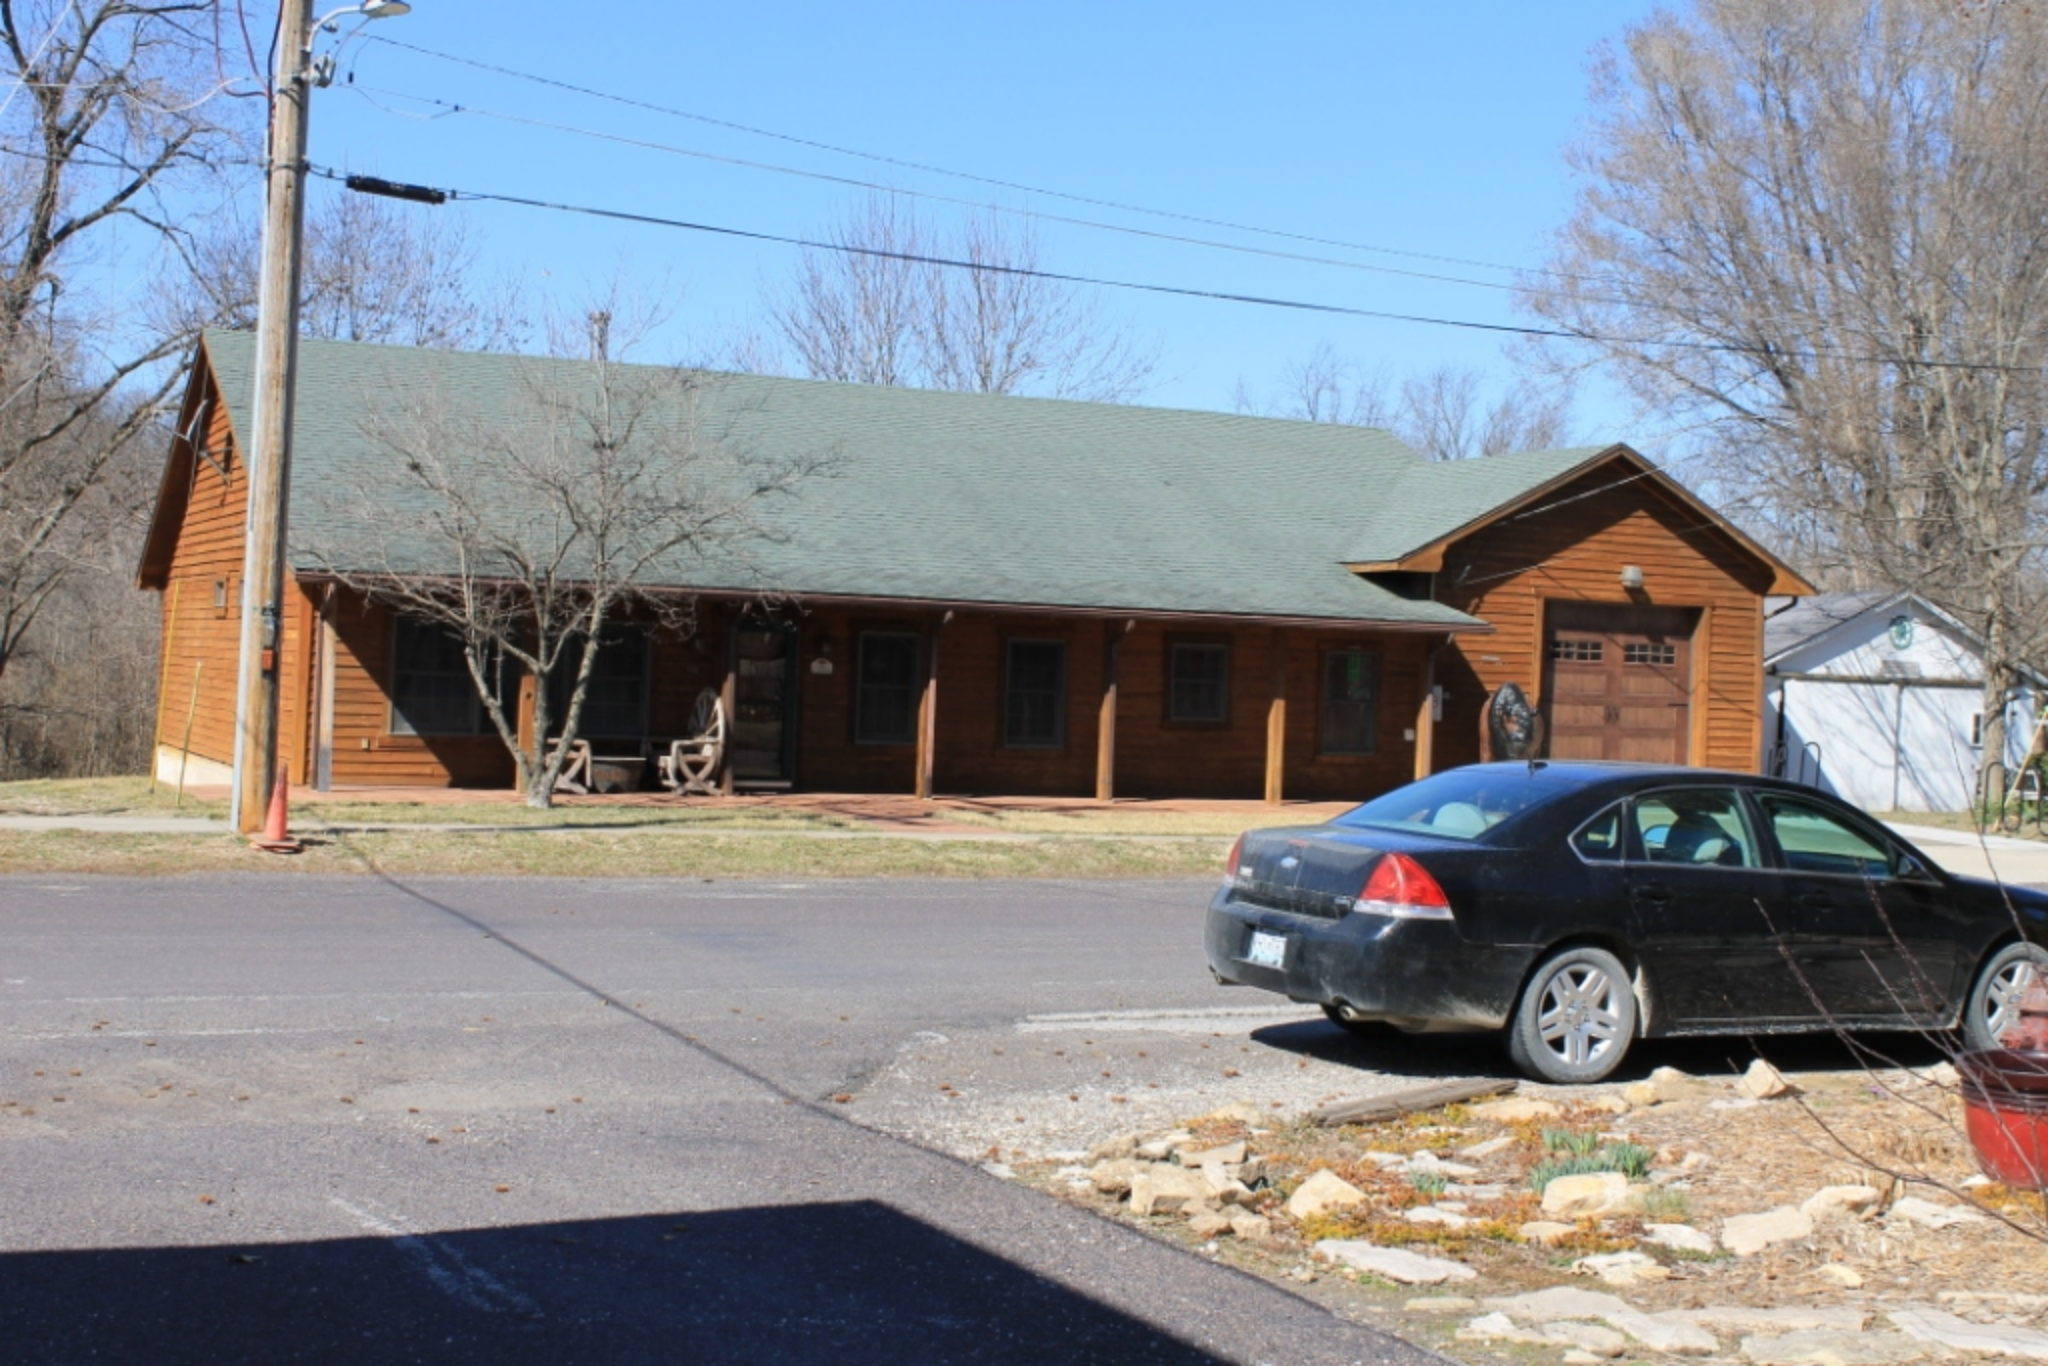
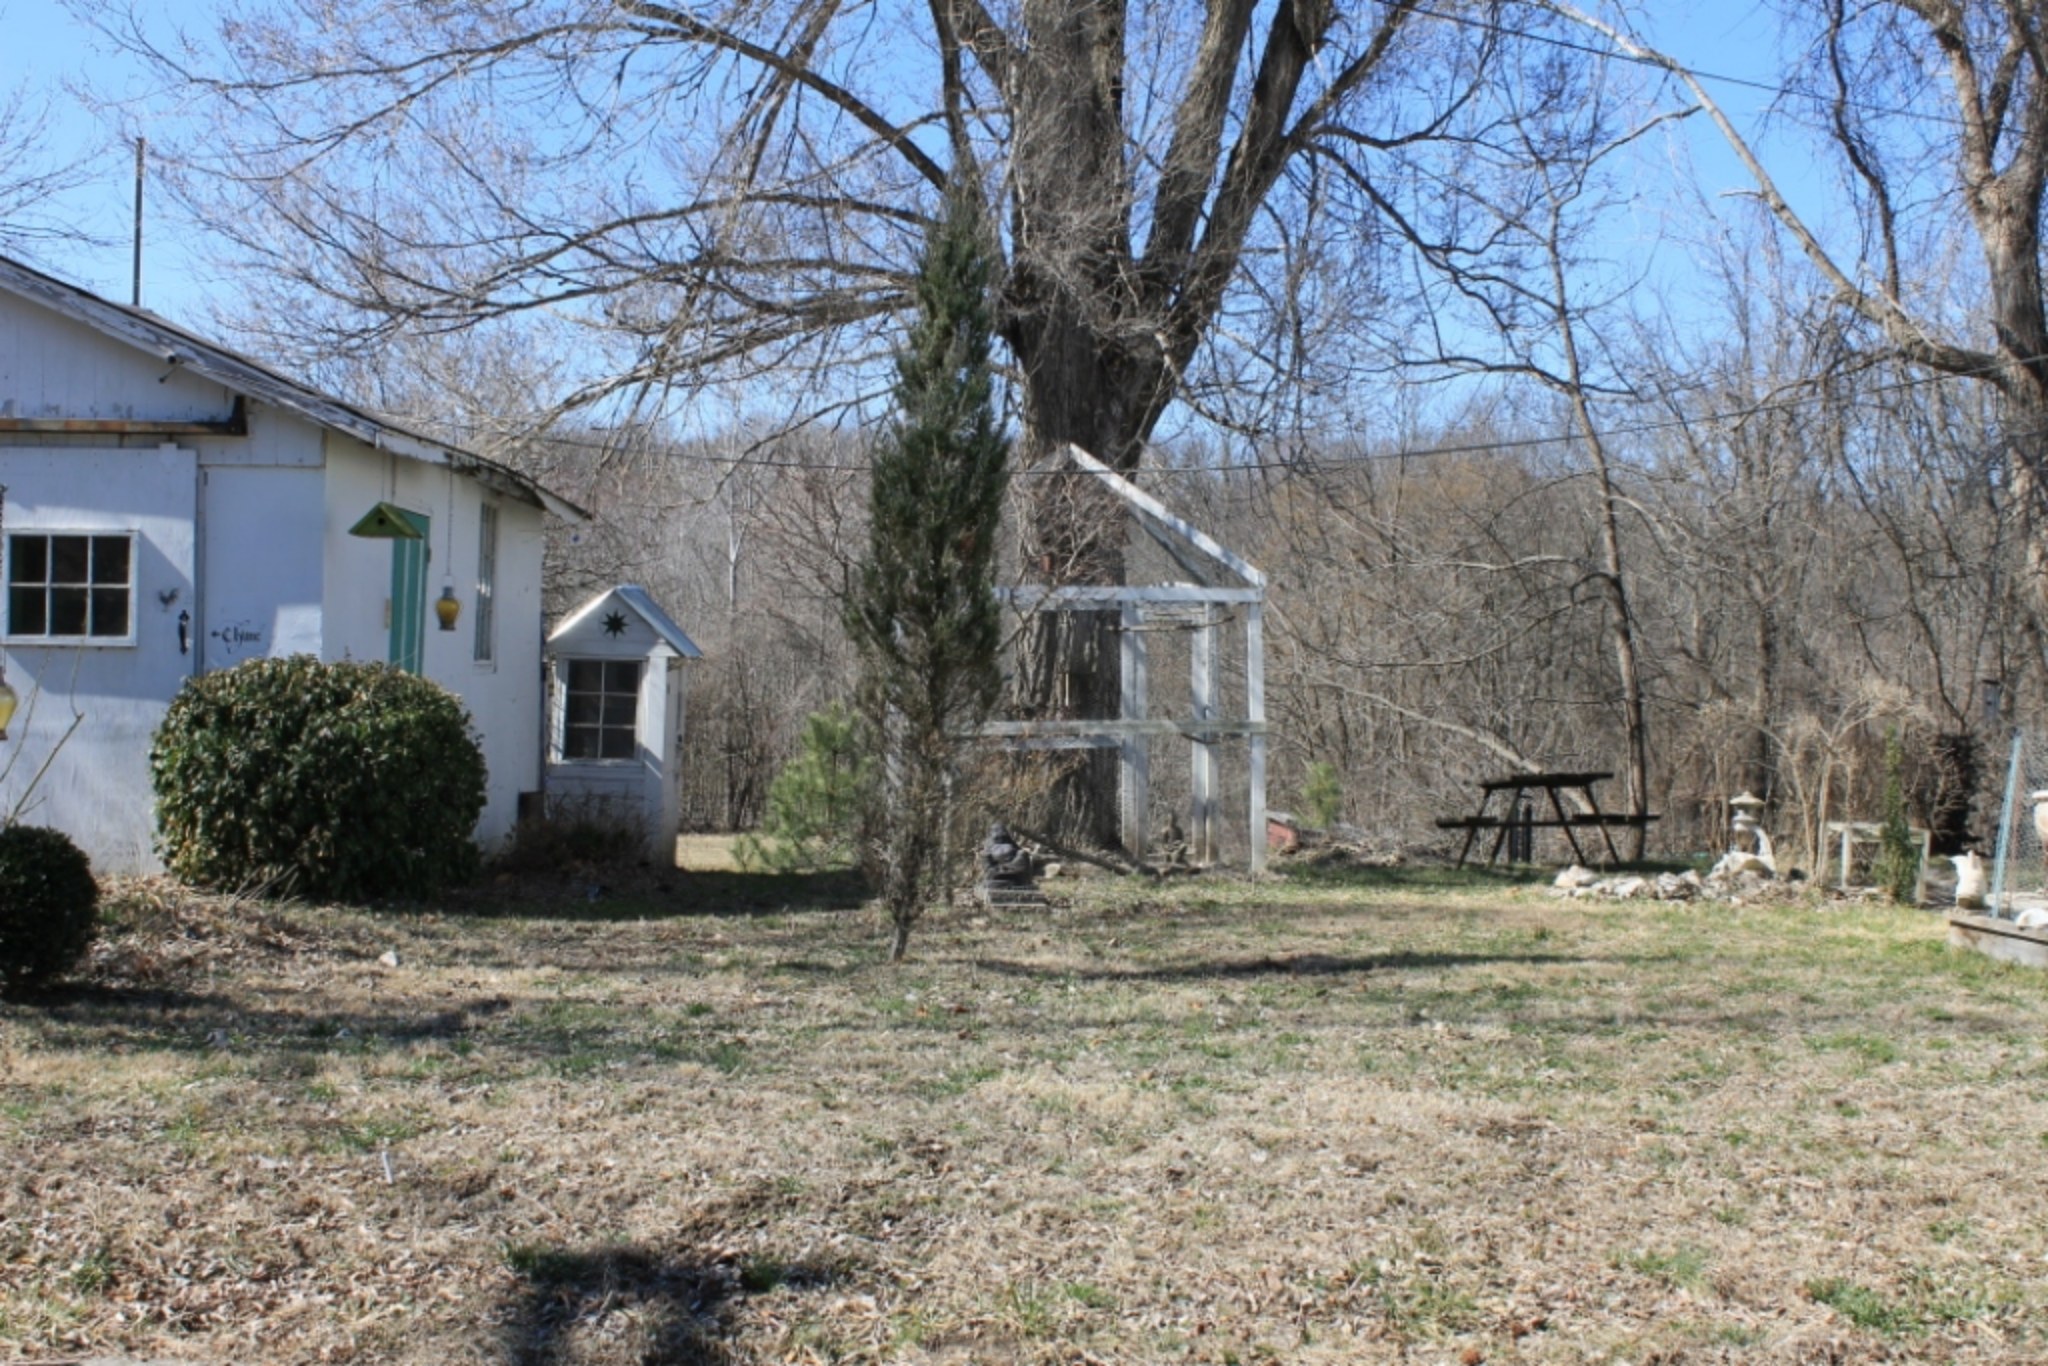
This building is a long, rectangular shaped, massed plan, one-story frame dwelling with a cross gable roof on the northern end of the building. The clapboard walls are currently stained brown. The wing of the building under the cross gable roof projects slightly to the east. Under the cross gable is a garage. Stretching across the front of the building from the garage to the end of the building is an open porch supported by wooden posts. The roof of the porch is an extension of the roof of the house. On the front of the house are seven bays. The leftmost bay contains three large six-over-six single hung windows. The next bay contains a door with a modern glass storm door. The next two bays each contain a large six-over-six single hung window. The next bay contains a smaller six-over-six single hung window. The next bay contains a large six-over-six single hung window. The rightmost bay is under the cross gable and contains an overhead door with two long horizontal windows, each with four-over-four fixed panes of glass. Below the windows in the overhead door are panels; the door is made to resemble an old-fashioned carriage house door and has black hinges and pulls.

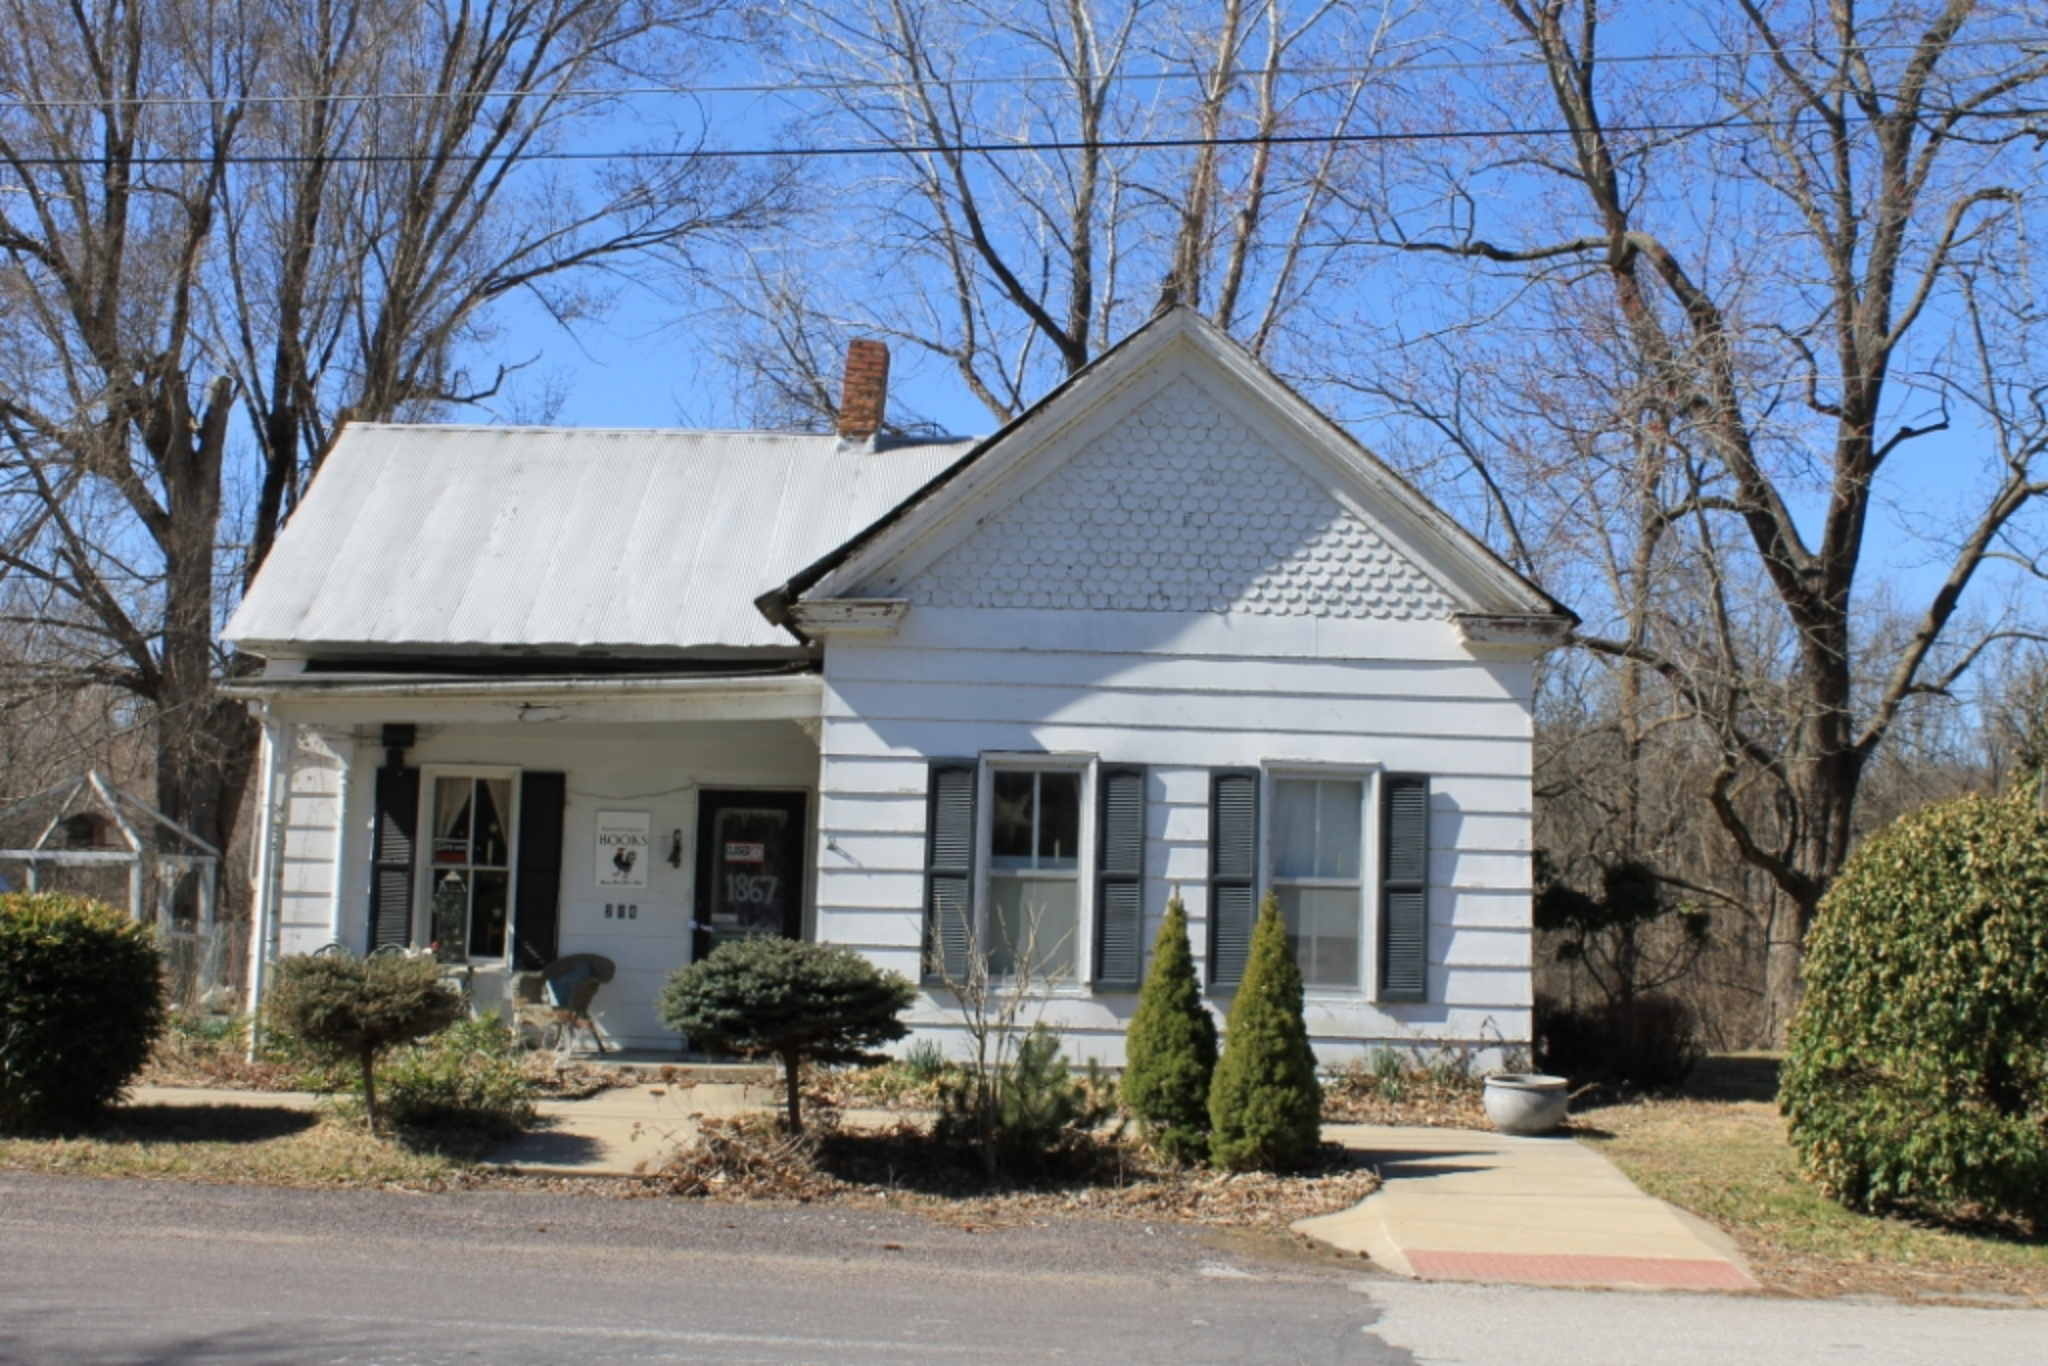
This one-story, massed plan gable and wing frame building was once clad in metal siding, but the metal siding is now being removed and narrow clapboards are being used as cladding on the building. The building has a metal roof. The wall under the gable roof is clad in wooden fishlap shingles. On the east facade, the main block of the building meets a cross gabled wing; at the point where these wings meet is an open flat roofed porch. The front (east) facade has four bays. The leftmost bay contains a two-over-two single hung wooden windows. The next bay contains a paneled door with a fixed paned window in the top; the door is covered by a modern metal and glass storm door. The two right bays, located on the gable wing of the house, each contain a two-over-two wooden single hung window. The windows are accented with shutters. A chimney rises from the center ridge of the main block of the house.
