MISSOURI DEPARTMENT OF NATURAL RESOURCES
STATE HISTORIC PRESERVATION OFFICE, P.O. Box 176, Jefferson City, MO 65102
ARCHITECTURAL/HISTORIC INVENTORY FORM

1. SURVEY NO. BO-AS-009-0001		2. SURVEY NAME: Rocheport Historic District	
3. COUNTY: Boone		4. ADDRESS (STREET NO.)	STREET (NAME) Katy Trail
5. CITY: Rocheport	VICINITY: <input checked="" type="checkbox"/>	6. UTM: / /	LAT: LONG: T: 48W R: 15W S: 1

8. HISTORIC NAME (IF KNOWN): M.K.&T. Railroad tunnel		9. PRESENT/OTHER NAME (IF KNOWN): Katy trail tunnel	
10. OWNERSHIP: <input type="checkbox"/> PRIVATE <input checked="" type="checkbox"/> PUBLIC		11A. HISTORIC USE (IF KNOWN): railroad tunnel	11B. CURRENT USE: Katy Trail tunnel
HISTORICAL INFORMATION

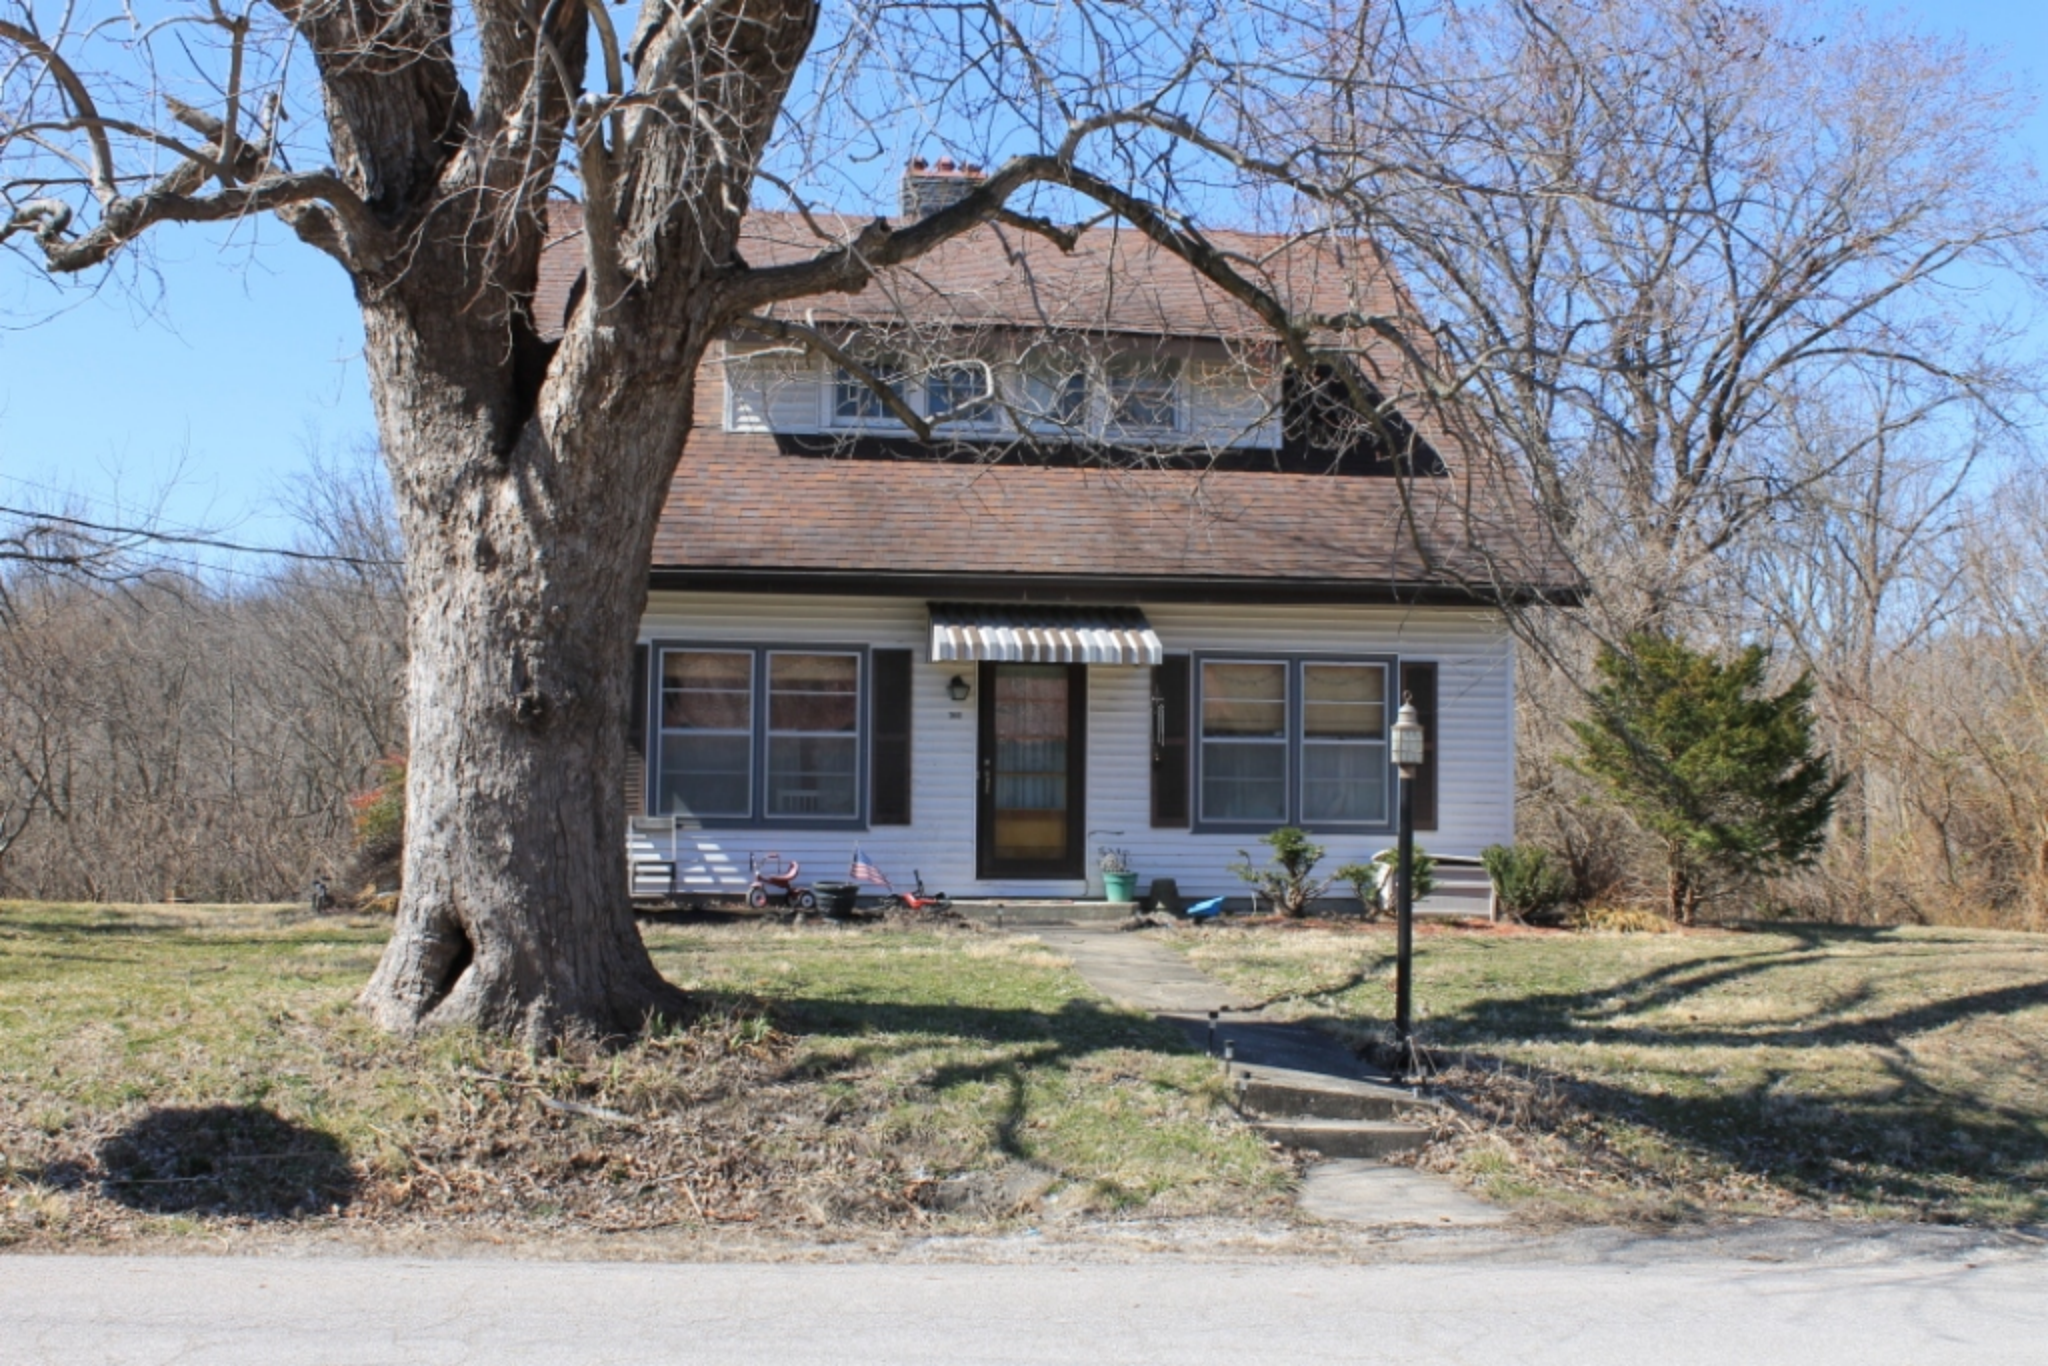
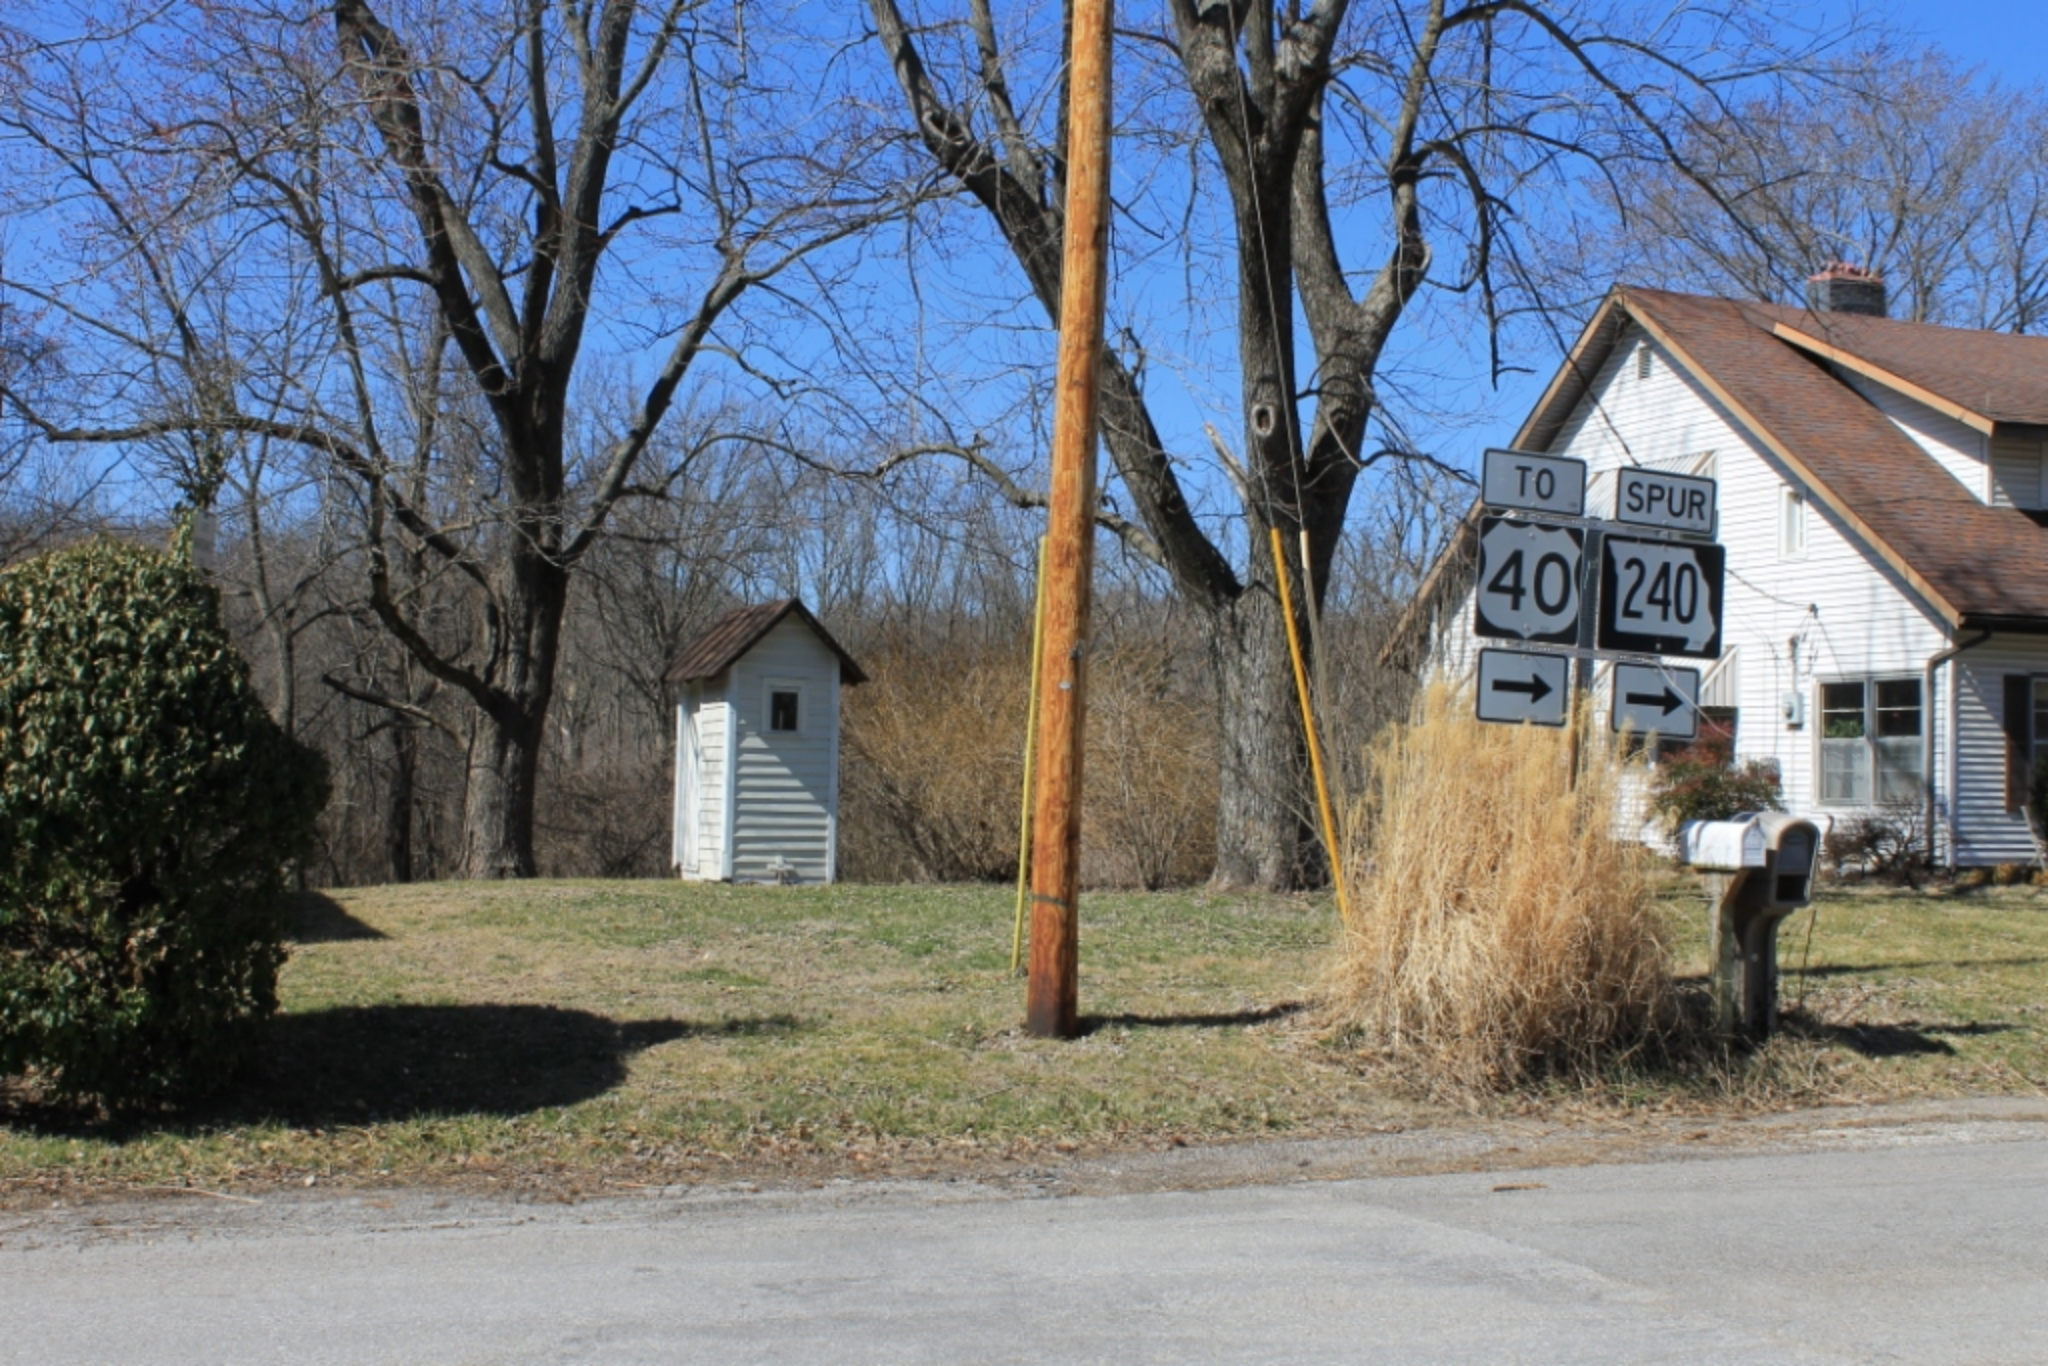
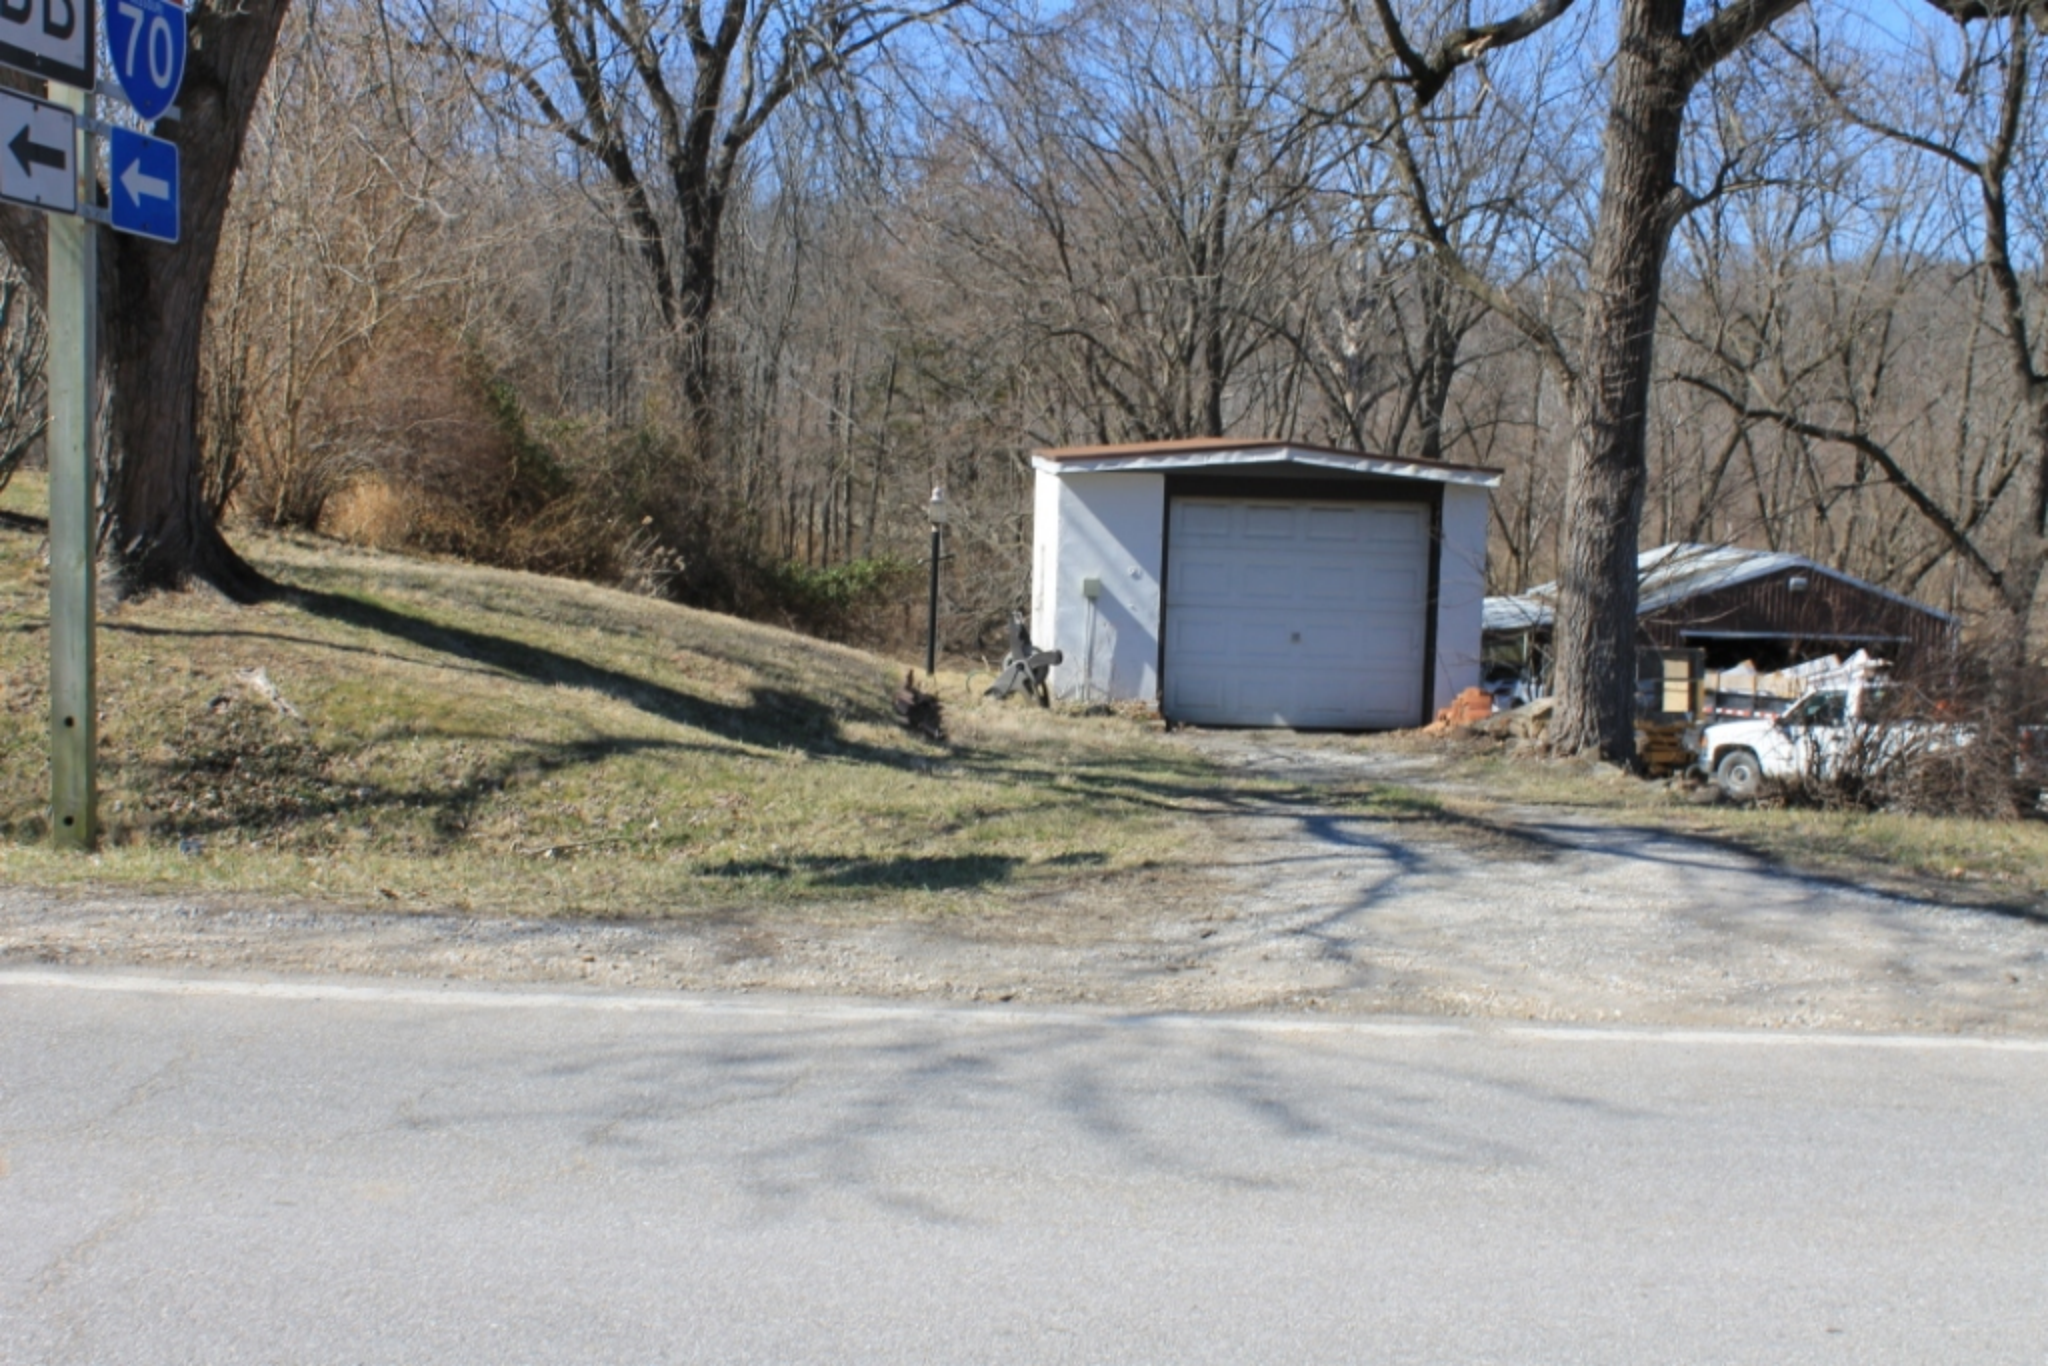
The 1 1/2 story, massed plan side gable, frame house has a gable roof with overhanging eaves and a shed-roofed dormer on the front (east) facade. The house is clad in vinyl siding and the roof is covered in asphalt shingles. The dormer has one bay containing four fixed pane windows set next to one another. On the front (east) facade of the first story, the house has three bays. The left bay contains a pair of two horizontal-over-two horizontal pane single hung vinyl windows. The center bay contains a modern glass and metal storm door with a metal awning above it. The door opens onto a concrete slab porch. The right bay contains a pair of two horizontal-over-two horizontal pane single hung vinyl windows. The windows are accented with decorative shutters. The side (north) facade of the first story has three bays. The bay closest to the street contains a pair of two-horizontal-over-two horizontal pane single hung vinyl windows. The center bay contains three six paned windows that appear to be original; these are placed high on the wall. The right bay contains a single one-over-one window that appears to be original. The house has a chimney in the center rear.

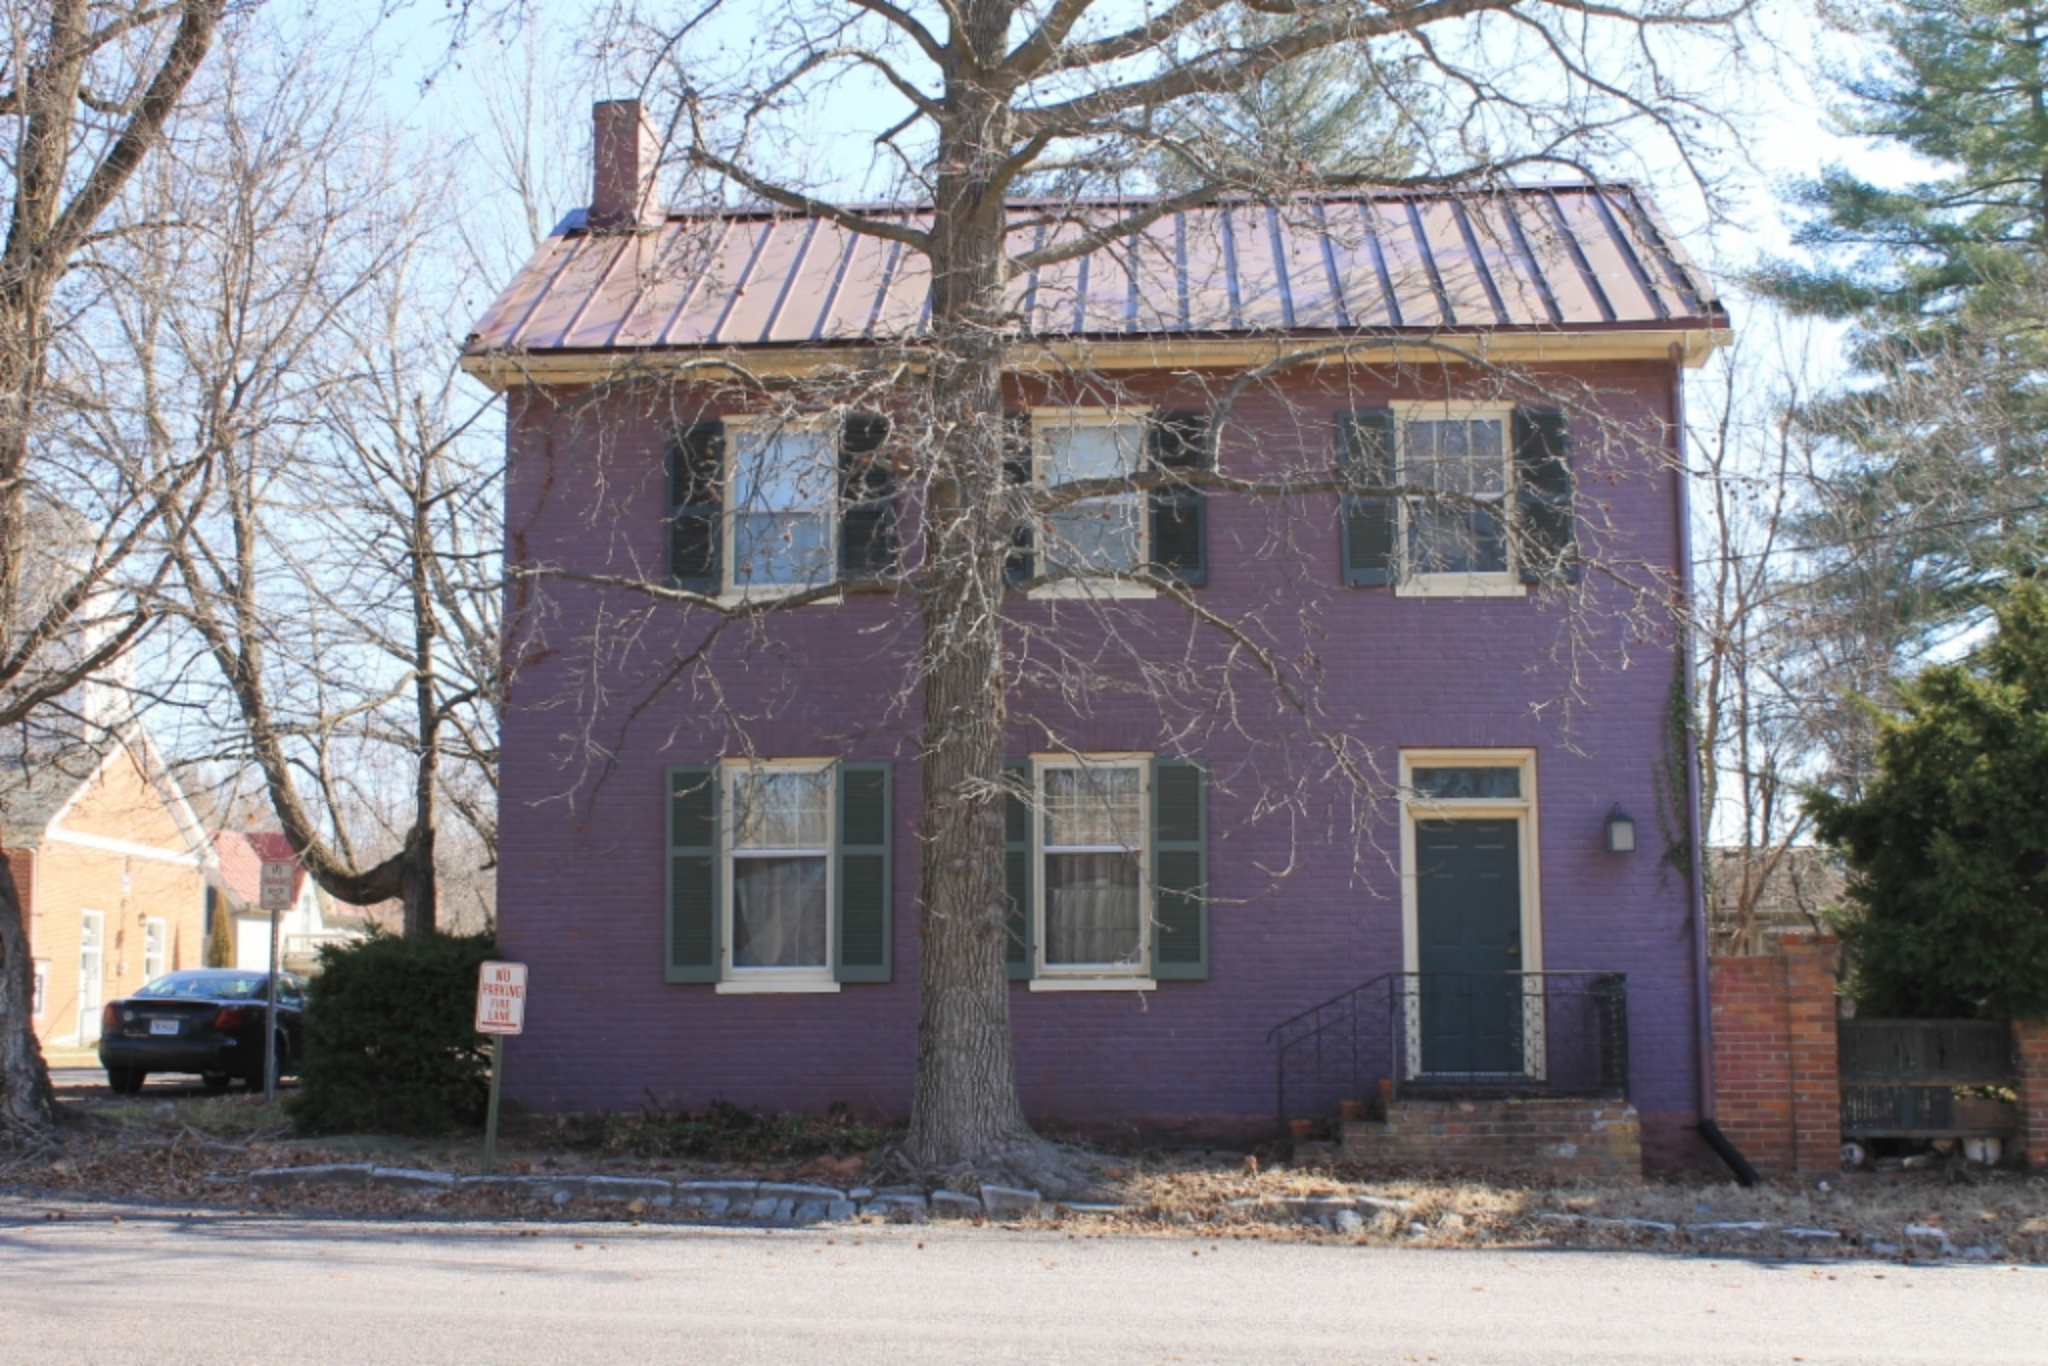
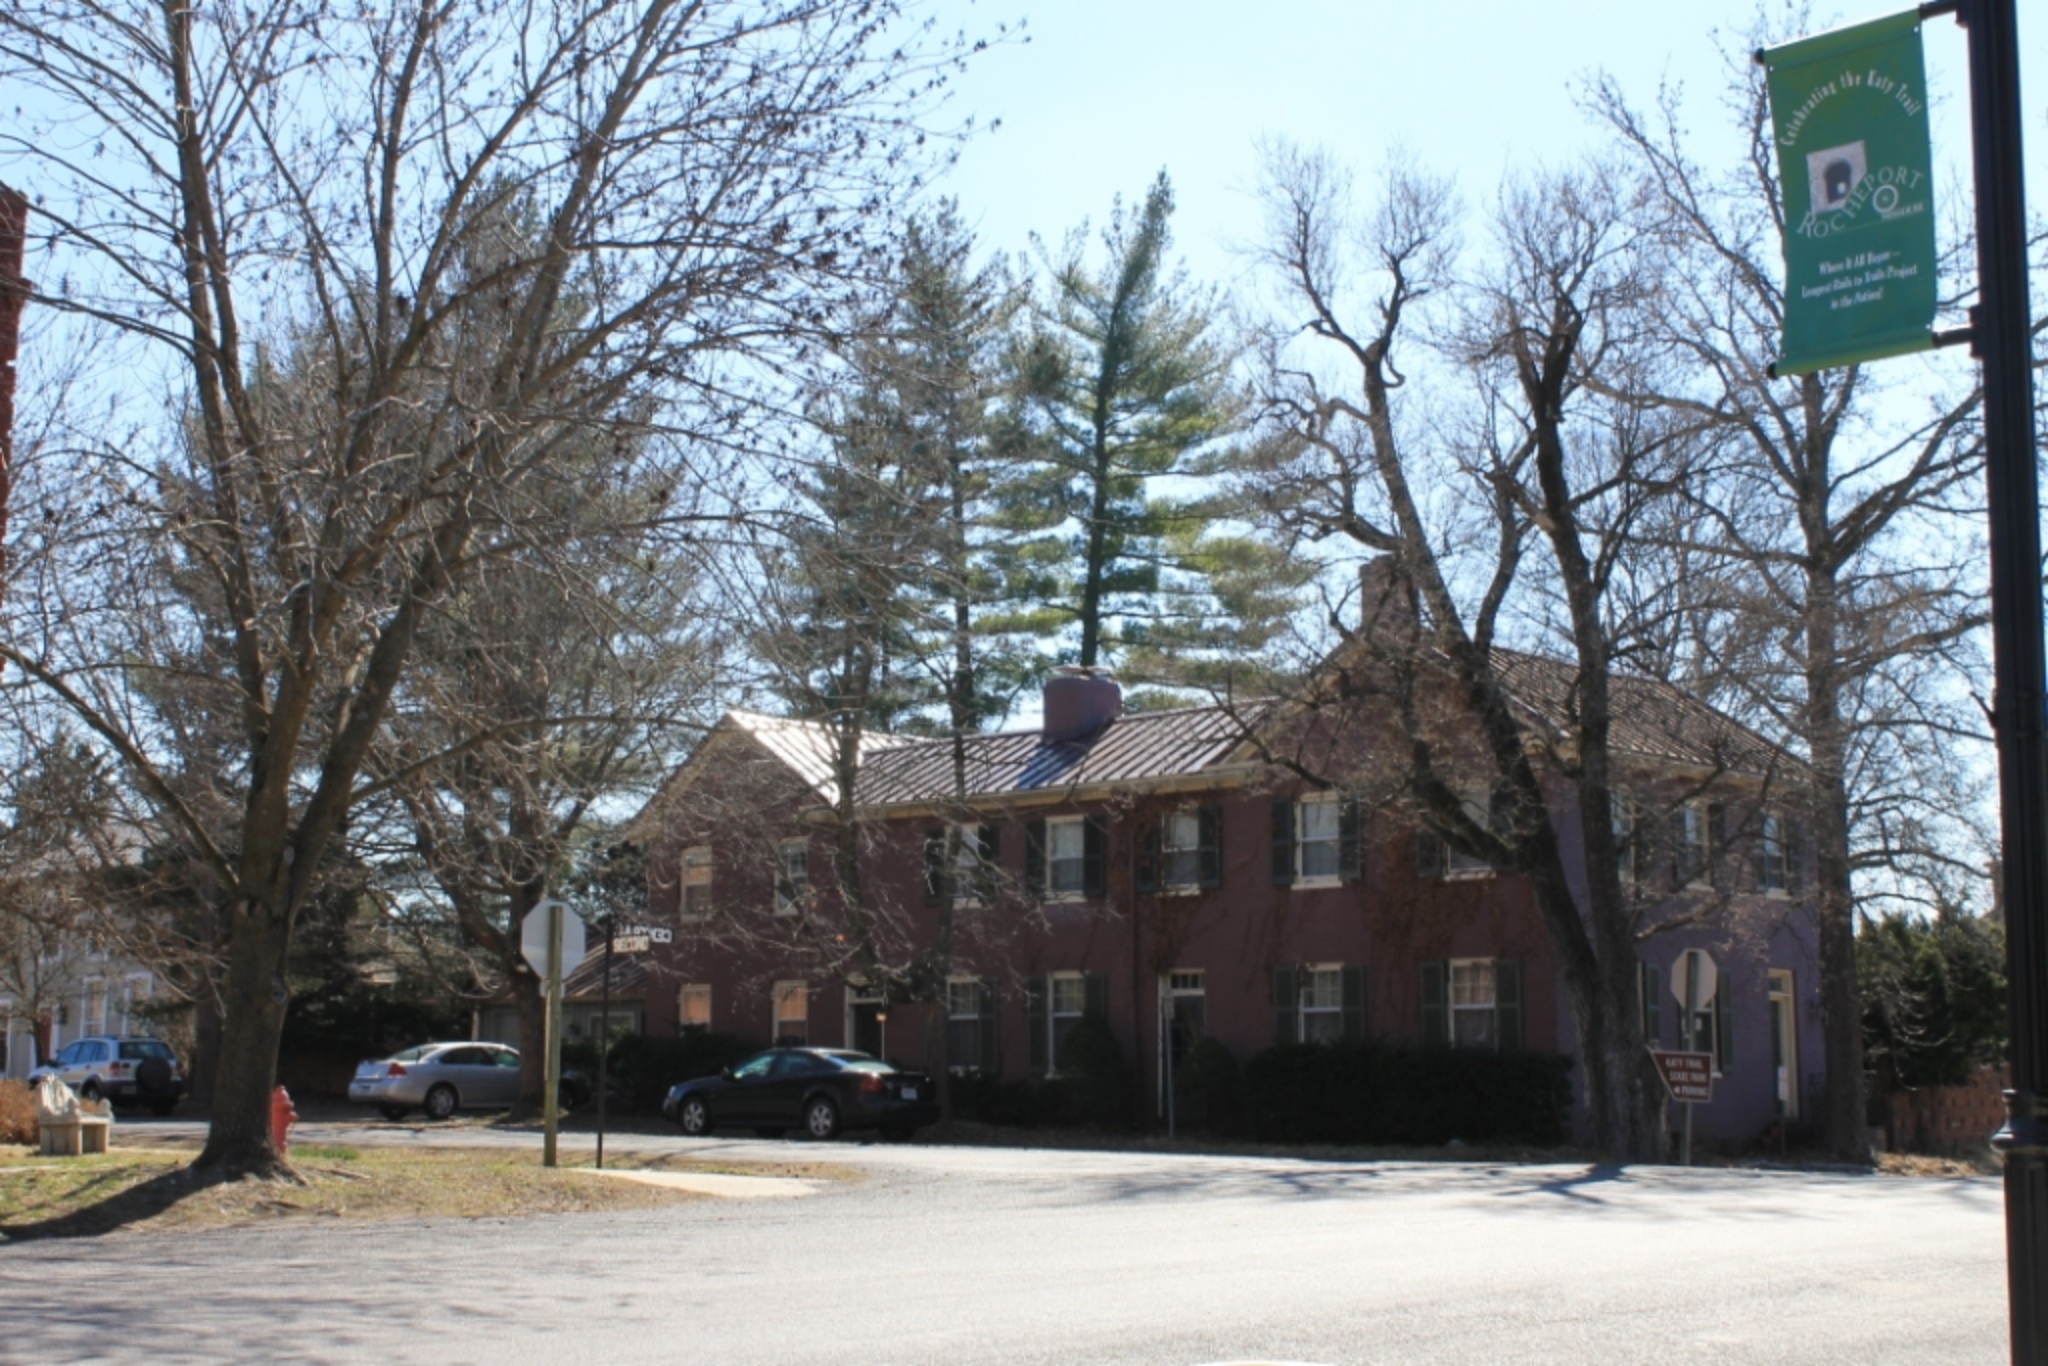
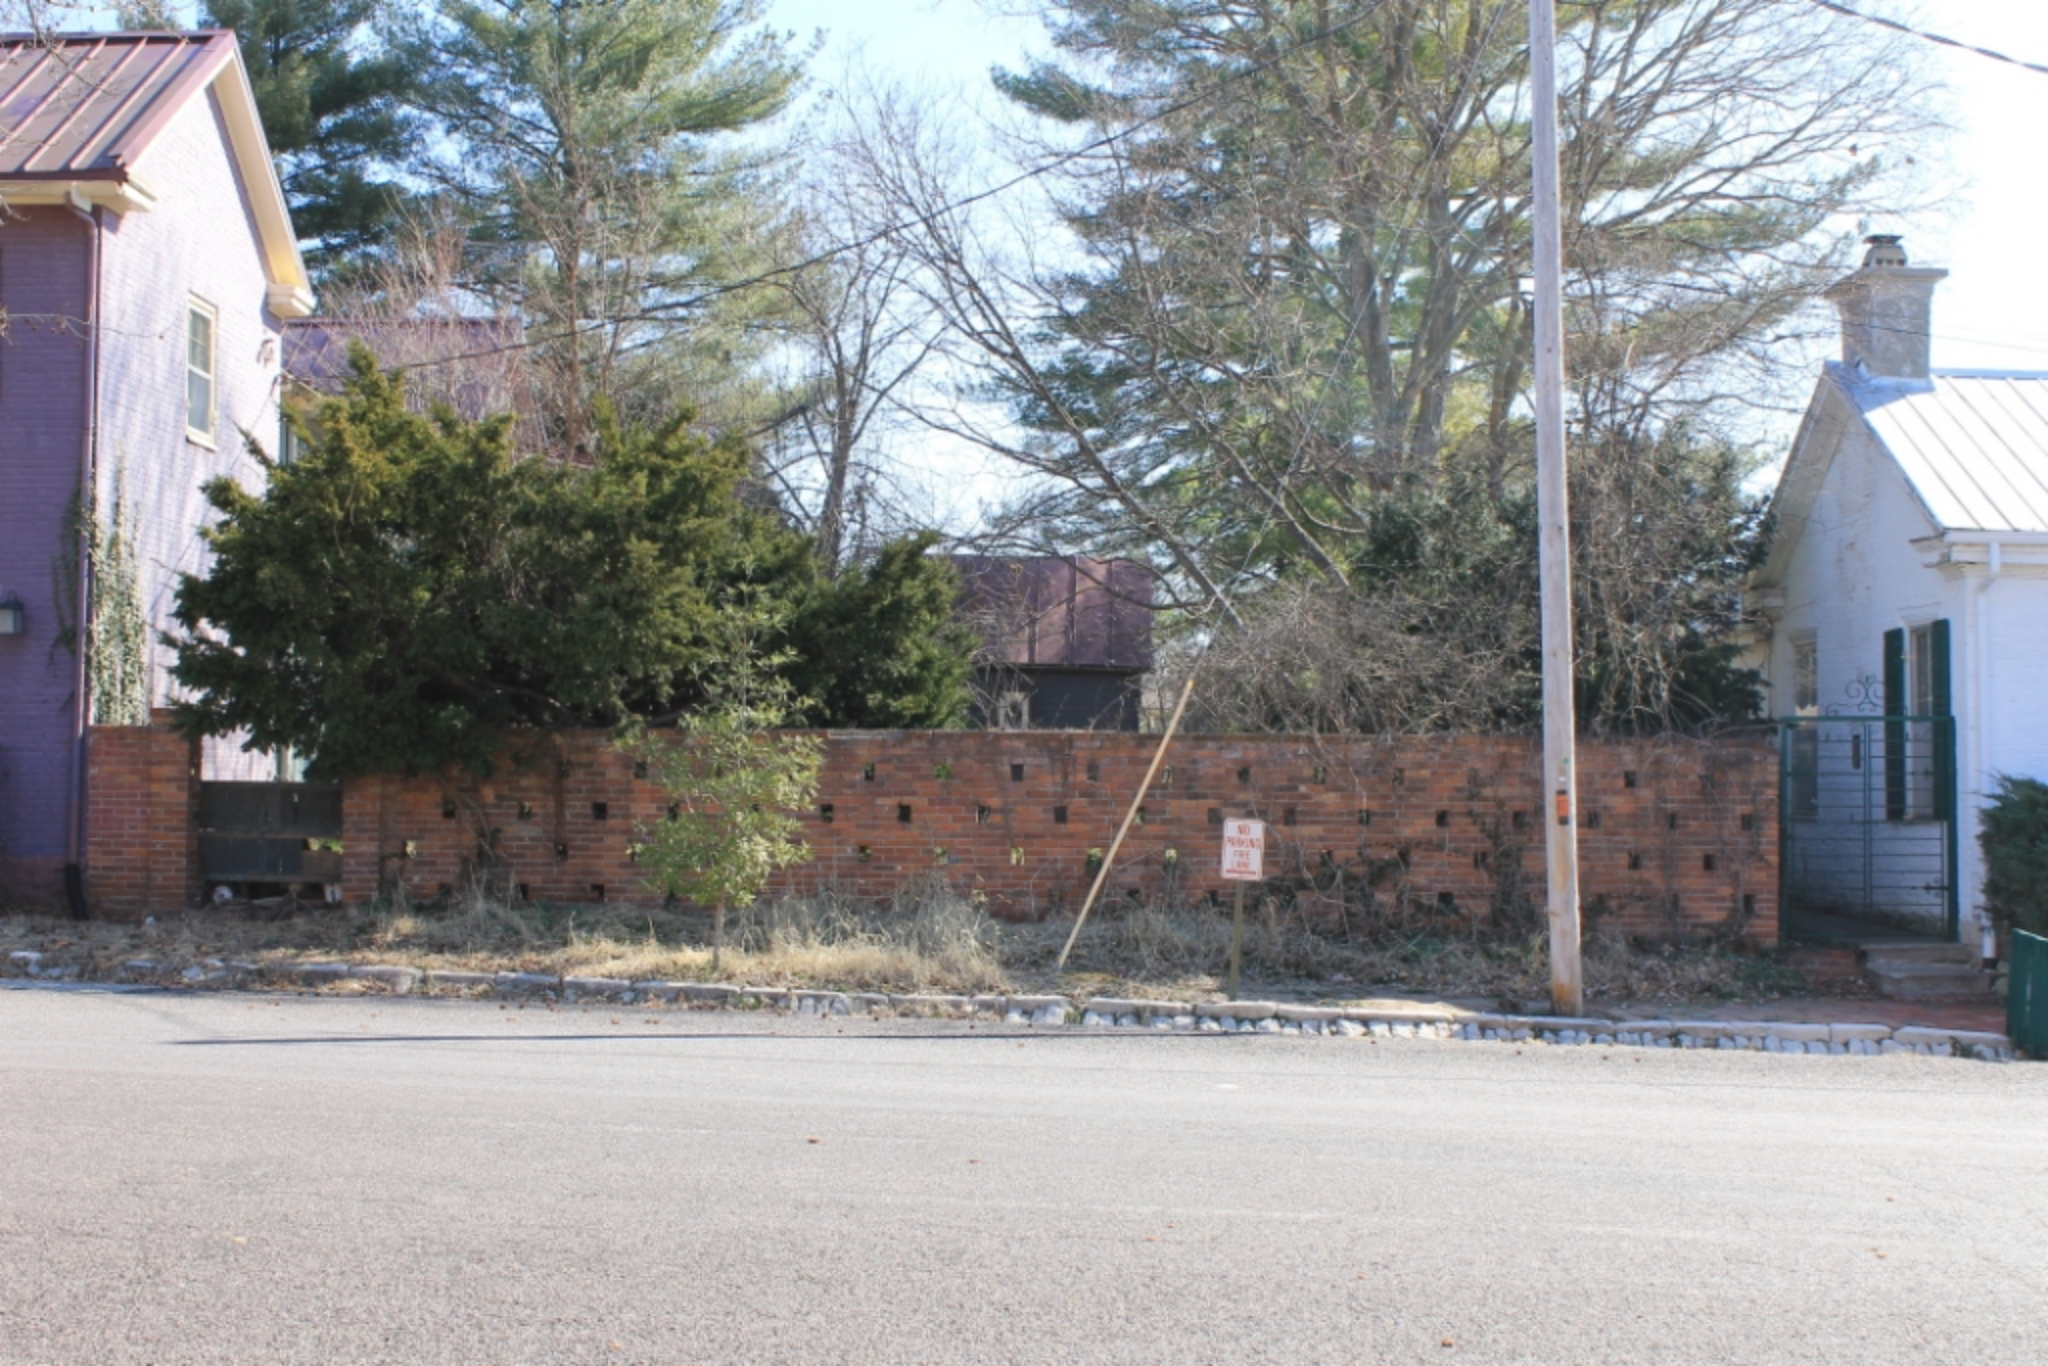
This two-story, brick, massed plan, Federal style dwelling consists of two wings whose gables face Second Street, a bridge wing between these gabled wings, and a 1 story board and batten garage wing on the east end of the house. The roof is metal. The first story of the Central Street facade has three bays. The left bay and the center bay each contain a 6 x 9 wooden window. The right bay contains a paneled door with a single pane transom. The windows and doors are topped with rows of vertically laid brick. The windows have stone sills. The door opens onto a small stoop. The second story of the Central Street facade has three evenly spaced bays, each containing a 6 x 6 wooden window. These windows are also topped with rows of vertically laid bricks. The Second Street facade has ten bays. The two left bays, which are located in the garage addition, each contains an overhead garage door. The next bay contains a window with 15 fixed glass panes. The next two bays, which are in the bridge wing, each contain a 6 x 9 wooden window. The next bay contains a door with a three paned transom. The next two bays each contain a 6 x 9 wooden window. The next bay contains a wooden door with glass panes. The two right bays each contain a 6 x 9 wooden window. The windows on this facade do not have the vertically laid brick at the tops, but they do have stone sills. The windows are accented with shutters. A chimney rises from the center ridge of the connecting wing. Another chimney rises from the north end of the gable fronted wing on the west end of the house.
