MISSOURI DEPARTMENT OF NATURAL RESOURCES
STATE HISTORIC PRESERVATION OFFICE, P.O. Box 176, Jefferson City, MO 65102
ARCHITECTURAL/HISTORIC INVENTORY FORM

1. SURVEY NO. BO-AS-009-0001		2. SURVEY NAME: Rocheport Historic District	
3. COUNTY: Boone		4. ADDRESS (STREET NO.)	STREET (NAME) Katy Trail
5. CITY: Rocheport	VICINITY: <input checked="" type="checkbox"/>	6. UTM: / /	LAT: LONG: T: 48W R: 15W S: 1

8. HISTORIC NAME (IF KNOWN): M.K.&T. Railroad tunnel		9. PRESENT/OTHER NAME (IF KNOWN): Katy trail tunnel	
10. OWNERSHIP: <input type="checkbox"/> PRIVATE <input checked="" type="checkbox"/> PUBLIC		11A. HISTORIC USE (IF KNOWN): railroad tunnel	11B. CURRENT USE: Katy Trail tunnel
HISTORICAL INFORMATION

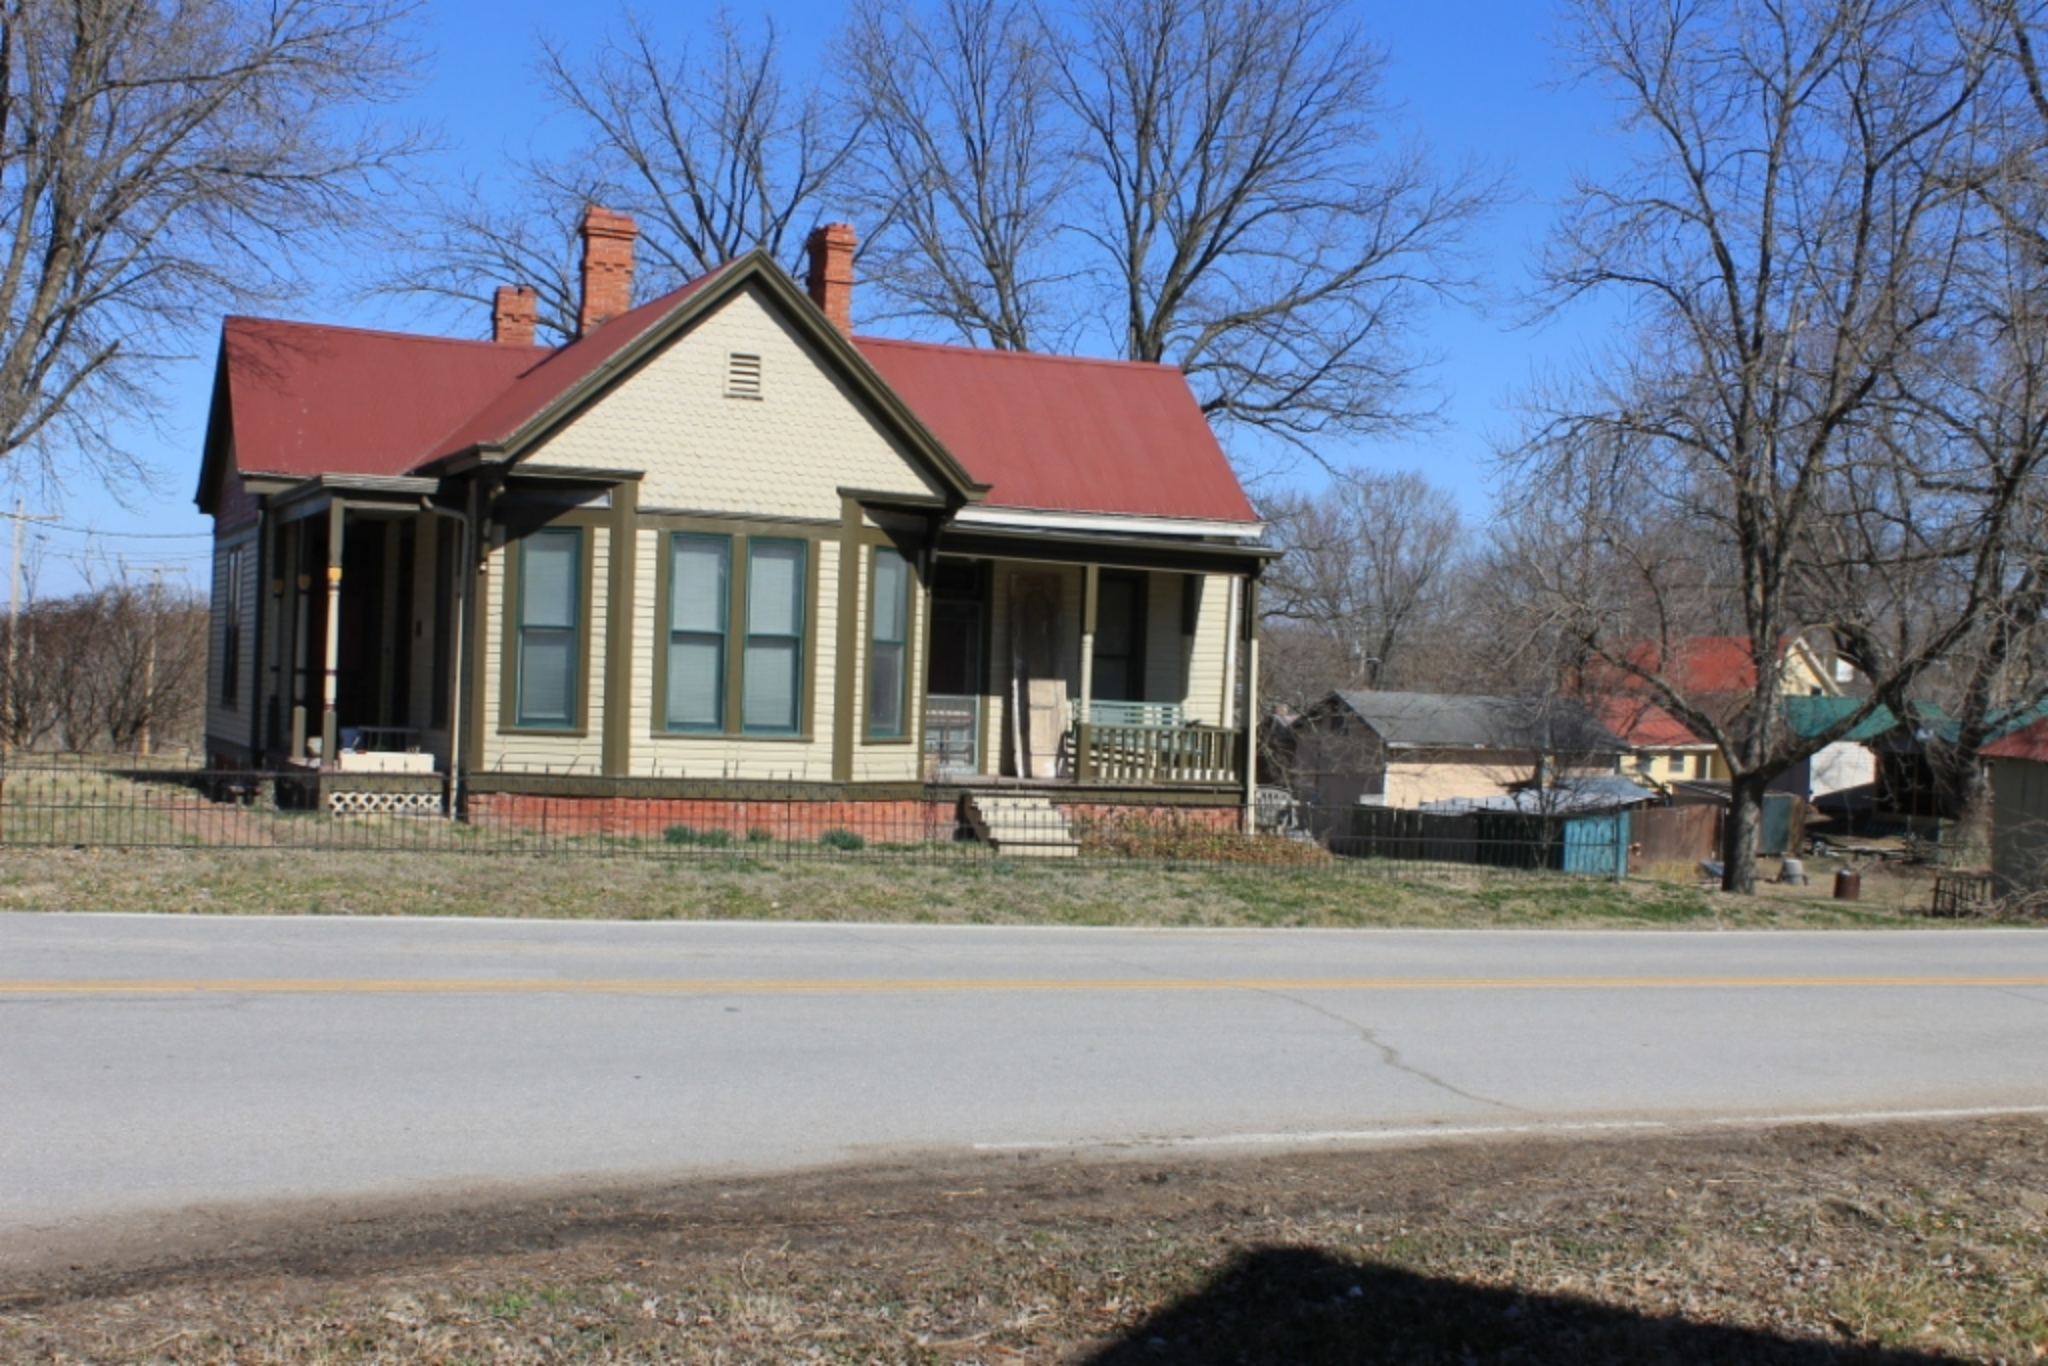
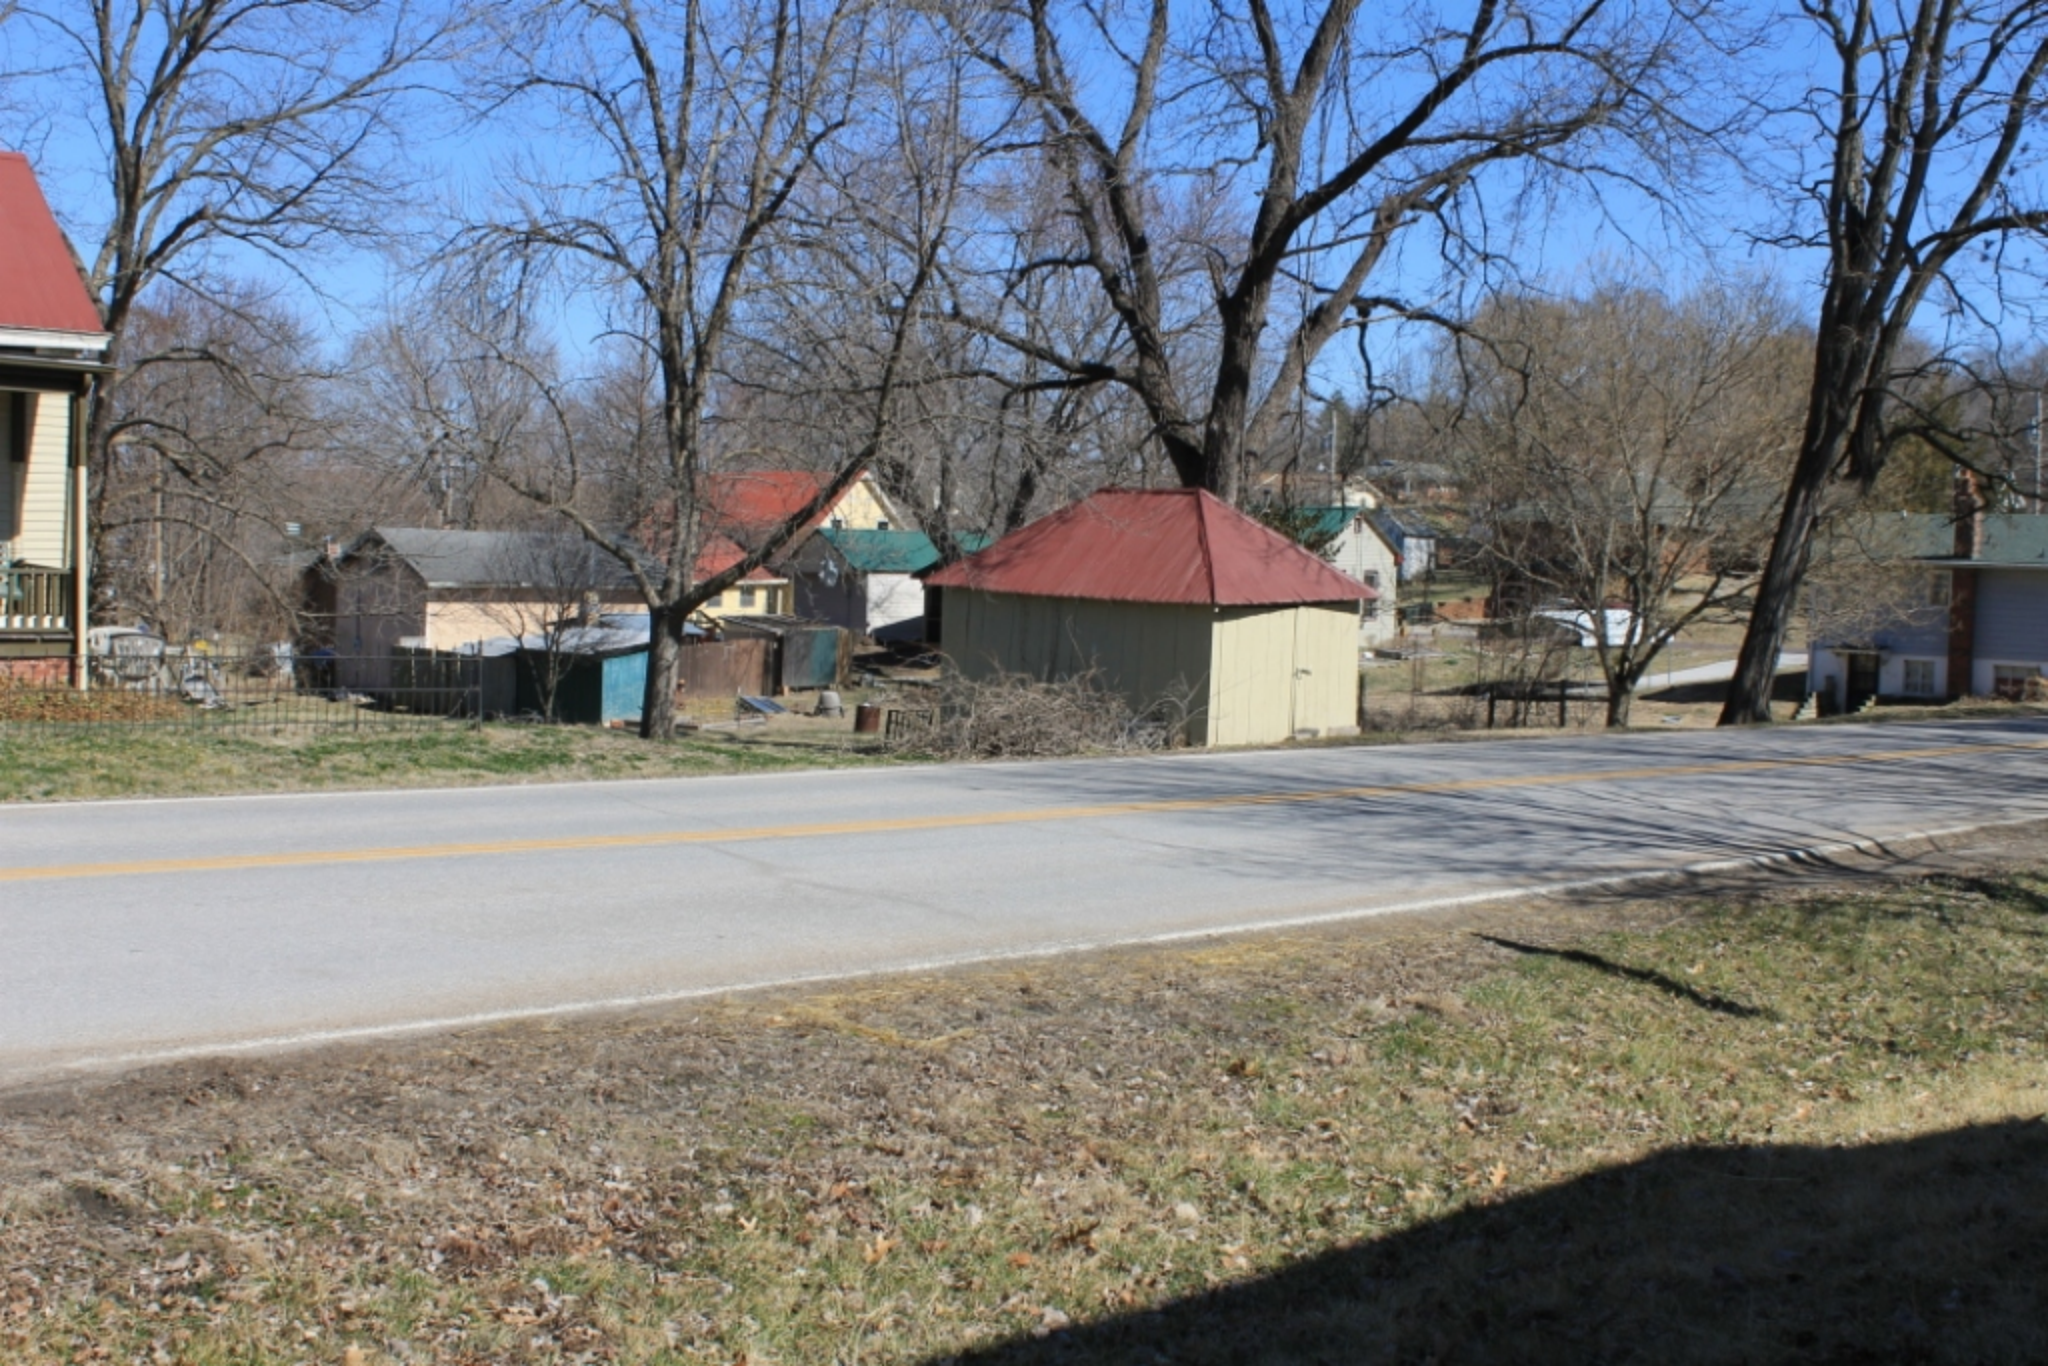
The one-story, massed plan, Folk Victorian, frame house with a slightly off-center cross gable roofed wing faces Third Street. The wall is clad in clapboards. The roof is of metal. The pediment under the gable roof is covered in fishlap shingles. The gable roof overhangs the canted walls that create a bay window that fronts the wing. Curved decorative brackets support the roof above the canted walls. On the west side of the gable roofed wing is a small flat roofed porch with turned spindles. On the east side of the gable roofed wing is a larger flat roofed porch with turned spindles and a railing. The front (south) facade of the house has six bays. The leftmost bay, which is under the west porch, contains a door. The next three bays, which are in the bay window created by the gable roofed wing, contain a single one-over-one wooden window, a pair of one-over-one wooden windows, and a single one-over-one wooden window. The next bay, which is under the east porch, contains a door with a wooden screen door. The rightmost bay contains a one-over-one wooden window. A band of decorative trim extends along the lintel line of the windows in the gable roofed wing to each edge of the wing. The house has three chimneys, two at the ridge of the main block of the house and the other on a wing to the rear of the main block of the house.

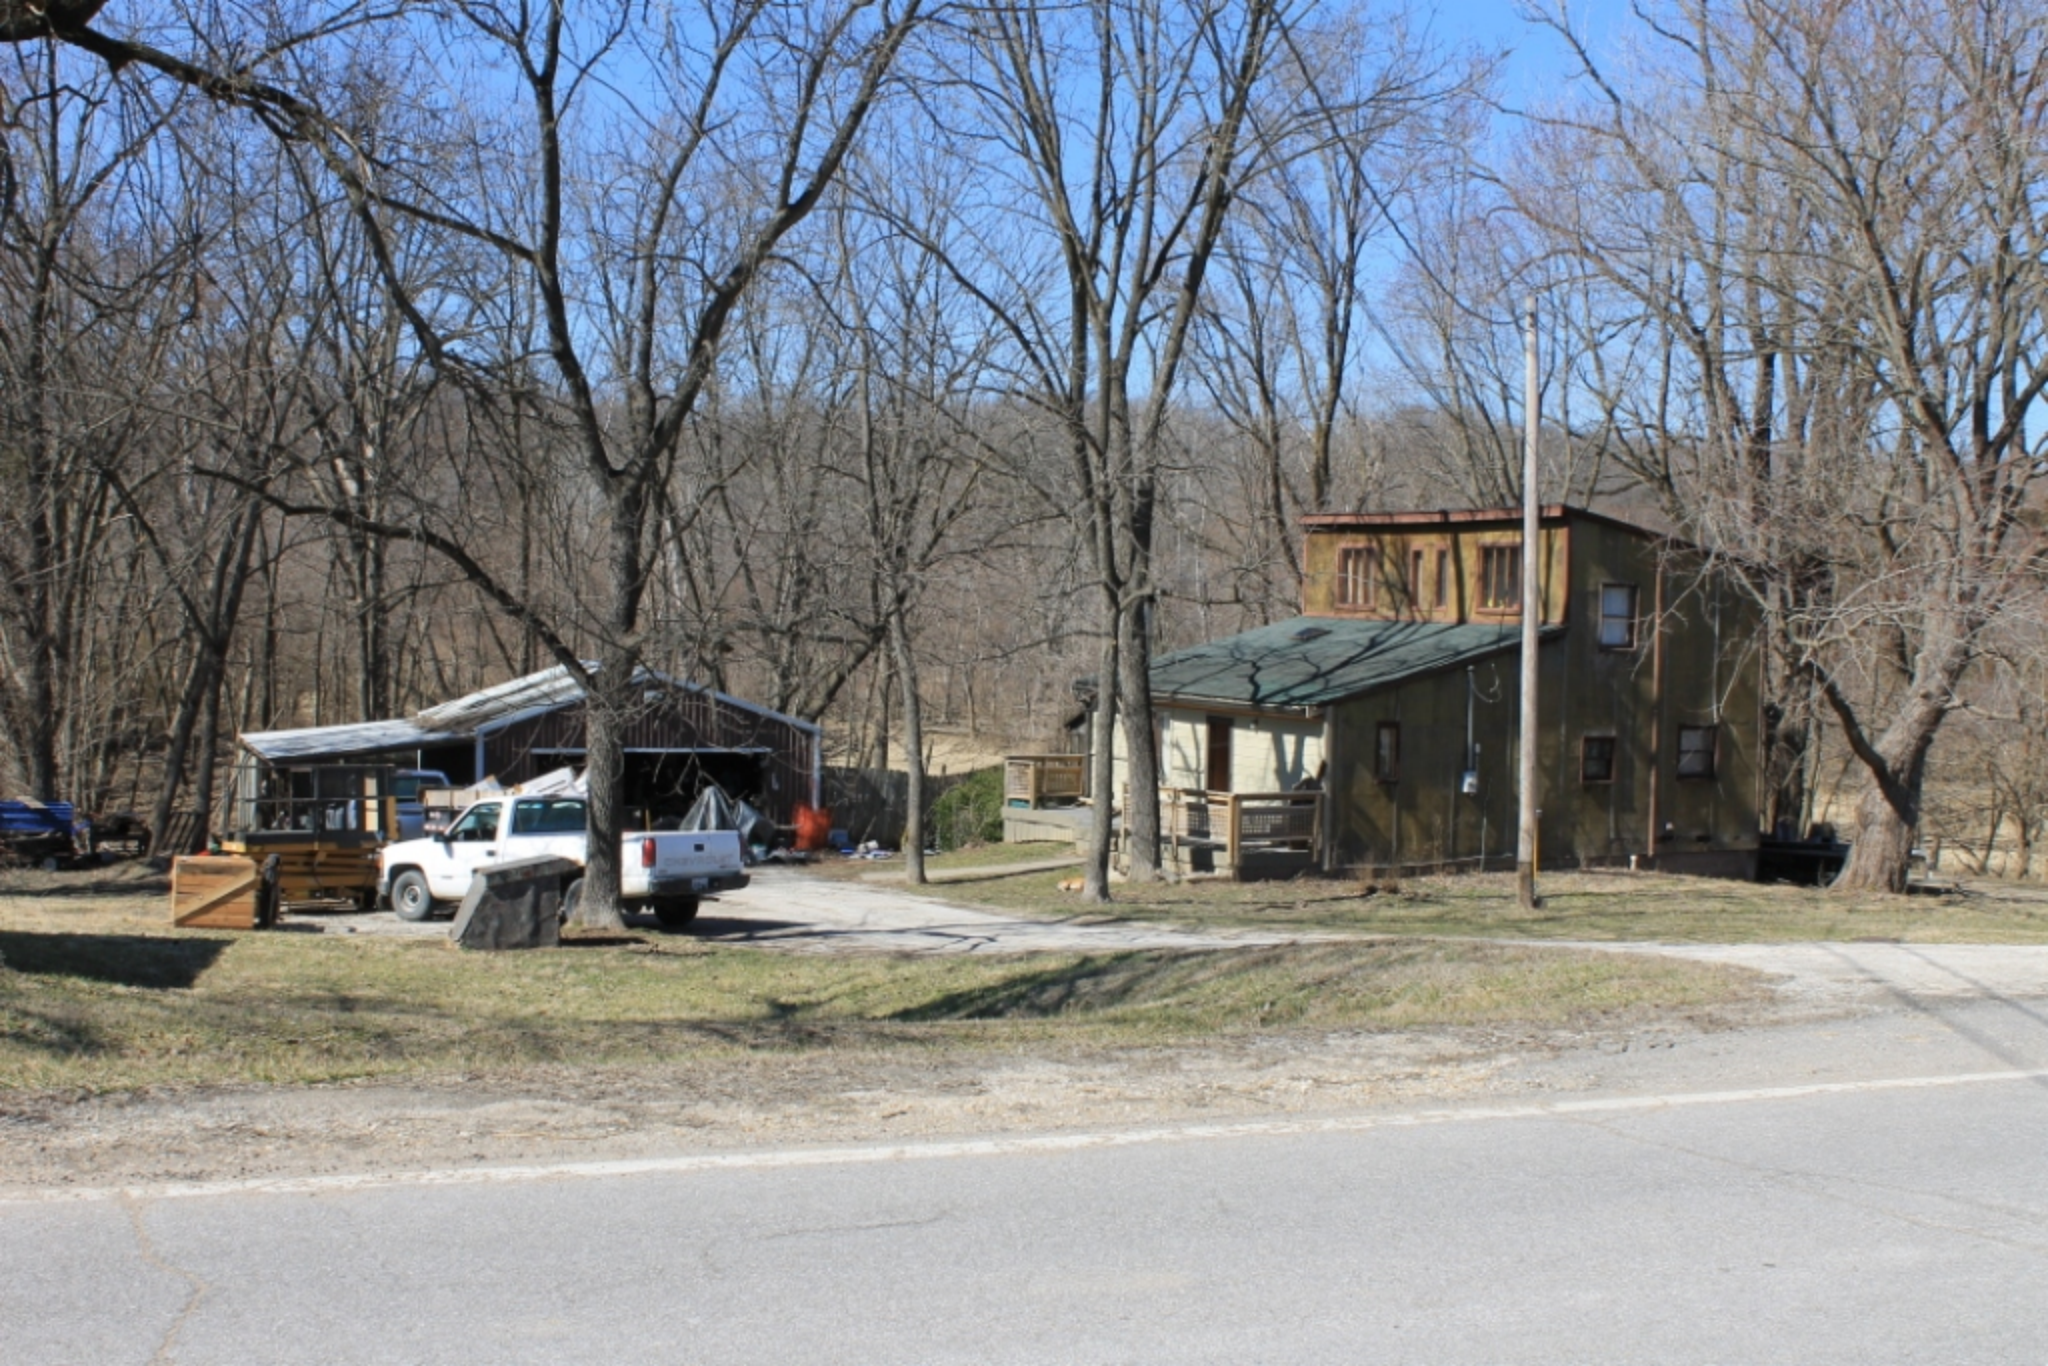
The massed plan Shed style house is clad in board and battens. The roof is covered in asphalt singles. The left wing of the building is a one story wing with a shed roof covered in asphalt shingles. A deck opens off this wing. The right wing of the building is a two story wing with a shed roof. The south facade of the one-story wing is clad in wide clapboards. The south facade has two bays. The left bay contains a fixed pane window and the right bay containing a door. The second story of the south facade of the two story wing has four bays that overlook the roof of the one story wing. The far left bay contains three fixed pane windows. To the right is a bay containing one fixed pane window. To the right of that bay is another bay containing one fixed pane window. To the right end of the building is a bay containing a group of three fixed pane windows. The east facade of the house has three bays. The left bay contains a fixed pane window. The center bay contains a one-over-one single hung window. The right bay contains a one-over-one single hung window. The second story of the east facade has one bay containing a one-over-one single hung window.

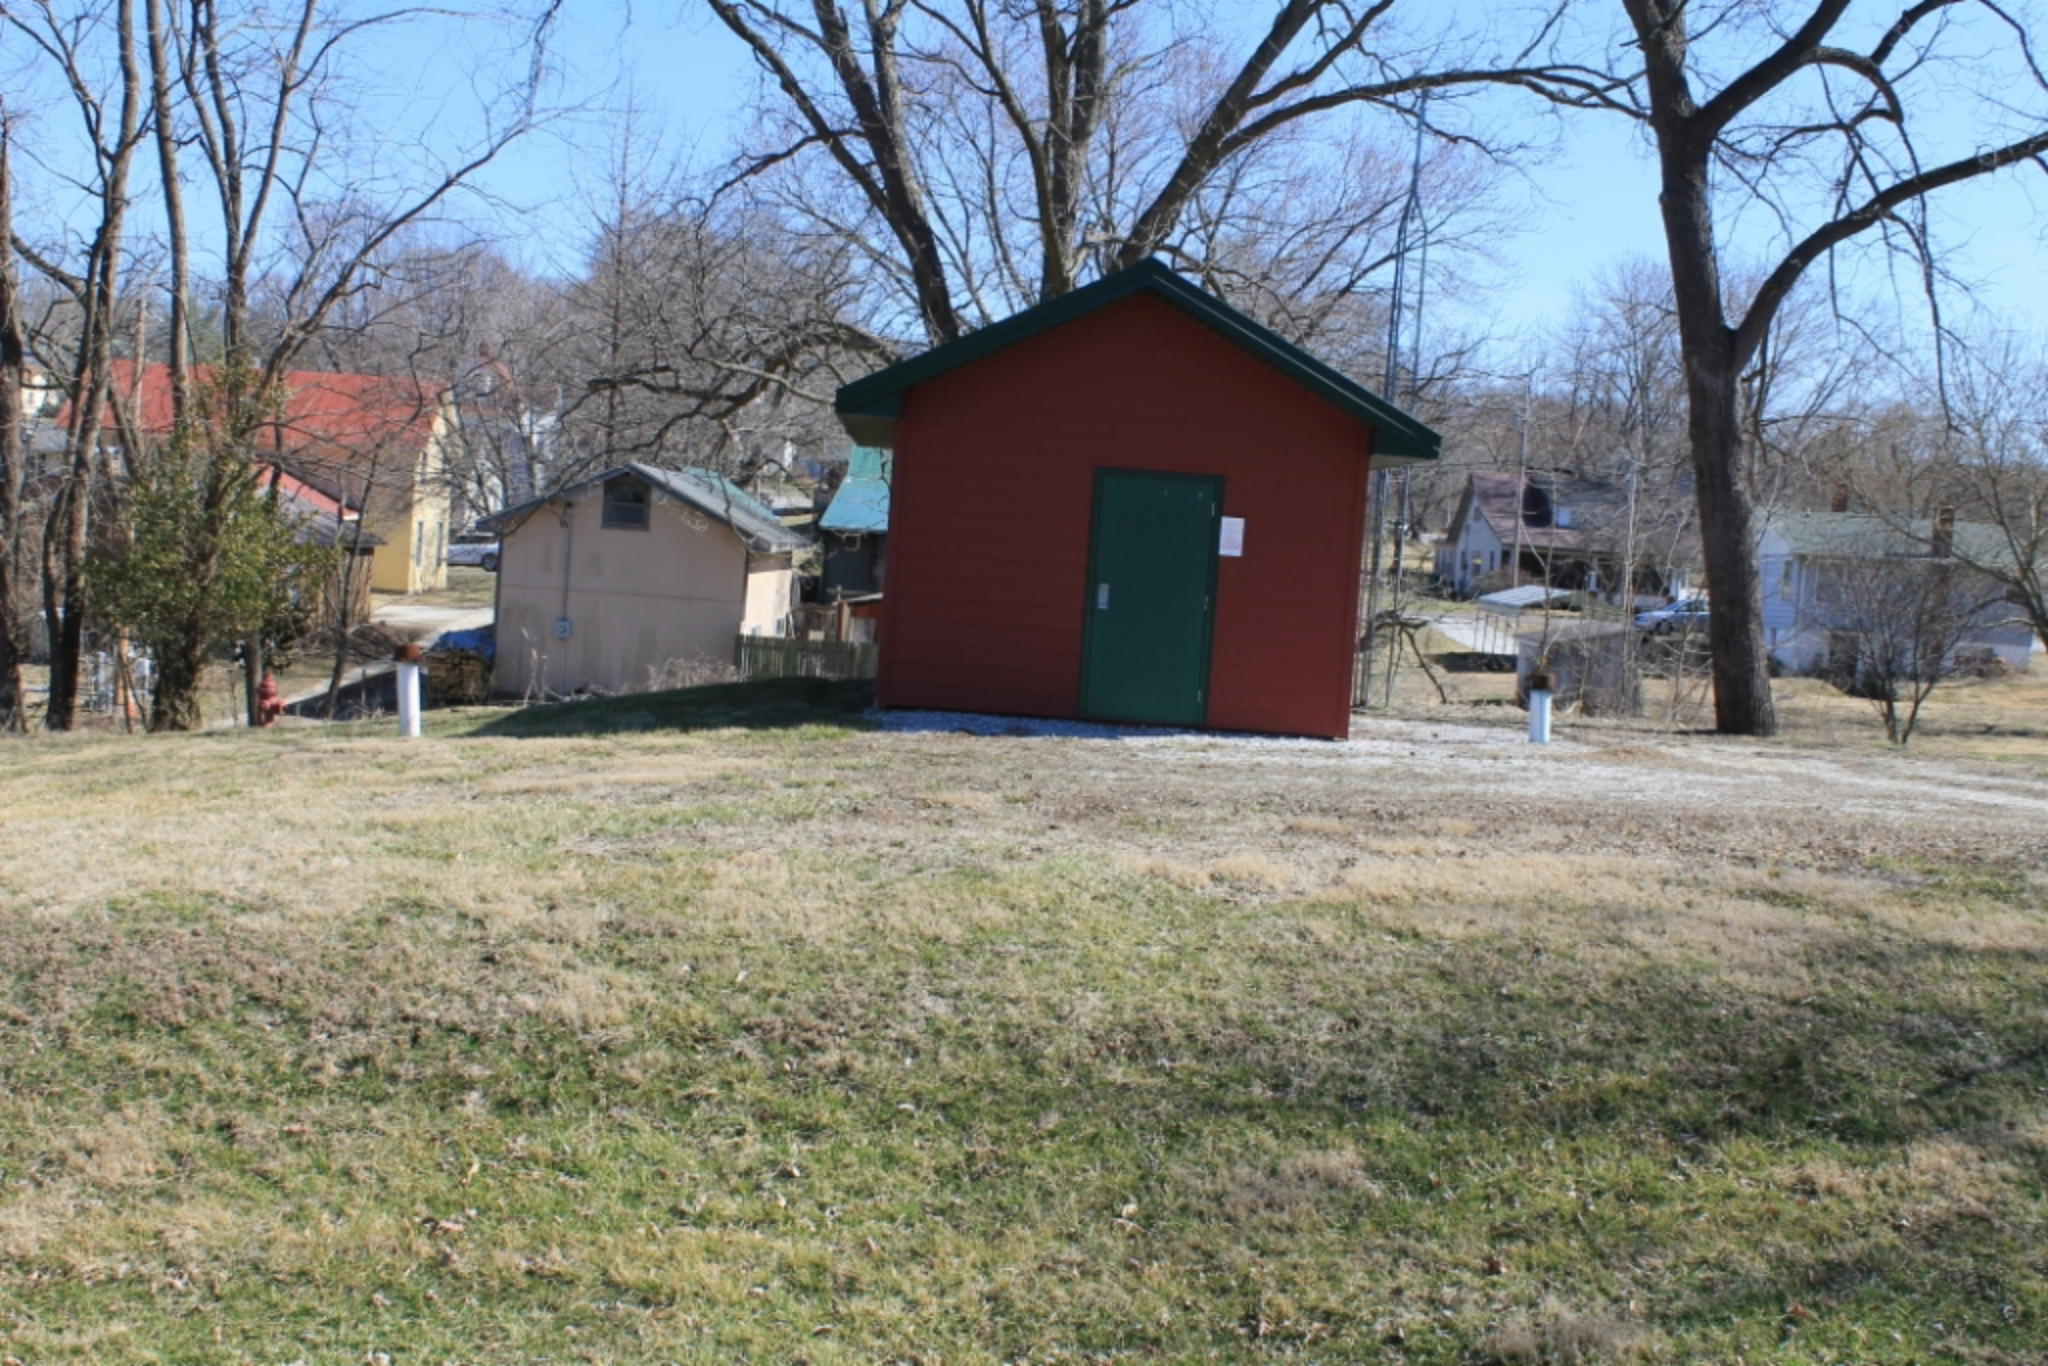
This simple one-story gable roofed utility building is clad in clapboards; its roof is covered in asphalt shingles. The building has one bay on the west facade; the bay contains a door.

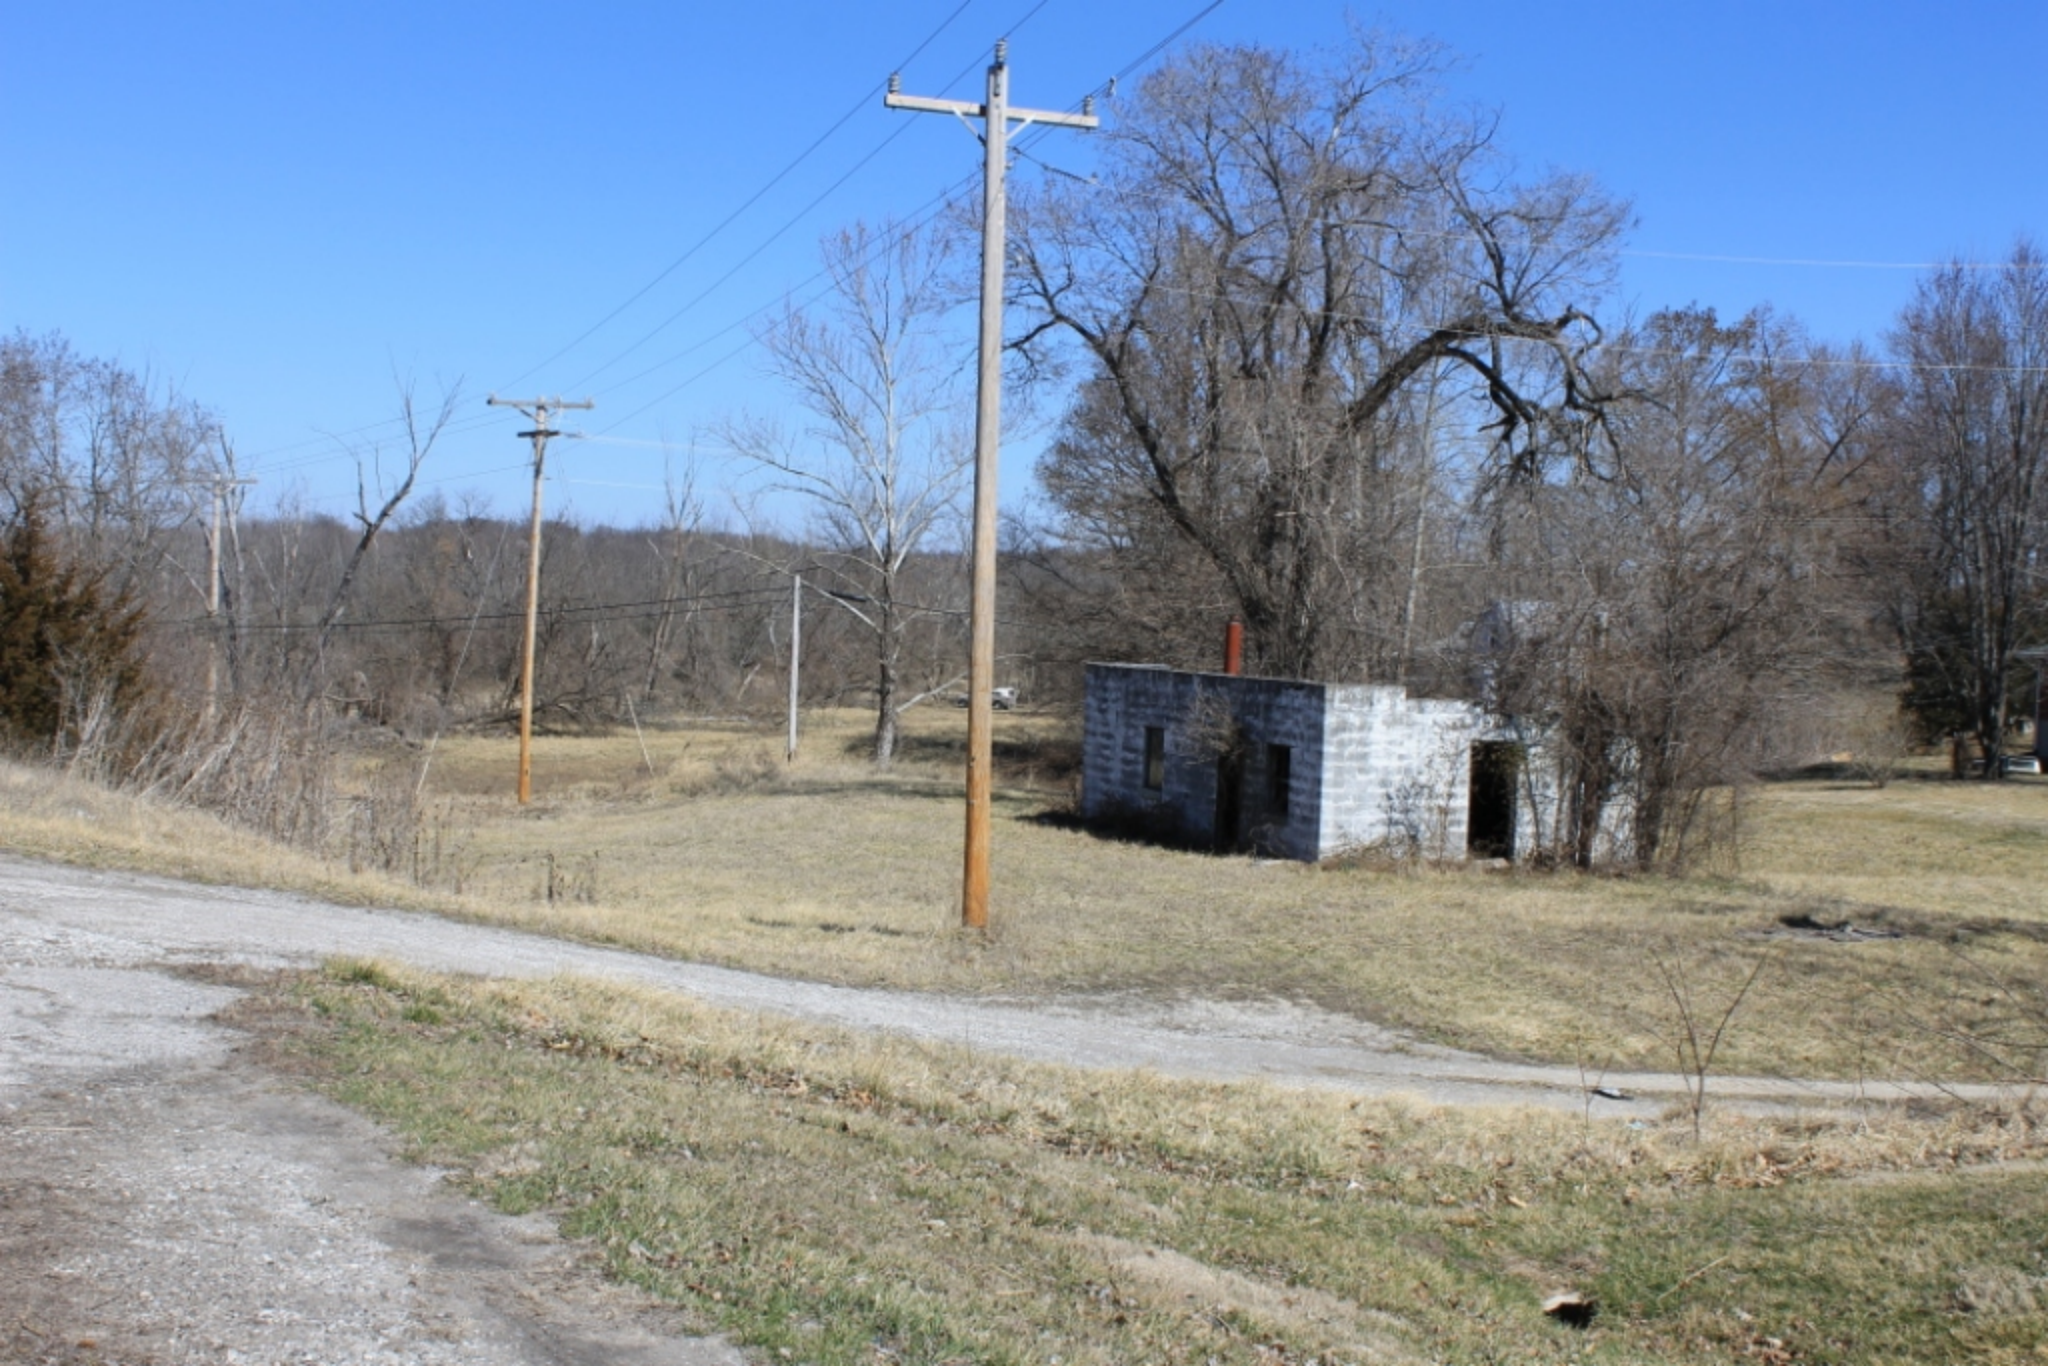
The one-story concrete block building has a stepped parapet on the north and south sides and a slightly sloping shed roof behind the parapet. The front (west) facade of the building has three bays; the left bay contains a two-over-two window, the center bay contains a door, and the right bay contains a two-over-two window. The glass is missing from some windows and vertical boards have been used to replace them. The side (south) facade has one bay containing a door centered on the wall. The building has one chimney, centered on the north side.

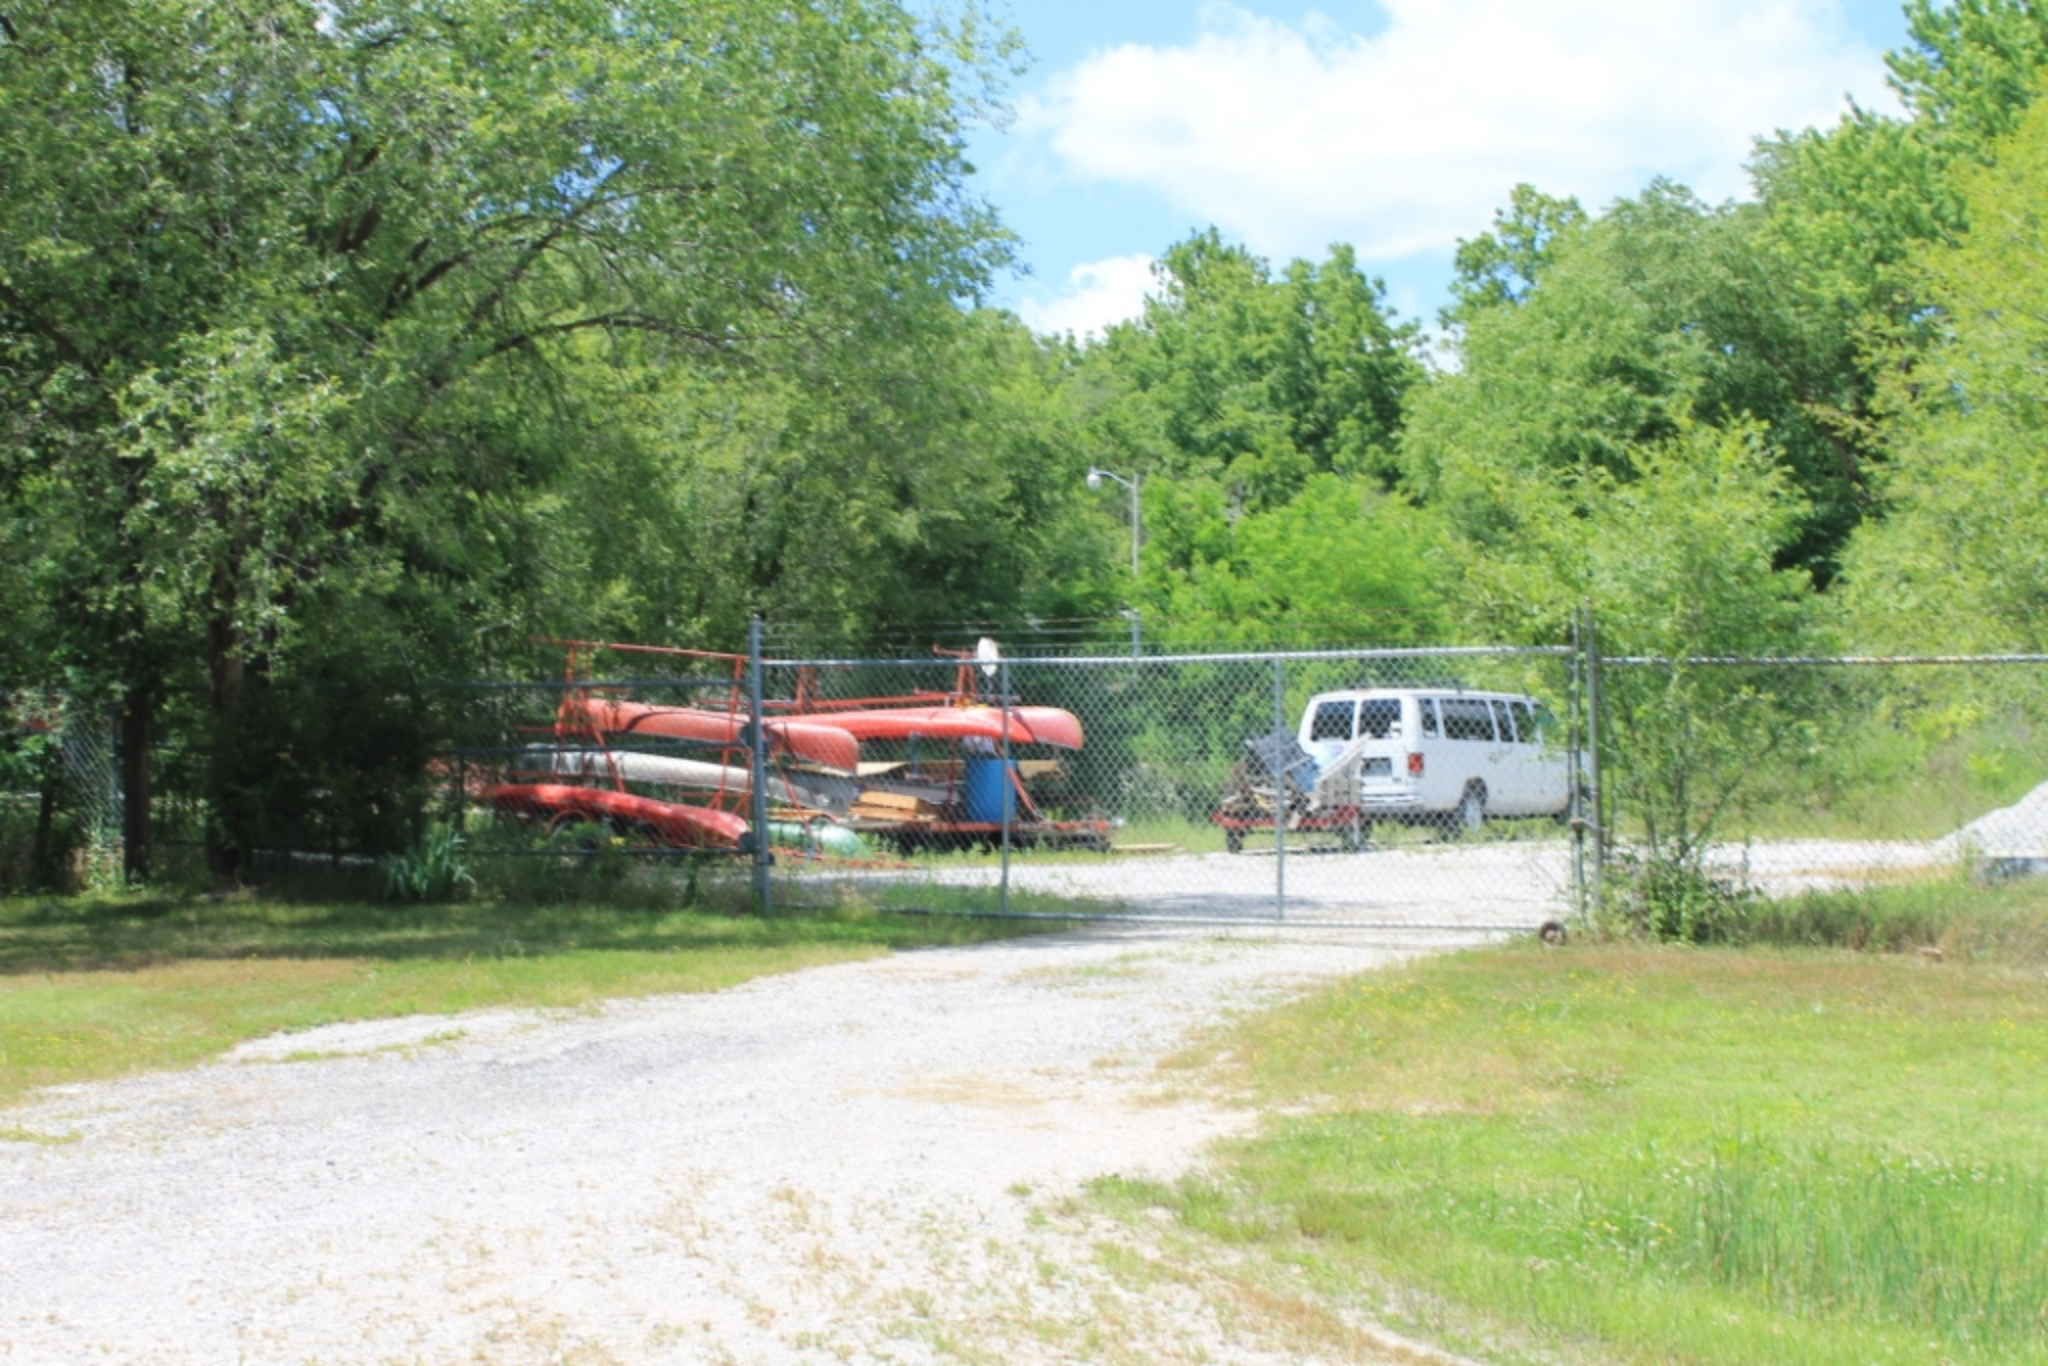
This gravel parking lot is surrounded by a chain link fence. It is used to store canoes and vehicles for the Might MO Canoe Rental. It is not marked into parking spaces.
