MISSOURI DEPARTMENT OF NATURAL RESOURCES
STATE HISTORIC PRESERVATION OFFICE, P.O. Box 176, Jefferson City, MO 65102
ARCHITECTURAL/HISTORIC INVENTORY FORM

1. SURVEY NO. BO-AS-009-0001		2. SURVEY NAME: Rocheport Historic District	
3. COUNTY: Boone		4. ADDRESS (STREET NO.)	STREET (NAME) Katy Trail
5. CITY: Rocheport	VICINITY: <input checked="" type="checkbox"/>	6. UTM: / /	LAT: LONG: T: 48W R: 15W S: 1

8. HISTORIC NAME (IF KNOWN): M.K.&T. Railroad tunnel		9. PRESENT/OTHER NAME (IF KNOWN): Katy trail tunnel	
10. OWNERSHIP: <input type="checkbox"/> PRIVATE <input checked="" type="checkbox"/> PUBLIC		11A. HISTORIC USE (IF KNOWN): railroad tunnel	11B. CURRENT USE: Katy Trail tunnel
HISTORICAL INFORMATION

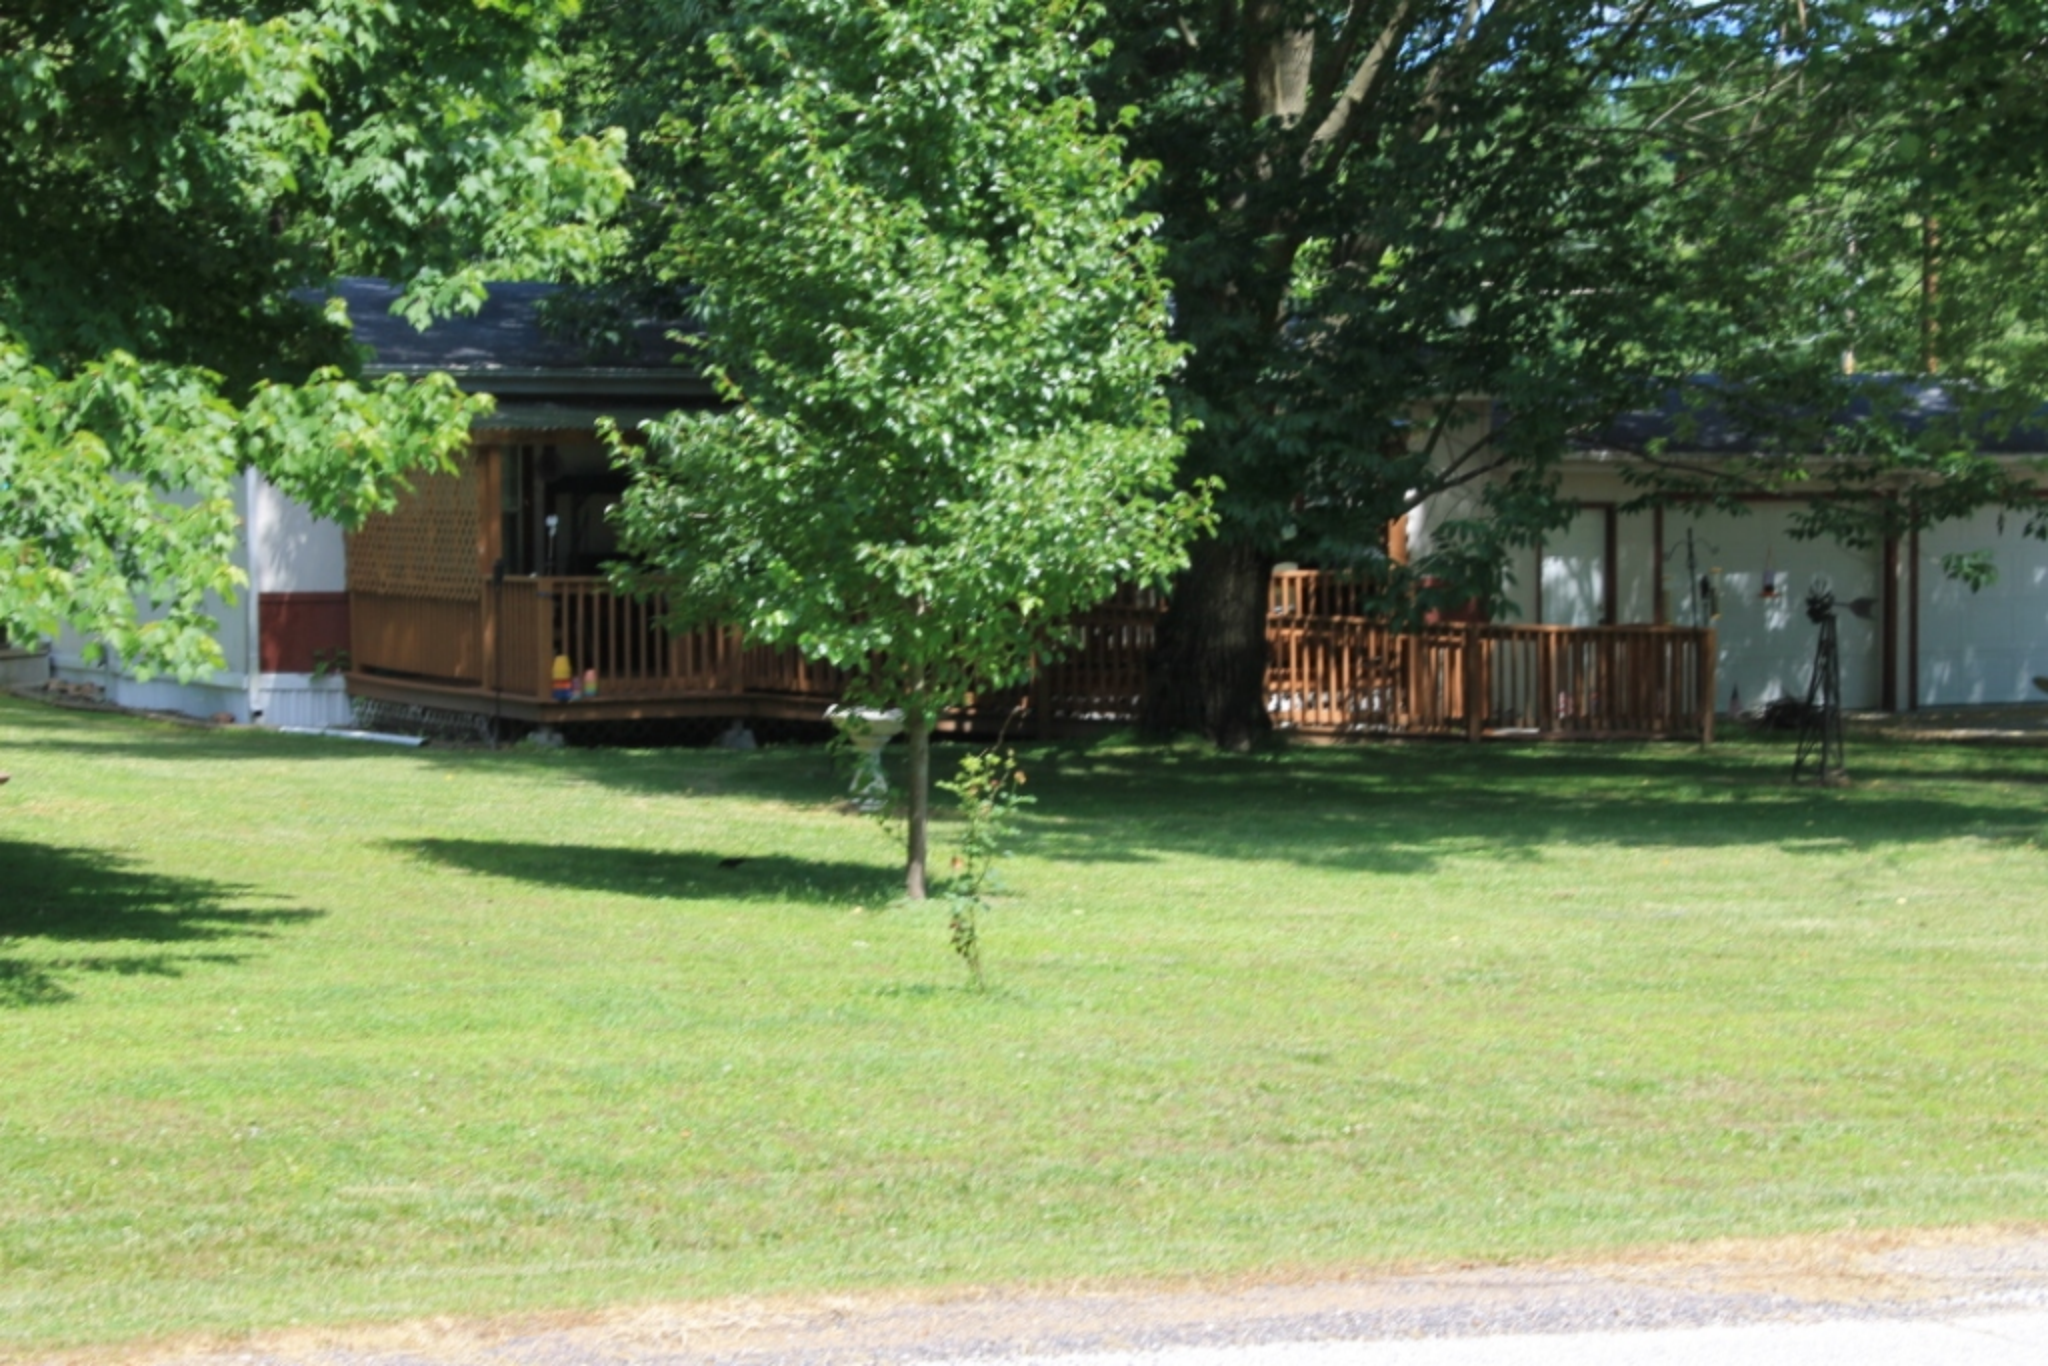
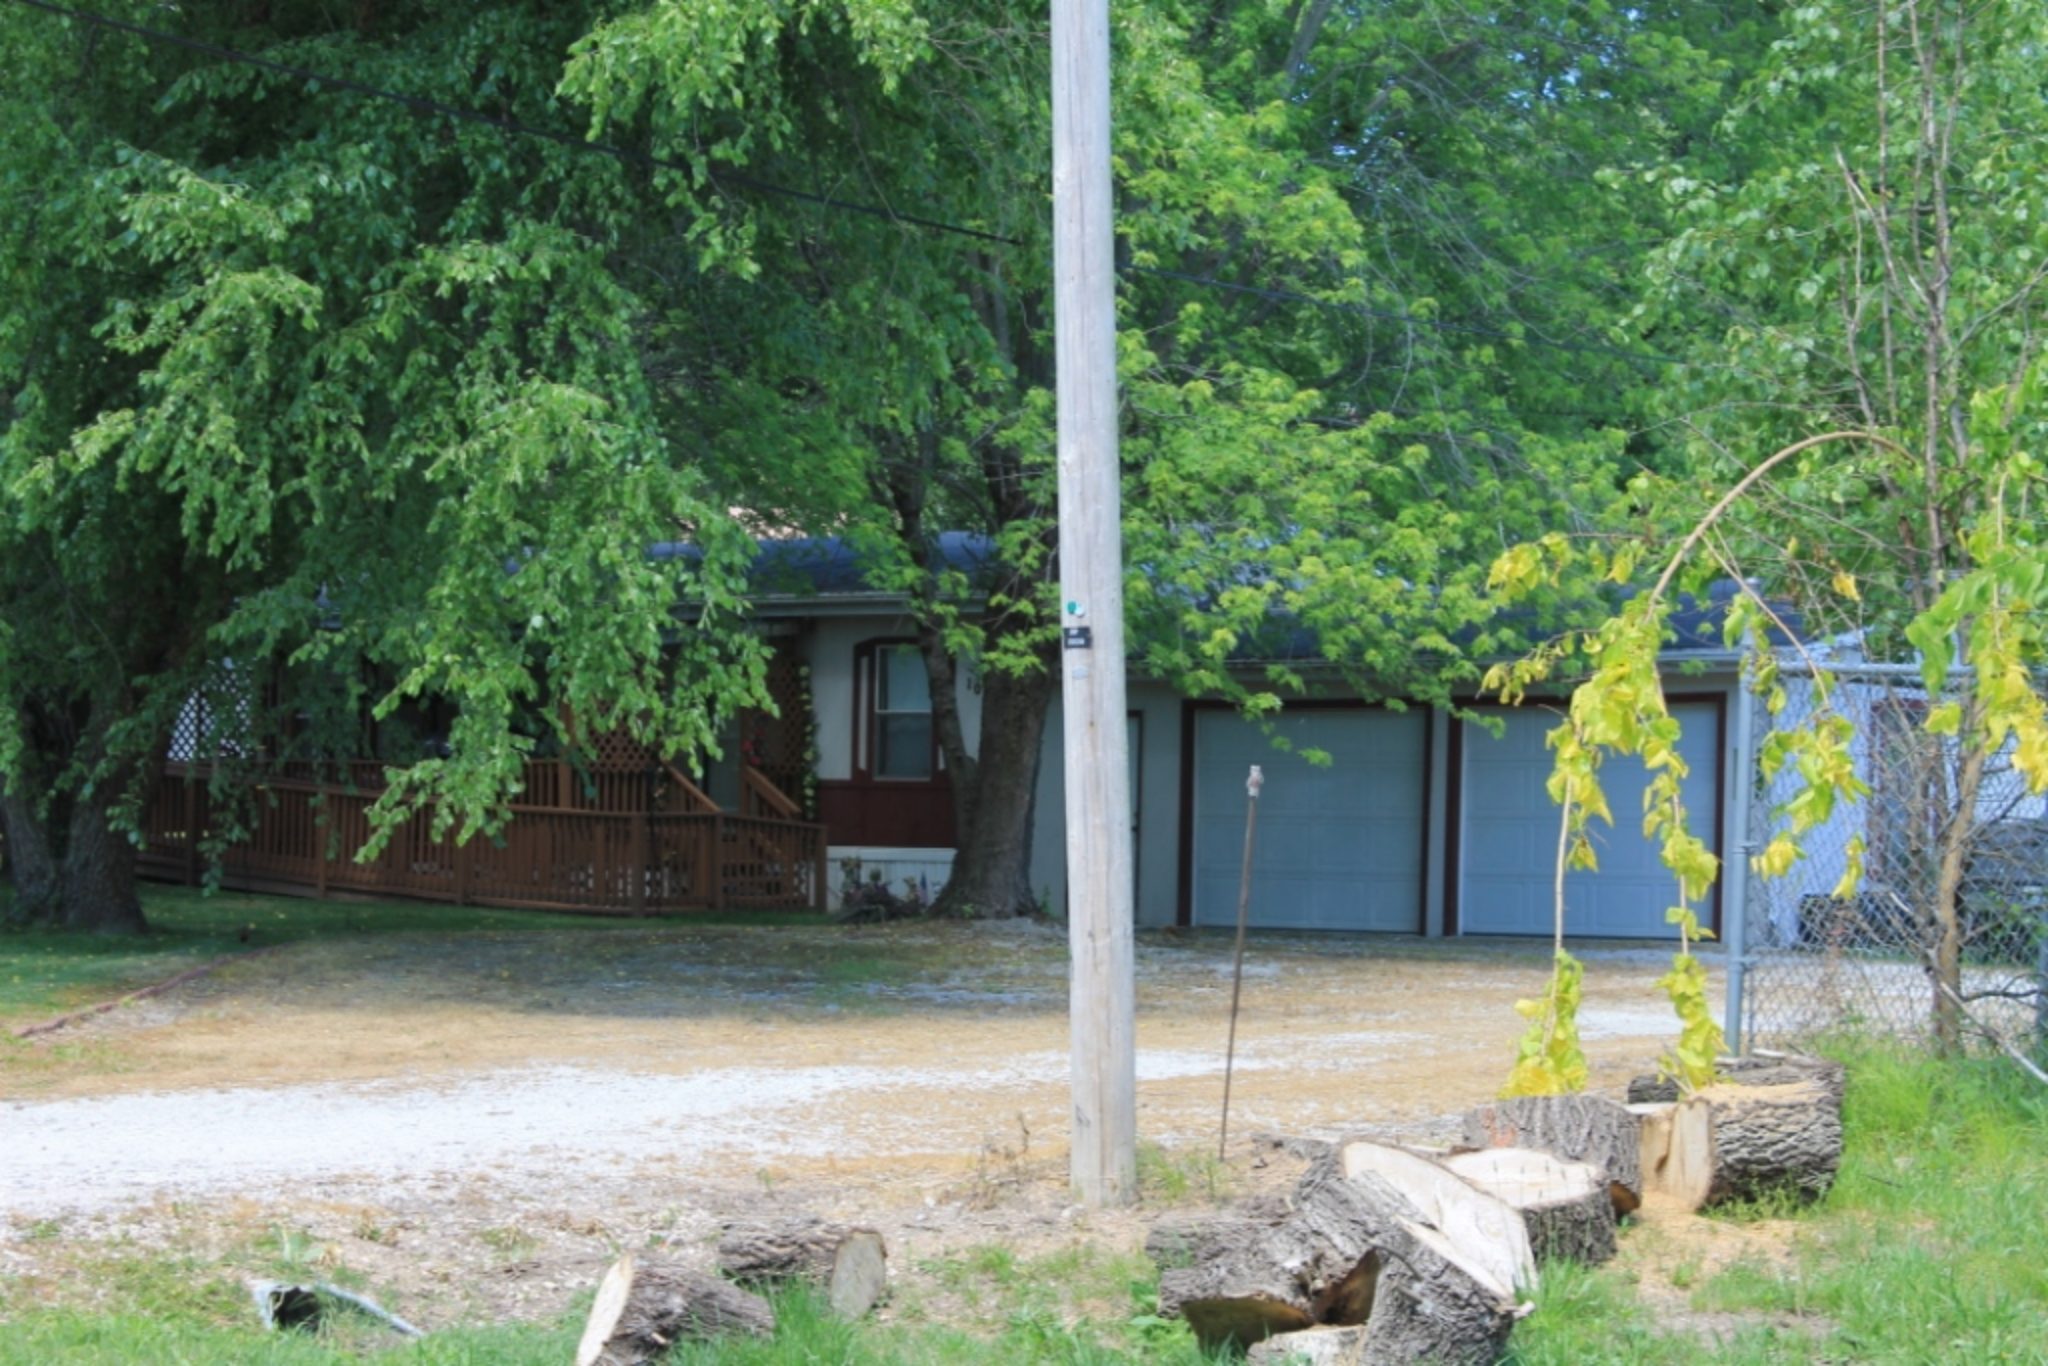
This one story, massed plan, side gable double wide mobile/modular ranch house is clad in vertical metal siding. The low gabled roof is covered in asphalt shingles. The building has two wings, with the south wing having a lower roofline than the north wing. The front (west) facade has eight bays. The leftmost bay contains a one-over-one single hung window. The next bay also has a one-over-one single hung window. The third bay also contains a one-over-one single hung window. The fourth bay contains a door. The fifth bay contains a one-over-one single hung window. The windows are accented with decorative shutters. The next three bays are in the garage attached to the right side of the building. The next bay contains a walk out door. The two rightmost bays contain overhead garage doors. A wooden ramp leads to the porch to allow handicapped accessibility.

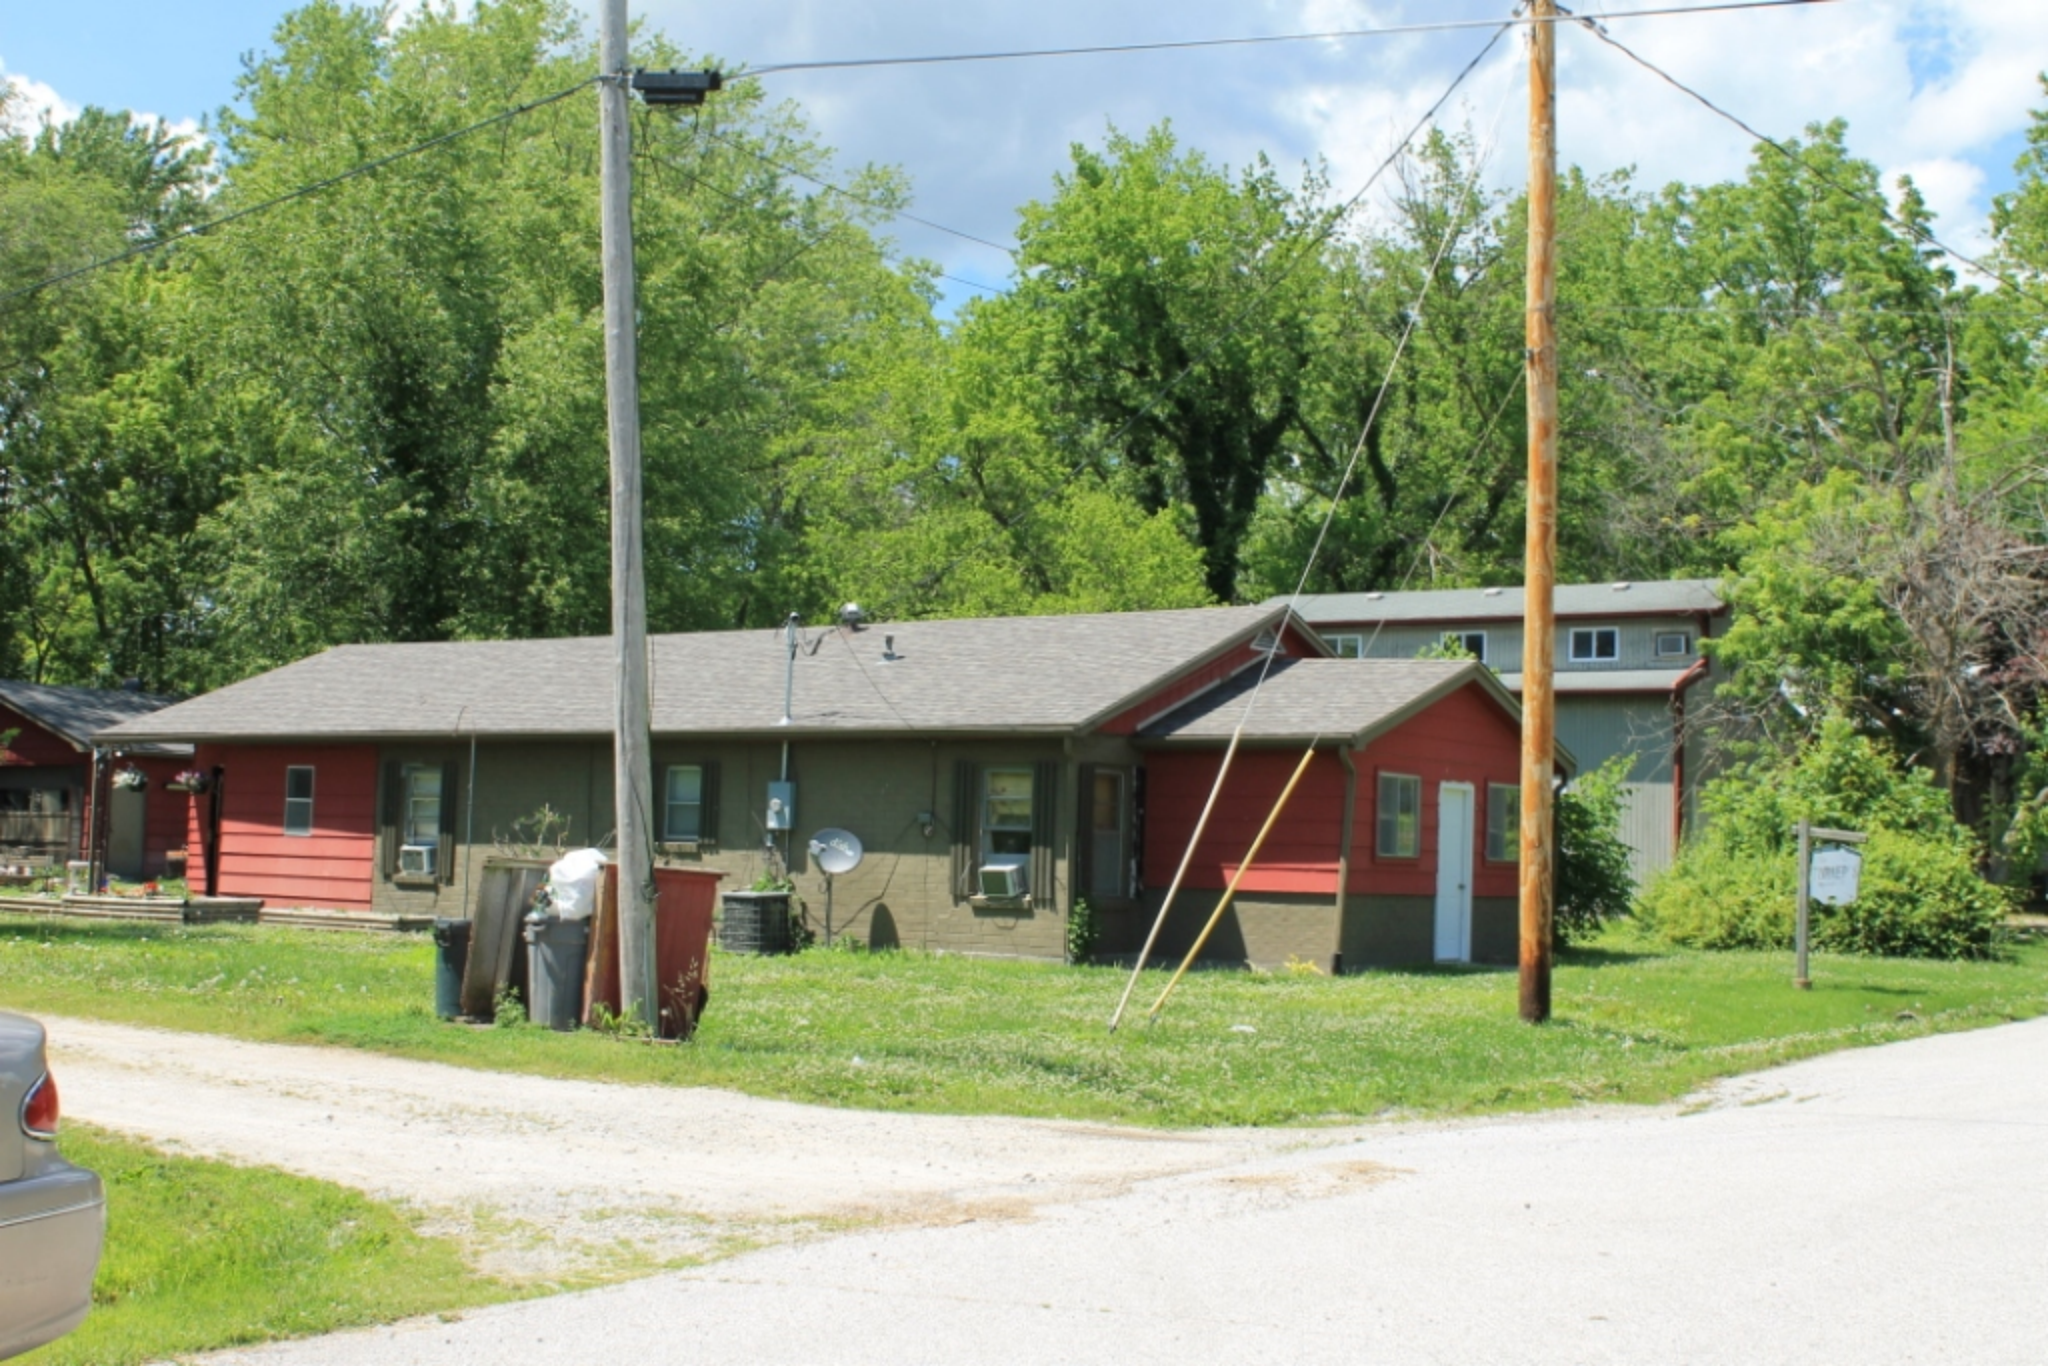
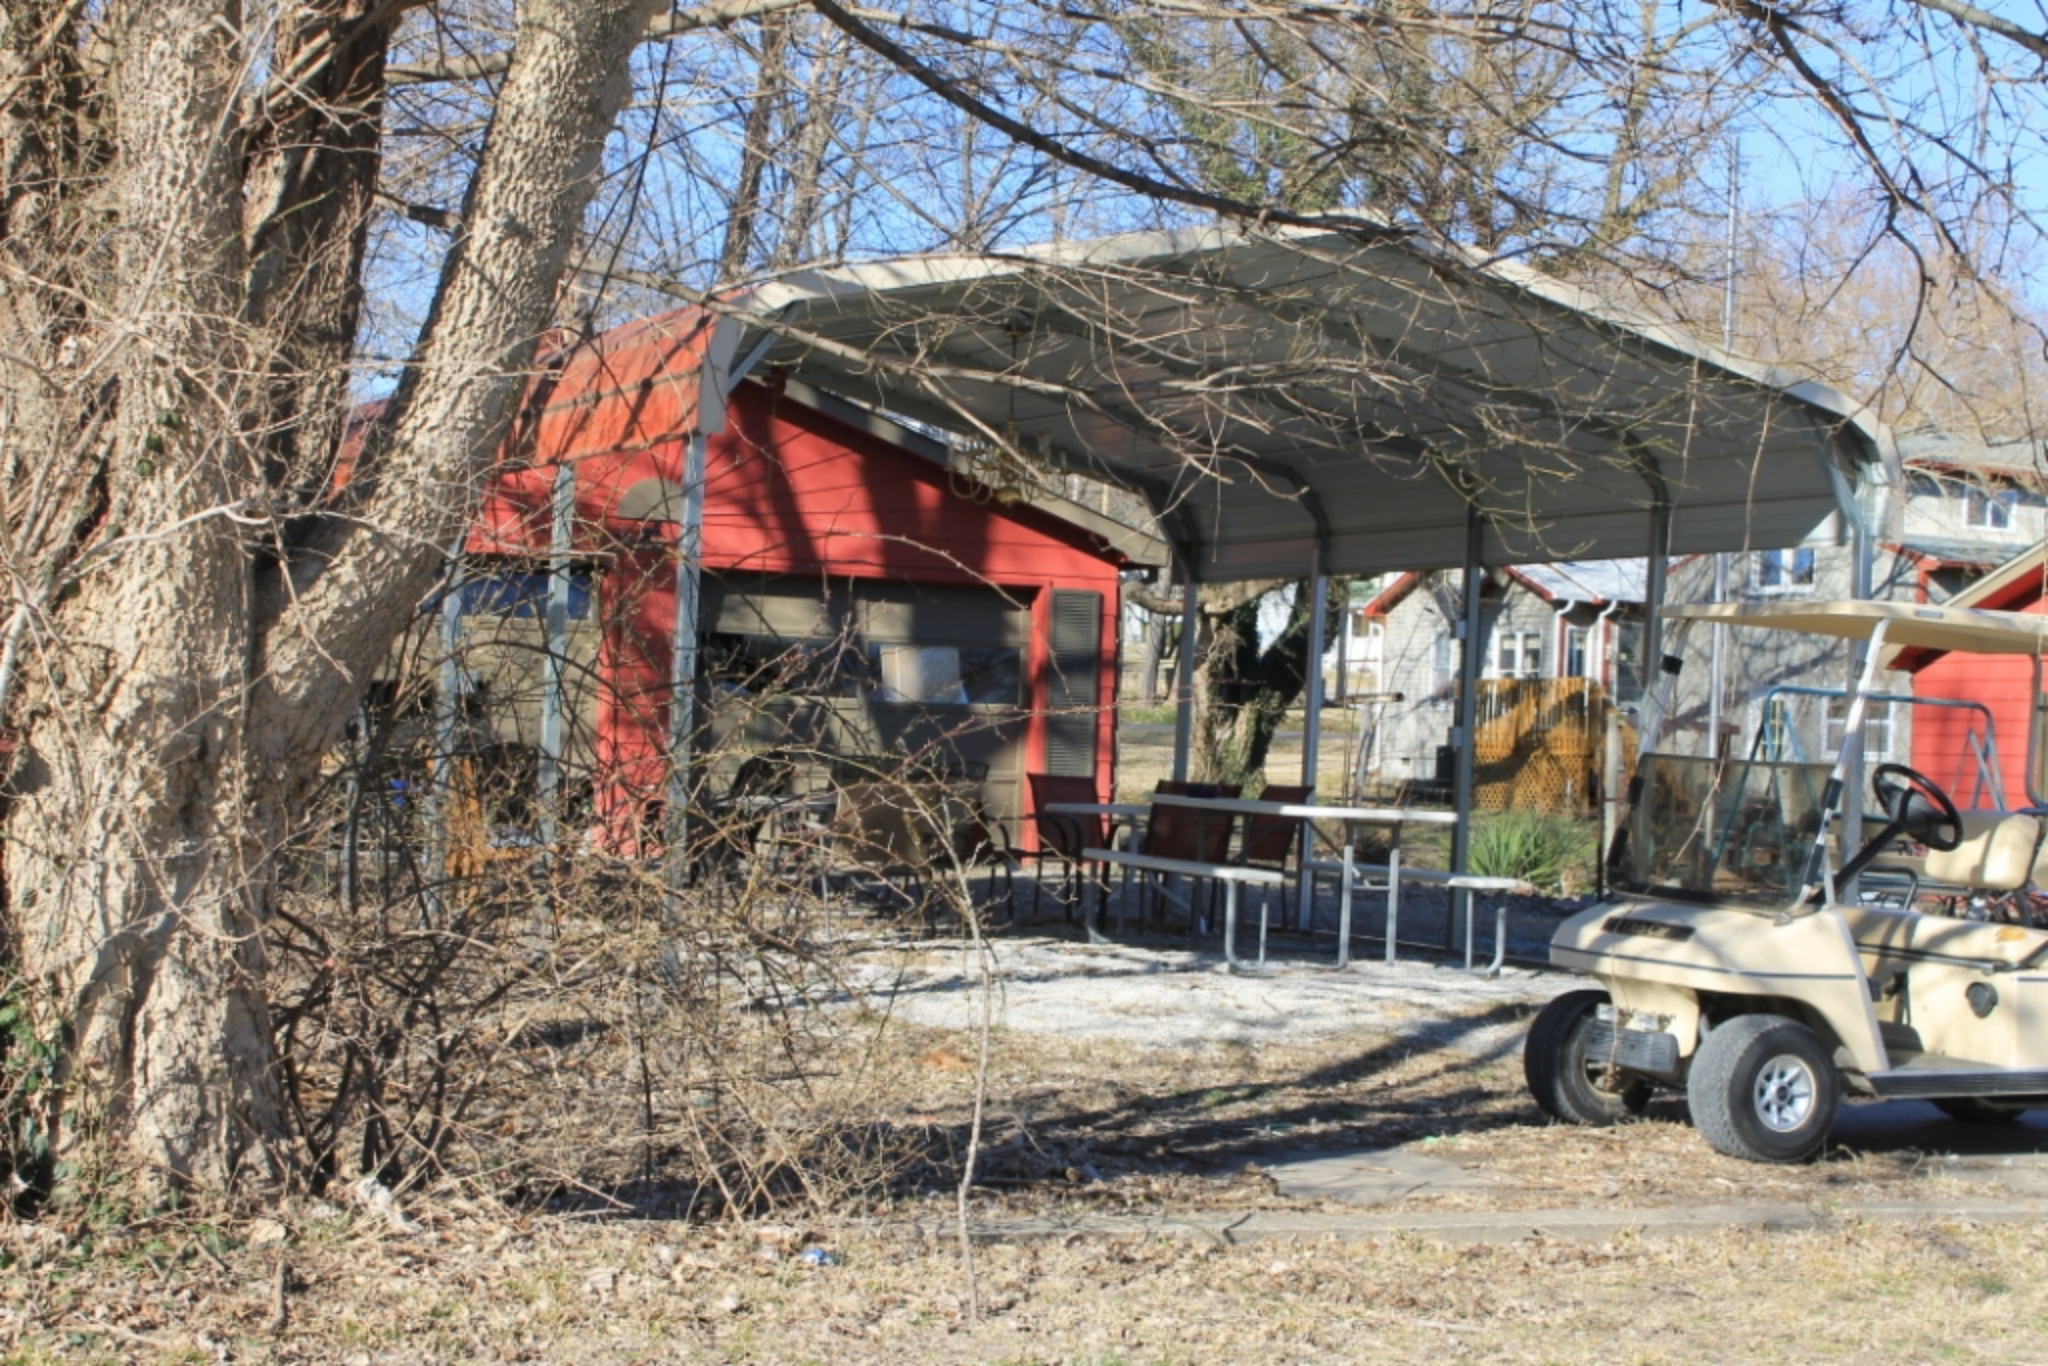
This one-story, massed plan, frame and brick house has a low gable roof of asphalt shingles. The building has an ell projecting from the east facade. The bottom portion of the front ell is brick, as is the central portion of the main block of the house. The upper portion of the front ell is covered in wide clapboards. The front portion and rear portion of the main block of the house are also covered with wide clapboards. The front (east) facade of the building has five bays. The left bay contains a one-over-one single hung window. The next bay, which is in the projecting ell, contains a small window with vertical sliding panes. The center bay, which is in the center ell, contains a door. The next bay, which is also in the projecting ell, contains a small window with vertical sliding glass panes. The far right bay contains a one-over-one single hung window. The windows on the main block of the house are accented with shutters.

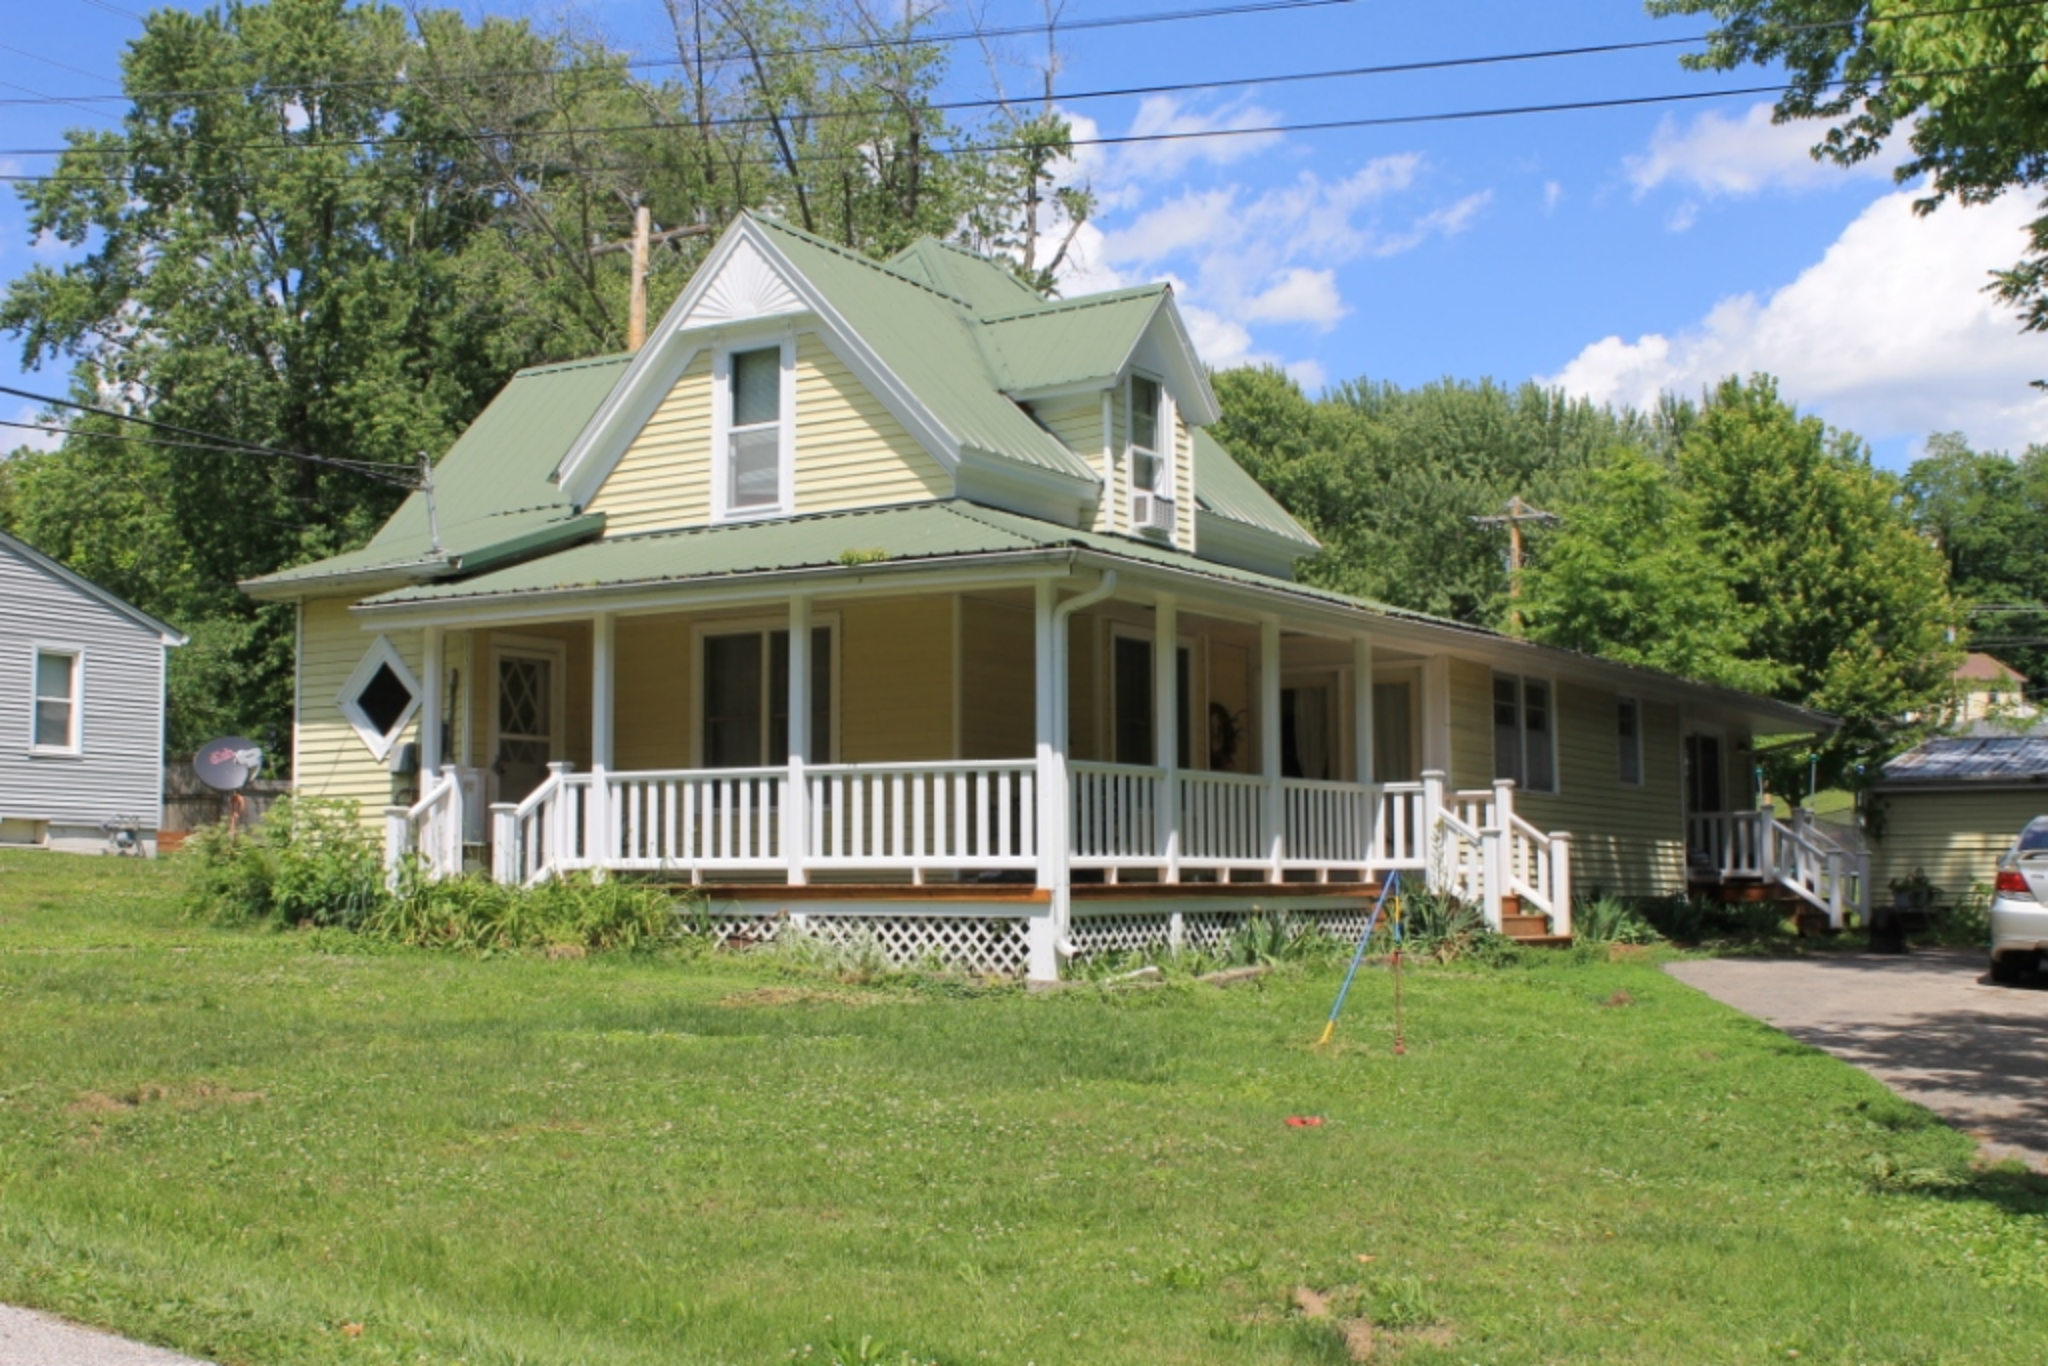
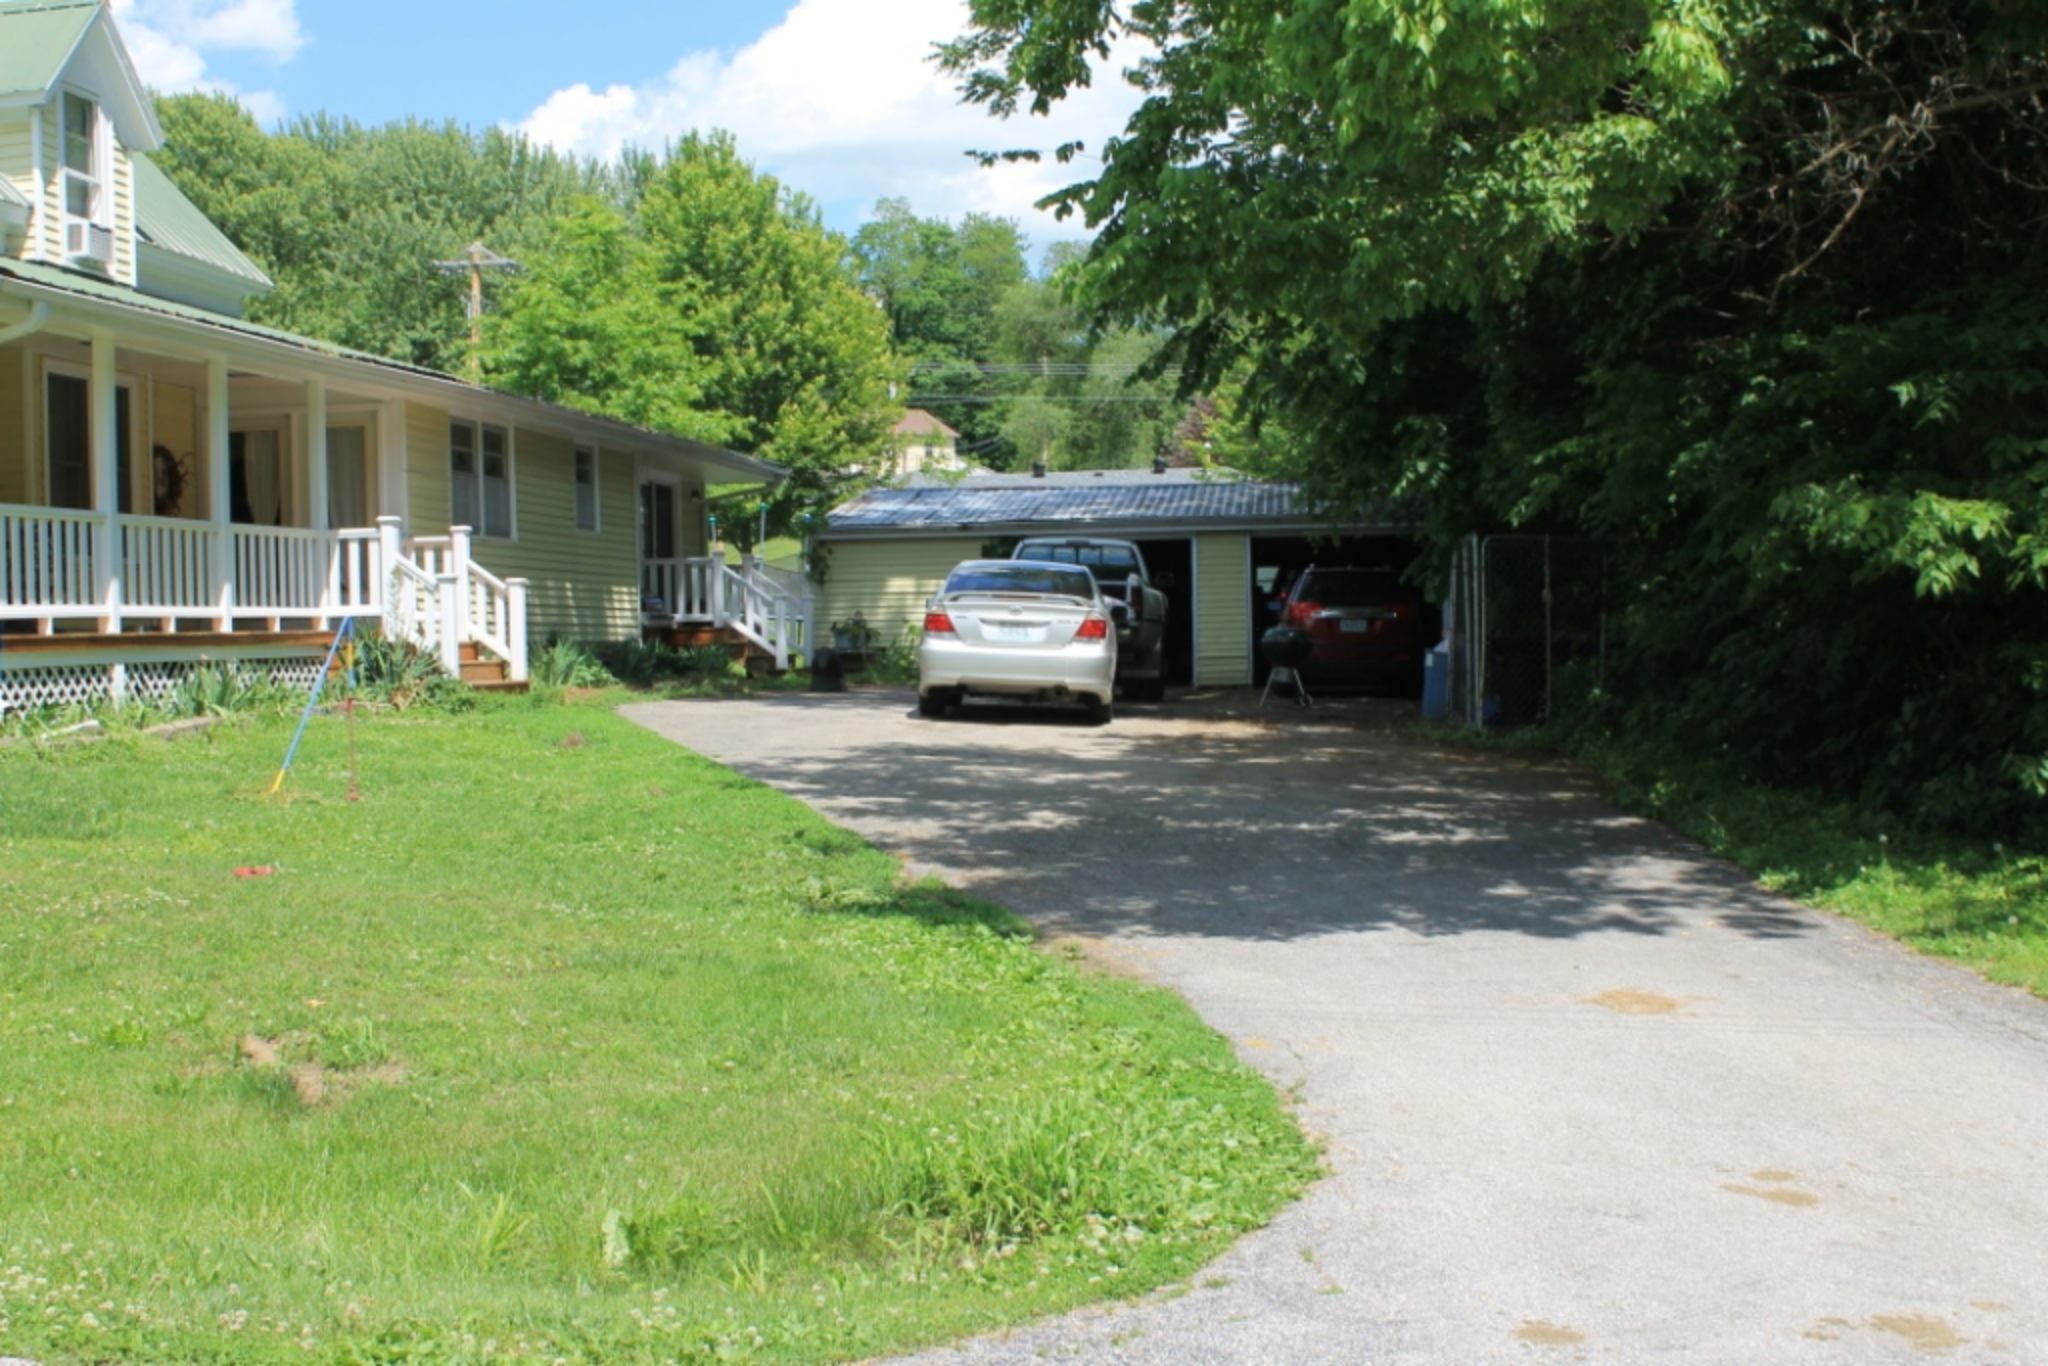
This 1 1/2 story, massed plan house has an irregular roof. The building is clad in clapboards and the roof is covered in metal. A wrap around porch extends across the building from the point where the cross gable wing meets the main block of the house and around the south facade to a south projecting wing at the rear of the house. The front (west) facade of the gable roof has a sunburst motif in the gable peak. Under this motif is a one-over-one single hung window. The front (west) facade has four bays. The left bay, located in what may have been the tower, contains a diamond shaped fixed pane window. The next bay, which is under the porch and under the gable roof, contains a pair of one-over-one single hung wooden windows. The next bay, which is located in the south projecting wing at the rear of the house, contains a one-over-one single hung wooden window. The rightmost bay contains a door. The side (south) facade has four bays. The left bay, which is located in what may have been the tower, contains a door. The remaining bays each contain one-over-one single hung wooden windows. On the second story of the south facade of the house is a gable roofed dormer that contains a one-over-one single hung window.

This building is significant under CRITERION C: ARCHITECTURE as an example of late Victorian domestic architecture in a modest Queen Anne style. This building was built c. 1900. A post 1976 addition appears to have been added to the rear of the building, but this addition blends into the design of the house and is not totally visible from the front facade. The ell on the north end of the front (west) facade may at one time have had a tower roof that has been removed, but no early photographs of the house have been found that would confirm this. If this tower did exist, it was removed before 1973. Despite these alterations, the building should be considered a contributing building. The building is associated with Sep Sexton, who owned the Rocheport flour mill during the late nineteenth and early twentieth centuries.

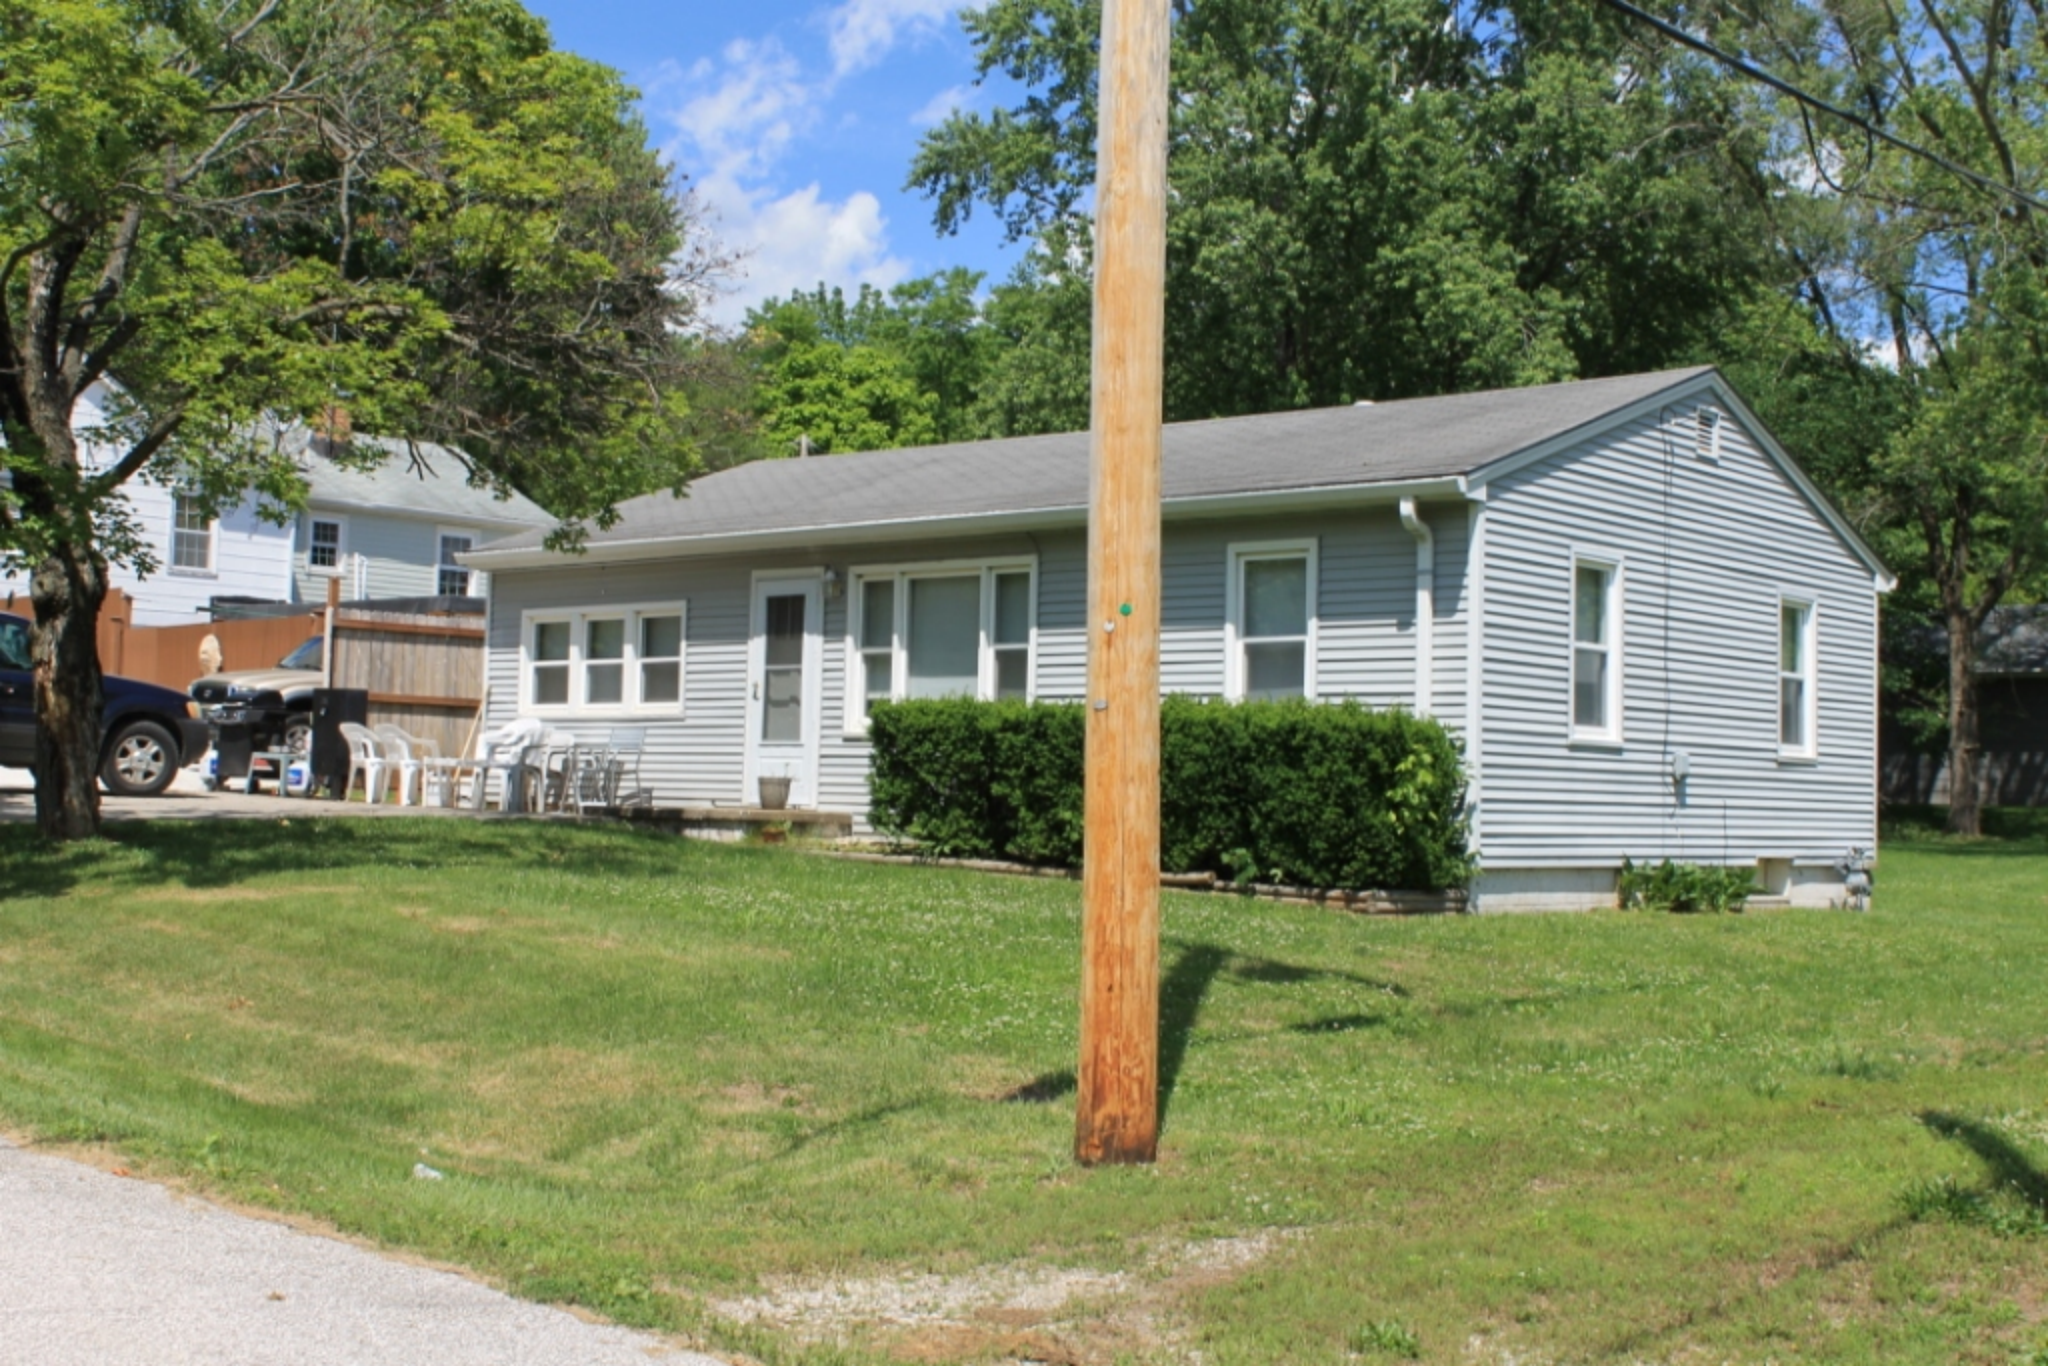
This one-story, massed plan side gable, frame house is clad in vinyl siding. Its low gable roof is covered in asphalt shingles. The house has four bays on the front (west) facade. The leftmost bay contains three small one-over-one single hung windows. The next bay to the right contains a door with a modern glass and metal storm door. The door opens onto a stoop. The next bay contains a fixed pane picture window flanked on either side by a one-over-one single hung window. The rightmost bay contains a one-over-one single hung window.
