MISSOURI DEPARTMENT OF NATURAL RESOURCES
STATE HISTORIC PRESERVATION OFFICE, P.O. Box 176, Jefferson City, MO 65102
ARCHITECTURAL/HISTORIC INVENTORY FORM

1. SURVEY NO. BO-AS-009-0001		2. SURVEY NAME: Rocheport Historic District	
3. COUNTY: Boone		4. ADDRESS (STREET NO.)	STREET (NAME) Katy Trail
5. CITY: Rocheport	VICINITY: <input checked="" type="checkbox"/>	6. UTM: / /	LAT: LONG: T: 48W R: 15W S: 1

8. HISTORIC NAME (IF KNOWN): M.K.&T. Railroad tunnel		9. PRESENT/OTHER NAME (IF KNOWN): Katy trail tunnel	
10. OWNERSHIP: <input type="checkbox"/> PRIVATE <input checked="" type="checkbox"/> PUBLIC		11A. HISTORIC USE (IF KNOWN): railroad tunnel	11B. CURRENT USE: Katy Trail tunnel
HISTORICAL INFORMATION

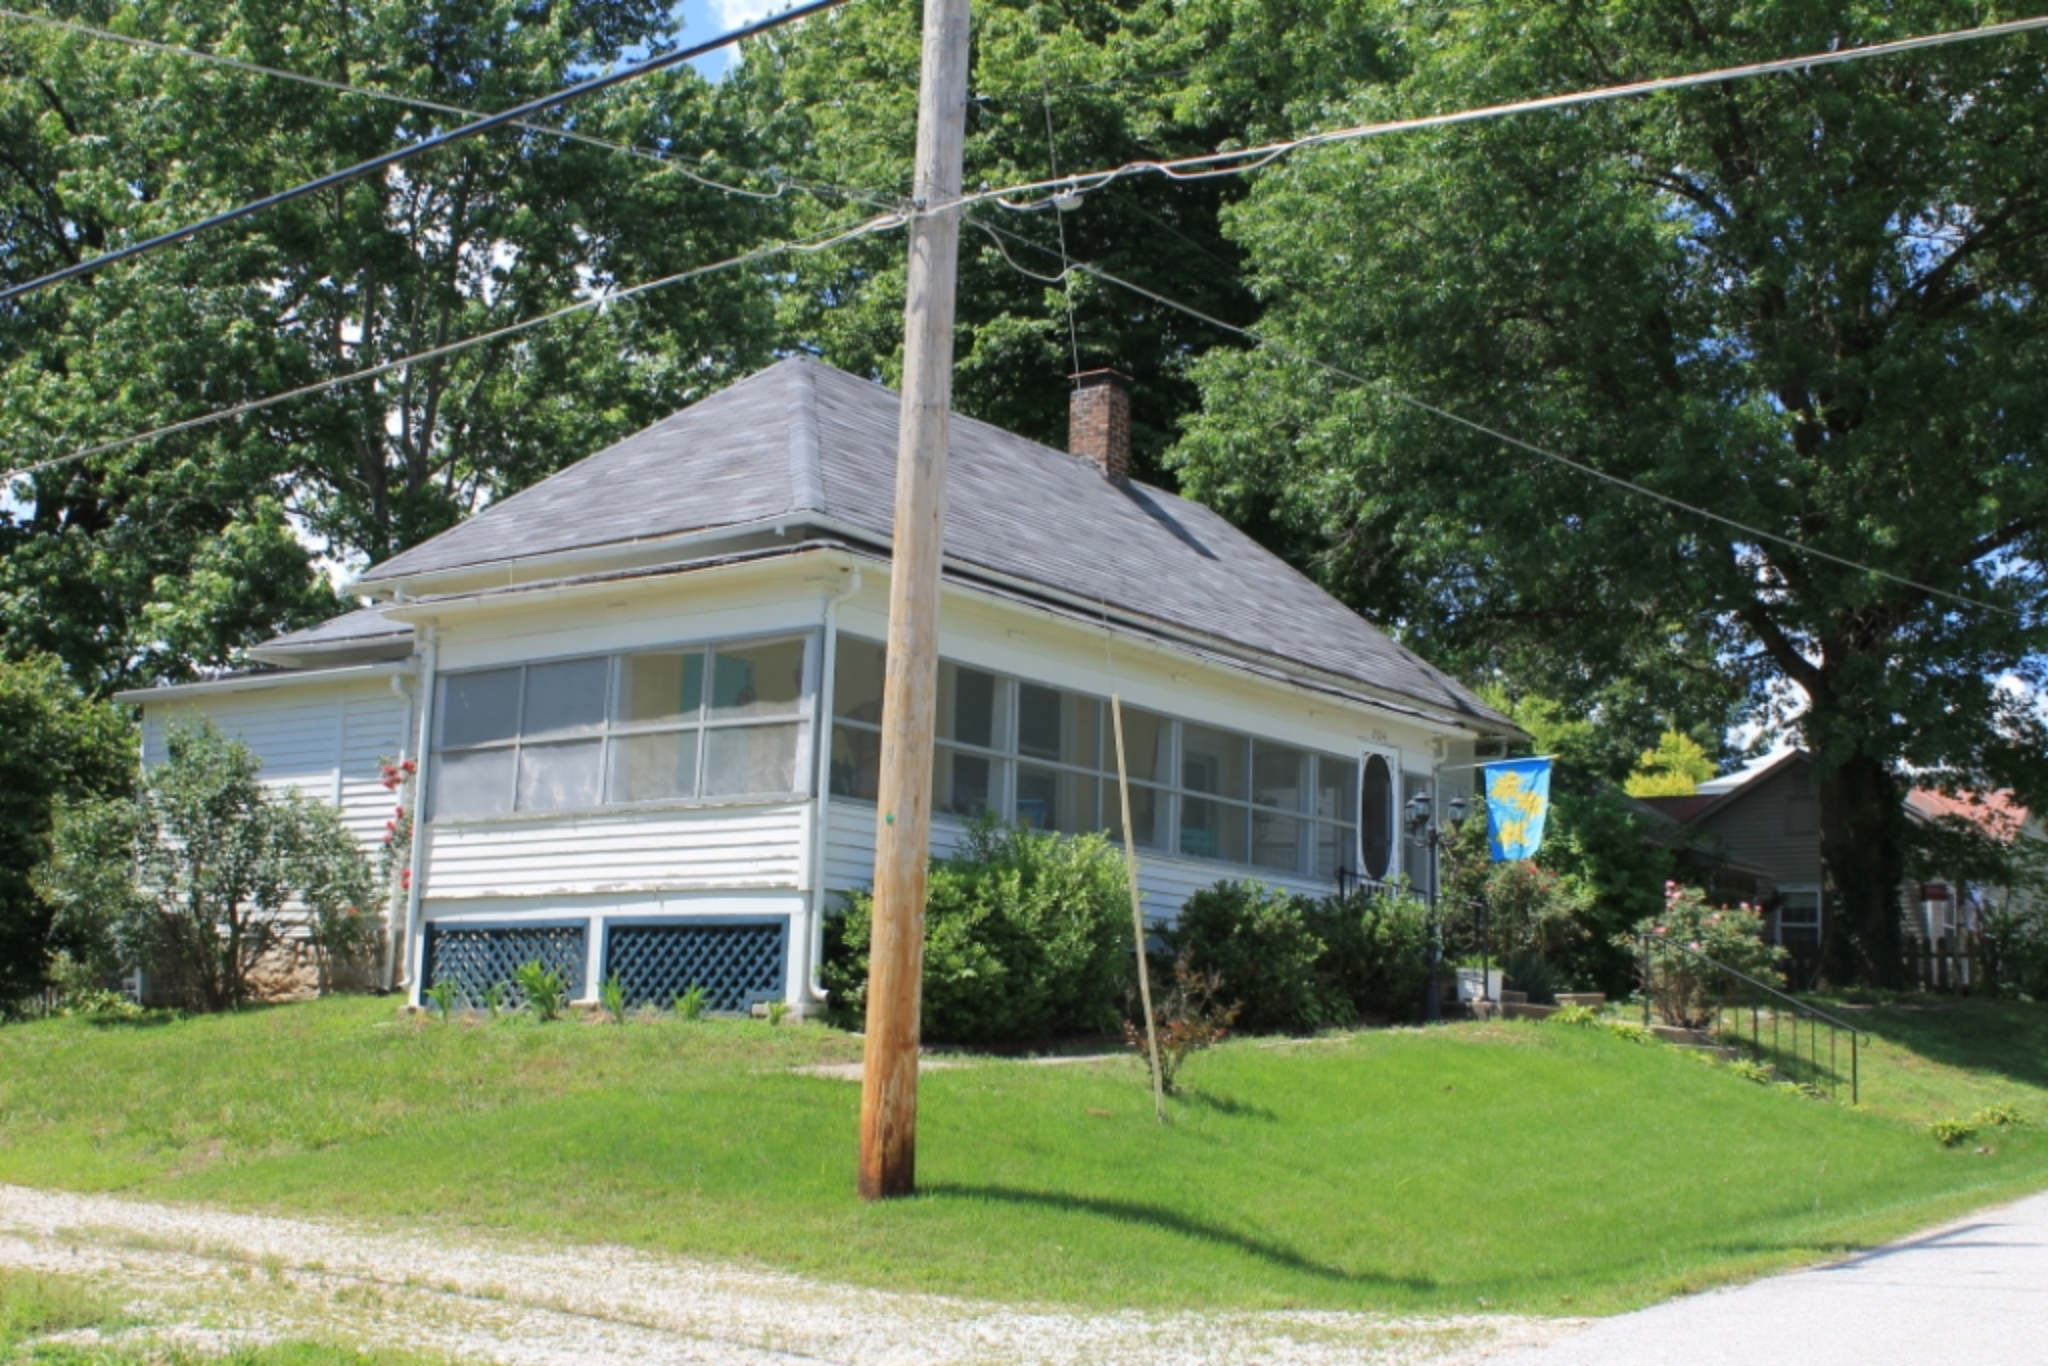
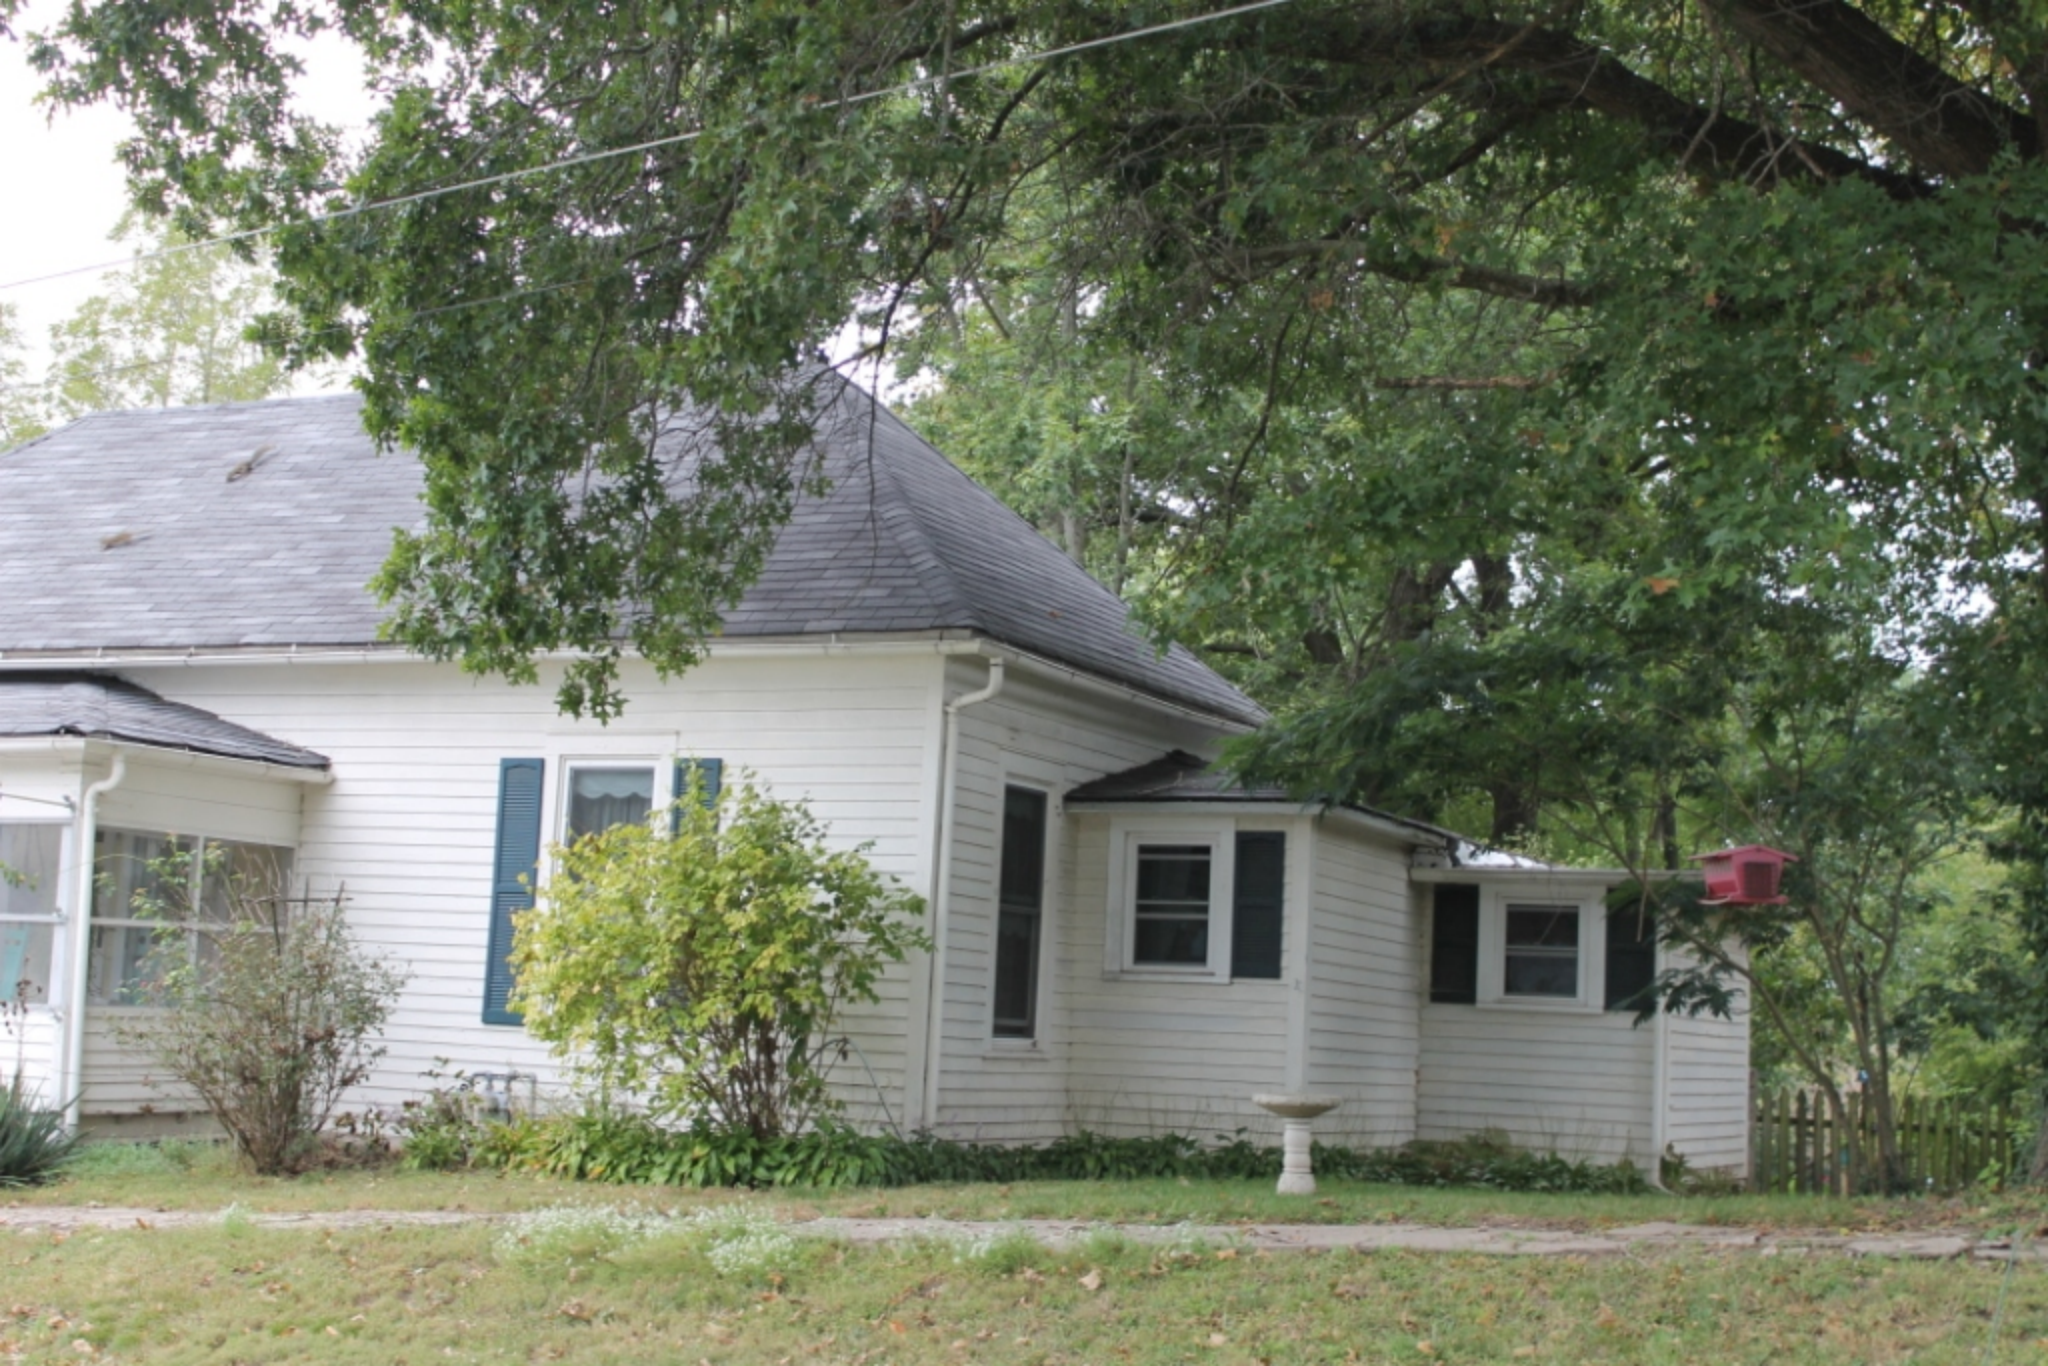
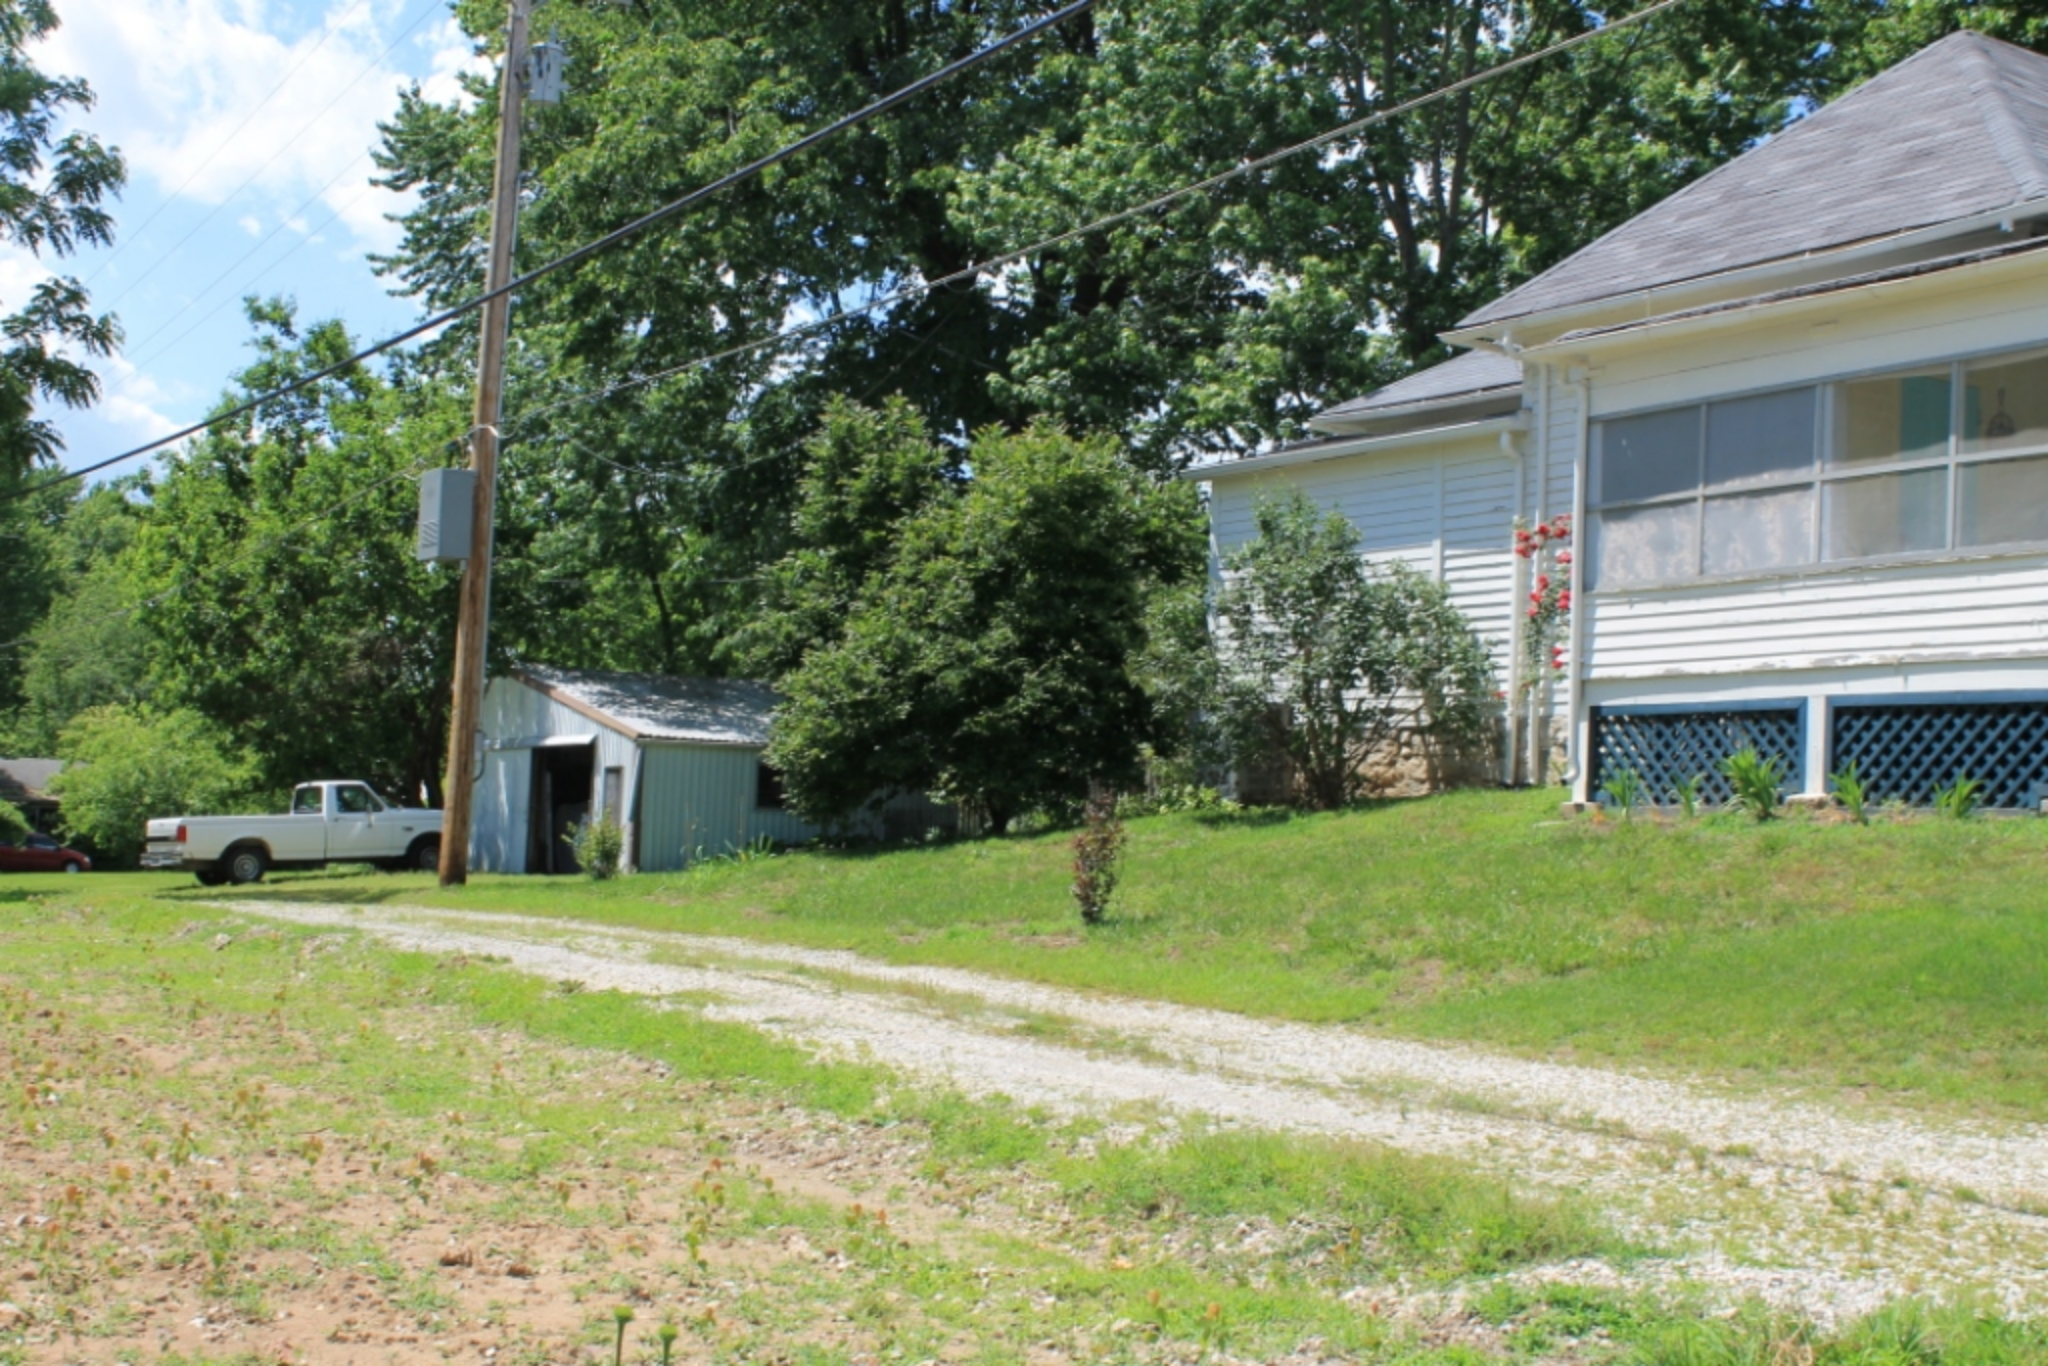
This one-story, frame, irregular shaped house has a hipped roof on the main block and a hipped roof on the wing that extends to the rear. A small flat roofed ell extends to the south from the hipped roofed rear wing. A small hipped roof ell extends from the north end of the main block of the house and a flat roofed ell extends to the north from the rear wing. A wrap around porch sits under a low hipped roof. The porch is enclosed in screen which makes the fenestration of the house difficult to see. The front (east) facade has twelve bays. The first seven bays are screens covering the porch. The next bay, also in the porch, contains a screened door. The next bay contains a screen. The next bay, which is located on the main block of the house, contains a one-over-one single hung window with decorative shutters. The next bay, which is located in the hipped roof ell to the north of the main block of the house, contains a one-over-one single hung window with one shutter. The rightmost bay, which is located in the flat roofed ell to the of the main block of the house; this bay contains a one-over-one single hung window with two shutters.

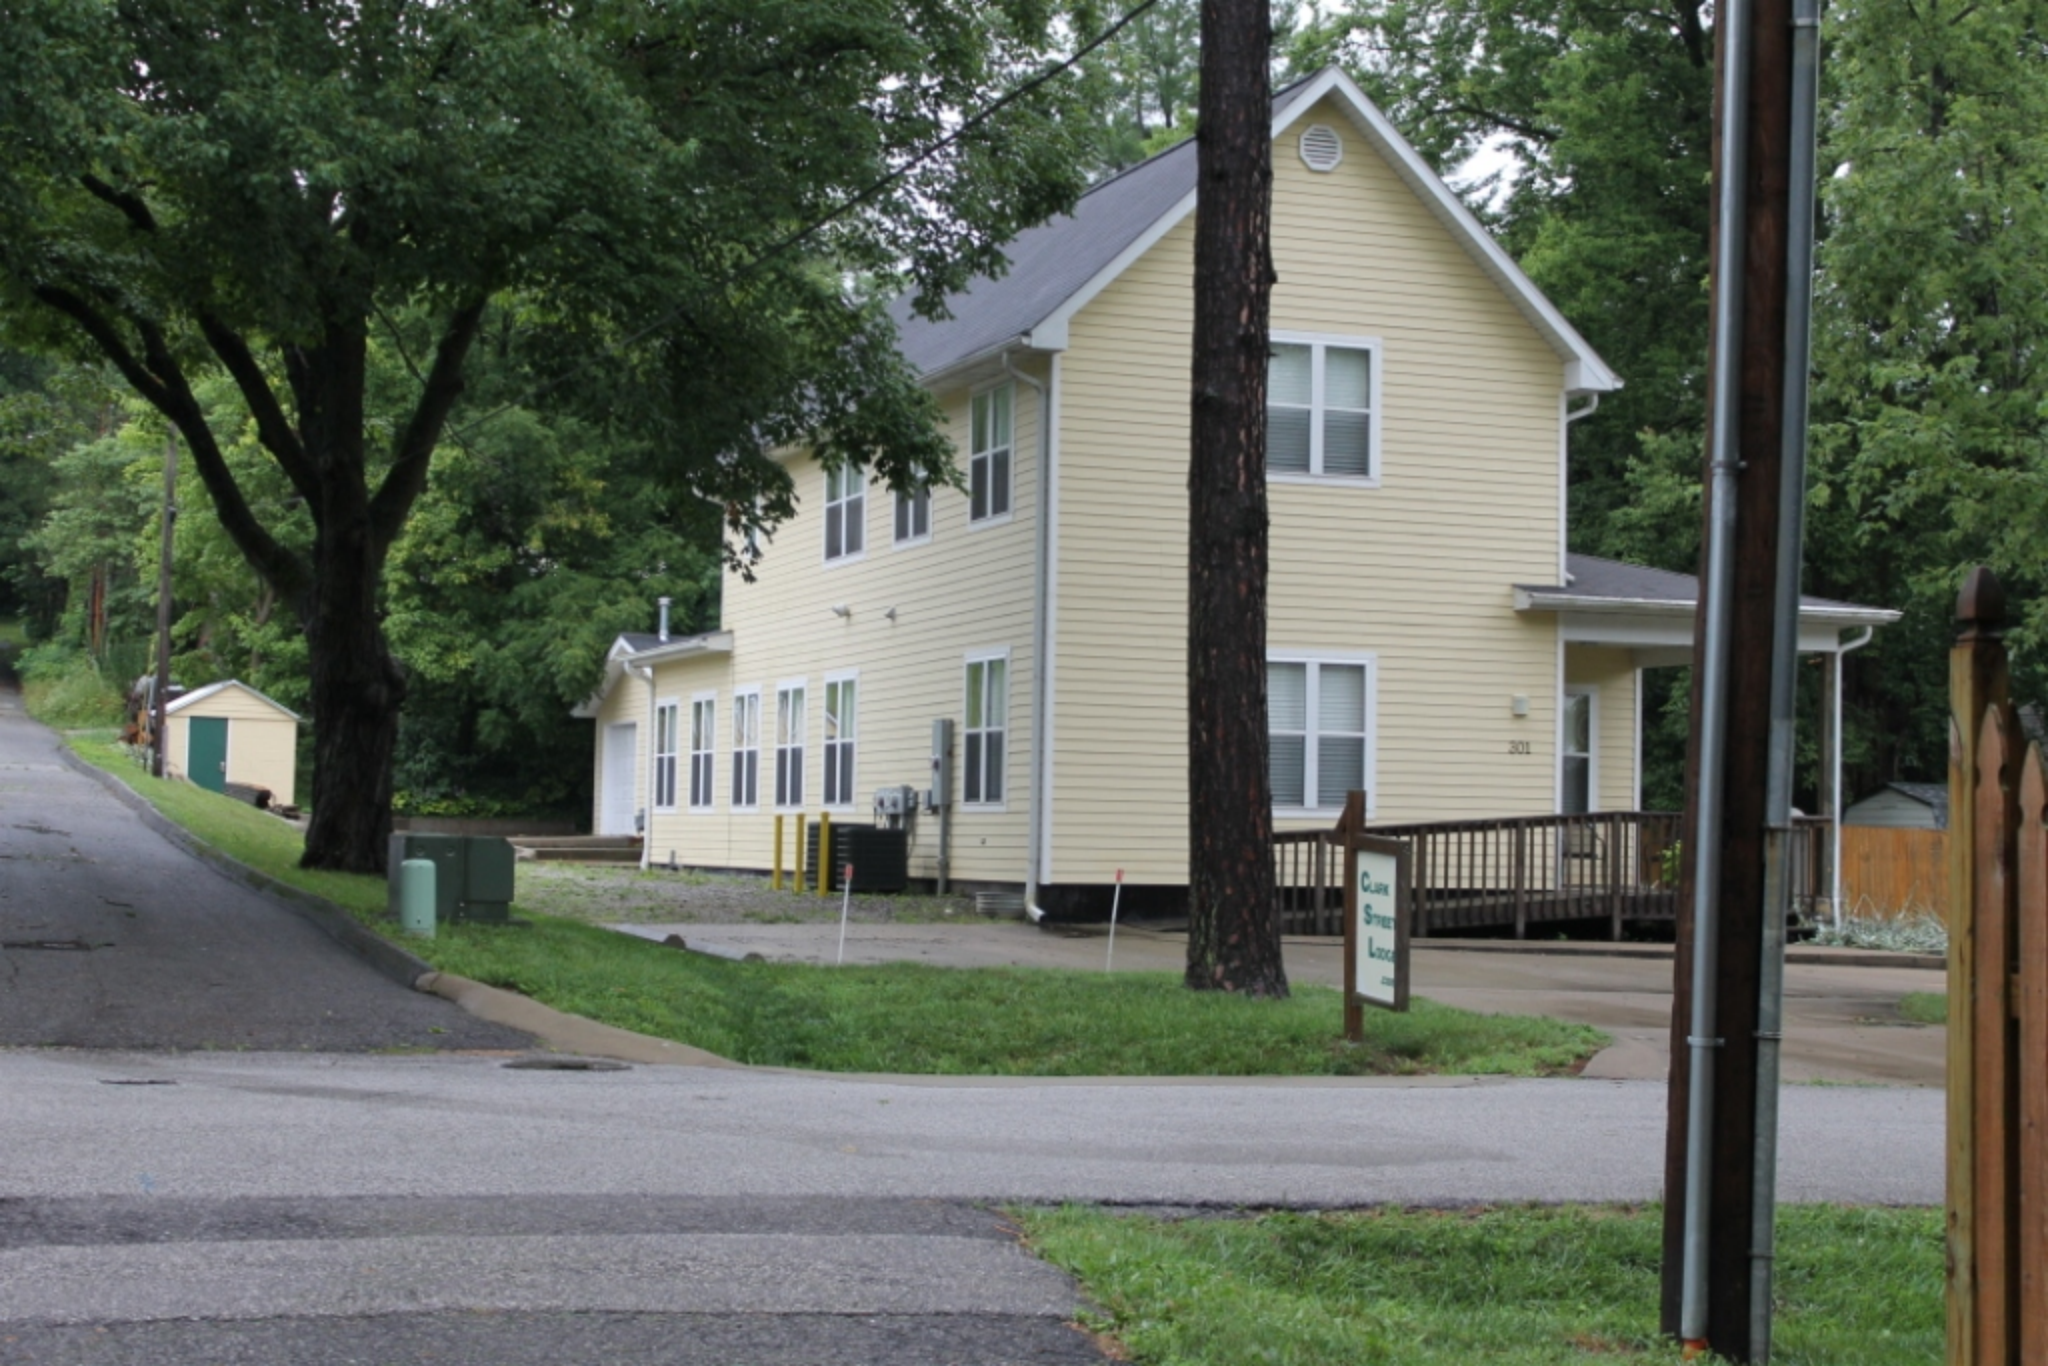
This frame, gable front and wing house is clad in vinyl siding and the roof is covered asphalt shingles. The north wing has two stories and a high gable roof facing west. The south wing is one story and has a hipped roof that extends to cover a porch. A wooden ramp makes the porch handicapped accessible. The first story of the front (west) facade of has three bays. The left bay contains a pair of one-over-one single hung windows. The next bay, which is under the porch, contains a door. The right bay, also under the porch, contains a pair of one-over-one single hung windows. The second story of the front facade has one bay that contains a pair of one-over-one single hung windows.

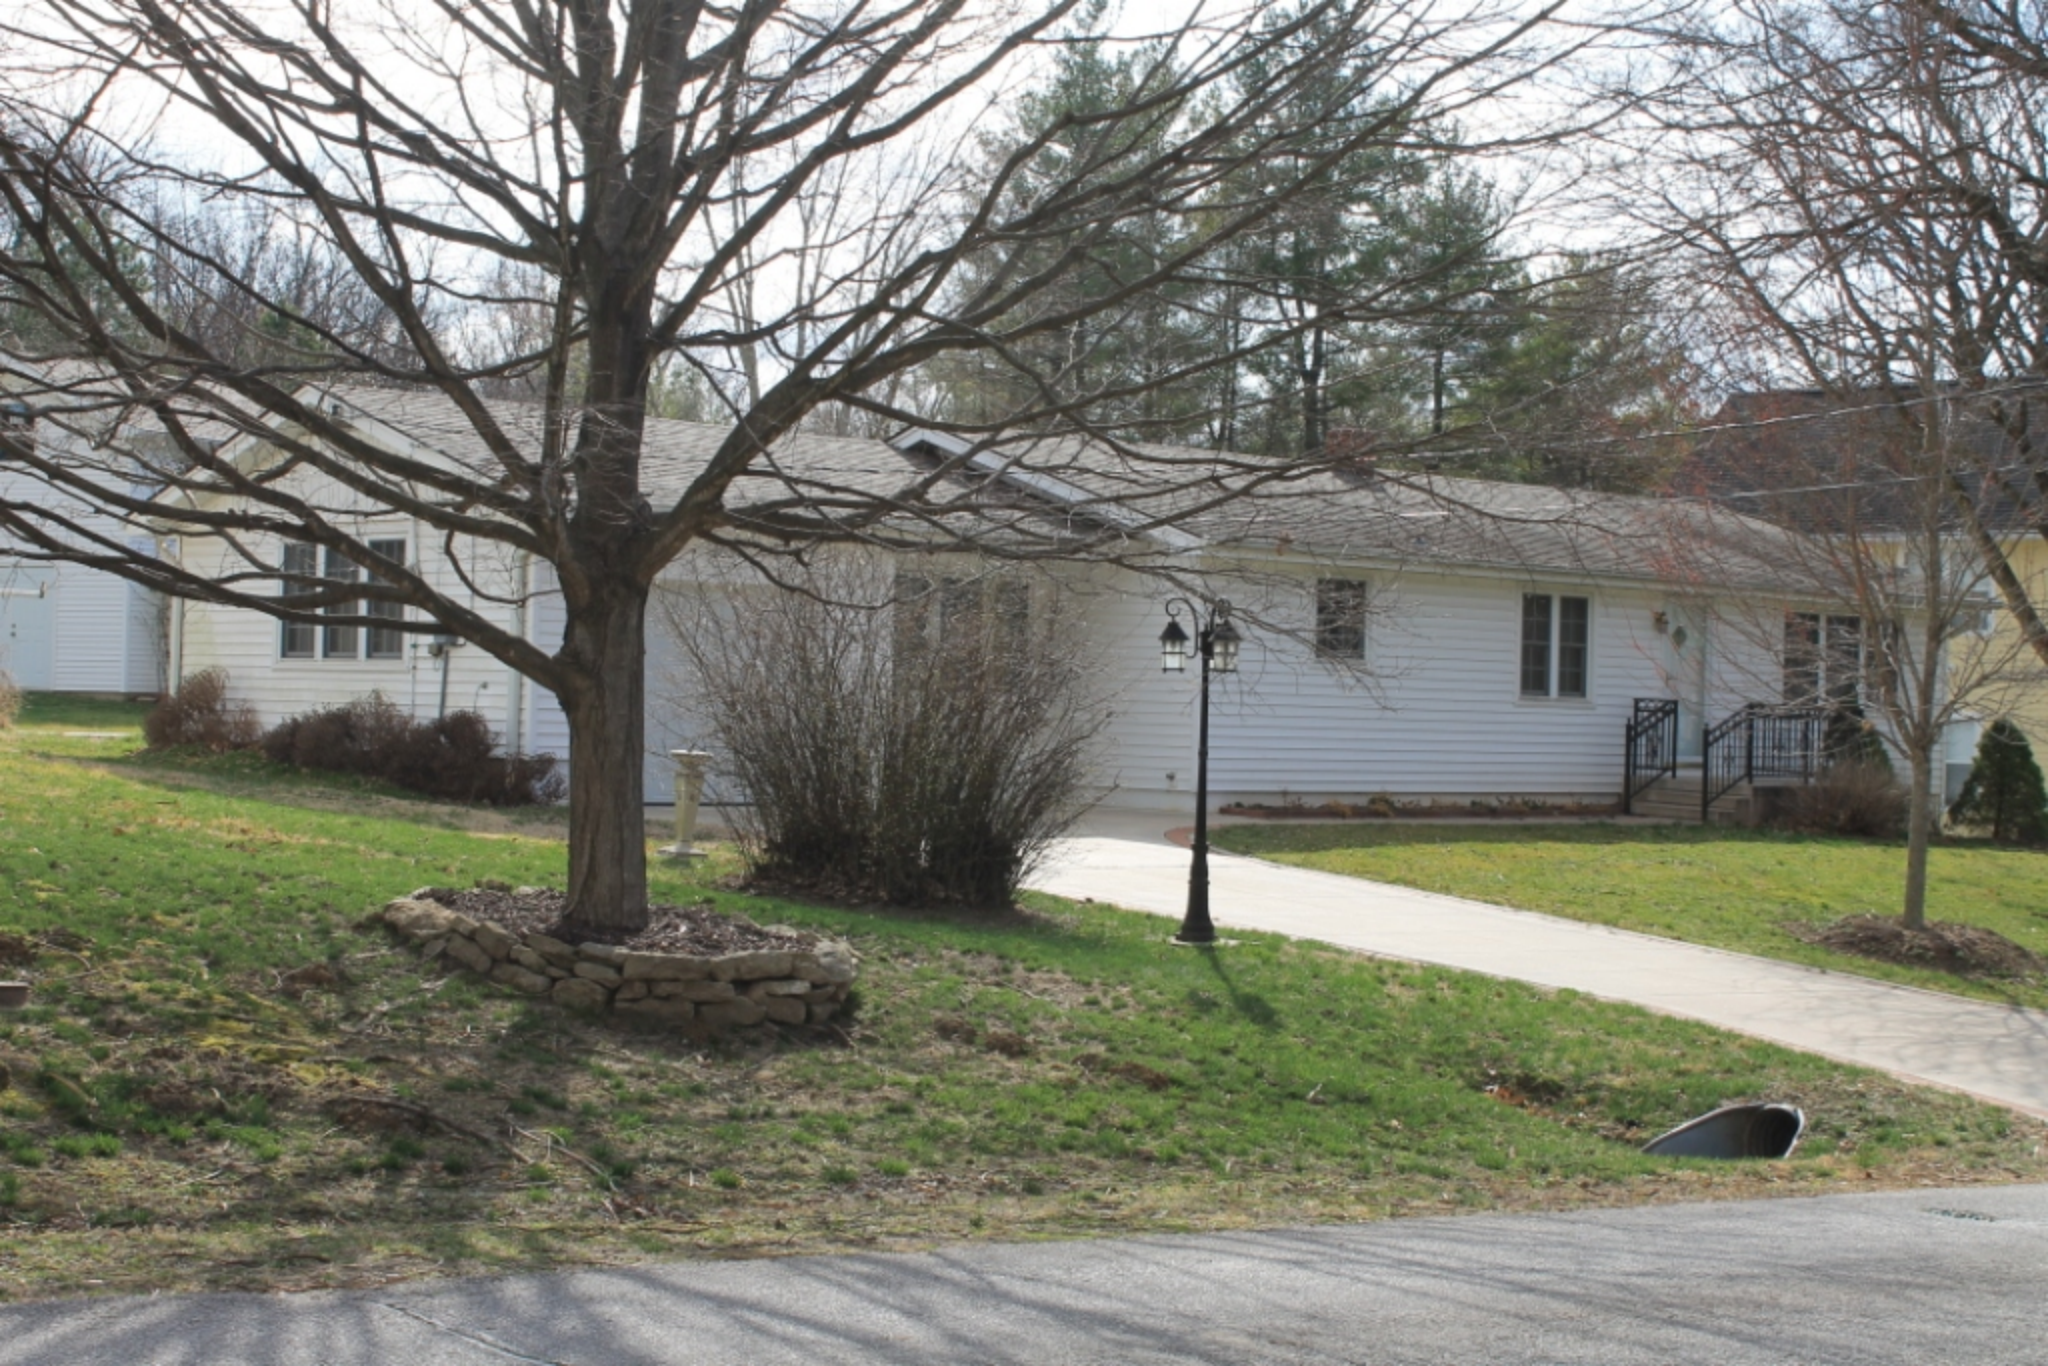
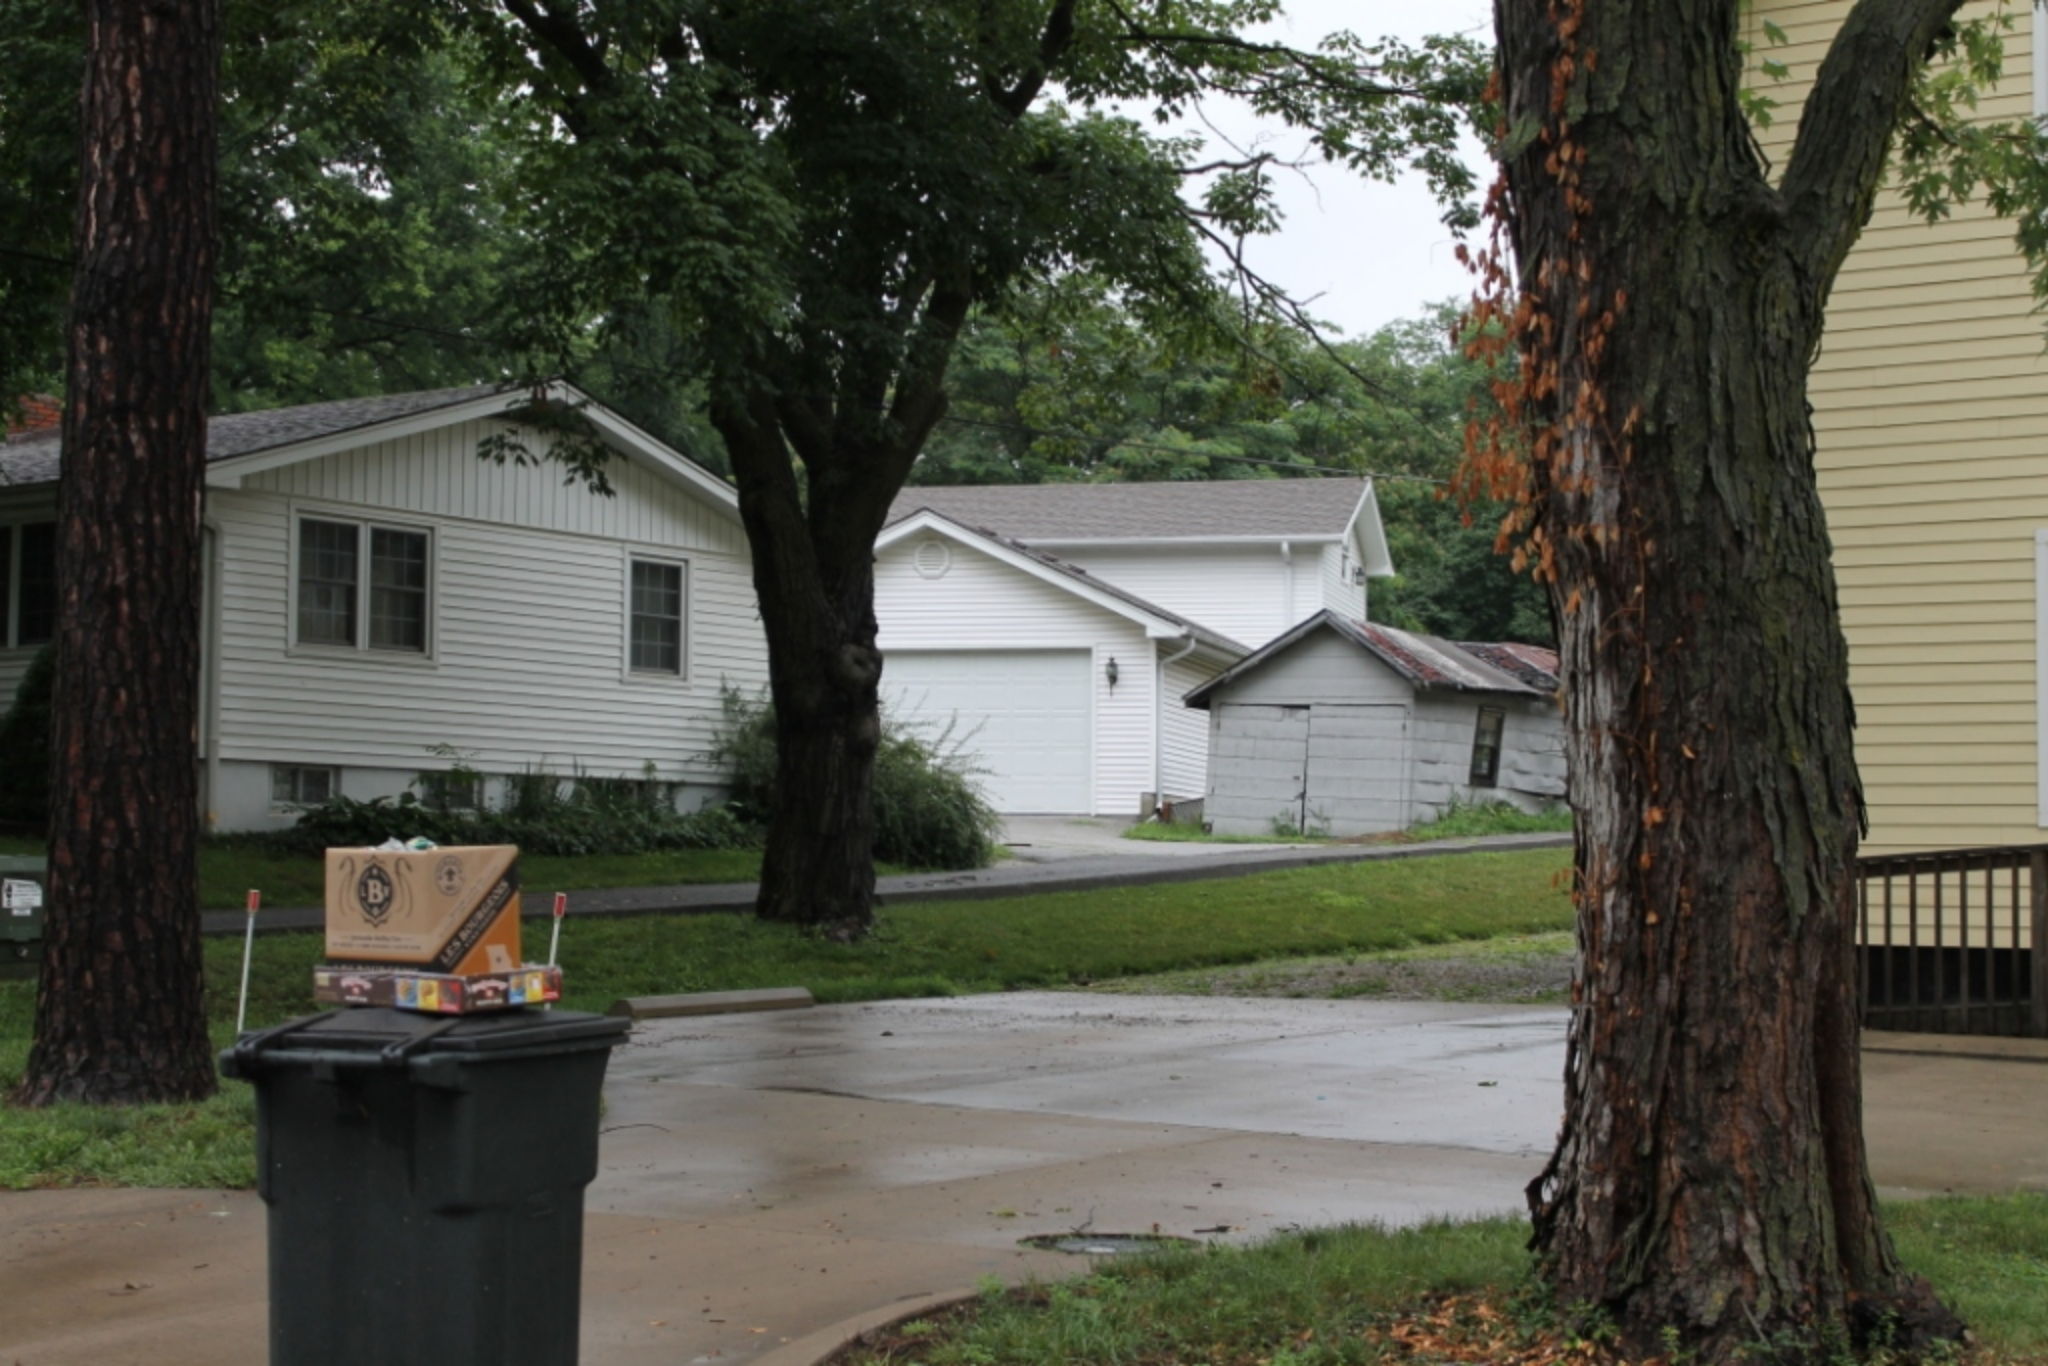
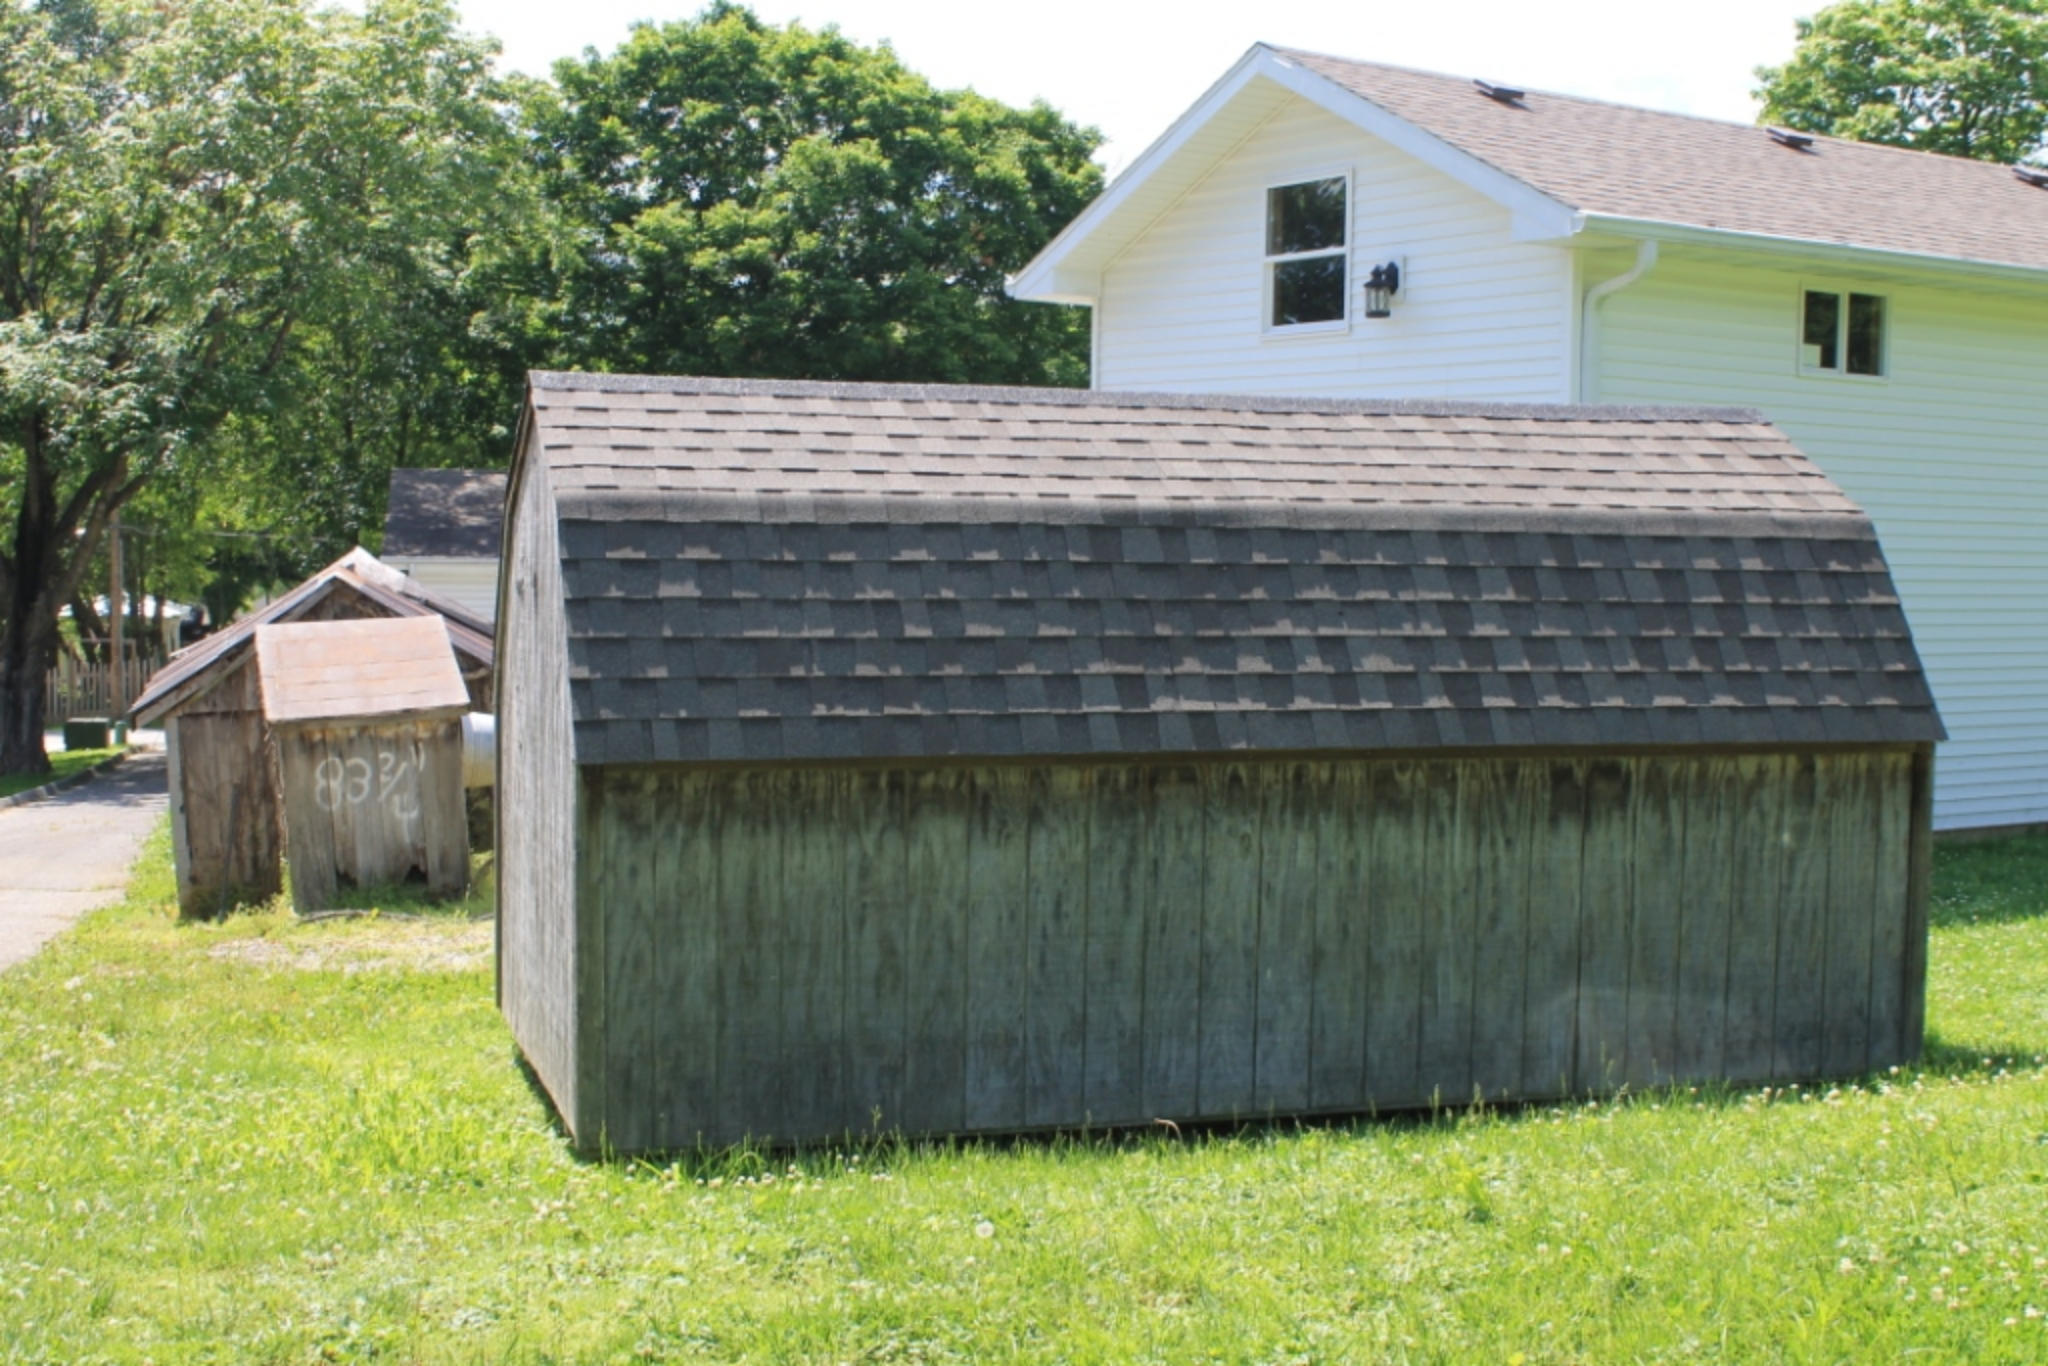
This one-story massed plan side gable, Ranch style house has a main block and a wing that extends to the north of the main block. This projecting wing also has a lower gable roof than the main block of the house. The house is clad in vinyl siding and the roof is covered with asphalt shingles. The front facade has seven bays. The leftmost bay contains an overhead one-car garage door. The next bay, which is located in an inset portion of the facade, contains a door with a modern metal and glass storm door. The next bay, which is also located in the inset portion, contains a series of three one-over-one single hung vinyl windows. The next bay, which is located on the main block of the house, contains a small six-over-six single hung vinyl window. The next bay, also located in the main block of the house, contains a pair of six-over-six single hung vinyl windows. The next bay contains a door with a modern metal and glass storm door covering a modern wooden door with fixed pane windows. The front door opens onto a small stoop with a wrought iron railing. The rightmost bay contains a pair of six-over-six single hung vinyl windows. A chimney rises from the center front slope of the roof.
