MISSOURI DEPARTMENT OF NATURAL RESOURCES
STATE HISTORIC PRESERVATION OFFICE, P.O. Box 176, Jefferson City, MO 65102
ARCHITECTURAL/HISTORIC INVENTORY FORM

1. SURVEY NO. BO-AS-009-0001		2. SURVEY NAME: Rocheport Historic District	
3. COUNTY: Boone		4. ADDRESS (STREET NO.)	STREET (NAME) Katy Trail
5. CITY: Rocheport	VICINITY: <input checked="" type="checkbox"/>	6. UTM: / /	LAT: LONG: T: 48W R: 15W S: 1

8. HISTORIC NAME (IF KNOWN): M.K.&T. Railroad tunnel		9. PRESENT/OTHER NAME (IF KNOWN): Katy trail tunnel	
10. OWNERSHIP: <input type="checkbox"/> PRIVATE <input checked="" type="checkbox"/> PUBLIC		11A. HISTORIC USE (IF KNOWN): railroad tunnel	11B. CURRENT USE: Katy Trail tunnel
HISTORICAL INFORMATION

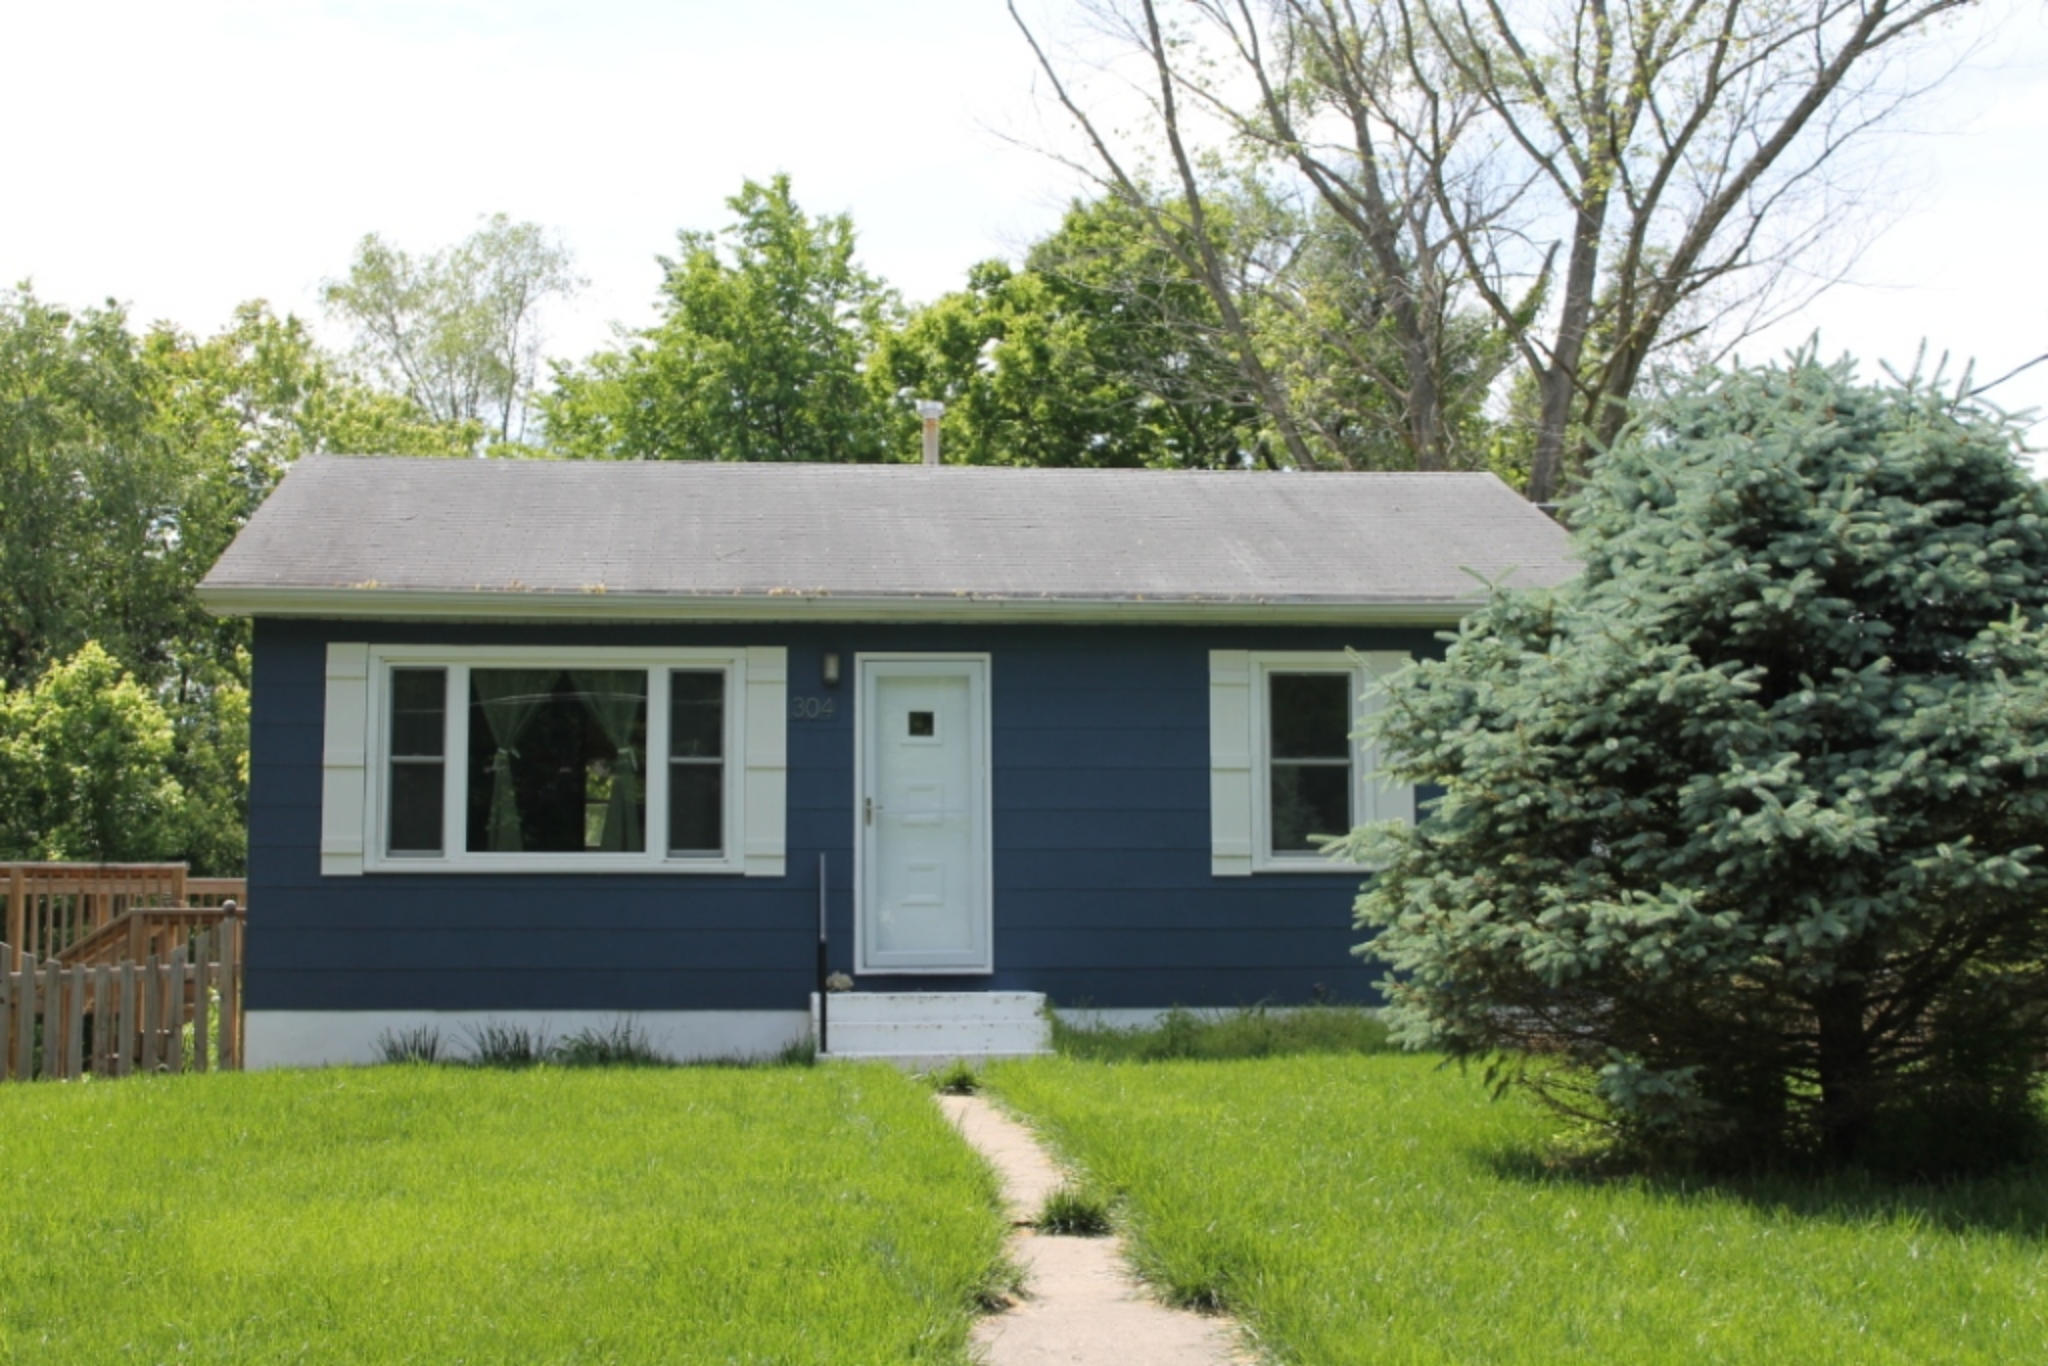
This one story, massed plan side gable, frame, ranch house is clad in clapboards. The low gable roof is covered in asphalt shingles. The front (east) facade has three bays. The left bay contains a picture window consisting of a large fixed pane window flanked on either side by one-over-one single hung windows. The center bay contains a wooden door covered by a modern metal and glass storm door. The door opens onto a small stoop. The right bay contains a one-over-one single hung window. The windows have decorative shutters. A deck extends from the south side of the house.

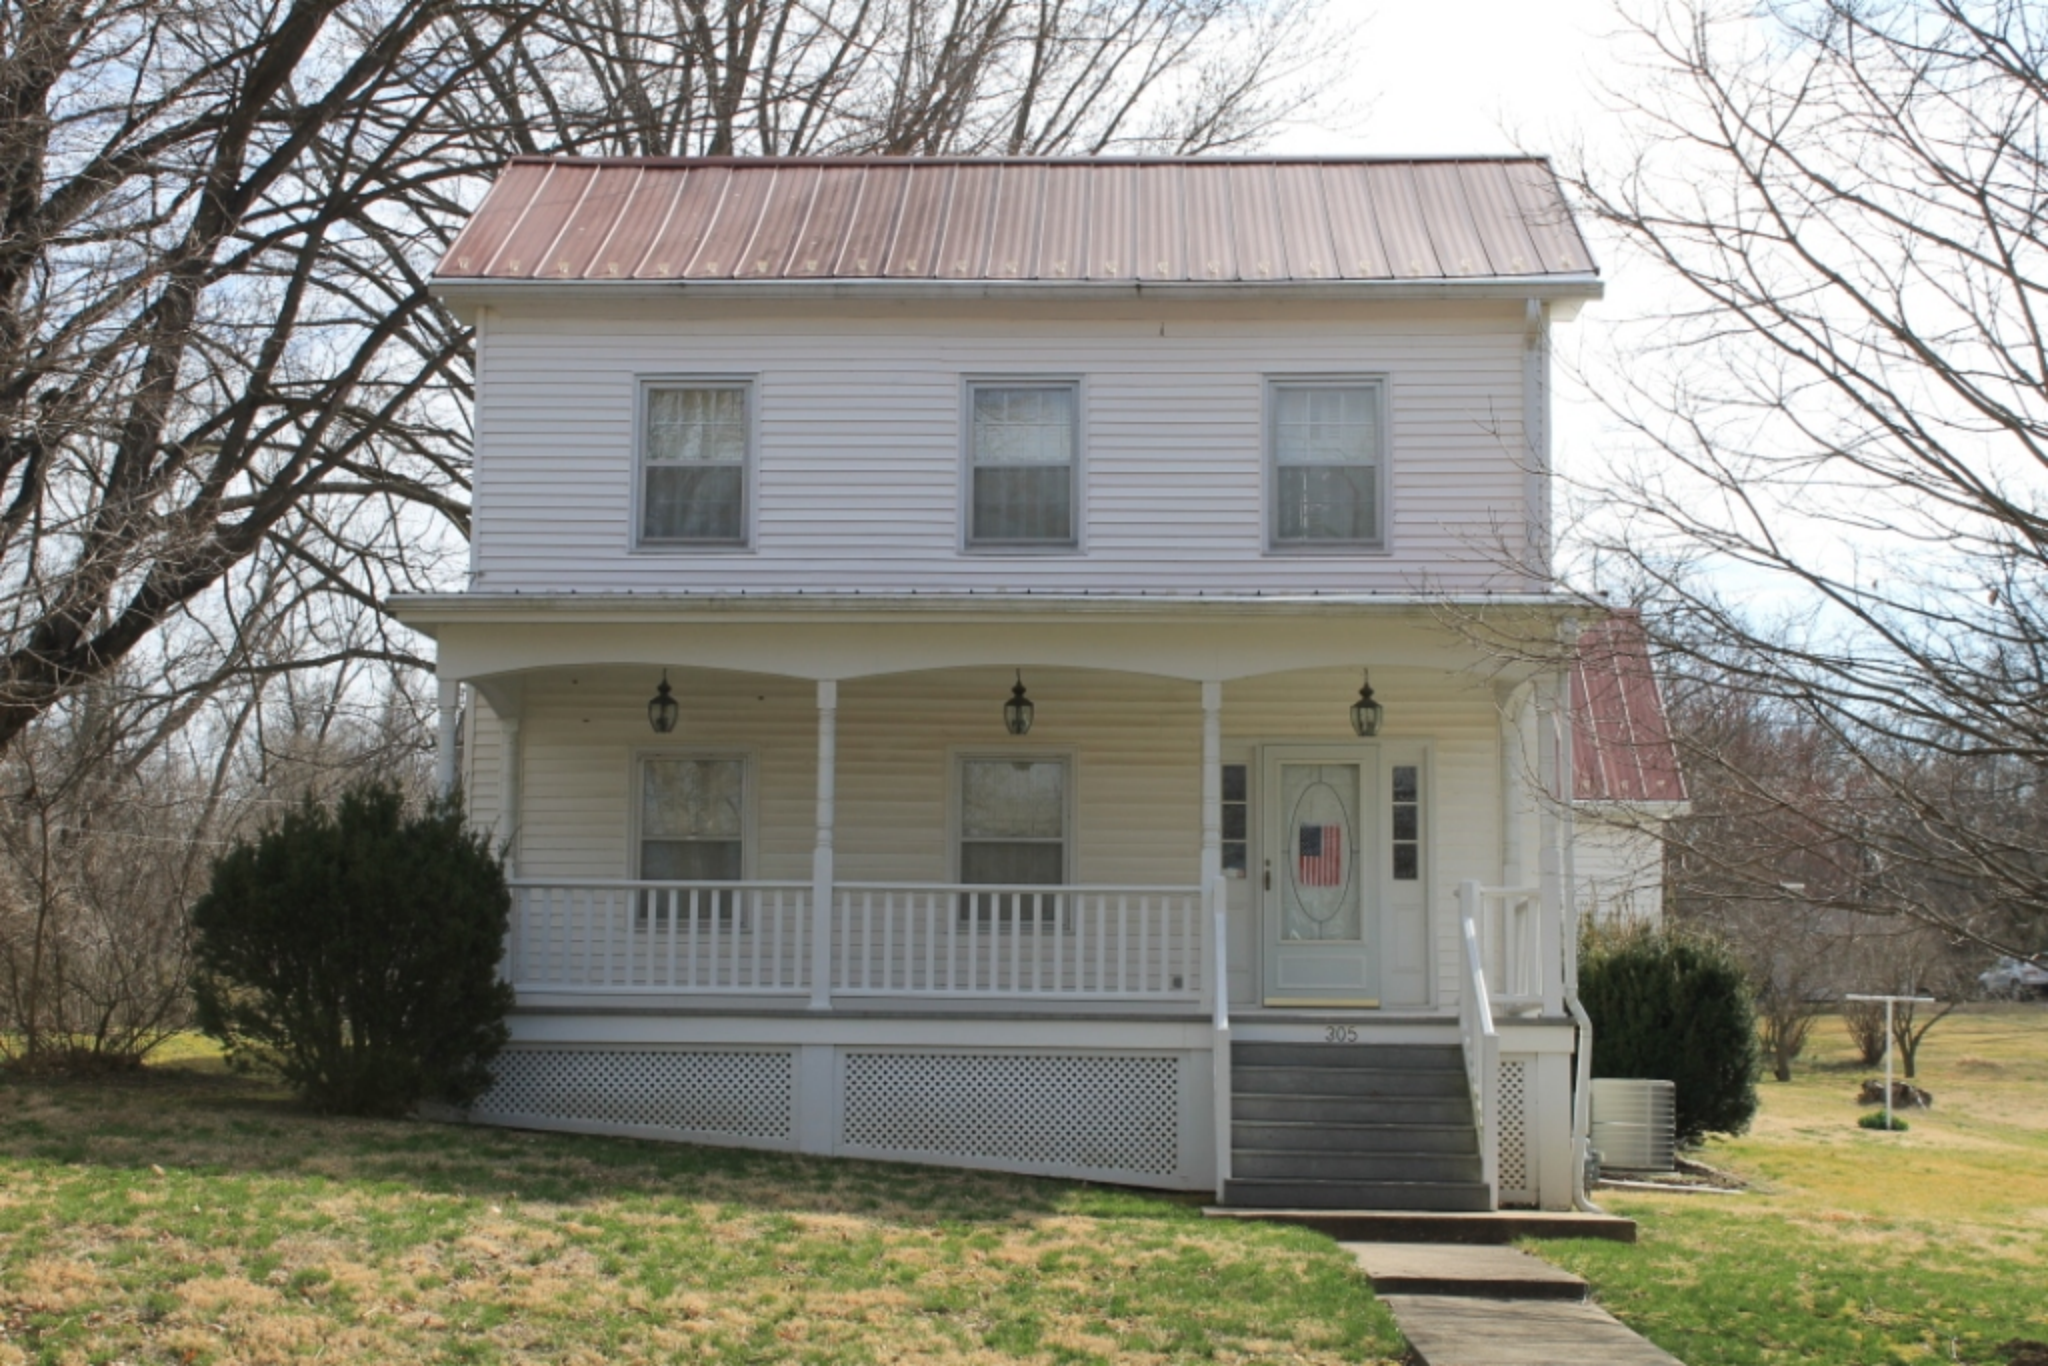
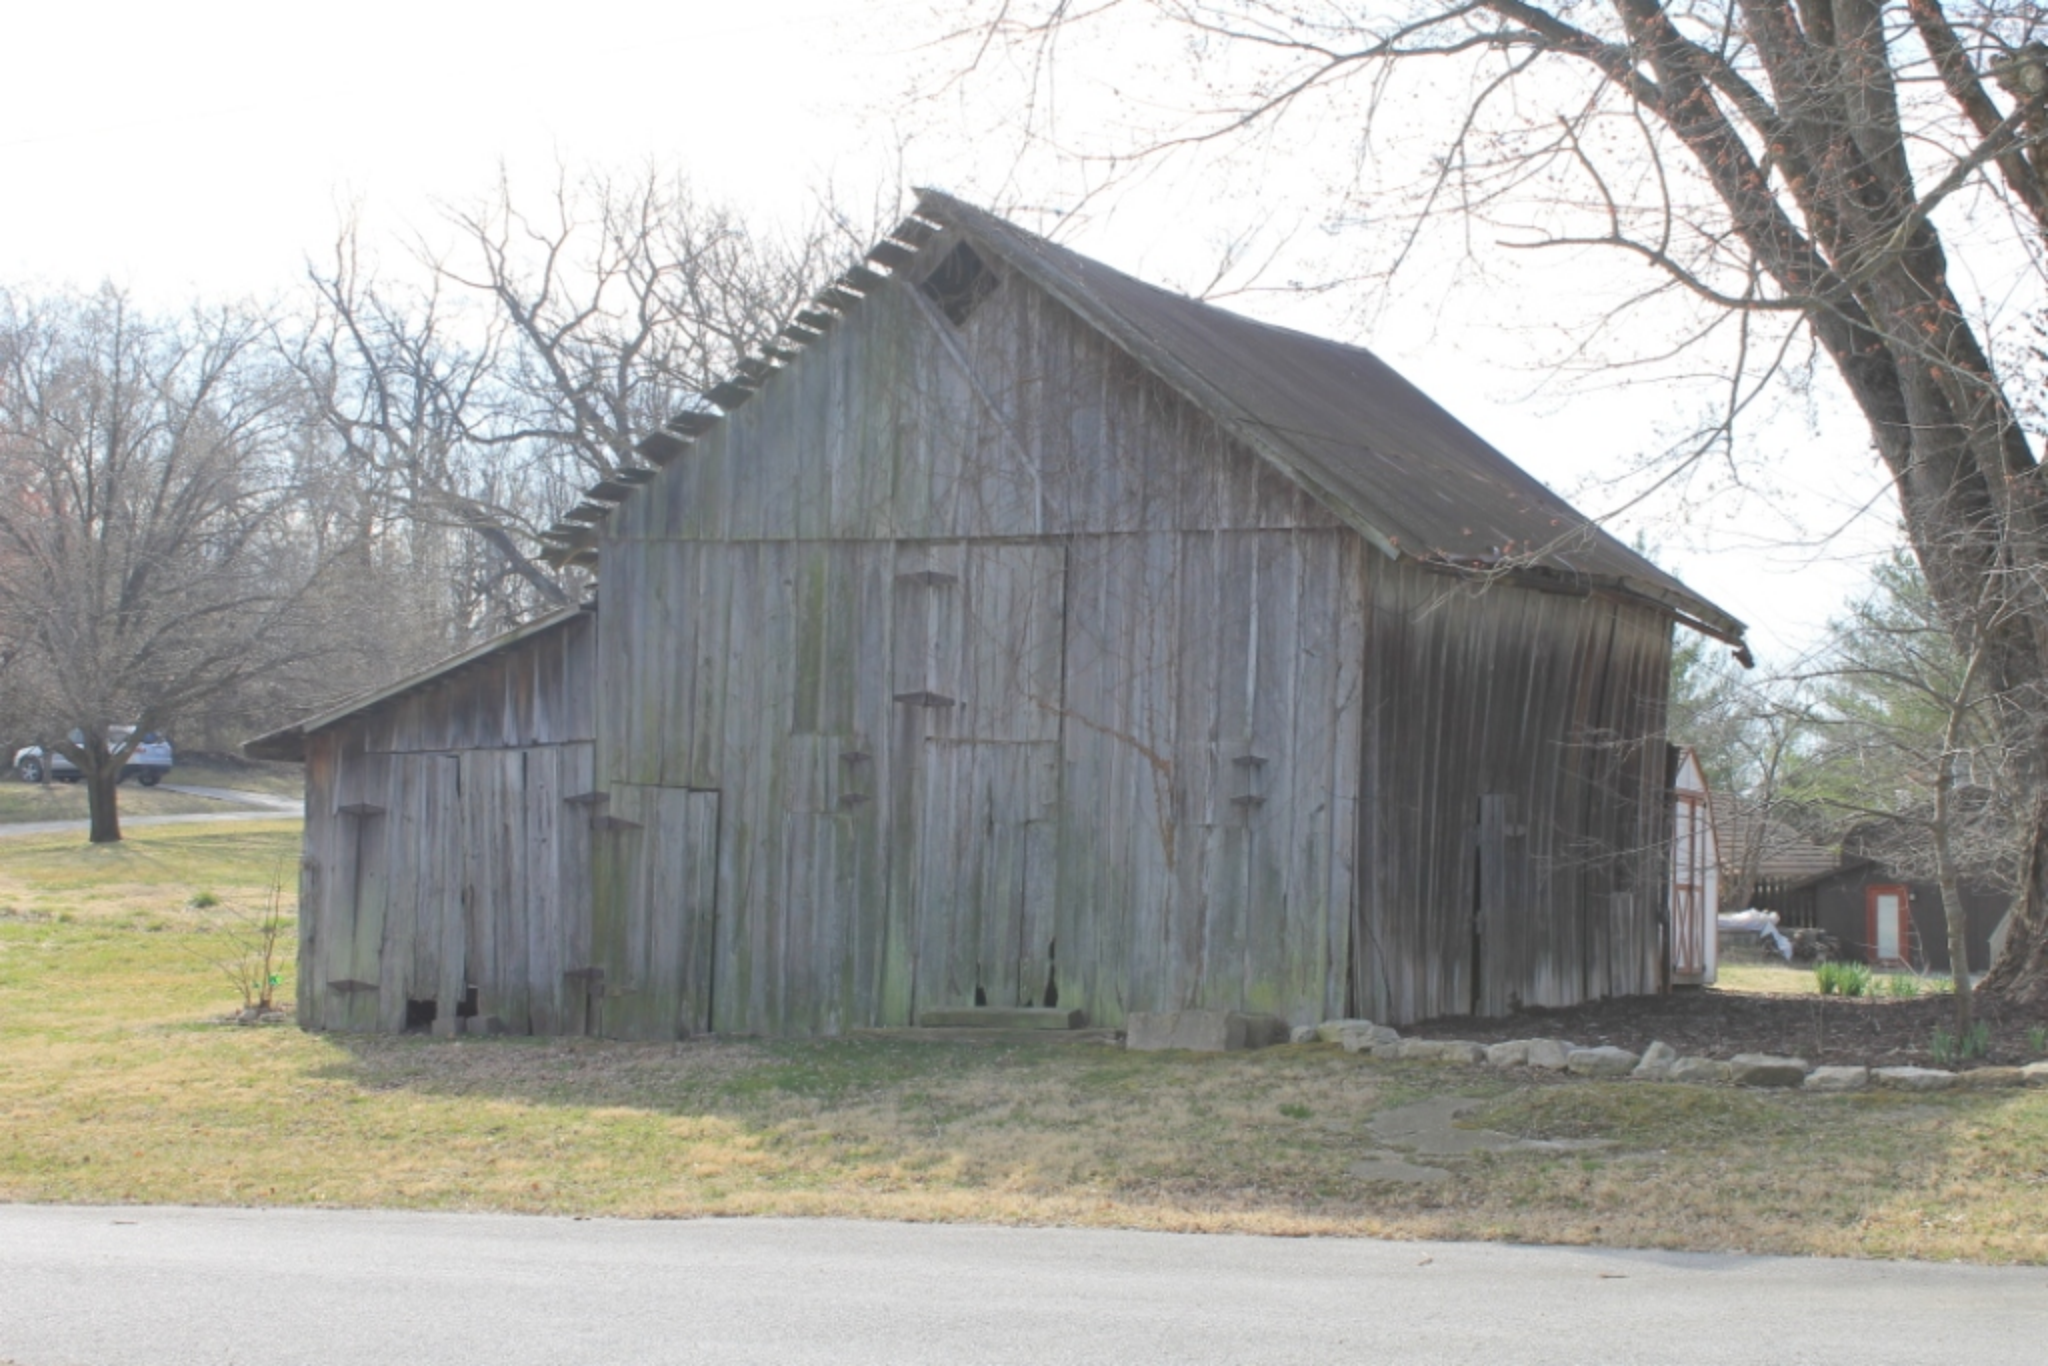
This two story, massed plan, T-shaped, frame house is clad in vinyl siding and the medium gable roof is covered in metal. The house has three bays on the first story of the front (west) facade; the leftmost two bays contain six-over-six single hung vinyl windows. The right most bay contains a doorway with sidelights consisting of three panes of glass above wooden panels; the door is a paneled door covered with a modern metal and glass storm door. The second story has three bays, each containing a six-over-six single hung vinyl window. These windows are placed above the windows and door of the first story, giving the house a pleasing symmetry. A flat roofed veranda extends the length of the front (west) facade. The roof of the veranda is supported by turned posts. At the roof line, a scalloped solid spandrel runs between the porch posts.

This building is significant under CRITERION C: ARCHITECTURE as an example of a mid-nineteenth century domestic architecture. The Rocheport Historic District survey photograph shows the house looking very much as it does today, but also notes the house was then covered in asphalt shingles textured to look like brick. The house was in poor condition in 1973. The front porch was added prior to the Rocheport Historic District survey. The house has been renovated; the asphalt shingles have been replaced with narrow vinyl siding. Despite the changes in wall cladding and windows, the building retains the feeling of an historic building and is there contributing.

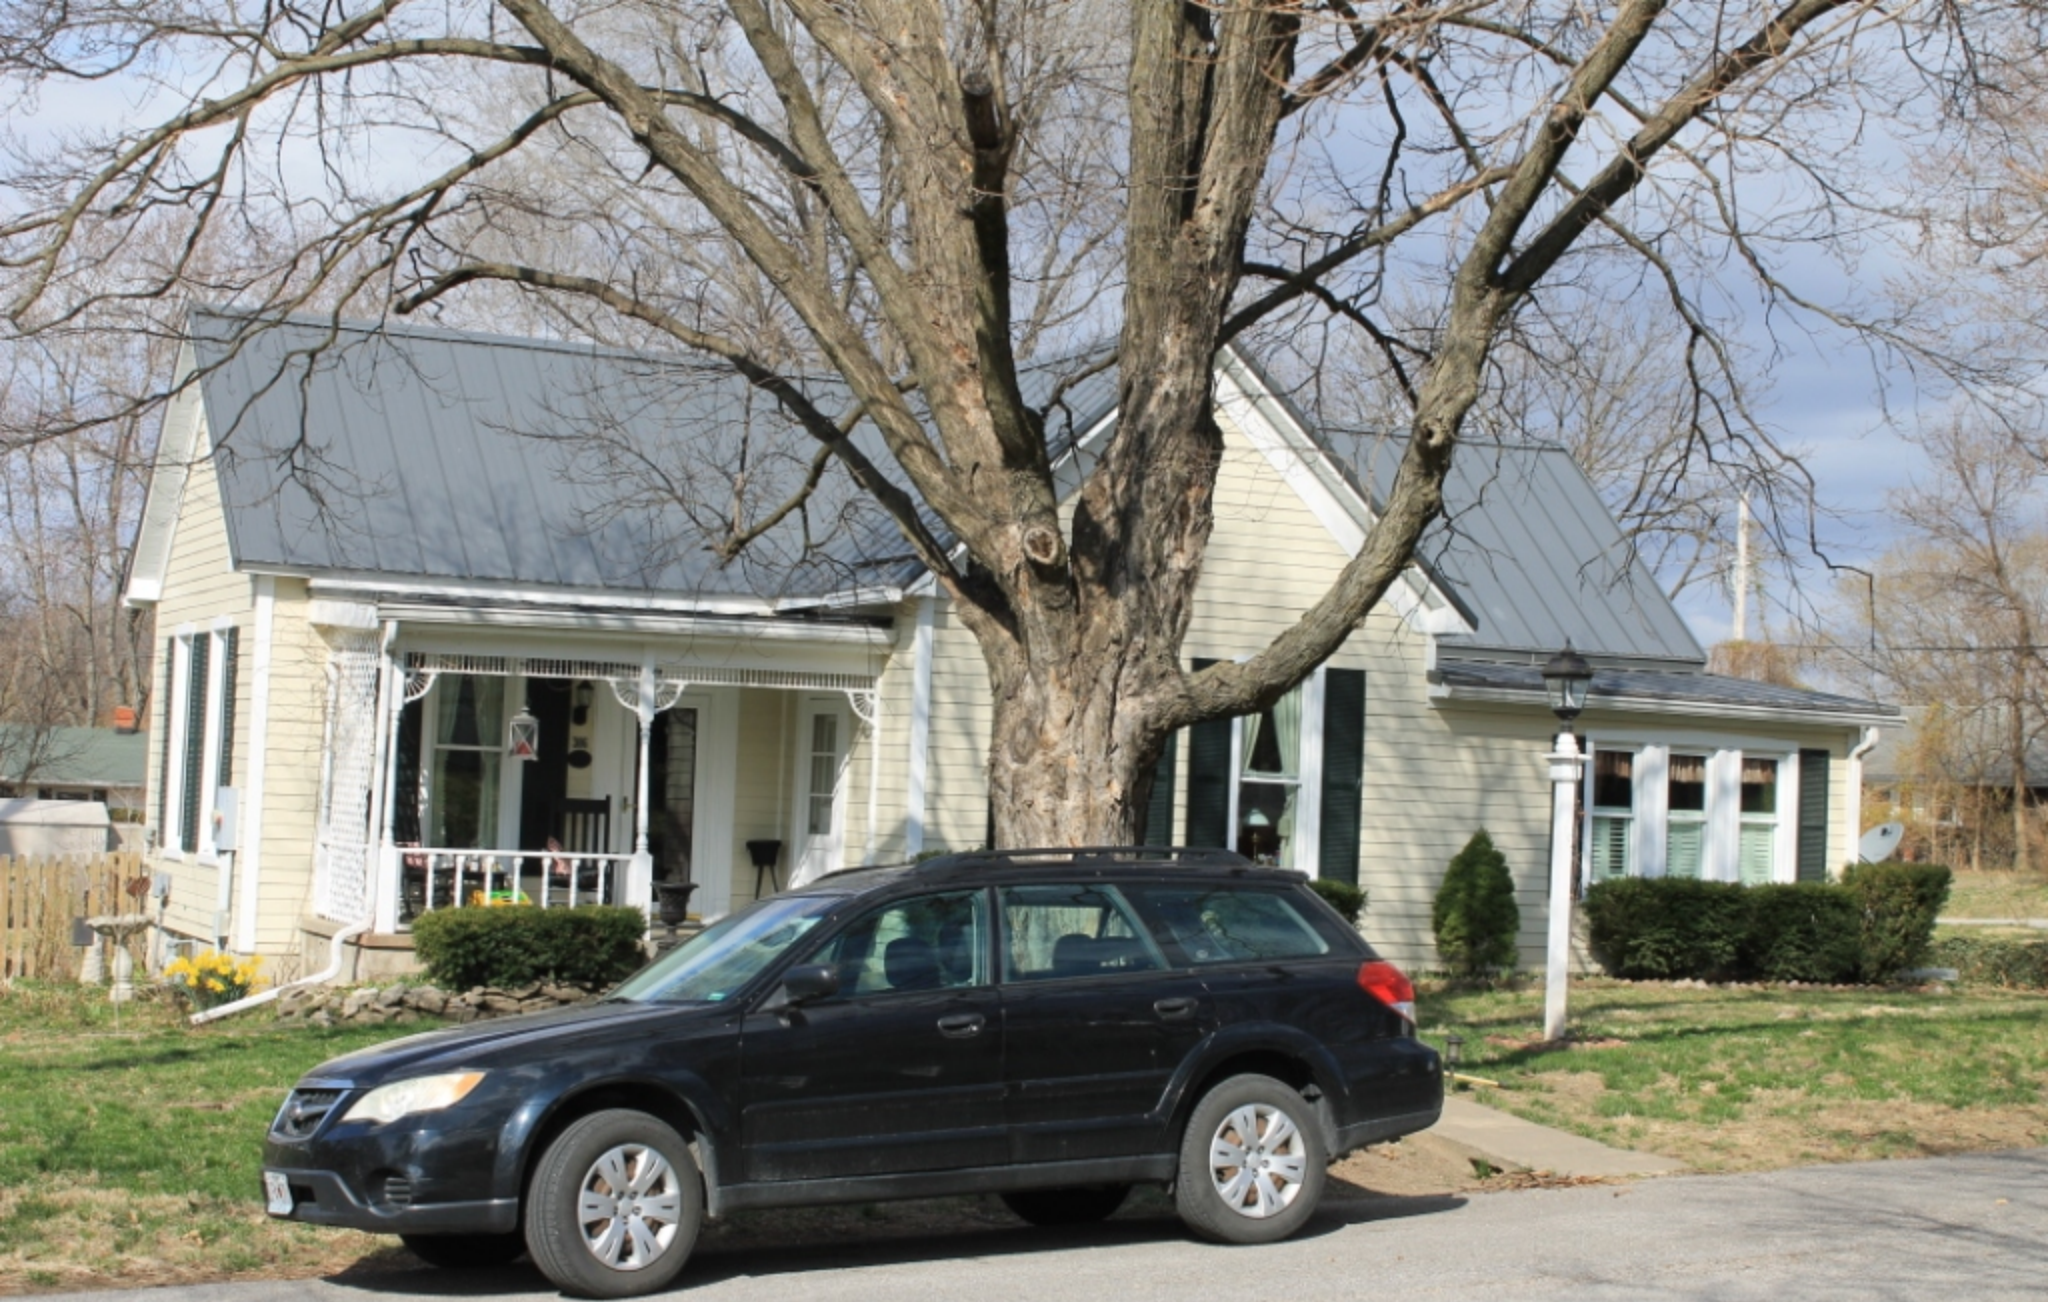
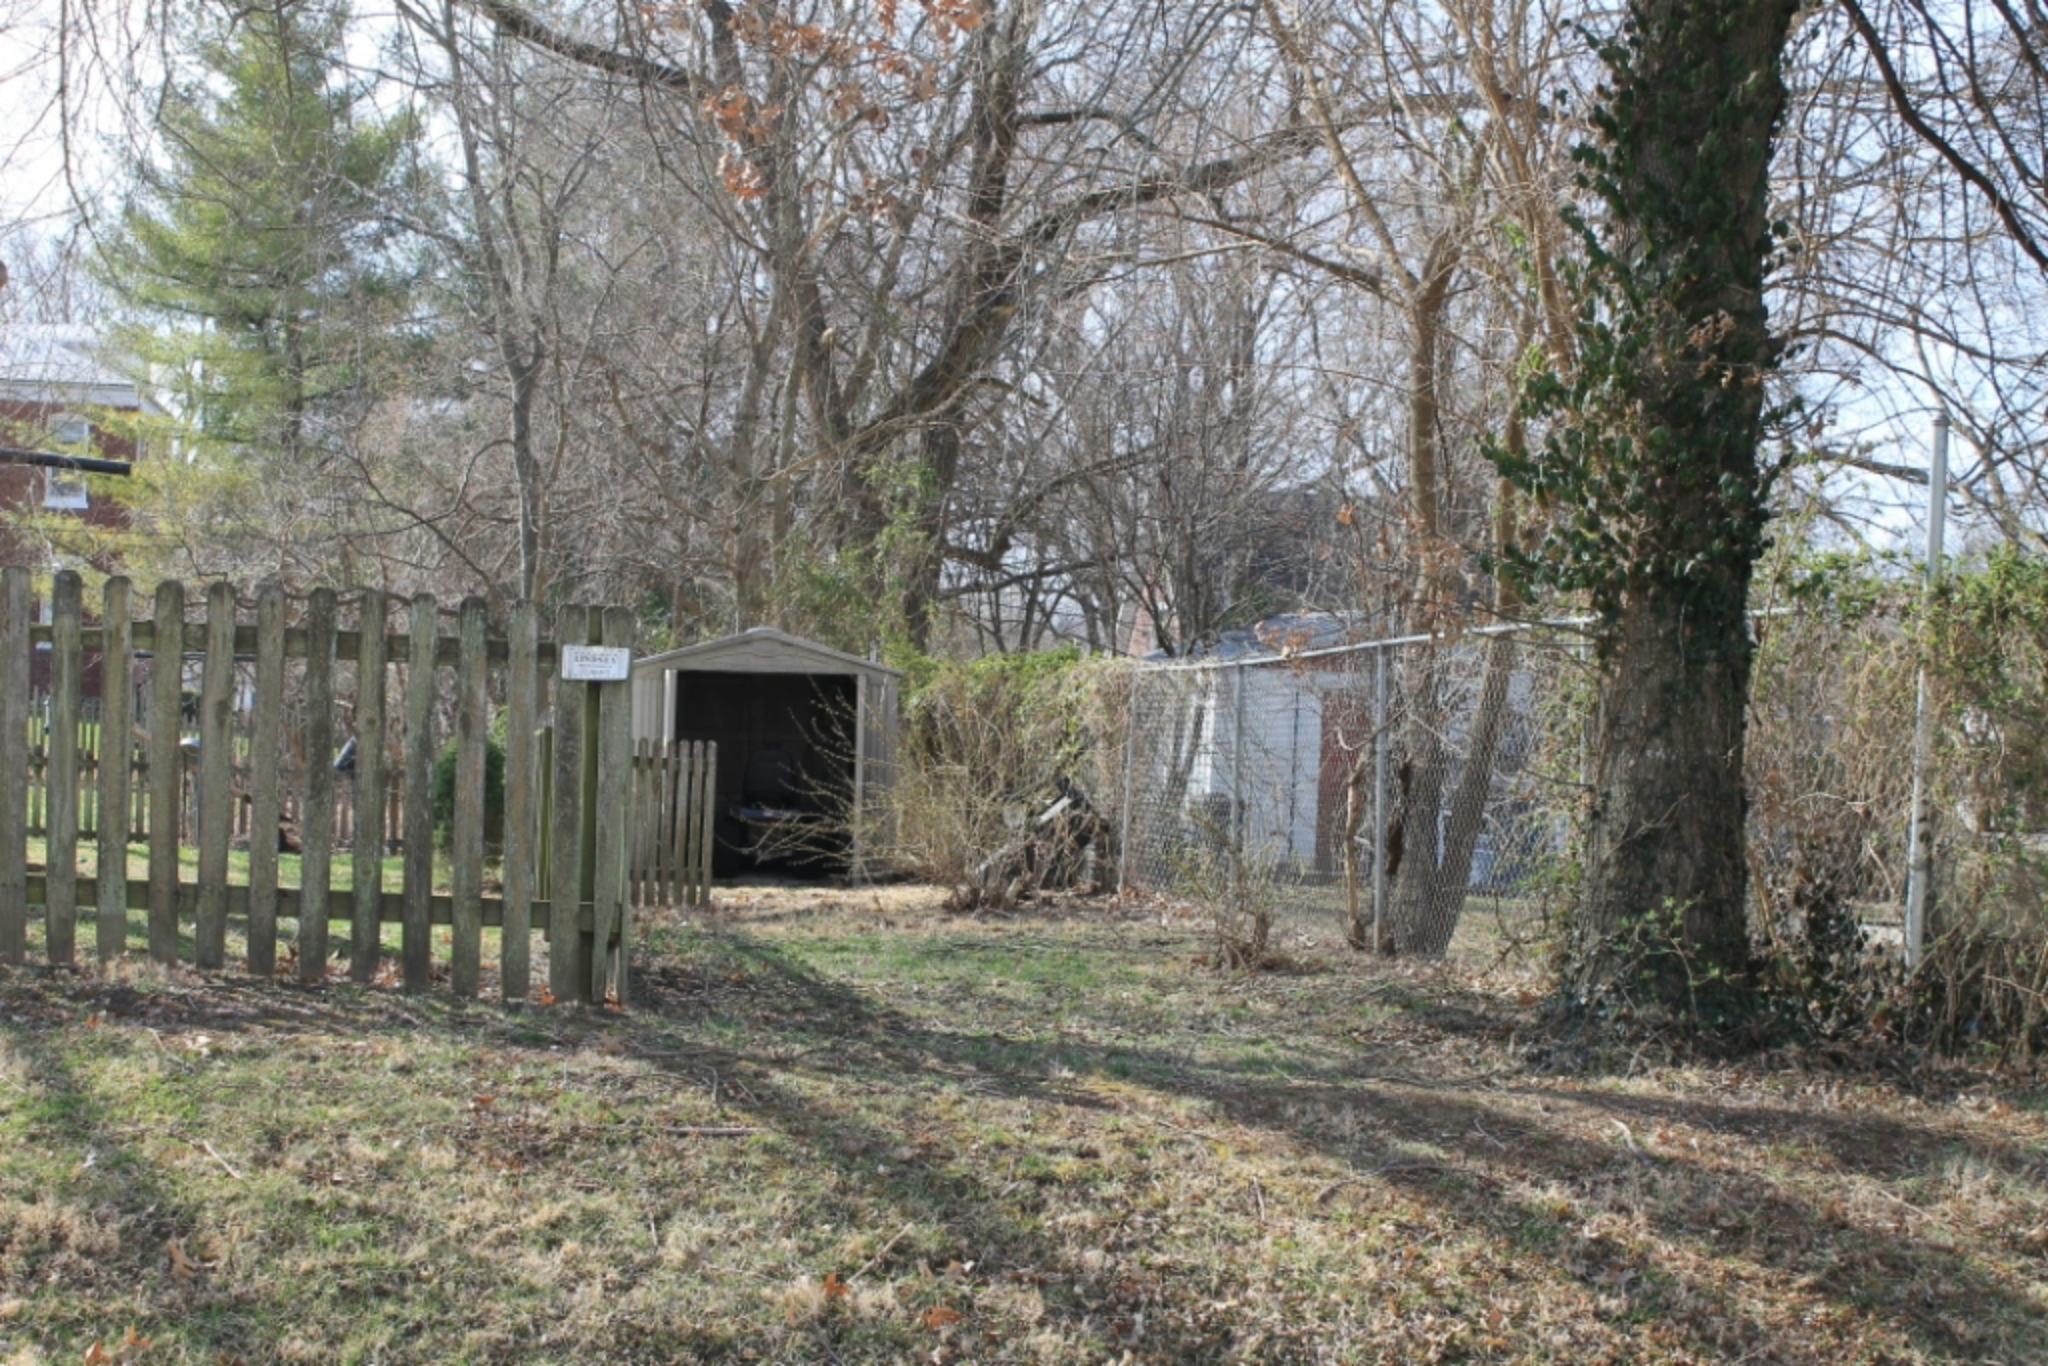
This one story, massed plan, Folk Victorian style, frame house is clad in clapboards. The high cross gable roof is covered in metal. The cross gable is in the center of the building and extends to both the east in the front and to the west in the rear. A side gable roofed wing extends to the right of the cross gabled portion of the house. A flat roofed ell extends to the north of the cross gabled portion. On the left side of the house at the point where the center front gabled wing meets the side wing of the house is a flat roofed porch with decorative spandrels and brackets. The front (east) facade has five bays. The left bay, which is under the porch, contains a large one-over-one single hung window accented with shutters. The next bay, which is also under the porch, contains a door that opens onto the porch. The next two bays, which are in the center cross gabled portion of the east facade, each contain a one-over-one single hung window accented with shutters. The rightmost bay, which is located on the wing to the right of the cross gabled portion of the house, contains three one-over-one single hung windows accented with shingles.
