MISSOURI DEPARTMENT OF NATURAL RESOURCES
STATE HISTORIC PRESERVATION OFFICE, P.O. Box 176, Jefferson City, MO 65102
ARCHITECTURAL/HISTORIC INVENTORY FORM

1. SURVEY NO. BO-AS-009-0001		2. SURVEY NAME: Rocheport Historic District	
3. COUNTY: Boone		4. ADDRESS (STREET NO.)	STREET (NAME) Katy Trail
5. CITY: Rocheport	VICINITY: <input checked="" type="checkbox"/>	6. UTM: / /	LAT: LONG: T: 48W R: 15W S: 1

8. HISTORIC NAME (IF KNOWN): M.K.&T. Railroad tunnel		9. PRESENT/OTHER NAME (IF KNOWN): Katy trail tunnel	
10. OWNERSHIP: <input type="checkbox"/> PRIVATE <input checked="" type="checkbox"/> PUBLIC		11A. HISTORIC USE (IF KNOWN): railroad tunnel	11B. CURRENT USE: Katy Trail tunnel
HISTORICAL INFORMATION

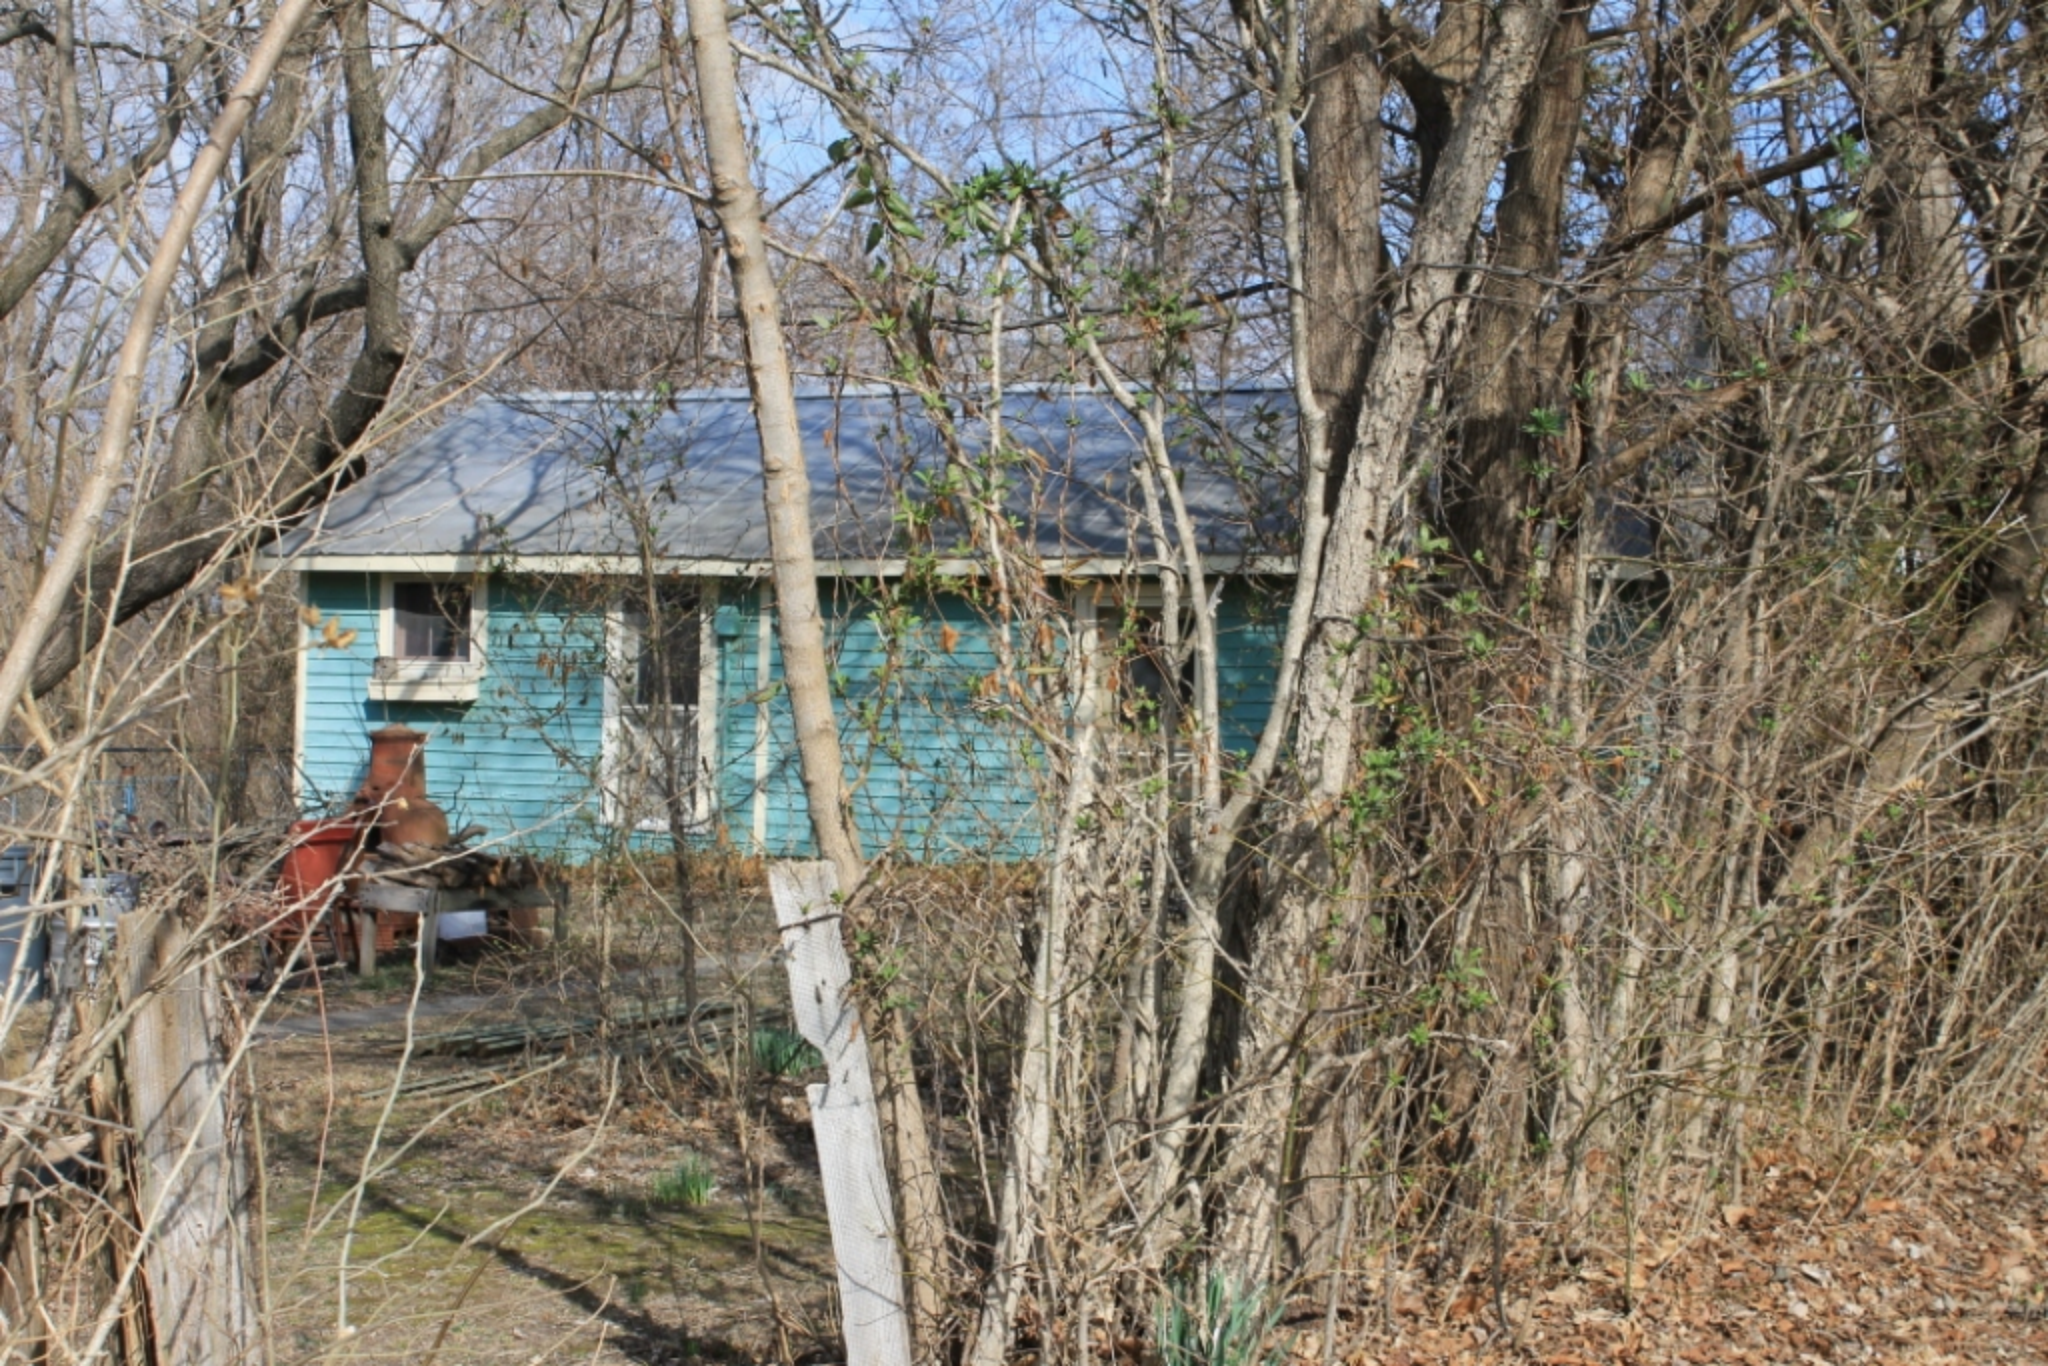
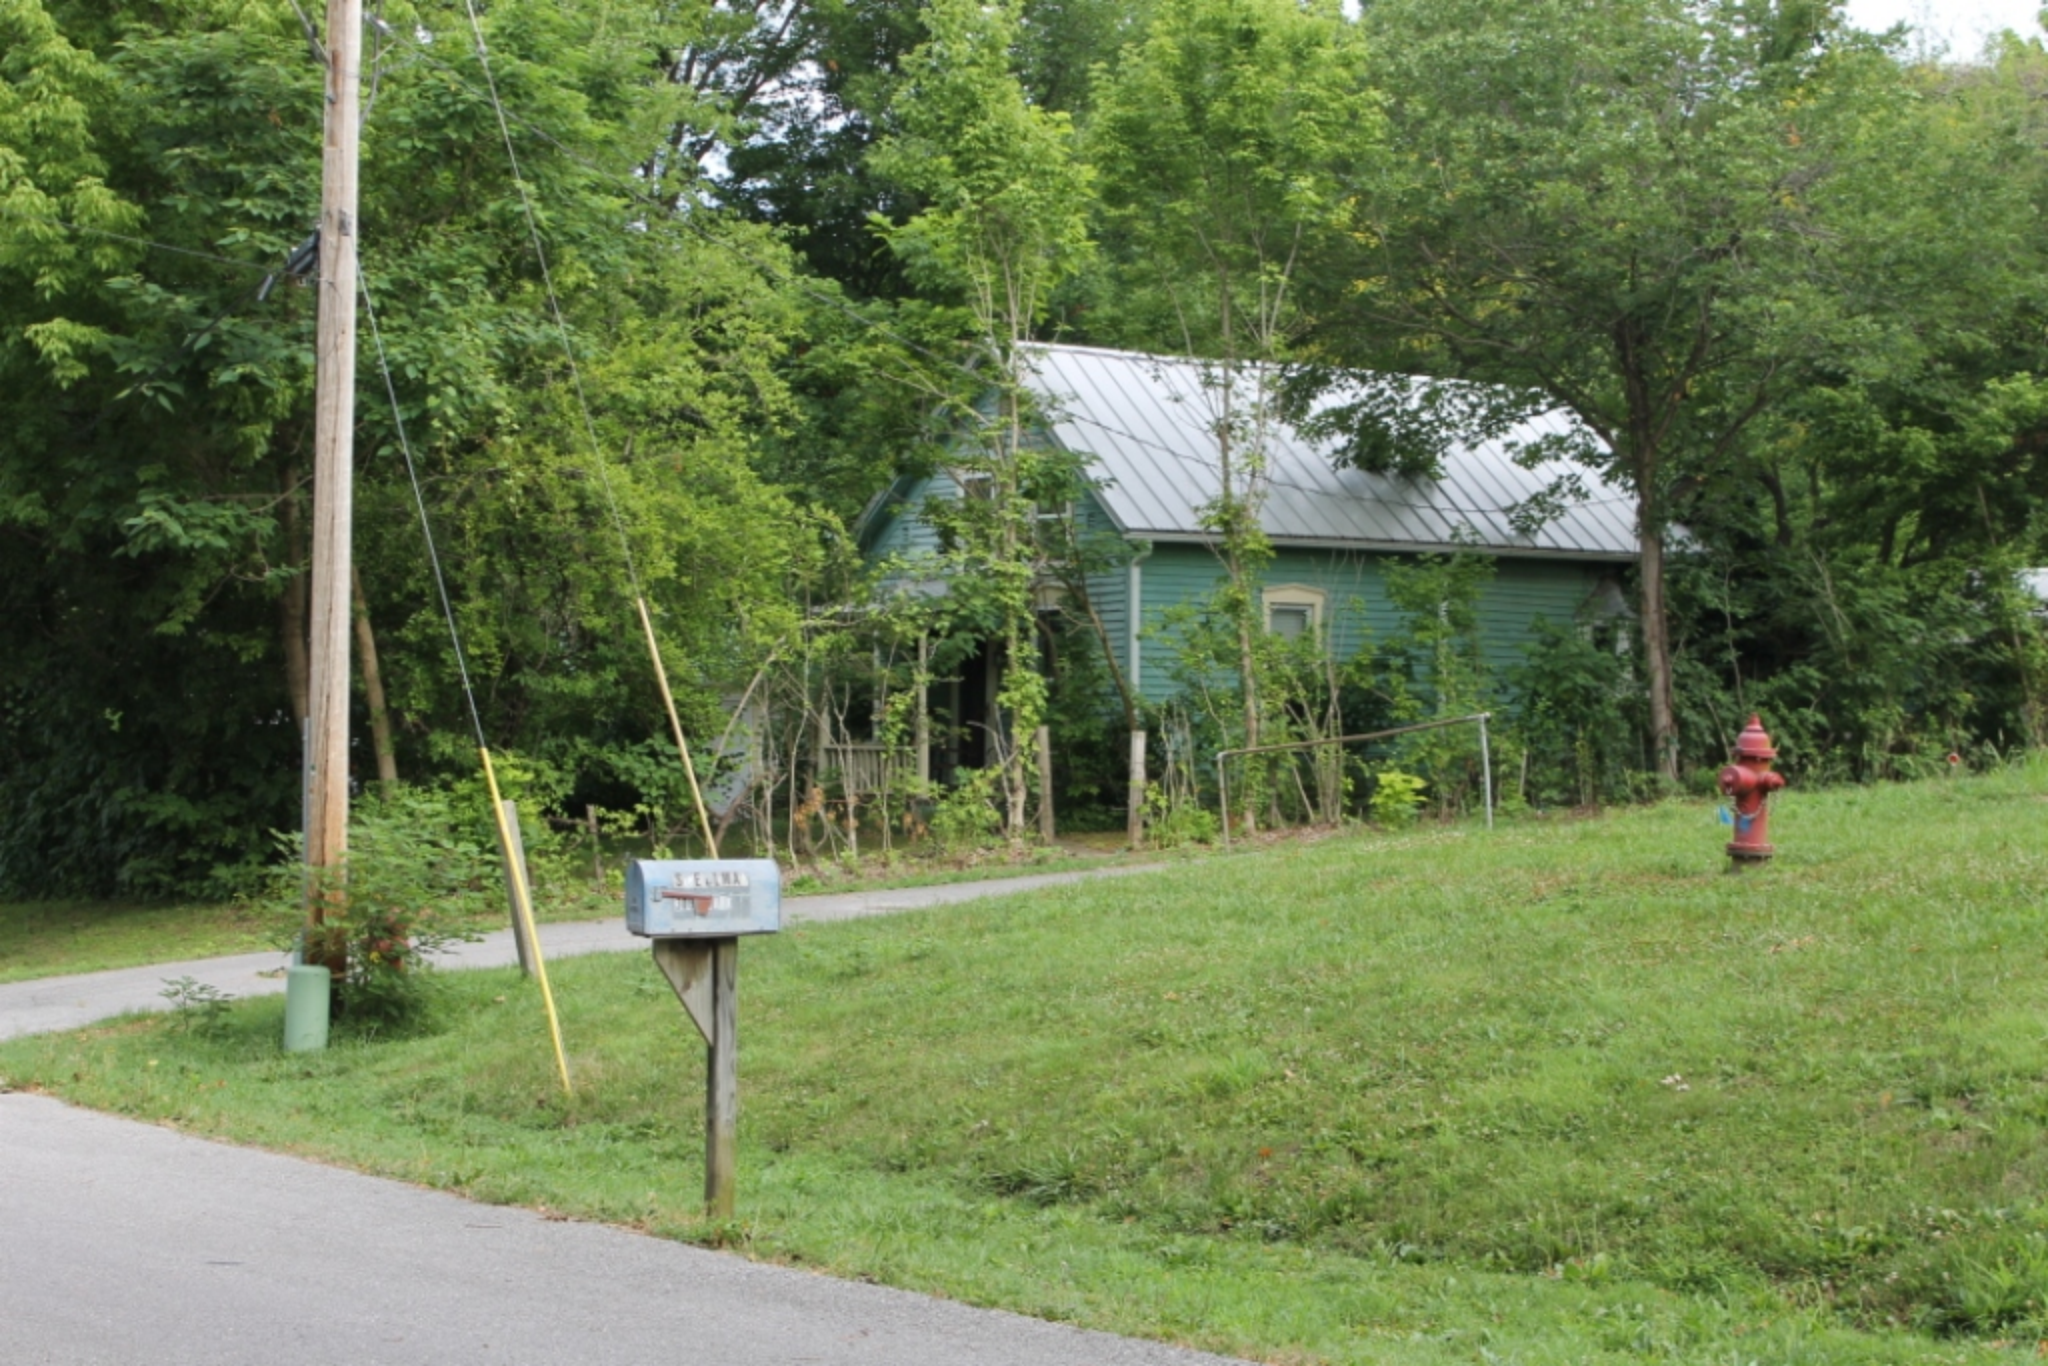
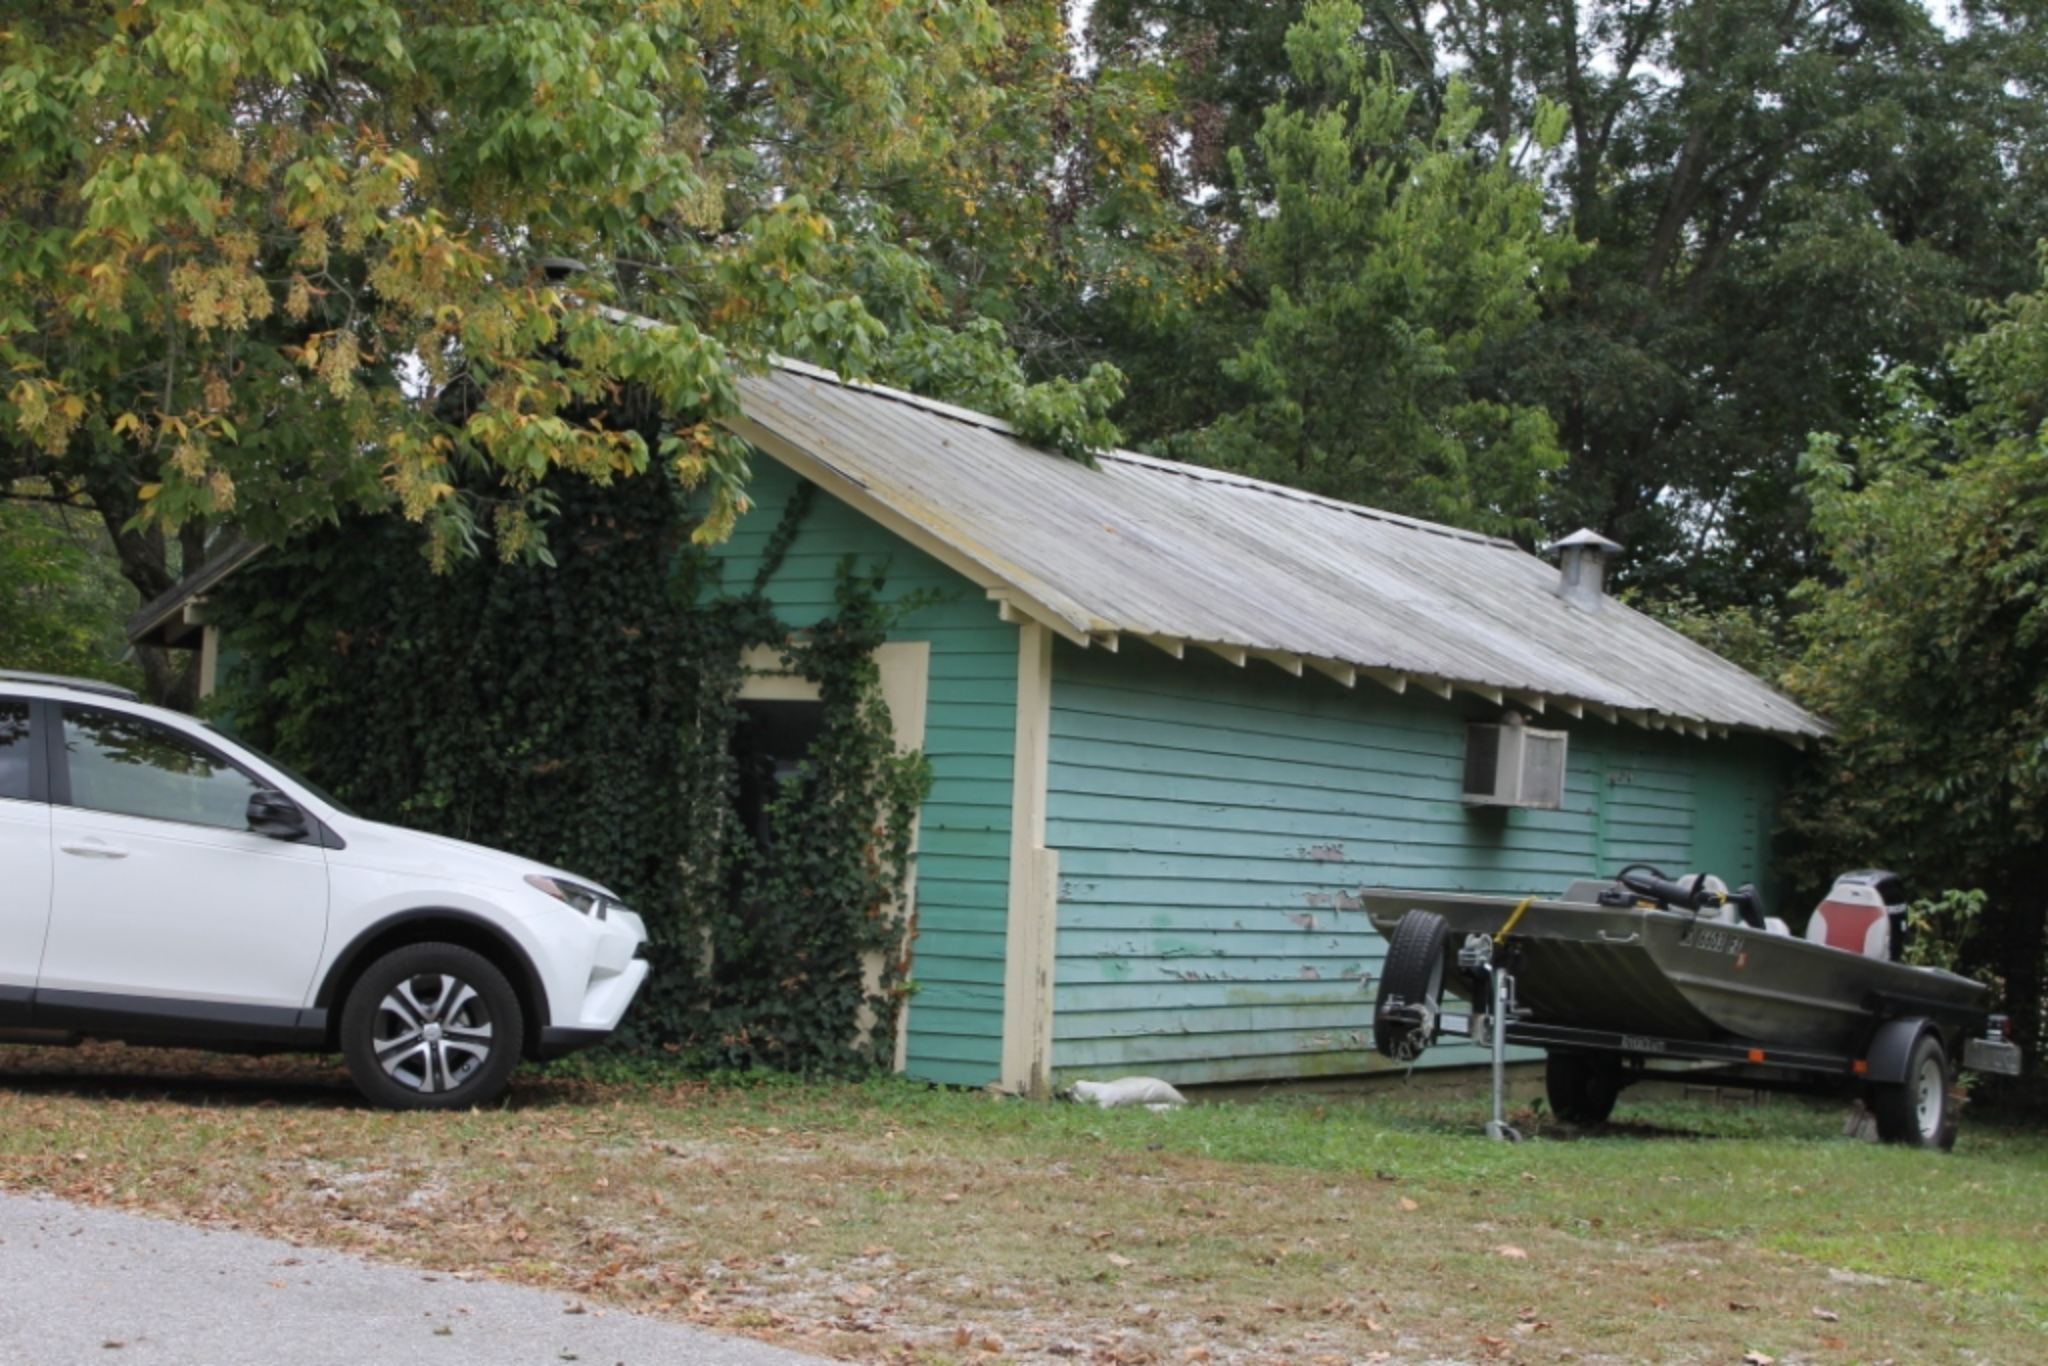
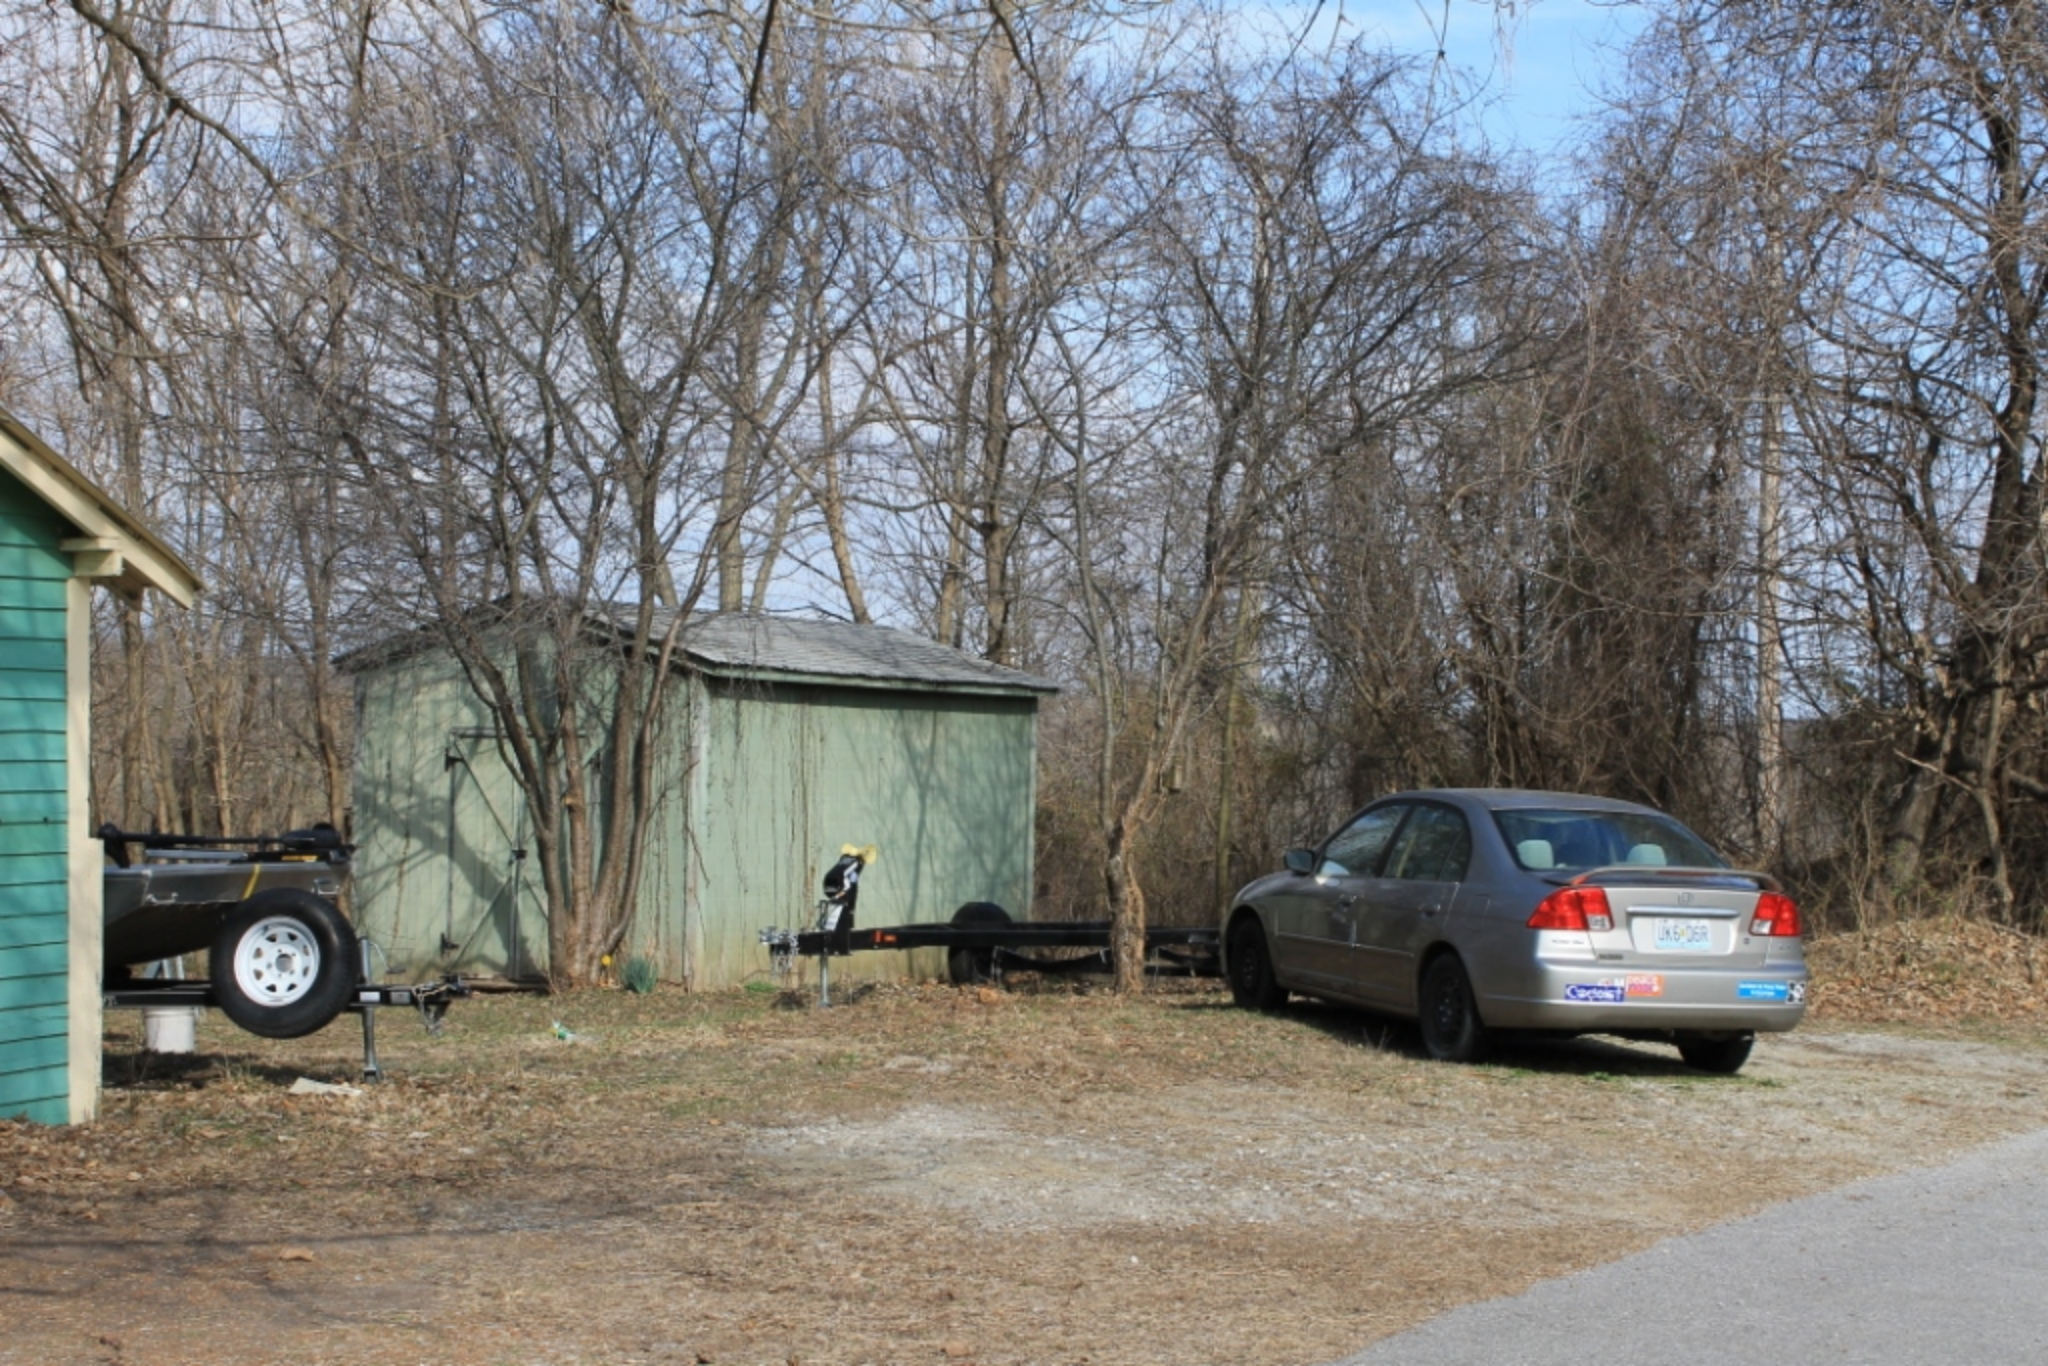
This 1 1/2 story frame house has a high gable roof. A shed roofed open porch covers a the center portion of the front facade. The porch is supported by wooden posts. The first story of the front (south) facade has three bays. The left bay contains a one-over-one single hung wooden window. The center bay contains a door; this bay is under the porch. The right bay contains a one-over-one wooden single hung window. The second story of the front (south) facade has one bay containing a one-over-one single hung wooden window. The first story of the side (east) facade has three bays. The left bay contains a small two-over-two single hung window. The next bay contains a larger two over two single hung window. The windows have arched lintels. The right bay contains a door with a modern metal and glass storm door.

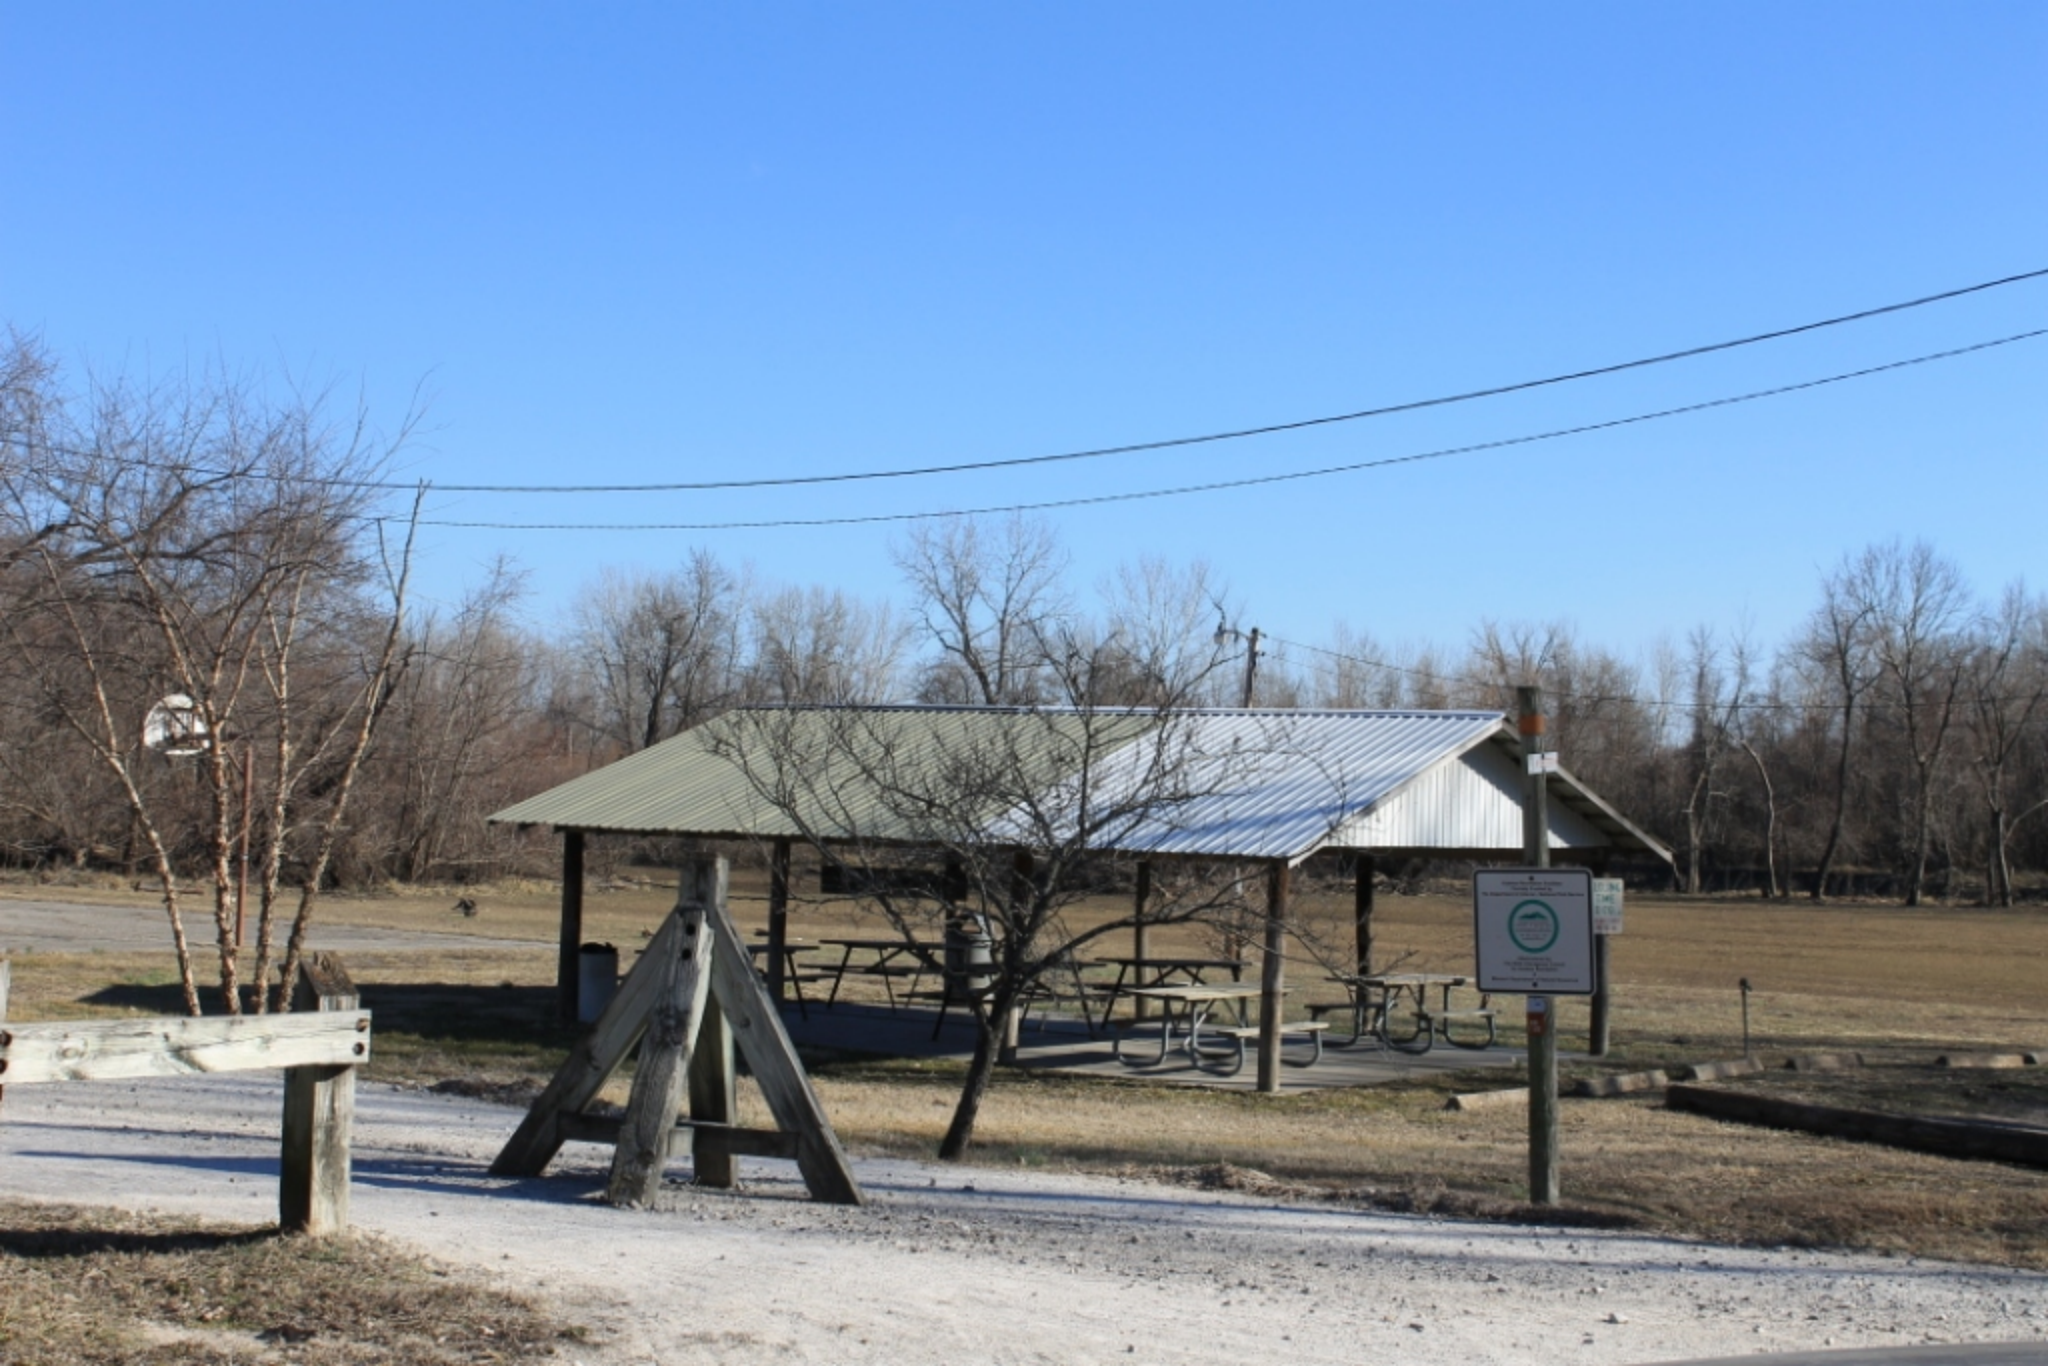
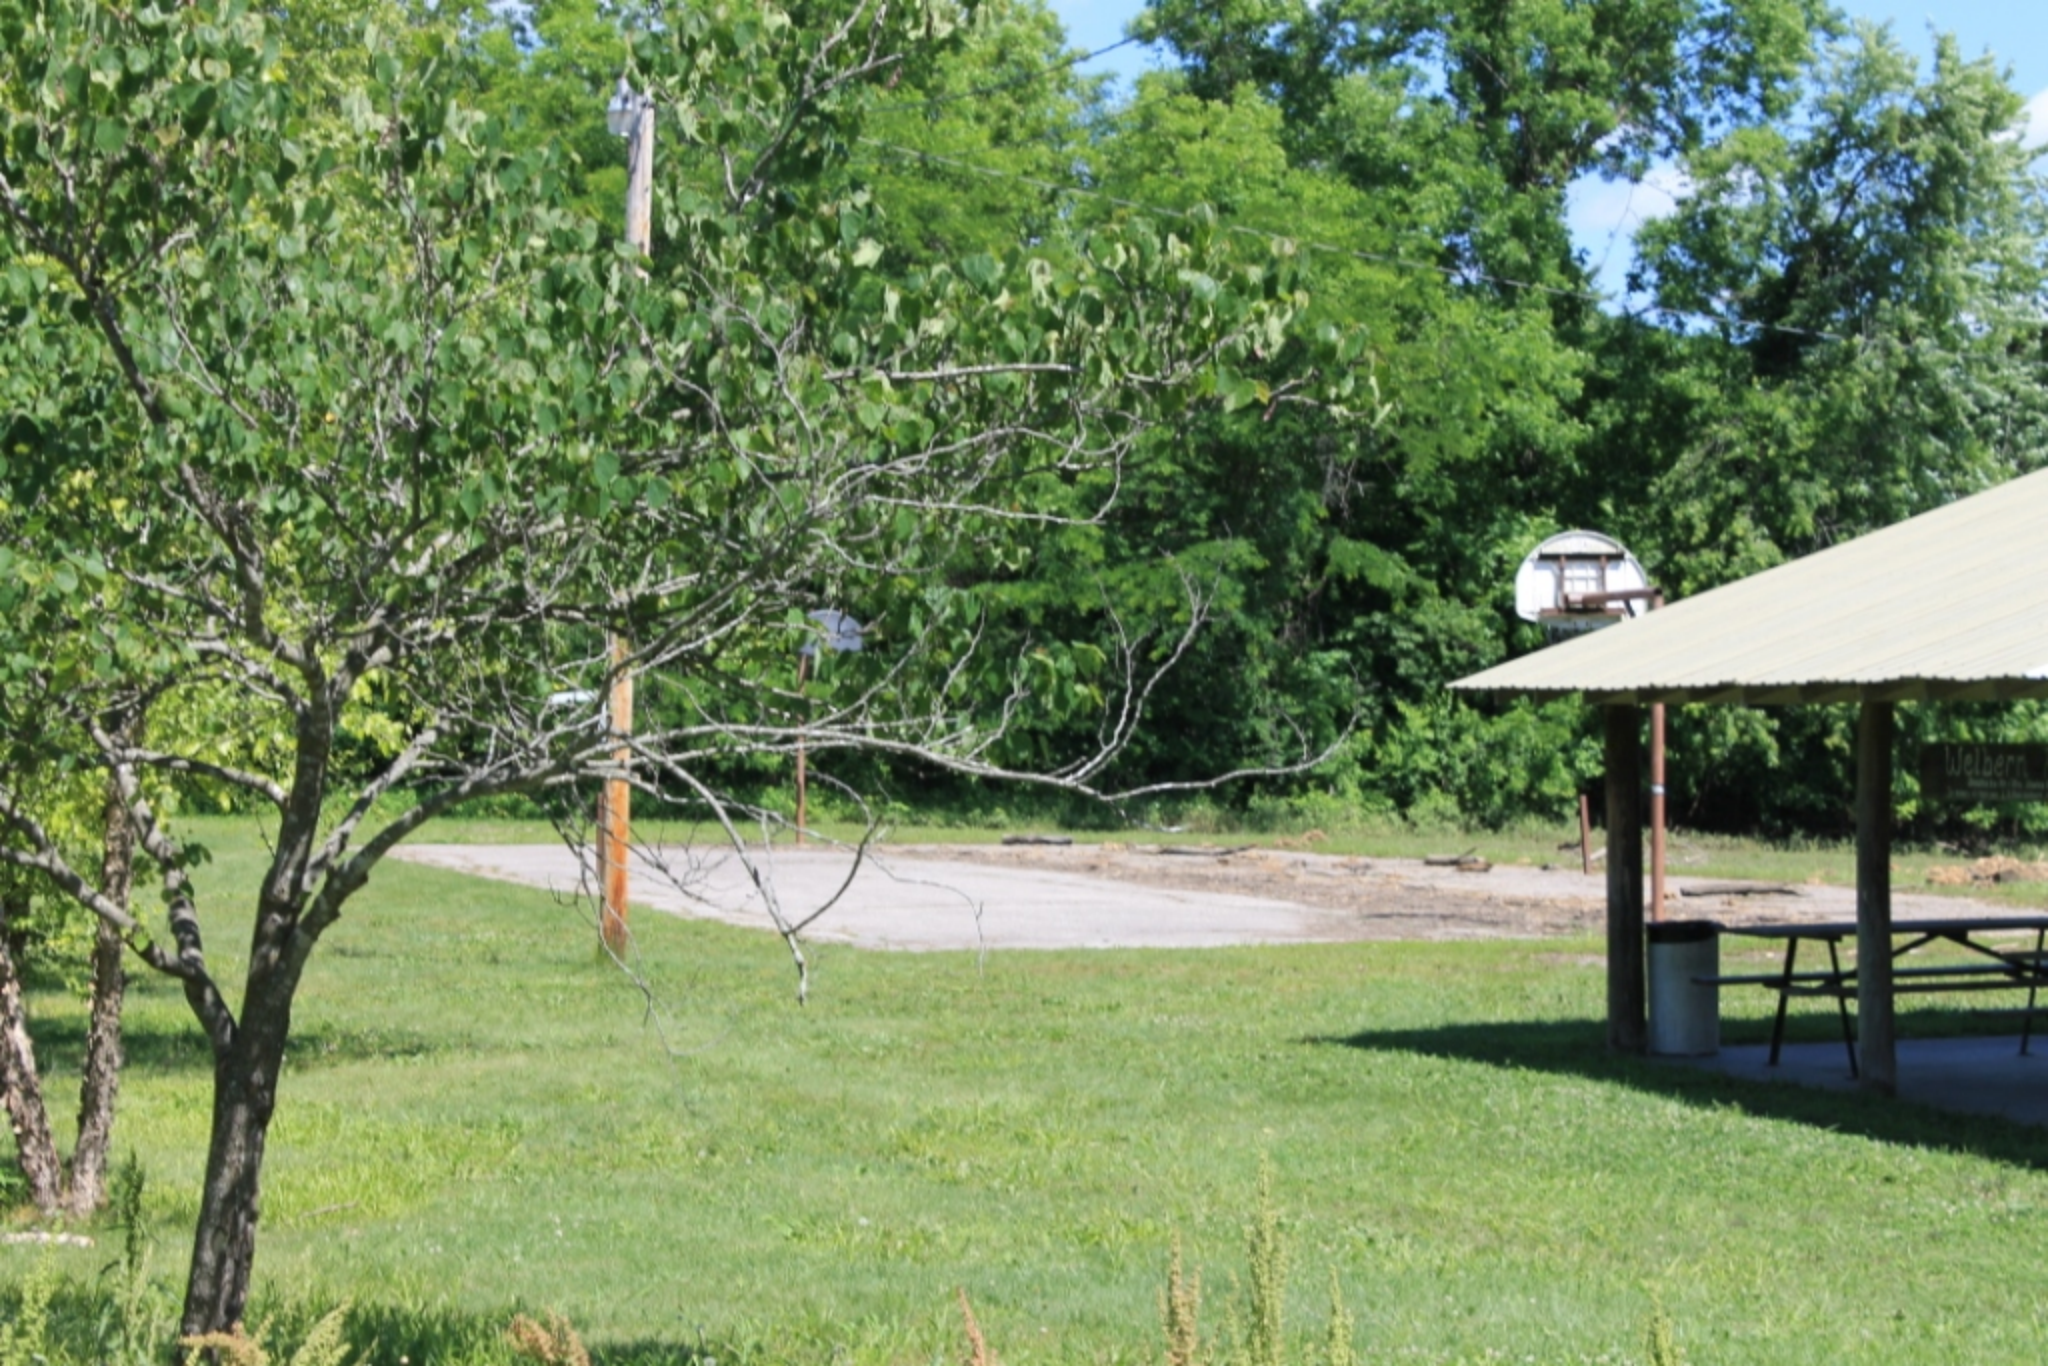
This picnic shelter is a very low gable metal roofed shelter supported by wooden posts. The floor is a concrete slab. A gravel parking area is to the west of the shelter. To the east of the picnic shelter is an asphalt paved court fitted with basketball goals and supports for a tennis net.

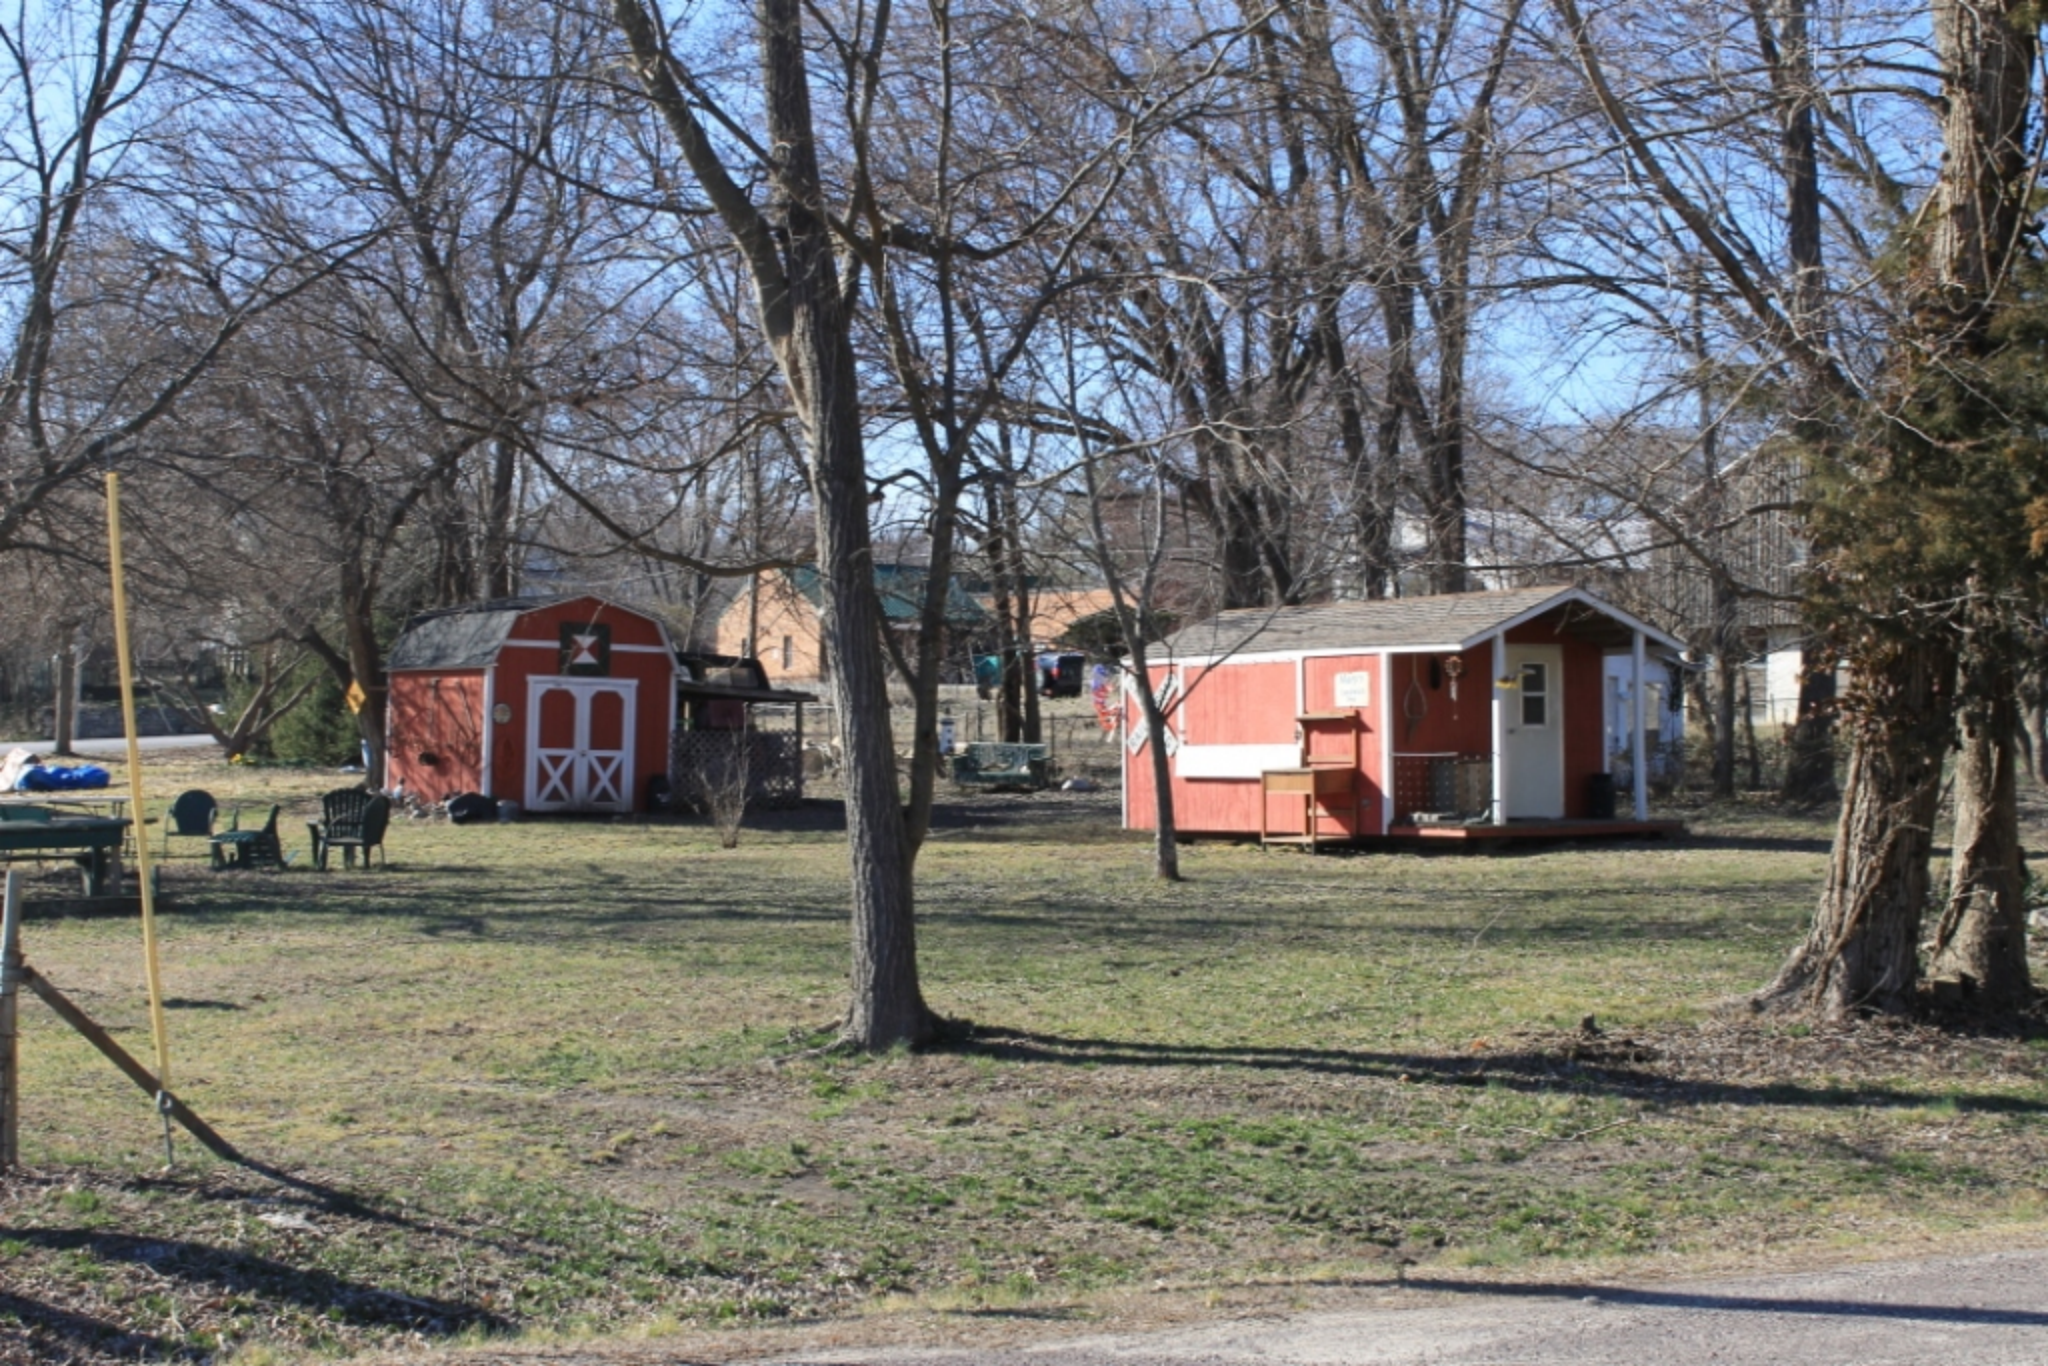
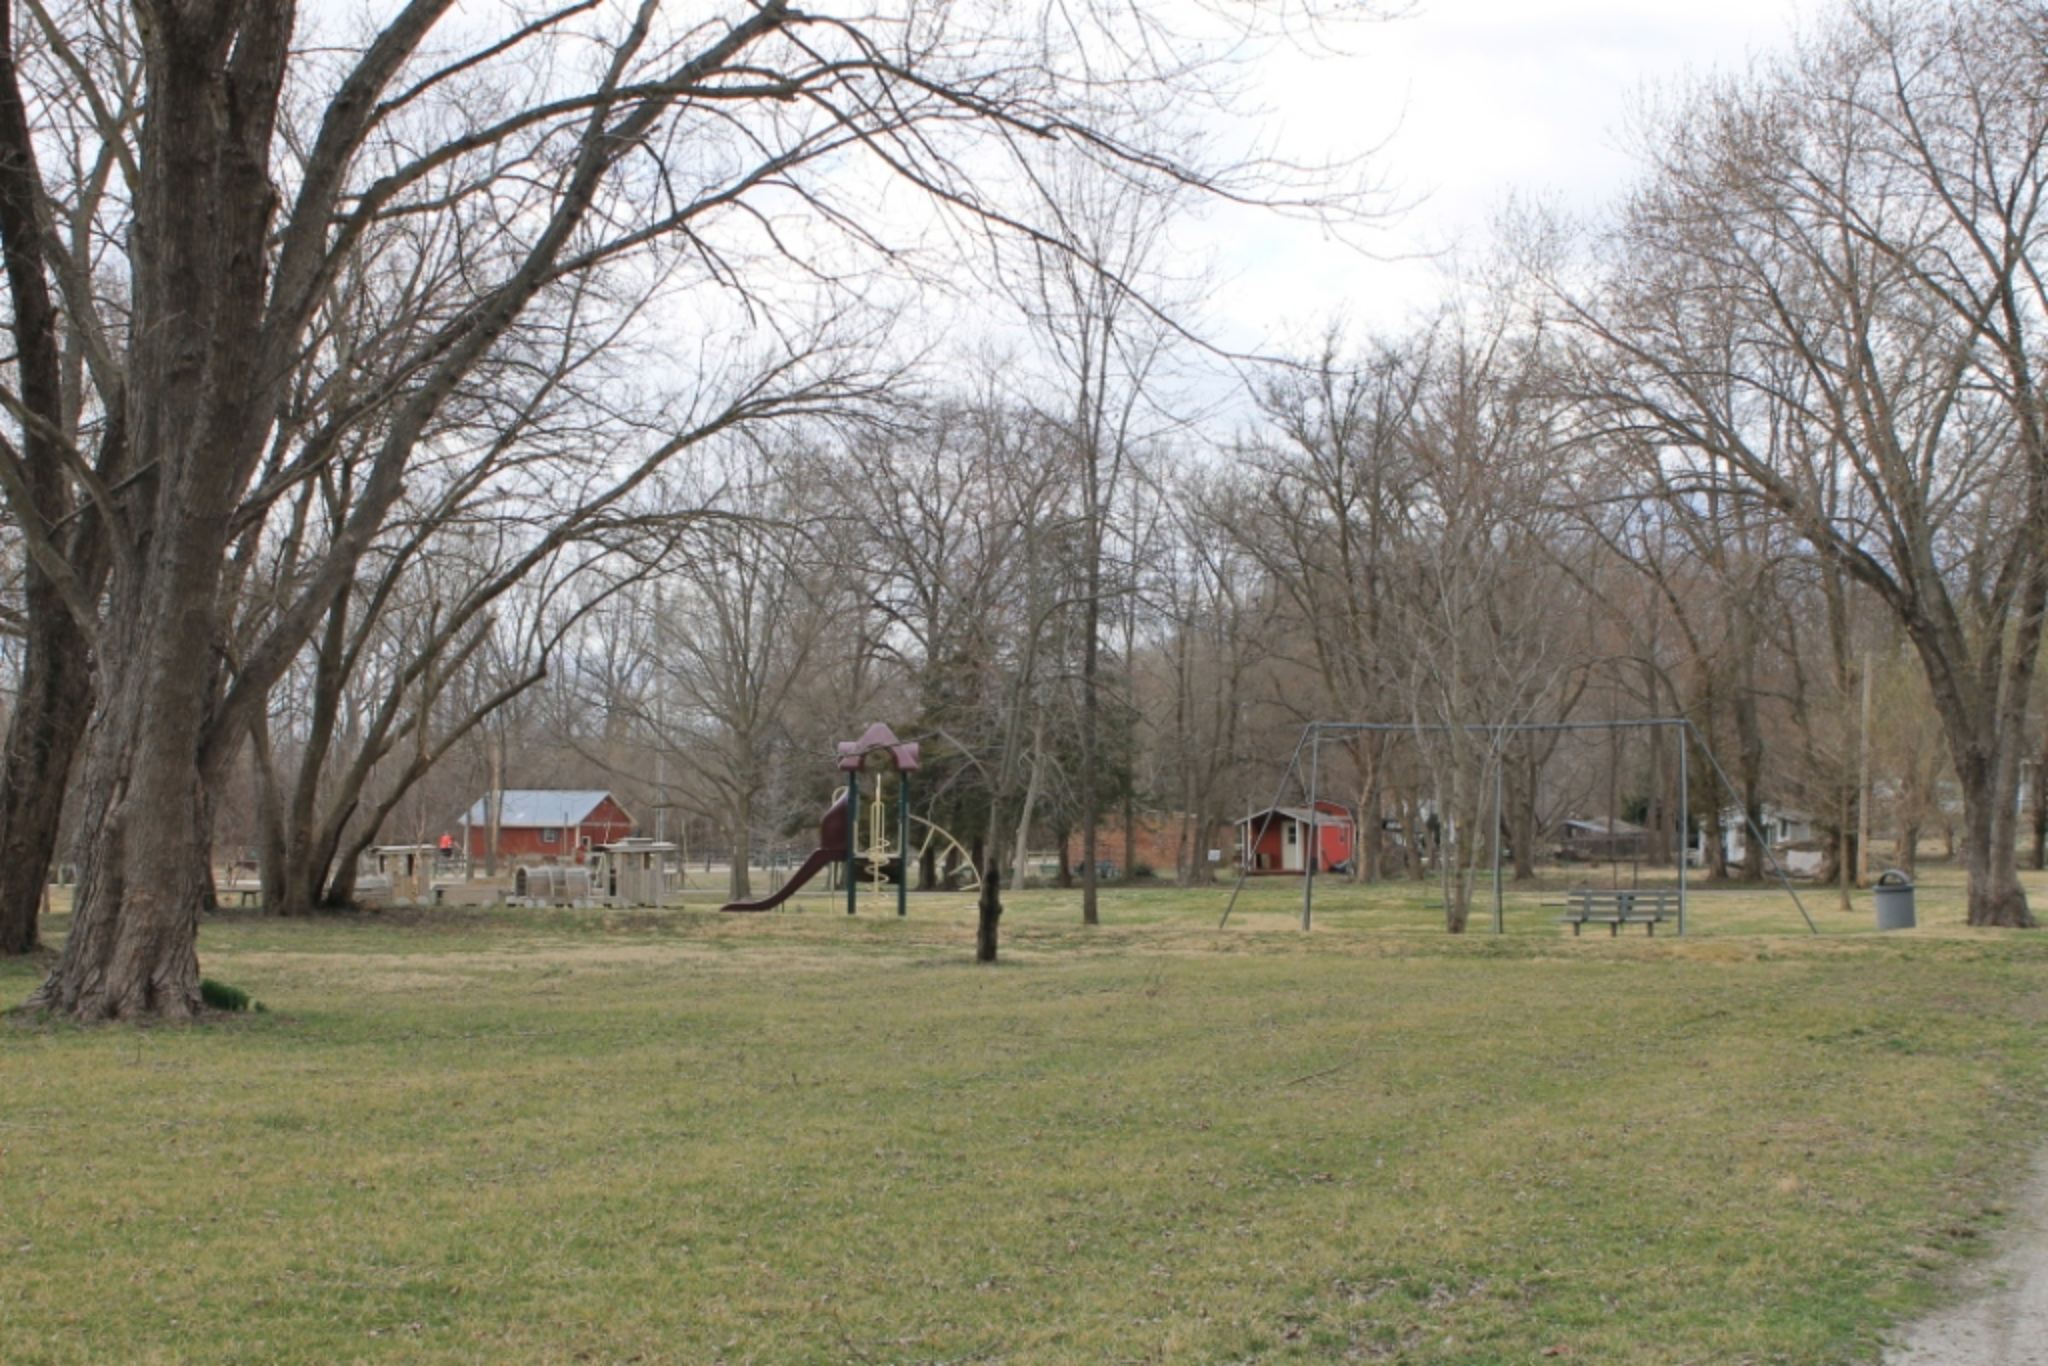
The primary resource is a one-story frame concession stand with a gable roof clad in asphalt shingles. The building is clad in plywood vertical siding. The building has awning type openings on the sides to allow the sale of food items. On the front (west) facade the roof extends over a covered porch. The east facade has one bay which contains an entry door opening onto the porch. The secondary resource is a gambrel roofed shed designed to look like a small barn. The shed is also clad in vertical plywood siding and its roof is covered with asphalt shingles. This shed has one bay on the east facade; the bay contains a pair of doors. The playground equipment, which sits on the park area between Columbia Street and Lewis Street consists of a wooden train model for children to play on and a metal swing structure.
