MISSOURI DEPARTMENT OF NATURAL RESOURCES
STATE HISTORIC PRESERVATION OFFICE, P.O. Box 176, Jefferson City, MO 65102
ARCHITECTURAL/HISTORIC INVENTORY FORM

1. SURVEY NO. BO-AS-009-0001		2. SURVEY NAME: Rocheport Historic District	
3. COUNTY: Boone		4. ADDRESS (STREET NO.)	STREET (NAME) Katy Trail
5. CITY: Rocheport	VICINITY: <input checked="" type="checkbox"/>	6. UTM: / /	LAT: LONG: T: 48W R: 15W S: 1

8. HISTORIC NAME (IF KNOWN): M.K.&T. Railroad tunnel		9. PRESENT/OTHER NAME (IF KNOWN): Katy trail tunnel	
10. OWNERSHIP: <input type="checkbox"/> PRIVATE <input checked="" type="checkbox"/> PUBLIC		11A. HISTORIC USE (IF KNOWN): railroad tunnel	11B. CURRENT USE: Katy Trail tunnel
HISTORICAL INFORMATION

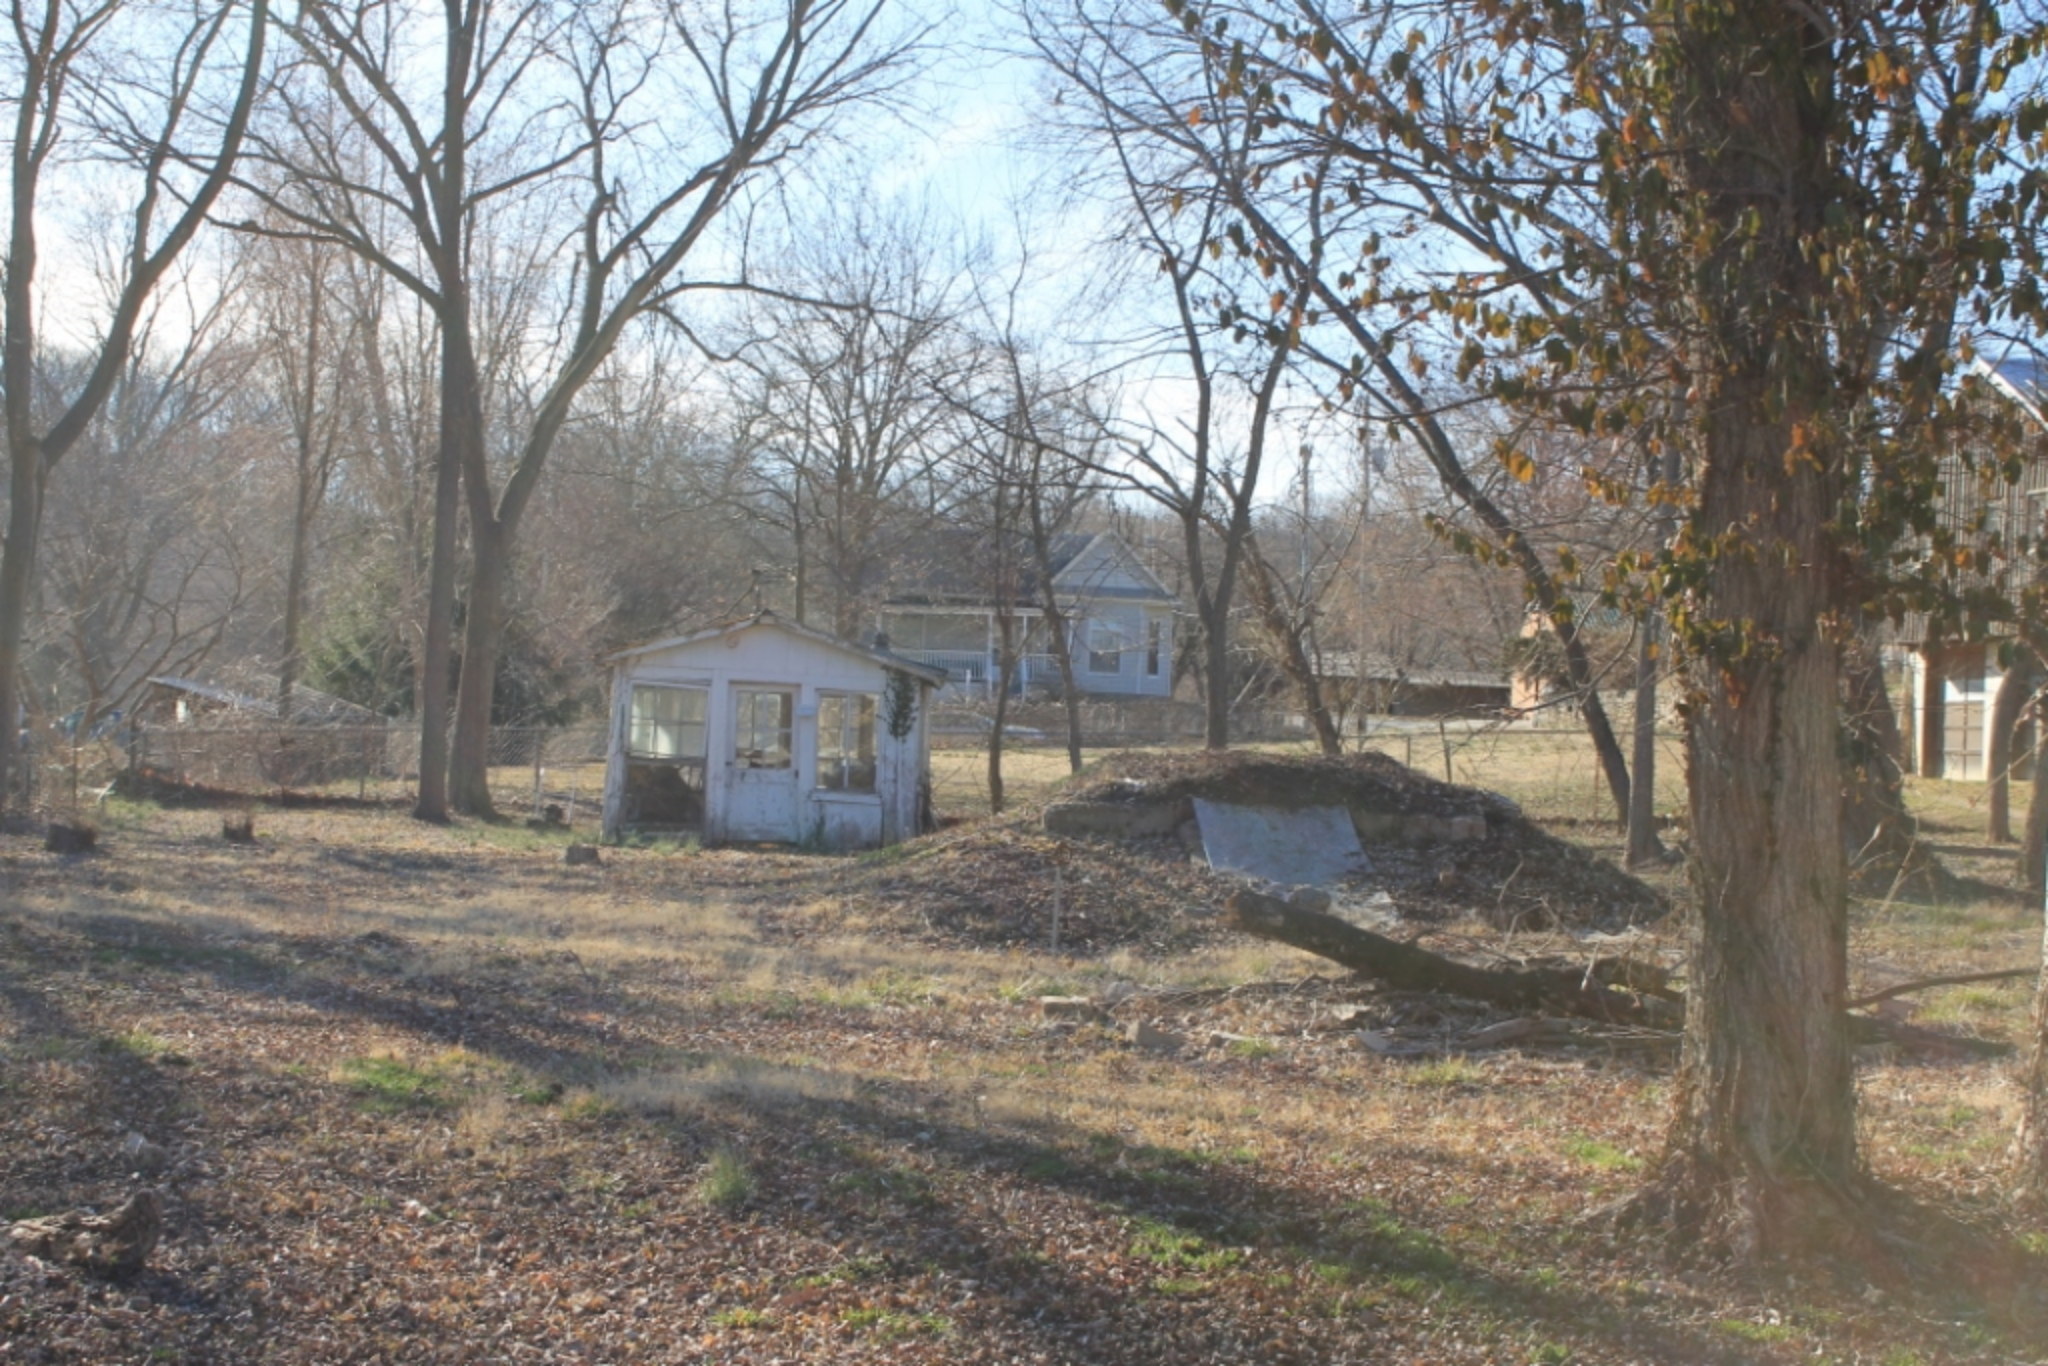
This storm cellar is typical of nineteenth century storm cellars, which were constructed to provide shelter from tornadoes and were also used for storage of root vegetables and home canned produce. The cellar has a mounded earthen roof over a partially underground cellar. A wooden door facing the west opens onto stairs that lead down into the cellar.

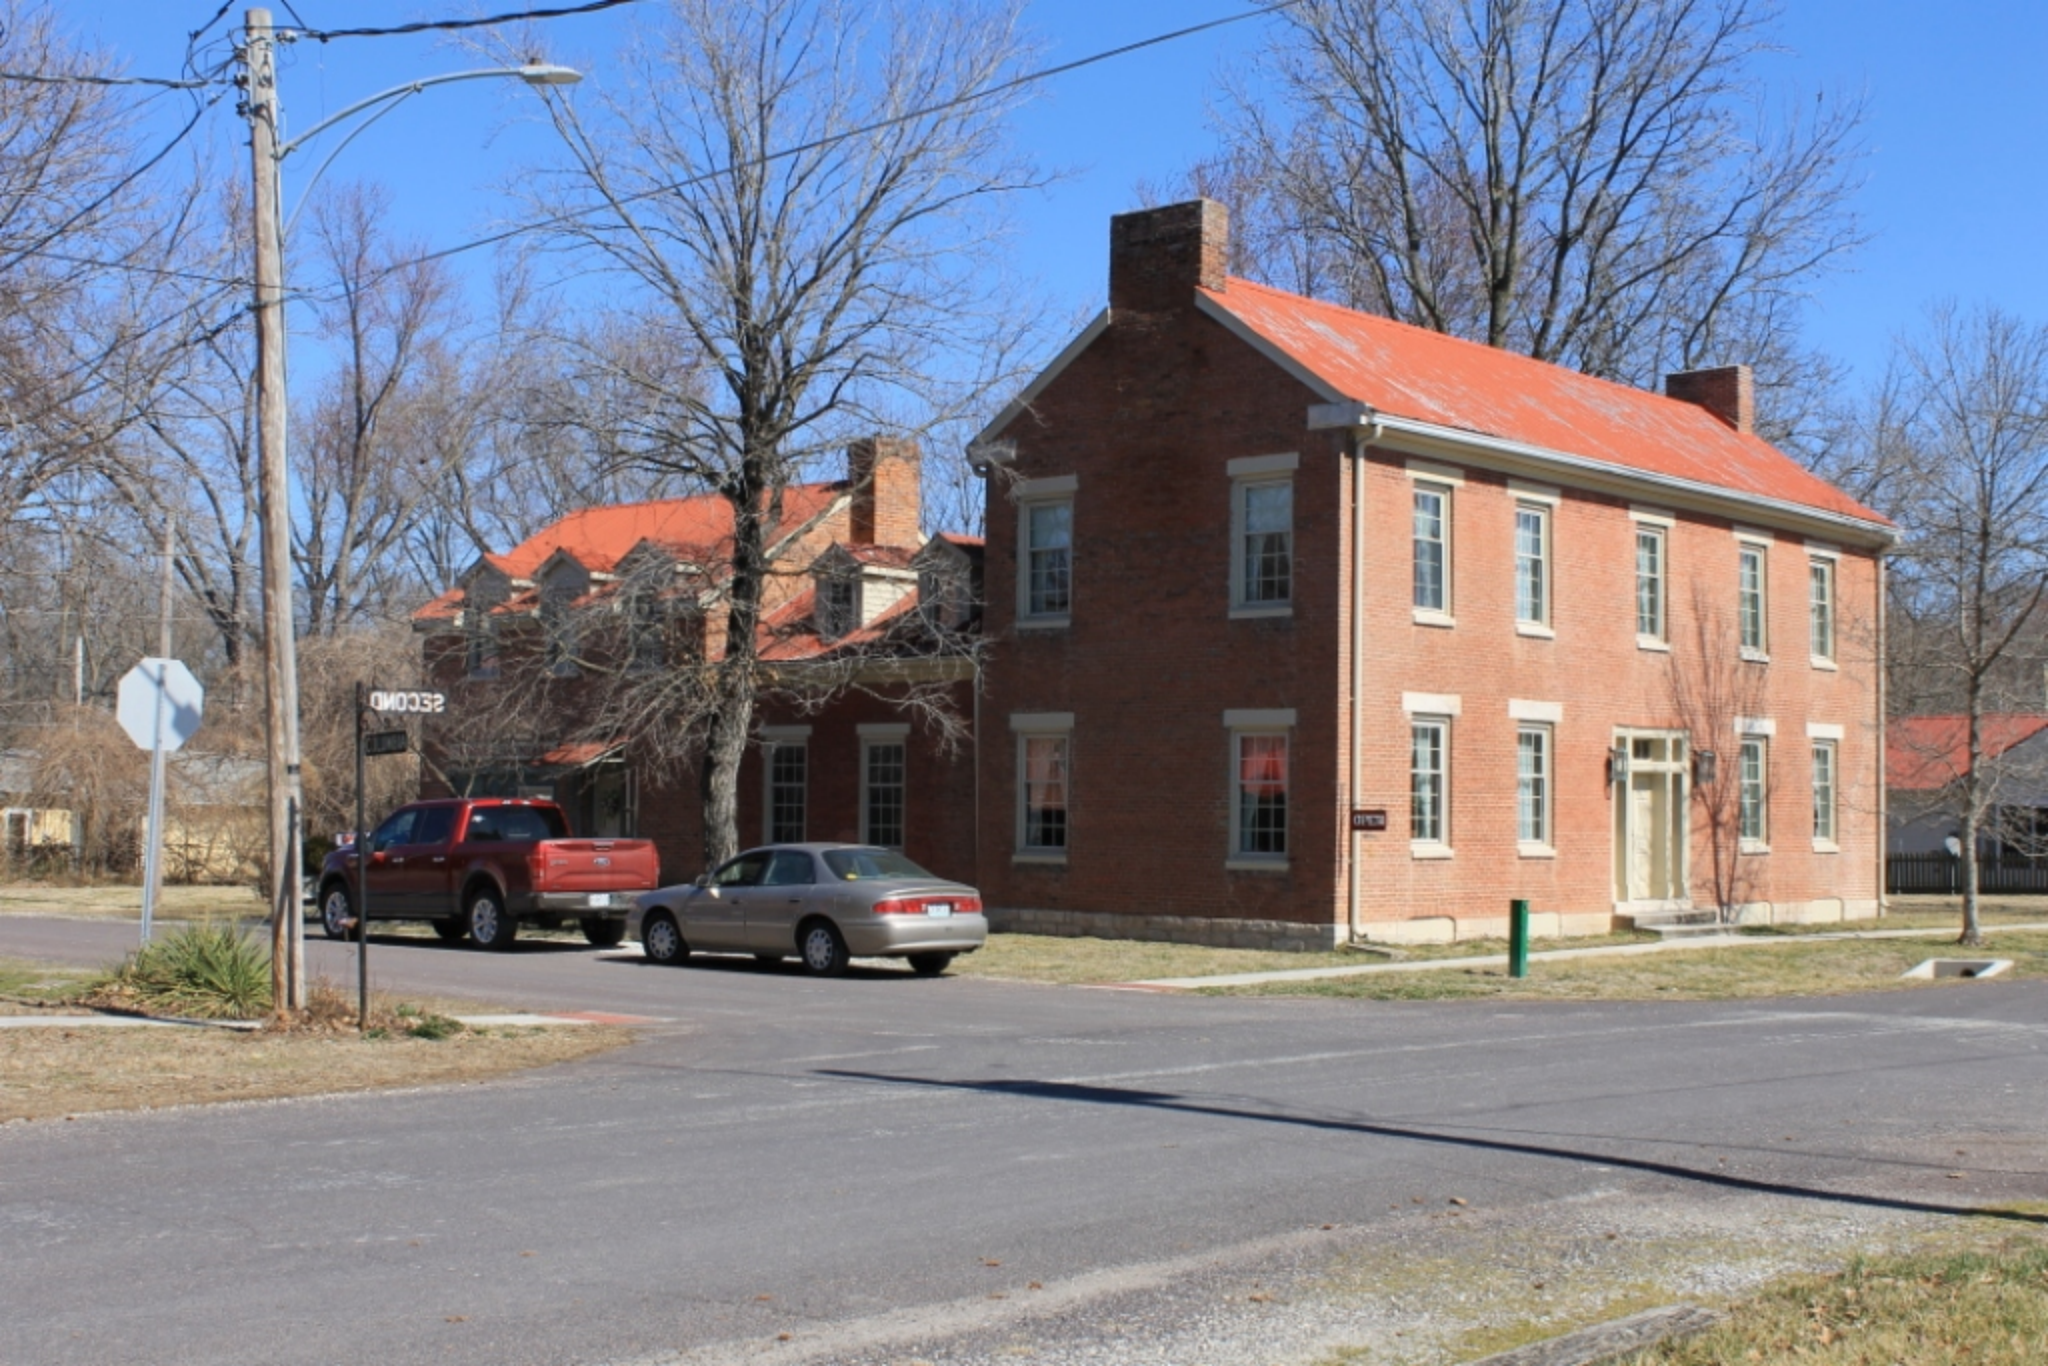
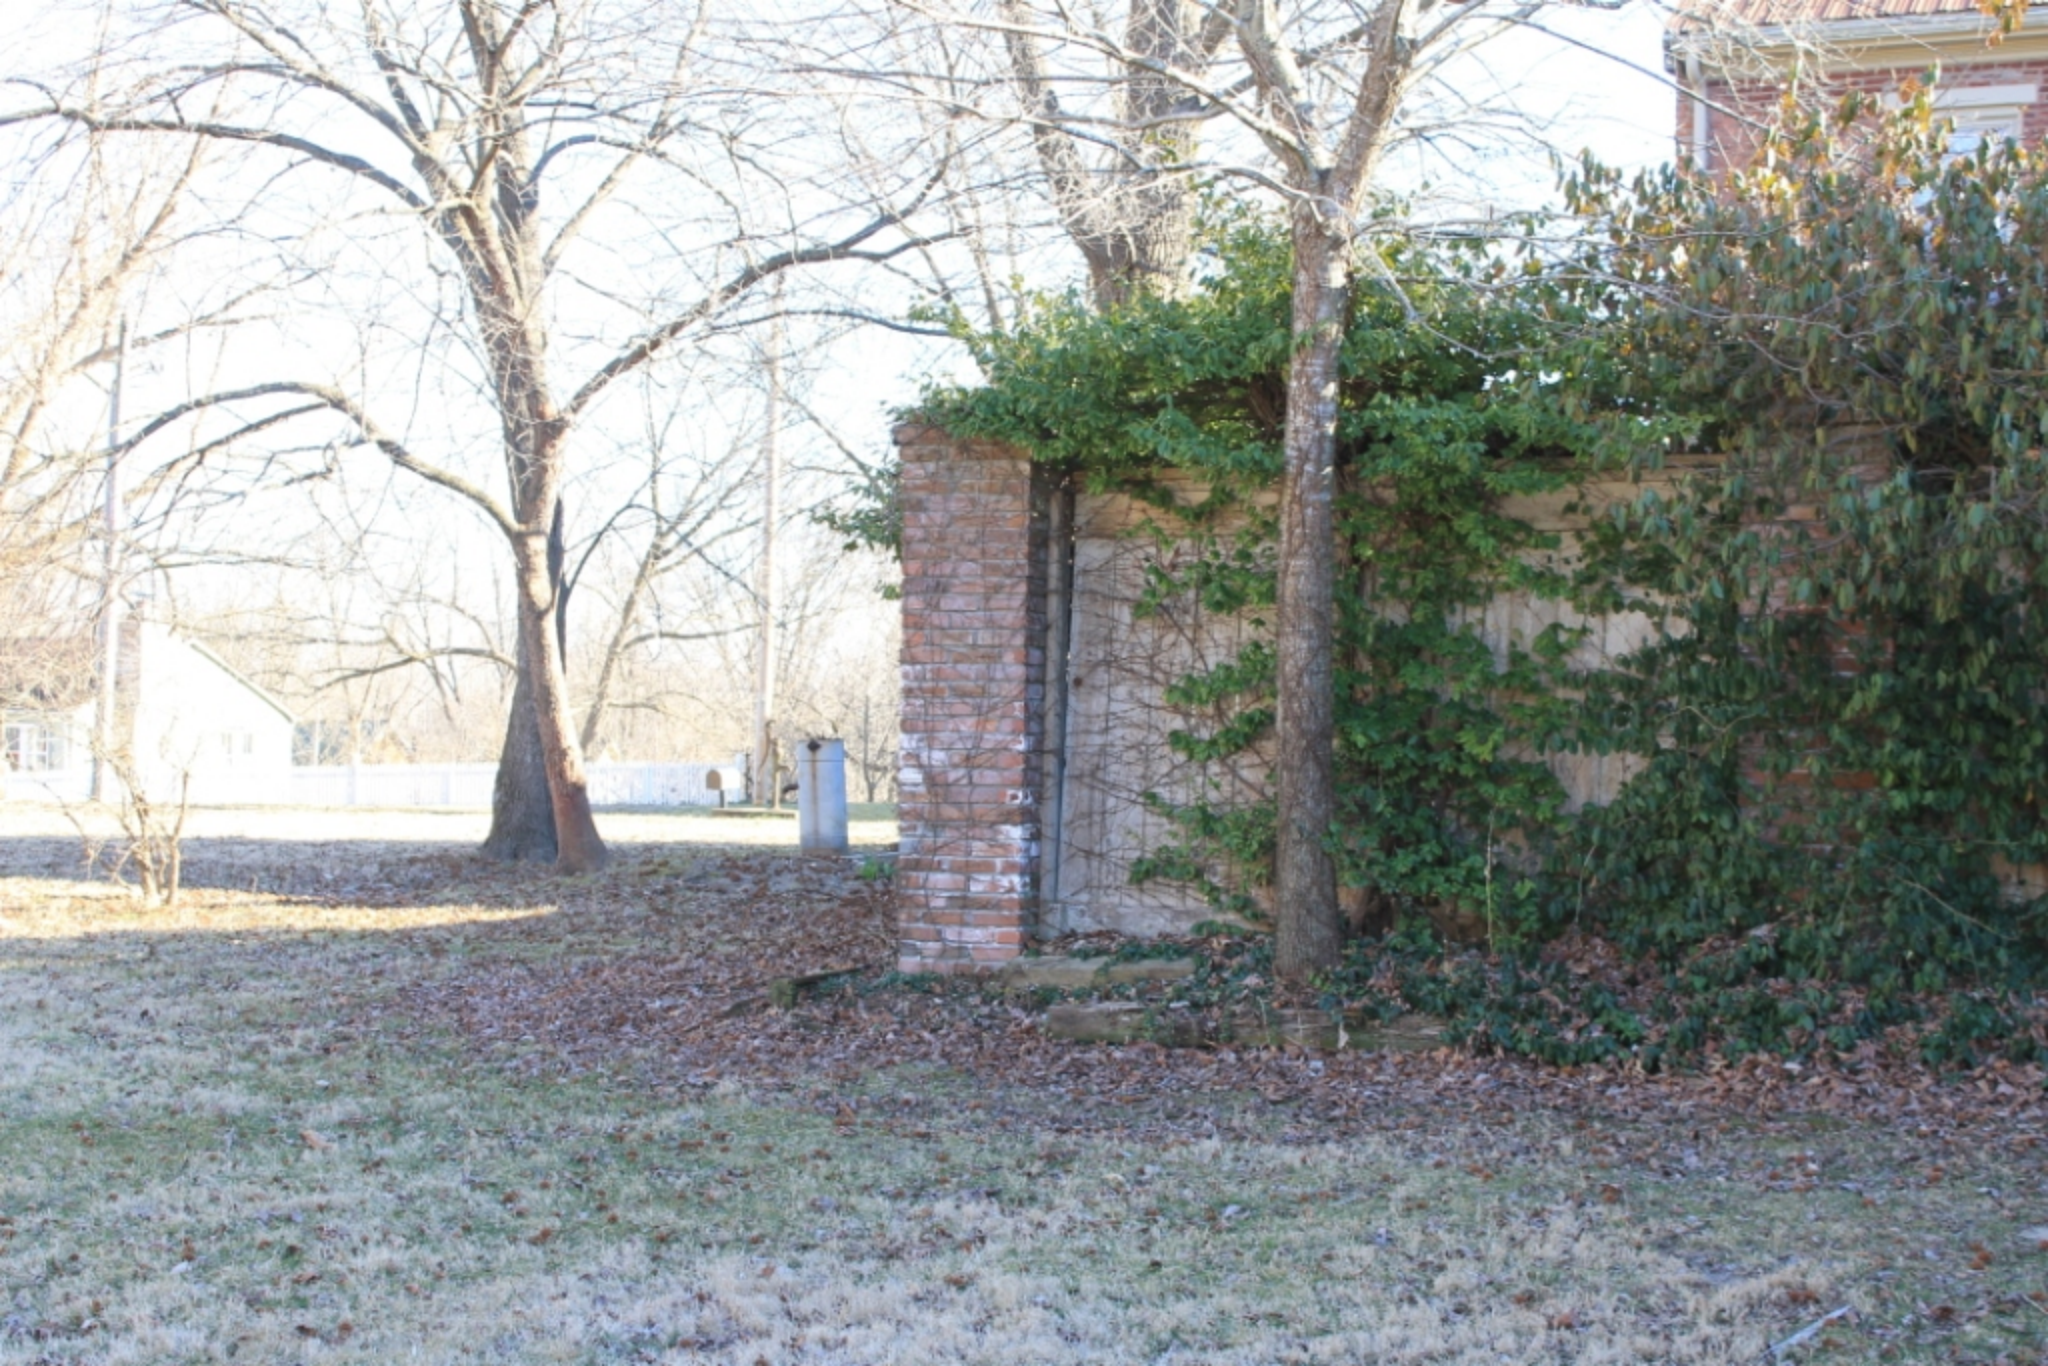
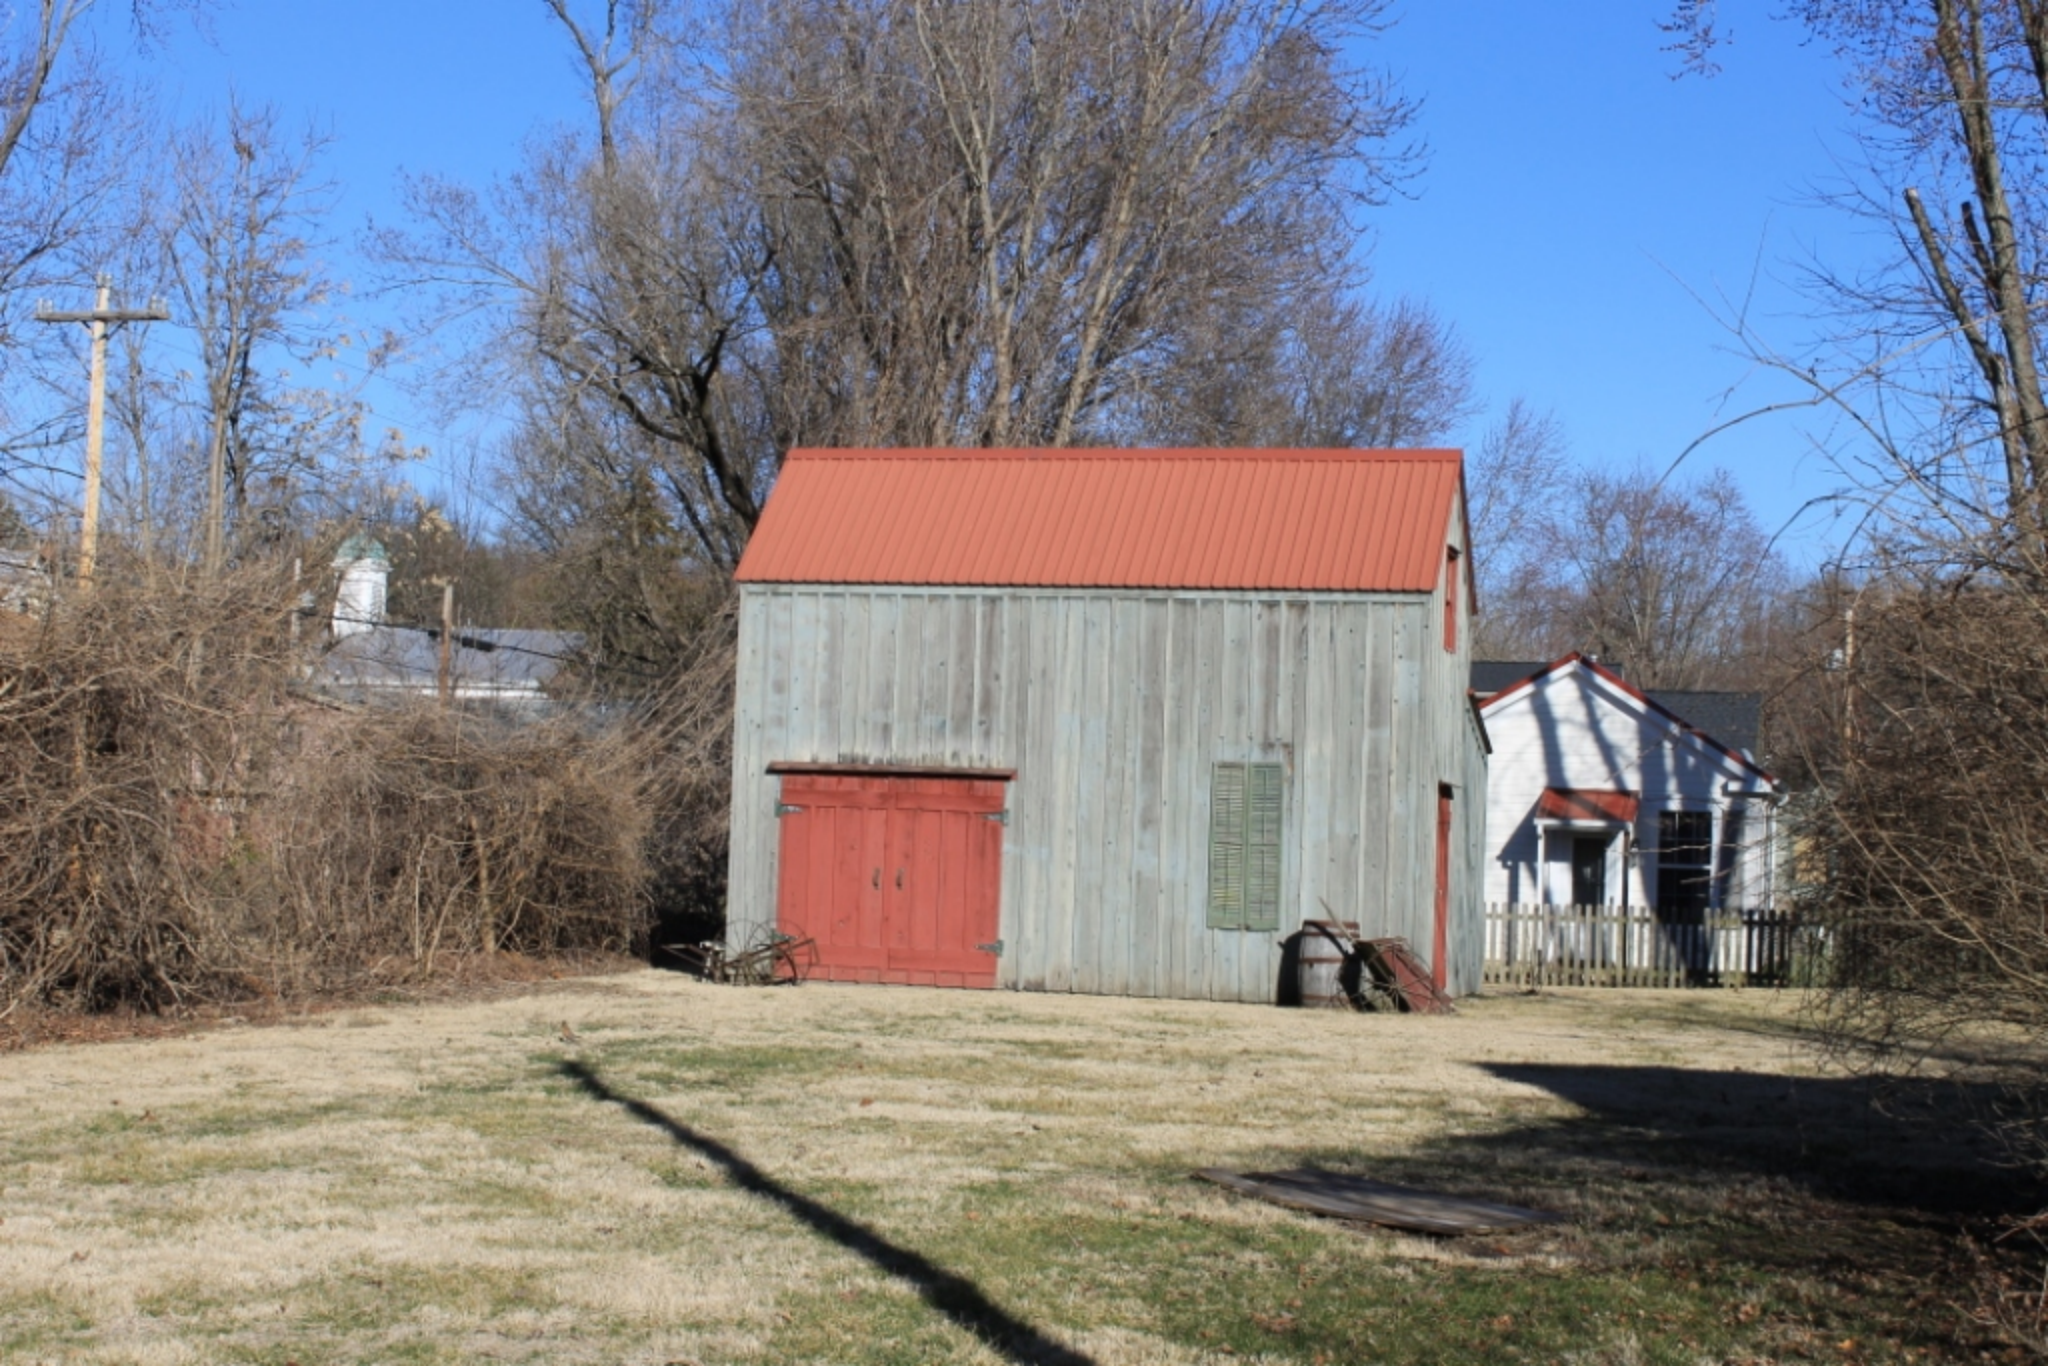
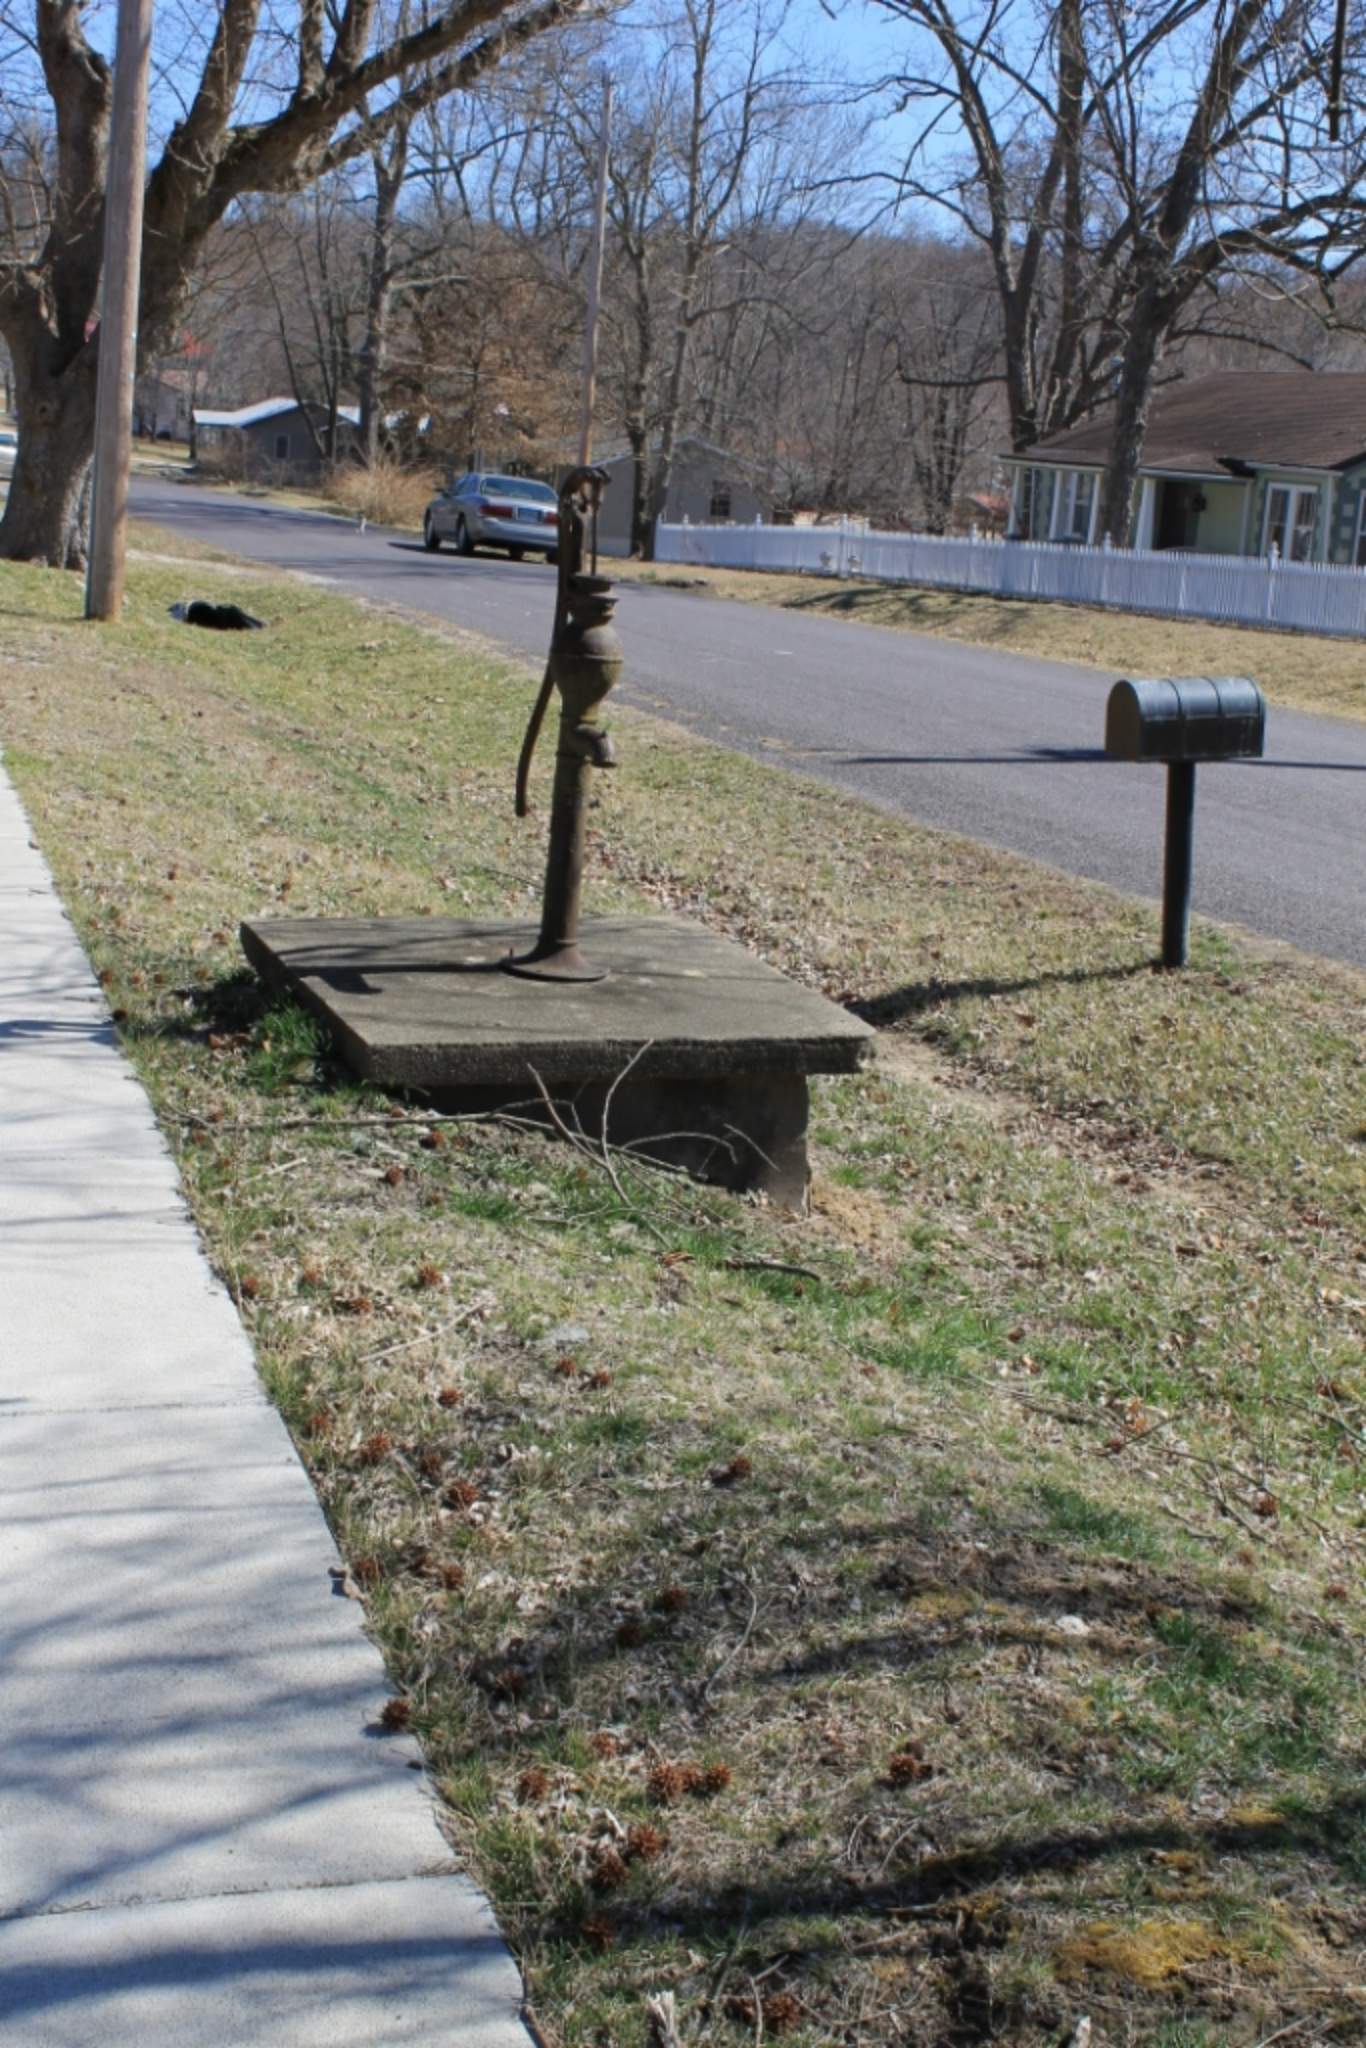
The main block of this two-story, brick, Federal style building has a low gable roof covered in metal. A 1 1/2 story wing with an intersecting gable roof projects to the north. A taller wing with a gable roof projects north from the 1 1/2 story wing. All the windows have stone lintels and sills. The front (south) facade of the first story has five evenly spaced bays. The two left bays each contain a six-over-nine vinyl window. The center bay contains a recessed door with a transom and sidelights. The two right bays each contain a six-over-nine vinyl window. The second story of the front facade has five bays placed above the bays on the first story. Each bay contains a six-over-nine vinyl window. The side (west) facade has six bays. The left bay, located in the northernmost projecting wing, contains a garage door sized opening now filled in with vertical boards. The next bay contains a door. The next two bays, located in the middle wing, each contain a six-over-nine window. The two right bays, located in the main block of the house, each contain a six-over-nine vinyl window. The second story of the rear wings have gable roofed dormers. The rear wing blends well with the original building. The main block of the house has interior chimneys at either end; the additions have a chimney at point where the rear projecting wings connect.

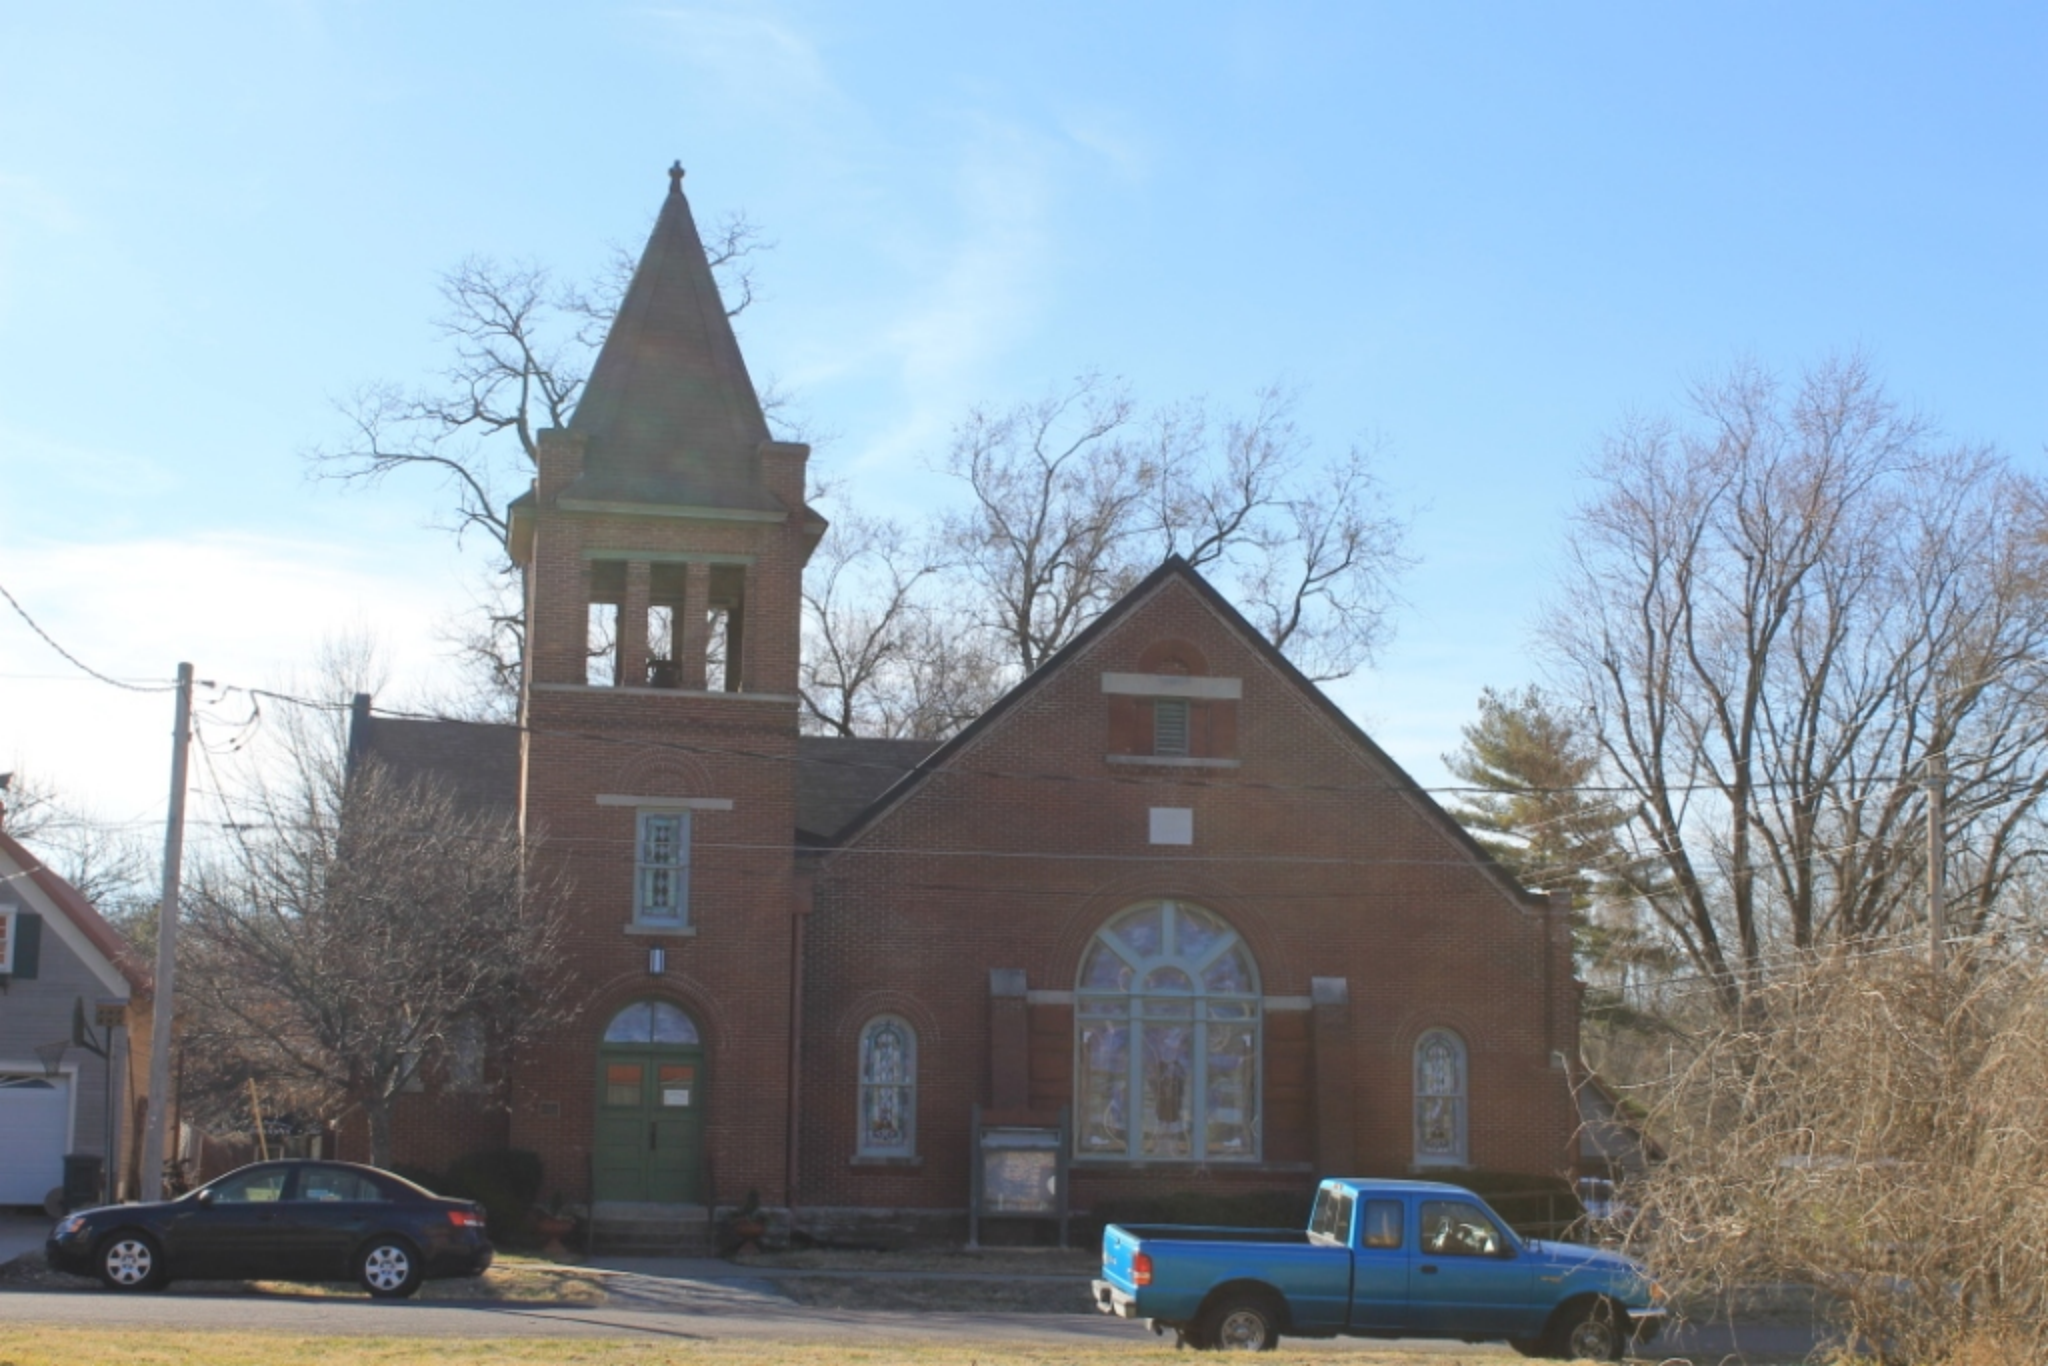
The Rocheport United Methodist Church is a red brick side steeple church building with a front gable roofed wing facing east. The first story of the front (east) facade of the building has five bays. The window sills are stone. A square steeple tower, located on the left (south) side of the building, rises above the gable roof. The bell area of the steeple tower is marked by three openings on each side. The pyramidal roof is topped with a finial. The left bay, located in steeple tower, has one bay which contains an entryway with a round arched double doorway with a rectangular door and a round arched stained glass transom. The next bay, located in the front gable roofed wing, contains a round arched opening with a small stained glass window. The center bay contains a large round arched opening with a seven paned stained glass window. The arch is accented with stone blocks that connect to stone topped buttresses on each side of the window. Above the center window is a stone plaque. Above the plaque is a round arched opening with a window. A stone lintel accents the window and extends to either side of the window. The next bay contains a round arched stained glass window. The rightmost bay, located in the hipped roof bay window on the east side of the building, contains a round arched stained glass window. The second level of the steeple tower has a round arch set with a rectangular stained glass window and accented with stone. Above the window are courses of protruding brick topped by a stone course. A side gabled wing extends to the south behind the steeple tower.

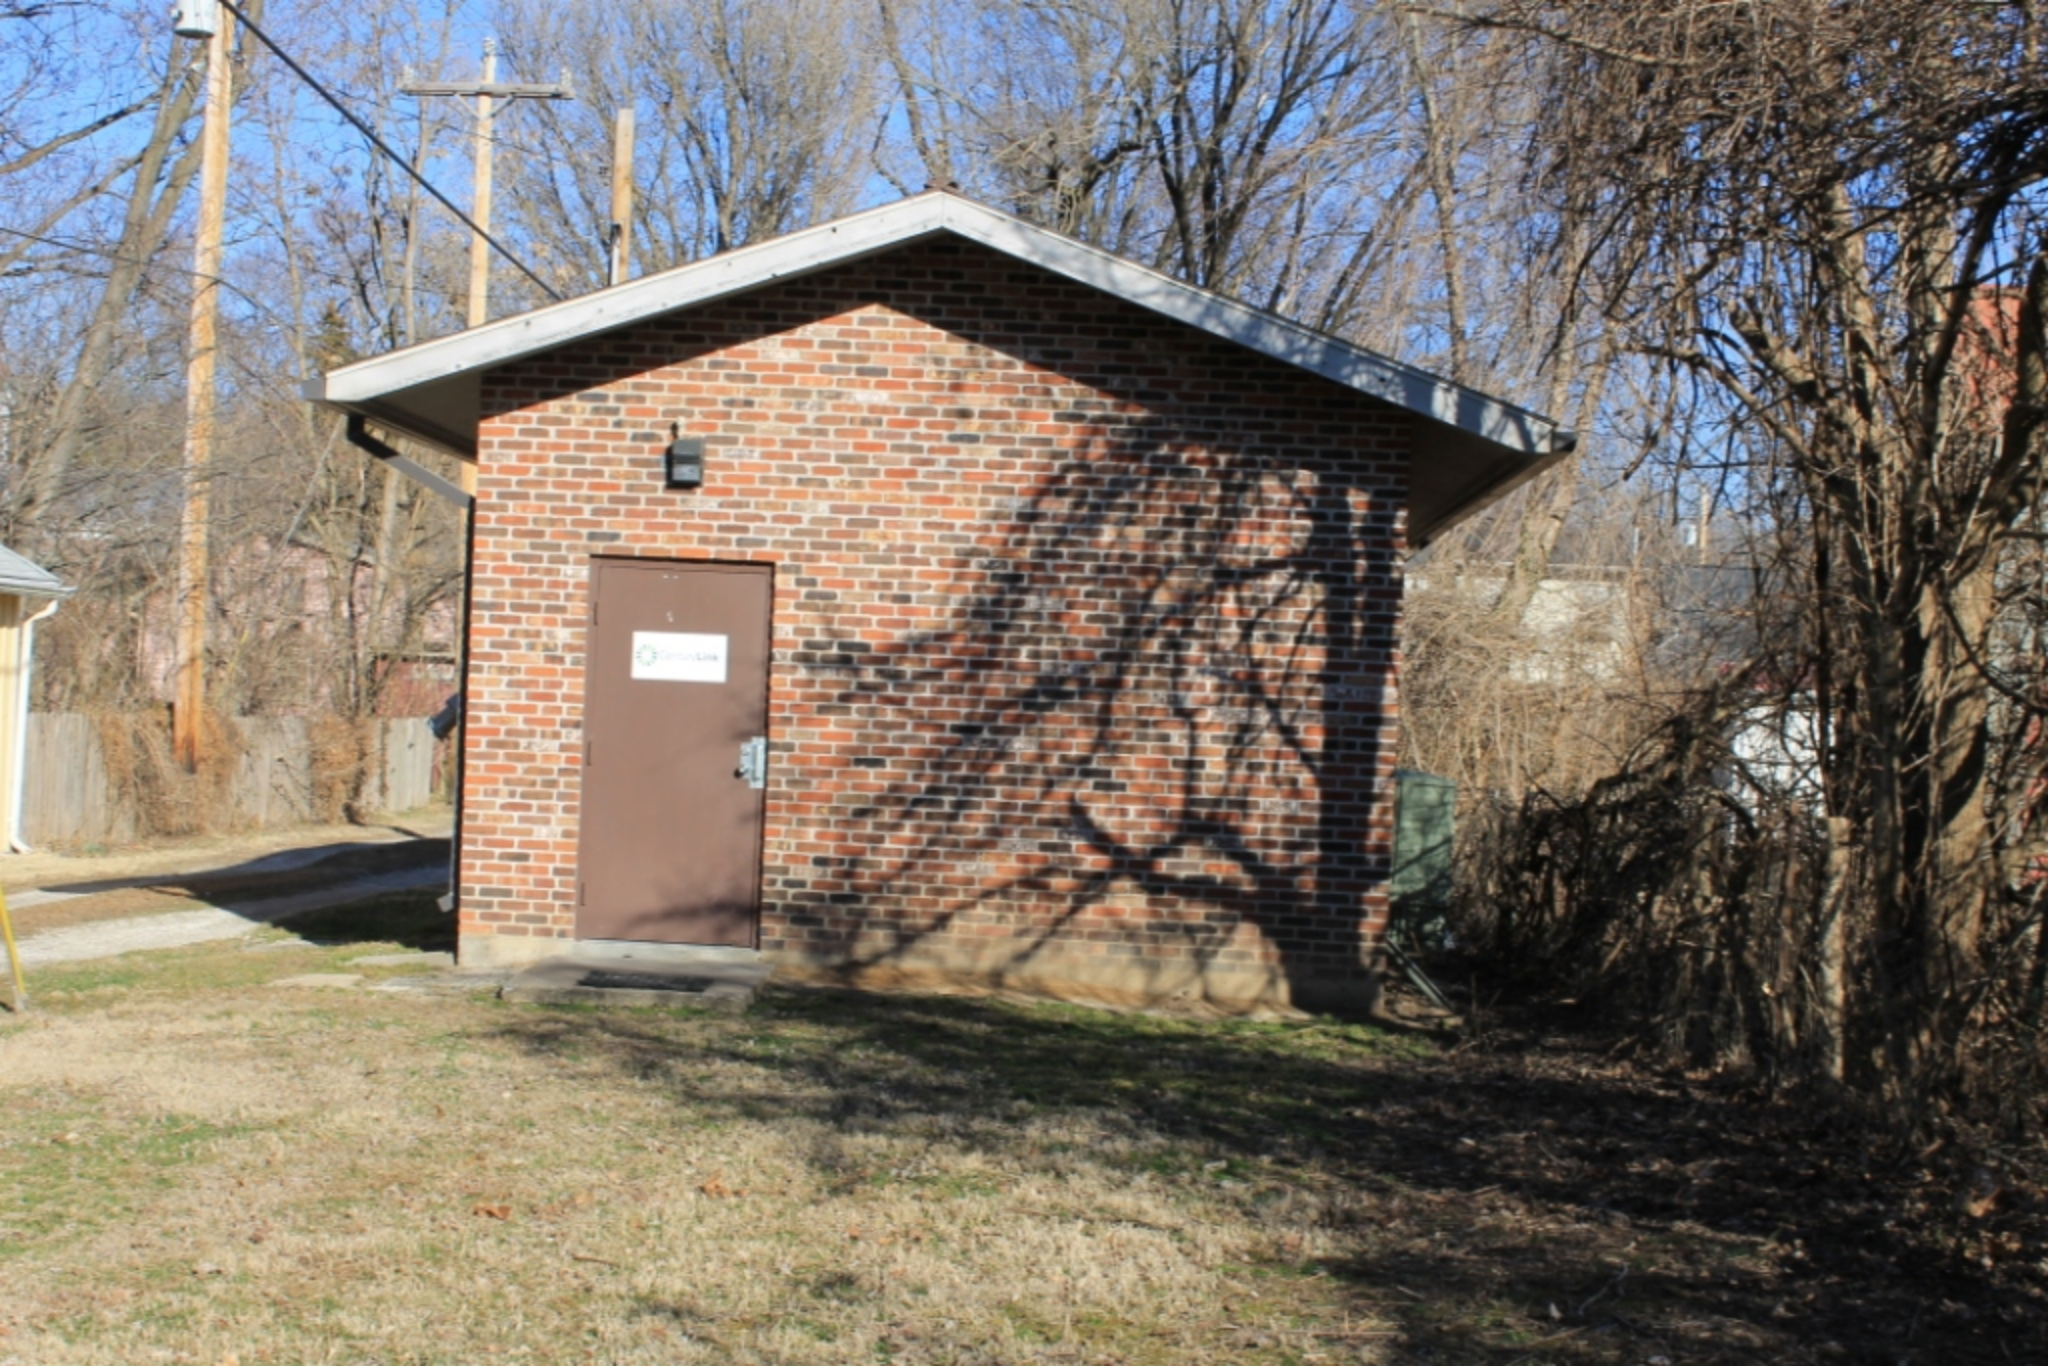
This building is a small, rectangular shaped brick building with a low gable roof covered in asphalt shingles. it was built to house telephone apparatus. The front (west) facade has one bay containing a metal door.
