MISSOURI DEPARTMENT OF NATURAL RESOURCES
STATE HISTORIC PRESERVATION OFFICE, P.O. Box 176, Jefferson City, MO 65102
ARCHITECTURAL/HISTORIC INVENTORY FORM

1. SURVEY NO. BO-AS-009-0001		2. SURVEY NAME: Rocheport Historic District	
3. COUNTY: Boone		4. ADDRESS (STREET NO.)	STREET (NAME) Katy Trail
5. CITY: Rocheport	VICINITY: <input checked="" type="checkbox"/>	6. UTM: / /	LAT: LONG: T: 48W R: 15W S: 1

8. HISTORIC NAME (IF KNOWN): M.K.&T. Railroad tunnel		9. PRESENT/OTHER NAME (IF KNOWN): Katy trail tunnel	
10. OWNERSHIP: <input type="checkbox"/> PRIVATE <input checked="" type="checkbox"/> PUBLIC		11A. HISTORIC USE (IF KNOWN): railroad tunnel	11B. CURRENT USE: Katy Trail tunnel
HISTORICAL INFORMATION

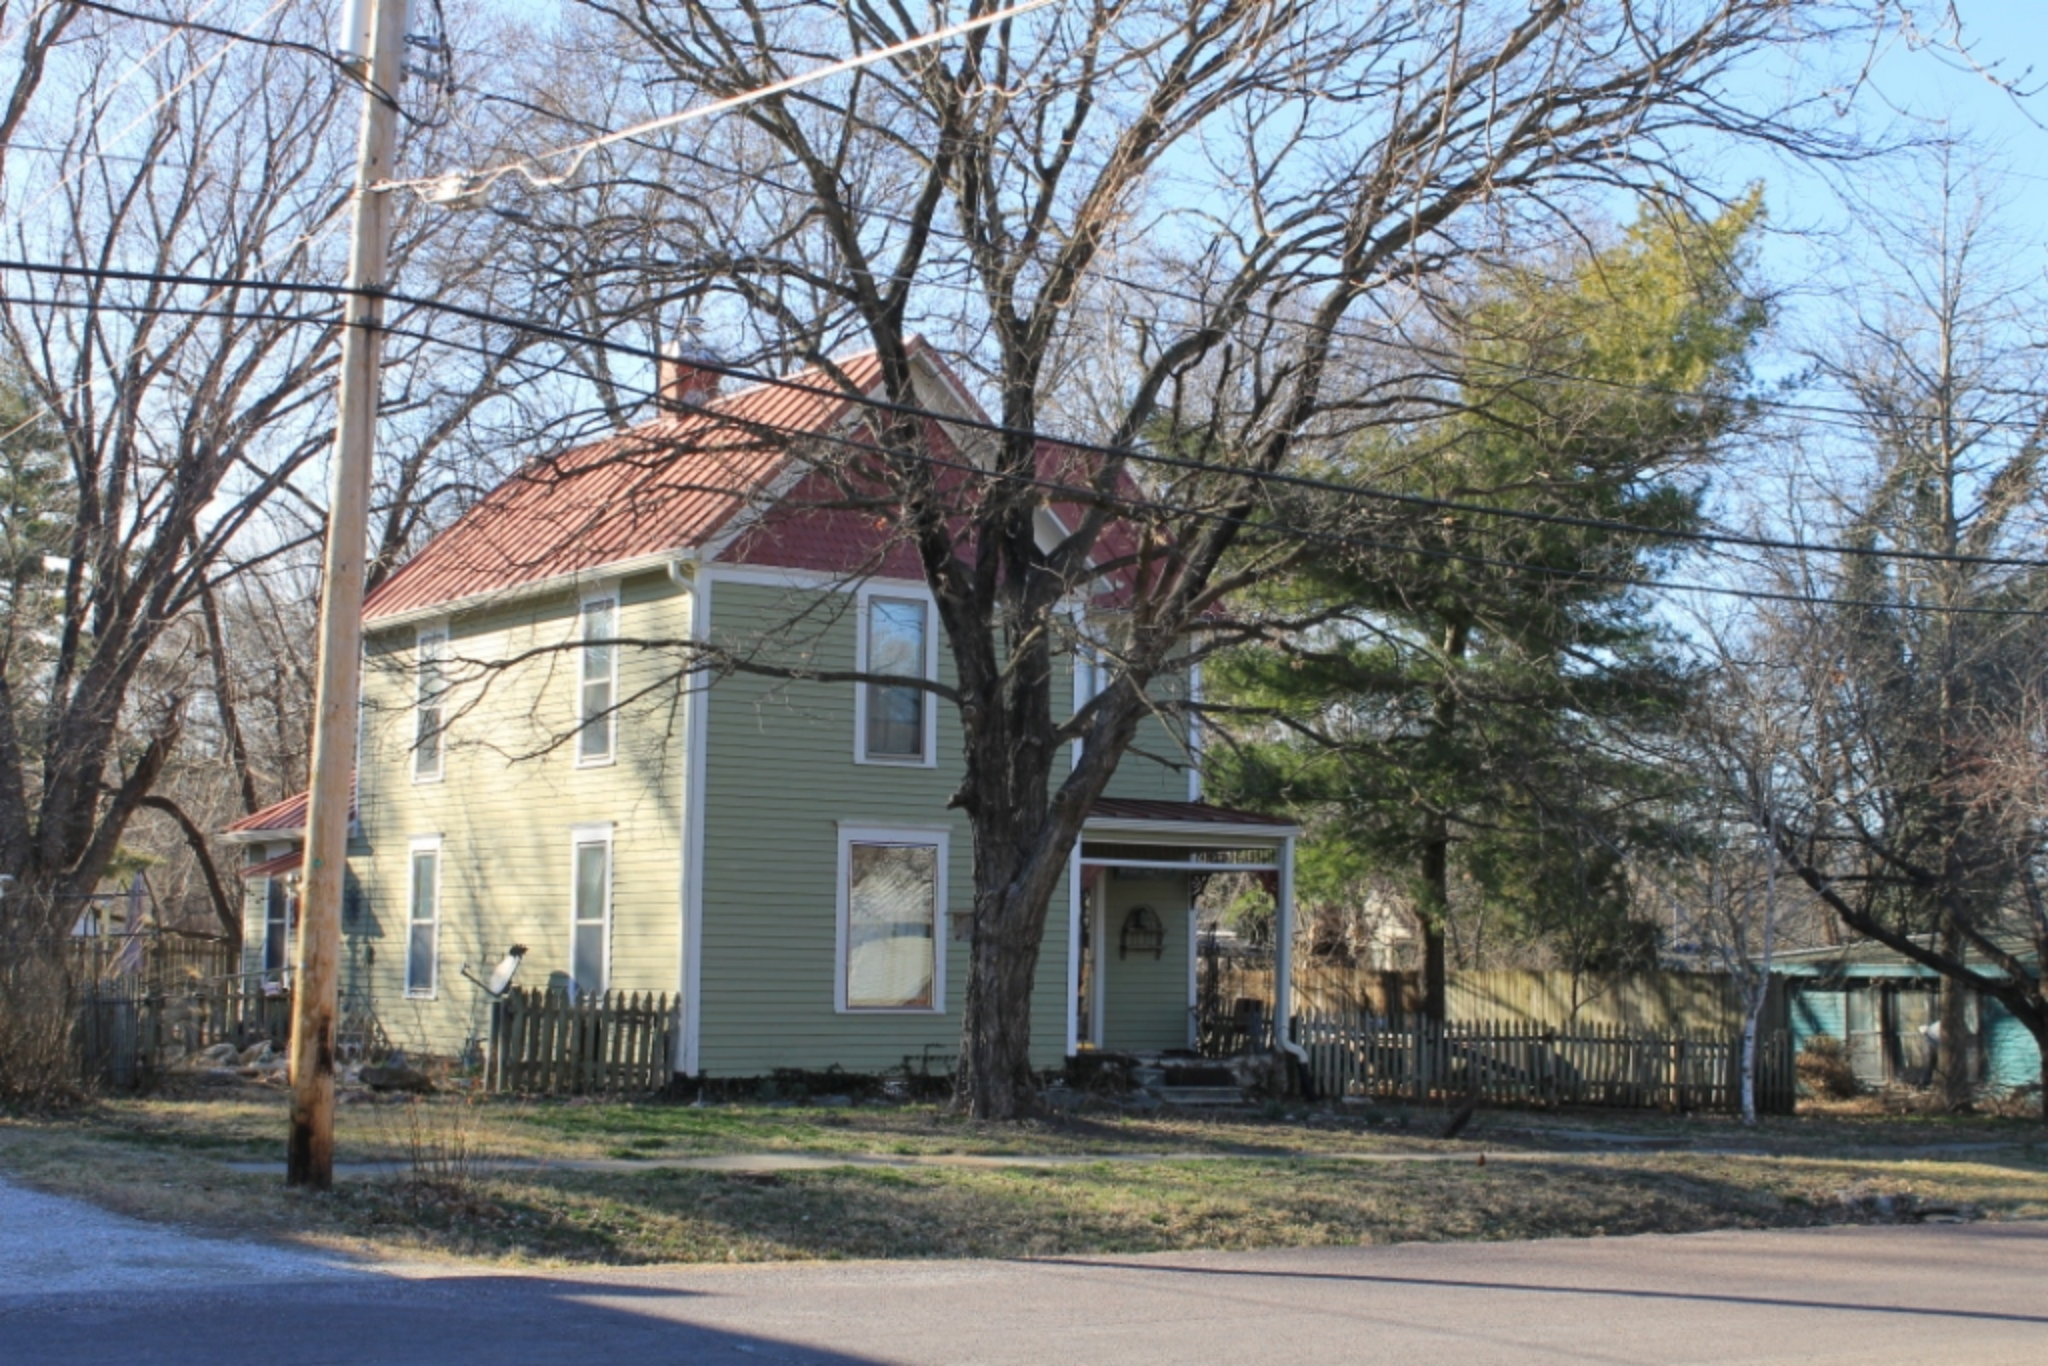
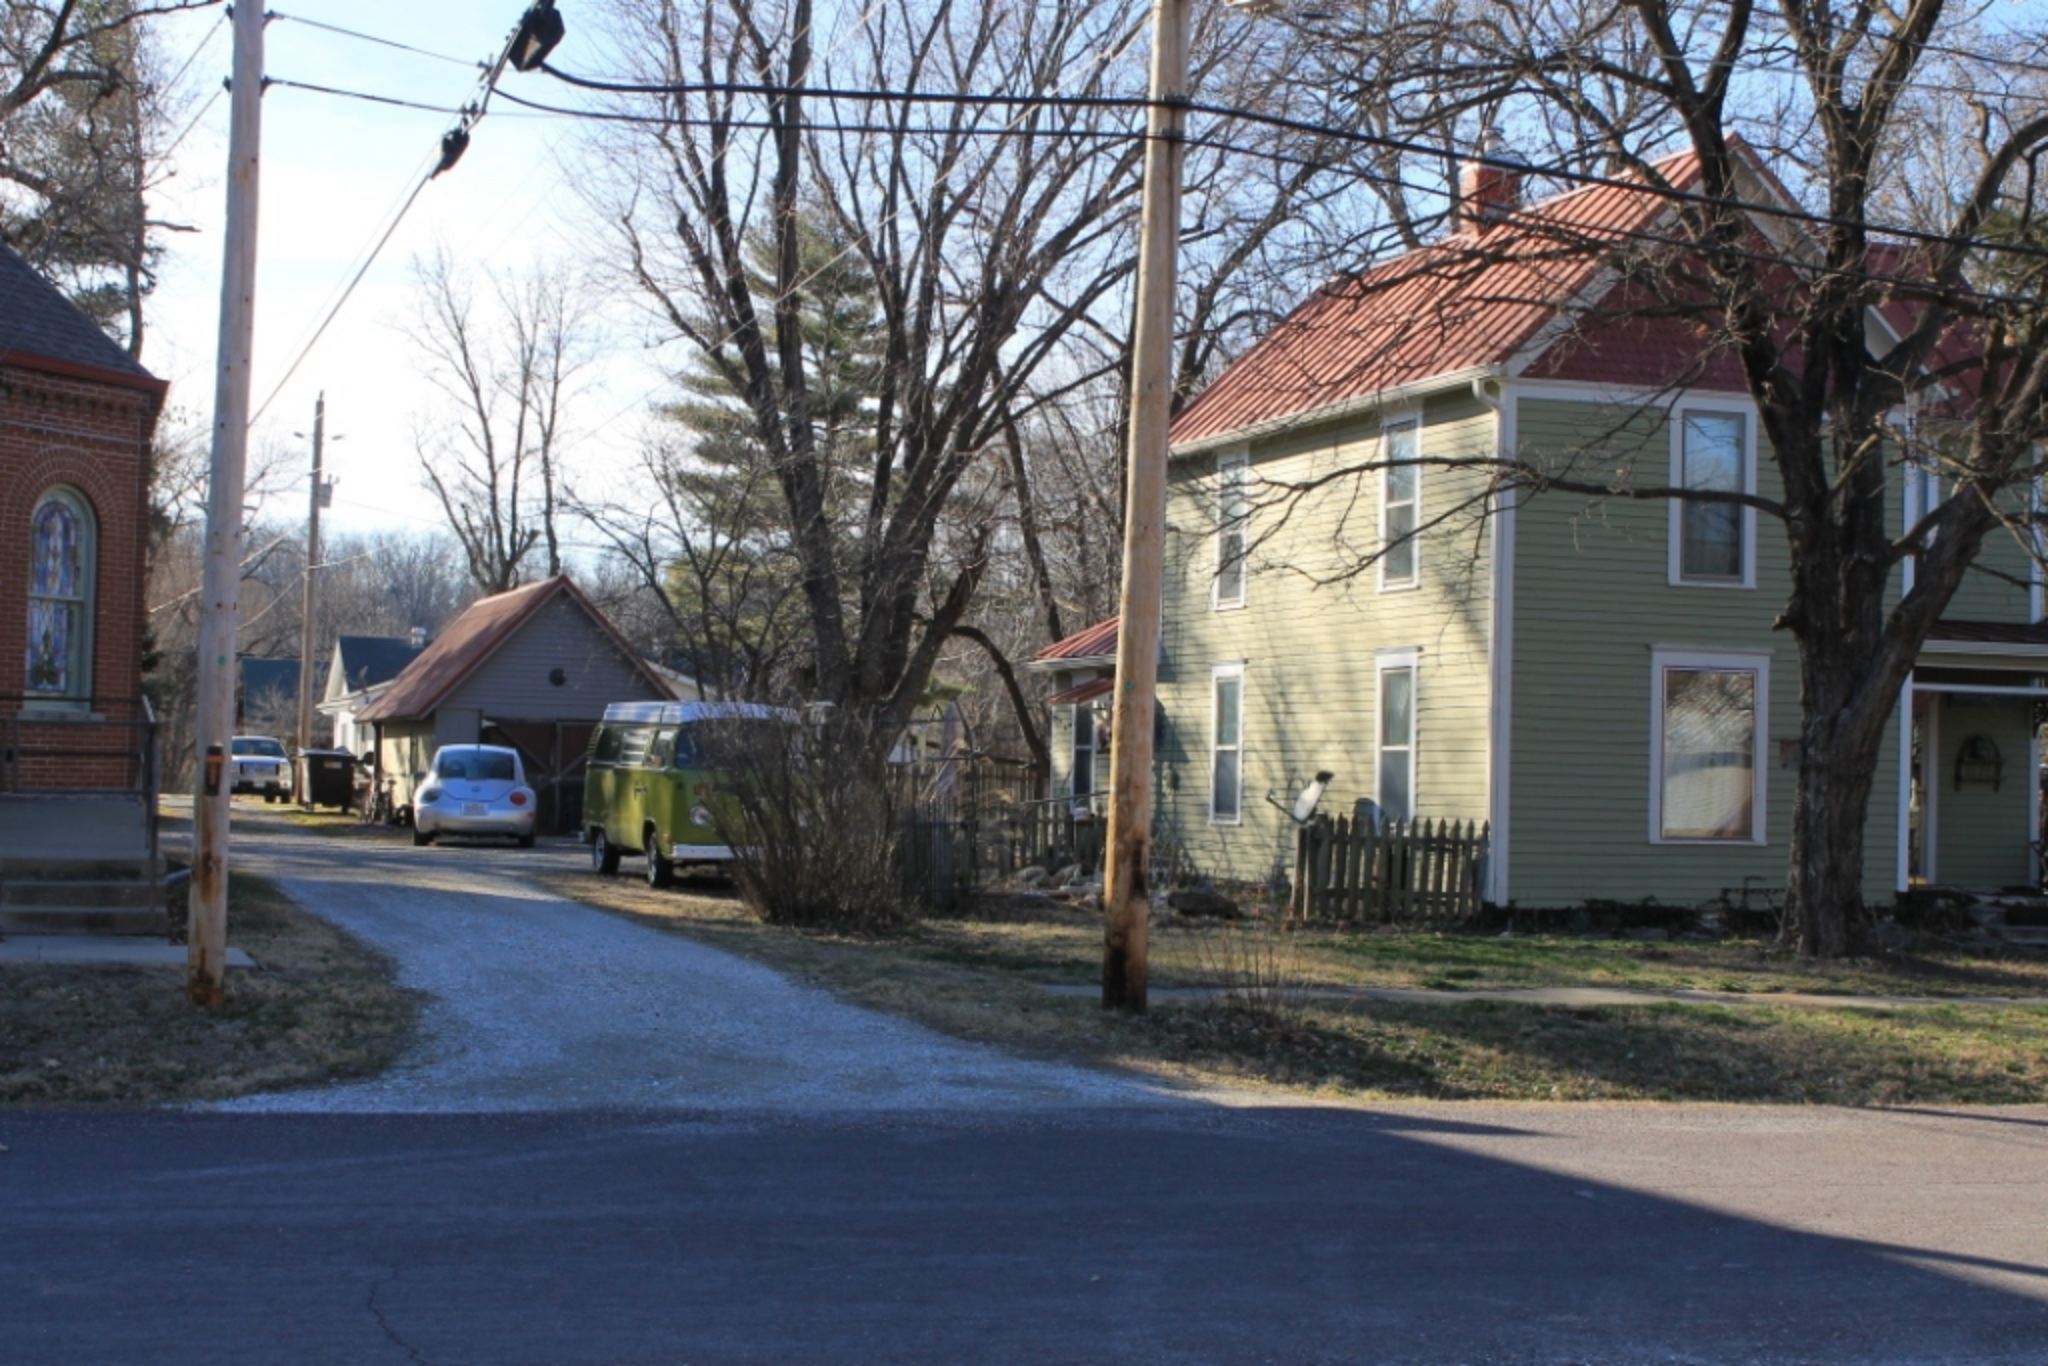
This two-story, massed plan gable and wing house is in the Folk Victorian style. A one story hipped roof wing extends to the rear of the south facade. The walls are clad in clapboards; the roof is covered in asphalt shingles. The area under the pedimented front facing gable is clad in fishlap shingles. An open porch that extends from the point where the wings meet to the north edge of the building is decorated with spandrels with spindlework. The first story of front (east) facade has two bays. The left bay, which is in the gable roofed wing of the building facing Columbia Street, contains a one-over-one single hung window topped with a drip cap. The right bay, which is in the cross gable wing of the building and sheltered by the porch, contains a door. The second story has two bays, one on the front facing wing of the building and another on the cross gabled wing. Each bay contains a one-over-one single hung window. The first story of the side (south) facade has four bays. The left bay, which is located in the rear wing, contains a one-over-one single hung window. The next bay, also located in the rear wing, contains a door sheltered by a shed roofed hood supported with sawn brackets. The next two bays, which are located in the main block of the house, each contain a one-over-one single hung window. The second story of the south facade has two bays, each containing a one-over-one single hung window.

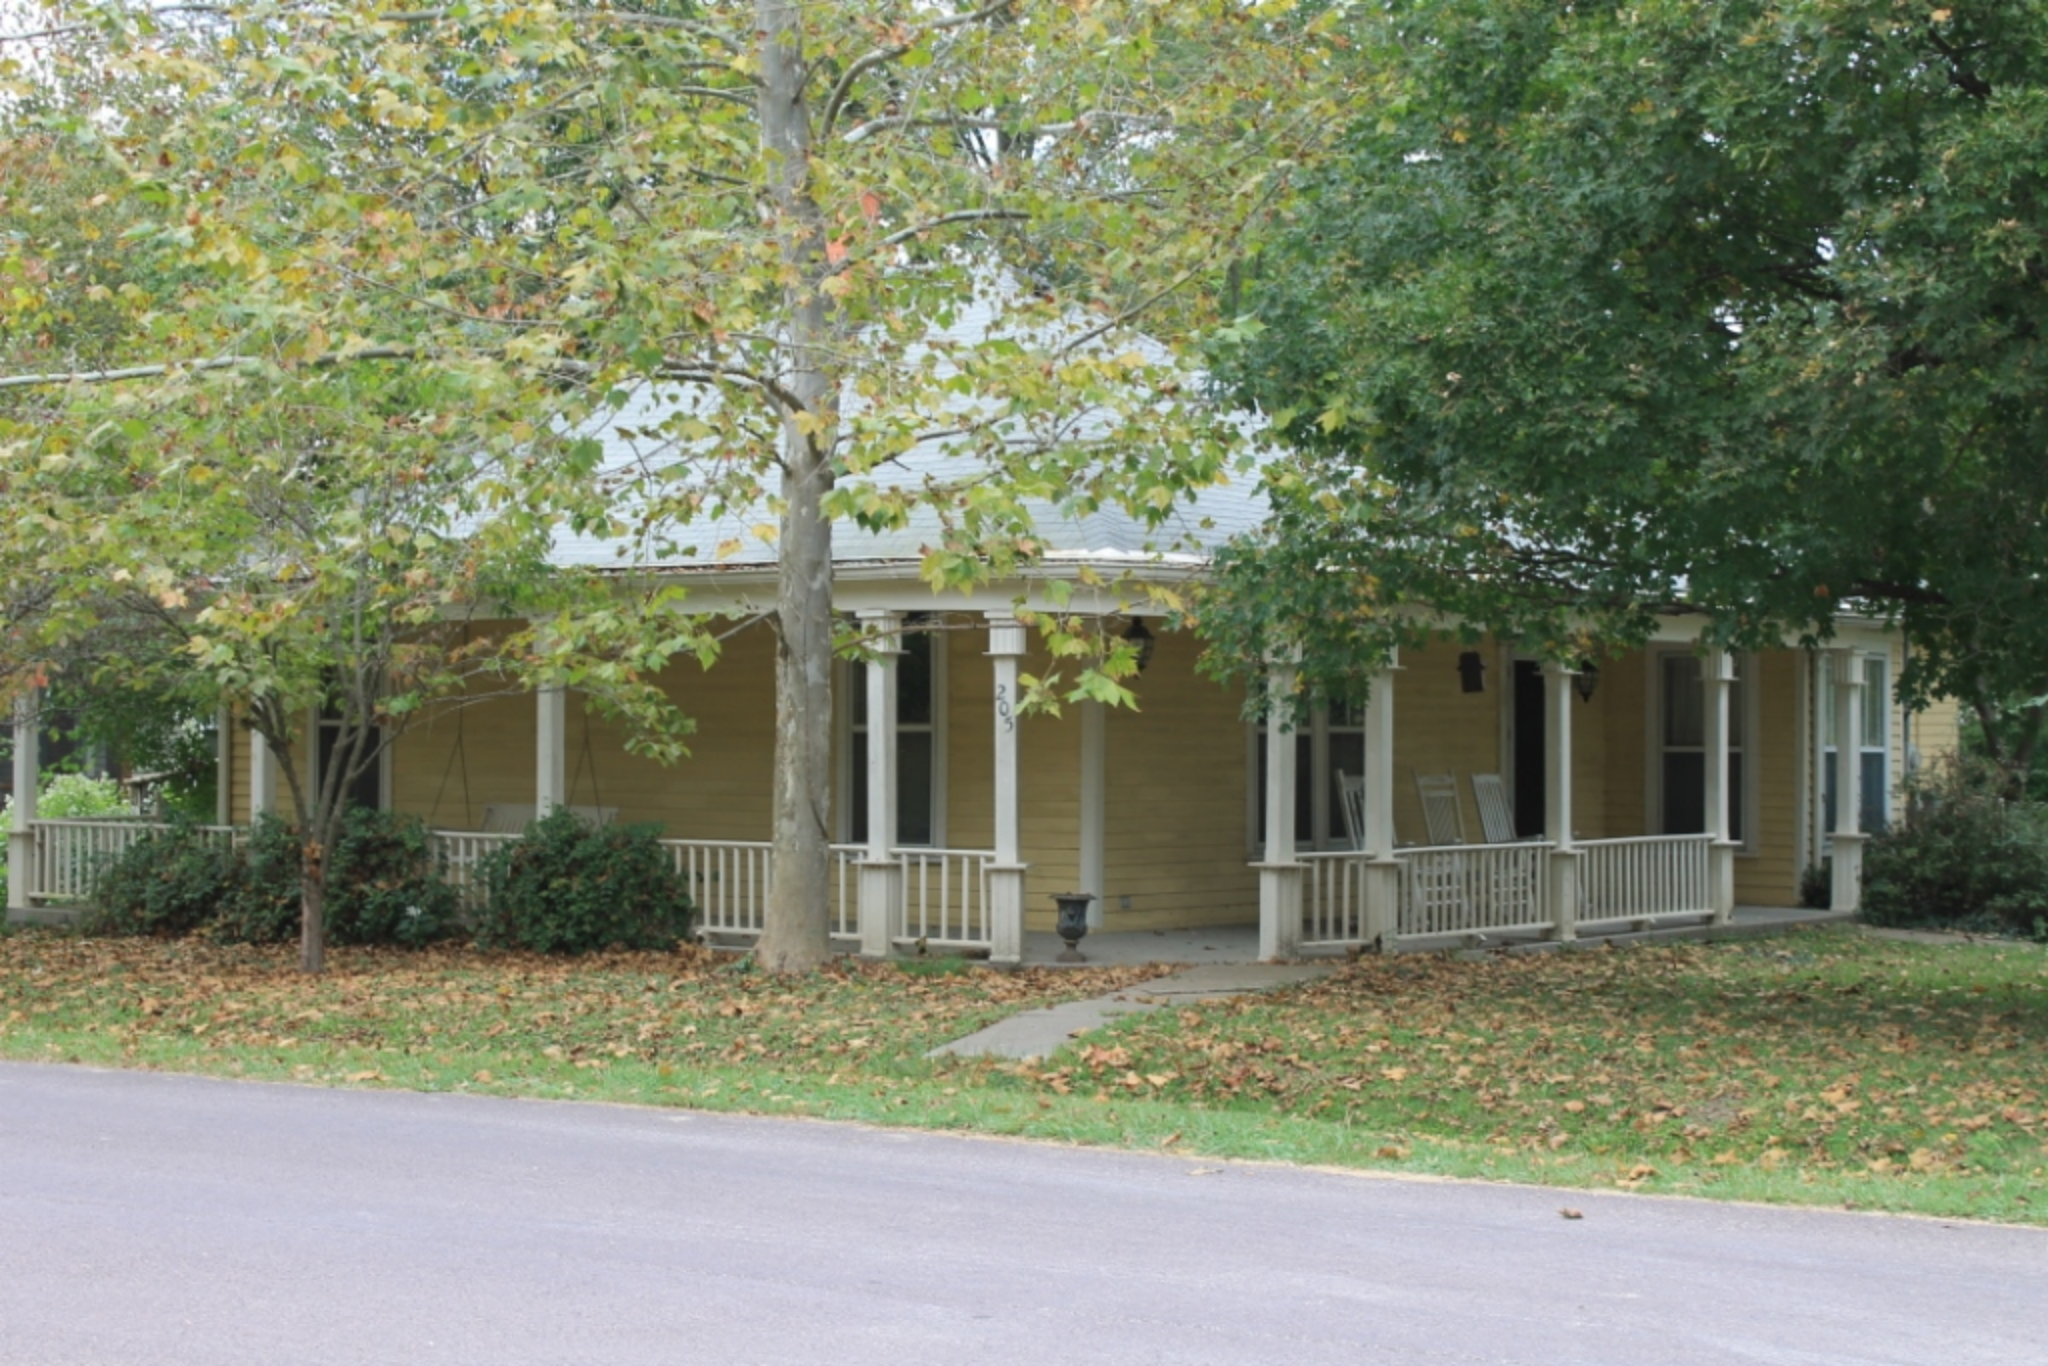
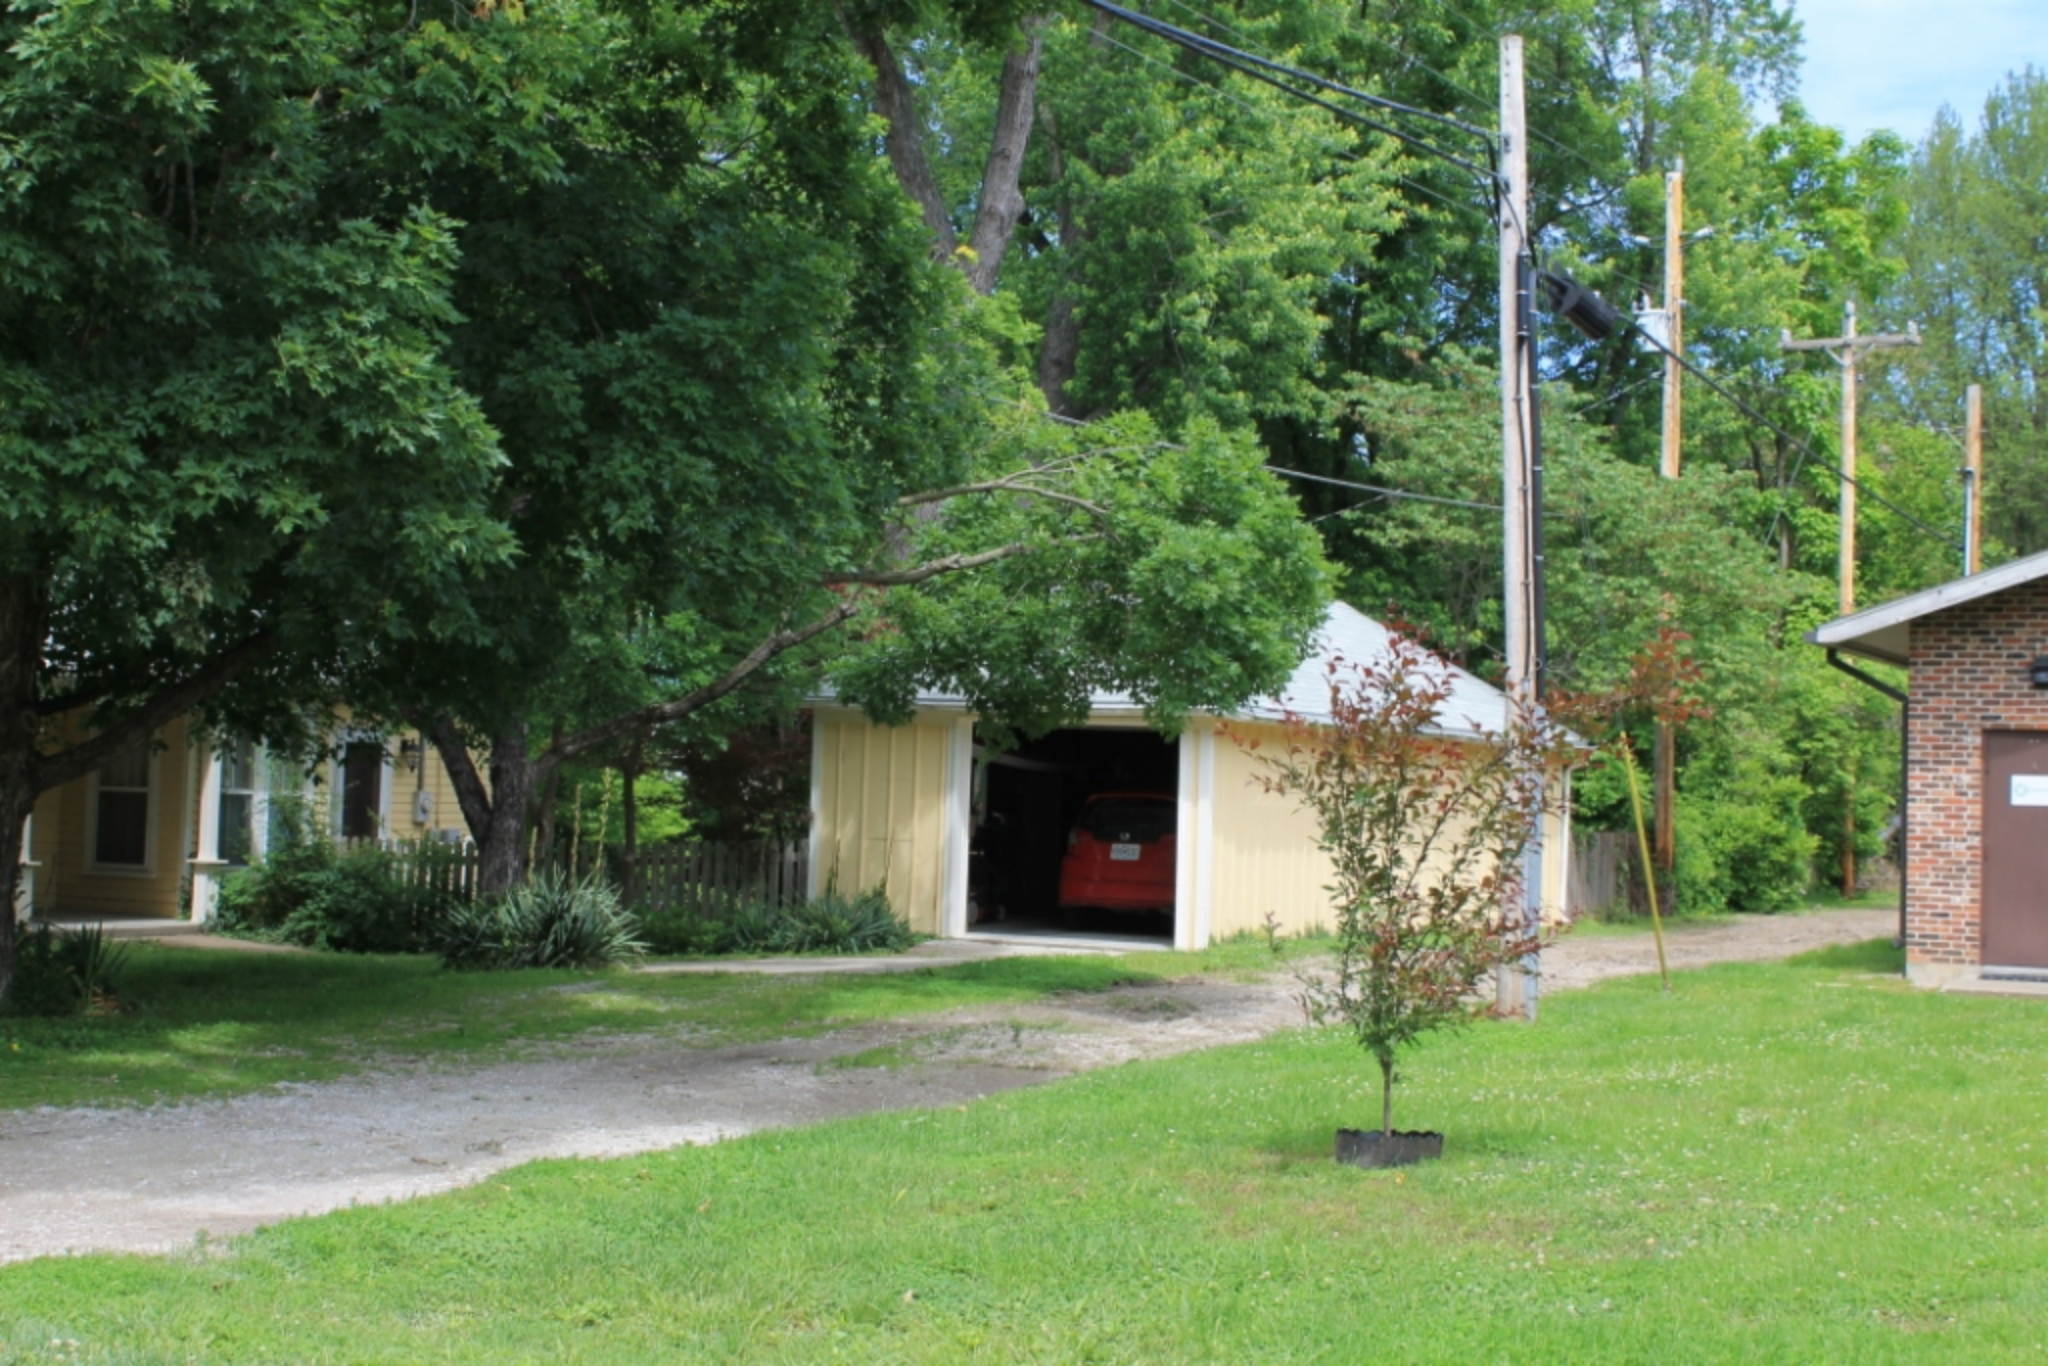
This one-story, massed plan pyramidal, frame house is clad in clapboards. The high hipped roof is covered in asphalt shingles. A wrap around porch extends along the front (west) and side (south) facades of the house. The house has a bay window on the north side and another on the south side. The front (west) facade has three bays. The two left bays, which are under the porch, each contain a two-over-one single hung window. The rightmost bay, which is in a bay window projecting from the south side of the house, contains a two-over-one single hung window. The south facade has four bays. The left bay contains a pair of two-over-one windows. The next bay contains a door flanked by narrow pilasters. The next bay, which is in the bay window, contains a pair of two-over-one windows. The rightmost bay contains a door. A chimney rises from the front slope of the roof.

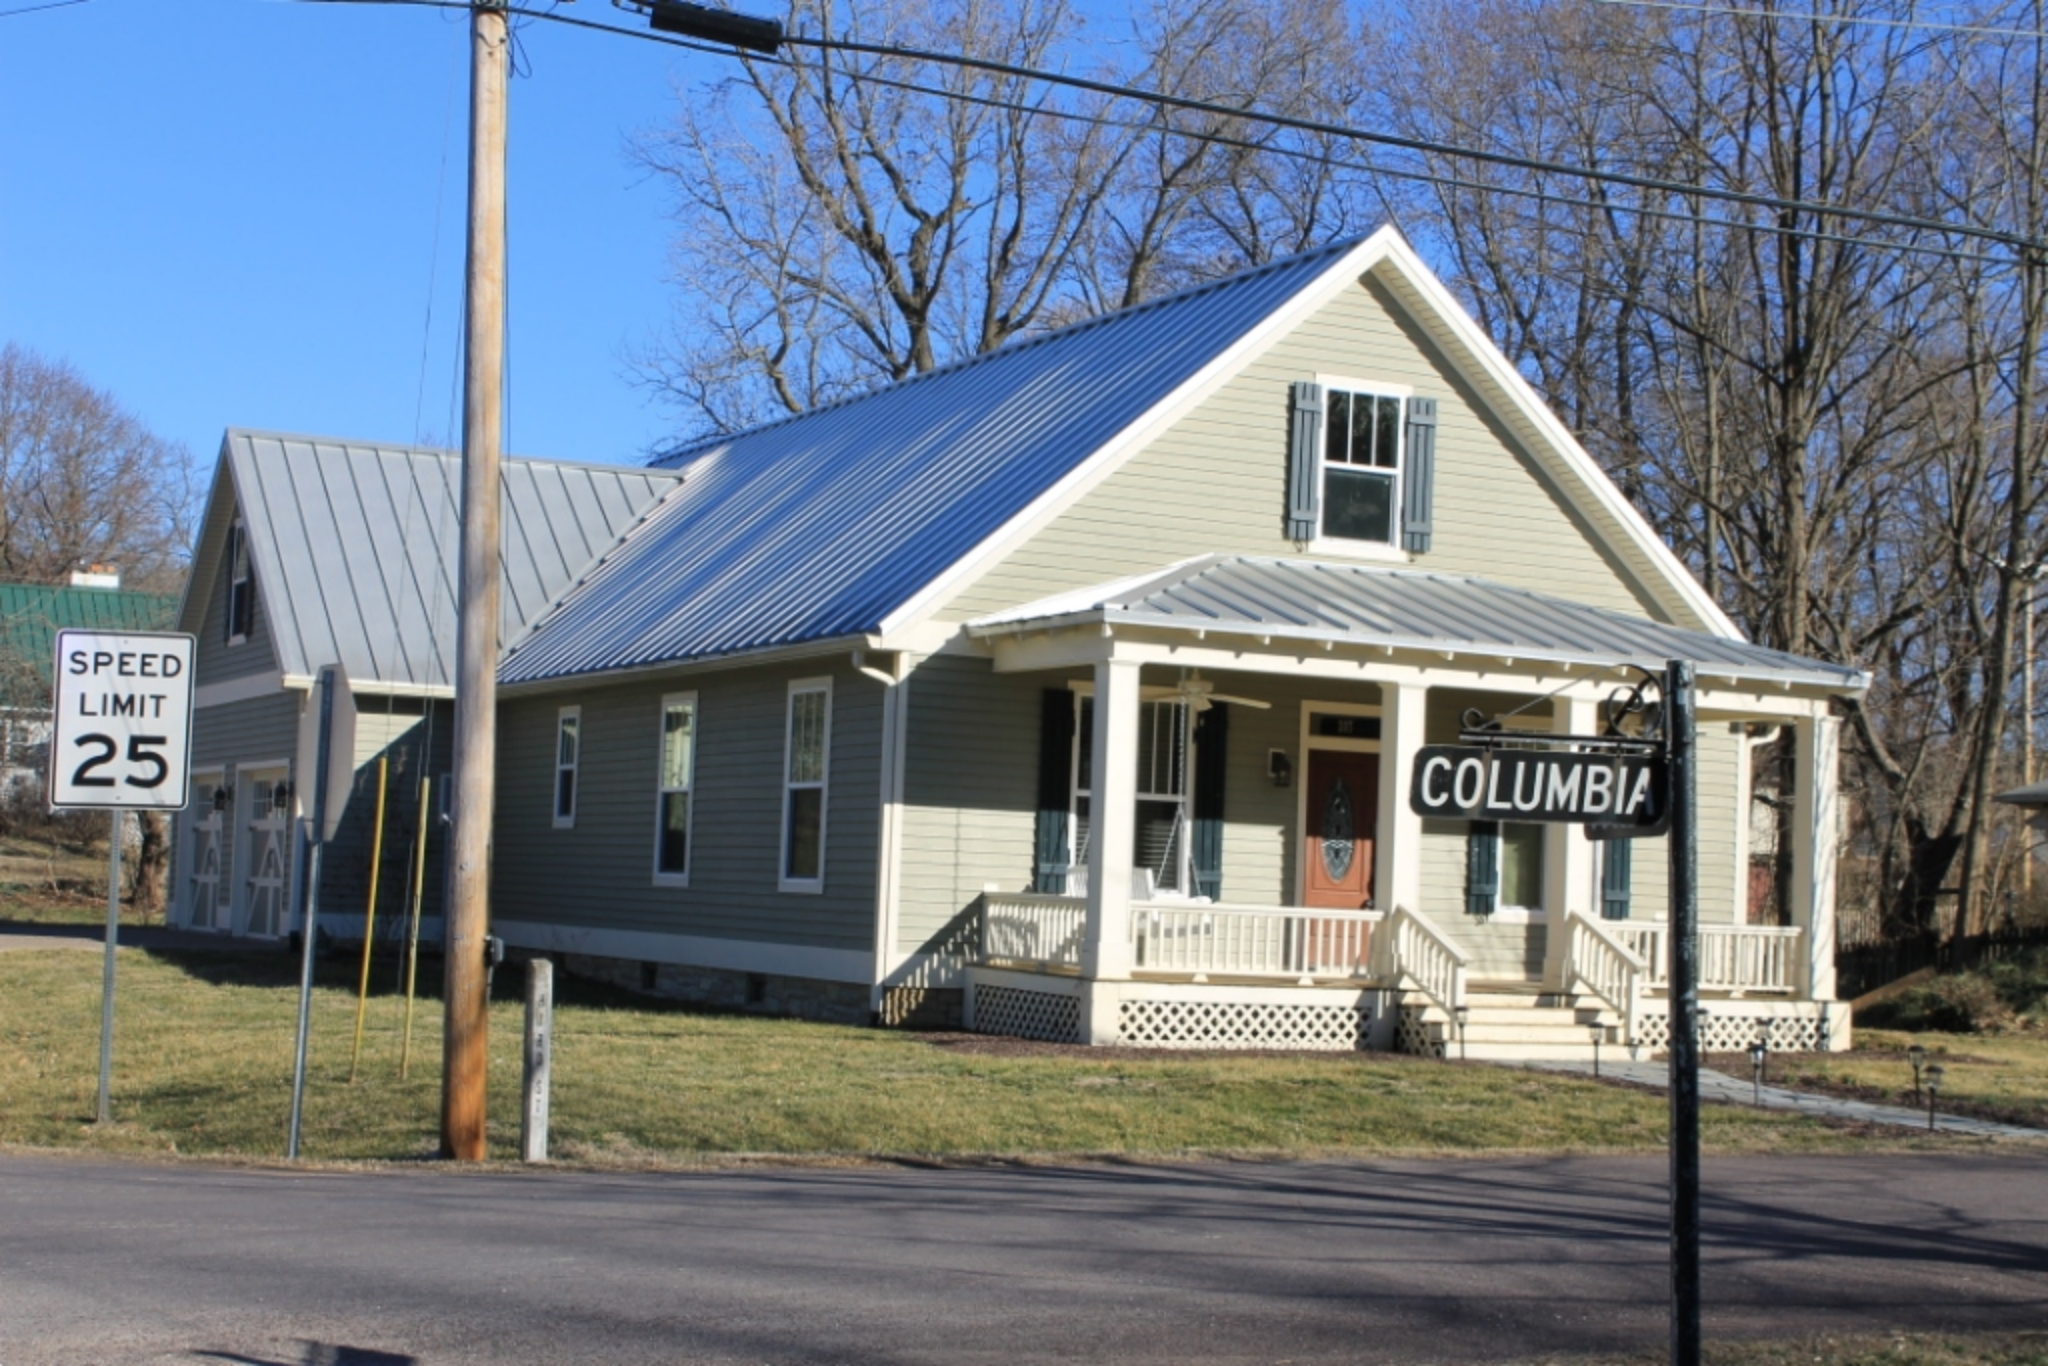
This building faces west and sits on the corner of Third Street and Columbia Street. The GPS coordinates 38.980055, -92.564987. The lot has a few mature trees to the east of the house. The lot was previously the location of the Huntington/Wiswall/Wyatt house identified in the Rocheport Historic District survey as being in fair condition in 1973 and shown in Siebeneck's book in 2012 as about to collapse. The house appears on the 2013 Google Maps image in dangerous dilapidated condition.

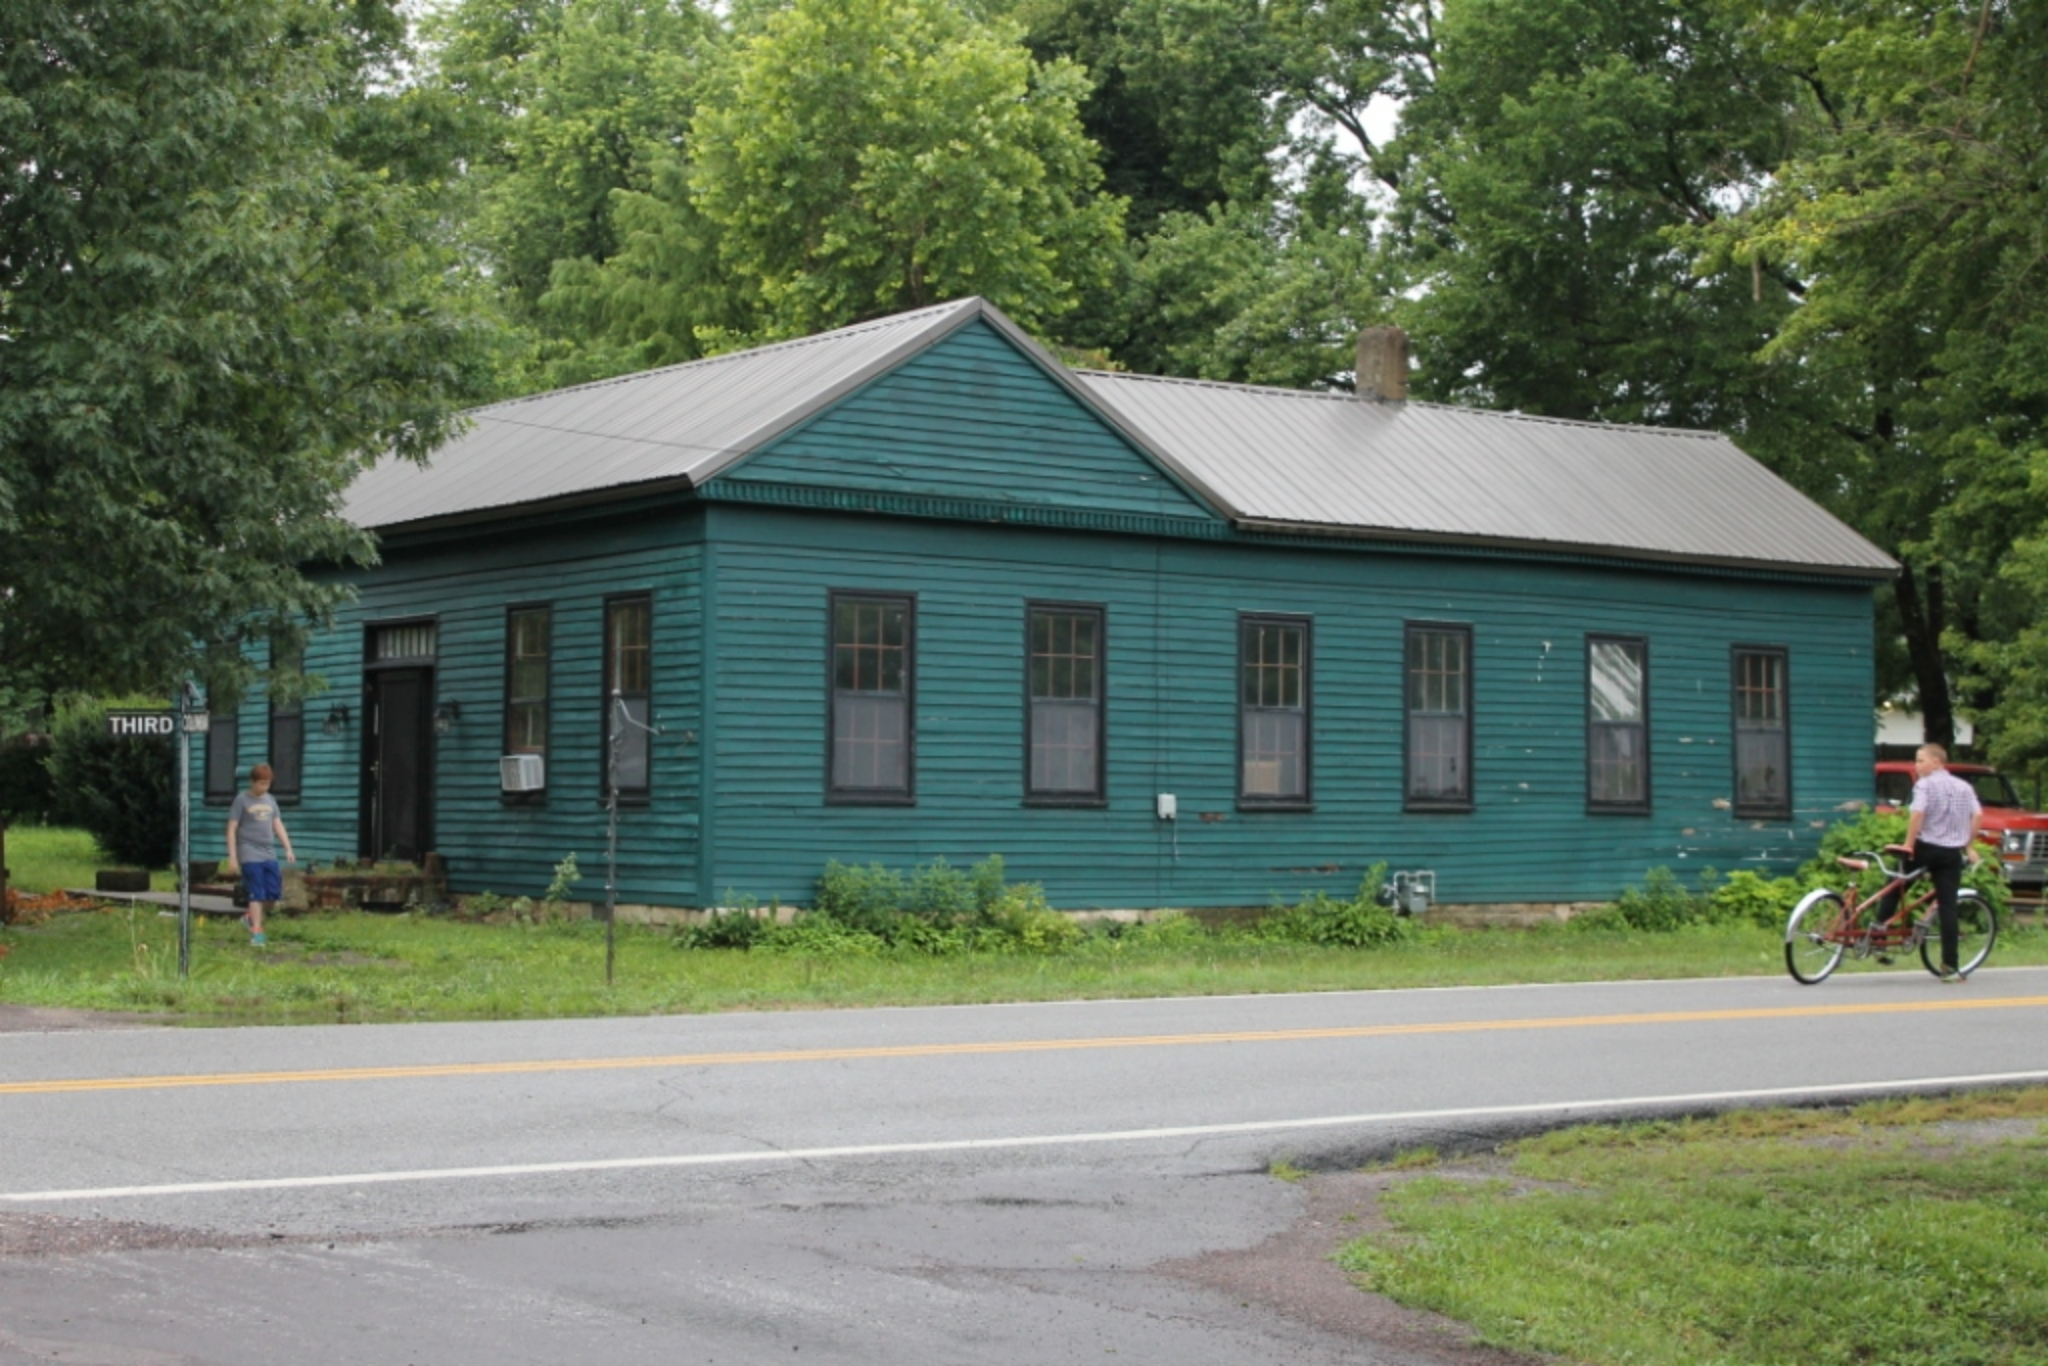
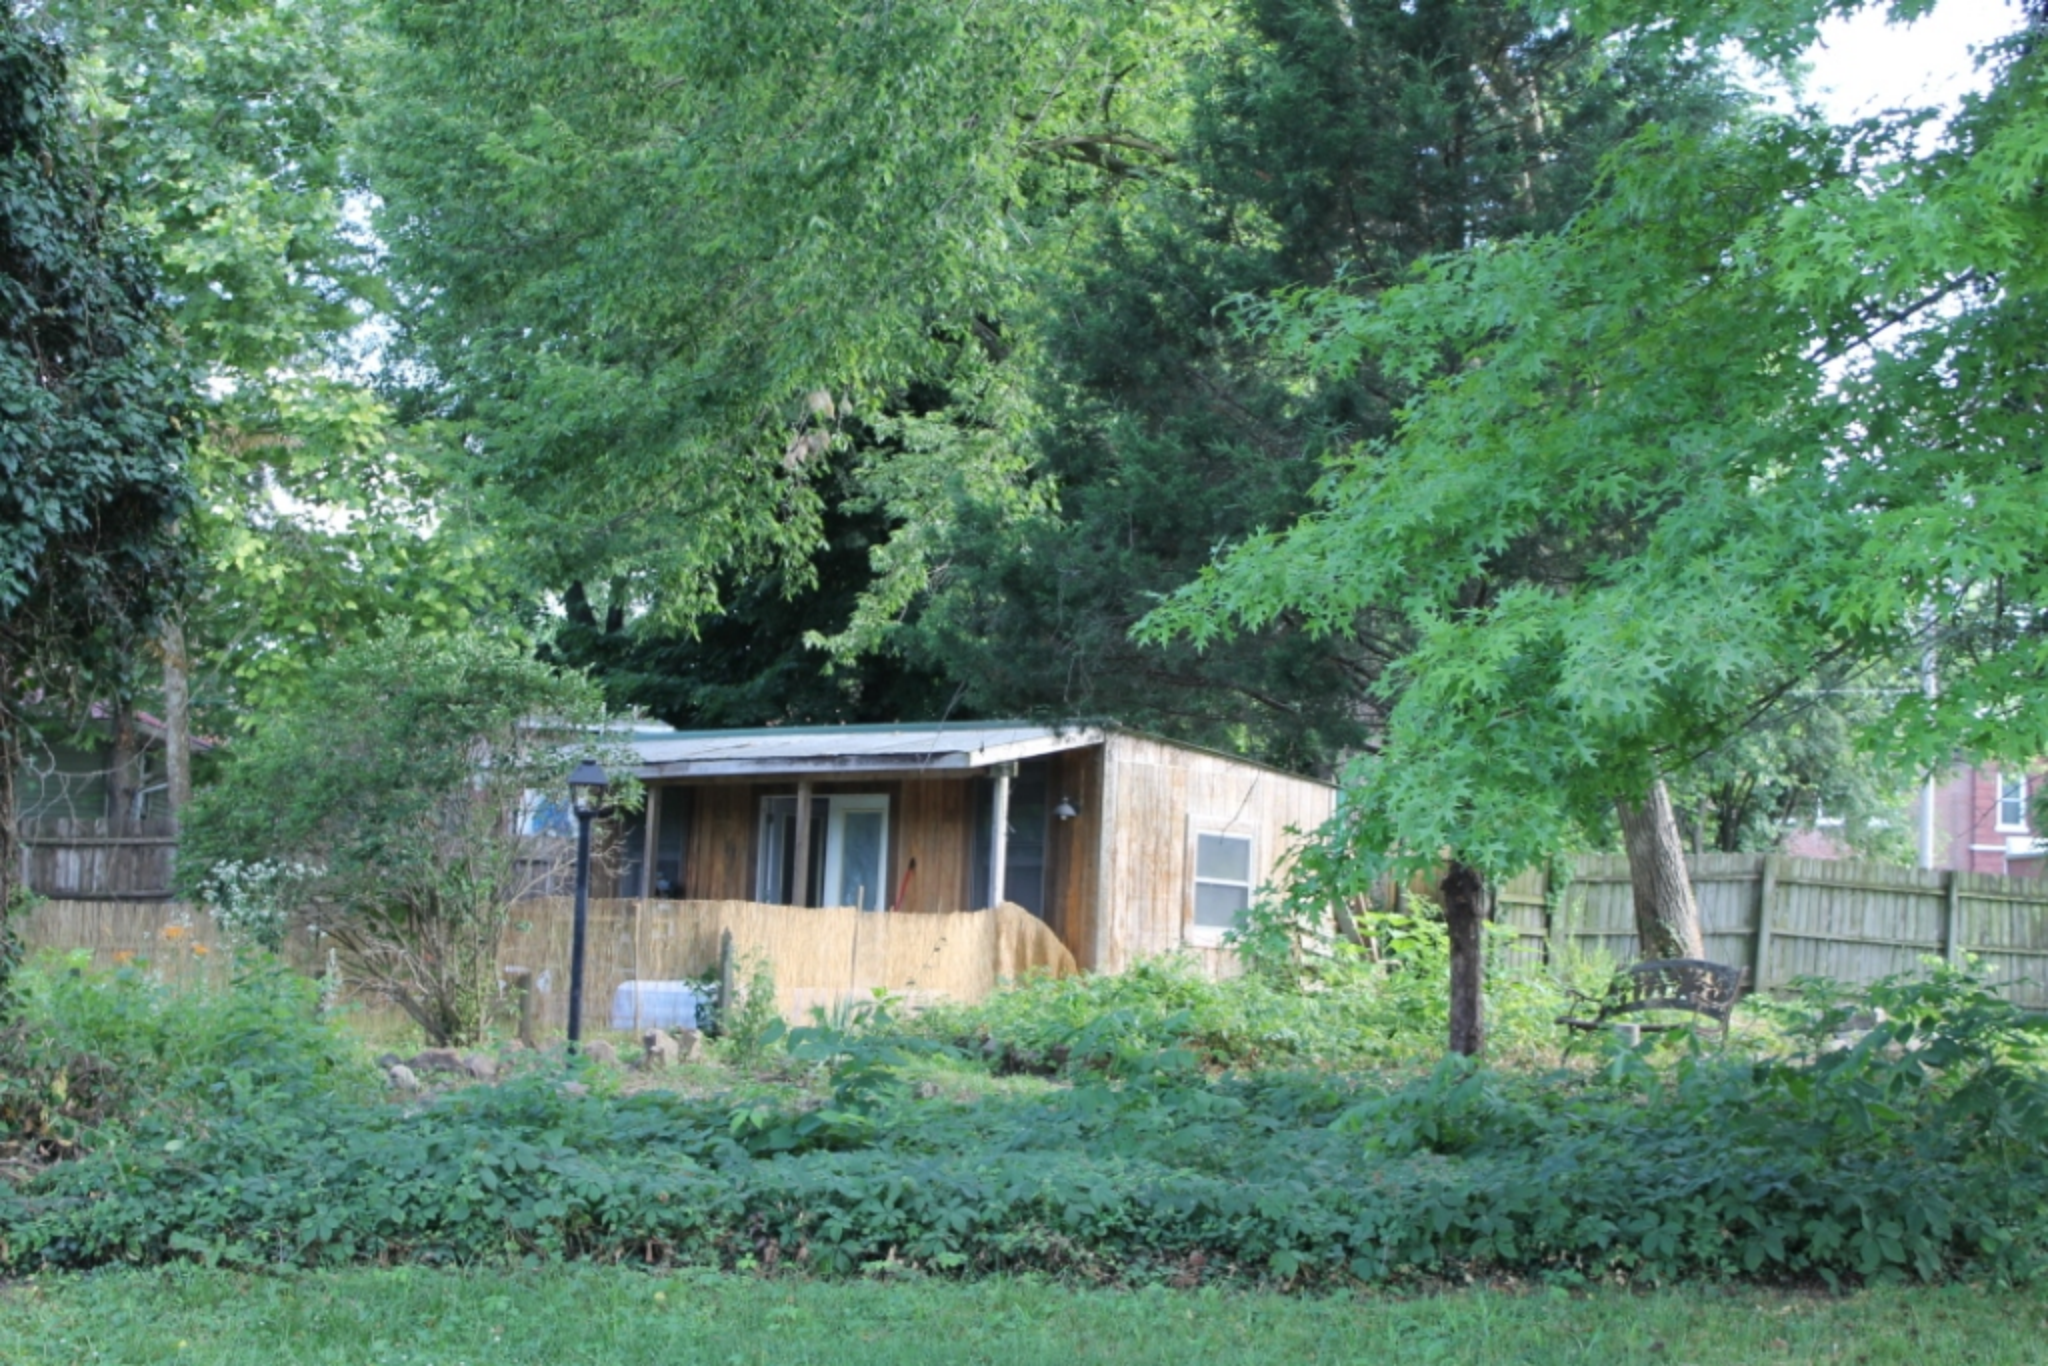
This one-story hall and parlor, frame, Federal style house has a low cross gable roof that covers the main block of the house and the rear (west) wing. The house is clad in clapboards and the roof is metal. The front (east) facade has dentils along the cornice line. The front (east) facade has five bays. The two left bays each contain a six-over-six single hung wooden window. The center bay contains a door with an eight paned transom and six paned sidelights. The two right bays each contain a six-over-six single hung wooden window. The side (north) facade reveals the cross gable wing. The side (north) facade has six bays evenly spaced along the facade. The two left bays, which are located on the main block of the house, each contain a six-over-six single hung window. The remaining bays, which are evenly spaced along the rear (west) wing, each contain a six-over-six single hung wooden window. The house has a bay window on the south wall. This bay window was believed by the preparers of the Rocheport Historic District survey to have been added during the late nineteenth century.
