MISSOURI DEPARTMENT OF NATURAL RESOURCES
STATE HISTORIC PRESERVATION OFFICE, P.O. Box 176, Jefferson City, MO 65102
ARCHITECTURAL/HISTORIC INVENTORY FORM

1. SURVEY NO. BO-AS-009-0001		2. SURVEY NAME: Rocheport Historic District	
3. COUNTY: Boone		4. ADDRESS (STREET NO.)	STREET (NAME) Katy Trail
5. CITY: Rocheport	VICINITY: <input checked="" type="checkbox"/>	6. UTM: / /	LAT: LONG: T: 48W R: 15W S: 1

8. HISTORIC NAME (IF KNOWN): M.K.&T. Railroad tunnel		9. PRESENT/OTHER NAME (IF KNOWN): Katy trail tunnel	
10. OWNERSHIP: <input type="checkbox"/> PRIVATE <input checked="" type="checkbox"/> PUBLIC		11A. HISTORIC USE (IF KNOWN): railroad tunnel	11B. CURRENT USE: Katy Trail tunnel
HISTORICAL INFORMATION

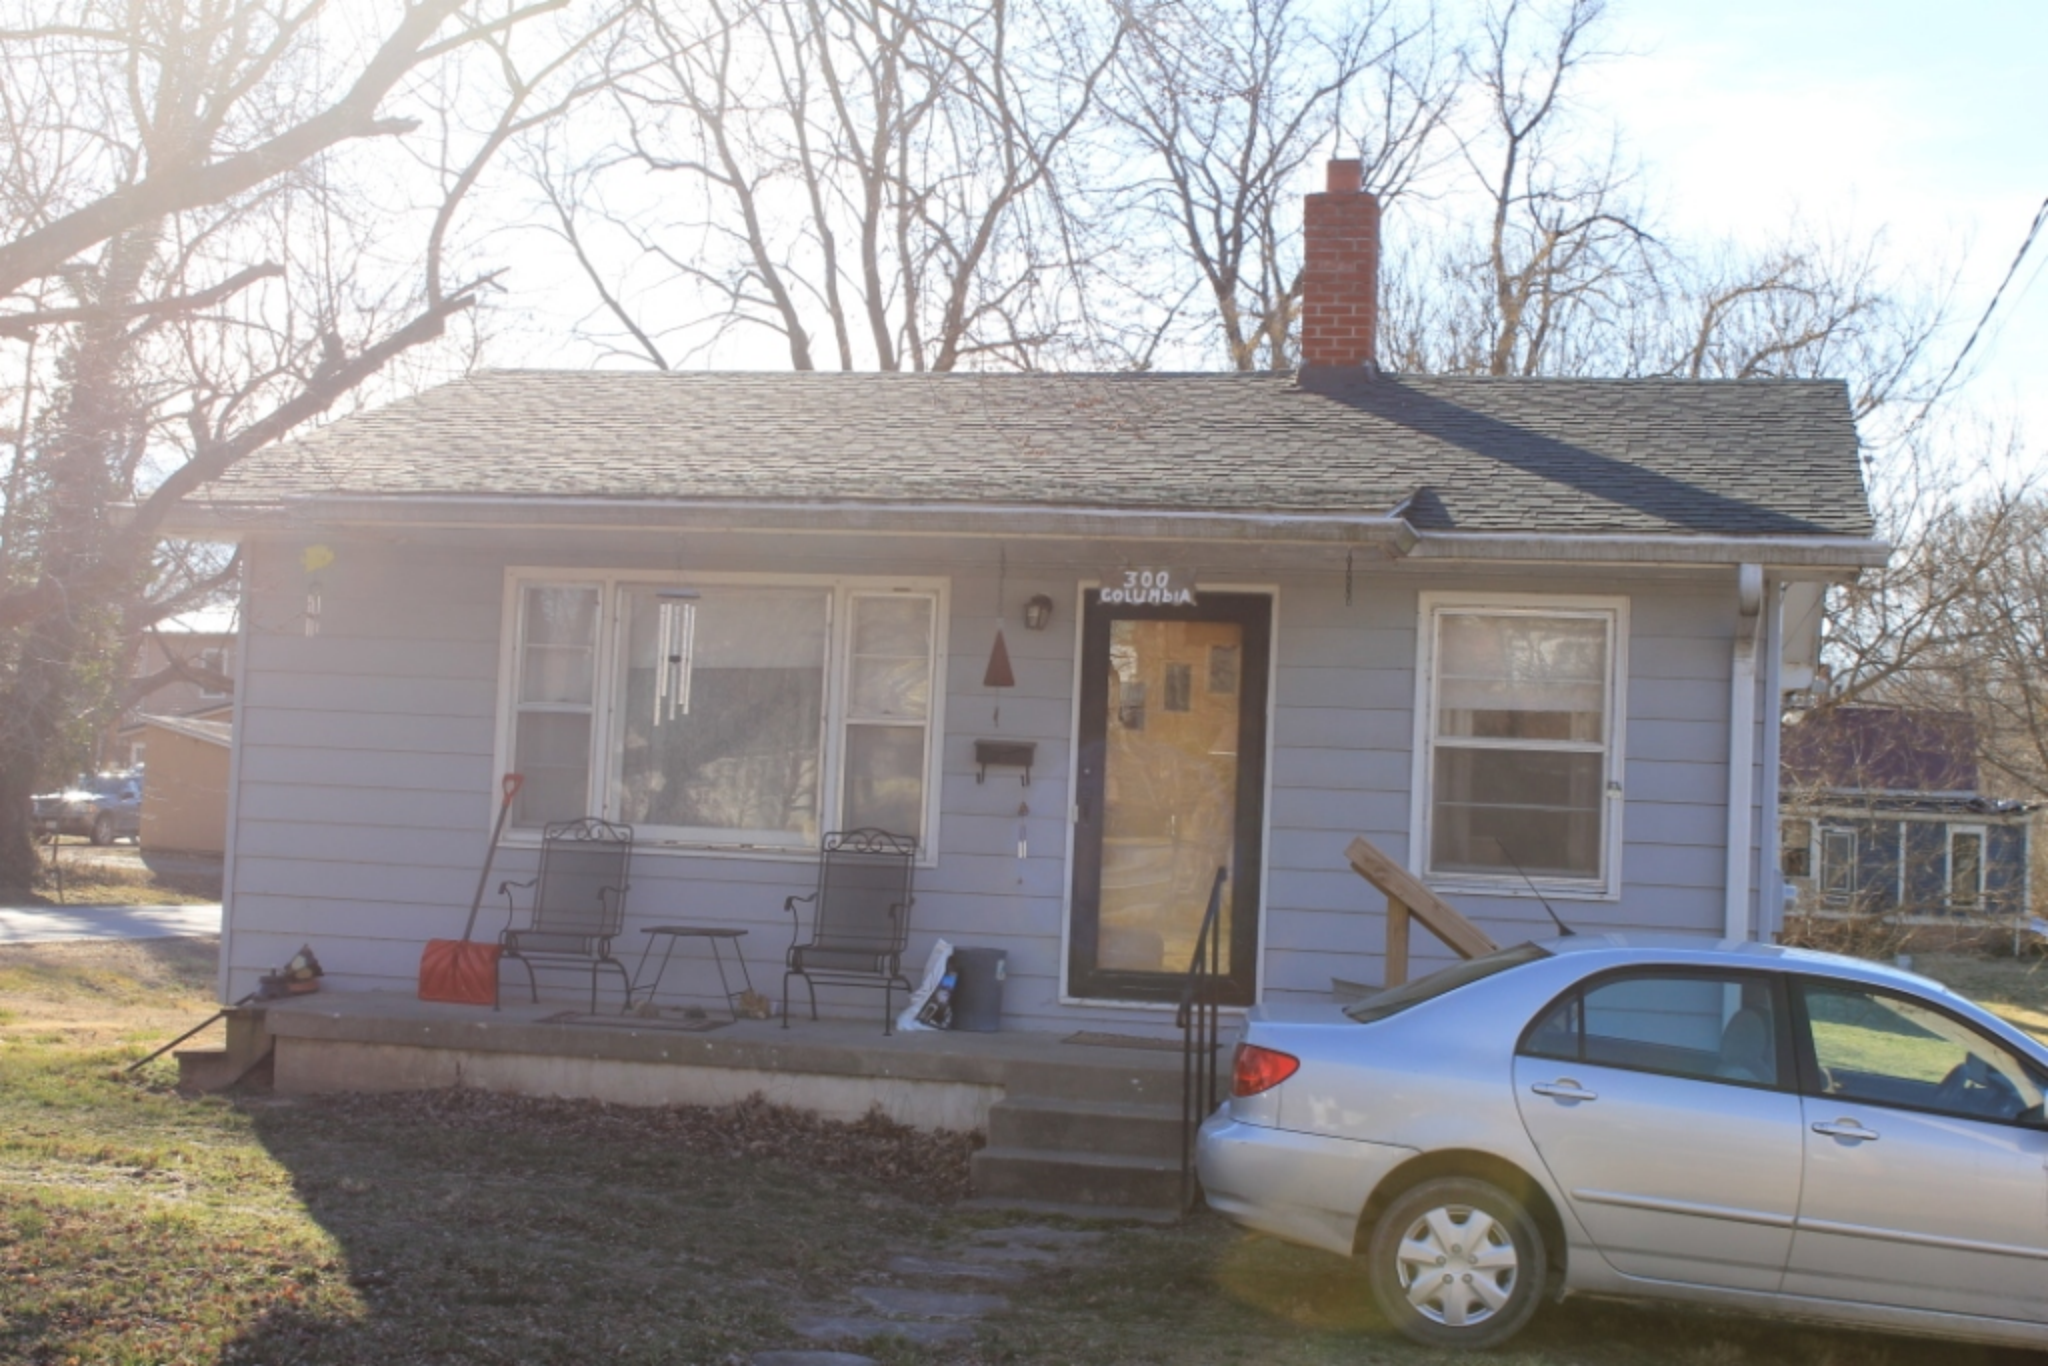
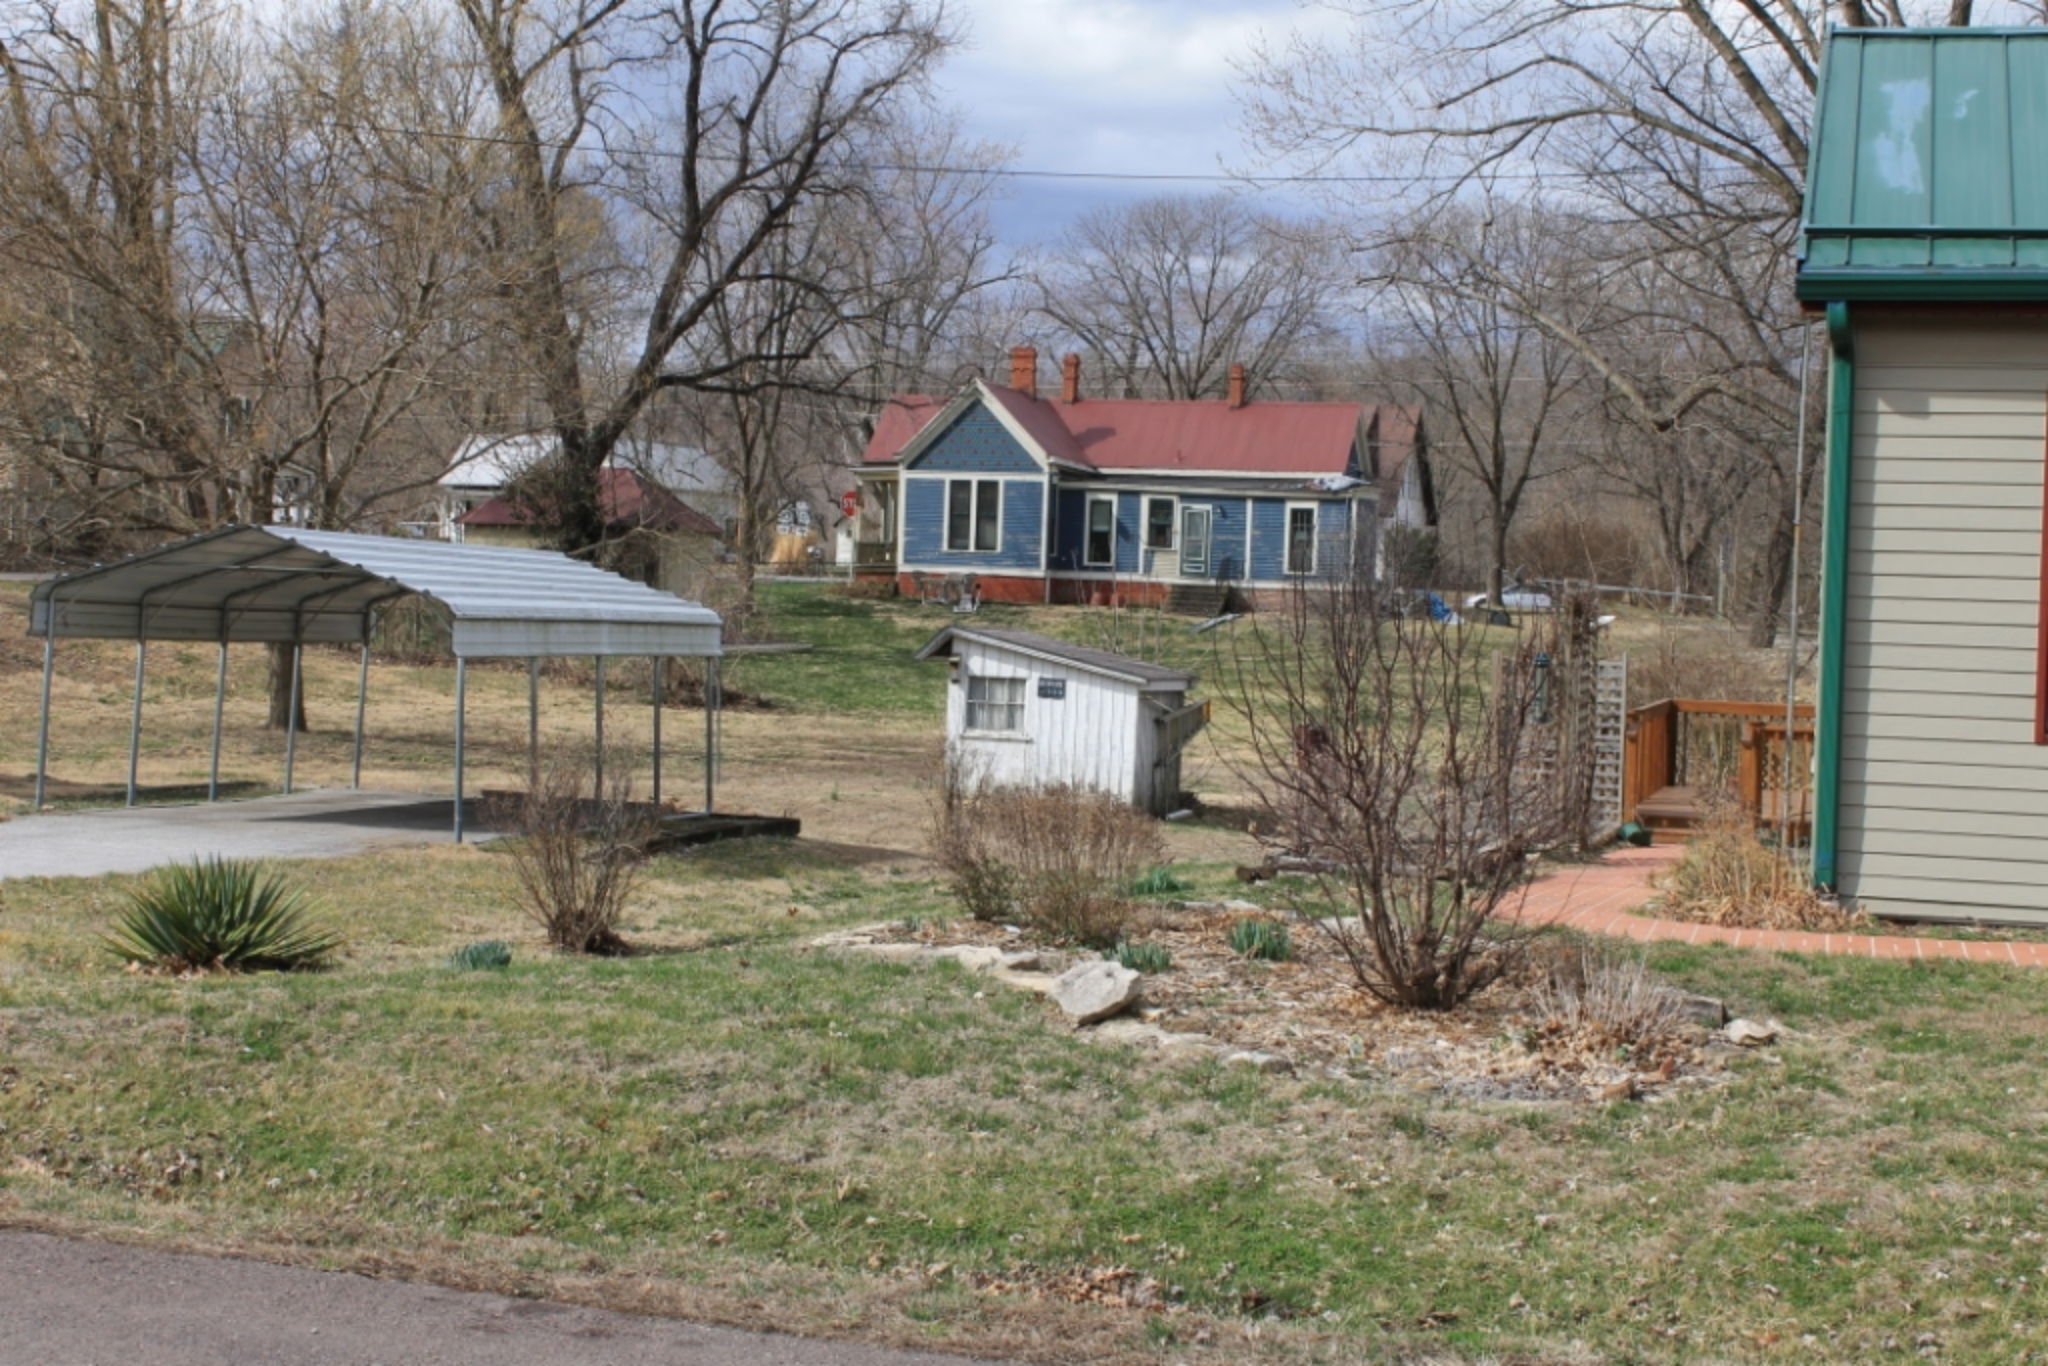
This one-story, massed plan side gable ranch house with a low gable roof is clad in clapboards. The roof is covered with asphalt shingles. The house has a concrete porch running along the front of the house. The roof projects slightly from the main block of the house to cover the porch. The front facade has three bays. The left bay contains a fixed pane picture window flanked on either side by one-over-one single hung windows. The center bay contains a wooden door with three fixed pane windows; the door is covered by a modern glass and metal storm door. The bay to the right contains a one-over-one single hung window. A brick chimney rises from the ridge slightly to the right of the center of the roof.

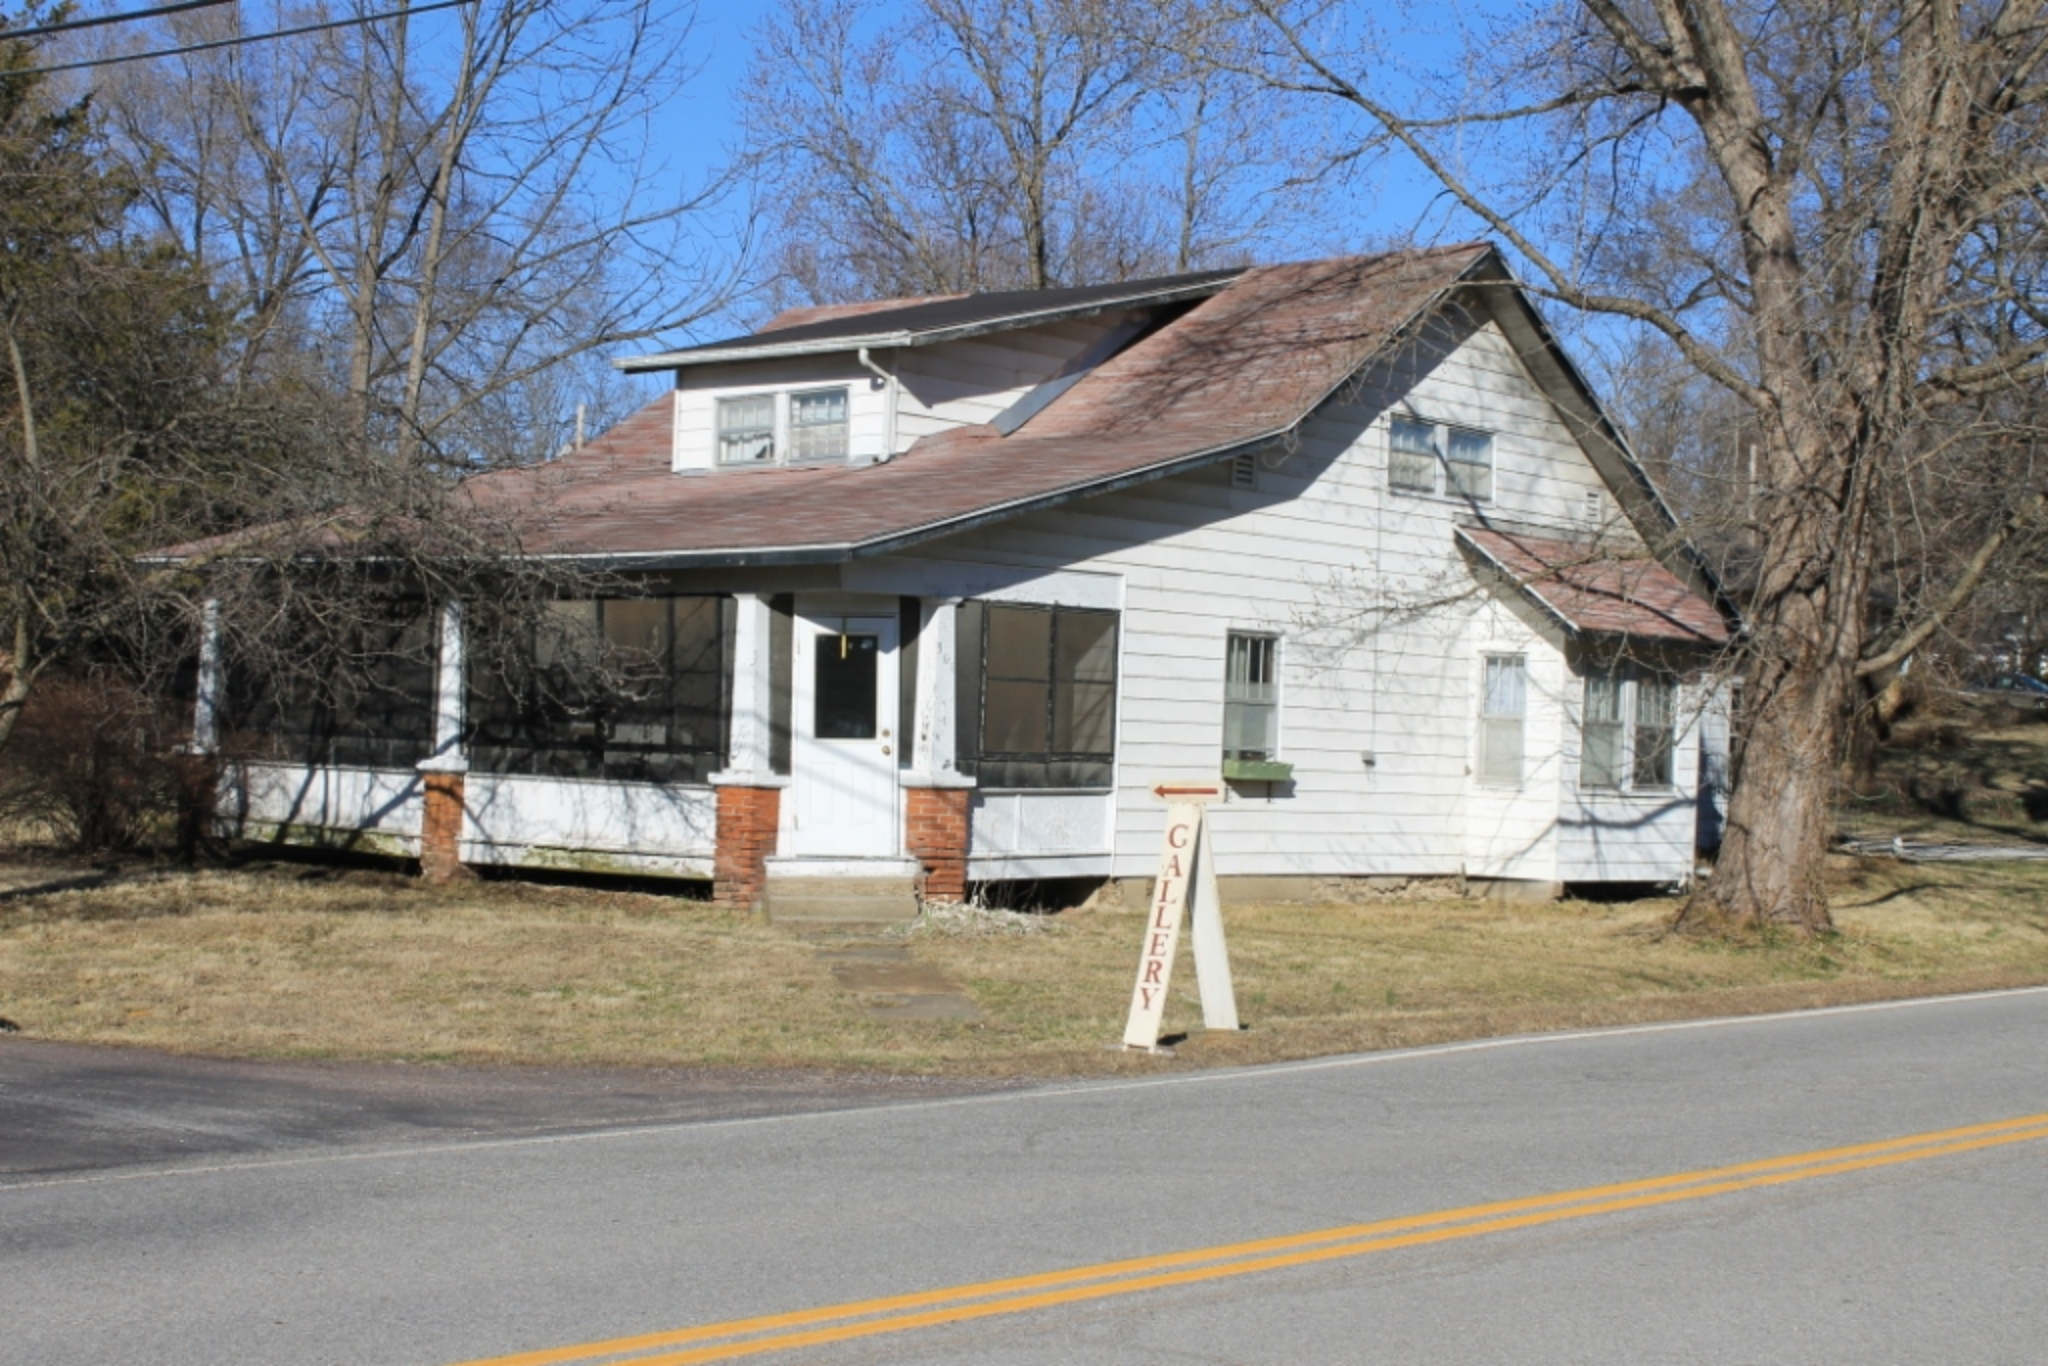
This 1 1/2 story, massed plan side gable house is clad in clapboards and its roof is covered in asphalt shingles. A wing with a saltbox roof extends to the east from the rear of the house. The house has some elements of Craftsman style, including windows with vertical panes in the top section over a single pane in the bottom section, a shed roofed dormer on the front, and a porch that spans the front of the house with pyramidal posts supported on brick pedestals. The porch, now enclosed with screen, has a side angled entry. The number of bays on the front (west) facade is difficult to determine as the screen is black and obscures the front facade. The shed roofed dormer on the second story has one bay containing a pair of five-over-five vertical paned single hung windows. The side (south) facade of the house facing Third Street has seven bays. The two left bays each contain a four vertical panes-over-one single hung window. The shed roofed bay window on the south wall of the house has one bay on the west containing a four vertical panes-over-one single hung window, a bay containing a pair of four vertical panes-over-one single hung windows on the south, and a bay containing four vertical panes-over-one pane single hung window on the east. The two rightmost bays each contain a four-over-four window. Under the gable of the main block of the house is one bay containing a pair of three vertical panes-over-six vertical pane windows.

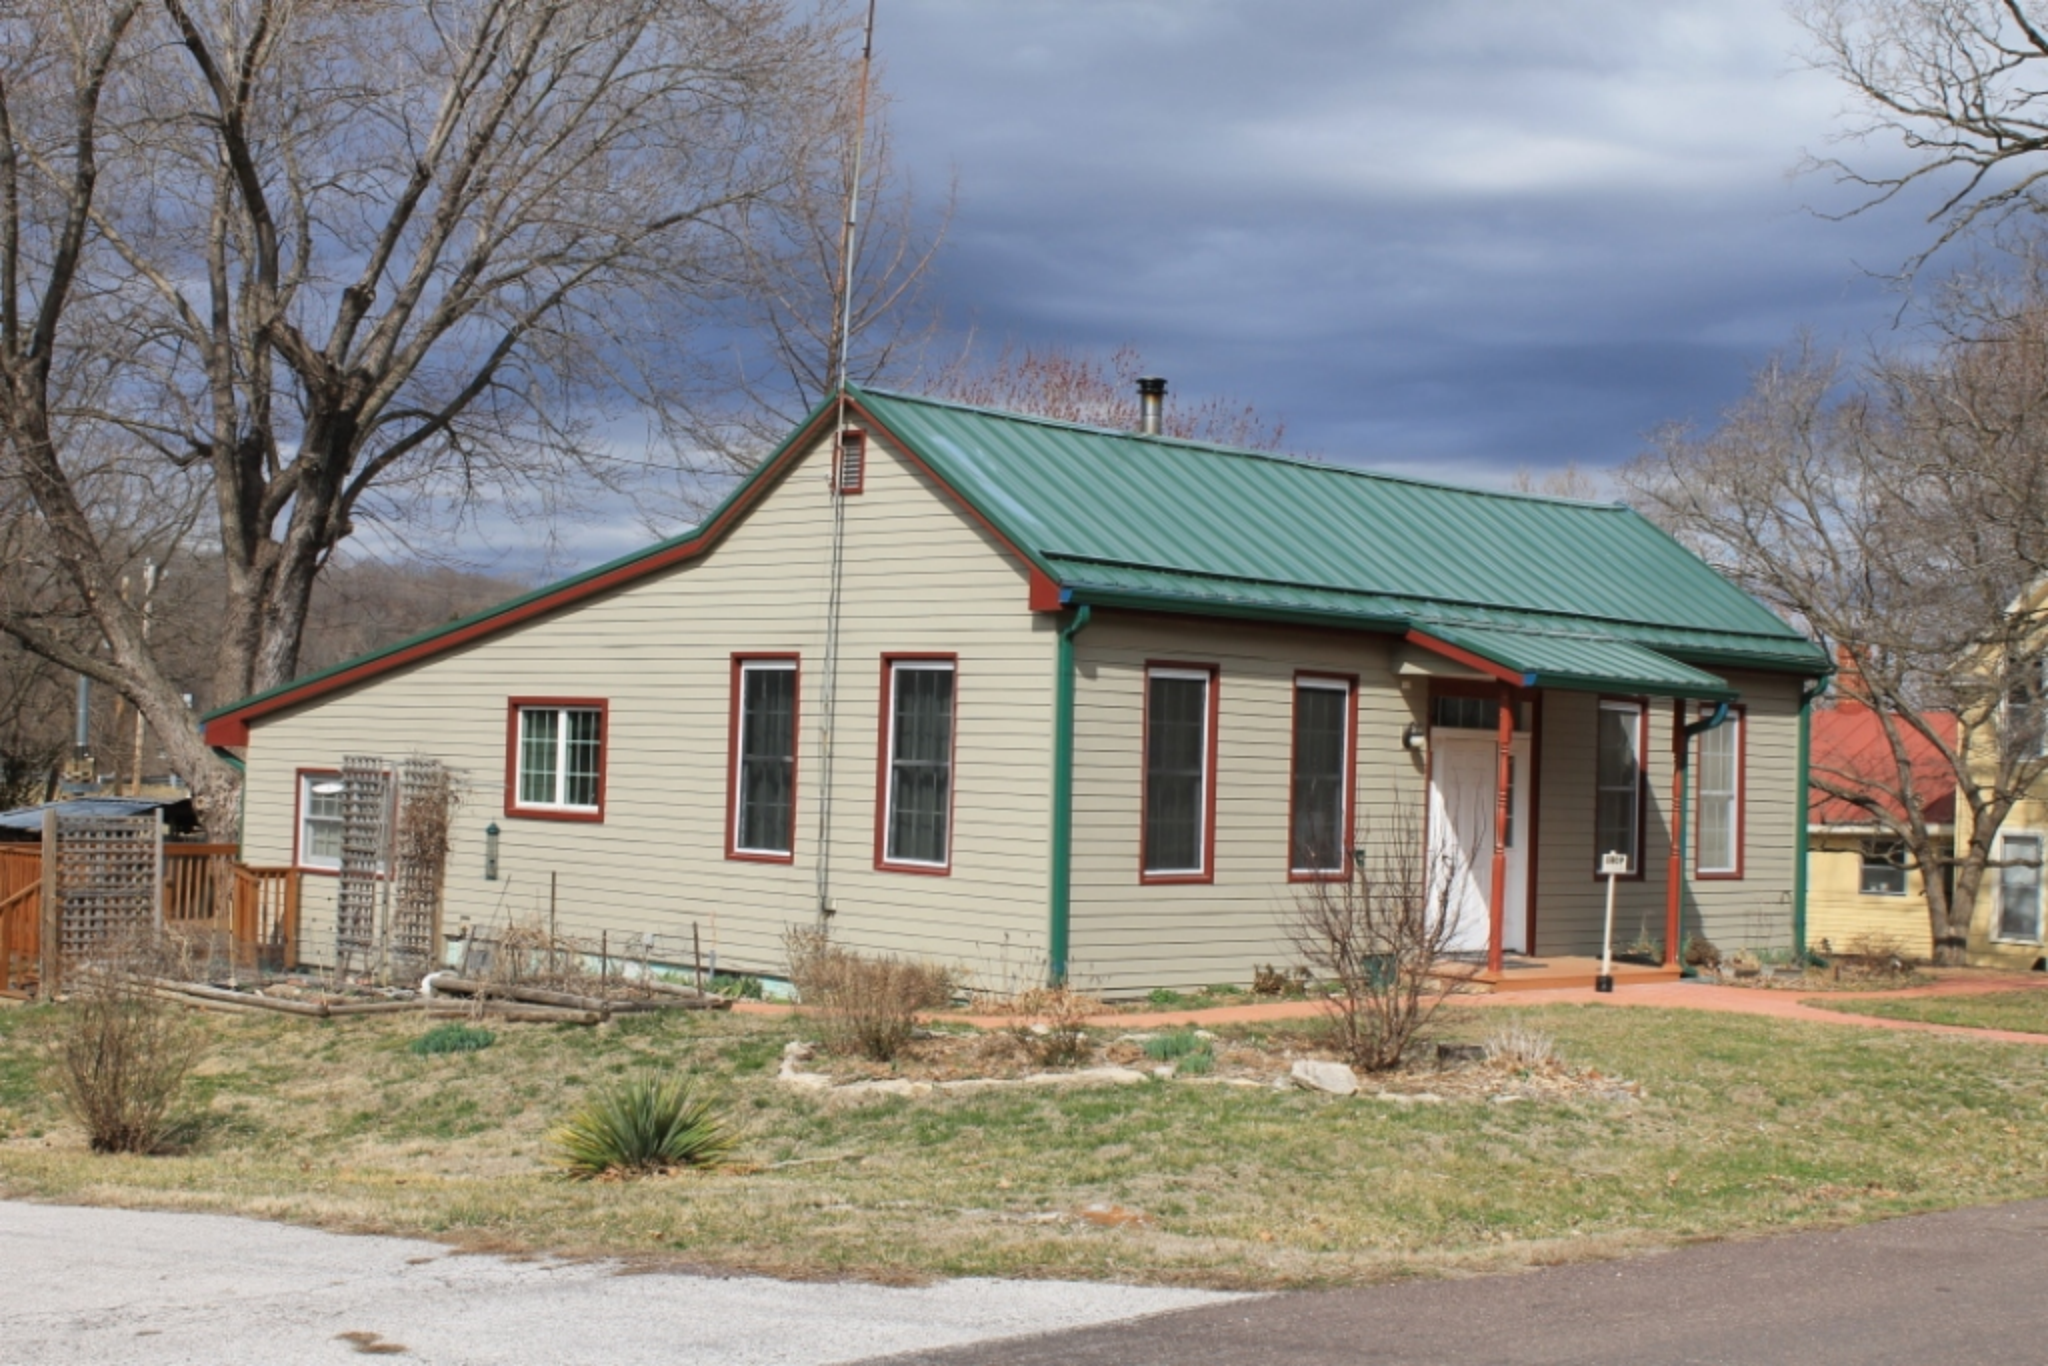
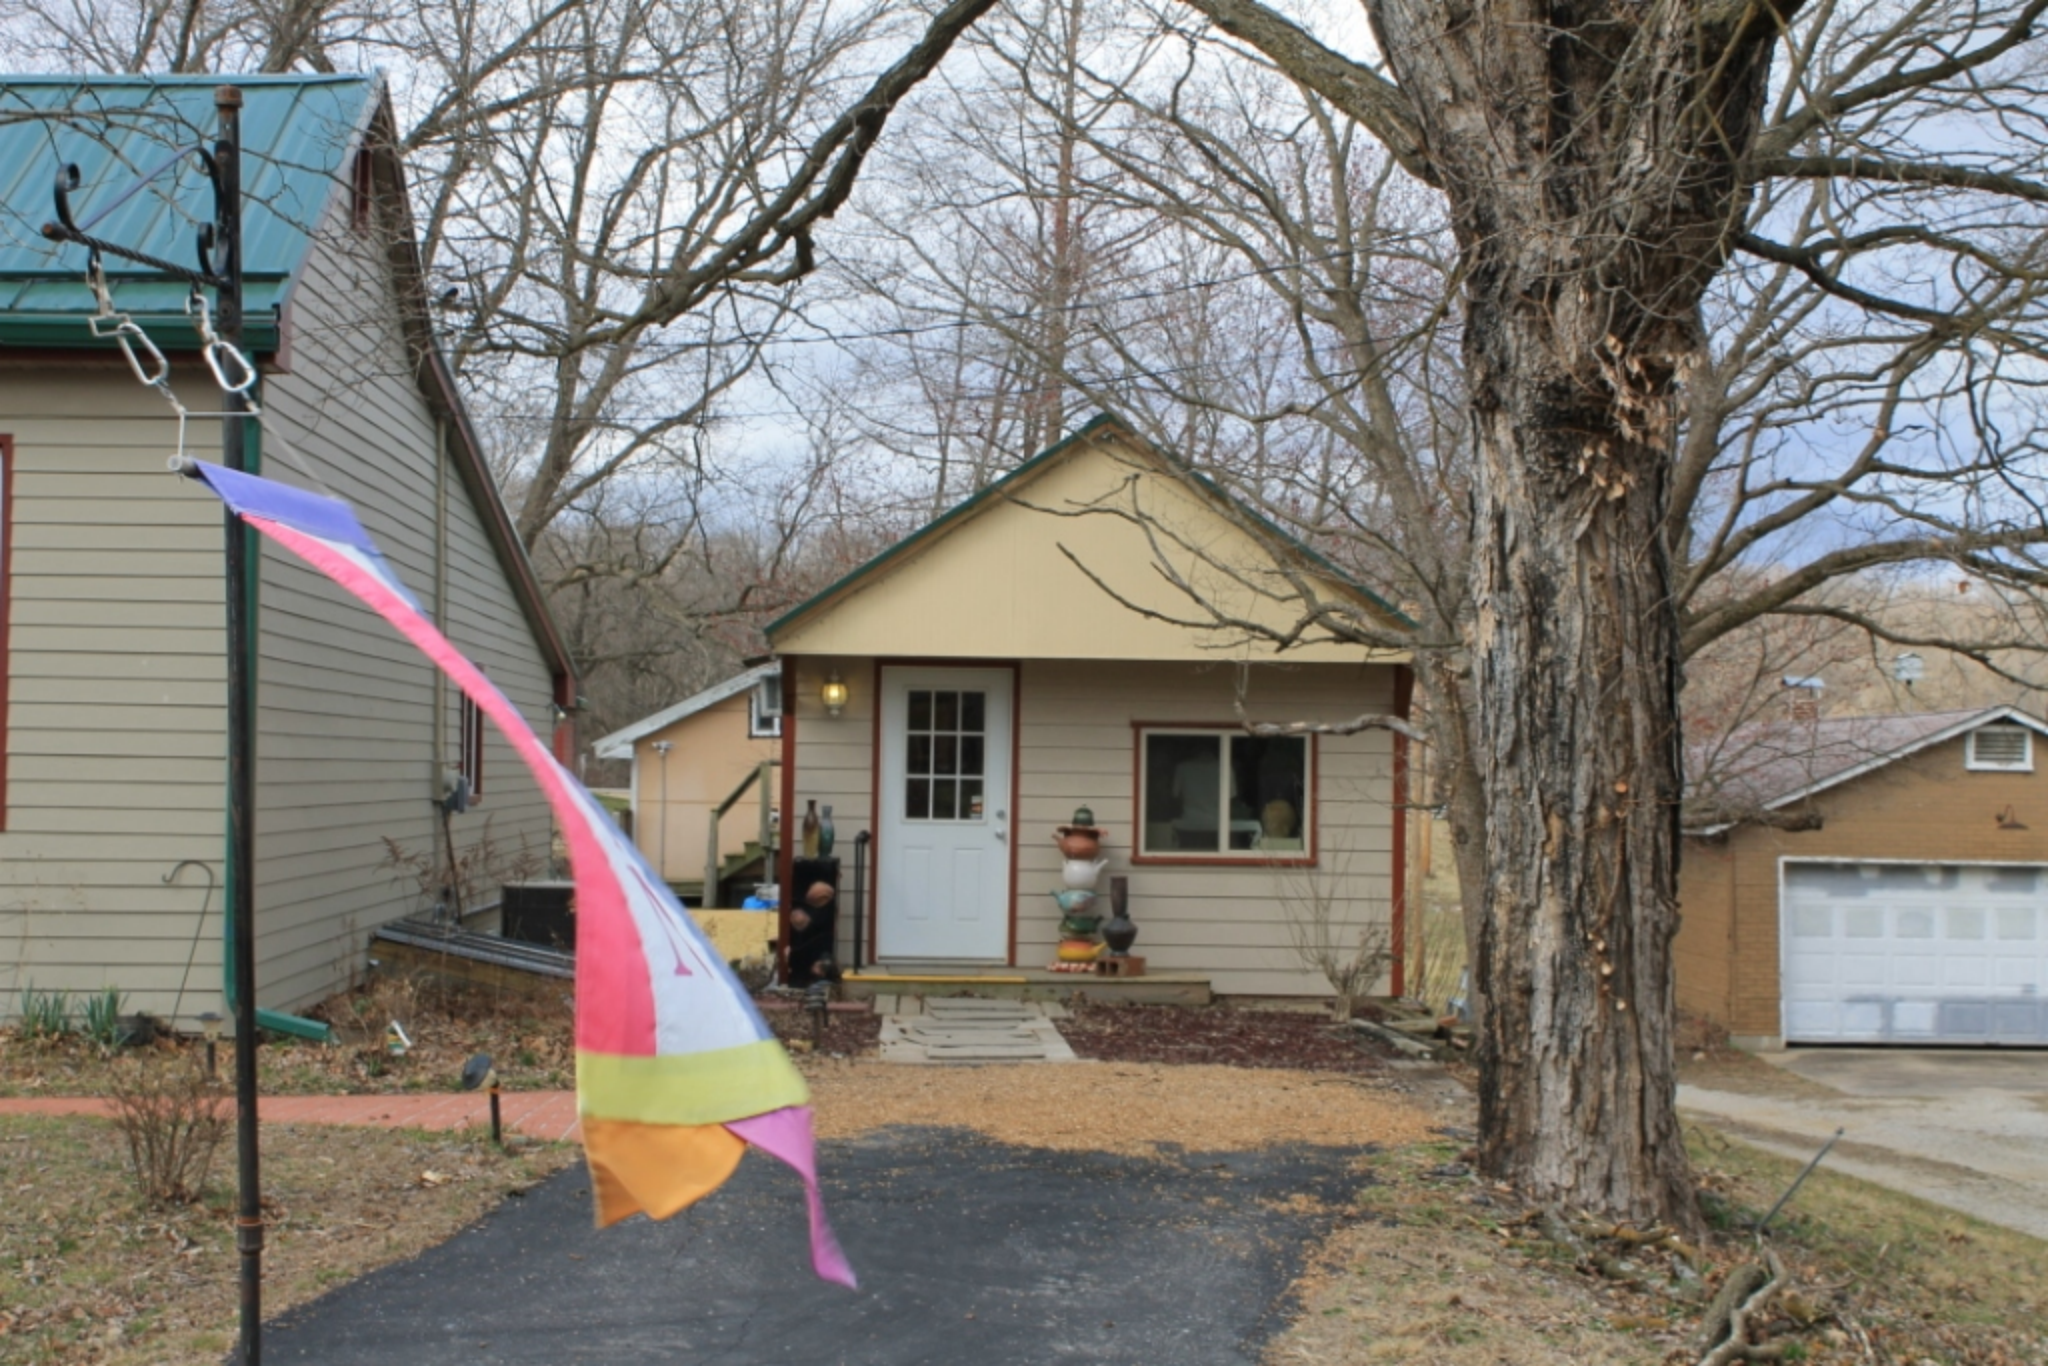
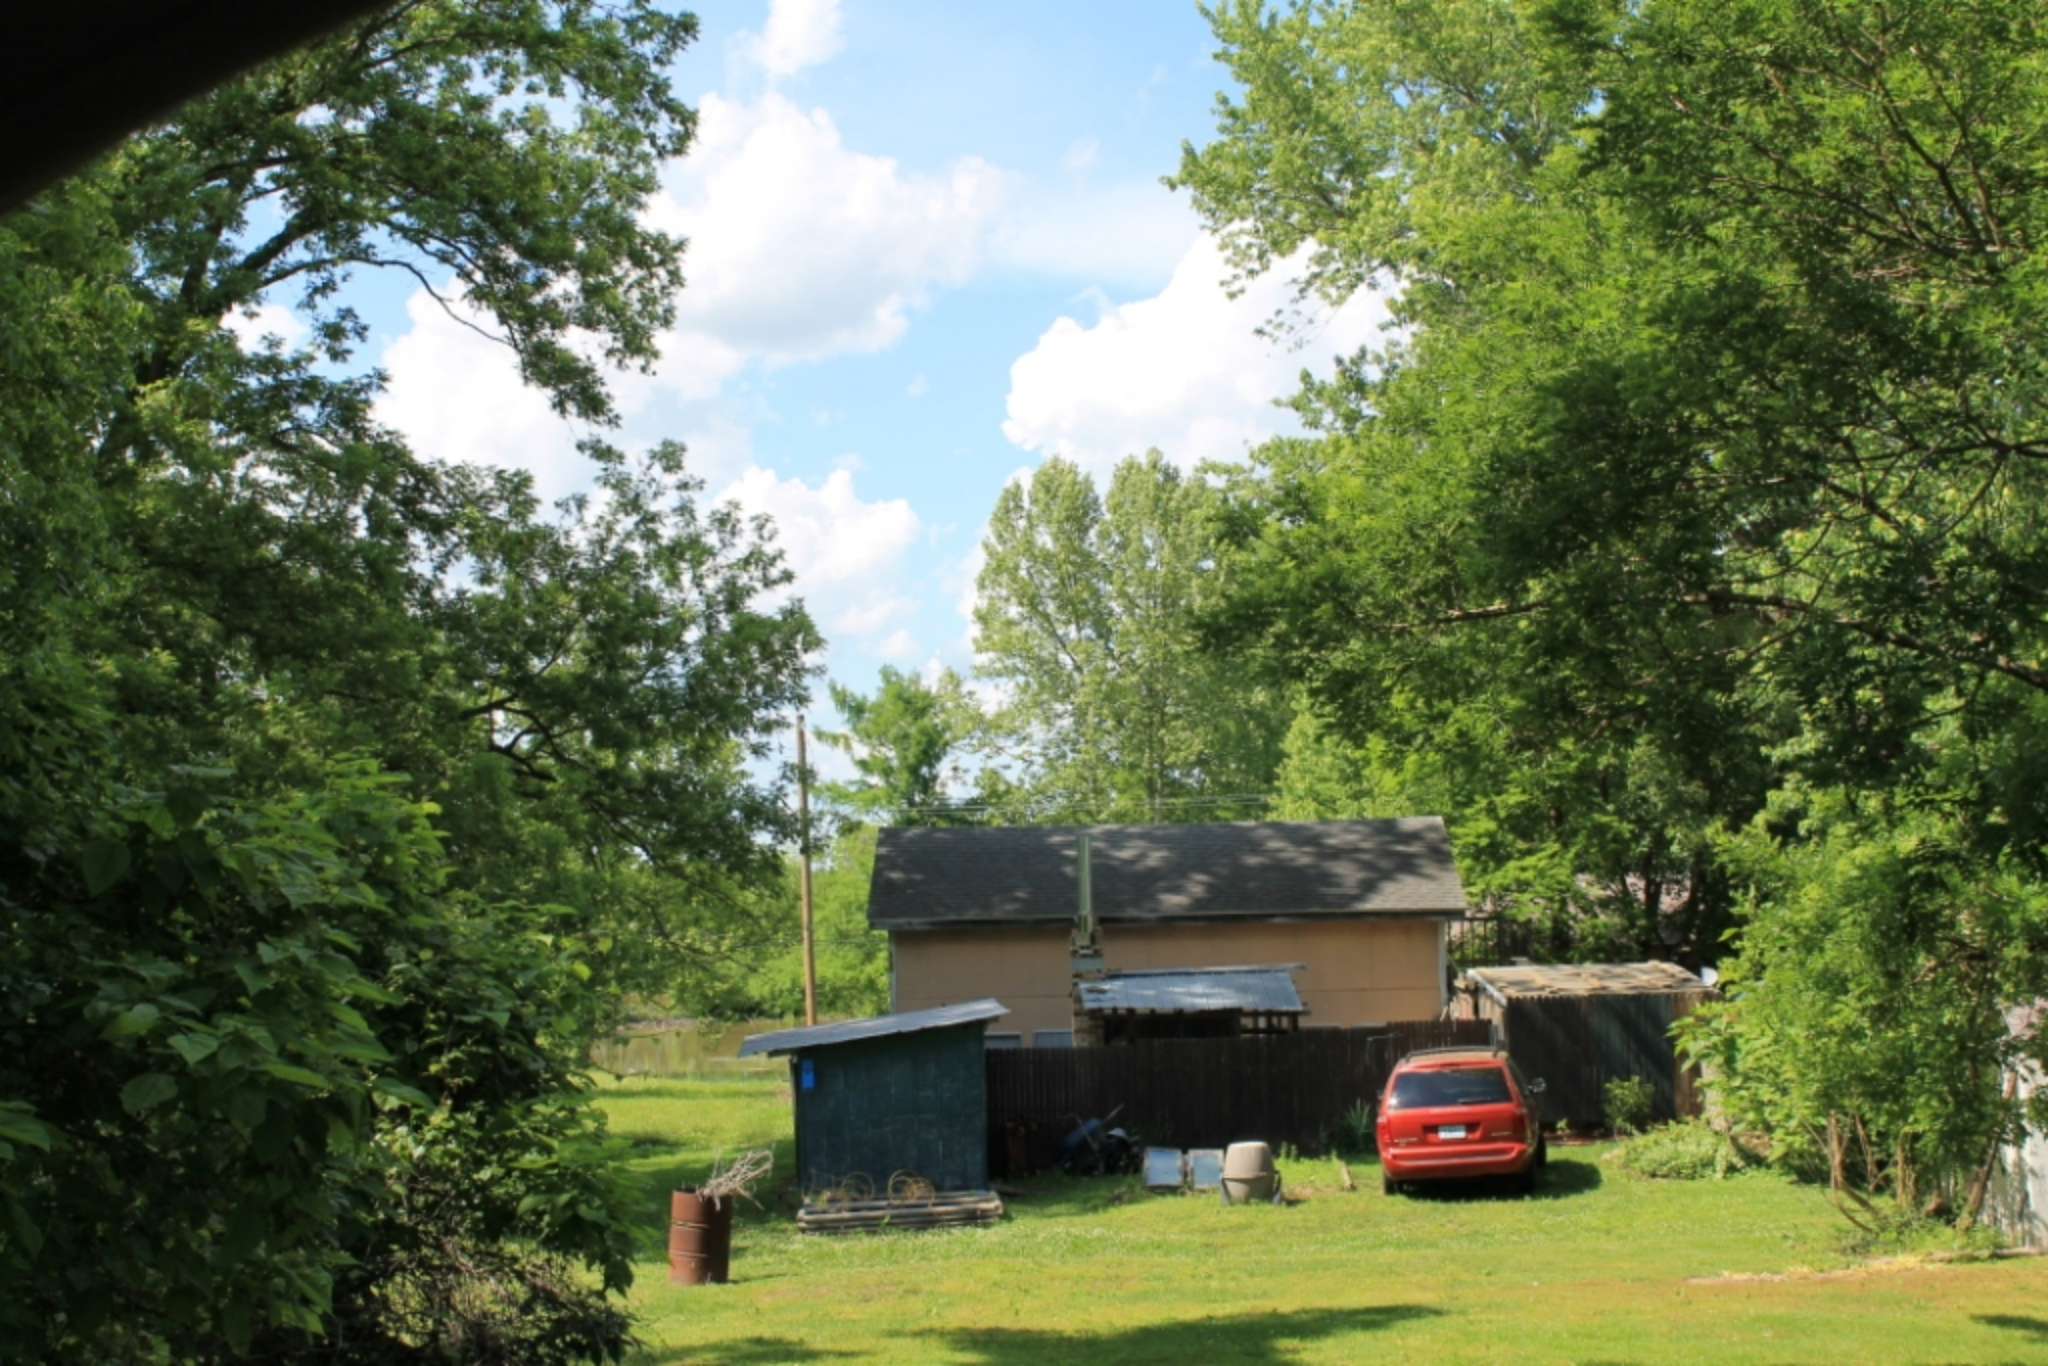
This one-story, hall and parlor plan house has a low pitched metal saltbox roof. The house is clad in clapboards and the roof is covered with metal. A shed roofed porch supported by modern turned posts is on the center front of the house. The front (east) facade has five bays. The two left bays each contain a six-over-six single hung vinyl window. The center bay, which is under the porch, contains a door with a five paned transom. The two right bays each contains six-over-six single hung vinyl window. The south facade of the building has four bays. The left bay contains a door. The next bay contains a pair of six-over-six single hung vinyl windows. The two right bays each contain a longer six-over-six single hung window. The right bay is set higher in the wall than the left bay.
