MISSOURI DEPARTMENT OF NATURAL RESOURCES
STATE HISTORIC PRESERVATION OFFICE, P.O. Box 176, Jefferson City, MO 65102
ARCHITECTURAL/HISTORIC INVENTORY FORM

1. SURVEY NO. BO-AS-009-0001		2. SURVEY NAME: Rocheport Historic District	
3. COUNTY: Boone		4. ADDRESS (STREET NO.)	STREET (NAME) Katy Trail
5. CITY: Rocheport	VICINITY: <input checked="" type="checkbox"/>	6. UTM: / /	LAT: LONG: T: 48W R: 15W S: 1

8. HISTORIC NAME (IF KNOWN): M.K.&T. Railroad tunnel		9. PRESENT/OTHER NAME (IF KNOWN): Katy trail tunnel	
10. OWNERSHIP: <input type="checkbox"/> PRIVATE <input checked="" type="checkbox"/> PUBLIC		11A. HISTORIC USE (IF KNOWN): railroad tunnel	11B. CURRENT USE: Katy Trail tunnel
HISTORICAL INFORMATION

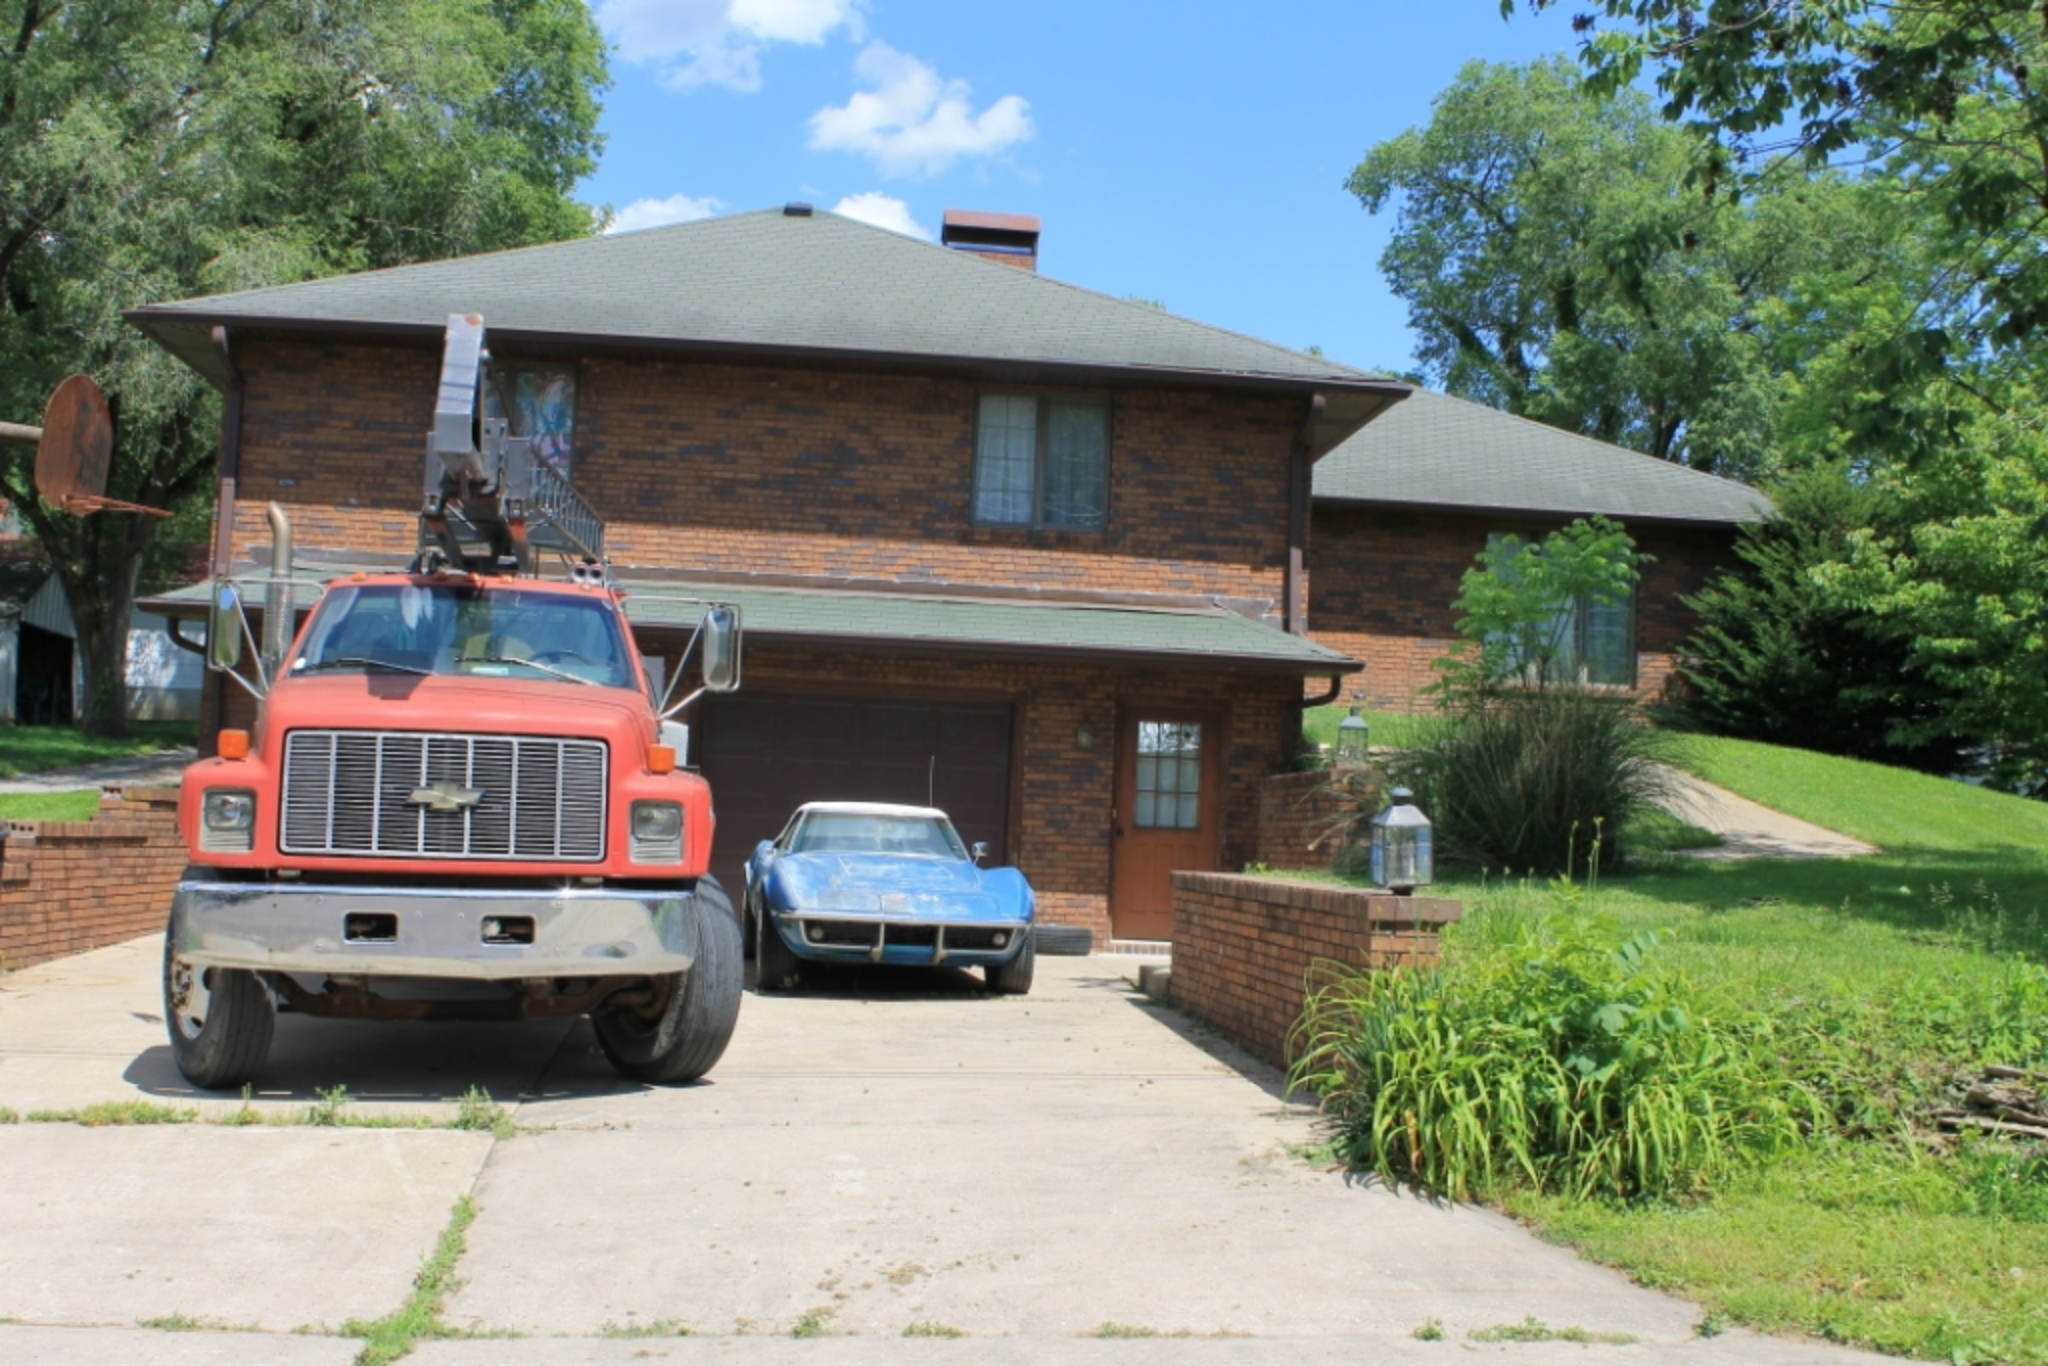
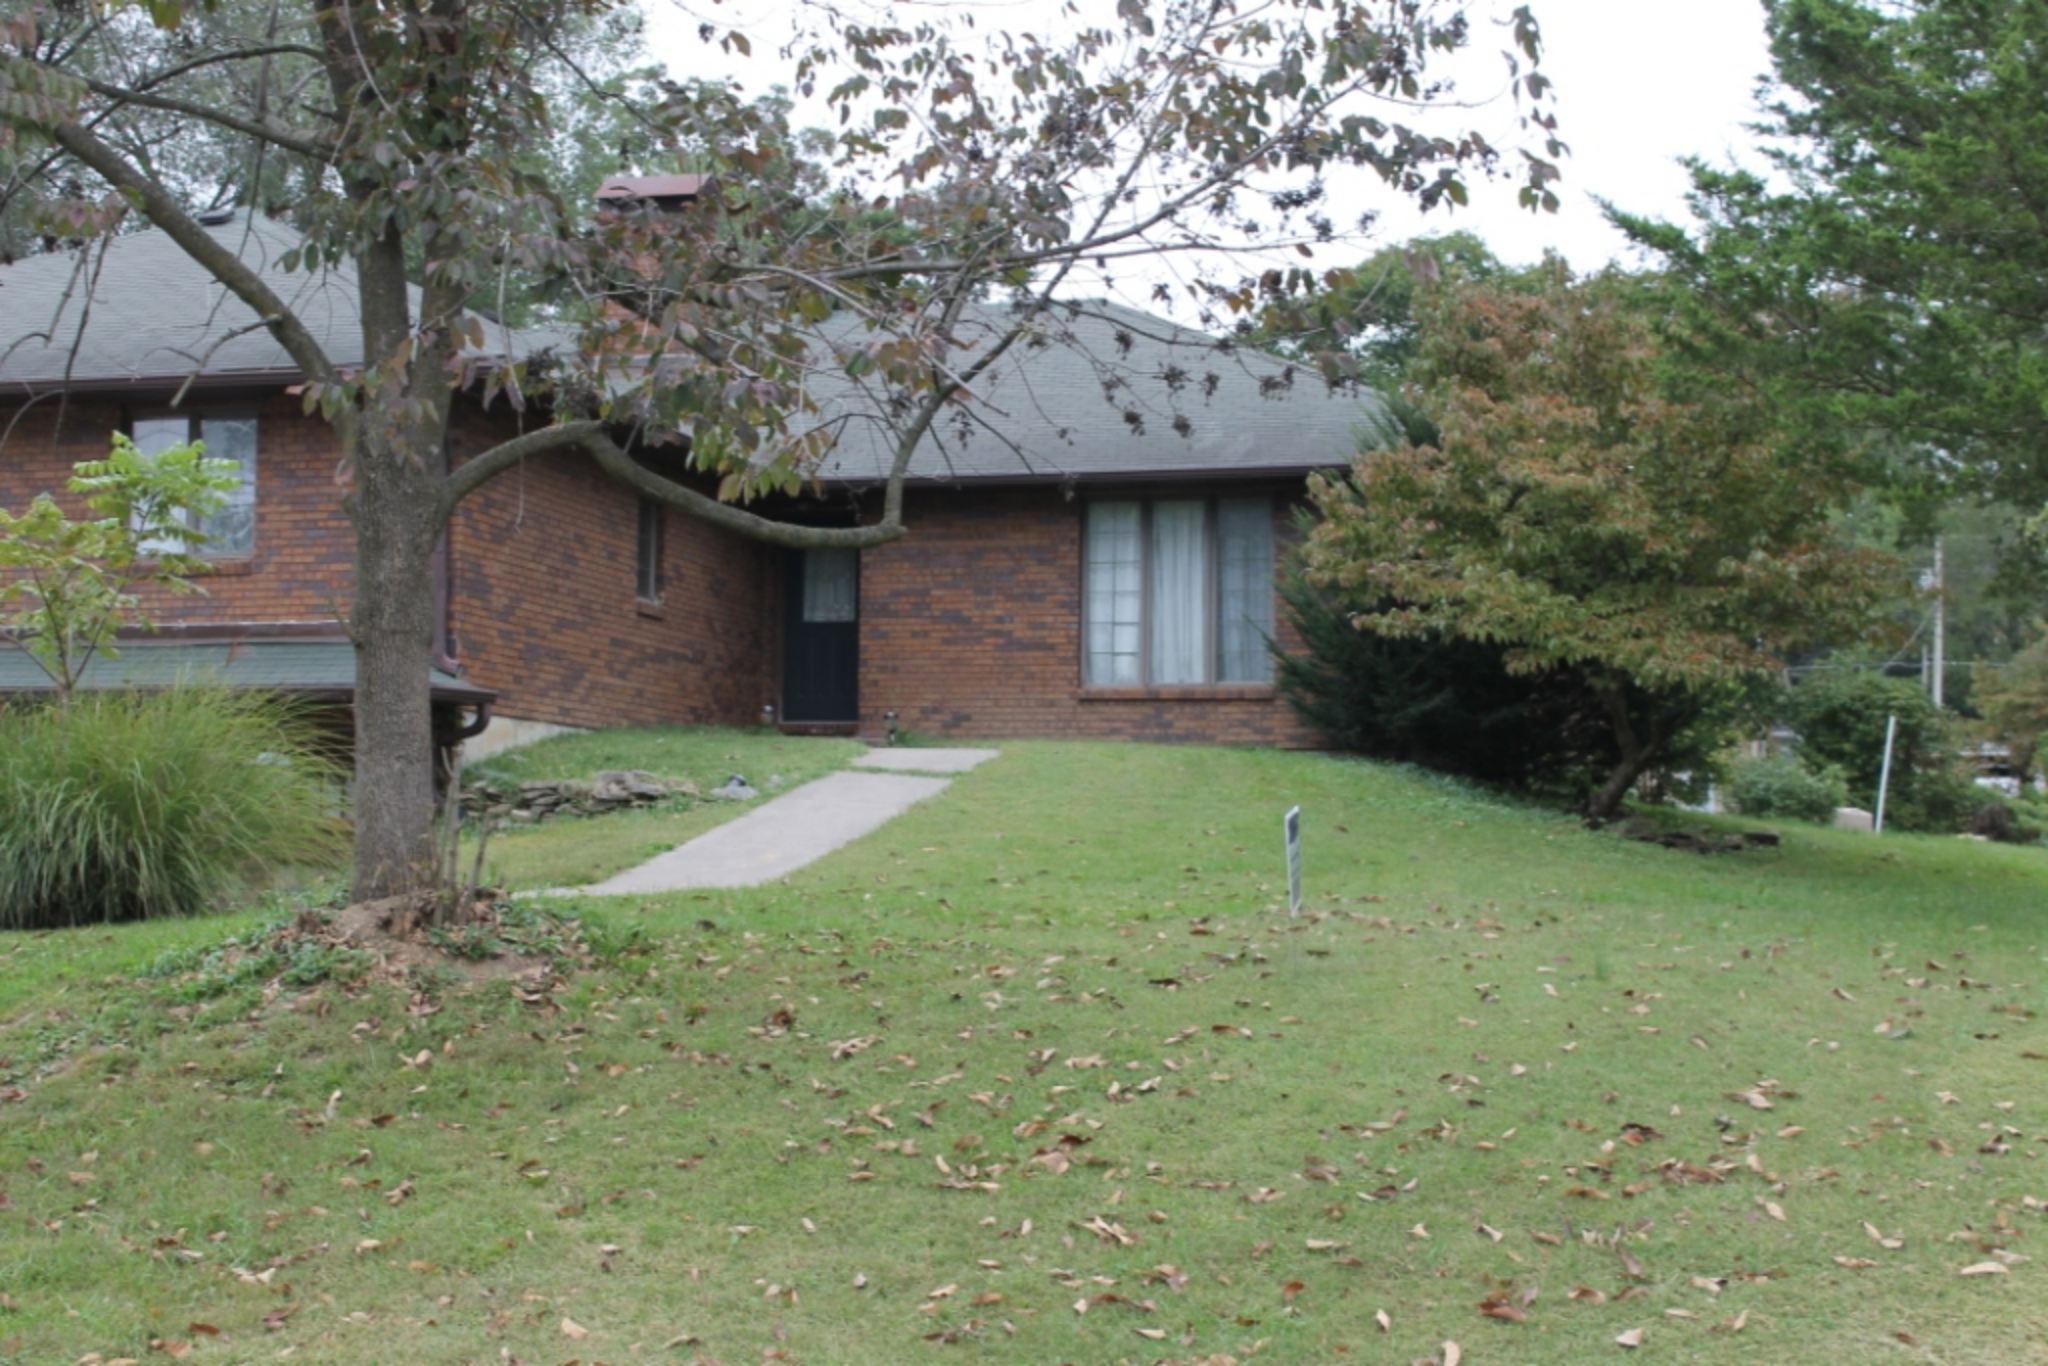
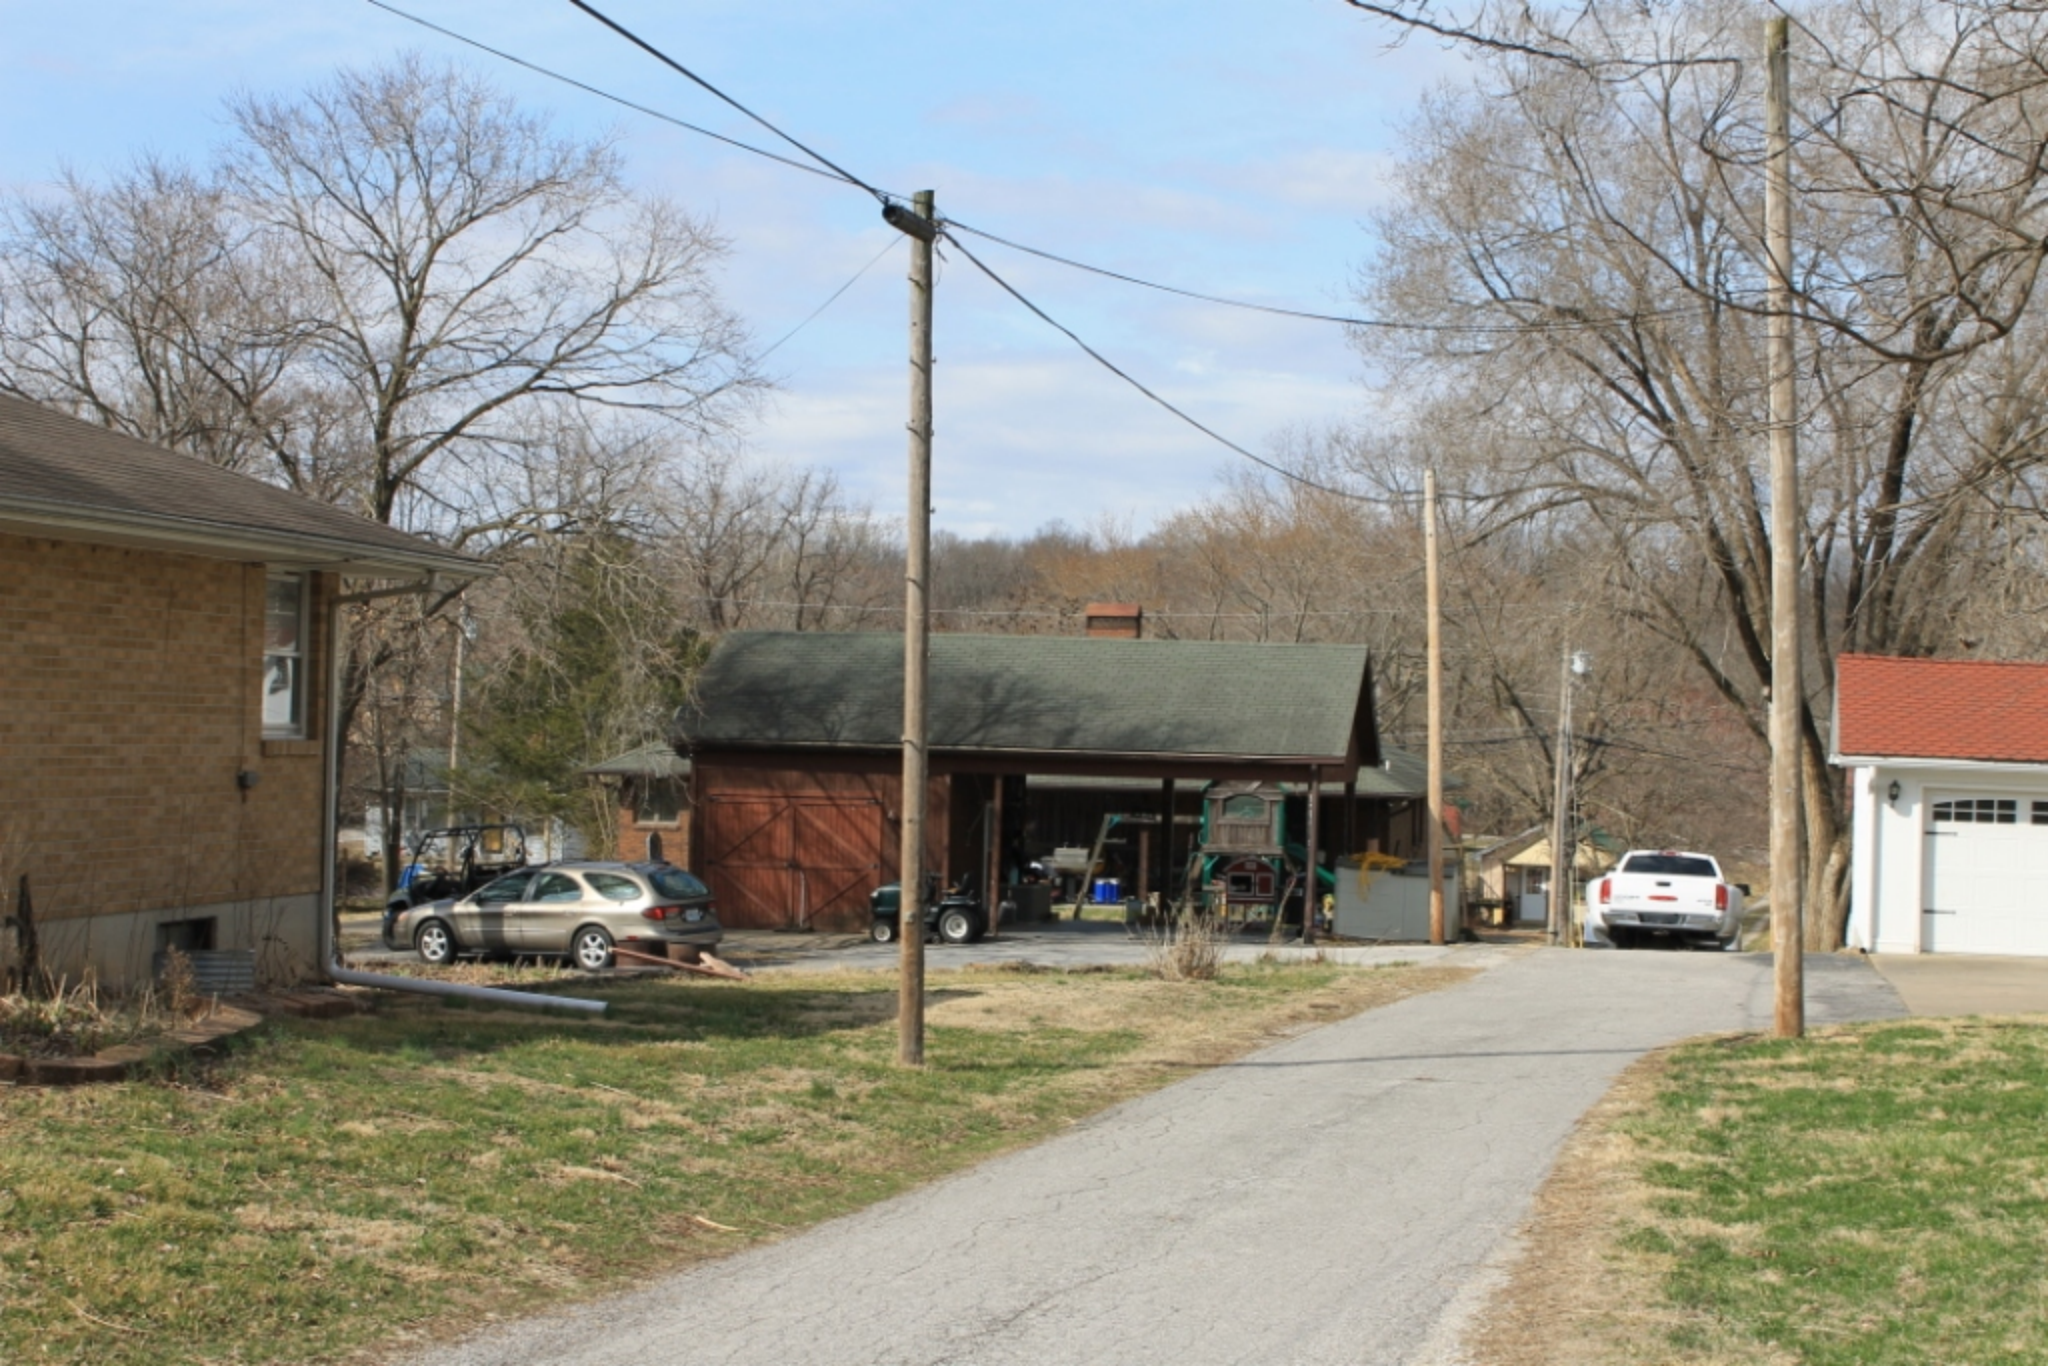
This massed plan, split level brick house has a ground level basement that houses a garage and faces west on Columbia Street. The wing containing the garage has a hipped roof; the south facing wing of the house that opens onto the higher ground lever entrance also has a hipped roof. The south facing wing of the house projects to the south from the rear portion of the garage wing. A narrow shed roof overhangs the two bays in the garage. The left most bay contains an overhead garage door; the right bay contains a walk out door with a nine paned window. The west facade of the main level of the house has three bays. The two left bays, which are located on the upper level of the garage wing, each contain a pair of eight paned sliding glass windows. The right bay, which is located on the south facing wing, contains a set of three twelve fixed paned sliding glass windows.

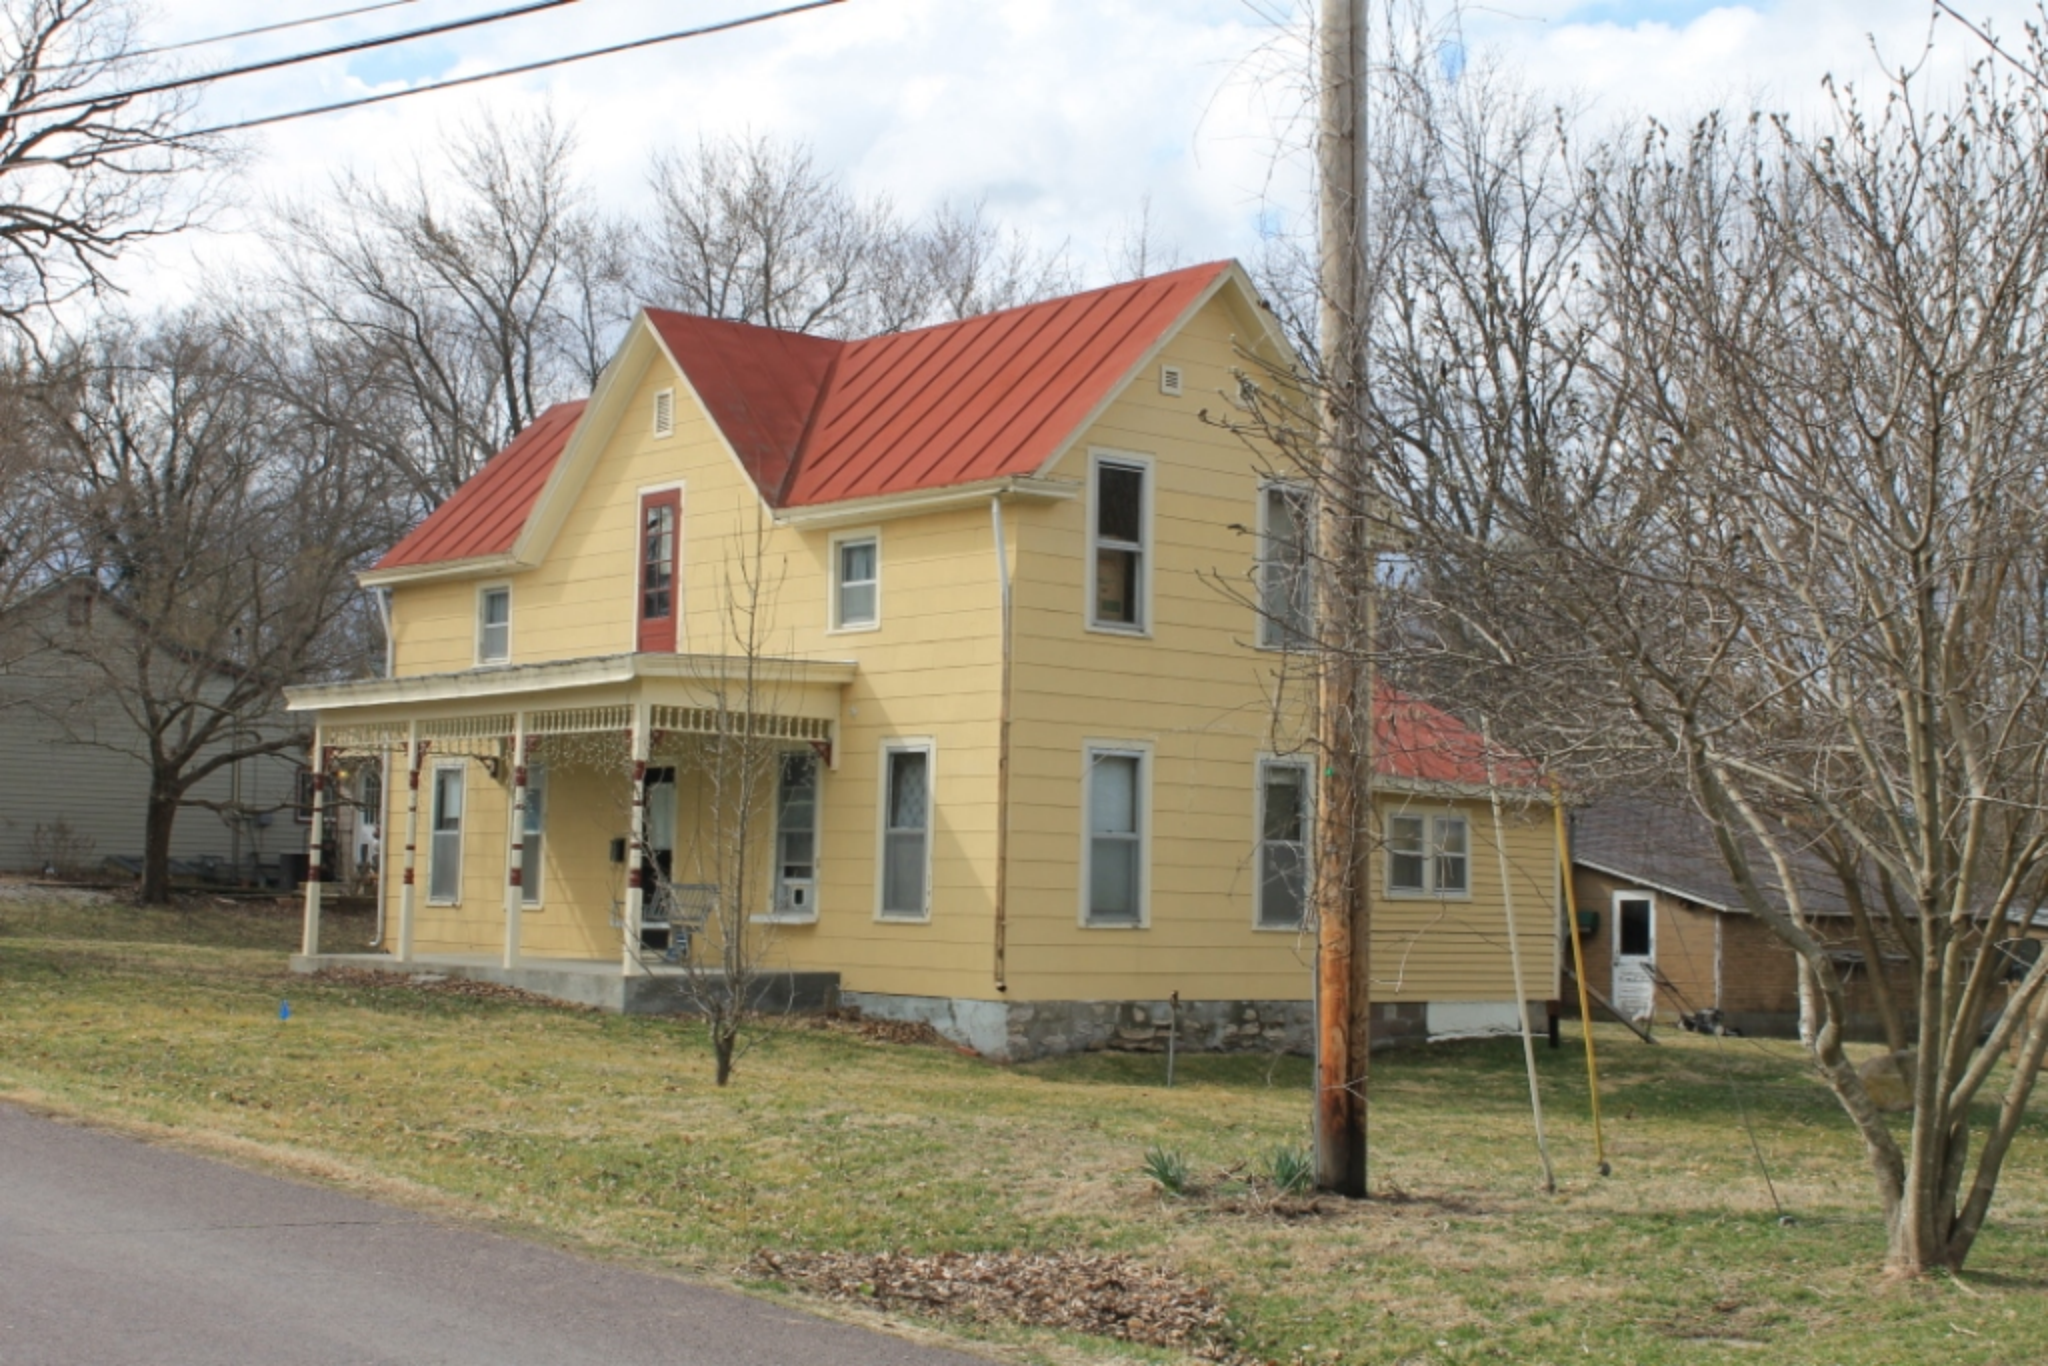
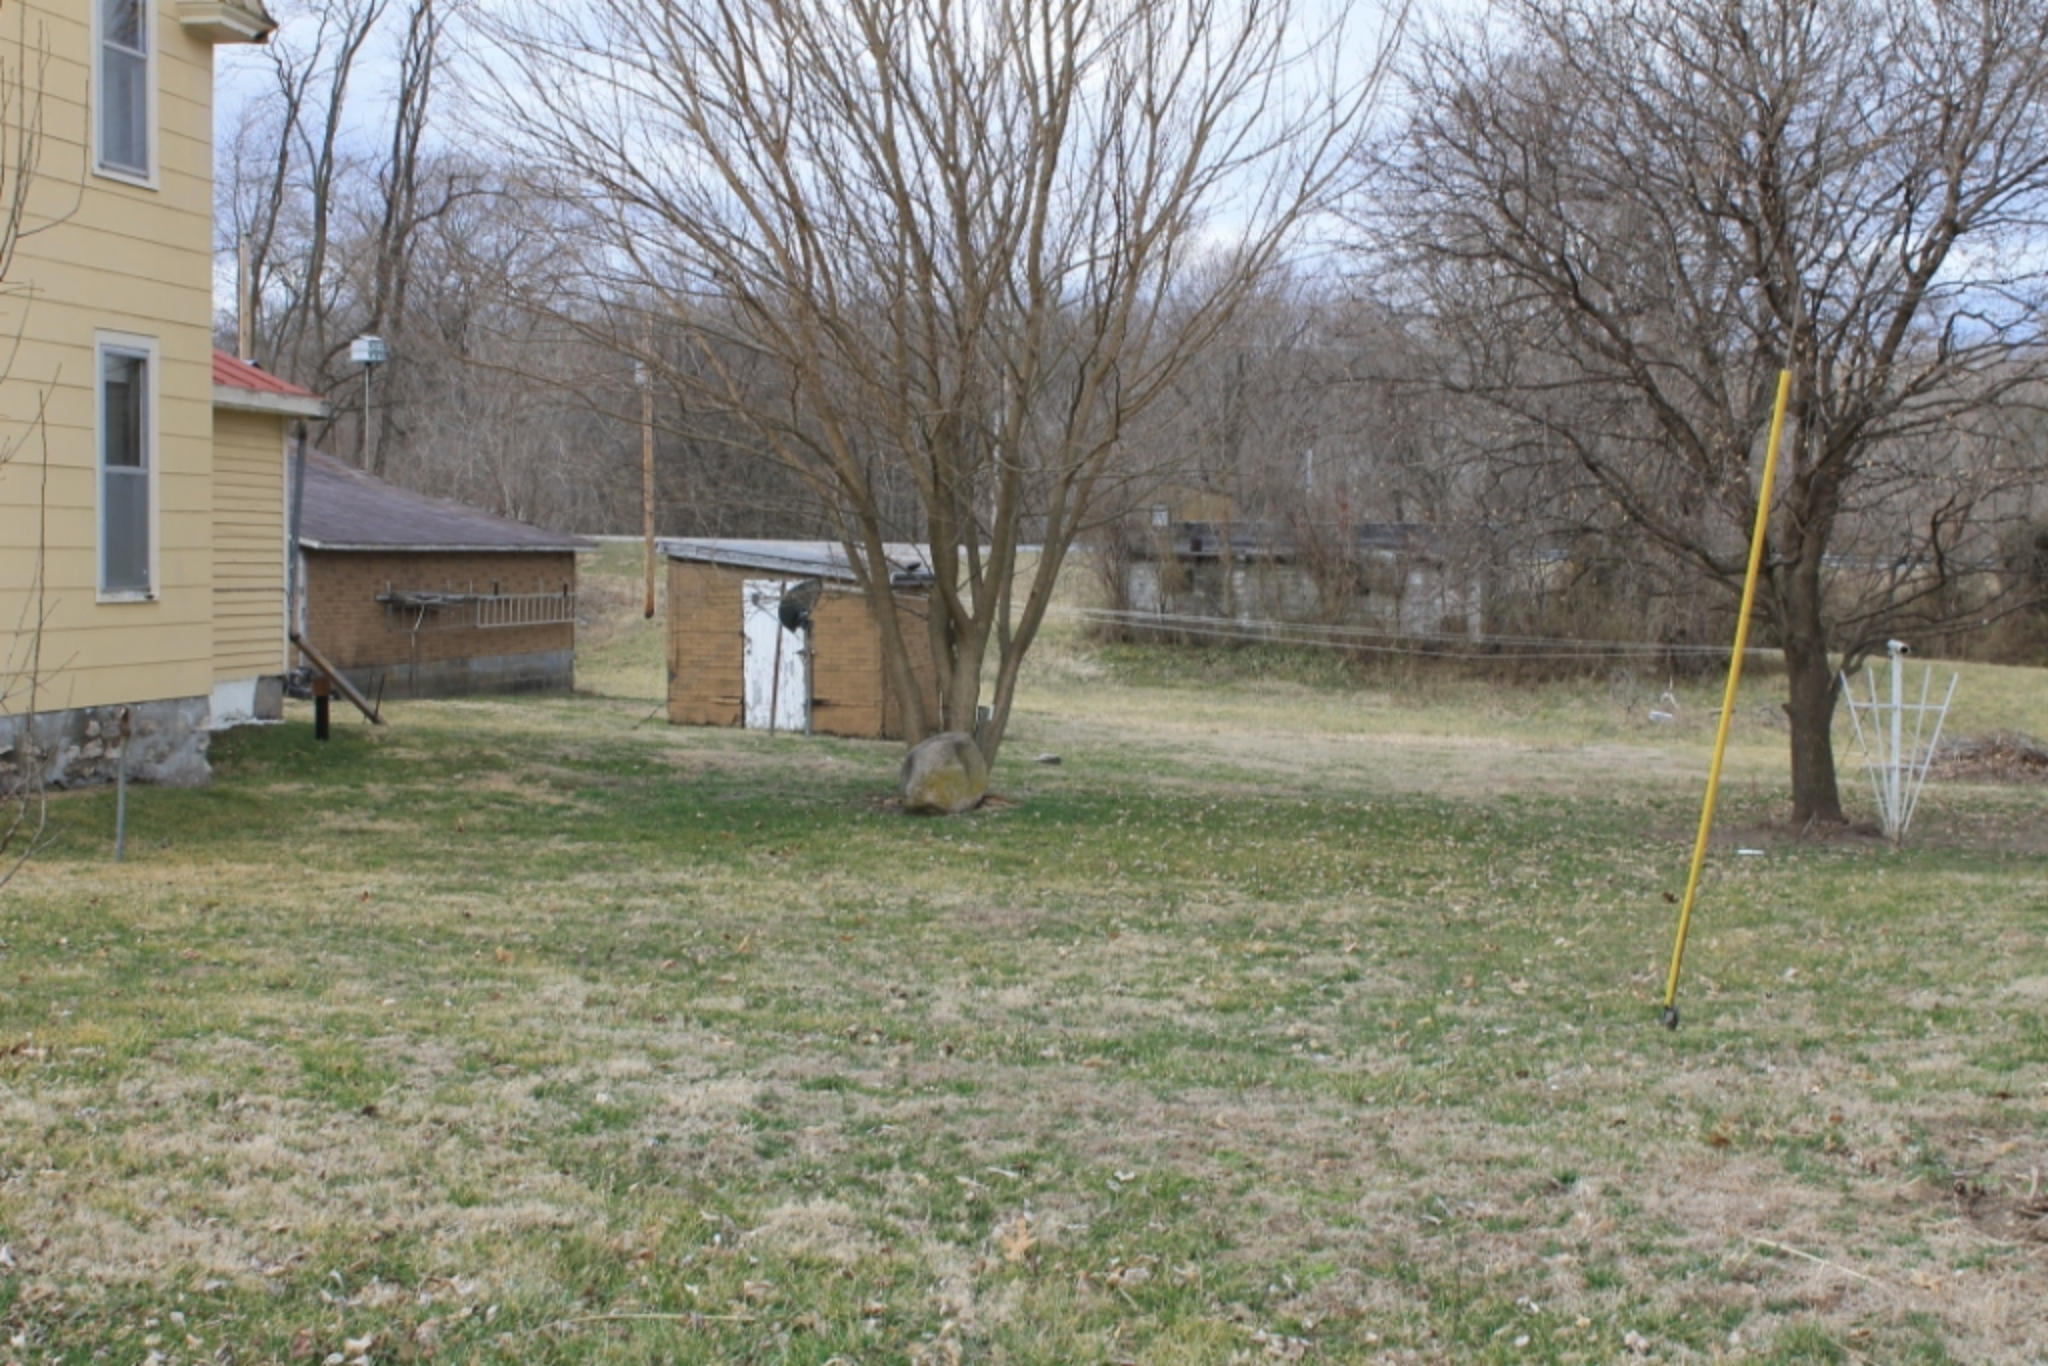
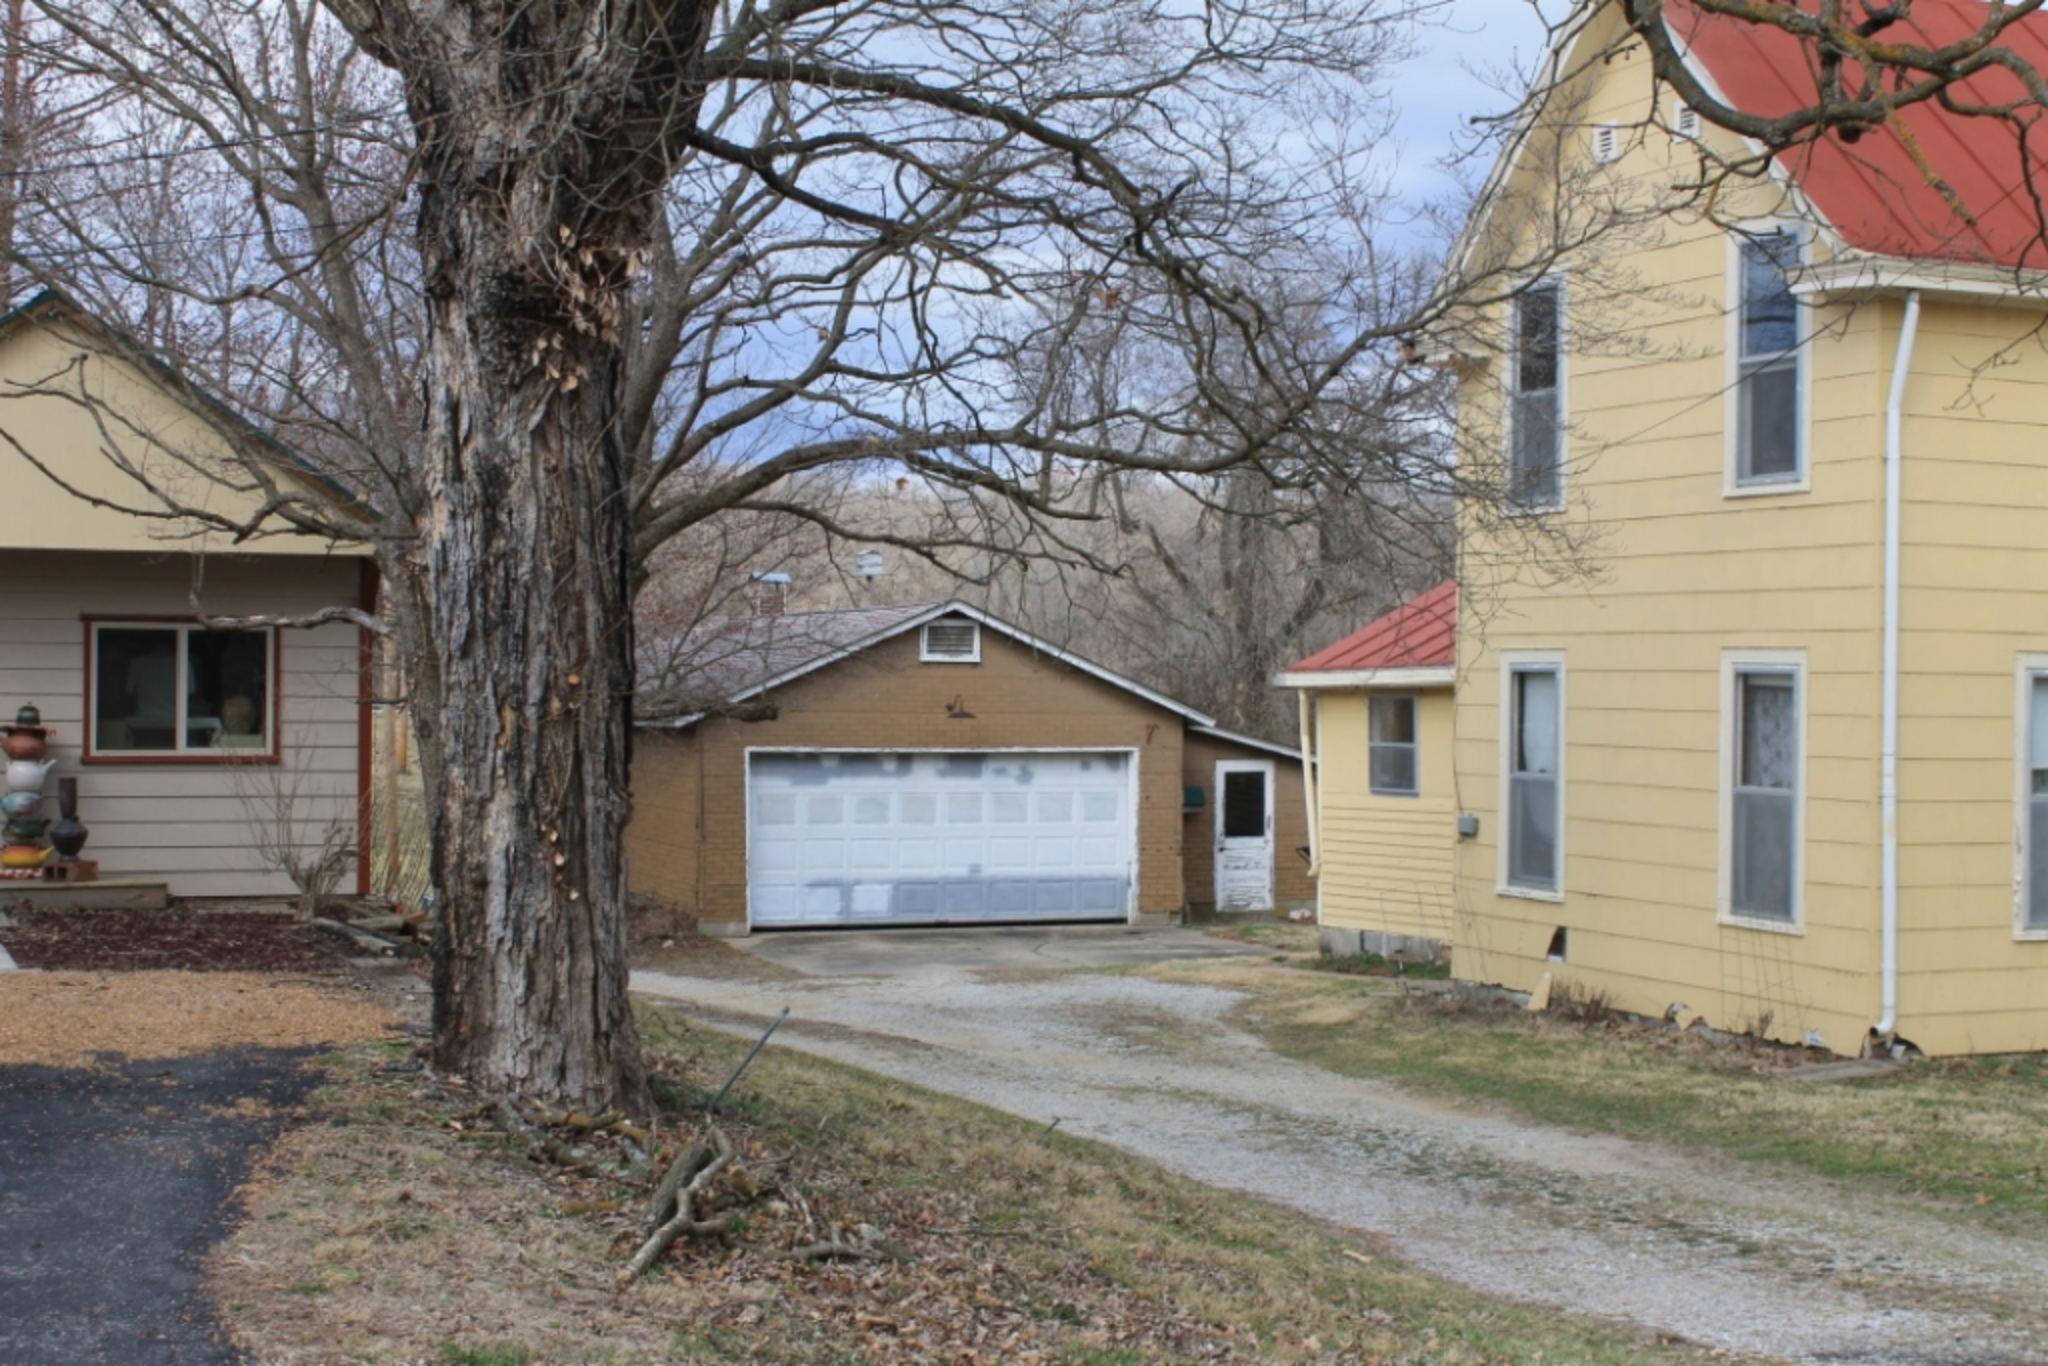
This two-story building is a high central gable I-house with a metal roof. The house is clad in asbestos shingles. The house has a flat roofed porch that spans much of the first story; the porch is supported by turned posts and decorated with spandrels with turned spindlework. The first story of the front (east) facade has five bays. The two left bays each contain one-over-one single hung windows. The center bay contains a door. The two right bays each contain a one-over-one single hung window. The second story of the front facade has three bays. The left bay contains a small one-over-one single hung window. The center bay, which is under the gable, contains a door, suggesting that a balcony once occupied the porch roof. The right bay contains a small one-over-one single hung window. The north facade of the first story of the main block of the house has three bays. The two left bays, which are in the main block of the house, each contain a one-over-one single hung windows. The right bay, which is in the rear projecting wing, contains a pair of small one-over-one single hung windows.
