MISSOURI DEPARTMENT OF NATURAL RESOURCES
STATE HISTORIC PRESERVATION OFFICE, P.O. Box 176, Jefferson City, MO 65102
ARCHITECTURAL/HISTORIC INVENTORY FORM

1. SURVEY NO. BO-AS-009-0001		2. SURVEY NAME: Rocheport Historic District	
3. COUNTY: Boone		4. ADDRESS (STREET NO.)	STREET (NAME) Katy Trail
5. CITY: Rocheport	VICINITY: <input checked="" type="checkbox"/>	6. UTM: / /	LAT: LONG: T: 48W R: 15W S: 1

8. HISTORIC NAME (IF KNOWN): M.K.&T. Railroad tunnel		9. PRESENT/OTHER NAME (IF KNOWN): Katy trail tunnel	
10. OWNERSHIP: <input type="checkbox"/> PRIVATE <input checked="" type="checkbox"/> PUBLIC		11A. HISTORIC USE (IF KNOWN): railroad tunnel	11B. CURRENT USE: Katy Trail tunnel
HISTORICAL INFORMATION

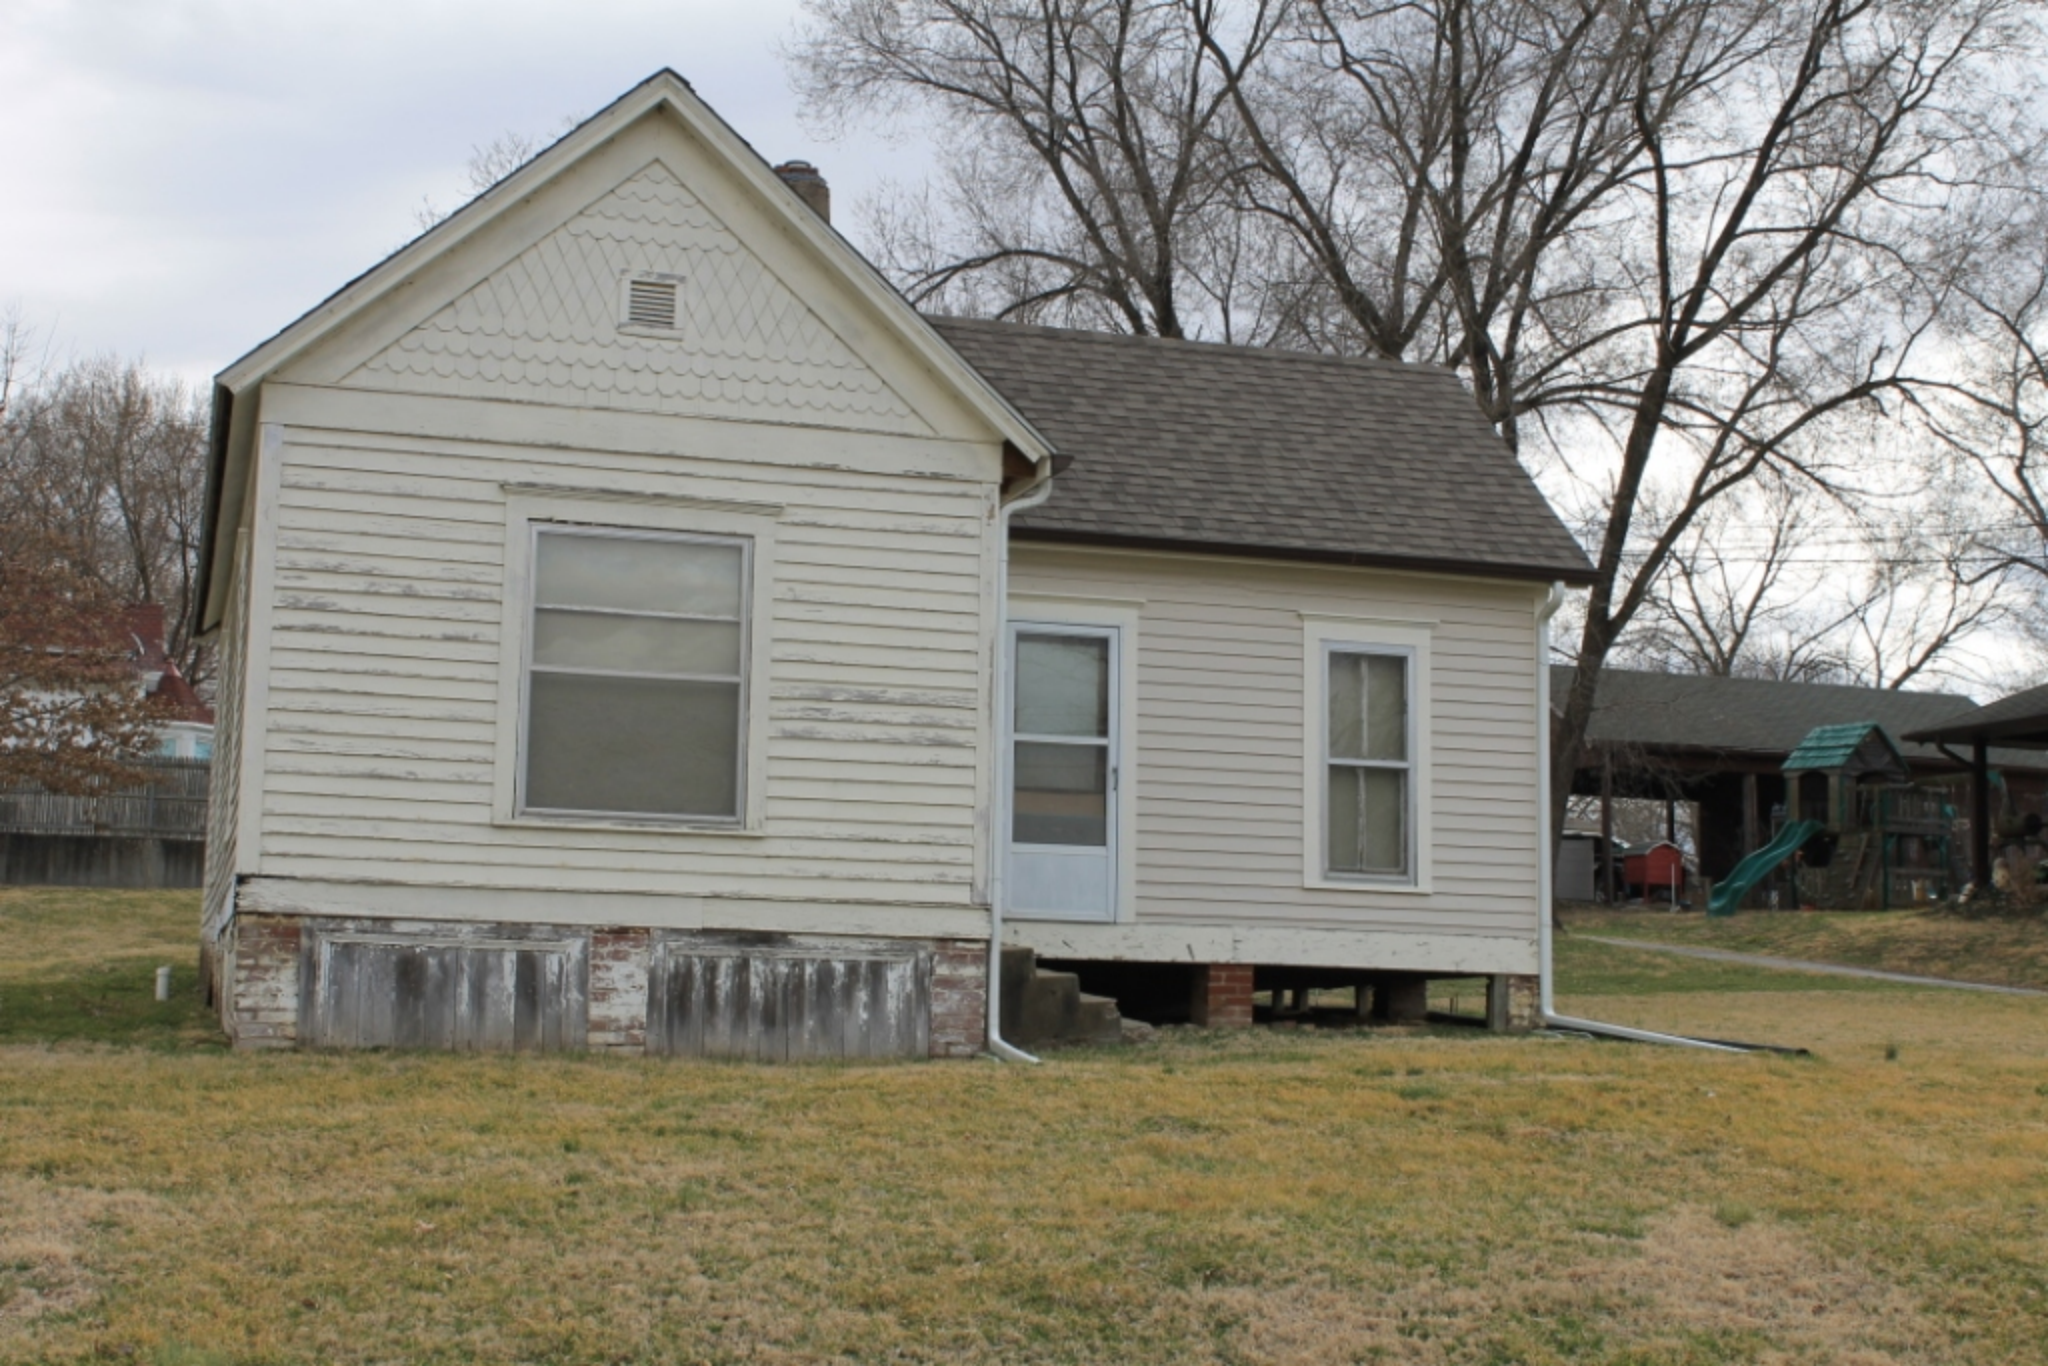
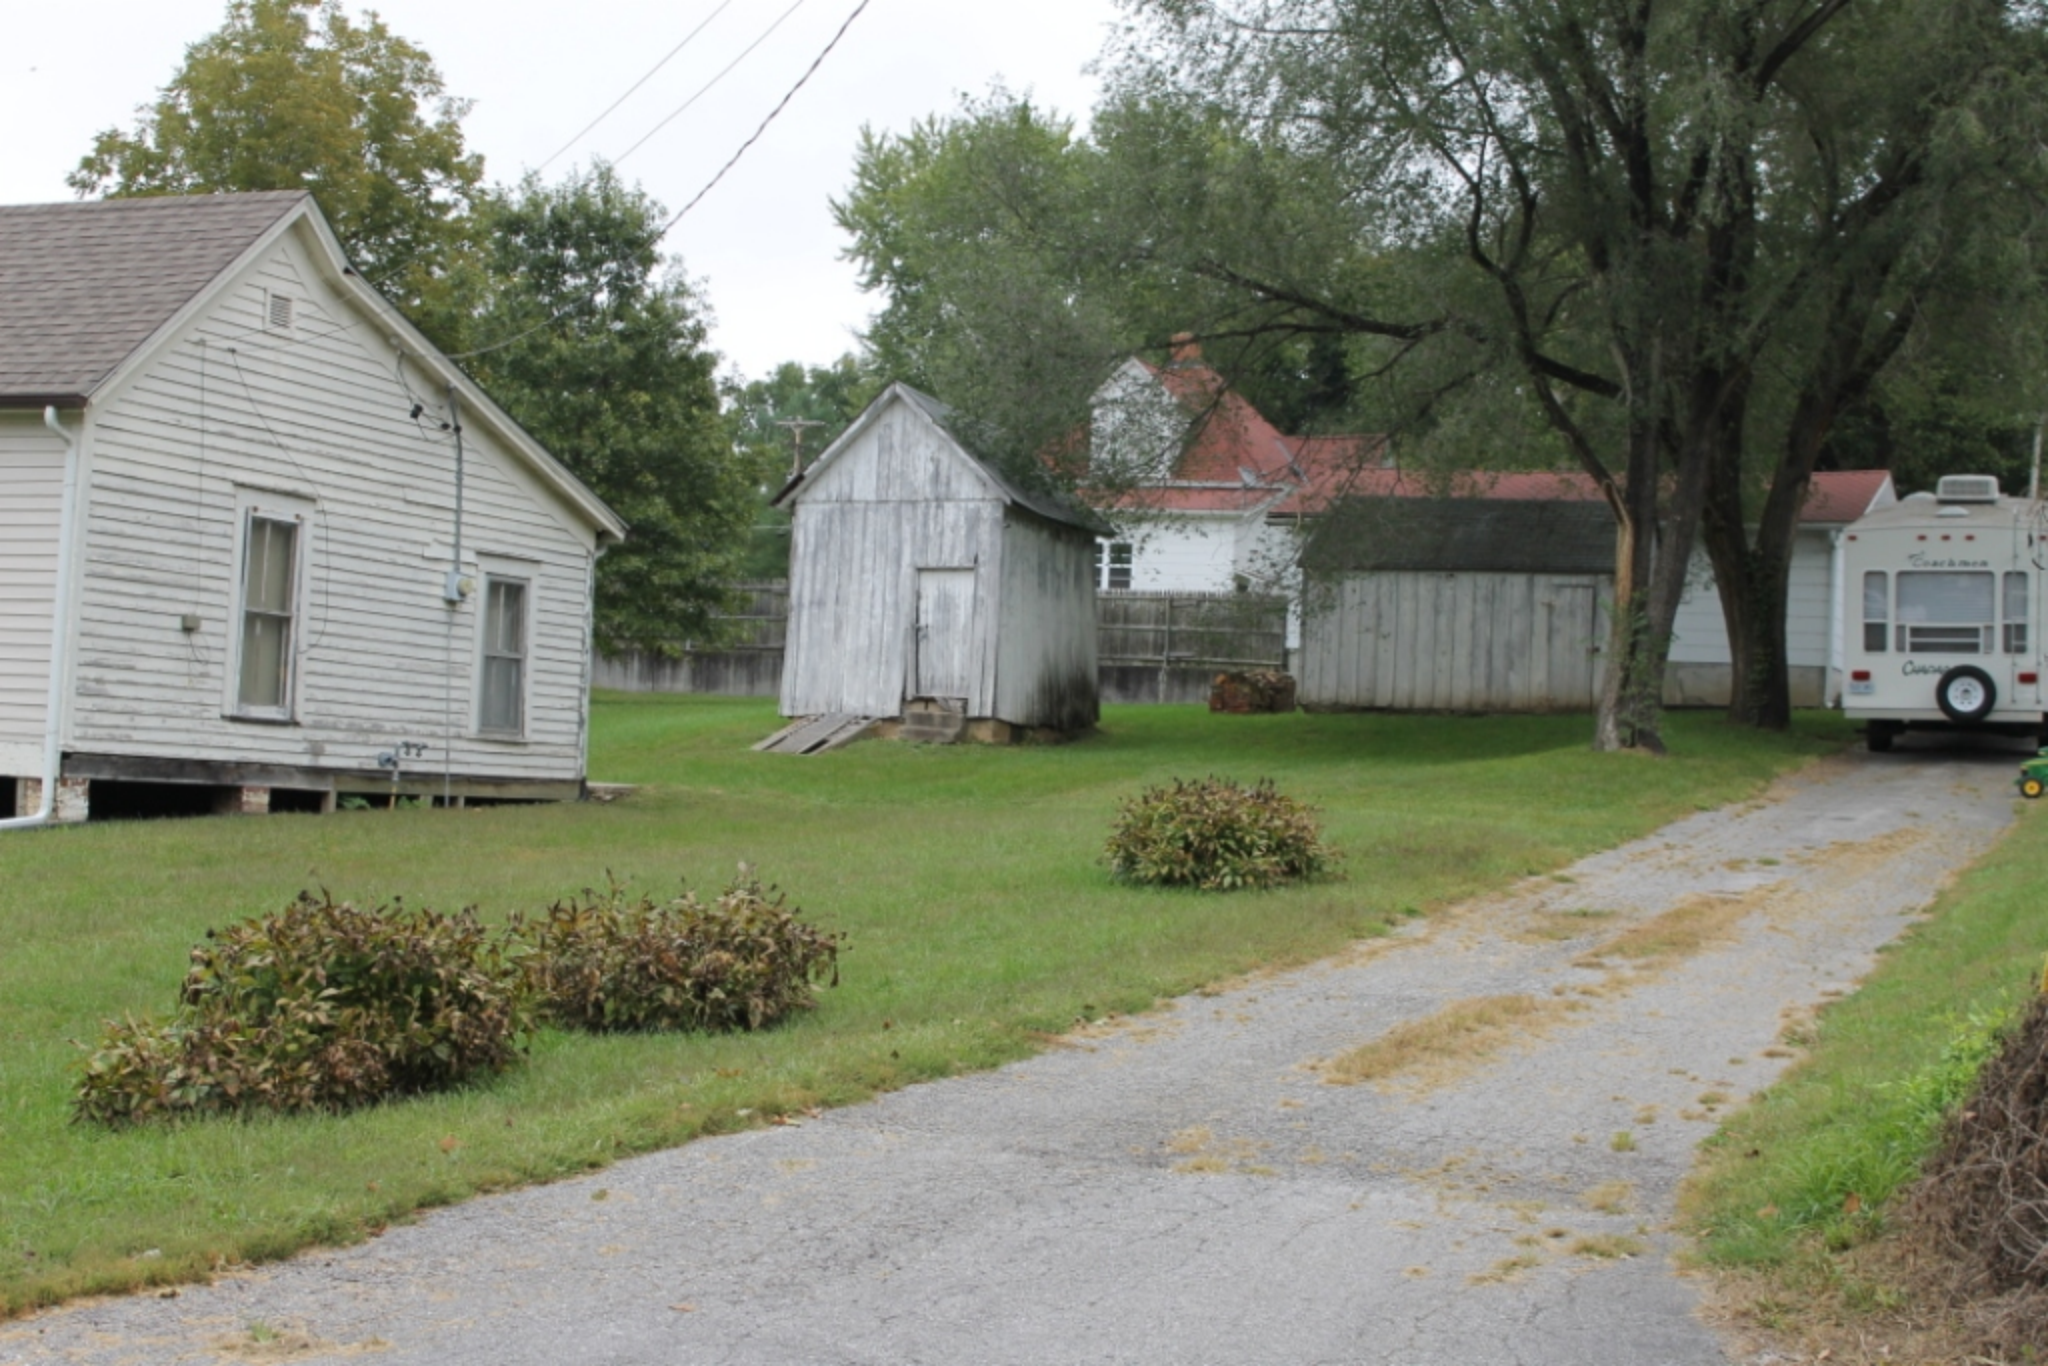
This building, although in poor condition, is significant under CRITERION C: ARCHITECTURE as an example of Folk Victorian gable and wing cottage built c.1900. In 1976 at the time of the Rocheport Historic District nomination, the building had Folk Victorian spandrels with turned spindlework and sawn brackets on the porch, but the entire porch is now missing. The building retains the decorative shingles in the front facing gable--three rows of fishlap shingles, four rows of diamond cut shingles, and three rows of fishlap shingles. The house was once occupied by the Robert Rapp family.

This one-story, massed plan gable and wing, frame cottage is clad in clapboards. The cross gable roof is covered in asphalt shingles. The building sits on brick piers rather than a foundation. The front (west) facing pedimented gable is clad in an interesting pattern of three bands of fishlap shingles topped by four bands of diamond shaped shingles topped with three bands of fishlap shingles. The front (west) facade of the house has three bays. The left bay, which is under the west facing gable, contains a large one-over-one wooden window with drip molding at the top. This window's muntins are not evenly spaced; the top portion of the window is much smaller than the bottom; this configuration suggests that at one time the upper window might have contained decorative glass, either stained or beveled. The next bay, which is on the south facing wing, contains a paneled wooden door with a fixed pane window in the top; the door is now covered with a modern metal and glass storm door. The rightmost bay contains a two-over-two single hung wooden window. A flat roofed porch once sat at the point where the two wings of the house meet. The porch has been demolished and replaced by a set of pre-formed modern concrete steps. The steps lead to a second door located on the south side of the west facing wing. The house is in poor condition.

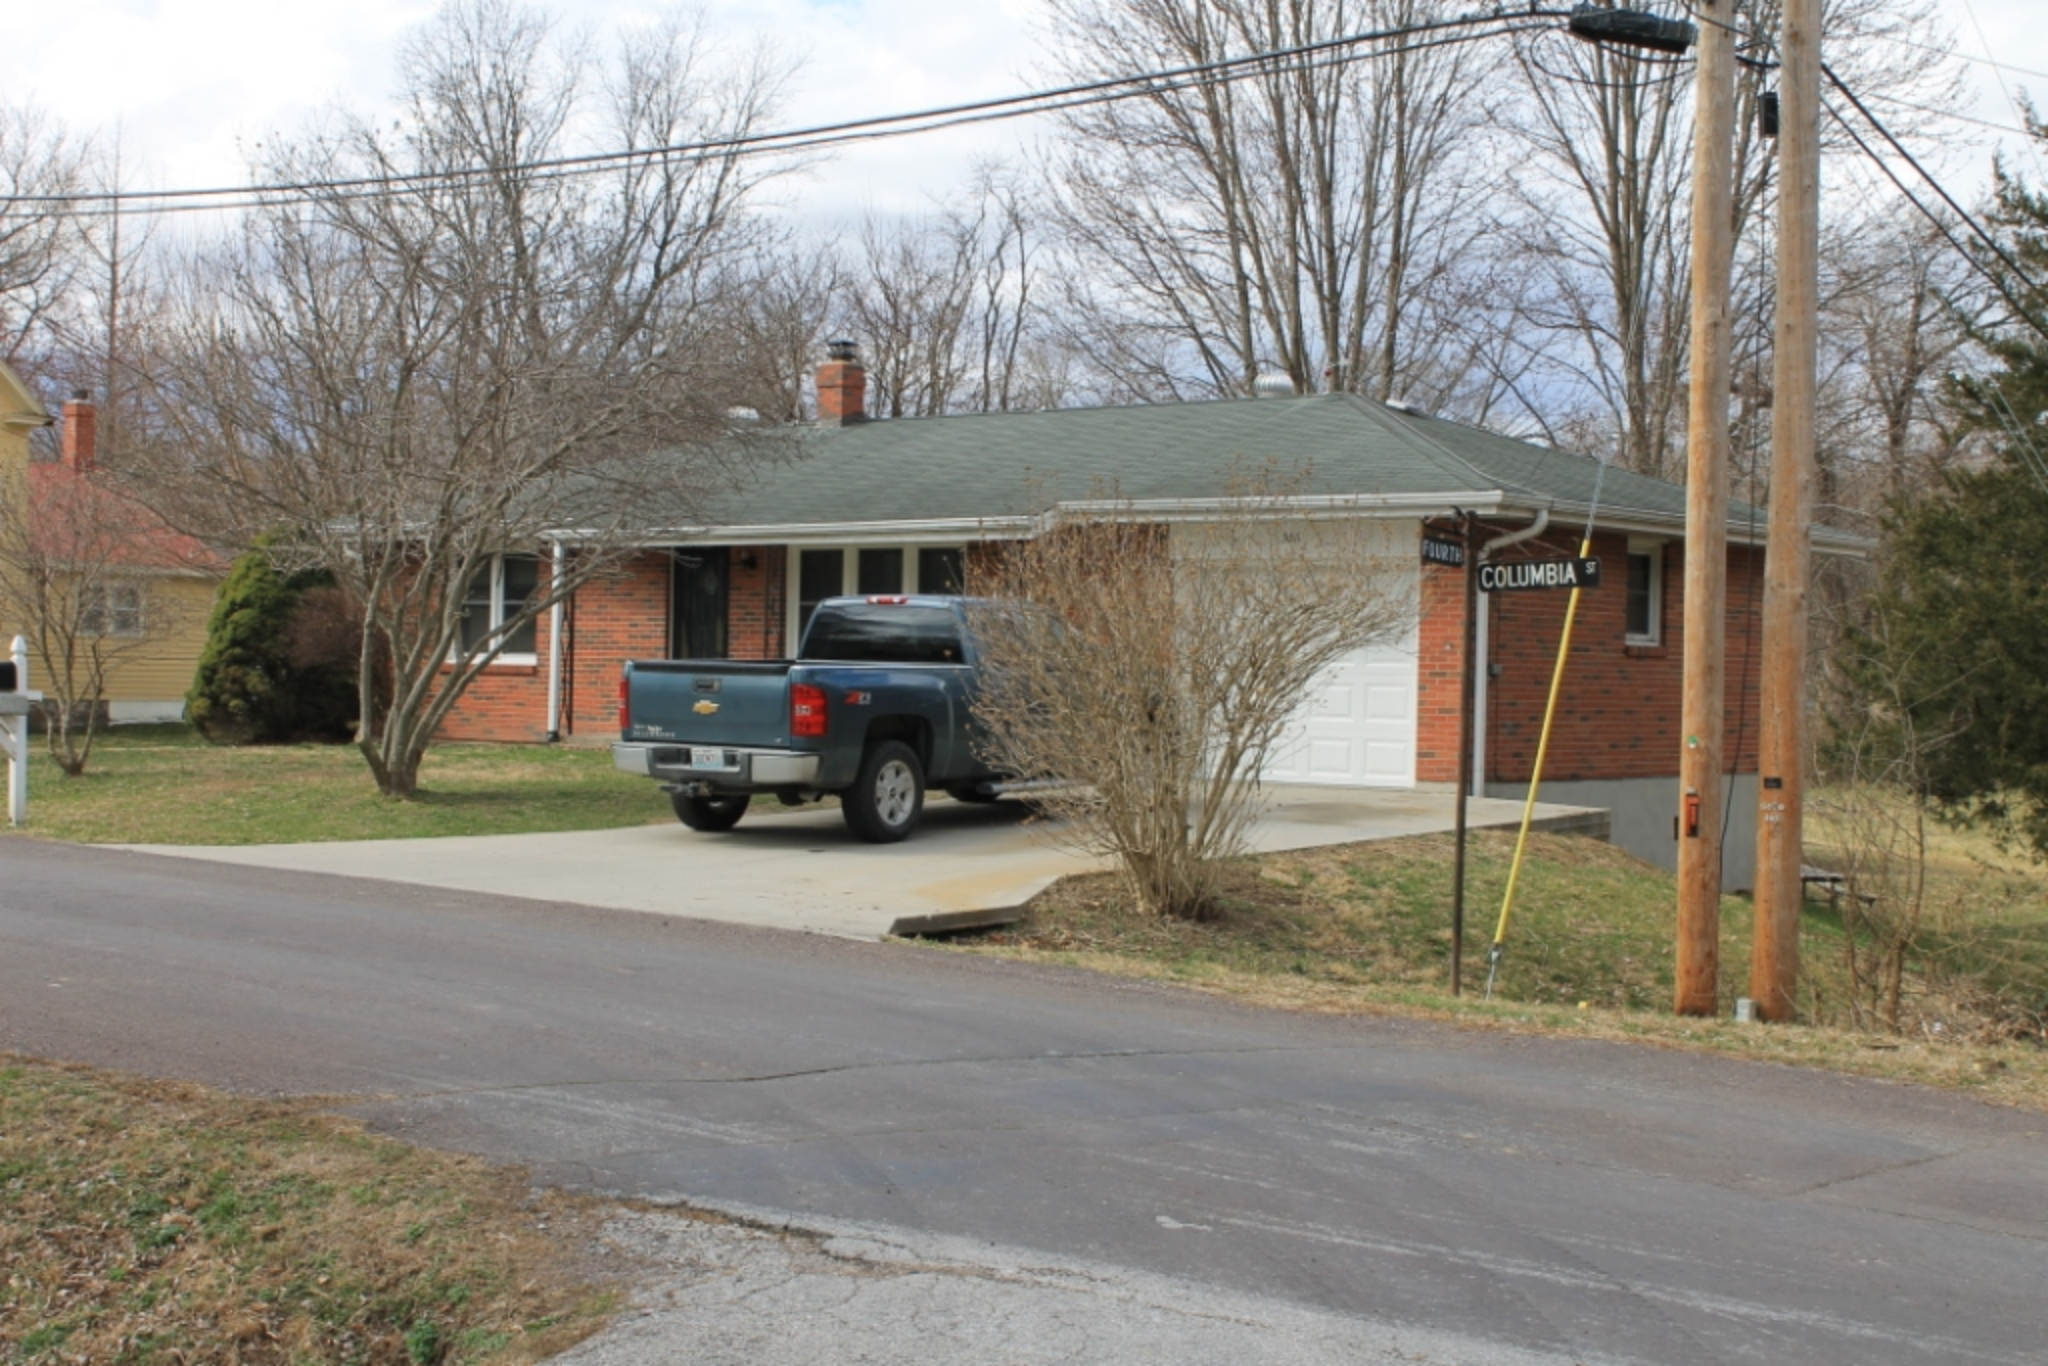
This one-story, massed plan pyramidal, ranch house is clad in red bricks and has a low hipped roof covered in asphalt shingles. The front of the house has four bays. To the left is a bay containing a pair of one-over-one single hung windows. The next bay contains a door. The next bay contains a set of three one-over-one single hung windows. The rightmost bay contains an overhead garage door. A porch extends from the left edge of the garage to the left of the door. A chimney sits on the ridge somewhat to the left of center.

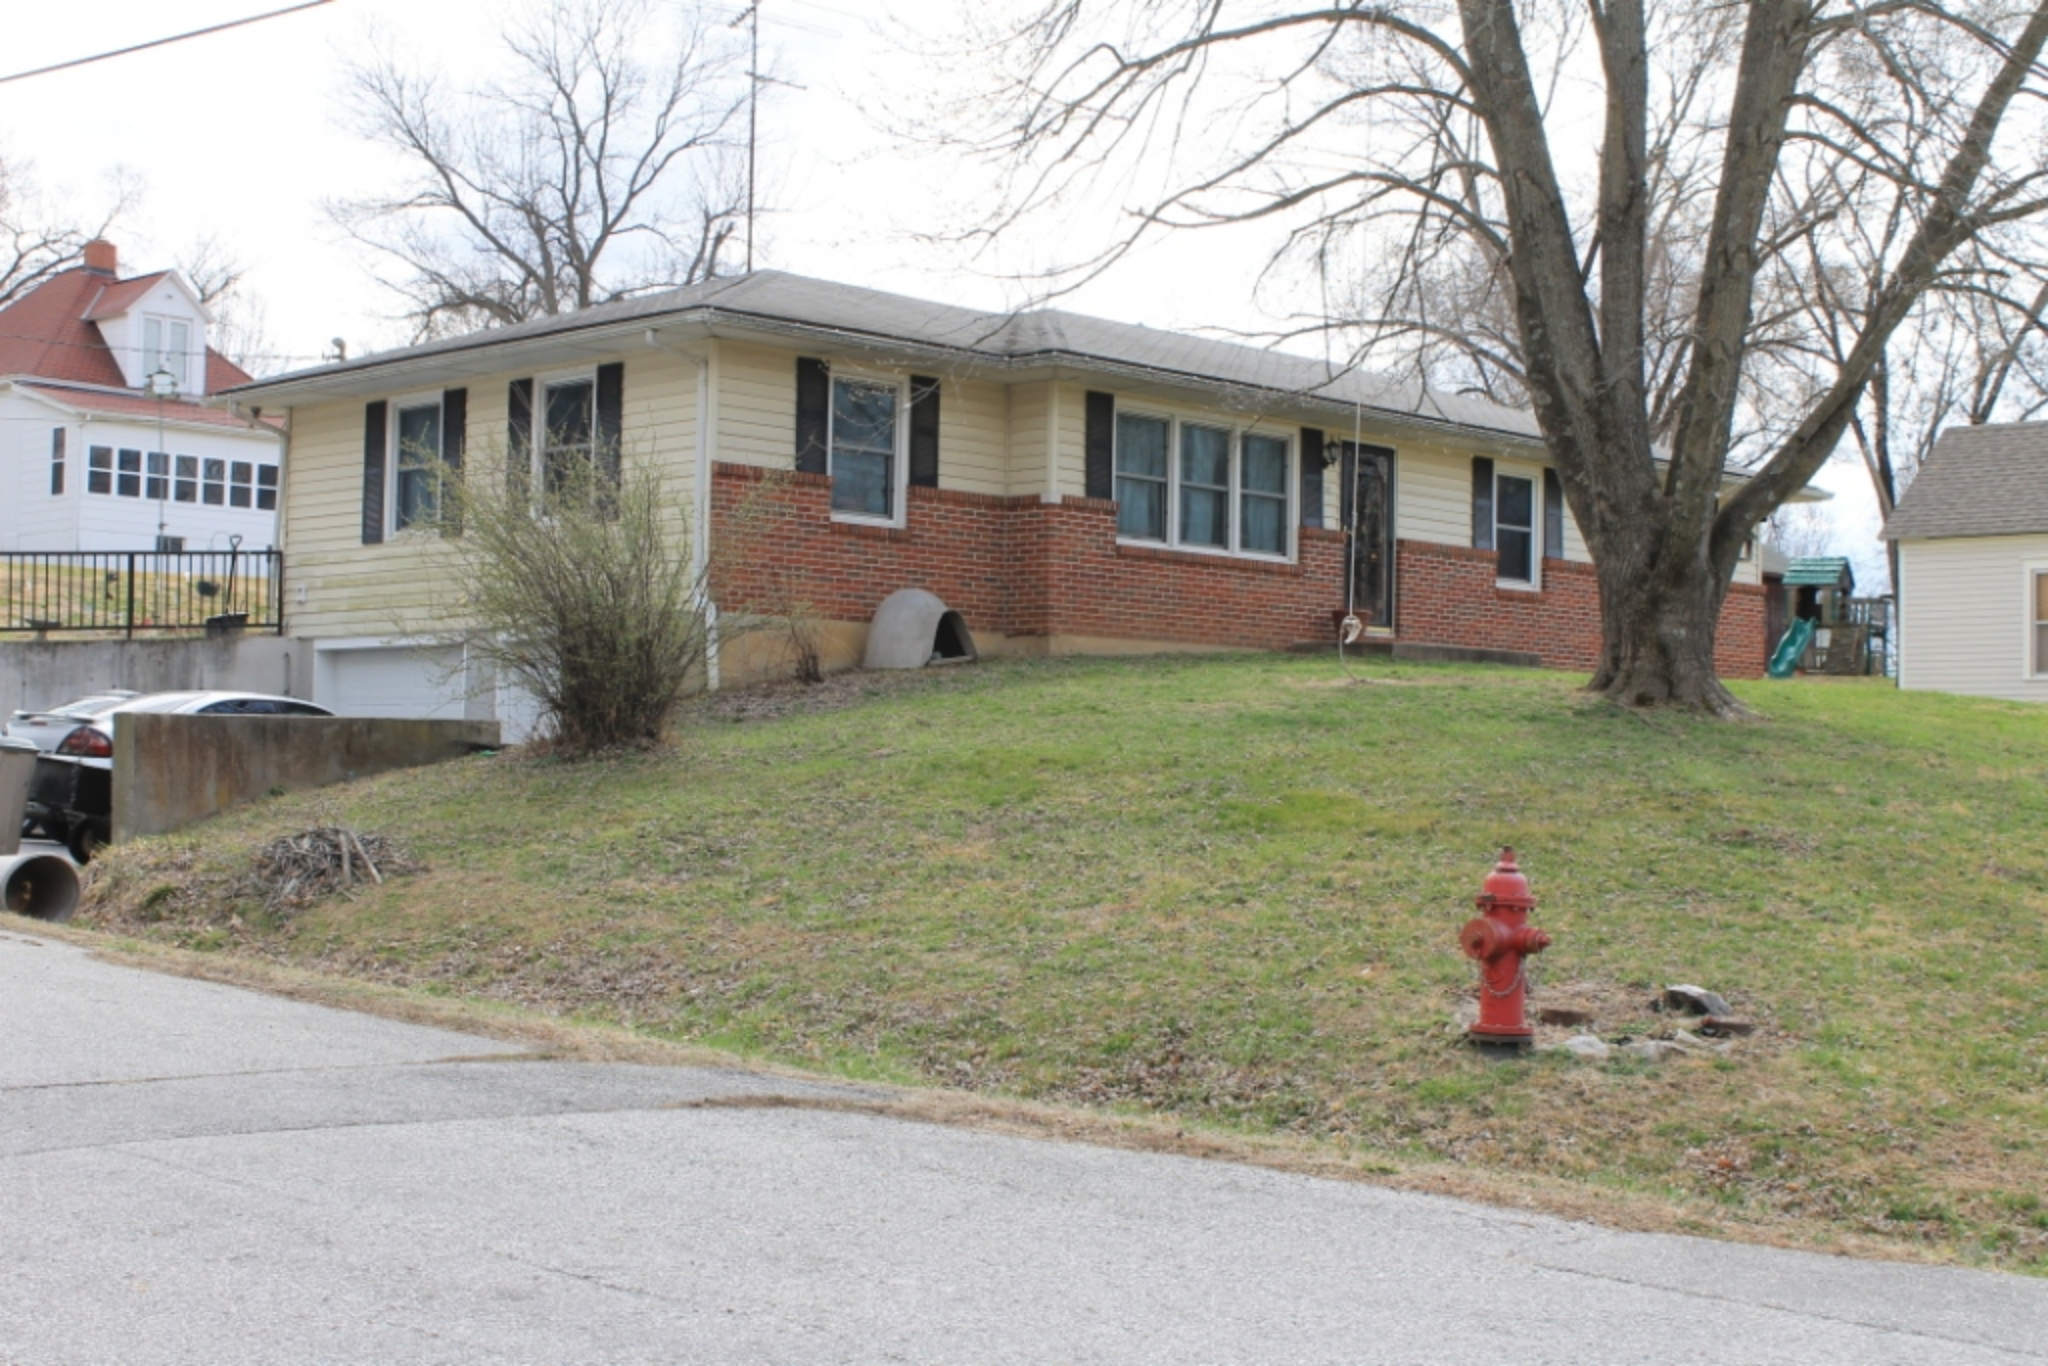
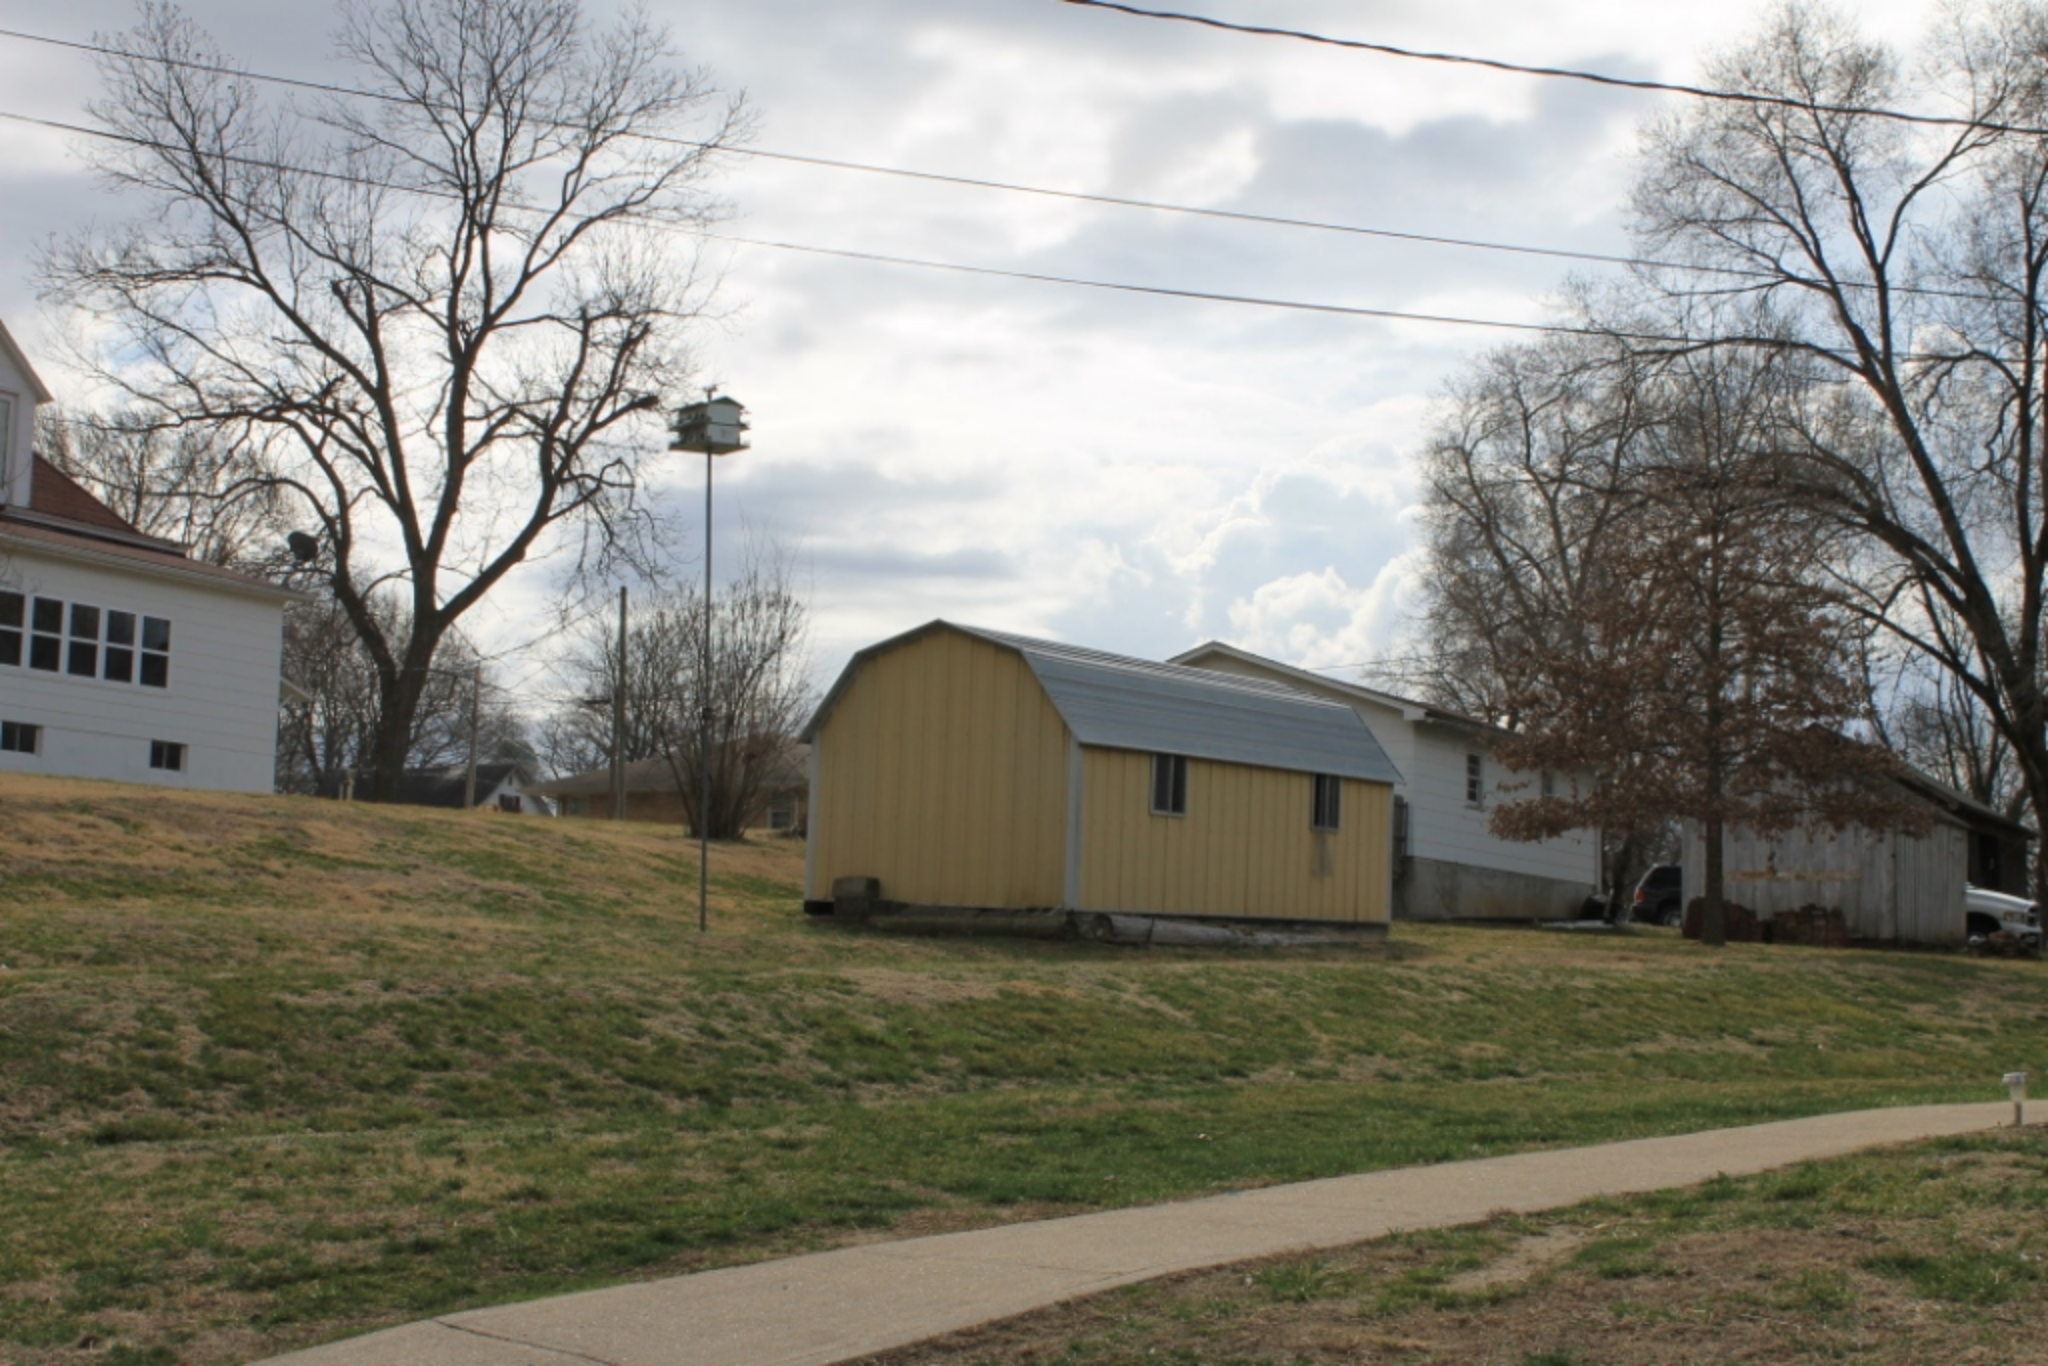
This one story, massed plan side gable, frame ranch house sits on a basement that contains a garage. The building has a low hipped roof. A portion of the front (west) facade of the house protrudes to the west beyond the rest of the house. This portion of the house also has a hipped roof. The bottom half of the front facade is covered in brick that extends above the bottom of the windows; the remainder of the front facade and the other facades of the house are clad in vinyl siding. The roof is covered in asphalt shingles. The front facade of the house has five bays. The left most bay contains a one-over-one single hung window. The next bay, which is located in the protruding portion of the west facade contains three one-over-one single hung windows. The next bay, also located in the protruding portion, contains a door with a modern glass and metal storm door. The next bay, also in the protruding portion, contains a one-over-one single hung window. The rightmost bay, also in the protruding portion, contains a one-over-one single hung window. The windows have decorative shutters that extend from the top of the windows to the top of the brick cladding.

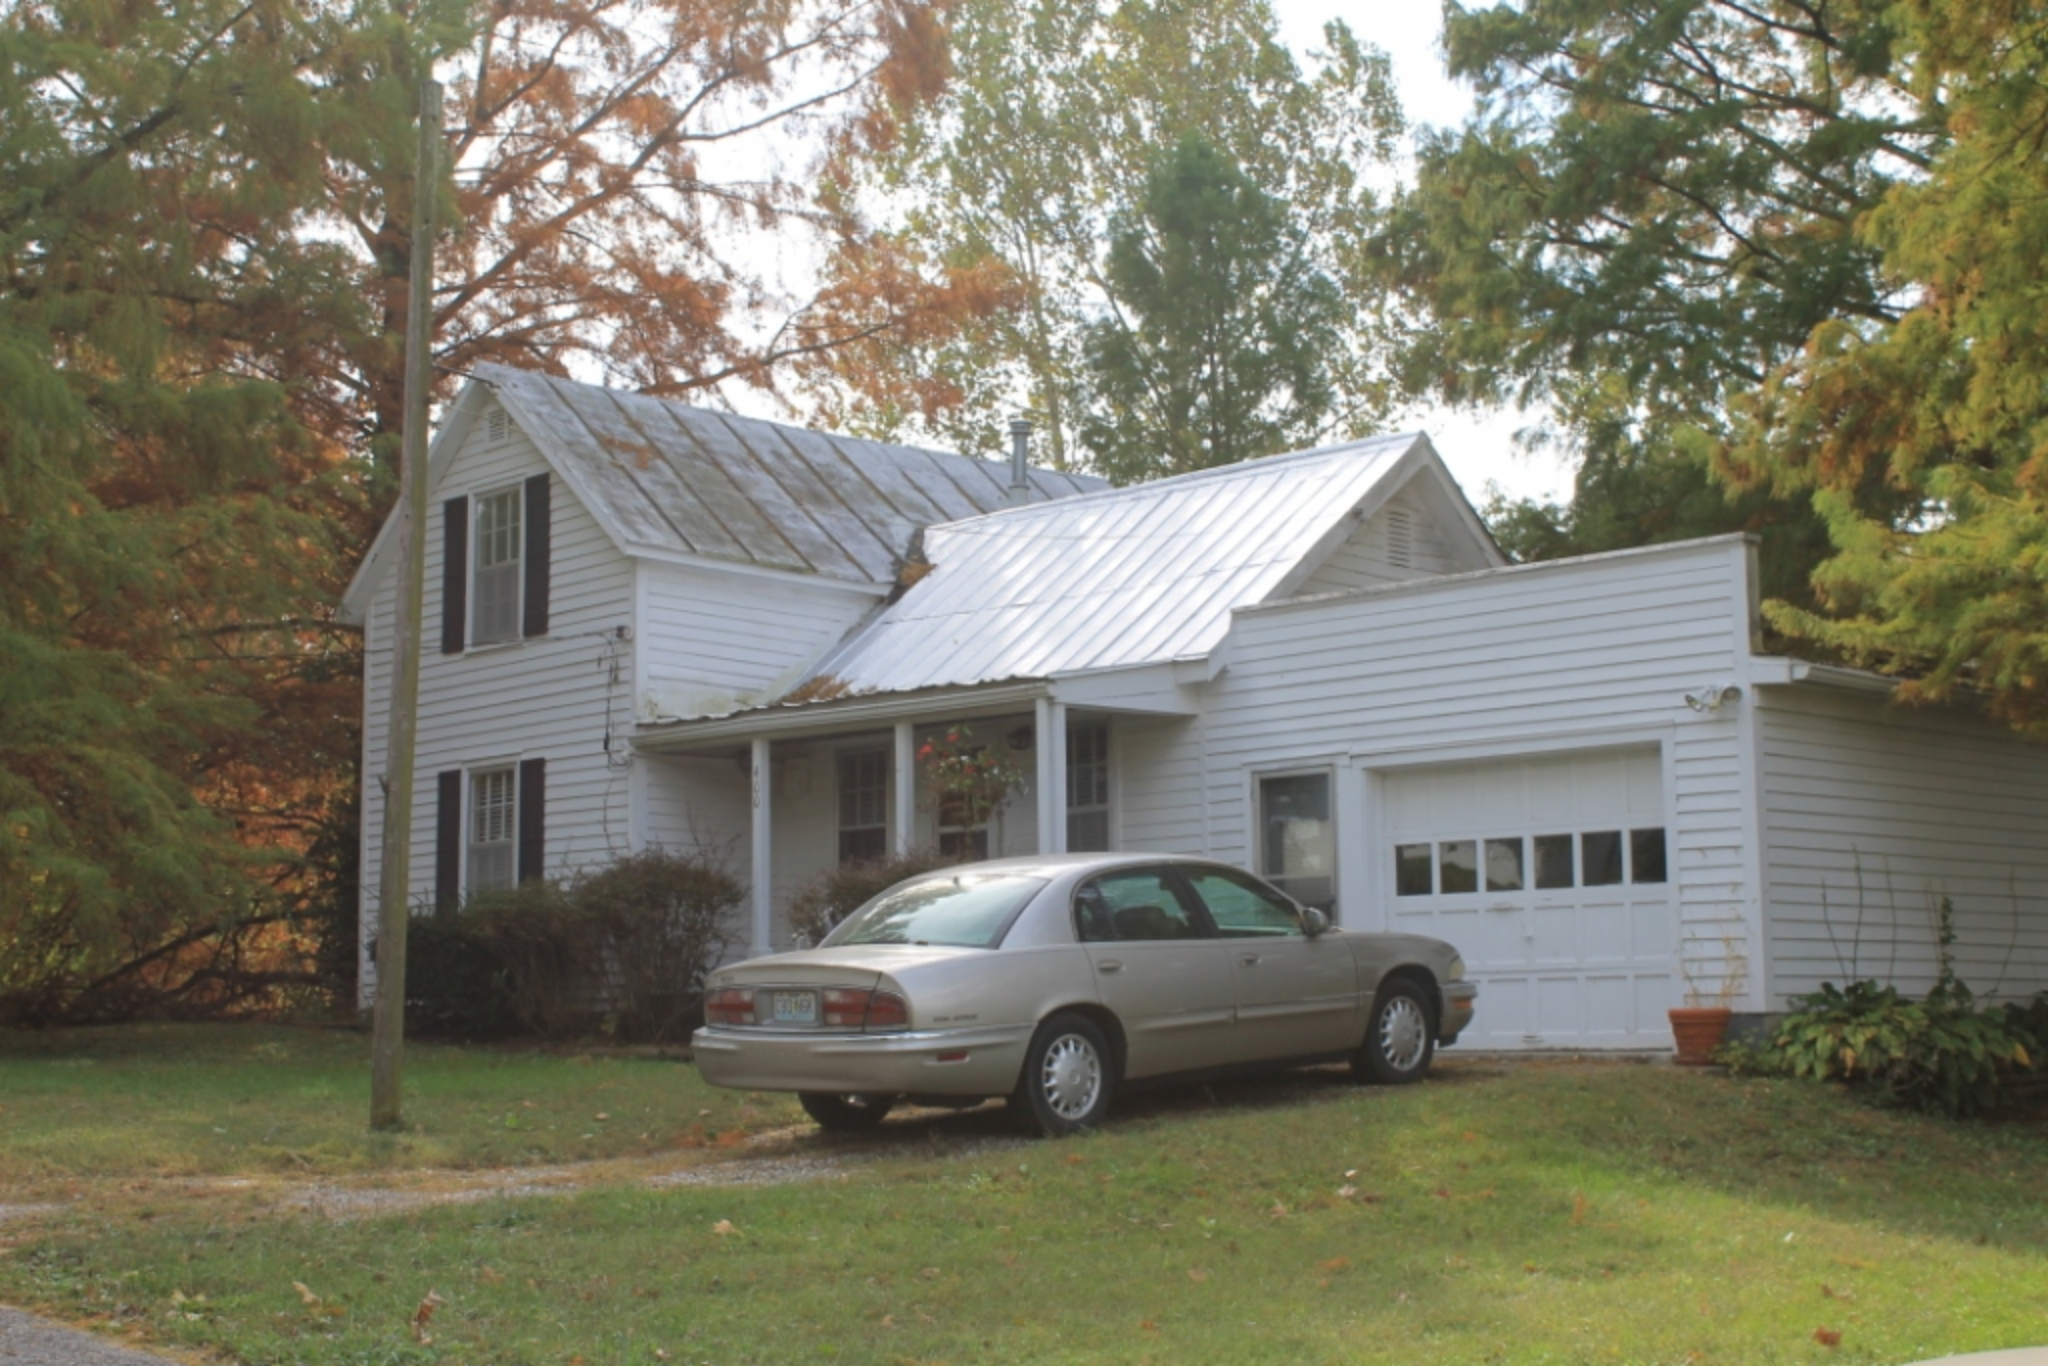
This 1 1/2 story, massed plan gable and wing house is clad in clapboards; the roof is covered with metal. The south wing of the house has a gable that faces front (east). The north wing of the house has a gable roof that faces north. At the point where the south wing of the house meets the north wing of the house is a shed roofed porch whose roof is an extension of the roof of that wing. To the north of the north facing gable roofed wing is a flat roofed garage. The house has six bays on the front (east) facade. The leftmost bay, which is in the south front facing wing of the house, contains a six-over-one single hung window with decorative shutters. The next bay, which is under the porch, contains a six-over-one single hung window. The next bay, which is also sheltered by the porch, contains a door with a modern half-circle window; the door is covered with a modern glass and metal storm door. The next bay, also under the porch, contains a six-over-one single hung window. The next bay, which is located in the garage, is a walkout door. The rightmost bay, also located in the garage, is a one-car overhead garage door with 5 fixed pane windows. The second story of the south wing has one bay containing a six-over-one single hung window with decorative shutters.

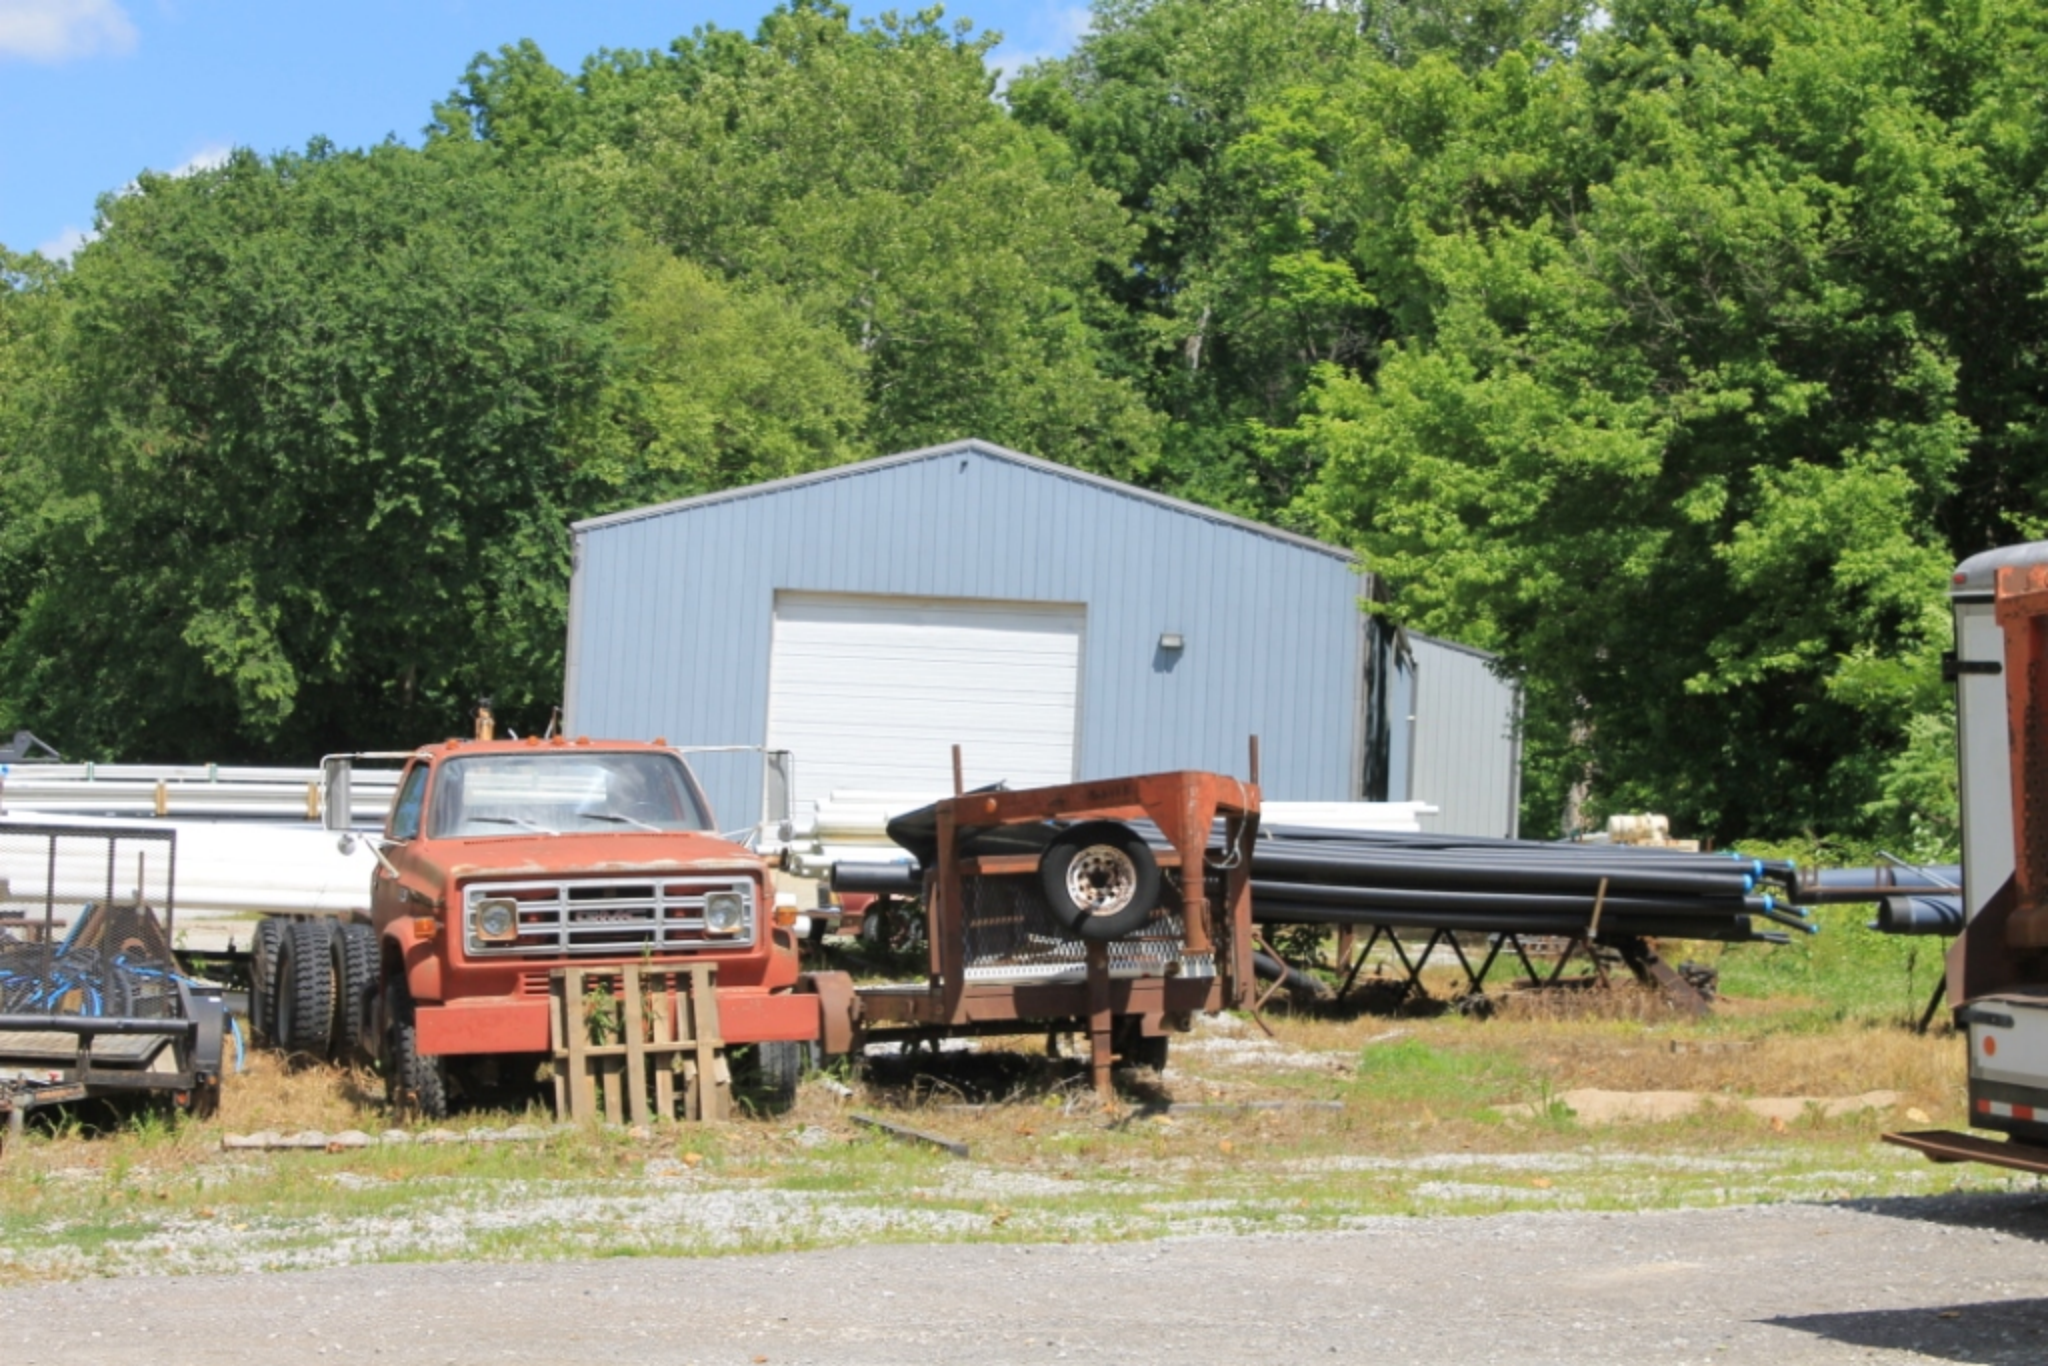
This metal clad, tall, one-story building is clad in metal and has a metal roof. The building has three wings. The west most wing has a gable roof that is somewhat shorter than the center wing. The center wing is also slightly wider than the west most wing. The east most wing has a shed roof and is shorter than the other two wings. The building has one bay on the front (west) facade. The bay contains a large overhead door allowing access to the large trucks and equipment used by the business. The building has two bays on the side (north) facade. Each bay contains an overhead door also allowing access by the large trucks and equipment used by the business.
