MISSOURI DEPARTMENT OF NATURAL RESOURCES
STATE HISTORIC PRESERVATION OFFICE, P.O. Box 176, Jefferson City, MO 65102
ARCHITECTURAL/HISTORIC INVENTORY FORM

1. SURVEY NO. BO-AS-009-0001		2. SURVEY NAME: Rocheport Historic District	
3. COUNTY: Boone		4. ADDRESS (STREET NO.)	STREET (NAME) Katy Trail
5. CITY: Rocheport	VICINITY: <input checked="" type="checkbox"/>	6. UTM: / /	LAT: LONG: T: 48W R: 15W S: 1

8. HISTORIC NAME (IF KNOWN): M.K.&T. Railroad tunnel		9. PRESENT/OTHER NAME (IF KNOWN): Katy trail tunnel	
10. OWNERSHIP: <input type="checkbox"/> PRIVATE <input checked="" type="checkbox"/> PUBLIC		11A. HISTORIC USE (IF KNOWN): railroad tunnel	11B. CURRENT USE: Katy Trail tunnel
HISTORICAL INFORMATION

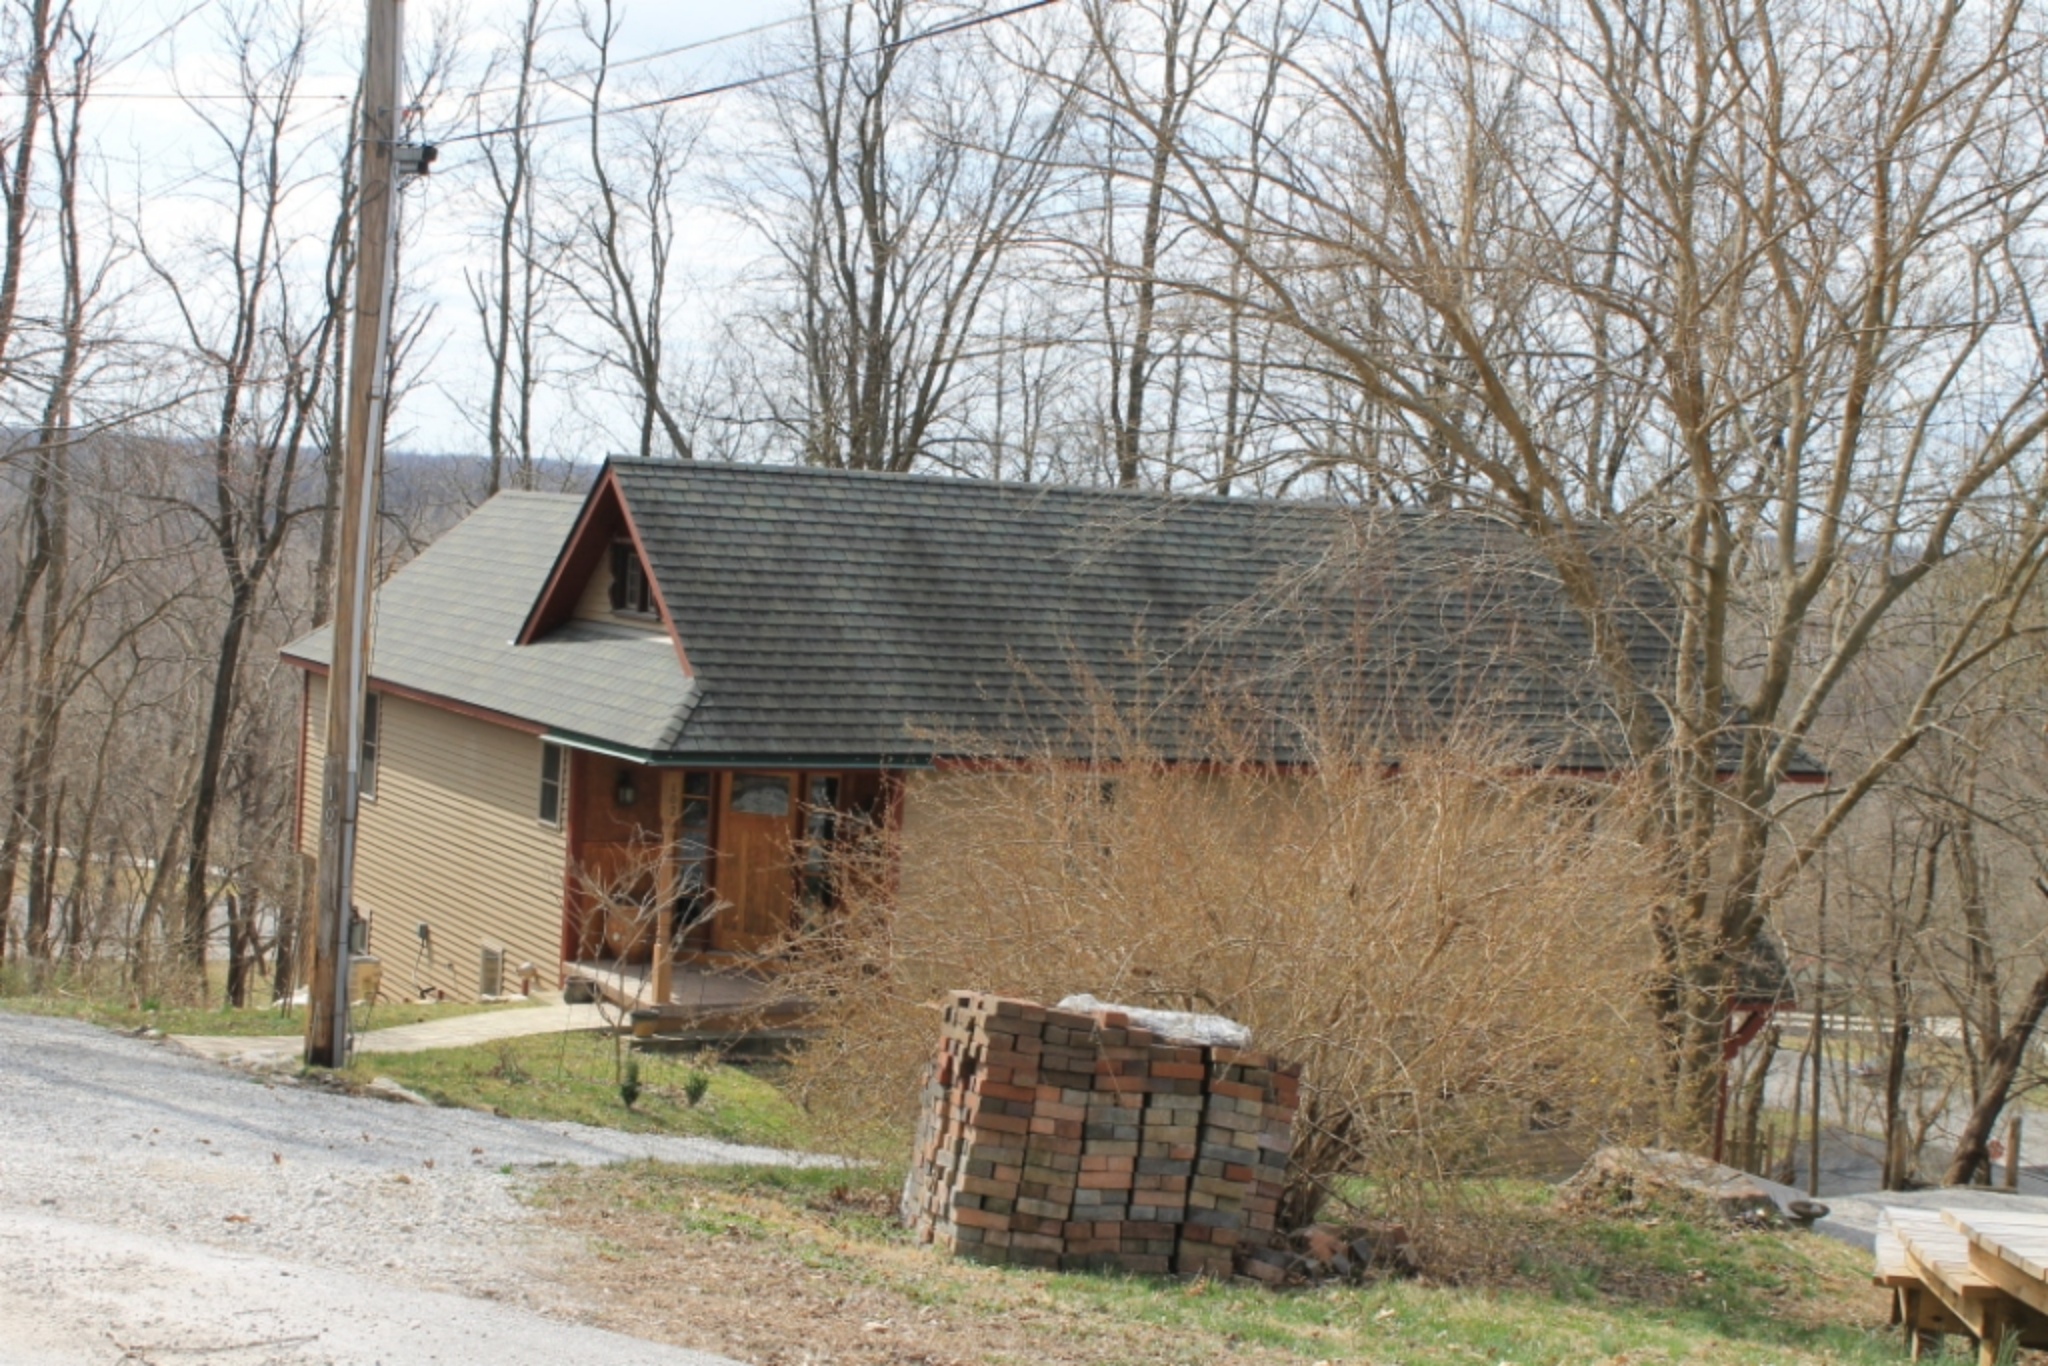
This massed plan house has a cross gable roof. The walls of the house are clad in vinyl siding and the roof is covered in asphalt shingles. It sits on a full raised basement that forms the ground floor. The east end of the roof of the first story of the north (north) facade shades an inset porch. The north facade of the main level has three bays. The left bay contains a one-over-one single hung window. The next bay contains a smaller one-over-one single hung window. The rightmost bay, which is under the porch, contains a door with sidelights. The doorway is set at an angle. The north facade of the ground floor contains two bays. The left bay contains a door. The right bay contains a one-over-one single hung window. The first floor of the east facade has two bays, each containing a one-over-one single hung window. The ground floor of the east facade has two bays. The left bay contains a door; the right bay contains a one-over-one single hung window. The area under the cross gable on the upper story has one bay which contains a pair of one-over-one single hung windows.

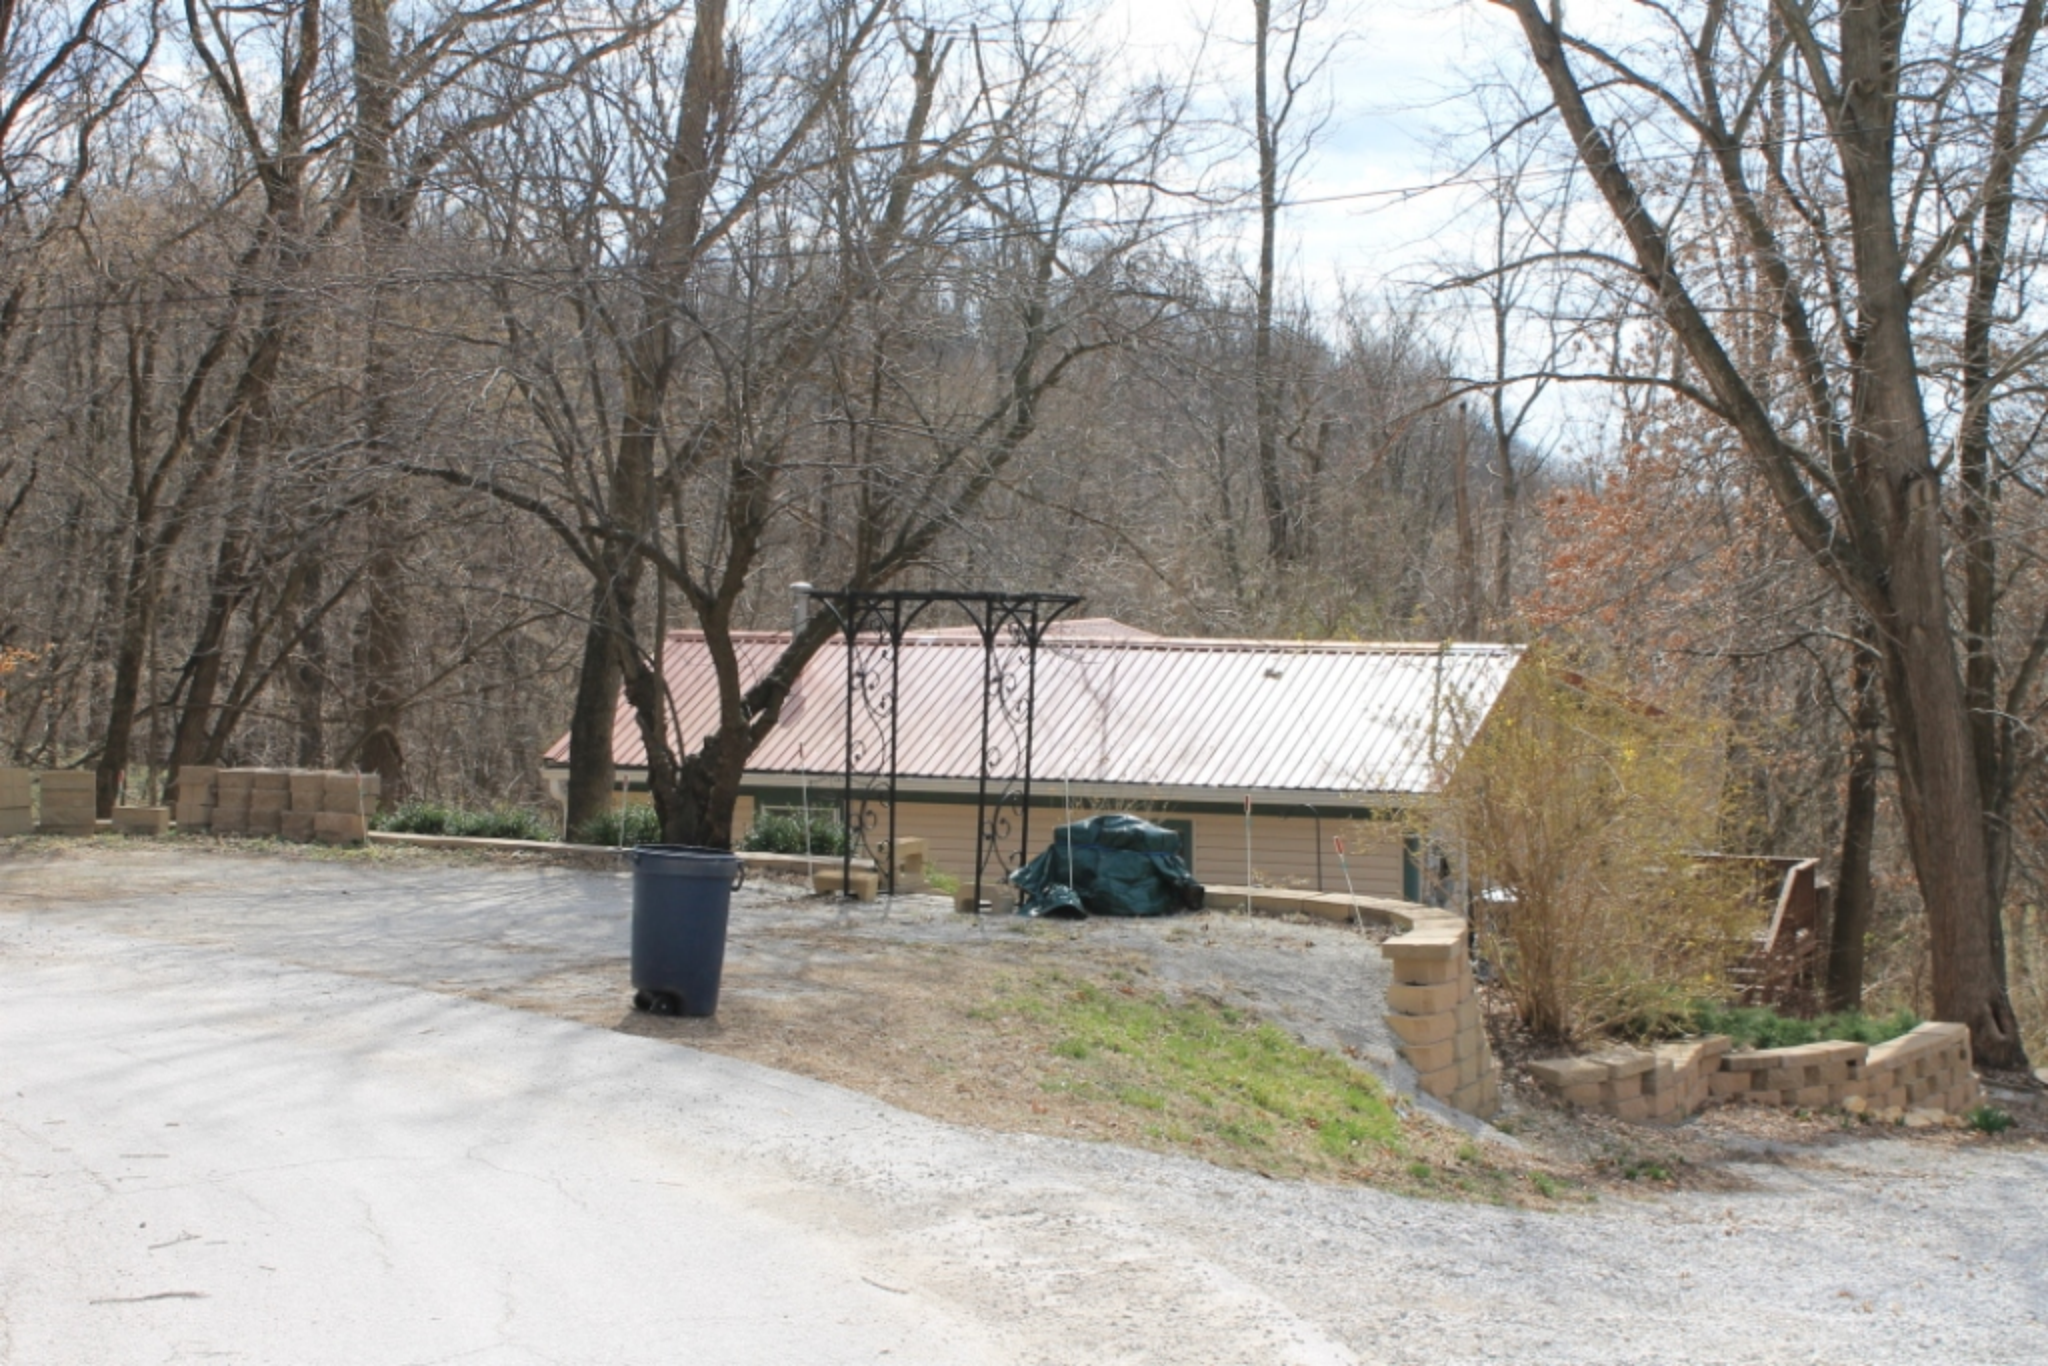
Only a part of the rear portion of this building is visible from the public road. The building is clad in vinyl siding. The building has a cross gable roof of metal. The only visible facade, a portion of the north (rear) facade, has two bays. The left bay contains a pair of one-over-one single hung windows. The right bay contains a two vertical pane sliding glass window/door. It is difficult to tell whether the right bay contains a window or door because only a portion of the facade is visible.

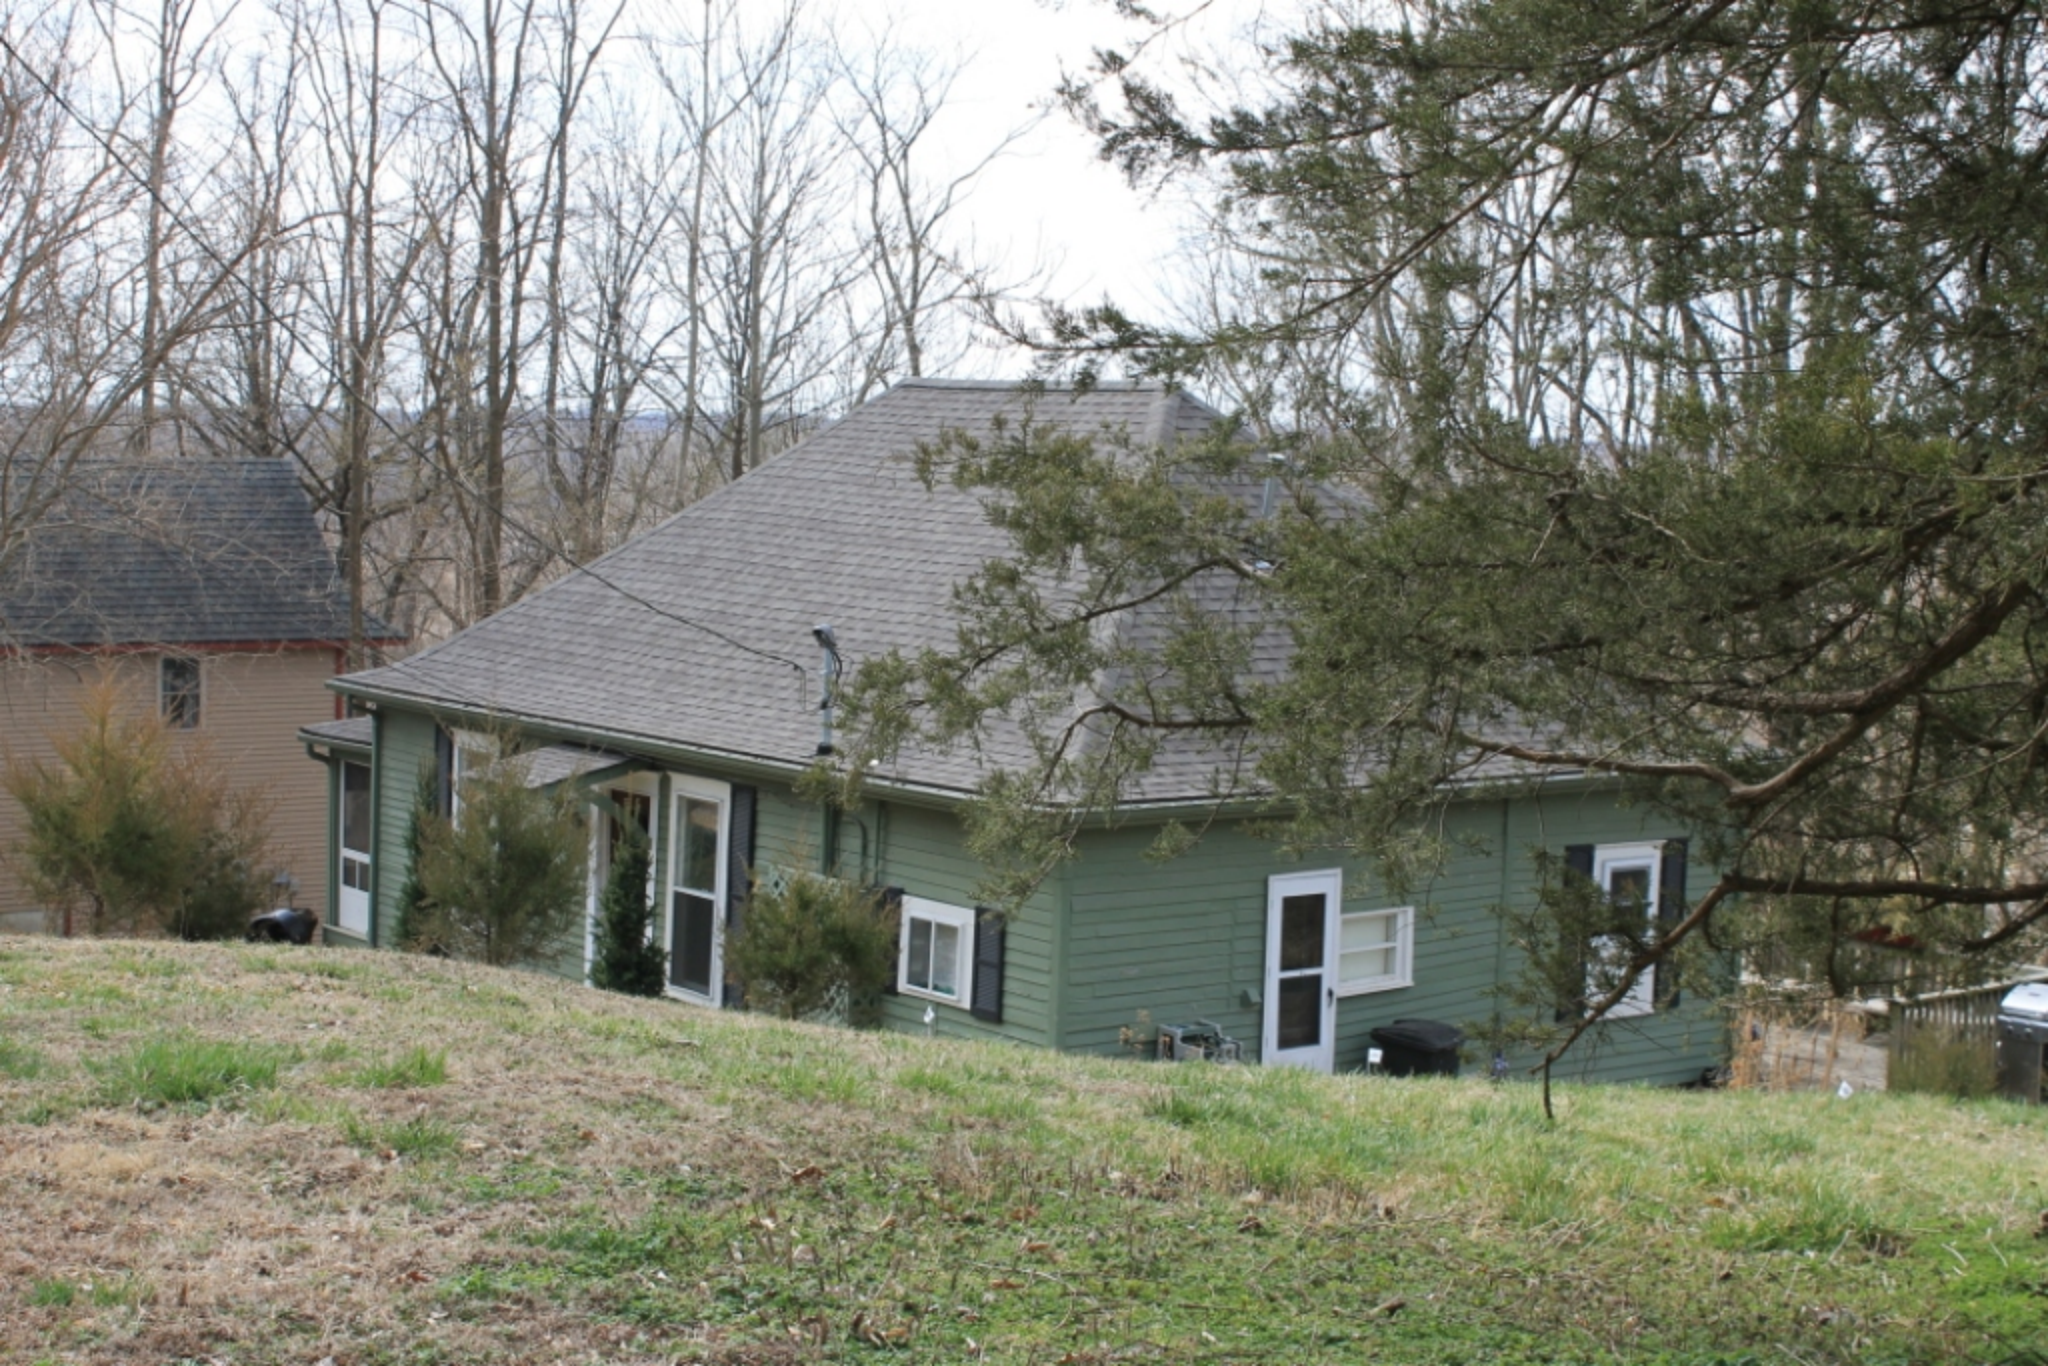
This one-story, massed plan pyramidal house has a high bellcast hipped roof with a gable roofed dormer facing the west. The building has a shed roofed ell on the south. The building is clad in clapboards and the roof is covered in asphalt shingles. The east facade has a total of five bays. The left bay, which is in the south facing ell, contains a door covered with a shed-roofed hood. The next bay contains a one-over-one single hung window accented with decorative shutters. The next bay contains a door; this door is also shielded by a shed roofed hood. Immediately to the right of the door is a bay containing a one-over-one single hung window with one shutter. The rightmost bay contains a small window with two vertical sliding panes and shutters. The north facade of the house has three bays. The leftmost bay contains a door with a metal and glass storm door. Immediately to the right of his door is a bay containing a small one-over-one single hung window. The rightmost bay of the north facade contains a one-over-one single hung window accented with shutters.

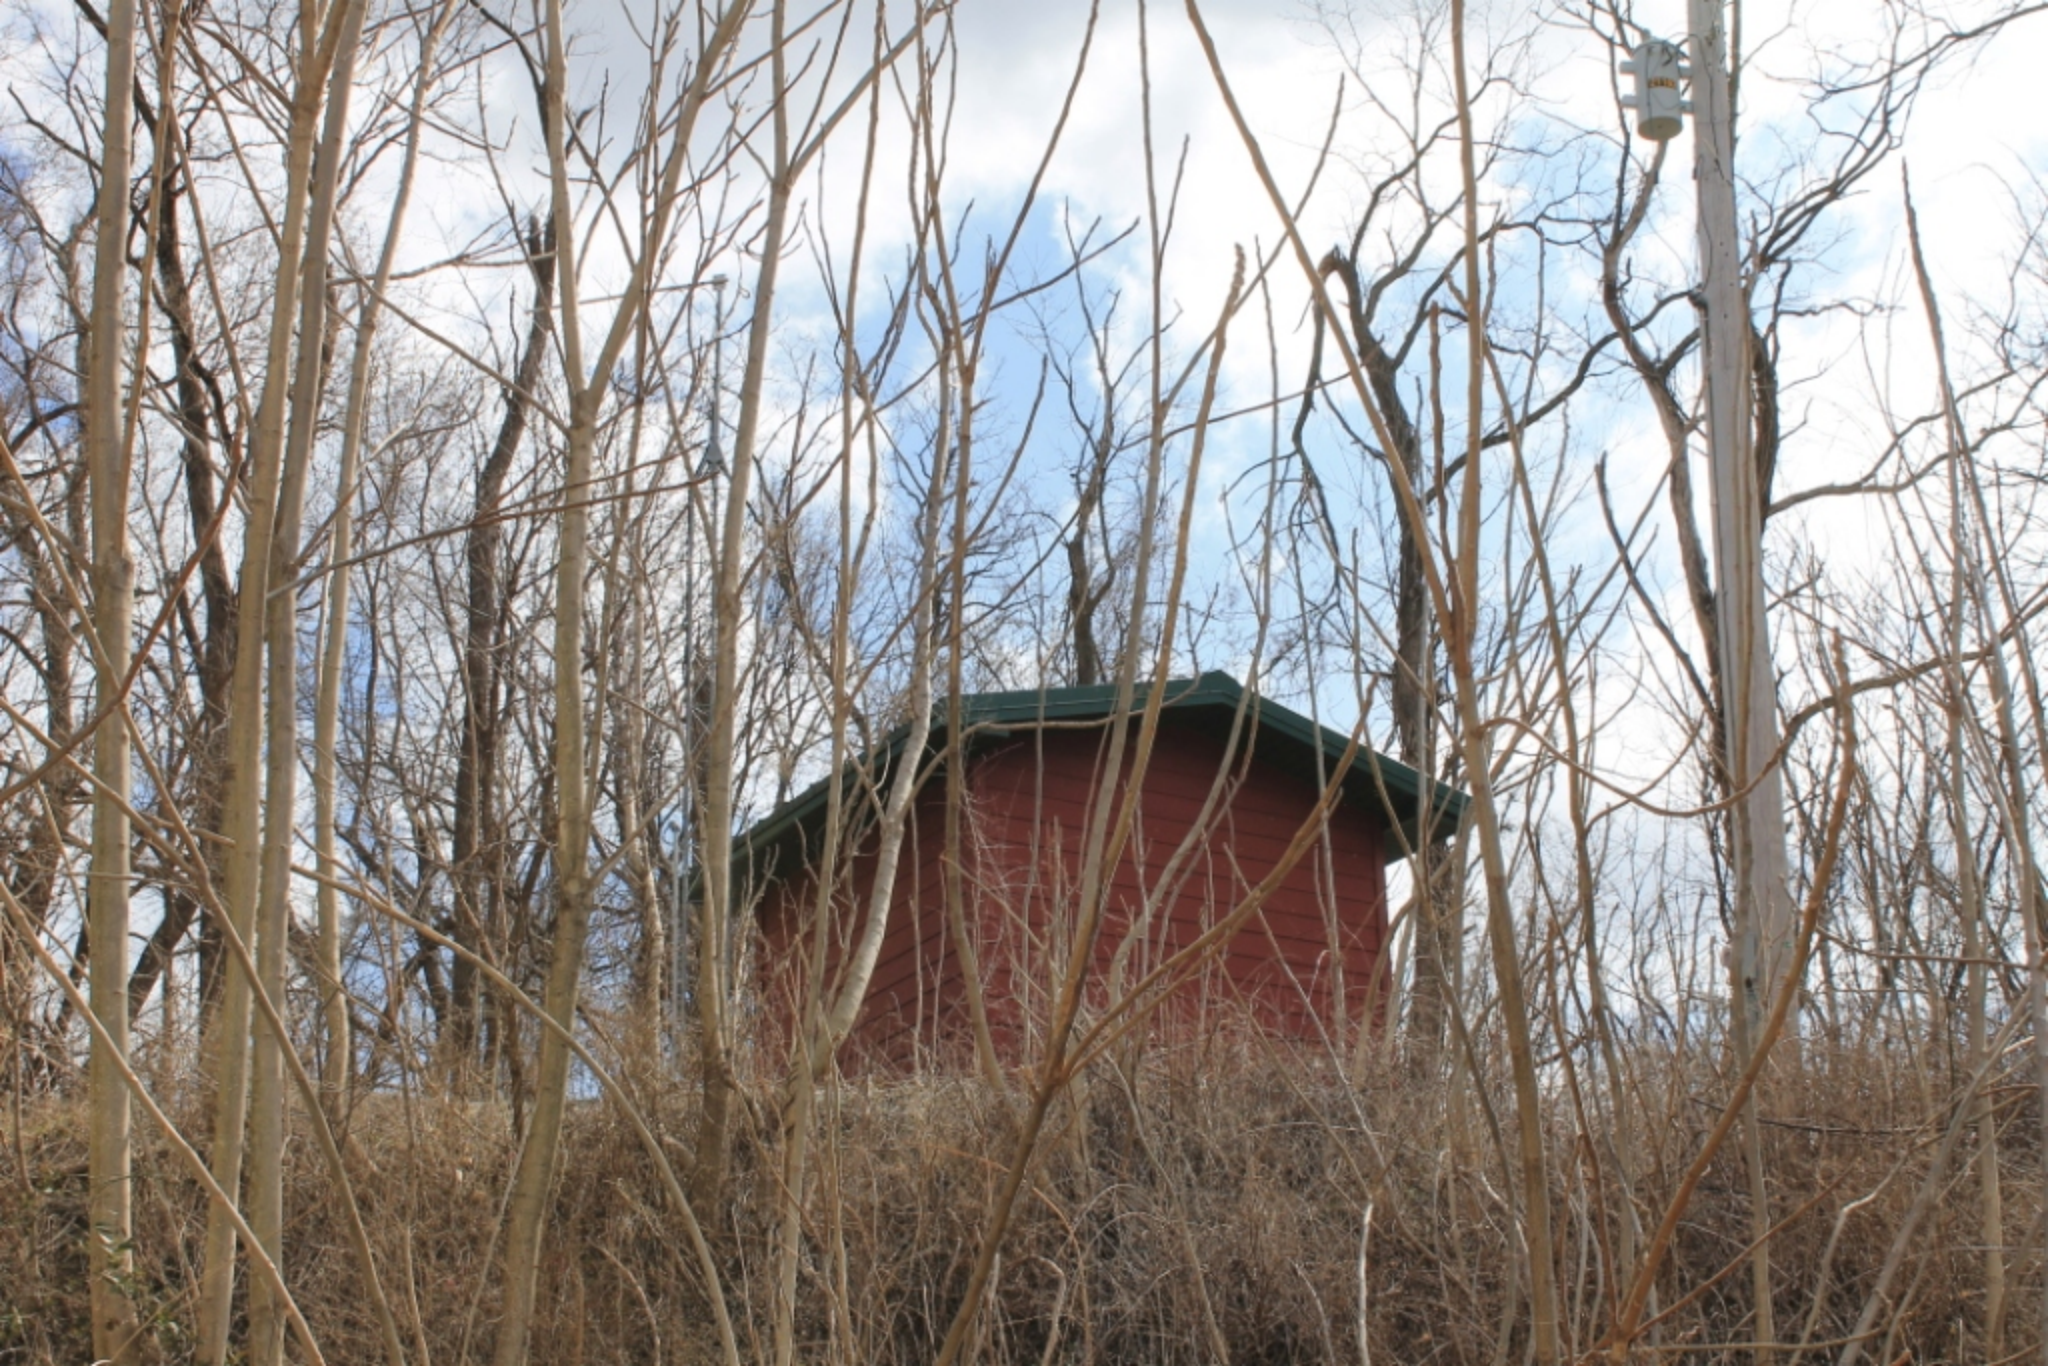
This one-story low gable roofed building is clad in clapboards and is covered with asphalt shingles. The building has no bays on the west facade, the only facade visible from the public road.

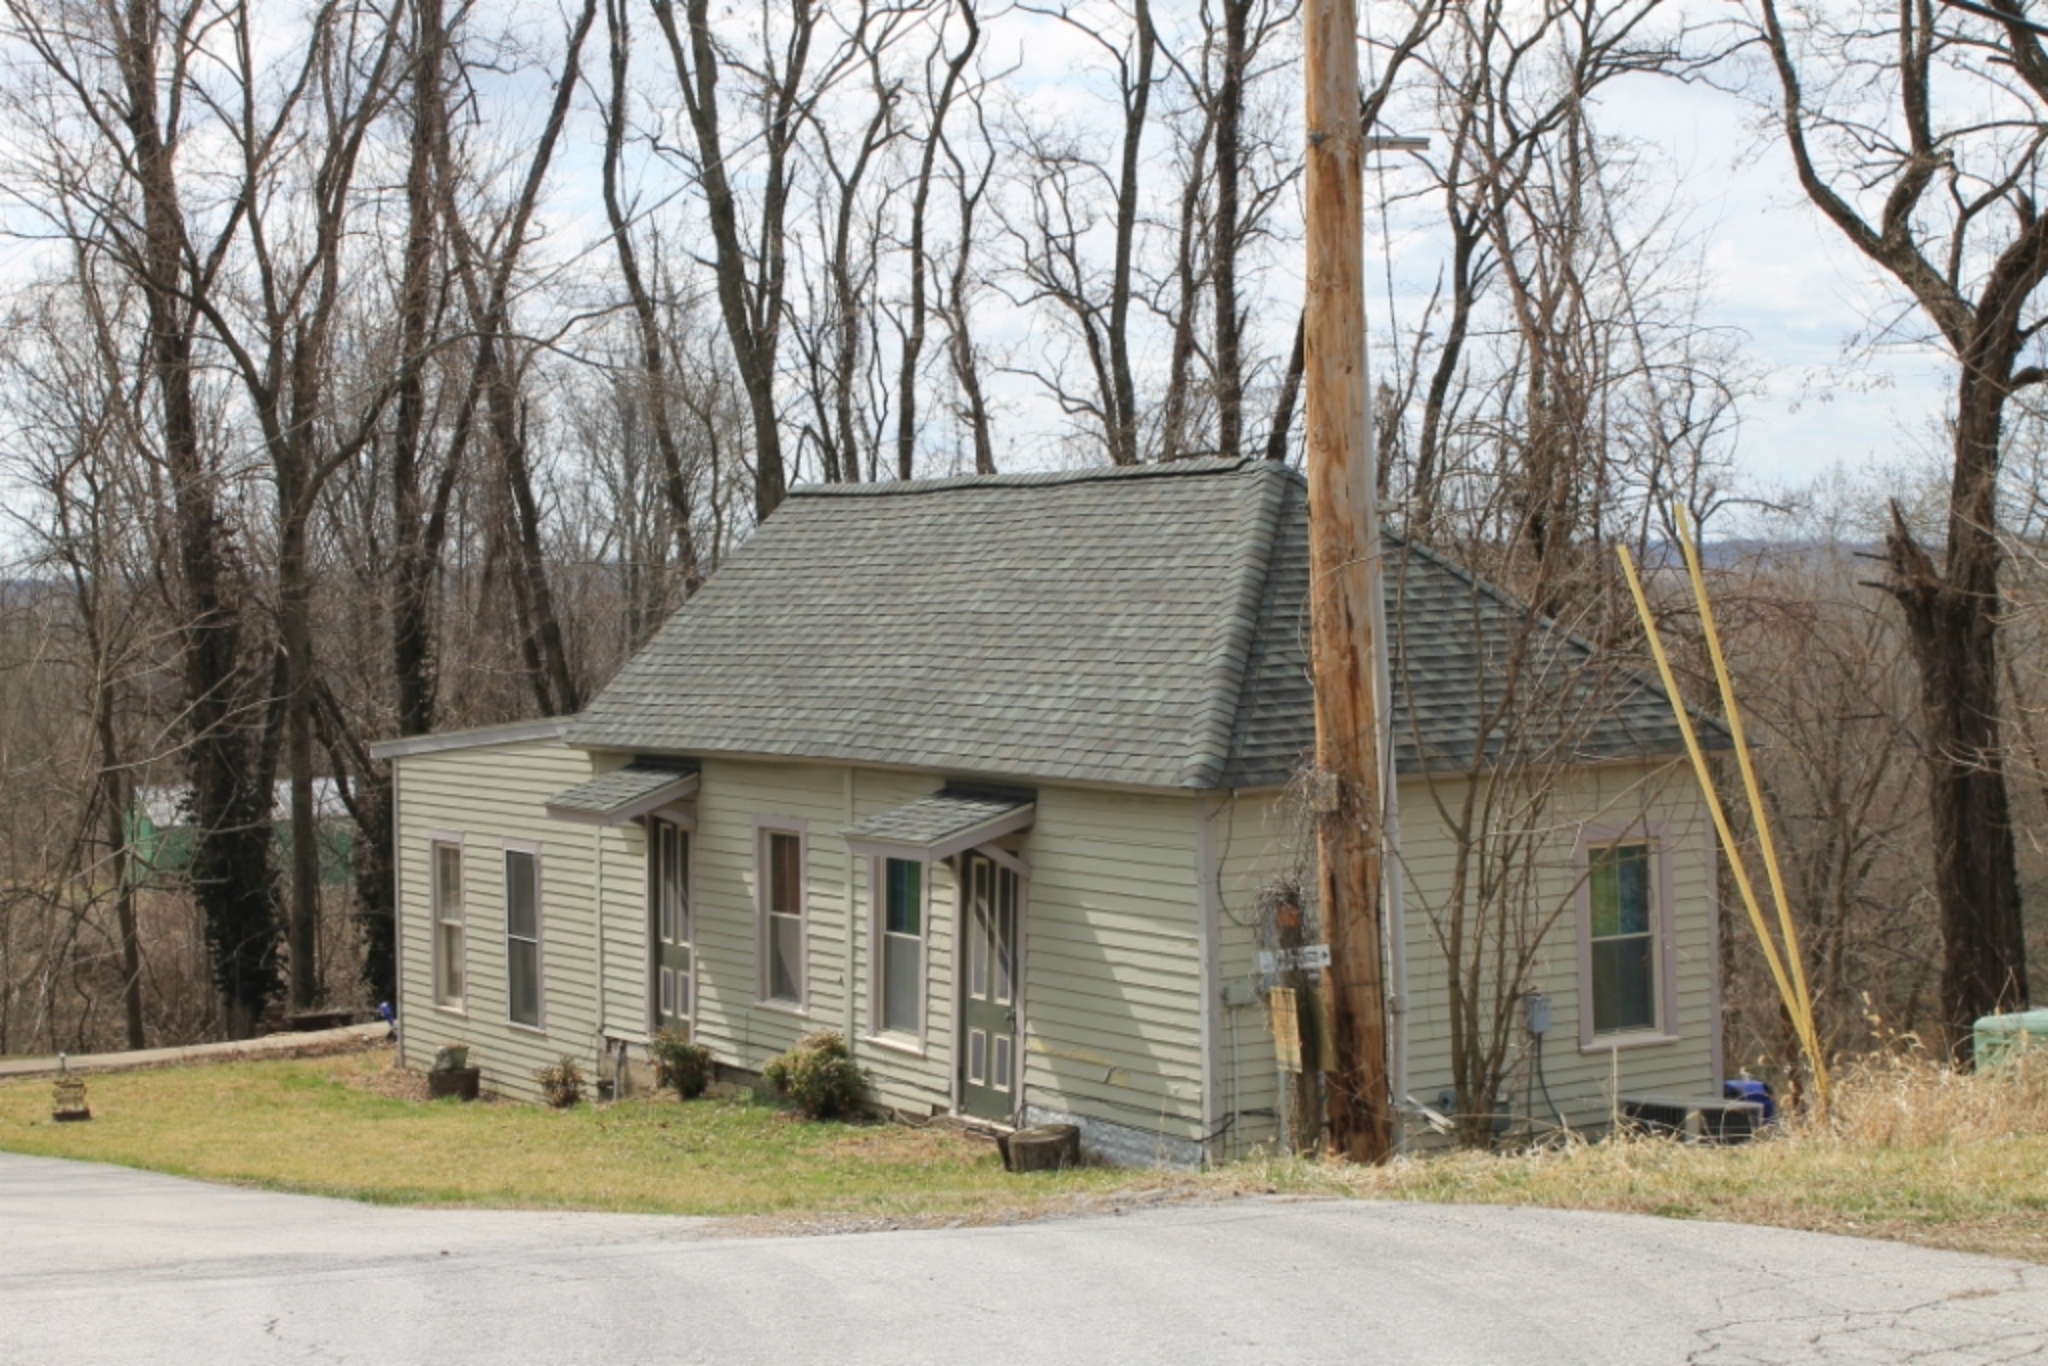
This rectangular shaped one story, massed plan pyramidal house has a main block with a high hipped roof. A shed roofed wing extends to the south of the main block of the house. The house is clad in clapboards and the roof is covered in asphalt shingles. The front (east) facade of the house has six bays. The two left bays, which are located on the shed roofed wing, each contain a two-over-two single hung window. The next bay, which is located on the main block of the house, contains a paneled wooden door; above the door is a shed roofed hood supported by brackets. The next bay contains a two-over-two single hung window. The next bay contains a two-over-two double hung window. The rightmost bay contains a paneled wooden door sheltered by a shed-roofed hood supported by brackets.

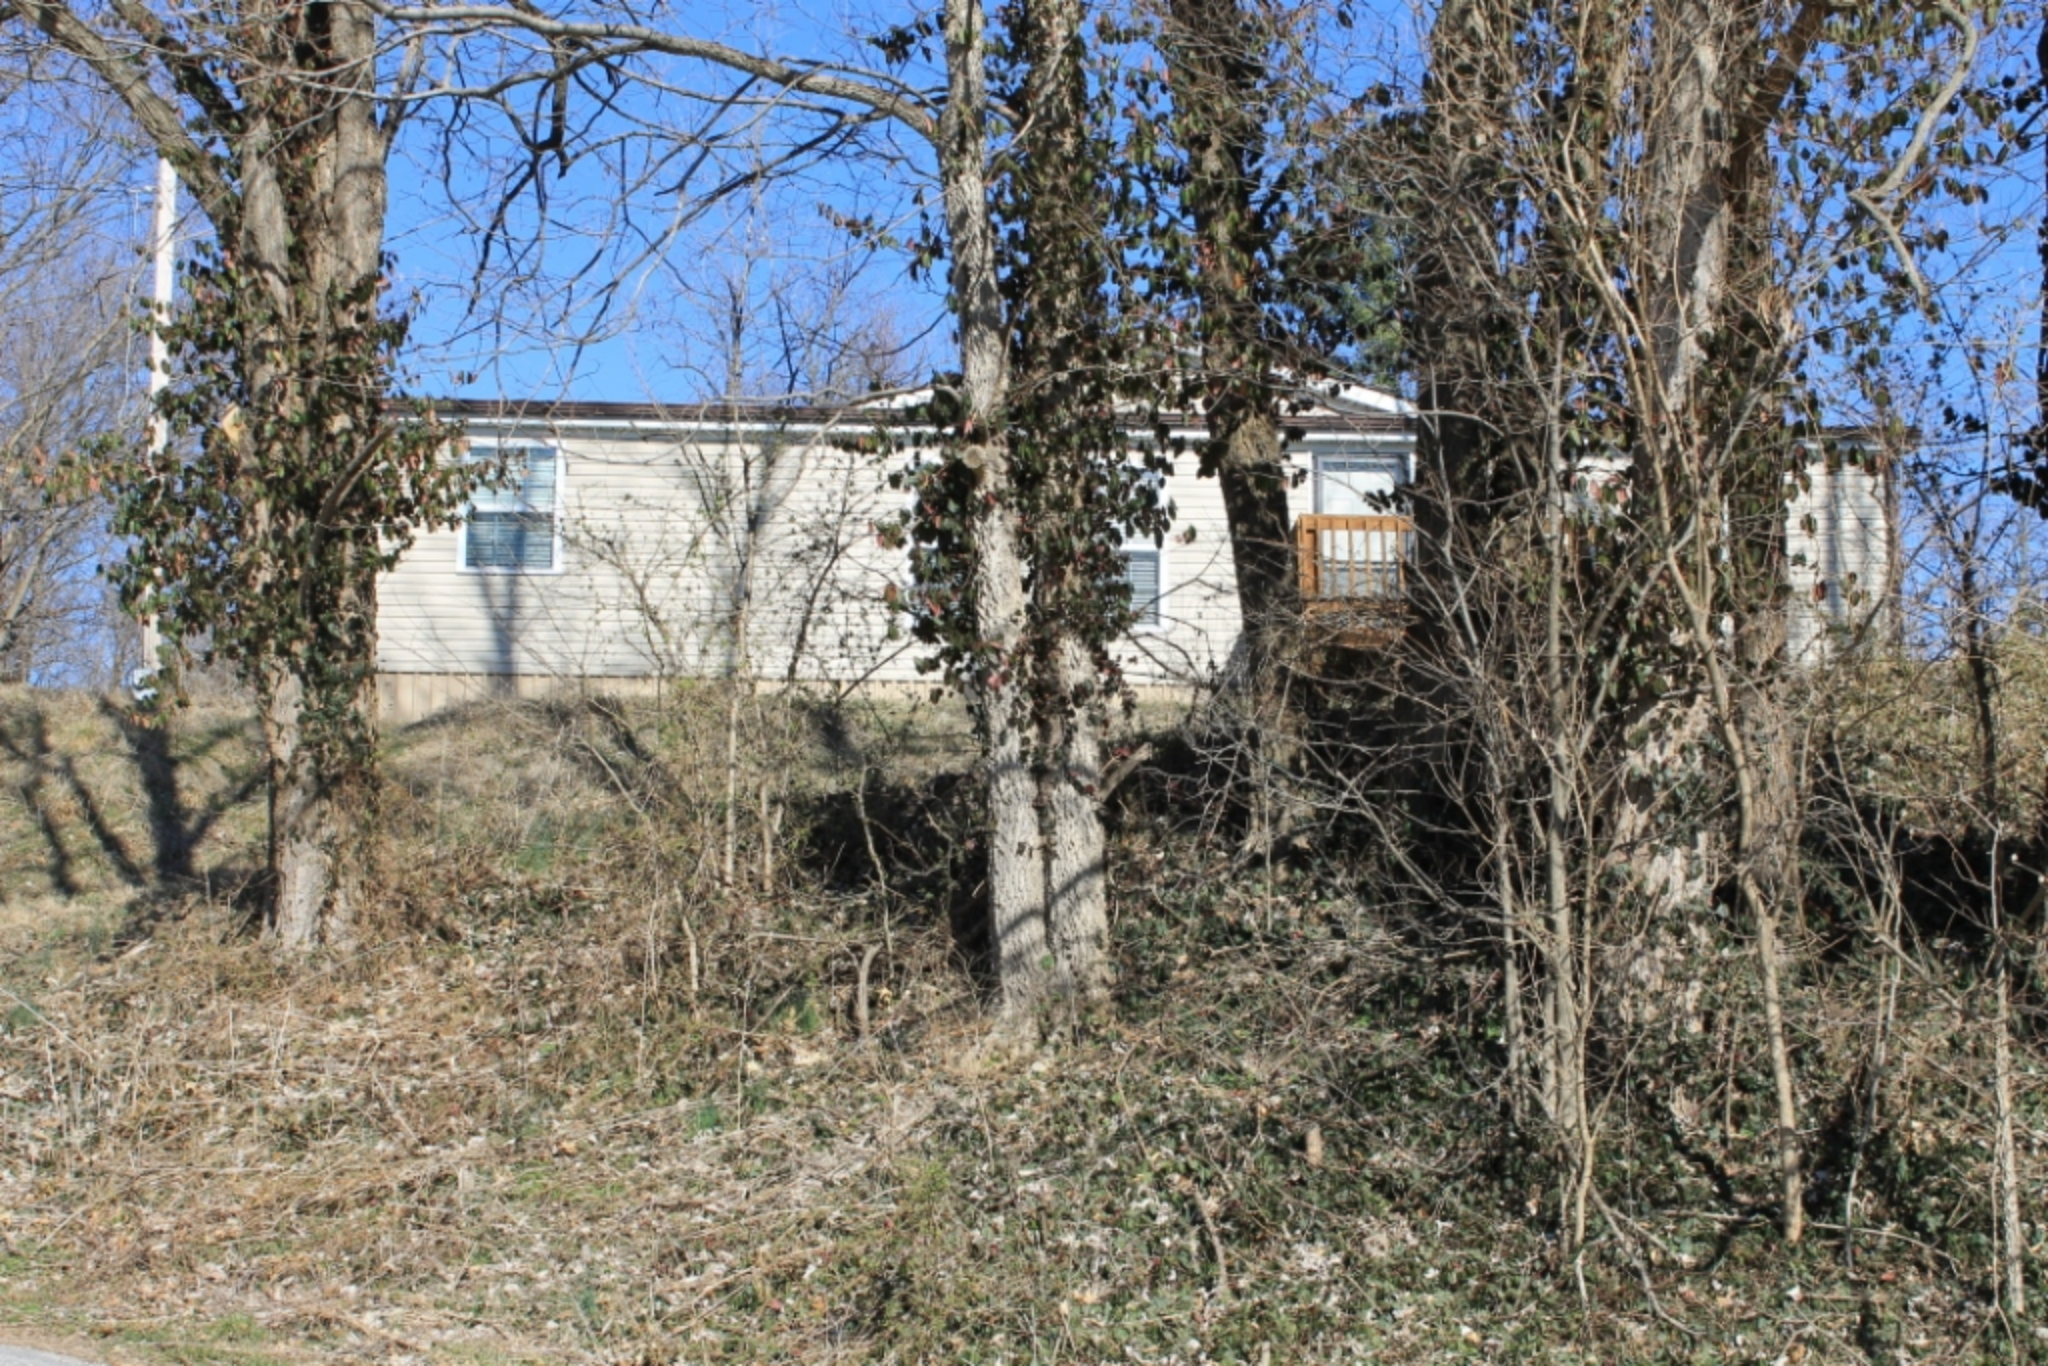
This double wide mobile home has a low cross gabled roof and a deck on the west side. The building is clad in vinyl siding; the roof is covered in asphalt shingles. The building has four bays. The left bay contains a one-over-one single hung window. The next bay contains a pair of one-over-one single hung windows. The next bay contains a door with a metal and glass storm door. The door opens onto a wooden deck. The rightmost bay contains a one-over-one single hung window.

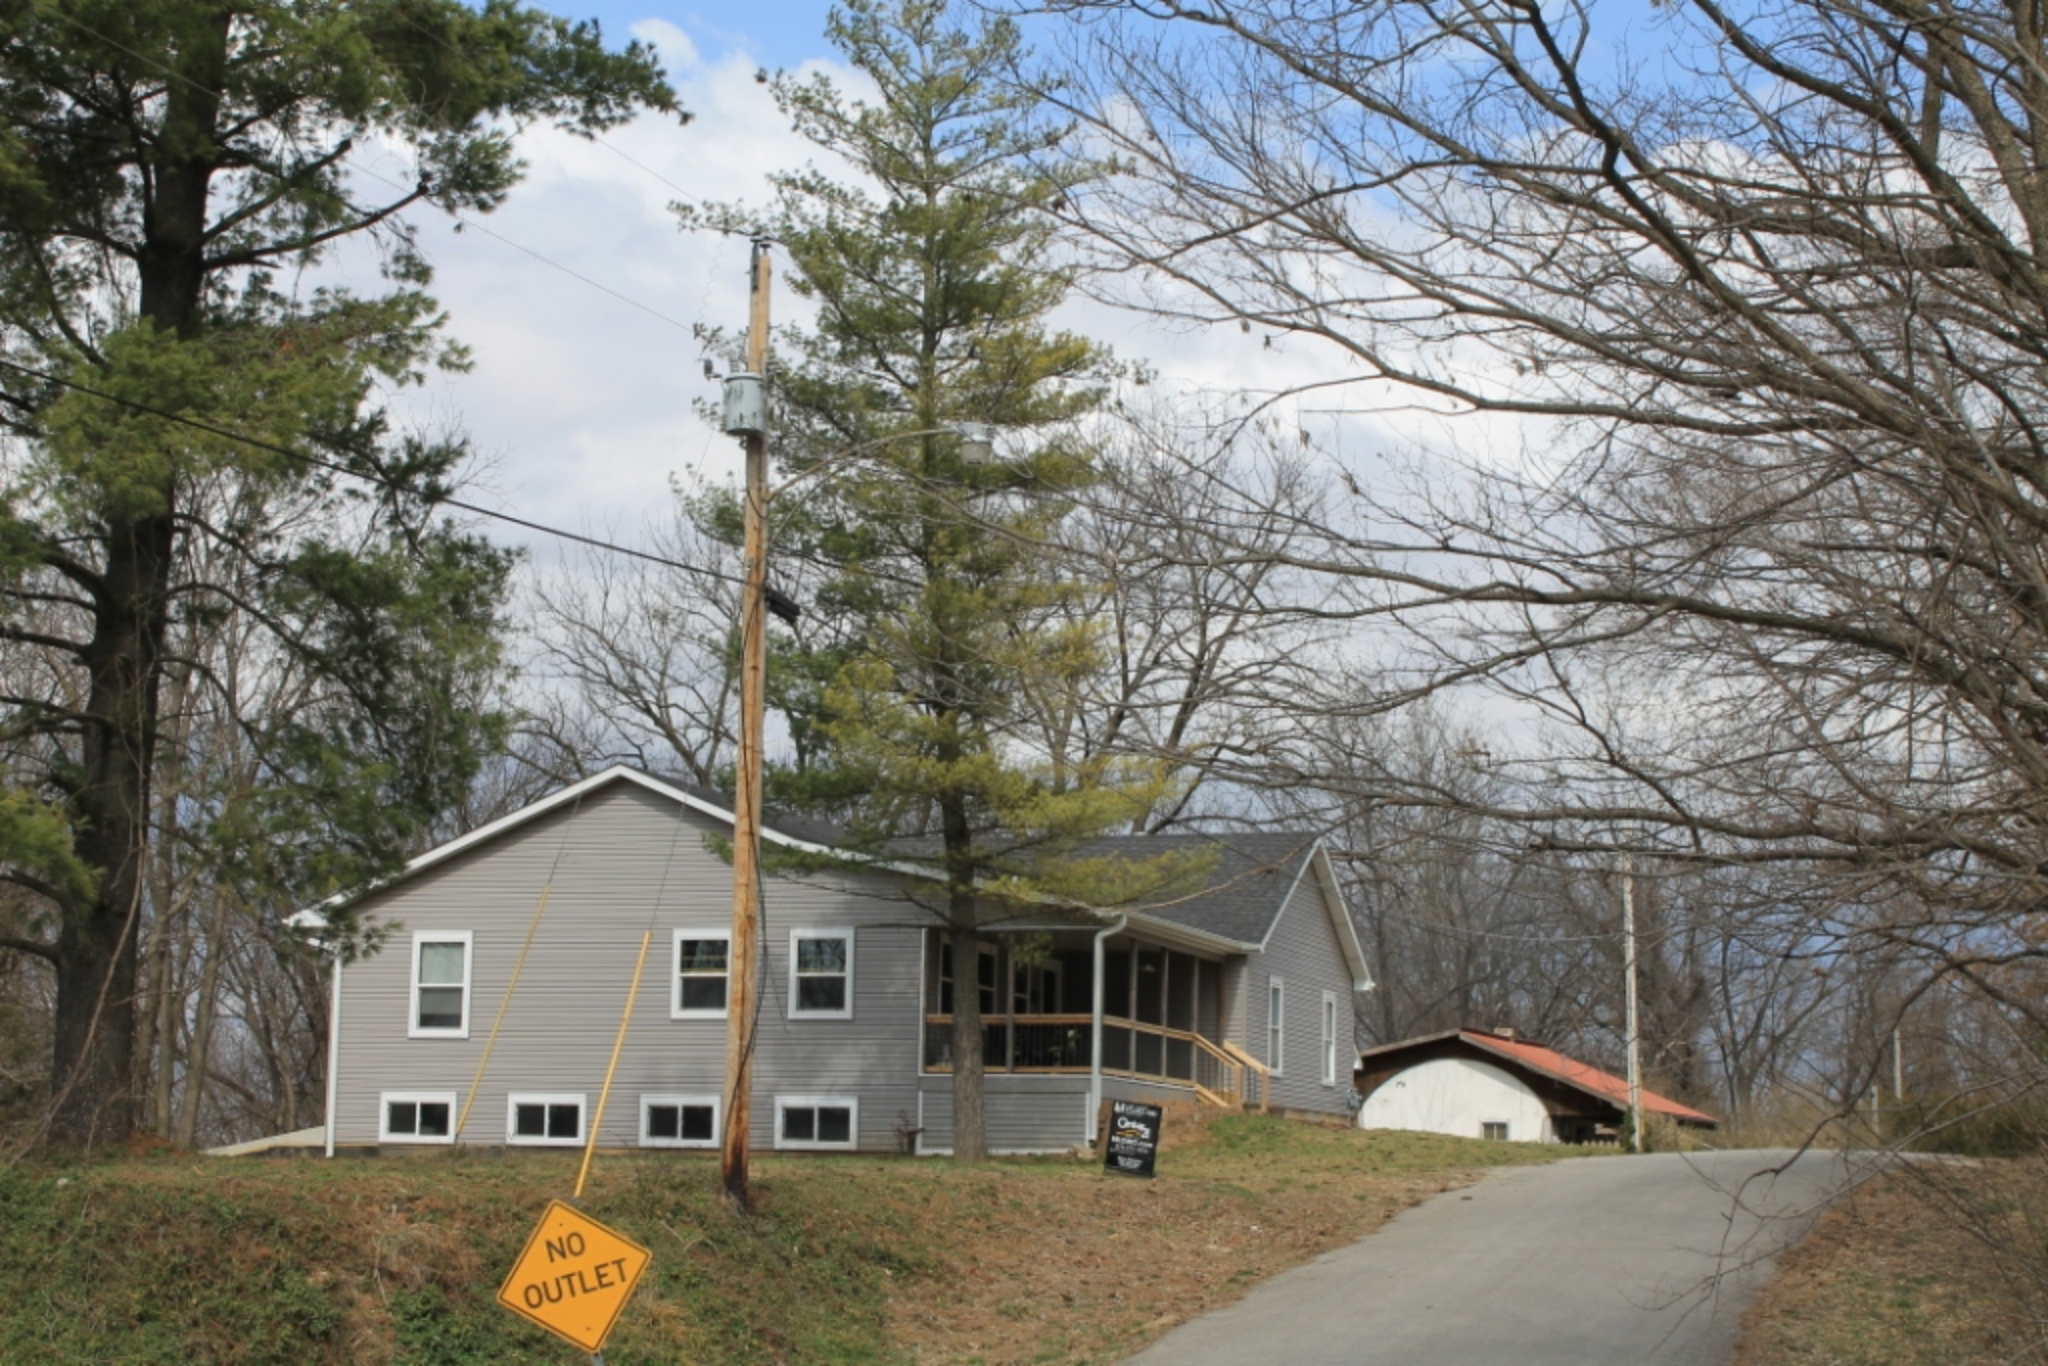
This one-story, massed plan, frame ranch house has a cross gabled roof. The house is clad in vinyl siding and the roof is covered in asphalt shingles. The lot slopes to the south so a portion of the house is on a raised basement. The main block of the house has four bays on the south facade of the raised basement. Each of the evenly spaced bays contains a two-vertical paned sliding window. The south facade of the main block of the house above the raised basement has three bays. The left bay contains a one-over-one single hung vinyl window. The two right bays each contain a one-over-one single hung vinyl window. On the east facade at the point where the main block of the house connects to the cross gabled wing is a large open porch. The east facade of the house has five bays. The left bay, which is under the porch, contains a pair of one-over-one single hung vinyl windows. The next bay contains a one-over one single hung vinyl window. The next bay contains a door with a metal and glass storm door. The two right bays, which are located on the east facing gable wing contains a one-over-one single hung vinyl window.
