MISSOURI DEPARTMENT OF NATURAL RESOURCES
STATE HISTORIC PRESERVATION OFFICE, P.O. Box 176, Jefferson City, MO 65102
ARCHITECTURAL/HISTORIC INVENTORY FORM

1. SURVEY NO. BO-AS-009-0001		2. SURVEY NAME: Rocheport Historic District	
3. COUNTY: Boone		4. ADDRESS (STREET NO.)	STREET (NAME) Katy Trail
5. CITY: Rocheport	VICINITY: <input checked="" type="checkbox"/>	6. UTM: / /	LAT: LONG: T: 48W R: 15W S: 1

8. HISTORIC NAME (IF KNOWN): M.K.&T. Railroad tunnel		9. PRESENT/OTHER NAME (IF KNOWN): Katy trail tunnel	
10. OWNERSHIP: <input type="checkbox"/> PRIVATE <input checked="" type="checkbox"/> PUBLIC		11A. HISTORIC USE (IF KNOWN): railroad tunnel	11B. CURRENT USE: Katy Trail tunnel
HISTORICAL INFORMATION

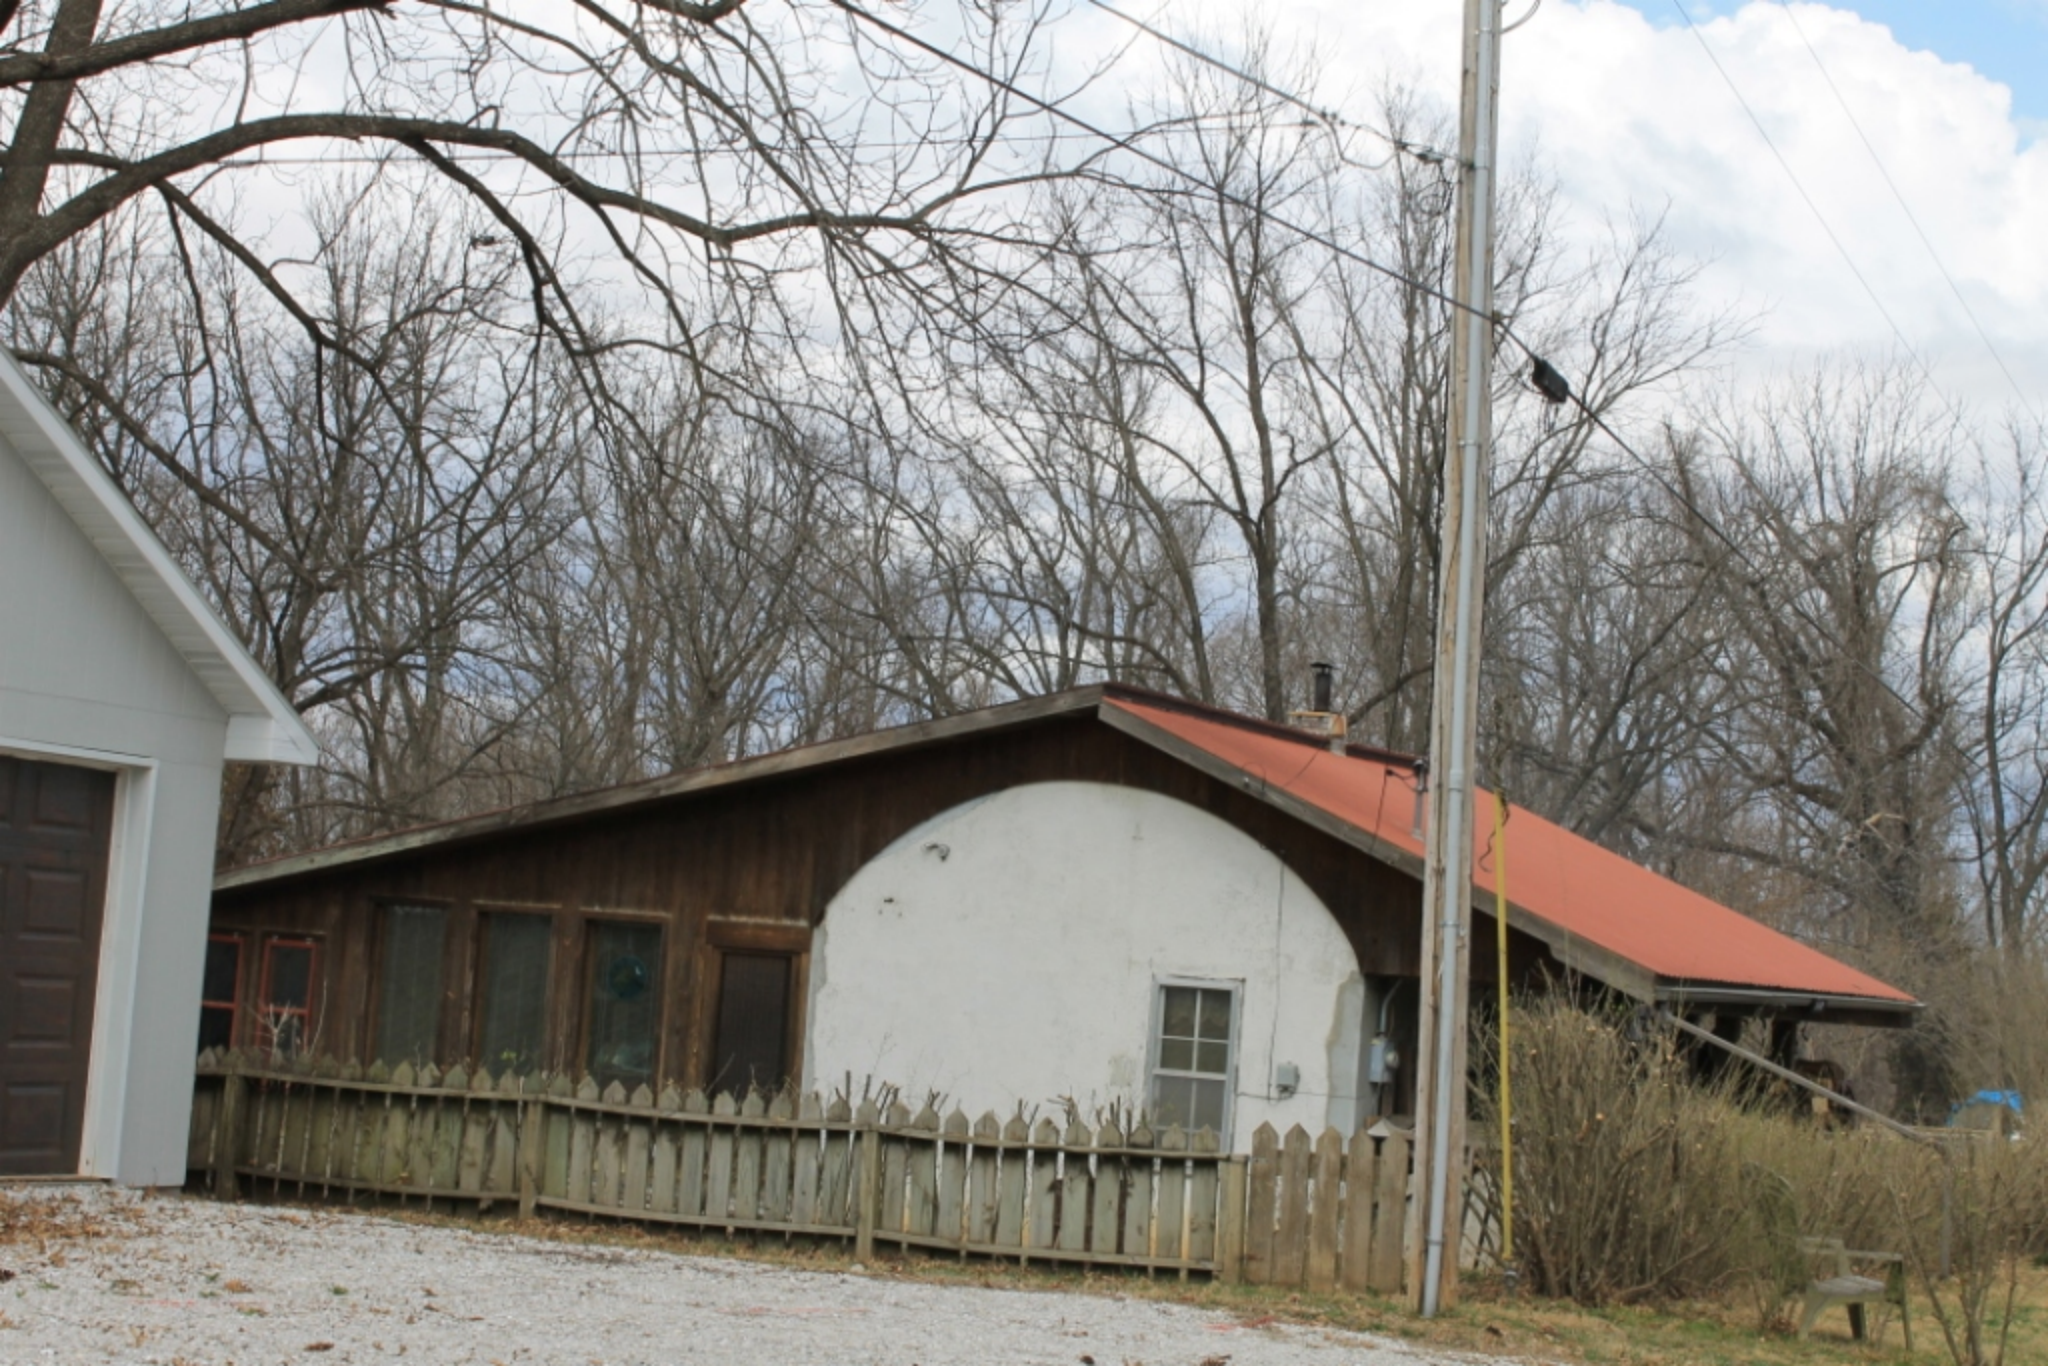
This one story, massed plan side gable house has a curious construction. It is built around and over a vaulted building covered in stucco. It has a front porch in to the east of the vaulted portion and a wing to the west the vaulted portion. A saltbox roof tops the building, with the ridge of the roof centered over the vaulted portion. The walls of the wing are clad in vertical boards and the roof is covered in asphalt shingles. The south facade of the building has a total of seven bays. The two left bays each contain a one-over-one single hung wooden window. The next three bays each contain a single pane window. The next bay contains a door. The rightmost bay, which is in the vaulted portion, contains a four-over-four single hung window covered with a modern metal storm window. A chimney sits on the center ridge toward the right side of the building.

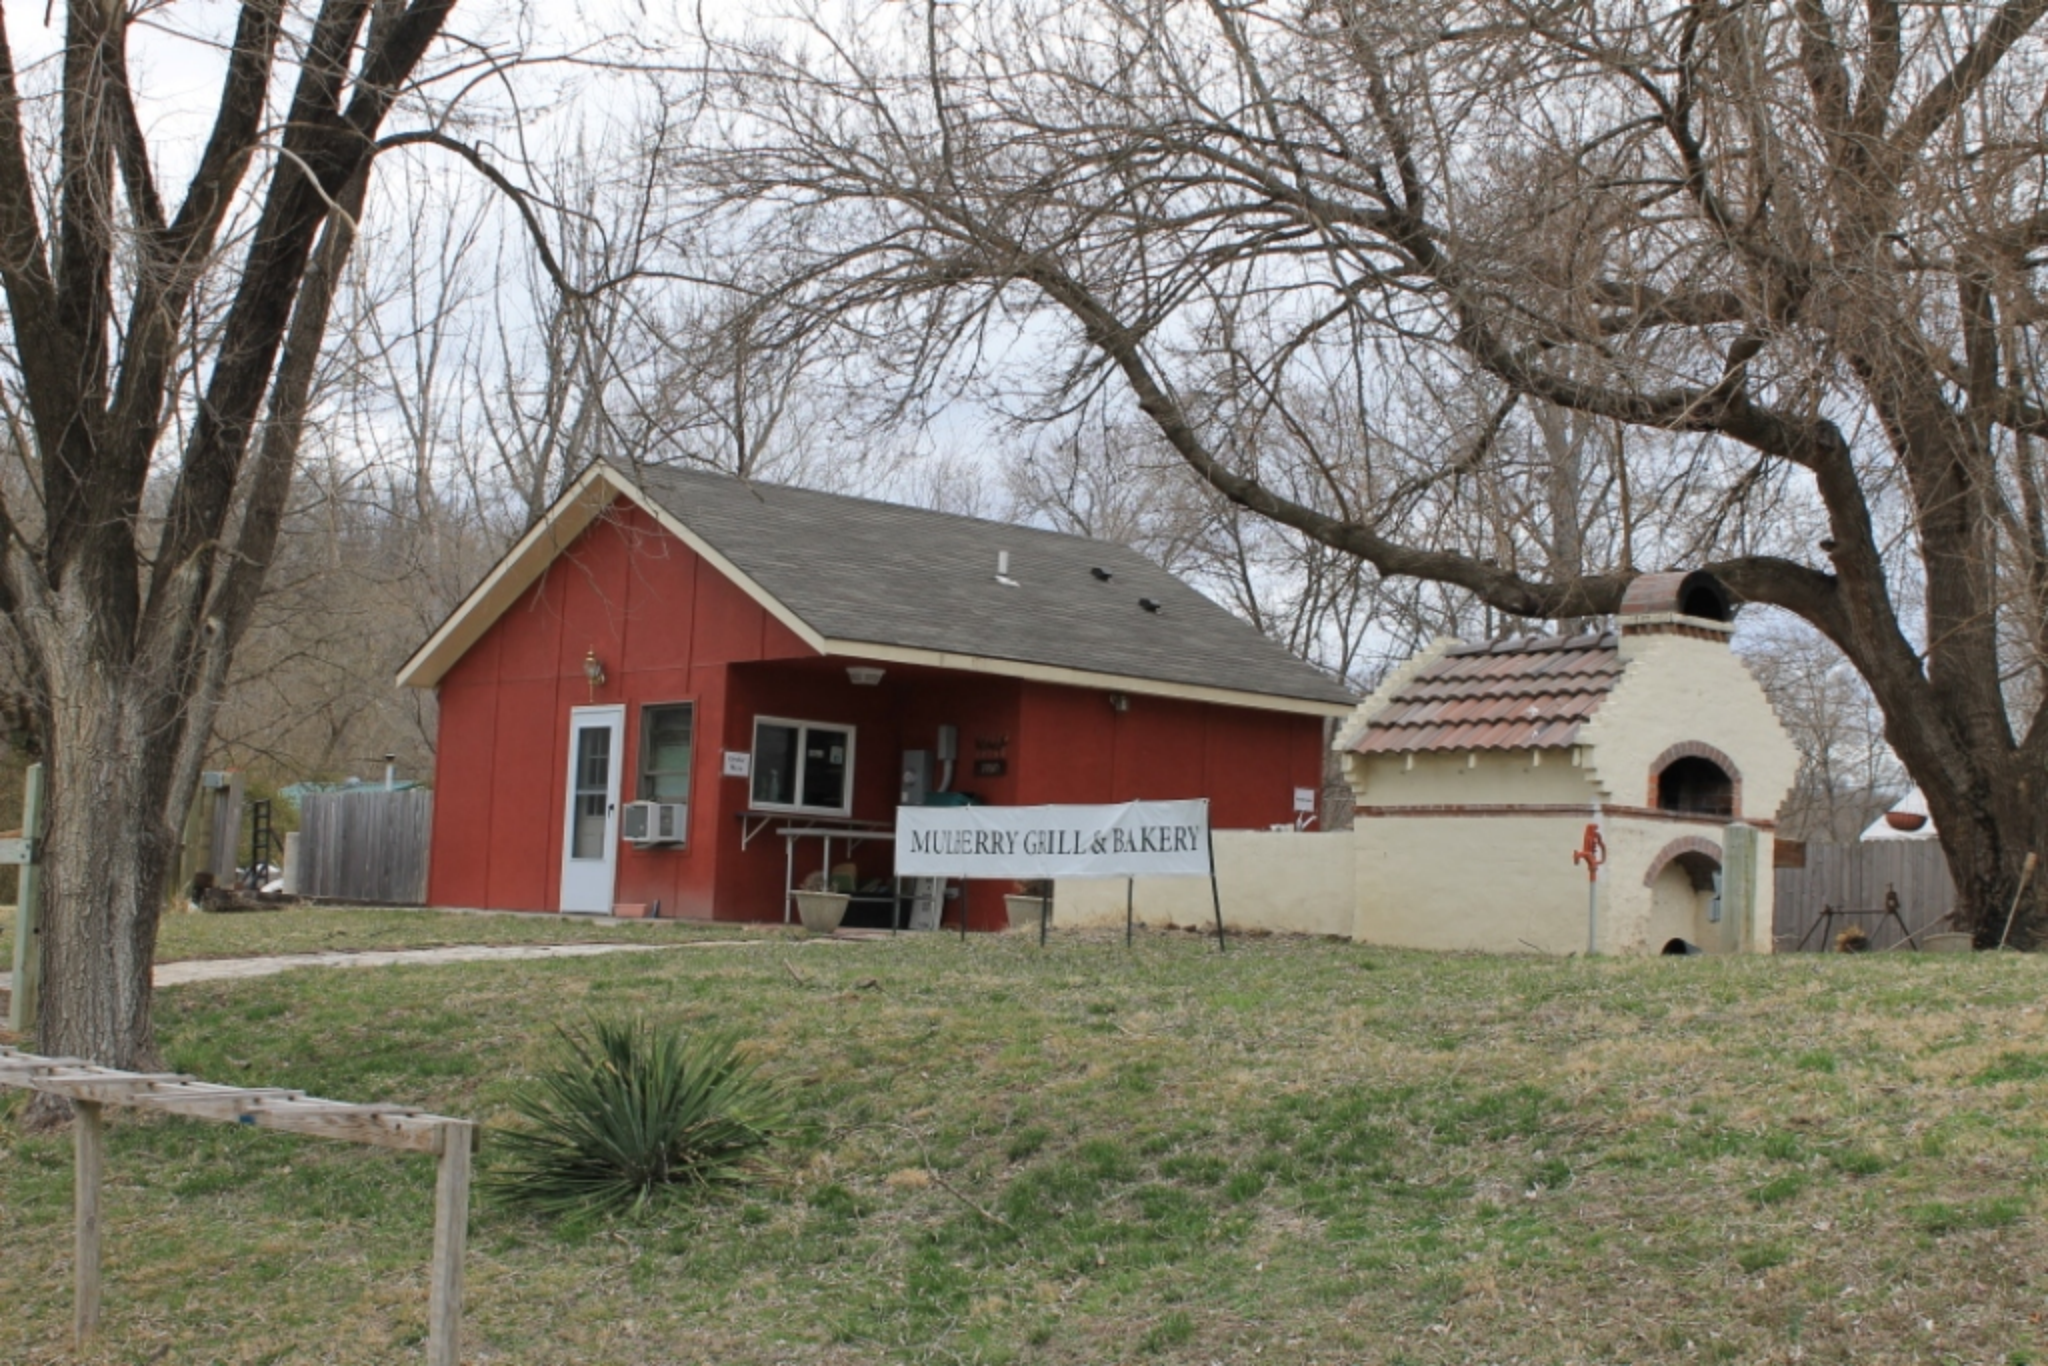
This one-story, frame, restaurant/food preparation building is clad in vertical wooden siding and has a medium gable roof covered with asphalt shingles. The building has an inset porch on the southeast corner; the building's roof covers the porch. The front (south) facade has two bays. The left bay contains a door. To the right of this bay is a bay containing a one-over-one single hung window. On the east facade under the porch roof is a bay containing a sliding glass window through which food can be served.

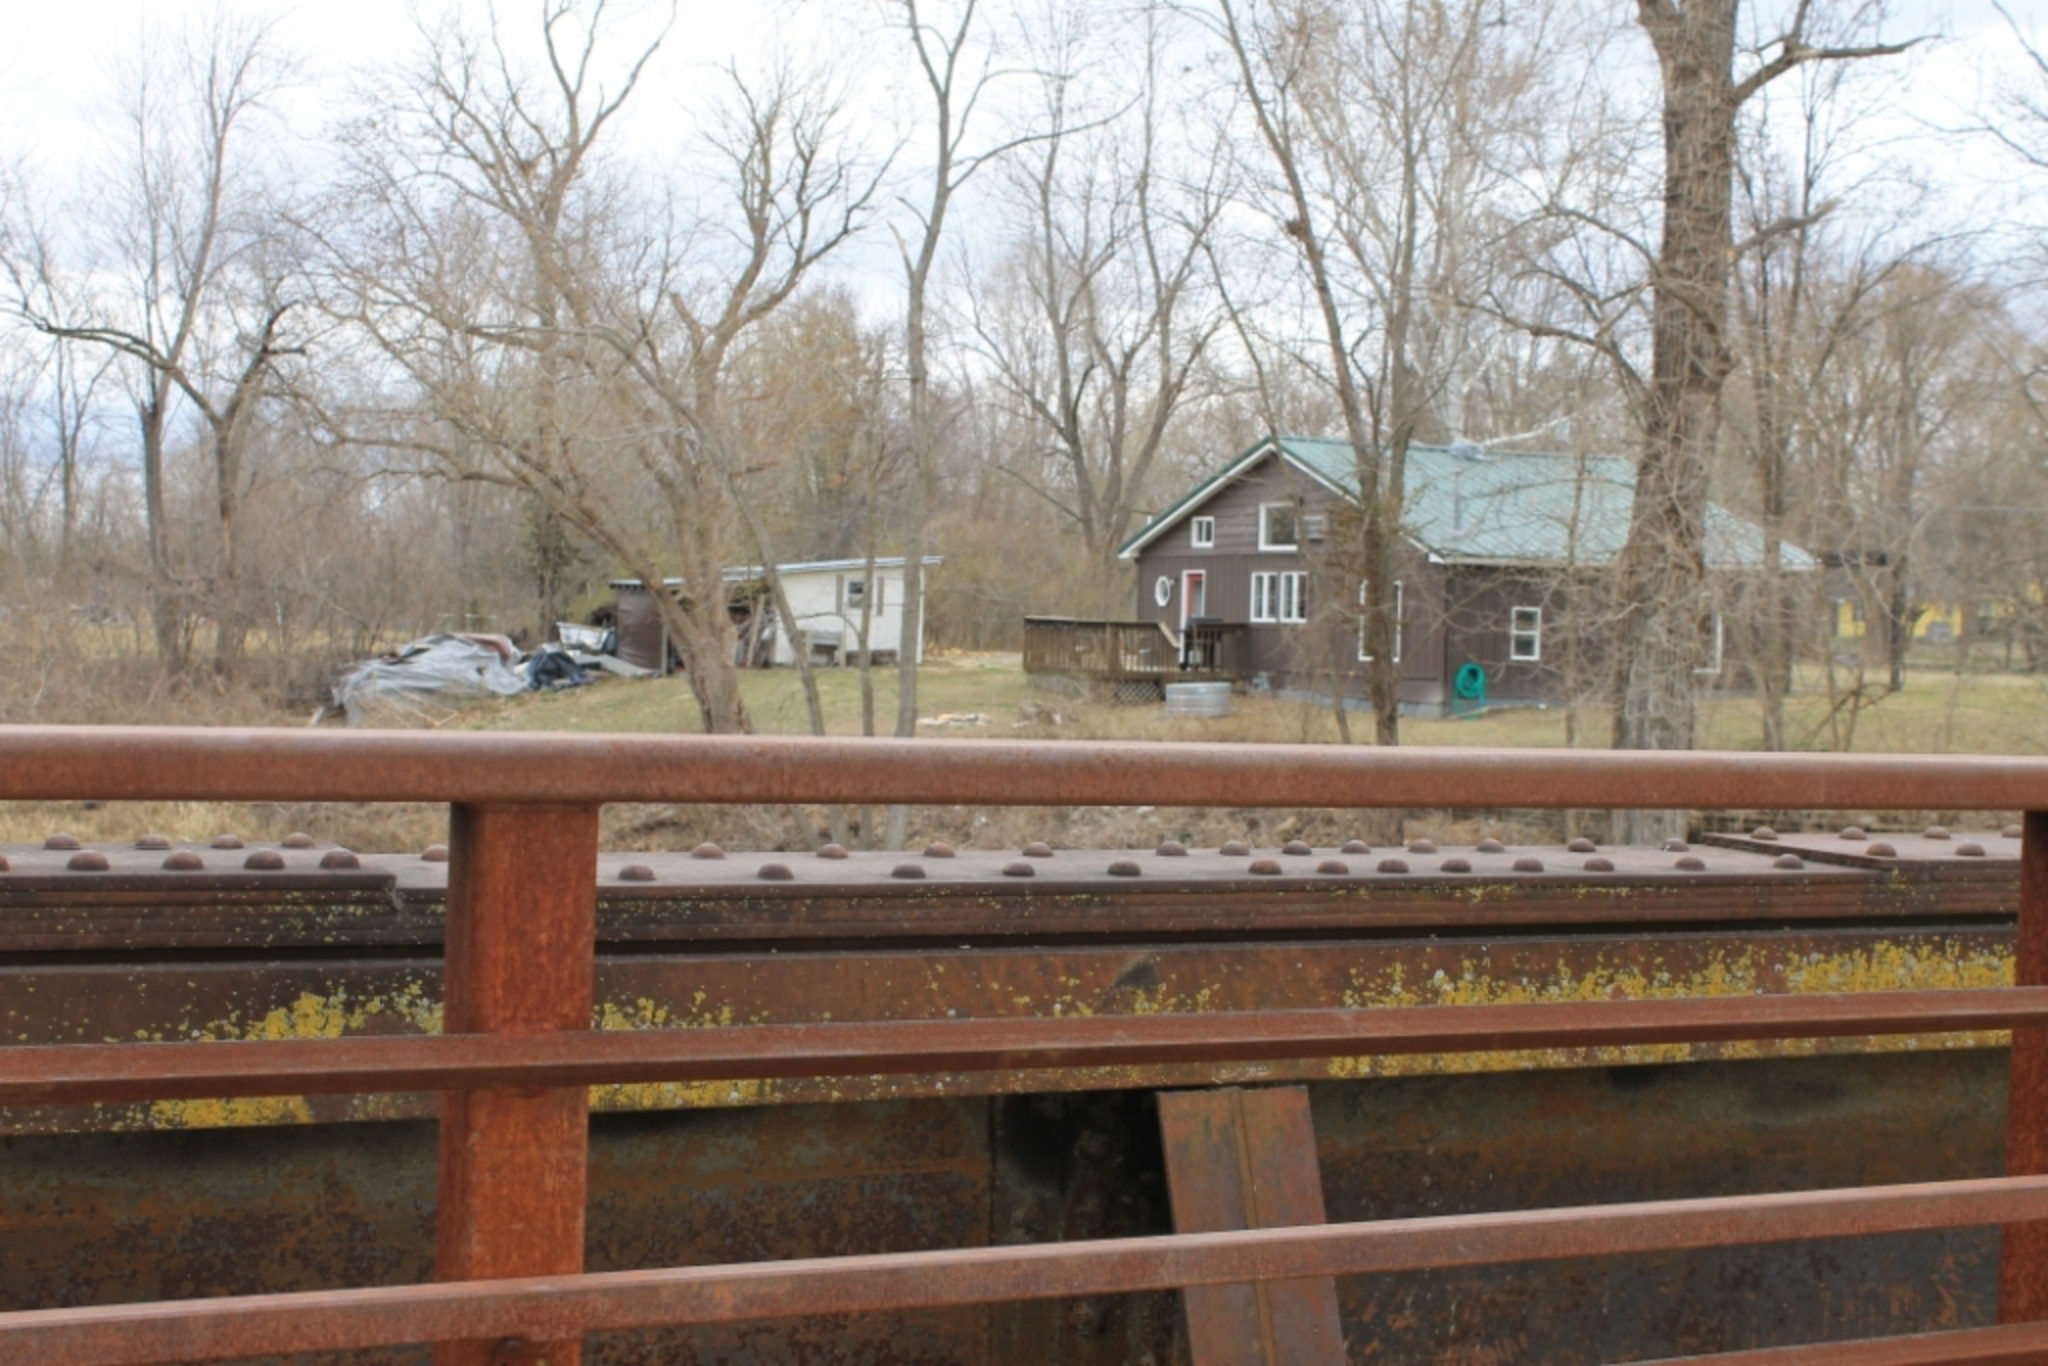
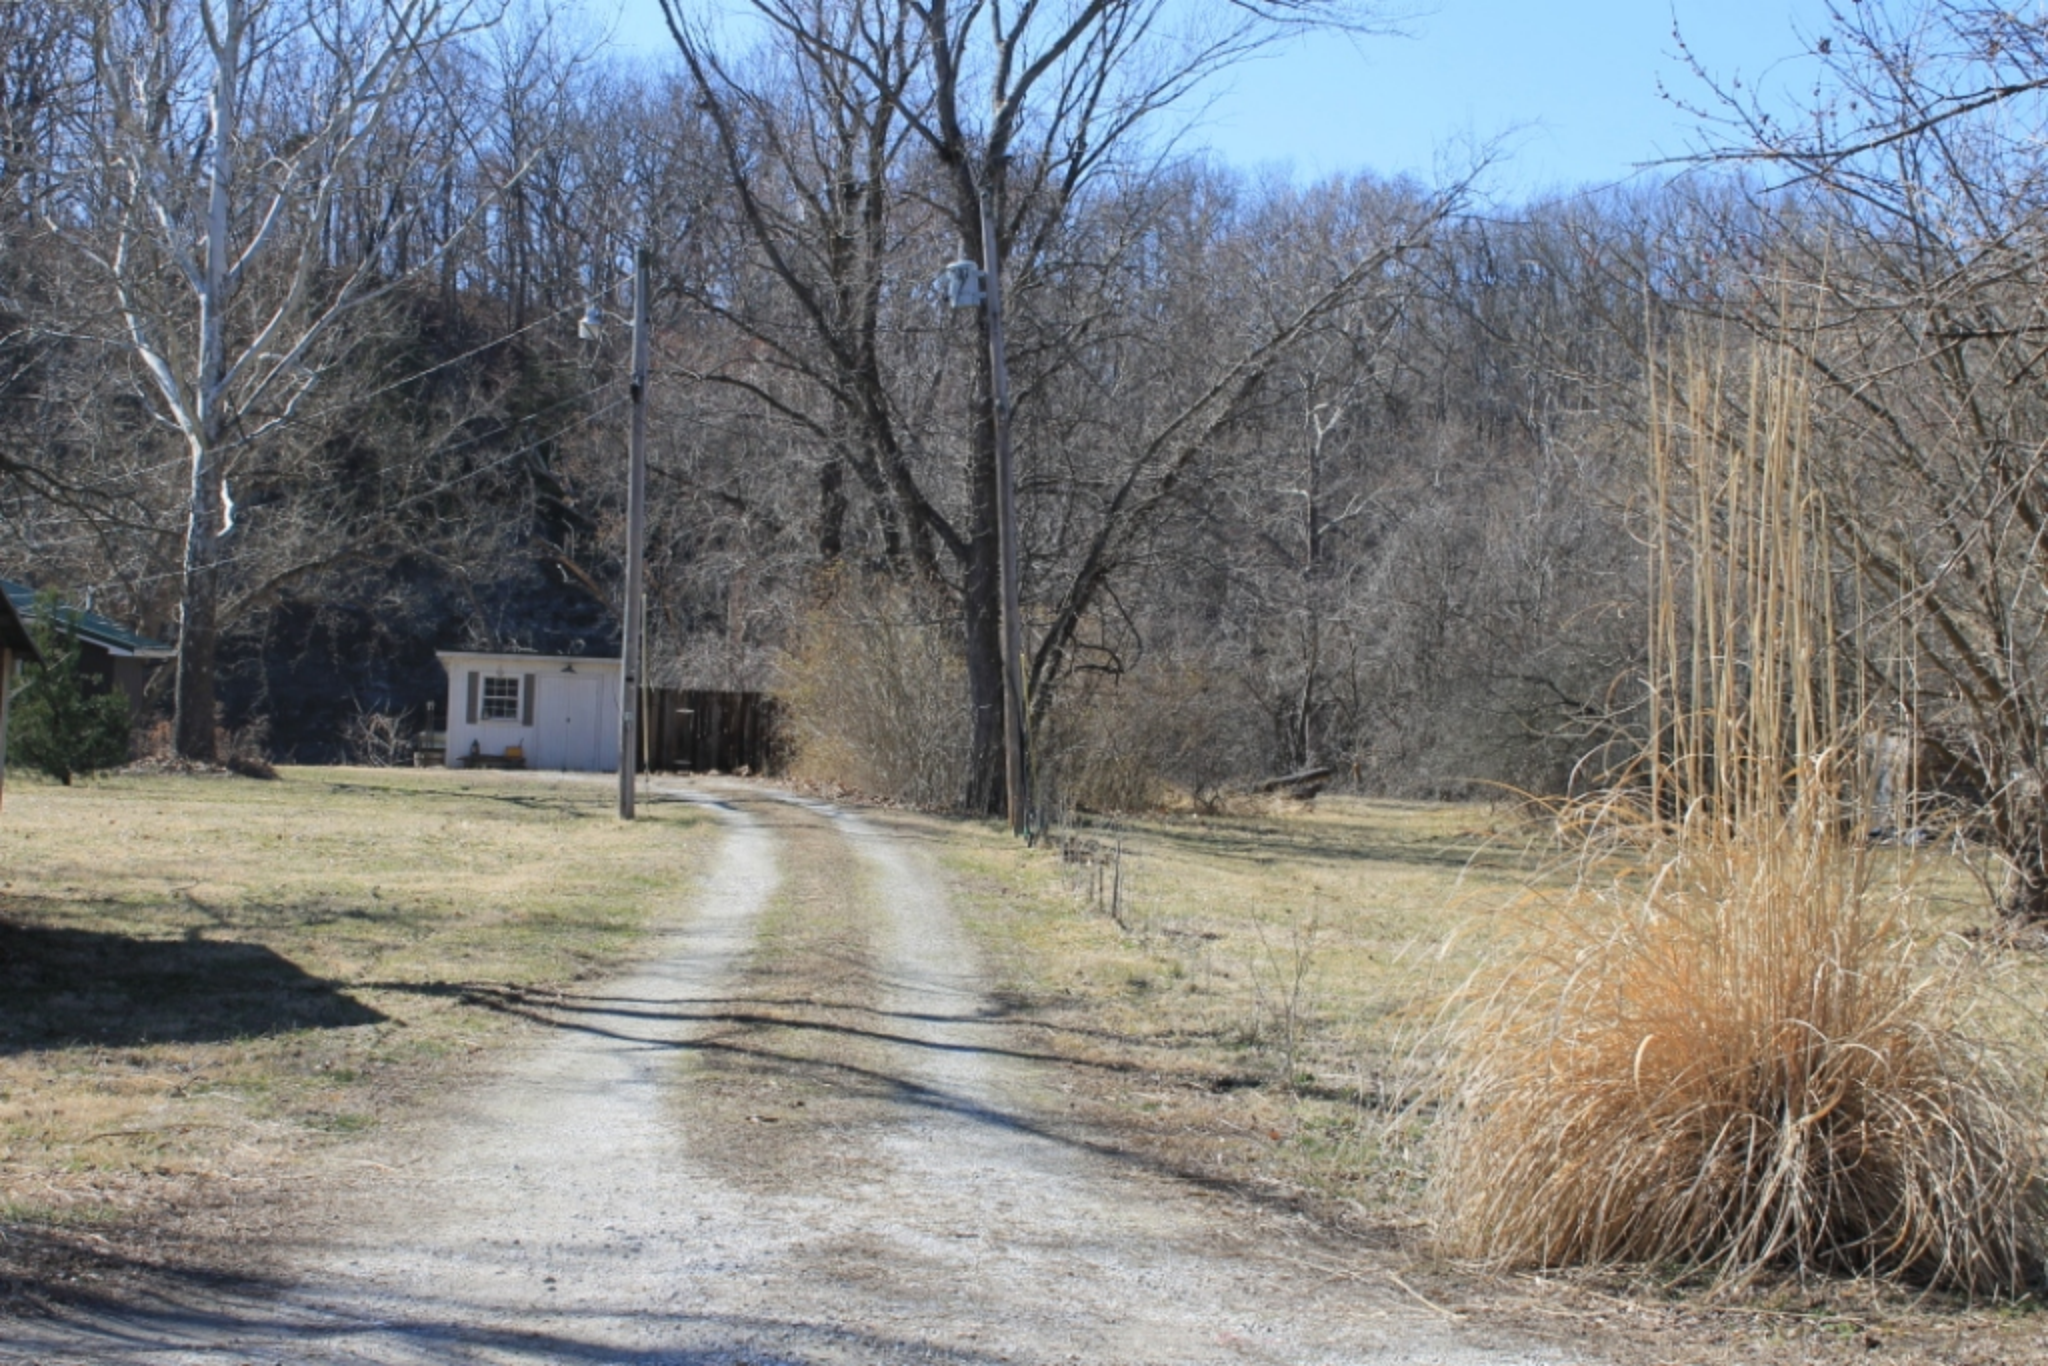
This 1 1/2 story, massed plan gable front, rectangular building has a medium pitched gable roof and a deck facing Moniteau Creek. The building is clad in clapboards and the roof is covered in metal. The first story of the building has four bays on its front (west) facade. The left bay contains a small six-sided fixed pane window. The next bay contains a door. The next bay contains two pair of one-over-one single hung windows. The far right bay contains a larger one-over-one single hung window. The second story has two bays. Under the peak of the gable roof is a bay containing a fixed pane window. On the left is a bay containing a pair of small windows.

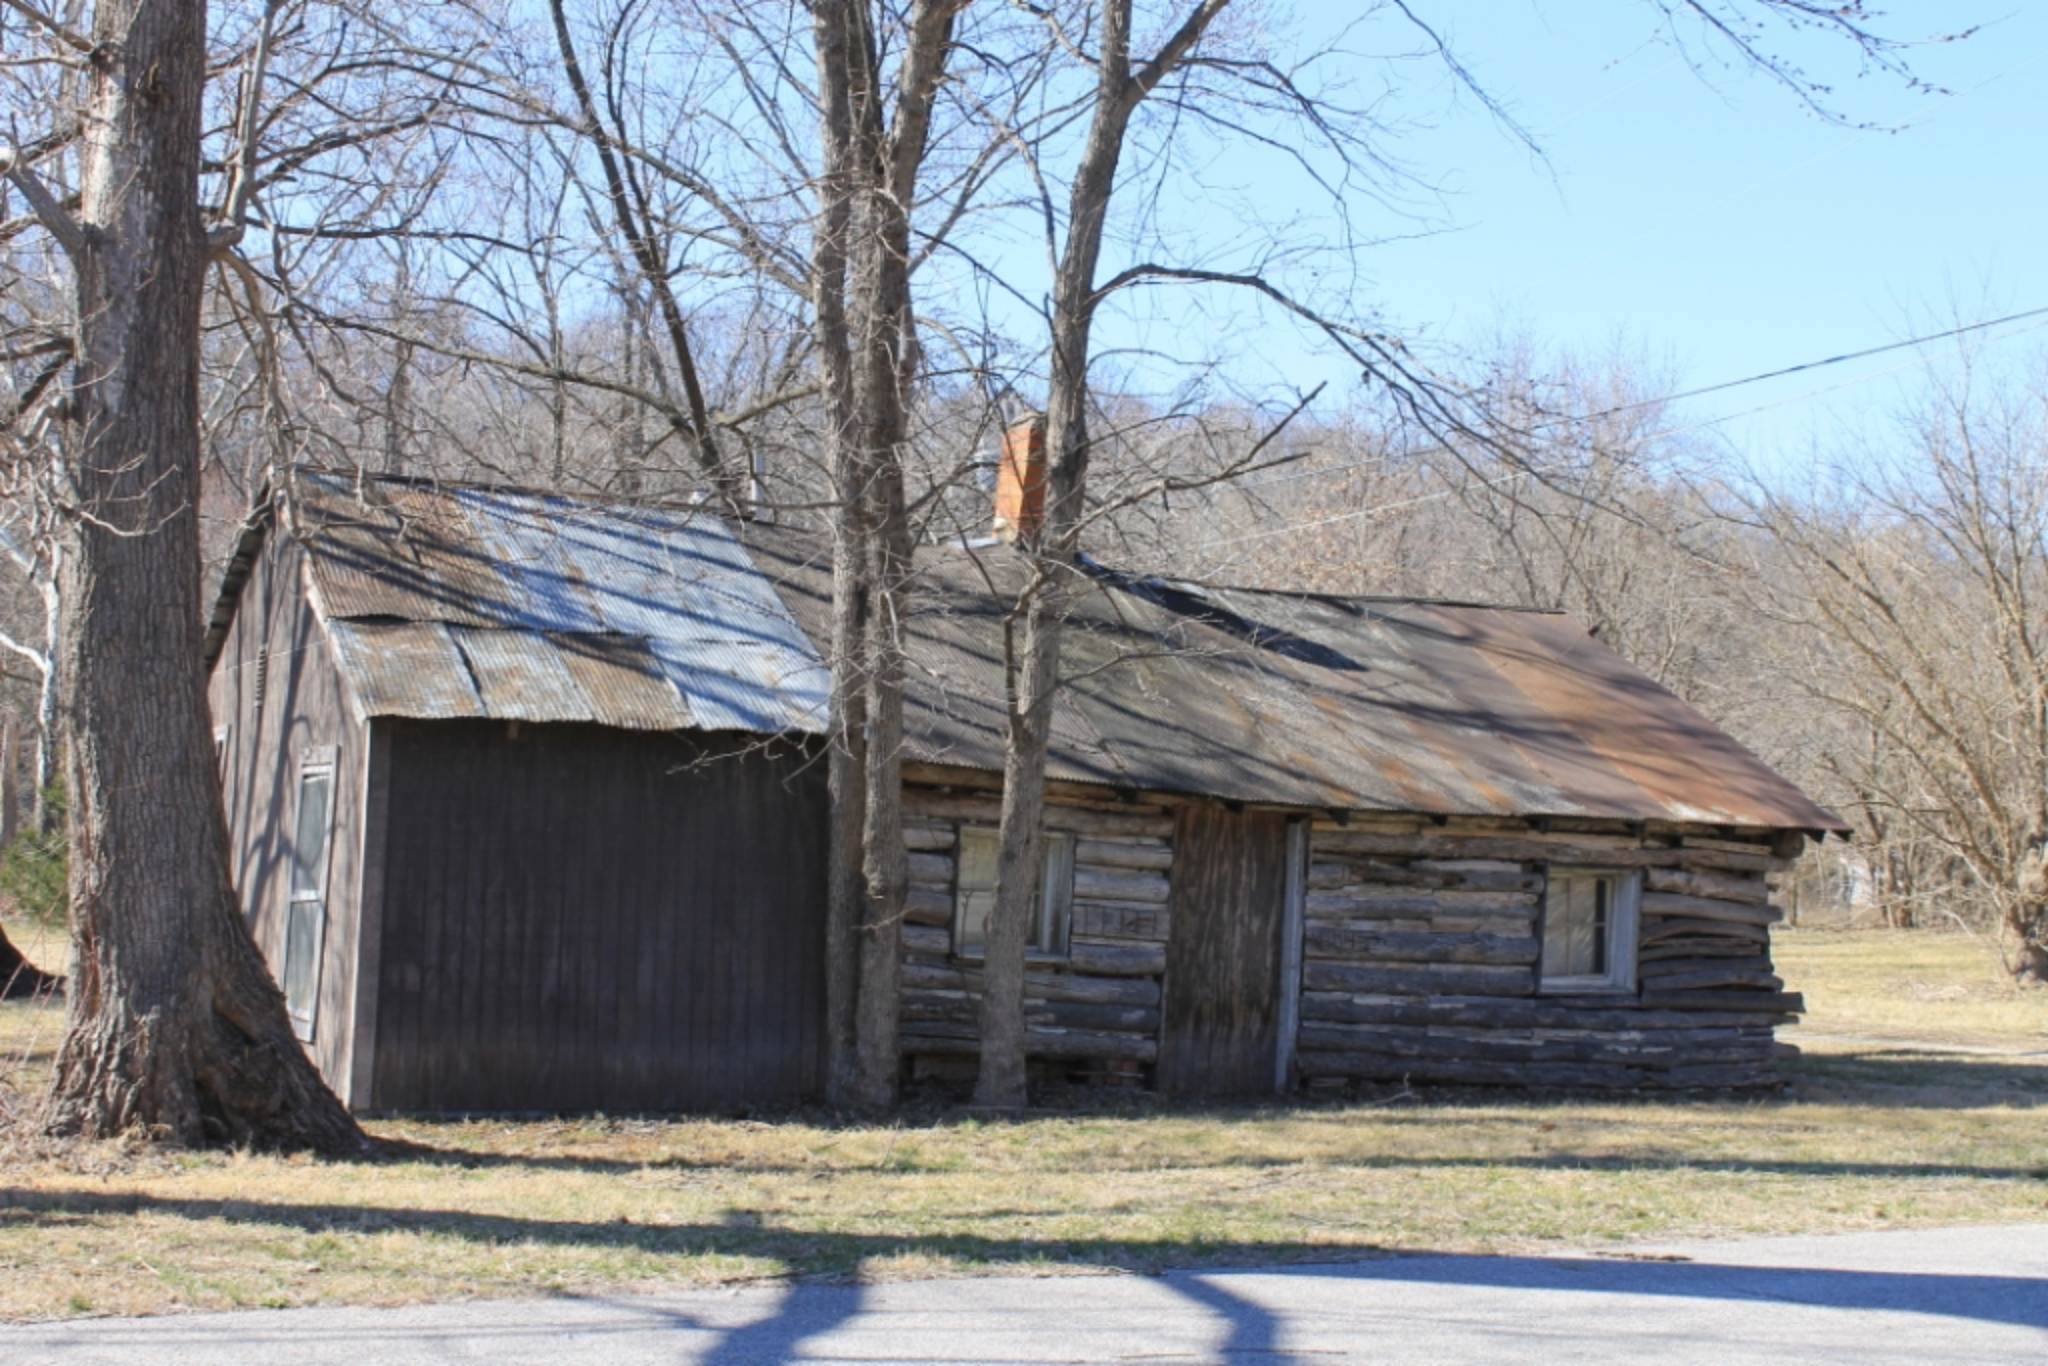
The house is a hall and parlor plan, rectangular shaped log house with a medium gable metal roof. Some of the logs are hewn; others are round. The joints between the logs are chinked with concrete. The south end of the house is covered with vertical plywood siding. The house has three bays on its east facade. The central bay is a door that extends from the threshold to the low roof line. On either side of the door is a bay containing a small four paned window. A chimney is on the central ridge of the building.

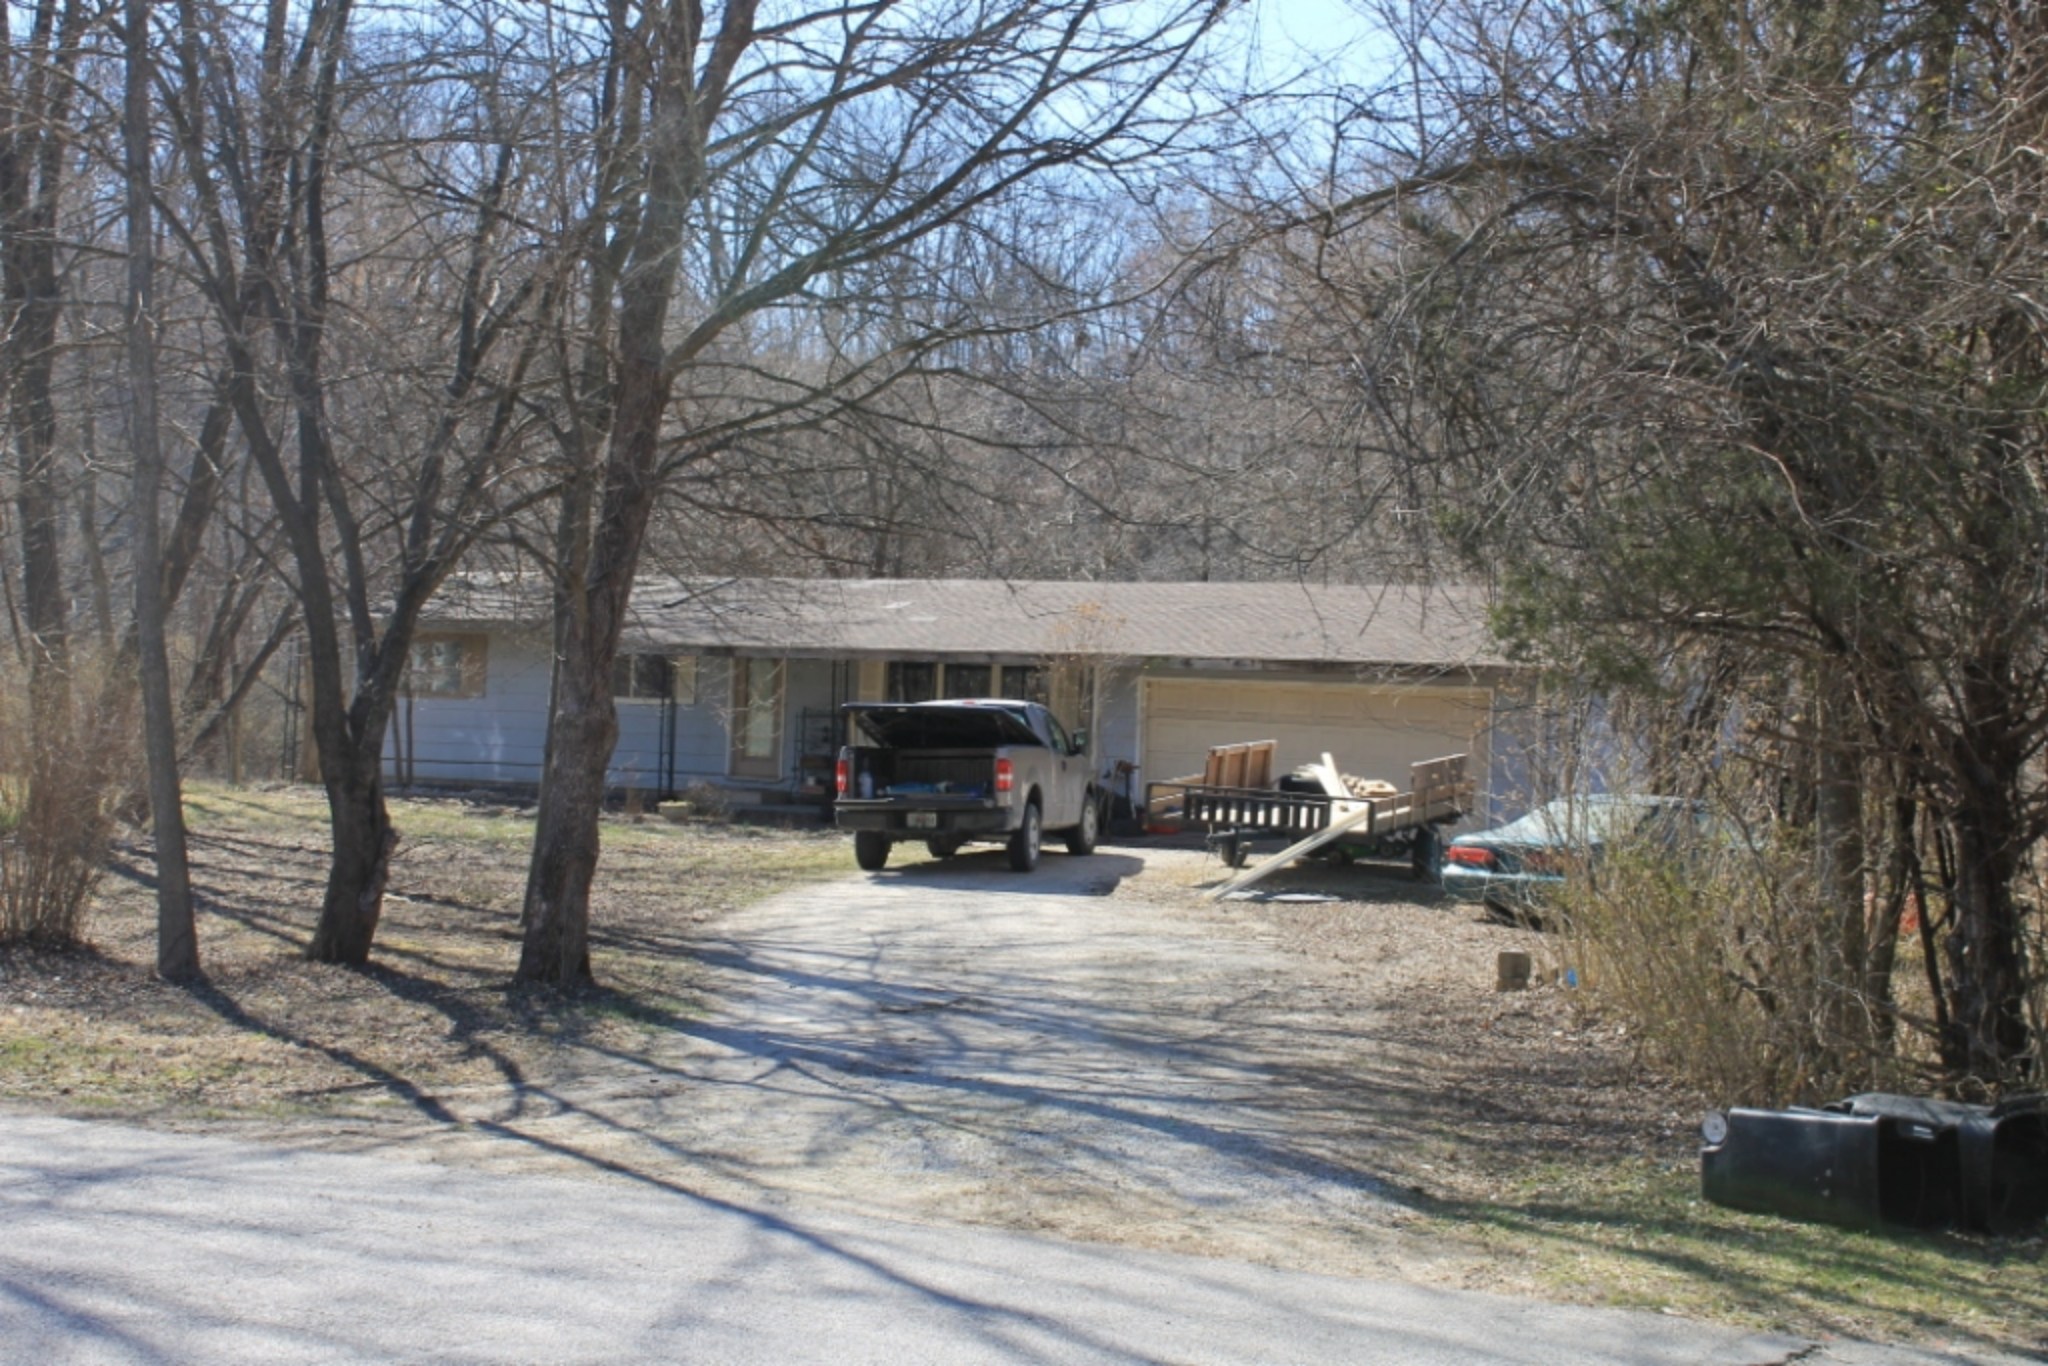
The house is a long one story massed plan side gable house with a low gable roof covered in asphalt shingles. The house is clad in wide synthetic clapboards. The shed roof porch on the east facade gives the house an L shape. The east (front) facade of the house has five bays. The left most bay contains a sliding glass window with two panes. The next bay also contains a sliding glass window with two panes. The next bay contains a door with a glass and metal storm door. The next bay contains three one-over-one windows. The rightmost bay contains an overhead garage door.

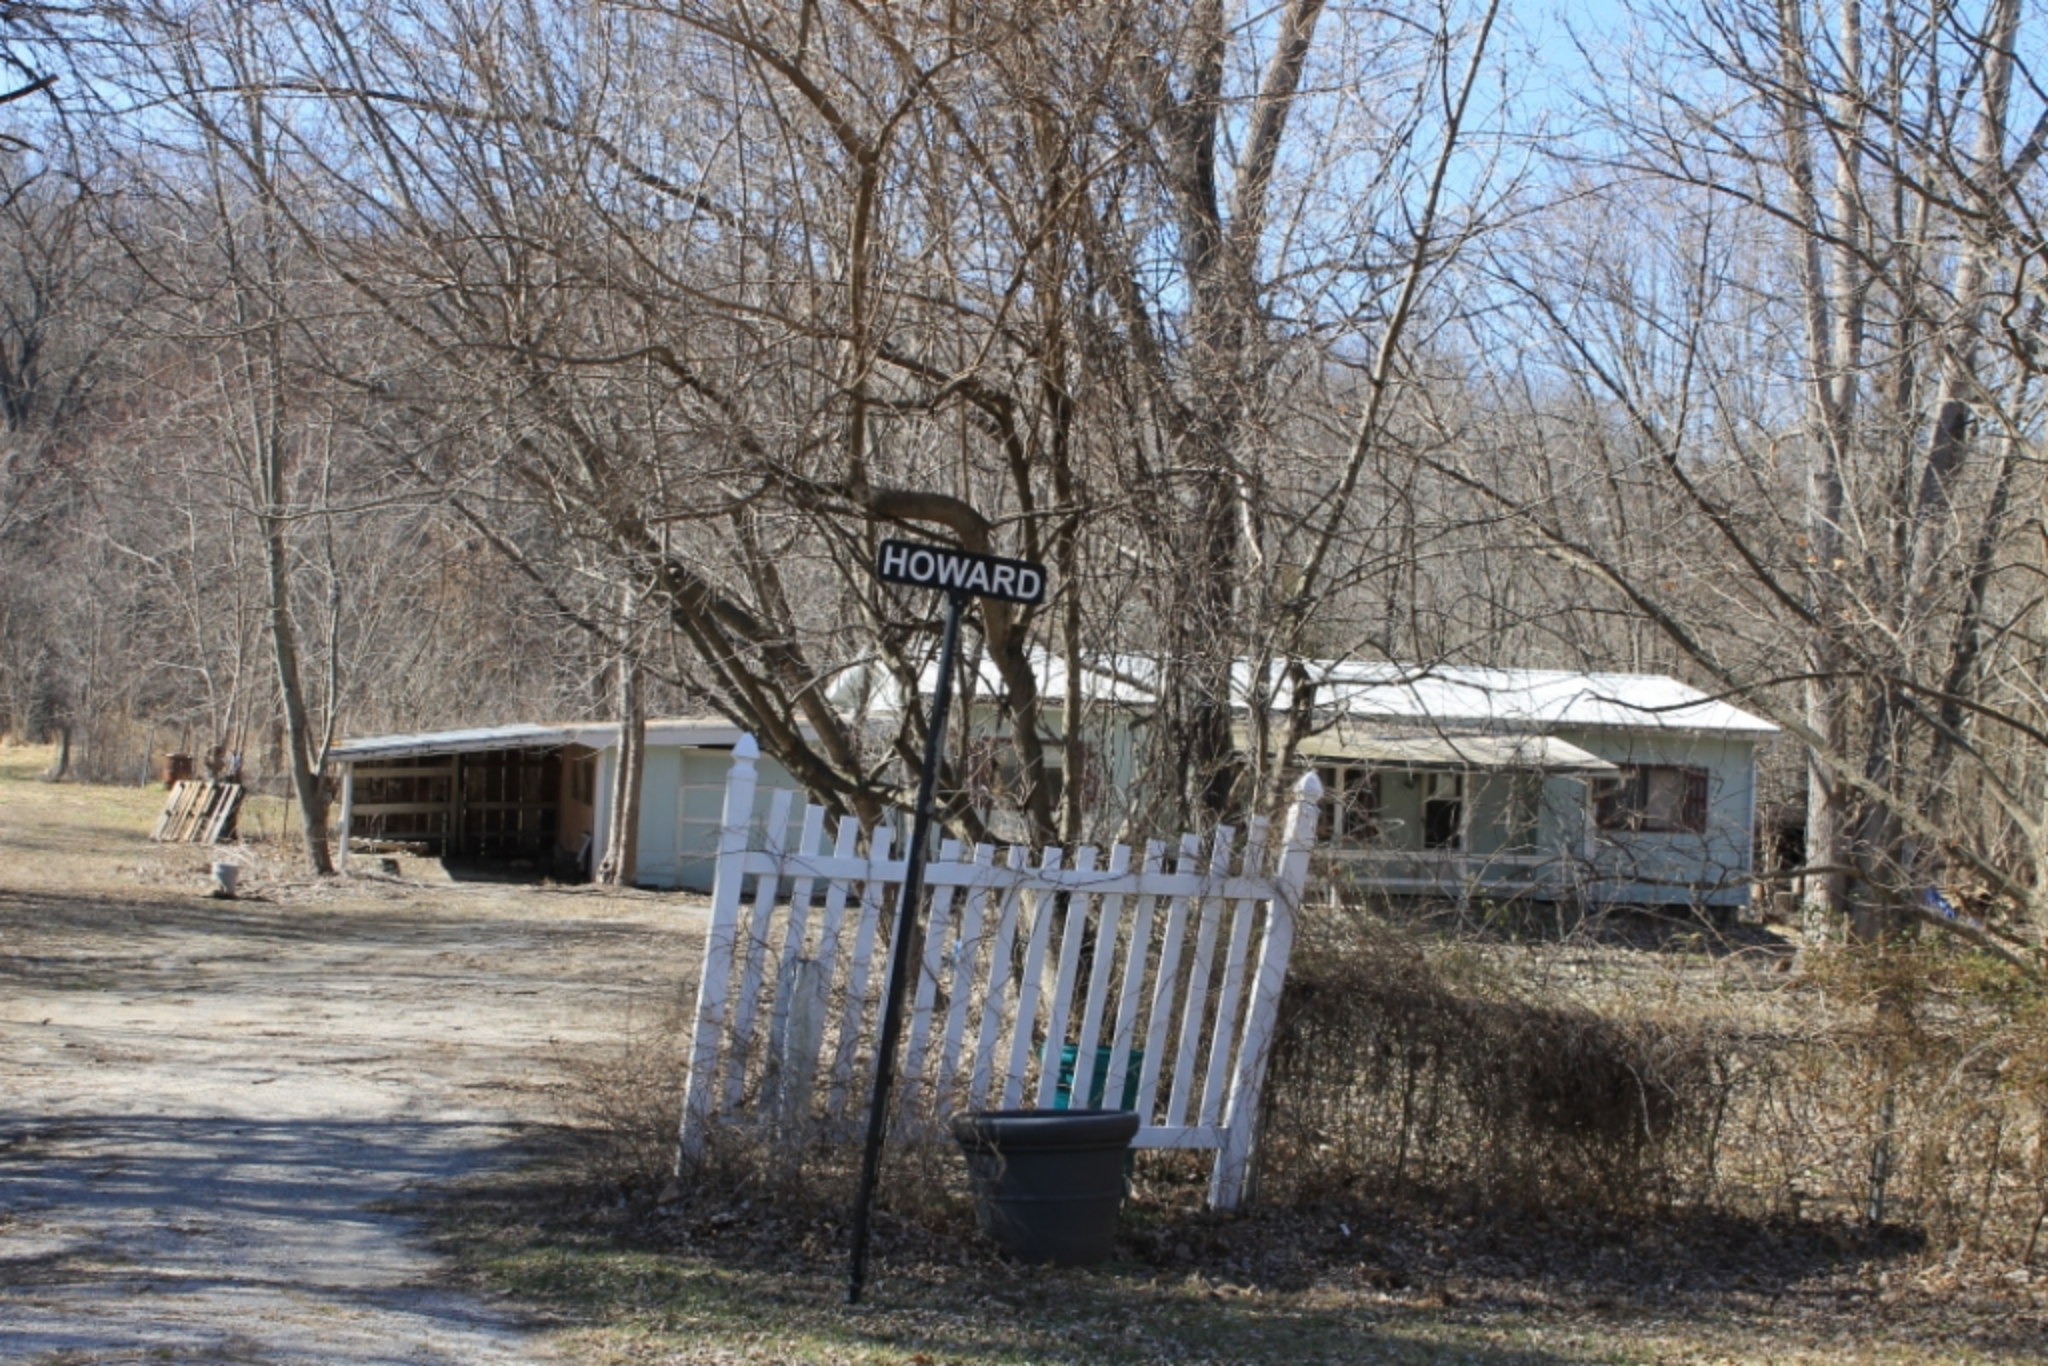
The one story, massed plan double wide mobile home has a low gable roof, a shed roofed addition to the south and a shed roofed porch covering a portion of the front (east) facade. The house is clad in plywood siding and the roof is covered in metal. The house has six bays. The leftmost bay contains a carport. The next bay contains a single car garage with an overhead garage door. The next bay contains a two paned sliding glass window. The next bay contains a larger two-paned sliding glass window. The next bay contains a door with a metal and glass storm door. The right bay contains three a two paned sliding glass window.
