MISSOURI DEPARTMENT OF NATURAL RESOURCES
STATE HISTORIC PRESERVATION OFFICE, P.O. Box 176, Jefferson City, MO 65102
ARCHITECTURAL/HISTORIC INVENTORY FORM

1. SURVEY NO. BO-AS-009-0001		2. SURVEY NAME: Rocheport Historic District	
3. COUNTY: Boone		4. ADDRESS (STREET NO.)	STREET (NAME) Katy Trail
5. CITY: Rocheport	VICINITY: <input checked="" type="checkbox"/>	6. UTM: / /	LAT: LONG: T: 48W R: 15W S: 1

8. HISTORIC NAME (IF KNOWN): M.K.&T. Railroad tunnel		9. PRESENT/OTHER NAME (IF KNOWN): Katy trail tunnel	
10. OWNERSHIP: <input type="checkbox"/> PRIVATE <input checked="" type="checkbox"/> PUBLIC		11A. HISTORIC USE (IF KNOWN): railroad tunnel	11B. CURRENT USE: Katy Trail tunnel
HISTORICAL INFORMATION

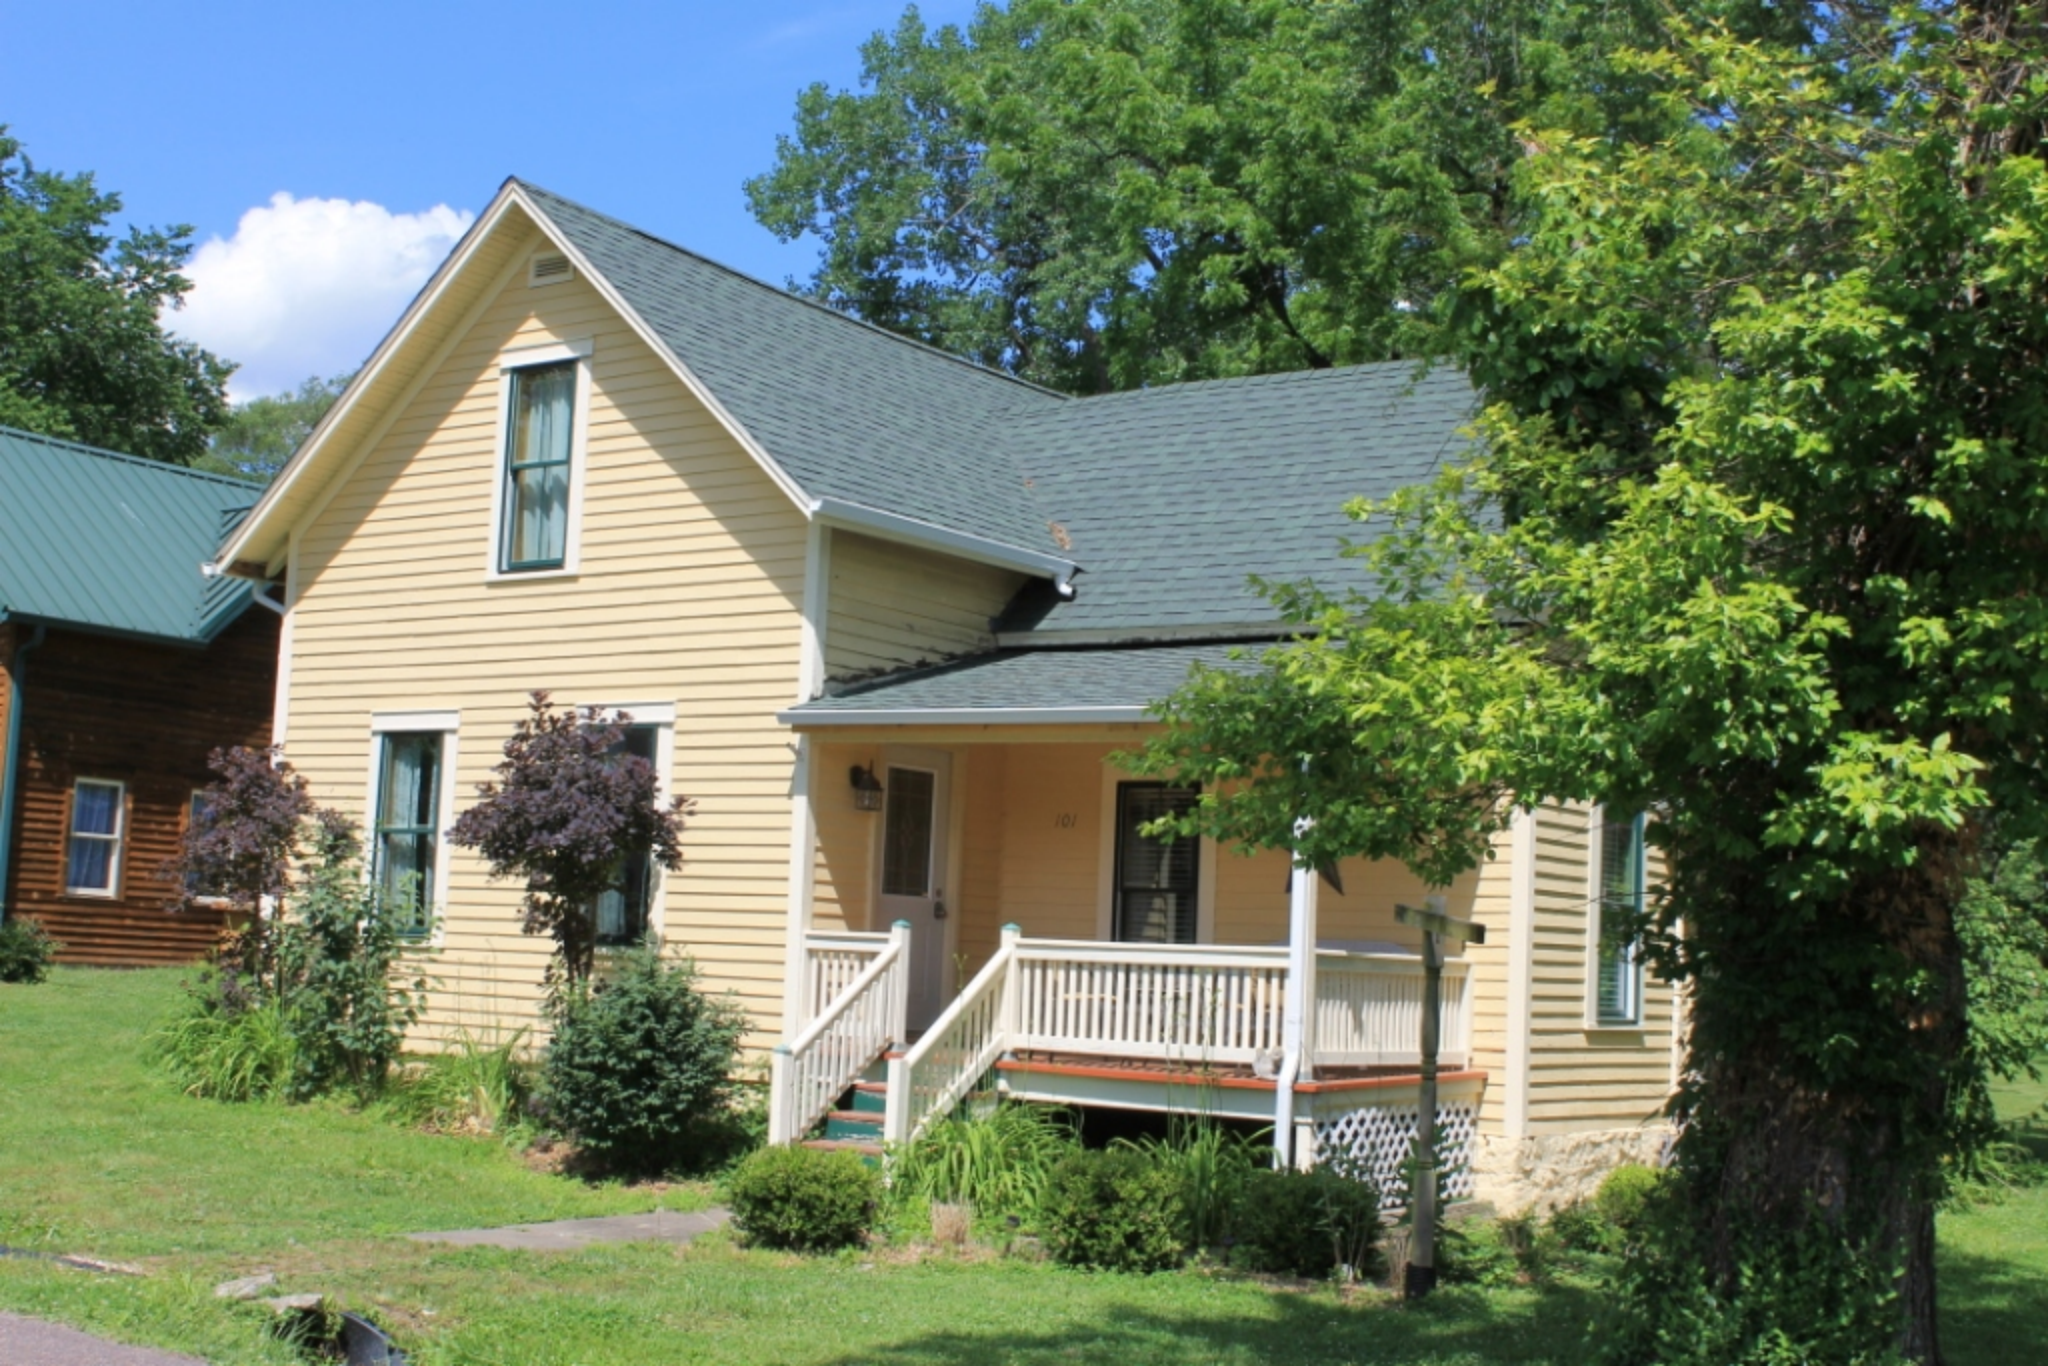
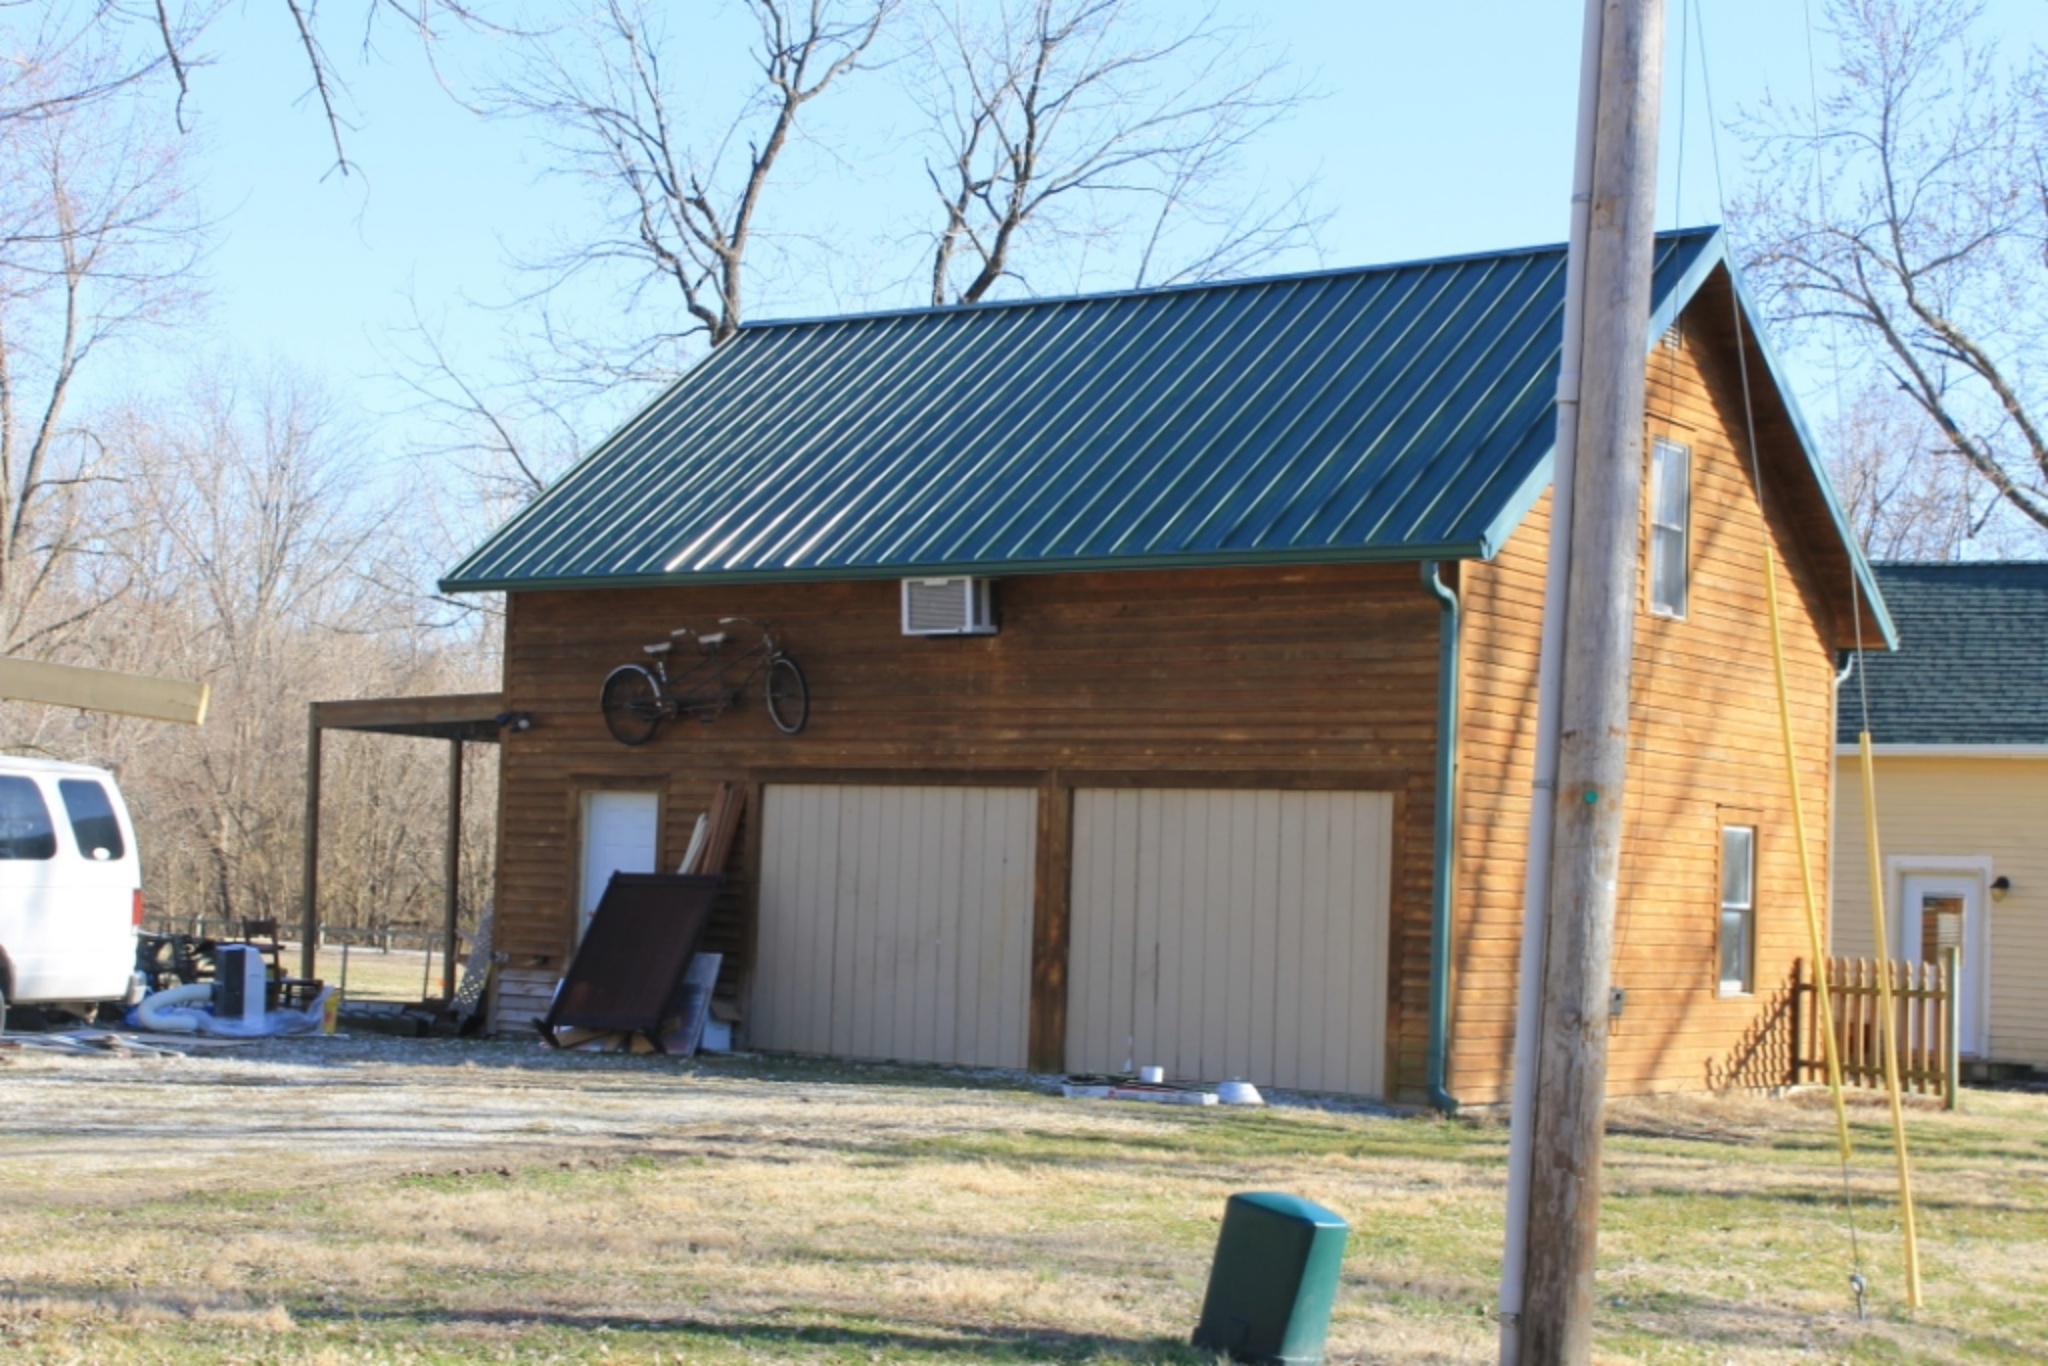
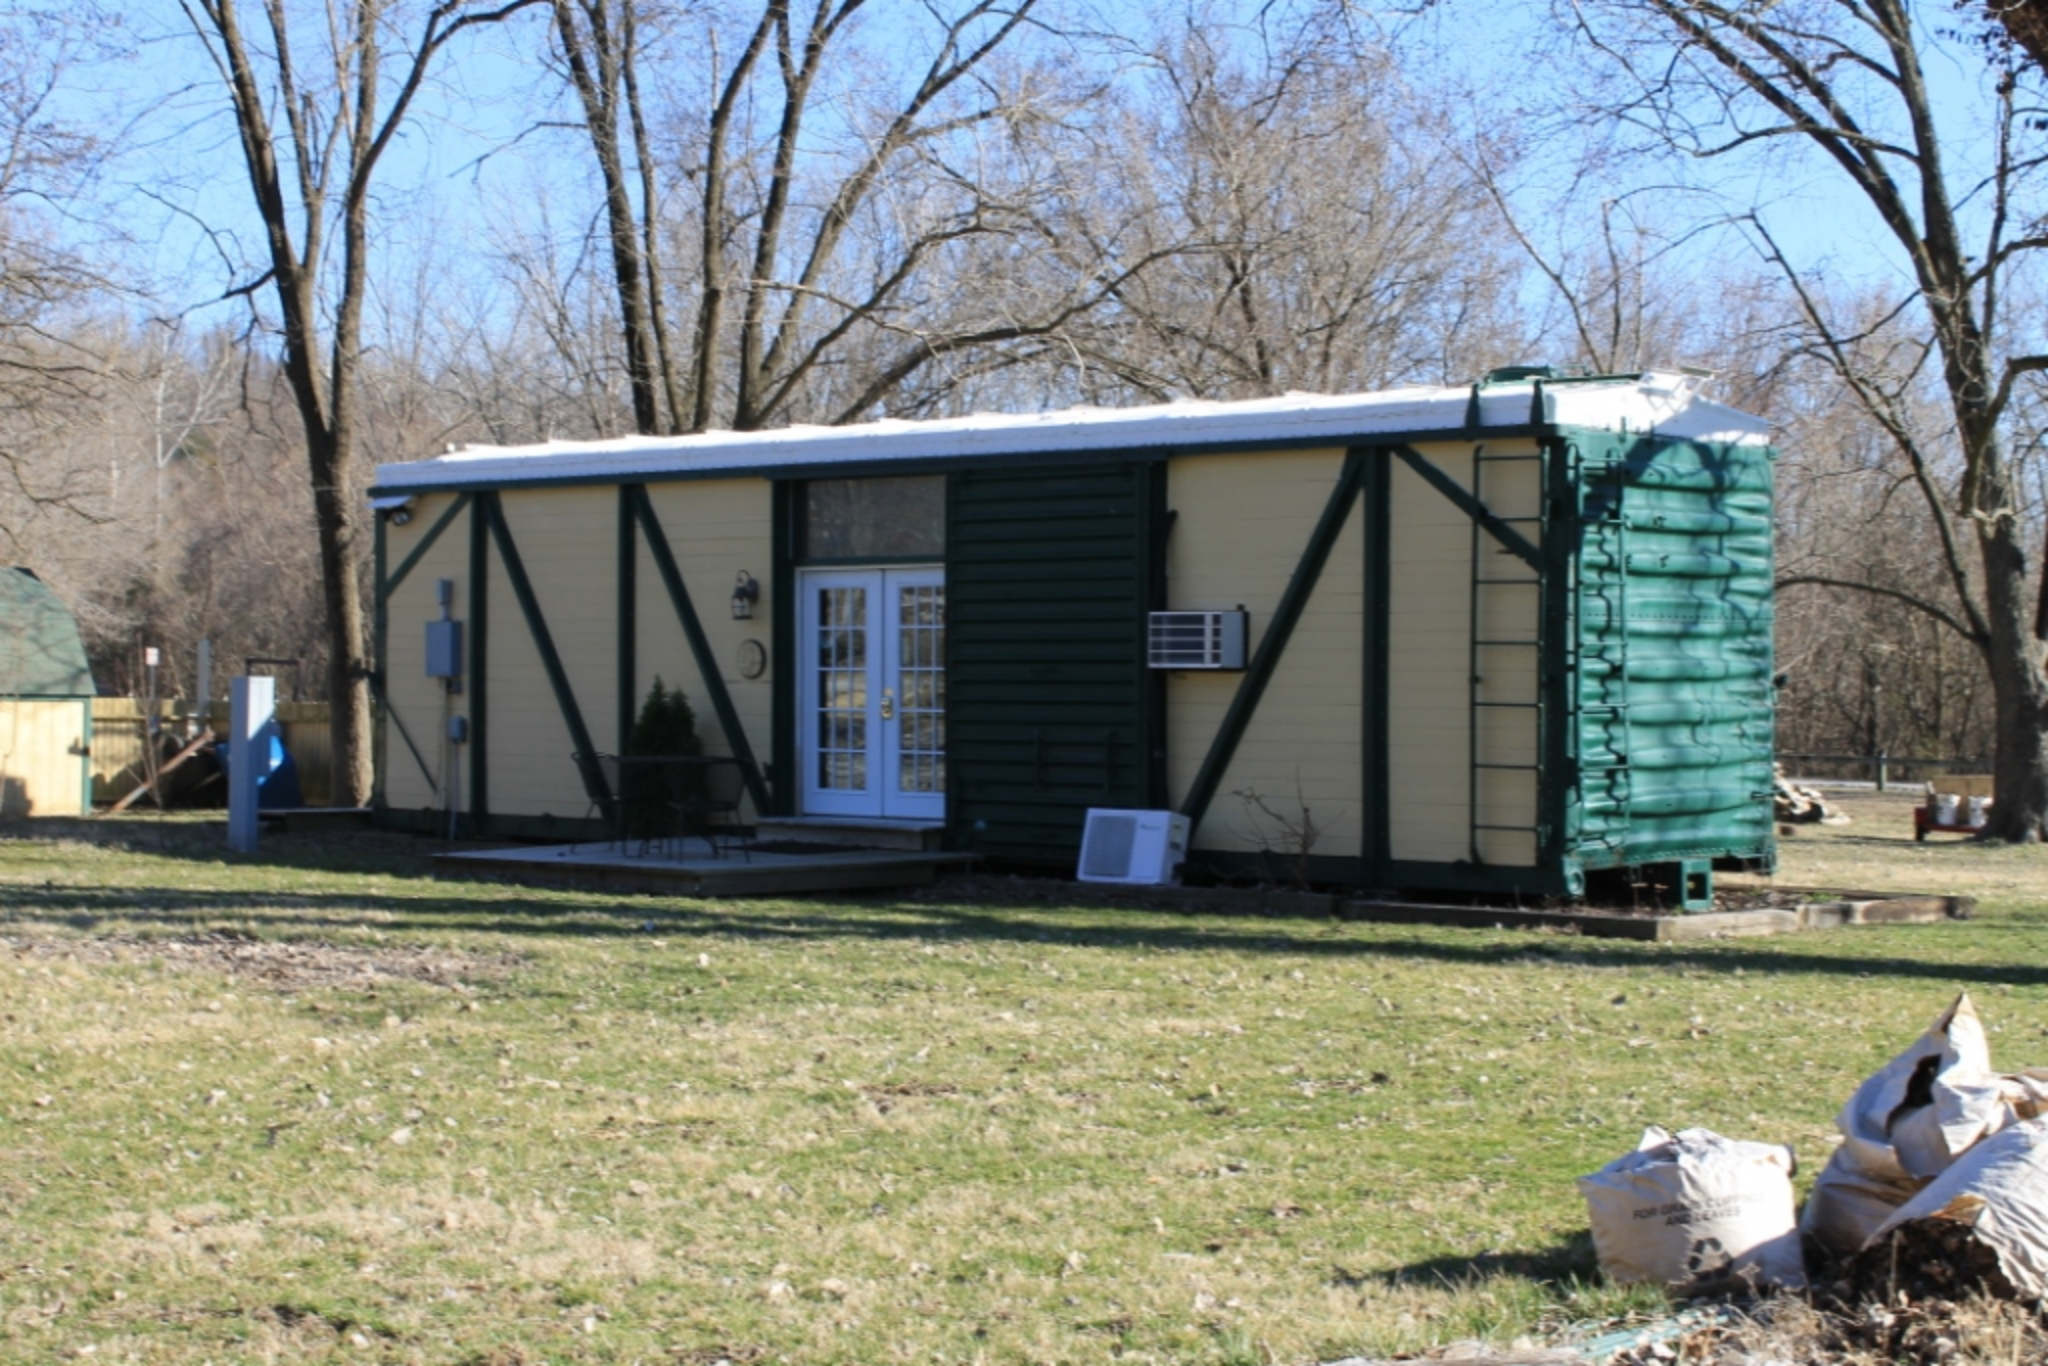
This 1 1/2 story, massed plan gable and wing, frame building has a high intersecting gable roof. The front gable wing faces west; the other wing has a hipped roof and faces south. The walls are clad in clapboards and the roof is covered in asphalt shingles. At the point where the two roof lines meet is a shed roofed porch supported by a wooden posts. The first story of the front (west) facade has three bays. The two left bays each contain a two-over-two single hung window. The right bay, which is under the porch, contains a two-over-two single hung window. Under the front (west) facing gable on the second story of the front (west) facade is a two-over-two single hung window. The south facade has three bays. The left bay, which is under the front porch, contains a door. The next bay contains a two-over-two single hung window. The rightmost bay on the south facade contains a door and is located under a small gable roofed porch that opens to the south.

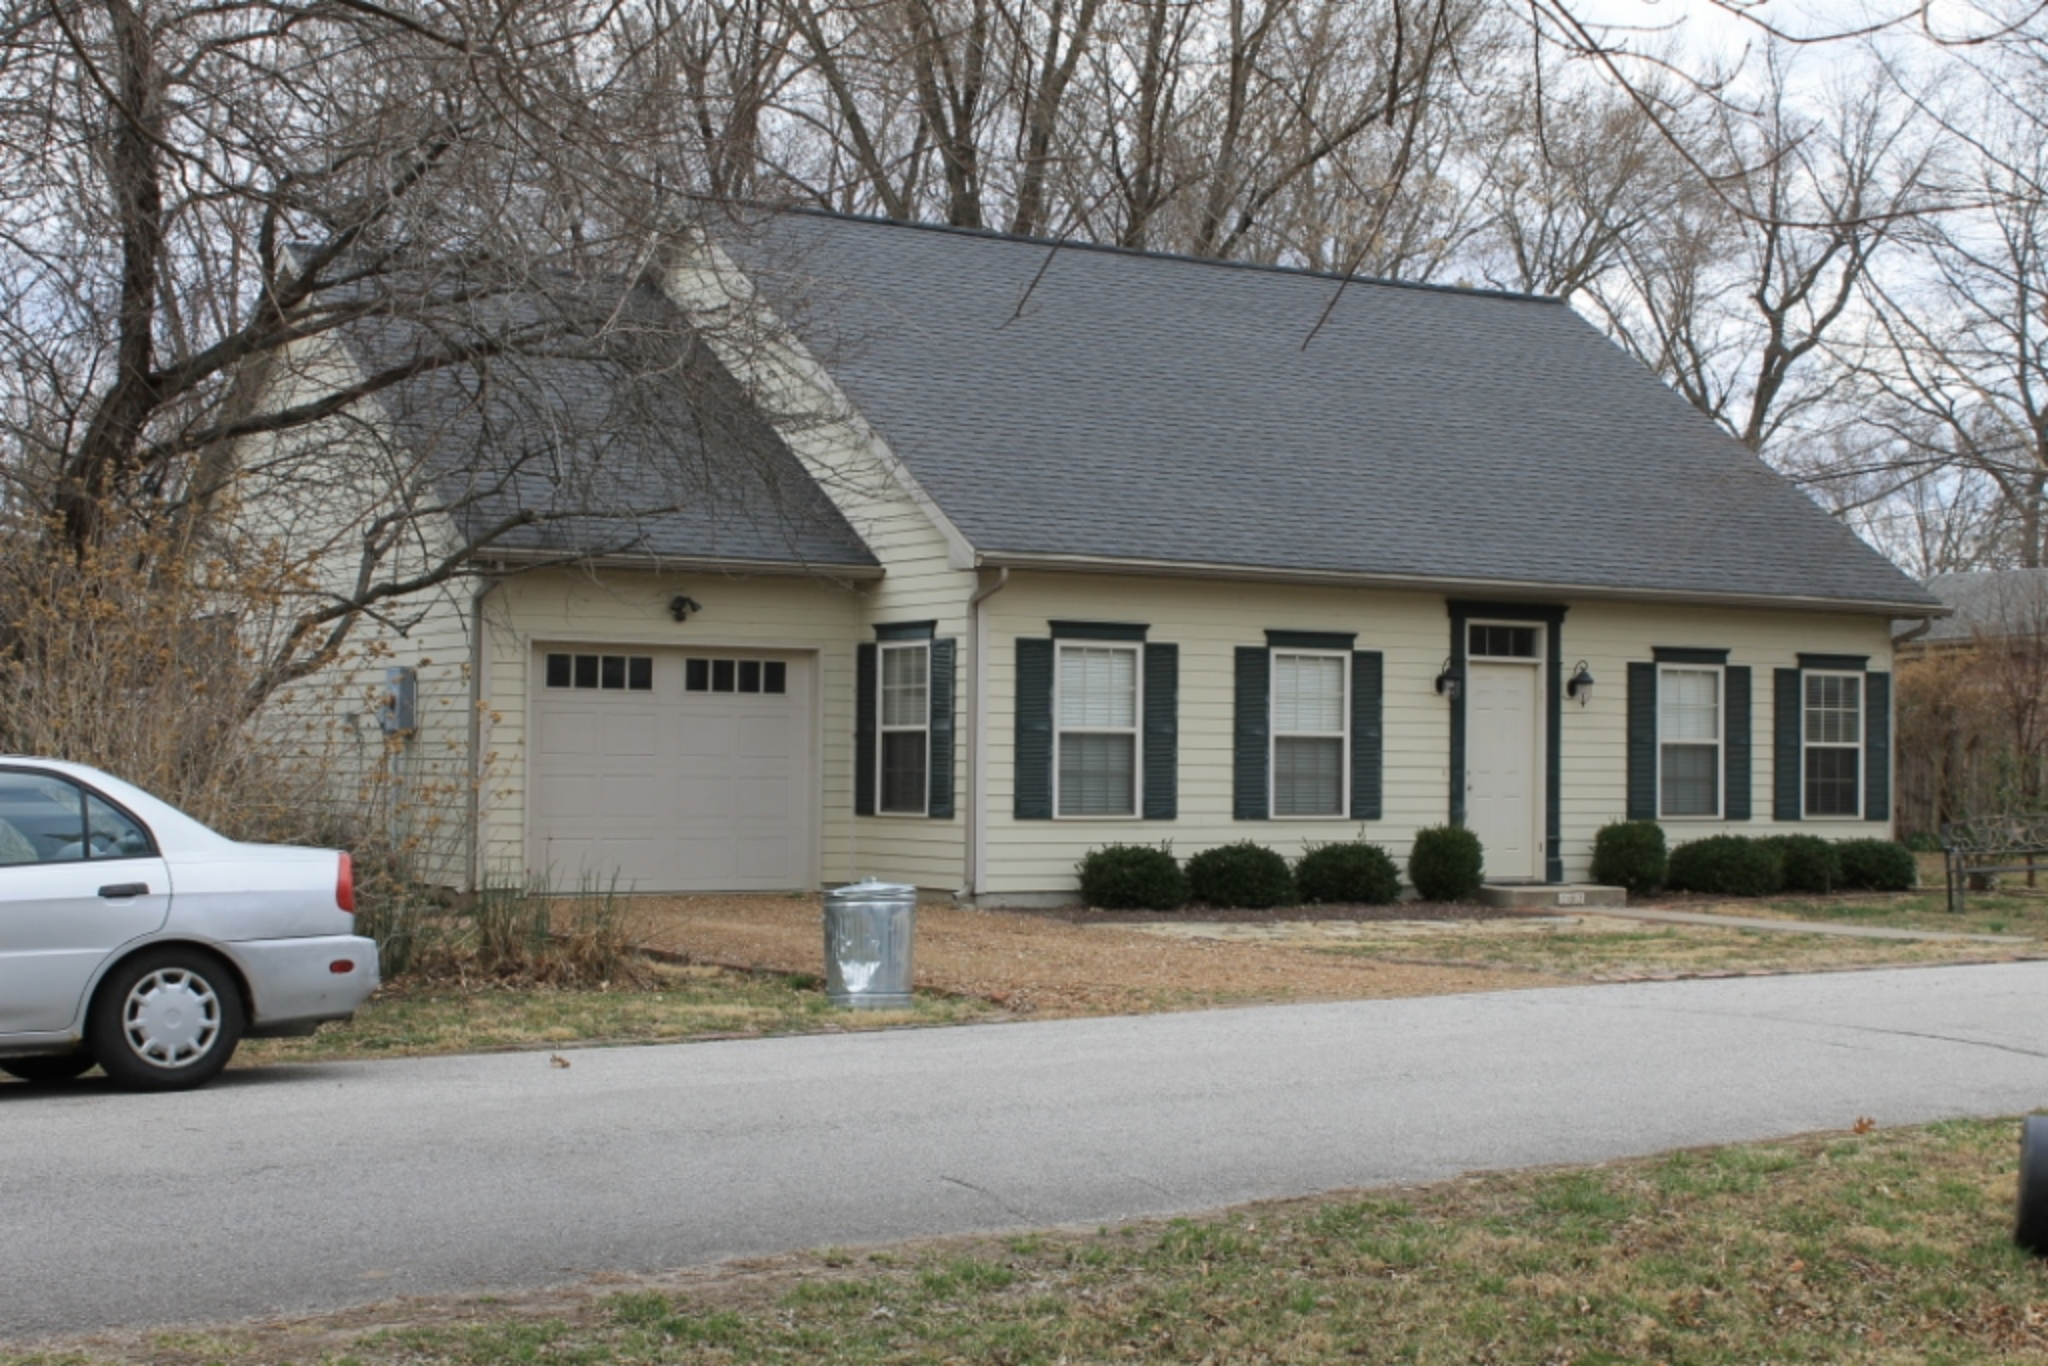
This 1 1/2 story, massed plan side gable, frame dwelling has a high gable roof and a shed roofed gable in the rear. A garage wing with a side gable roof lower than that of the main block of the house sits to the south of the main block of the building. The building is clad in clapboards and the roof is covered in asphalt shingles. The building has elements of Federal style. The front facade has six bays. The leftmost bay contains an overhead garage door. The next two bays each contain a six-over-six single hung vinyl window. The center bay contains a wooden door with a three paned transom. The sides of the door frame are accented with pilasters. The two right bays each contain a six-over-six single hung vinyl window. The prominent lintels of the door and of the windows are highlighted with green paint that matches the posts of the door and the decorative shutters. The second story of the side facade of the house has one bay centered under the gable that contains one small one-over-one single hung window.

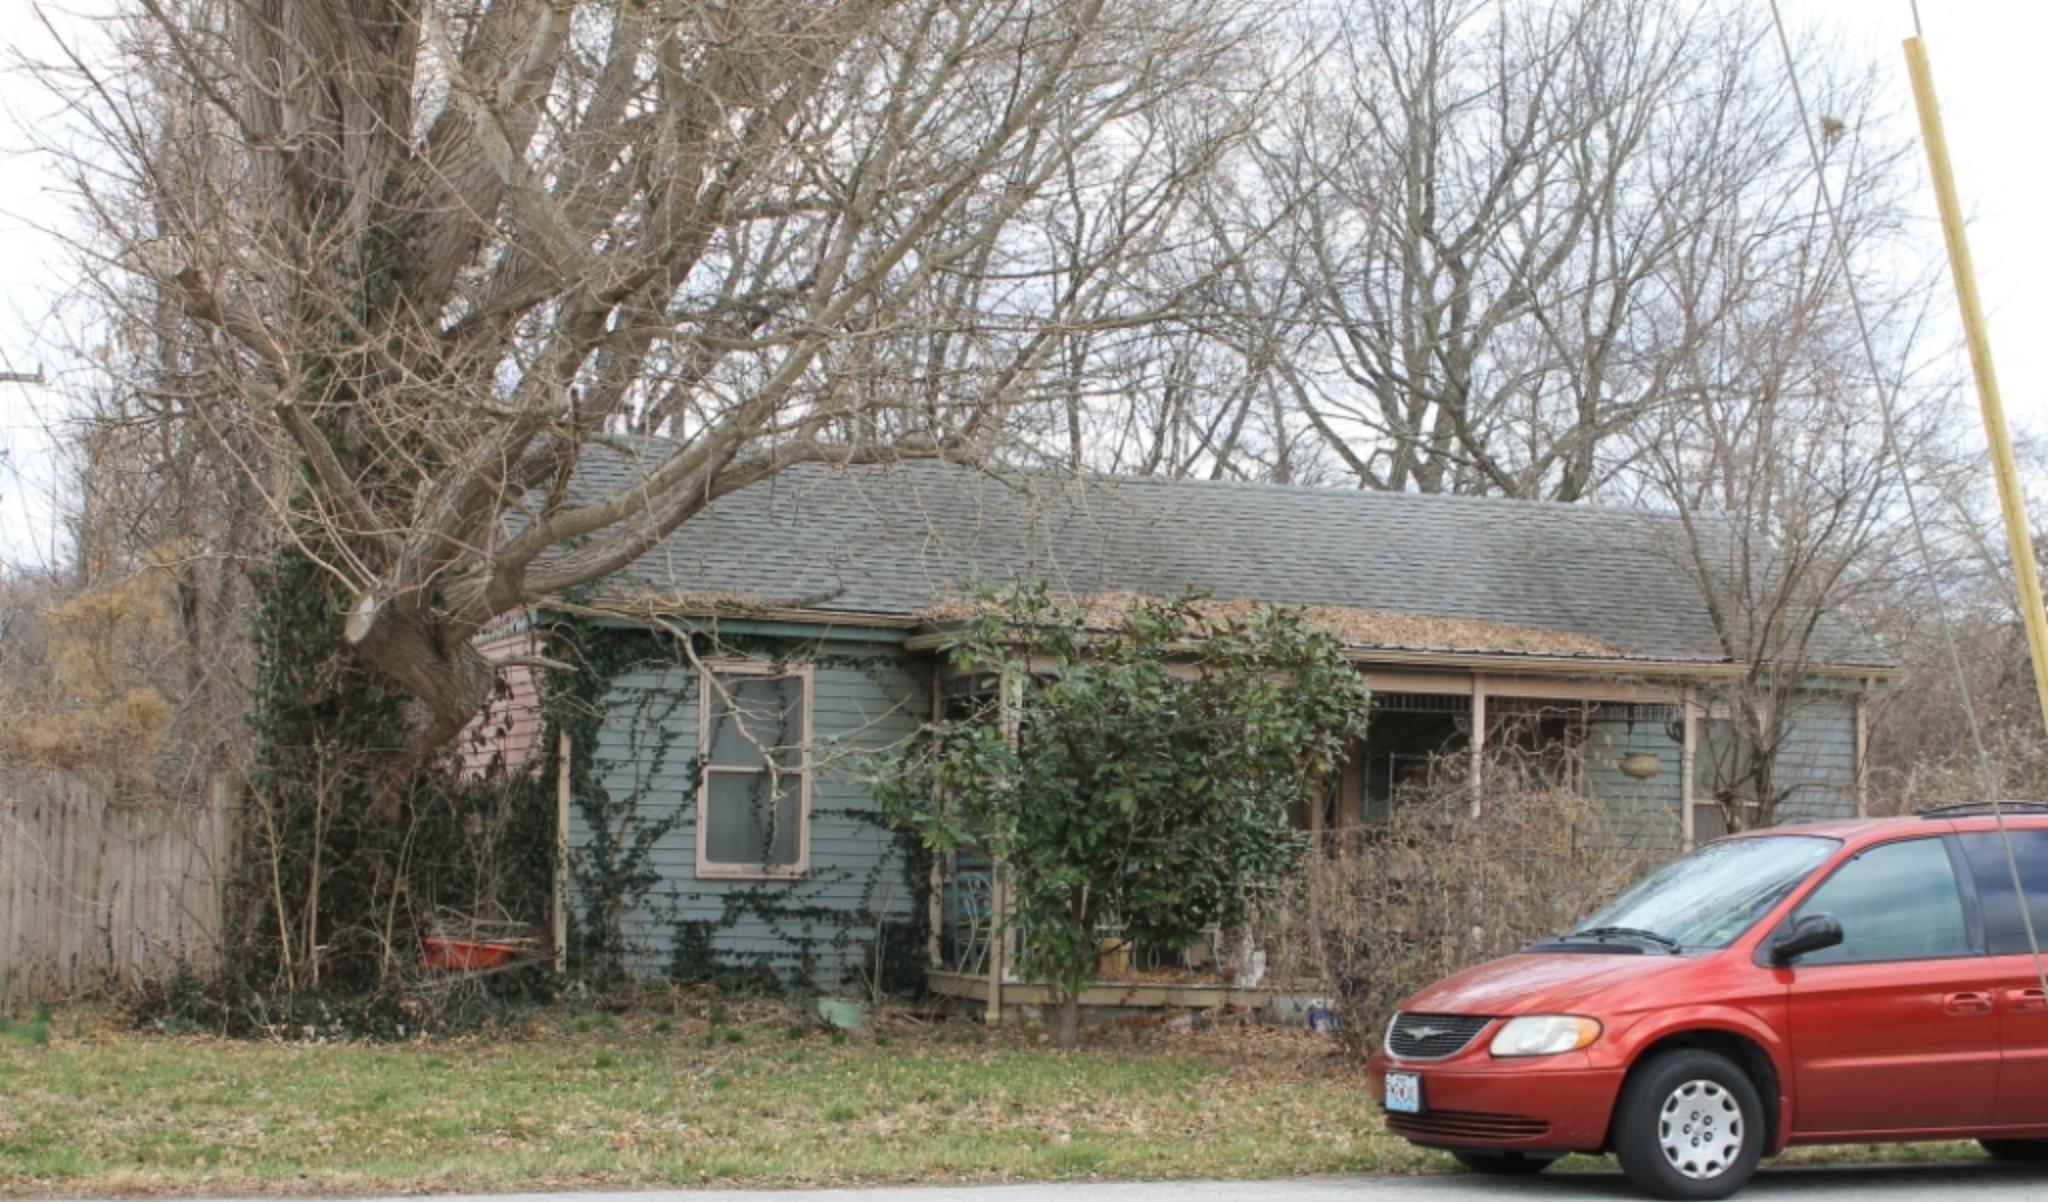
This one story, hall and parlor house has a gable roofed addition to the rear that gives the house a T shape. The house is clad in clapboards and the roof is covered in asphalt shingles. The house has a shed roof front porch that, according to an image from 2013 provided by Google Maps, at one time was decorated with a spandrel with turned spindles and decorative corner brackets. The building has five bays. The two left bays each contain a one-over-one single hung wooden window. The center bay contains a door. The right two bays each contain a one-over-one single hung wooden window. The area under the gable on the south facade is clad in fishlap shingles. The house is in poor condition.

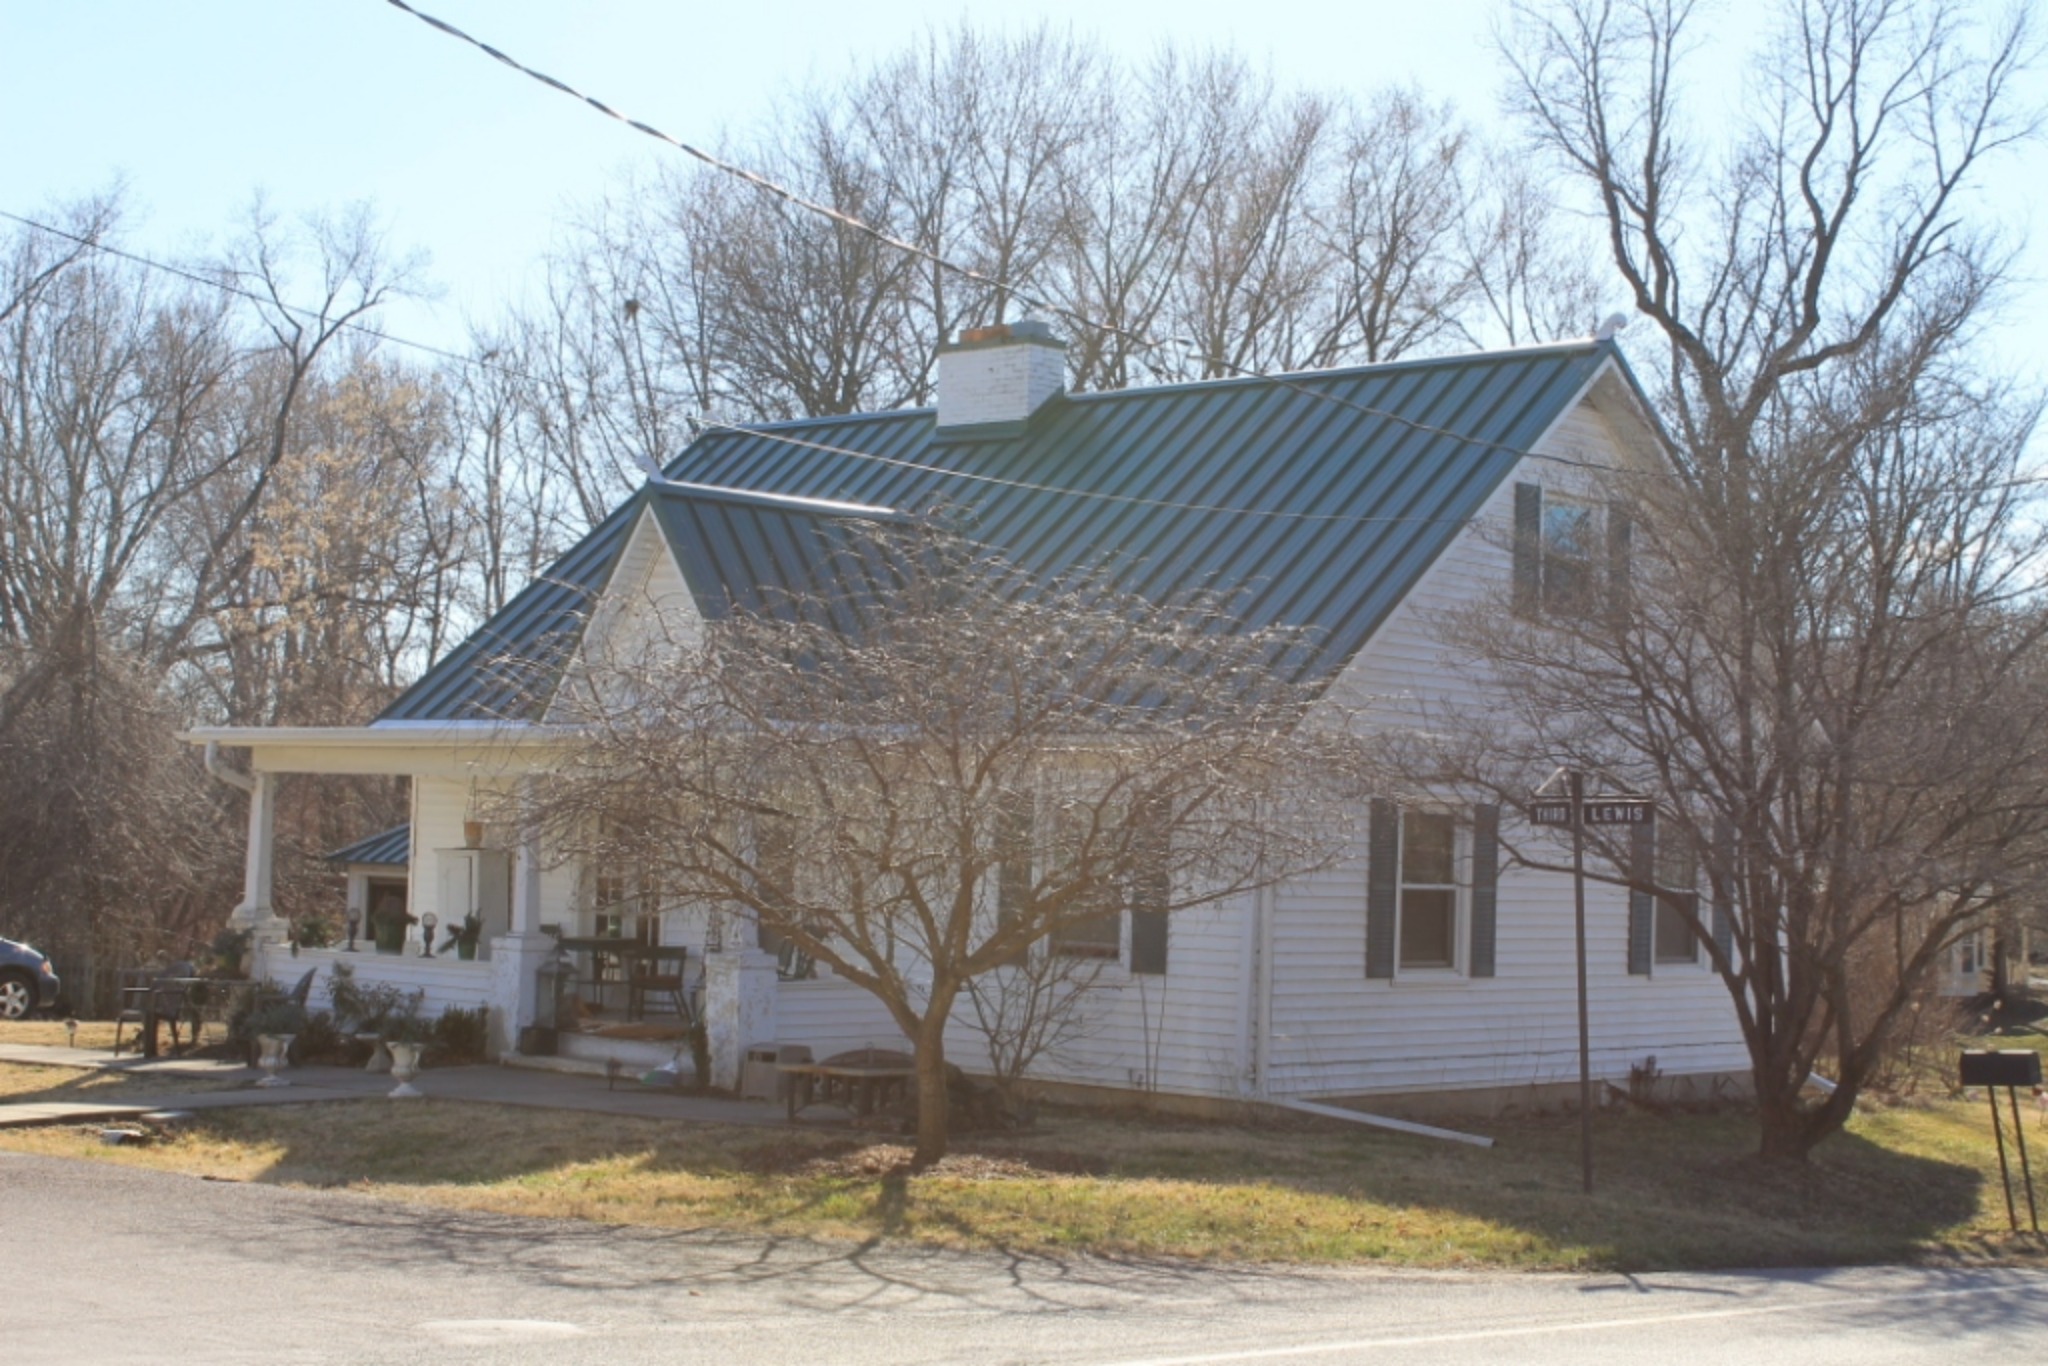
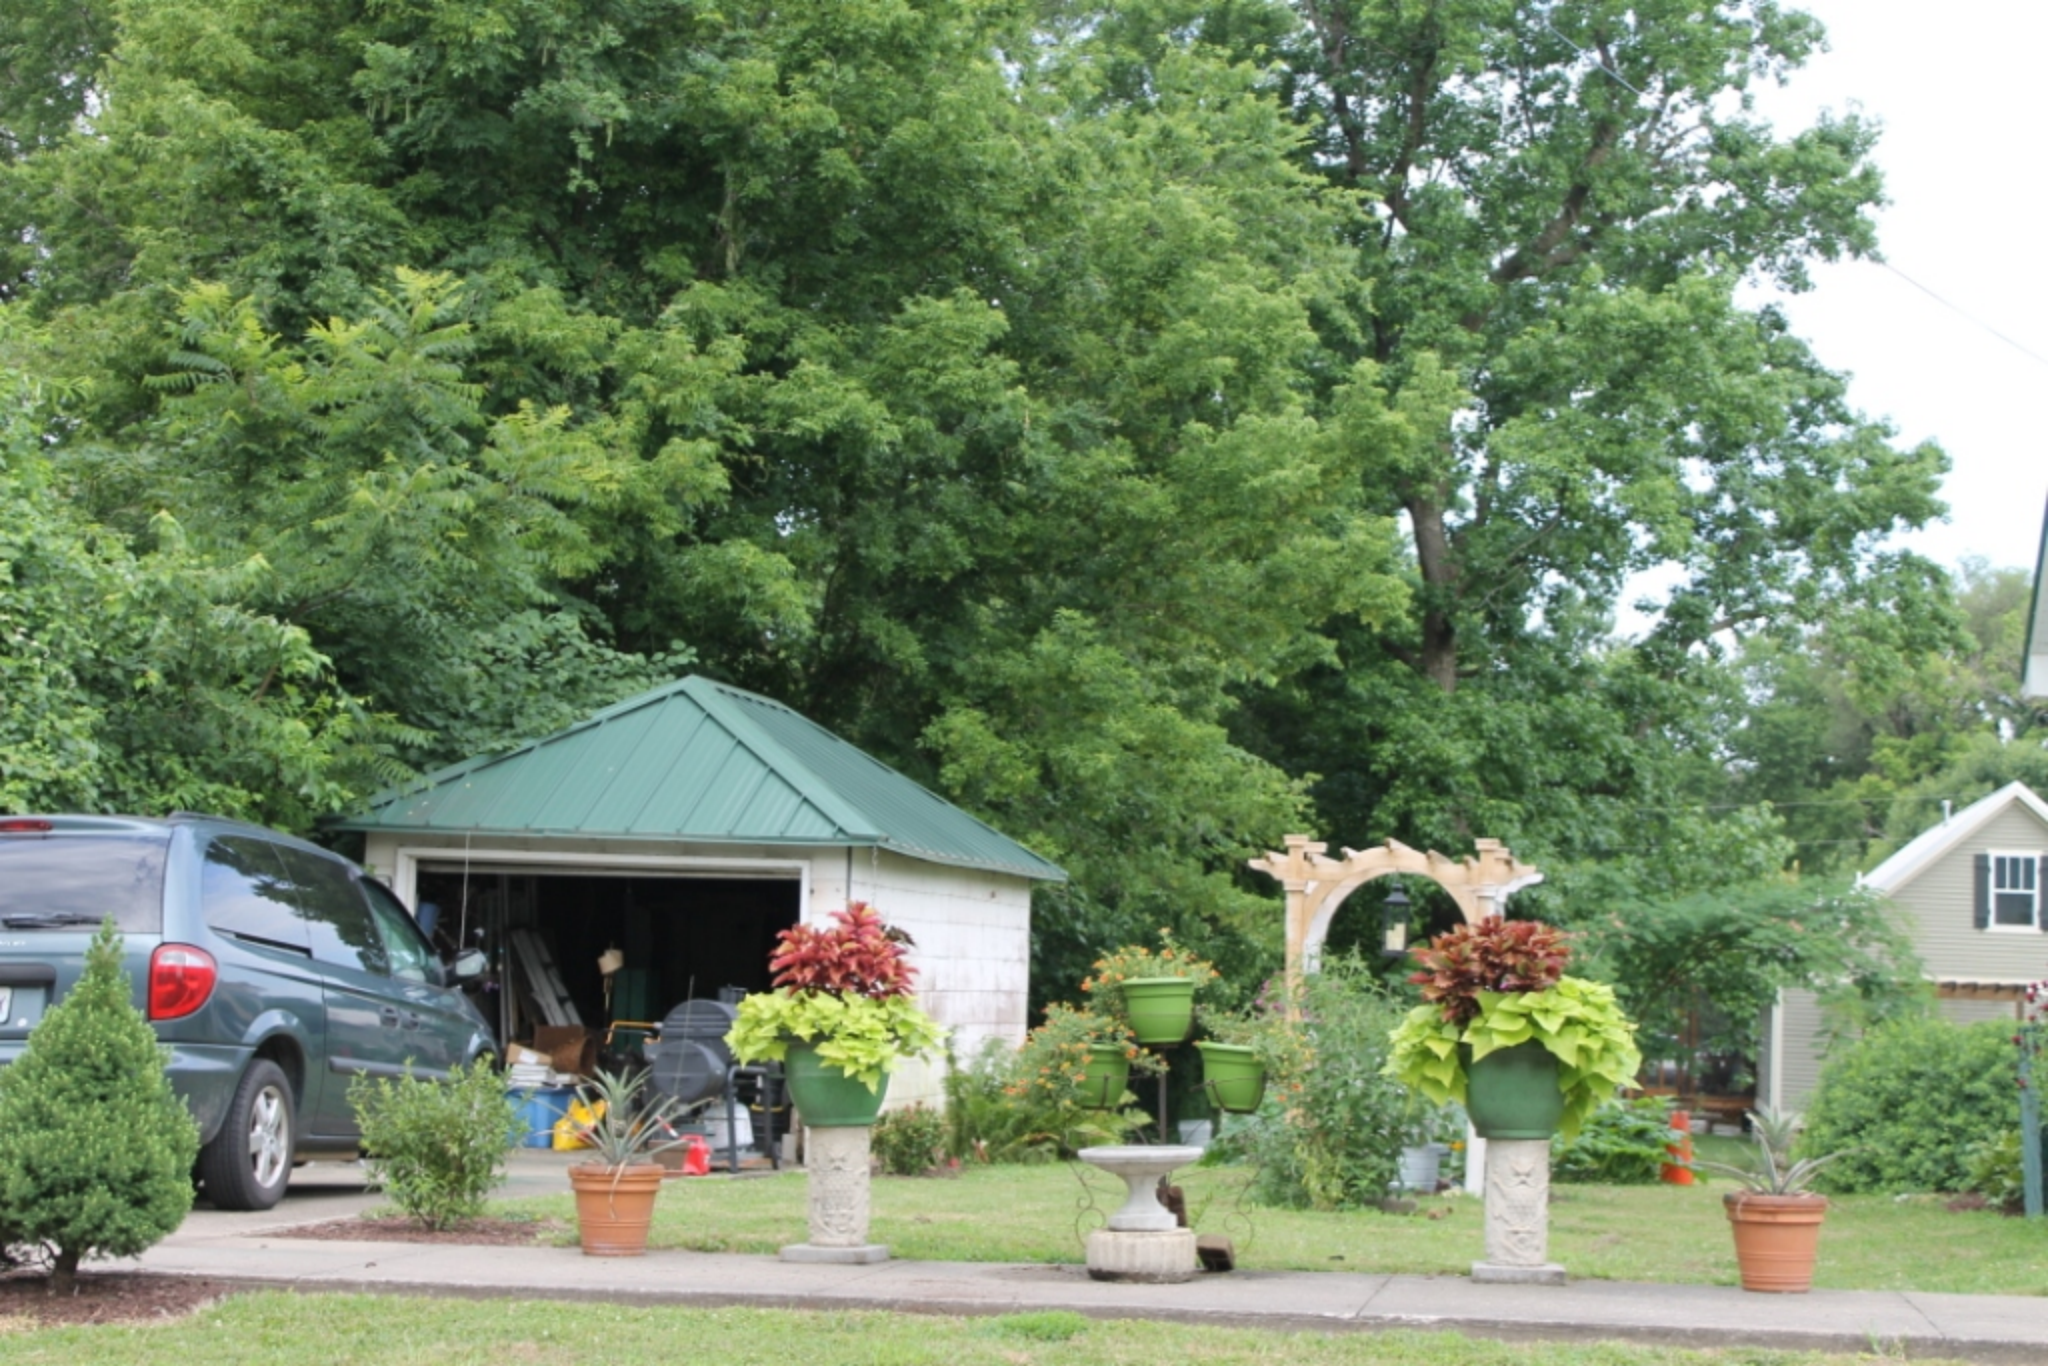
This 1 1/2 story, massed plan frame house with a metal roof has a small gable covering a part of the front porch. The remaining part of the porch, which reaches from the gable to the south end of the house, has a flat roof. The porch is supported by pyramidal columns resting on square bases. The house has a gable on the rear (east) facade, giving the house an irregular shape. The house is clad in vinyl siding and the roof is covered in asphalt shingles. The first story of the front (east) facade has three bays. The left bay contains a multi-paned French door that opens onto the porch. The center bay, directly under the center gable, contains a wooden door with three vertical panes at the top. The rightmost bay, which is not under the porch, contains a one-over-one single hung window. On the side (south) facade of the house are two bays, each with a one-over-one single hung window with shutters. On the second story of the south facade is a single bay containing a one-over-one window. The ends of the roof ridge are accented with curled finials. The house has a center ridge chimney.
