MISSOURI DEPARTMENT OF NATURAL RESOURCES
STATE HISTORIC PRESERVATION OFFICE, P.O. Box 176, Jefferson City, MO 65102
ARCHITECTURAL/HISTORIC INVENTORY FORM

1. SURVEY NO. BO-AS-009-0001		2. SURVEY NAME: Rocheport Historic District	
3. COUNTY: Boone		4. ADDRESS (STREET NO.)	STREET (NAME) Katy Trail
5. CITY: Rocheport	VICINITY: <input checked="" type="checkbox"/>	6. UTM: / /	LAT: LONG: T: 48W R: 15W S: 1

8. HISTORIC NAME (IF KNOWN): M.K.&T. Railroad tunnel		9. PRESENT/OTHER NAME (IF KNOWN): Katy trail tunnel	
10. OWNERSHIP: <input type="checkbox"/> PRIVATE <input checked="" type="checkbox"/> PUBLIC		11A. HISTORIC USE (IF KNOWN): railroad tunnel	11B. CURRENT USE: Katy Trail tunnel
HISTORICAL INFORMATION

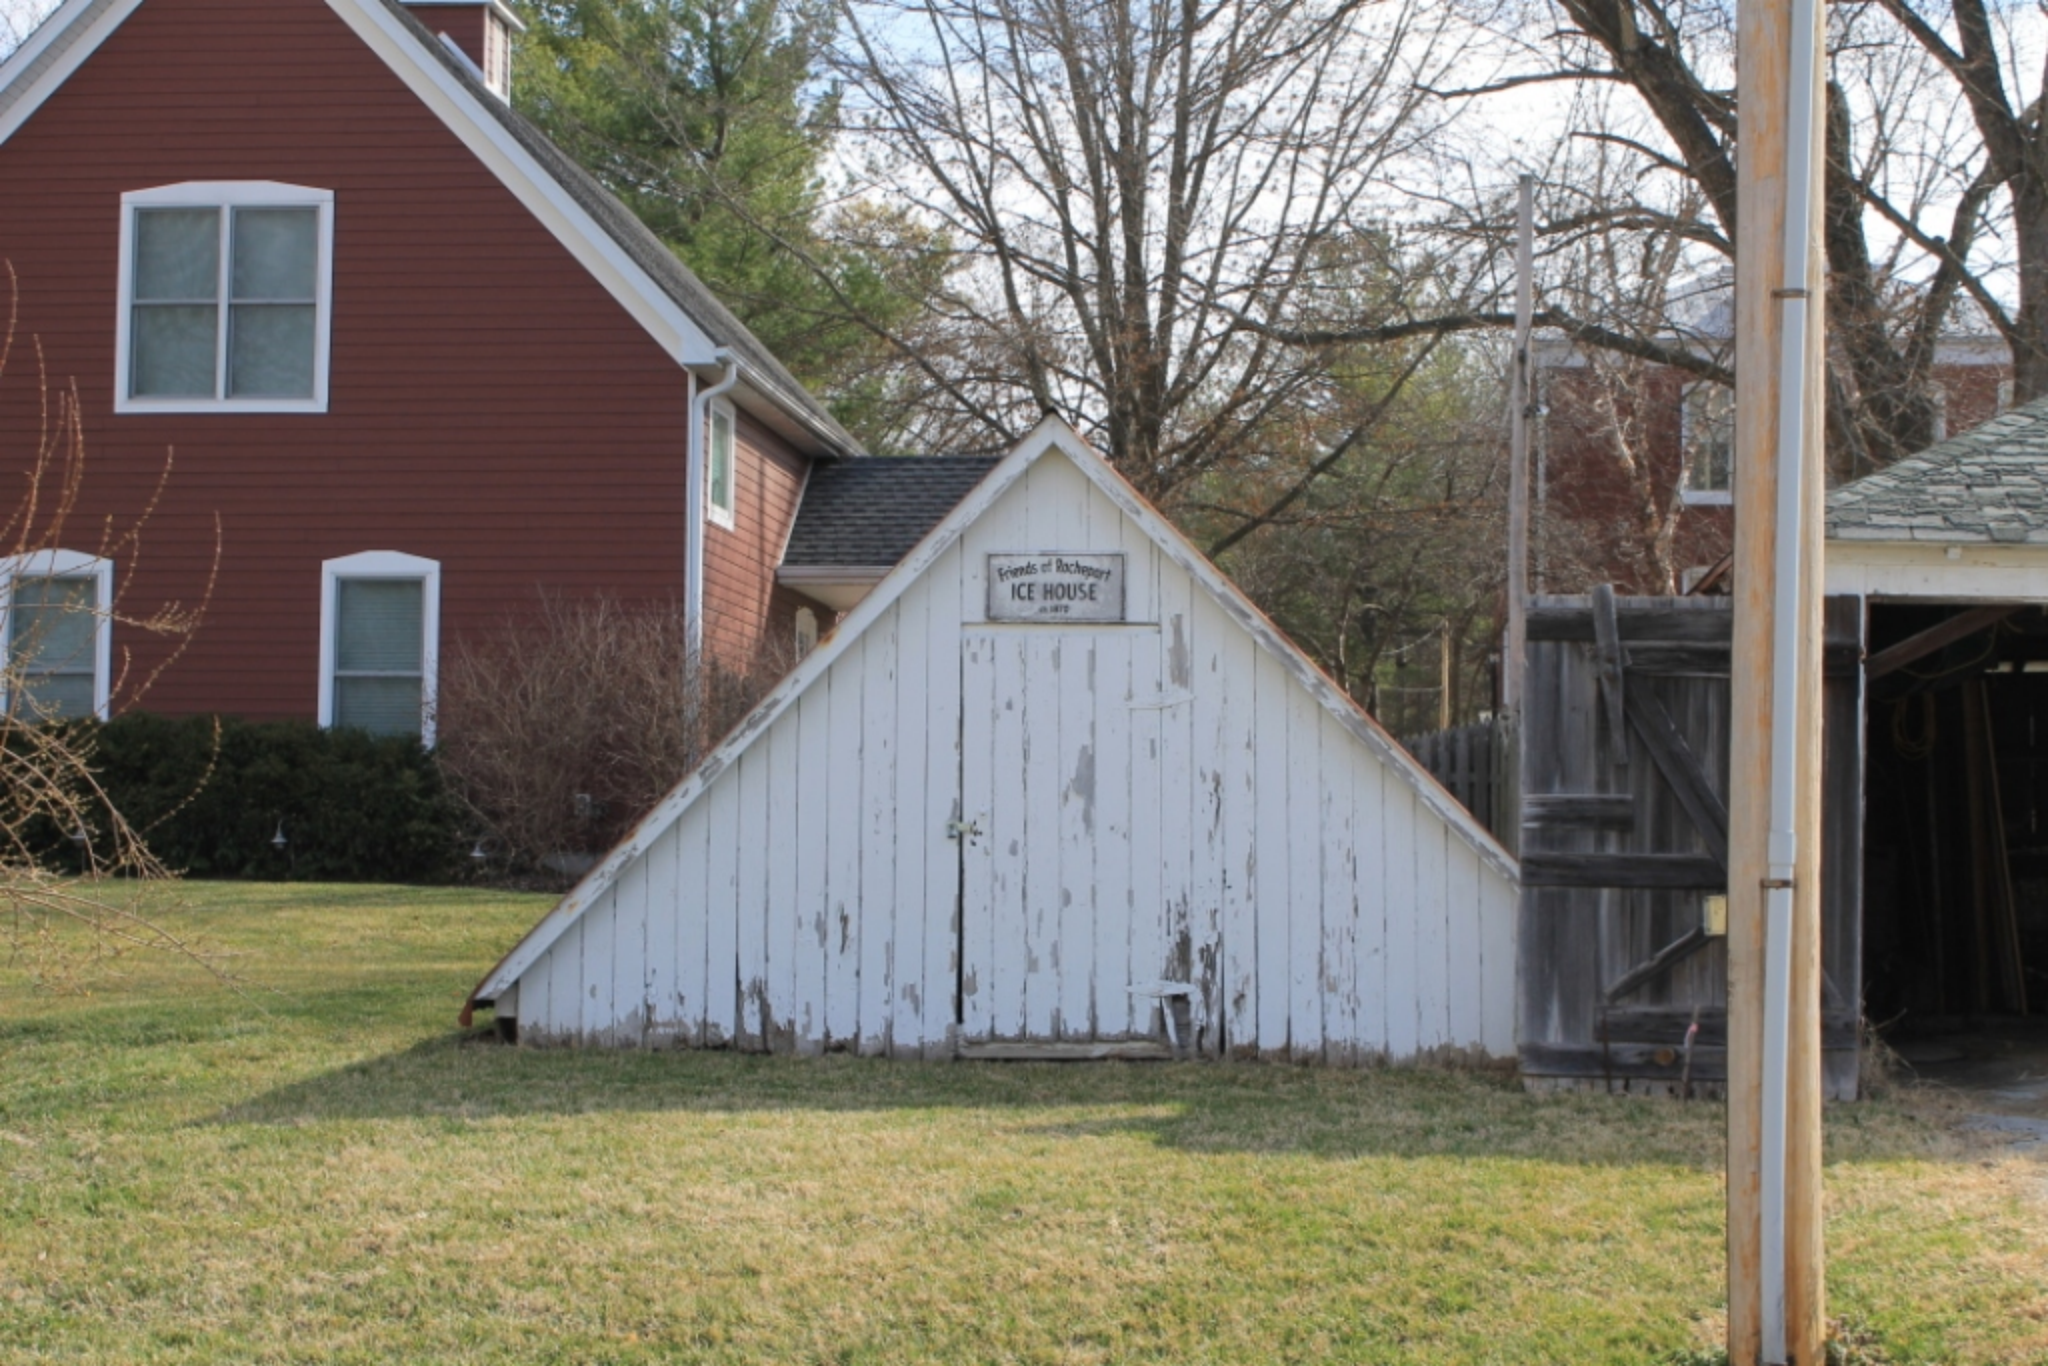
The ice house is a white painted wooden building with a high gable roof that reaches the ground. The rood is clad in asphalt shingles. The west and east walls are covered in vertical boards. The basement is lined with bricks and the building is insulated to keep the ice stored inside frozen. The west facade has one bay containing a door. Above the door is a plaque noting that the building is owned by the Friends of Rocheport.

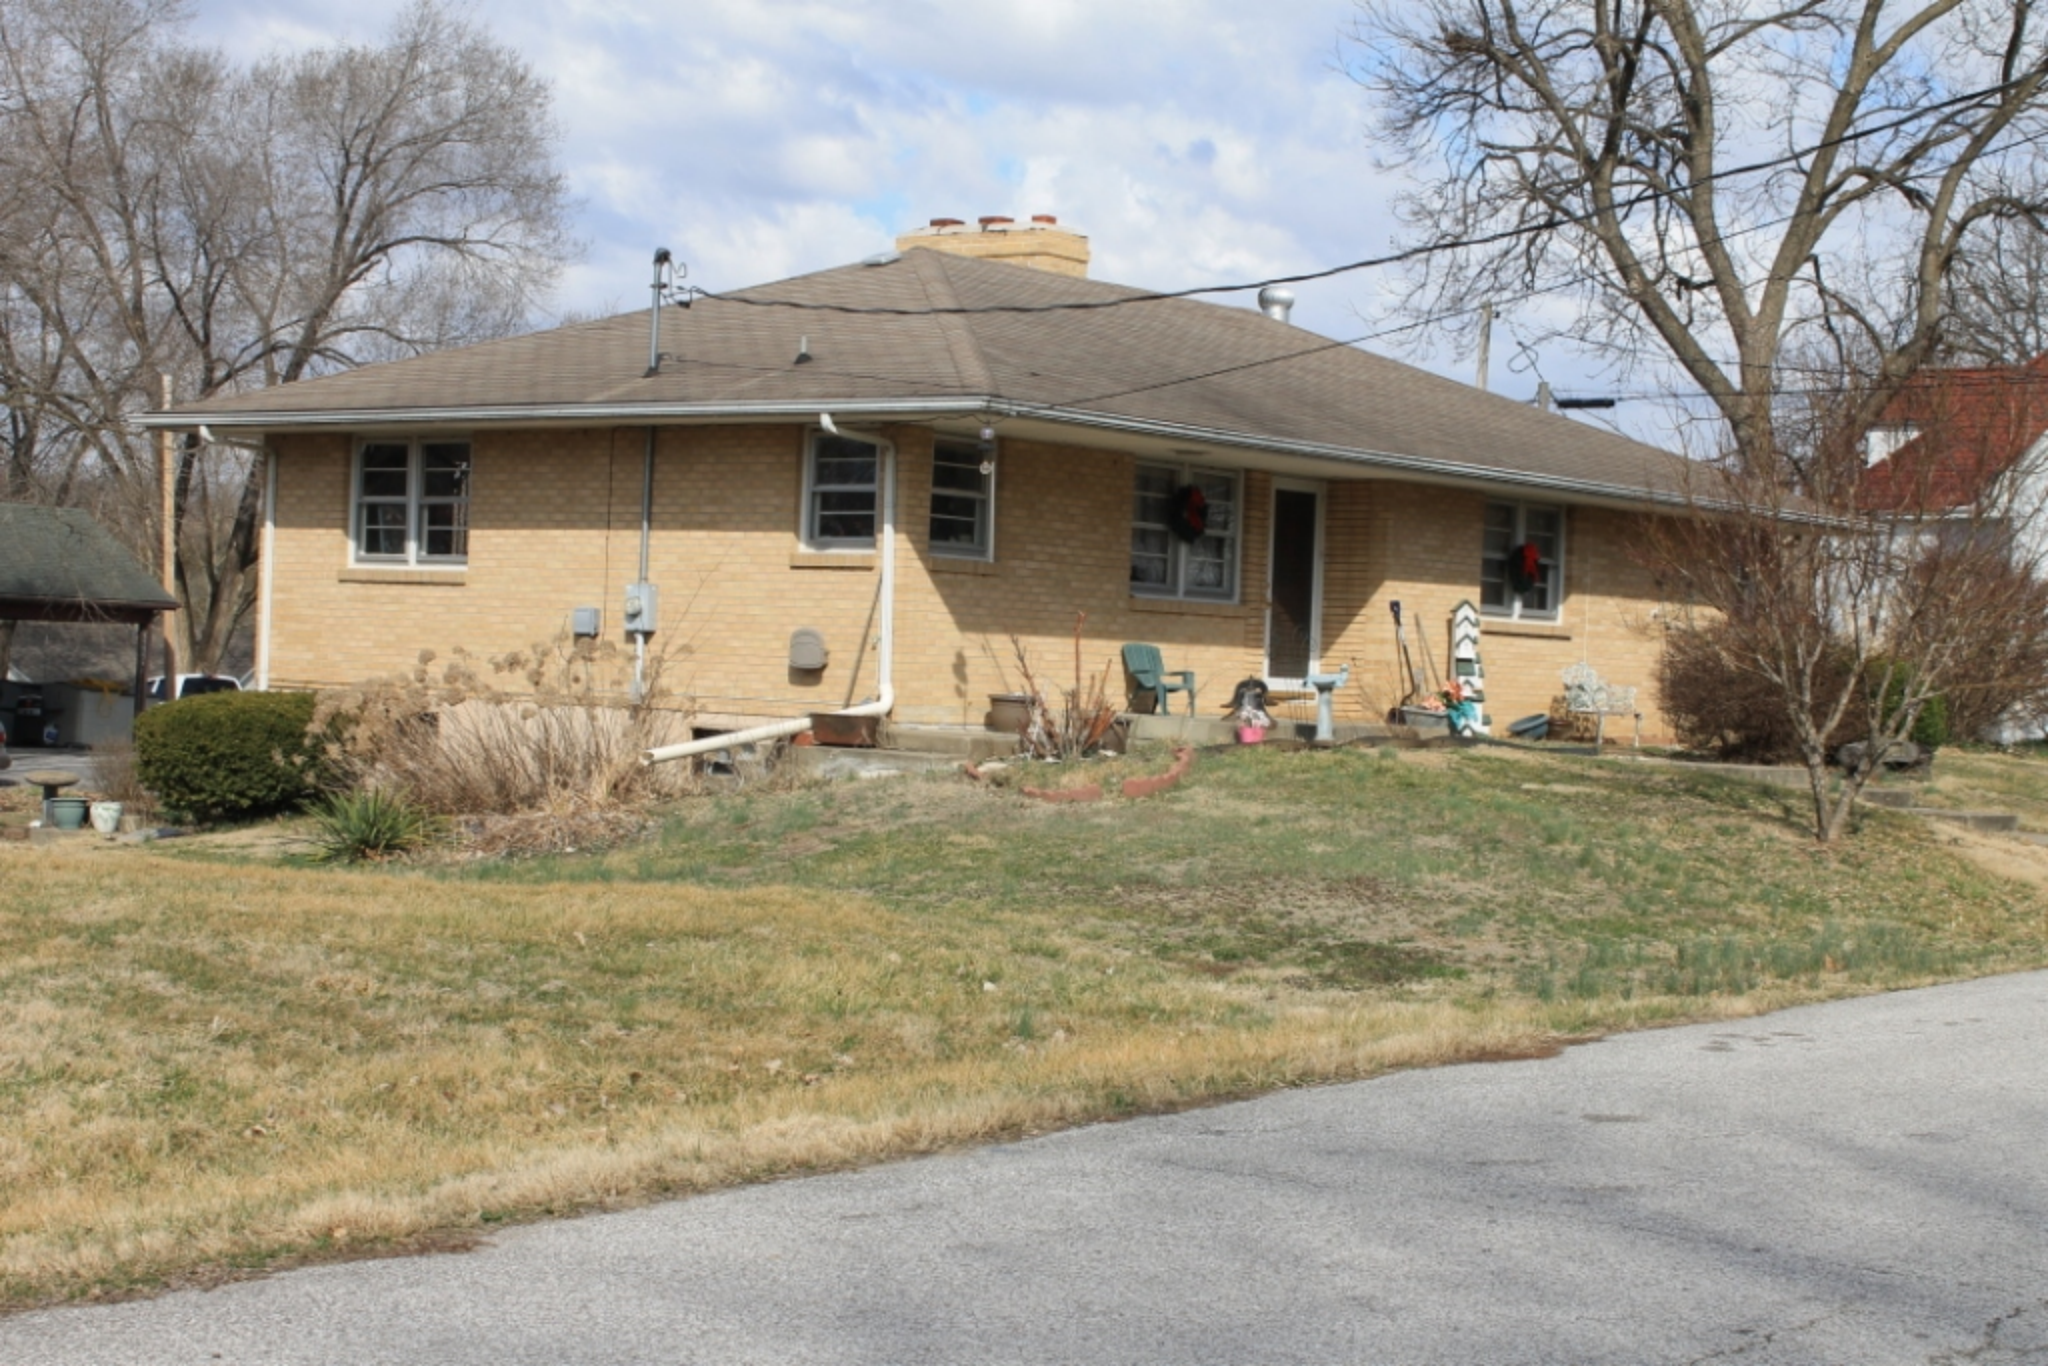
This one story, massed plan pyramidal, tan brick ranch house has a hipped roof covered in asphalt shingles. The house has five bays on the front (east) facade. The left bay contains a small two horizontal-over-two horizontal single hung wooden window with a brick sill. The next bay contains a pair of two horizontal-over-two horizontal single hung wooden windows with a brick sill. The next bay contains a door with a modern metal and glass storm door. The door opens onto a stoop. The next bay contains a pair of two horizontal-over-two horizontal single hung wooden windows. The far right bay contains a two horizontal-over-two horizontal single hung wooden window. The side (south) facade has two bays. The left bay contains a pair of two horizontal-over-two horizontal single hung wooden windows. The right bay contains a two horizontal-over-two horizontal single hung wooden window. The house has a brick chimney with three flues on the center rear slope of the roof.

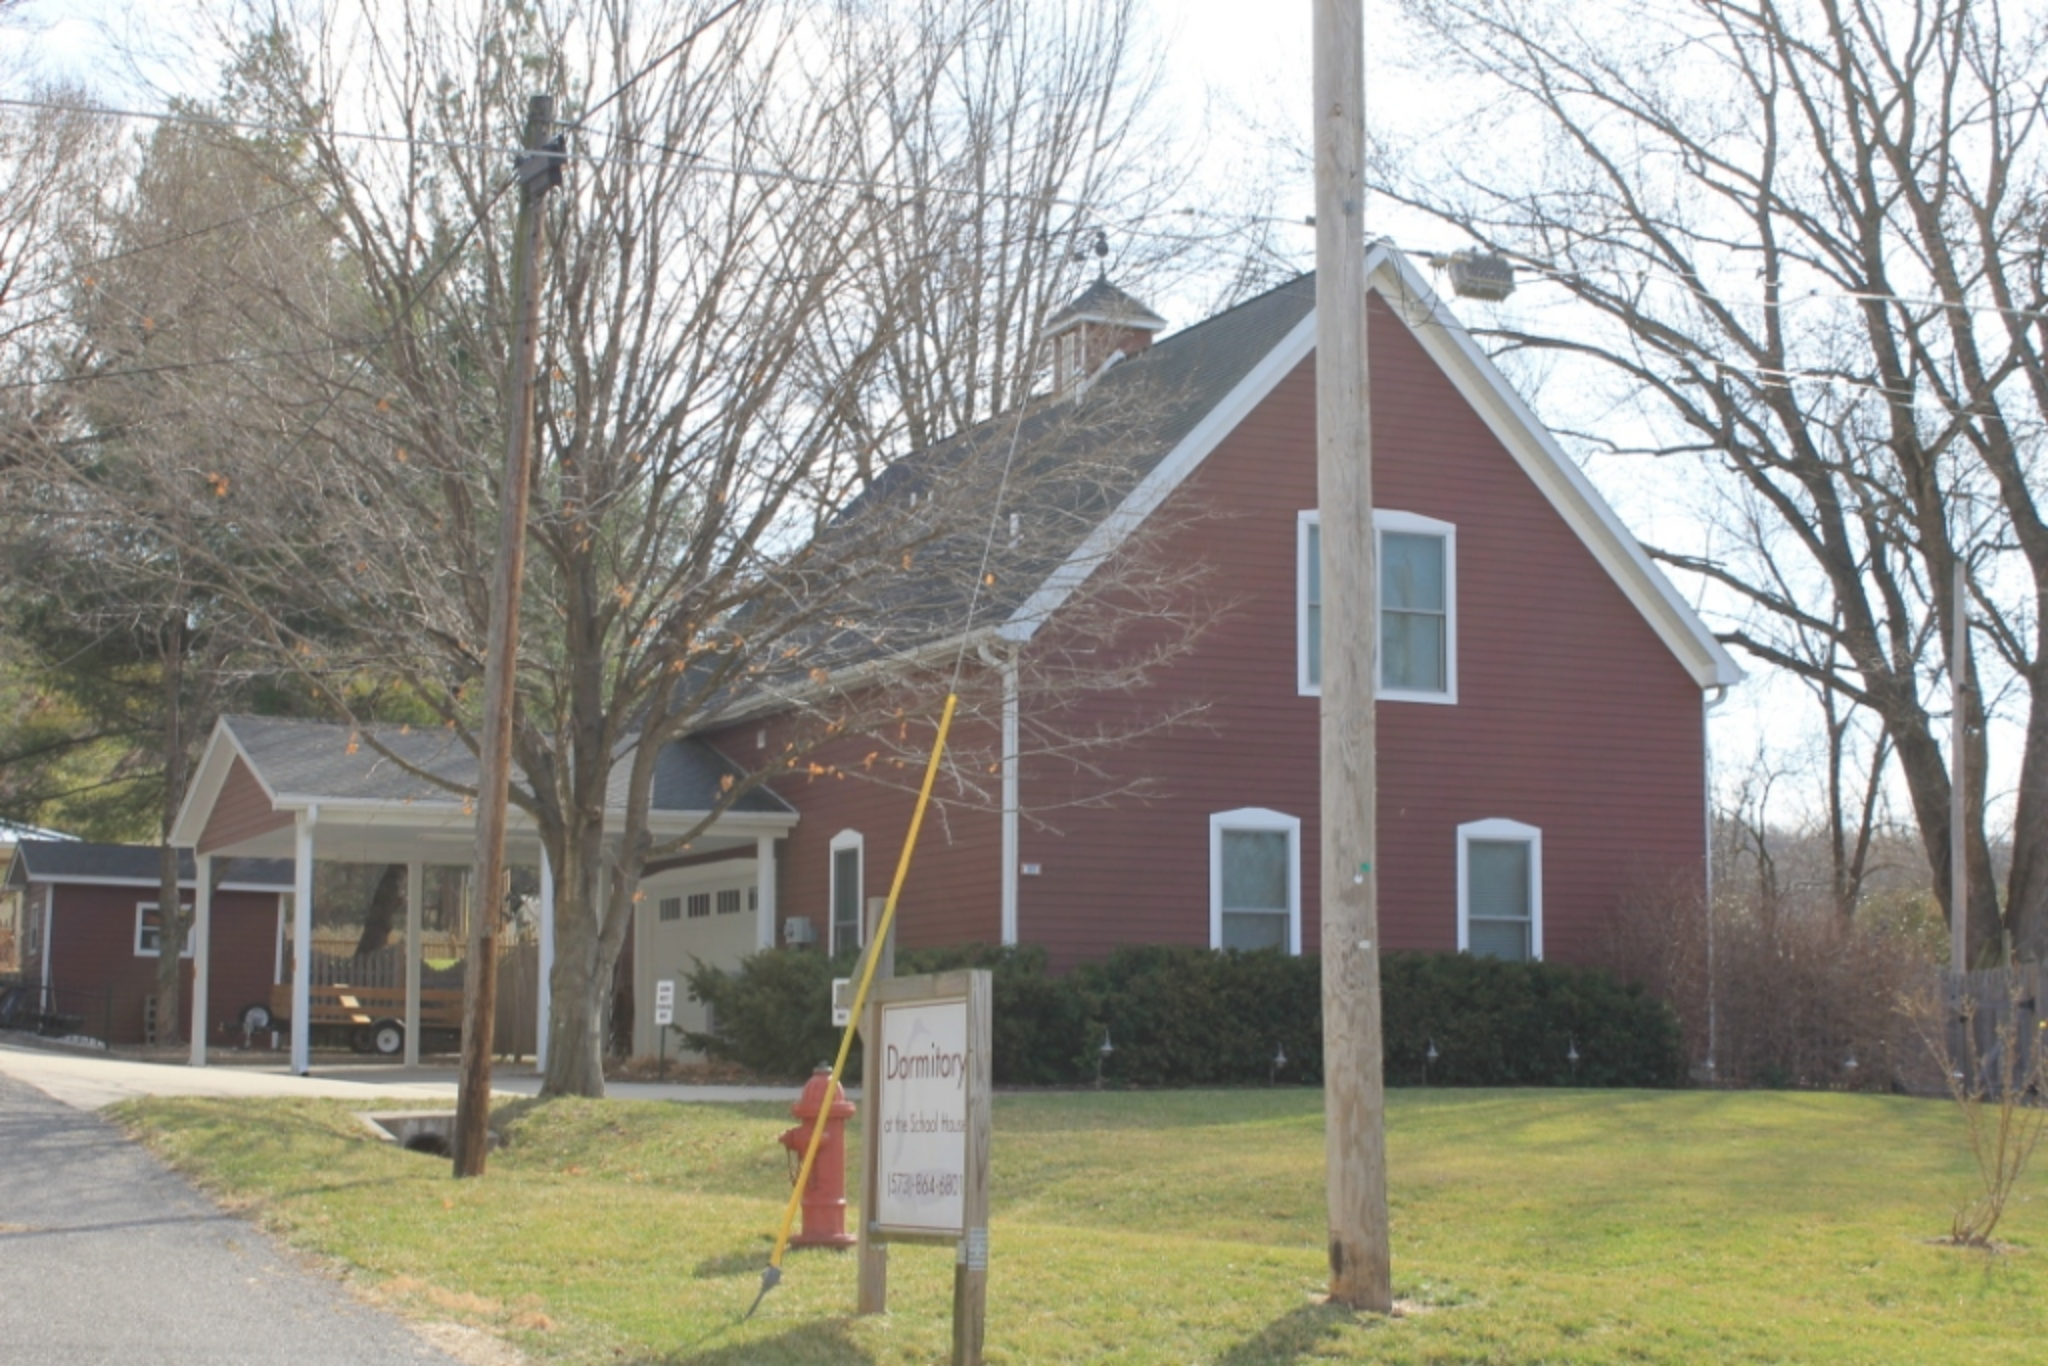
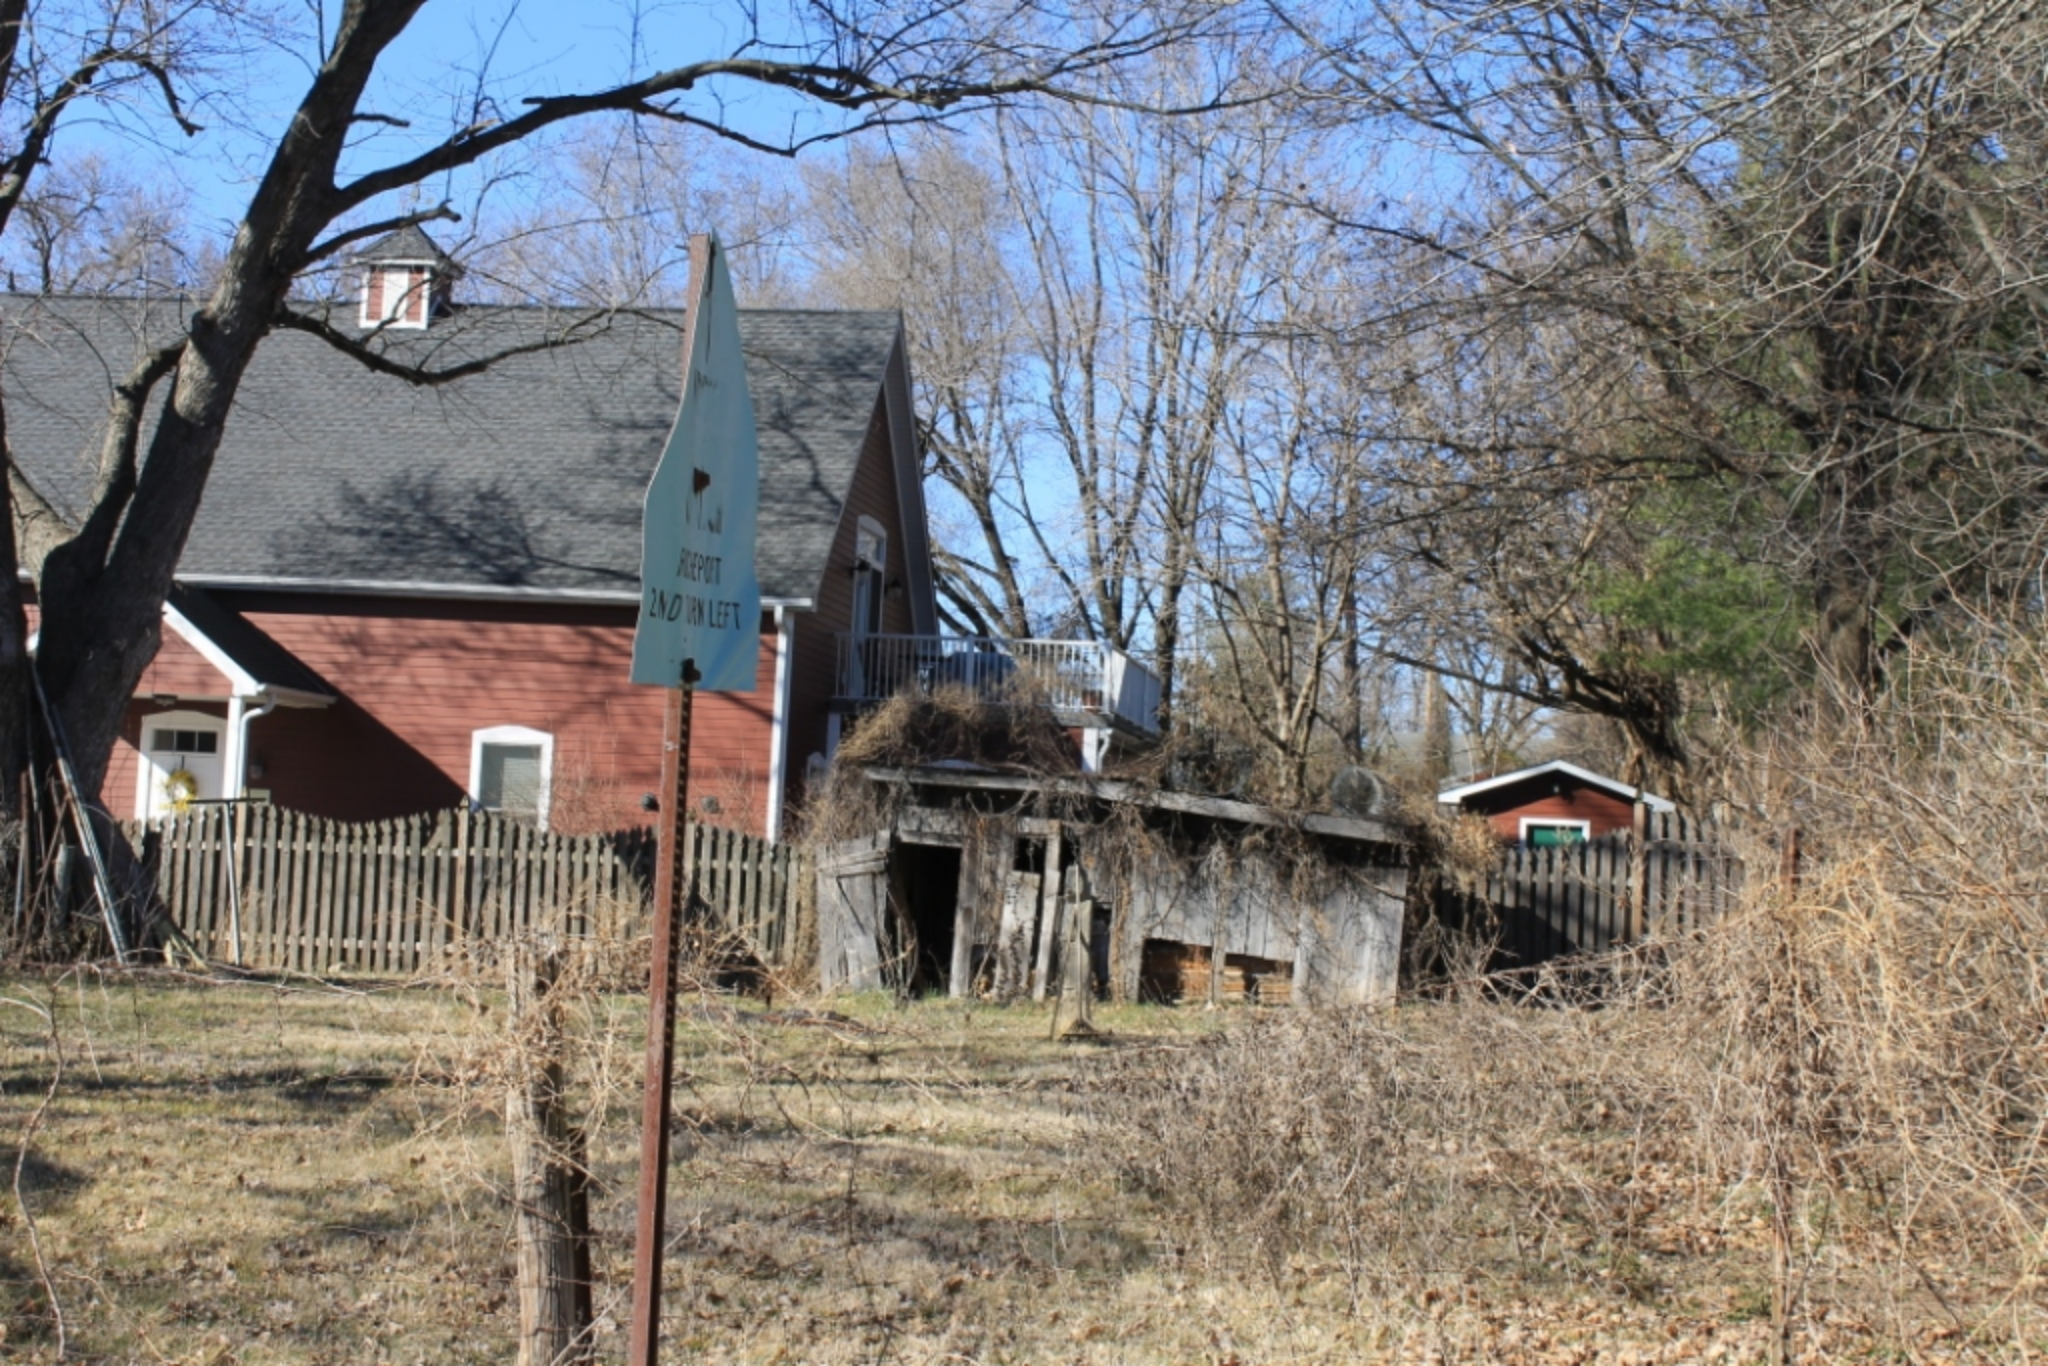
This massed plan brick 1 1/2 story building has a high pitched gable roof that faces west and a 1 story intersecting gable roofed carport that extends to the north and faces north. The walls are clad in clapboards and the roof is covered in asphalt shingles. The roof is topped with a square cupola and weather vane. The front (north) facade facing the alley between Third Street and Fourth Street has two bays, the left bay containing an overhead garage door and the right bay containing a rectangular one-over-one single hung window set into a segmental arched opening. The gable roofed car port sits in front of the garage door. The first story of the west facade has two bays, each containing a rectangular one-over-one single hung window set into a segmental arched opening. On the second story of the west facades above the bays on the first story is one bay containing a pair of rectangular one-over-one modern single hung windows with a wooden segmental arched opening.

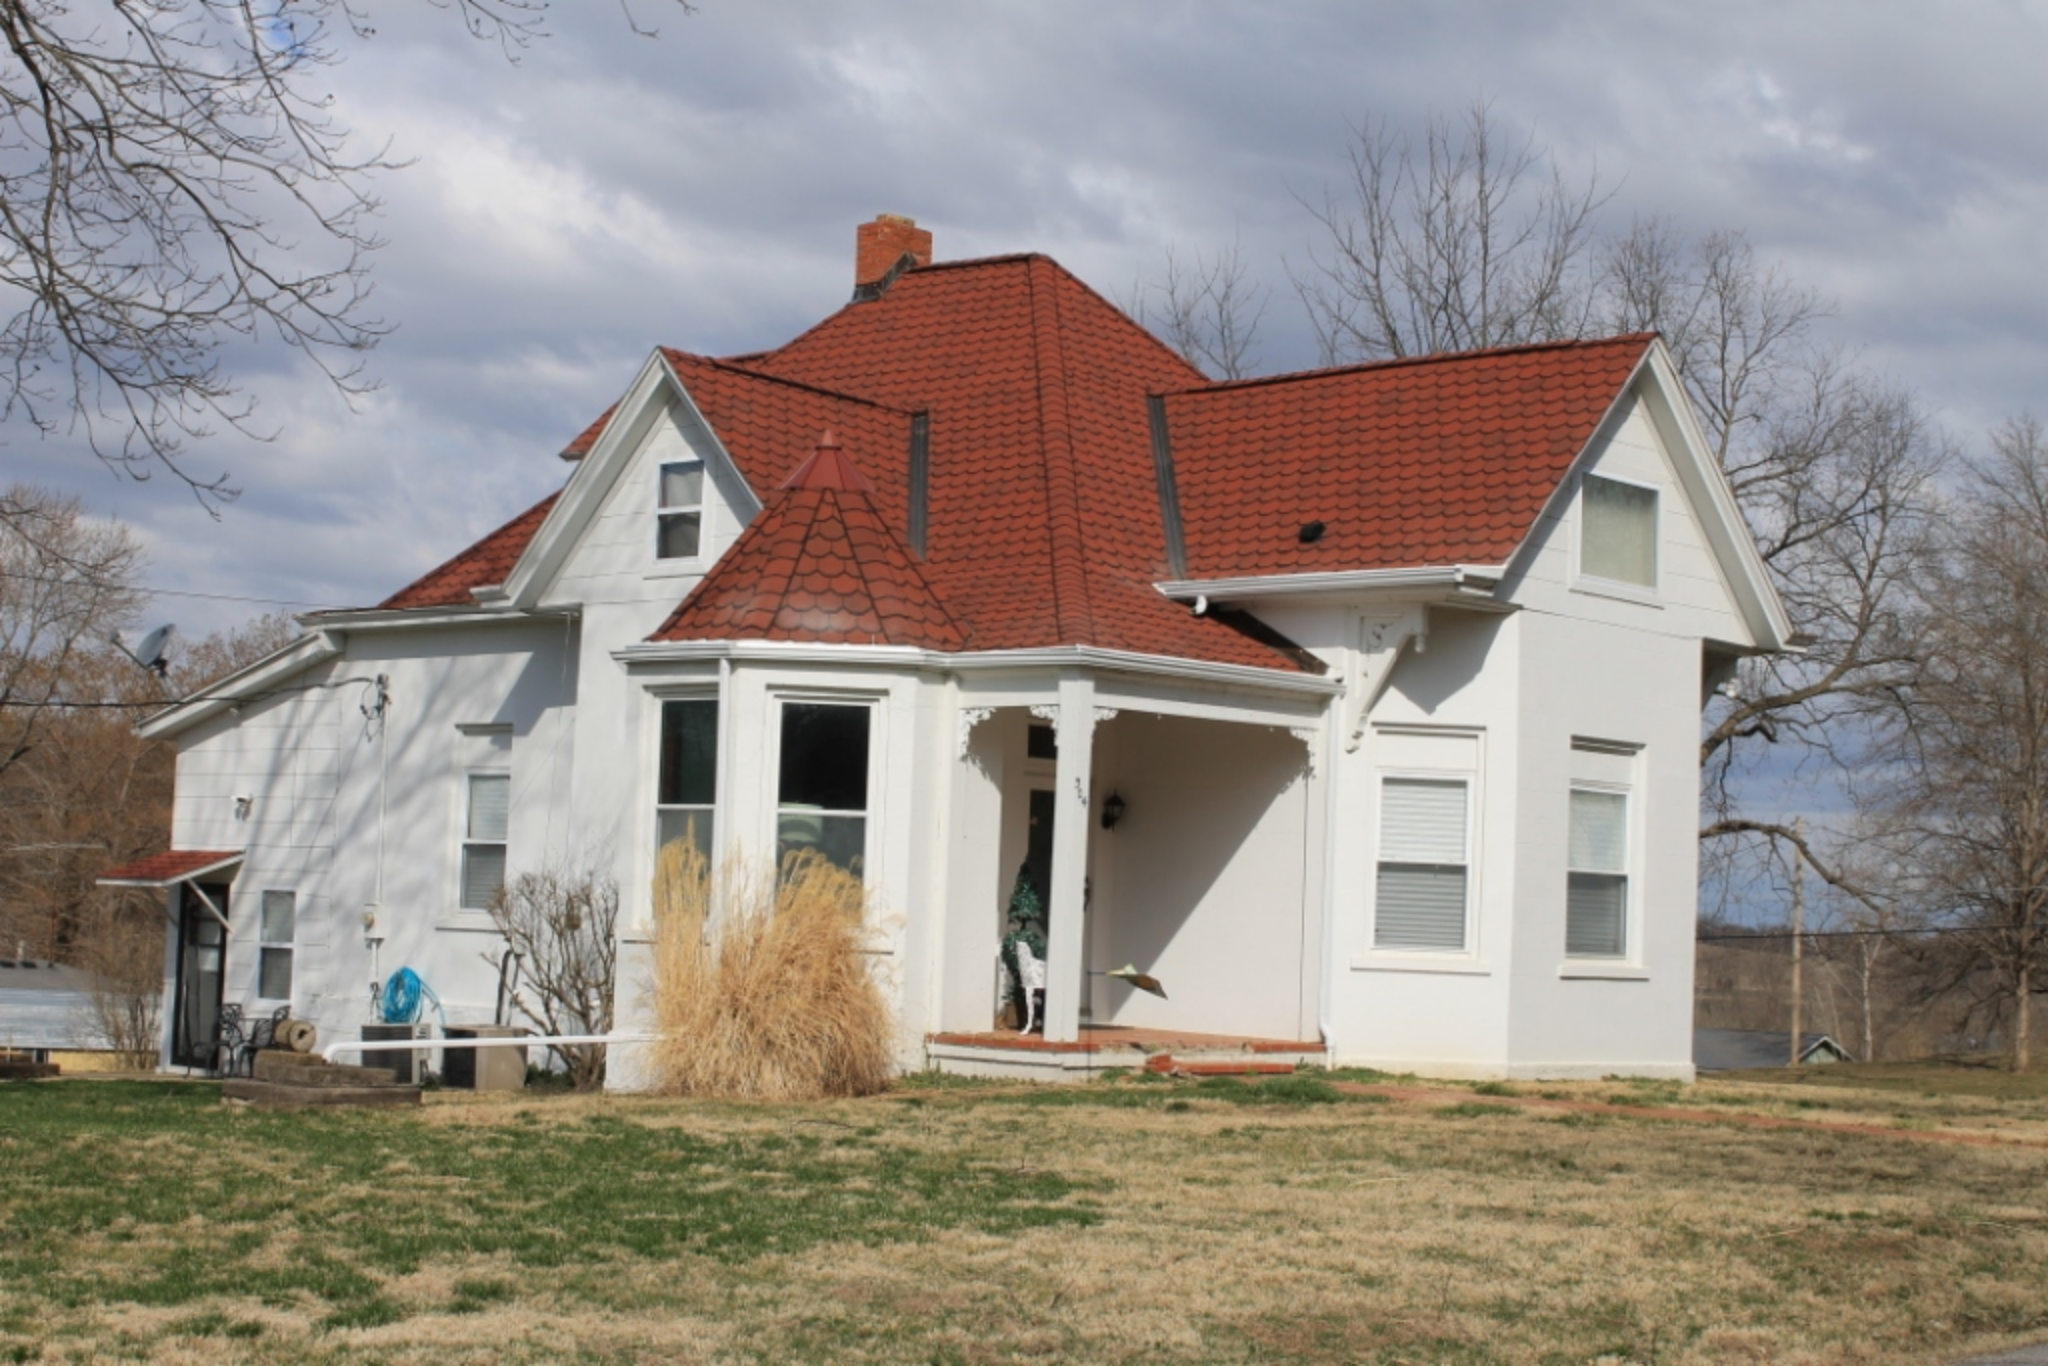
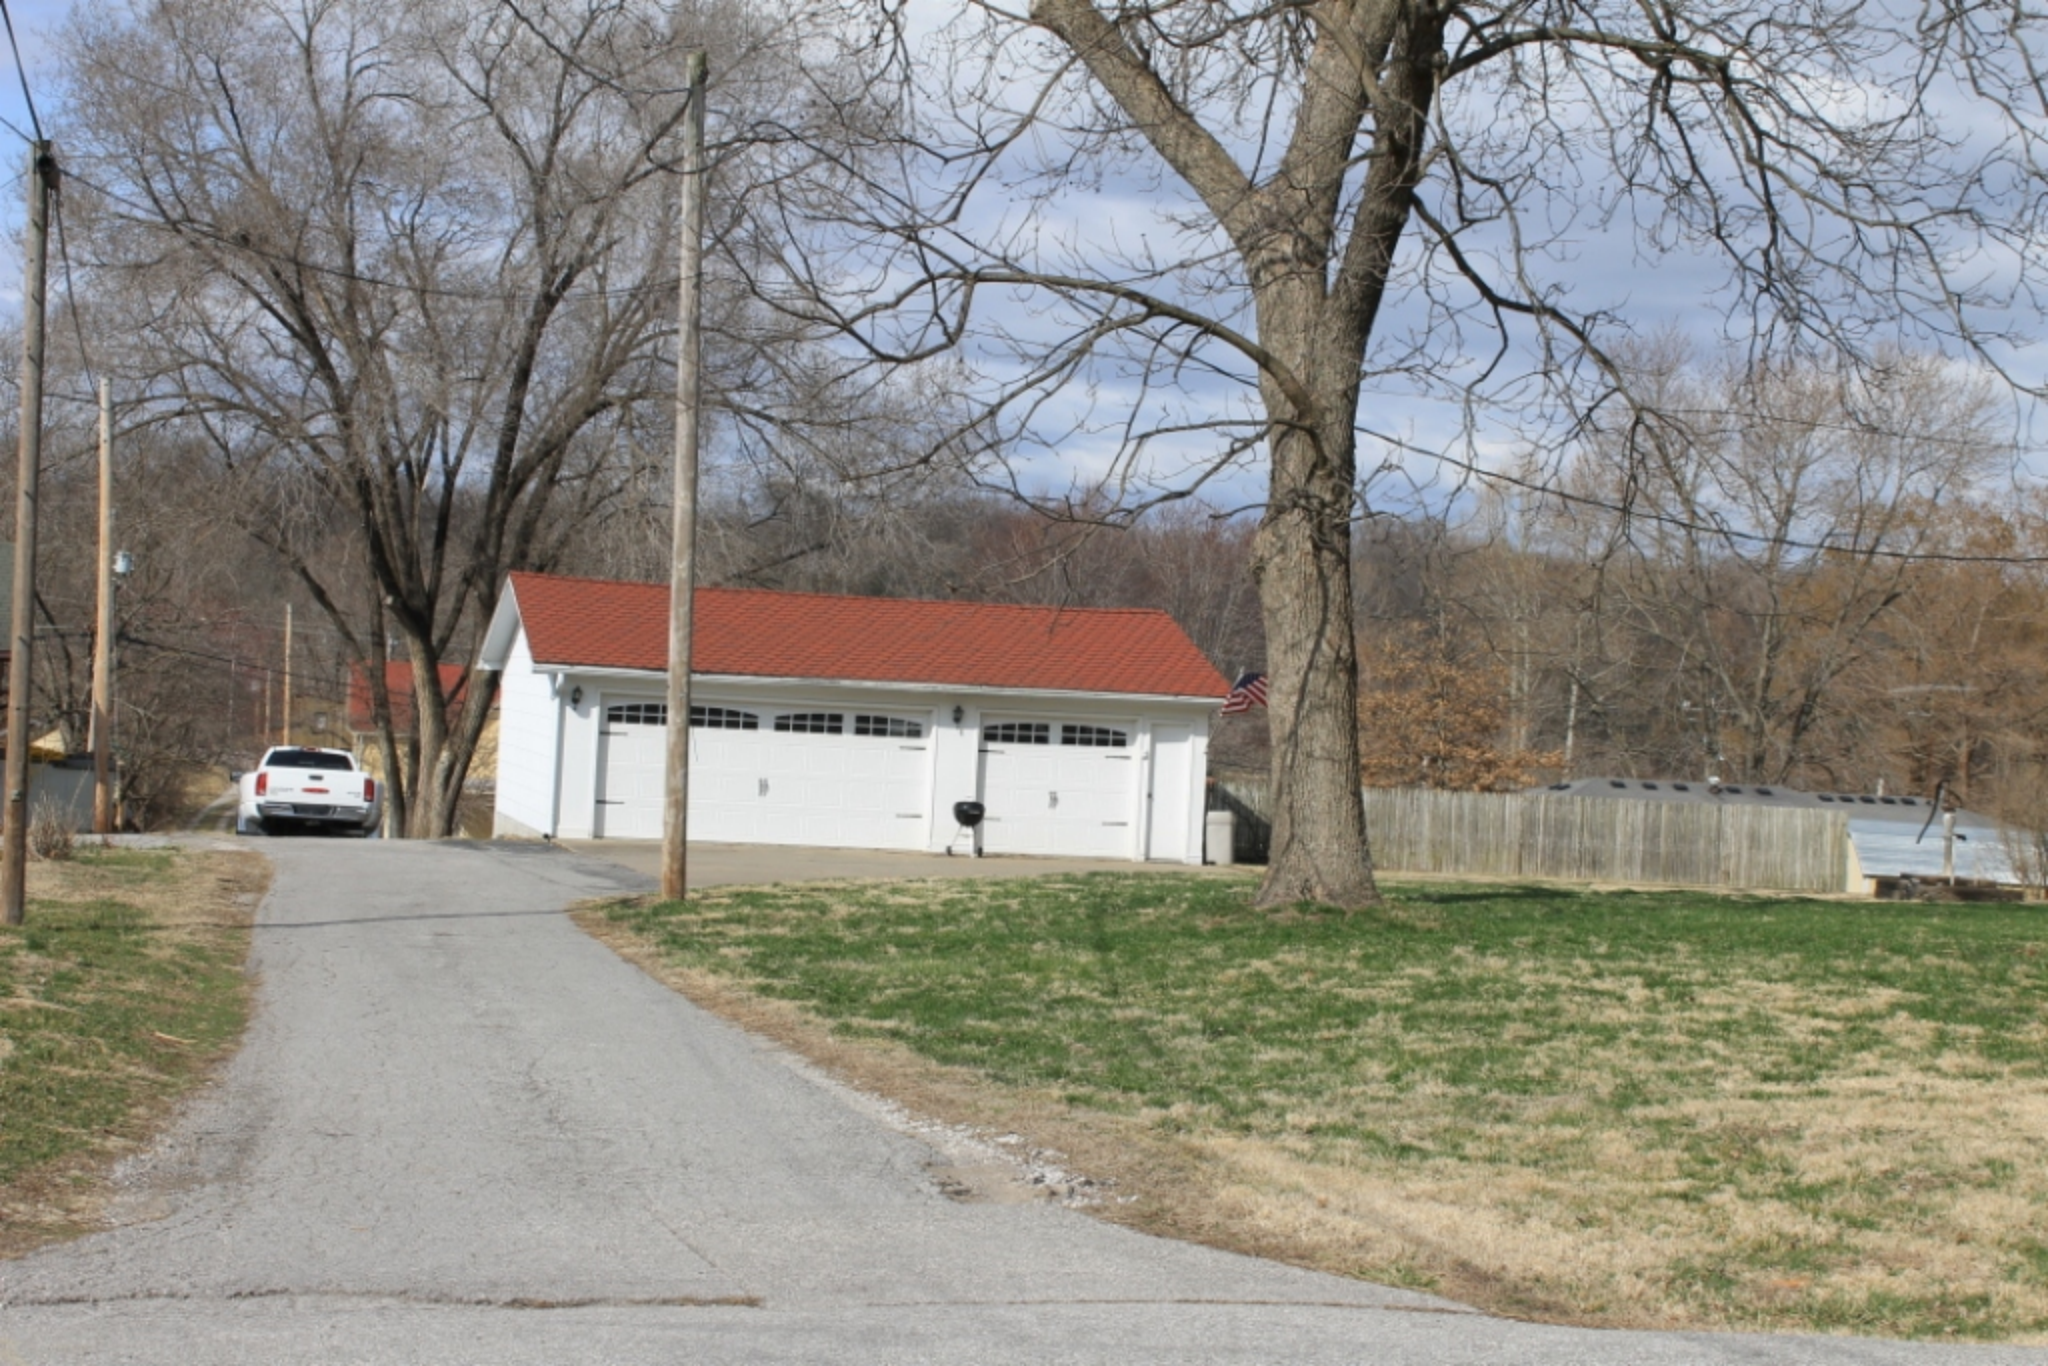
This 1 1/2 story, massed plan, poured concrete house has a high hipped roof with three intersecting gables covered in metal fishlap shingles. The front facing gable roofed wing projects to the east and is canted on the corners to form a bay window whose roof is supported by decorative cut wooden brackets. At the point where the main block of the house and the front facing gable roofed wing meet is a small porch. The porch roof is supported by modern decorative metal brackets. The house has a three sided bay window with a peaked roof on the south. All of the windows are one-over-one single hung vinyl windows. The front (east) facade has six bays. The left bay, which is located in the bay window on the south side of the house, contains a window. The next bay, located under the porch, contains a door with a transom. The next three bays, located in the bay window of the front facing gable, each contain a window placed in a larger opening. The rightmost bay is on the main block of the house and contains a window. The south facade of the house reveals an intersecting gabled ell extending south behind the bay window from the main block of the house, and a shed roofed wing to the rear. The first story of the south facade has five bays. The leftmost bay is a door, located in the shed roofed addition and covered by a shed roofed hood supported by brackets. The next bay contains a window. The next bay, on the main block of the house, contains a window. The two rightmost bays, located in the south facing bay window, each contain a window. A chimney rises from the center rear roof.
