MISSOURI DEPARTMENT OF NATURAL RESOURCES
STATE HISTORIC PRESERVATION OFFICE, P.O. Box 176, Jefferson City, MO 65102
ARCHITECTURAL/HISTORIC INVENTORY FORM

1. SURVEY NO. BO-AS-009-0001		2. SURVEY NAME: Rocheport Historic District	
3. COUNTY: Boone		4. ADDRESS (STREET NO.)	STREET (NAME) Katy Trail
5. CITY: Rocheport	VICINITY: <input checked="" type="checkbox"/>	6. UTM: / /	LAT: LONG: T: 48W R: 15W S: 1

8. HISTORIC NAME (IF KNOWN): M.K.&T. Railroad tunnel		9. PRESENT/OTHER NAME (IF KNOWN): Katy trail tunnel	
10. OWNERSHIP: <input type="checkbox"/> PRIVATE <input checked="" type="checkbox"/> PUBLIC		11A. HISTORIC USE (IF KNOWN): railroad tunnel	11B. CURRENT USE: Katy Trail tunnel
HISTORICAL INFORMATION

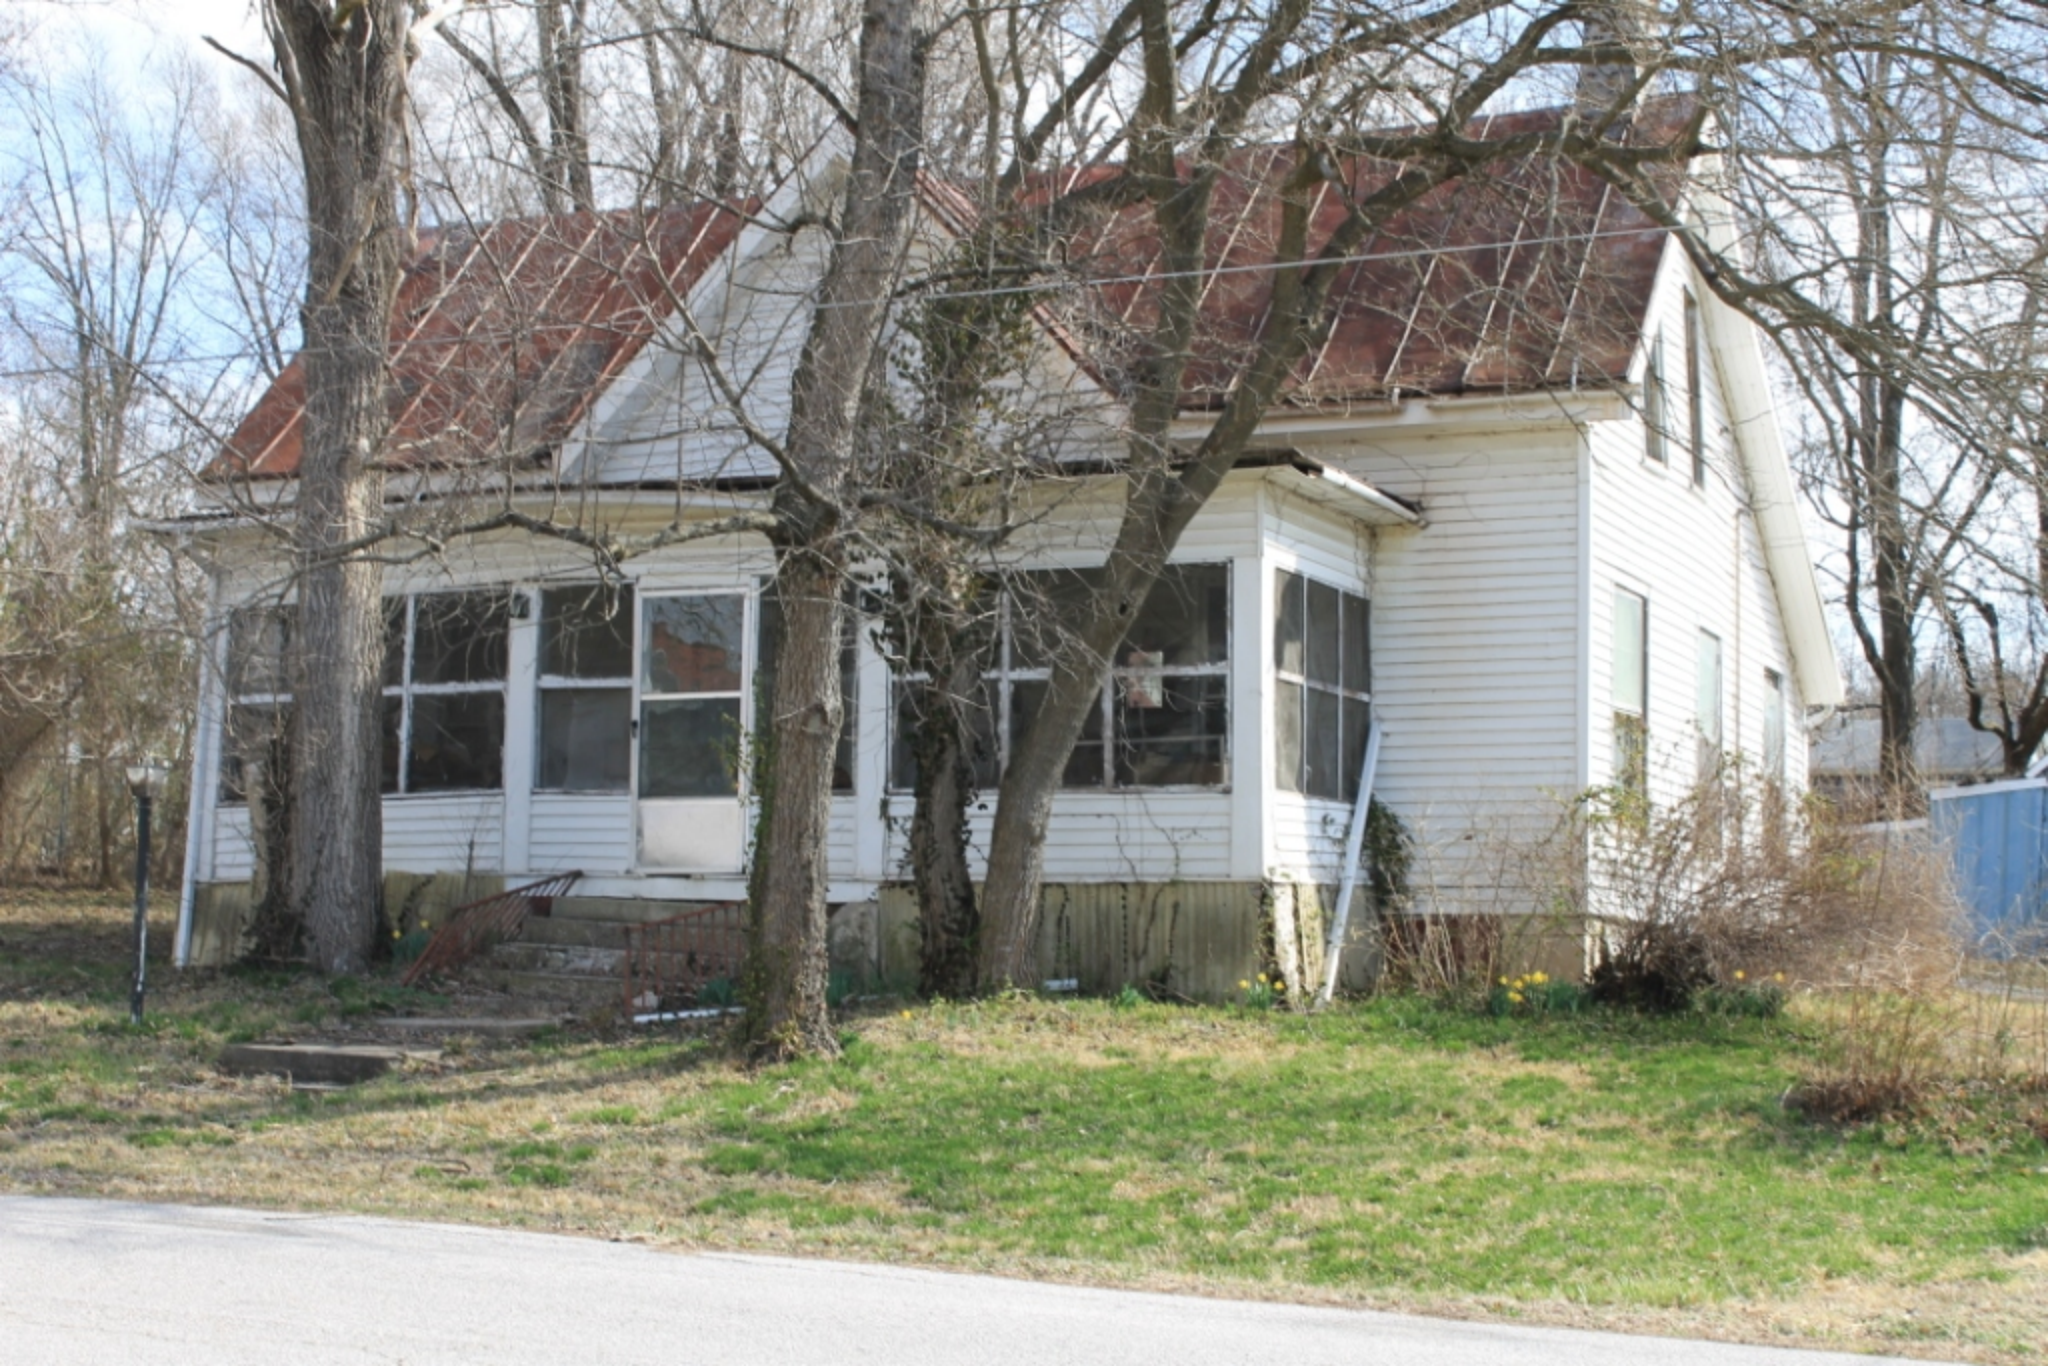
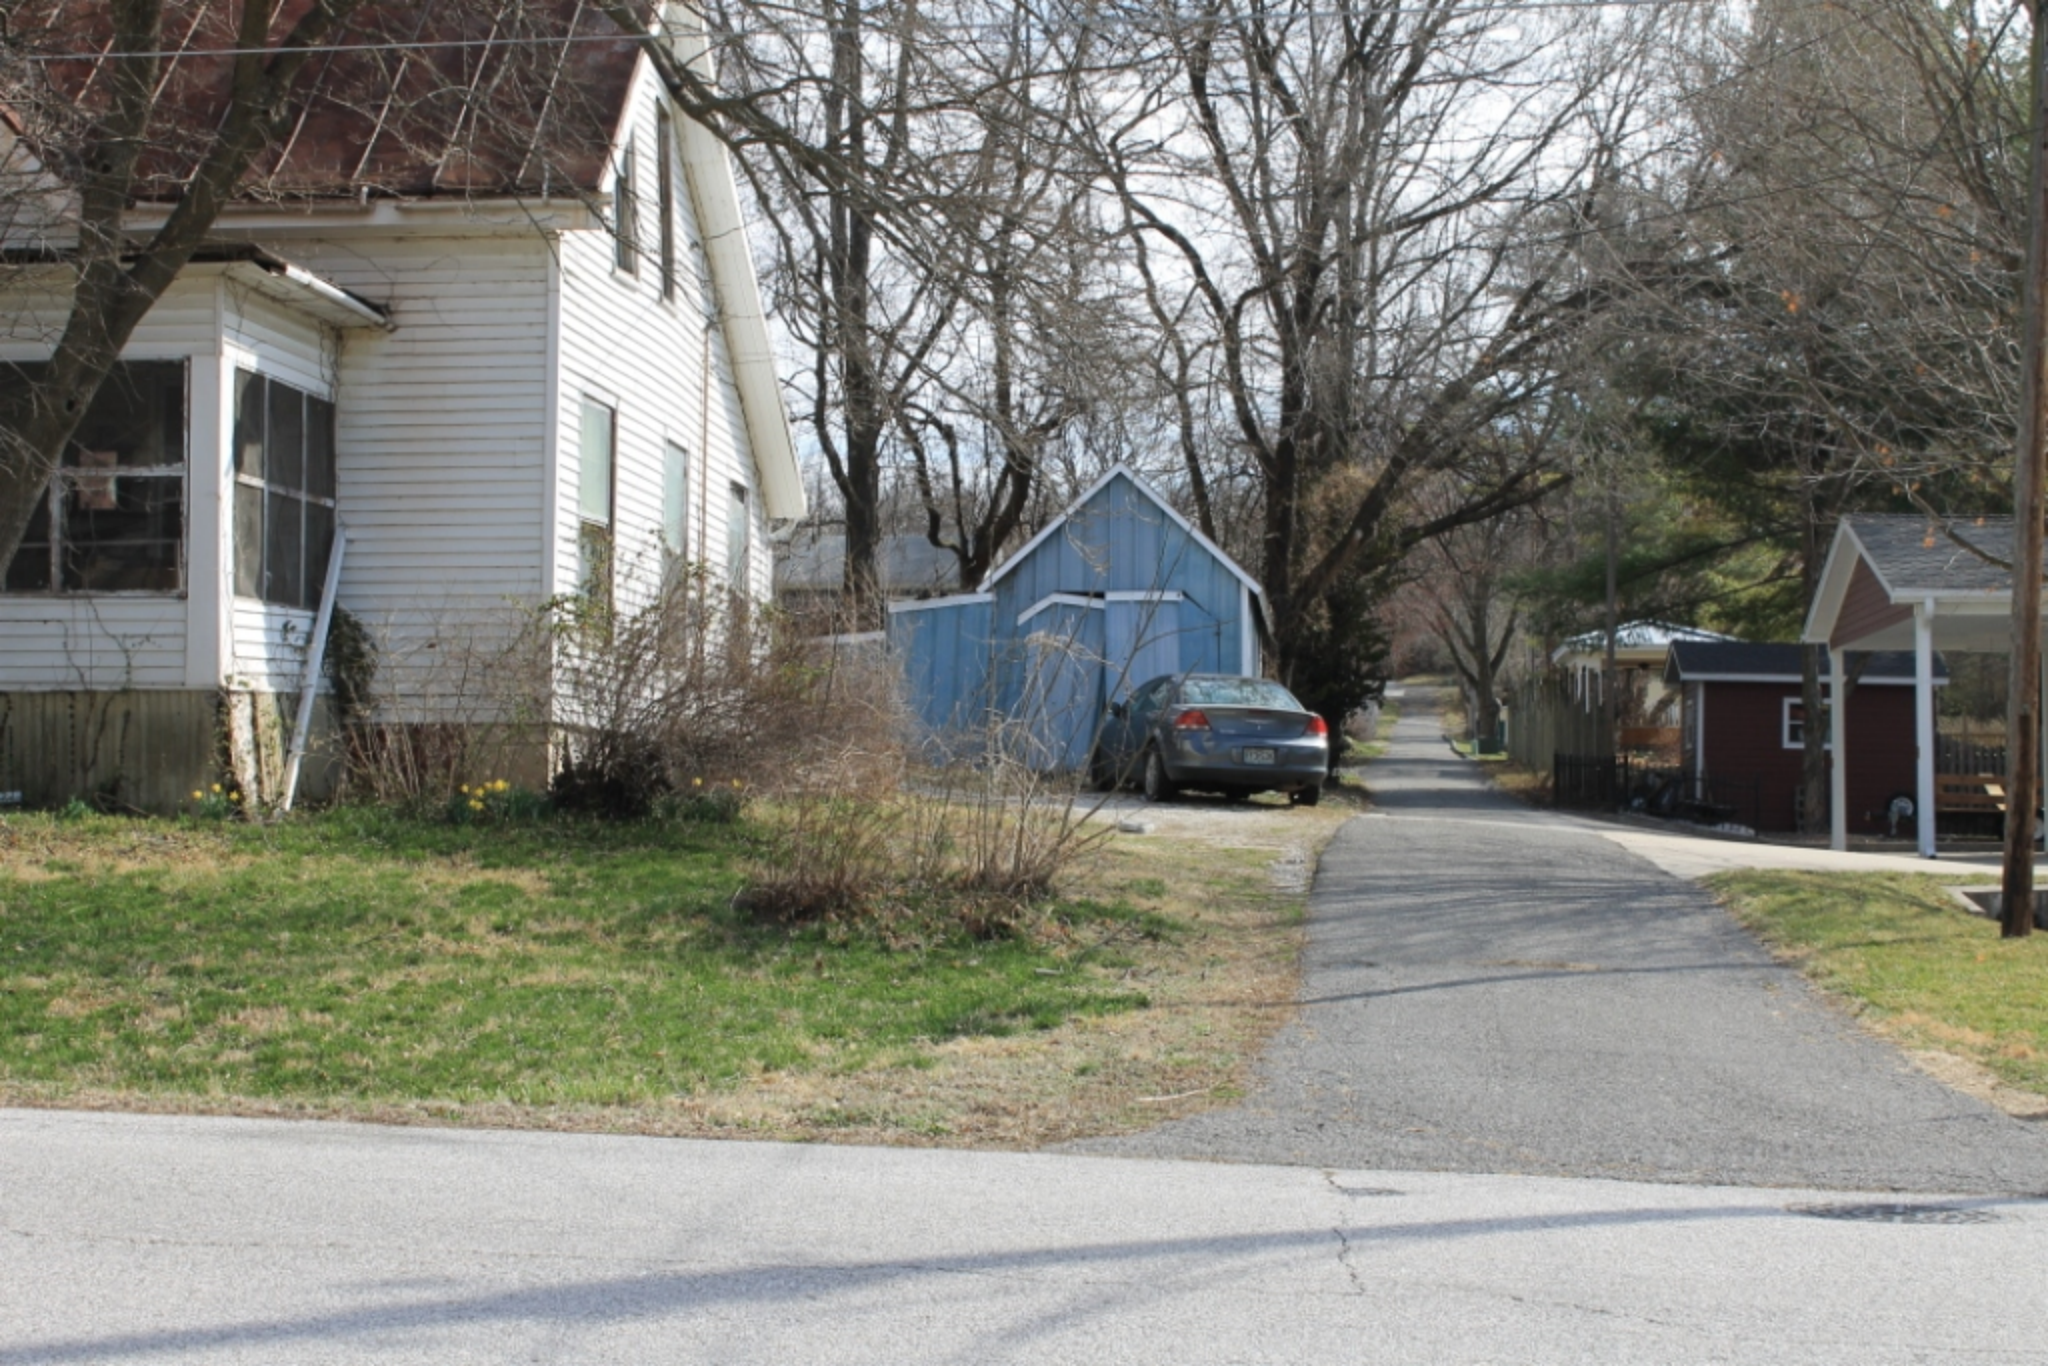
This 1 1/2 story frame house with a center gable on a saltbox roof has a flat roofed enclosed porch across much of the front (west) facade. The Rocheport Historic District survey says that the porch was enlarged before 1971. The house is clad in clapboards and the roof is covered in metal. The porch obscures the fenestration of the front facade. The screened porch itself has nine bays. The four left bays contain screens. The center bay contains a door covered with a modern glass and metal storm door. The remaining four right bays each contain a screen. The first story of the side (north) facade has three bays, evenly spaced along the facade. Each bay contains a one-over-one single hung vinyl window. The second story of the side facade has two bays under the gable. Each bay contains a one-over-one single hung vinyl window.

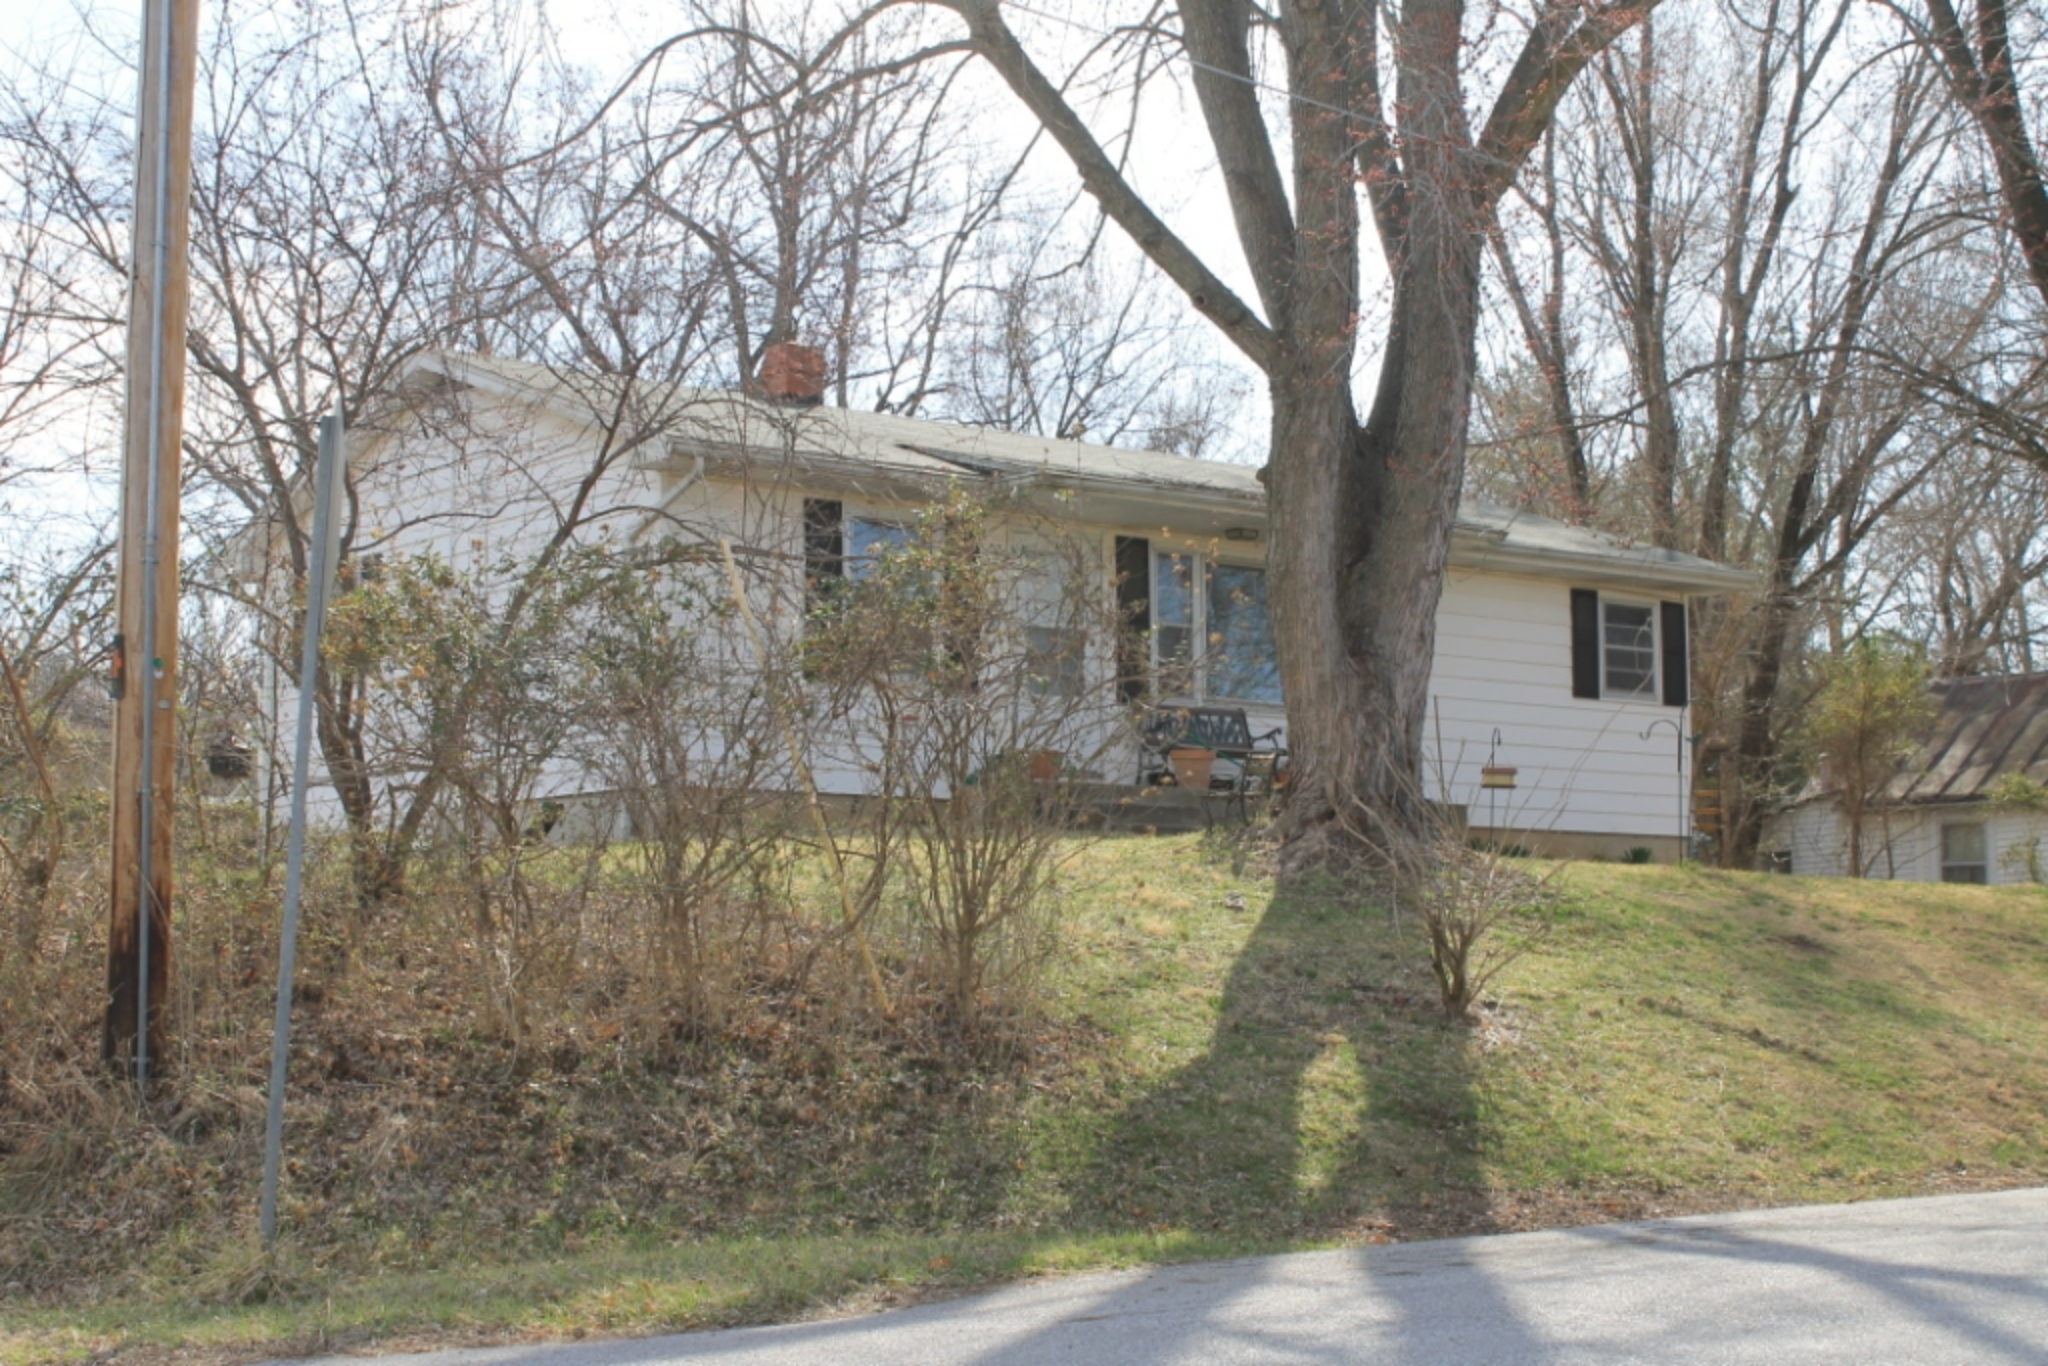
This one-story, massed plan side gable, frame ranch house has a low gable roof. The walls are clad in clapboards and the roof is covered in asphalt shingles. The center portion of the roof is slightly raised and extends to the west to cover a porch. The front (west) facade has four bays. The leftmost bay contains a two horizontal-over-two horizontal single hung wooden window. The next bay contains a door. The next bay contains a large fixed glass window flanked by small two horizontal-over-two horizontal wooden windows. The rightmost bay contains a two horizontal-over-two horizontal single hung wooden window.

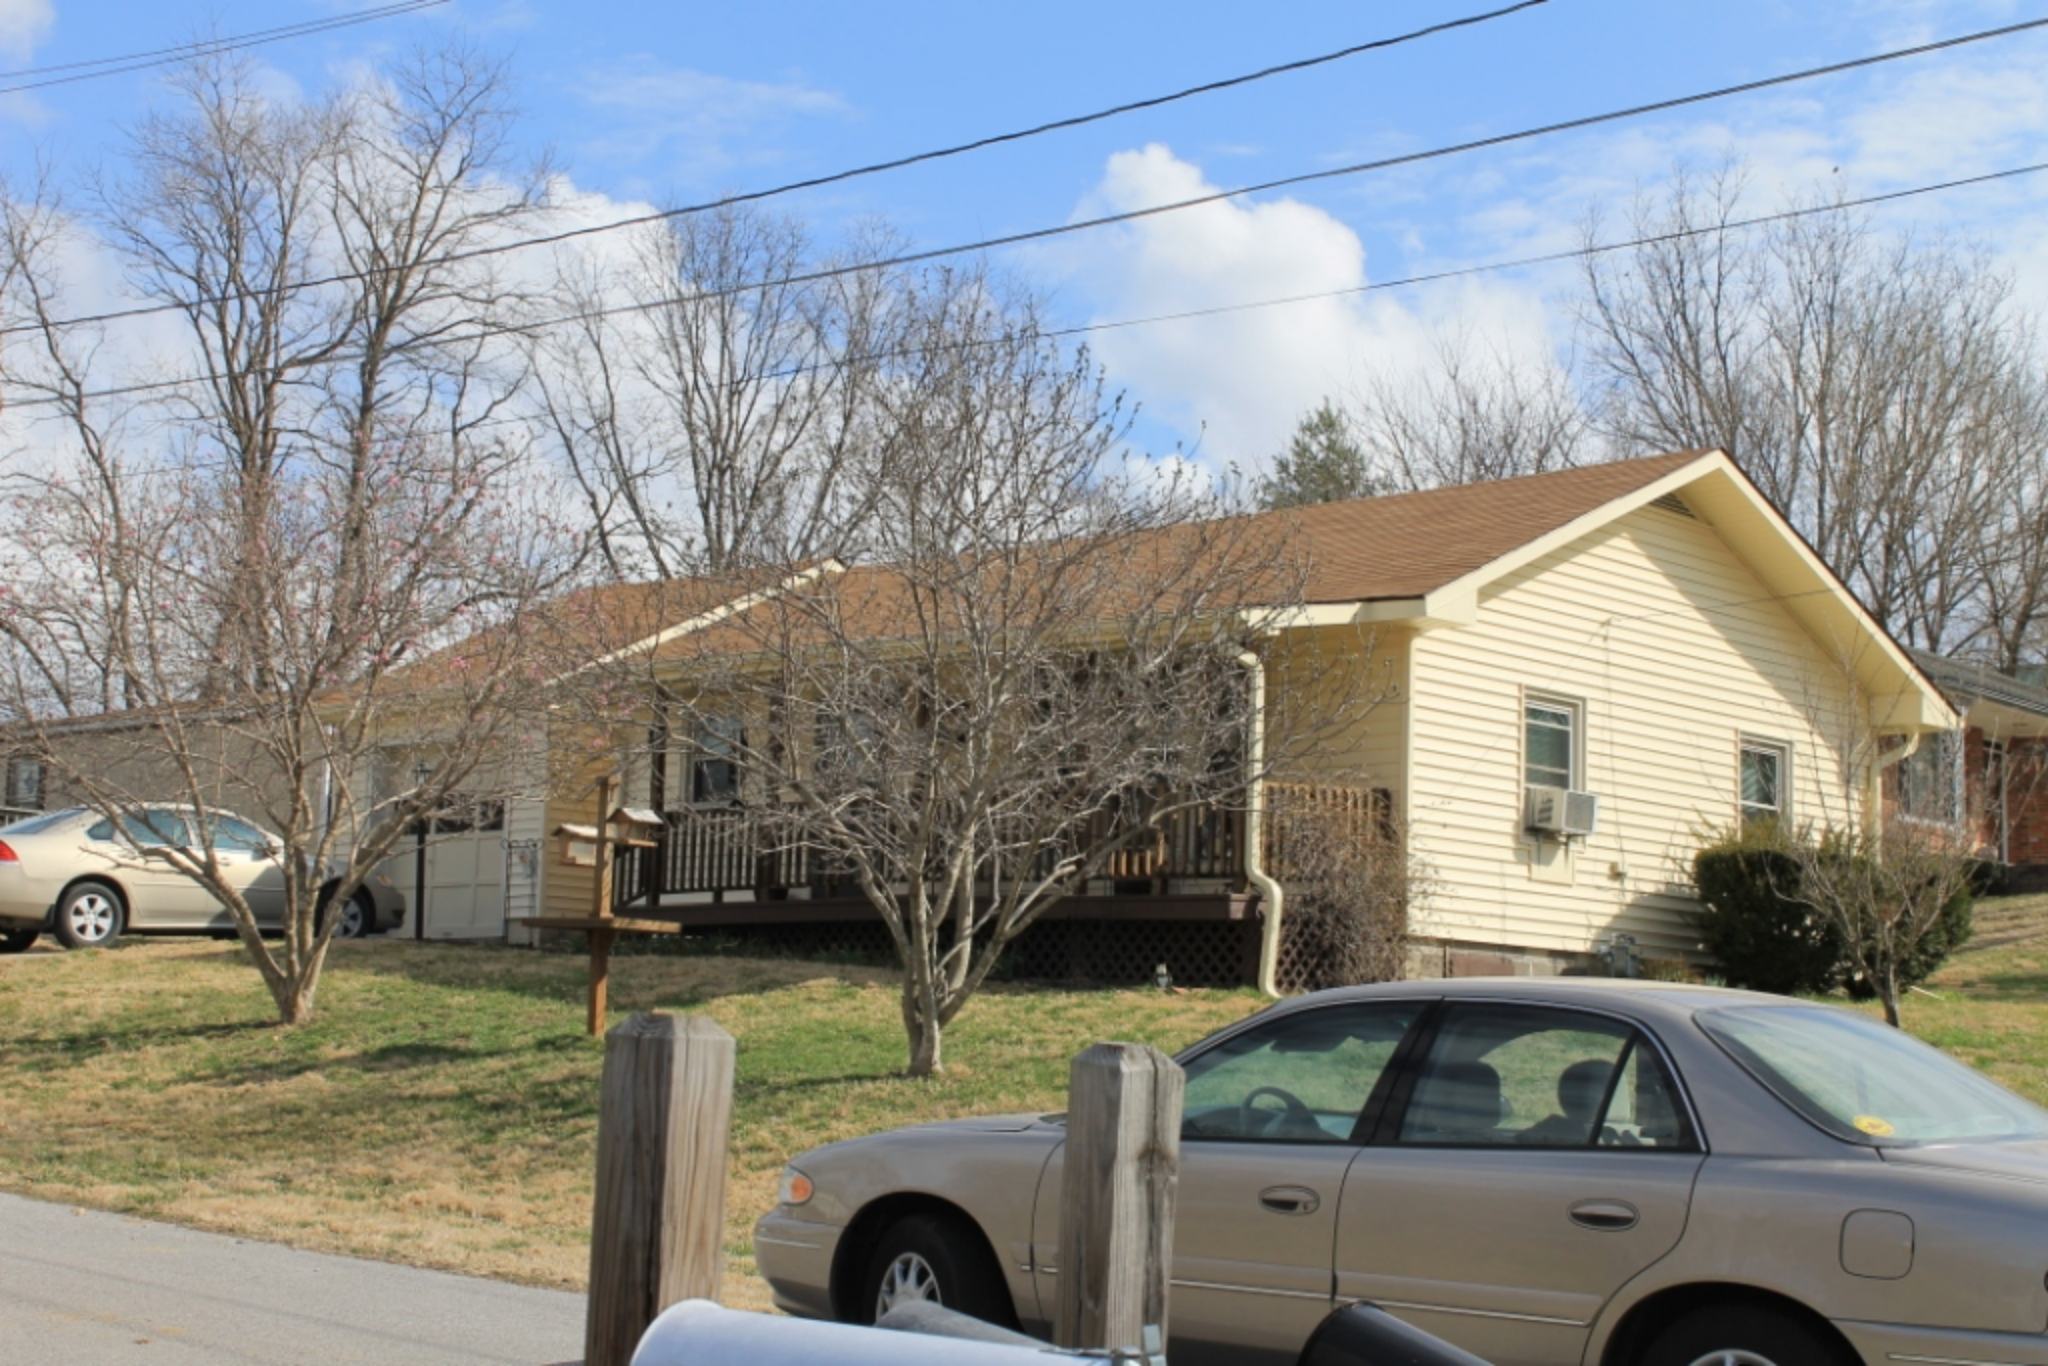
This one-story, massed plan side gable, frame ranch house is clad in vinyl siding. The low gable roof is covered in asphalt shingles. To the north end of the house is a single car garage whose roof is slightly higher than the roof of the house and which protrudes slightly from the front (west) facade. At the point where the garage meets the main block of the house is a porch that extends the remaining length of the front facade. The roof of the porch is supported by wooden posts and the porch is surrounded by a railing. The (front) west facade has five bays. The left bay, which is located in the garage wing, contains an overhead garage door. The next two bays each contain a one-over-one single hung vinyl window. The next bay contains a door with a modern metal and glass storm door. The door opens onto the porch. The rightmost bay contains a one-over-one single hung vinyl window. The (side) south facade has two bays, each containing a one-over-one single hung vinyl window.

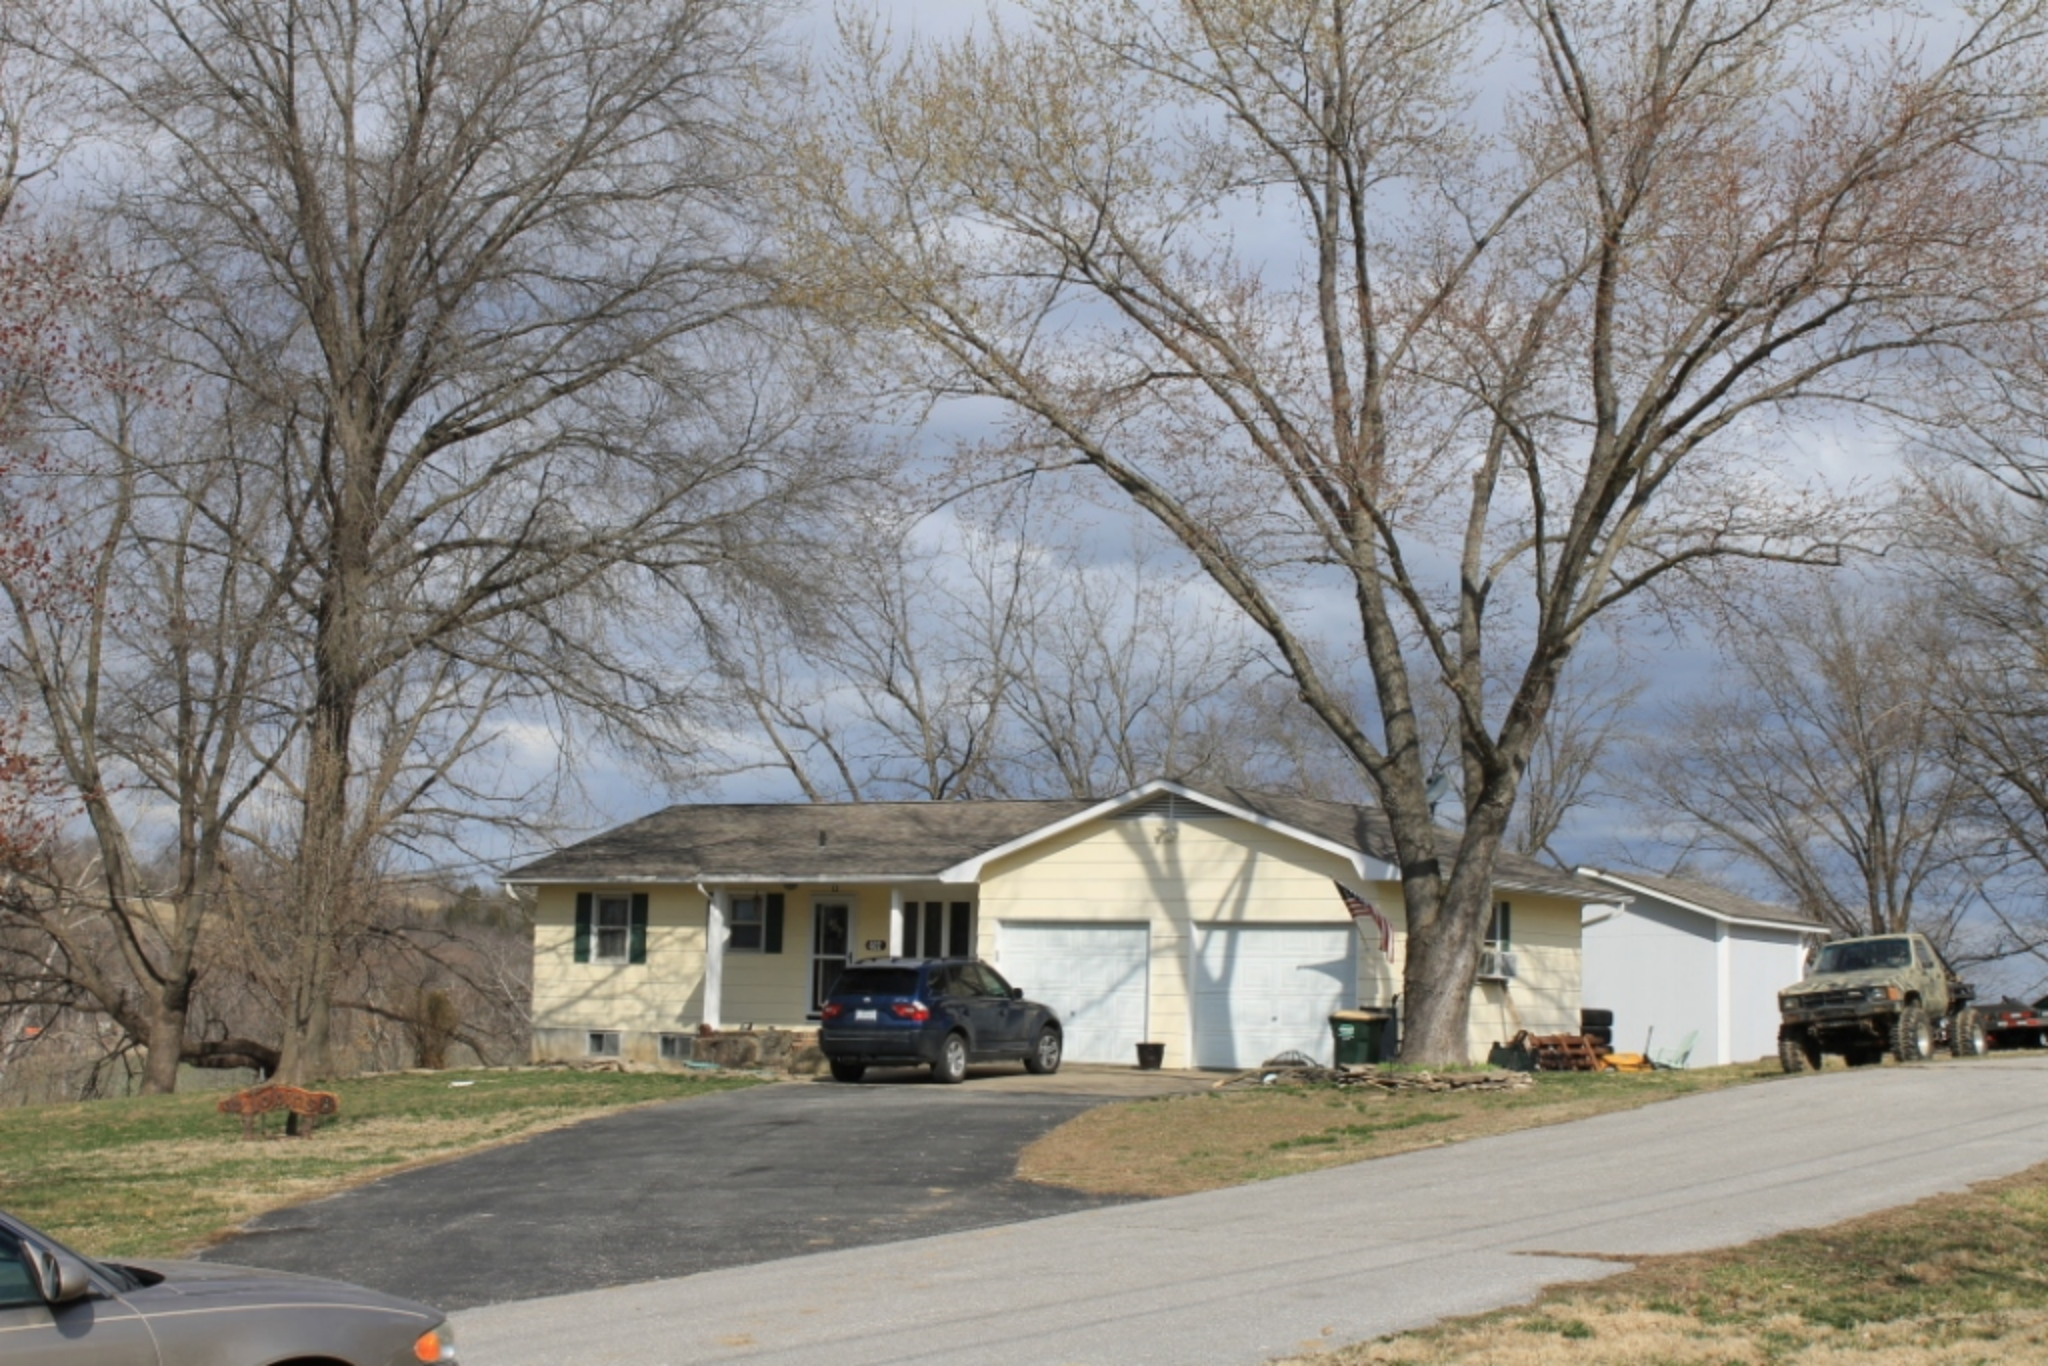
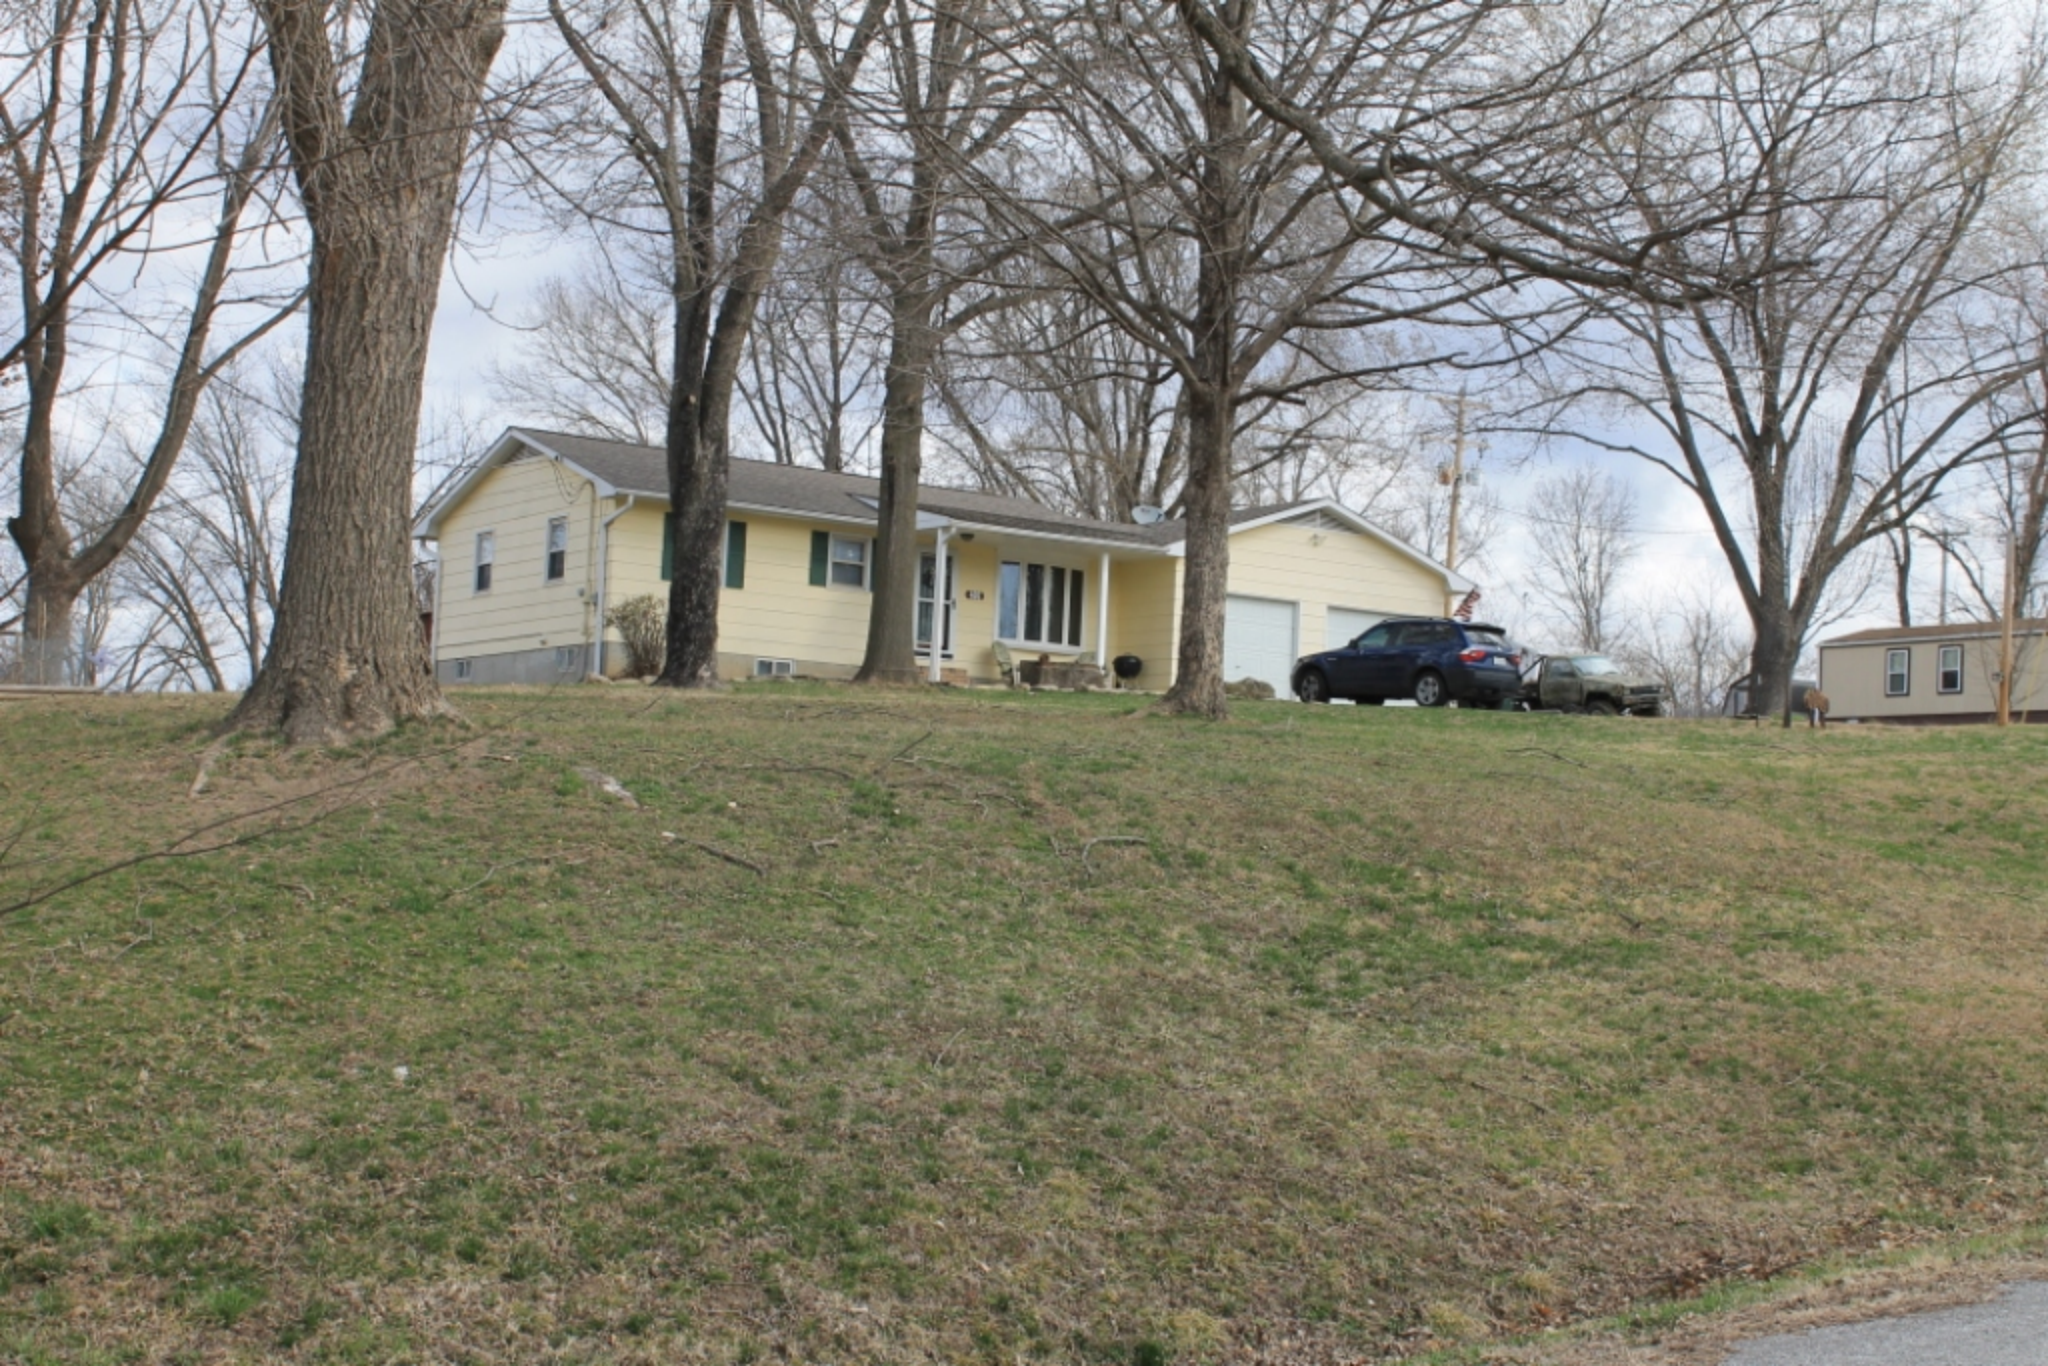
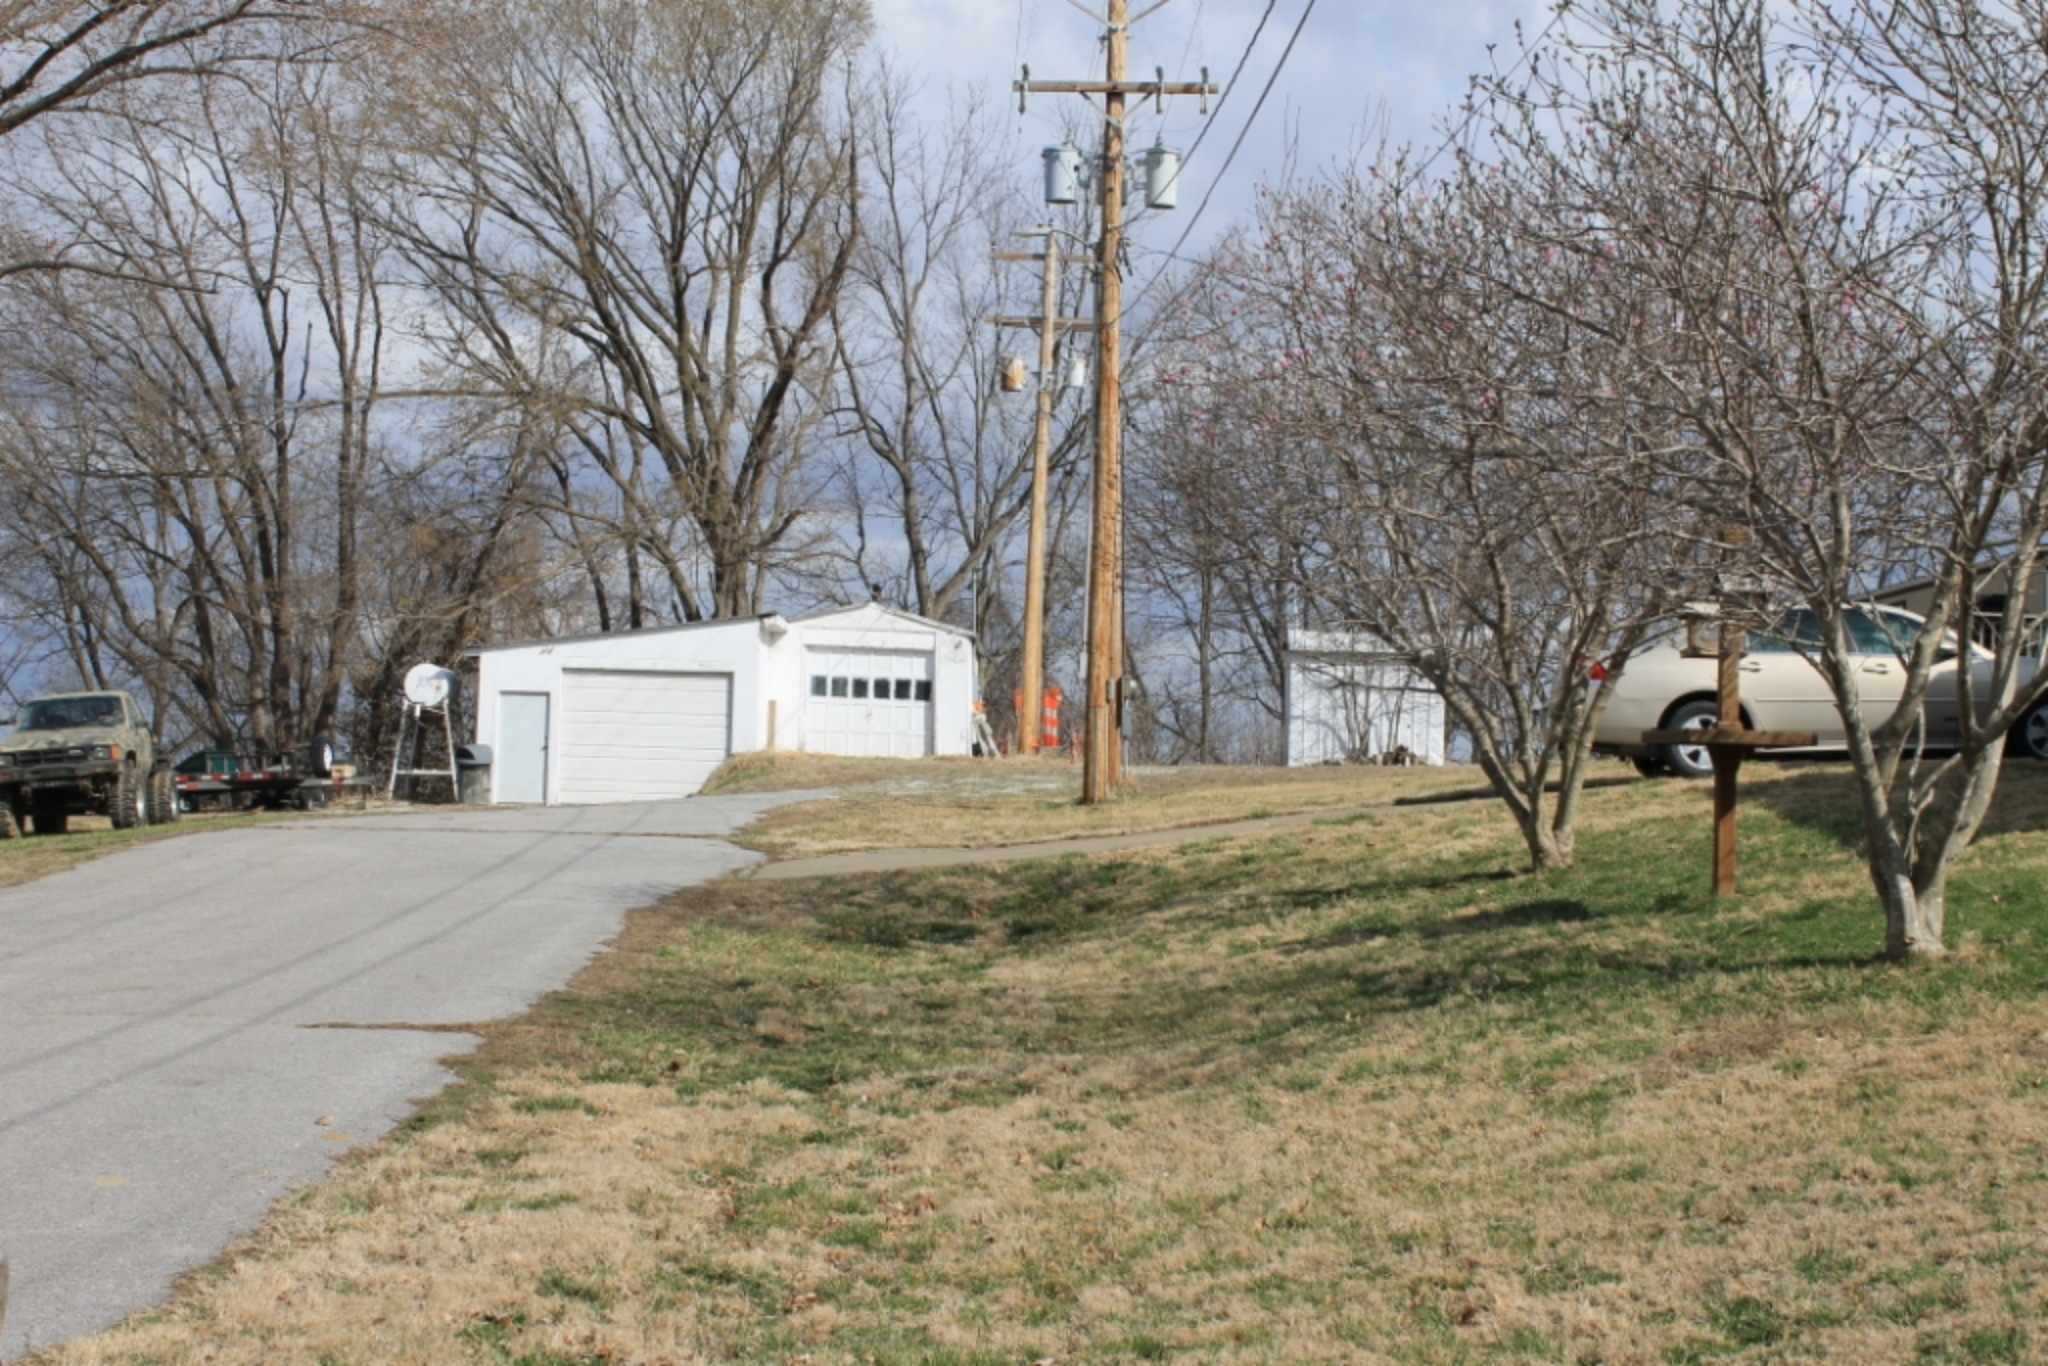
This one-story, massed plan, frame ranch house has a low cross gabled roof. The walls are clad in wide synthetic clapboards and the roof is covered in asphalt shingles. The portion of the building under the cross gable is on the right side of the building and houses a garage. At the point where the cross gable roofed garage and the main block of the house meet is a porch whose roof is an extension of the roof of the main block of the house. Wooden posts support the porch roof. The front (south) facade of the house has six bays. The left bay contains a one-over-one single hung wooden window. The next bay contains a shorter one-over-one single hung wooden window. The next bay contains a door covered with a metal and glass storm door. The next bay contains has a bow window with four vertical fixed glass panes. The rightmost two bays each contain an overhead garage door.
