MISSOURI DEPARTMENT OF NATURAL RESOURCES
STATE HISTORIC PRESERVATION OFFICE, P.O. Box 176, Jefferson City, MO 65102
ARCHITECTURAL/HISTORIC INVENTORY FORM

1. SURVEY NO. BO-AS-009-0001		2. SURVEY NAME: Rocheport Historic District	
3. COUNTY: Boone		4. ADDRESS (STREET NO.)	STREET (NAME) Katy Trail
5. CITY: Rocheport	VICINITY: <input checked="" type="checkbox"/>	6. UTM: / /	LAT: LONG: T: 48W R: 15W S: 1

8. HISTORIC NAME (IF KNOWN): M.K.&T. Railroad tunnel		9. PRESENT/OTHER NAME (IF KNOWN): Katy trail tunnel	
10. OWNERSHIP: <input type="checkbox"/> PRIVATE <input checked="" type="checkbox"/> PUBLIC		11A. HISTORIC USE (IF KNOWN): railroad tunnel	11B. CURRENT USE: Katy Trail tunnel
HISTORICAL INFORMATION

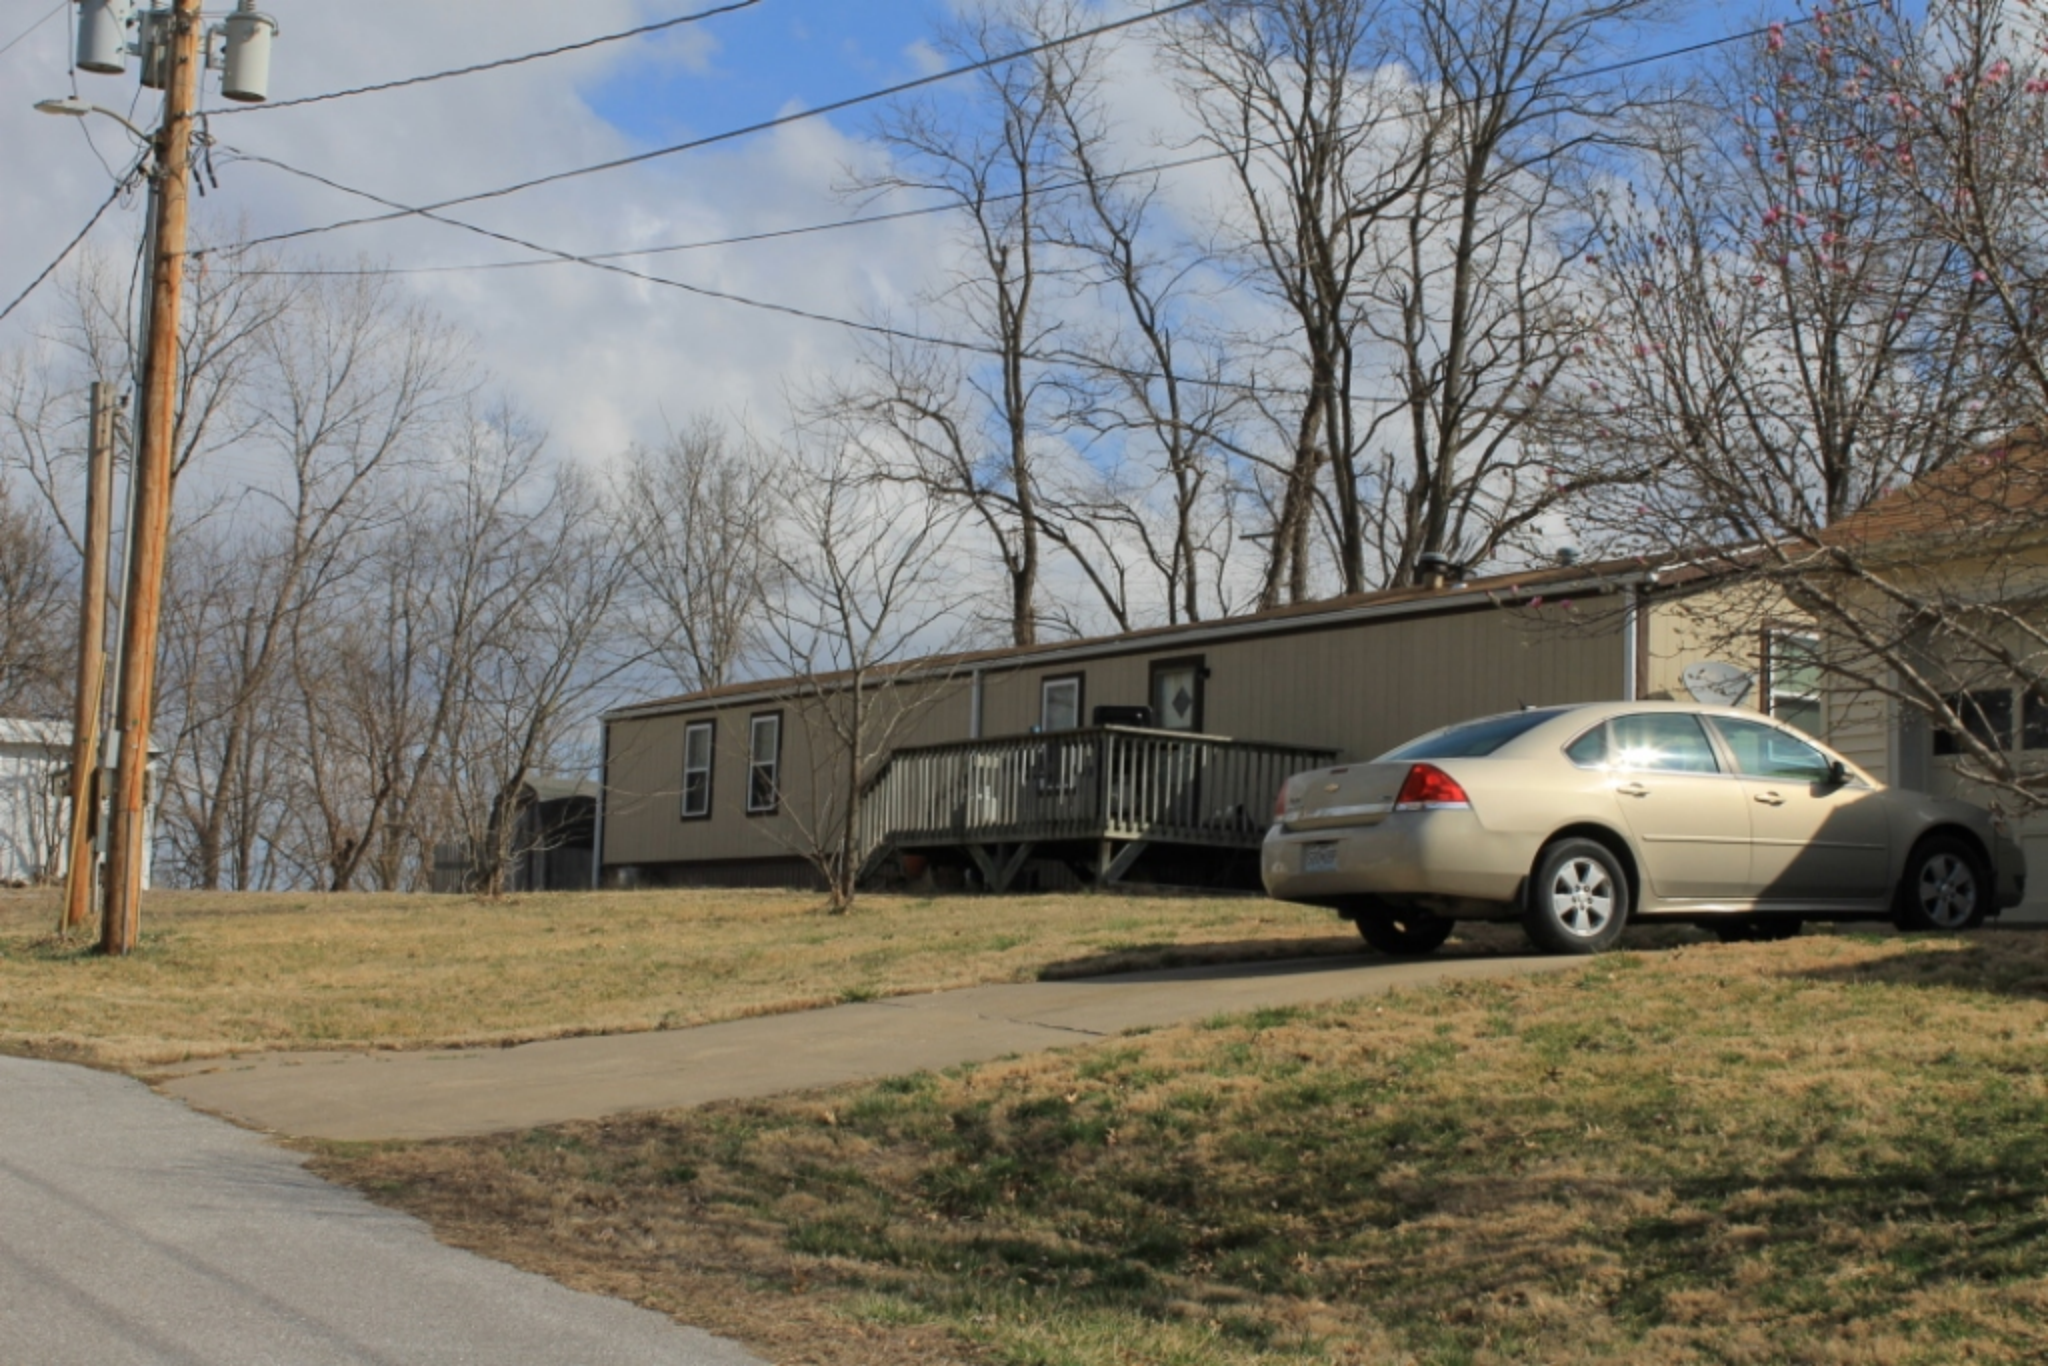
This mobile home is a long single-wide mobile home with a very low pitched gable roof. The walls are clad in vertical plywood siding and the roof is covered in asphalt shingles. A deck extends to the west from the central portion of the front facade. The front (west) facade of the mobile home has four bays. The leftmost bay contains a single one-over-one single hung vinyl window. To the right is a second bay containing a single one-over-one single hung vinyl window. To the right is a third bay containing a single one-over-one single hung vinyl window. To the right is a bay containing a door with a diamond shaped window. The door opens onto the deck. The bays are located on the northern two-thirds of the mobile home, leaving a large expanse of the wall without bays. The side (south) facade has one bay containing a one-over-one single hung window.

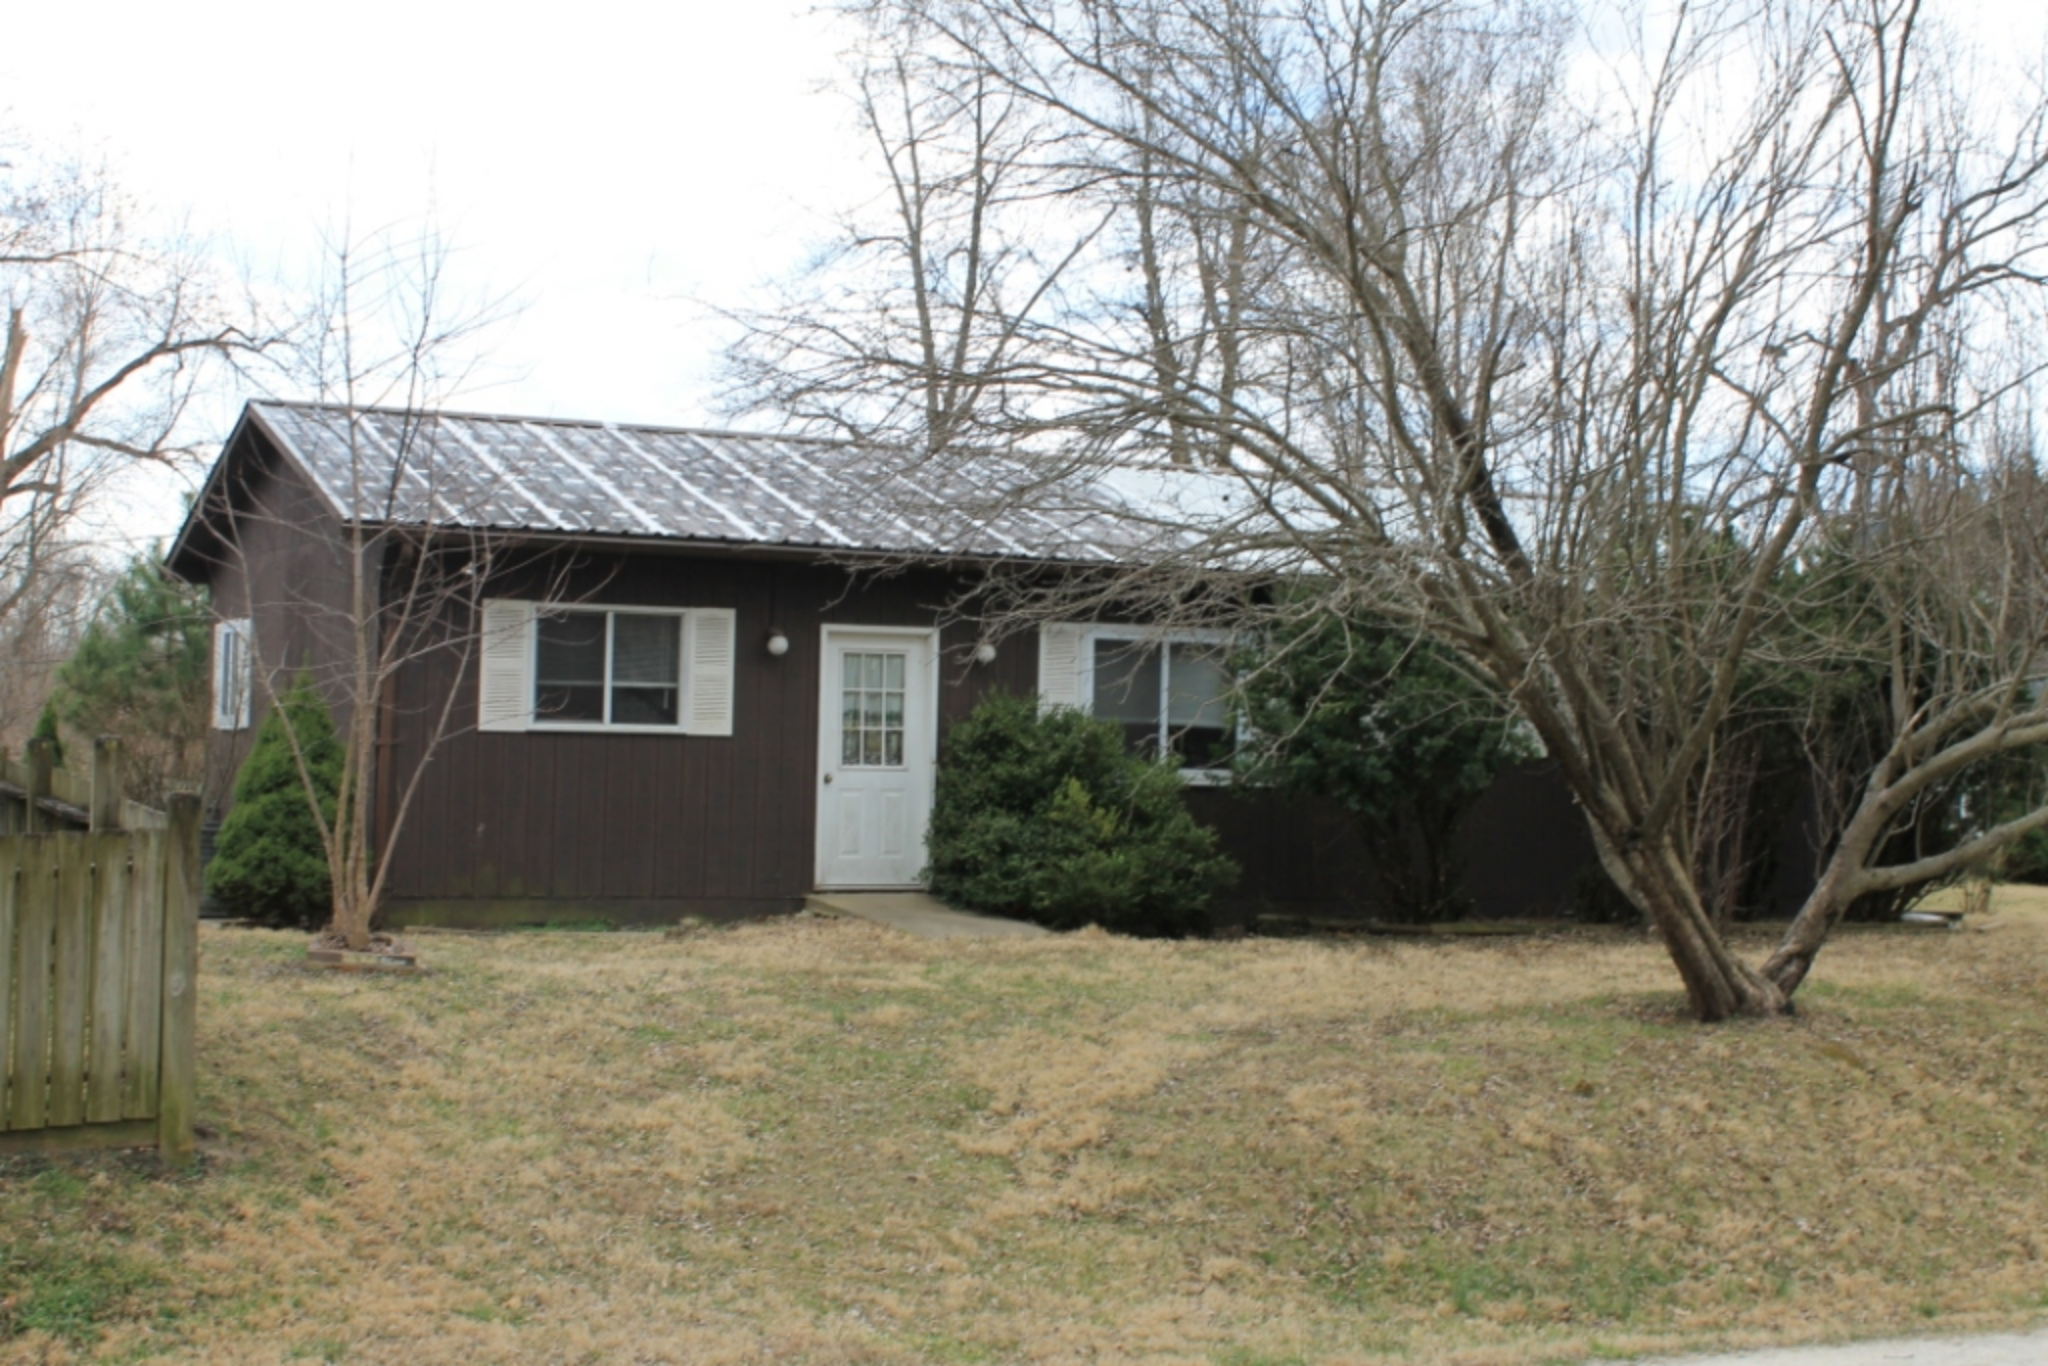
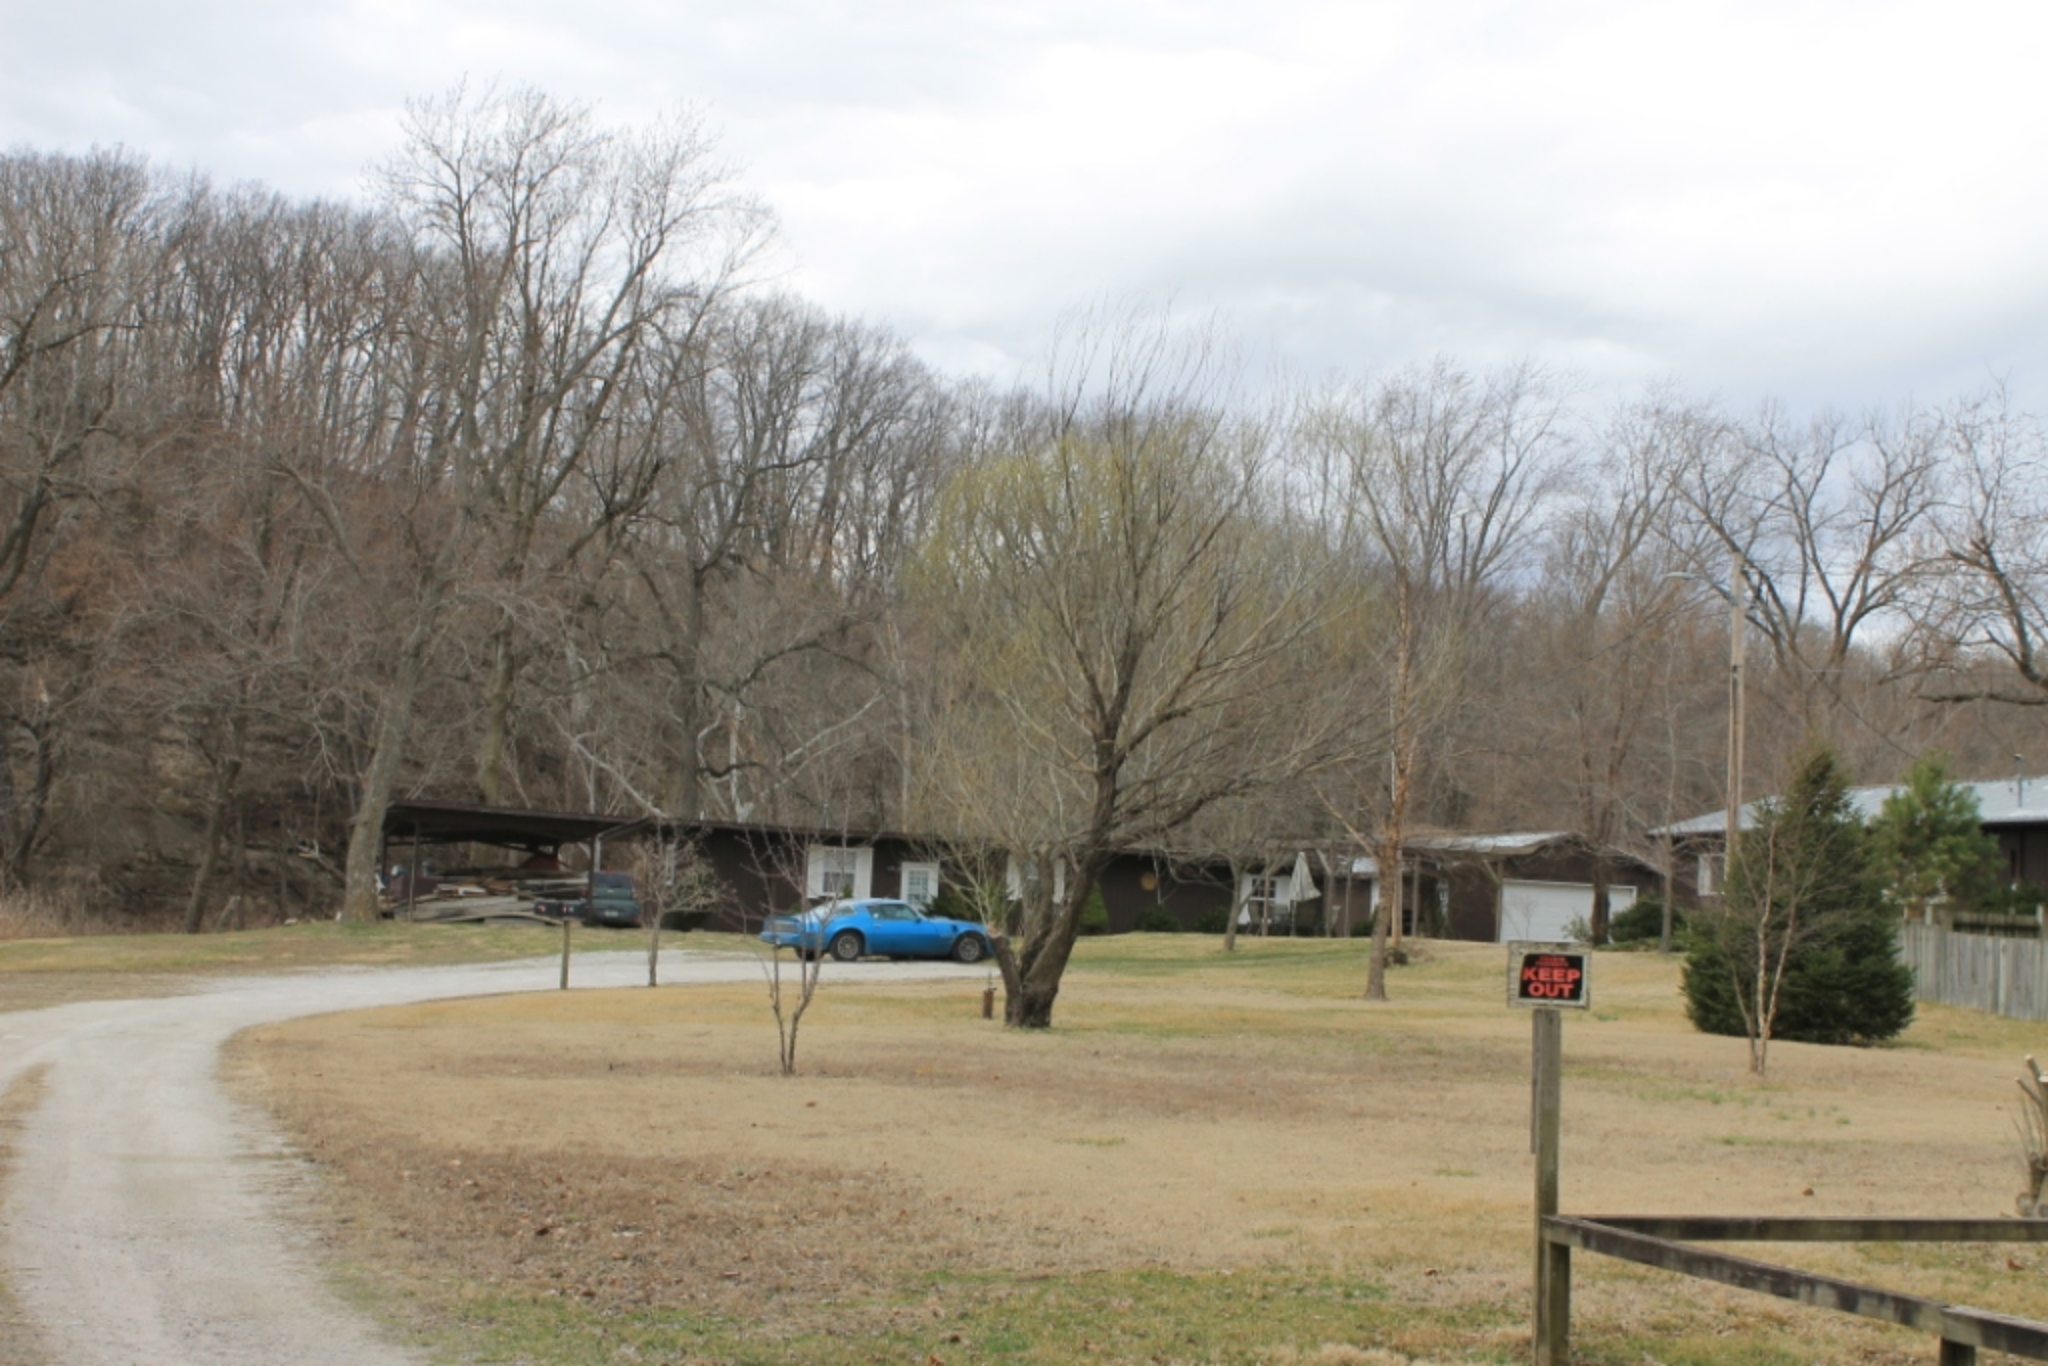
The primary building is a one-story, massed plan side gable, frame ranch house. The house is clad in vertical synthetic siding and the roof is covered in metal. The house has three bays on the front (east) facade. The left bay contains a two paned sliding glass window. The center bay contains a modern door with a nine-paned window. The right bay containing a longer two paned sliding glass window. The windows have decorative shutters.

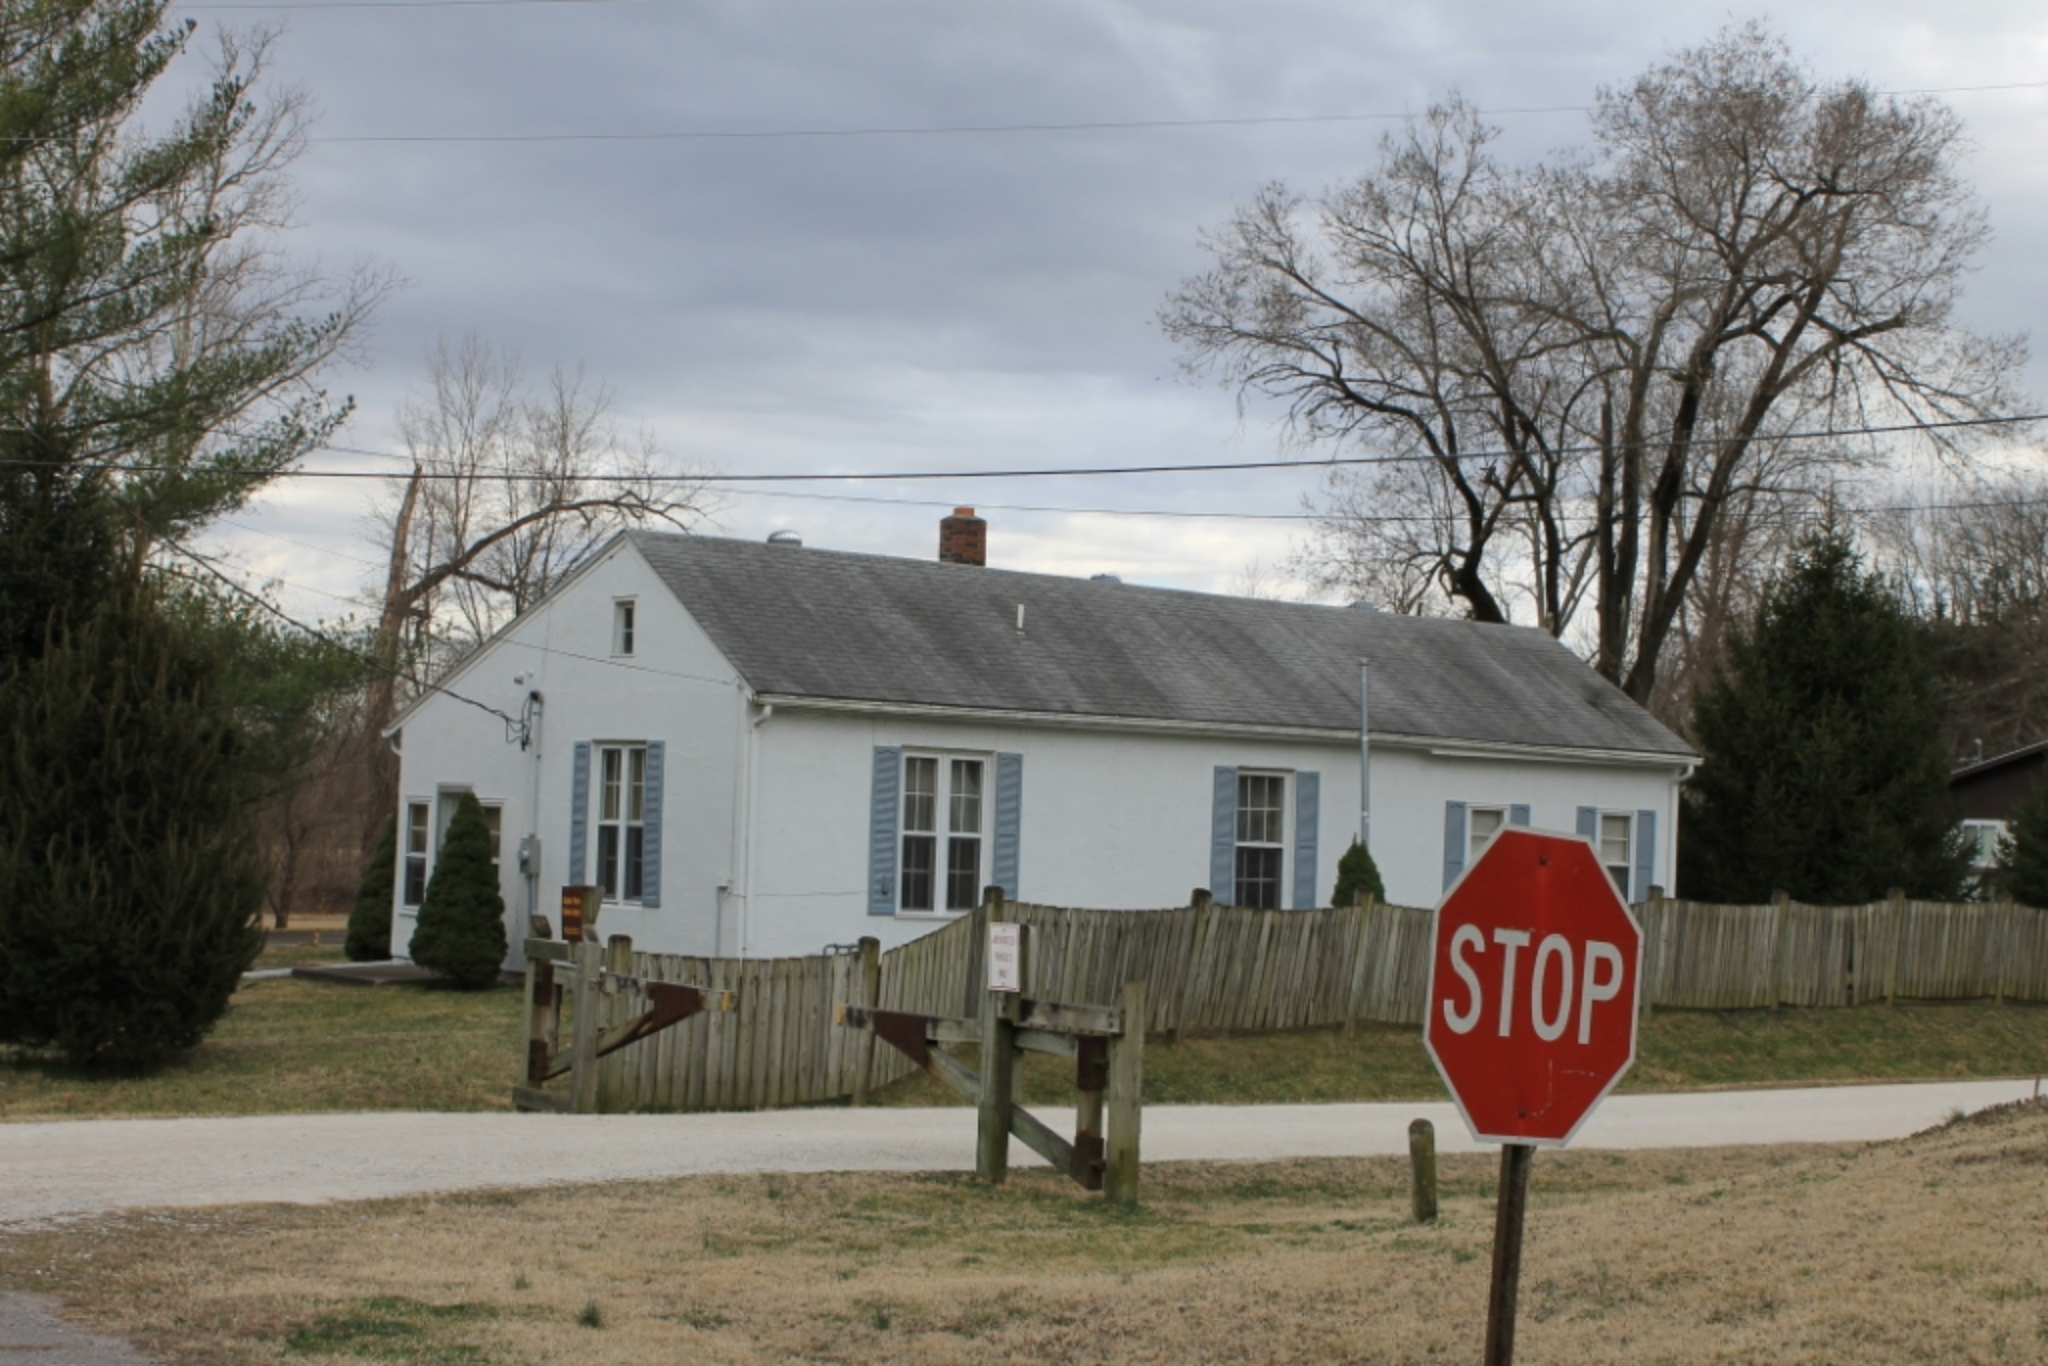
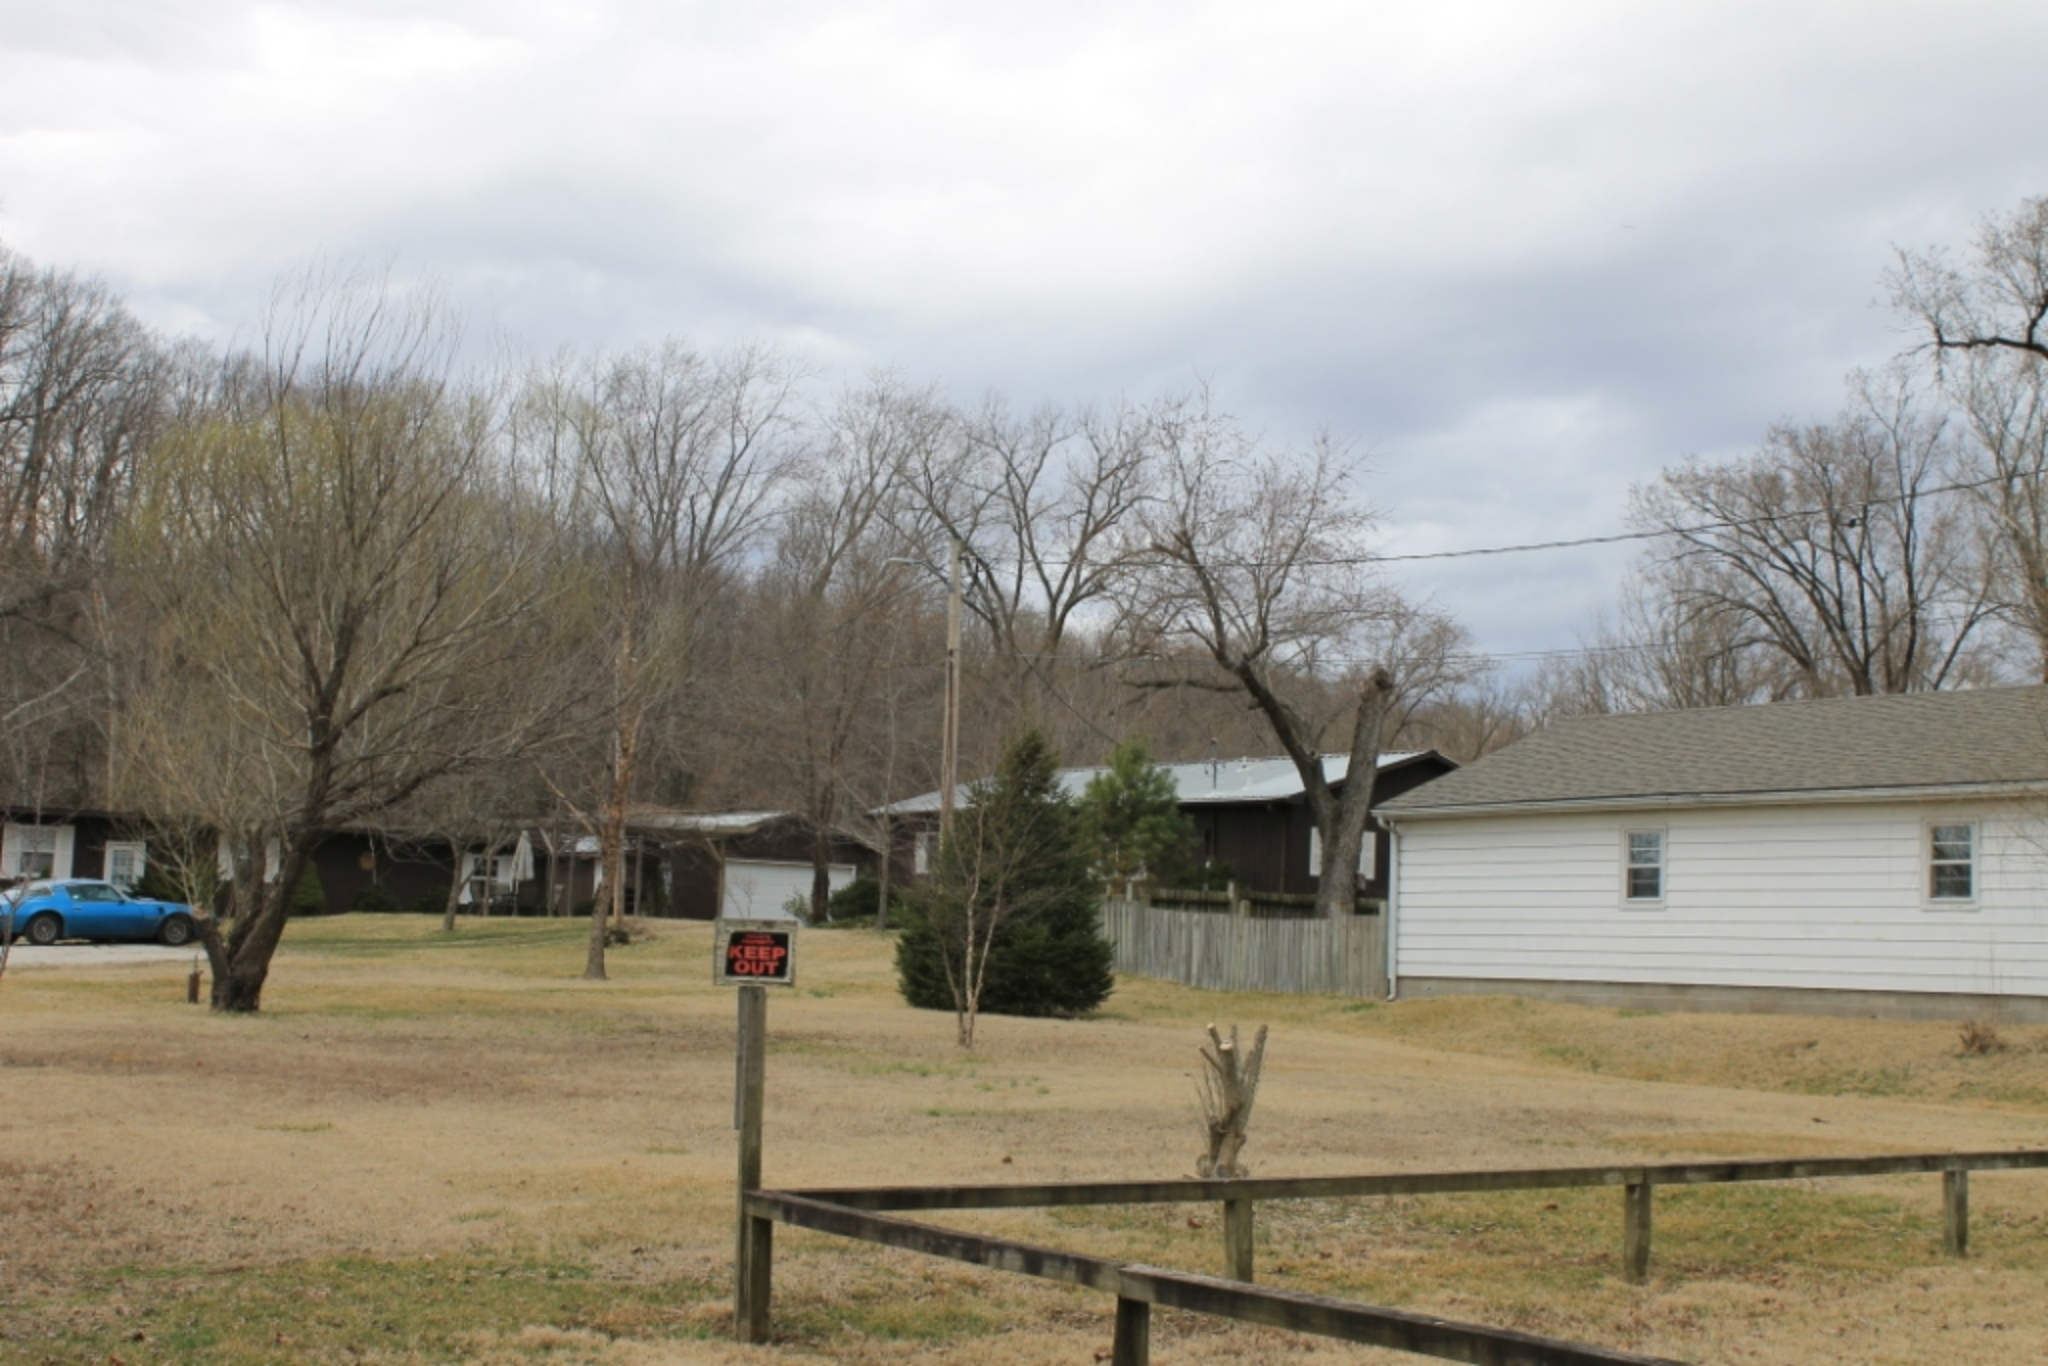
The building is a one-story, massed plan side gable house with a low pitched saltbox roof. The house is clad in stucco and the roof is asphalt shingles. The front (north) facade has four bays. The left bay contains a pair of four-over-four single hung vinyl windows. The next bay has one six-over-six single hung vinyl window. The two right bays each contain a shorter two-over-two single two-over-two single hung vinyl window. The west facade has four bays. The right bay contains a small two-over-two single hung vinyl window. The next bay, immediately to the right, contains a modern door with a metal and glass storm door. The next bay, immediately to the right of the door, contains a small two-over-two single hung vinyl window. These bays are fronted by a flat concrete slab forming a porch. The rightmost bay, which is centered below the gable roof, contains a pair of four-over-four single hung vinyl windows. Above this bay near the roof line is a small one-over-one window allowing light into the low pitched attic. The chimney sits to the left of center rear.

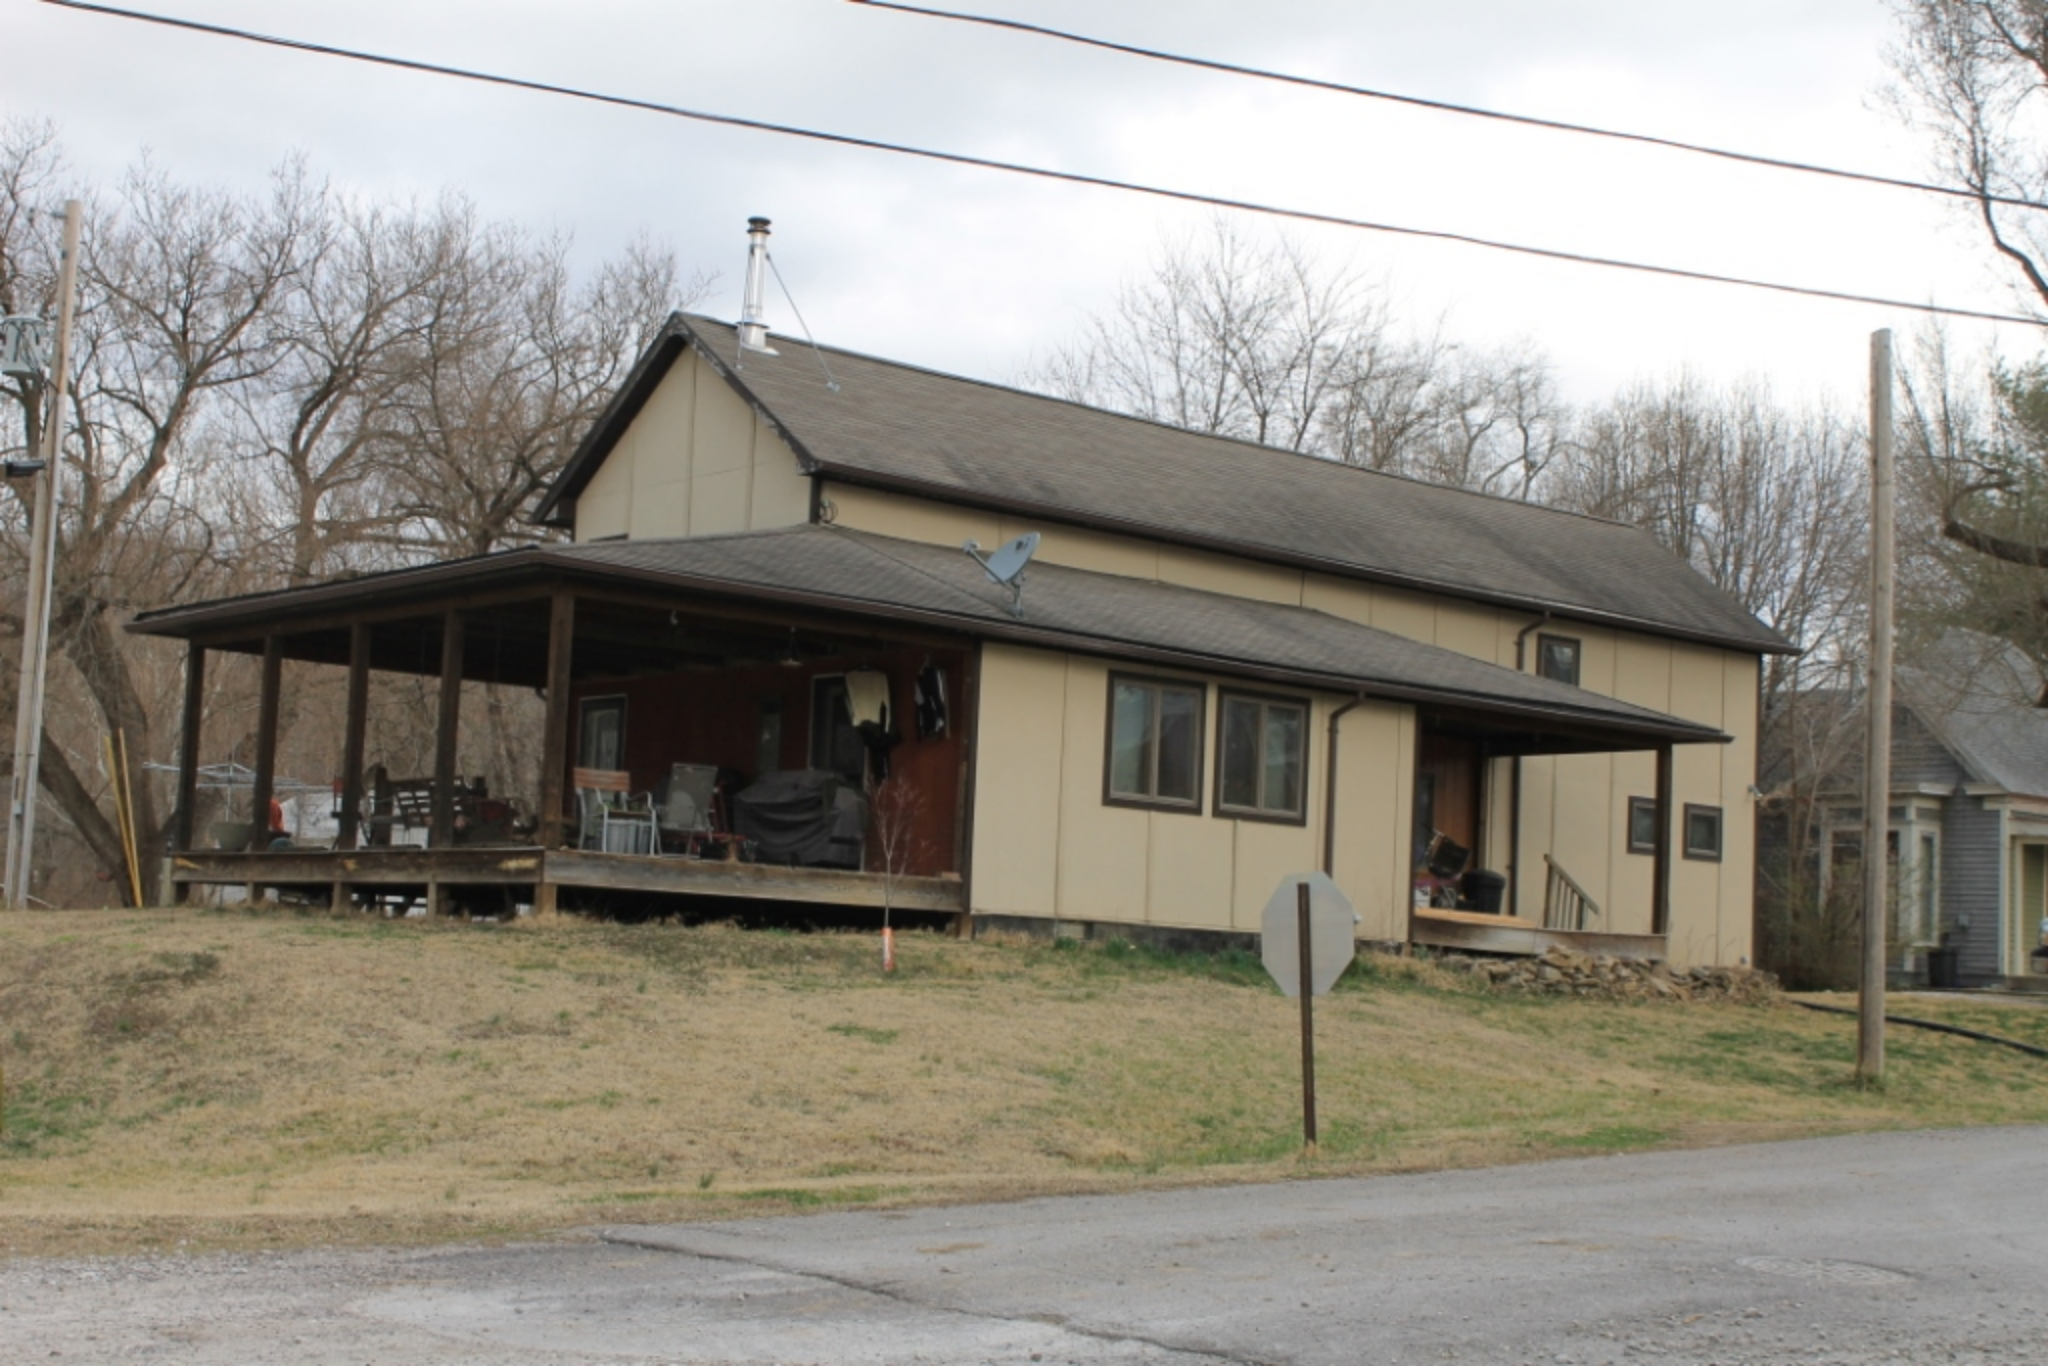
This 1 1/2 story, massed plan, house with a high gable roof has a hipped roof porch that wraps around the south end of the building and covers a wing protruding east from the main block of the house and a porch in the center of the east facade. The south facade, which is located under the porch roof, has three bays. The left bay contains a door covered with a modern metal and glass storm door. The center bay contains a tall narrow window. The right bay contains a door covered with a modern metal and glass storm door. The first story of the front (east) facade has five bays. The left bay, which is located on the east protruding wing, contains a pair of a two vertical pane sliding glass windows. The next bay, which is located on the main block of the house, contains a door. The two right bays each contain a two pane sliding glass window. The second story of the front (east) facade has one bay. This bay sits to the north of the porch roof and contains a one-over-one single hung window.
