MISSOURI DEPARTMENT OF NATURAL RESOURCES
STATE HISTORIC PRESERVATION OFFICE, P.O. Box 176, Jefferson City, MO 65102
ARCHITECTURAL/HISTORIC INVENTORY FORM

1. SURVEY NO. BO-AS-009-0001		2. SURVEY NAME: Rocheport Historic District	
3. COUNTY: Boone		4. ADDRESS (STREET NO.)	STREET (NAME) Katy Trail
5. CITY: Rocheport	VICINITY: <input checked="" type="checkbox"/>	6. UTM: / /	LAT: LONG: T: 48W R: 15W S: 1

8. HISTORIC NAME (IF KNOWN): M.K.&T. Railroad tunnel		9. PRESENT/OTHER NAME (IF KNOWN): Katy trail tunnel	
10. OWNERSHIP: <input type="checkbox"/> PRIVATE <input checked="" type="checkbox"/> PUBLIC		11A. HISTORIC USE (IF KNOWN): railroad tunnel	11B. CURRENT USE: Katy Trail tunnel
HISTORICAL INFORMATION

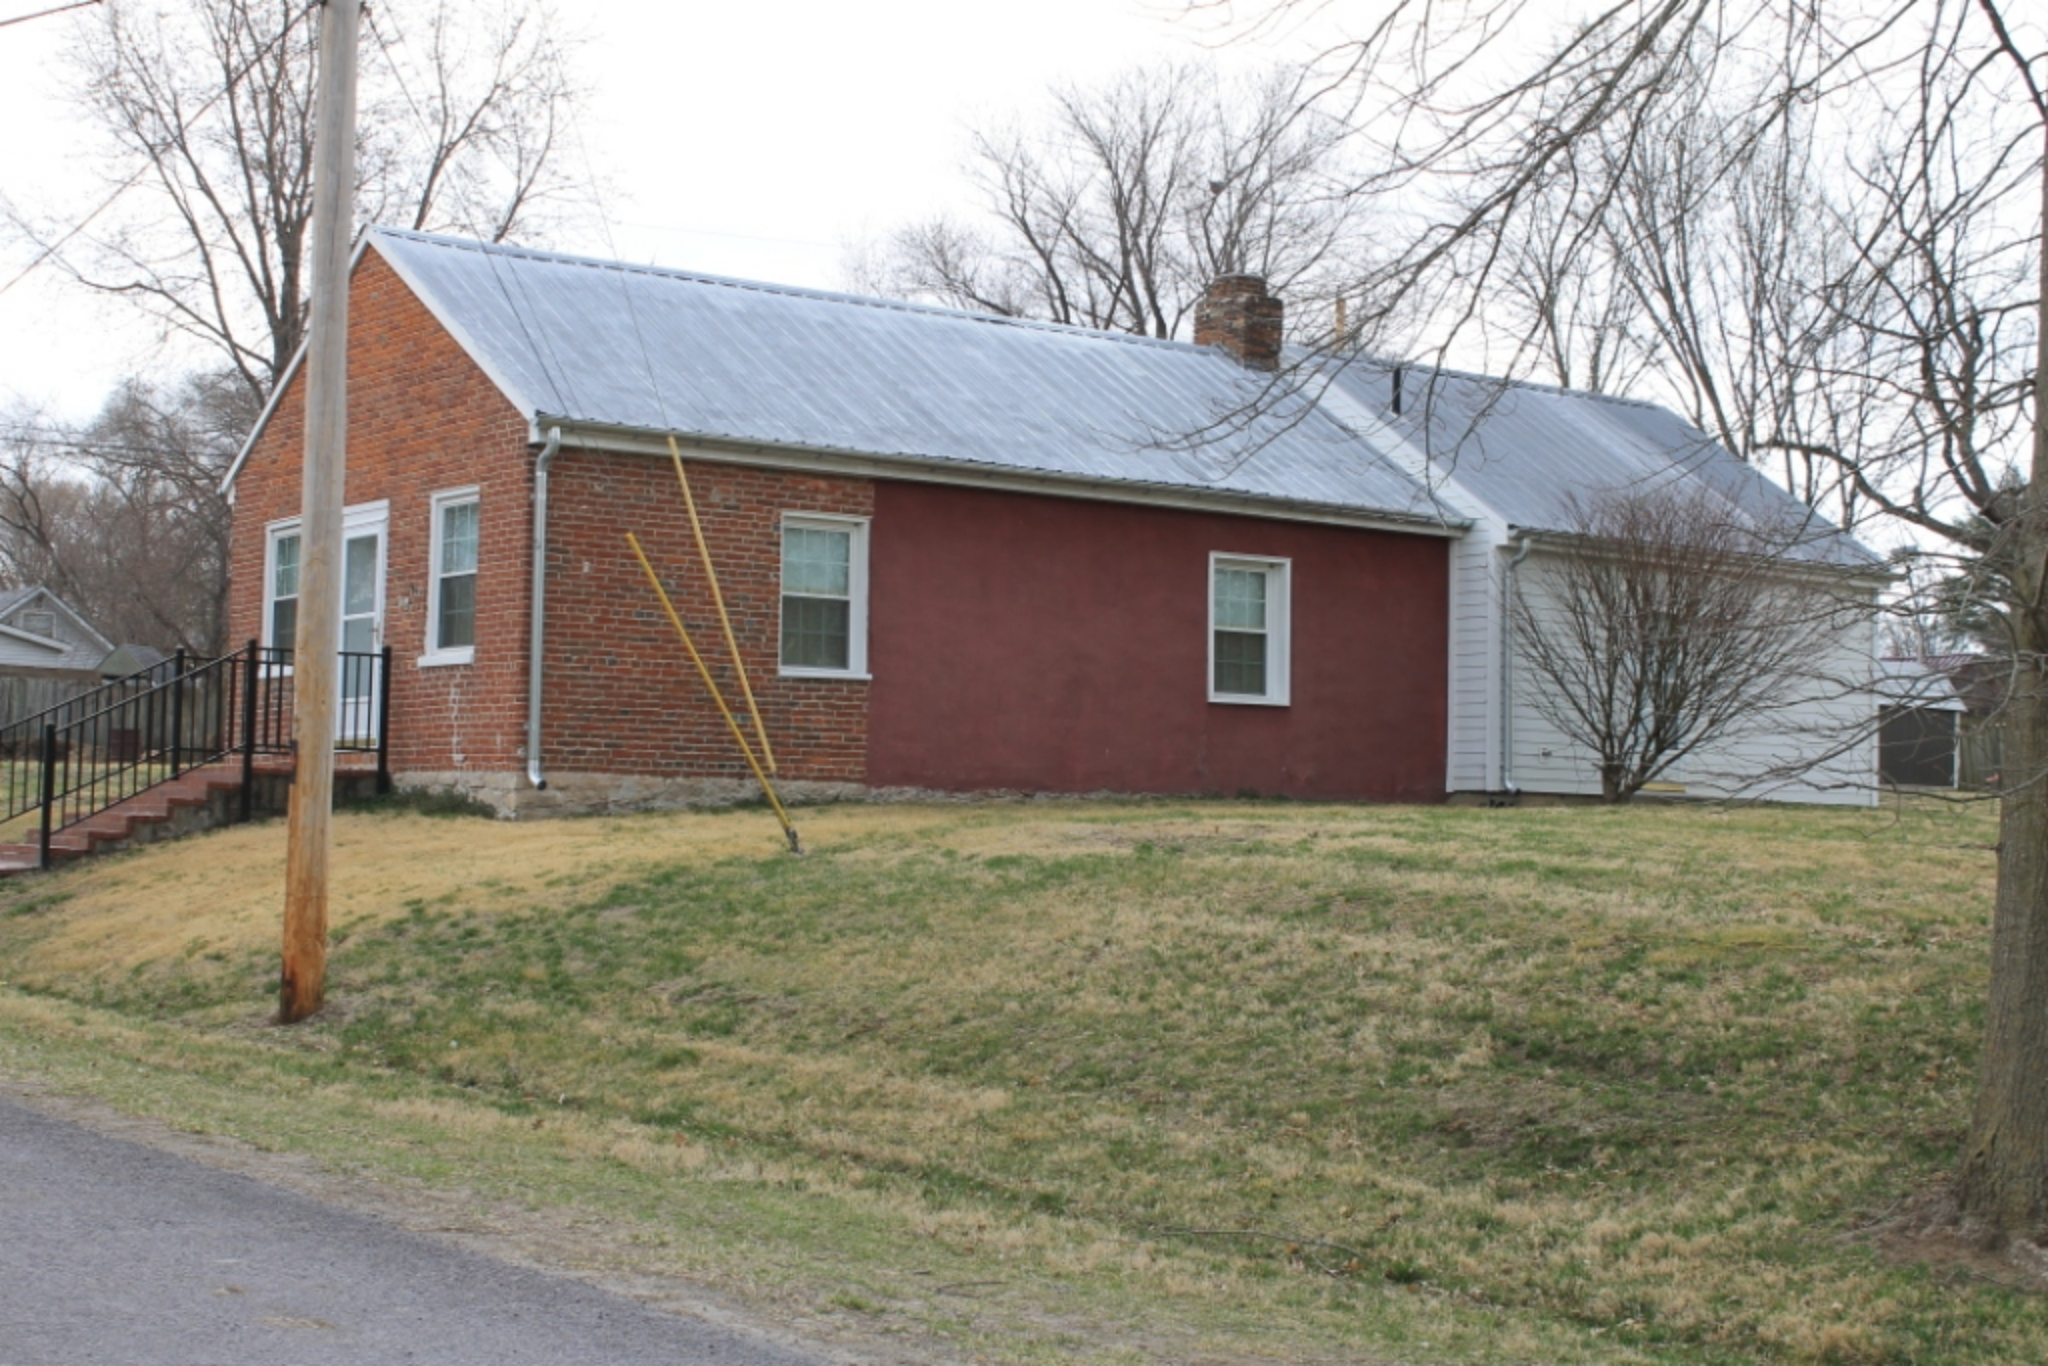
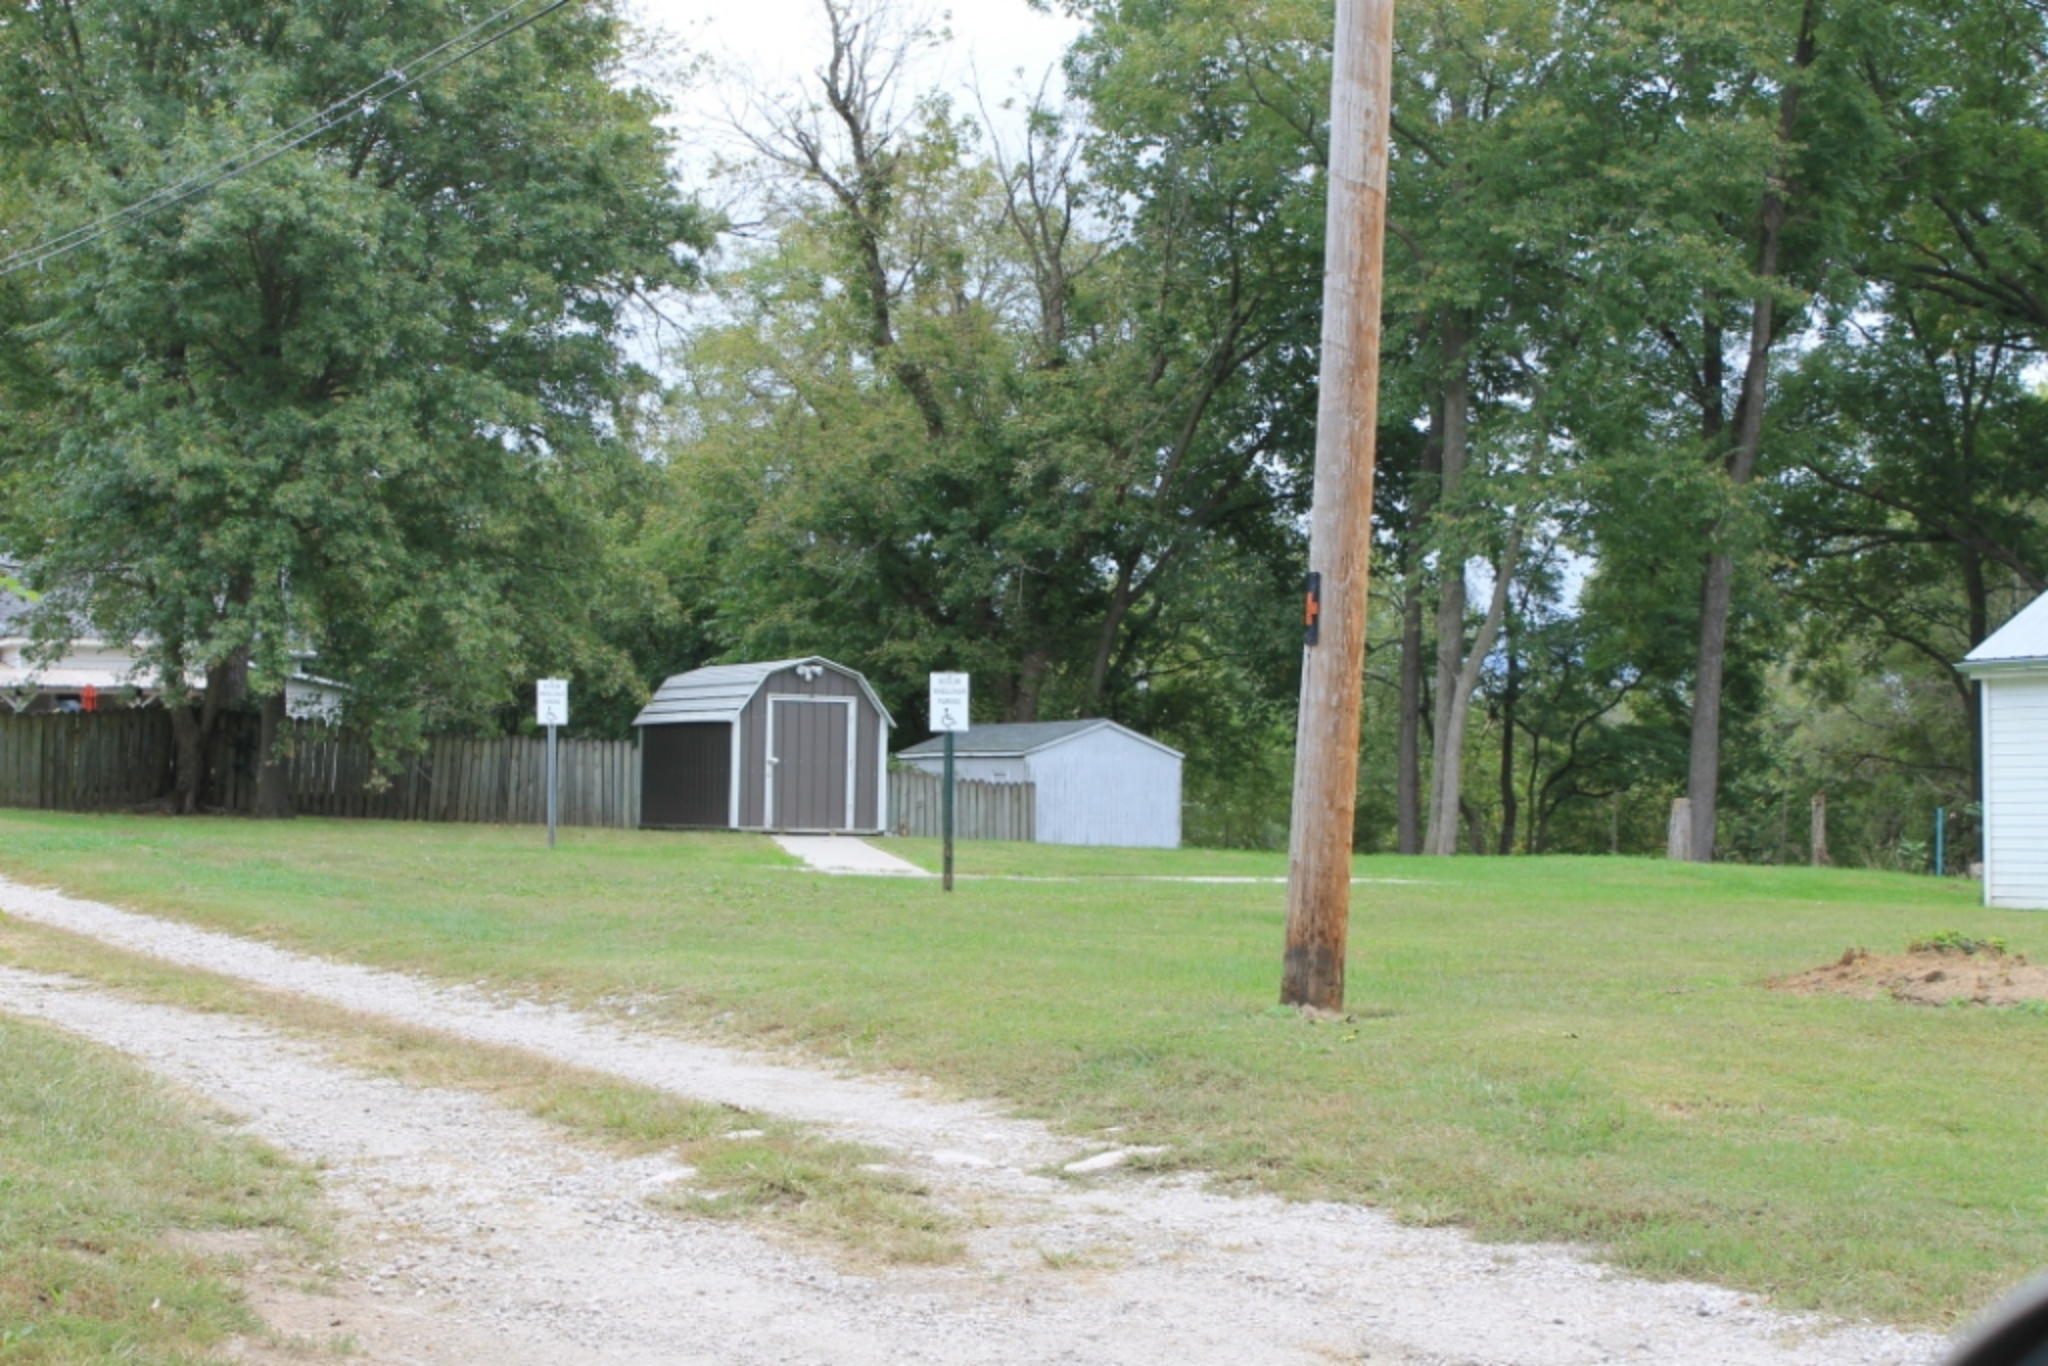
This one-story, massed plan front gable roof, brick building faces west on Moniteau Street. The brick on the north side of the main block of the building has been parged and painted brick red. The brick on two-thirds of the south side of the wall has been parged and painted red. The front (west) facade is unparged and reveals the original brick, which consists of header and stretcher bricks laid in a random pattern. The brick on the south side of the building is laid in a pattern of one row of header bricks, then five rows of stretcher bricks, and then a row of header bricks. Before the Civil War a frame addition was built to the rear of the building. At some point before the 1940s, this frame addition was rebuilt. The frame addition protrudes slightly from the sides of the original building. The roof of the building is metal. The front (west) facade has three bays. The left bay contains a six-over-six single hung vinyl window. The center bay contains a modern door that opens onto a brick stoop leading down to a brick walkway. The right bay contains a six-over-six single hung vinyl window. The side (south) facade has three bays. Two left bays, which are located in the original building, each contain a six-over-one single hung vinyl window. The right bay, which is in the frame addition, contains a six-over-one single hung vinyl window. One chimney rises from the point where the gable roof of the original building and the gable roof of the frame addition meet.

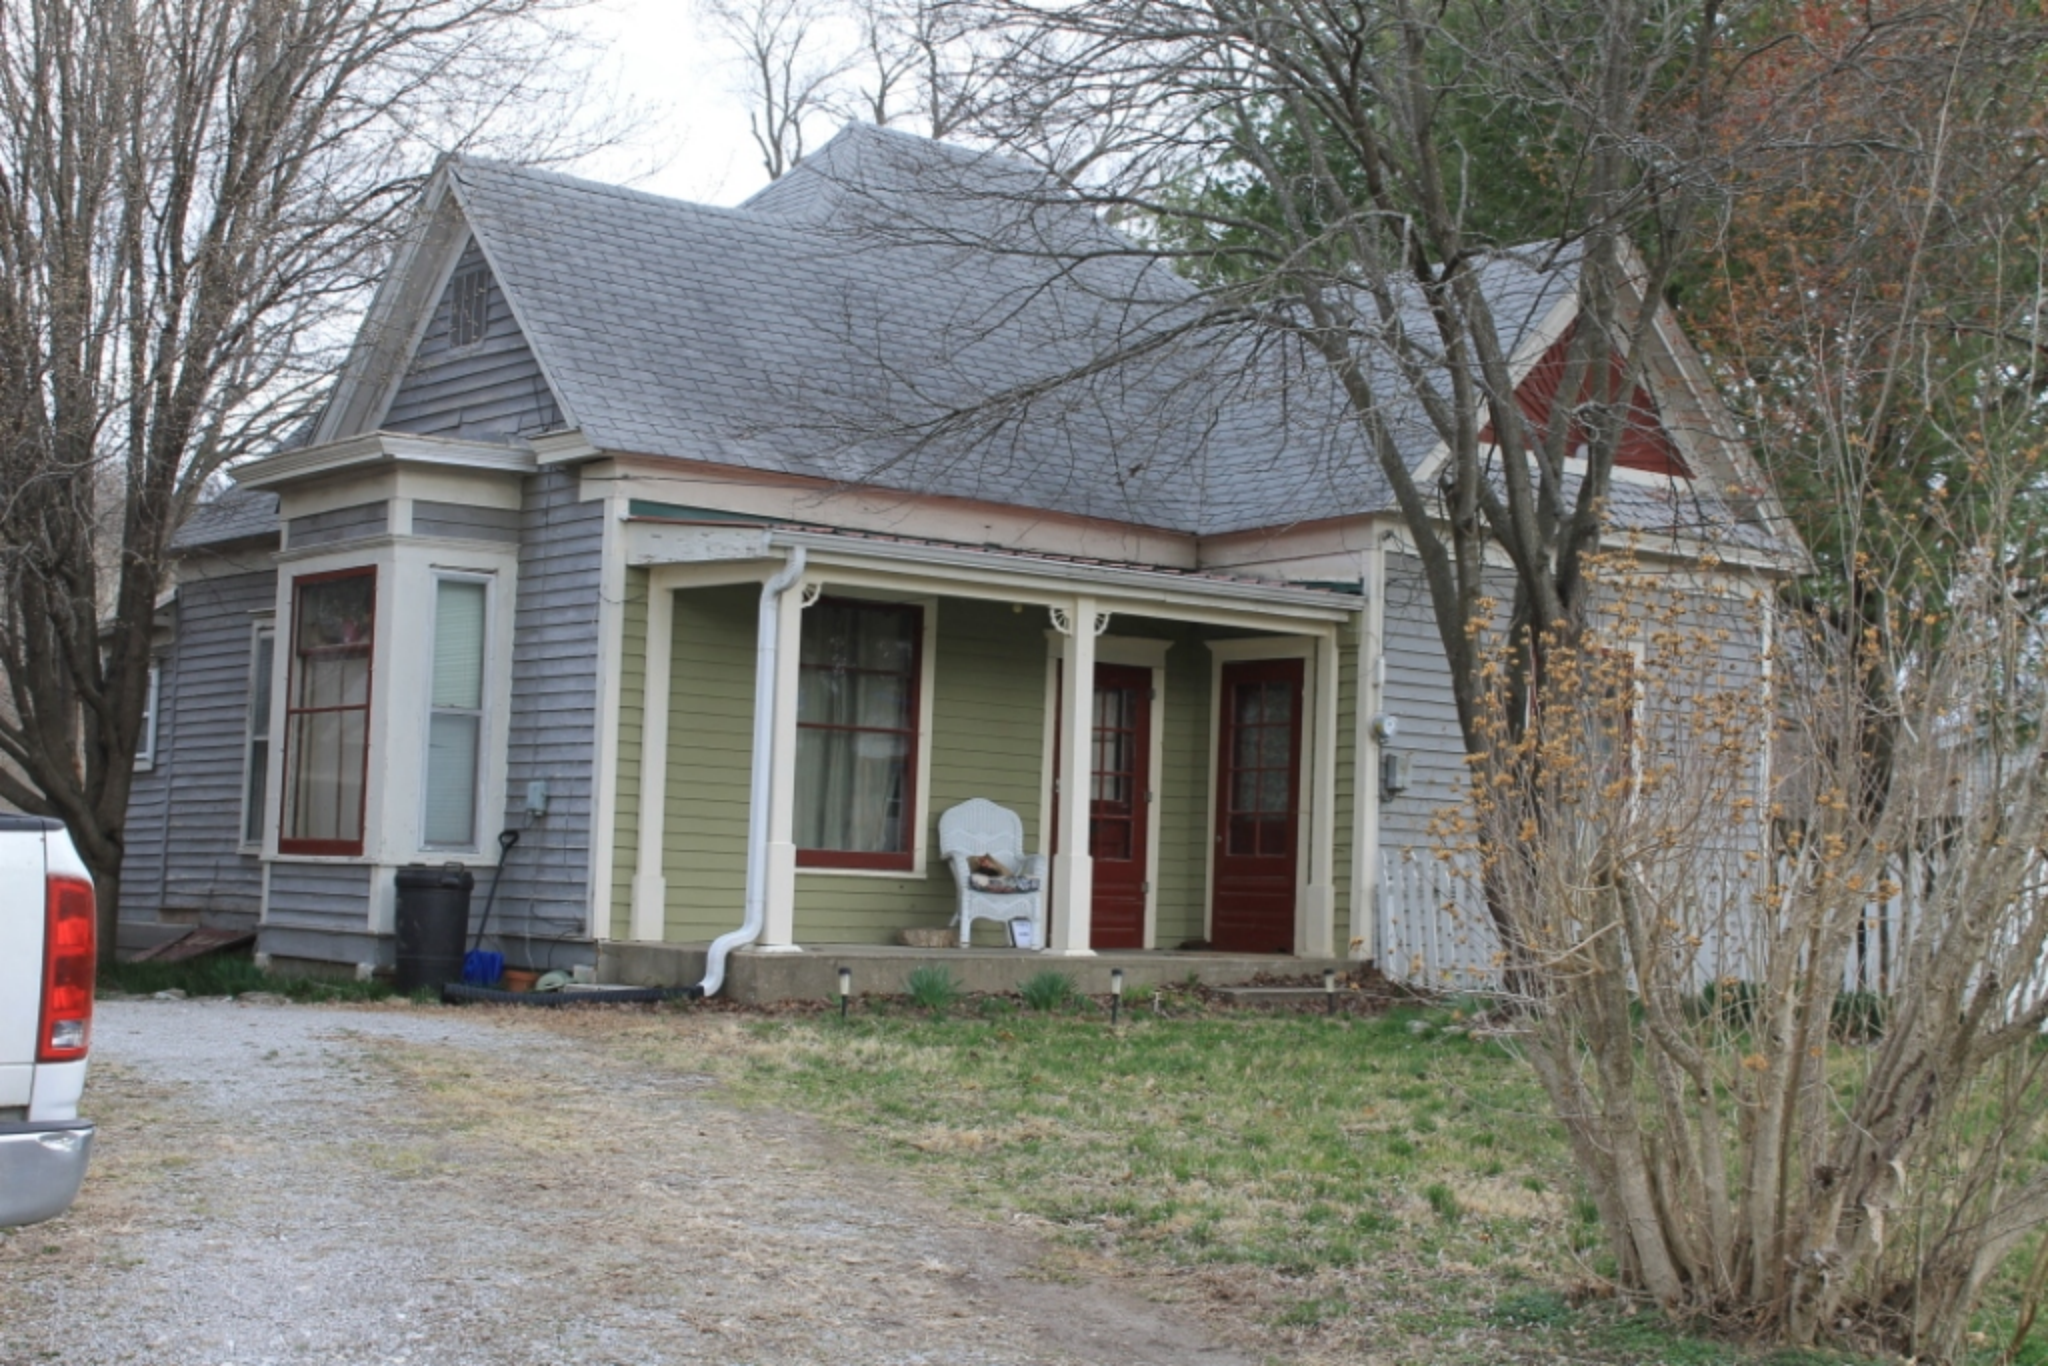
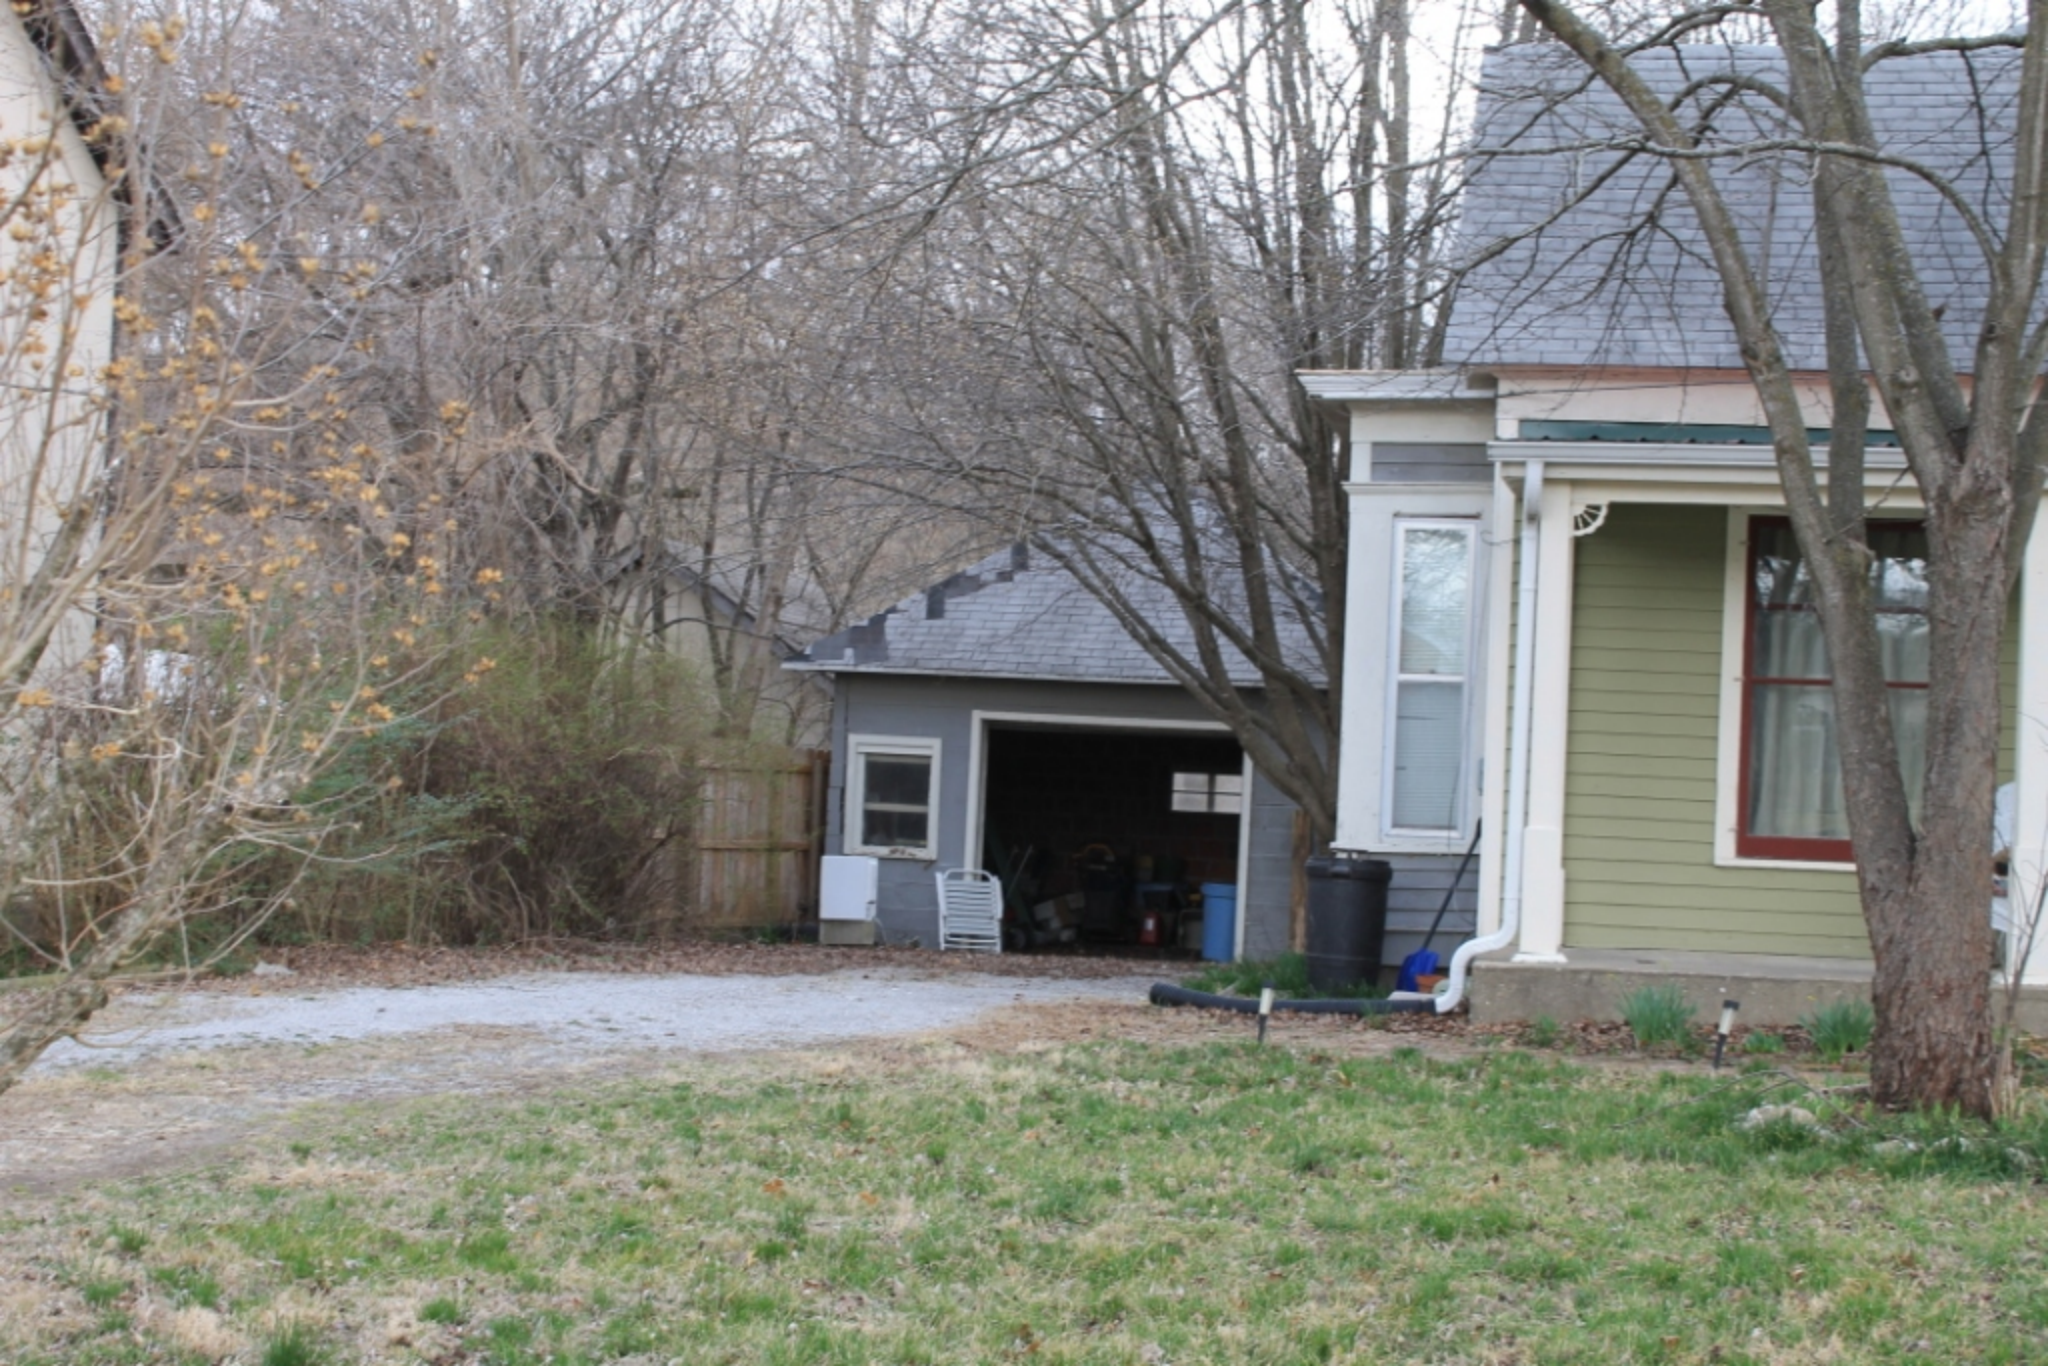
This one-story, massed plan house has a high hipped roof with intersecting gables. The house is clad clapboards and the roof is covered in asphalt shingles. One of the gables face east on Moniteau Street. and has a pedimented gable end clad in fishlap shingles. The other gable faces south and is above a flat roofed bay window. At the point where the main block of the house meets the front facing gable is a shed roofed porch that extends to the south along the front of the house. The porch is supported by square wooden columns. The porch is accented with beaded corner brackets. The front (east) facade of the house has four bays. The left bay, which is located in the bay window, contains a one-over-one single hung wooden window. The next bay contains a two-over-two single hung wooden window. The next bay, which is under the porch, contains a door with fixed pane windows and a wooden storm door. The right bay, which is located in the front facing gable roofed ell, contains a one-over-one single hung wooden window.

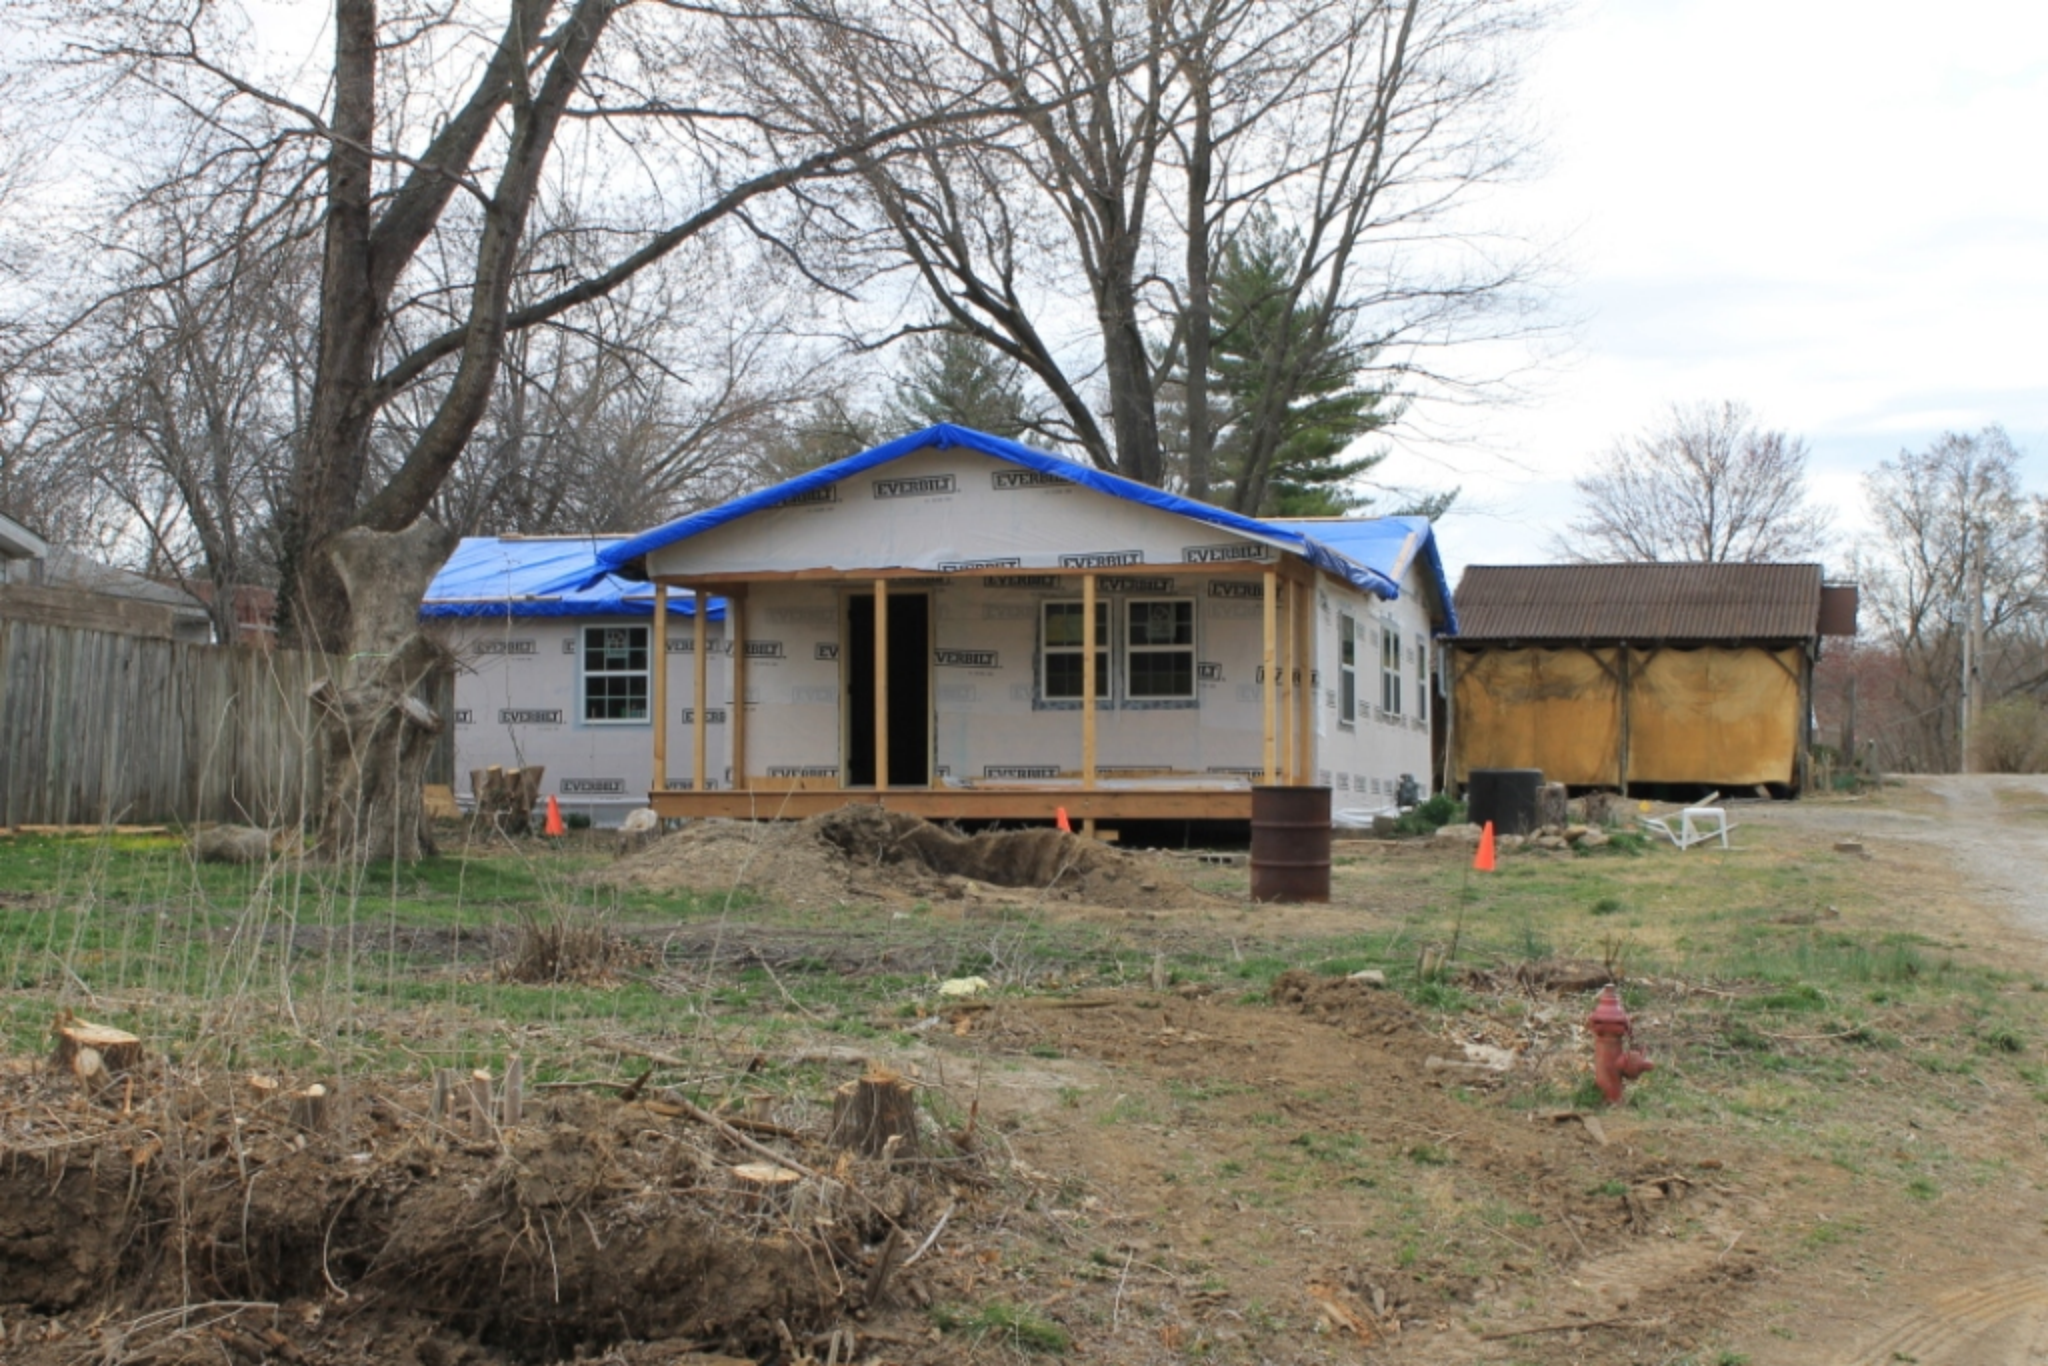
This one-story, massed plan, frame ranch house is currently under construction, so the wall cladding is not known. The roof is covered in asphalt shingles. The one-story cross gable building has a low pitched gable roofed wing facing Moniteau Street and a cross gable roofed wing facing the alley between First Street and Second Street. The front (west) facade has a veranda supported now by wooden posts. The front facade has two bays. The left bay contains a door. The right bay contains a pair of six-over-one single hung vinyl windows. The south facade has three bays. The left bay contains a six-over-one single hung vinyl window. The center bay contains a pair of six-over-one single hung vinyl windows. The right bay contains a six-over-one single hung vinyl window.

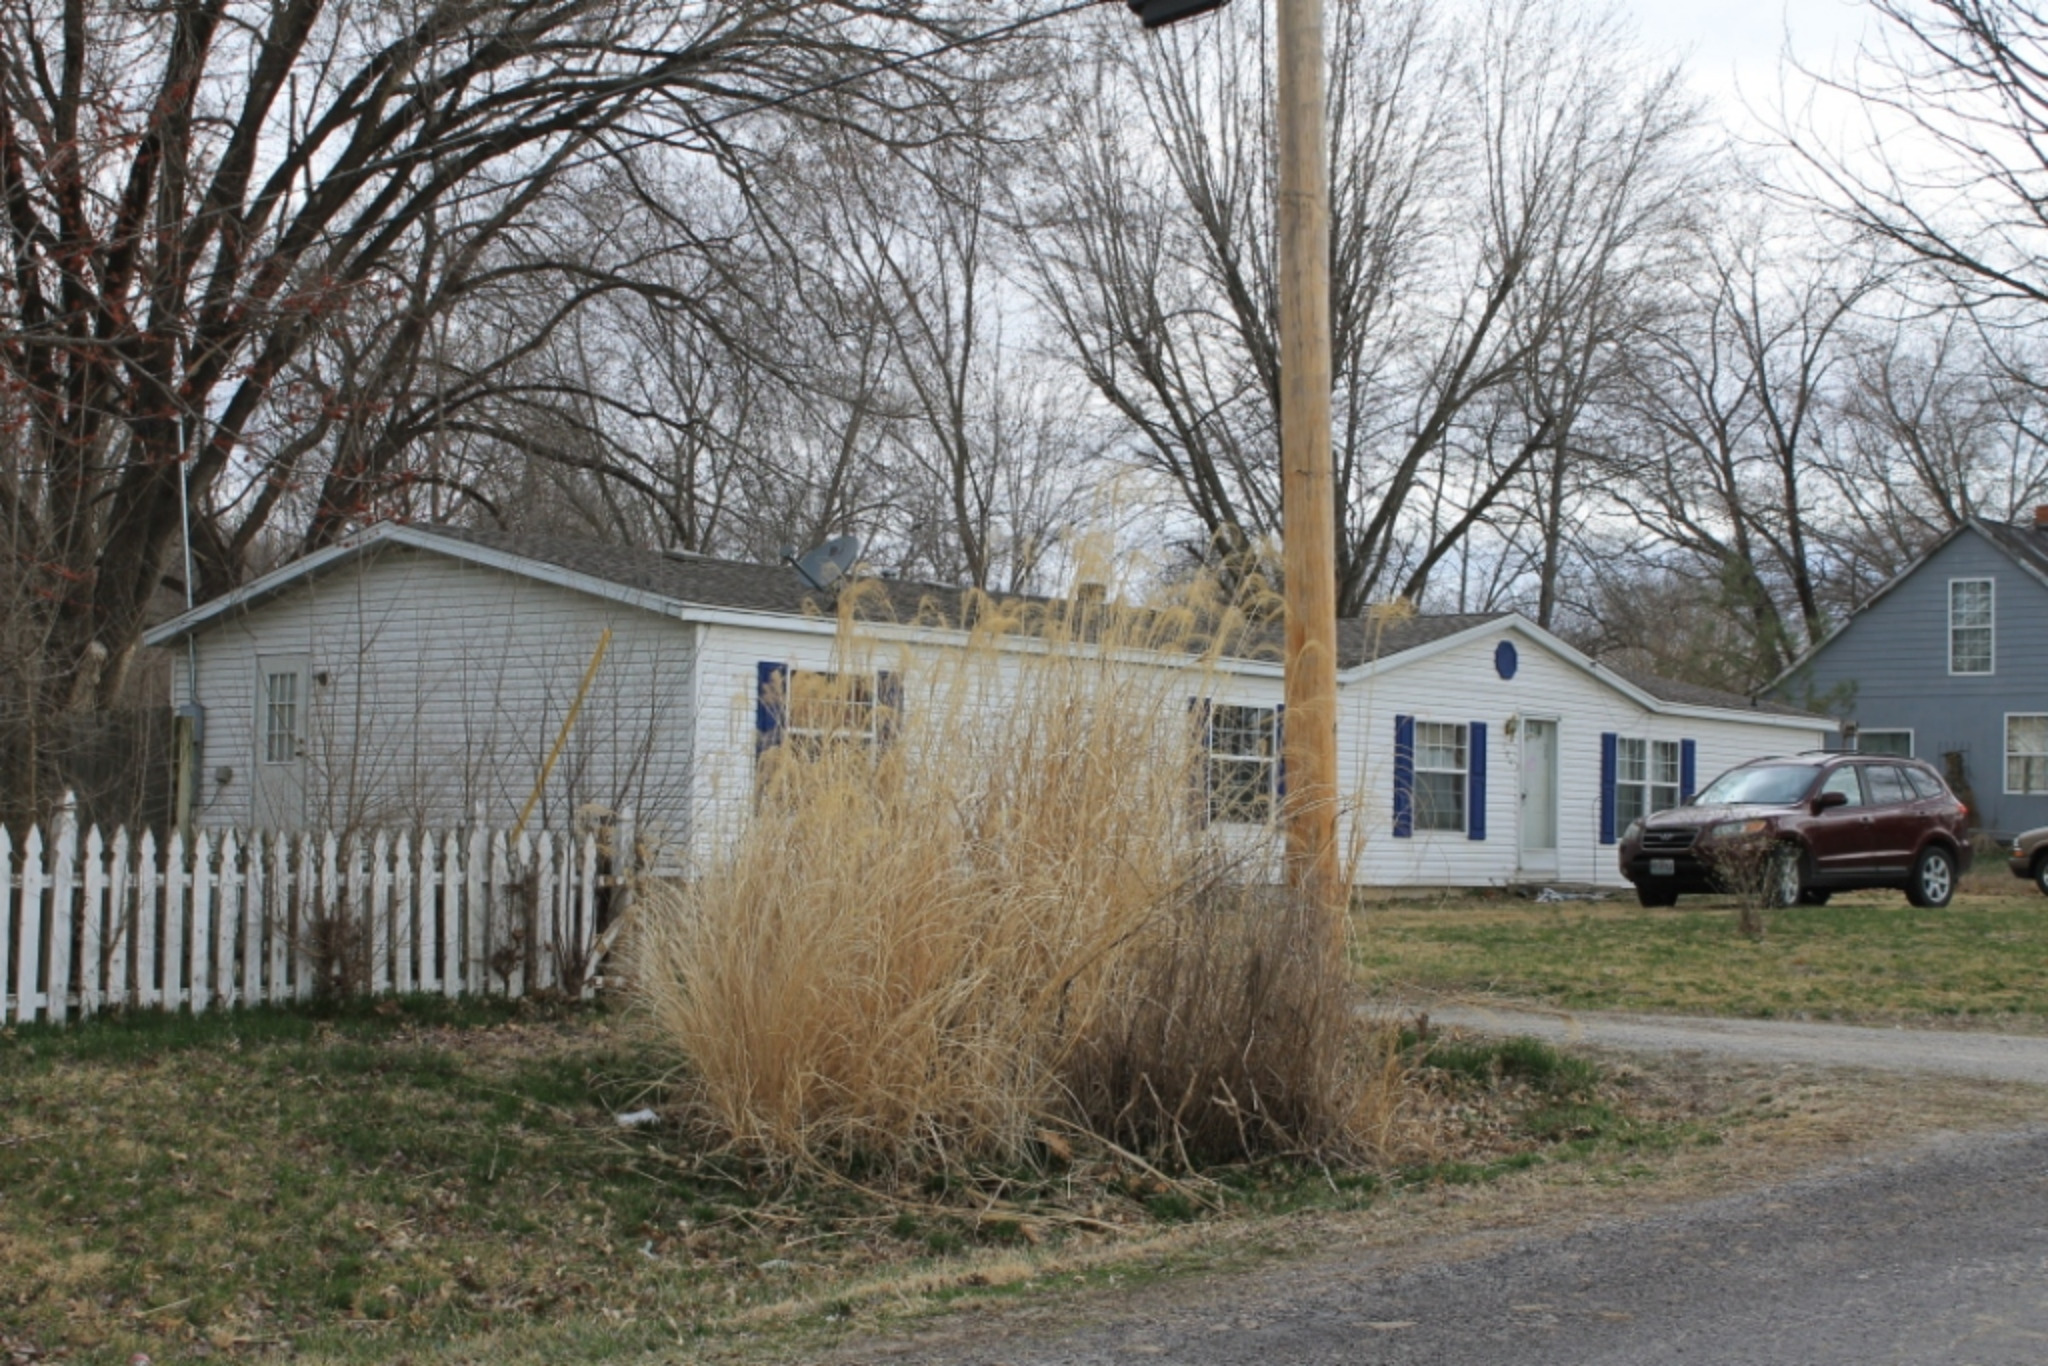
This long, one-story, massed plan, double wide mobile home has a low side gable roof with a low cross gable in the center. The buildings is clad in vinyl siding and the roof is covered in asphalt shingles. The front (east) facade has five bays. The leftmost bay contains an eight-over-twelve single hung vinyl window. The next bay contains an eight-over-twelve single hung vinyl window. The next bay contains an eight-over-twelve single hung vinyl window. The next bay contains a door covered with a glass and metal storm door. The rightmost bay contains a pair of six-over-nine single hung vinyl windows. The windows are accented with decorative shutters.
