MISSOURI DEPARTMENT OF NATURAL RESOURCES
STATE HISTORIC PRESERVATION OFFICE, P.O. Box 176, Jefferson City, MO 65102
ARCHITECTURAL/HISTORIC INVENTORY FORM

1. SURVEY NO. BO-AS-009-0001		2. SURVEY NAME: Rocheport Historic District	
3. COUNTY: Boone		4. ADDRESS (STREET NO.)	STREET (NAME) Katy Trail
5. CITY: Rocheport	VICINITY: <input checked="" type="checkbox"/>	6. UTM: / /	LAT: LONG: T: 48W R: 15W S: 1

8. HISTORIC NAME (IF KNOWN): M.K.&T. Railroad tunnel		9. PRESENT/OTHER NAME (IF KNOWN): Katy trail tunnel	
10. OWNERSHIP: <input type="checkbox"/> PRIVATE <input checked="" type="checkbox"/> PUBLIC		11A. HISTORIC USE (IF KNOWN): railroad tunnel	11B. CURRENT USE: Katy Trail tunnel
HISTORICAL INFORMATION

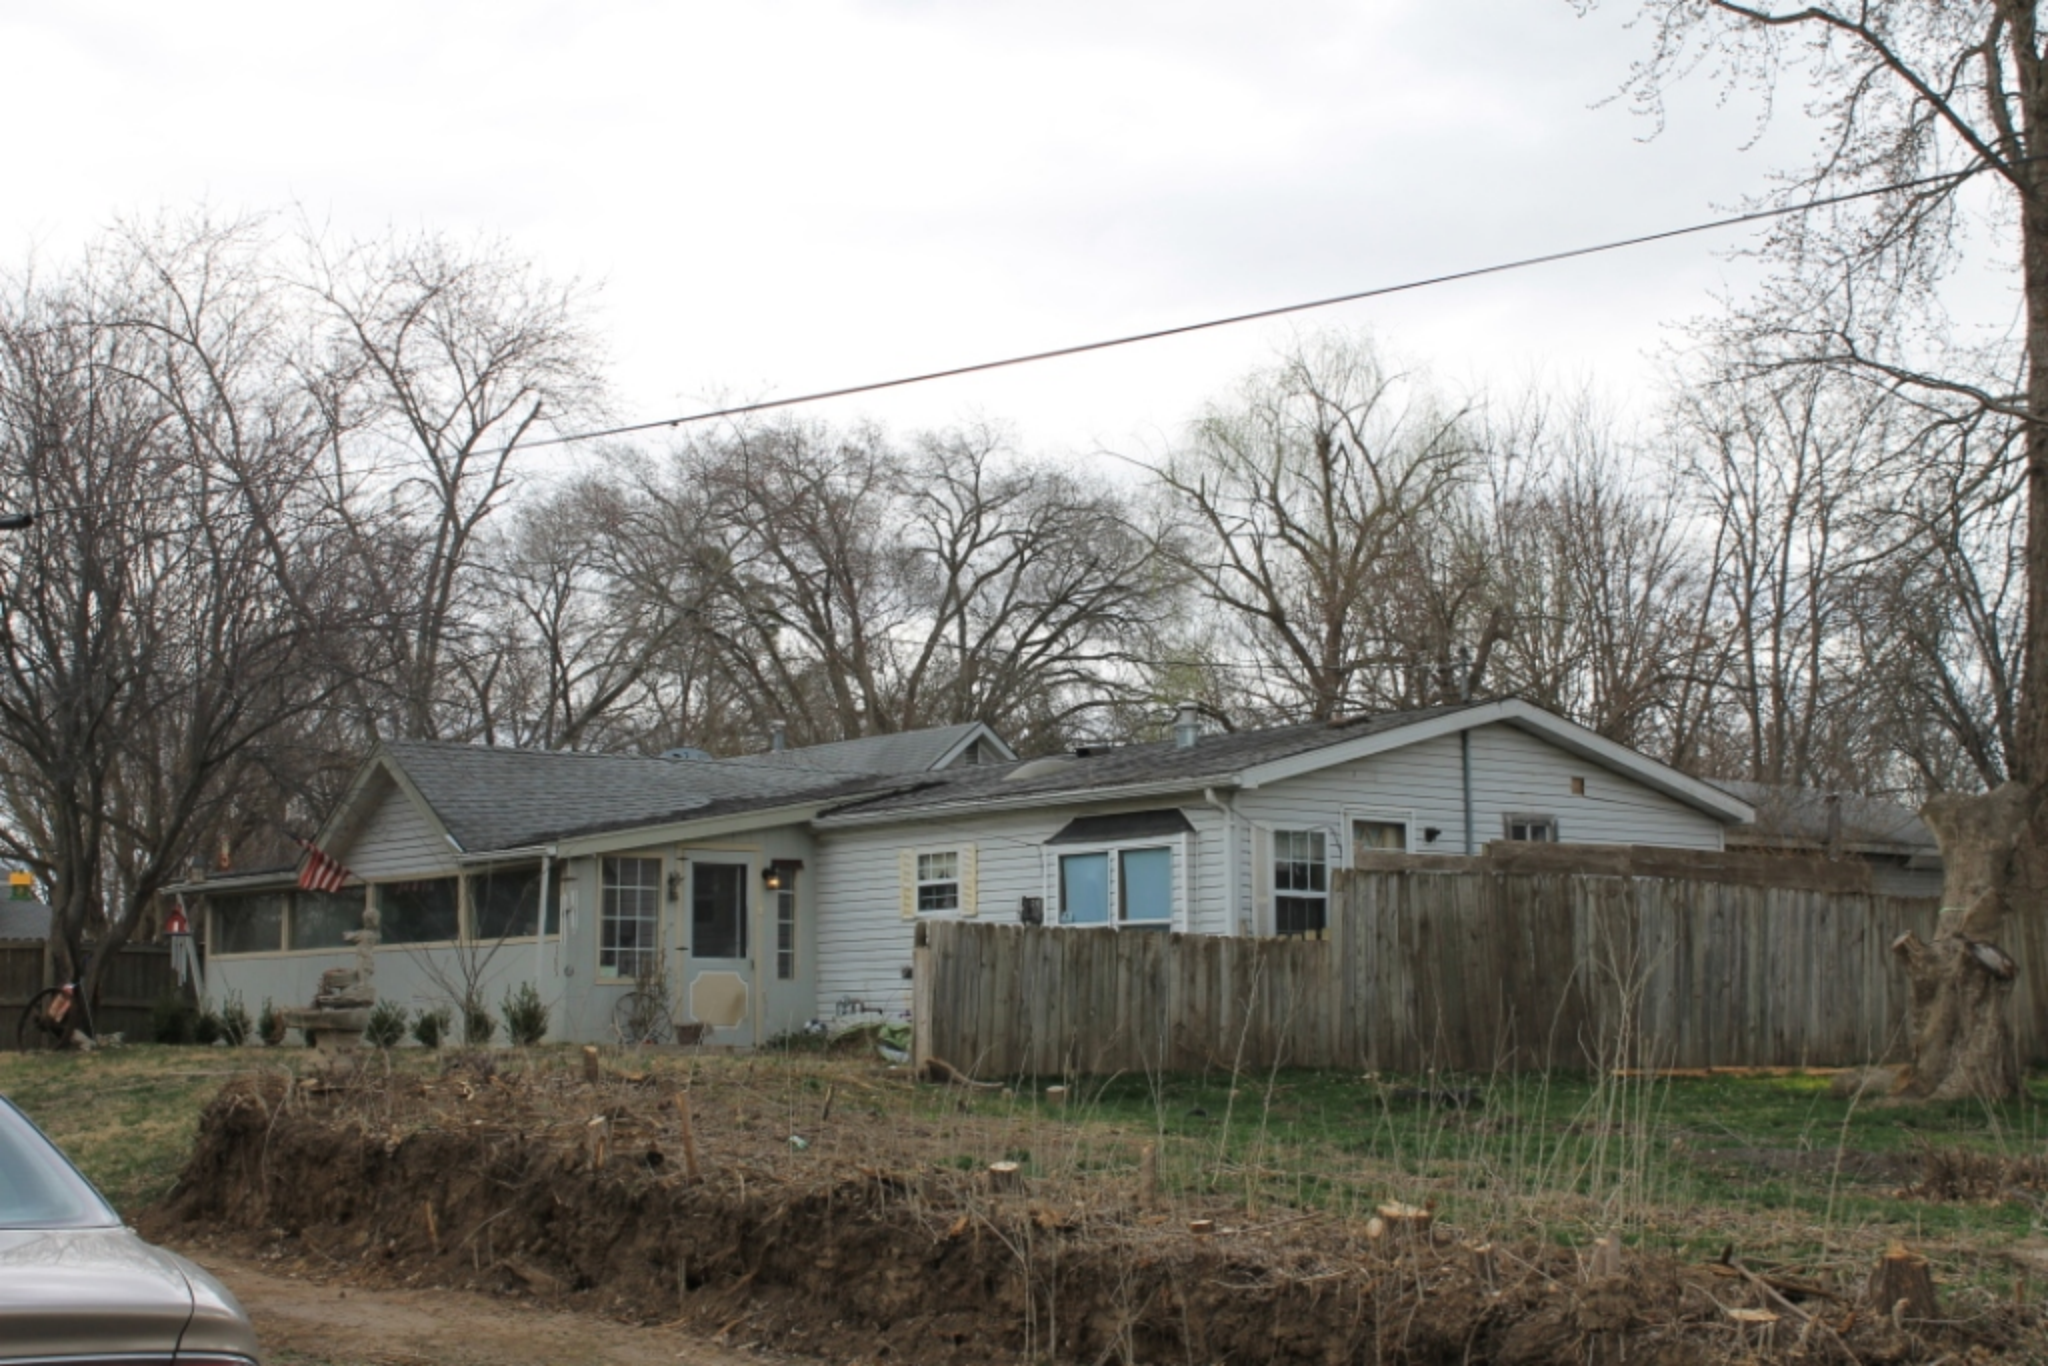
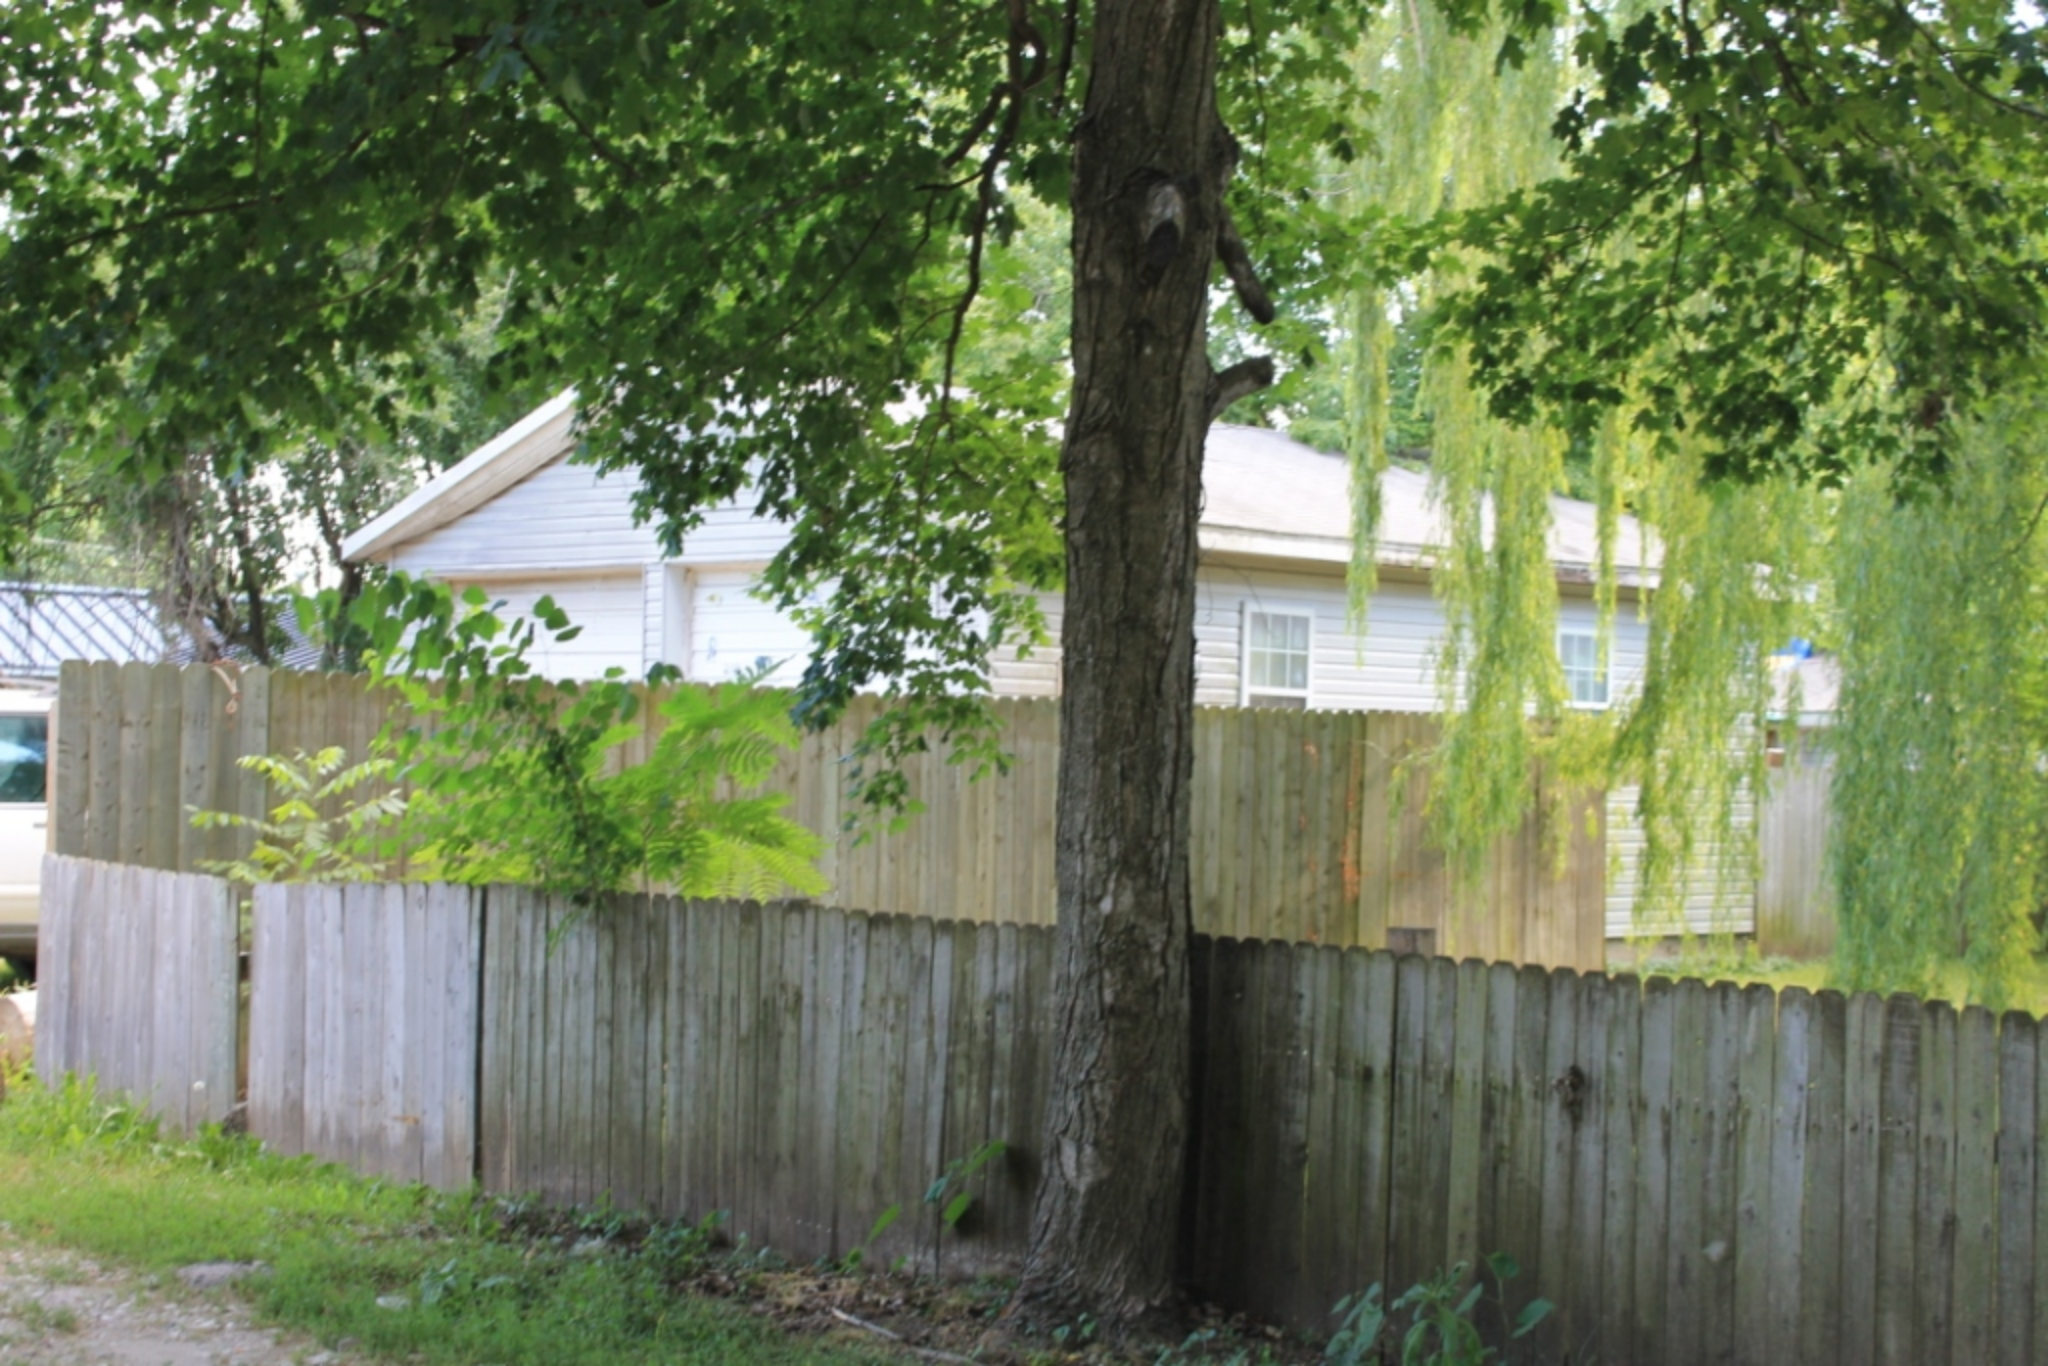
This one-story, massed plan, frame ranch house has multiple wings with different roof types. The real estate website www.trulia.com identifies this house as a manufactured home. The house is clad in vinyl siding and the roof is covered with asphalt shingles. The house has had several additions. The main block of the building has a cross gabled roof. The roof extends to cover a porch enclosed with screen. Attached to the cross gabled main block and offset from the front facade is a low-side gabled wing. The west (front) facade has six bays. The four left bays, which are on the porch, each contain a screen. The next bay, which is located on the low gabled side wing, contains a small one-over-one single hung vinyl window. The rightmost bay contains a slightly projecting bay window with a pair of one-over-one single hung windows.

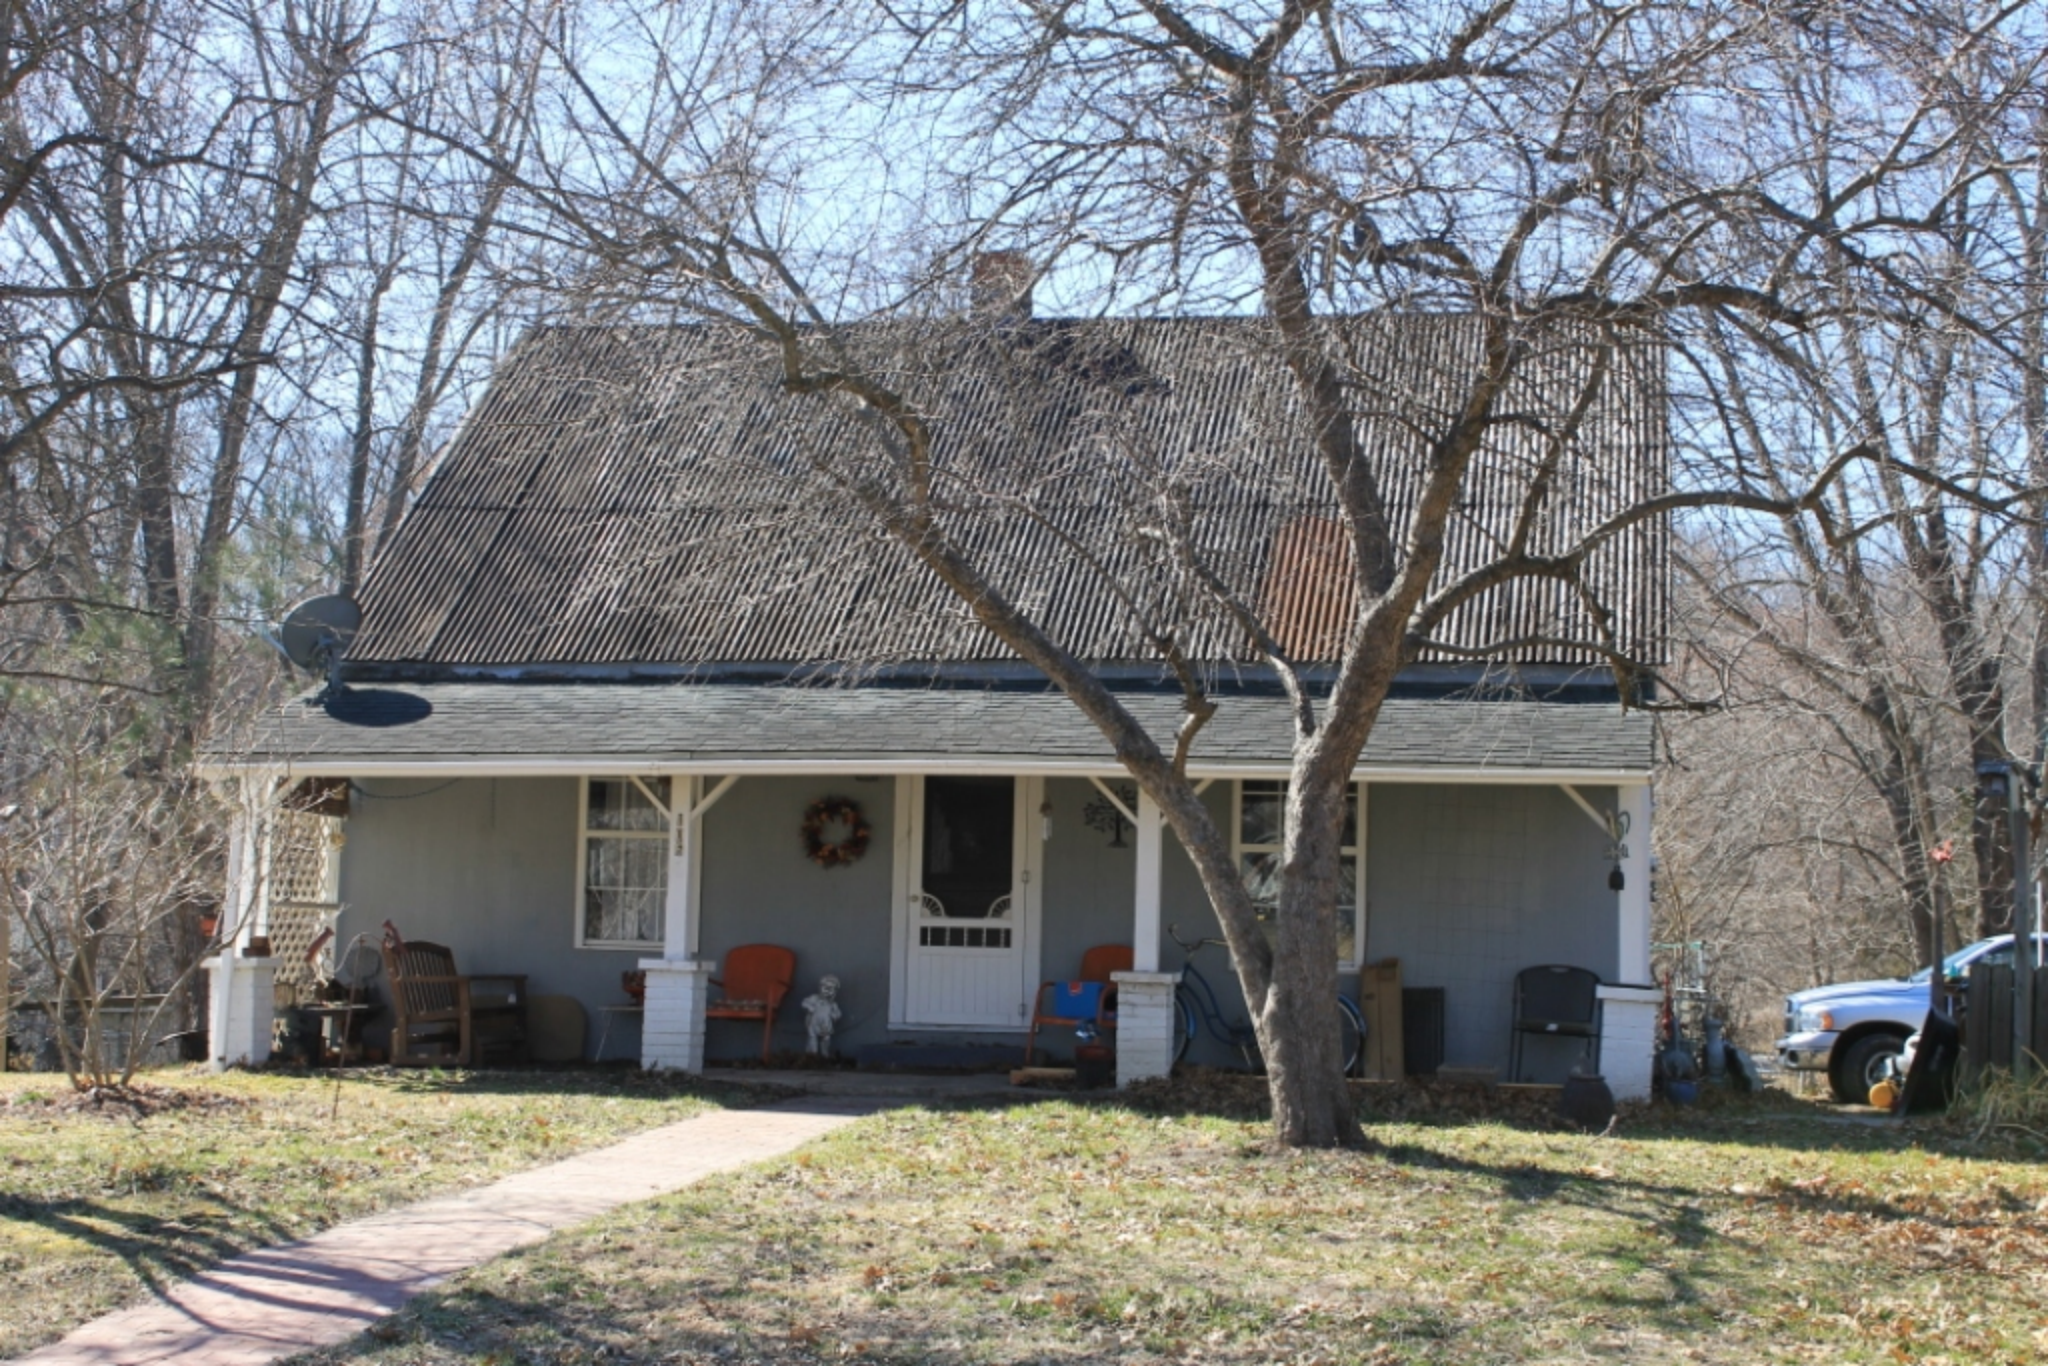
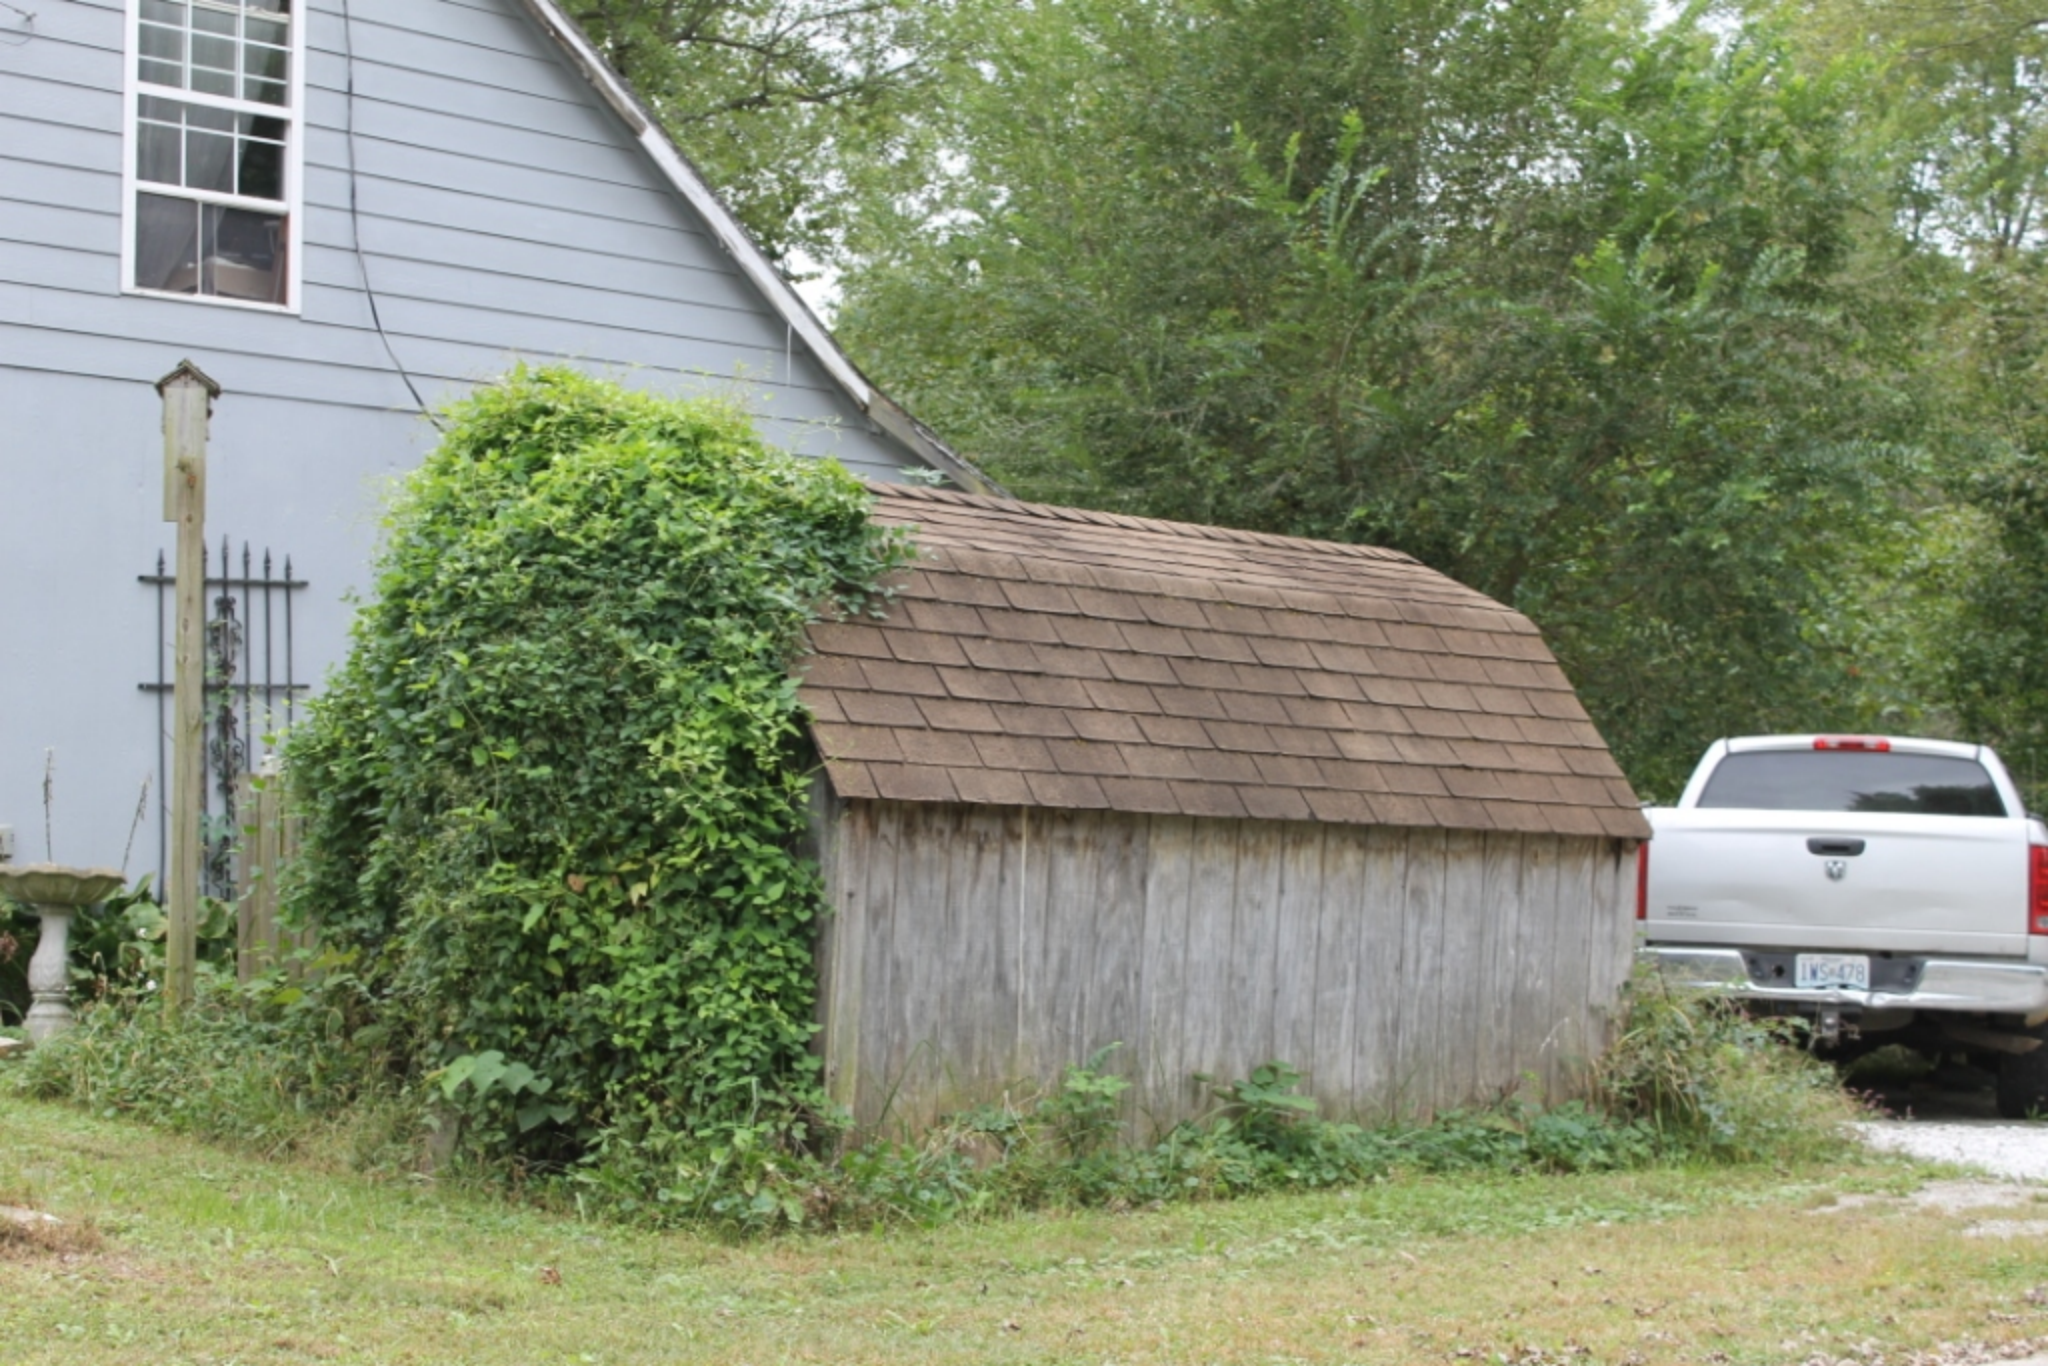
The 1 1/2 story, massed plan side gable, frame house has elements of the Craftsman style. The house has a saltbox roof covered in metal. The walls are clad in vertical plywood siding. The house has three bays on the front (east) facade. The left bay contains a six-over-six single hung vinyl window. The center bay contains a door. The right bay contains a six-over-six single hung vinyl window. A shed roofed porch covered in asphalt shingles spans the first story of the house. The pyramidal porch posts rest on square bases. The porch is flush with the ground. A chimney rises from the center rear of the roof.

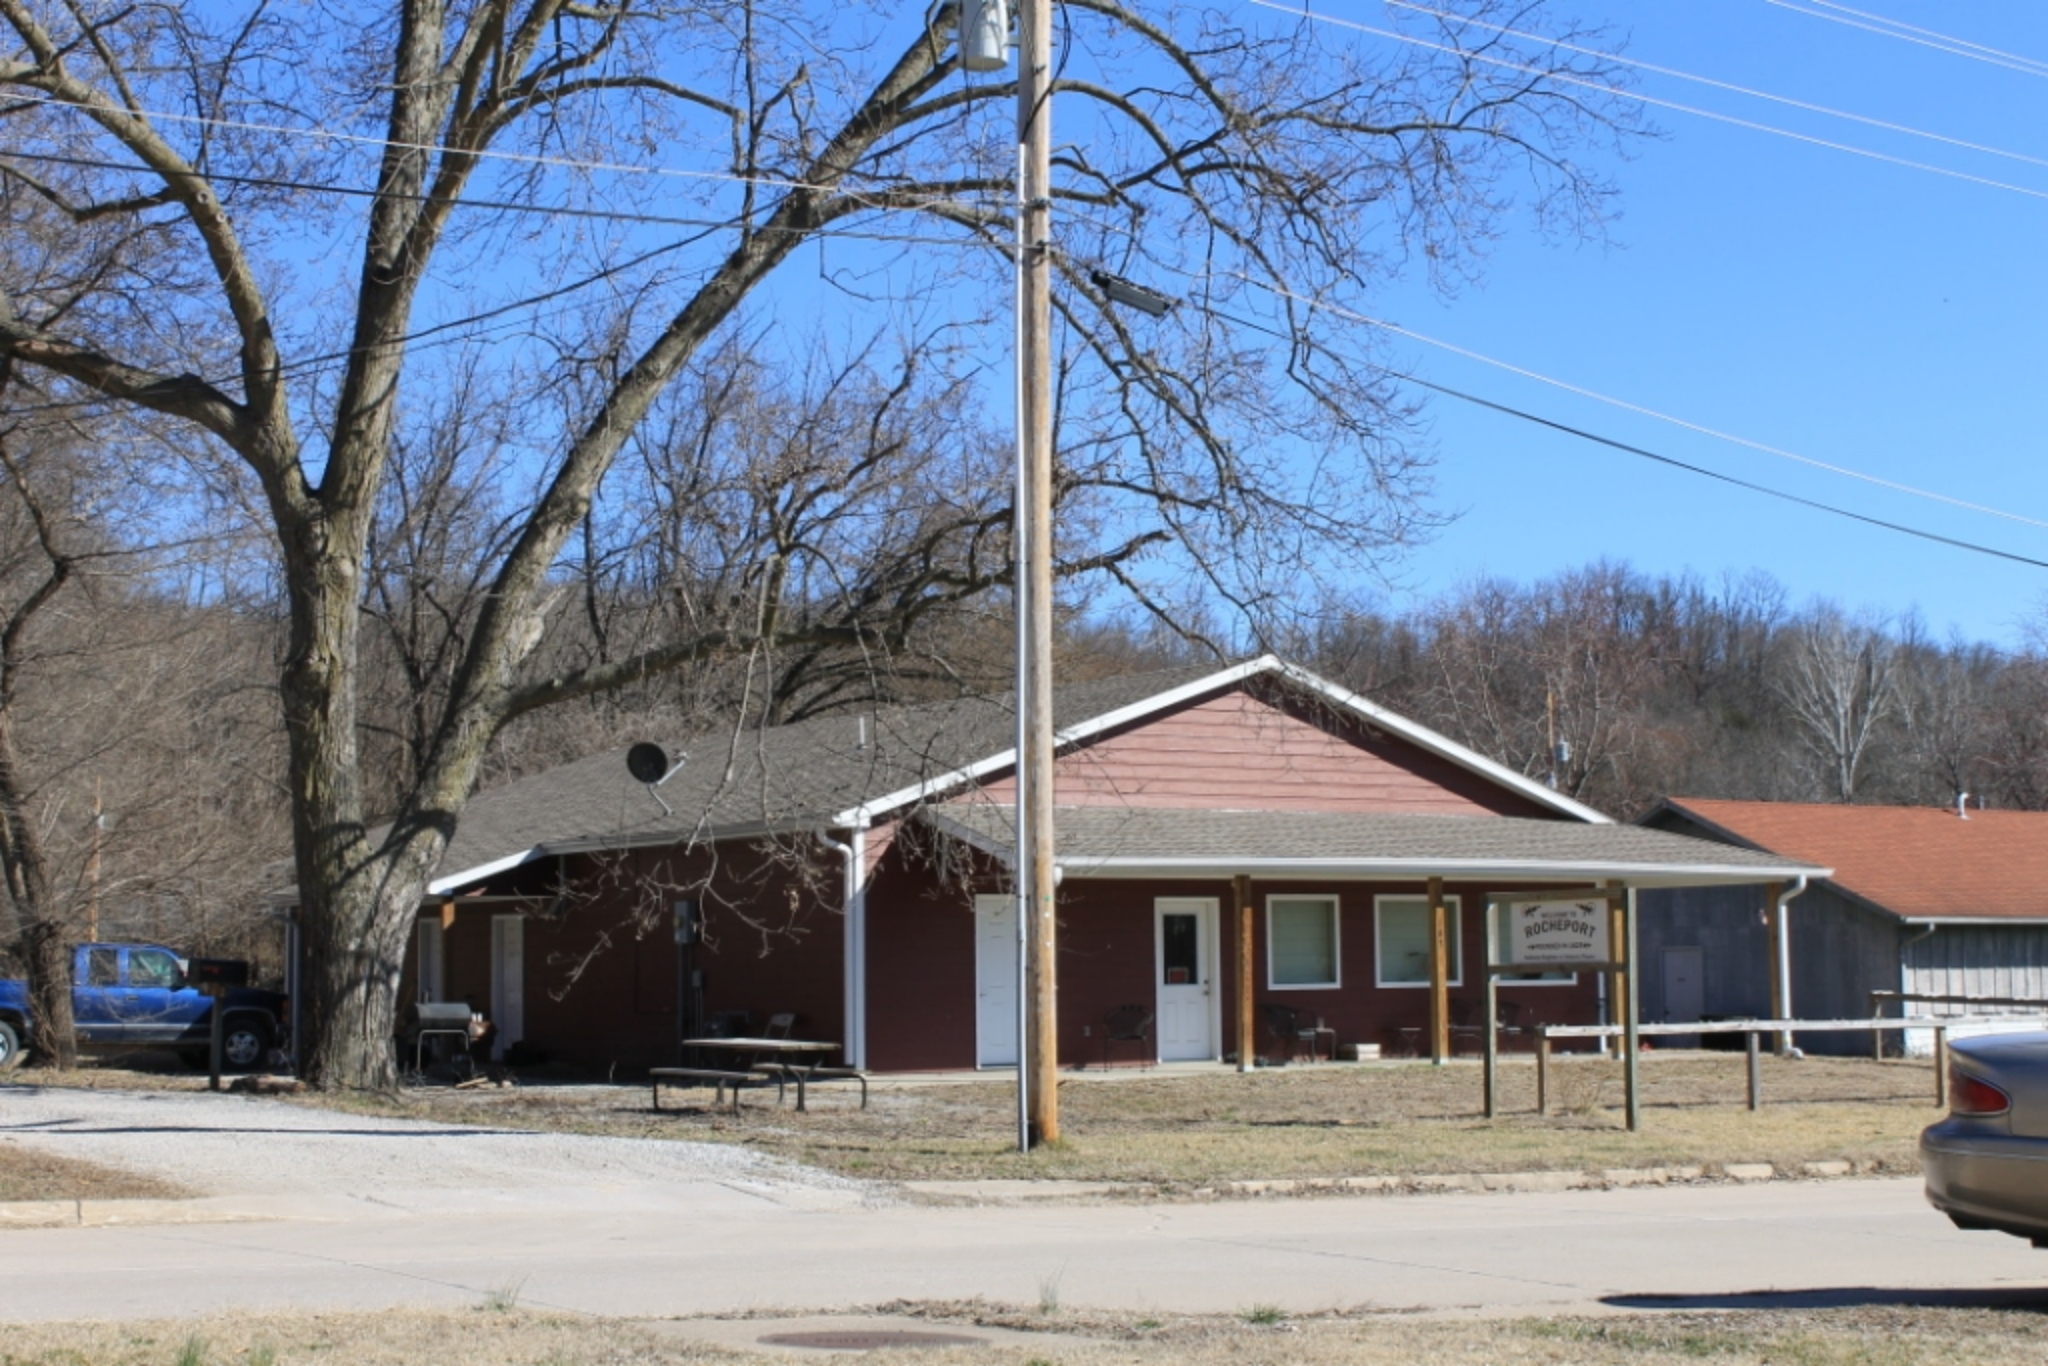
This one-story, massed plan front gable, frame building has a low gable roof facing Pike Street. The building is clad in clapboards and the roof is covered with asphalt shingles. The building has a small shed roofed hood over an entrance on the north side. A hipped shed roof porch runs along the front (west) facade and wraps around the south side. The front (west) facade has five bays. The left bay contains a paneled door. The next bay contains a door with a window in the upper portion. The three right bays are evenly spaced along the facade and each bay contains a fixed single pane window.

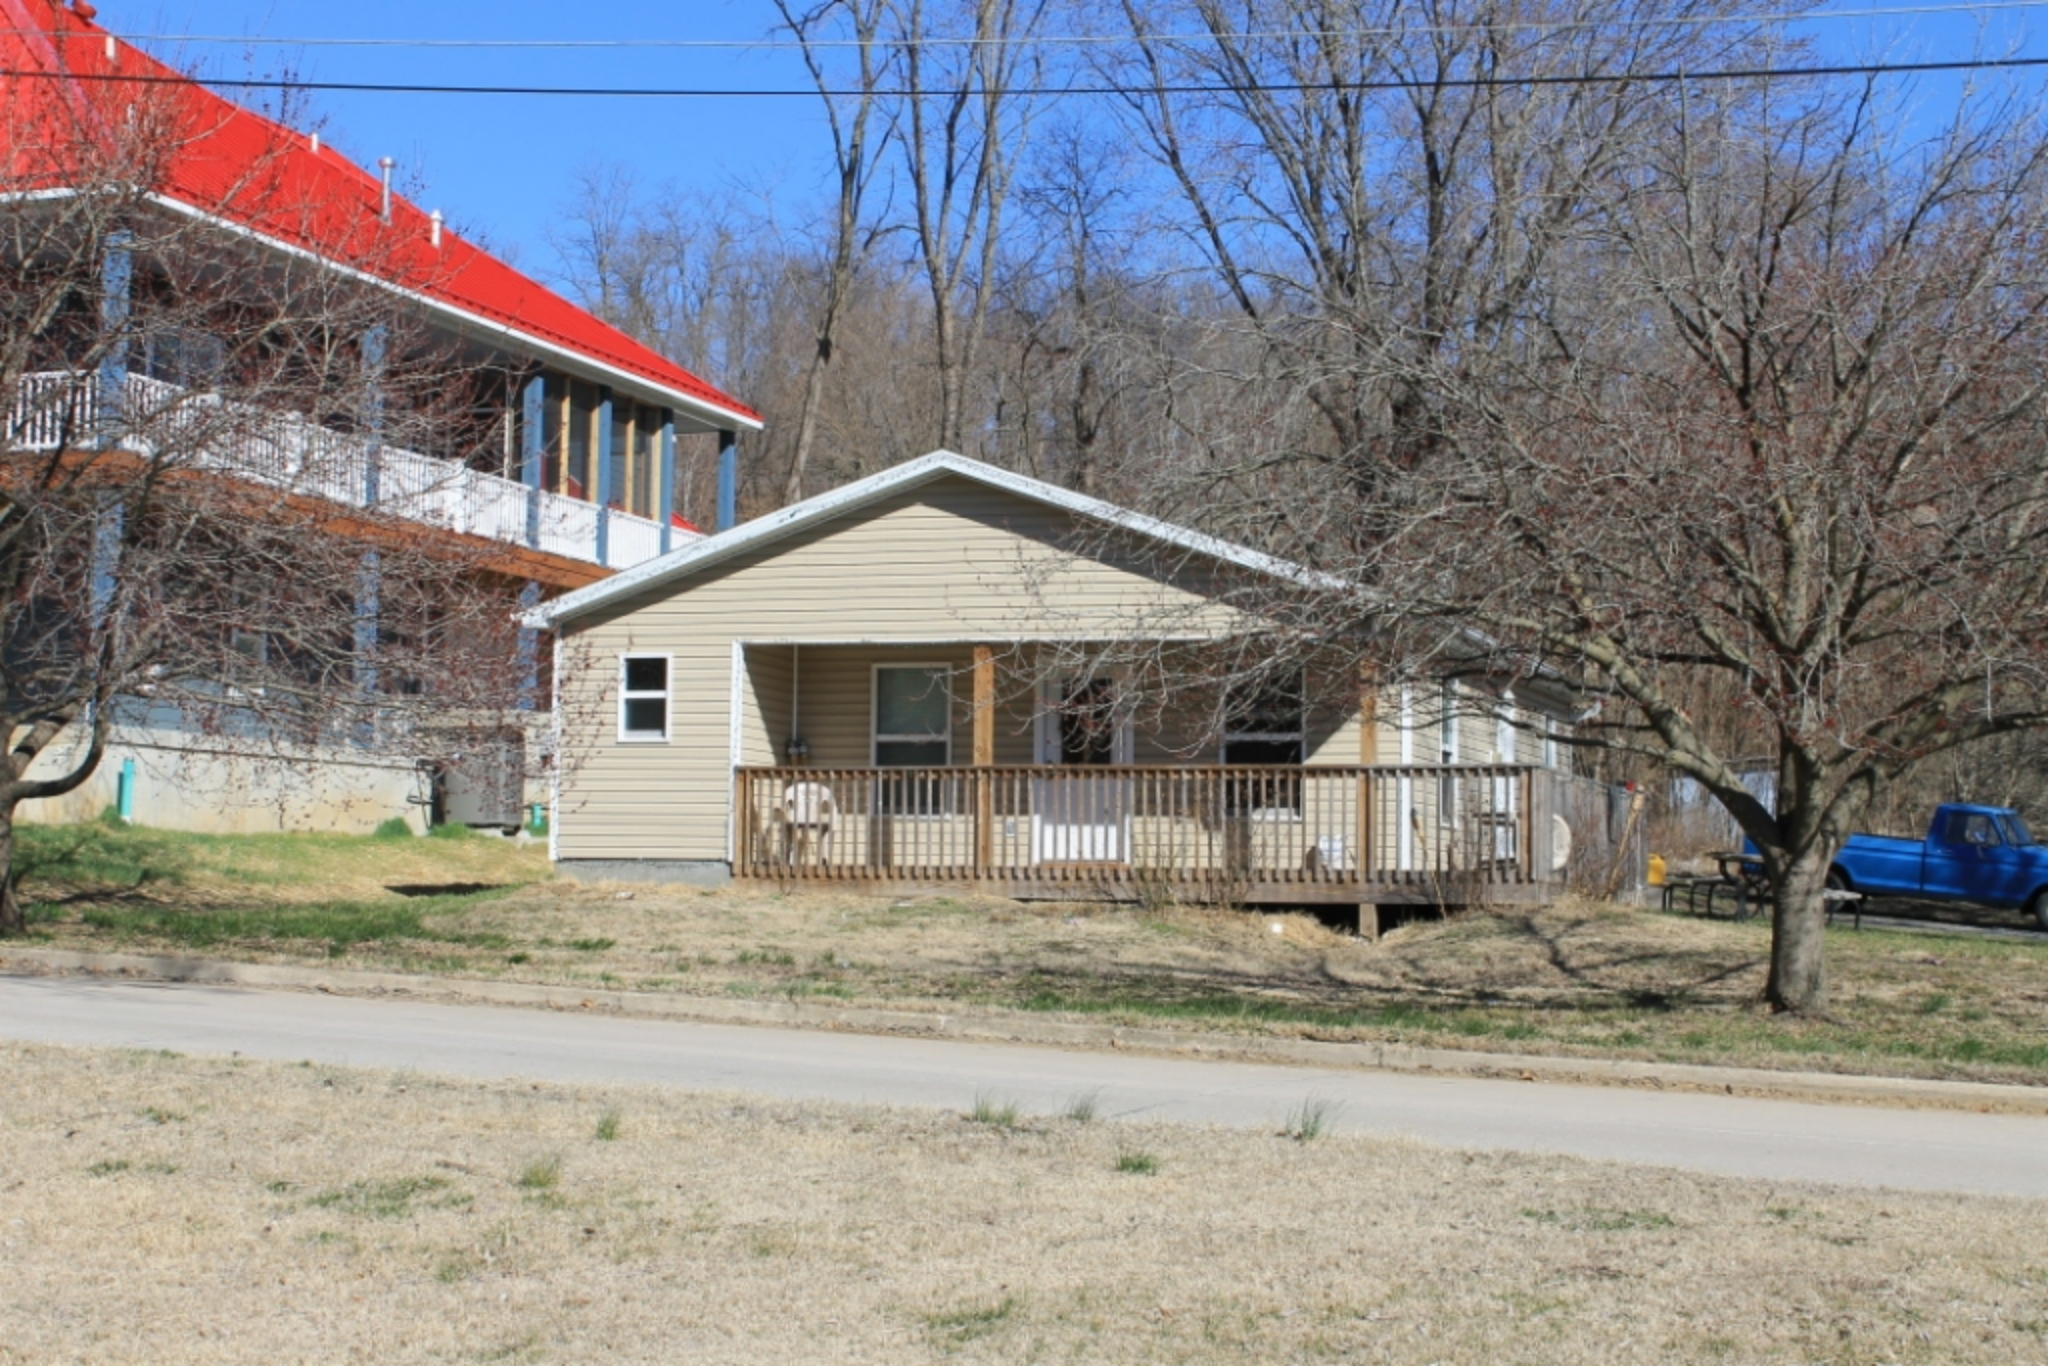
This one story, massed plan front gable, frame ranch house is clad in vinyl siding and its roof is covered in asphalt shingles. The house has a recessed porch on the right side of the front (west) facade that wraps around the south facade of the house. The portion of the porch on the south facade has no roof. The porch has wooden posts and balustrades. The front (west) facade of the house has four bays. The left bay contains a small one-over-one single hung vinyl window. The next bay, which is under the recessed porch, contains a one-over-one single hung vinyl window. The center bay, also under the recessed porch, contains a door. The right bay, also under the recessed porch, contains a one-over-one single hung vinyl window.

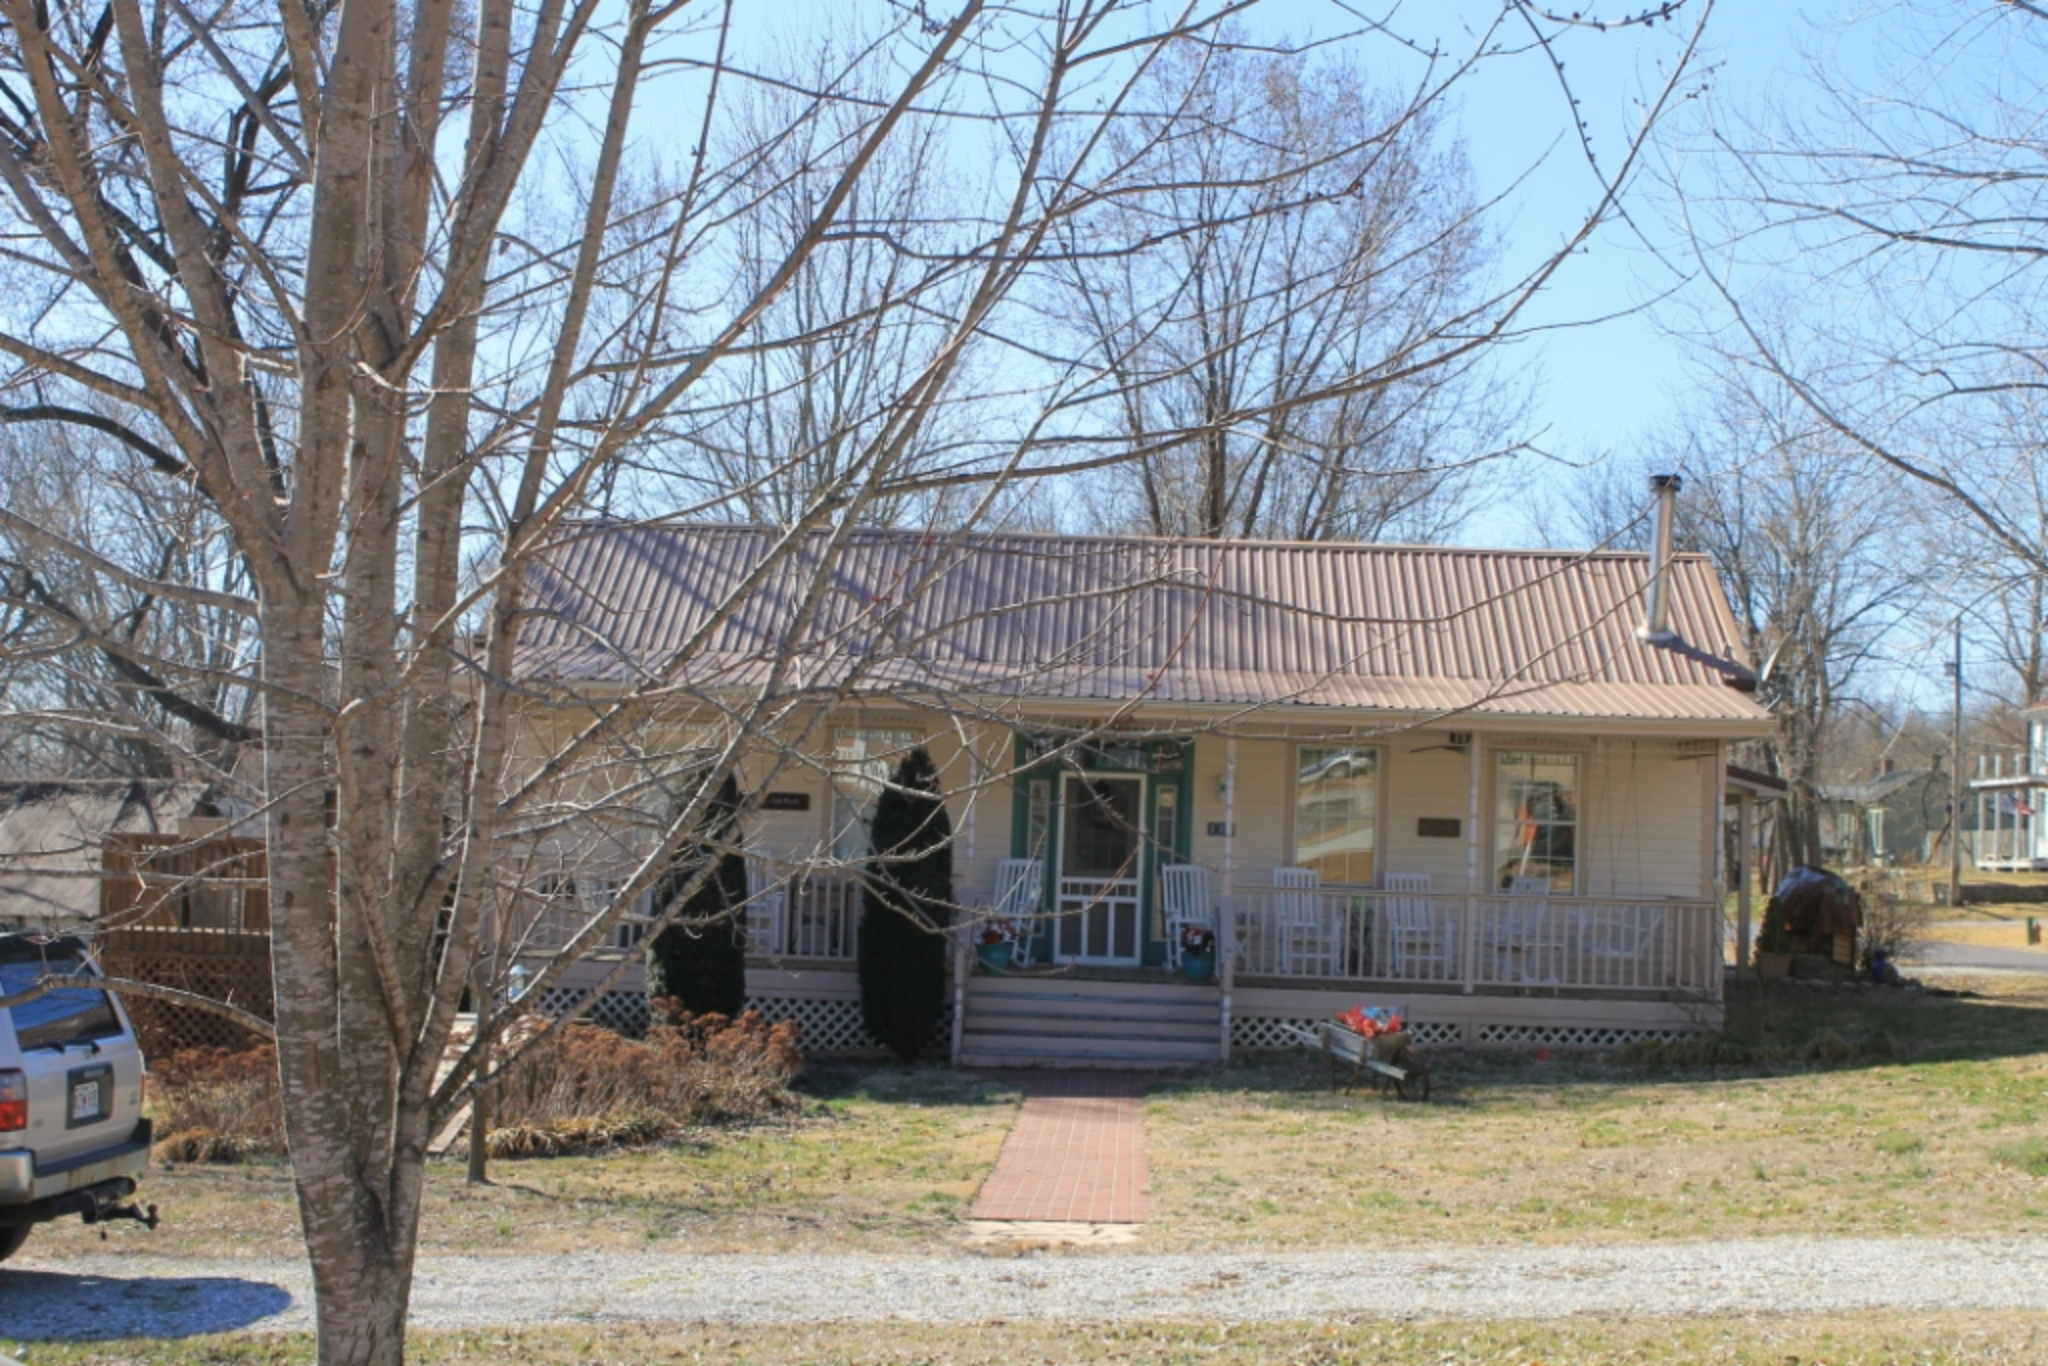
This one-story, side gable roofed, hall and parlor plan frame house has a veranda along the width of the front facade. The house is clad in vinyl siding. The roof is metal. The roof of the veranda is a shed roof that extends from the roof of the house. The front facade has five bays. The two left bays each contain a six-over-six single hung vinyl windows. The center bay contains a door with sidelights and a wooden screen door. The two right bays each contain a six- over-six single hung vinyl window. The windows have slightly arched window lintels. A metal stovepipe rises from the front slope near the right end of the building.
