MISSOURI DEPARTMENT OF NATURAL RESOURCES
STATE HISTORIC PRESERVATION OFFICE, P.O. Box 176, Jefferson City, MO 65102
ARCHITECTURAL/HISTORIC INVENTORY FORM

1. SURVEY NO. BO-AS-009-0001		2. SURVEY NAME: Rocheport Historic District	
3. COUNTY: Boone		4. ADDRESS (STREET NO.)	STREET (NAME) Katy Trail
5. CITY: Rocheport	VICINITY: <input checked="" type="checkbox"/>	6. UTM: / /	LAT: LONG: T: 48W R: 15W S: 1

8. HISTORIC NAME (IF KNOWN): M.K.&T. Railroad tunnel		9. PRESENT/OTHER NAME (IF KNOWN): Katy trail tunnel	
10. OWNERSHIP: <input type="checkbox"/> PRIVATE <input checked="" type="checkbox"/> PUBLIC		11A. HISTORIC USE (IF KNOWN): railroad tunnel	11B. CURRENT USE: Katy Trail tunnel
HISTORICAL INFORMATION

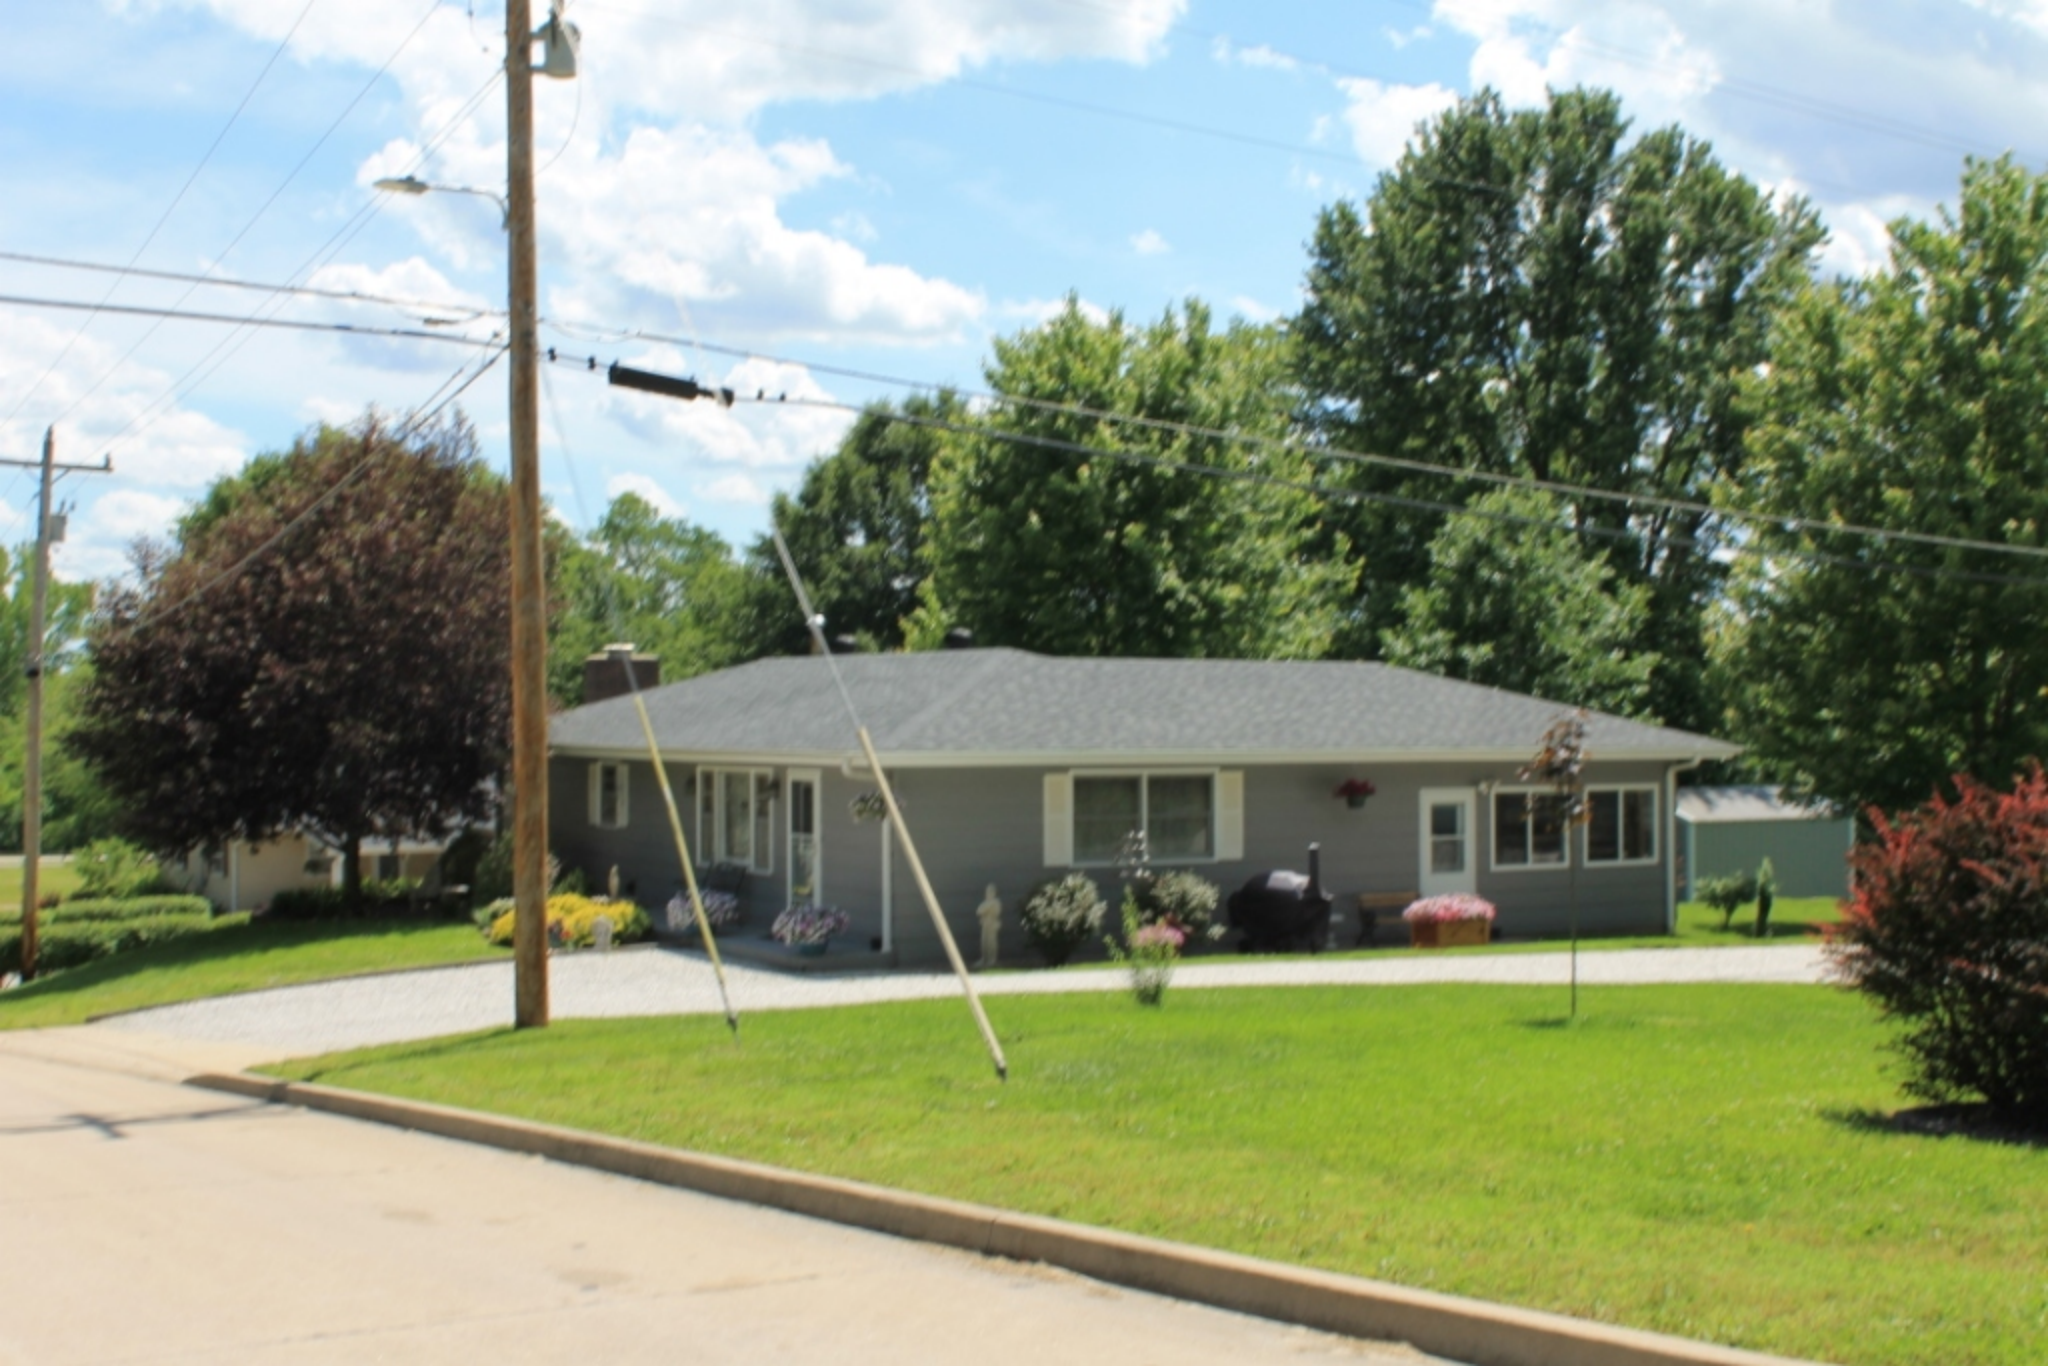
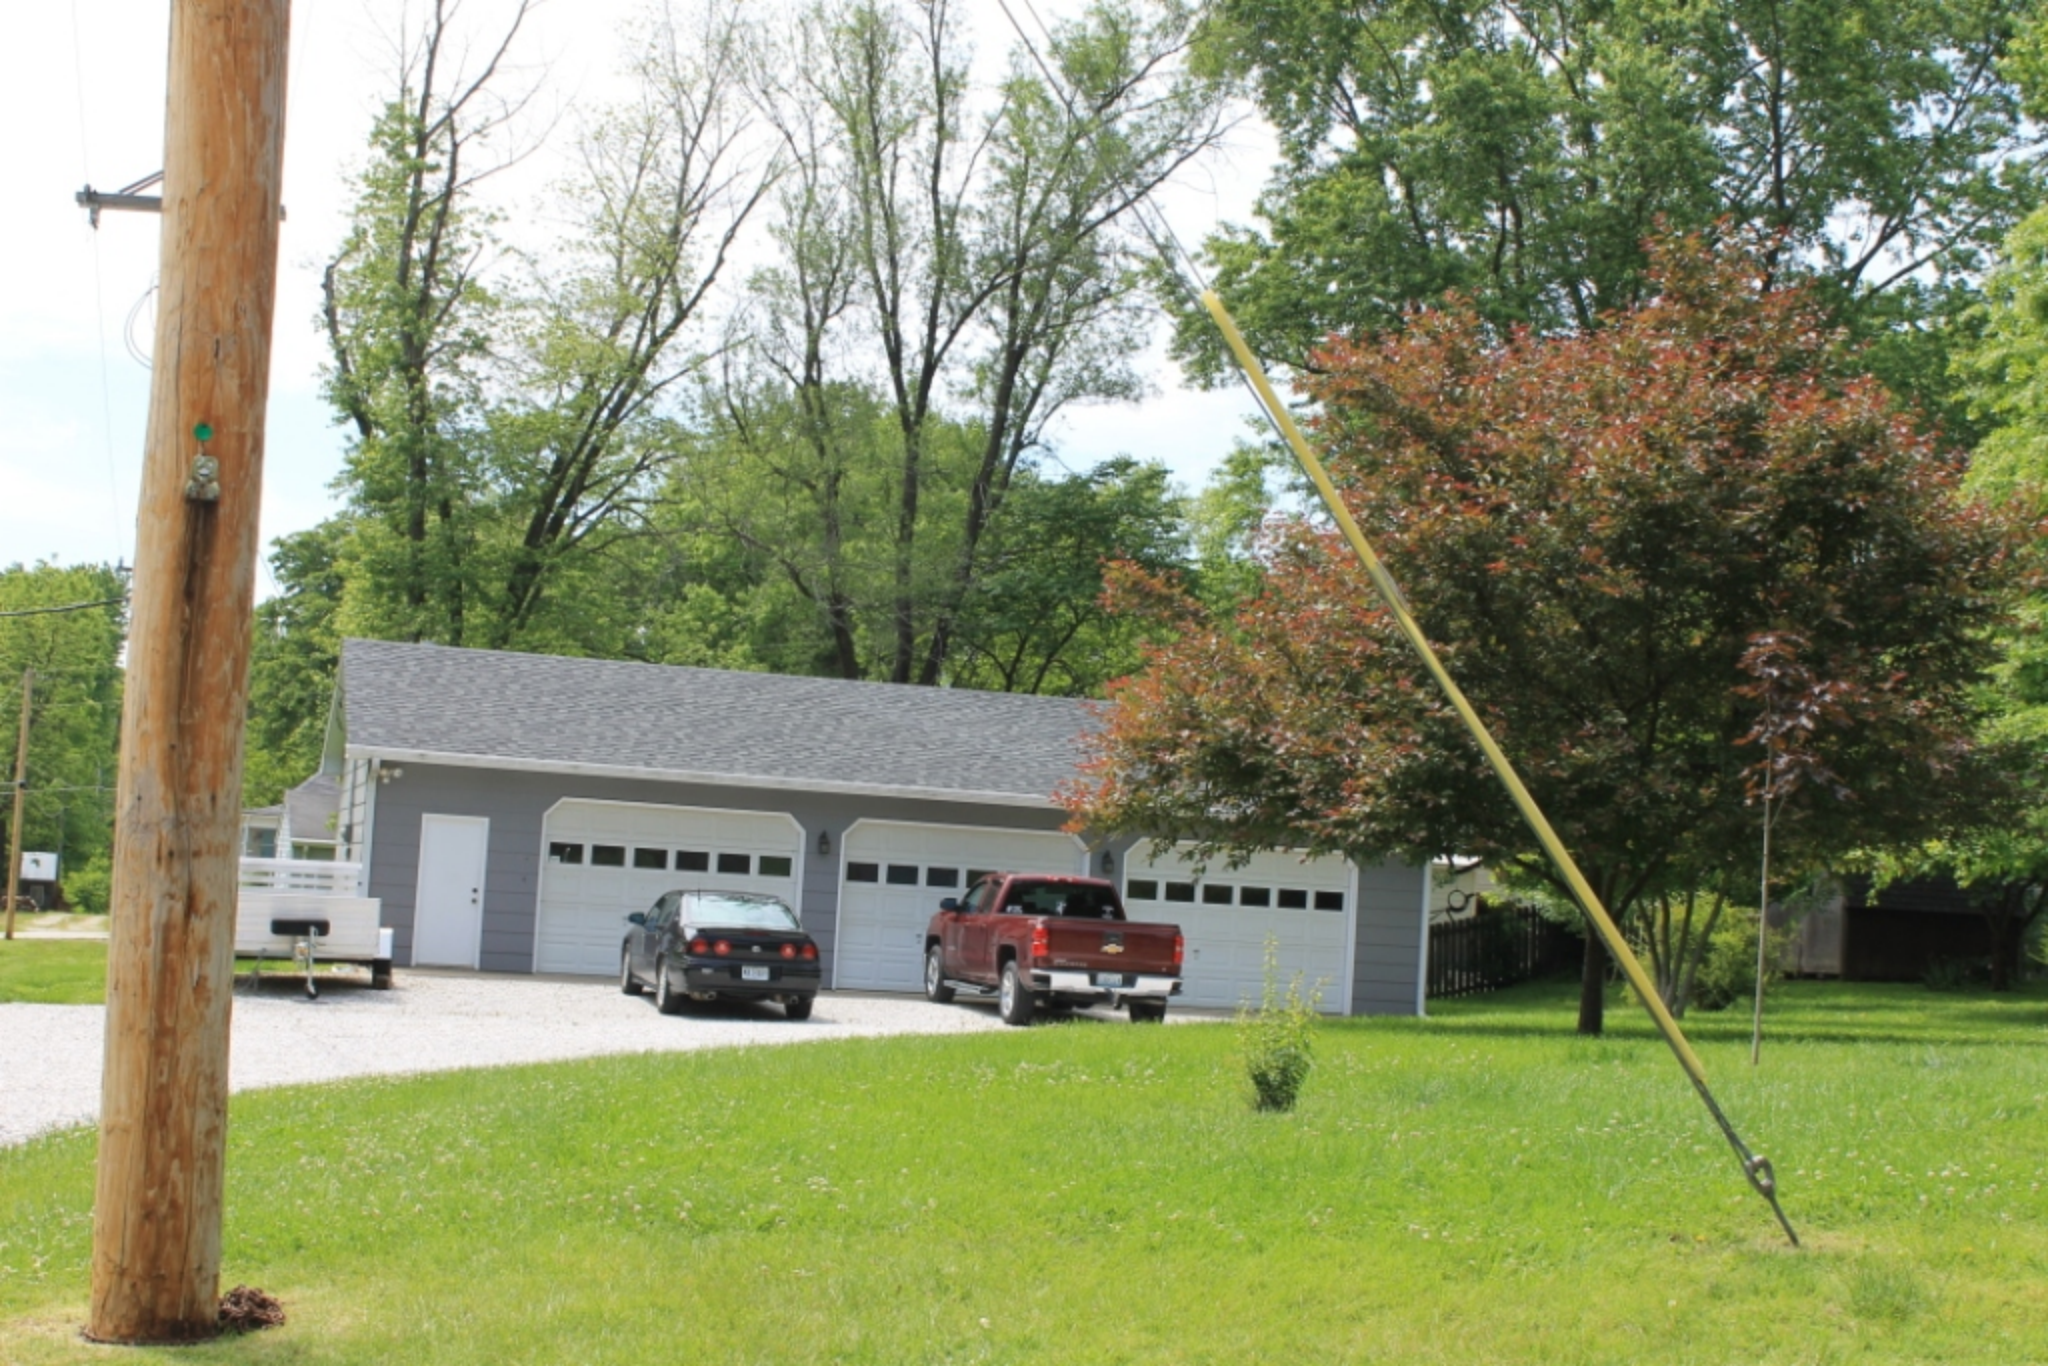
This one-story, massed plan, frame ranch house is clad in wide synthetic siding. The house has two wings. The east facing wing faces Pike Street; the west facing wing projects from the north side of the east facing wing creating an L shaped house. The low hipped roof is covered in asphalt shingles. The house has three bays on the front (east) facade. The left most bay contains a small two horizontal-over-two horizontal single hung woodwn window. The next bay contains a fixed glass picture window flanked on either side by a two horizontal-over-two horizontal single hung wooden window. The right bay contains a door with a modern glass and metal storm door. The side (north) facade has four bays. The left bay contains a pair of one-over-one single hung wooden window. The next bay contains a door with a metal and glass storm door. The two bays to the right each contain a two-paned sliding glass windows. The house has an exterior brick chimney is on the left side of the building.

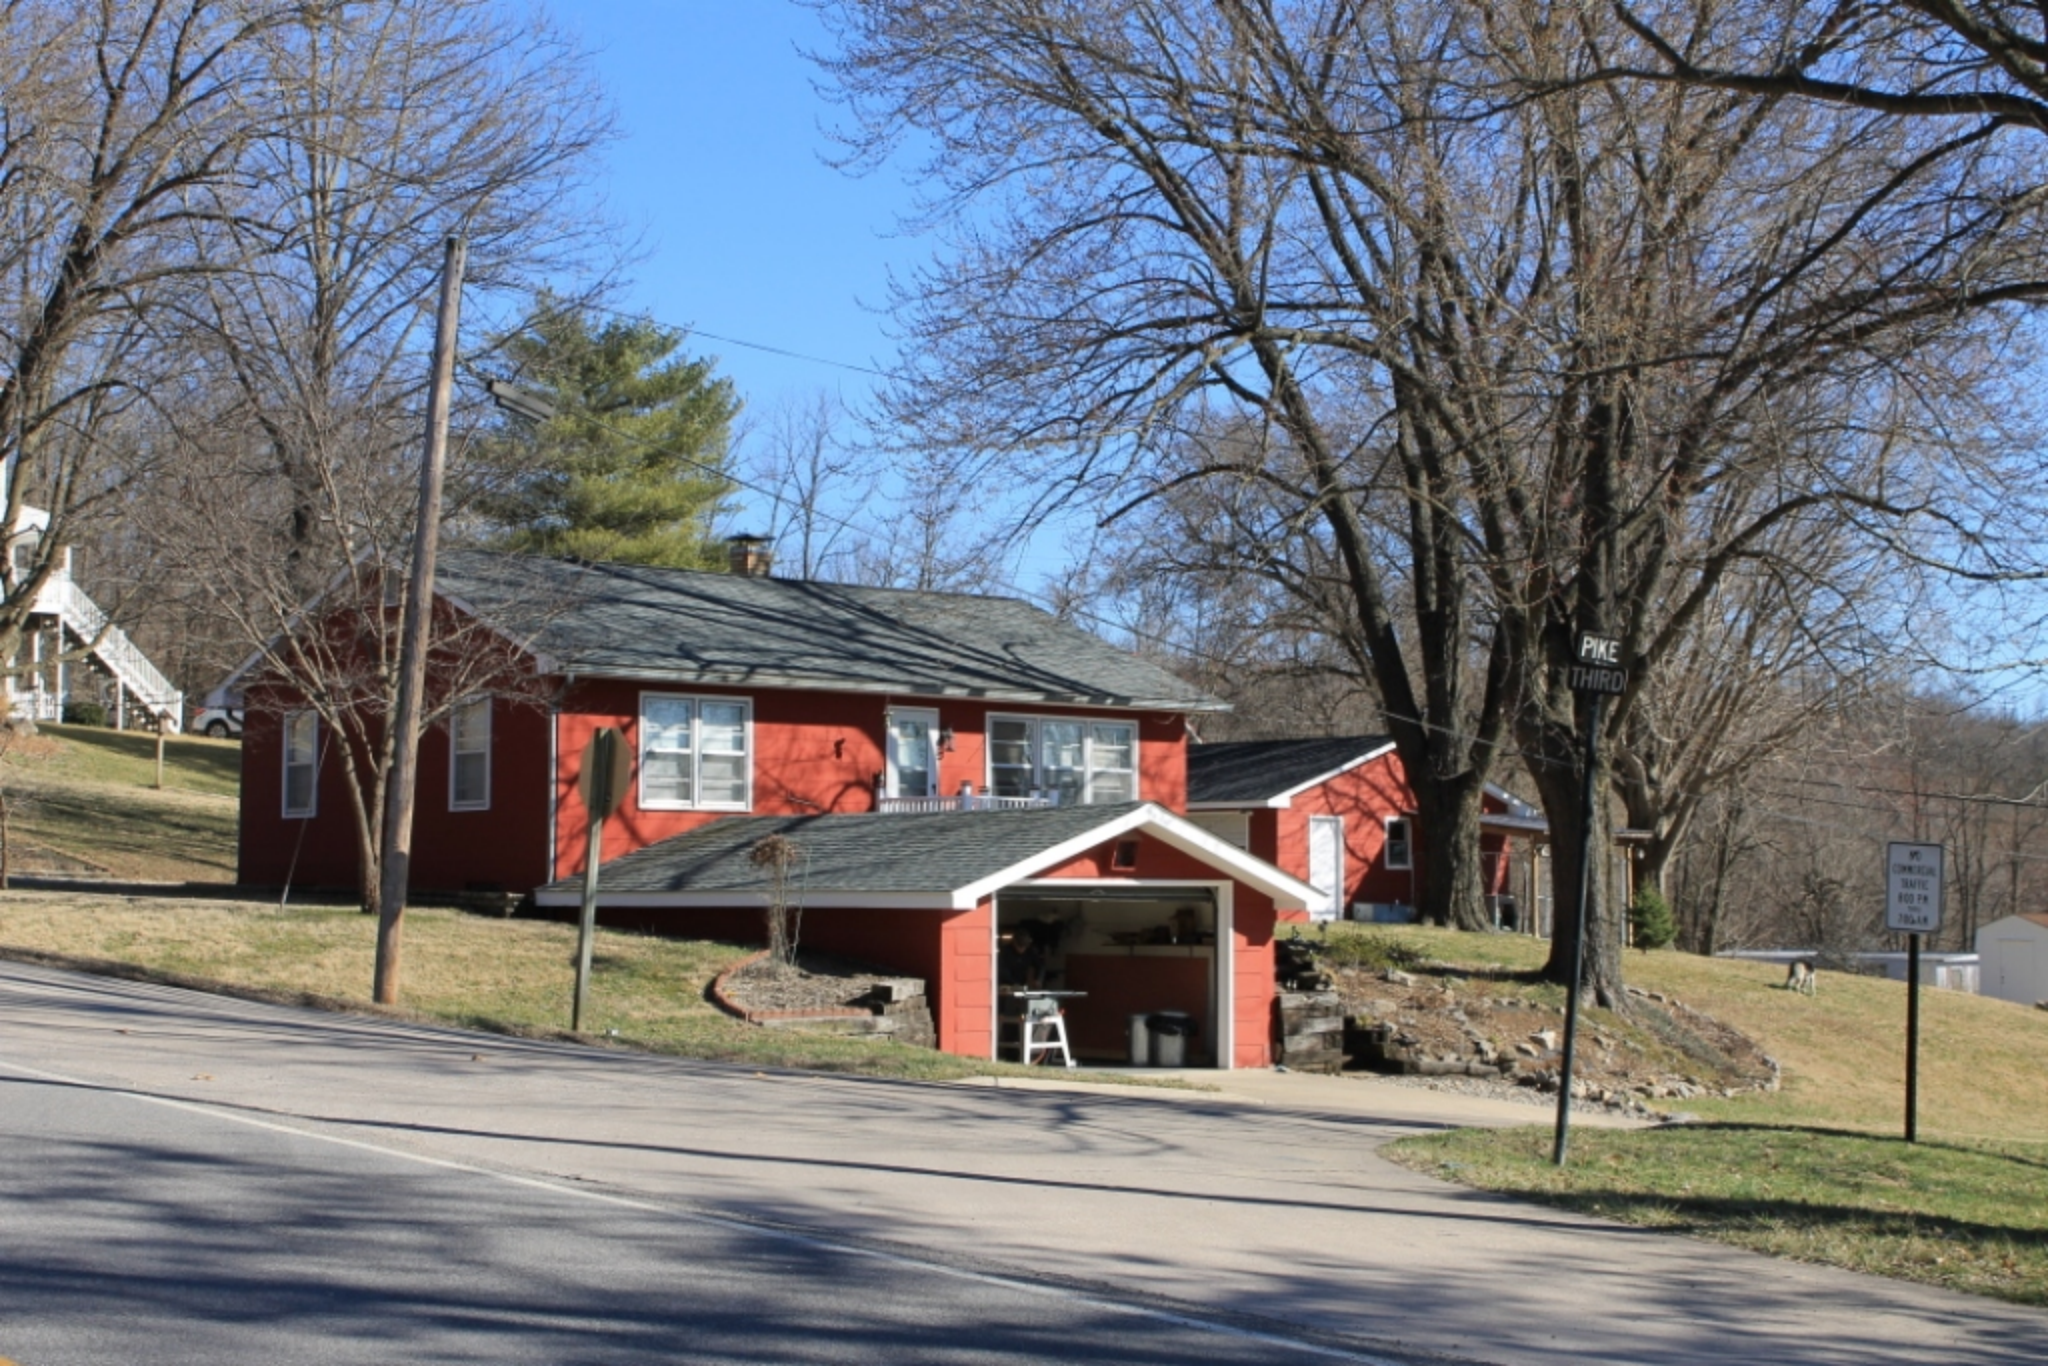
This one-story, massed plan side gable, frame ranch house has a street level front gabled garage wing facing Pike Street. The house is clad in asbestos shingles and the roof is covered with asphalt shingles. The front facade has three bays. The left bay contains a pair of two horizontal-over-two horizontal single hung wooden windows. The center bay contains a door. The right bay contains three two horizontal-over-two horizontal single hung wooden windows. The front gabled garage wing has one bay containing a large overhead door. There is a brick chimney of the center rear slope.

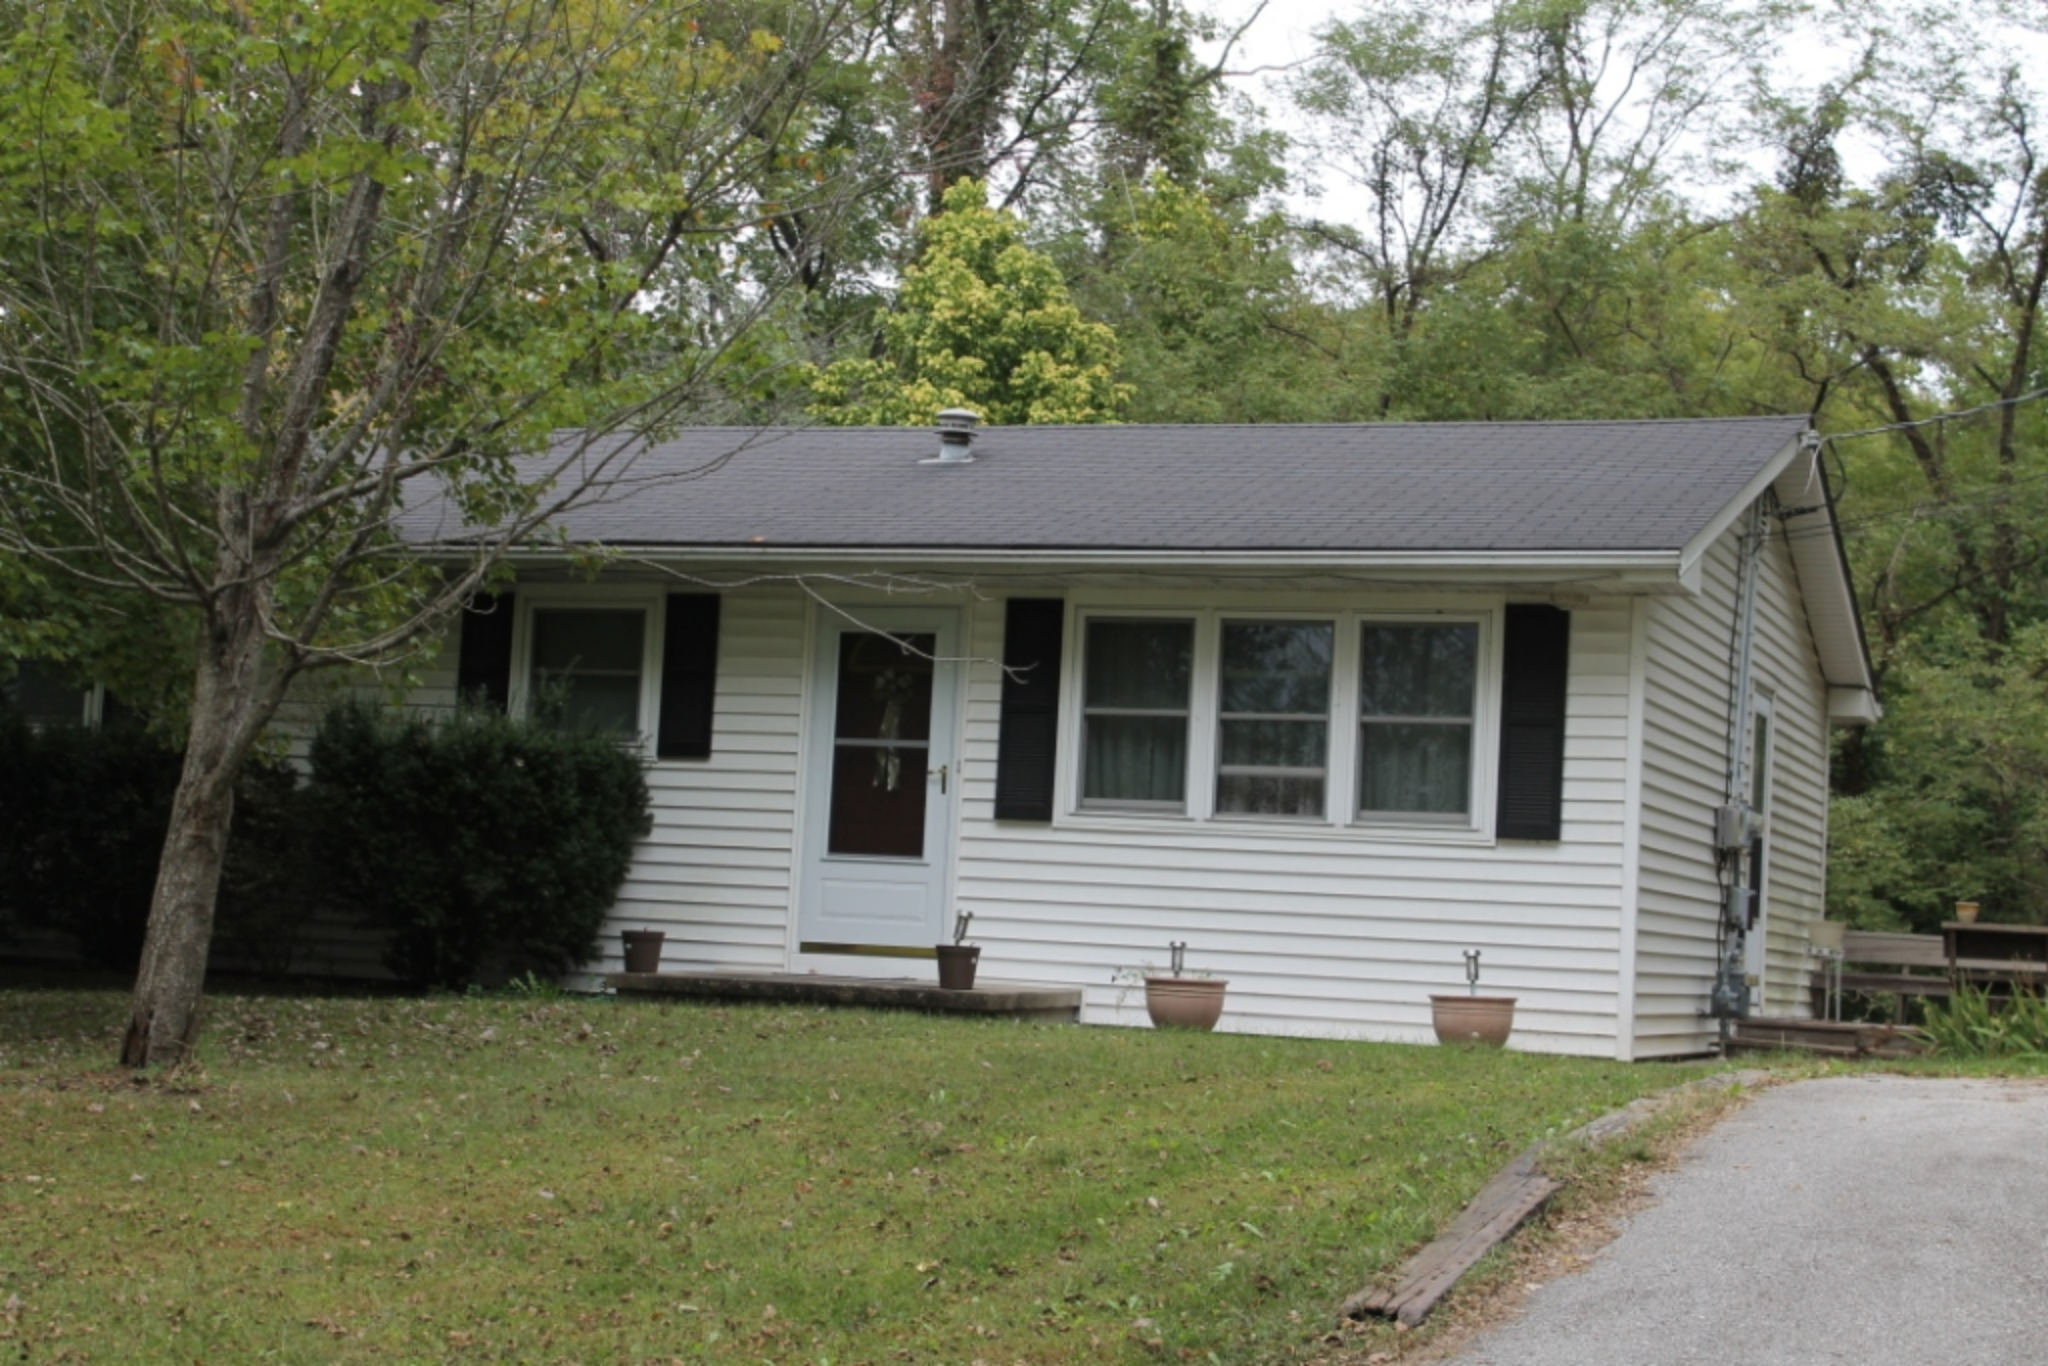
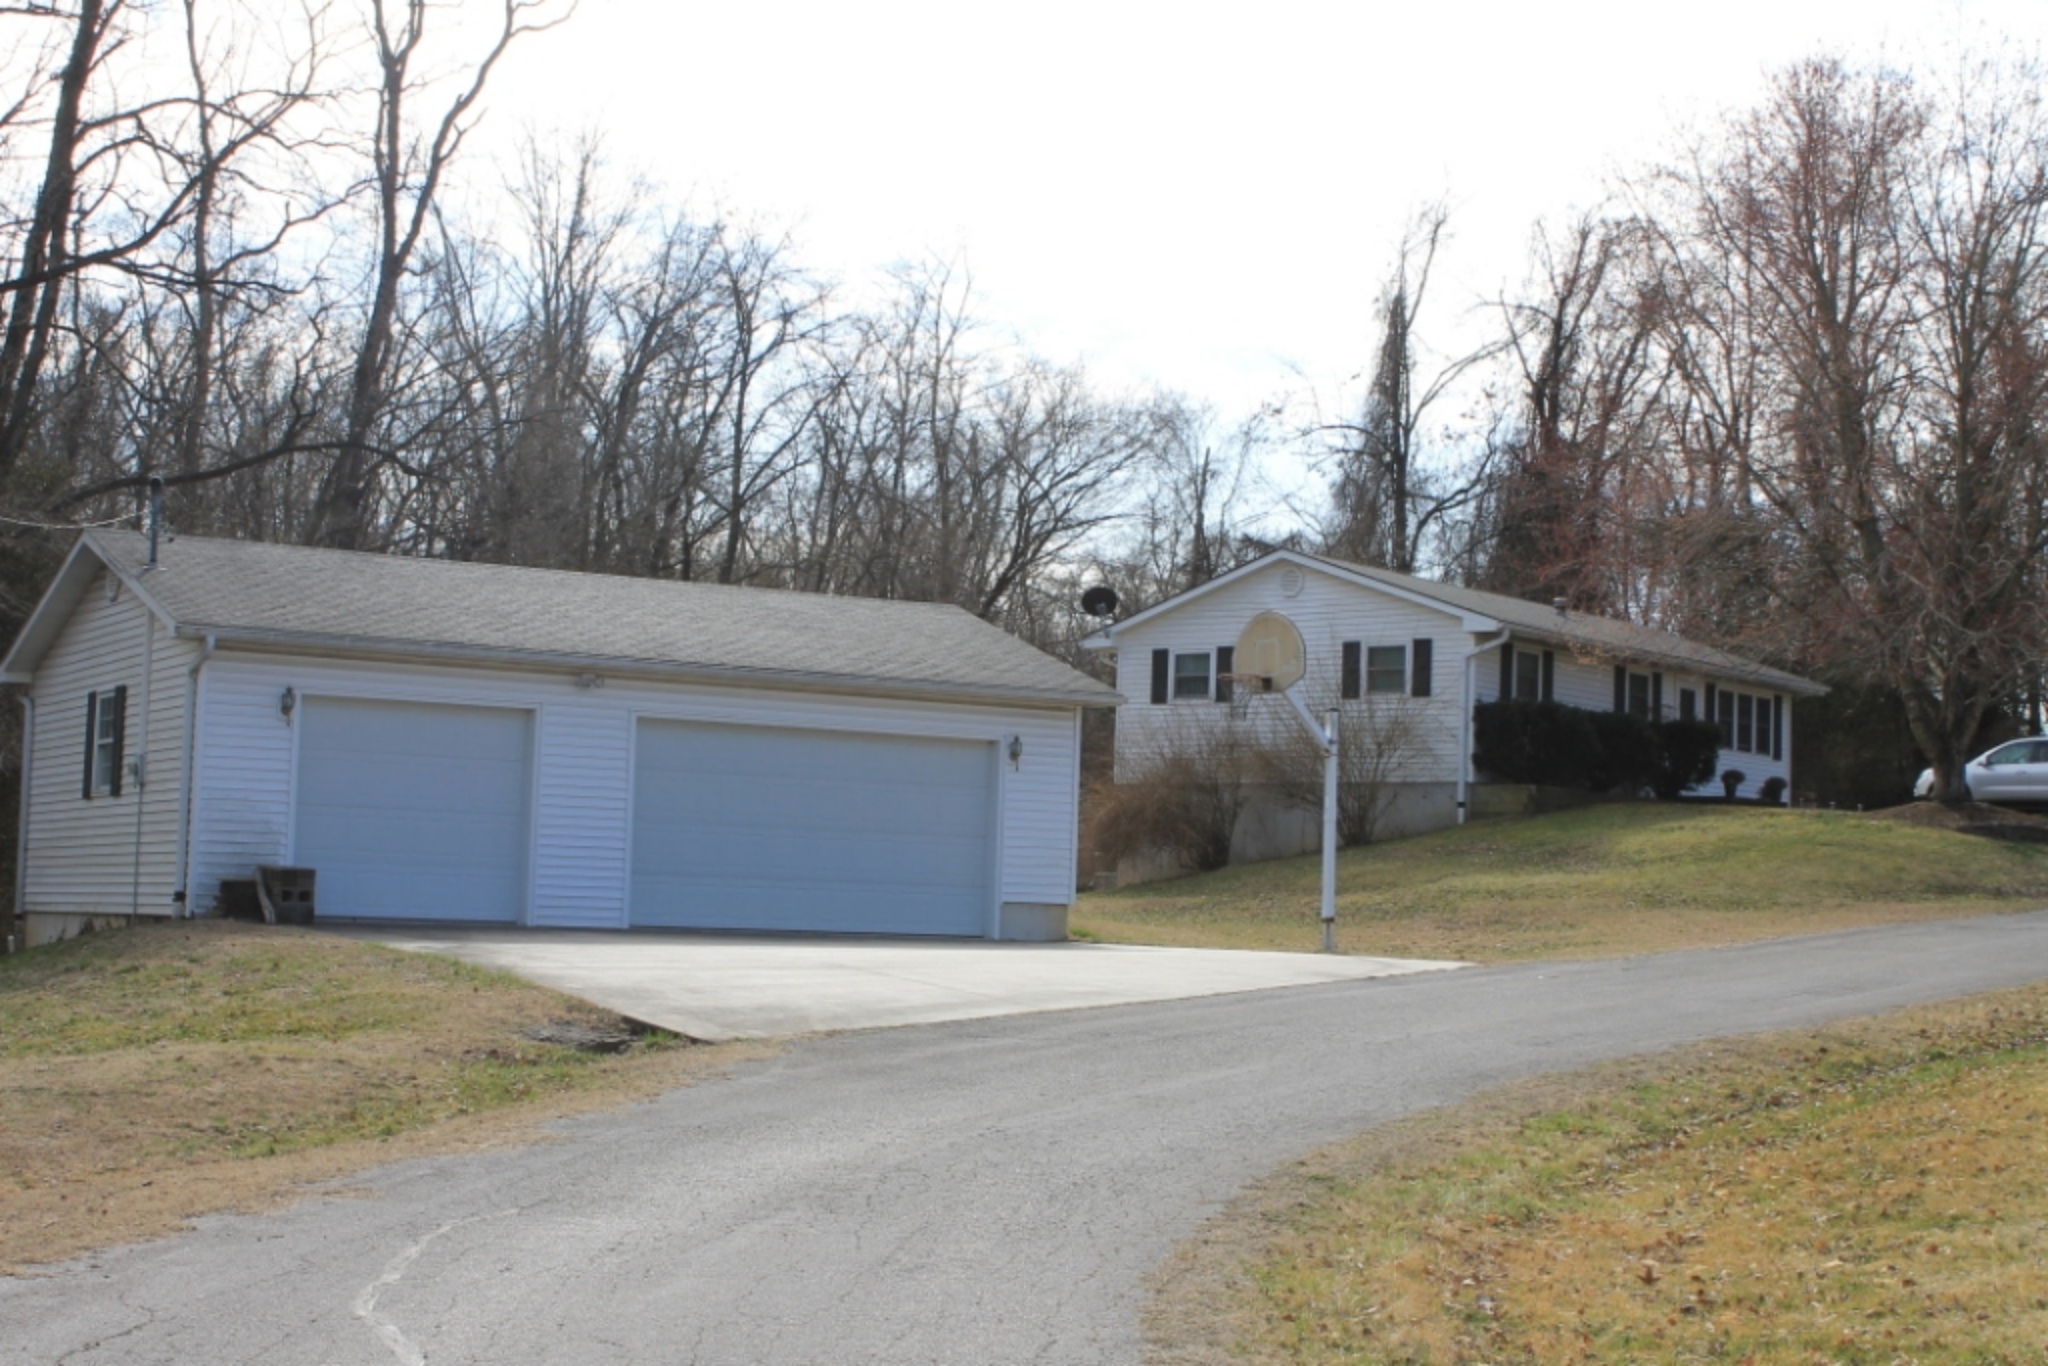
This one-story, massed plan side gable, frame ranch house is clad in clapboards. The low gable roof is covered in asphalt shingles. The front facade has four bays. The left bay contains a one-over-one single hung wooden window. The next bay contains a one-over-one single hung wooden window. The next bay contains a door covered with a glass and metal storm door that opens onto a stoop. The rightmost bay contains three one-over-one single hung wooden windows.

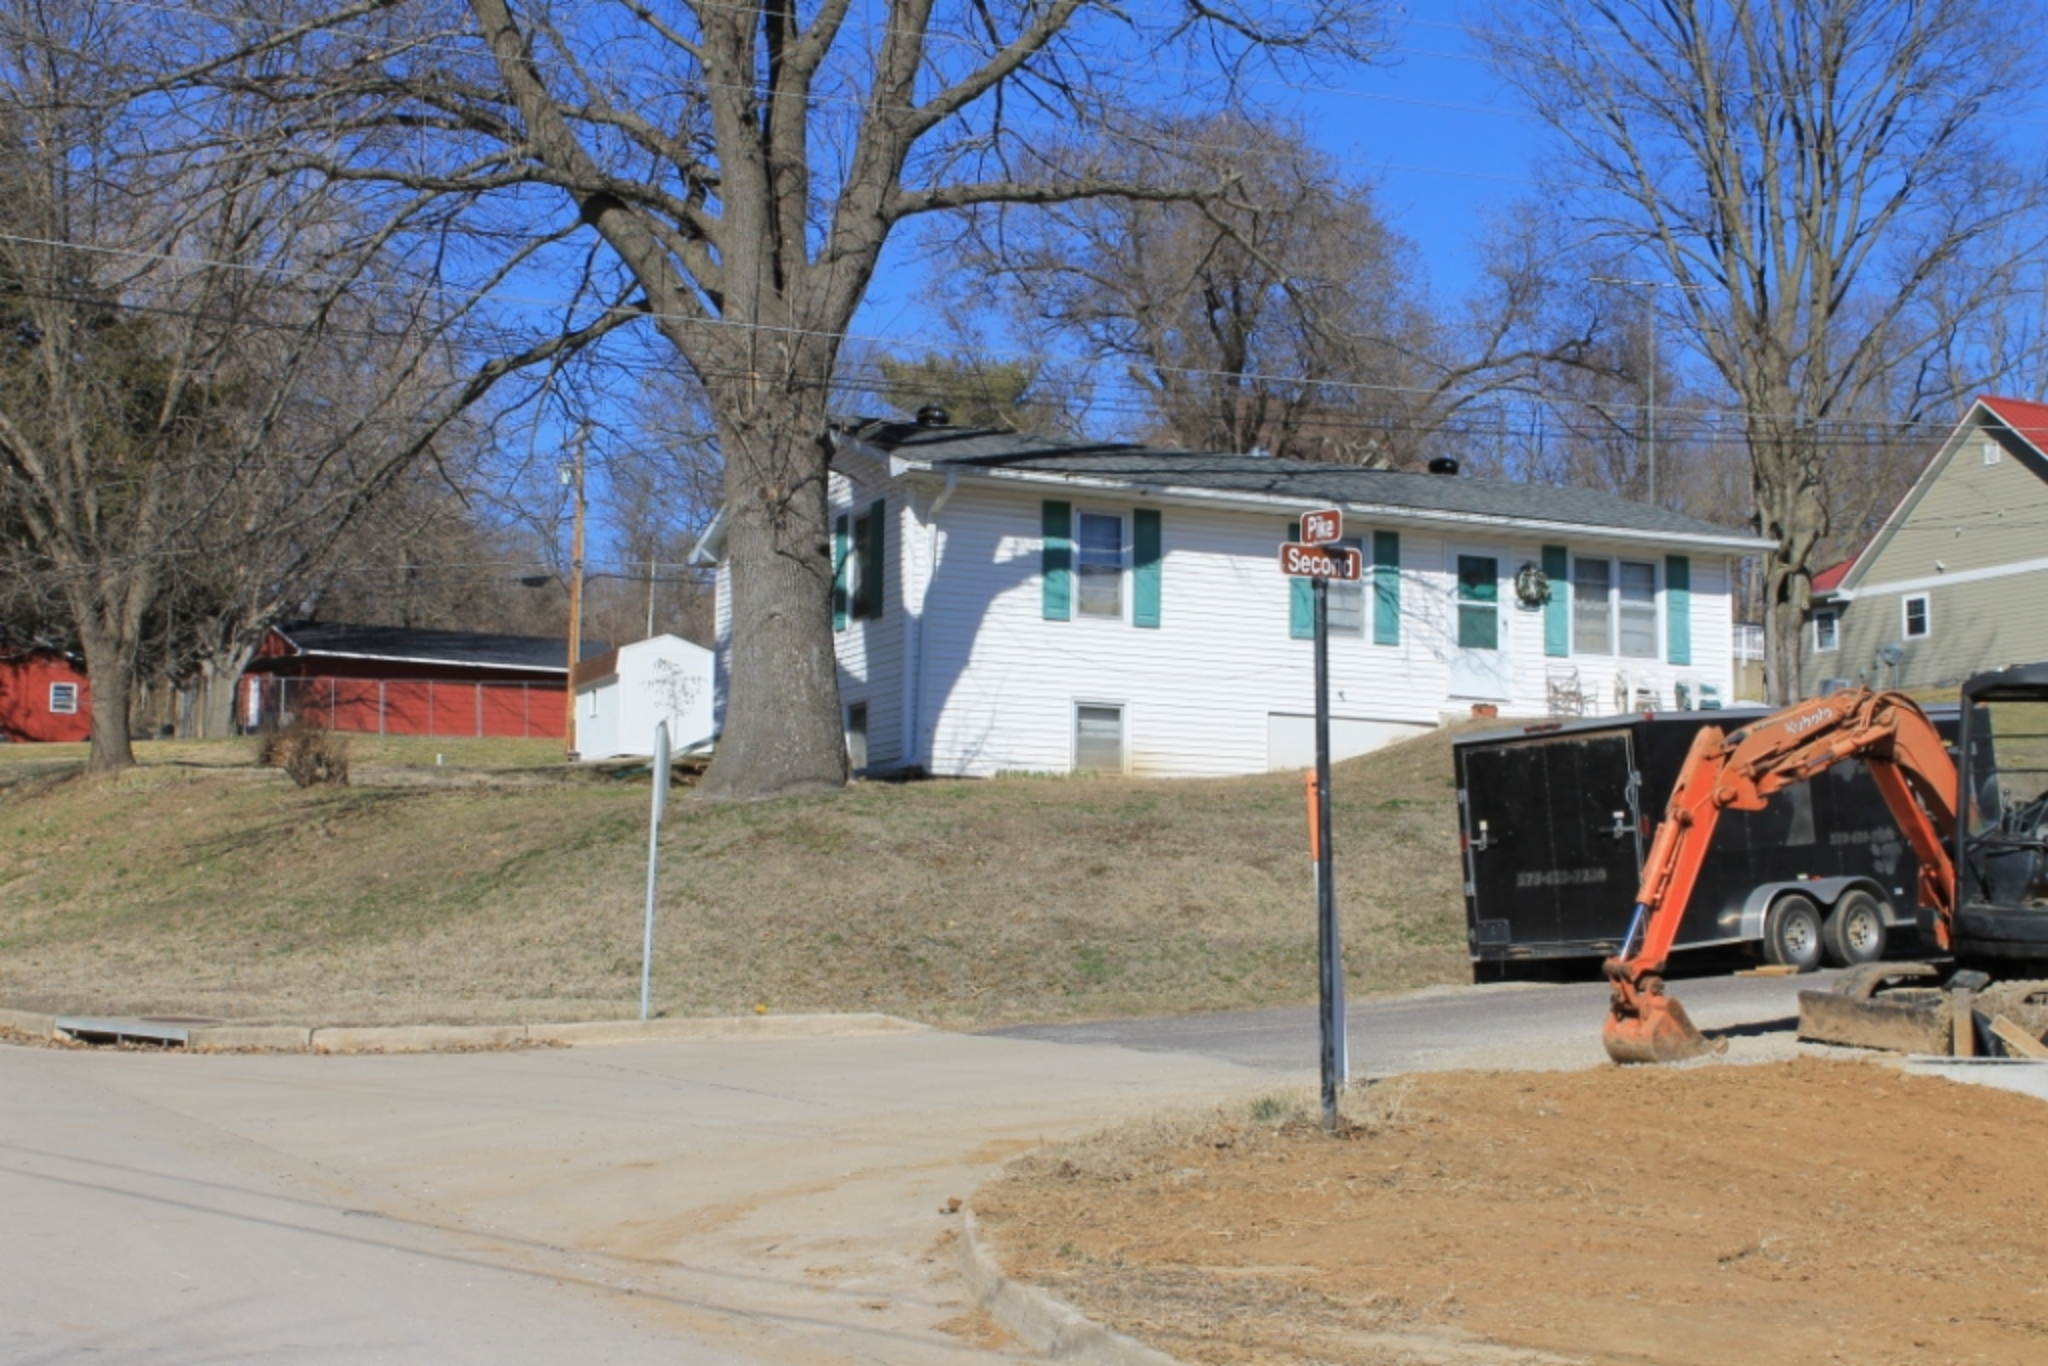
This one-story, massed plan side gable, frame ranch house sits on a raised basement. The building is clad in vinyl siding and its roof is covered in asphalt shingles. The building has four bays on the front facade. The leftmost bay contains a one-over-one single hung vinyl window. The next bay contains a one-over-one single hung vinyl window. The next bay contains a door covered with a metal and glass storm door. The rightmost bay contains a pair of one-over-one single hung vinyl windows. The windows are accented with decorative shutters. On the left end of the raised basement is a bay containing a one-over-one single hung vinyl window without shutters.

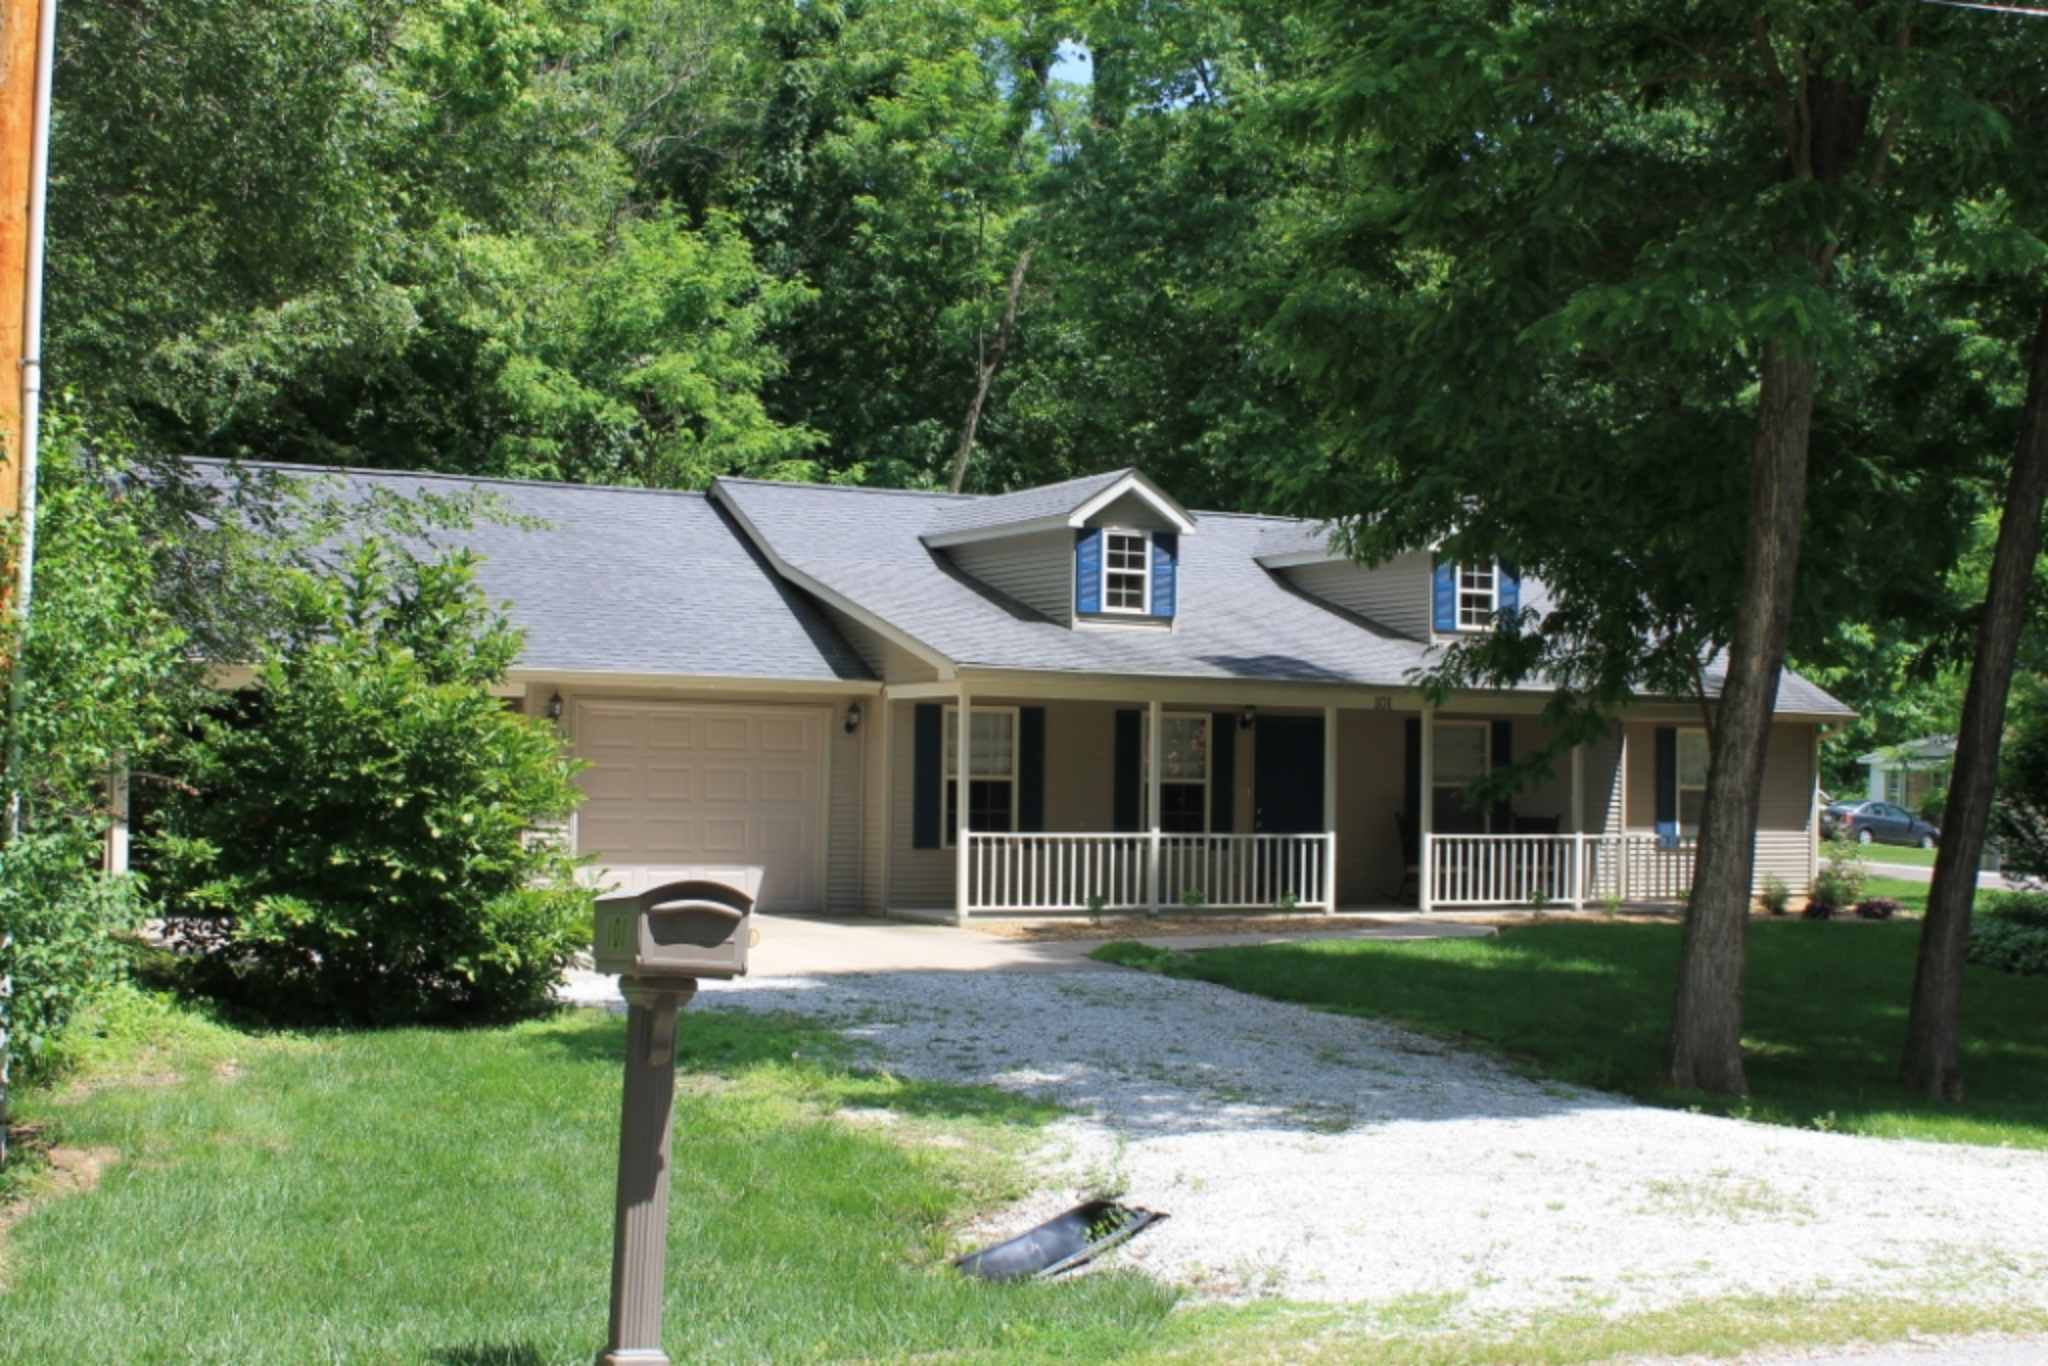
This 1 1/2 story, massed plan side gable house has gable roofed dormers centered on the roof of the main block of the house. The dormers and 1 1/2 story of the house result in it being called a styled ranch house. The house is clad in vinyl siding and the roof is covered in asphalt shingles. To the left of the main block of the house is a two-car attached garage. The mid-high gable roof extends outward to form a shed roof over the veranda that runs the length of the main block of the building. The veranda is supported by square wooden posts and has a balustrade between the posts. The first story of the front (west) facade of the house has seven bays. The two left bays each contain an overhead garage door. The next two bays, which are in the main block of the house, each contain a six-over-six single hung vinyl window. The next bay is the center of the main block of the house; it contains a door. The two rightmost bays each contain a six-over-six single hung vinyl window. The windows have decorative shutters. On the second story of the main block of the house are two evenly spaced gable roofed dormers, each with a single bay containing a four-over-four single hung vinyl window. The windows in the dormers also have decorative shutters.
