MISSOURI DEPARTMENT OF NATURAL RESOURCES
STATE HISTORIC PRESERVATION OFFICE, P.O. Box 176, Jefferson City, MO 65102
ARCHITECTURAL/HISTORIC INVENTORY FORM

1. SURVEY NO. BO-AS-009-0001		2. SURVEY NAME: Rocheport Historic District	
3. COUNTY: Boone		4. ADDRESS (STREET NO.)	STREET (NAME) Katy Trail
5. CITY: Rocheport	VICINITY: <input checked="" type="checkbox"/>	6. UTM: / /	LAT: LONG: T: 48W R: 15W S: 1

8. HISTORIC NAME (IF KNOWN): M.K.&T. Railroad tunnel		9. PRESENT/OTHER NAME (IF KNOWN): Katy trail tunnel	
10. OWNERSHIP: <input type="checkbox"/> PRIVATE <input checked="" type="checkbox"/> PUBLIC		11A. HISTORIC USE (IF KNOWN): railroad tunnel	11B. CURRENT USE: Katy Trail tunnel
HISTORICAL INFORMATION

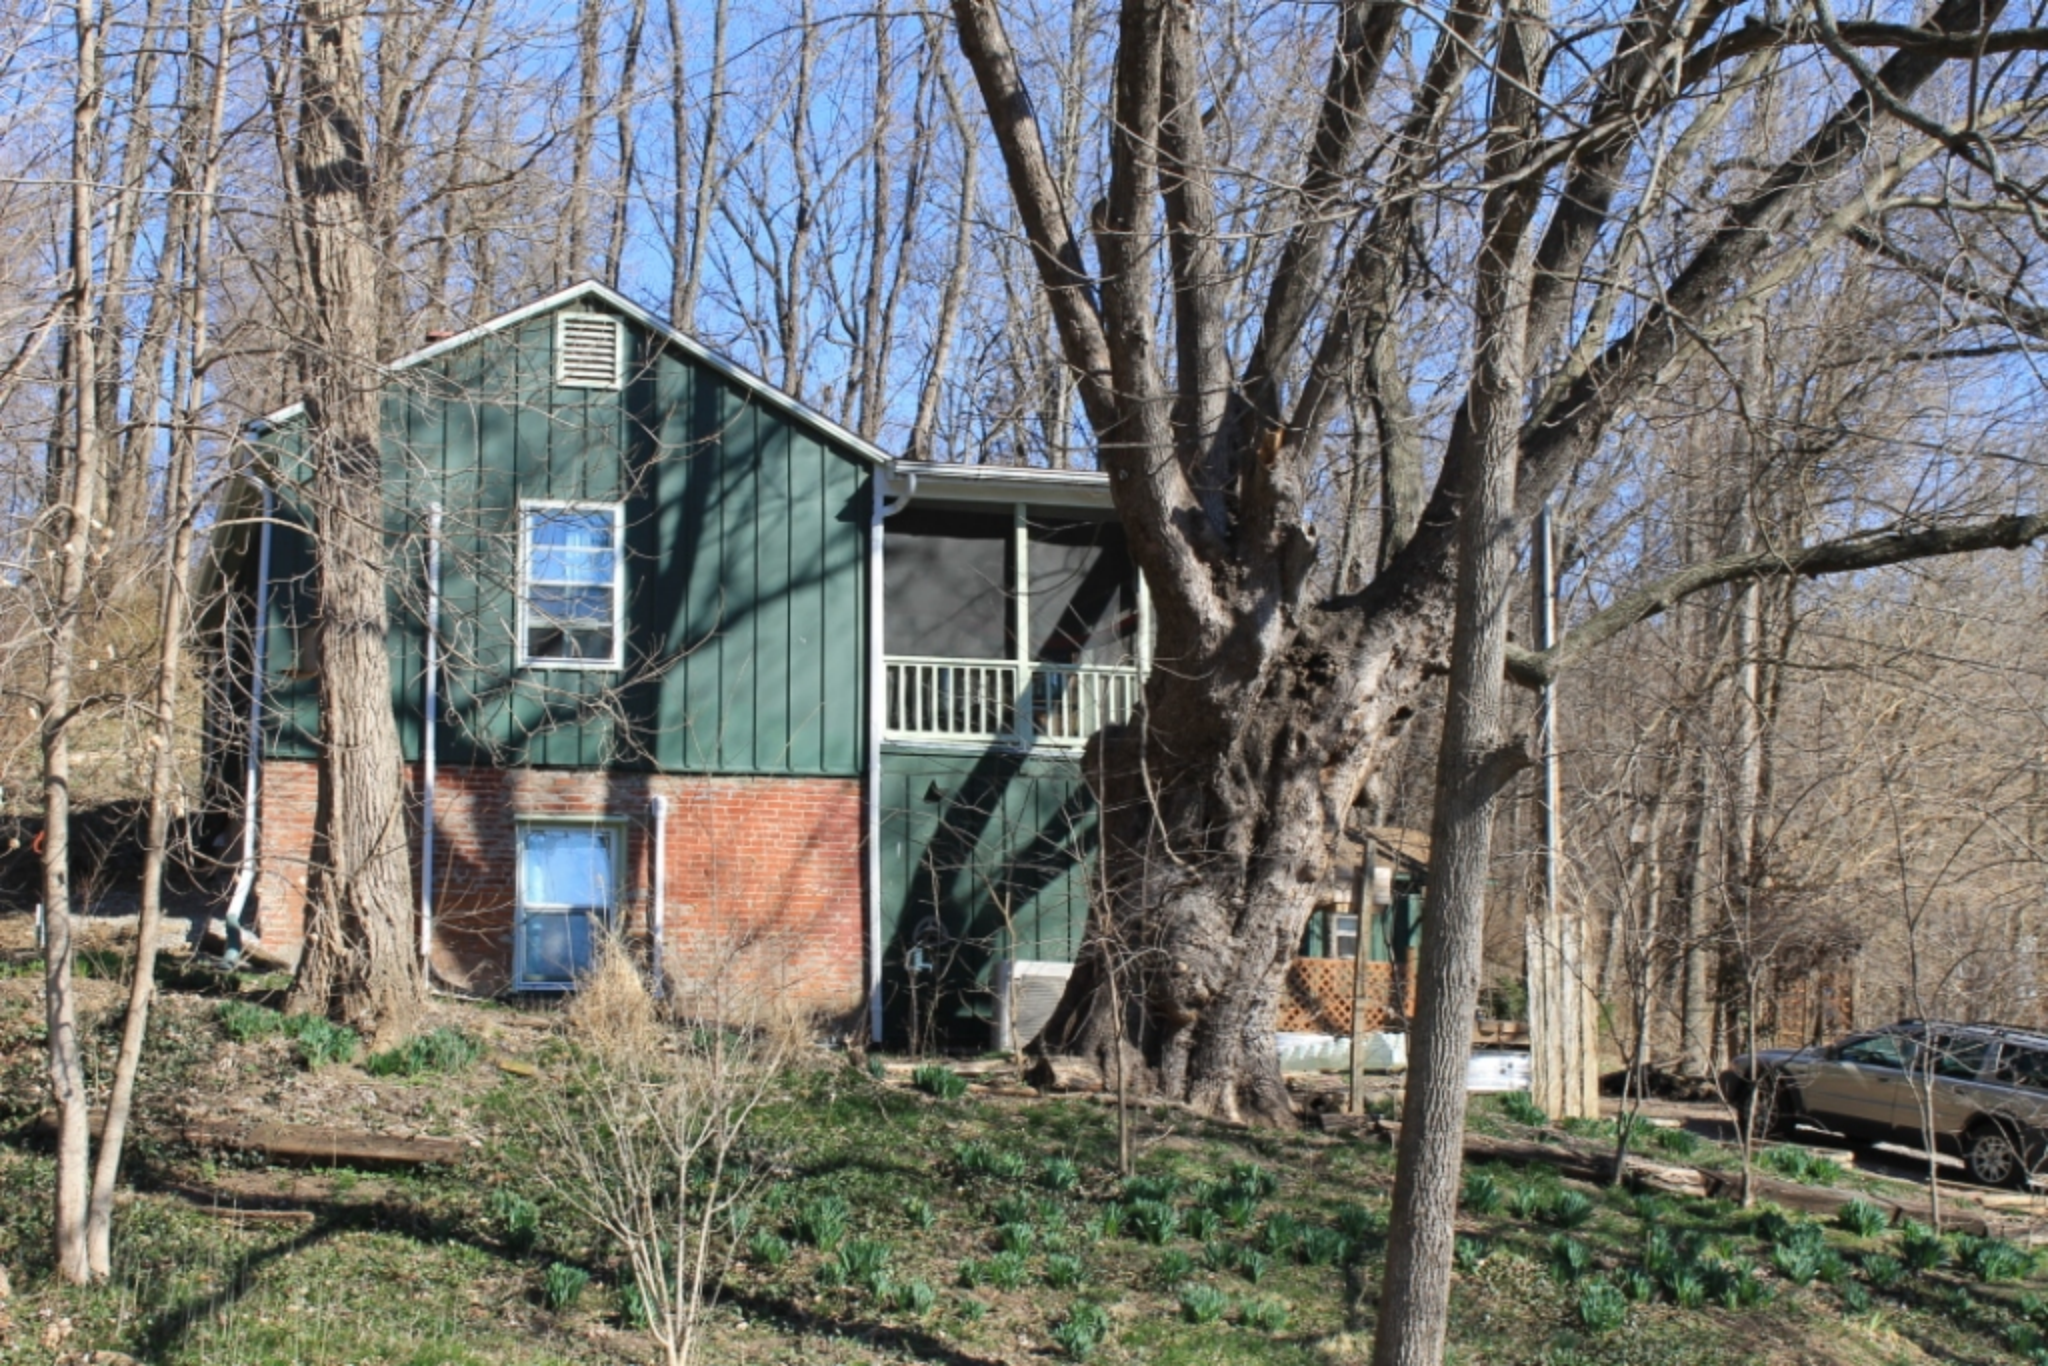
This two-story, massed plan house has two wings. The original wing is a rectangular shaped side gabled building originally made of brick on the first story and frame on the second story. At some point after 1973, a two story cross gabled wing was added to the south of the original building, making the footprint square rather than rectangular. This wing has a screened porch that spans the south facade of the second story of the house. The north portion of the first story reveals the original brickwork. The first story of the west facade has one bay located in the old portion of the house. This bay contains a one-over-one rectangular single hung vinyl window set into a segmental arched opening. The entire south portion of the west facade of the first story is covered with vertical metal panels and has no bays. The second story of the west facade of the house is covered with vertical metal panels. The west facade of the second story has one bay containing a one-over-one single hung vinyl window. The entire second story is covered in metal panels. The second story of the south facade has three bays. The left bay contains a one-over-one single hung vinyl window. The next two bays are part of a screened porch that occupies the south facade of the second story.

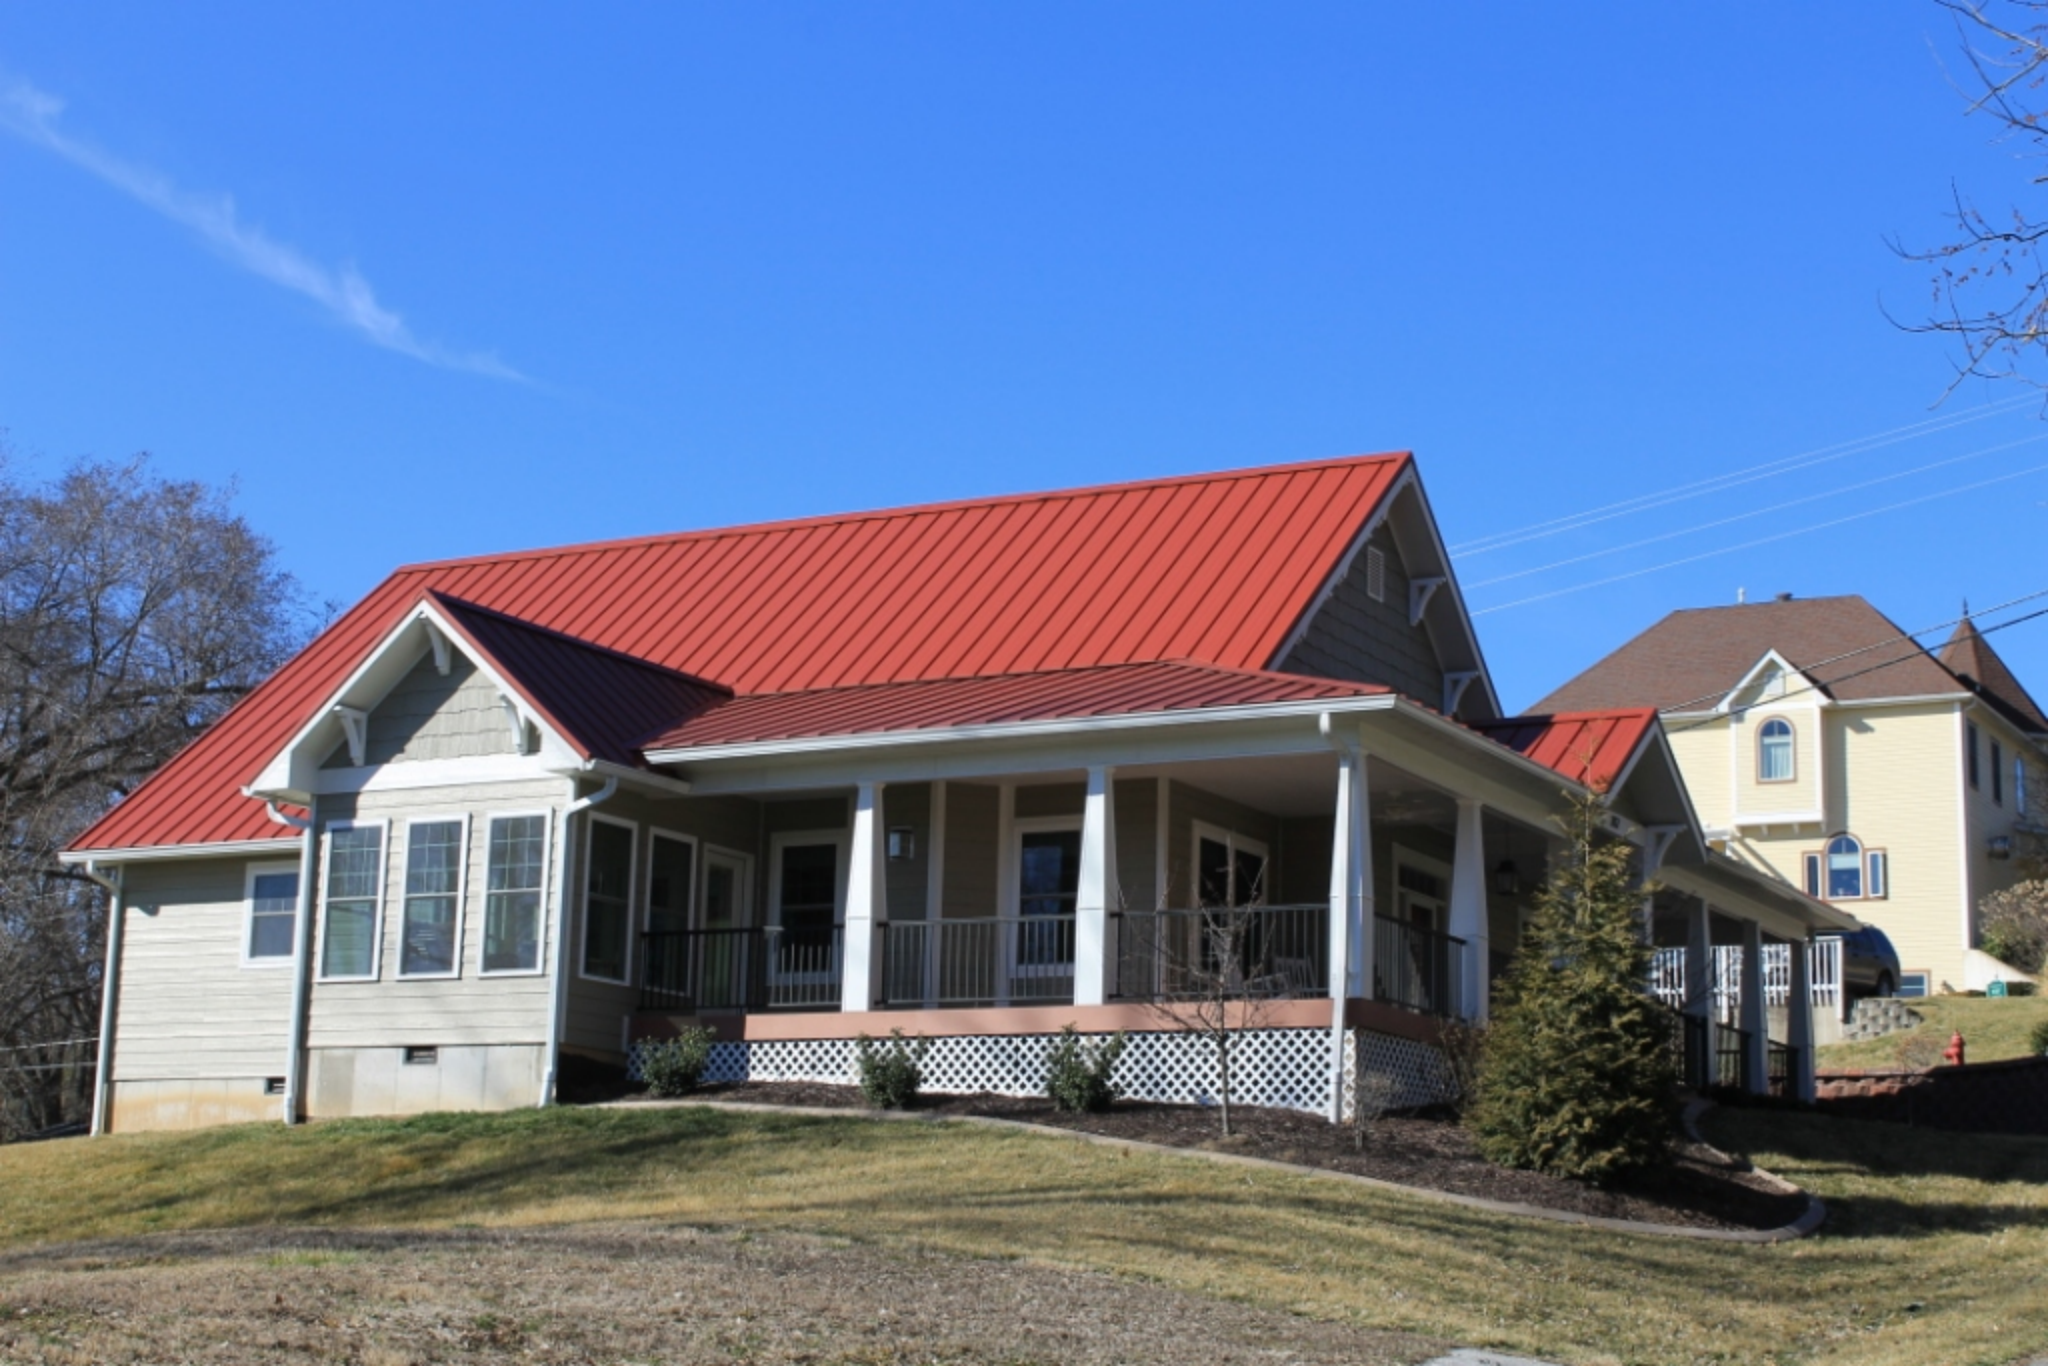
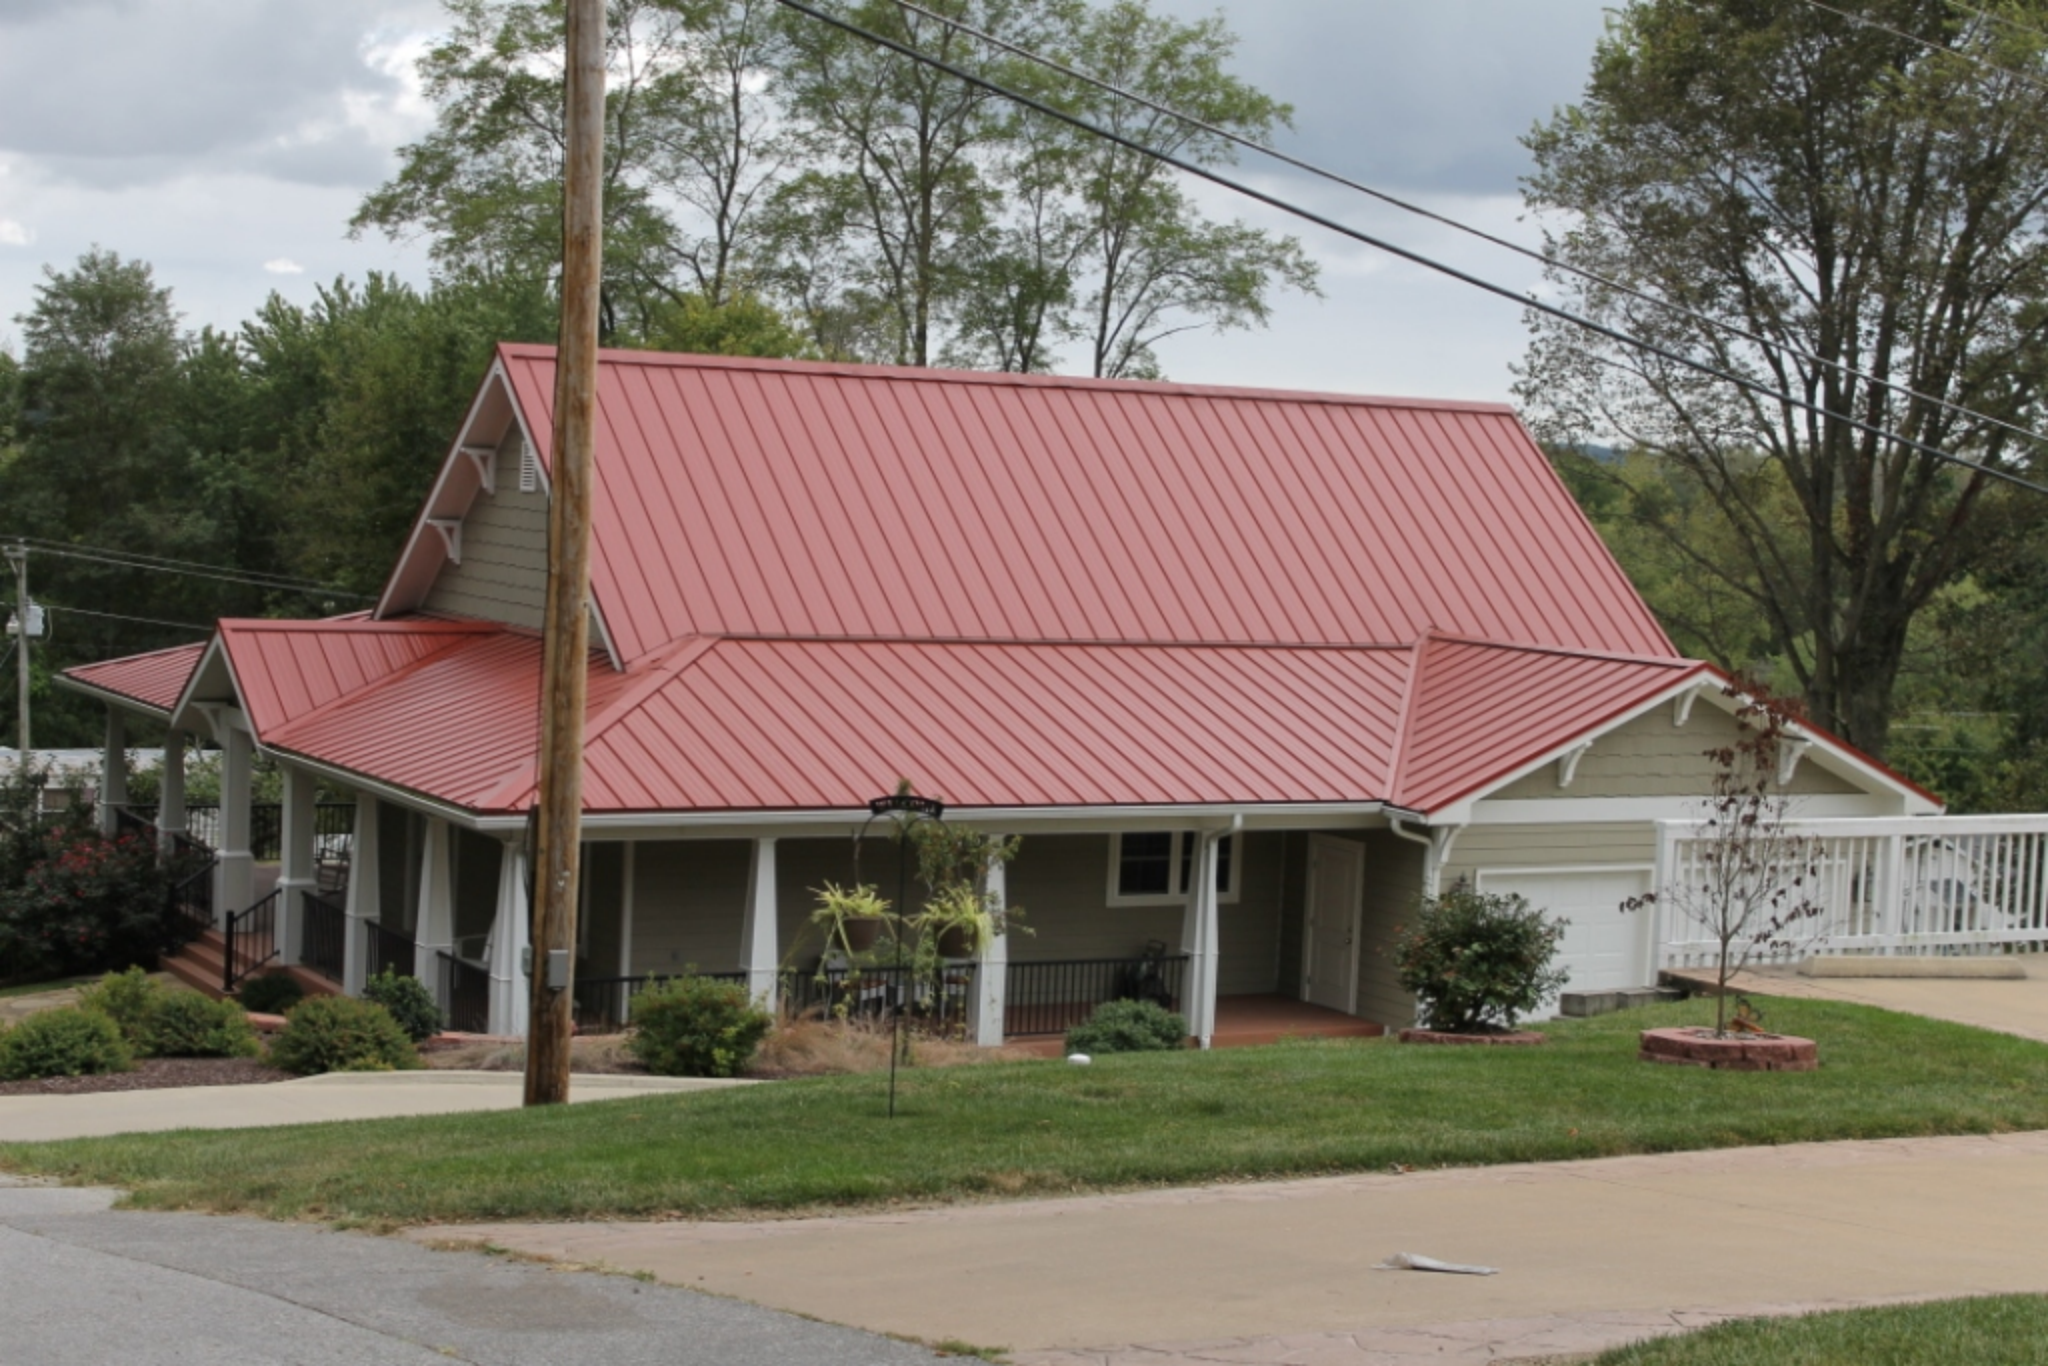
This 1 1/2 story, massed plan pyramidal house is in the New Traditional-Craftsman style. The walls are clad in vinyl siding and the roof is covered in metal. The house has a high gable roof on the front facade with a smaller front facing gable marking the front entrance on the hipped roof wrap around porch. The building has an intersecting gable roofed wing on the south, and a larger intersecting gable roofed wing on the north. The gable roofs are supported by wooden knee brackets. The siding in the gable ends is vinyl siding textured to look like cedar shakes. The porch is supported by pyramidal posts. The front (east) facade has seven bays. The two left bays, which are located in the gable roofed wing to the south, each contain a nine-over-nine single hung vinyl window. The next bay, which is located on the main block of the house, contains a pair of nine-over-nine single hung vinyl windows. The next bay contains a wooden paneled door with a modern metal and glass storm door flanked by six pane sidelights and a five paned transom. The next bays each contain a pair of one-over-one single hung vinyl windows. The rightmost bay, which is located in the north gable roofed wing, contains a nine-over-nine single hung vinyl window. A two car garage is located in the north gable roofed wing.
