MISSOURI DEPARTMENT OF NATURAL RESOURCES
STATE HISTORIC PRESERVATION OFFICE, P.O. Box 176, Jefferson City, MO 65102
ARCHITECTURAL/HISTORIC INVENTORY FORM

1. Survey No. JP-AS-007-001		2. Survey name: East Town (Original Joplin) Historic Survey Phase 2	
3. County: JASPER		4. Address (Street No.) 618	Street (name) E. 2 nd Street
5. City: Joplin	Vicinity: <input type="checkbox"/>	6. Geographical Reference:	7. Township/Range/Section: T: R: S:
8. Historic name (if known):		9. Present/other name (if known):	
10. Ownership: <input checked="" type="checkbox"/> Private <input type="checkbox"/> Public		11a. Historic use (if known): Domestic: Single Dwelling	11b. Current use: Domestic: Single Dwelling

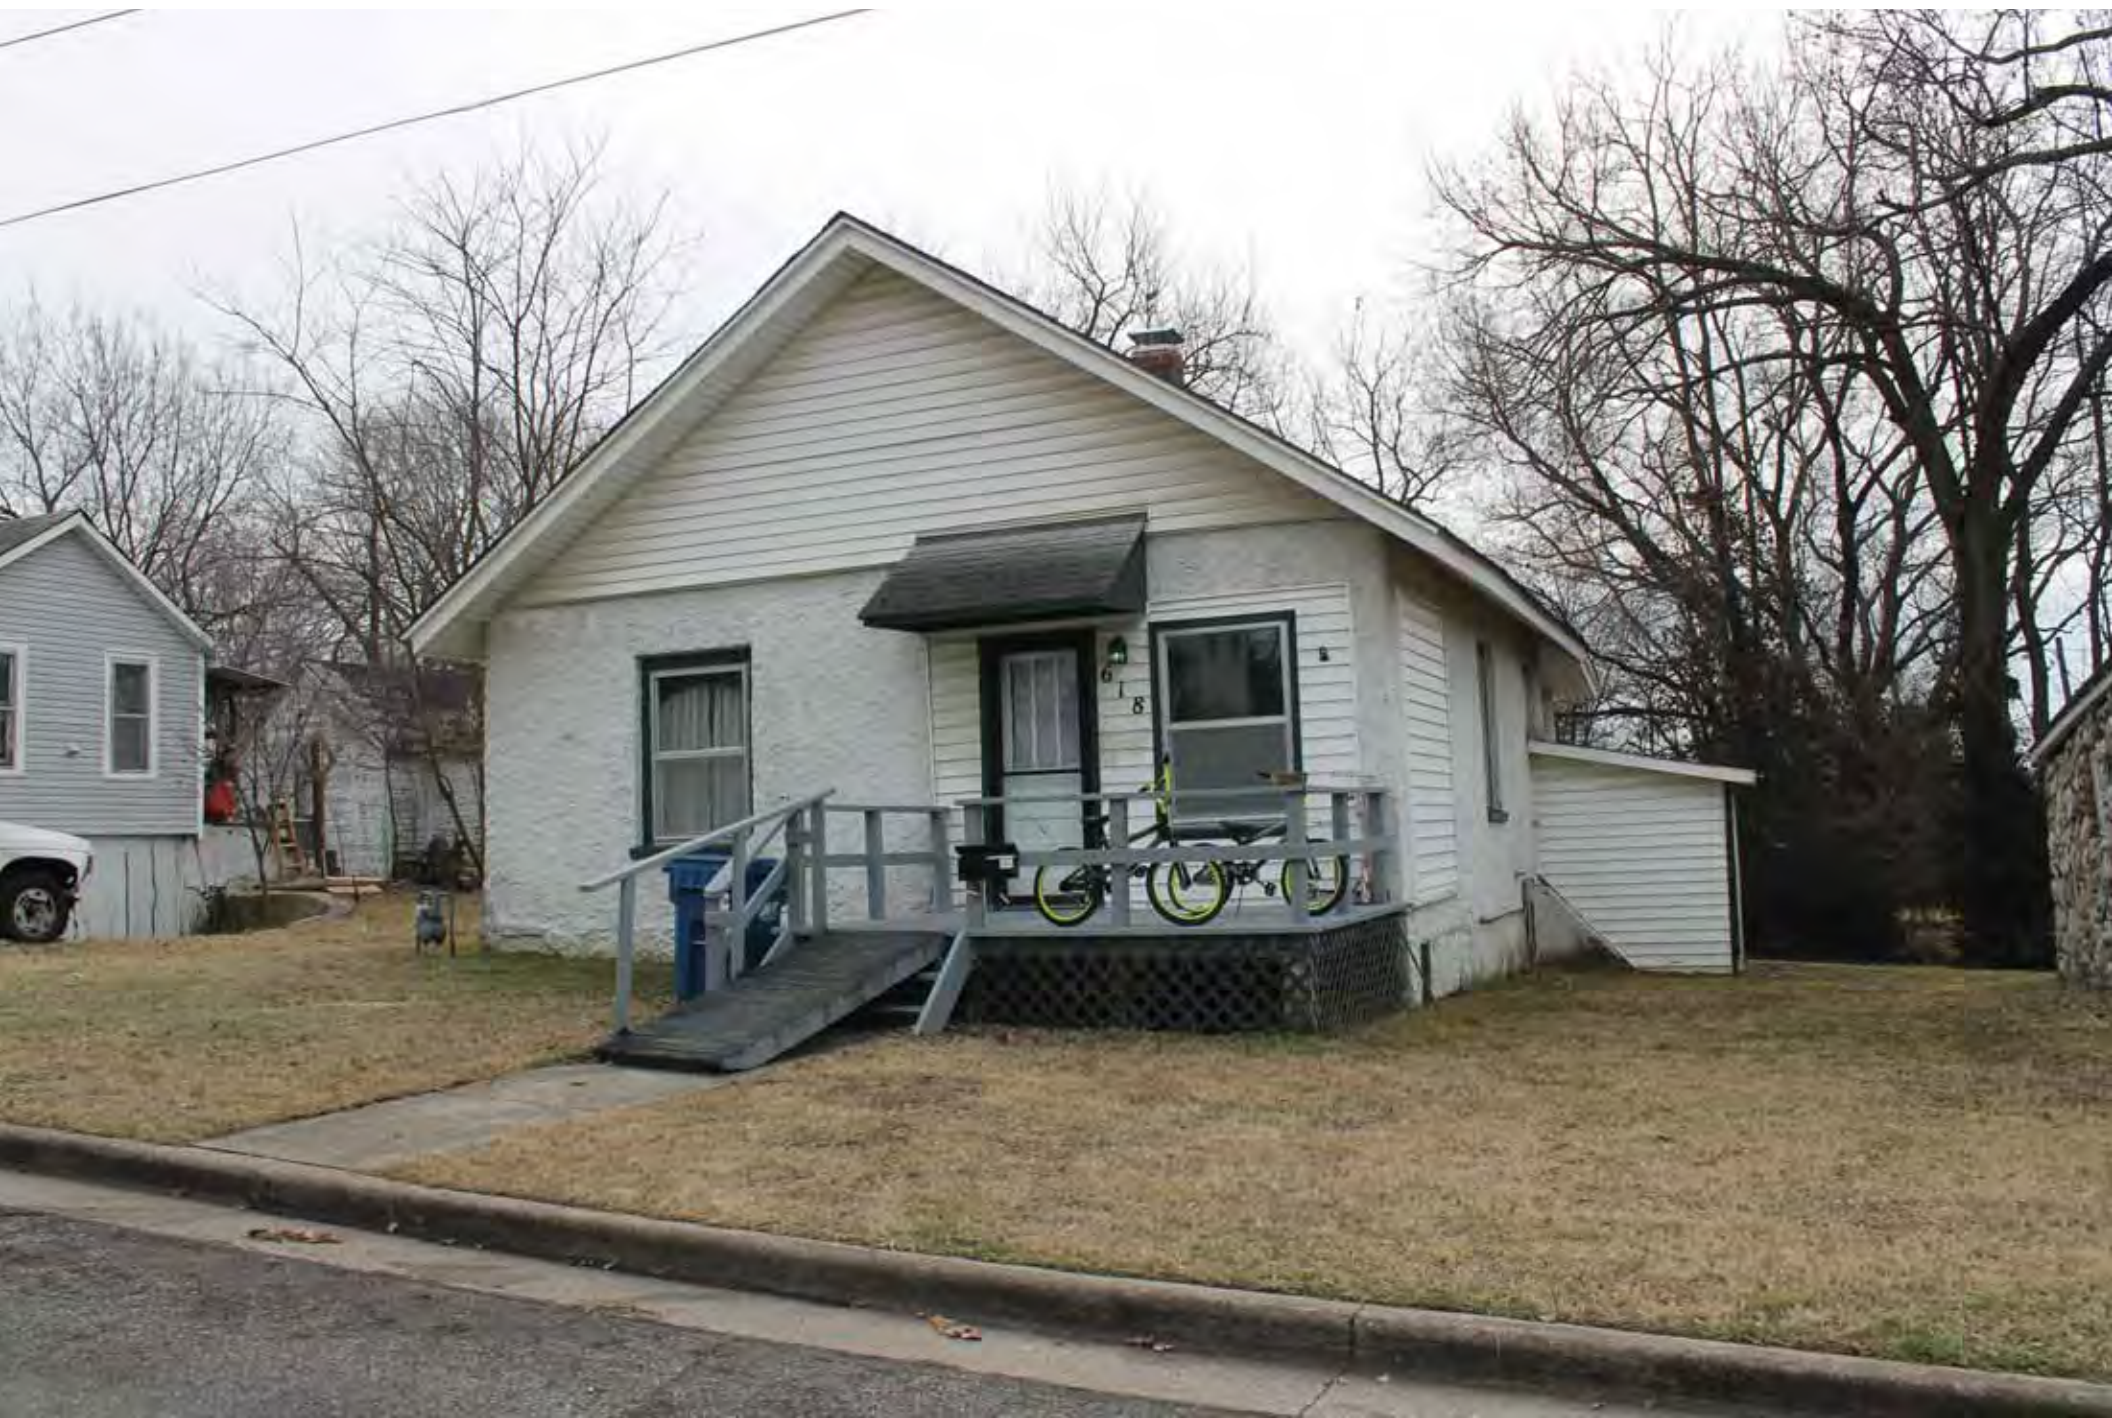
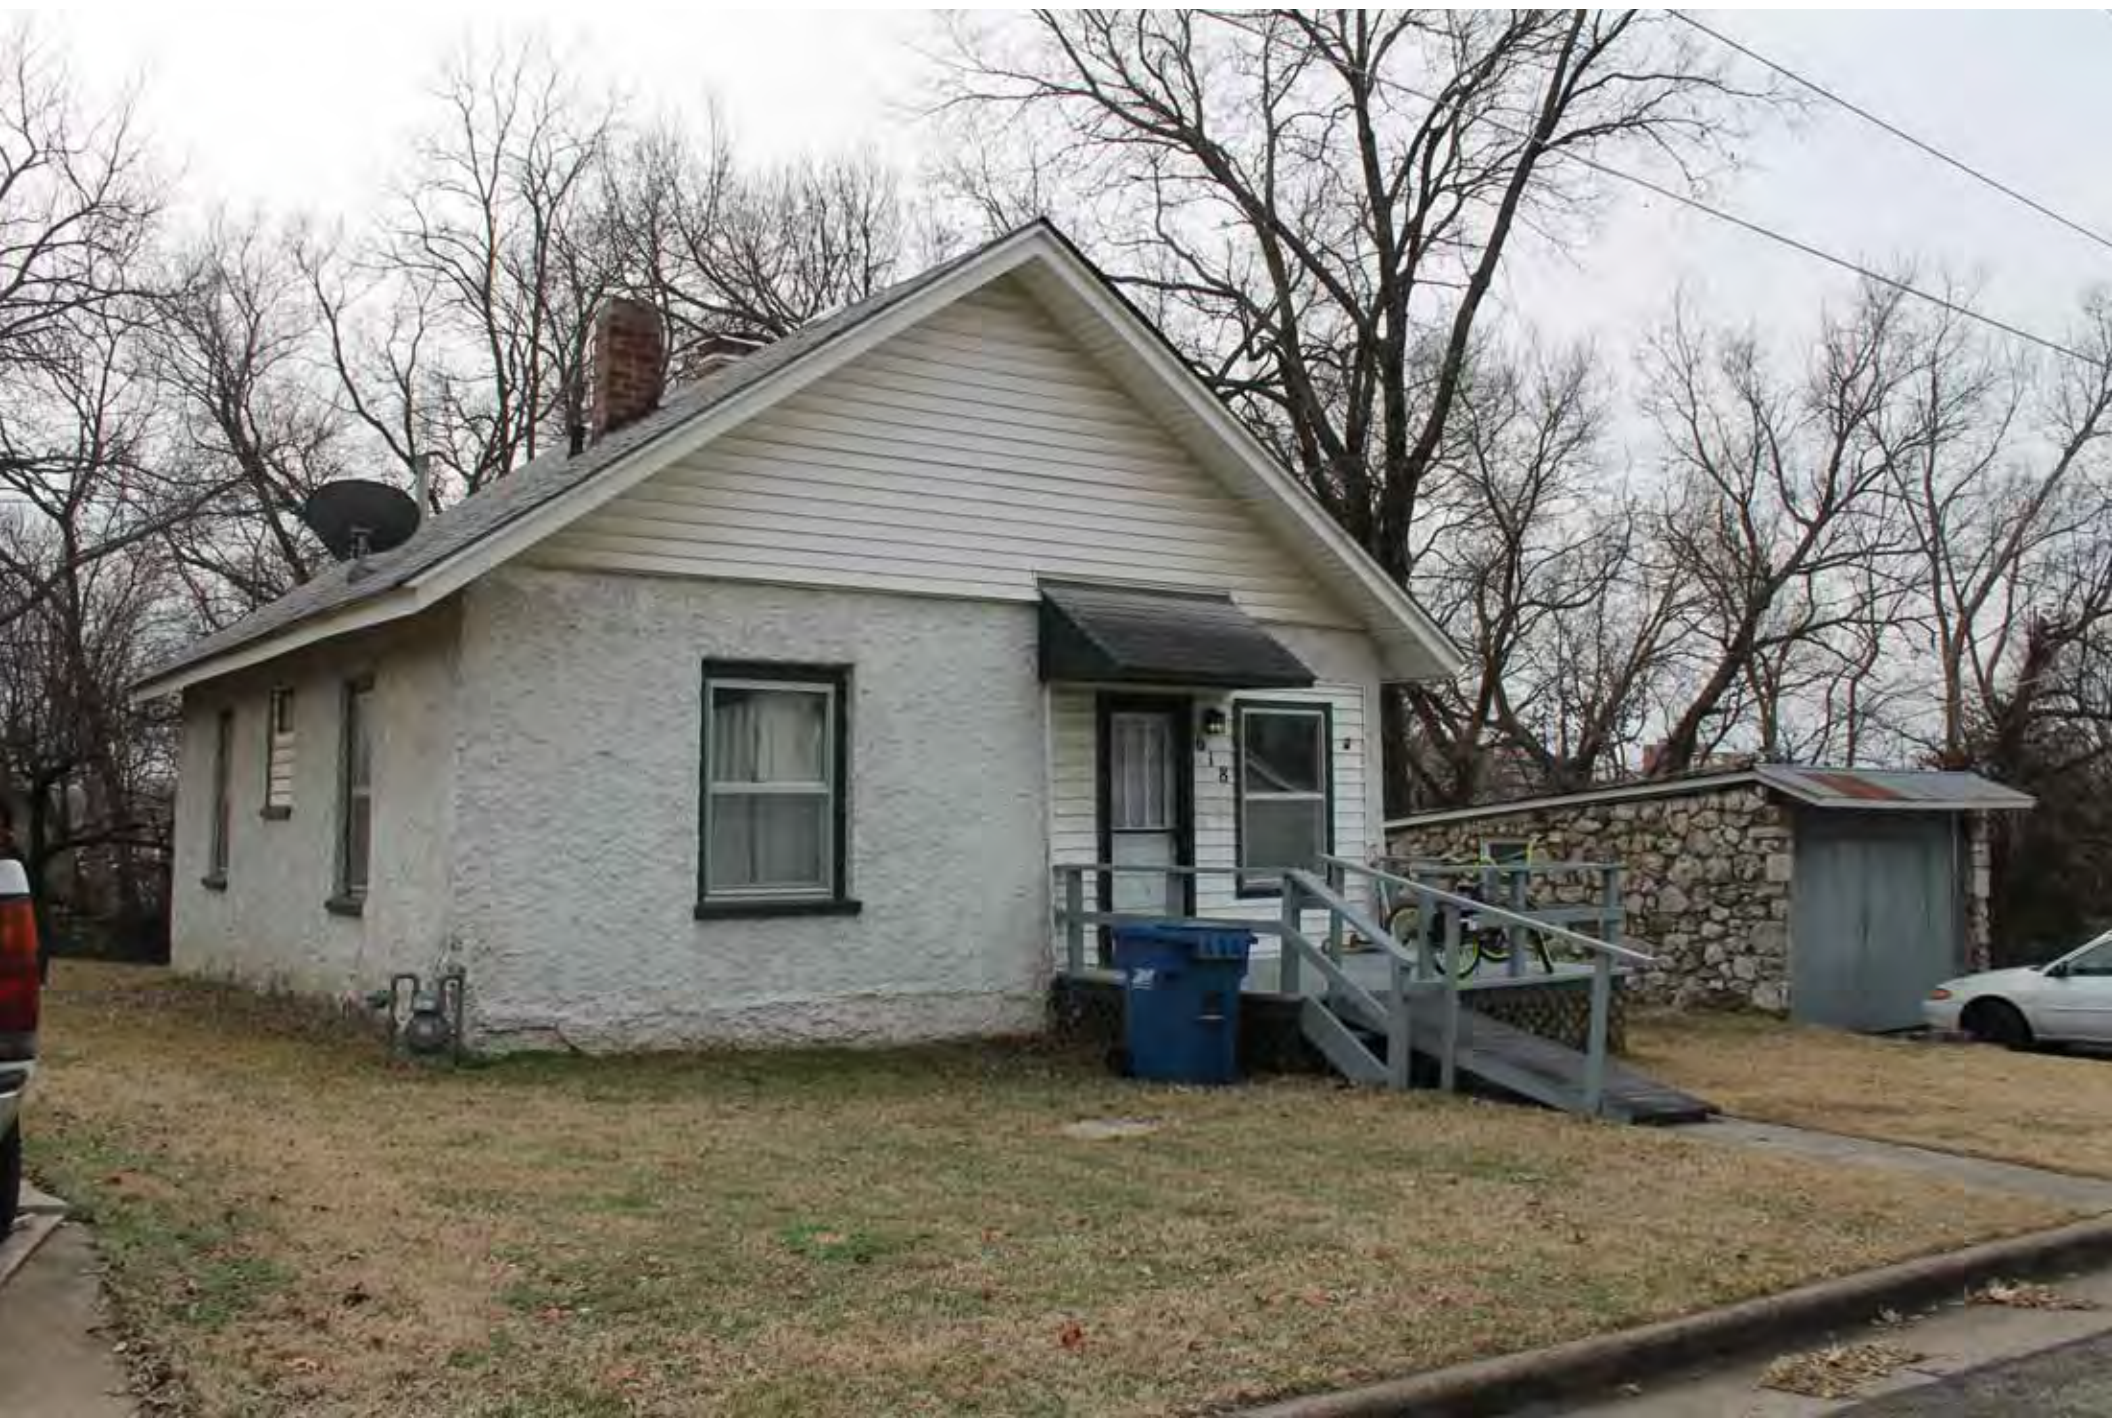
To the east of the house is a rubble stone garage that appears to have been built in the 1930s. It has a shed roof with a small wooden awning or overhang on its front elevation. This awning is covered in corrugated metal. The garage is one bay wide, with wooden replacement doors on the front elevation. The side and rear walls of the garage are constructed of small to medium rubble stones. On the east elevation is a small casement window. There is a gravel driveway along the west elevation of the garage. It does not appear that the garage is individually eligible for listing on the National Register.

The property at 618 E. 2nd Street is a one-story frame house. The house has a front facing gable roof covered in asphalt shingles. There is an interior brick chimney. The gable end of the house is covered in vinyl siding. The majority of the exterior walls are stucco. On the front façade, or north elevation of the house, are two bays. The bay on the left is a single one-over-one replacement window. The bay on the right, or to the west, is the front door and a single one-over-one replacement window. A non-historic wood awning is above the door. There is an open wooden porch or deck in front of this second bay.

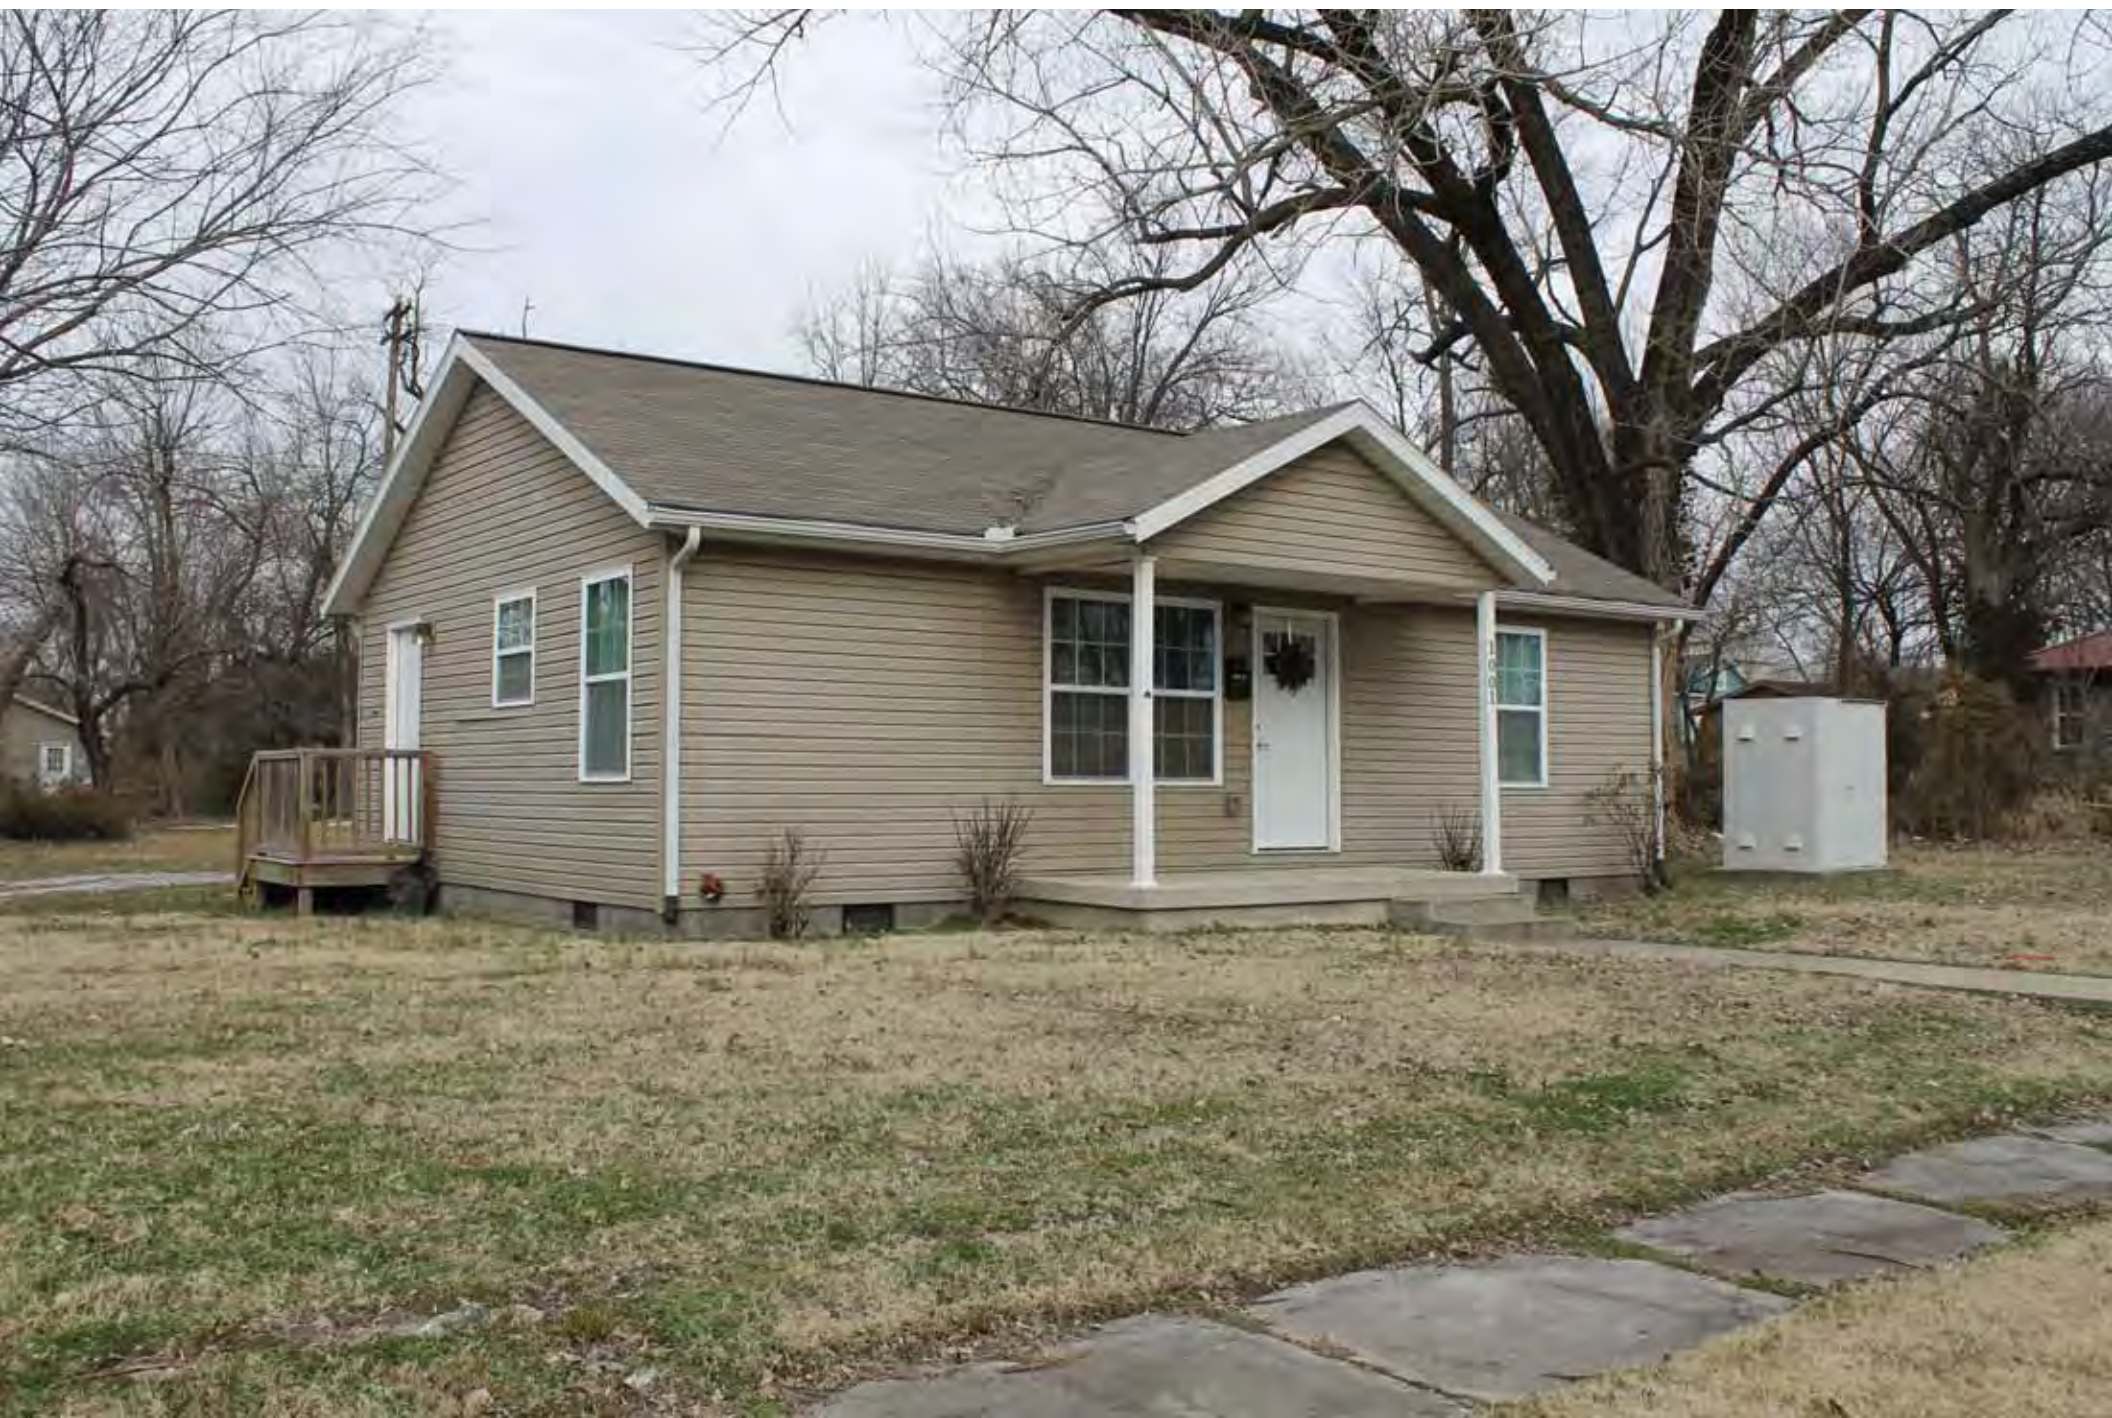
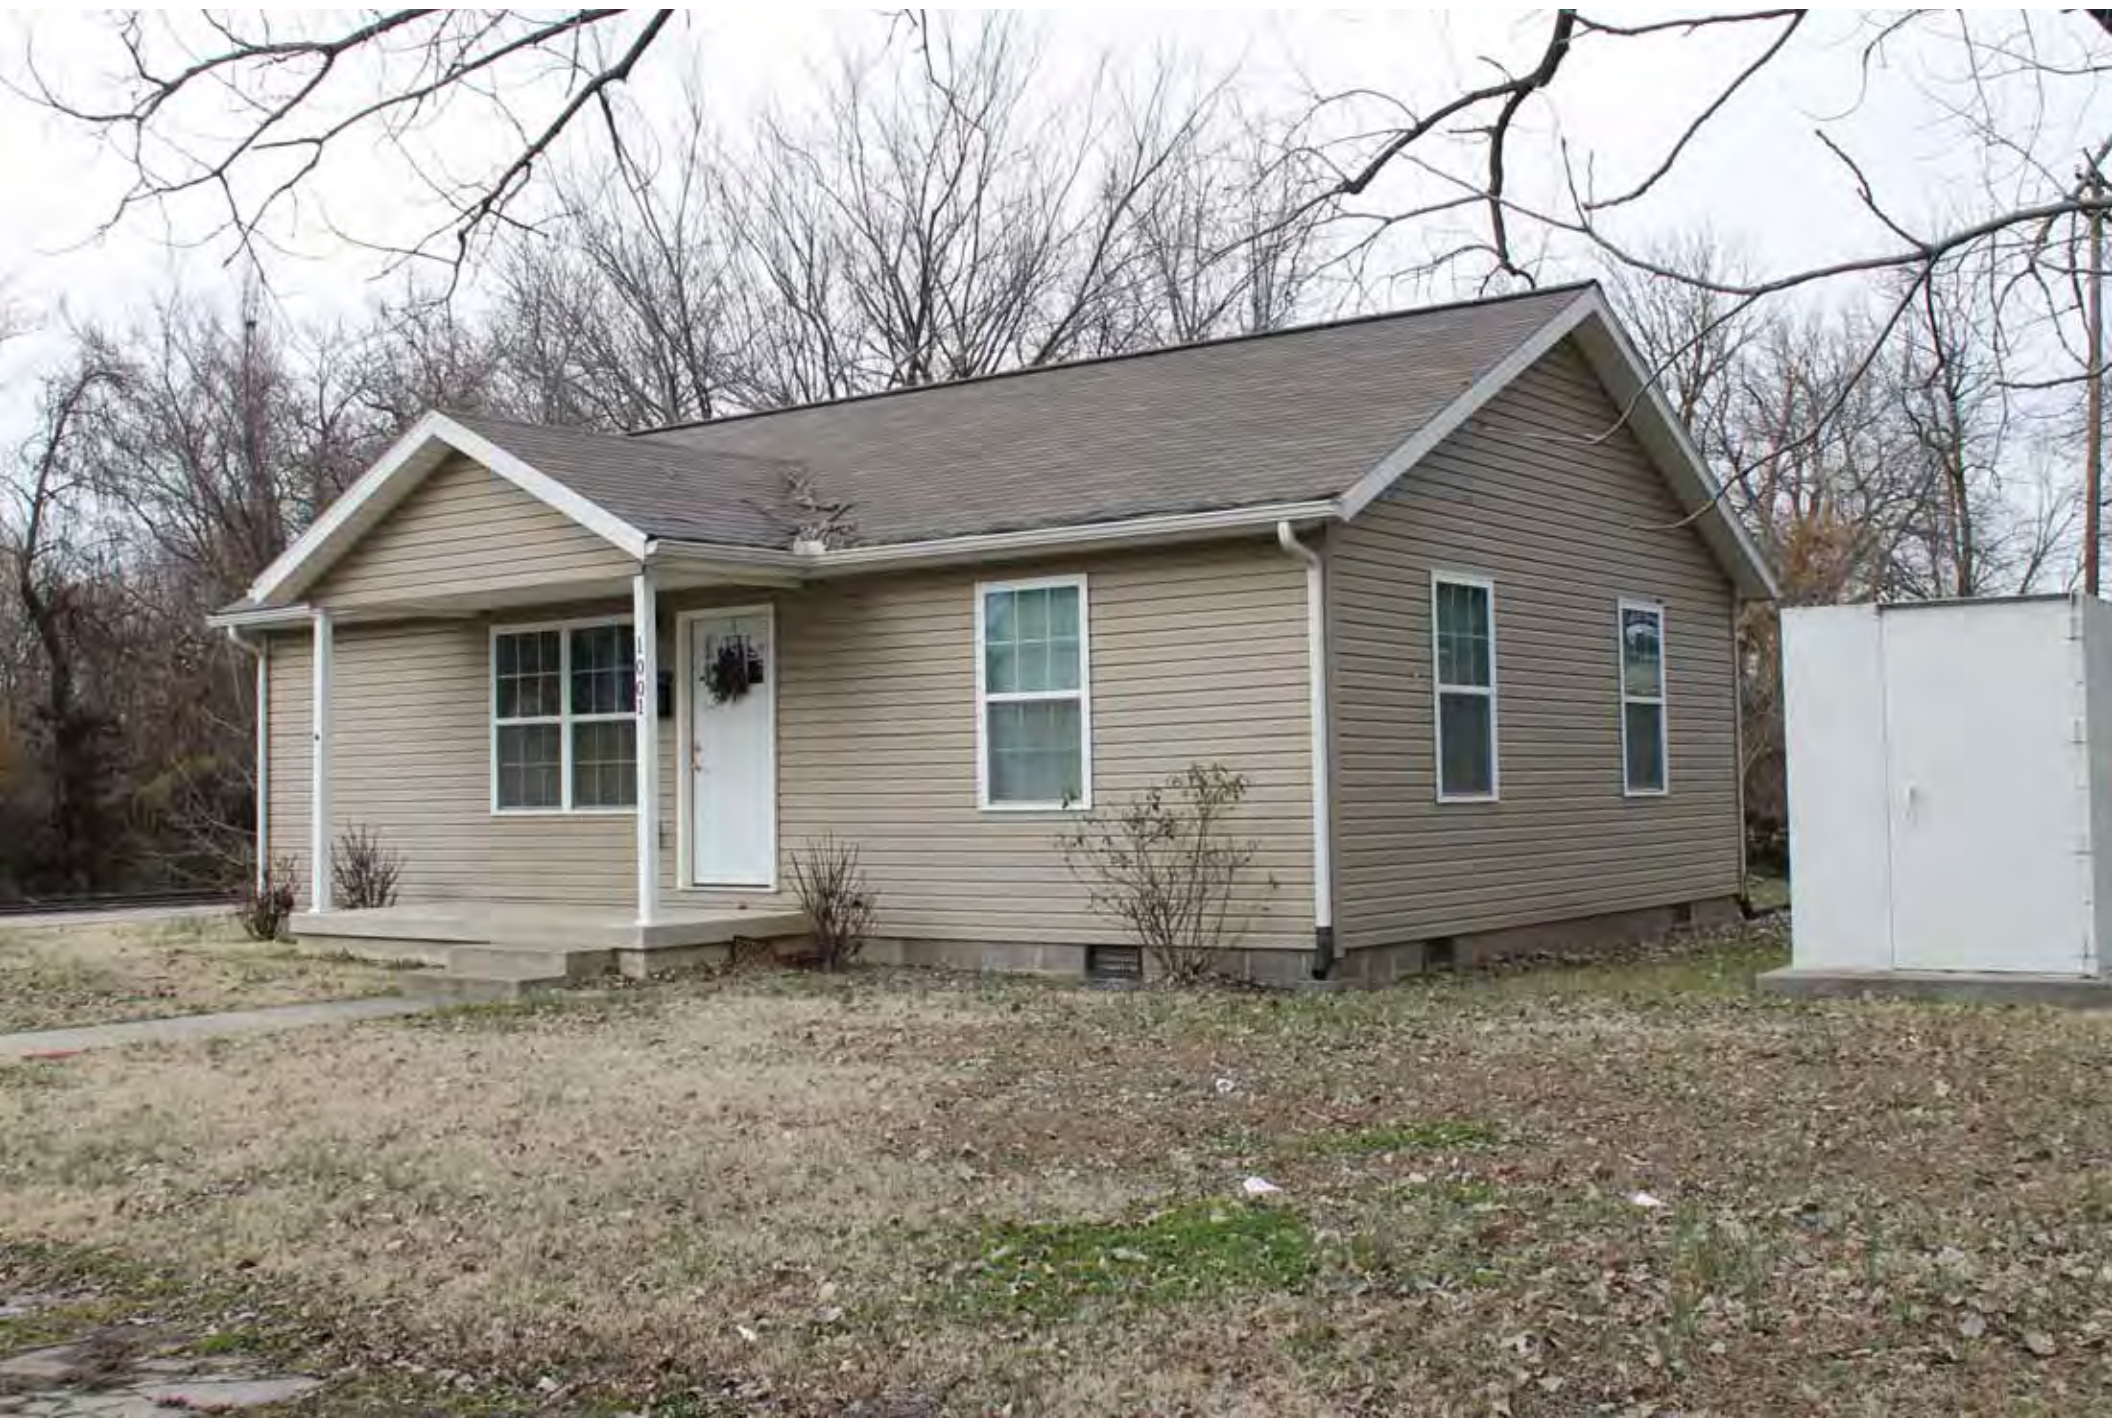
The property at 1001 E. 2nd Street is a one-story frame house. It has a side-gabled roof covered in asphalt shingles. In the middle of the front or south elevation, is a front-facing gable roofed porch with a concrete foundation. It shelters the front door and double vinyl windows. To the right of the porch is a single one-over-one vinyl window. On the west elevation of the house is a small open wooden porch leading to a side entrance of the house. The entire house is covered in vinyl siding. There are two vinyl windows on each of the side elevations.

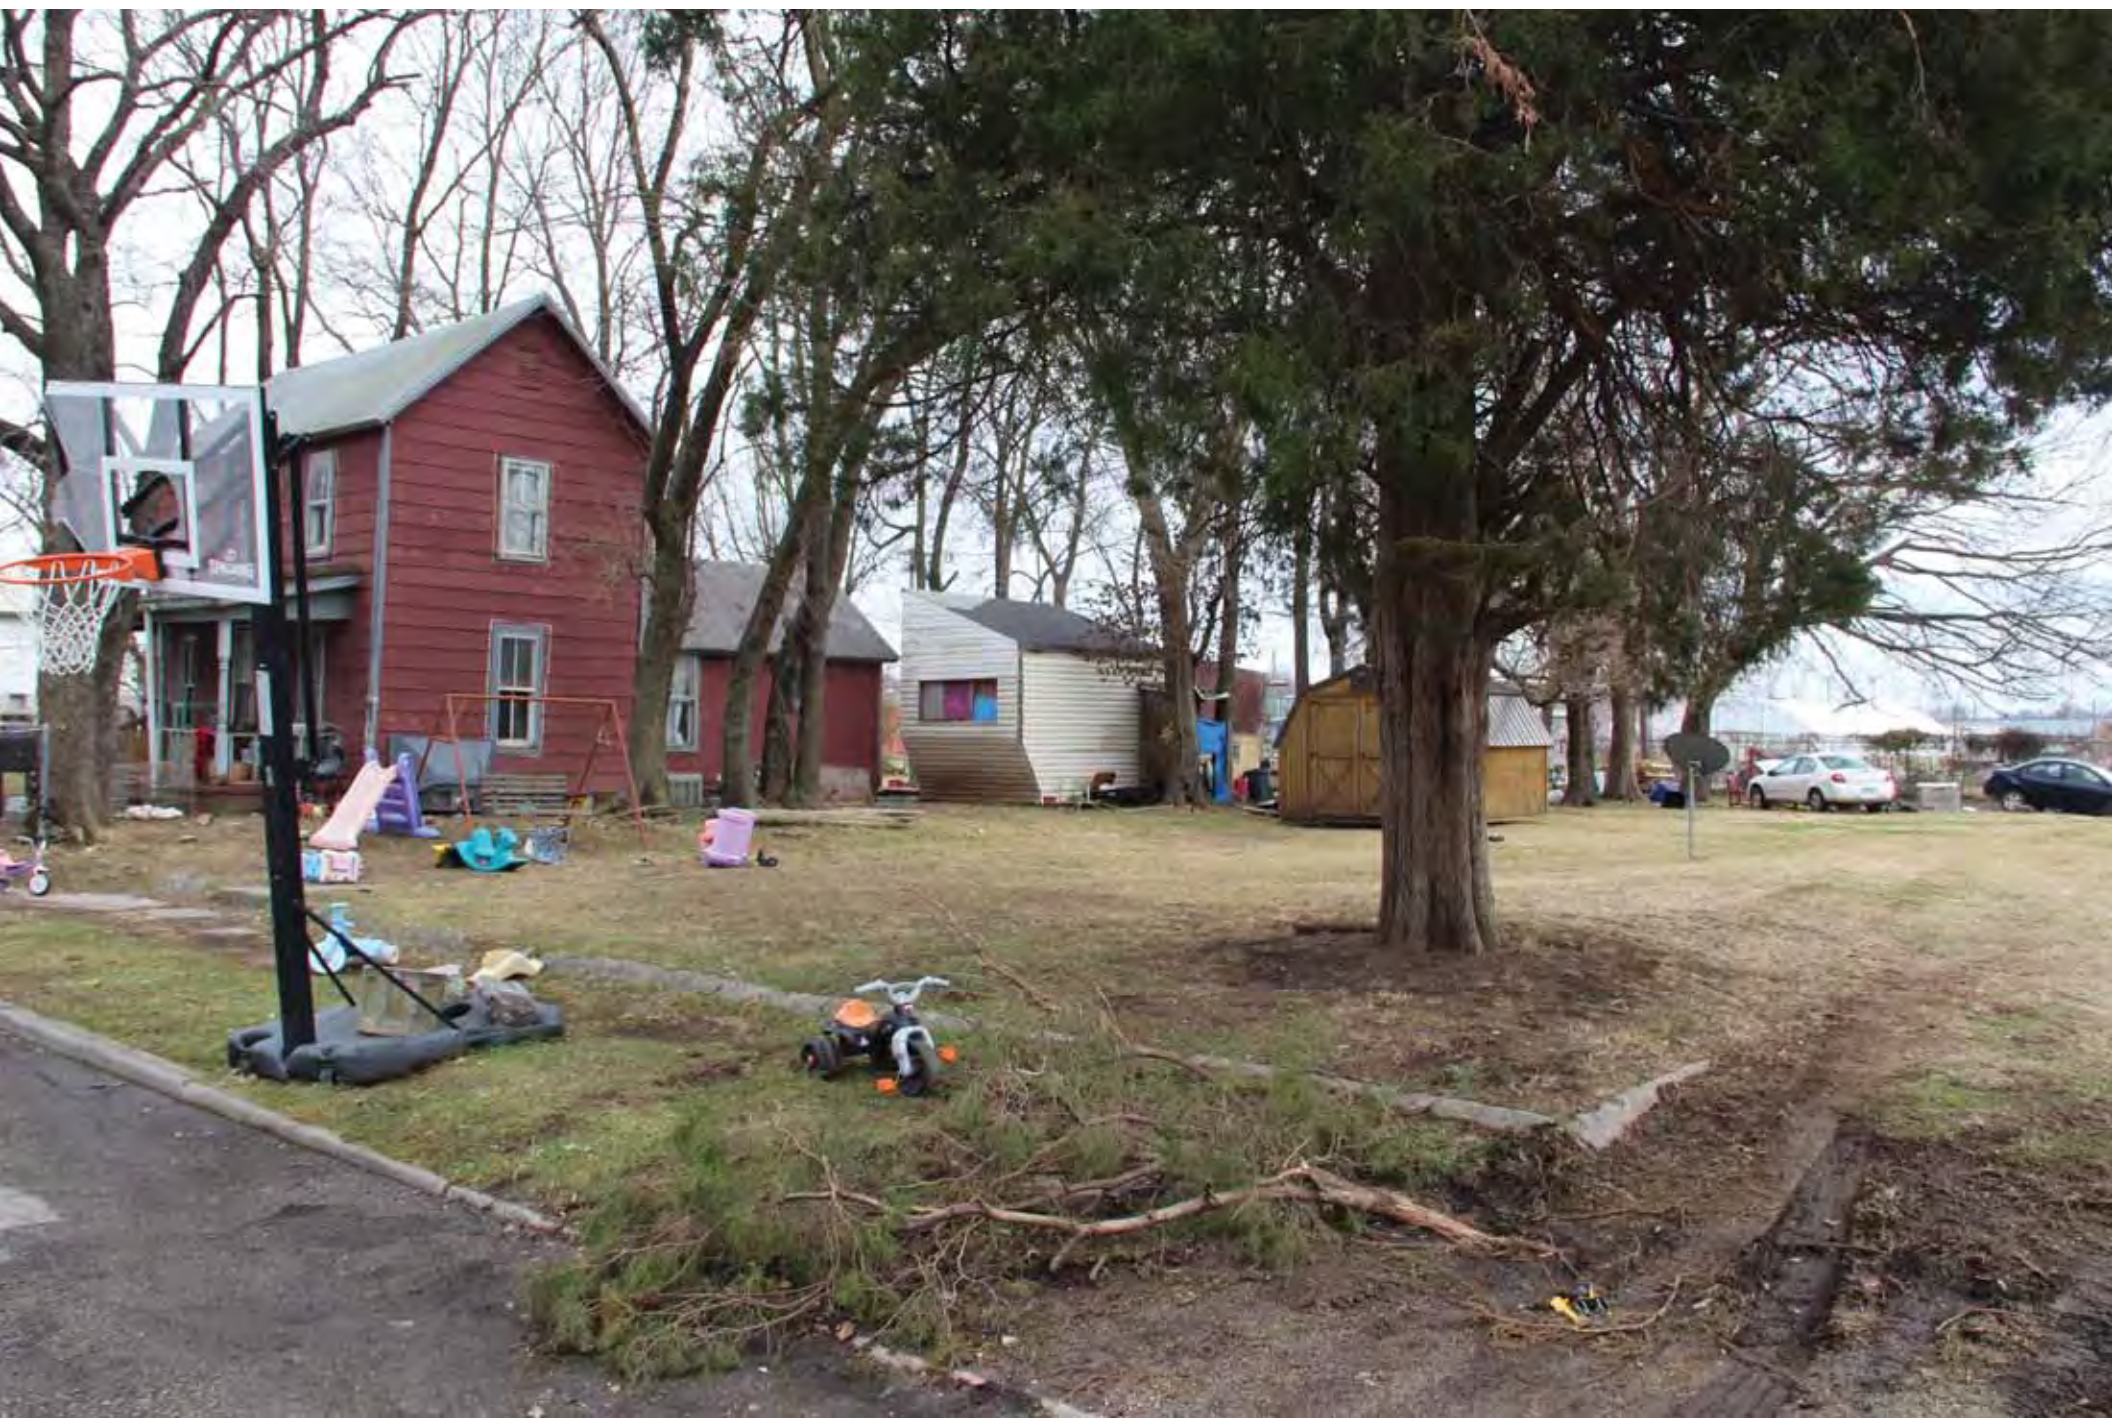
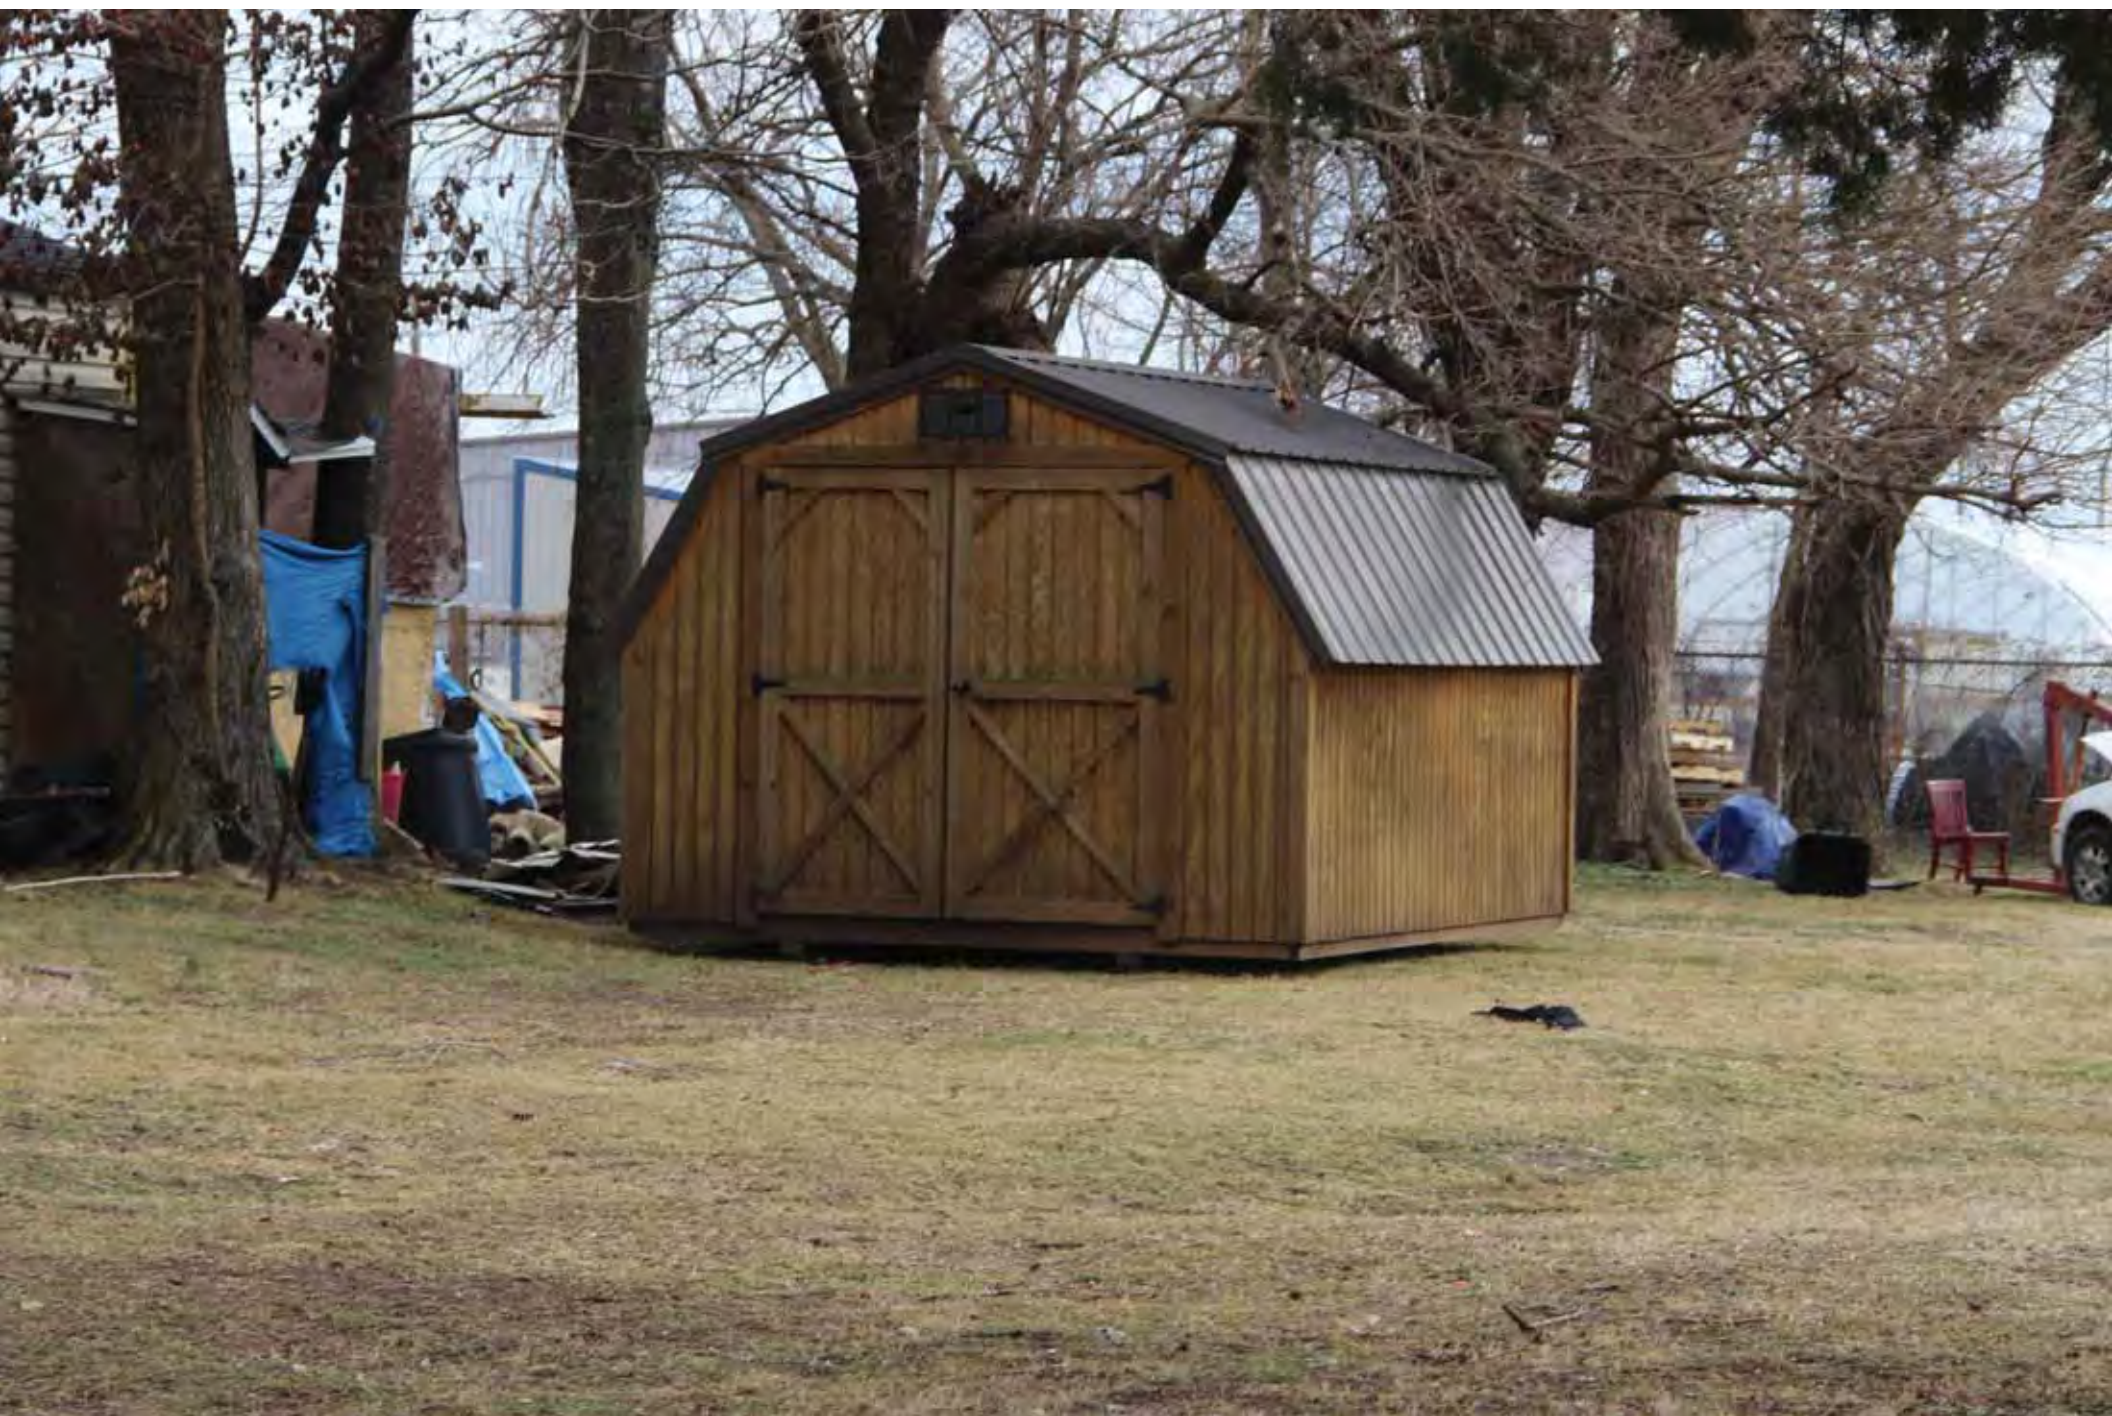
This property is a vacant lot covered in grass.
