MISSOURI DEPARTMENT OF NATURAL RESOURCES
STATE HISTORIC PRESERVATION OFFICE, P.O. Box 176, Jefferson City, MO 65102
ARCHITECTURAL/HISTORIC INVENTORY FORM

1. Survey No. JP-AS-007-001		2. Survey name: East Town (Original Joplin) Historic Survey Phase 2	
3. County: JASPER		4. Address (Street No.) 618	Street (name) E. 2 nd Street
5. City: Joplin	Vicinity: <input type="checkbox"/>	6. Geographical Reference:	7. Township/Range/Section: T: R: S:
8. Historic name (if known):		9. Present/other name (if known):	
10. Ownership: <input checked="" type="checkbox"/> Private <input type="checkbox"/> Public		11a. Historic use (if known): Domestic: Single Dwelling	11b. Current use: Domestic: Single Dwelling

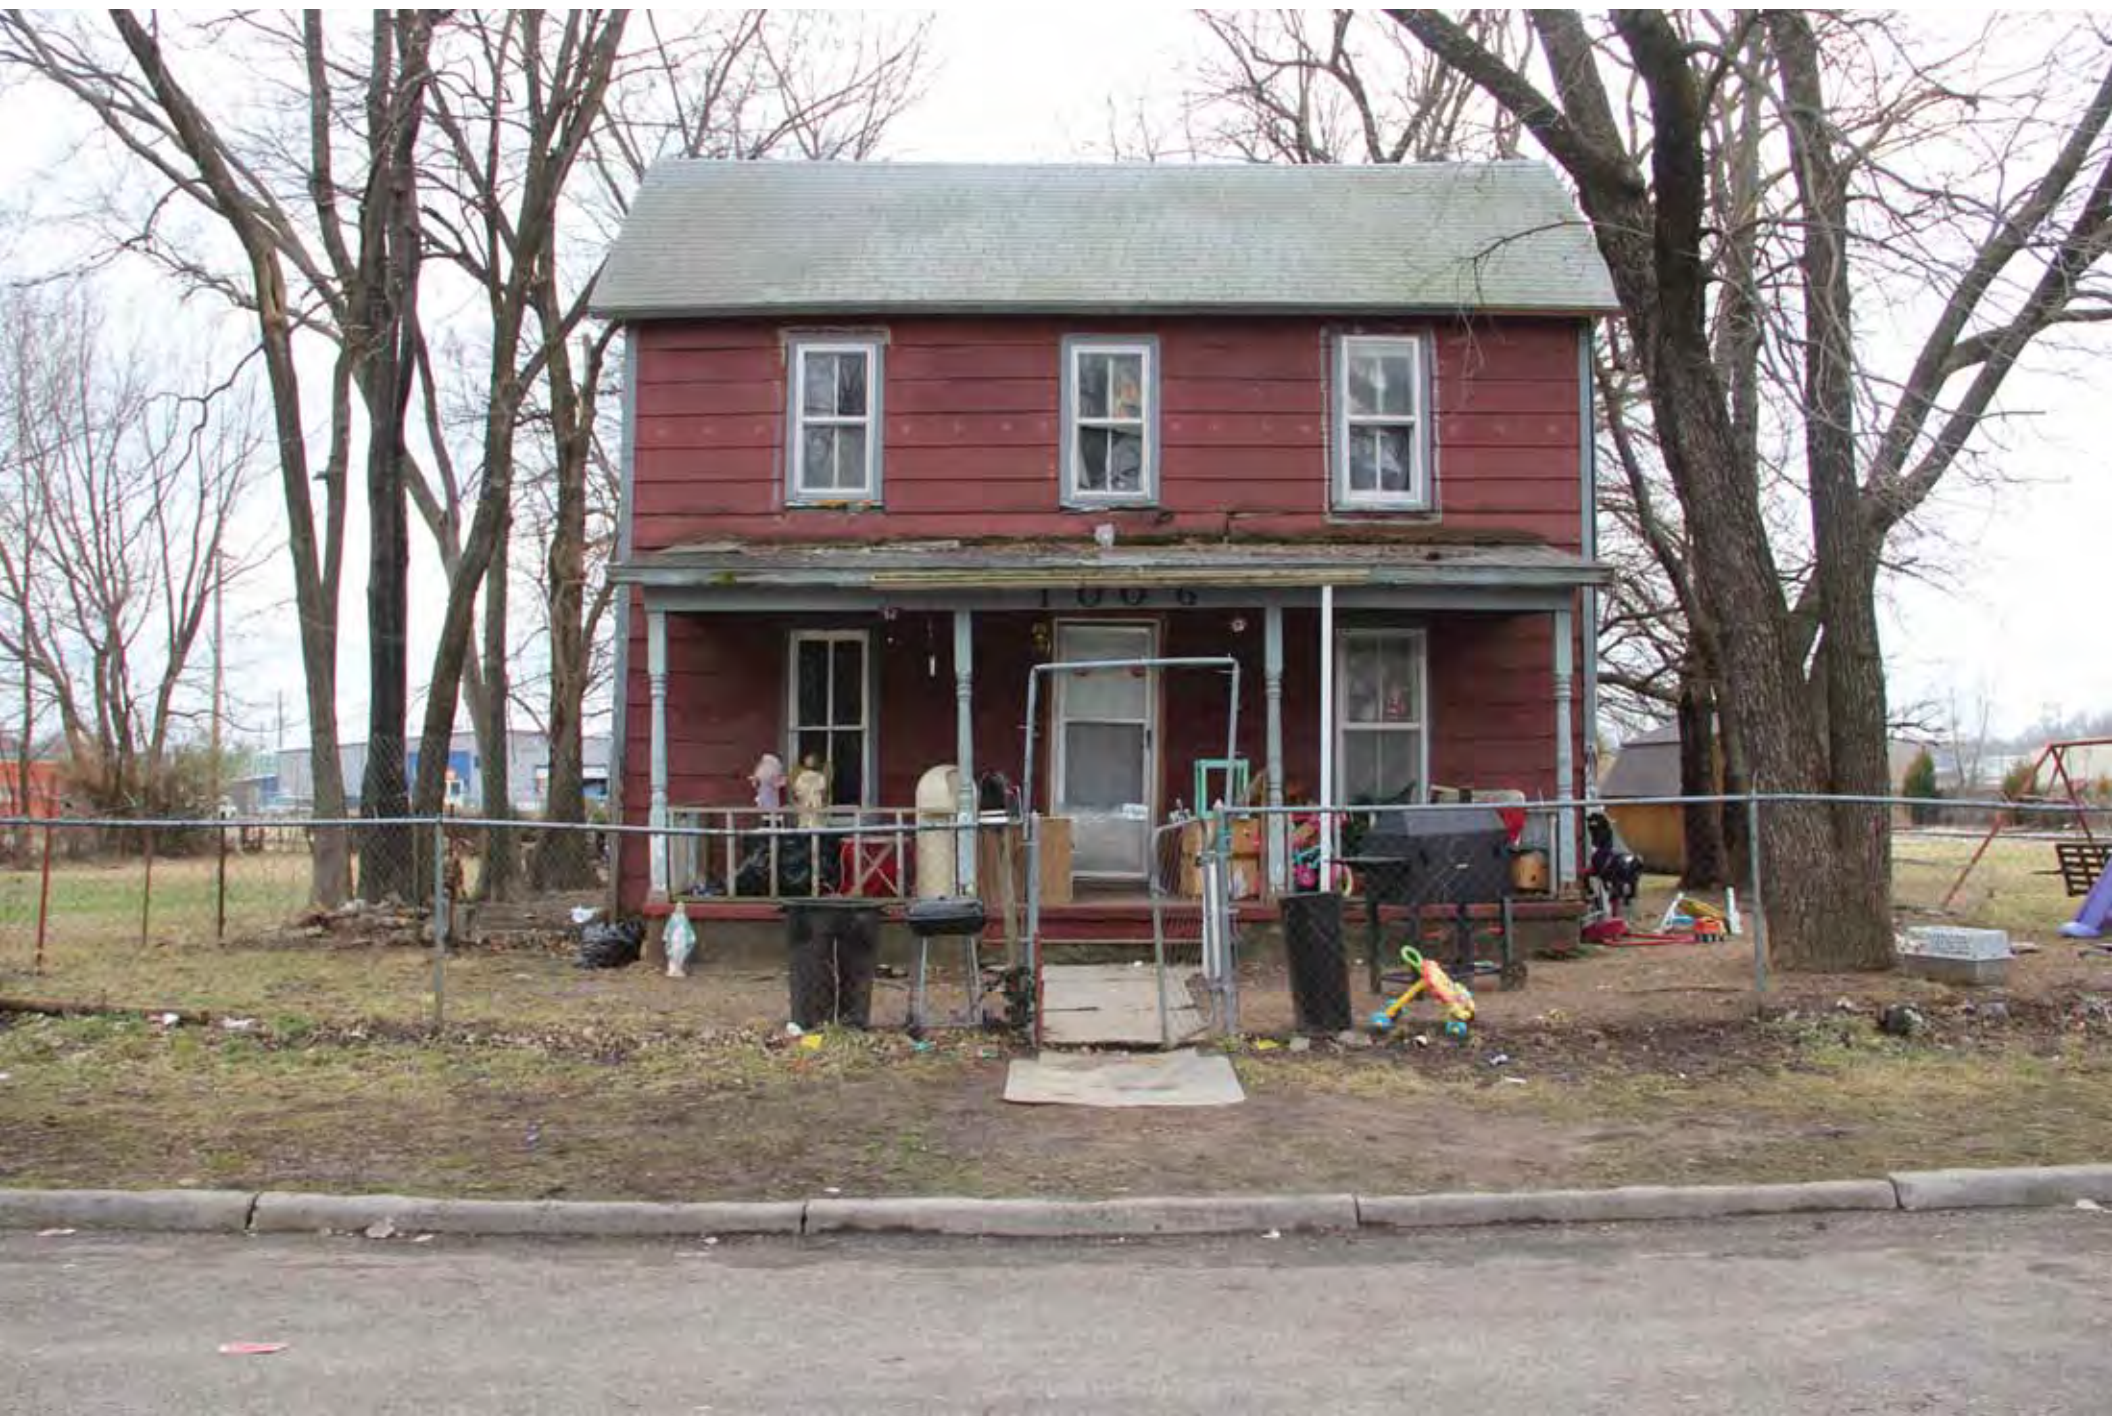
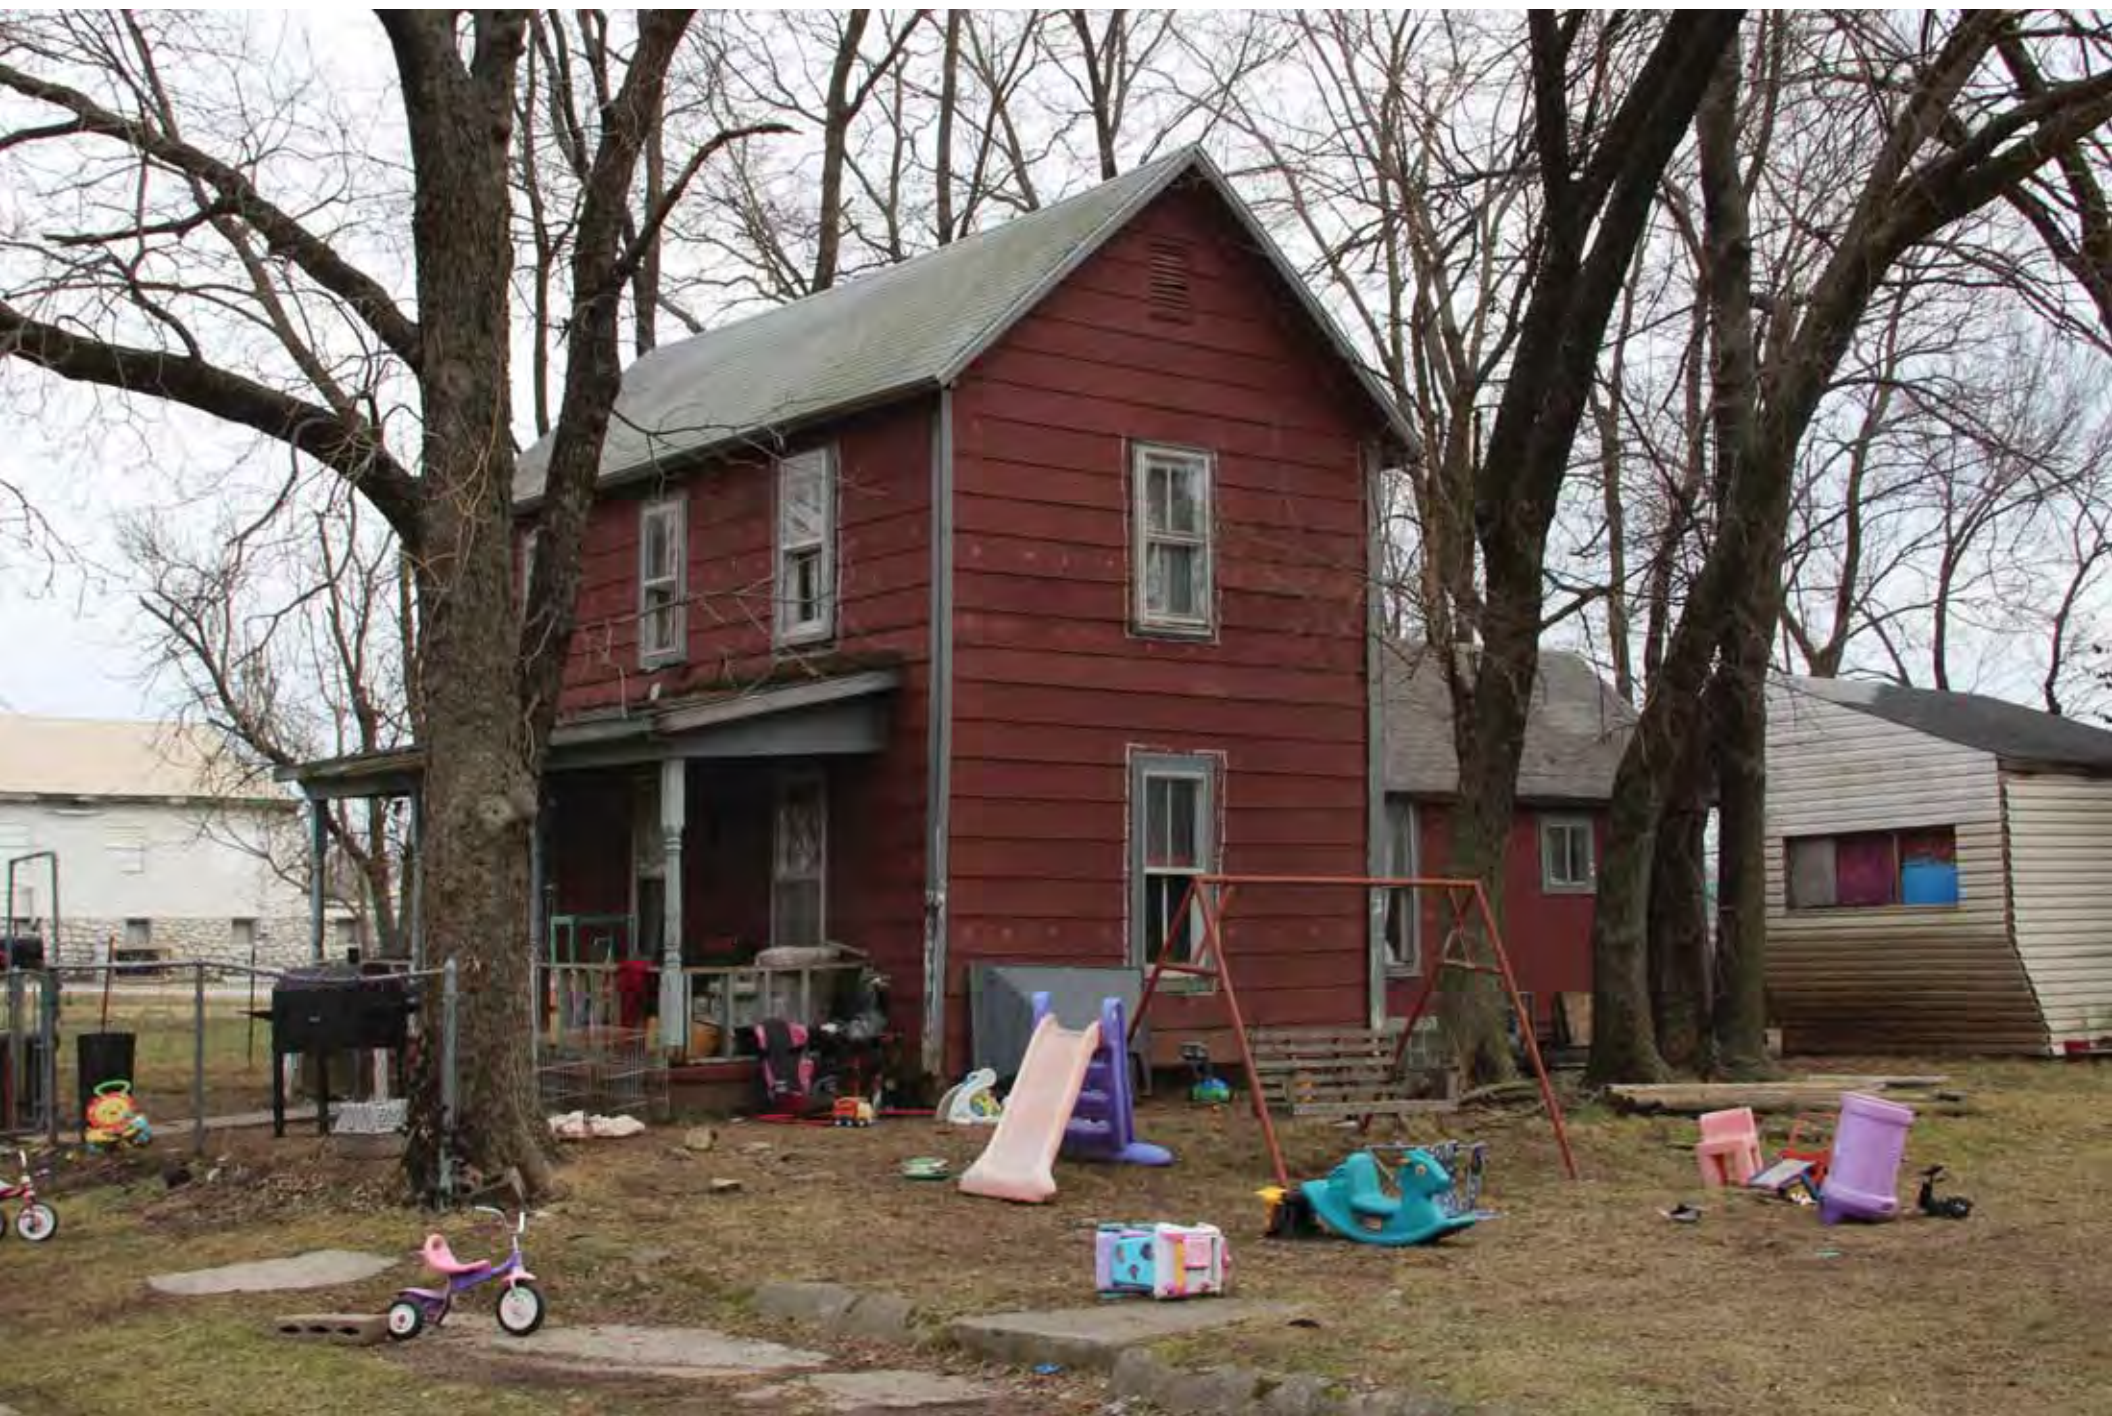
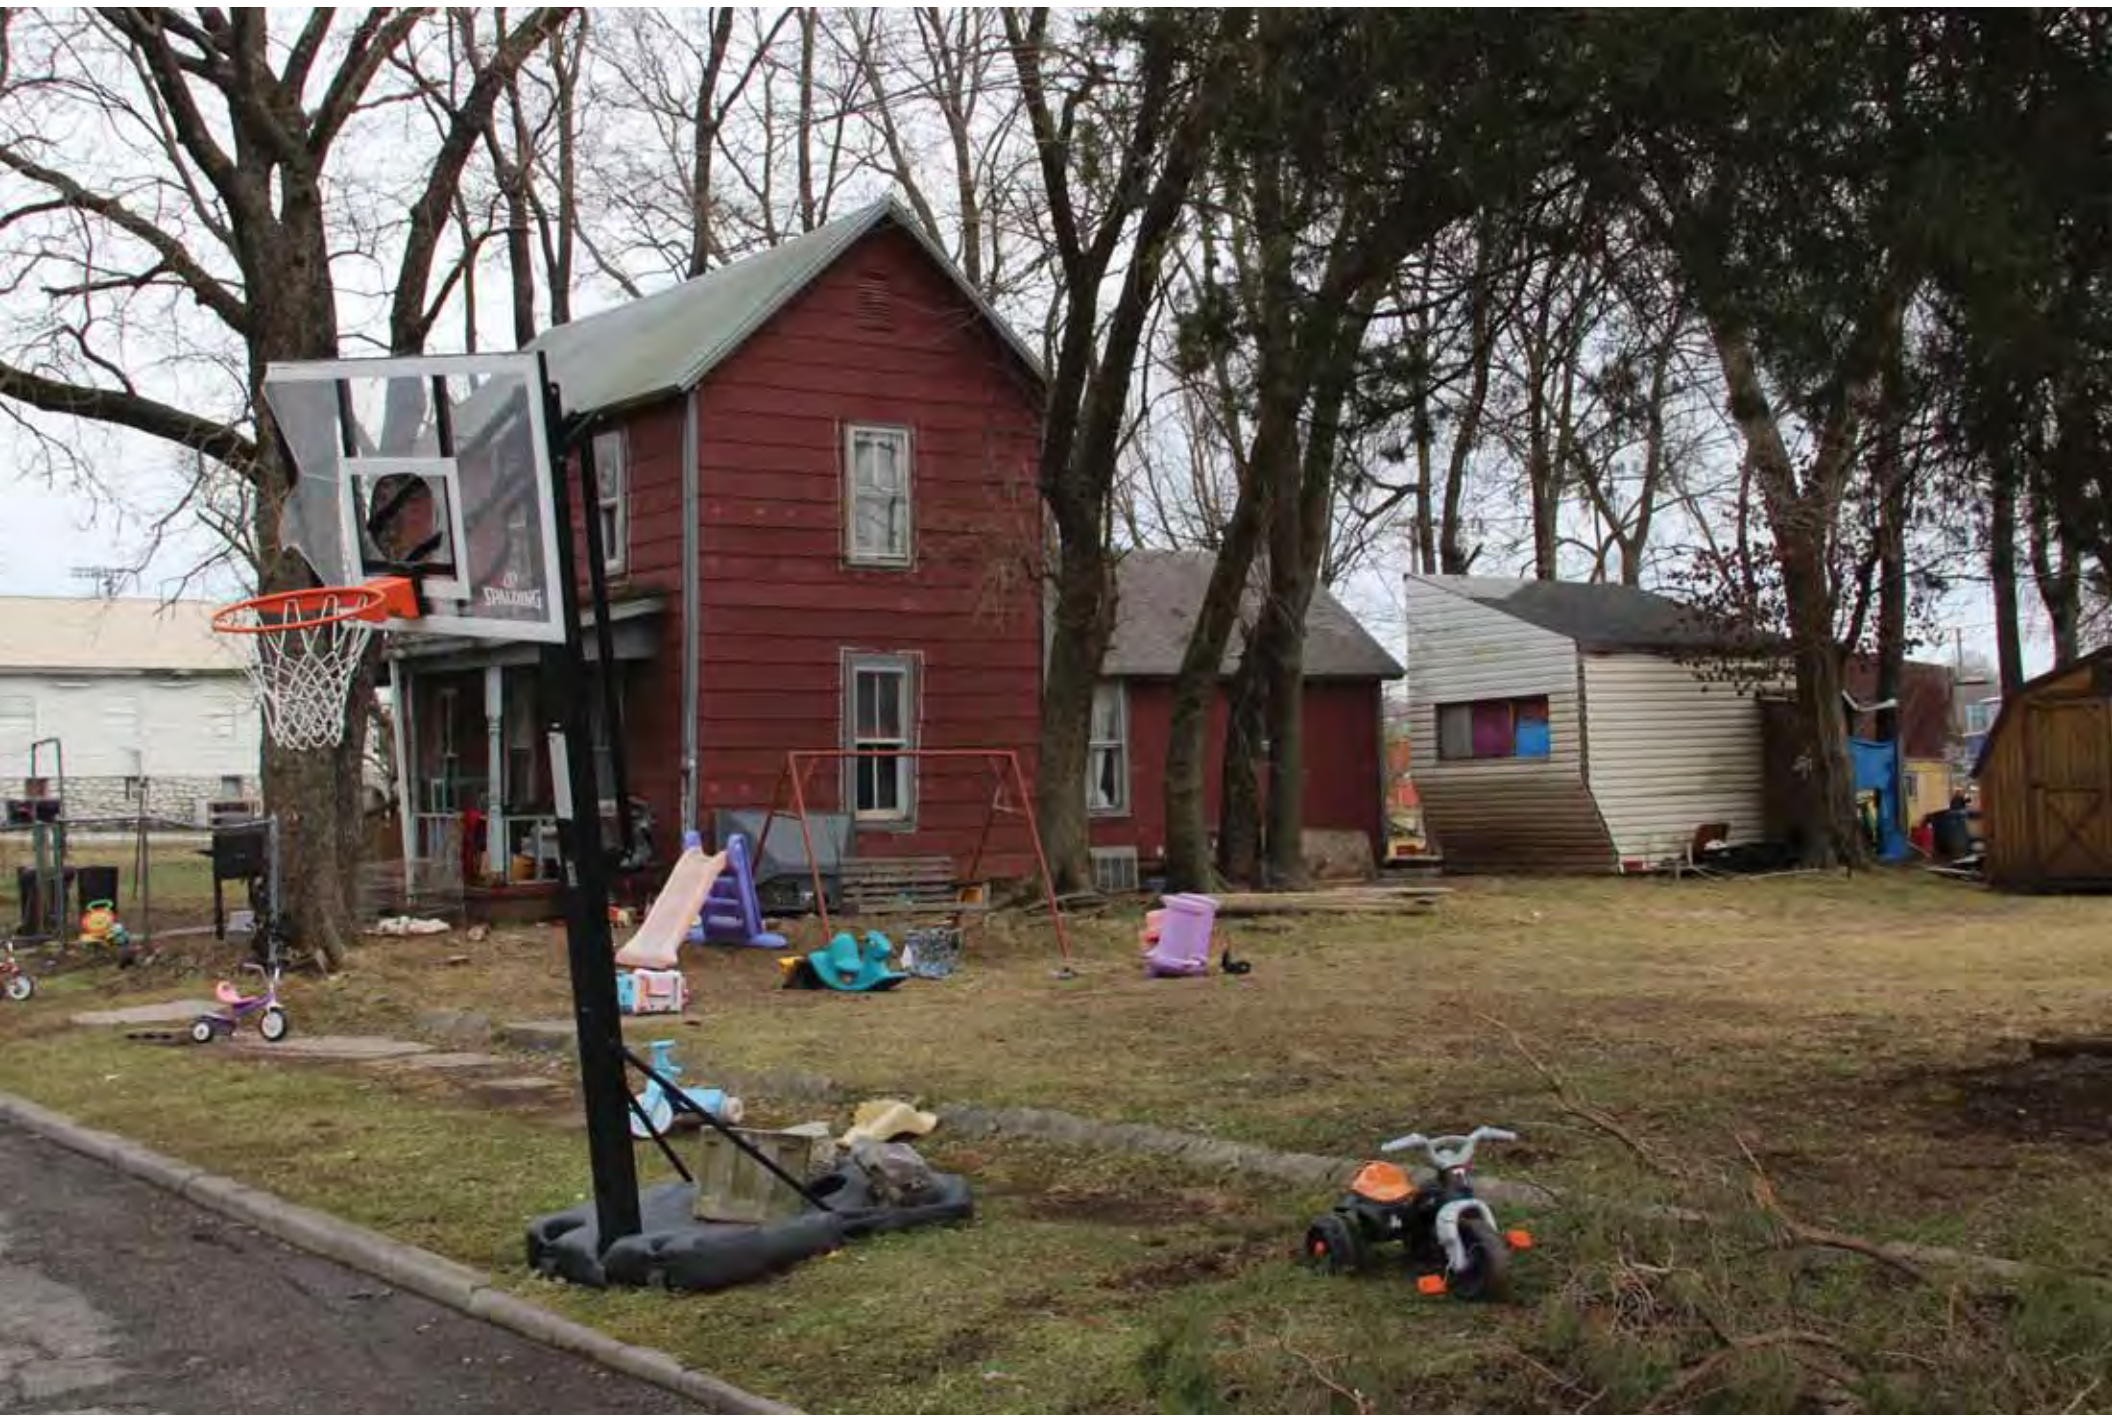
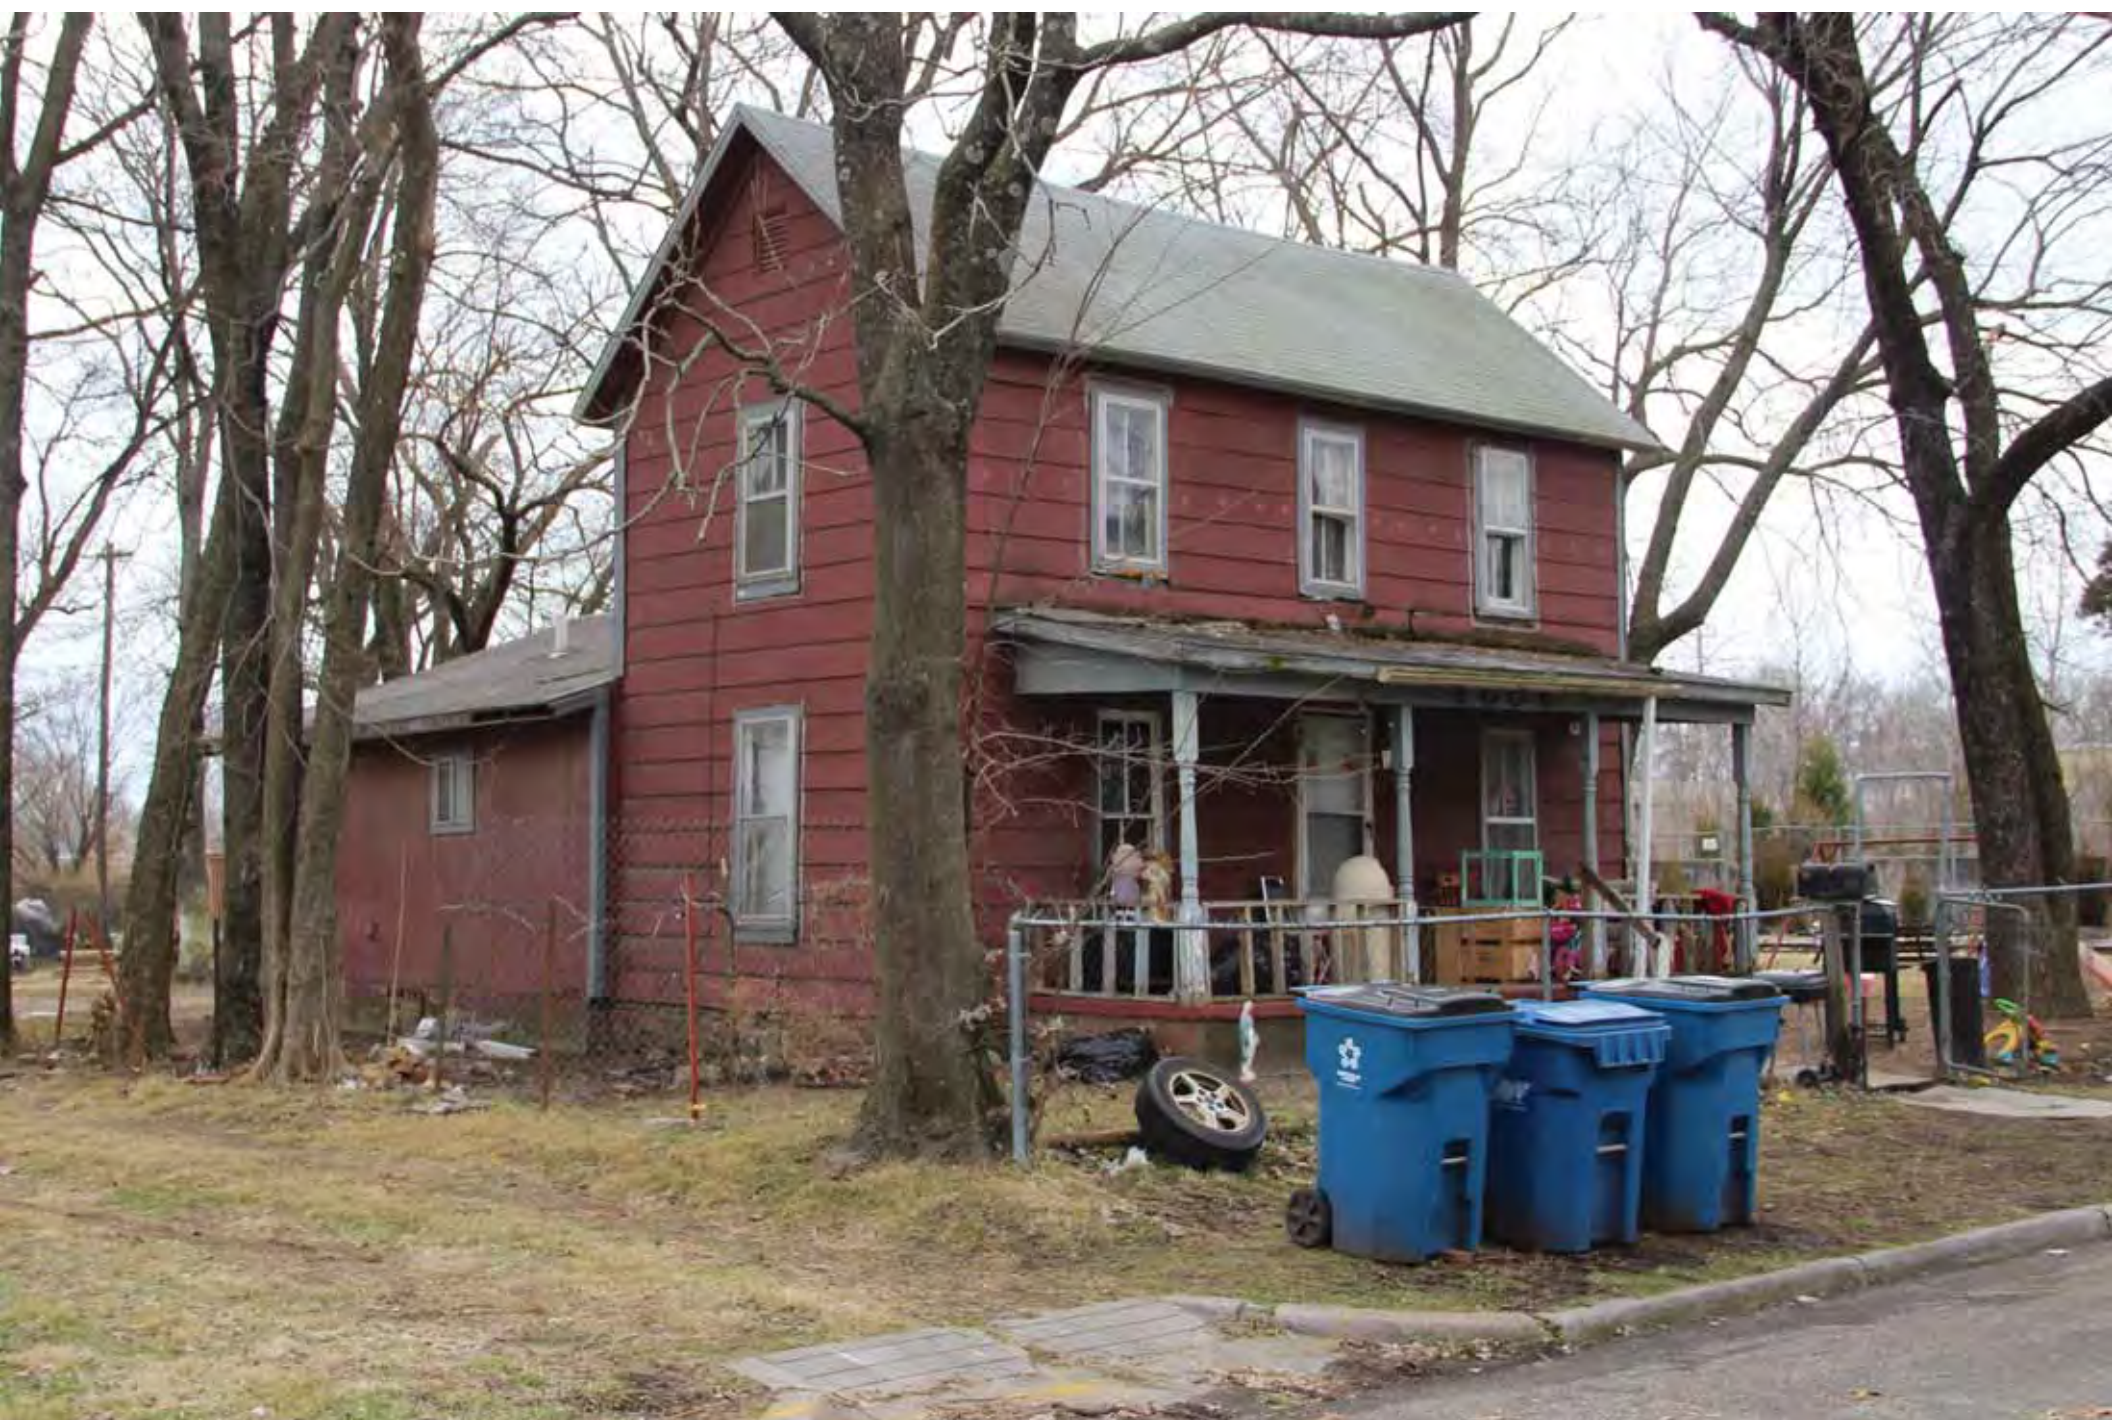
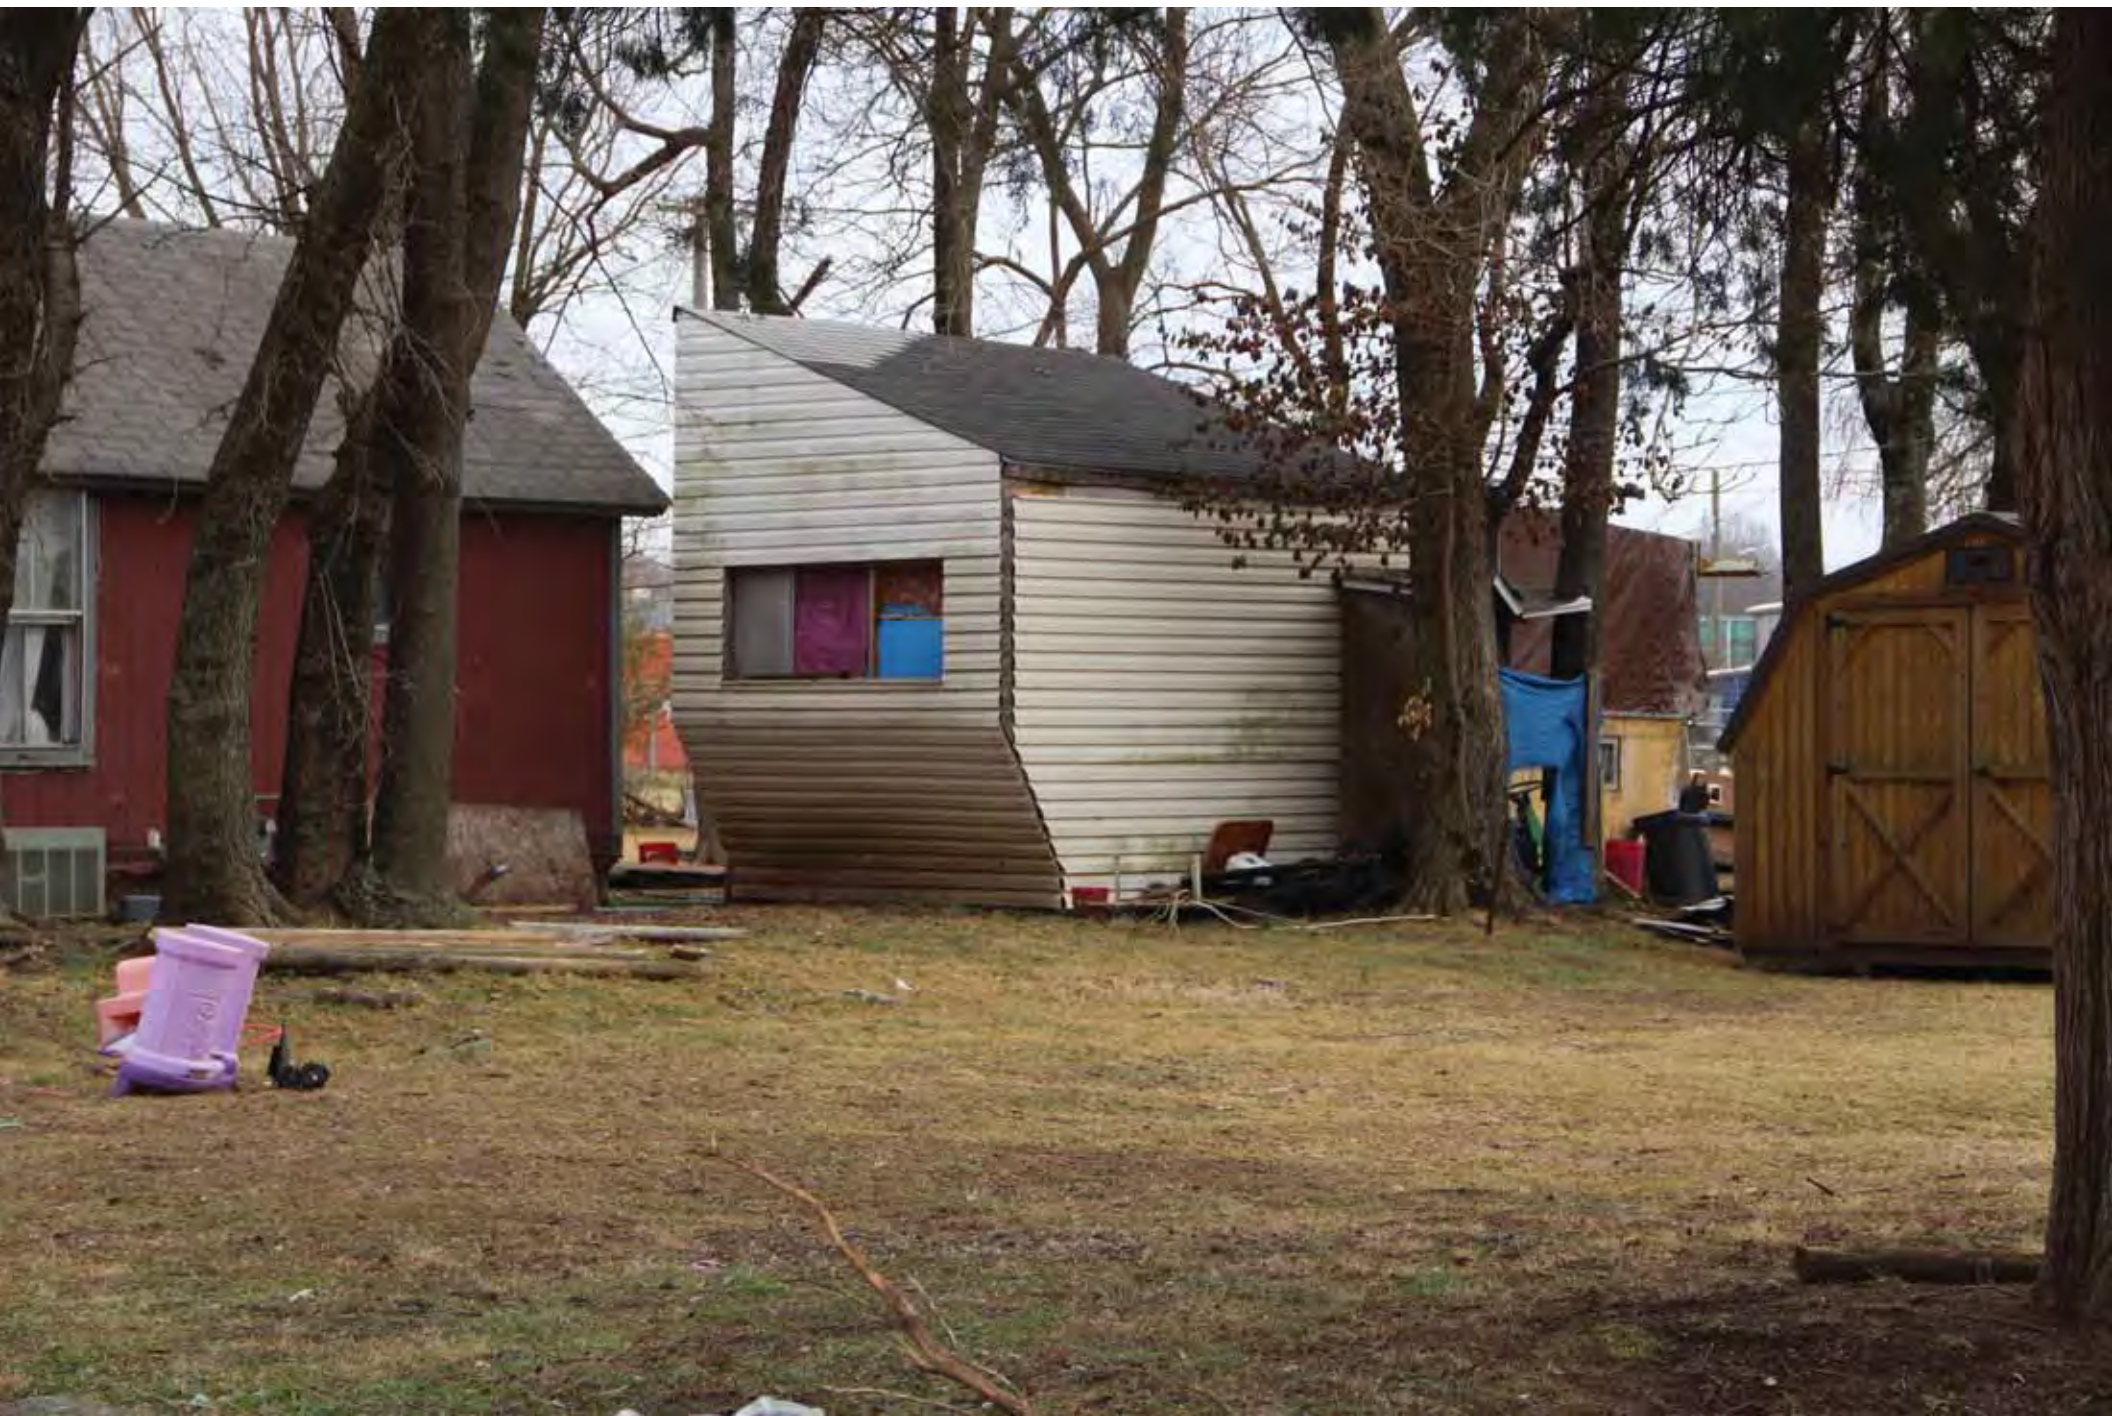
<p>21. (cont.) History and significance. Expand box as necessary, or add continuation pages.</p> <p>The dwelling at 1006 E. 2nd Street was built c. 1880 according to the Jasper County GIS records. It is located on the south side of E. 2nd Street.</p> <p>The house appears on the 1939 Sanborn maps. It does not show up in the 1921 City Directory. In the 1931 and 1941 City Directories it was occupied by Charles J. Emmerich.</p> <p>The dwelling does not retain enough integrity to be individually eligible for the National Register of Historic Places. The dwelling is not situated in an area recommended as a historic district.</p>
<p>22. (cont.) Sources of information. Expand box as necessary, or add continuation pages.</p> <p>Jasper County GIS (Beacon) Database (https://beacon.schneidercorp.com/), Access date: 3 April 2020. Leshnick's Joplin City Directory, 1921. Polk's Joplin City Directories, 1931 and 1941. Sanborn Fire Insurance Maps, Joplin (Jasper County), 1906; Updated 1939; Sheet 64.</p>

<p>40. (cont.) Description of environment and outbuildings. Expand box as necessary, or add continuation pages.</p> <p>The building and its associated garage are both on the south side of E. 2nd Street. There is a concrete walkway leading to the front door of the house. There is a chain link fence in front of the house.</p> <p>To the east of the house is a modern shed. It technically sits on the grass lot at 1002 E. 2nd Street. The outbuilding is not individually eligible for listing on the National Register.</p>
<p>41. (cont.) Description of primary resource. Expand box as necessary, or add continuation pages.</p> <p>The property at 1006 E. 2nd Street is a two-story frame house. The house has a side gable roof covered in asphalt shingles. The front elevation of the house is symmetrical. It has a central entrance door flanked on either side by two-over-two wood windows. On the second floor are three single two-over-two wood windows. A wooden front porch extends the length of the front façade. It has a shed roof supported on four turned wood posts. On the side of the house are single wood windows at both floors. At the rear of the house is a one-story addition with a gable roof.</p>

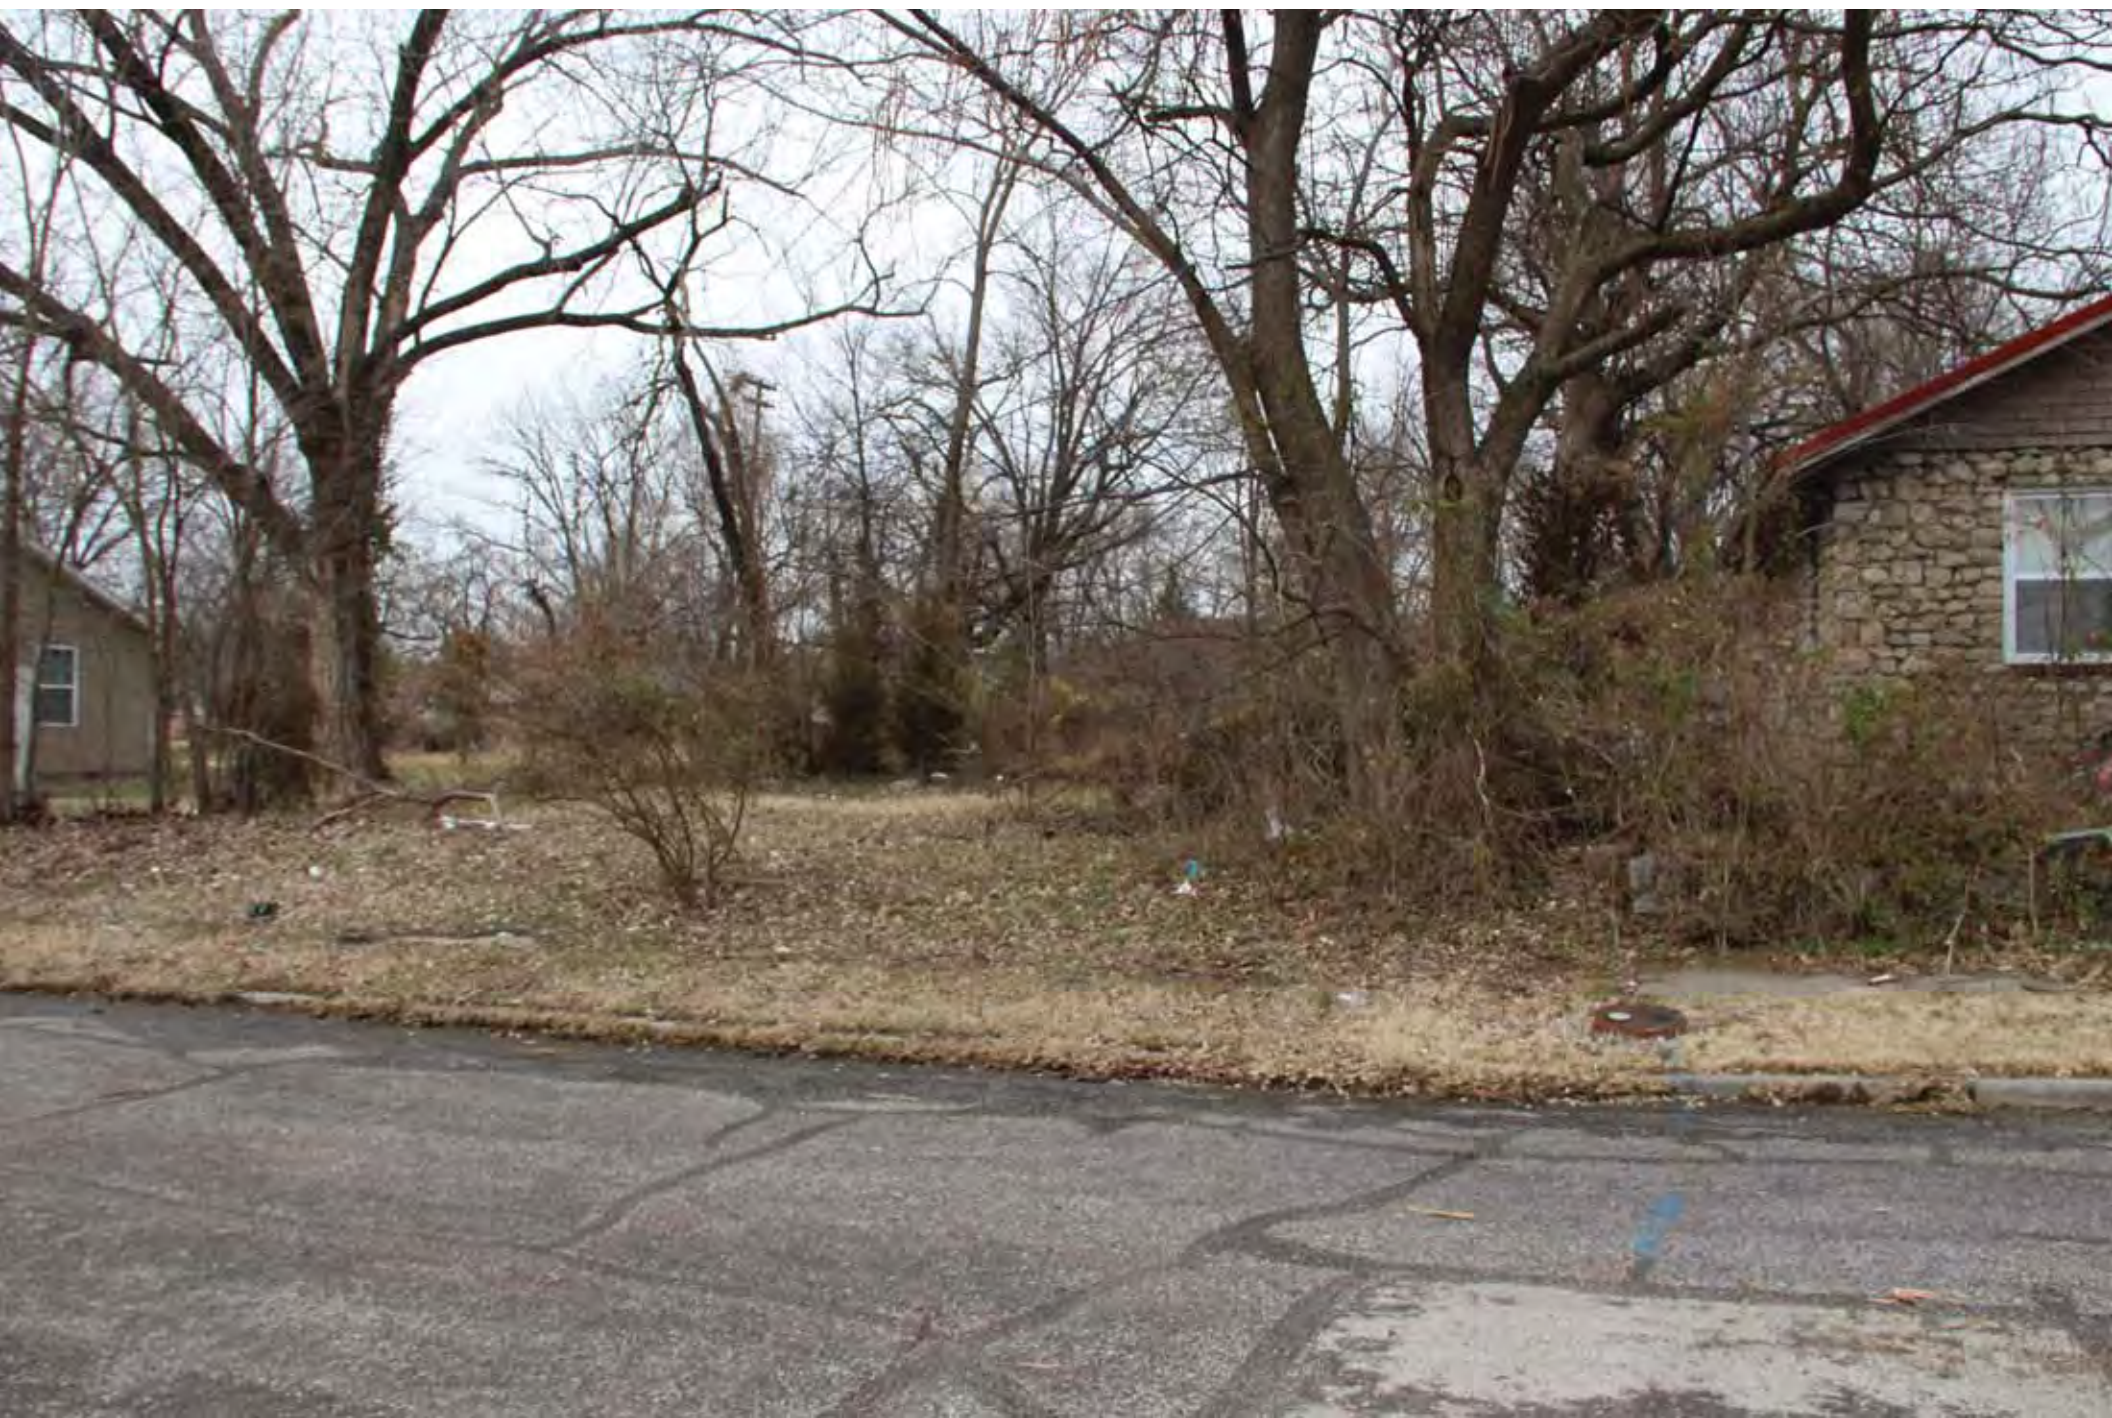
This property is a vacant lot covered in grass.
