MISSOURI DEPARTMENT OF NATURAL RESOURCES
STATE HISTORIC PRESERVATION OFFICE, P.O. Box 176, Jefferson City, MO 65102
ARCHITECTURAL/HISTORIC INVENTORY FORM

1. Survey No. JP-AS-007-001		2. Survey name: East Town (Original Joplin) Historic Survey Phase 2	
3. County: JASPER		4. Address (Street No.) 618	Street (name) E. 2 nd Street
5. City: Joplin	Vicinity: <input type="checkbox"/>	6. Geographical Reference:	7. Township/Range/Section: T: R: S:
8. Historic name (if known):		9. Present/other name (if known):	
10. Ownership: <input checked="" type="checkbox"/> Private <input type="checkbox"/> Public		11a. Historic use (if known): Domestic: Single Dwelling	11b. Current use: Domestic: Single Dwelling

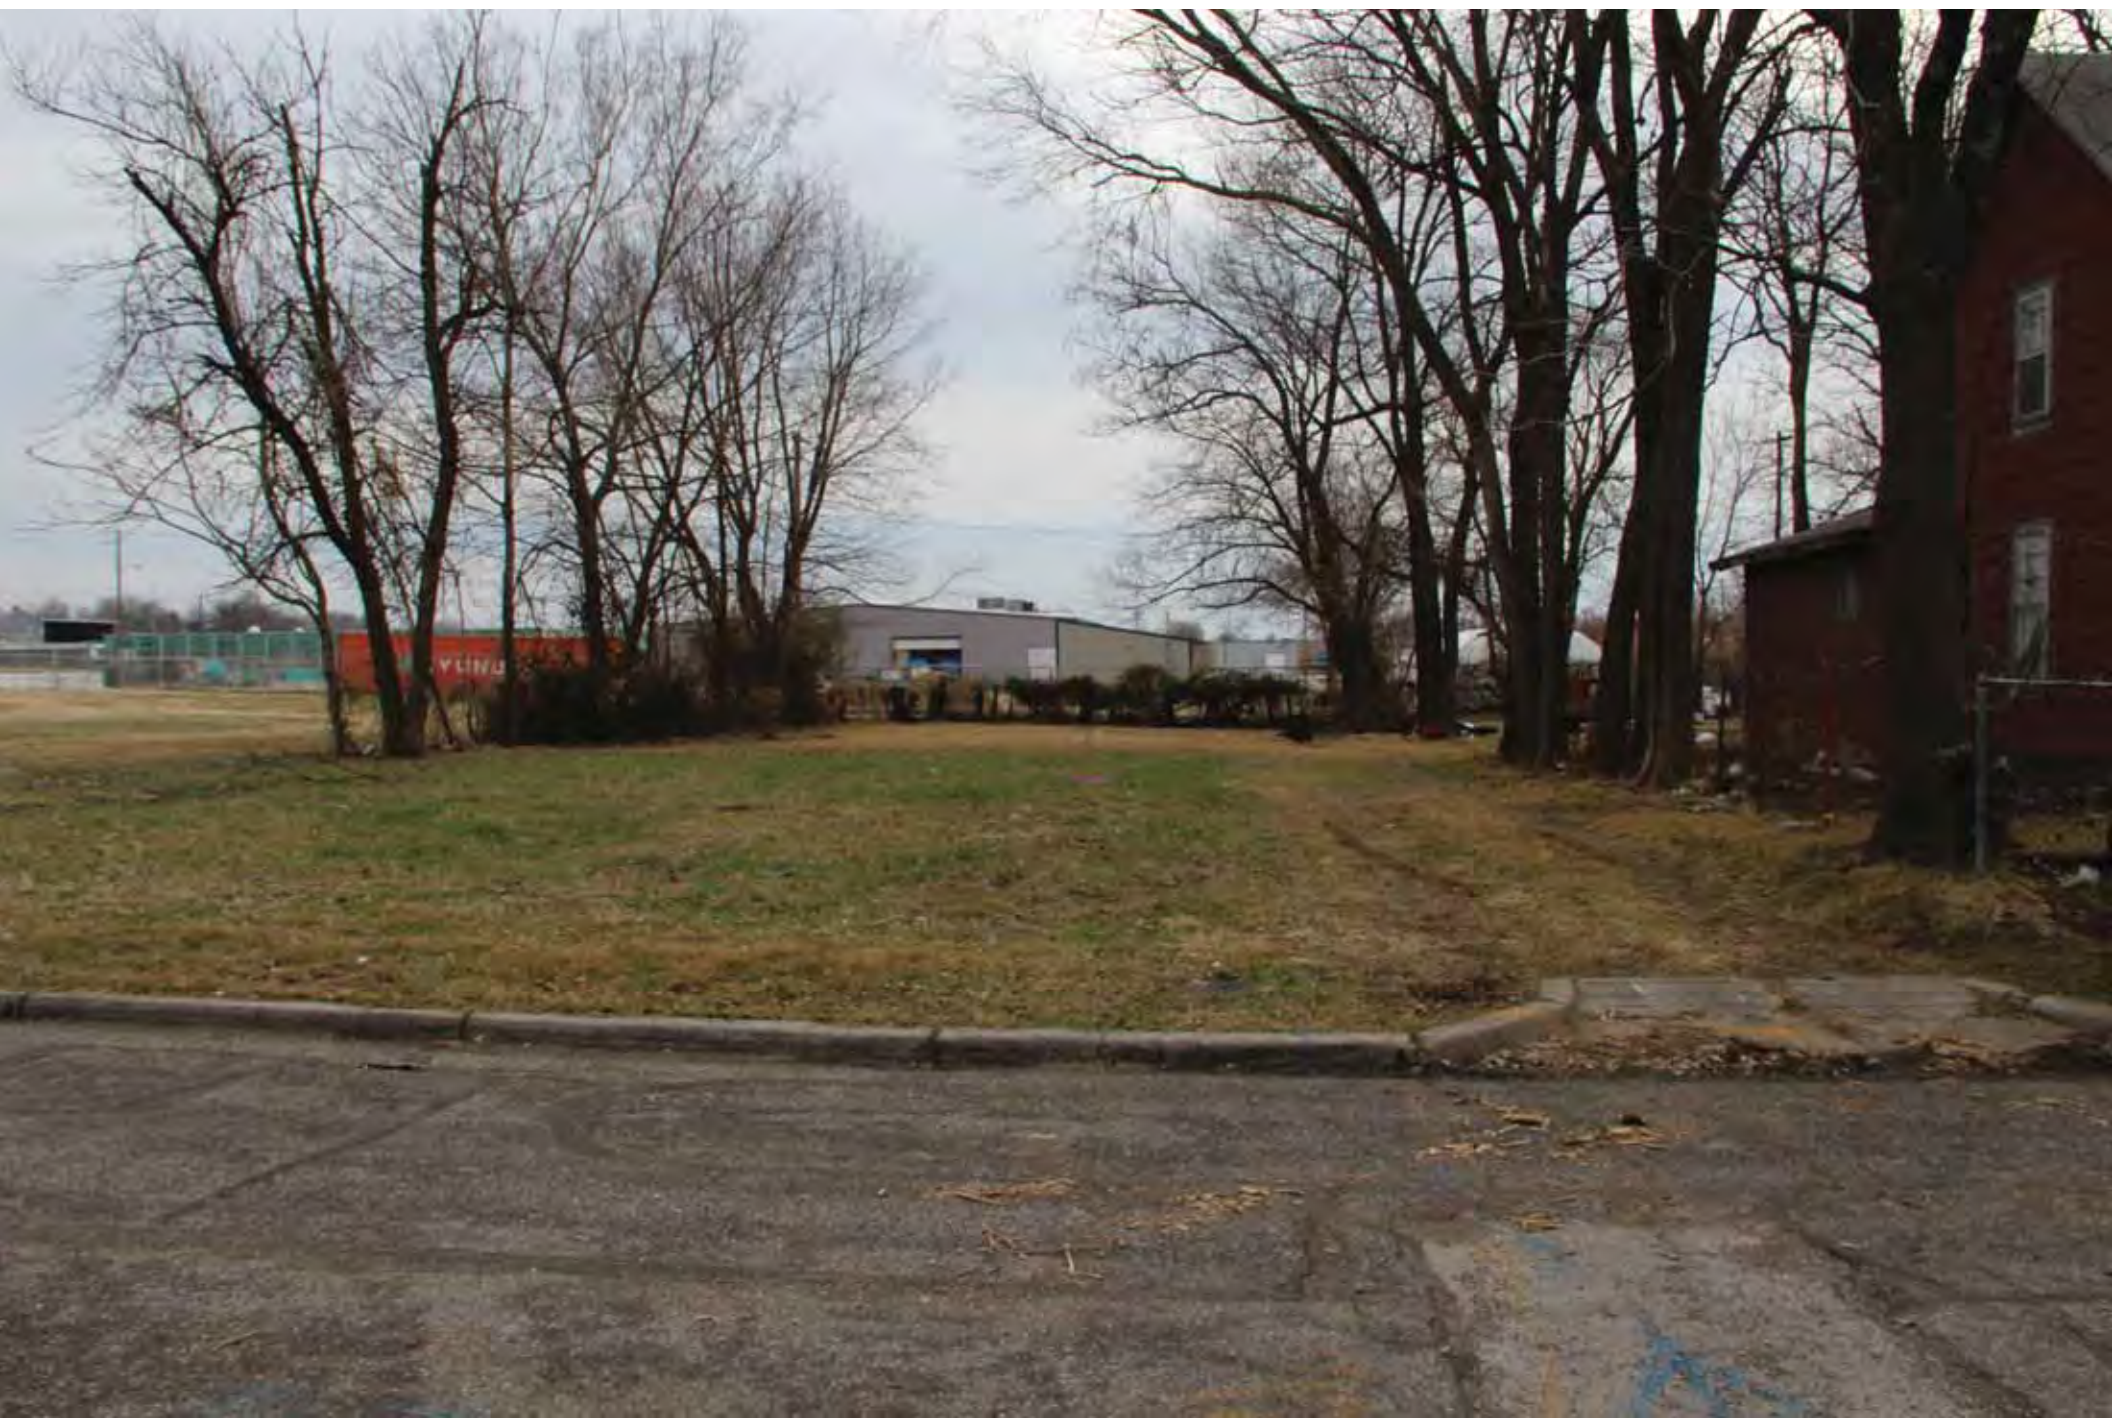
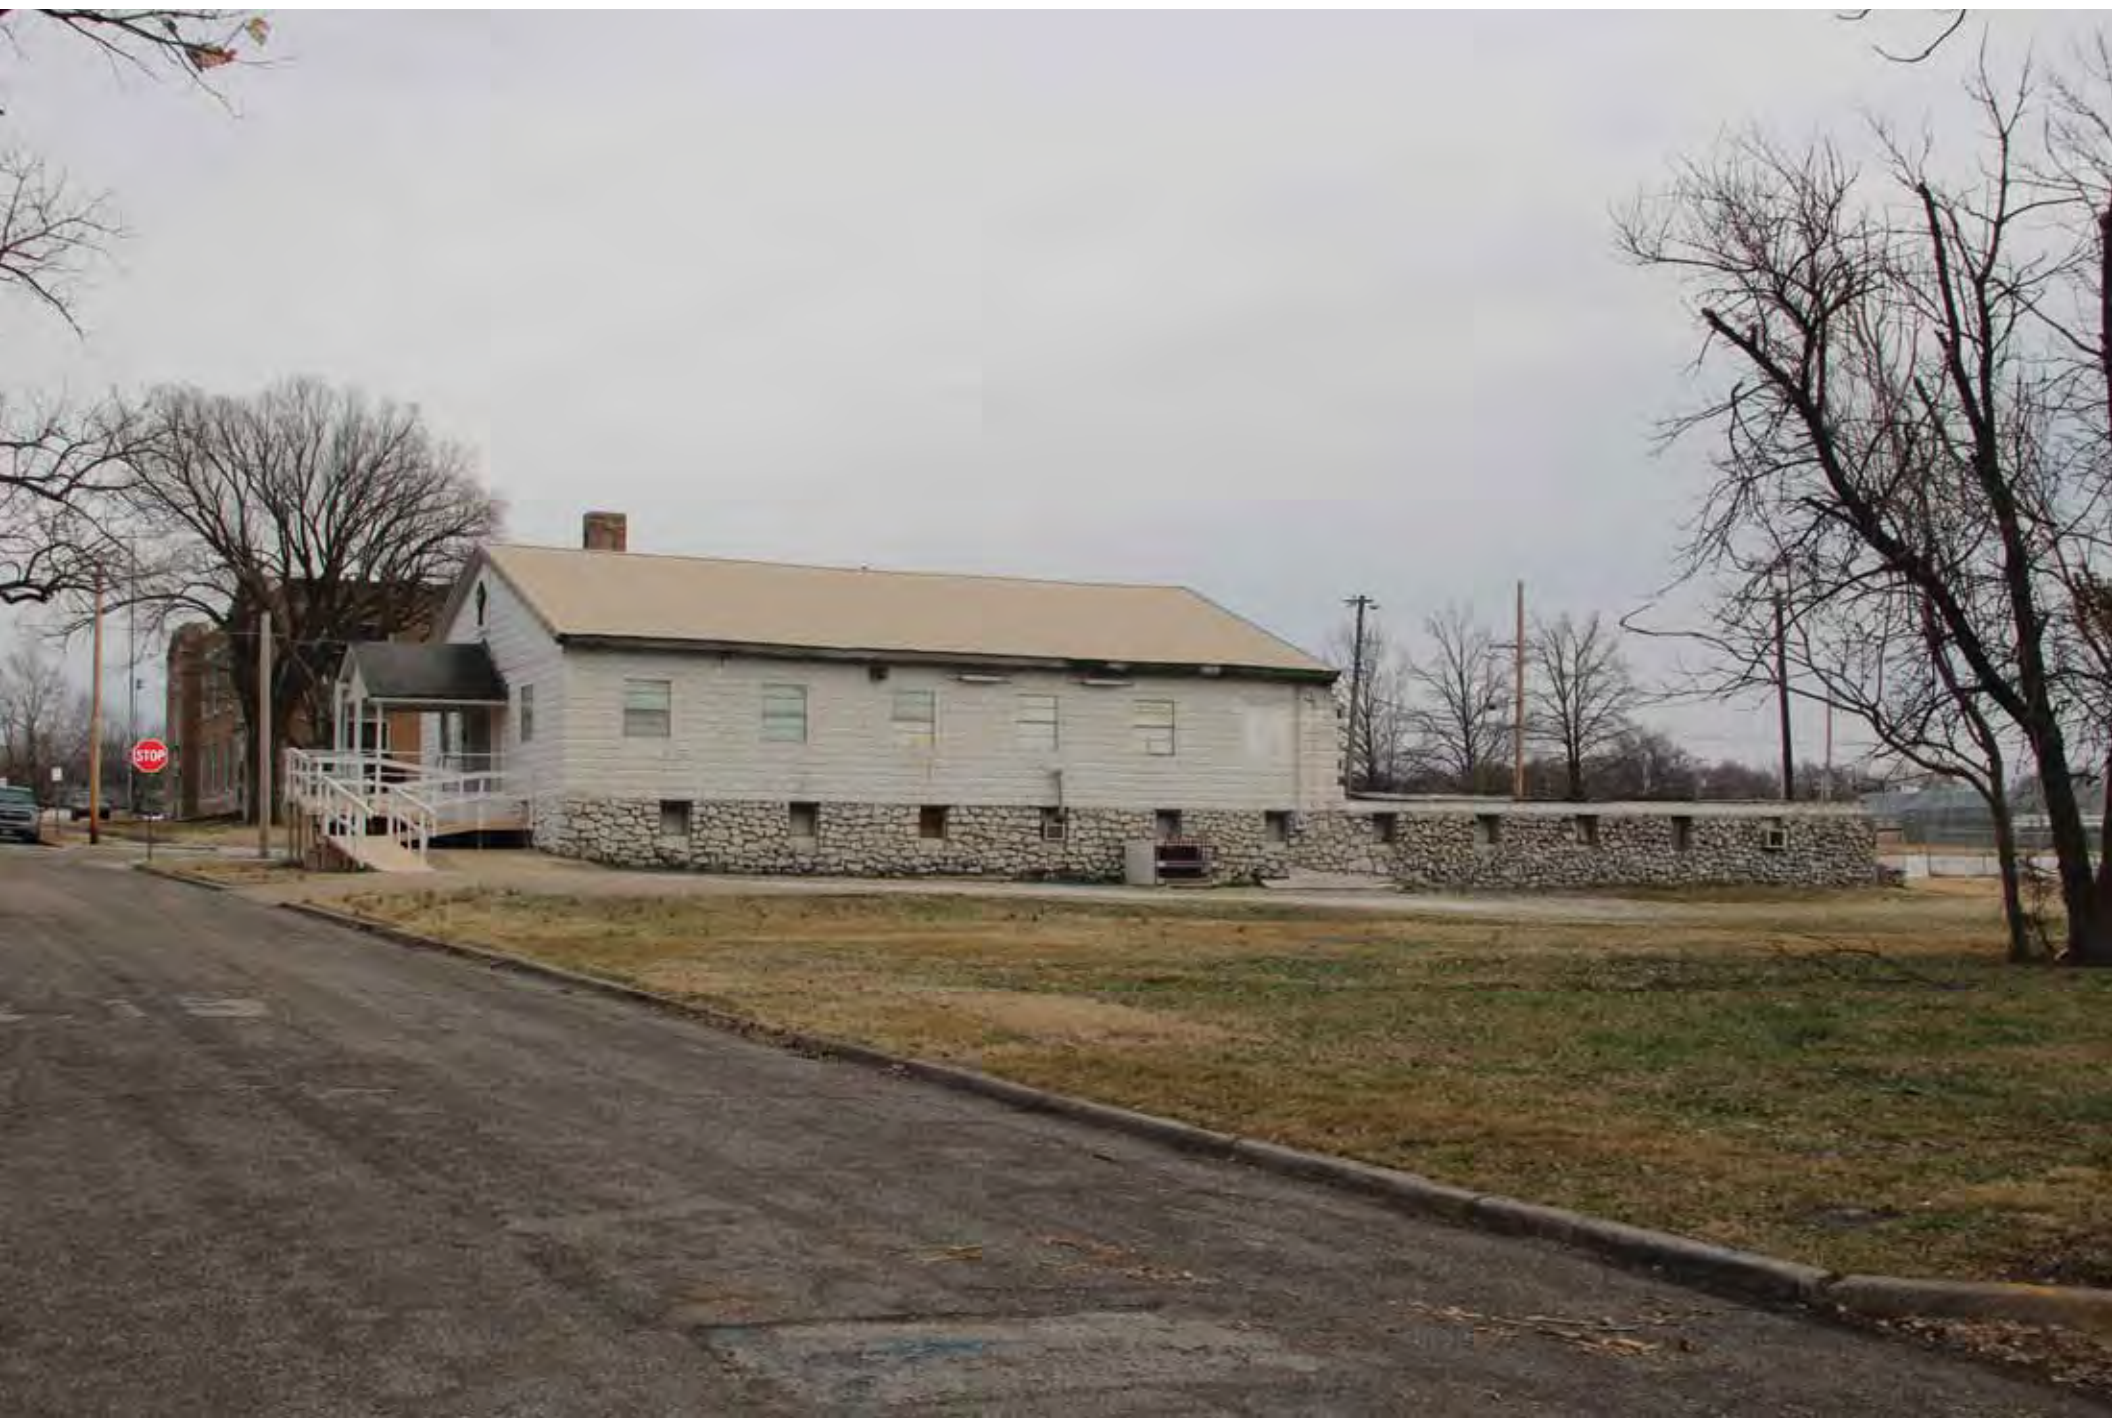
This property is a vacant lot covered in grass.

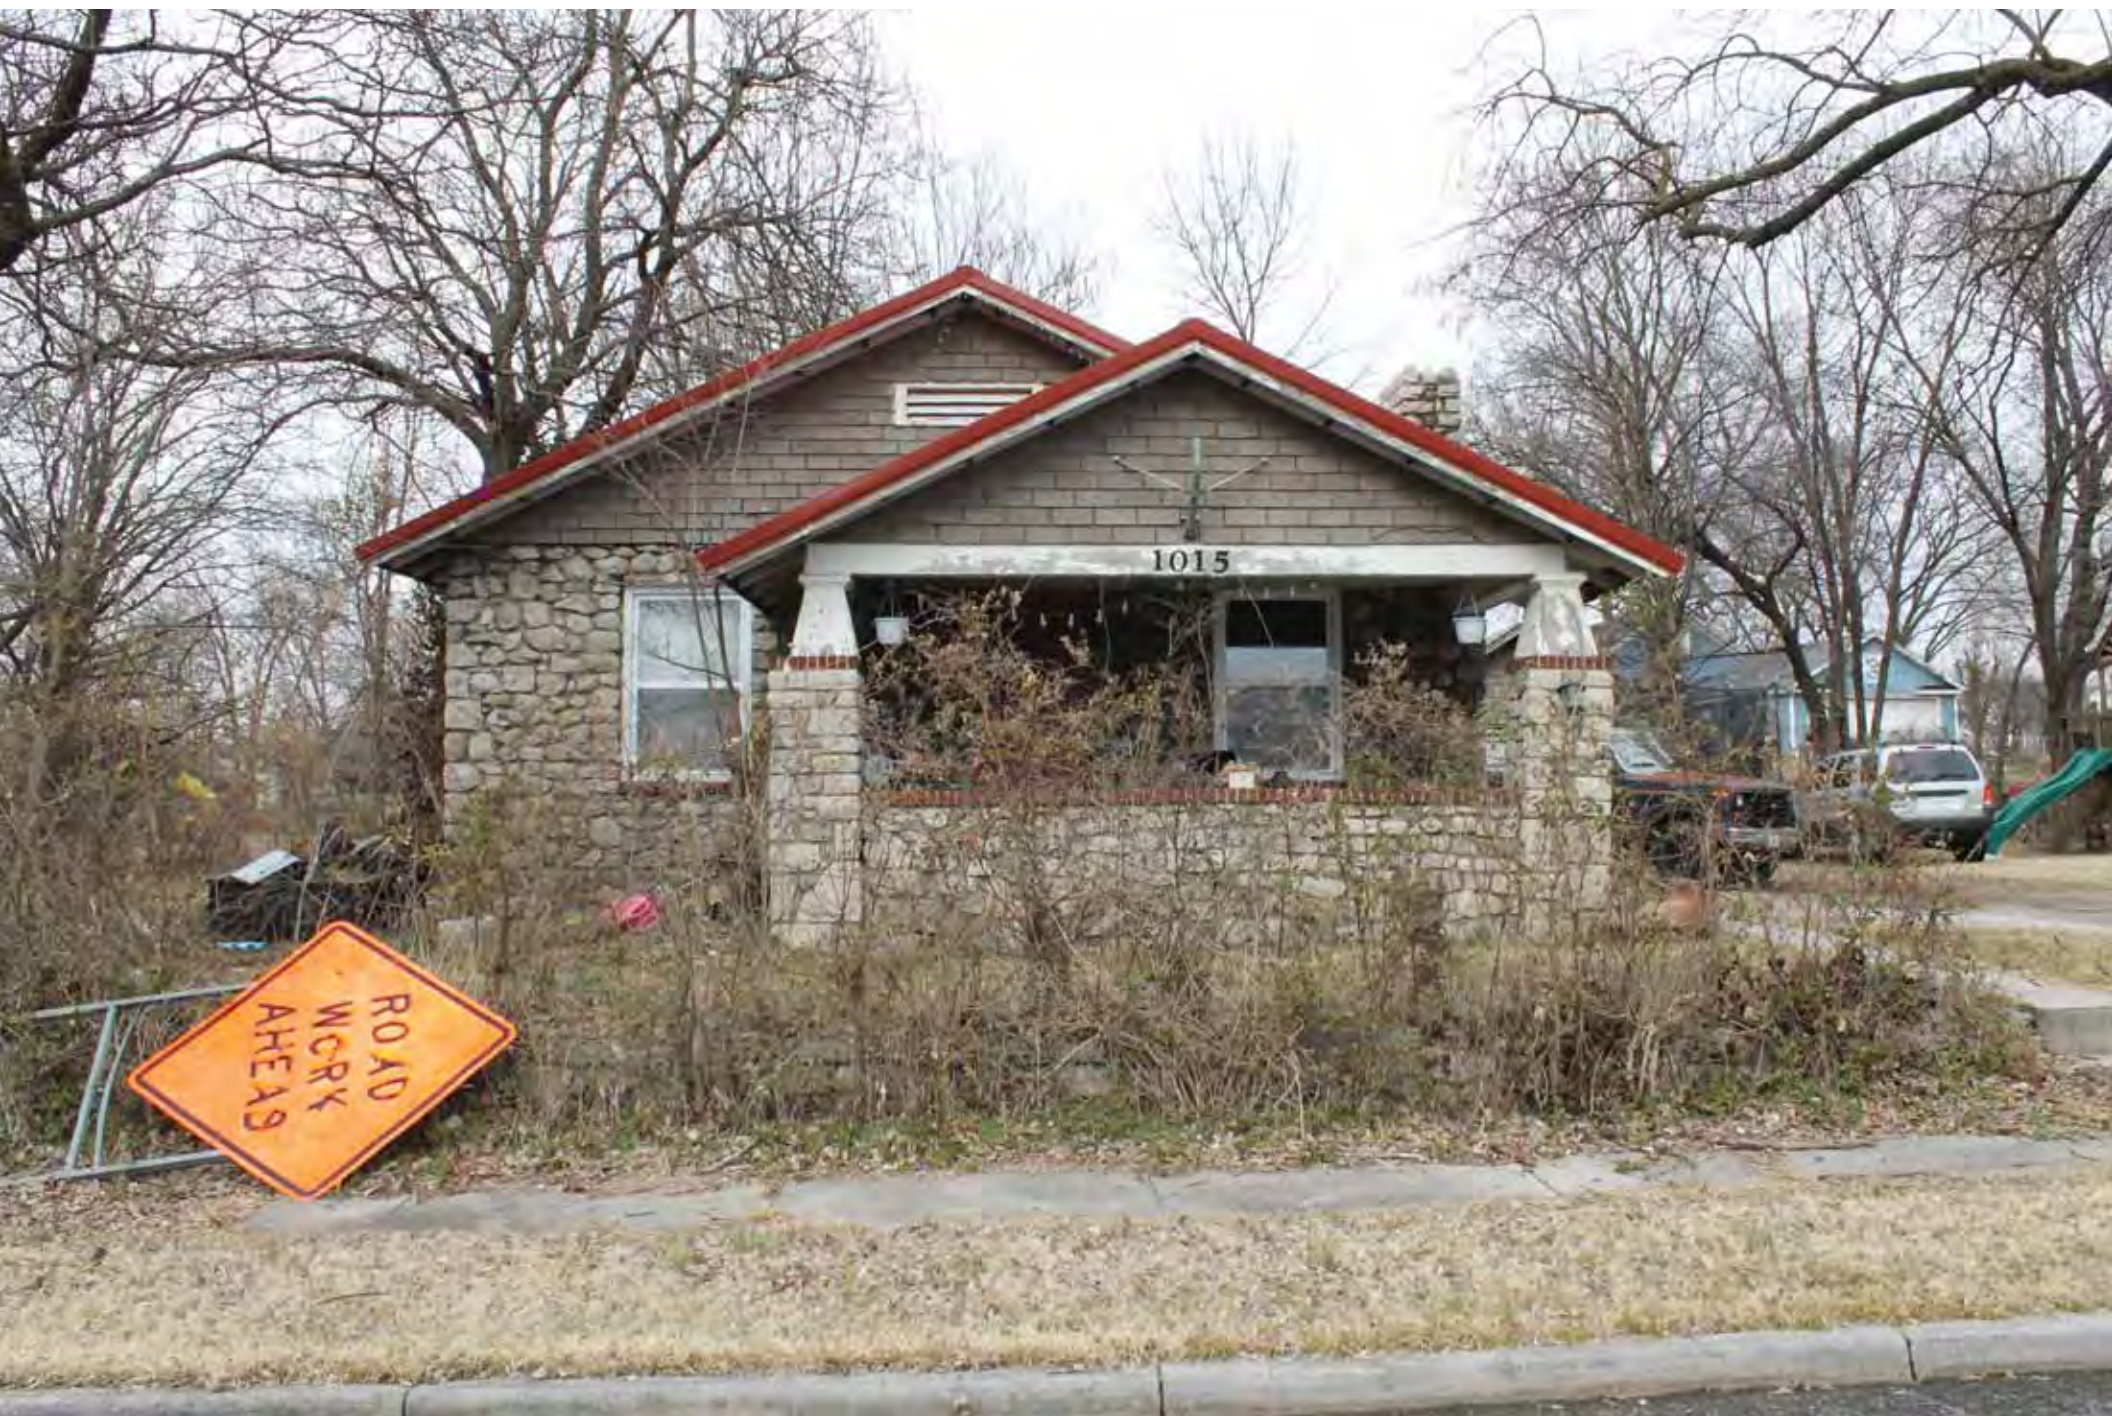
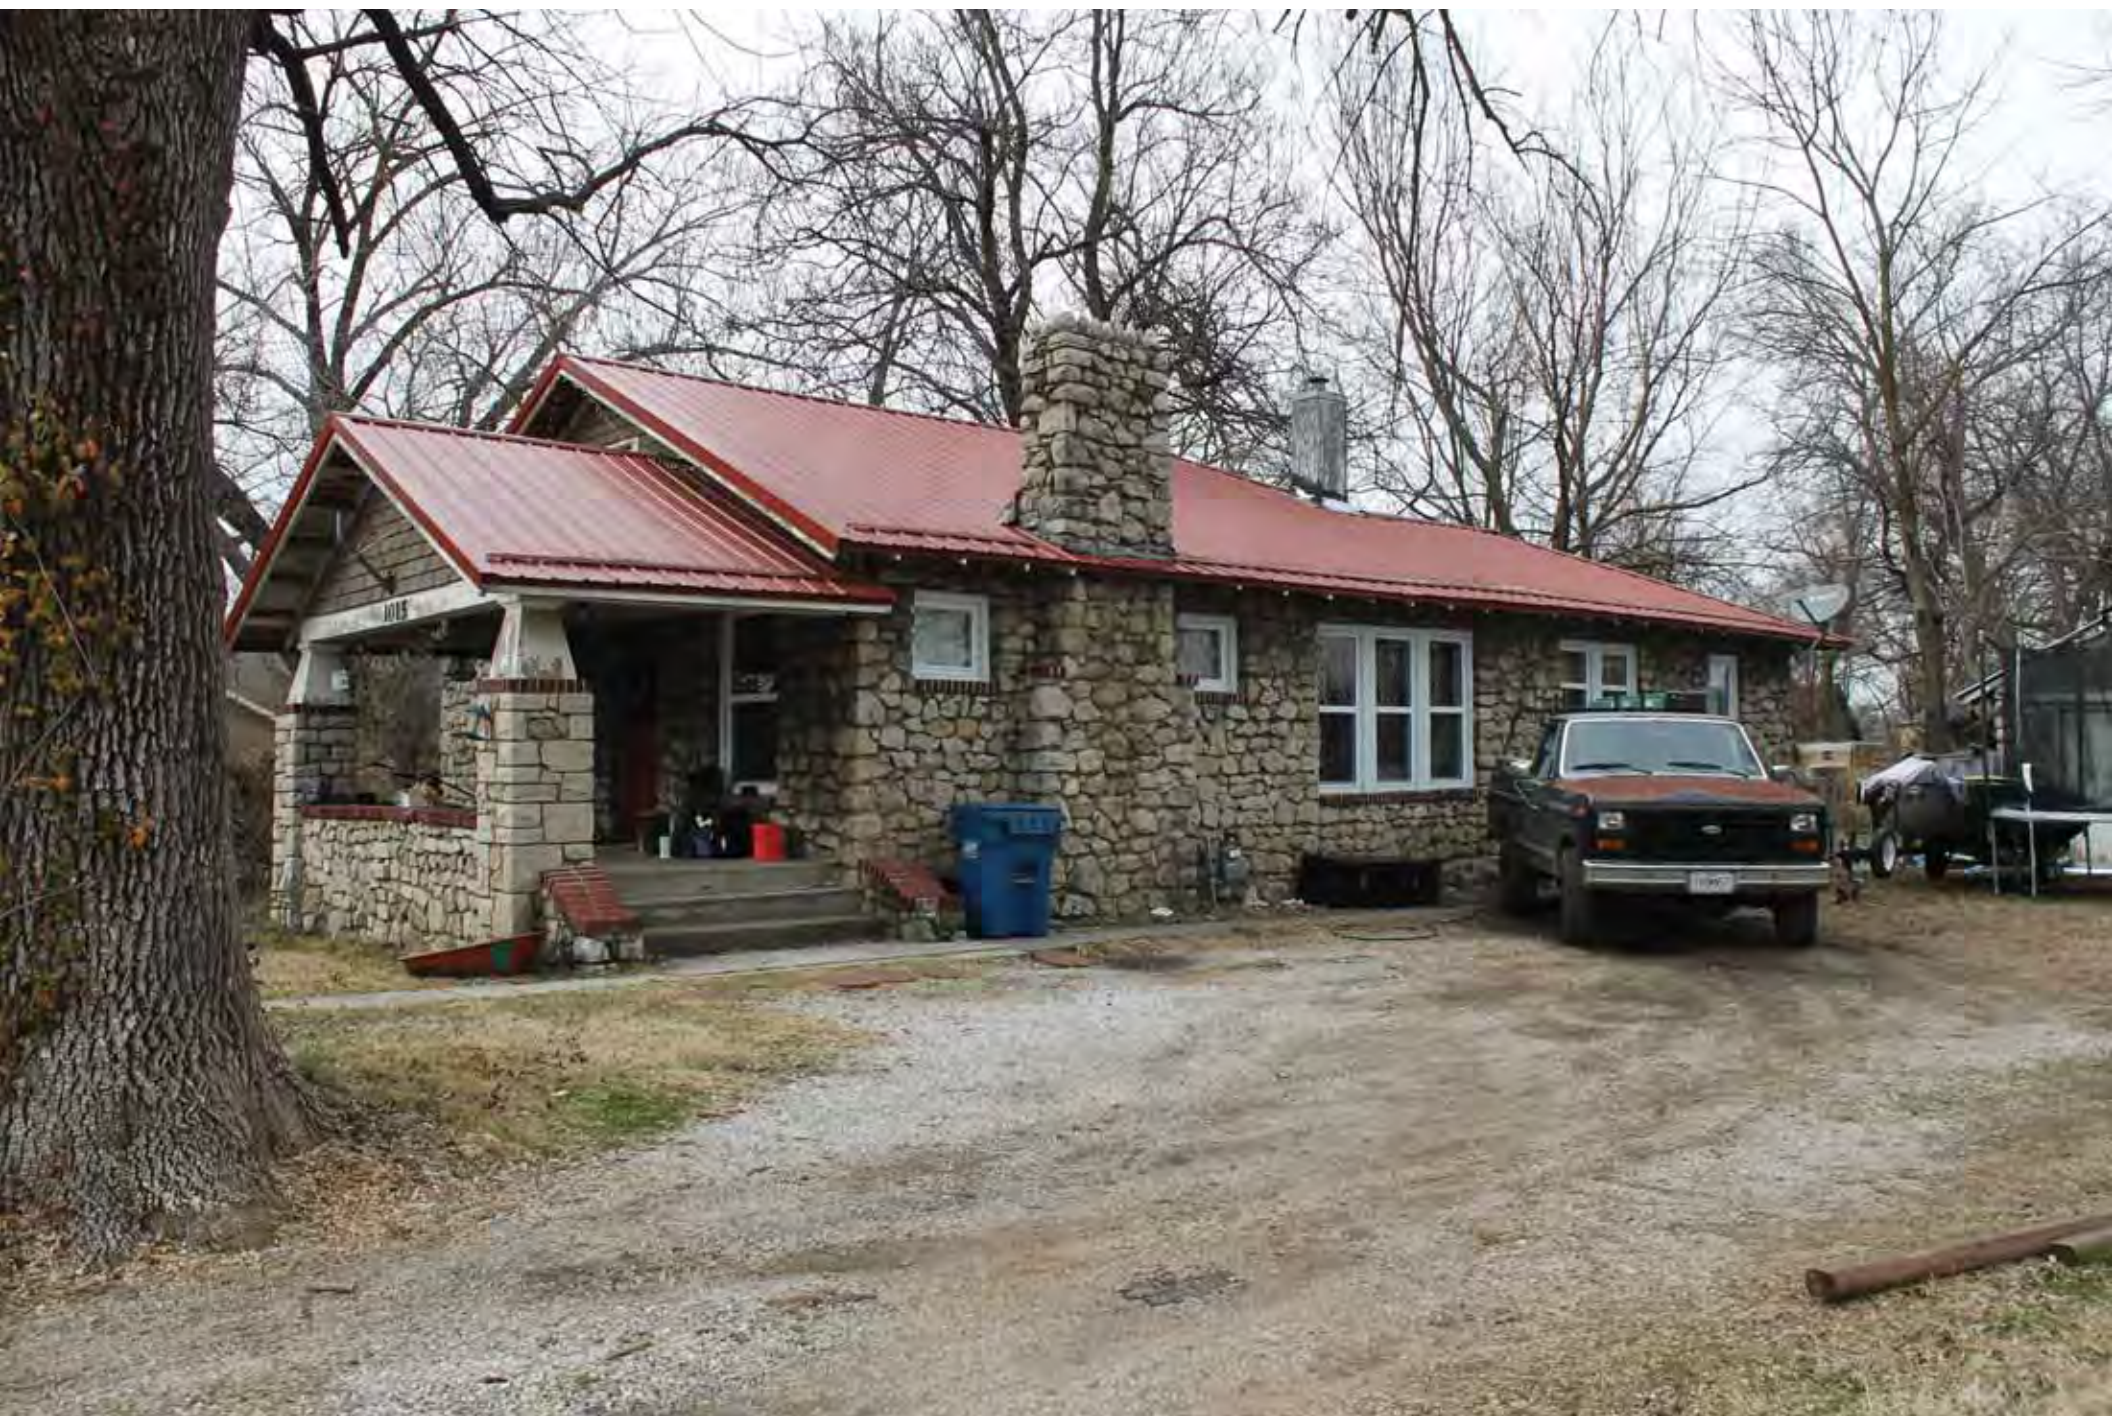
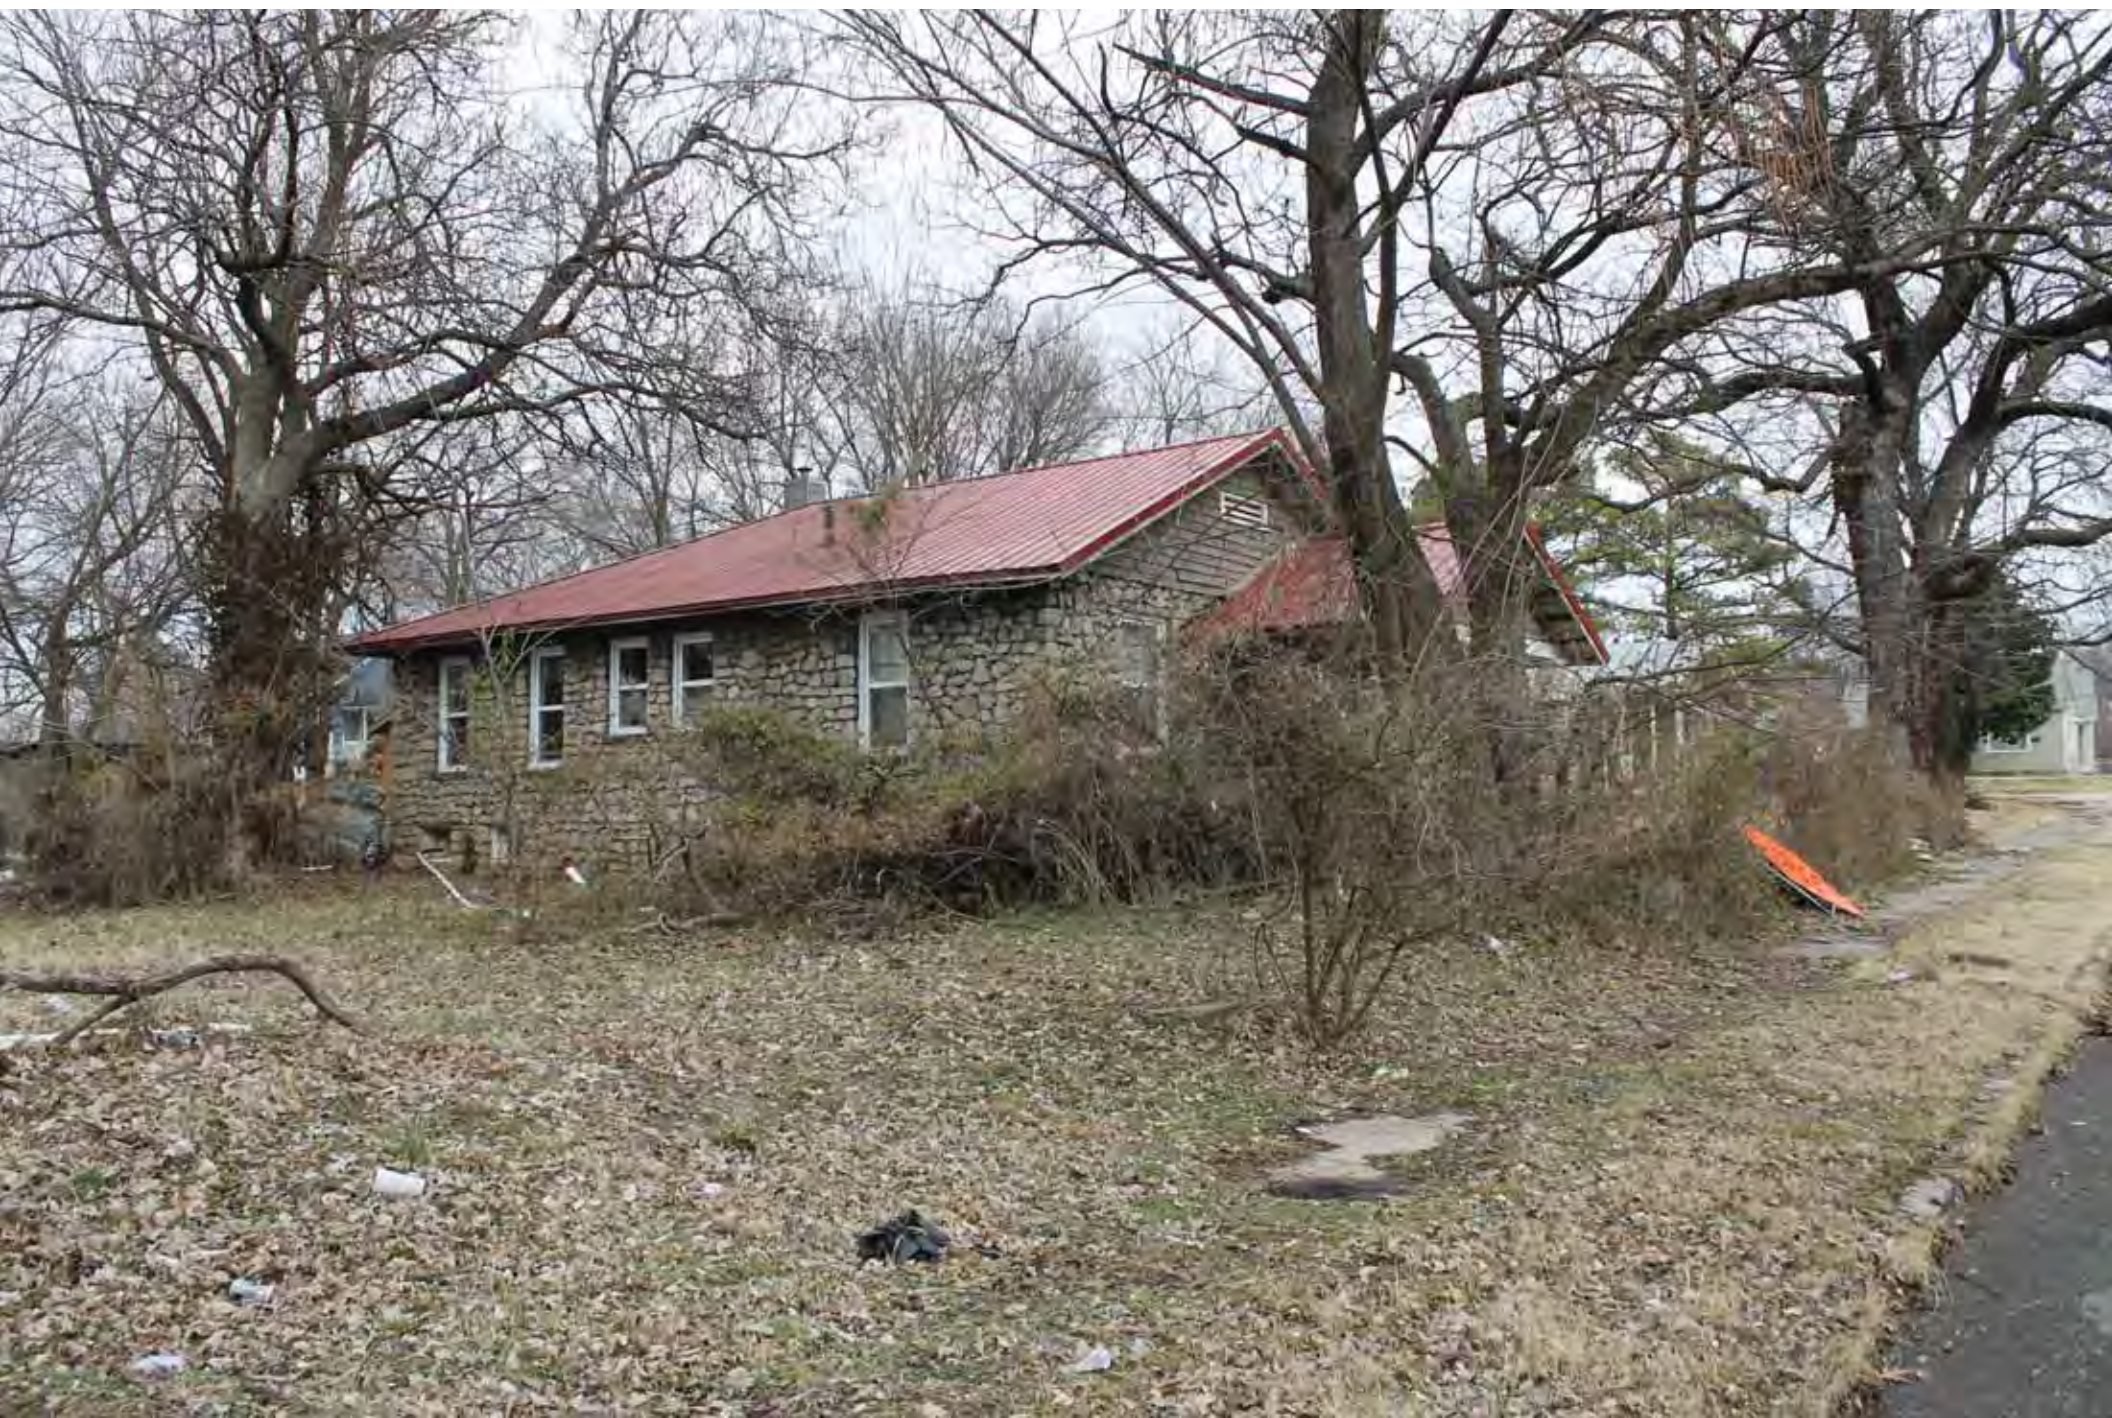
Because of its unique stone construction and high degree of integrity the house is individually eligible for the National Register of Historic Places under Criterion C: Architecture. The period of significance is the time of construction, 1920. The dwelling is not situated in an area recommended as a historic district.

The property at 1015 E. 2nd Street is a one-story stone house. The house has a front facing gable roof covered in metal with exposed wooden brackets along the side gable. The house is constructed entirely of rubble stone. On the front of the house is the original front facing gable-roofed porch. The porch covers most of the front elevation, but sits to the right or east side on the front façade. It has tapered wooden piers that sit on square rubble stone columns. It has an entirely stone balustrade. Brick accents the top of the stone on the porch. Stairs on the east side of the porch access the porch and the front door. The front door is central on the front façade, and flanked on either side by single one-over-one windows. The gable ends of the roof and the porch are covered in asphalt shingles.

On the east side elevation is a large exterior stone chimney. Flanking the chimney on either side are small casement windows. In the middle of the eastern elevation is a ribbon of three one-over-one windows. Near the rear of the house is a pair of double windows, and a single one-over-one window. The west elevation of the house has five single one-over-one windows.

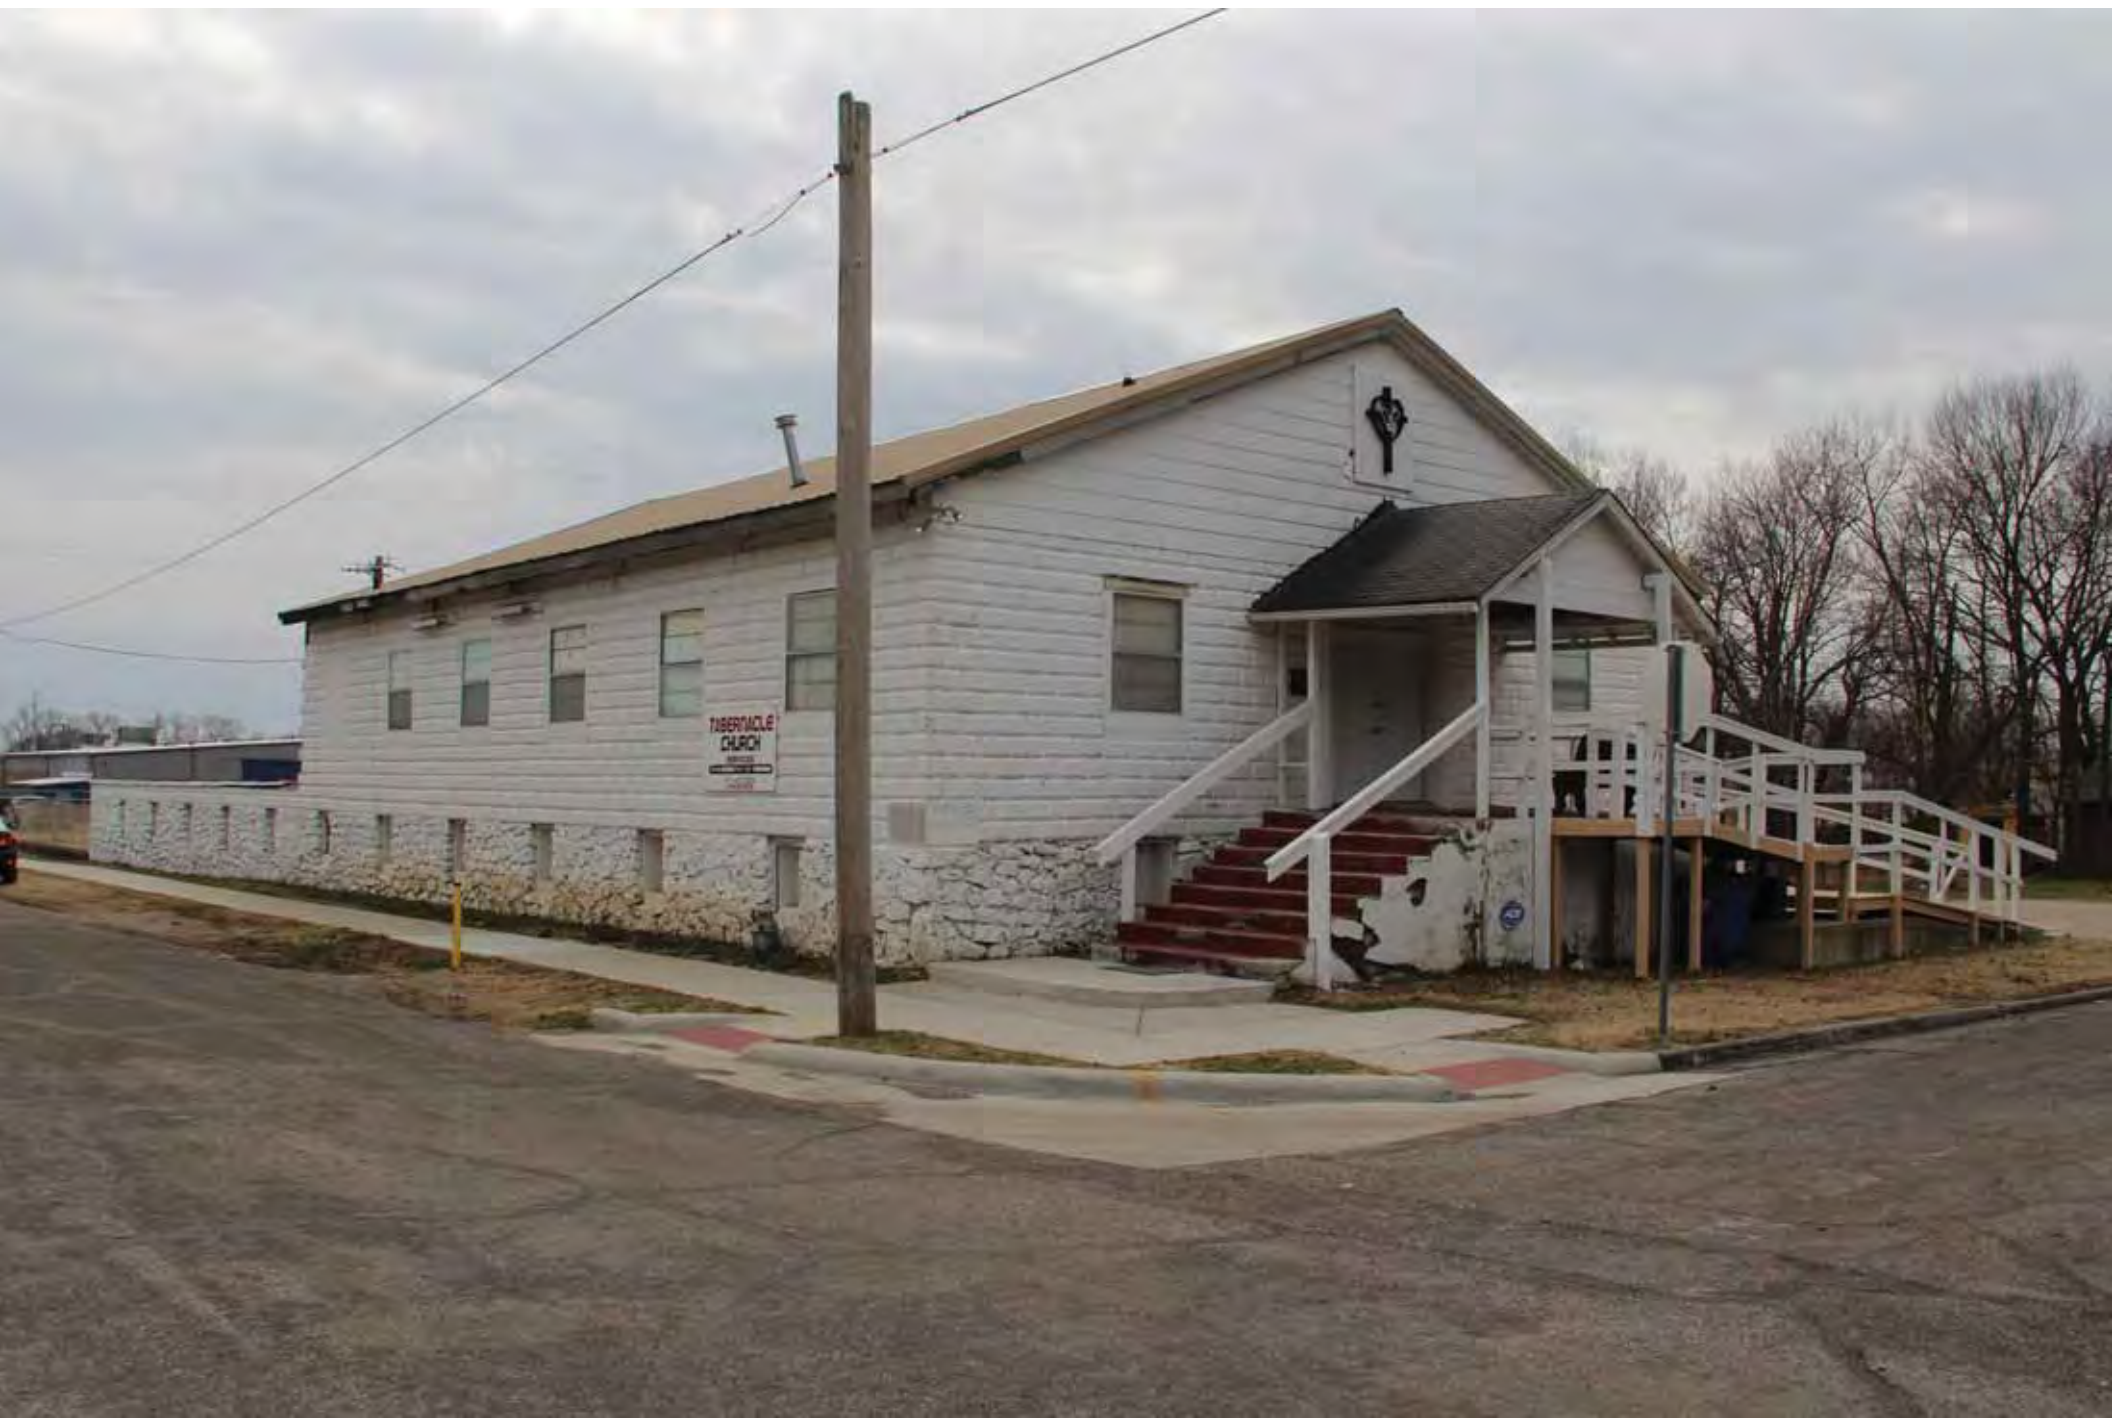
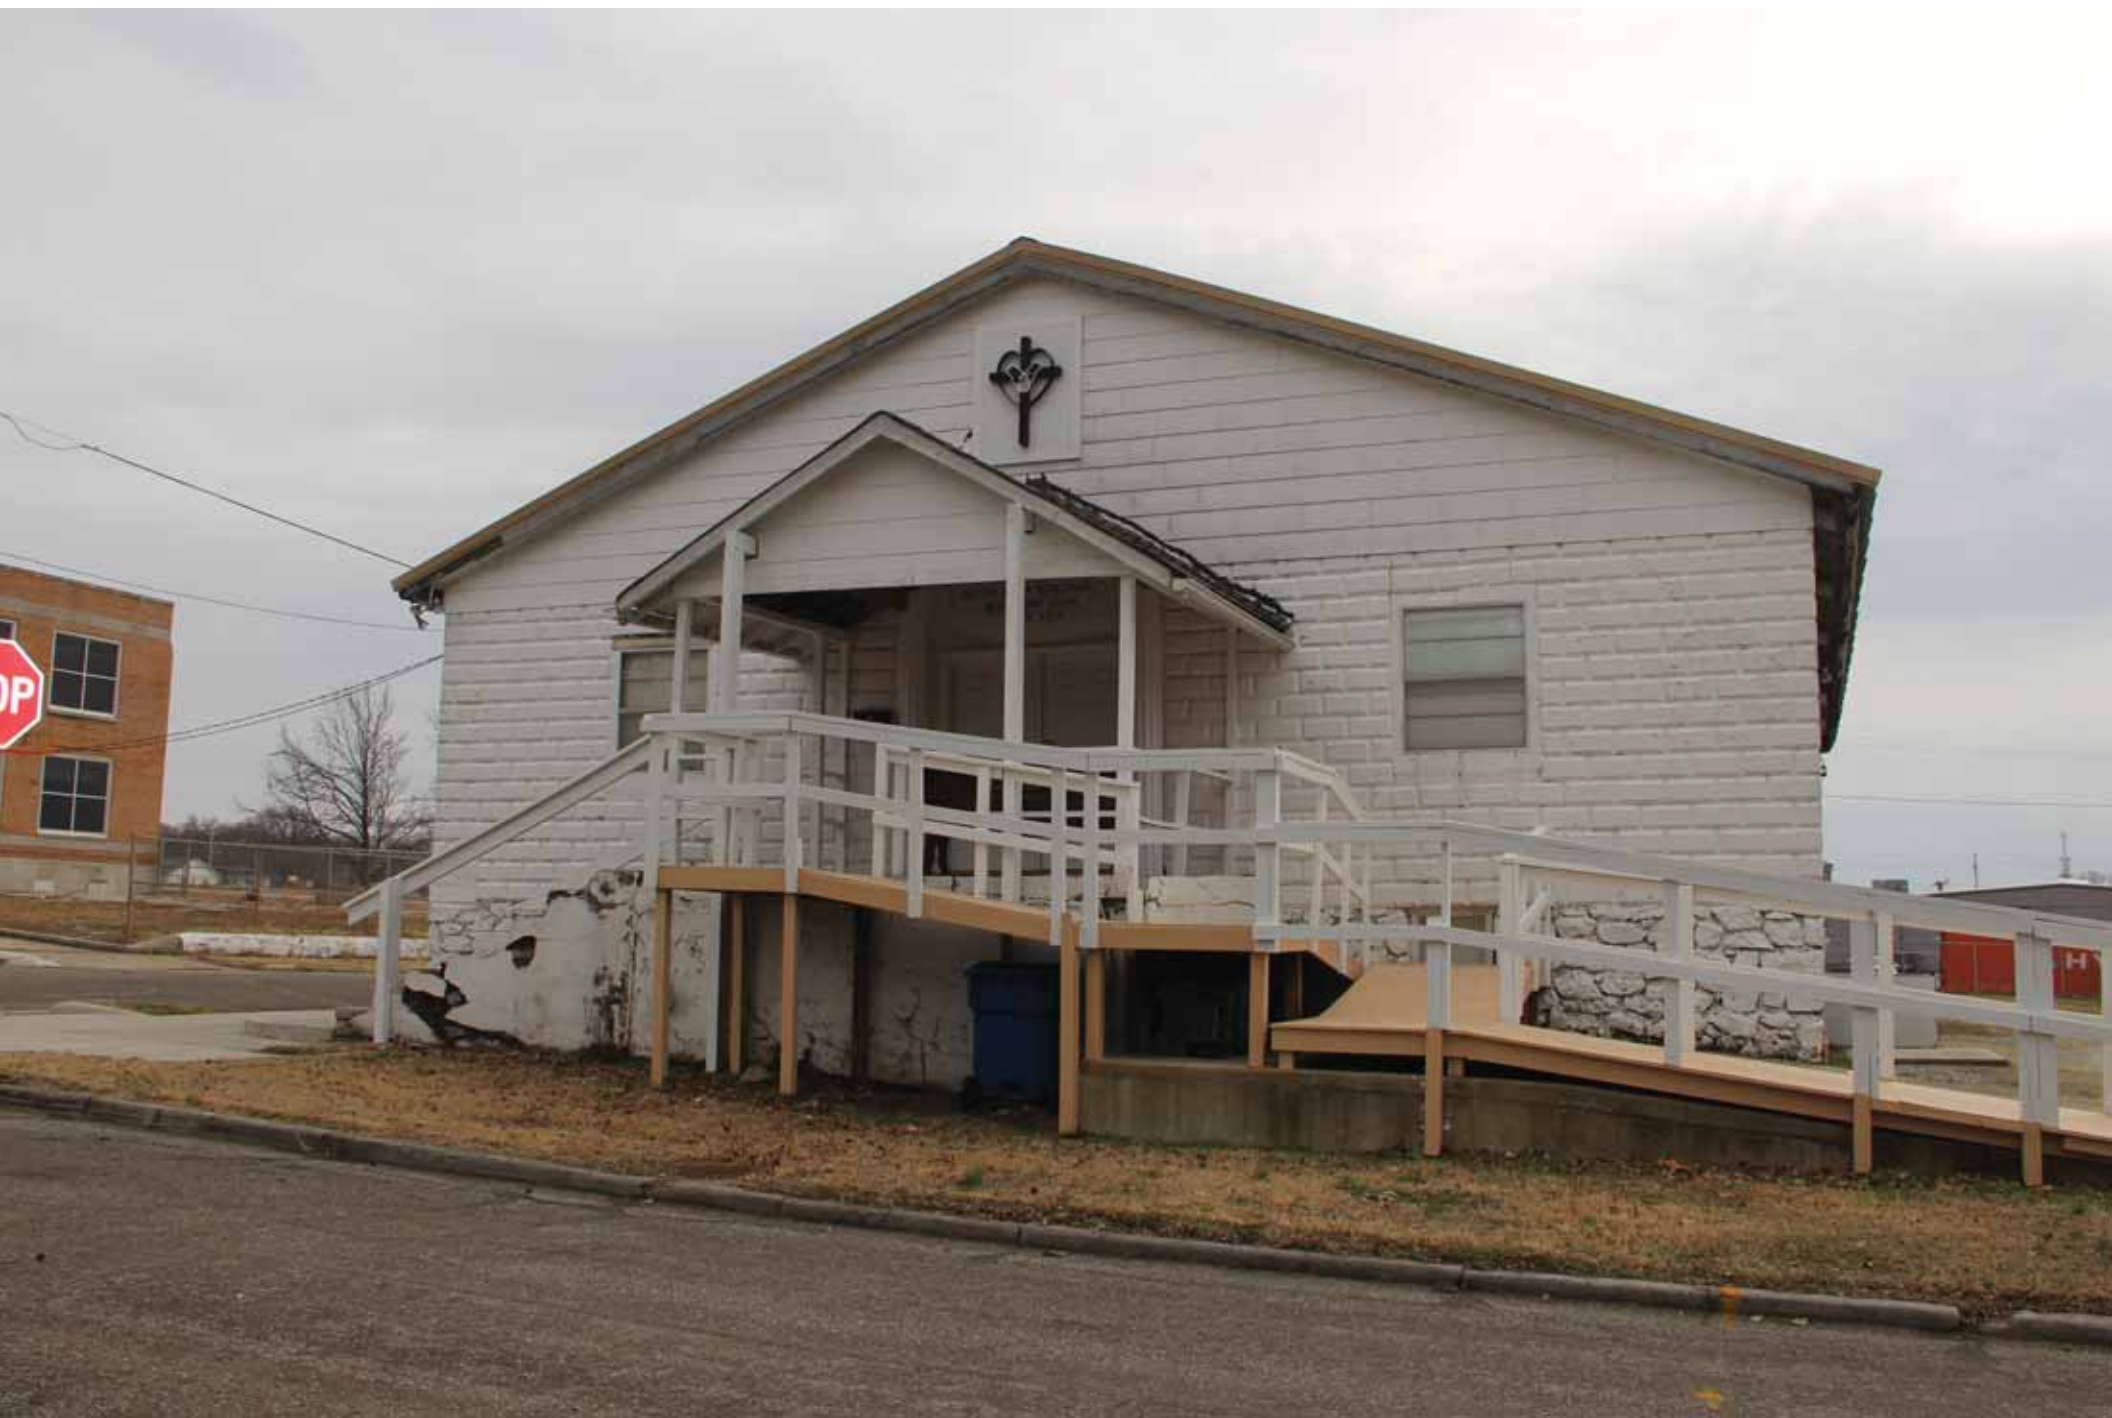
Additional information is sought to determine whether the church may have historical associations that would make this an important property to the East Town neighborhood. Due to the removal of a rear large wing (or so it appears), the building does not retain sufficient integrity to be individually eligible for the National Register of Historic Places. The church is not within an area recommended as a historic district.

The property at 1024 E. 2nd Street is a one-story frame church. It has a rubble stone foundation that has been painted. It has a rectangular plan with a front-facing gable roof. The building is frame with a wooden truss roof. At some point the exterior walls were covered with a brick veneer, and then painted. On the front façade is a front facing gable-roofed porch, accessed by concrete stairs on the east side. On the west side of the porch is a large wooden ramp. The porch shelters the entrance to the church, which is in the middle of the front façade. To the west of the porch is a single one-over-one replacement window. Along the side elevations are several replacement windows. At the rear of the building is a continuation of the stone foundation, with no building on top. The basement level is accessible however, and has a concrete drive and loading dock leading to a garage door on the rear elevation. The construction indicates that an older building may have been on the stone foundation, and the 1938 church replaced that building.
