MISSOURI DEPARTMENT OF NATURAL RESOURCES
STATE HISTORIC PRESERVATION OFFICE, P.O. Box 176, Jefferson City, MO 65102
ARCHITECTURAL/HISTORIC INVENTORY FORM

1. Survey No. JP-AS-007-001		2. Survey name: East Town (Original Joplin) Historic Survey Phase 2	
3. County: JASPER		4. Address (Street No.) 618	Street (name) E. 2 nd Street
5. City: Joplin	Vicinity: <input type="checkbox"/>	6. Geographical Reference:	7. Township/Range/Section: T: R: S:
8. Historic name (if known):		9. Present/other name (if known):	
10. Ownership: <input checked="" type="checkbox"/> Private <input type="checkbox"/> Public		11a. Historic use (if known): Domestic: Single Dwelling	11b. Current use: Domestic: Single Dwelling

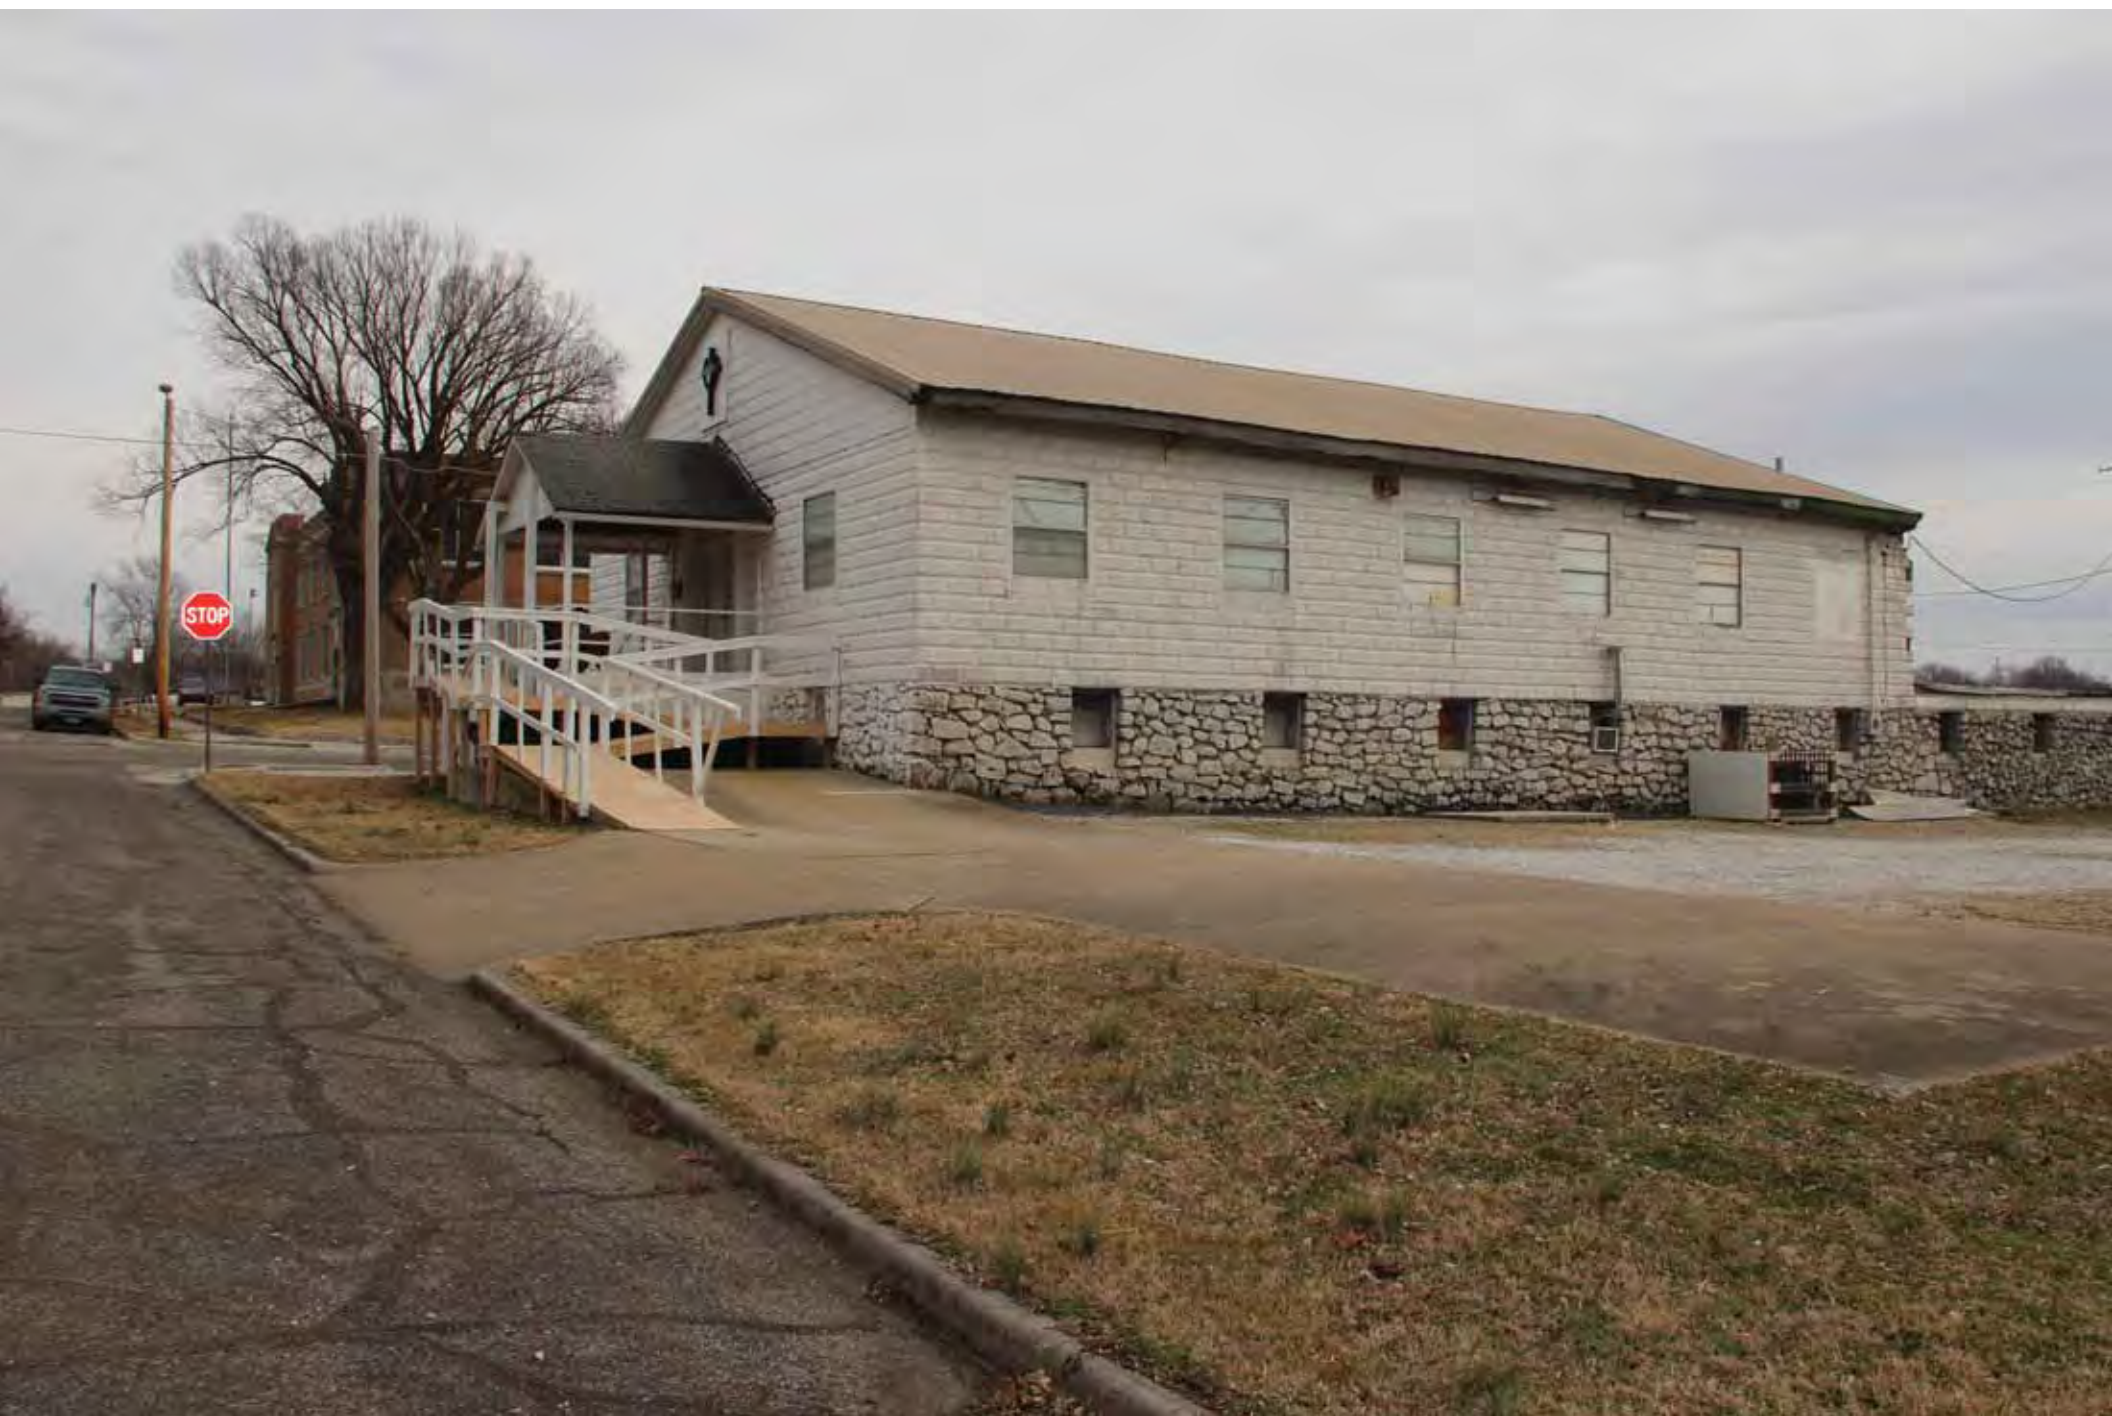
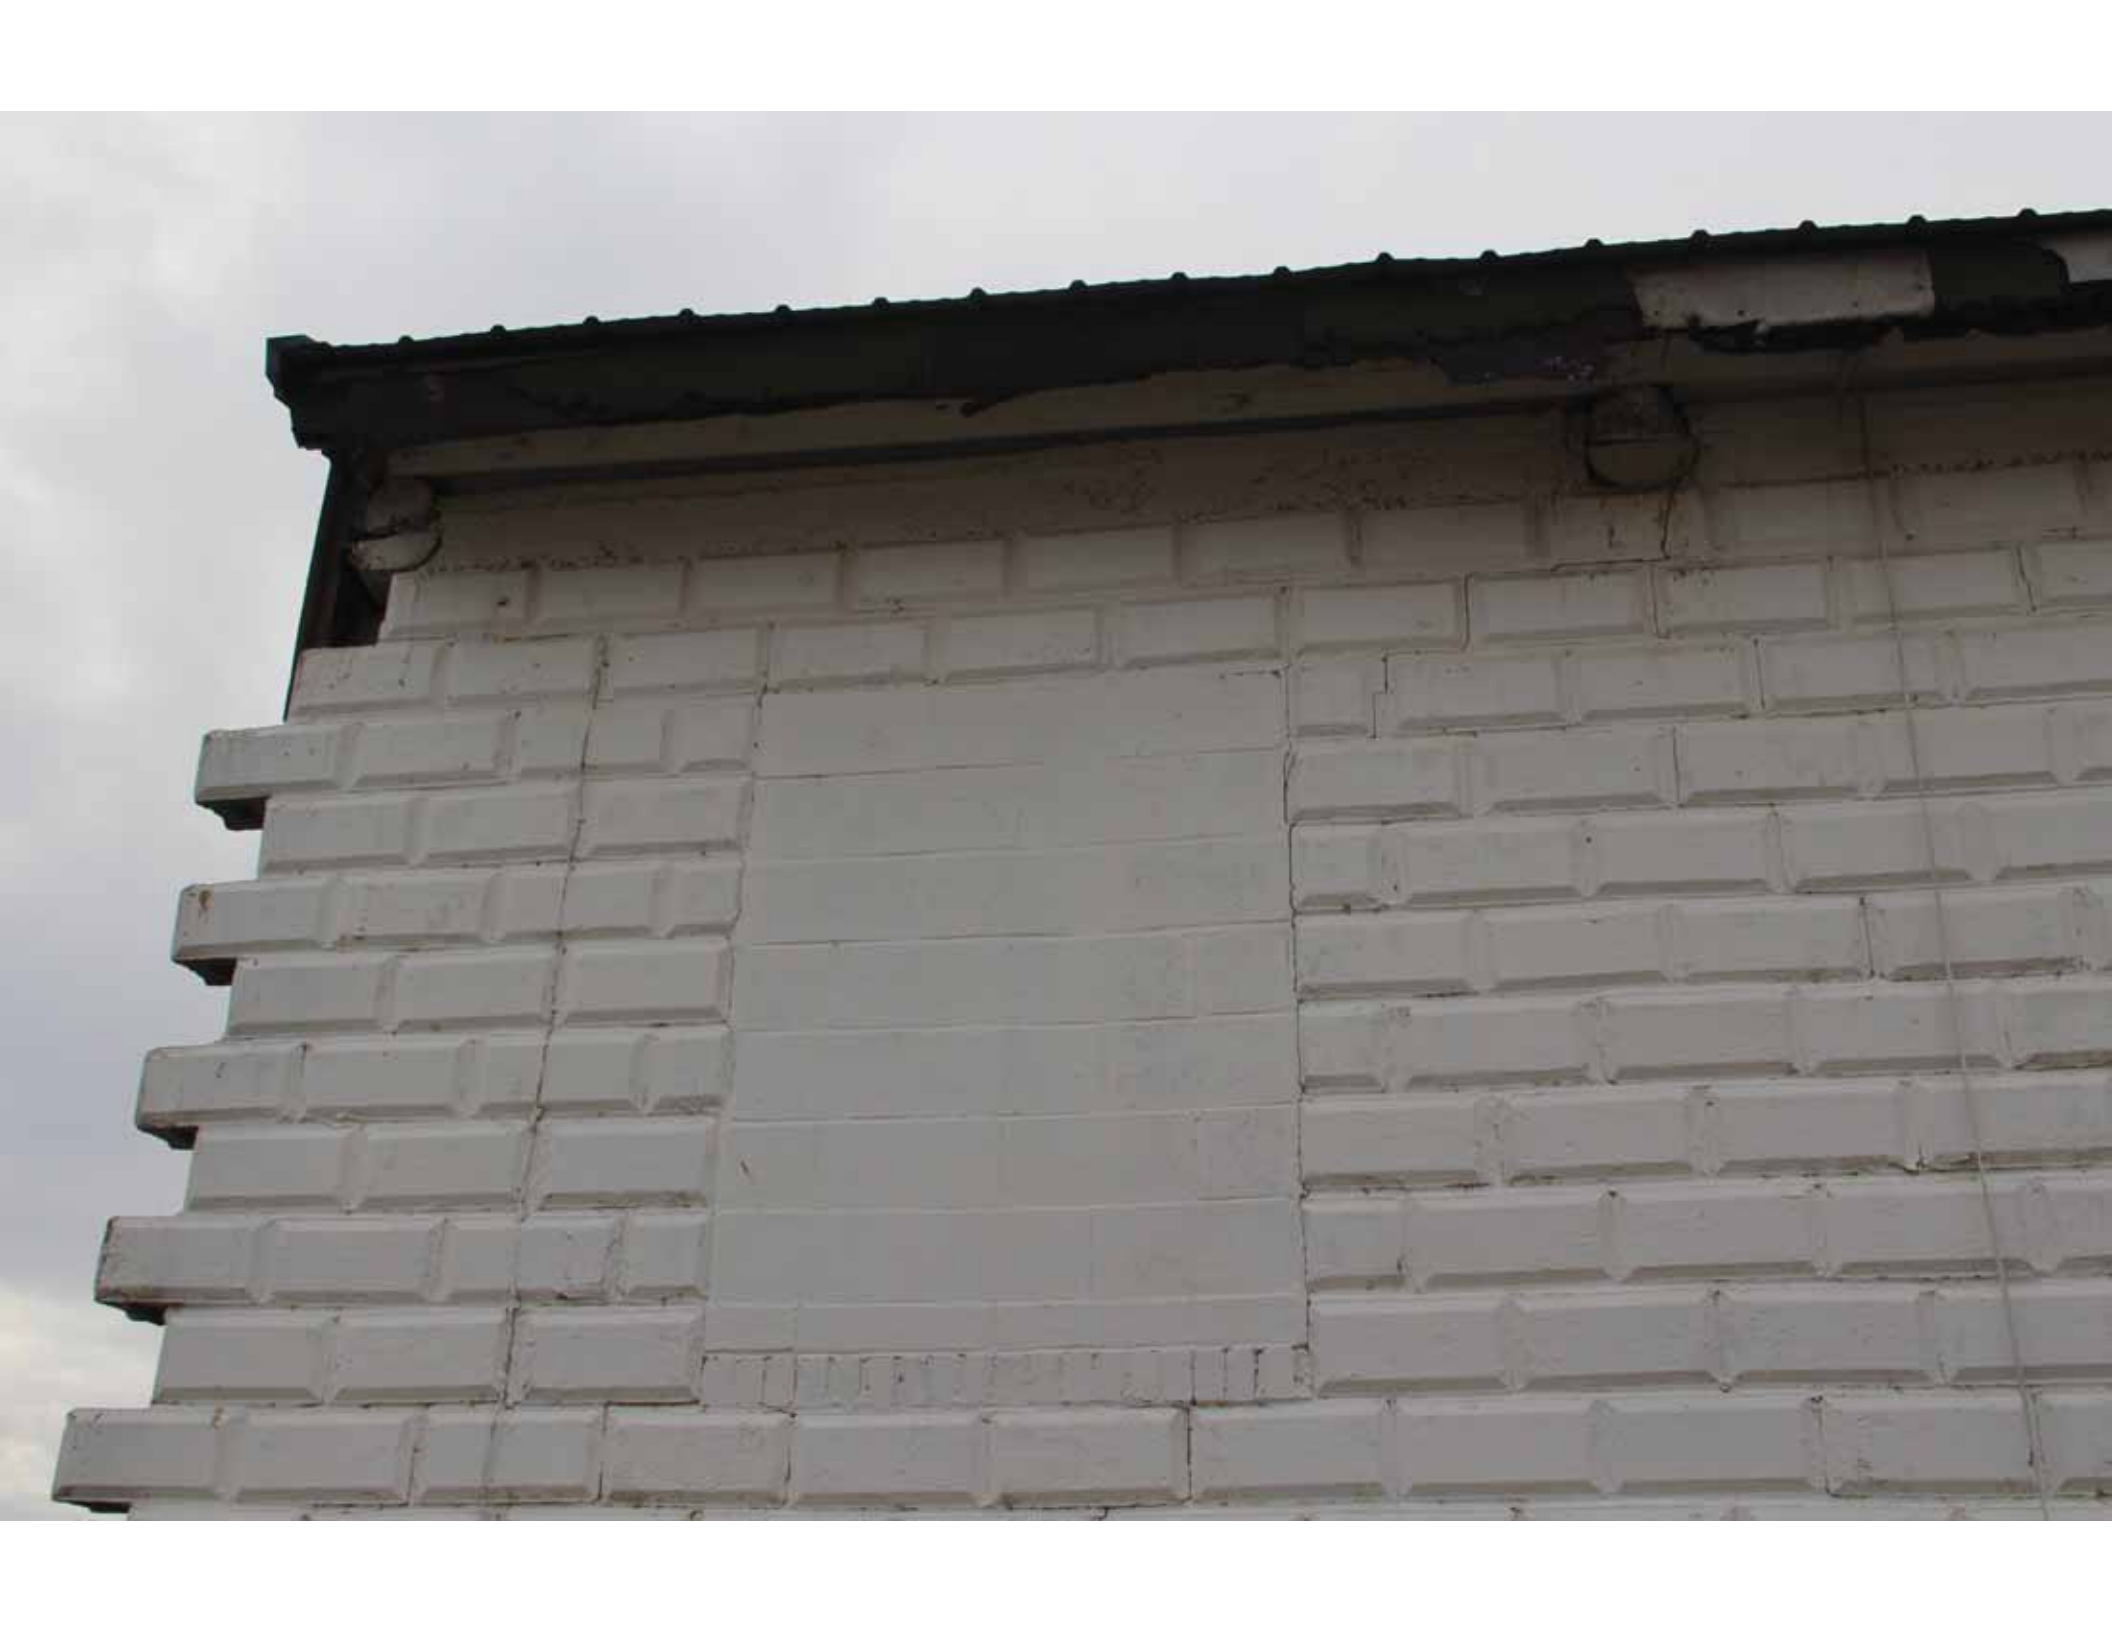
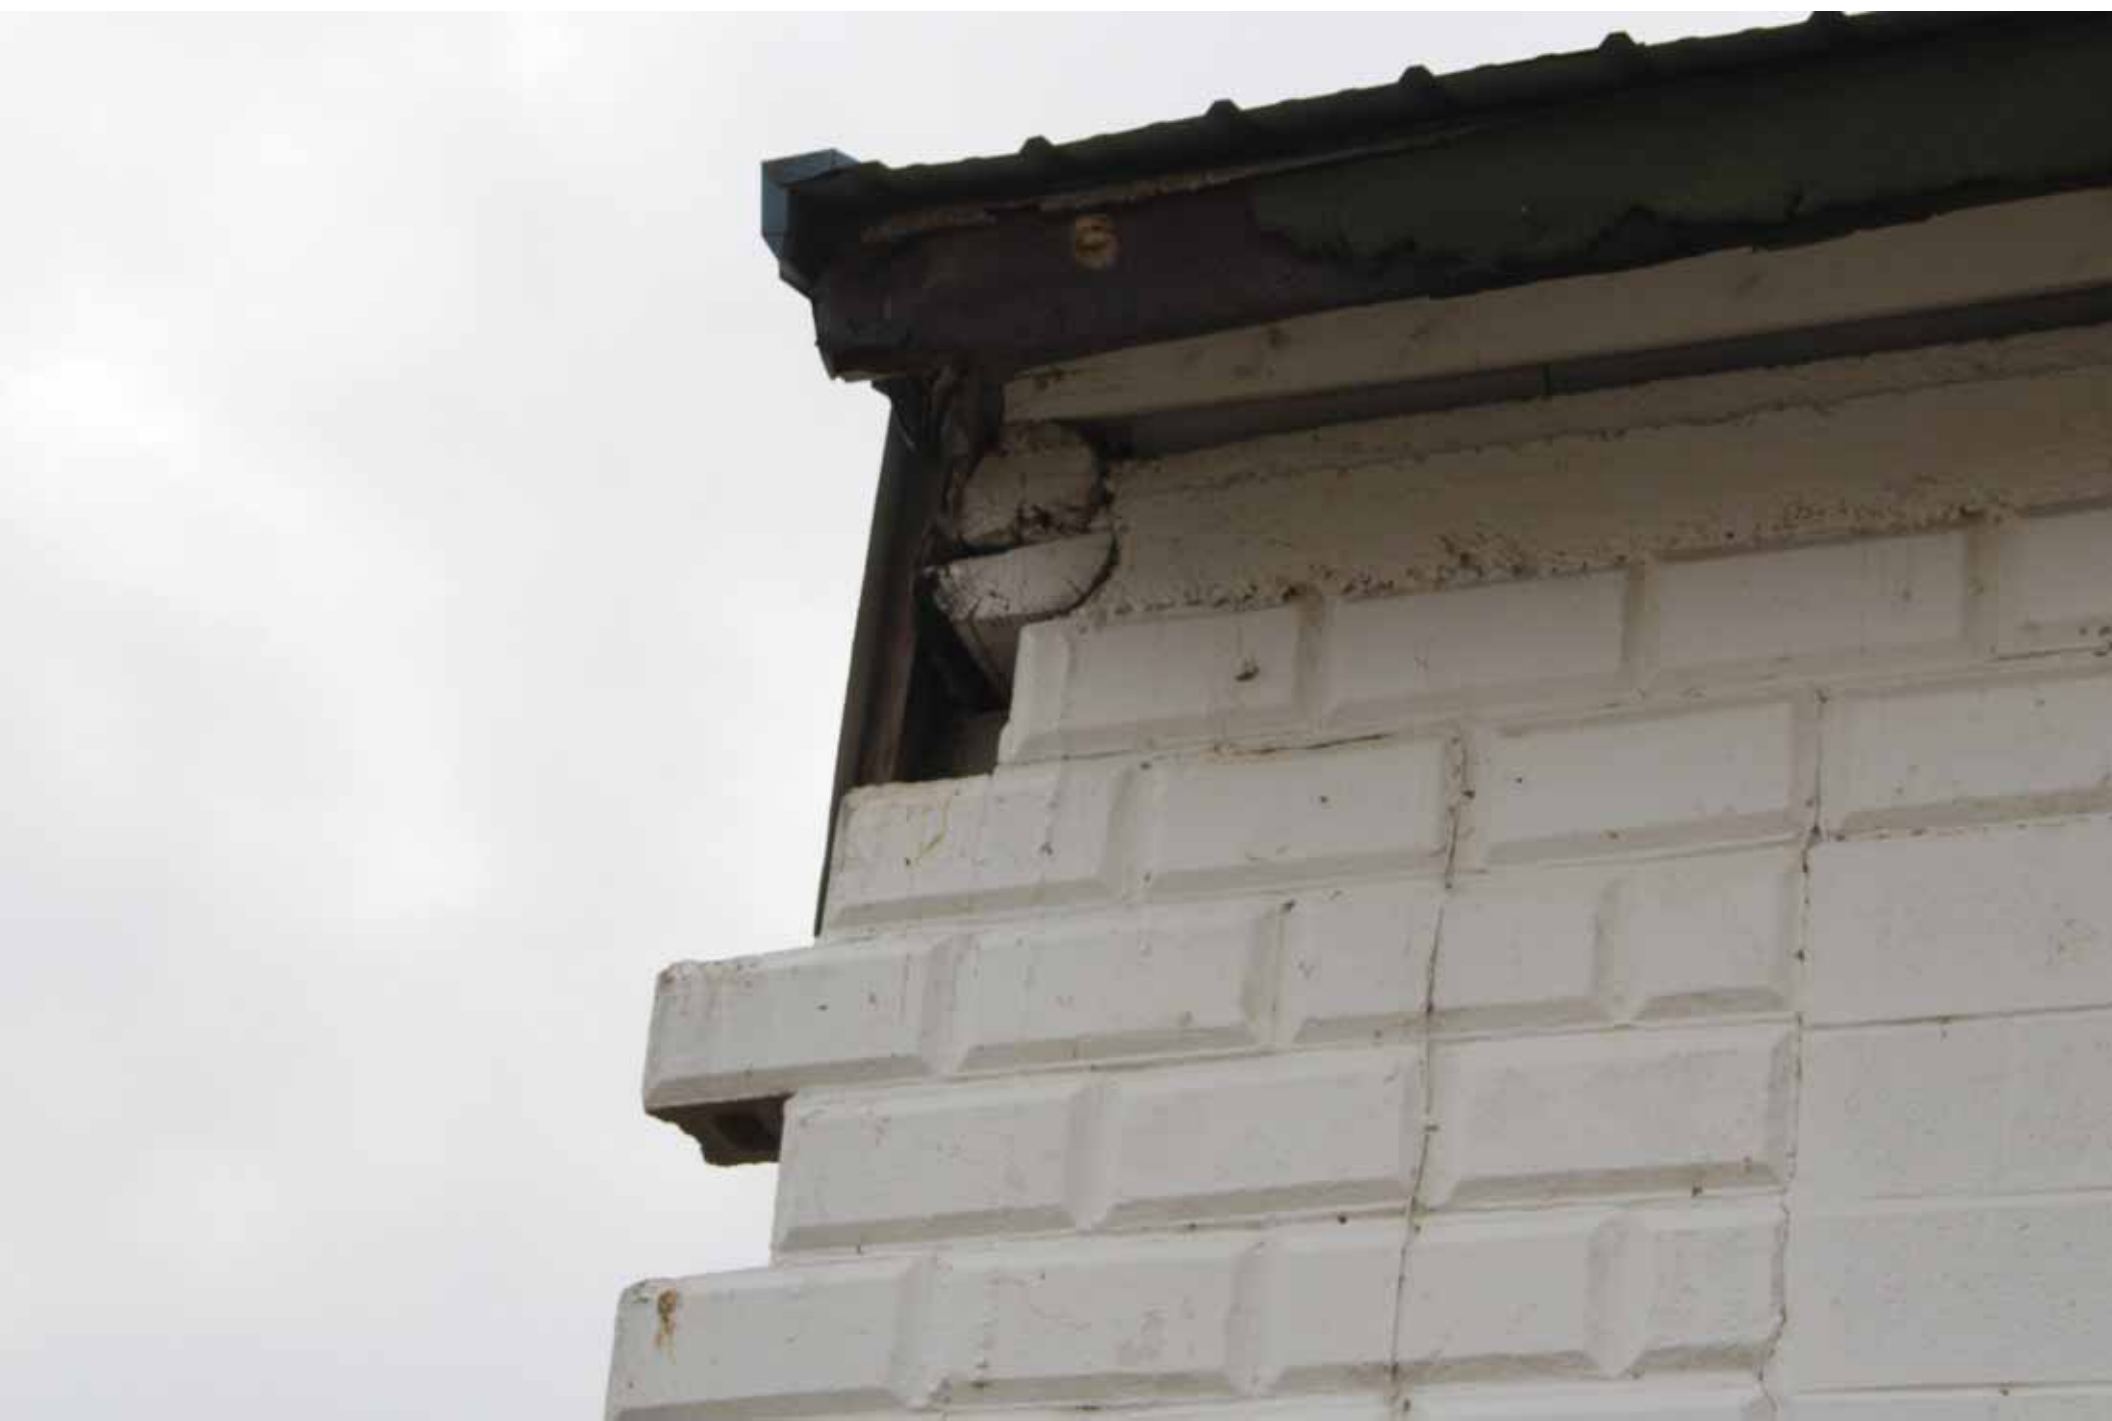
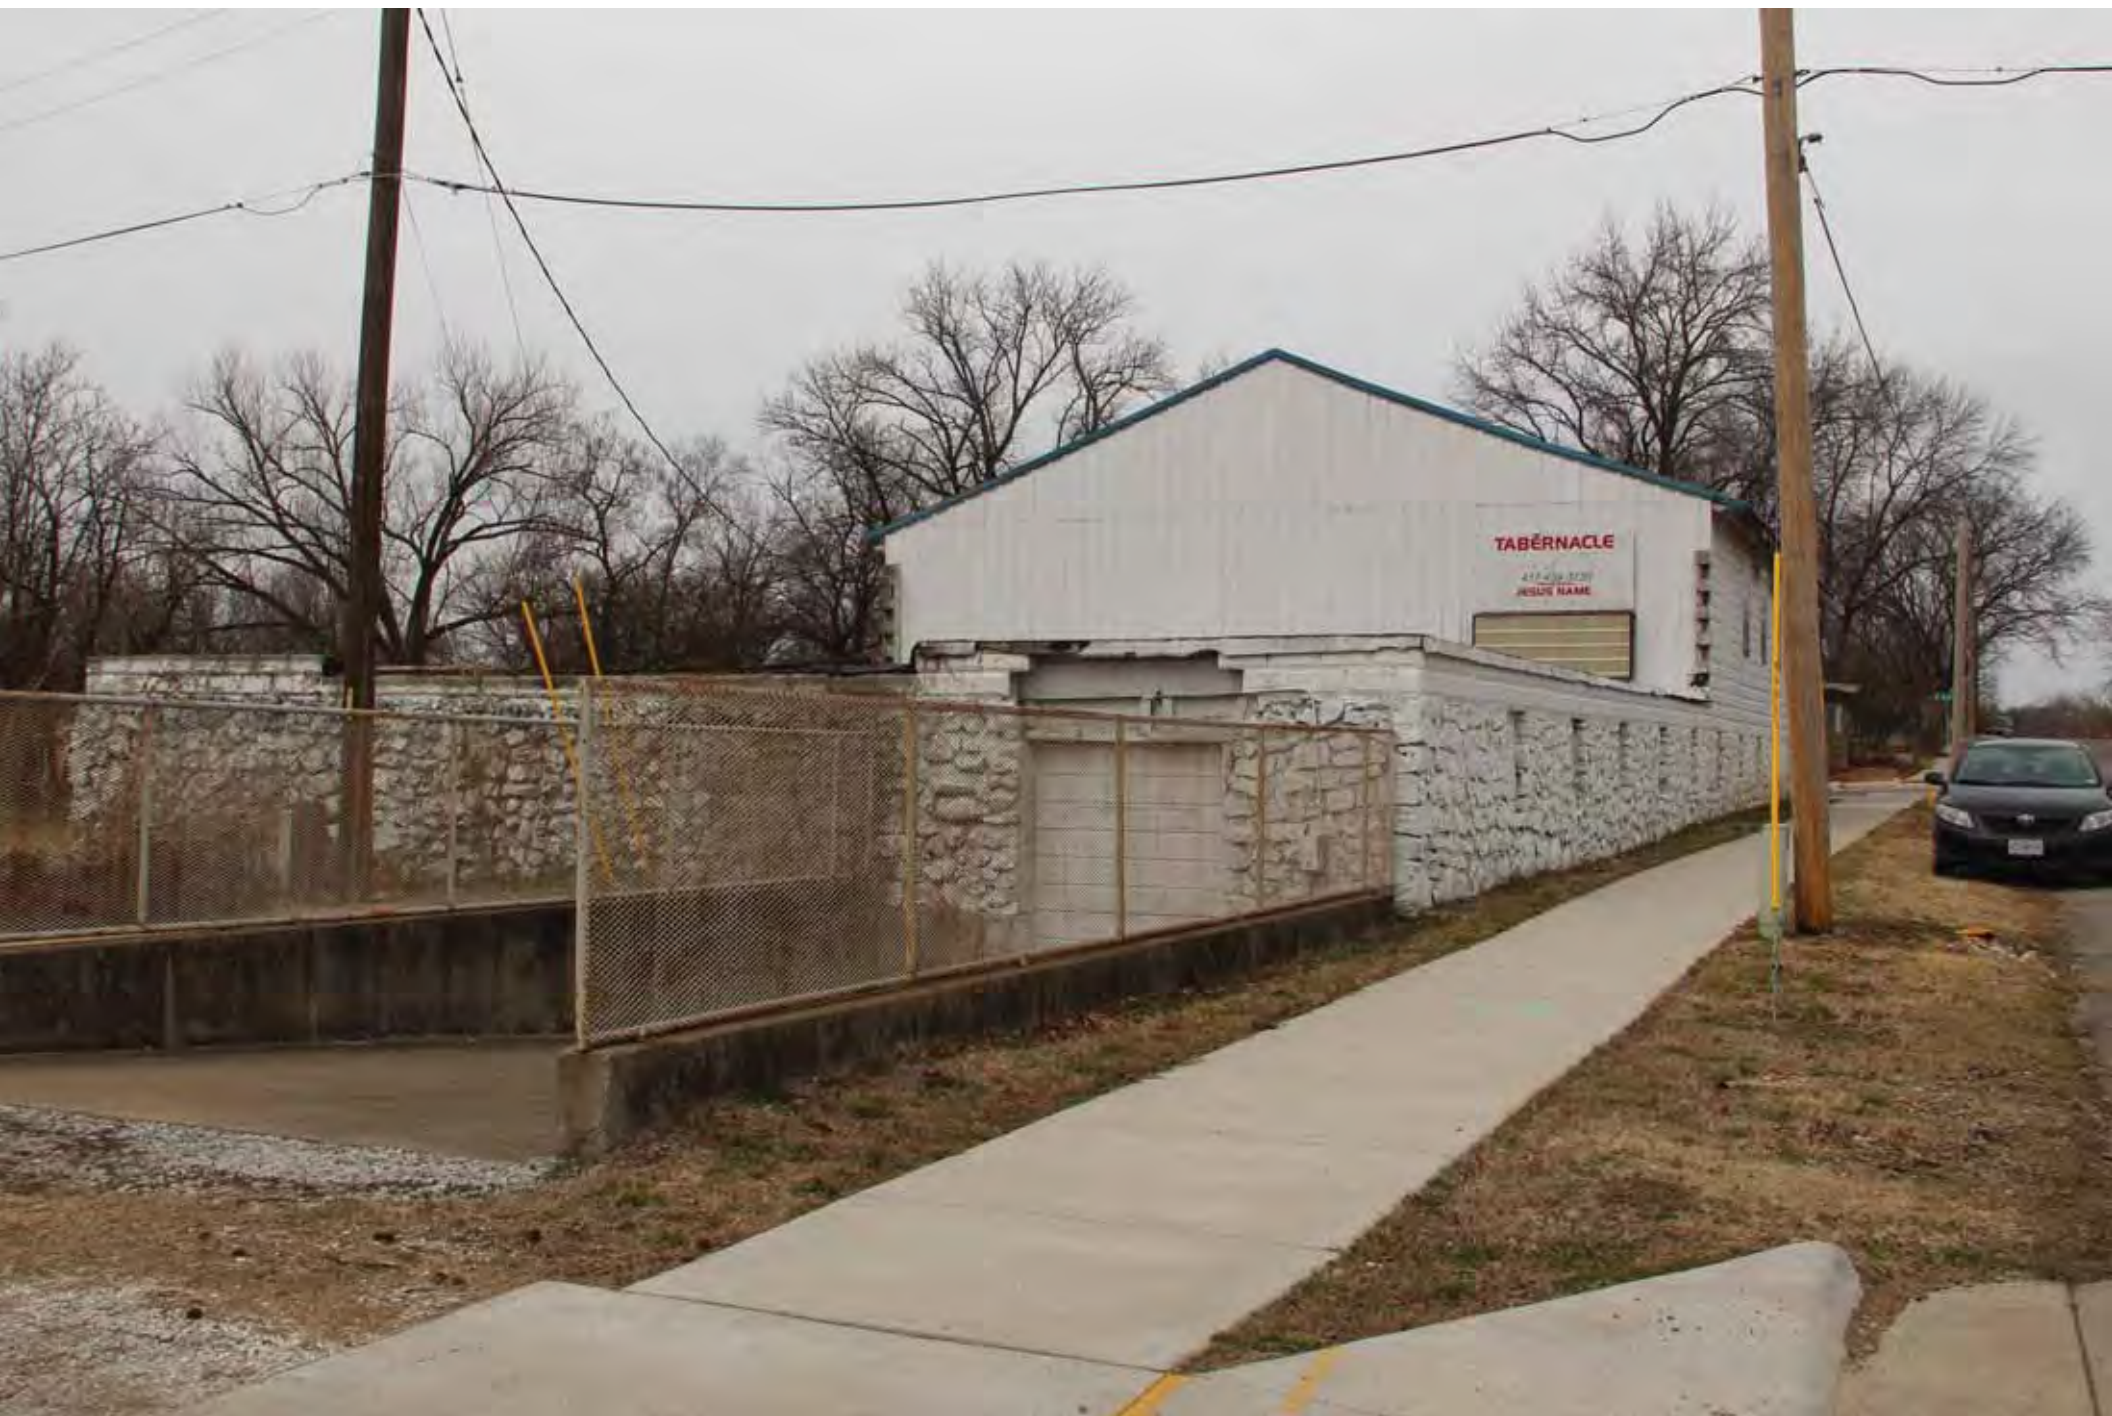
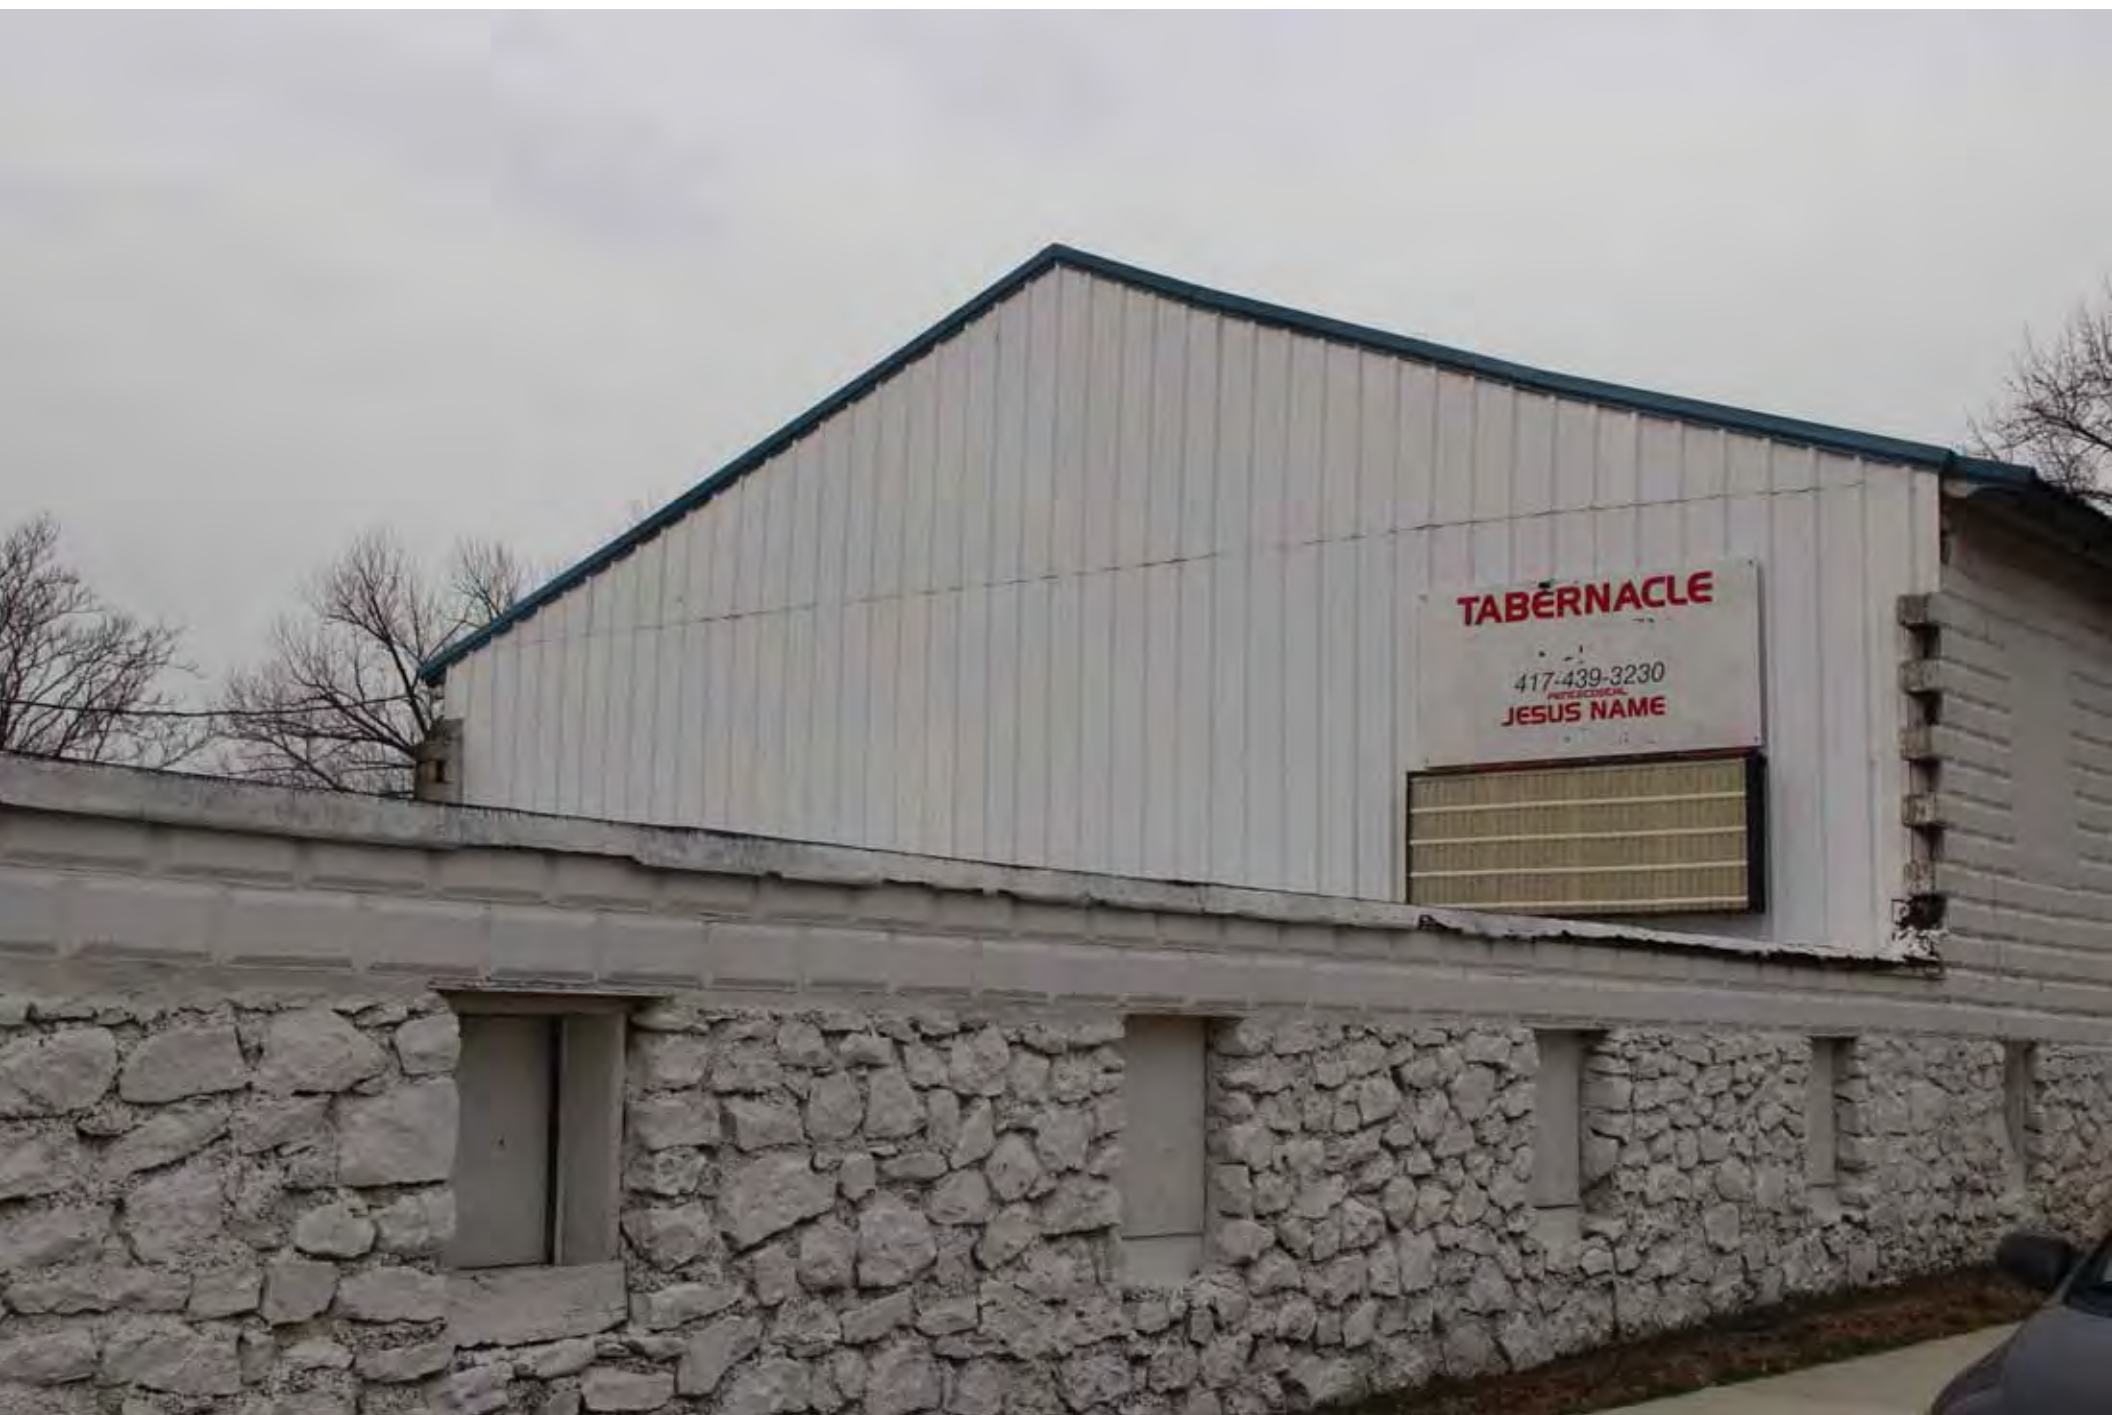
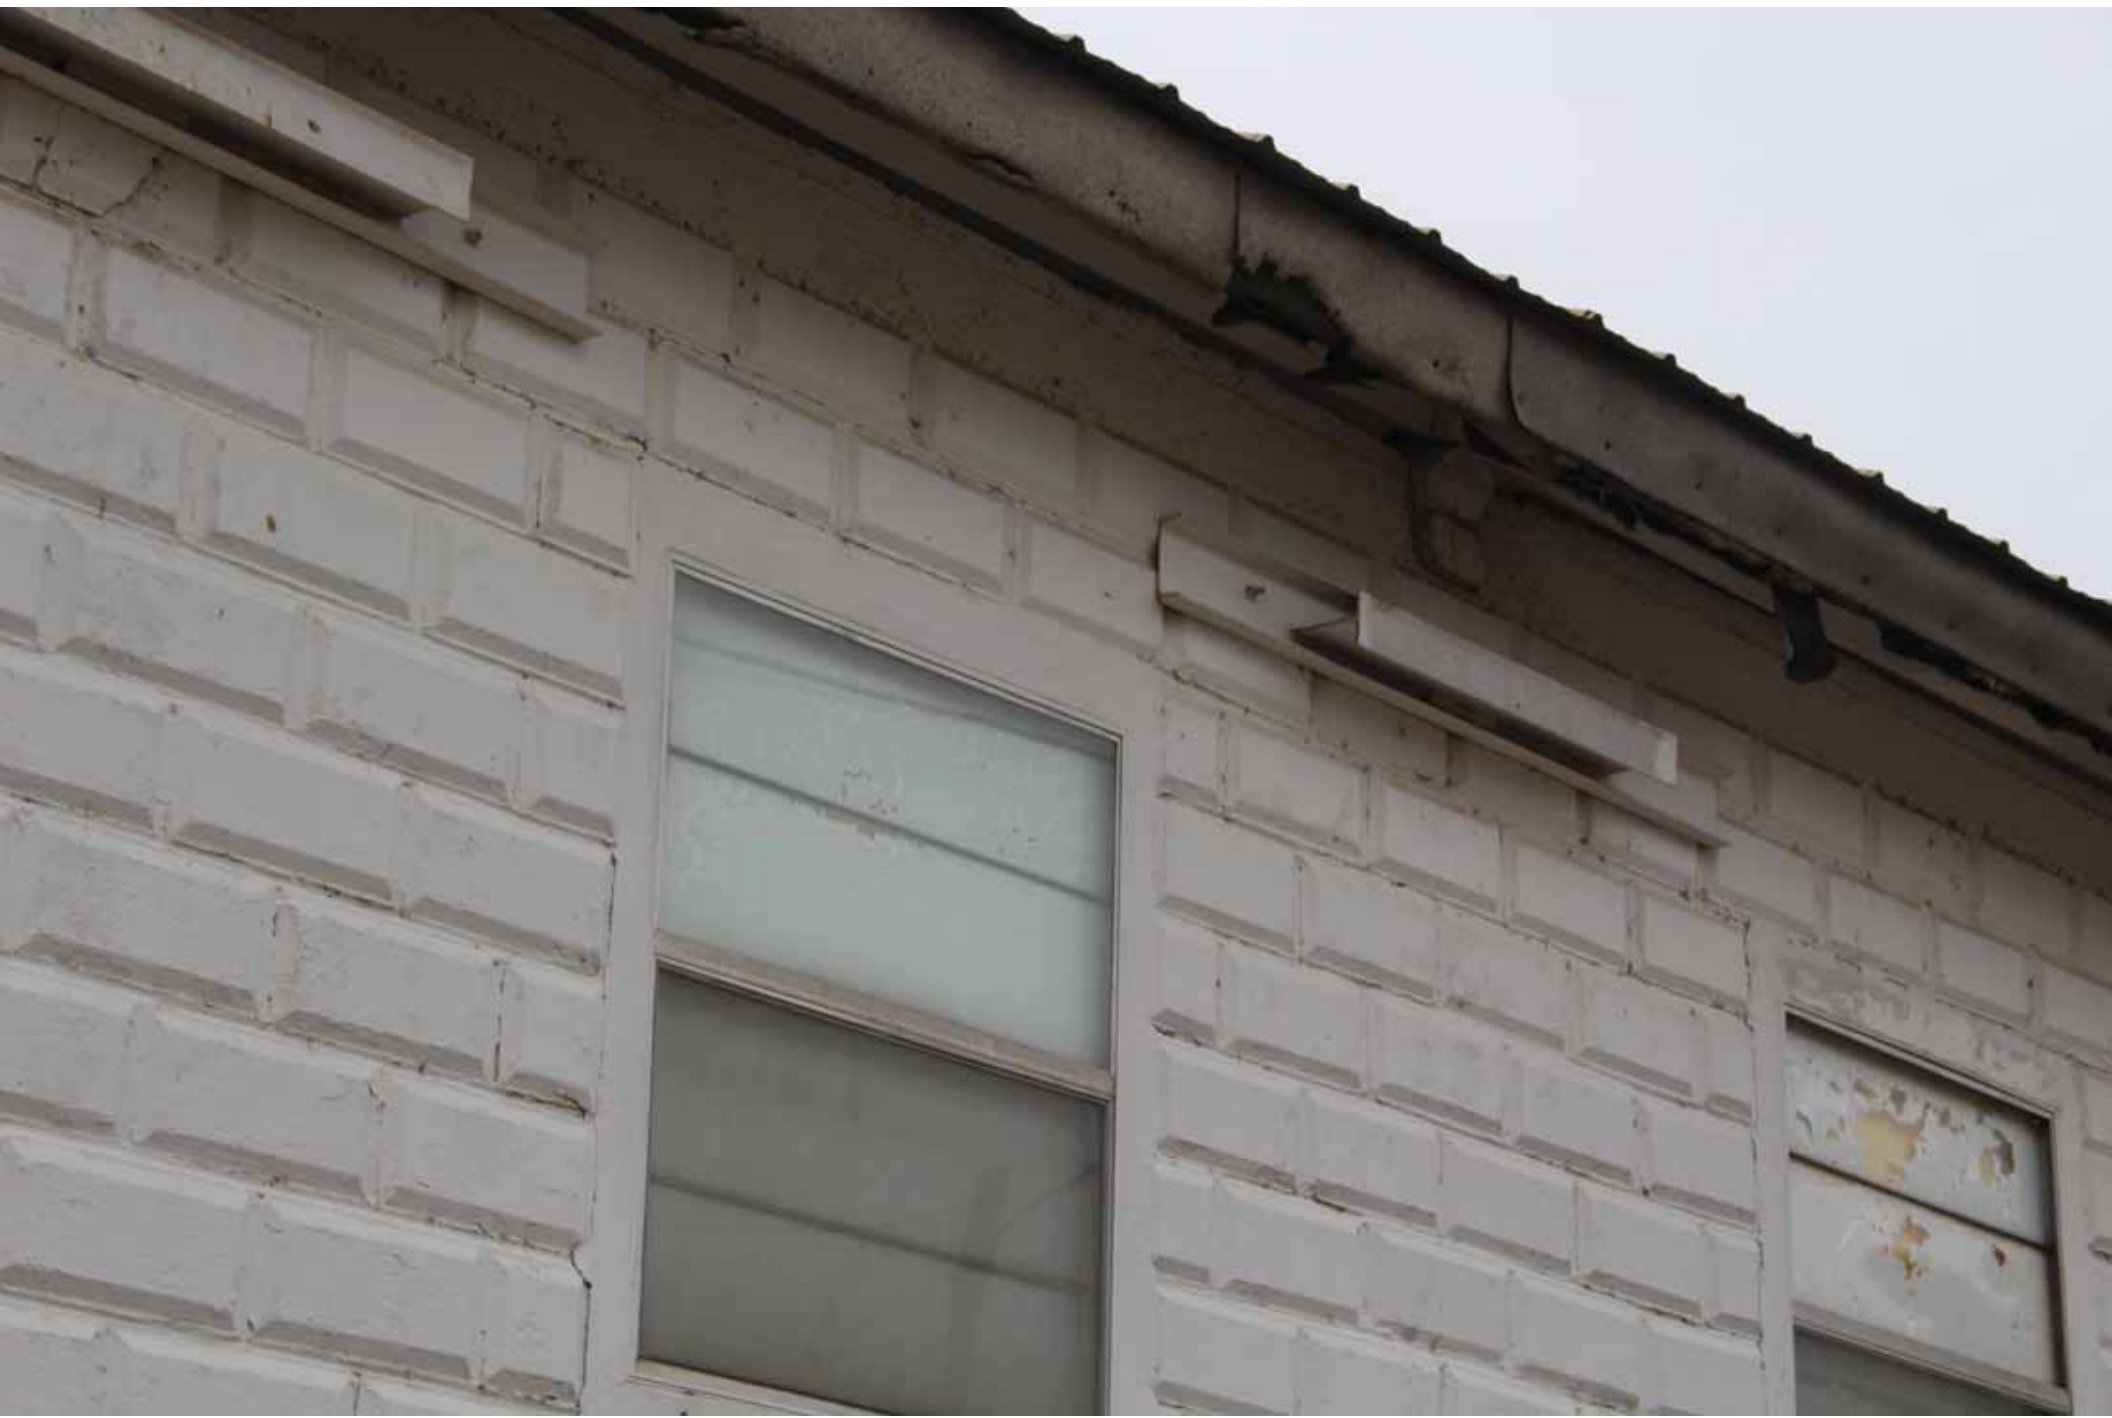
Additional information is sought to determine whether the church may have historical associations that would make this an important property to the East Town neighborhood. Due to the removal of a rear large wing (or so it appears), the building does not retain sufficient integrity to be individually eligible for the National Register of Historic Places. The church is not within an area recommended as a historic district.

The property at 1024 E. 2nd Street is a one-story frame church. It has a rubble stone foundation that has been painted. It has a rectangular plan with a front-facing gable roof. The building is frame with a wooden truss roof. At some point the exterior walls were covered with a brick veneer, and then painted. On the front façade is a front facing gable-roofed porch, accessed by concrete stairs on the east side. On the west side of the porch is a large wooden ramp. The porch shelters the entrance to the church, which is in the middle of the front façade. To the west of the porch is a single one-over-one replacement window. Along the side elevations are several replacement windows. At the rear of the building is a continuation of the stone foundation, with no building on top. The basement level is accessible however, and has a concrete drive and loading dock leading to a garage door on the rear elevation. The construction indicates that an older building may have been on the stone foundation, and the 1938 church replaced that building.
