MISSOURI DEPARTMENT OF NATURAL RESOURCES
STATE HISTORIC PRESERVATION OFFICE, P.O. Box 176, Jefferson City, MO 65102
ARCHITECTURAL/HISTORIC INVENTORY FORM

1. Survey No. JP-AS-007-001		2. Survey name: East Town (Original Joplin) Historic Survey Phase 2	
3. County: JASPER		4. Address (Street No.) 618	Street (name) E. 2 nd Street
5. City: Joplin	Vicinity: <input type="checkbox"/>	6. Geographical Reference:	7. Township/Range/Section: T: R: S:
8. Historic name (if known):		9. Present/other name (if known):	
10. Ownership: <input checked="" type="checkbox"/> Private <input type="checkbox"/> Public		11a. Historic use (if known): Domestic: Single Dwelling	11b. Current use: Domestic: Single Dwelling

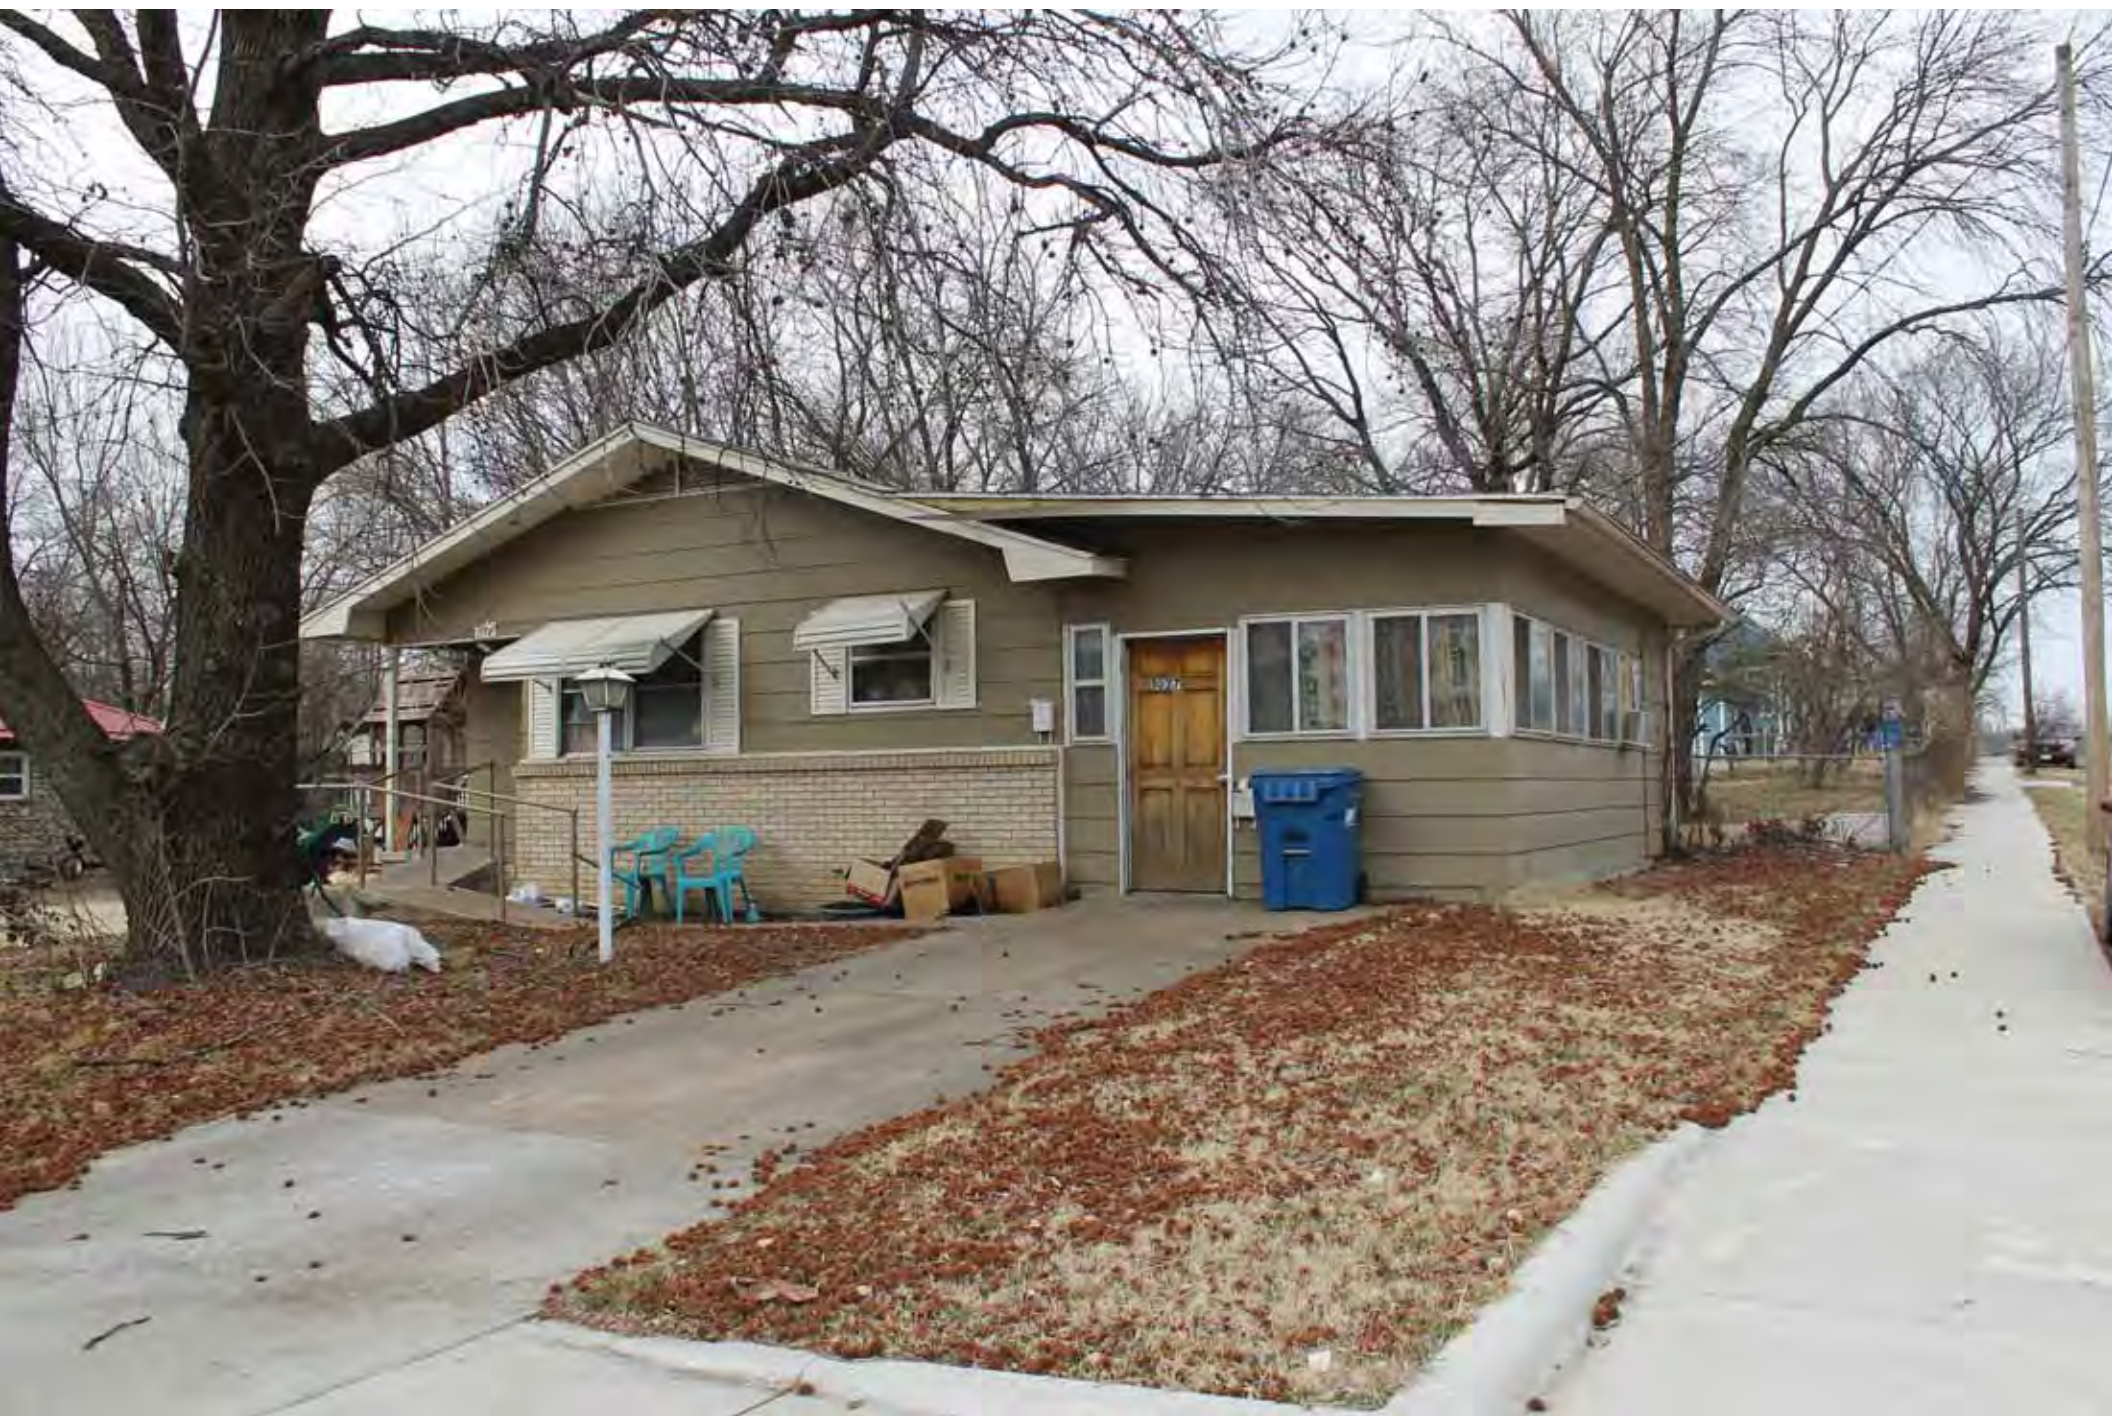
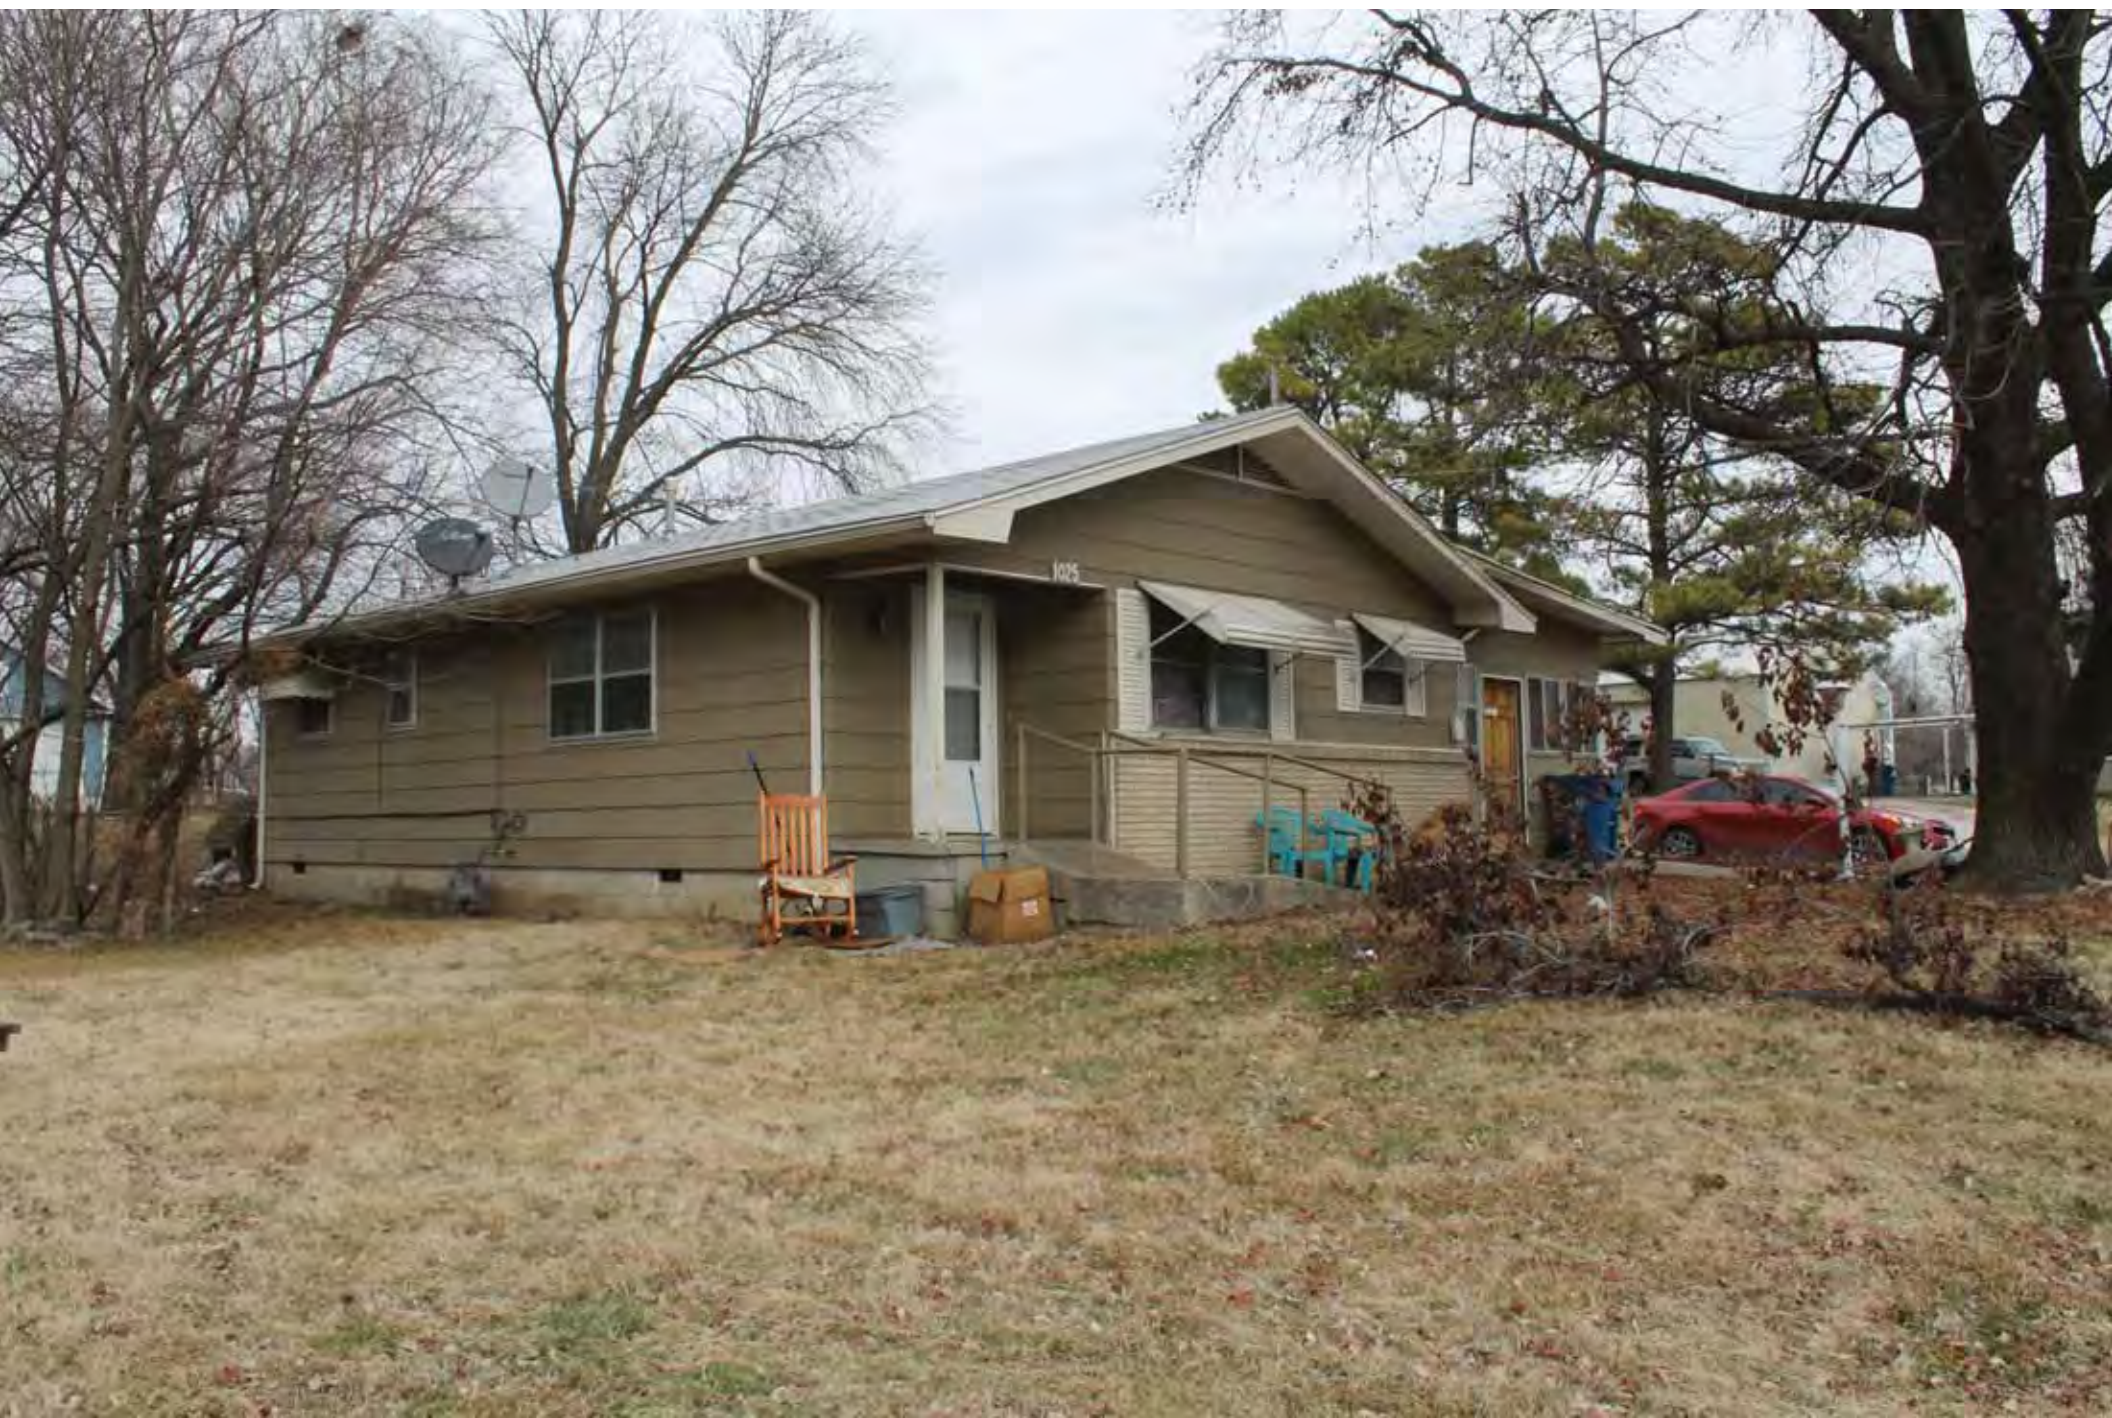
The dwelling does not retain enough integrity to be individually eligible for the National Register of Historic Places. The dwelling is not situated in an area recommended as a historic district.

The property at 1027 E. 2nd Street is a one-story frame house. It does not appear in the Jasper County records, but the main portion of the house appears to have been built c. 1960. It is a frame house with a medium-pitched front facing gable roof with returned eaves. On the east side of the house is a shed-roof addition, which likely is an enclosed carport. A concrete walkway and ramp leads to the front entrance of the house, which is recessed at the southwest corner on the front elevation. On the original portion of the house are two fixed windows, with non-functioning metal shutters and metal awnings. Below these windows the front façade is covered in a decorative brick veneer. The enclosed addition to the east has a single wooden door between a ribbon of small fixed windows. This ribbon of windows continues on the side, or east elevation of the house.

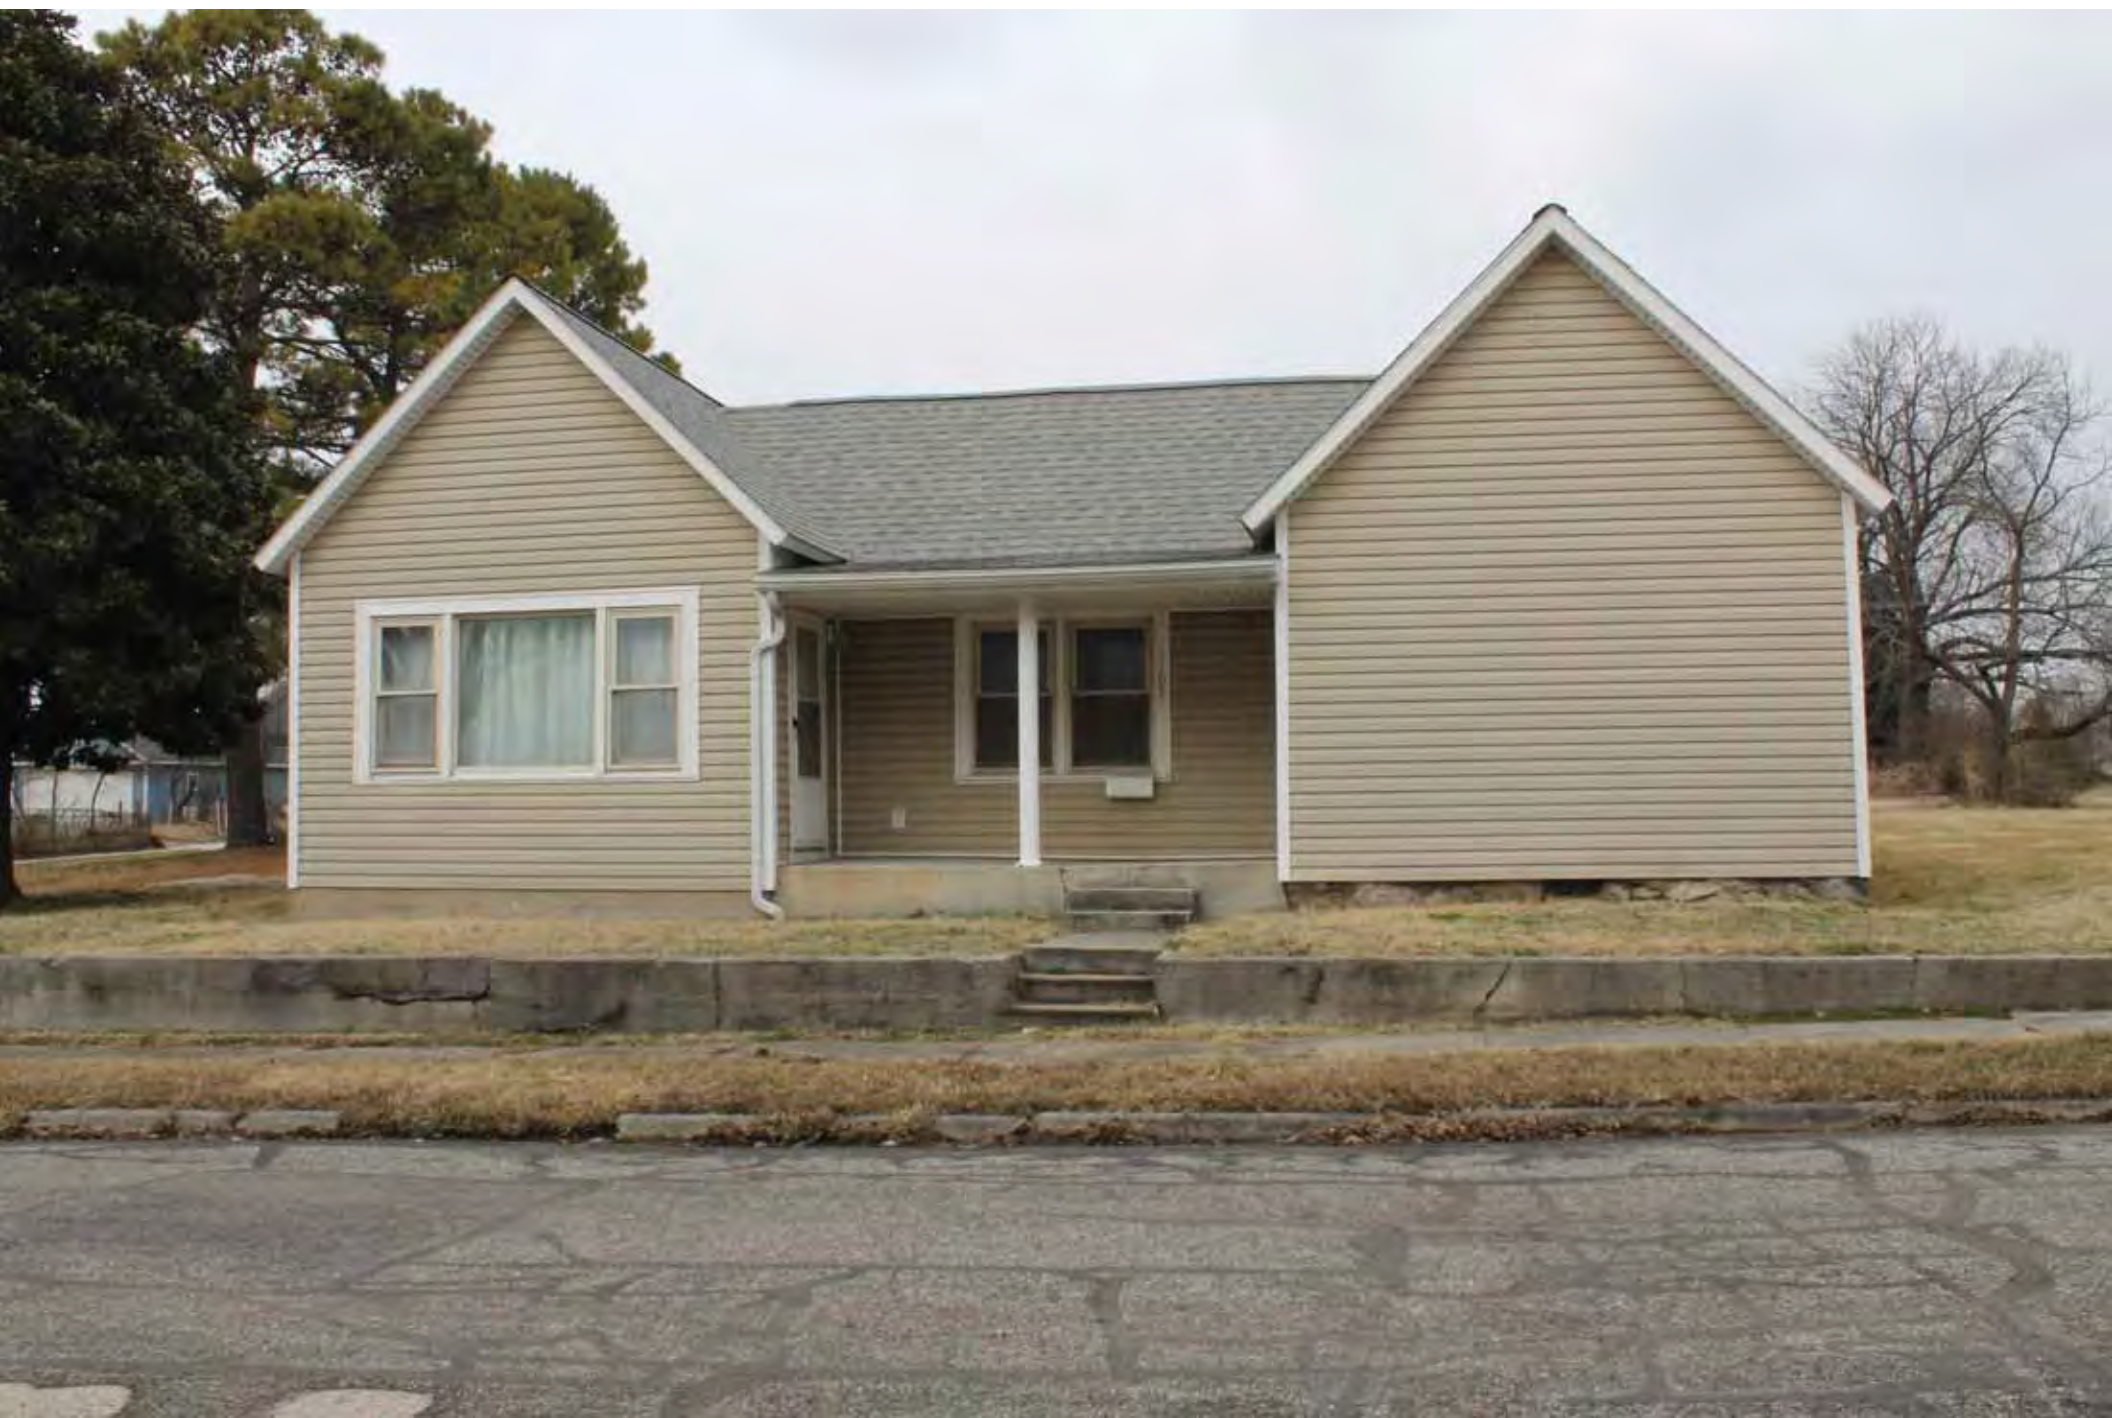
The dwelling has been extensively altered through the addition of c. 2019 exterior siding (vinyl) and replacement of original windows. Additionally, the dwelling appears to have been enlarged since 1950 (per Sanborn map). Due to the lack of exterior original siding and extensive remodeling in recent years, the dwelling does not retain integrity that would render it individually eligible for the National Register of Historic Places. The dwelling is not situated in an area recommended as a historic district.

The property 1105 E. 2nd Street features a single-story dwelling with an asphalt-shingled side gable roof. At either end of the dwelling (east/west) are front-gabled wings. The foundation at the east end of the dwelling is stone rubble, indicating this is the earliest part of the house. The remaining foundation is poured concrete. The dwelling has exterior vinyl siding and windows are replacement one-over-one. The west (newer) wing holds a picture style window on the primary (south) elevation. The central wing, which connects the east and west wings, is set back, creating a recessed central porch. Primary entrance to the dwelling is on the east wall facing the porch area. A contemporary storm door fills the bay. The south wall of the porch recess holds paired one-over-one windows. There is no fenestration on the primary (south) elevation of the east wing. Remaining windows are one-over-one and fixed sash single-light design.

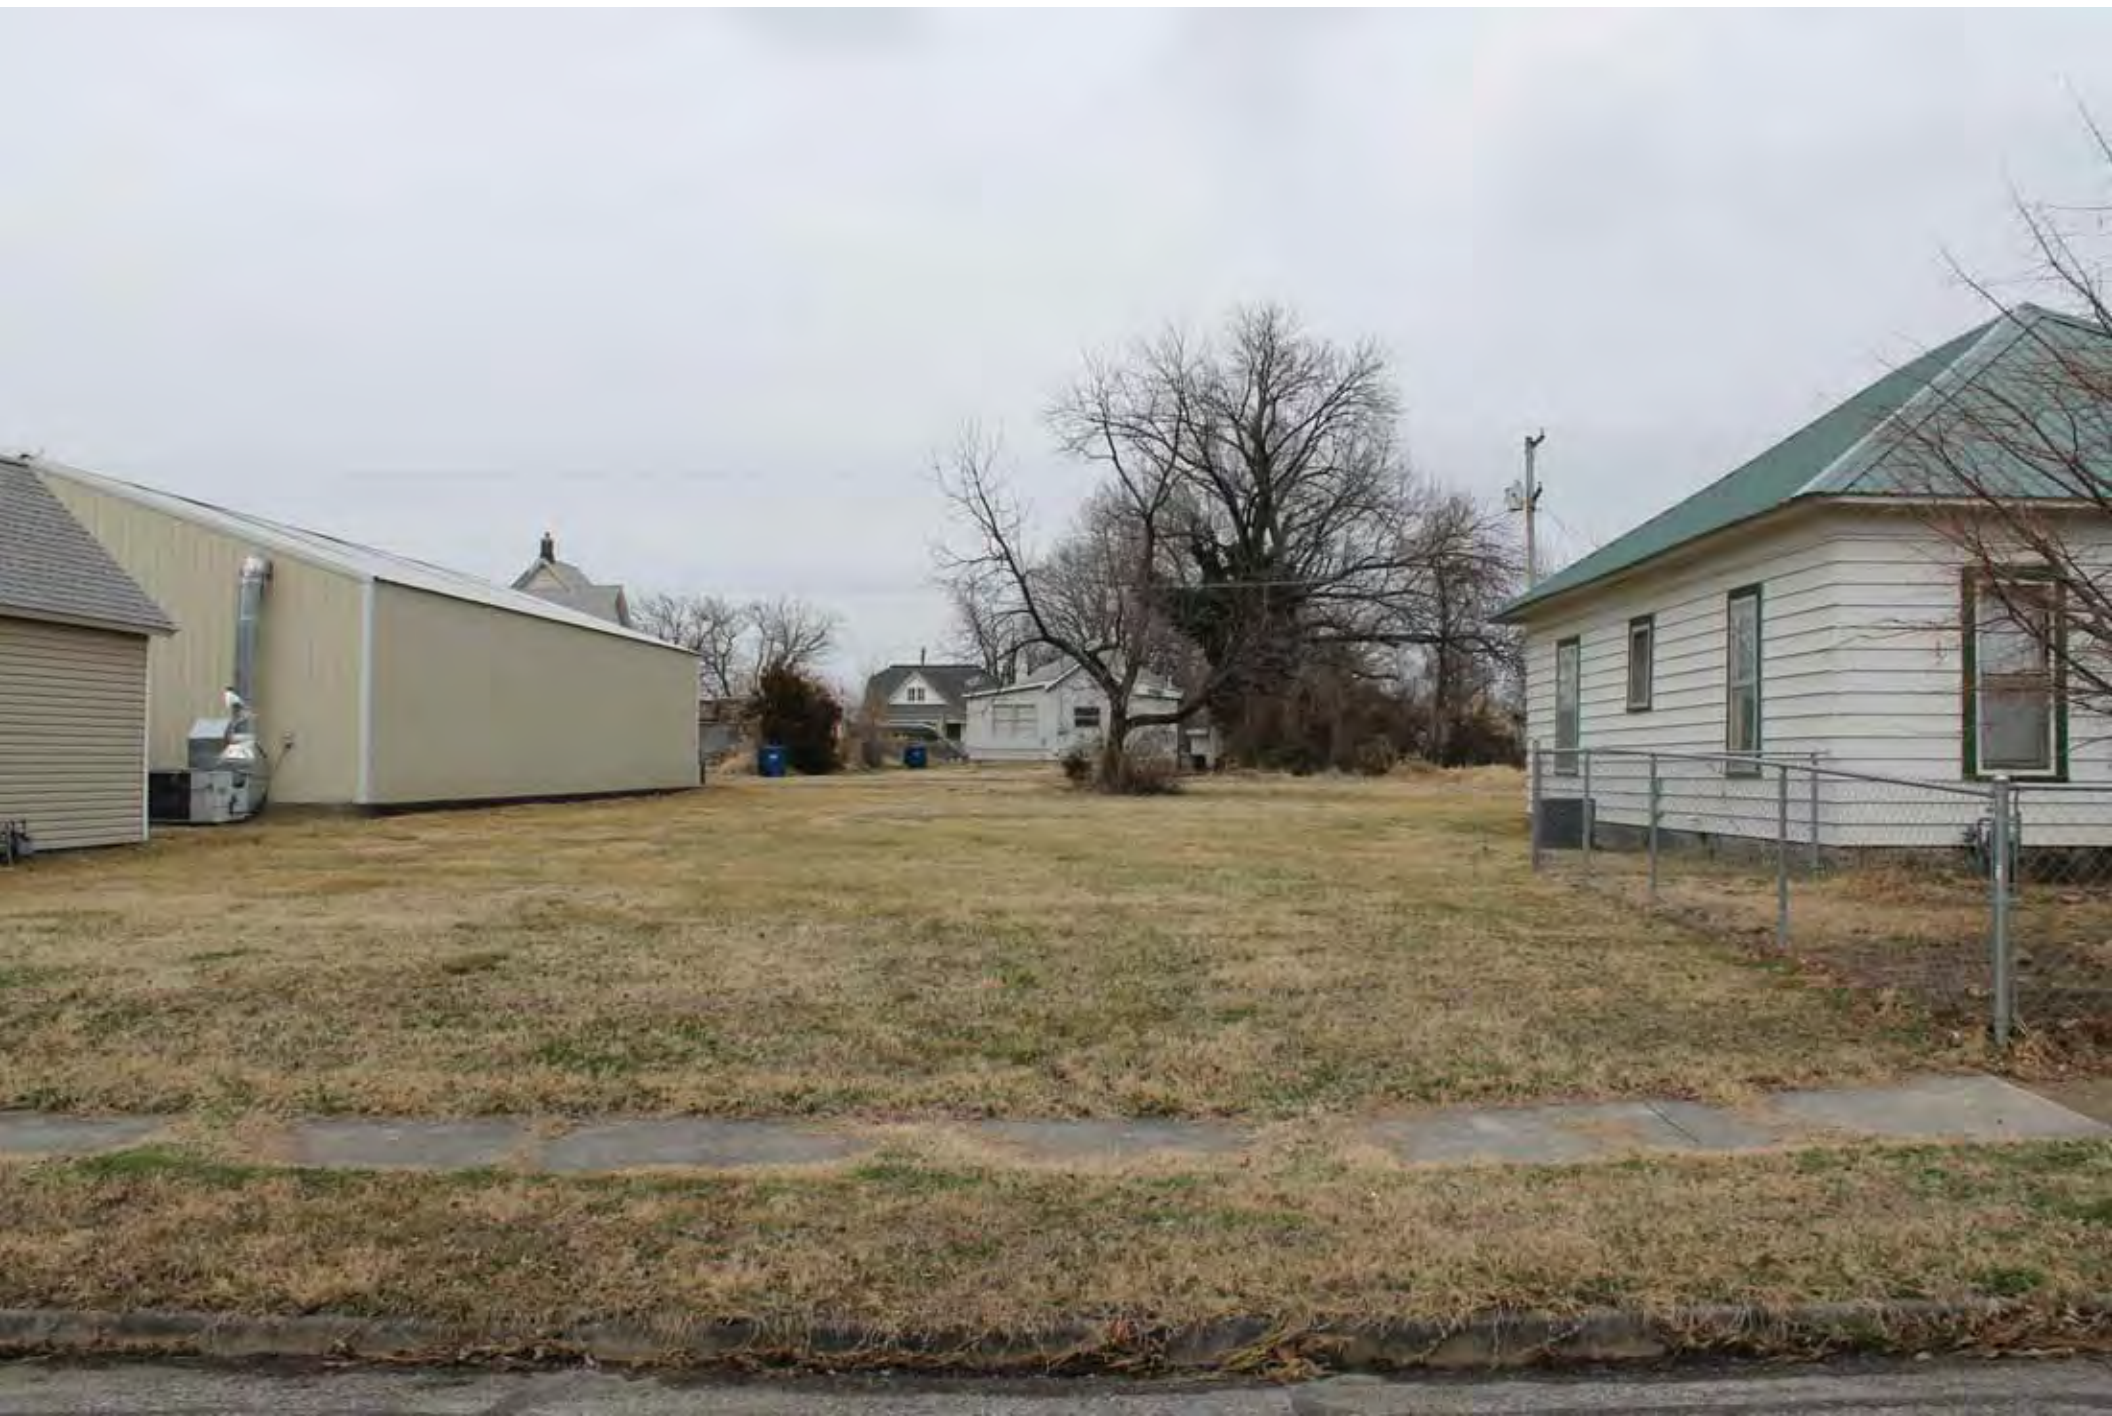
The property 1107 E. 2nd Street is a vacant lot covered with grass. A chain link fence associated with the dwelling on the east bounds the southeast end of the lot. A single mature tree is situated near the south end of the lot adjacent to the alley.
