MISSOURI DEPARTMENT OF NATURAL RESOURCES
STATE HISTORIC PRESERVATION OFFICE, P.O. Box 176, Jefferson City, MO 65102
ARCHITECTURAL/HISTORIC INVENTORY FORM

1. Survey No. JP-AS-007-001		2. Survey name: East Town (Original Joplin) Historic Survey Phase 2	
3. County: JASPER		4. Address (Street No.) 618	Street (name) E. 2 nd Street
5. City: Joplin	Vicinity: <input type="checkbox"/>	6. Geographical Reference:	7. Township/Range/Section: T: R: S:
8. Historic name (if known):		9. Present/other name (if known):	
10. Ownership: <input checked="" type="checkbox"/> Private <input type="checkbox"/> Public		11a. Historic use (if known): Domestic: Single Dwelling	11b. Current use: Domestic: Single Dwelling

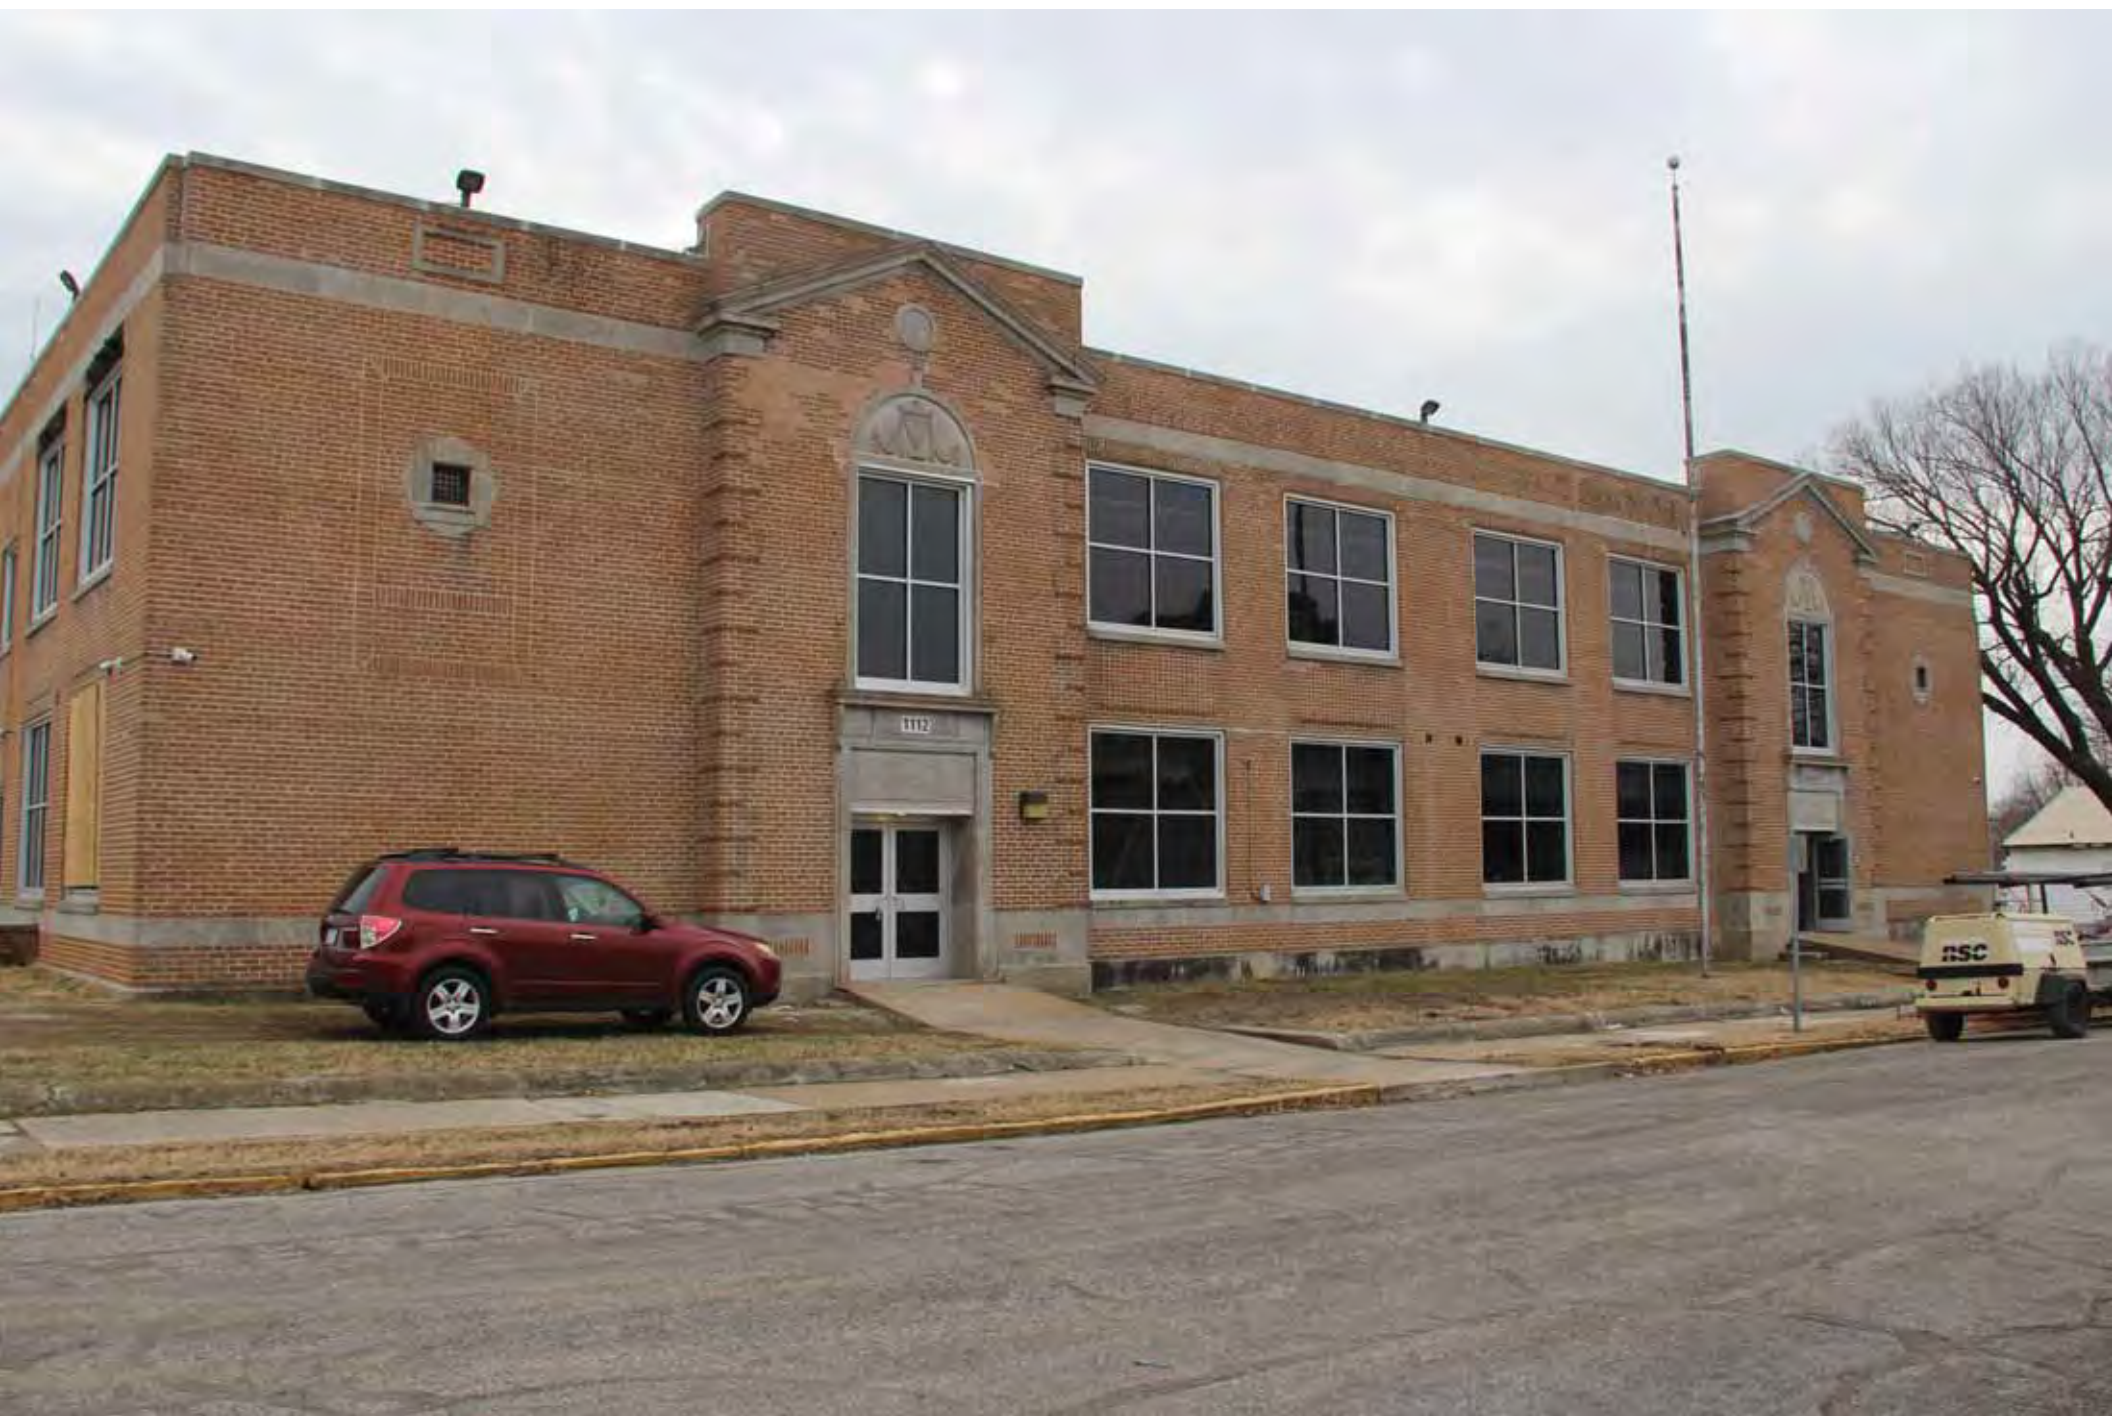
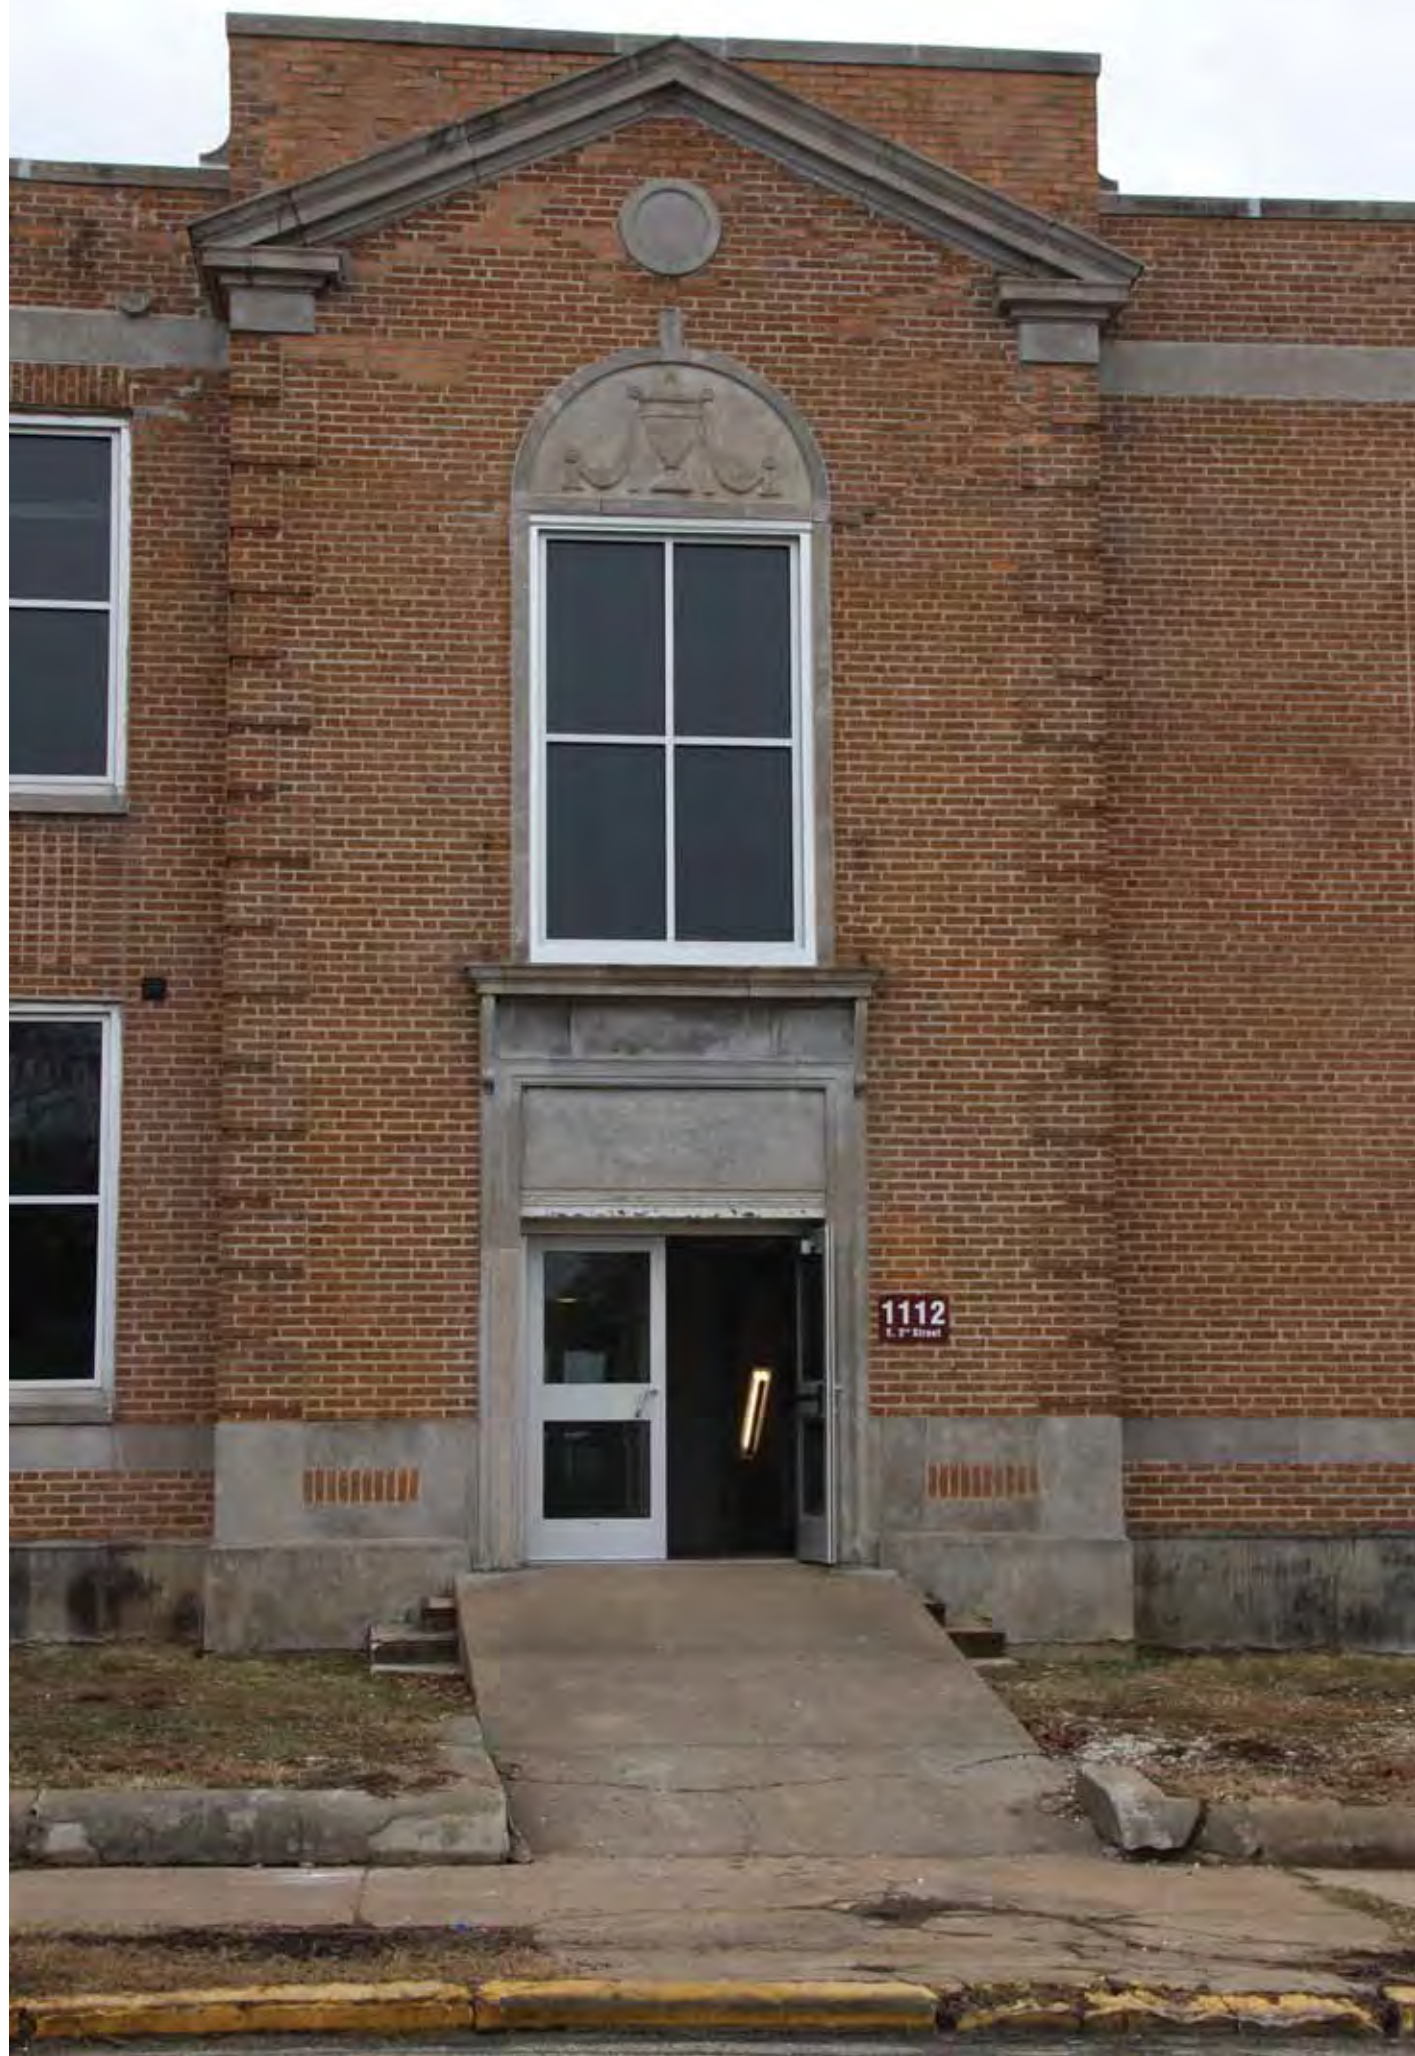
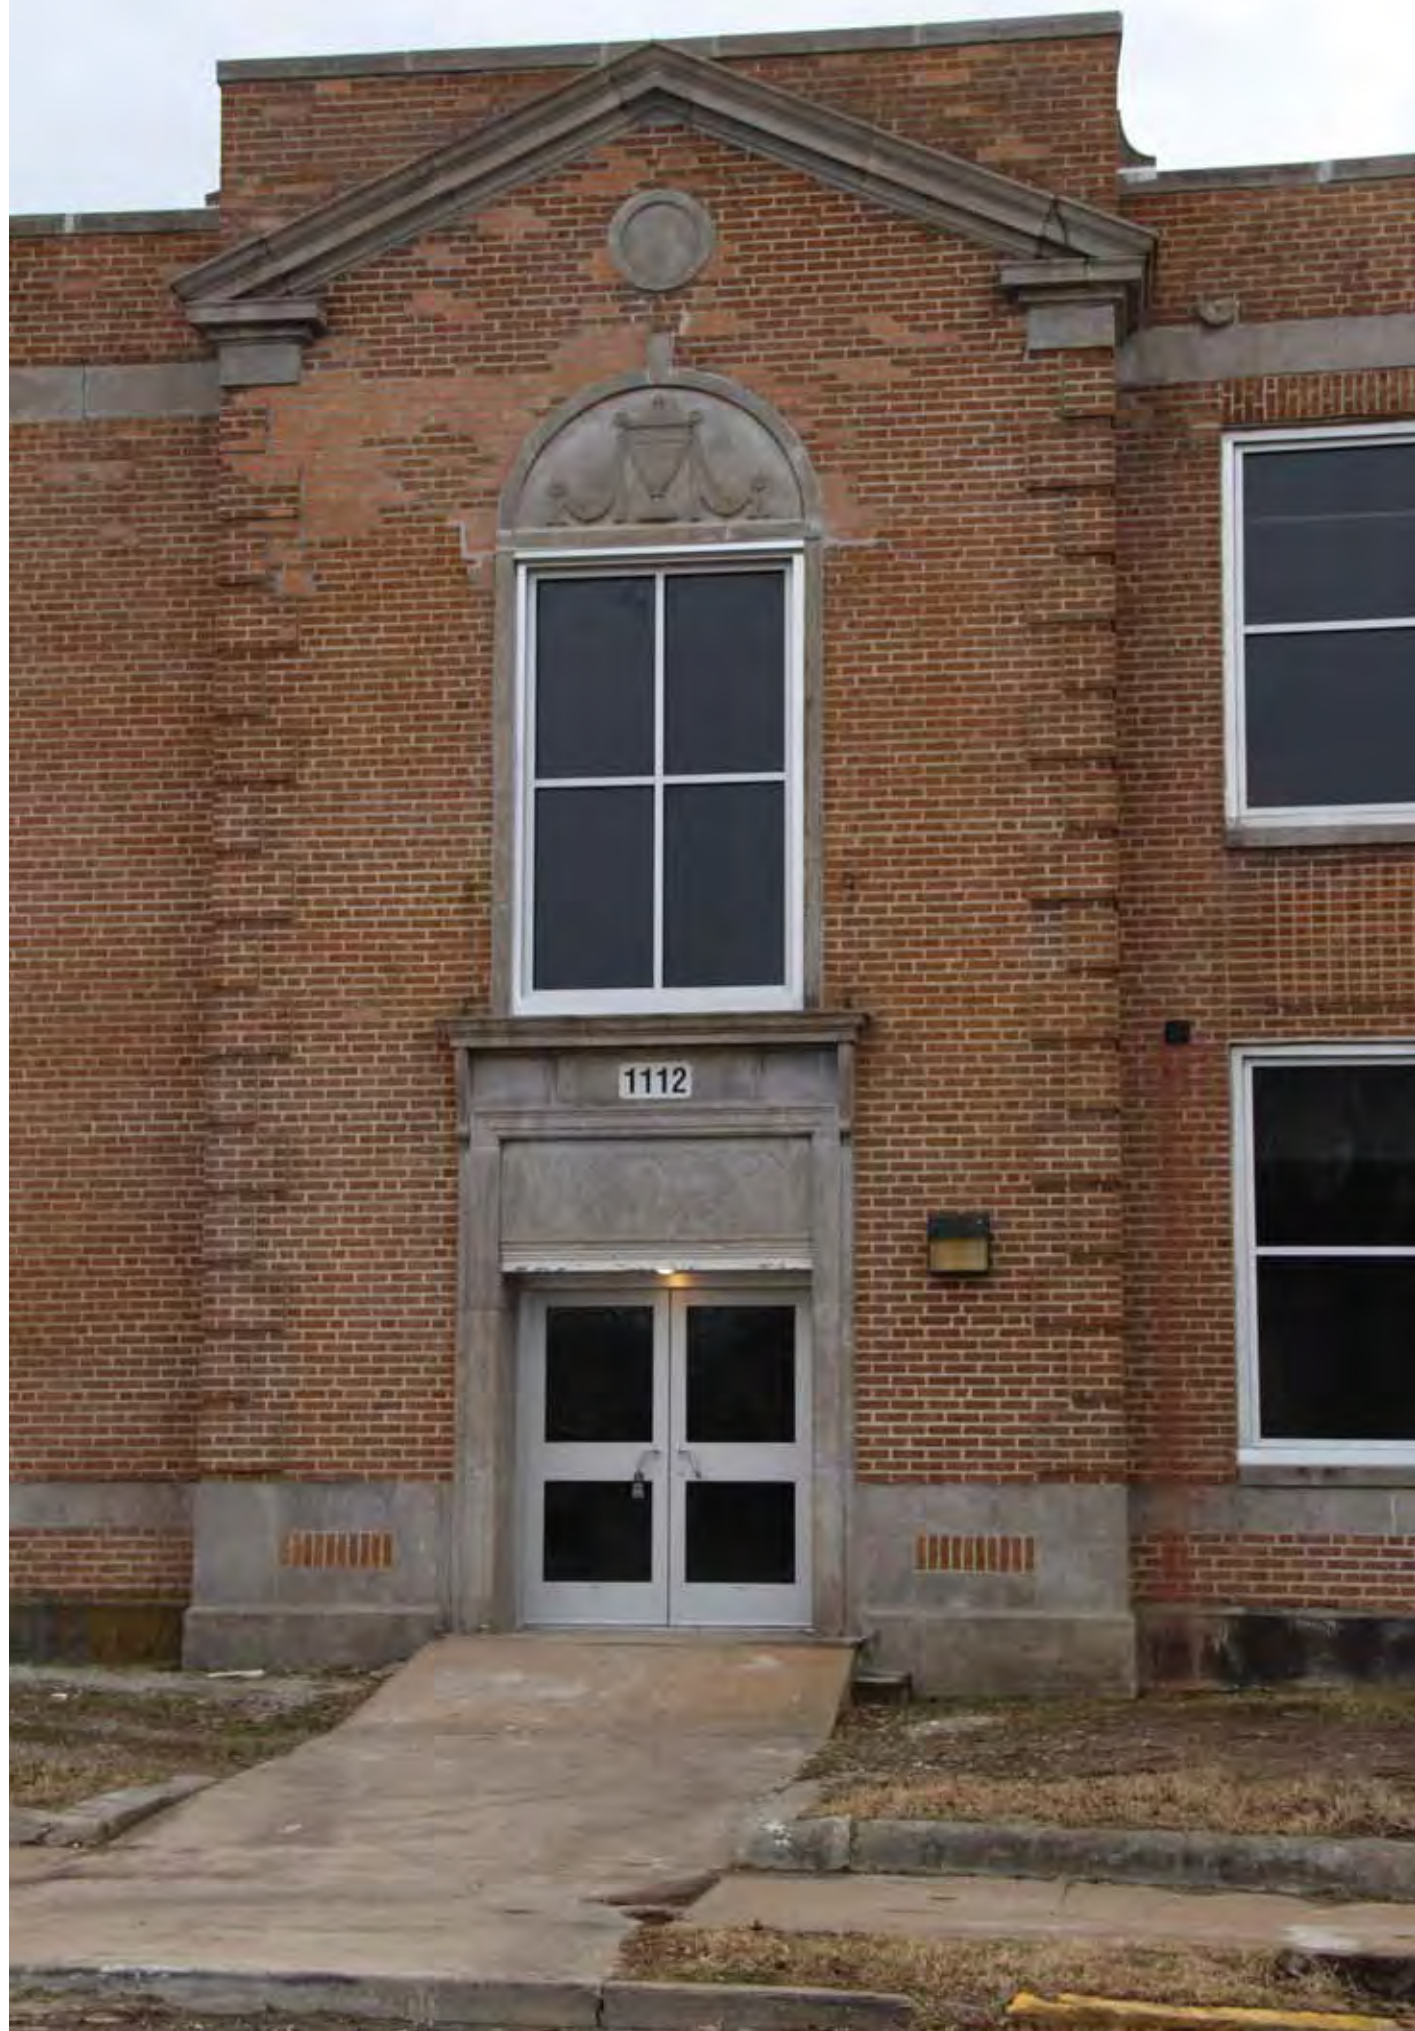
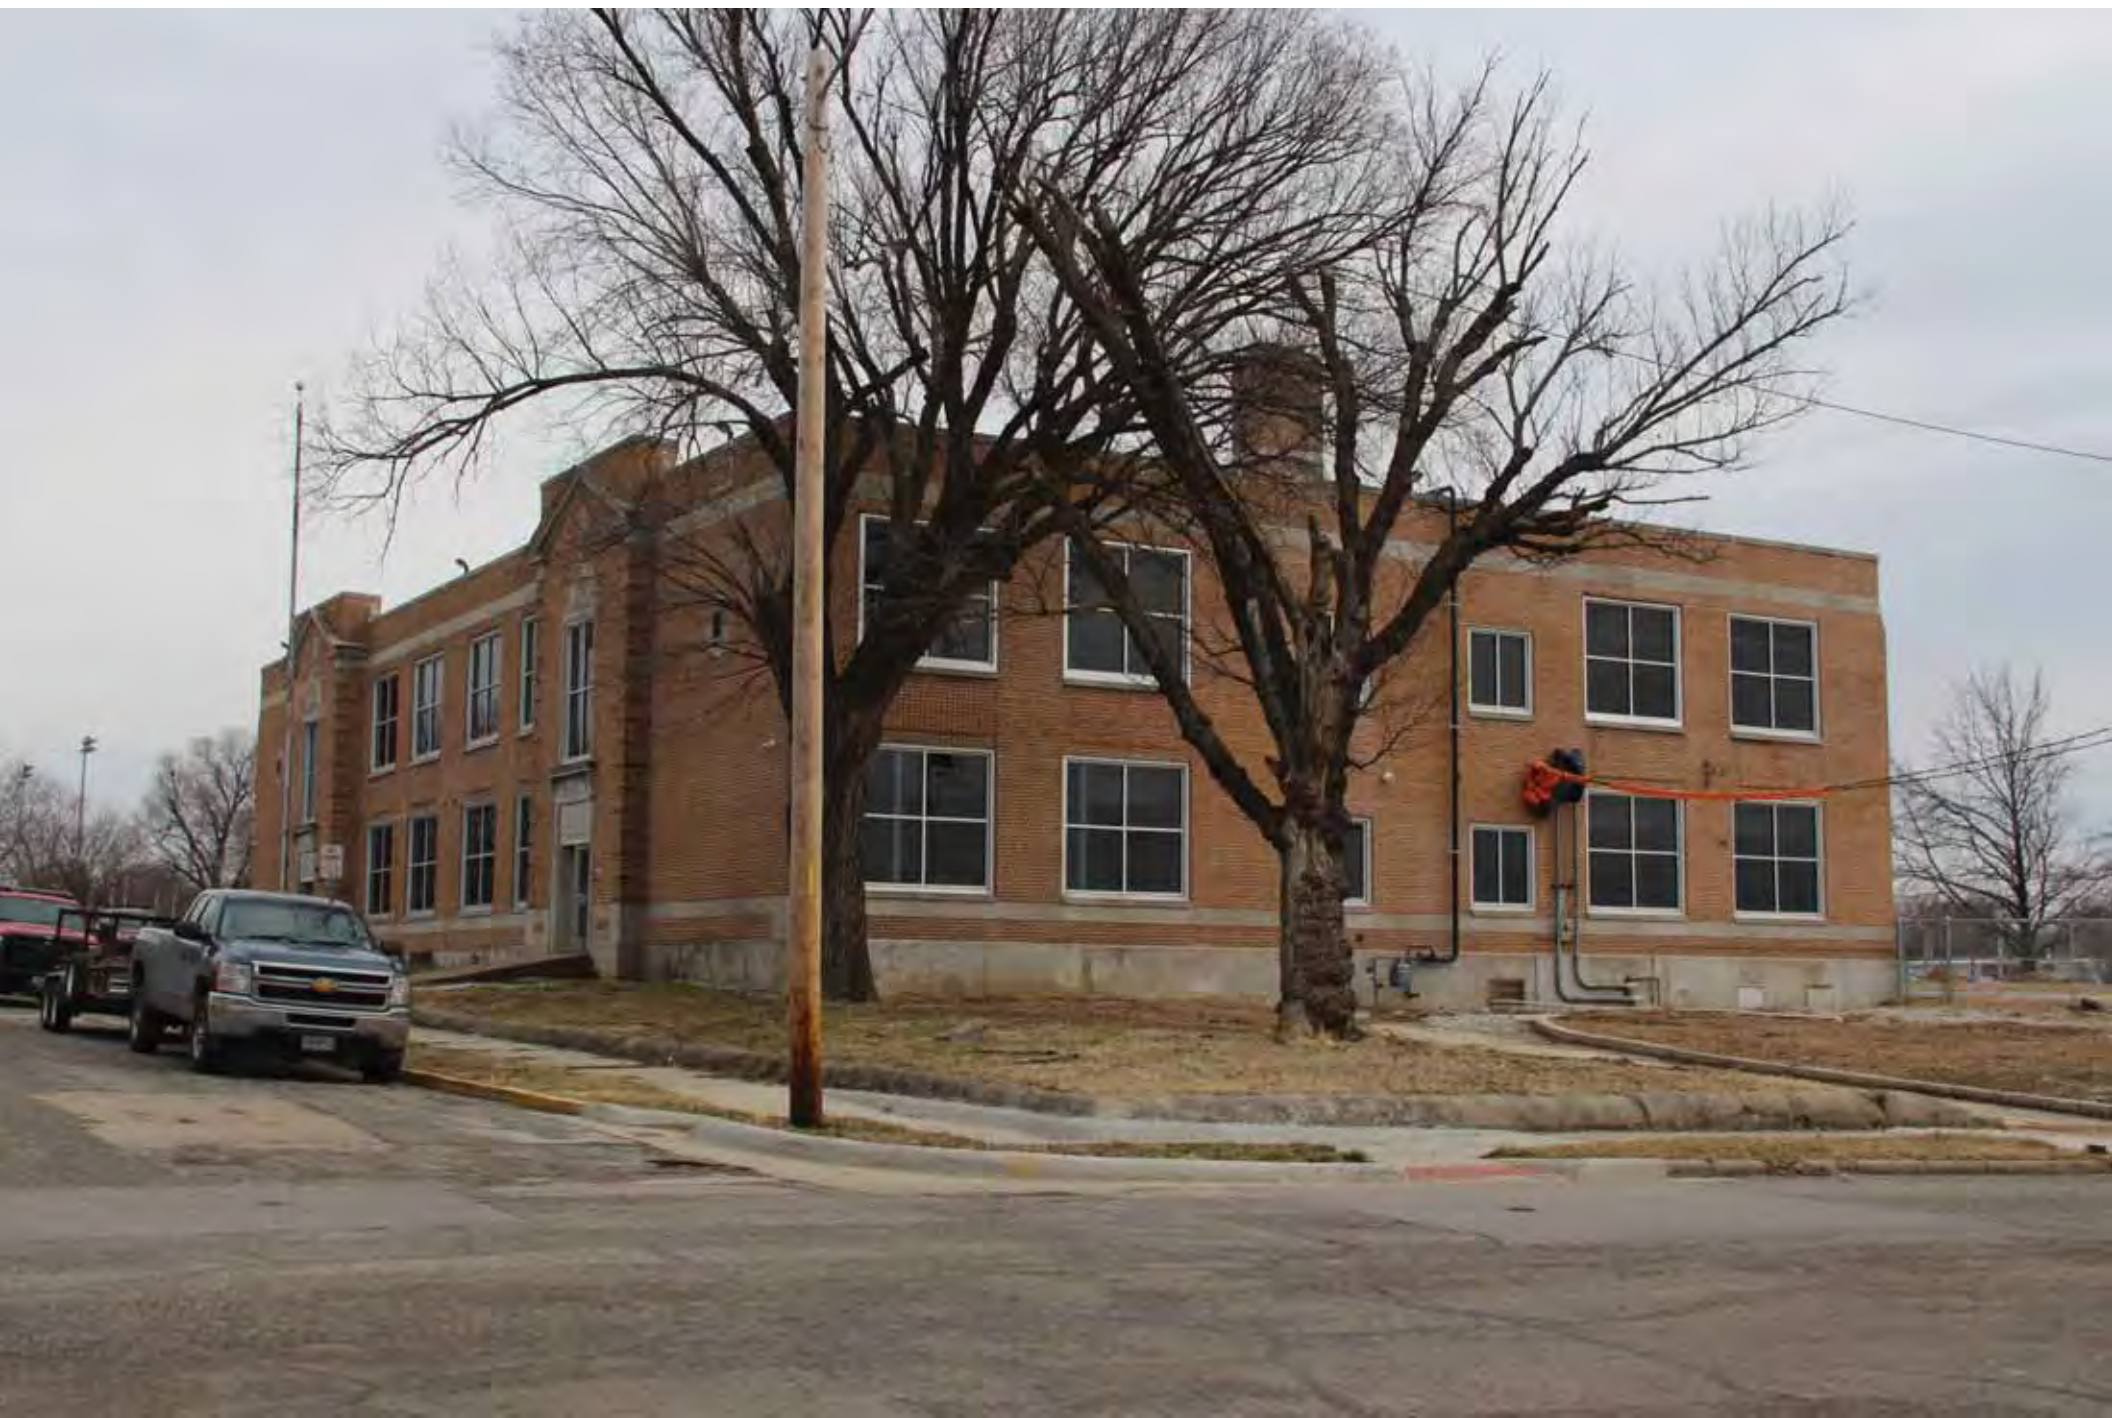
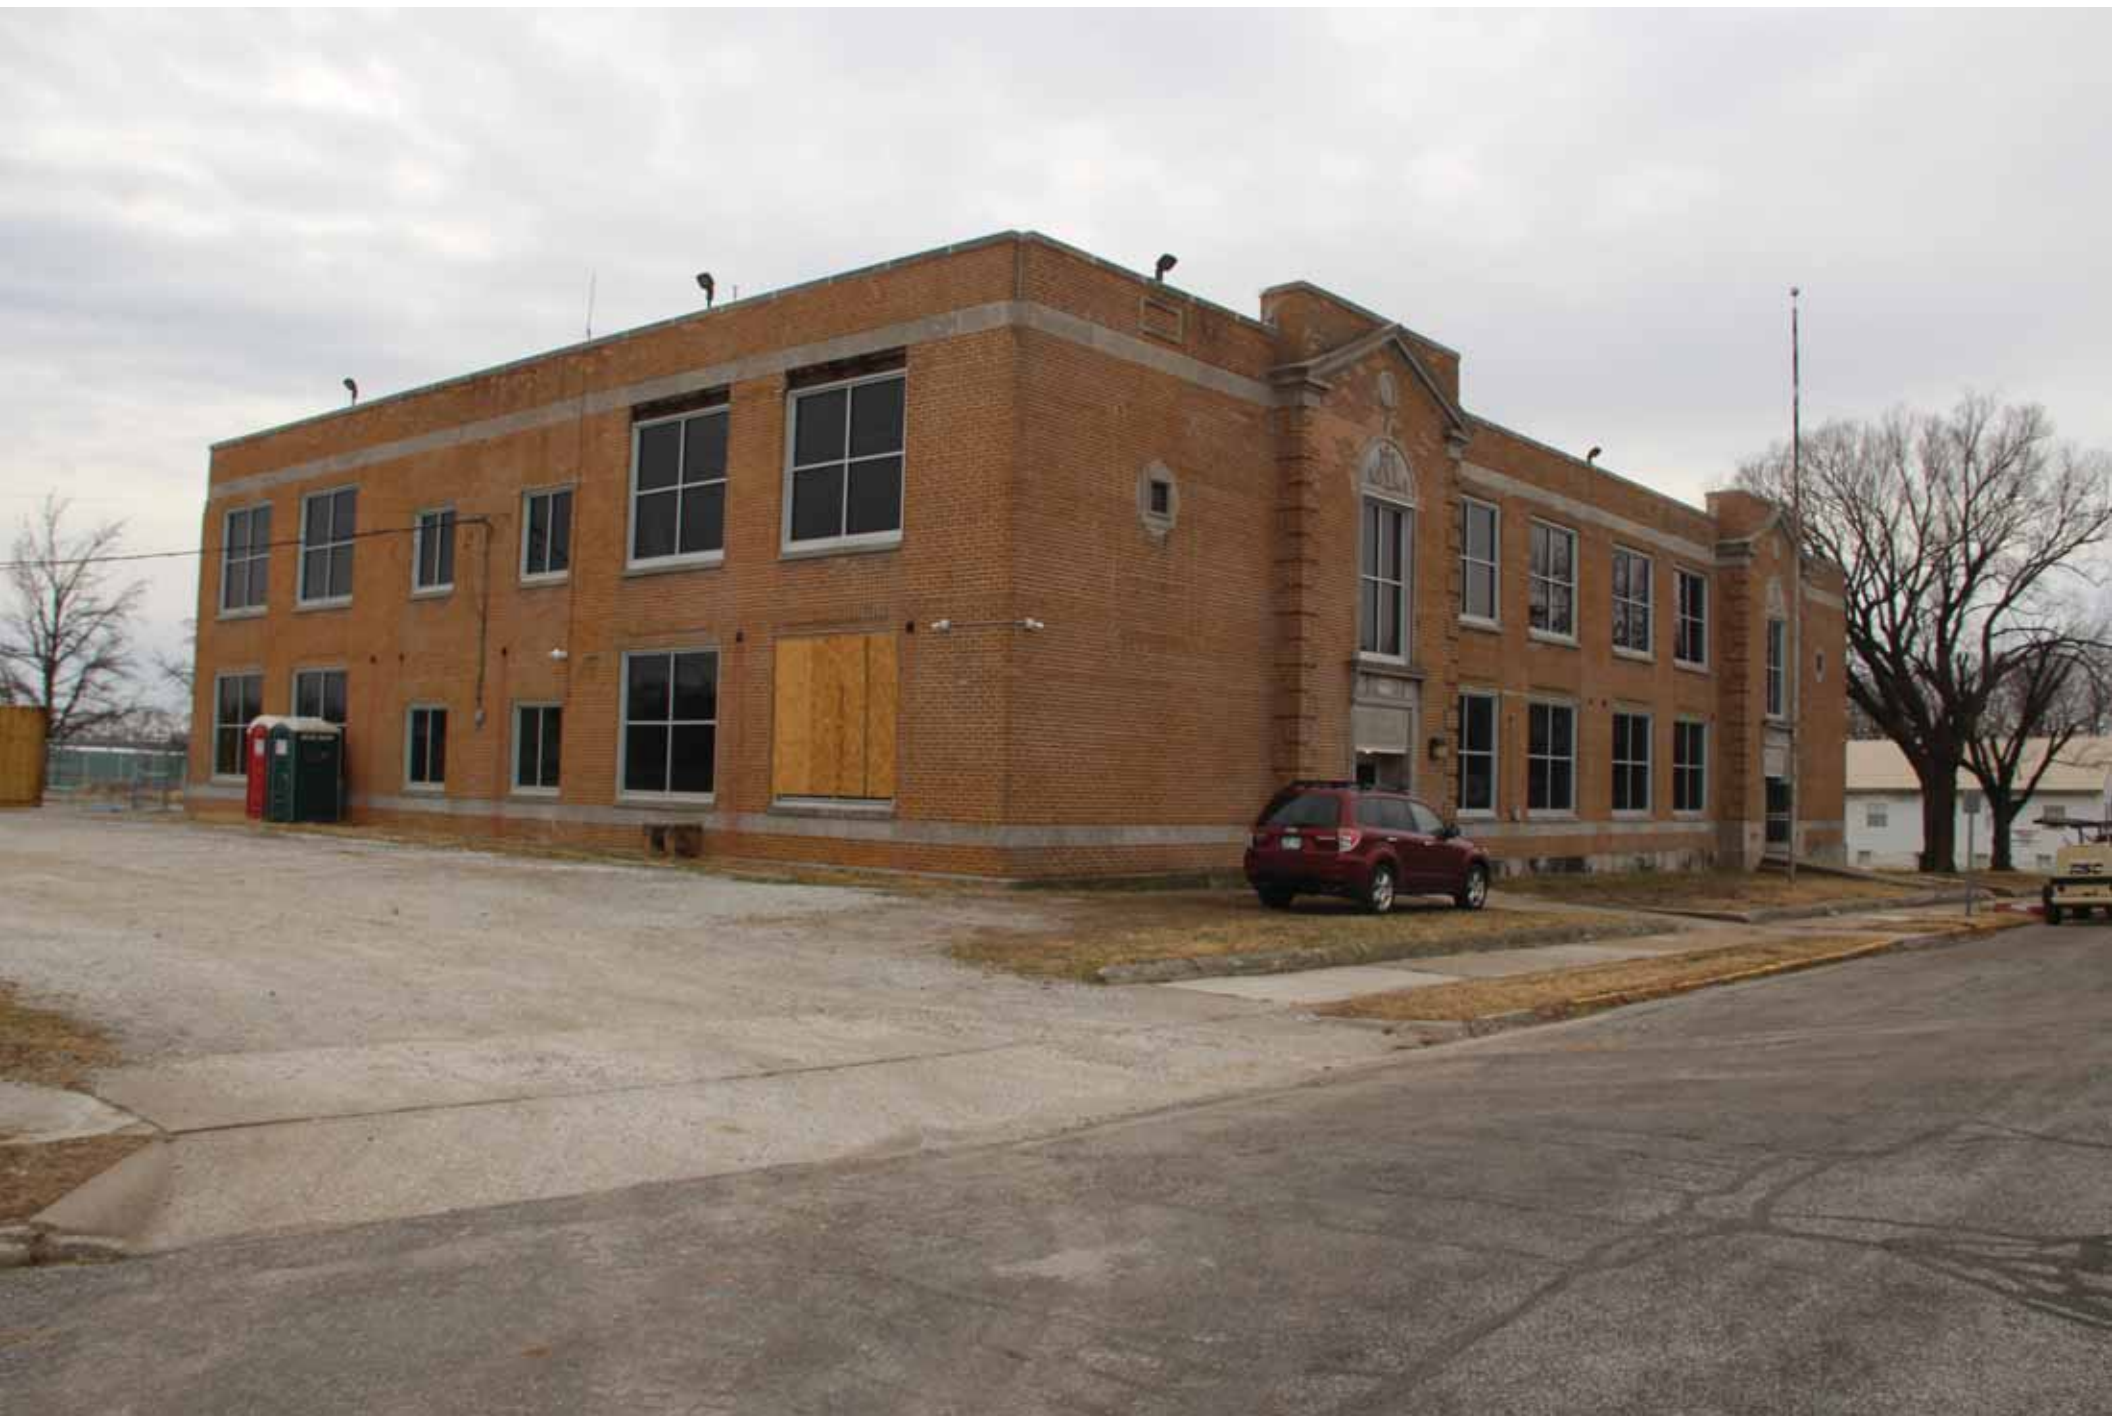
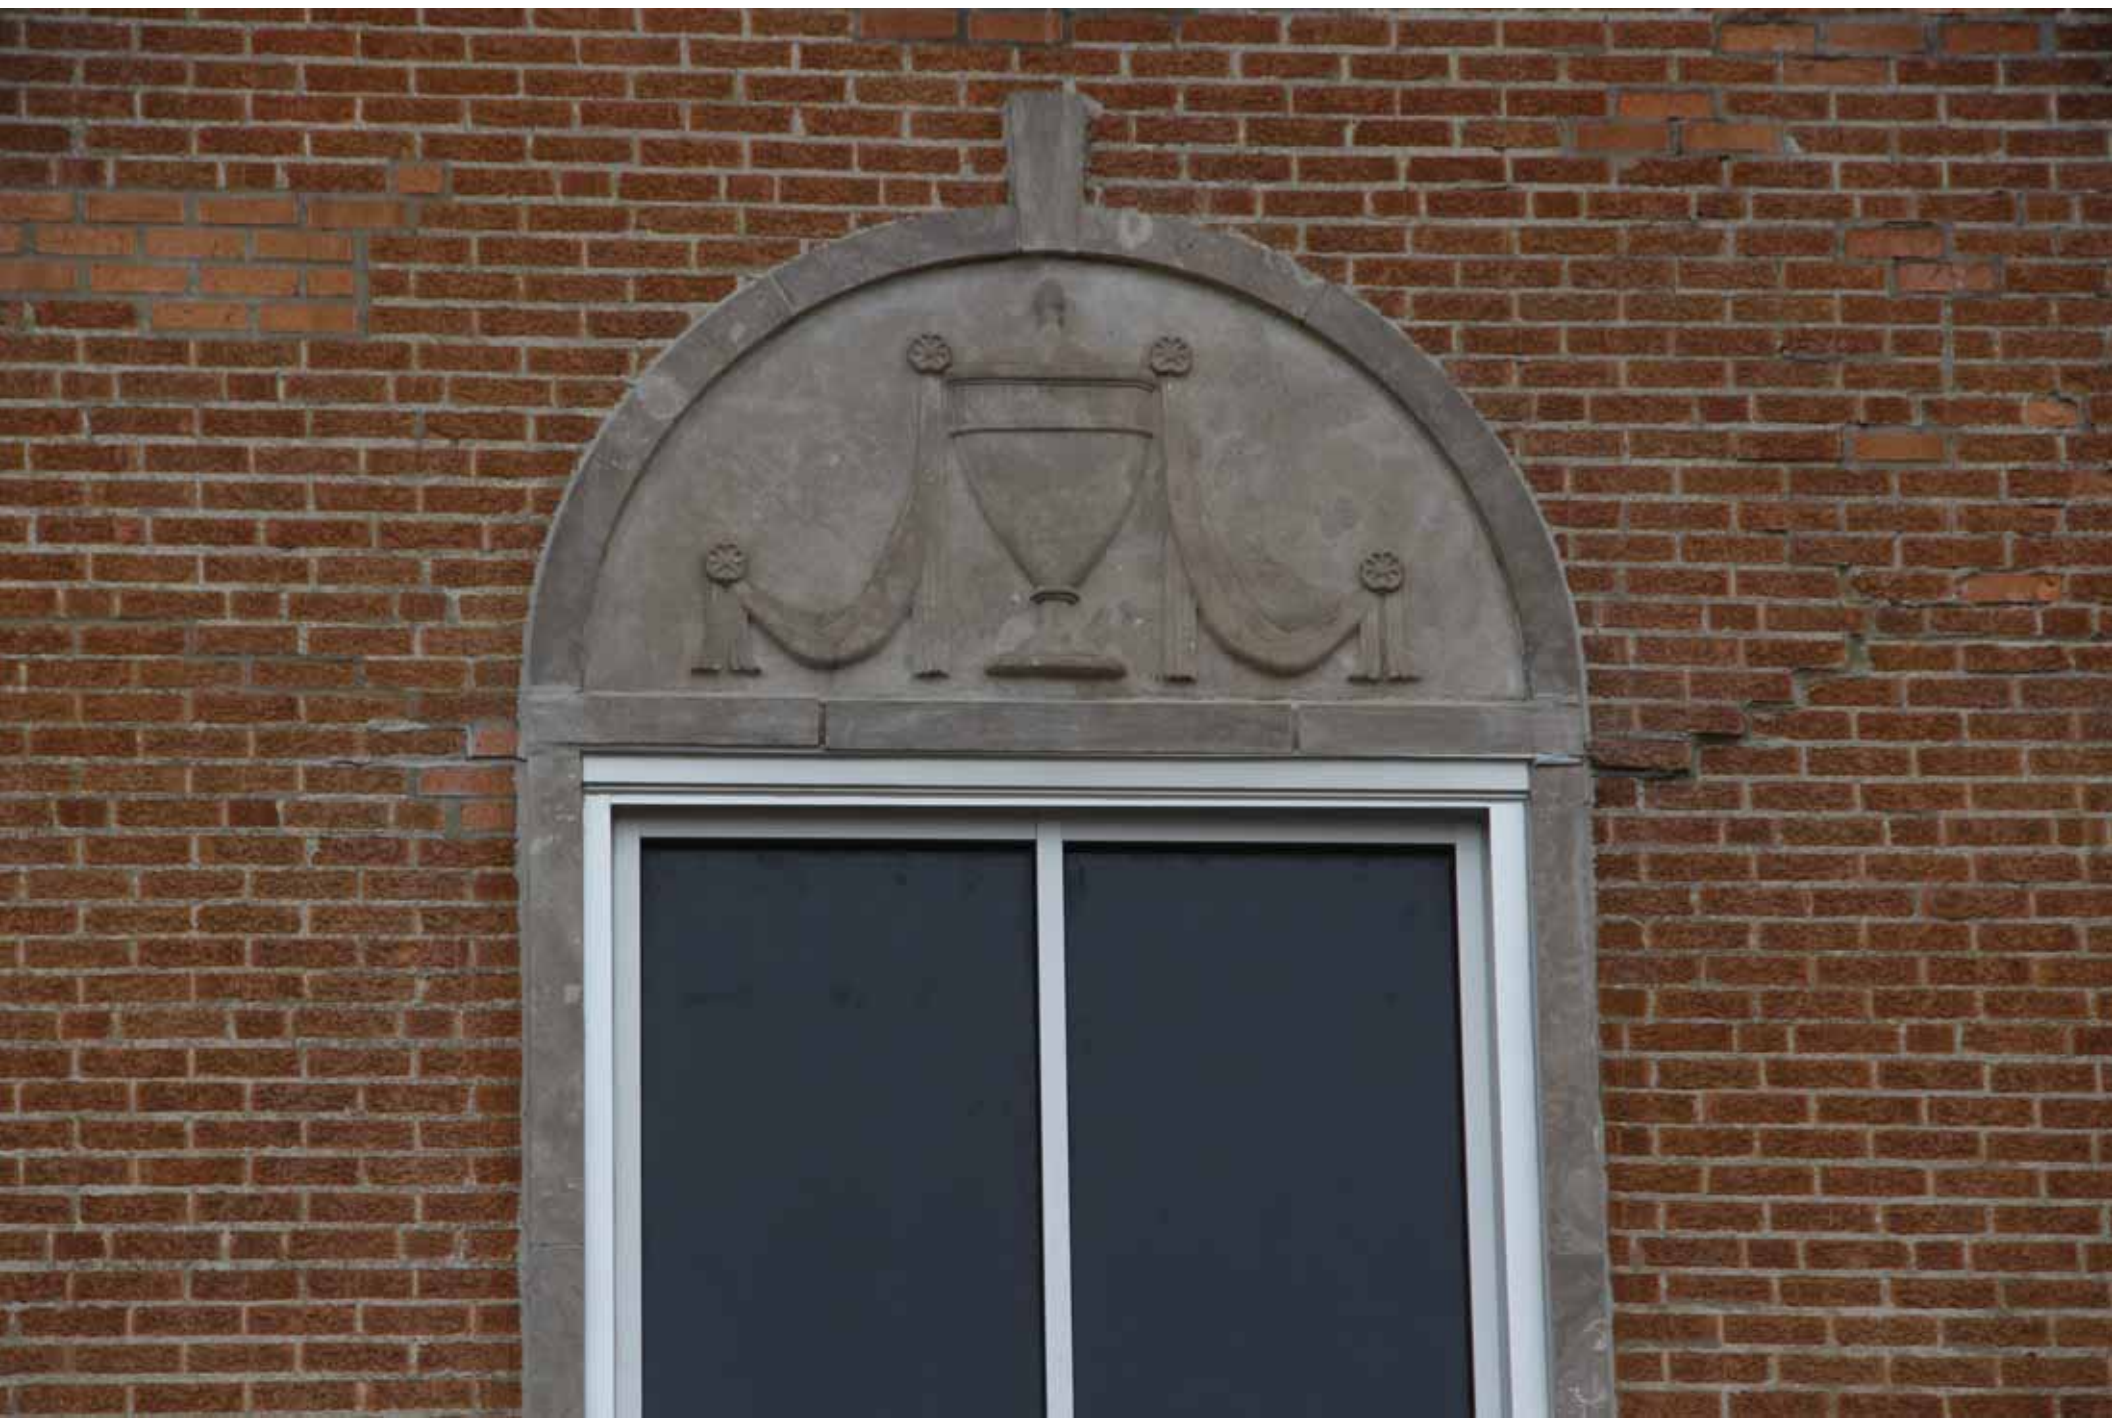
arch featuring an urn. A round concrete circle is above each of the urns. Concrete arches are capped by keystones. A band of concrete coping spans the upper elevation of the building on all sides. Windows have original concrete sills and brick jack arches. Dividing the projecting bays on the façade are four bays, each of which holds symmetrically placed large four-light replacement windows on the first and second floors. Dividing upper and lower window bays, the elevation has decorative brick headers. A date stone is noted near the foundation at the northwest corner of the façade. The roofline is capped by concrete coping.
