MISSOURI DEPARTMENT OF NATURAL RESOURCES
STATE HISTORIC PRESERVATION OFFICE, P.O. Box 176, Jefferson City, MO 65102
ARCHITECTURAL/HISTORIC INVENTORY FORM

1. Survey No. JP-AS-007-001		2. Survey name: East Town (Original Joplin) Historic Survey Phase 2	
3. County: JASPER		4. Address (Street No.) 618	Street (name) E. 2 nd Street
5. City: Joplin	Vicinity: <input type="checkbox"/>	6. Geographical Reference:	7. Township/Range/Section: T: R: S:
8. Historic name (if known):		9. Present/other name (if known):	
10. Ownership: <input checked="" type="checkbox"/> Private <input type="checkbox"/> Public		11a. Historic use (if known): Domestic: Single Dwelling	11b. Current use: Domestic: Single Dwelling

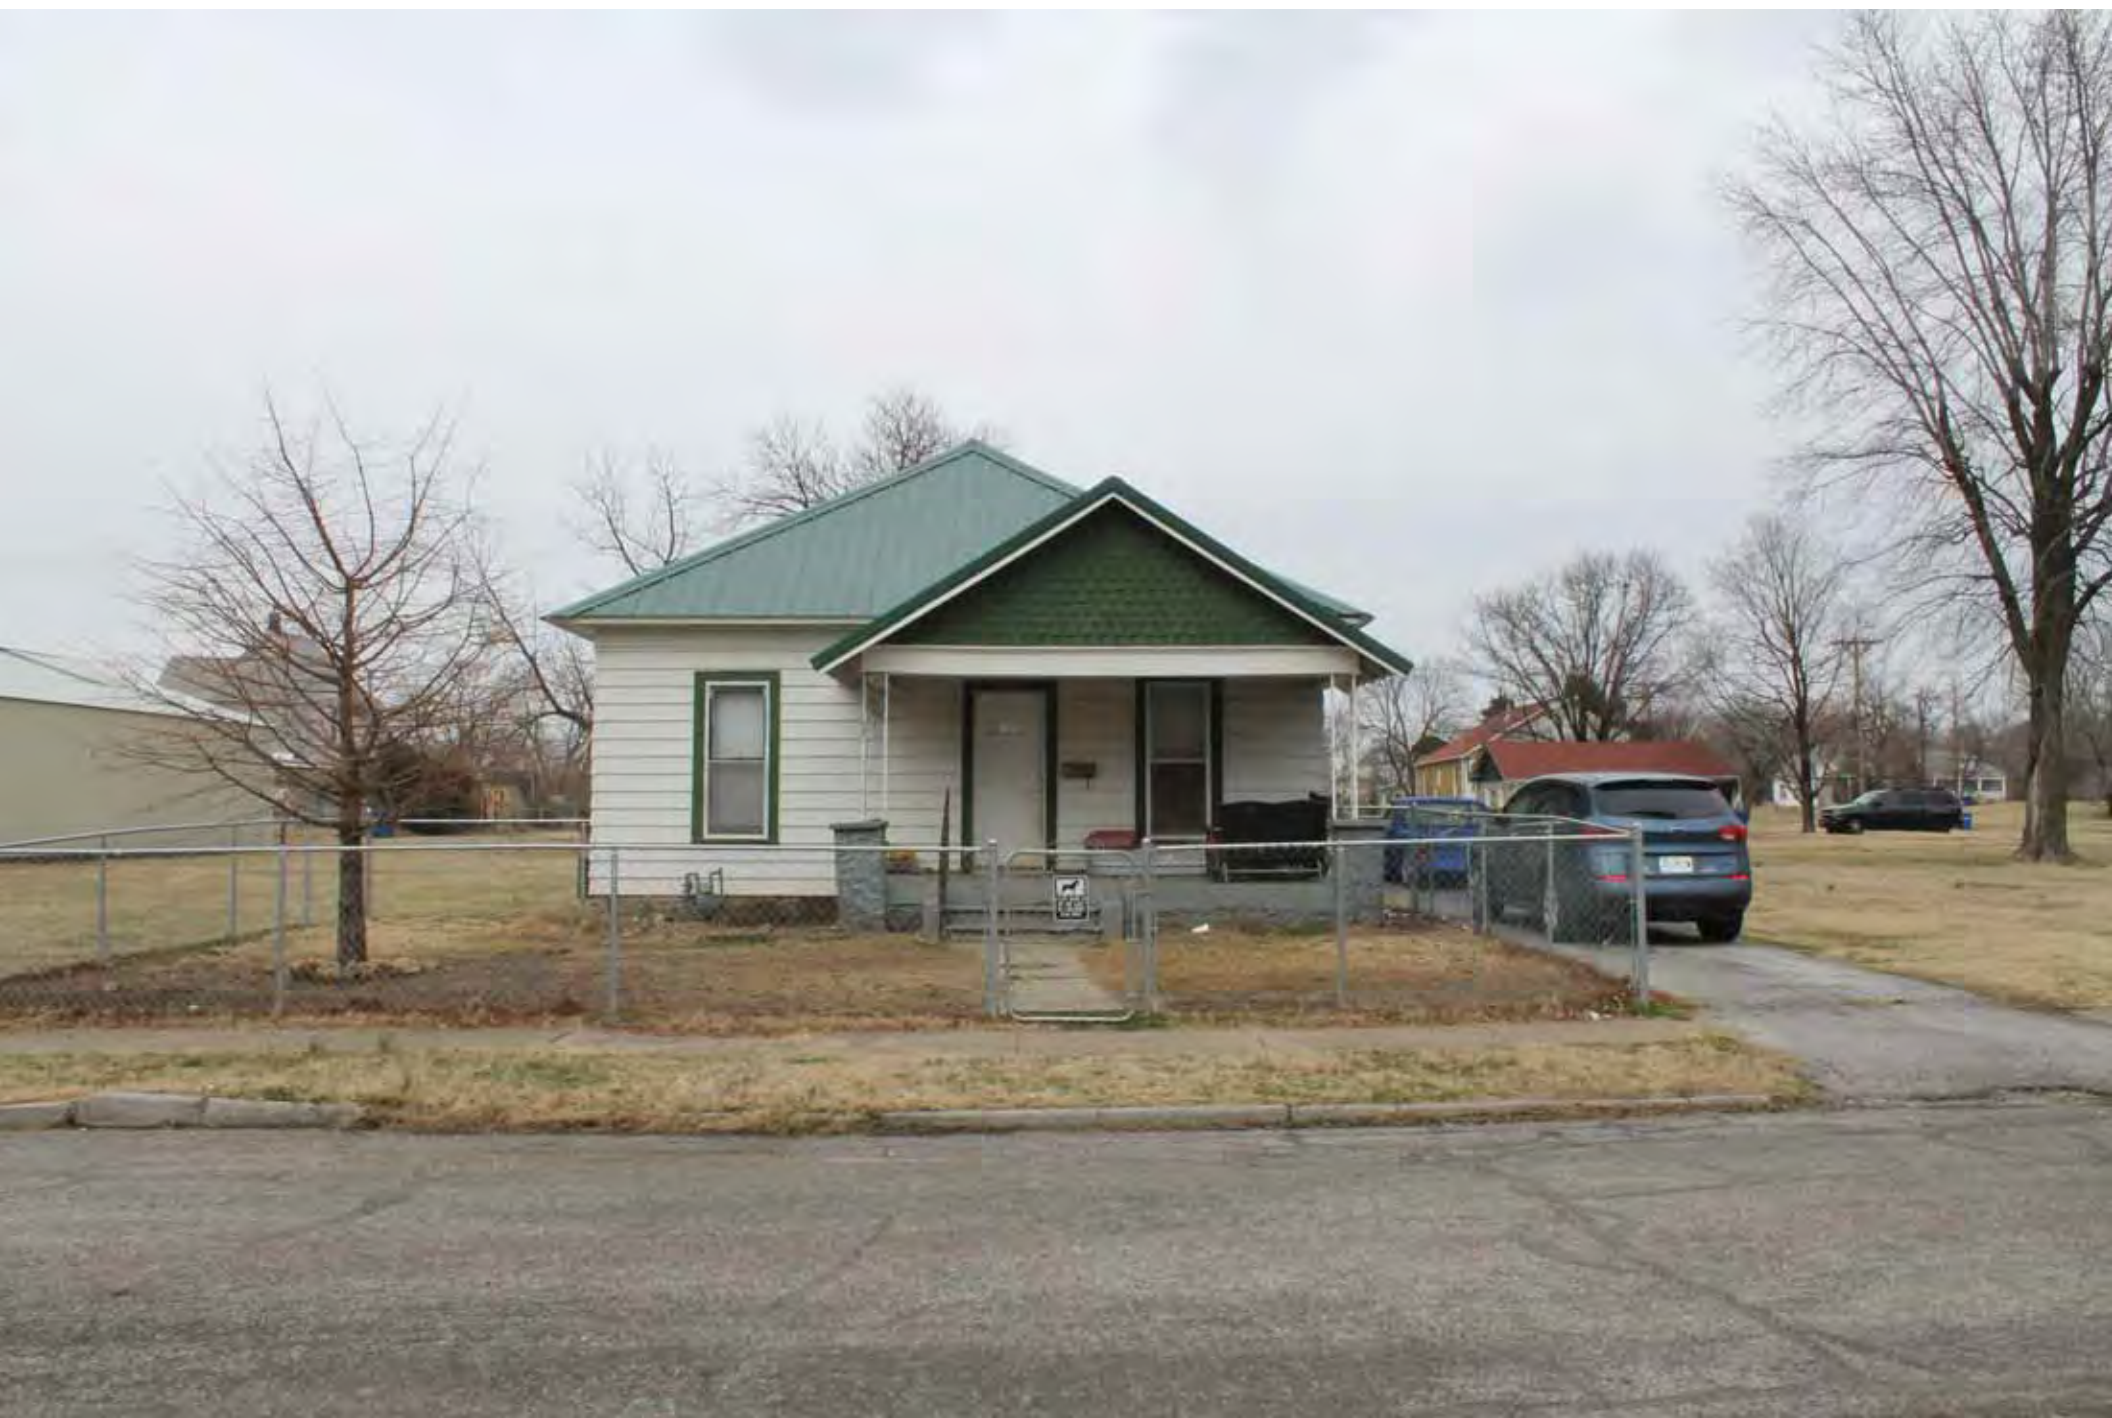
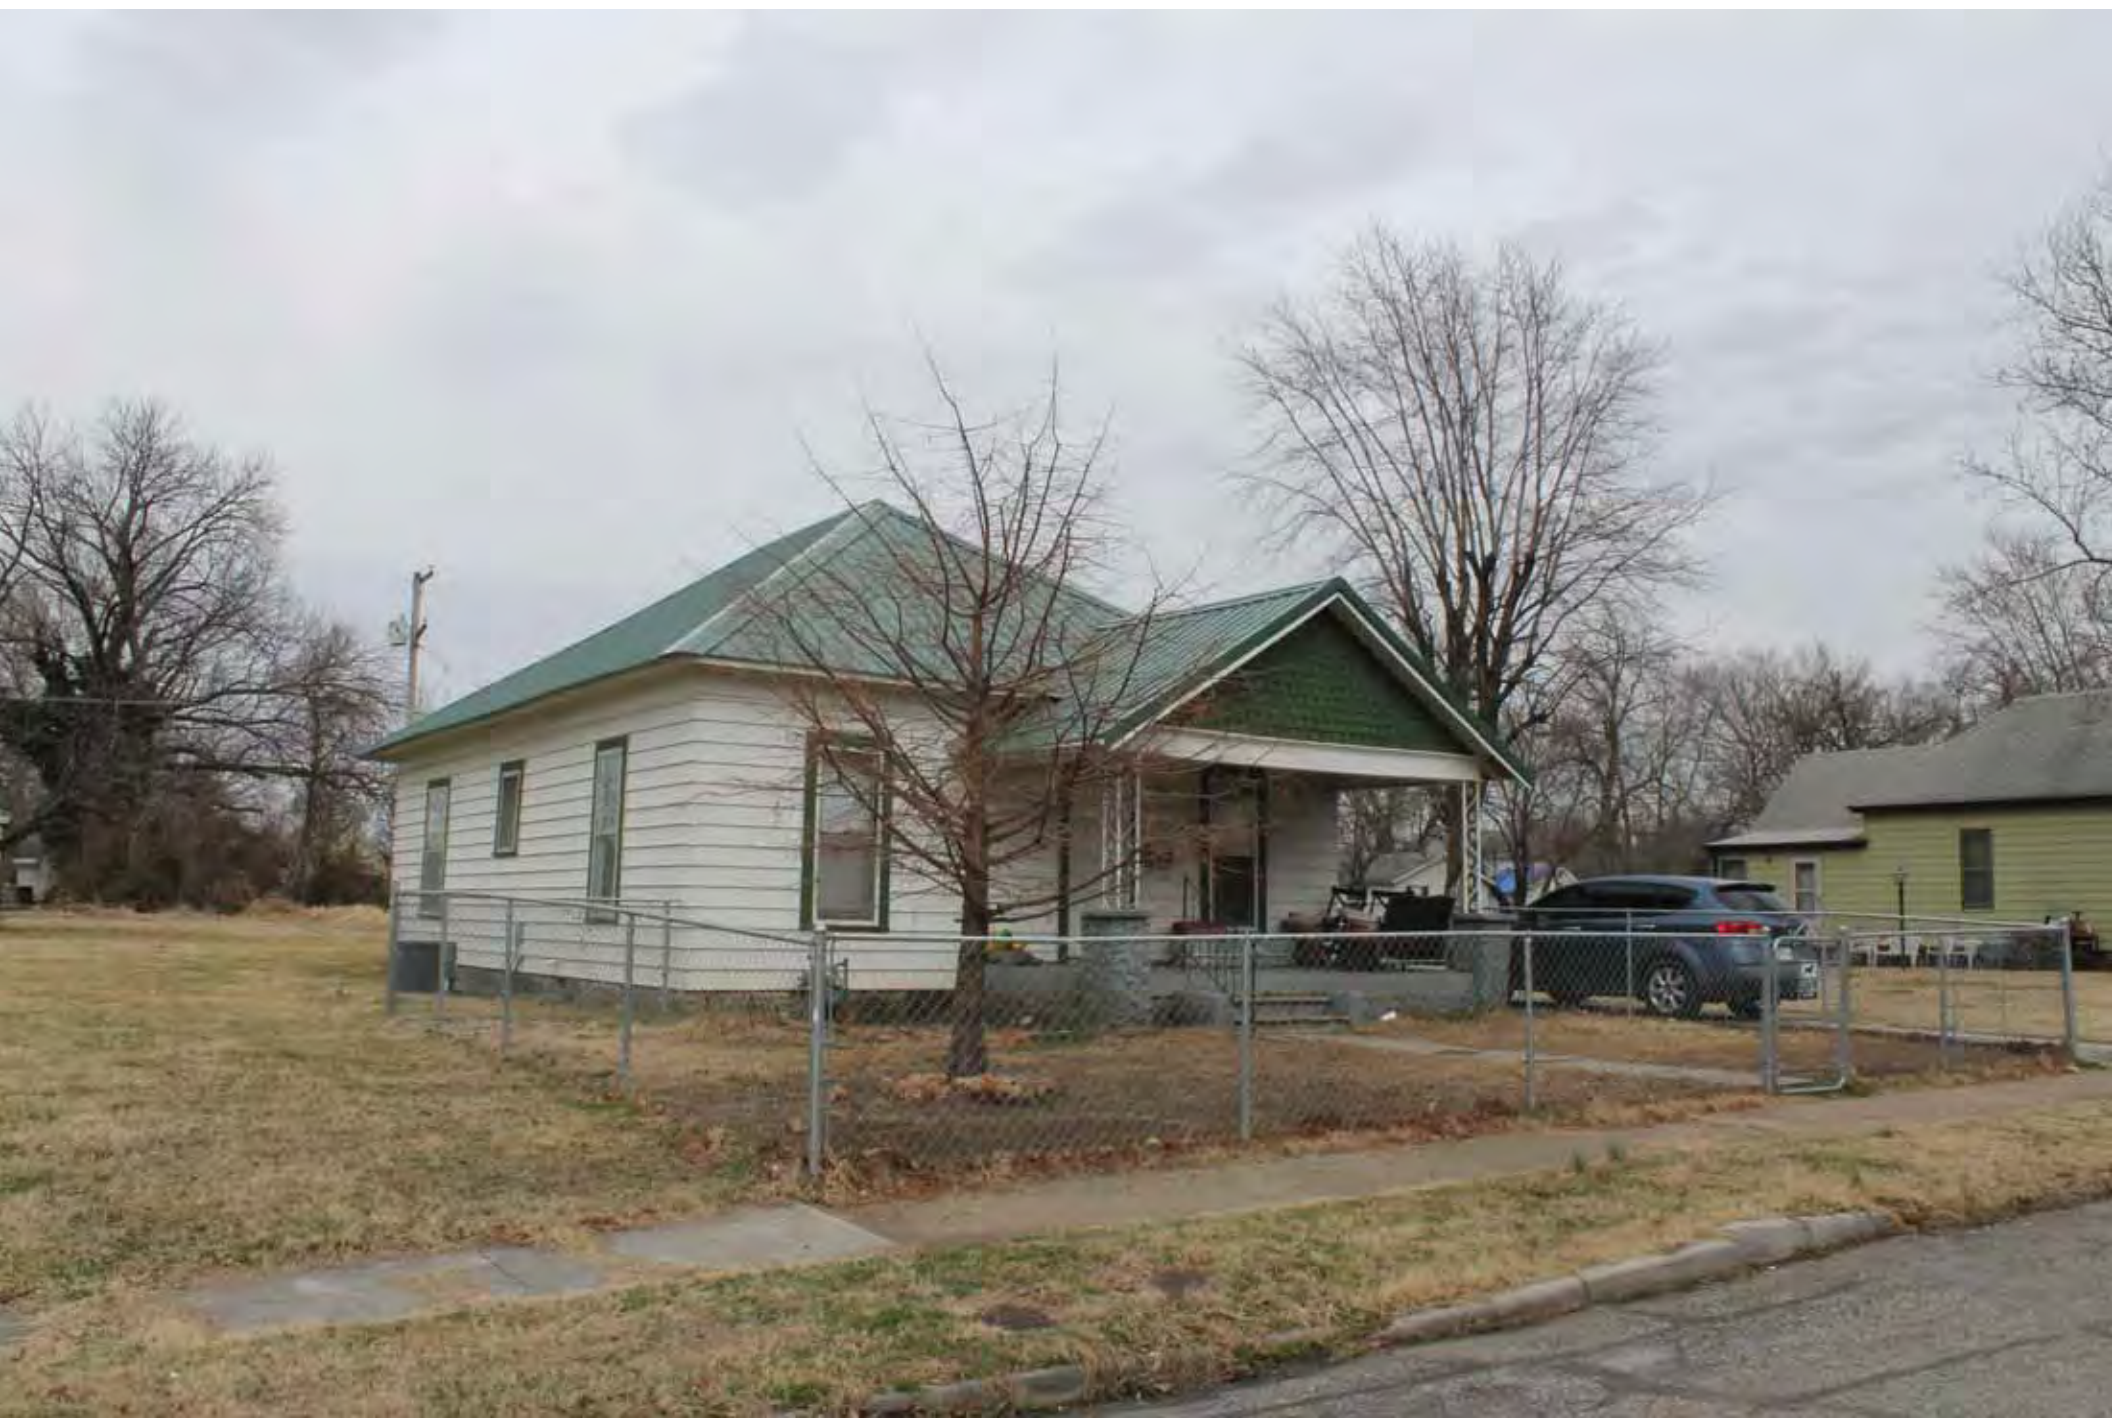
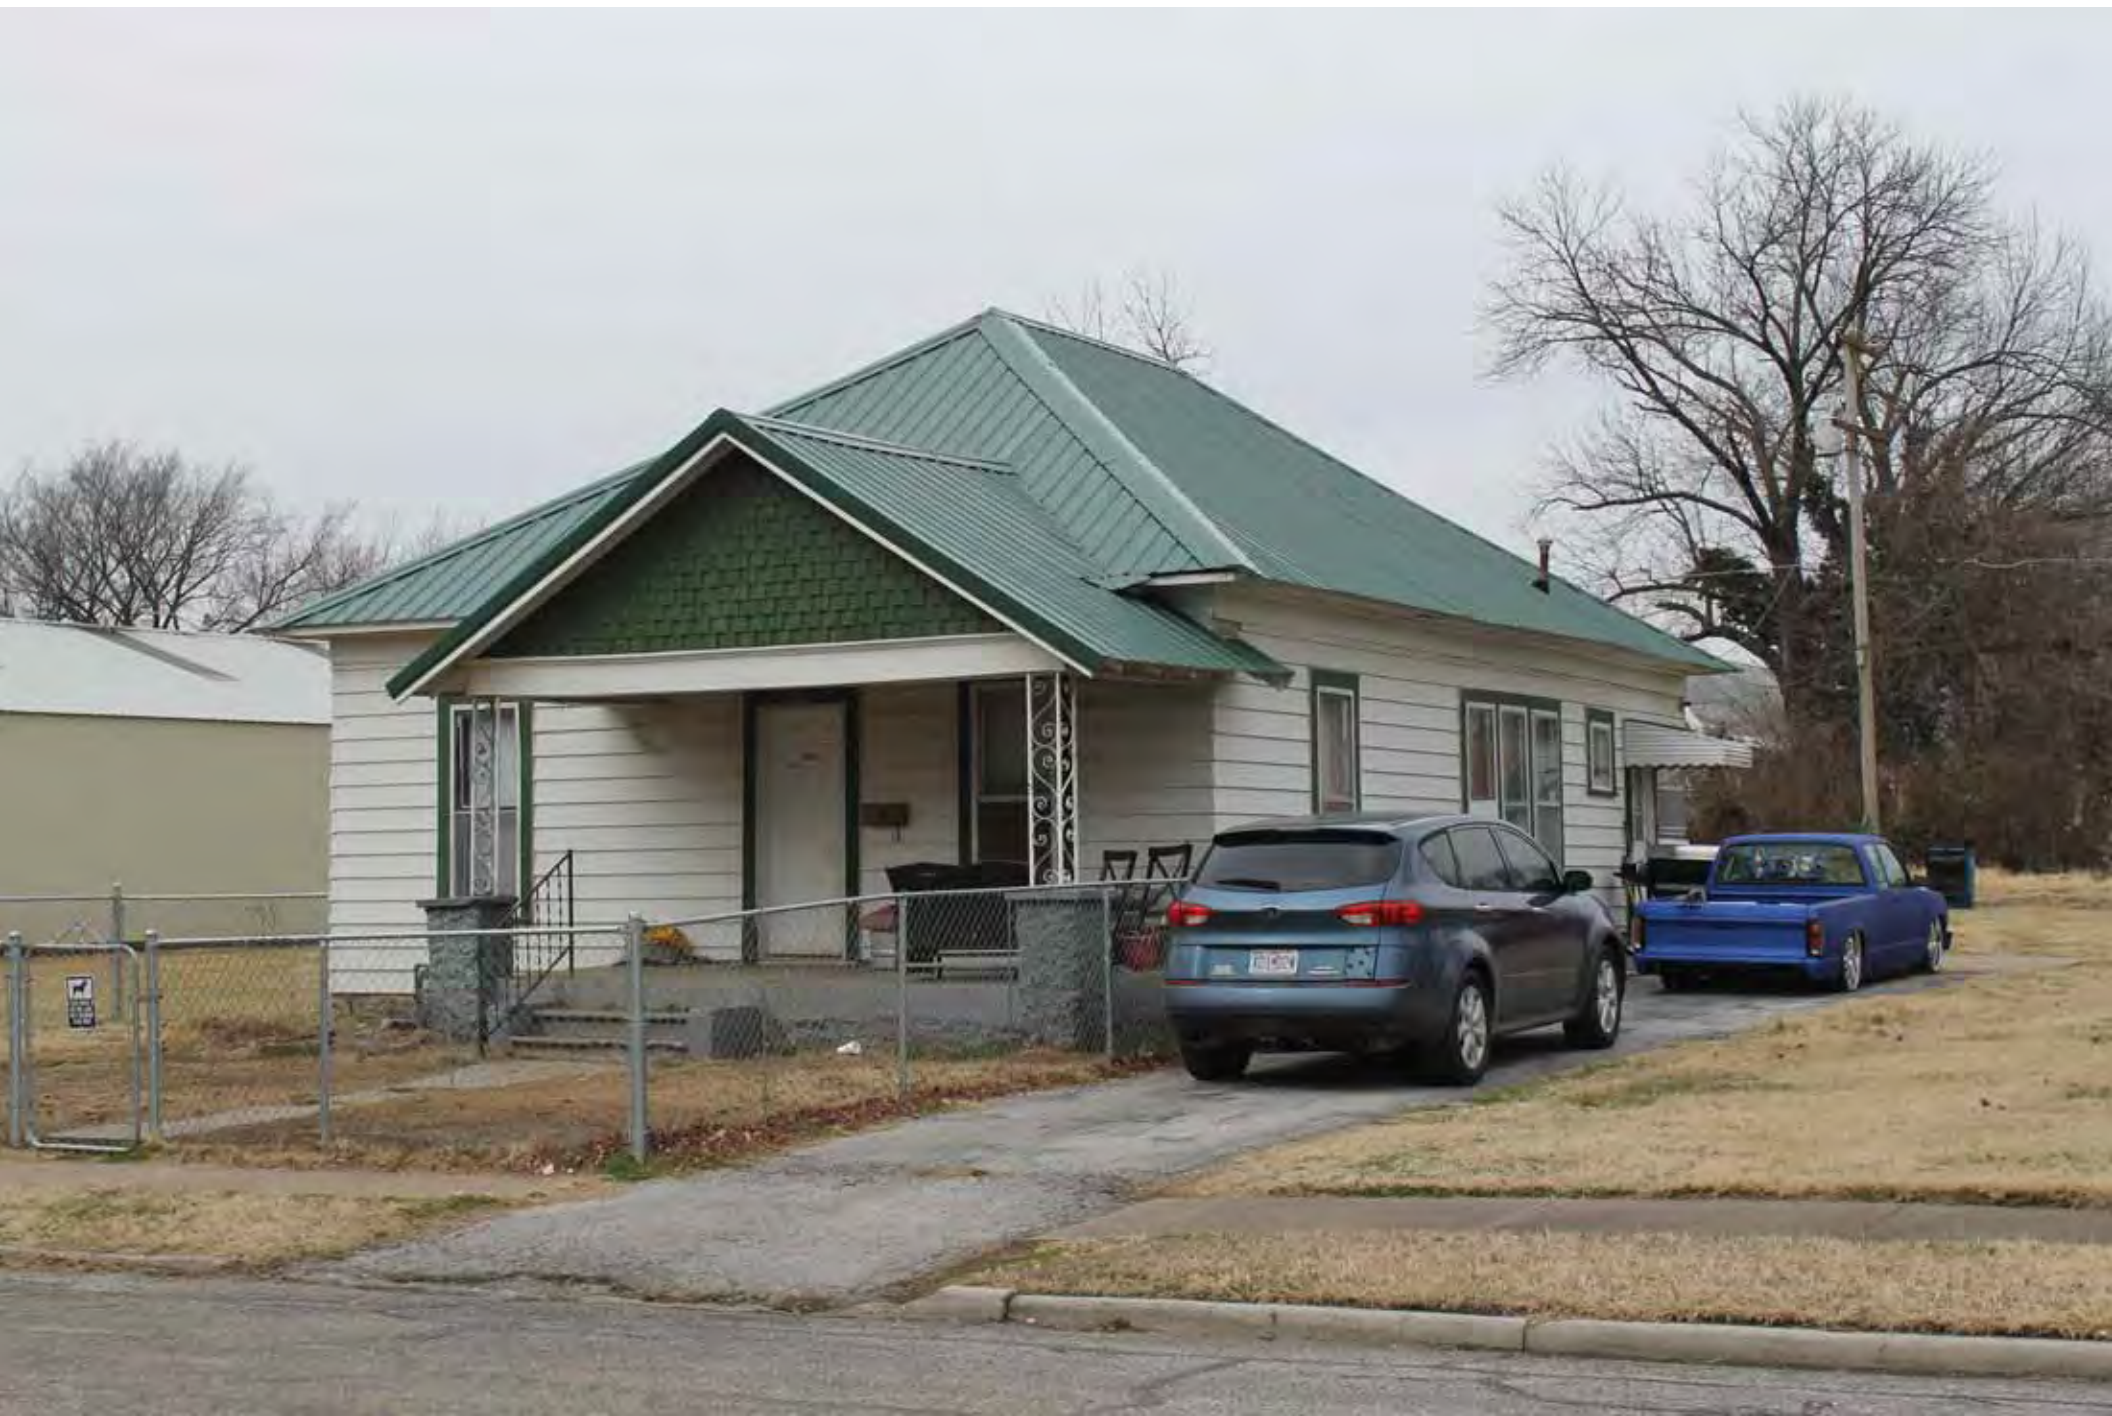
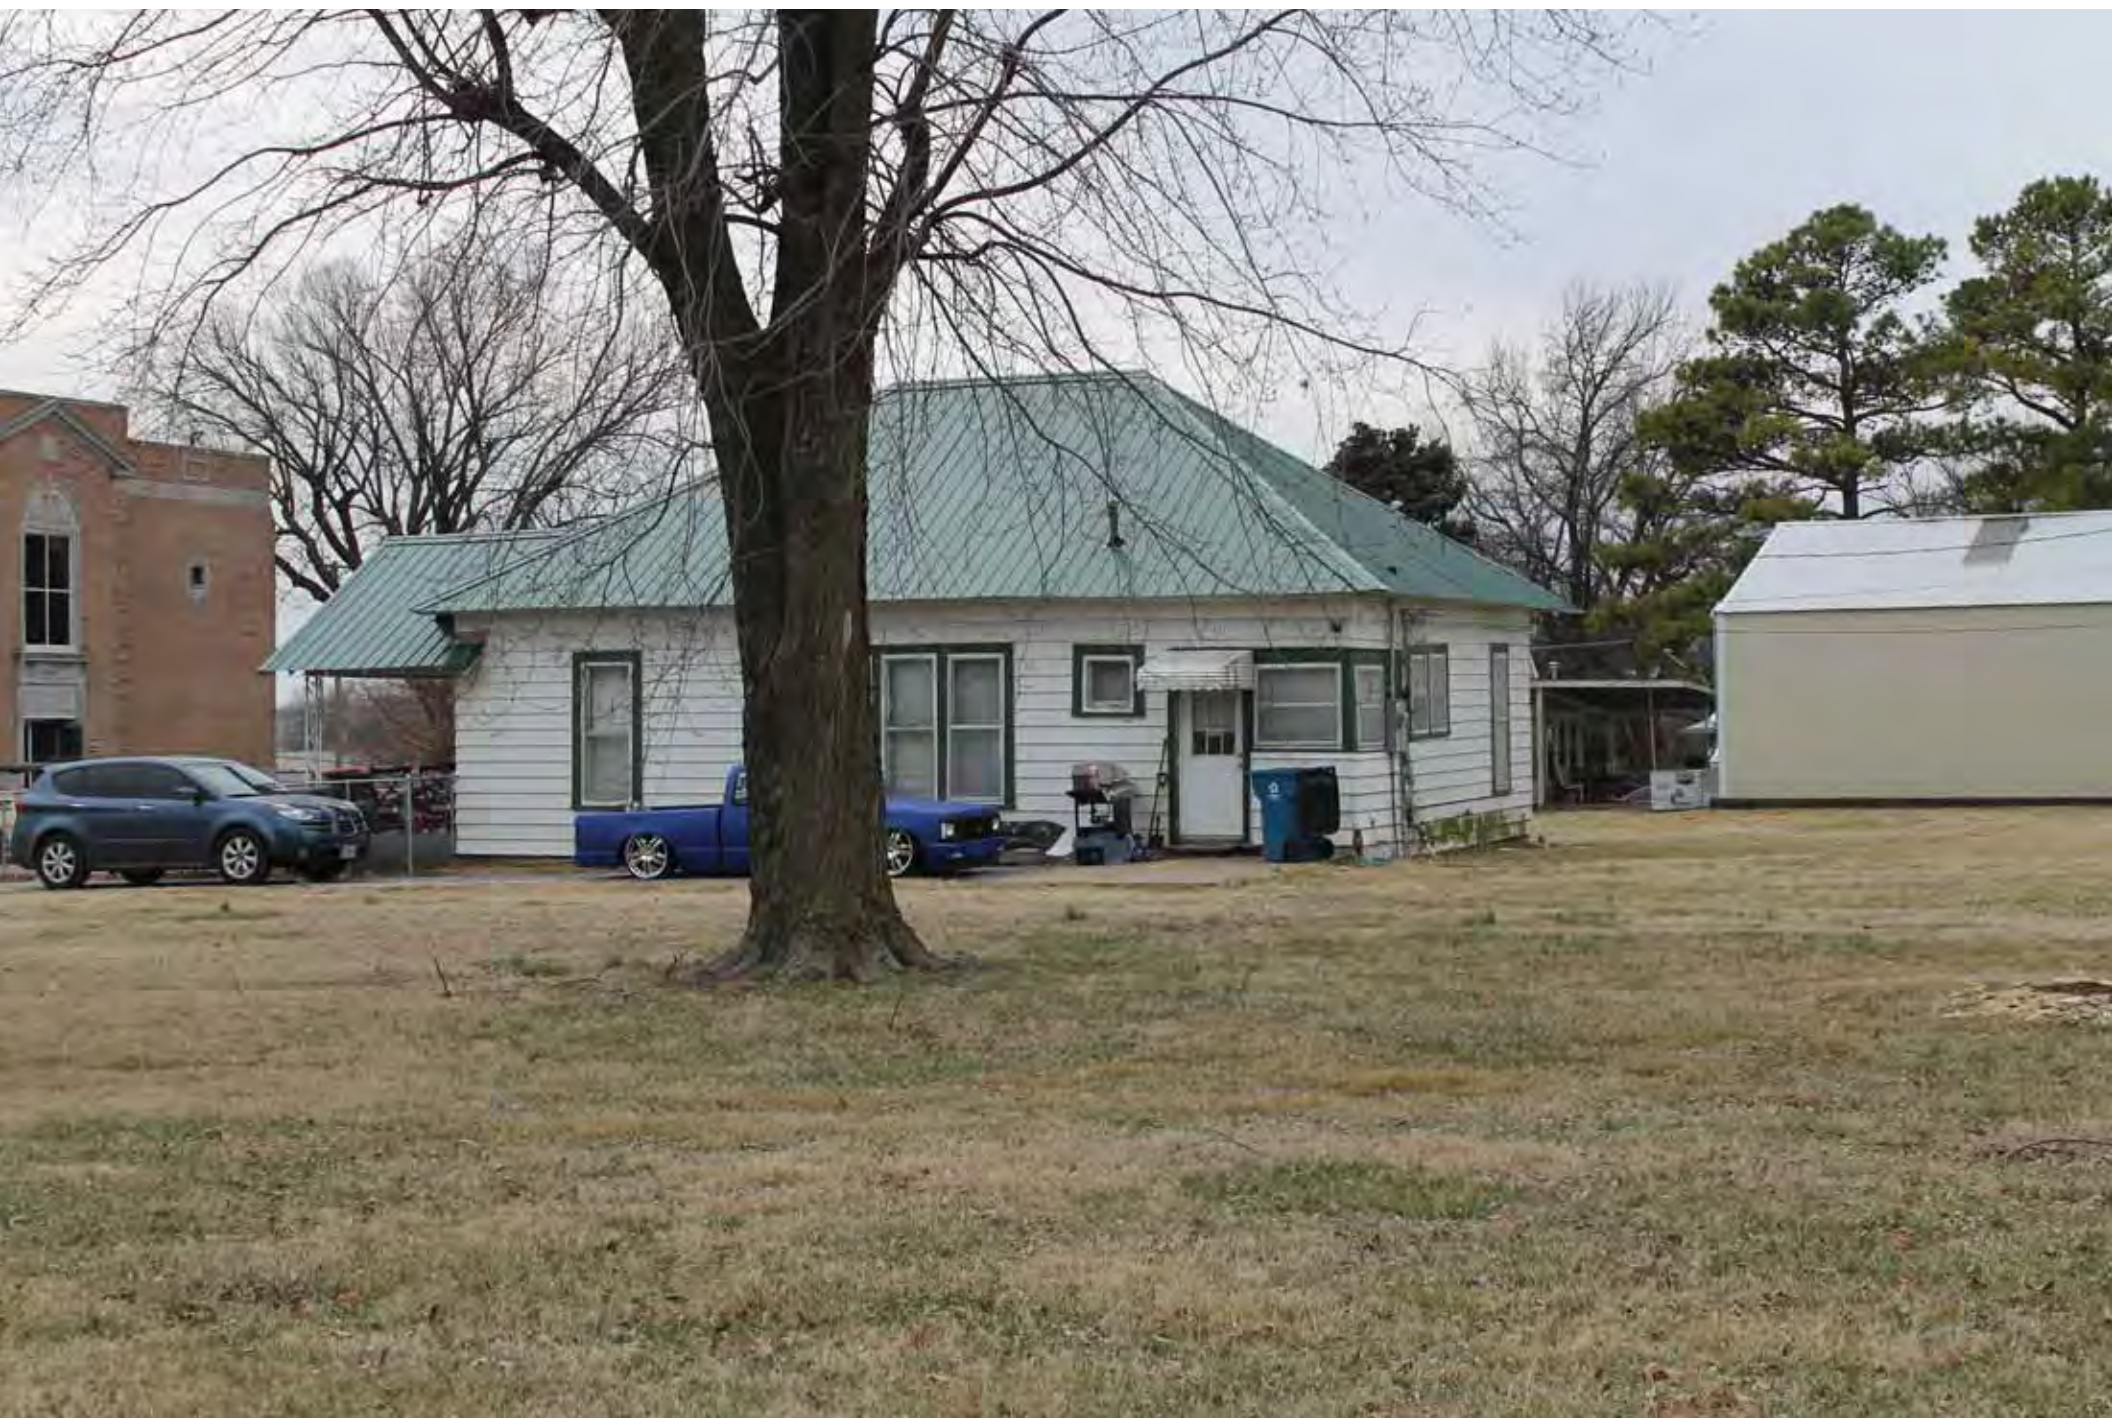
This dwelling has been altered through the addition of c. 2010 exterior siding (vinyl). Due to the lack of exterior original siding, the dwelling does not retain integrity that would render it individually eligible for the National Register of Historic Places. The dwelling is not situated in an area recommended as a historic district.

The property at 1115 E. 2nd Street features a single-story dwelling with a pyramidal hipped roof clad with metal. Exterior walls are covered with vinyl siding (c. 2010). The dwelling faces south, toward E. 2nd Street and features a primary off-enter gabled porch on the façade (south elevation). The porch has a metal roof, exposed rafter tails and an asphalt shingled gable field. The porch roof is supported by wrought iron columns resting on rubble piers. Within the porch bay is a single entry bay with a paneled c. 2010 door. The door is flanked by one-over-one windows. A secondary entry with a metal shed awning is situated on the east elevation. The east elevation additionally holds single and triple one-over-one windows. The west elevation holds three single double-hung windows.

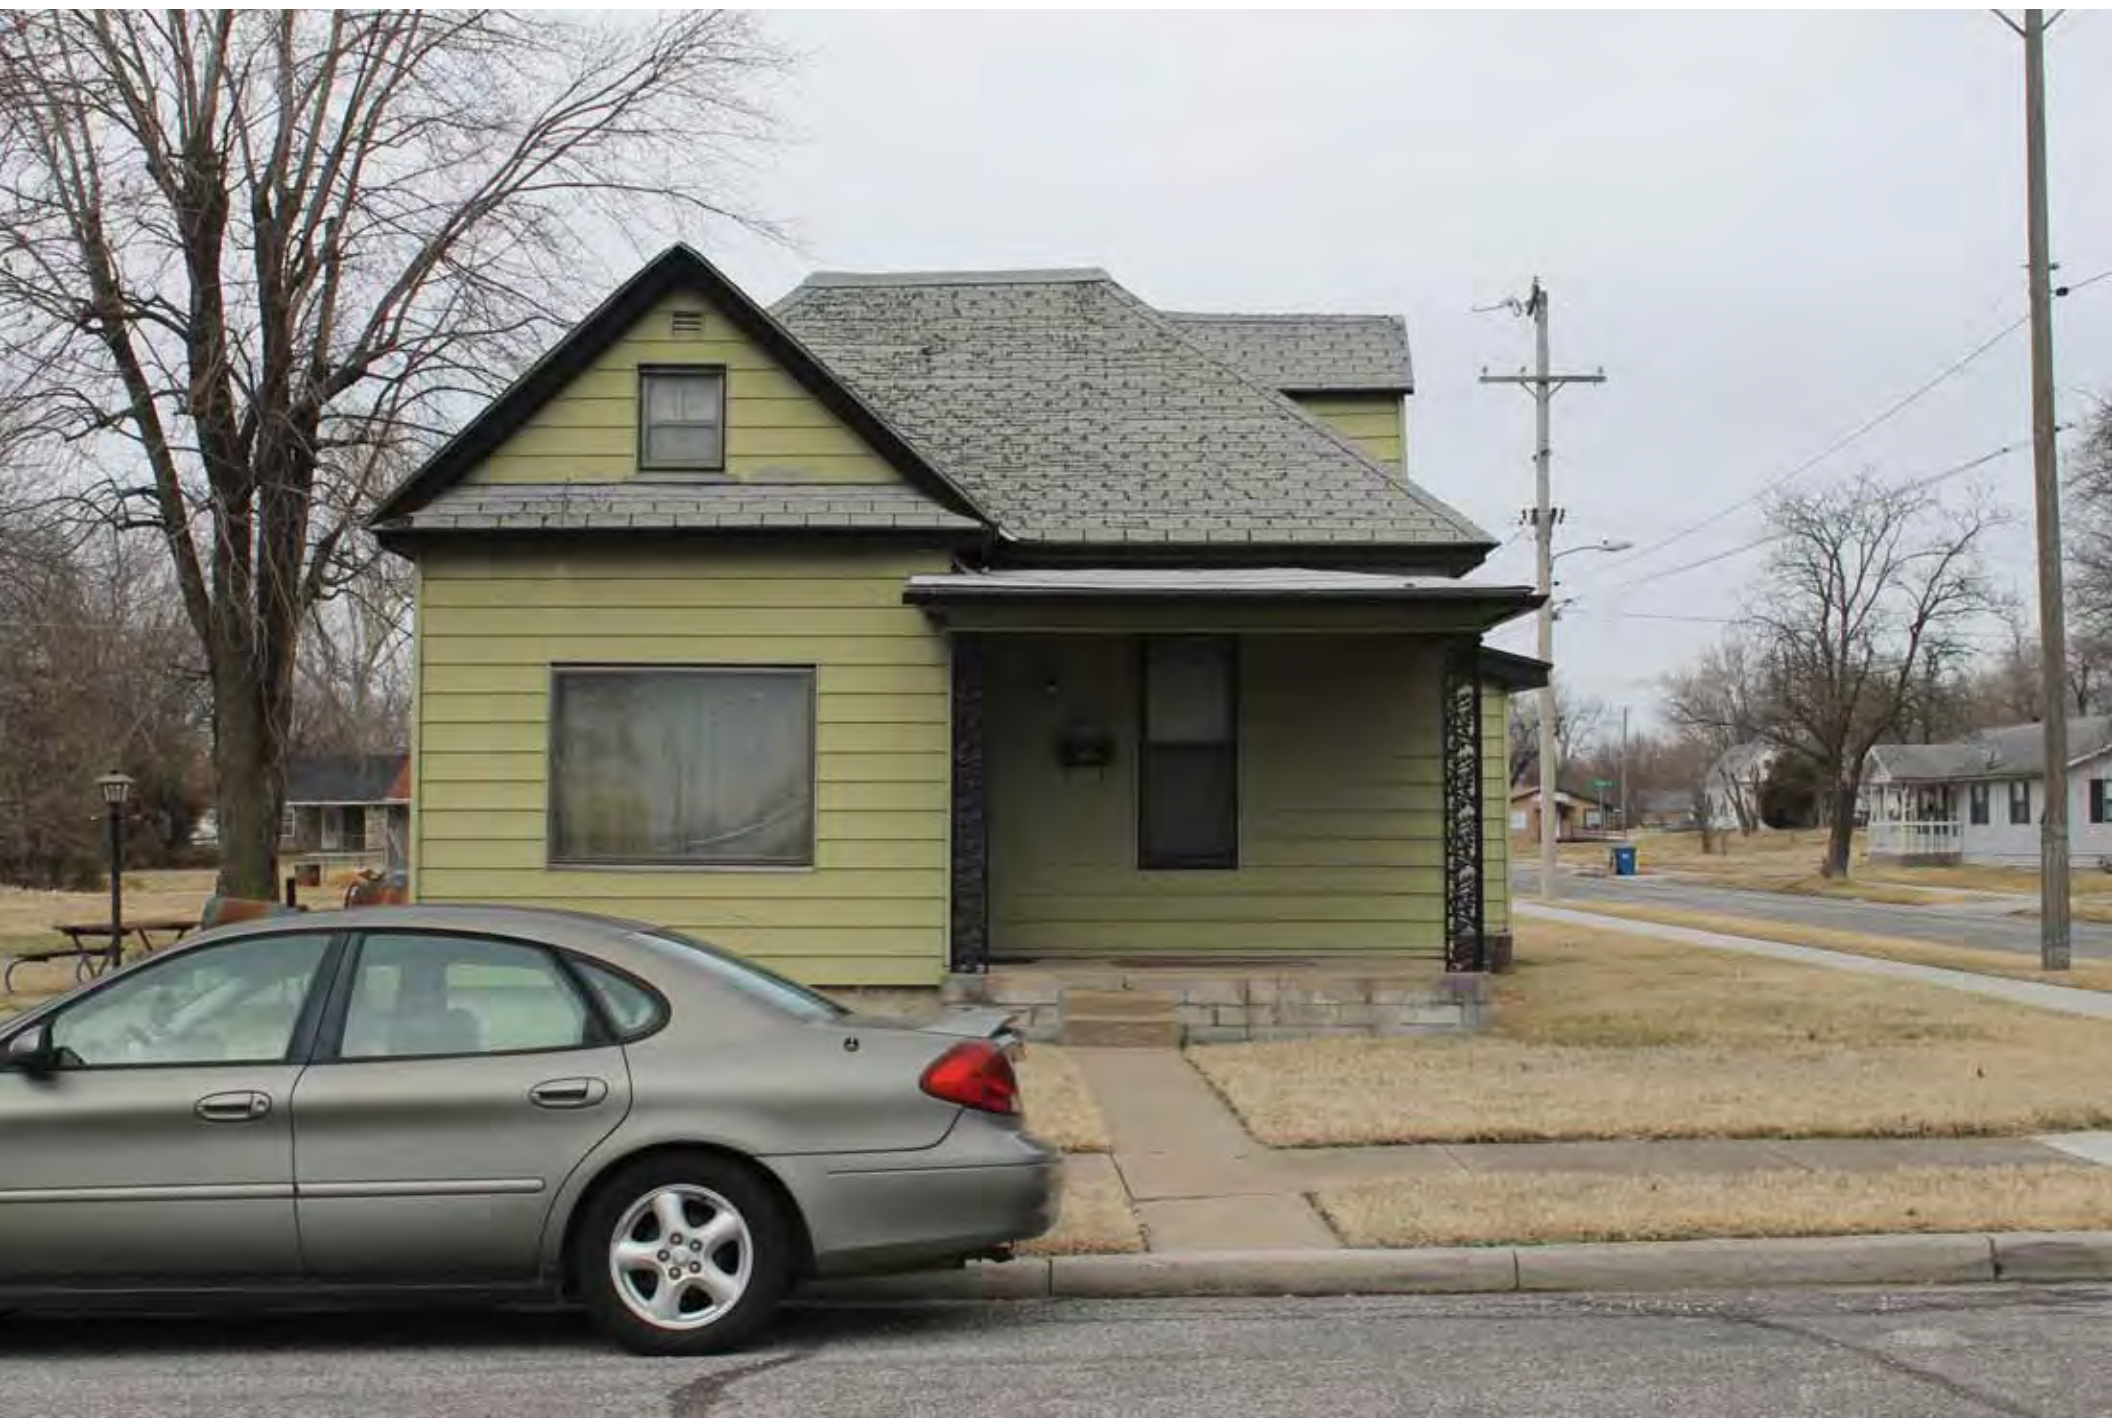
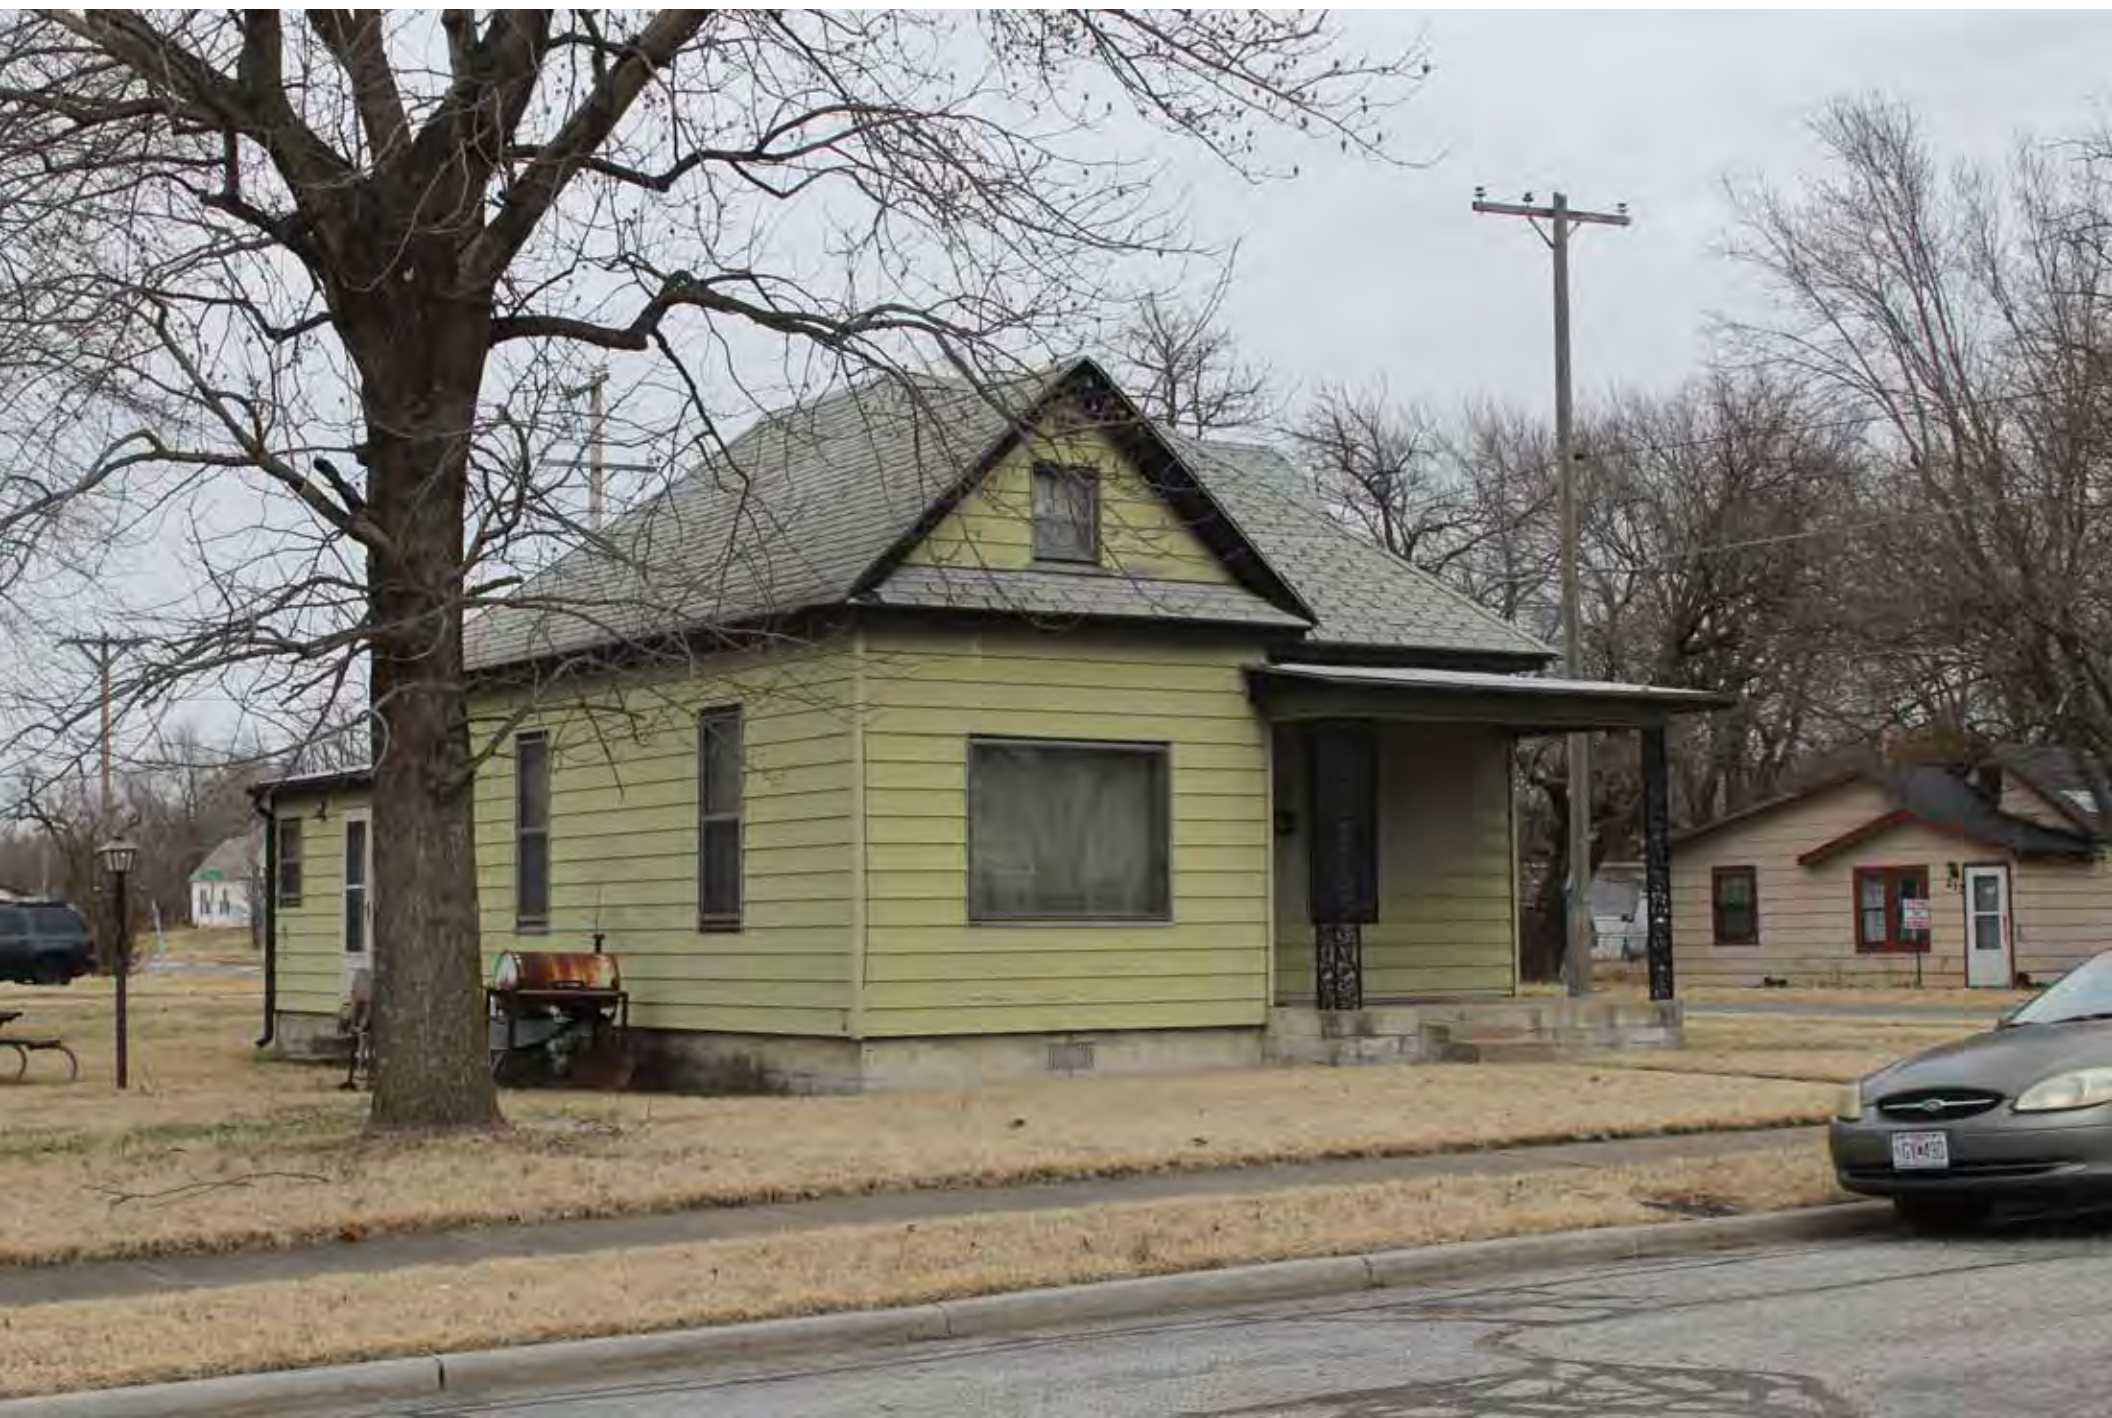
The property at 1125 E. 2nd Street features a 1.5-story dwelling with a hipped and gabled asphalt shingled roof, wide board siding and a concrete (primarily block) foundation. The primary (south) elevation supports an off-center flat hipped roof supported by wrought iron columns resting on a concrete base. A front gabled wing extends south at the west end of the porch. The primary entry is set within the projecting east wall of the gabled wing. The porch south wall holds a one-over-one window; the gabled front south wall holds a fixed sash window. Above this large fixed window, within the gable field, is a small one-over-one window and louvered vent. The east roofline supports a gabled dormer with a one-over-one window. Below the window is an air conditioner. The rear northeast roofline extends to create a shed wing void of fenestration on all but the rear (north) elevation which supports a one-over-one window. The remaining north elevation features two small one-over-one windows. The west elevation supports one-over-one windows and a secondary entry near the north end of the elevation.
