MISSOURI DEPARTMENT OF NATURAL RESOURCES
STATE HISTORIC PRESERVATION OFFICE, P.O. Box 176, Jefferson City, MO 65102
ARCHITECTURAL/HISTORIC INVENTORY FORM

1. Survey No. JP-AS-007-001		2. Survey name: East Town (Original Joplin) Historic Survey Phase 2	
3. County: JASPER		4. Address (Street No.) 618	Street (name) E. 2 nd Street
5. City: Joplin	Vicinity: <input type="checkbox"/>	6. Geographical Reference:	7. Township/Range/Section: T: R: S:
8. Historic name (if known):		9. Present/other name (if known):	
10. Ownership: <input checked="" type="checkbox"/> Private <input type="checkbox"/> Public		11a. Historic use (if known): Domestic: Single Dwelling	11b. Current use: Domestic: Single Dwelling

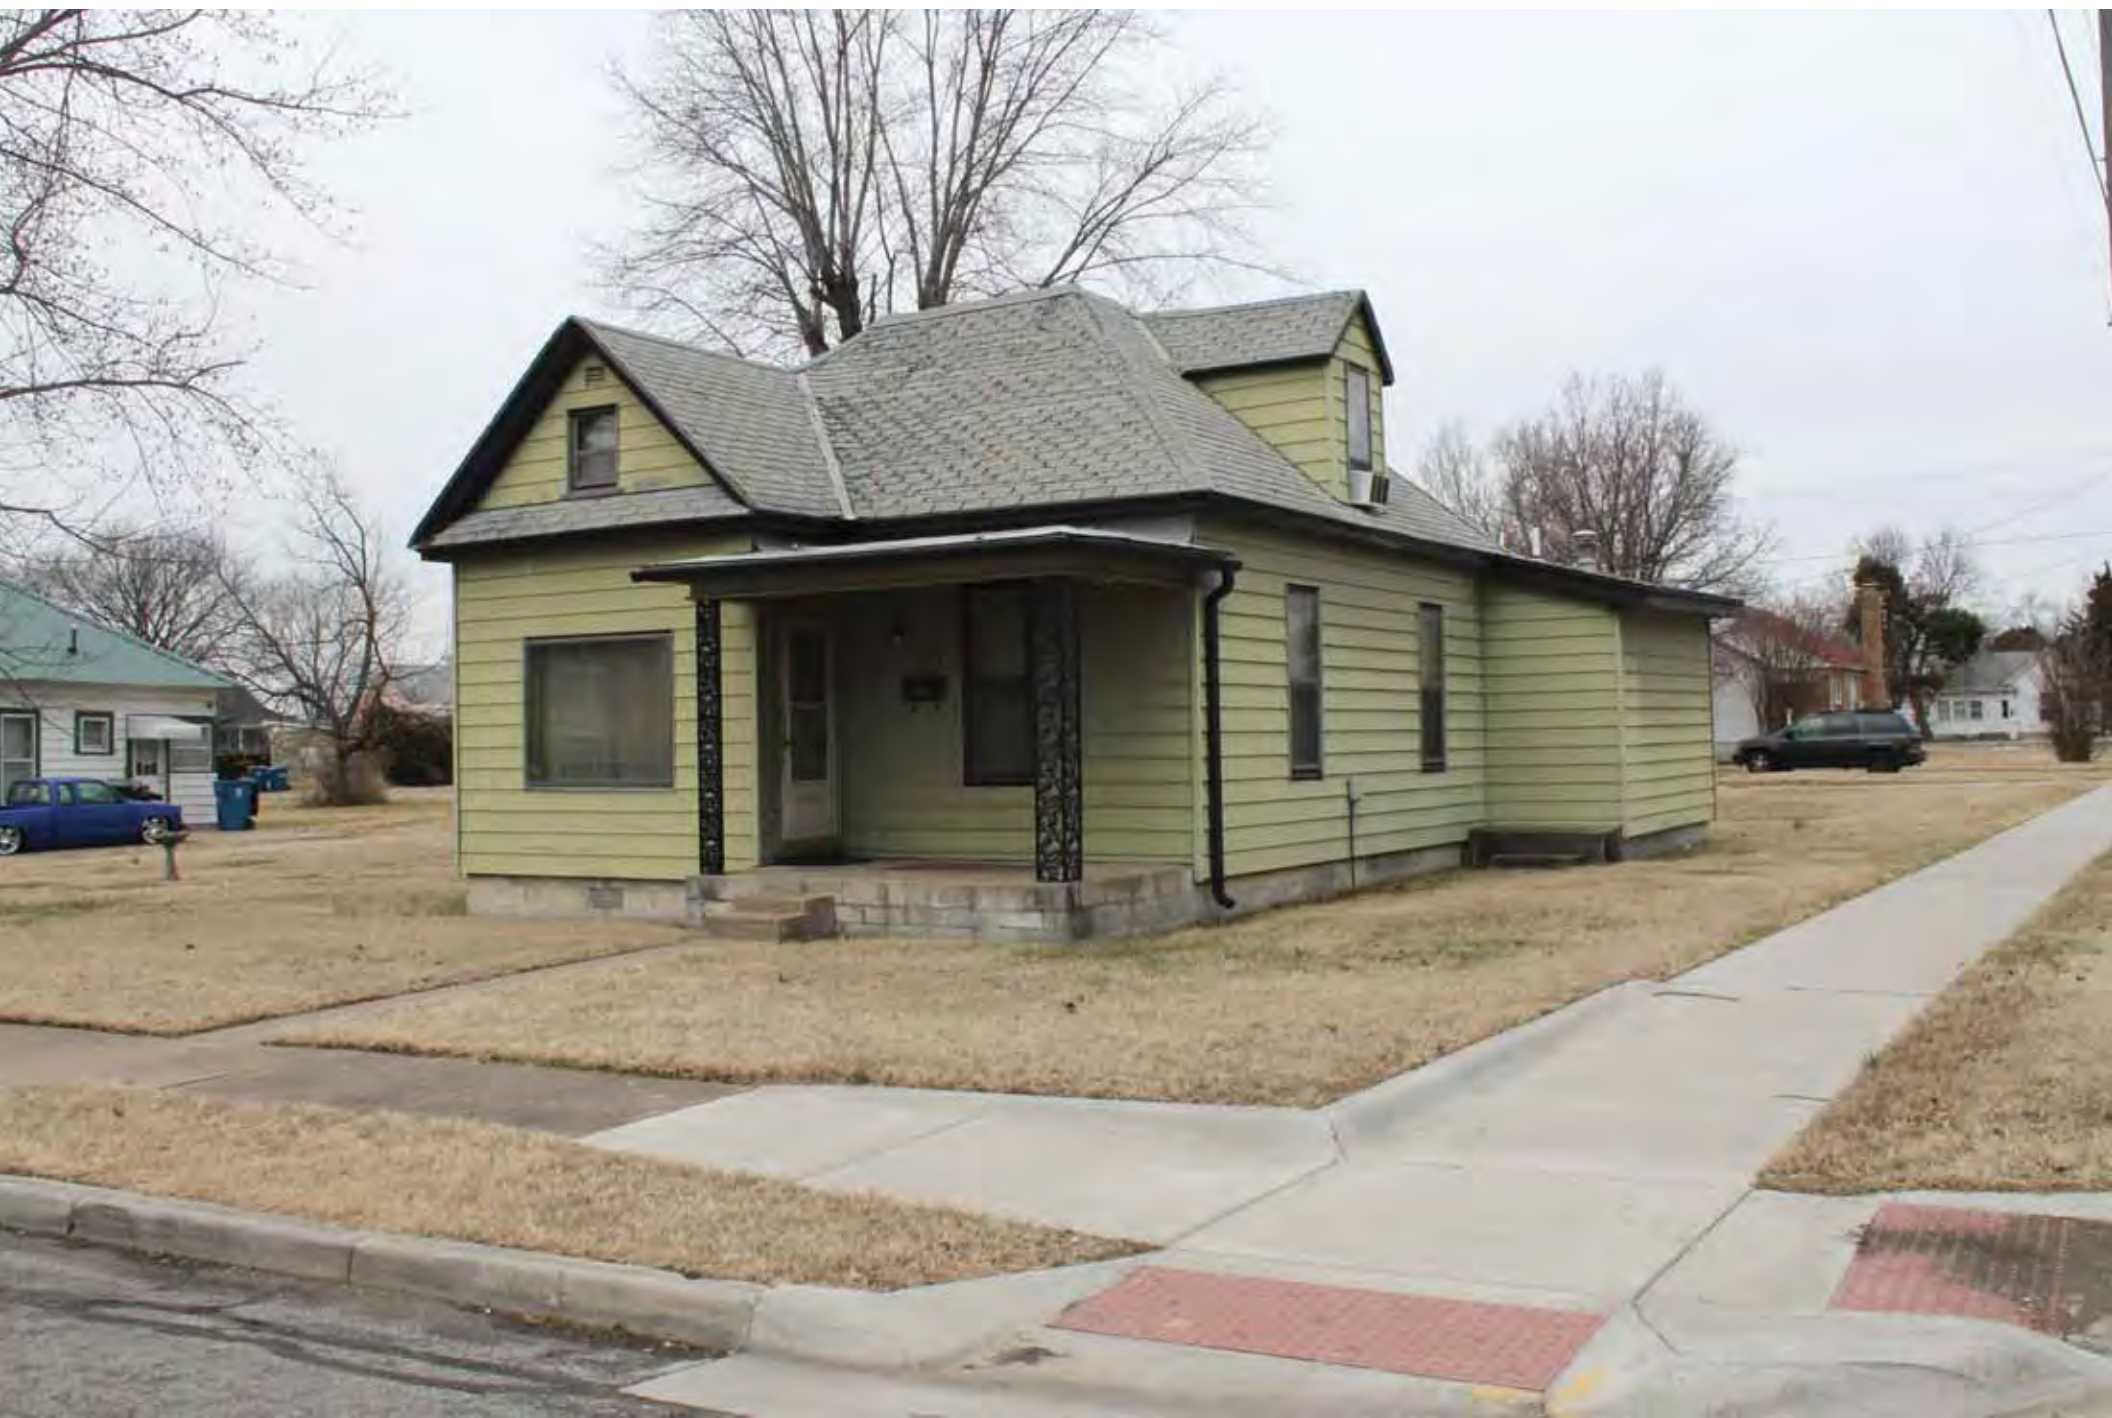
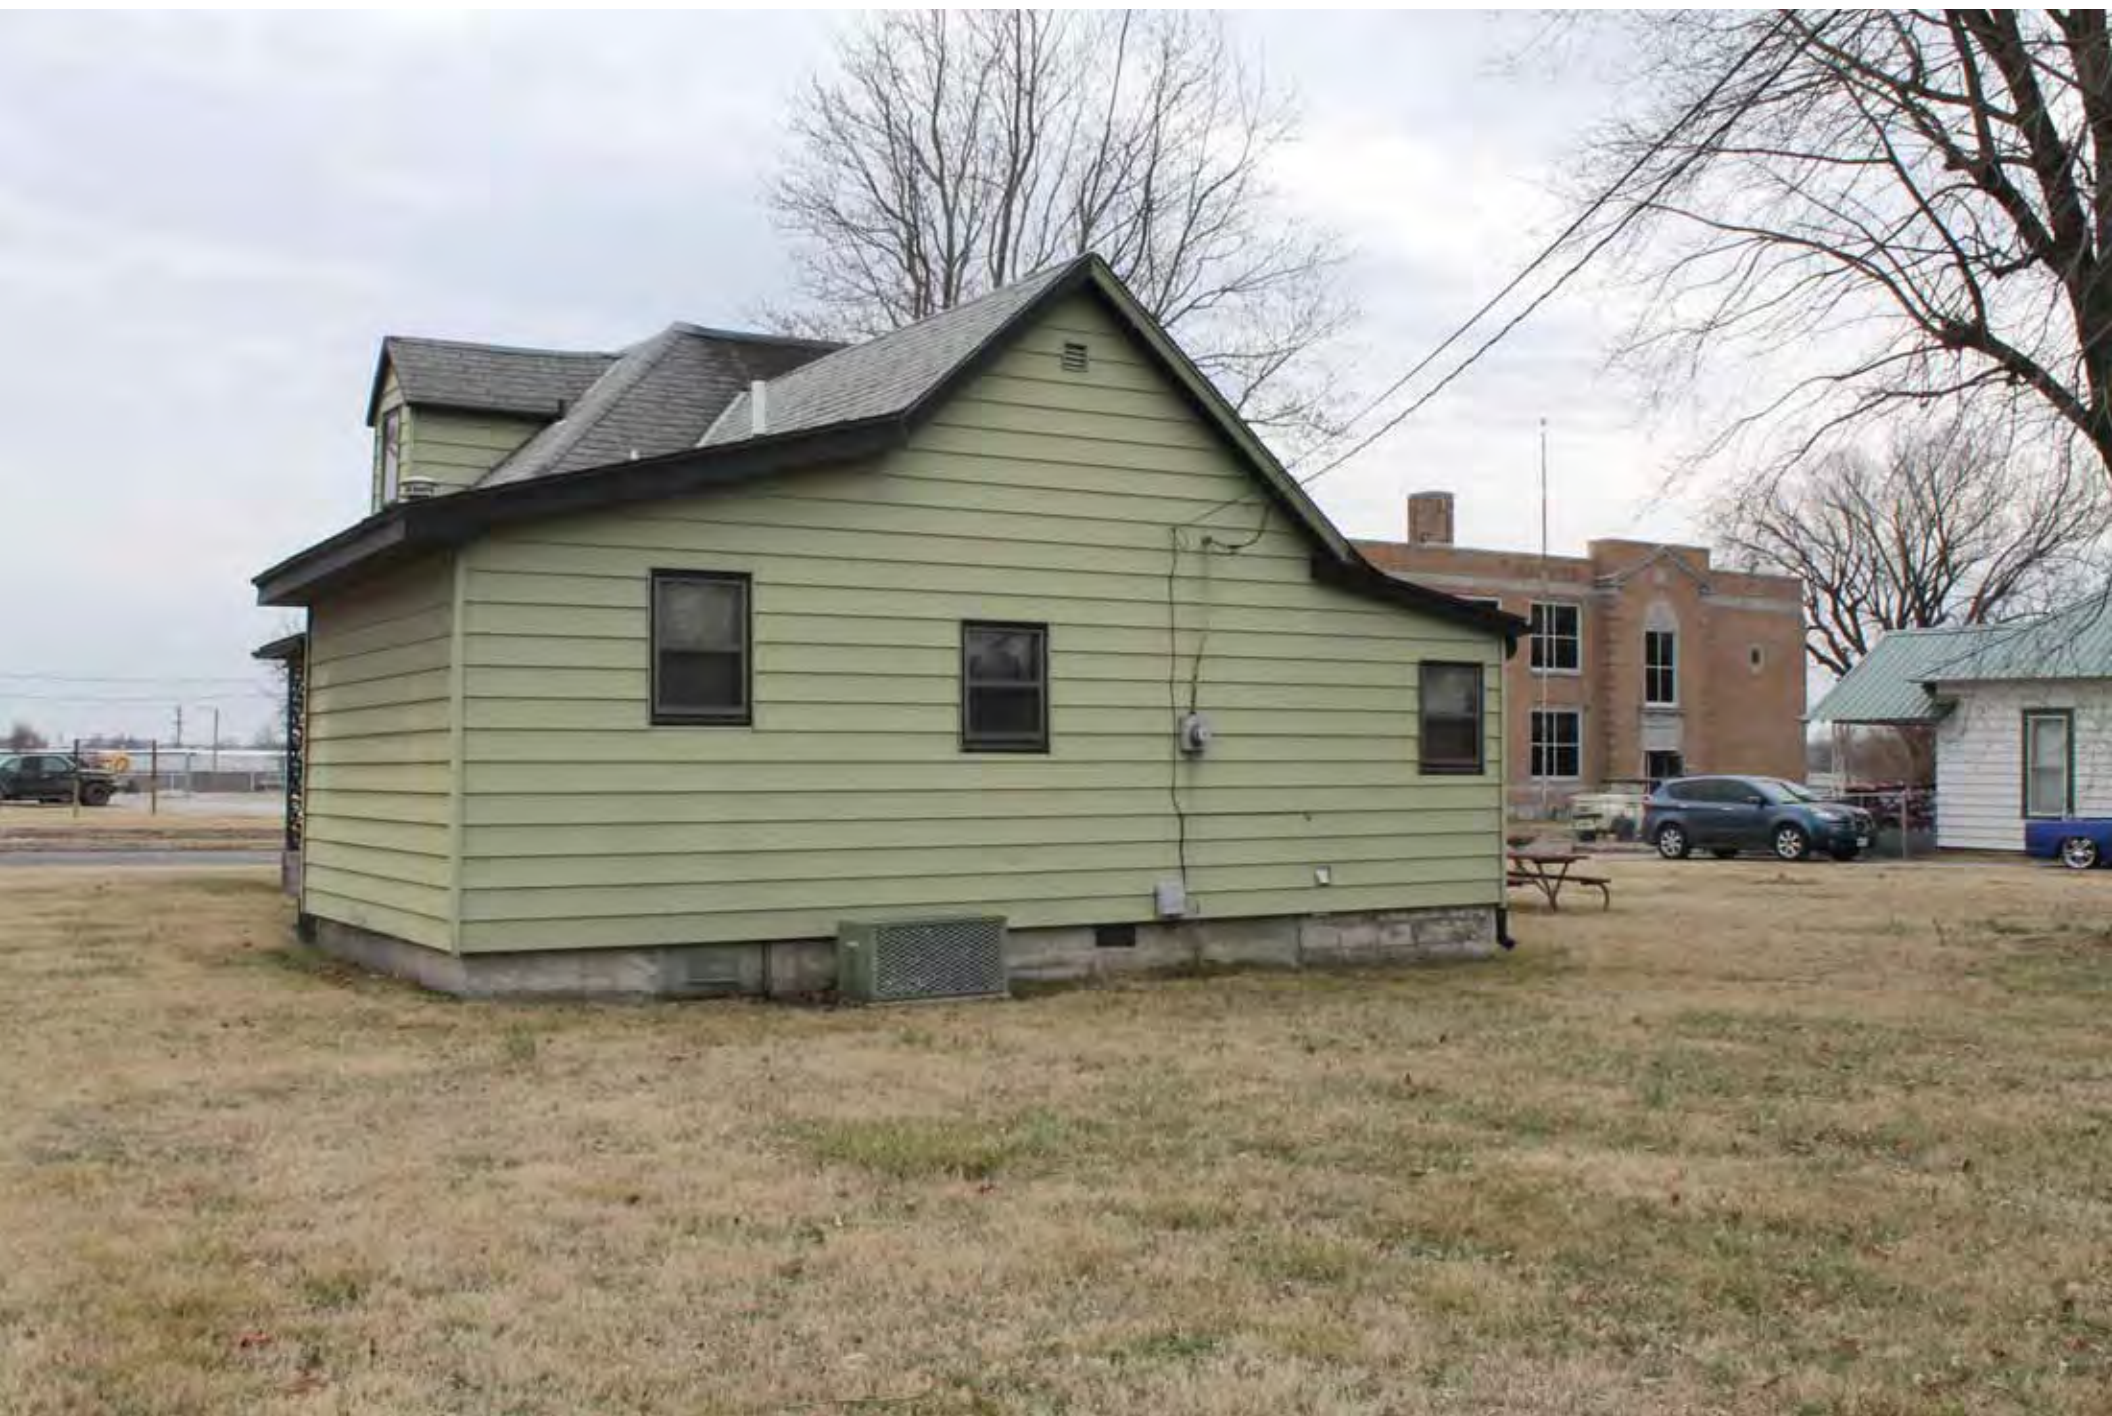
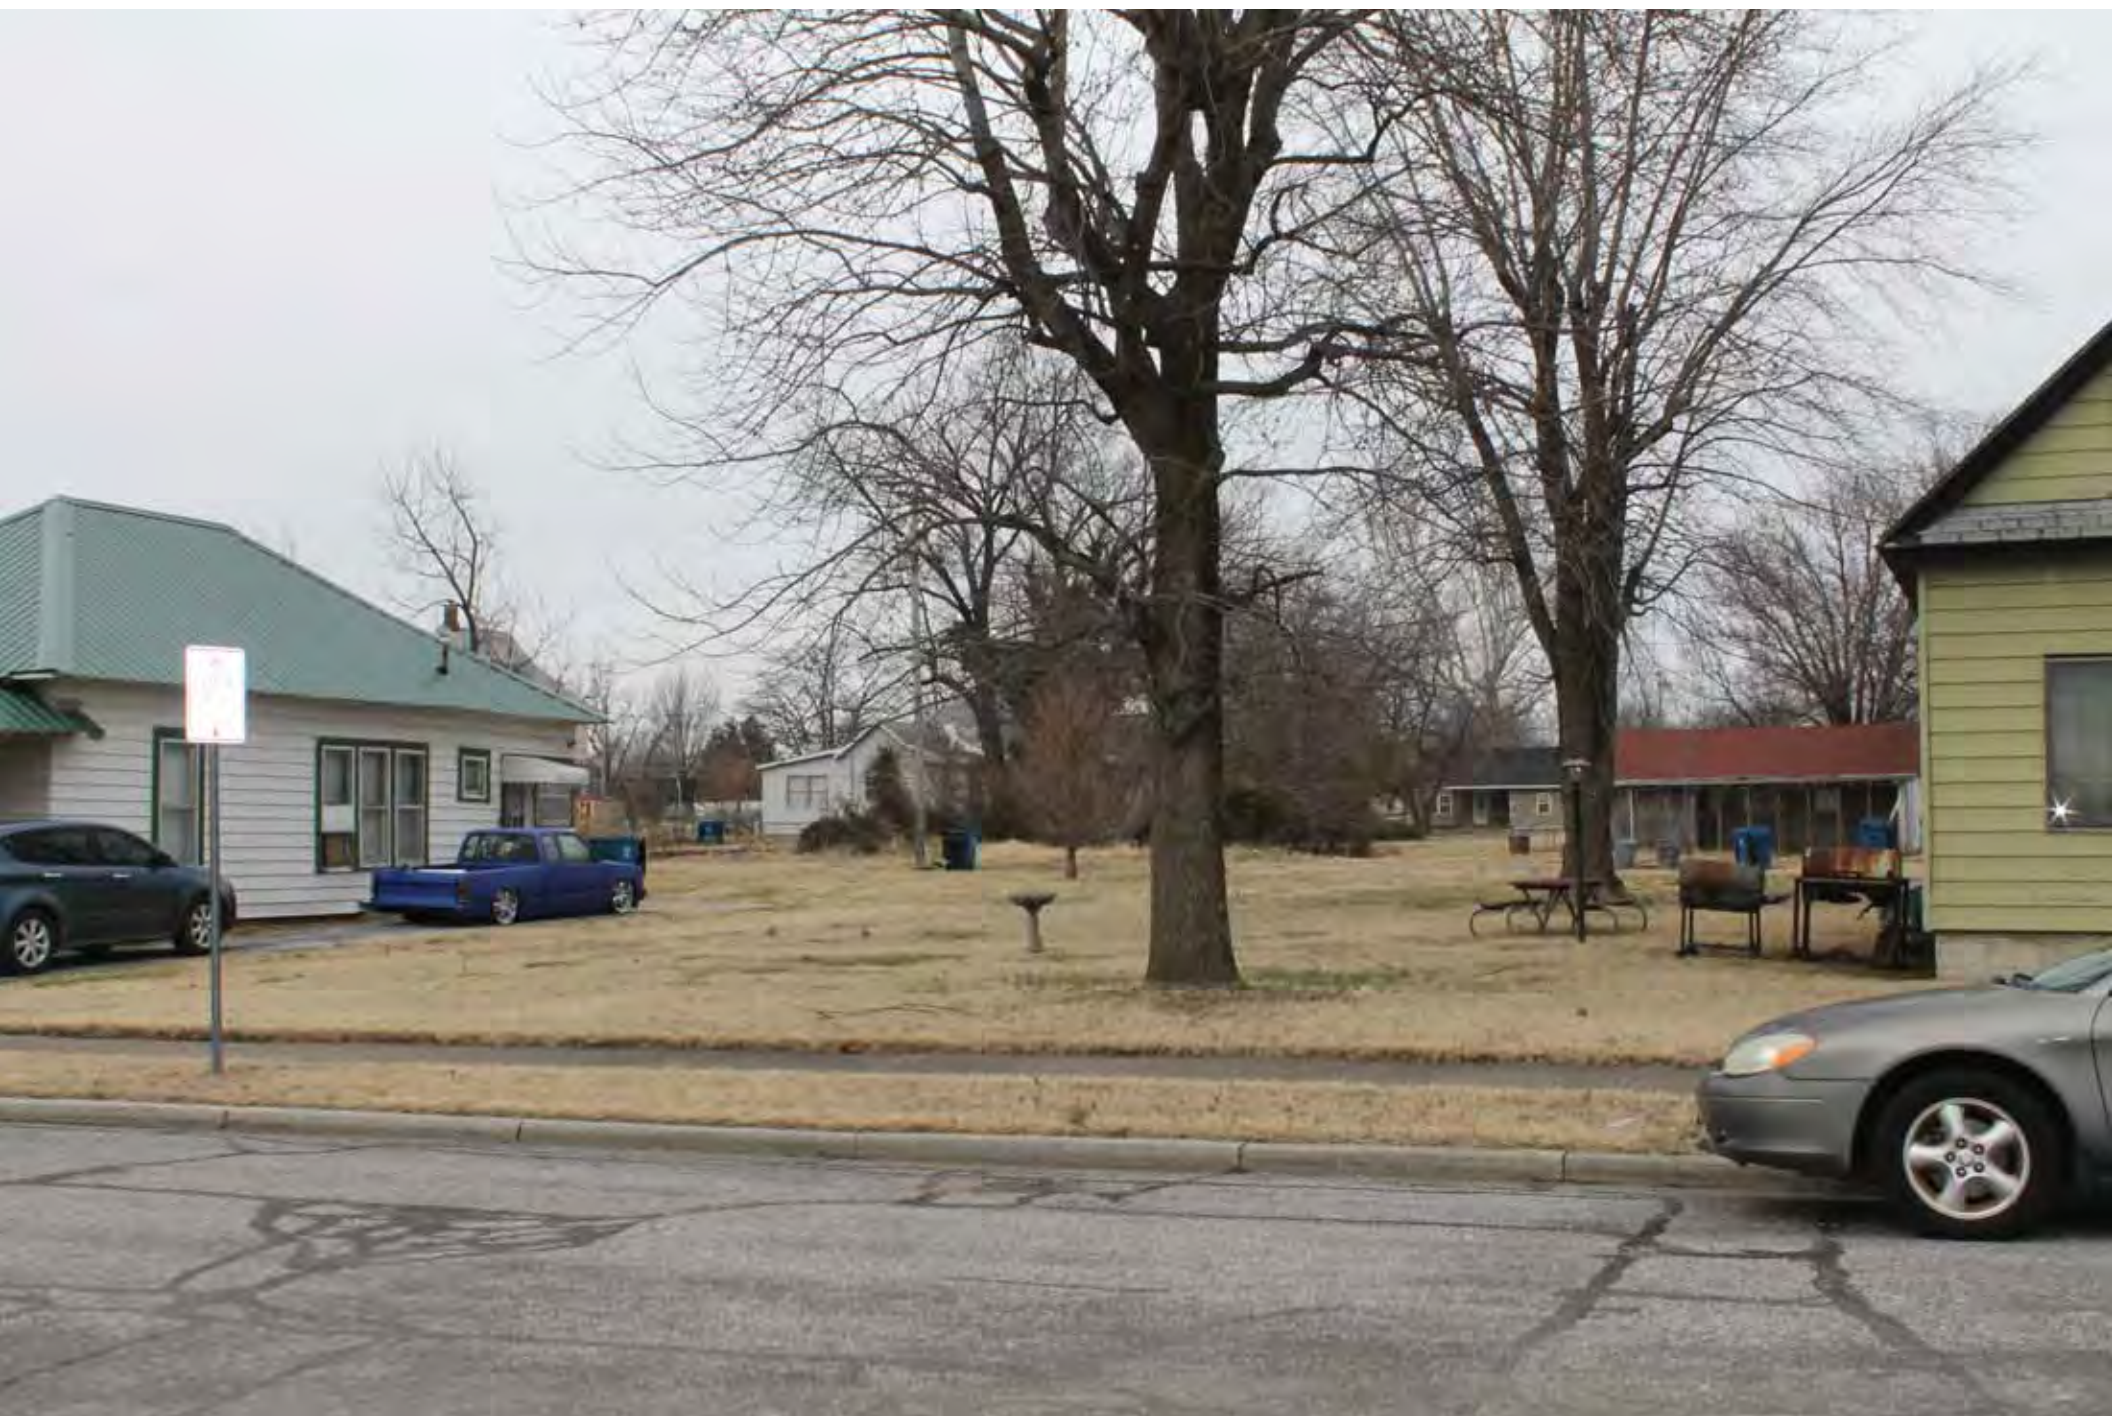
This dwelling has been moved to the current parcel and for that reason is not eligible for the National Register of Historic Places. The dwelling is not situated in an area recommended as a historic district. The dwelling reflects a common property type and has been altered with replacement of original windows, further compromising the property's architectural integrity.

The property at 1125 E. 2nd Street features a 1.5-story dwelling with a hipped and gabled asphalt shingled roof, wide board siding and a concrete (primarily block) foundation. The primary (south) elevation supports an off-center flat hipped roof supported by wrought iron columns resting on a concrete base. A front gabled wing extends south at the west end of the porch. The primary entry is set within the projecting east wall of the gabled wing. The porch south wall holds a one-over-one window; the gabled front south wall holds a fixed sash window. Above this large fixed window, within the gable field, is a small one-over-one window and louvered vent. The east roofline supports a gabled dormer with a one-over-one window. Below the window is an air conditioner. The rear northeast roofline extends to create a shed wing void of fenestration on all but the rear (north) elevation which supports a one-over-one window. The remaining north elevation features two small one-over-one windows. The west elevation supports one-over-one windows and a secondary entry near the north end of the elevation.

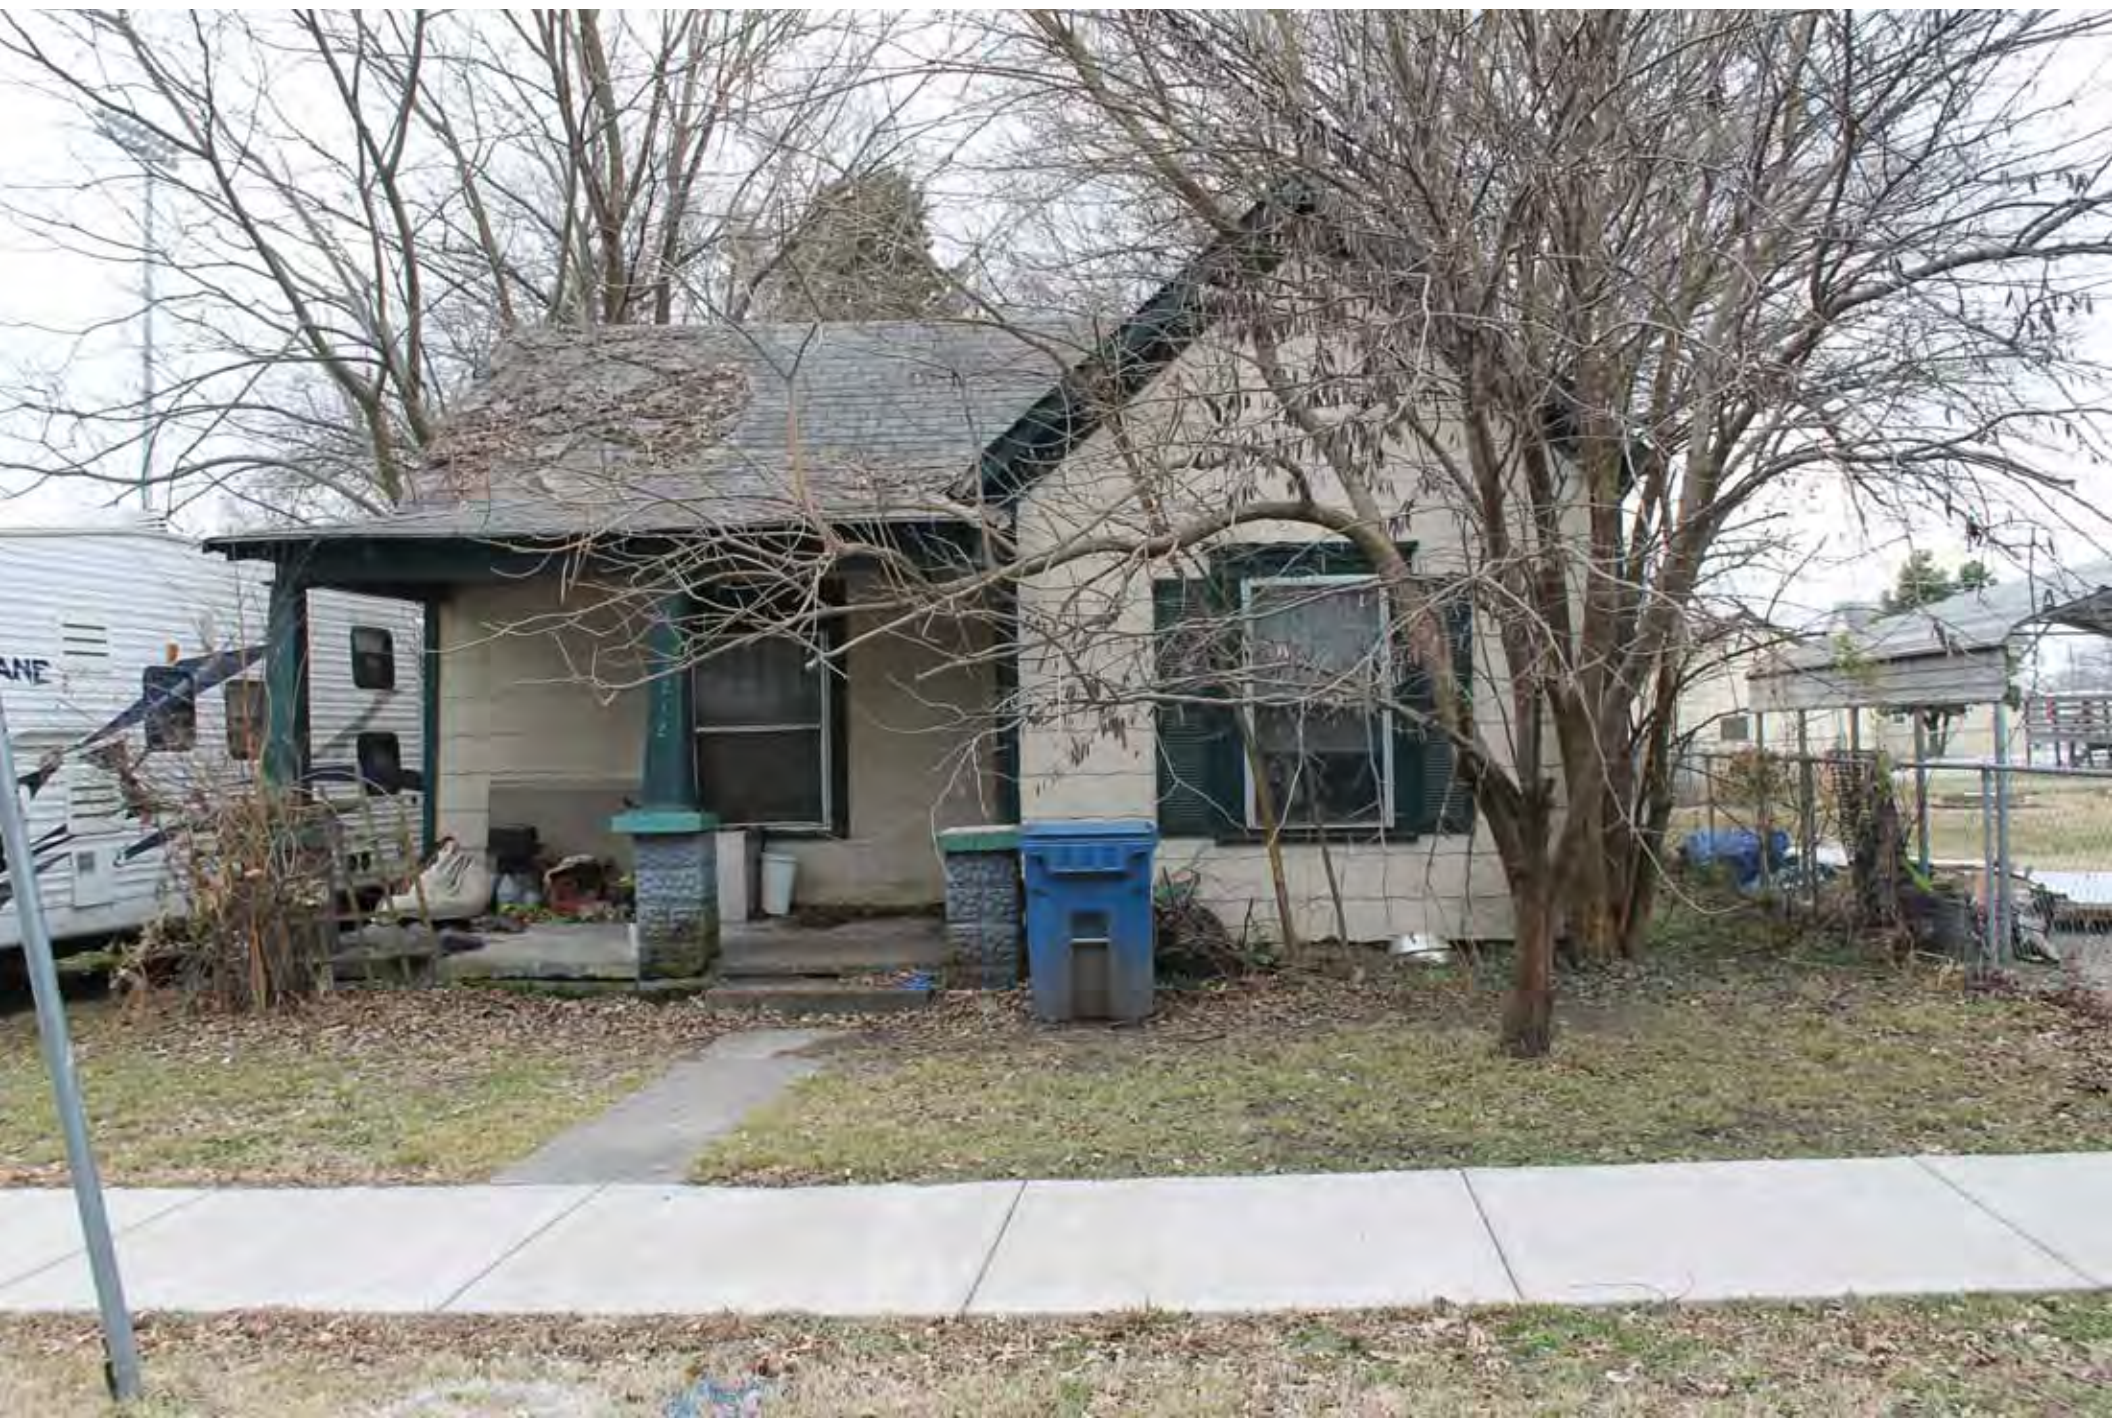
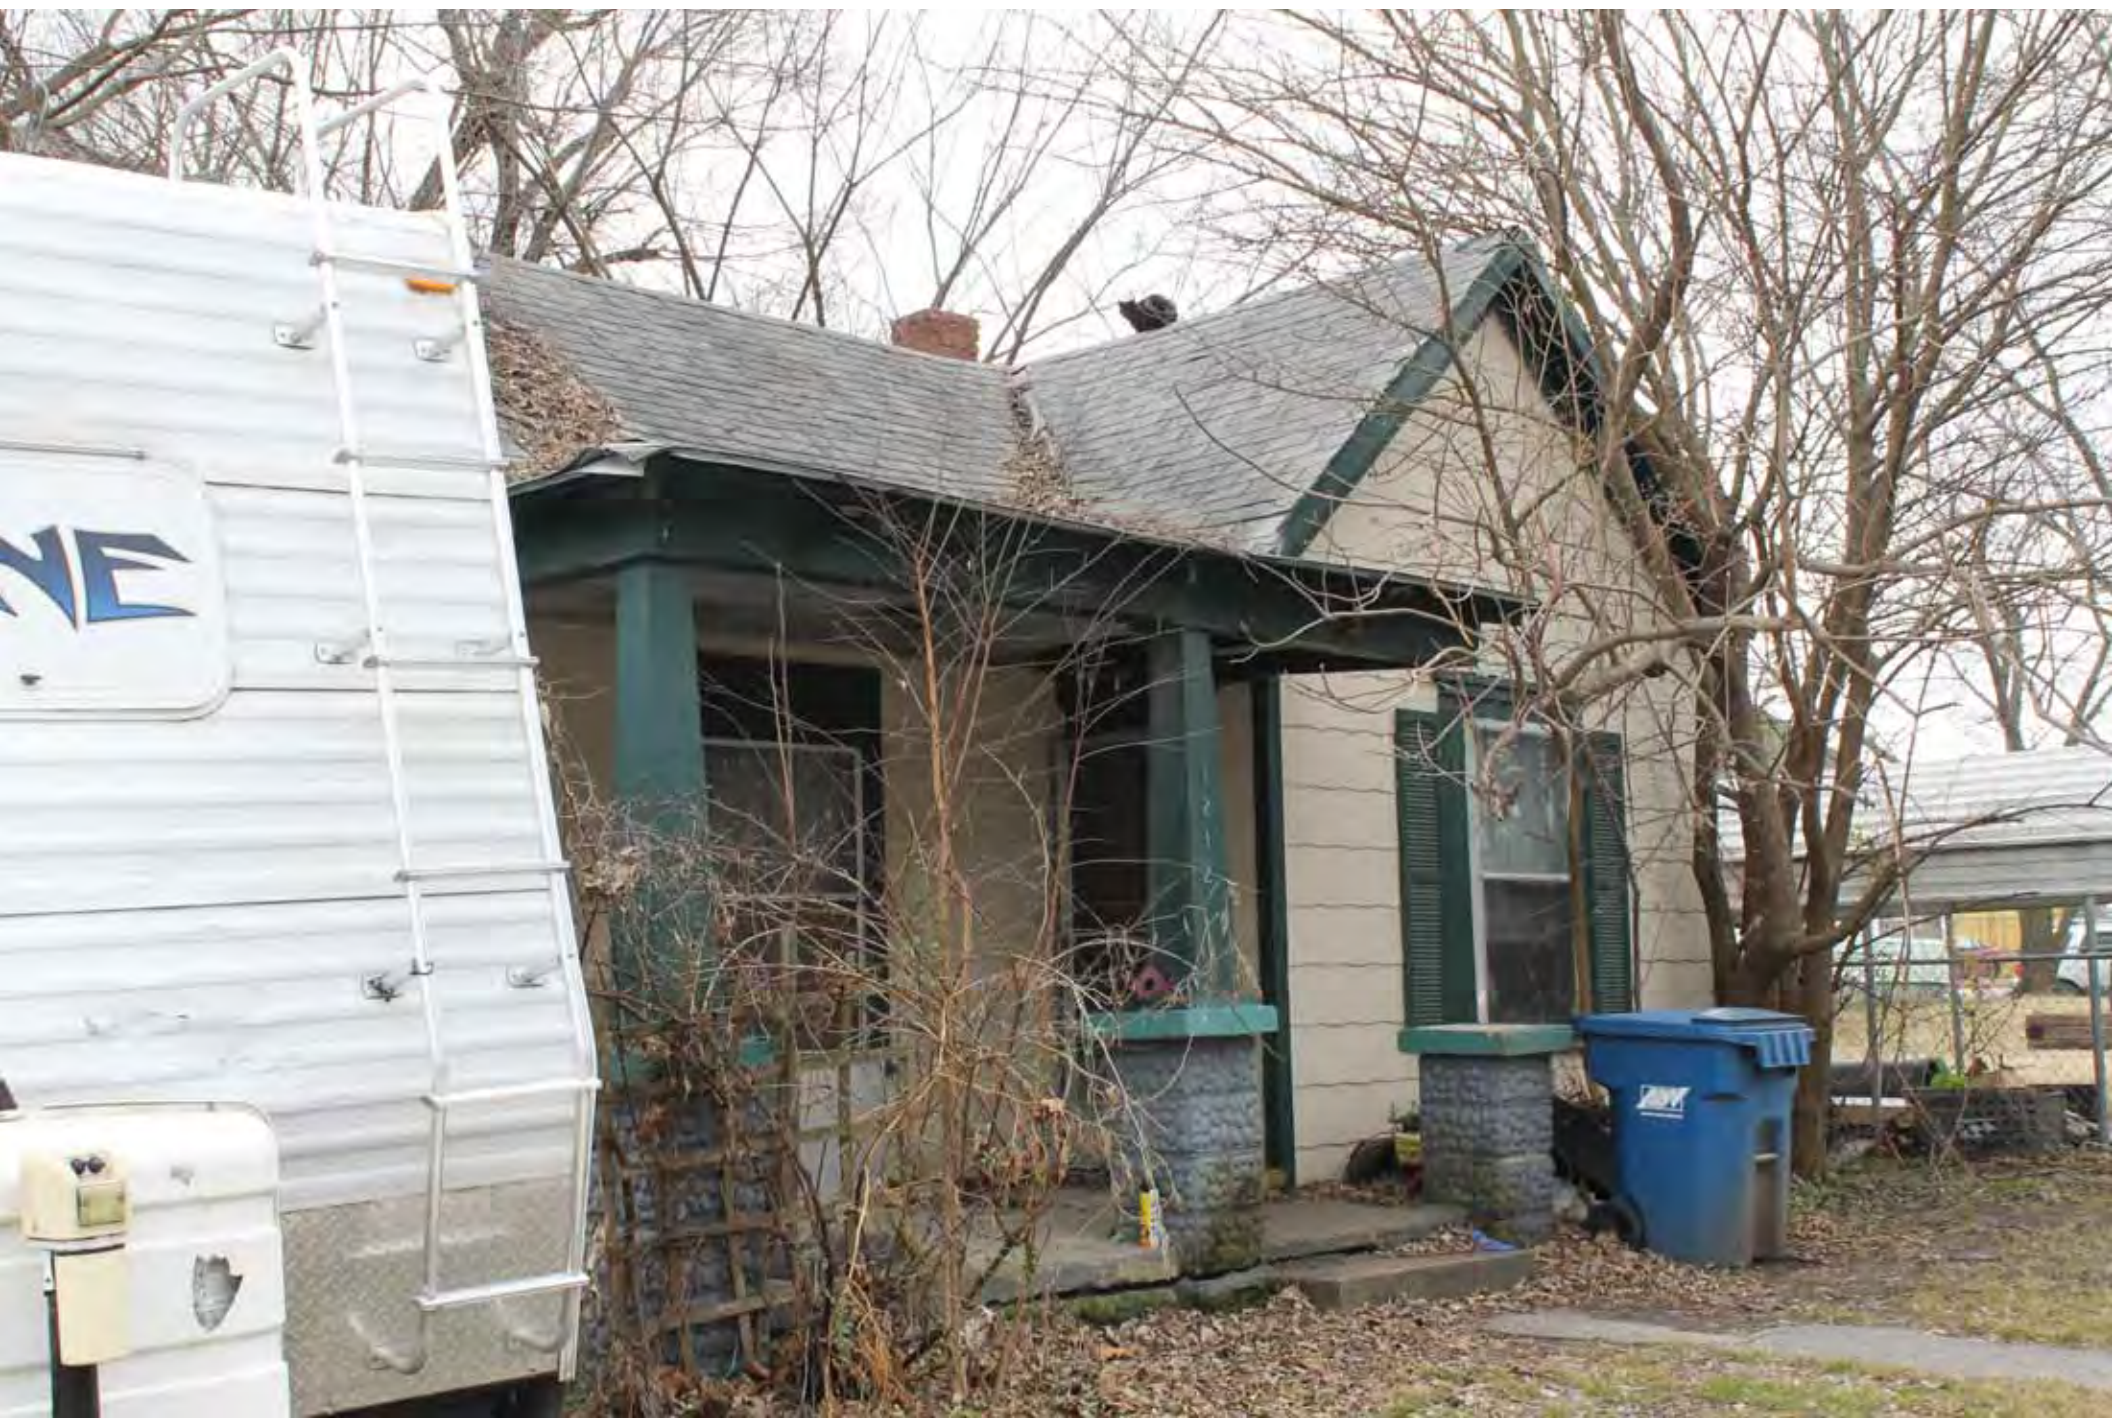
The property at 1212 E. 2nd Street features a front gable and wing plan dwelling with an asphalt shingled roof, exterior asbestos shingle siding and a stone foundation. The primary (north) elevation features a front gabled projecting wing with a single four-over-one window on the north elevation. Offsetting the wing to the east is a shed porch supported by tapered columns resting on faux rubbed block piers. The porch has a concrete floor and leads to a single door below a transom on the gabled wing's east wall. Within the porch bay, the north wall features a five-over-one window. The dwelling has single windows (three) on east and west elevations. The house has a rear single-story wing. Interior brick chimneys are situated at the central roofline ridge of both gabled wings.

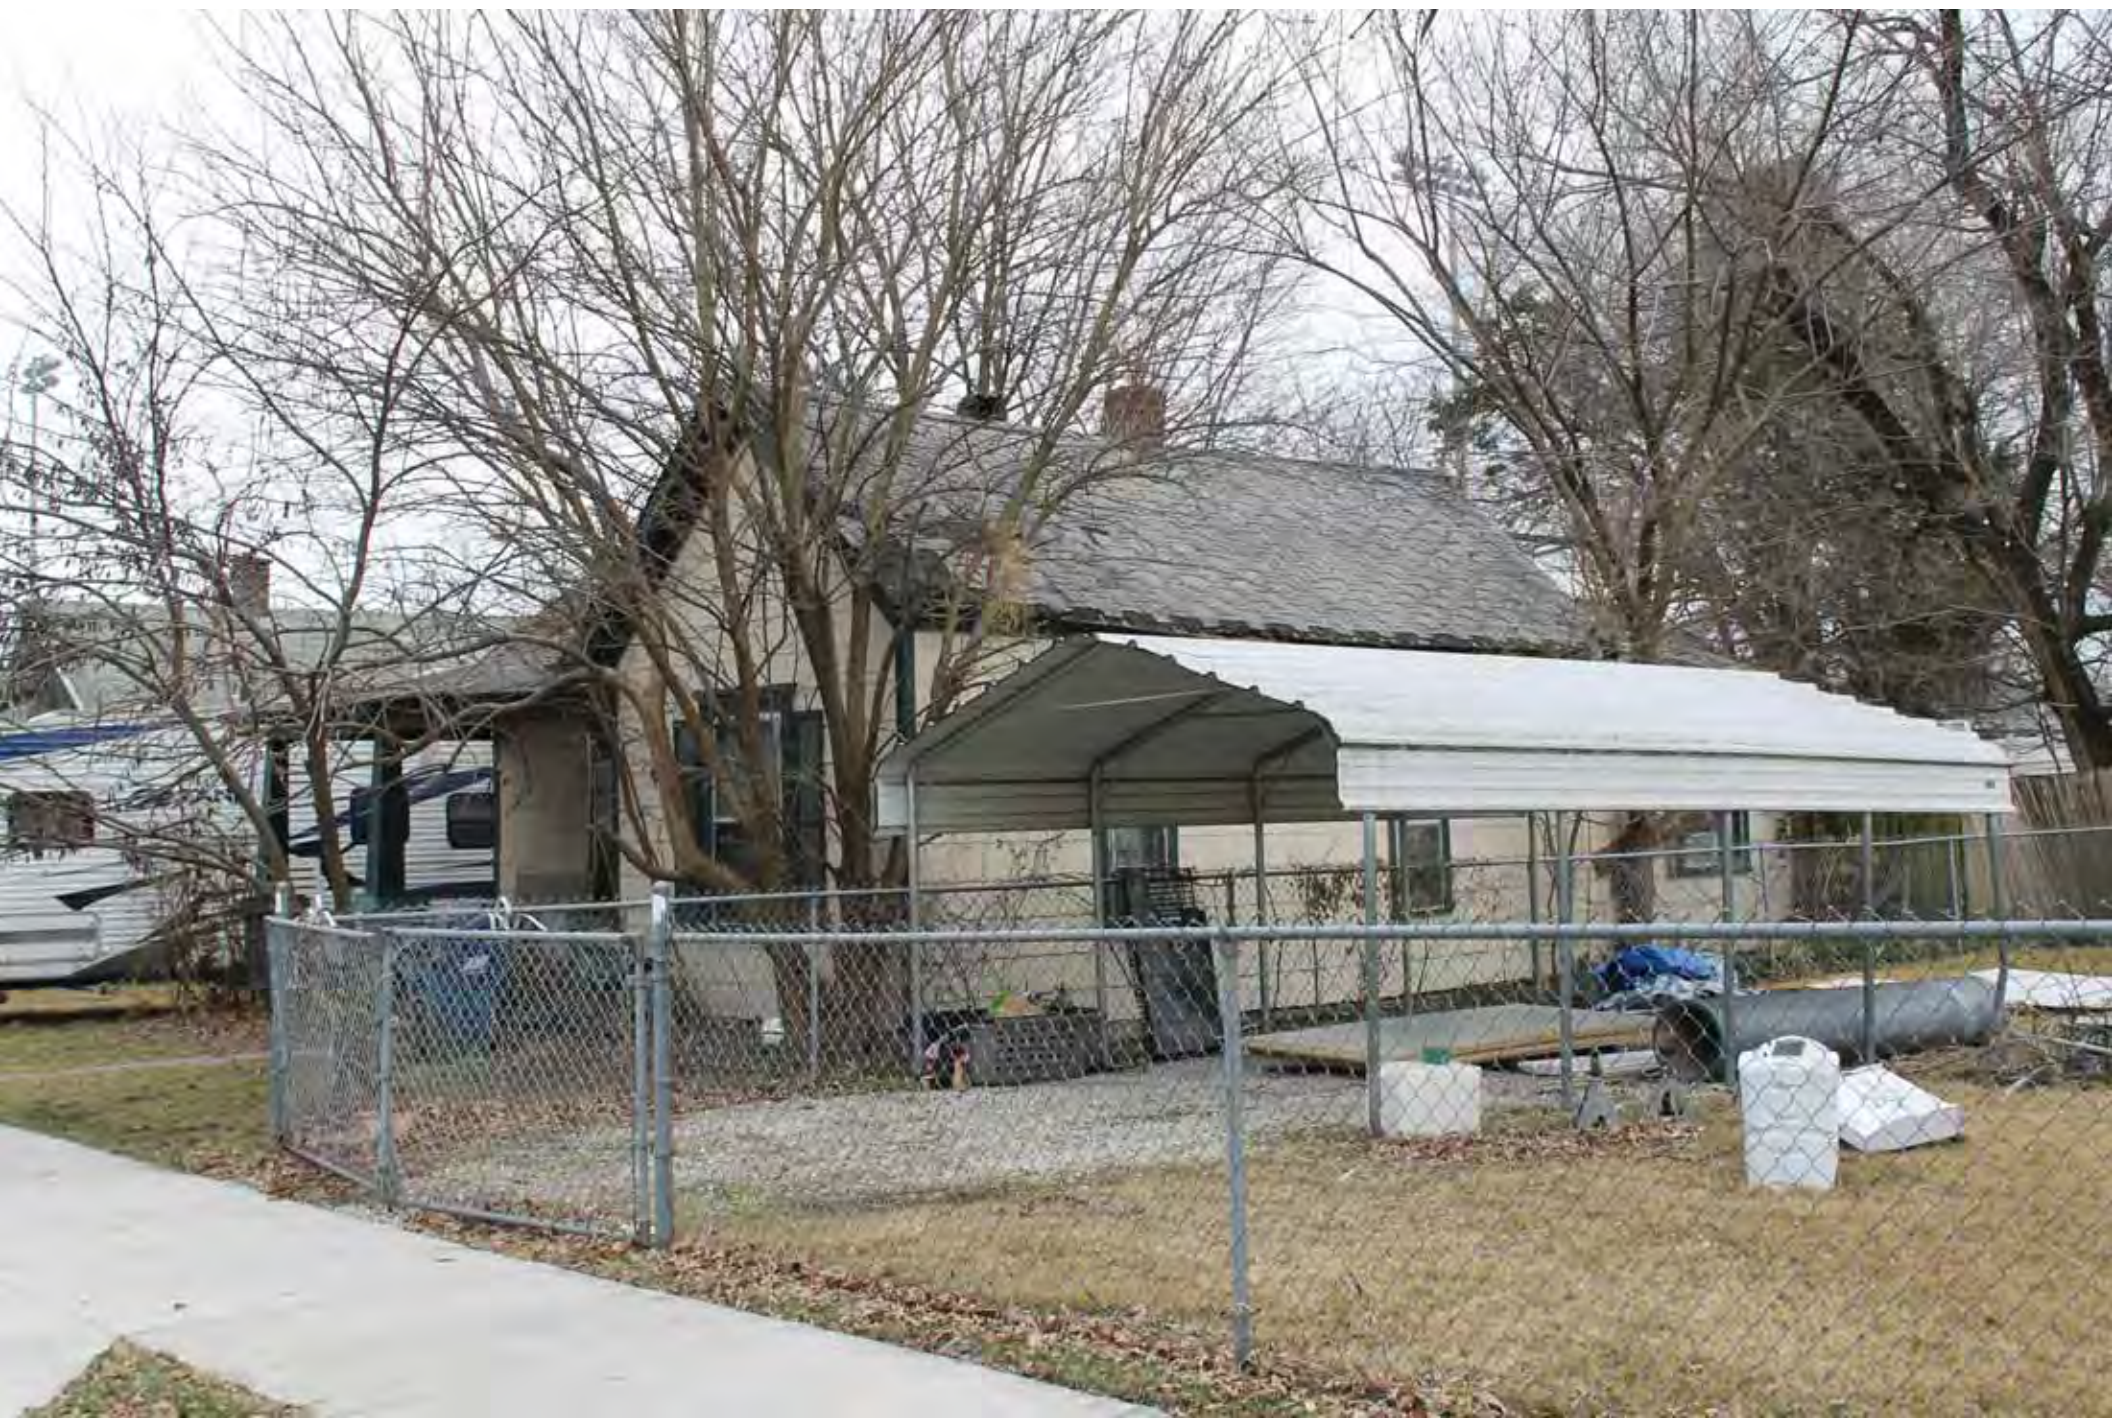
This dwelling has been modified with the addition of exterior asbestos shingle siding (c. 1950). The dwelling does not exhibit exceptional architectural detailing (Criterion C), nor is the dwelling associated with any individual (Criterion B) or historical event (Criterion A) that would render the property individually eligible for the National Register of Historic Places. The property is not within an area recommended as a historic district.
