MISSOURI DEPARTMENT OF NATURAL RESOURCES
STATE HISTORIC PRESERVATION OFFICE, P.O. Box 176, Jefferson City, MO 65102
ARCHITECTURAL/HISTORIC INVENTORY FORM

1. Survey No. JP-AS-007-001		2. Survey name: East Town (Original Joplin) Historic Survey Phase 2	
3. County: JASPER		4. Address (Street No.) 618	Street (name) E. 2 nd Street
5. City: Joplin	Vicinity: <input type="checkbox"/>	6. Geographical Reference:	7. Township/Range/Section: T: R: S:
8. Historic name (if known):		9. Present/other name (if known):	
10. Ownership: <input checked="" type="checkbox"/> Private <input type="checkbox"/> Public		11a. Historic use (if known): Domestic: Single Dwelling	11b. Current use: Domestic: Single Dwelling

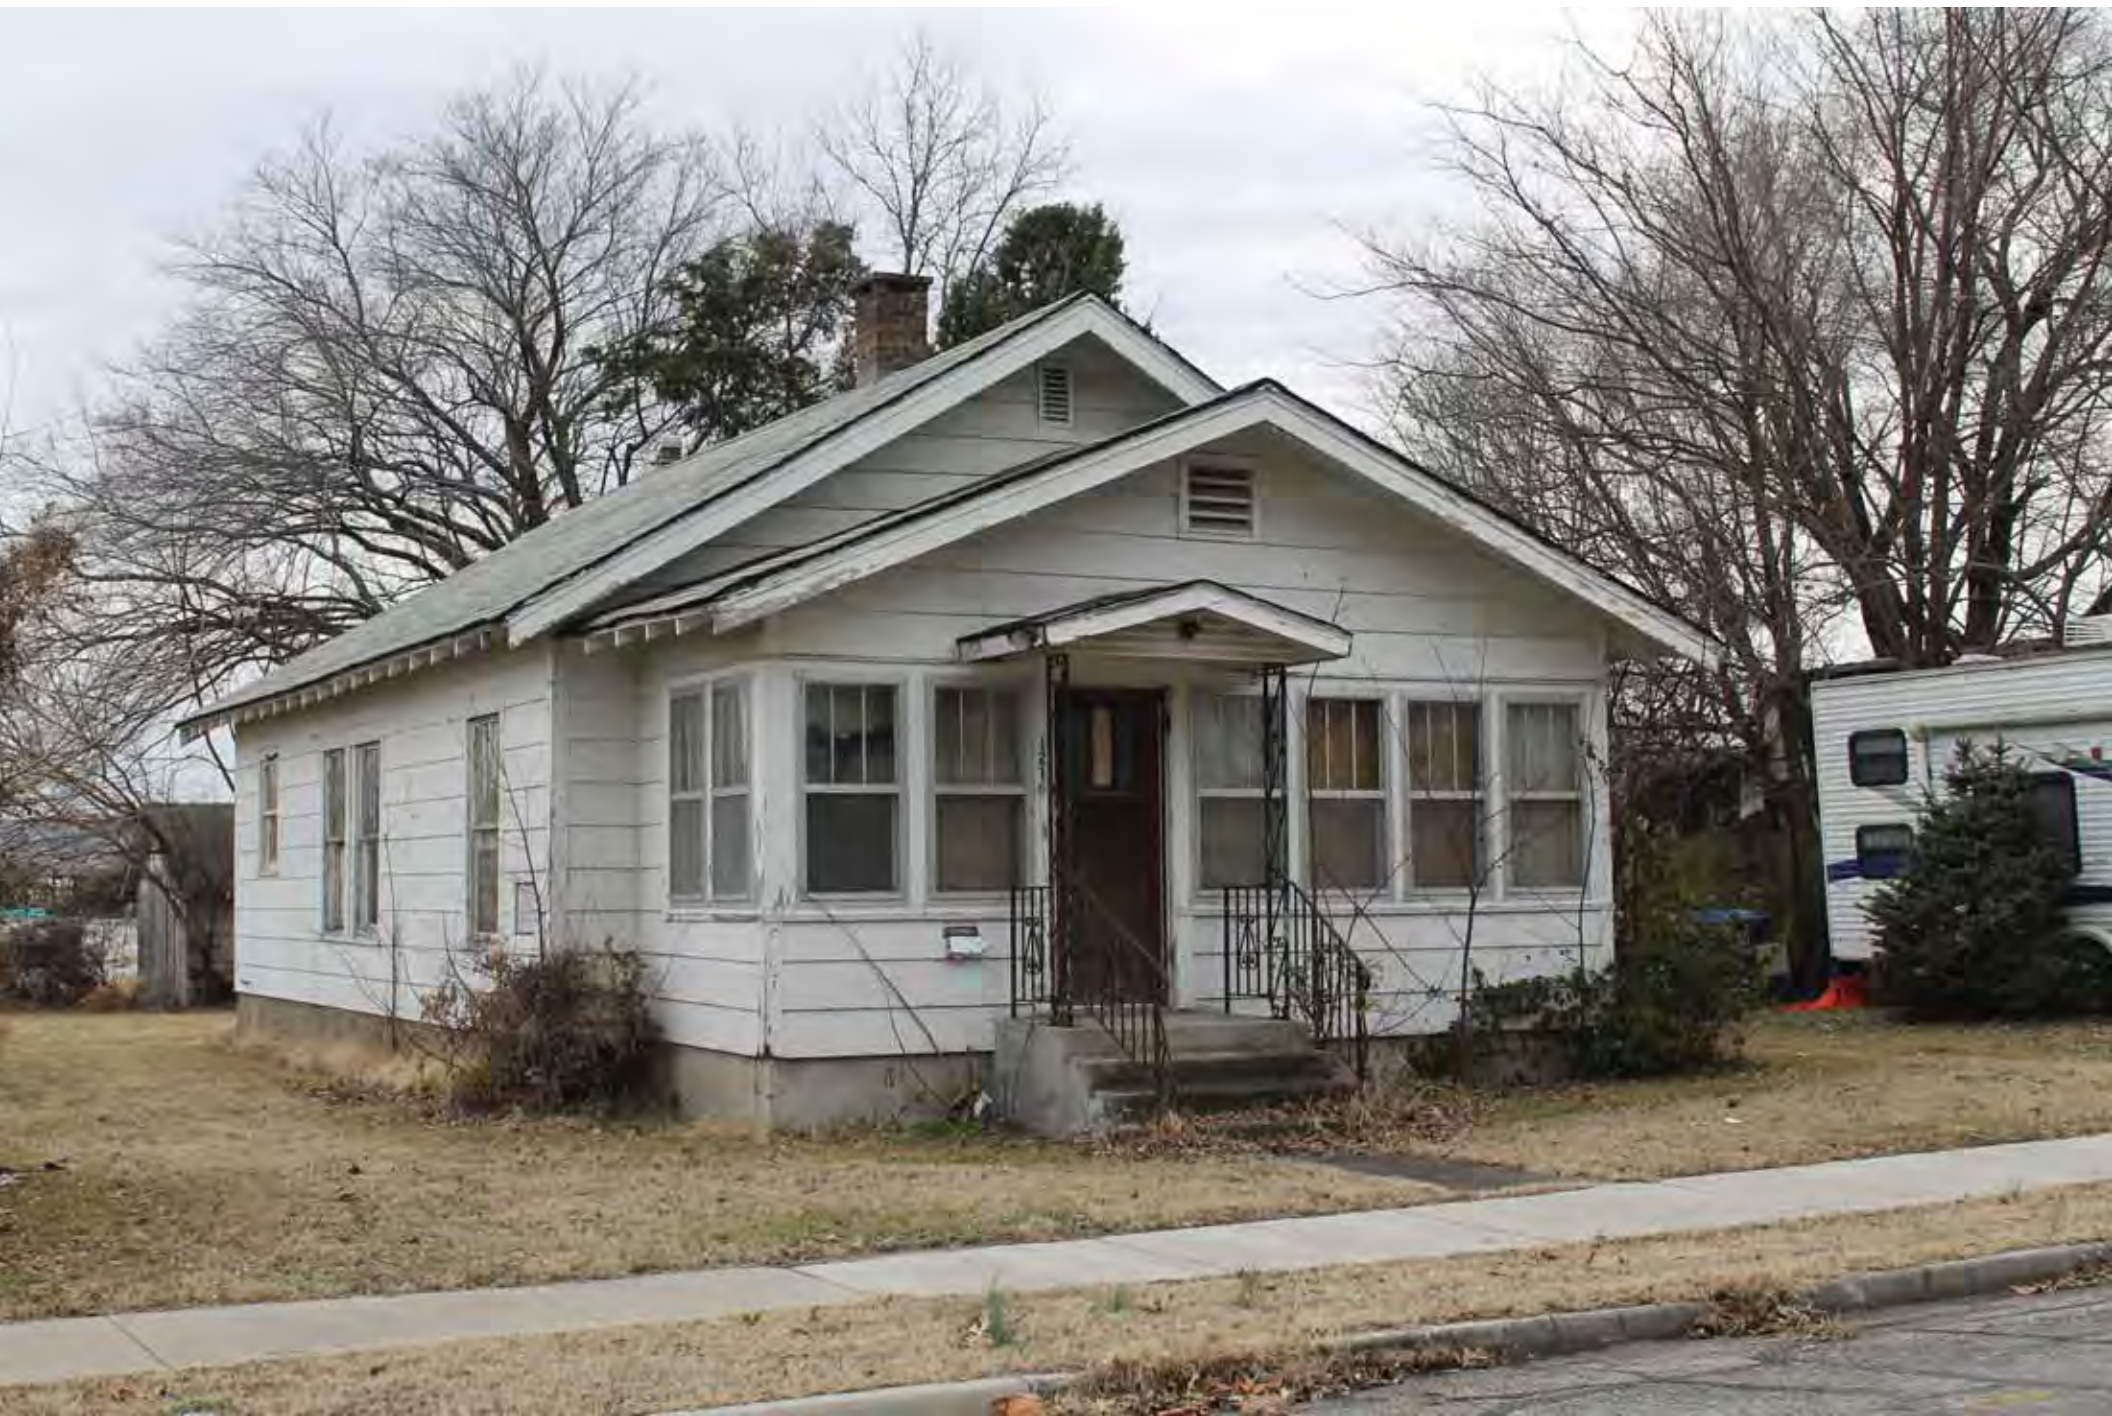
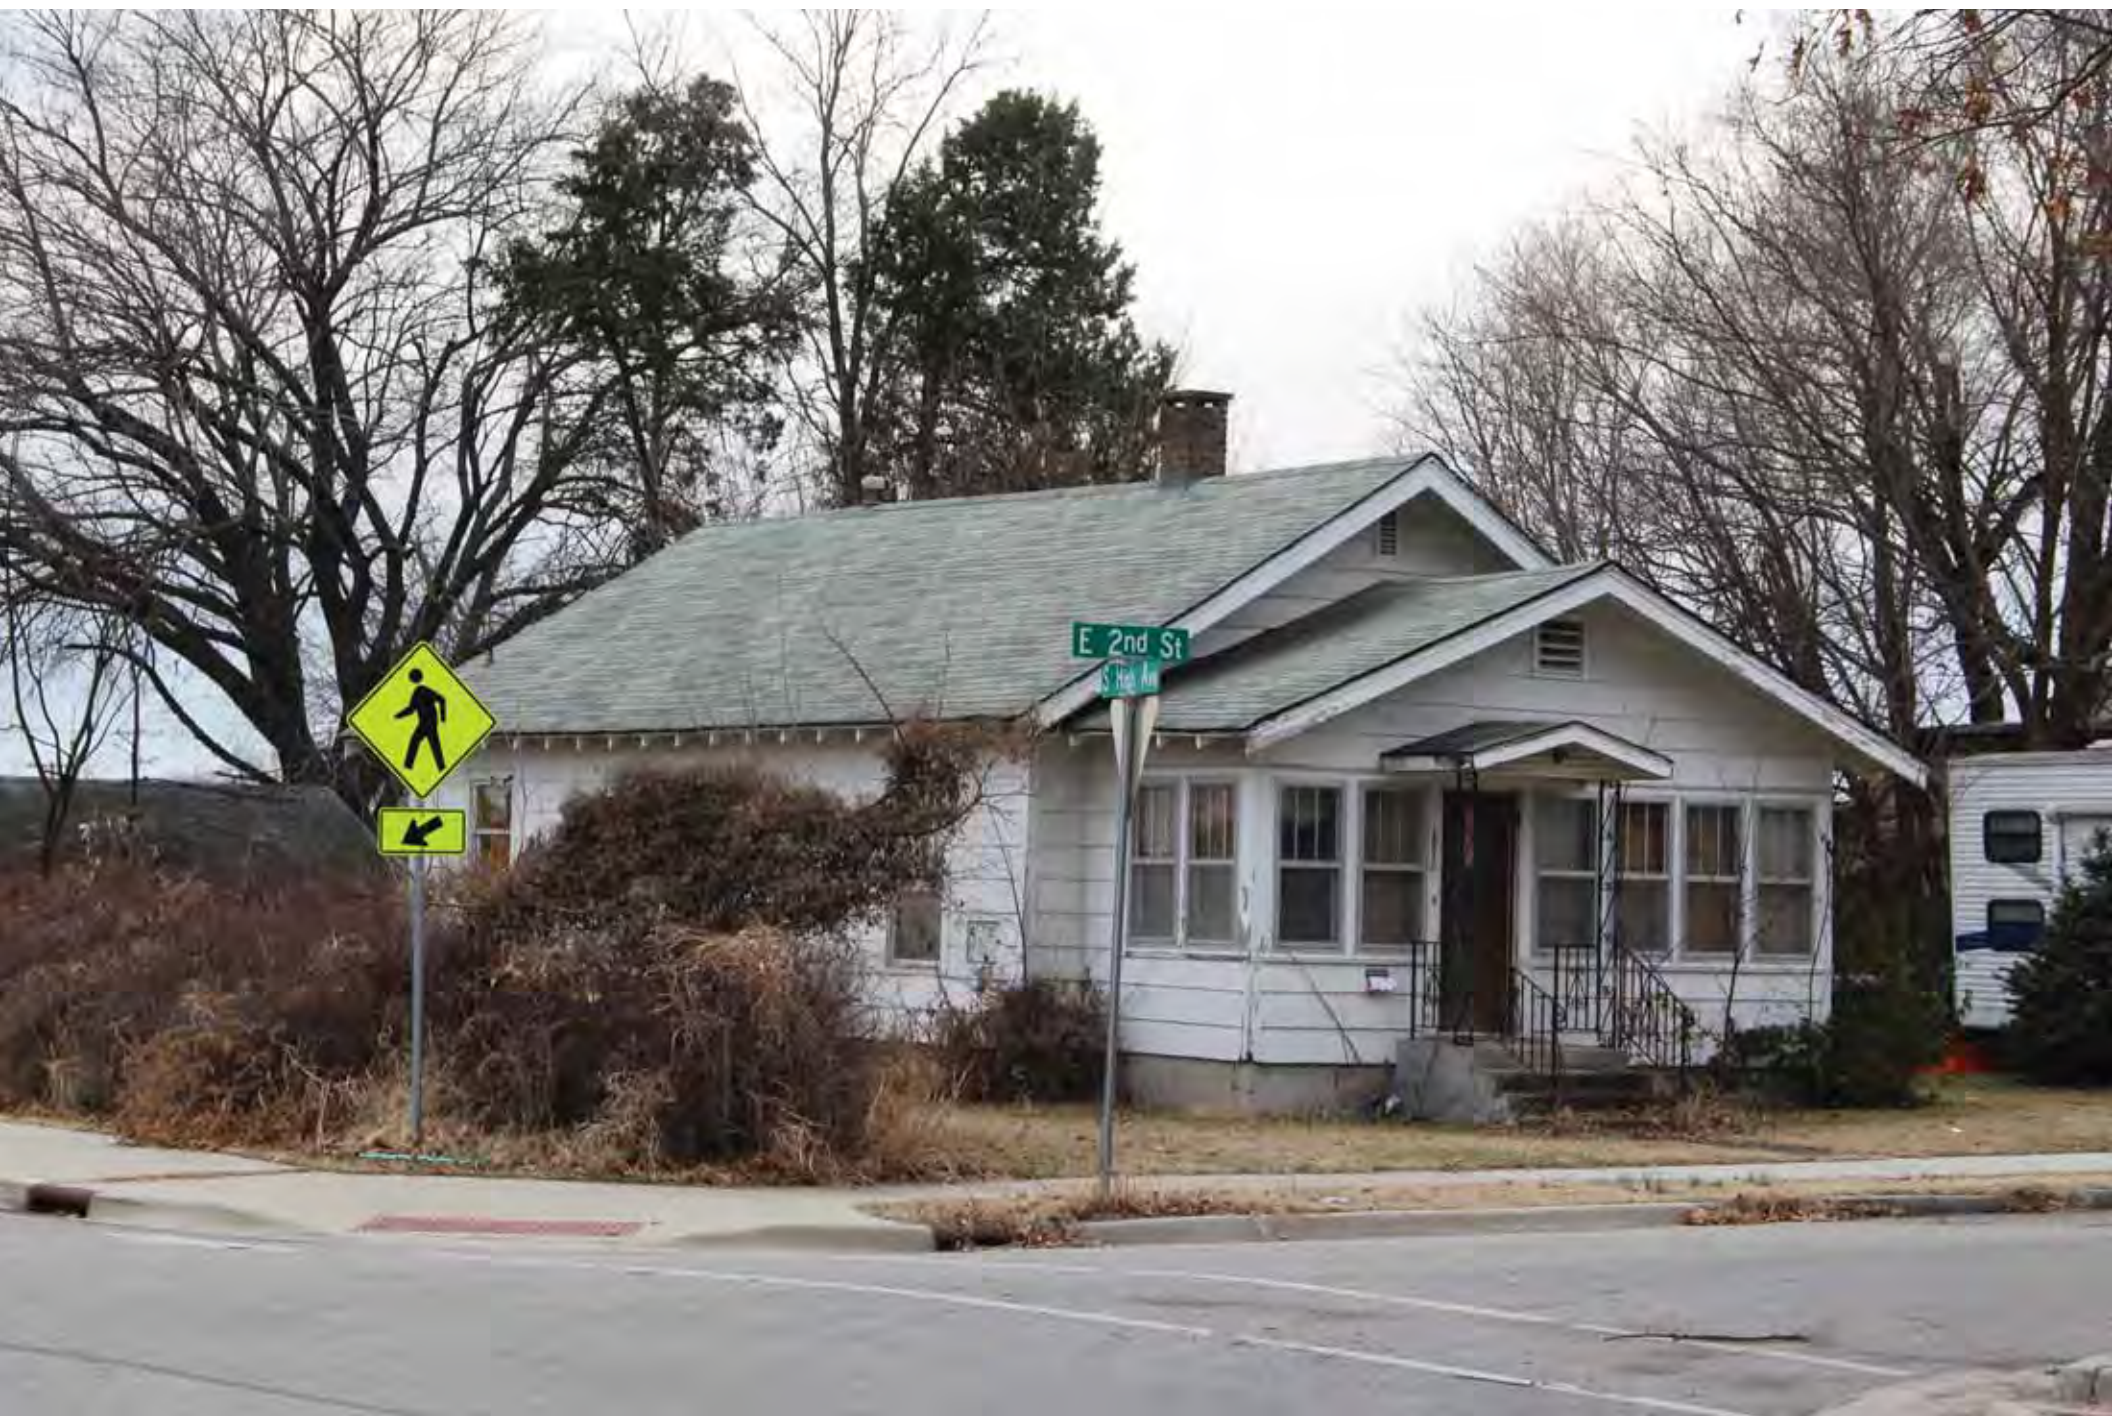
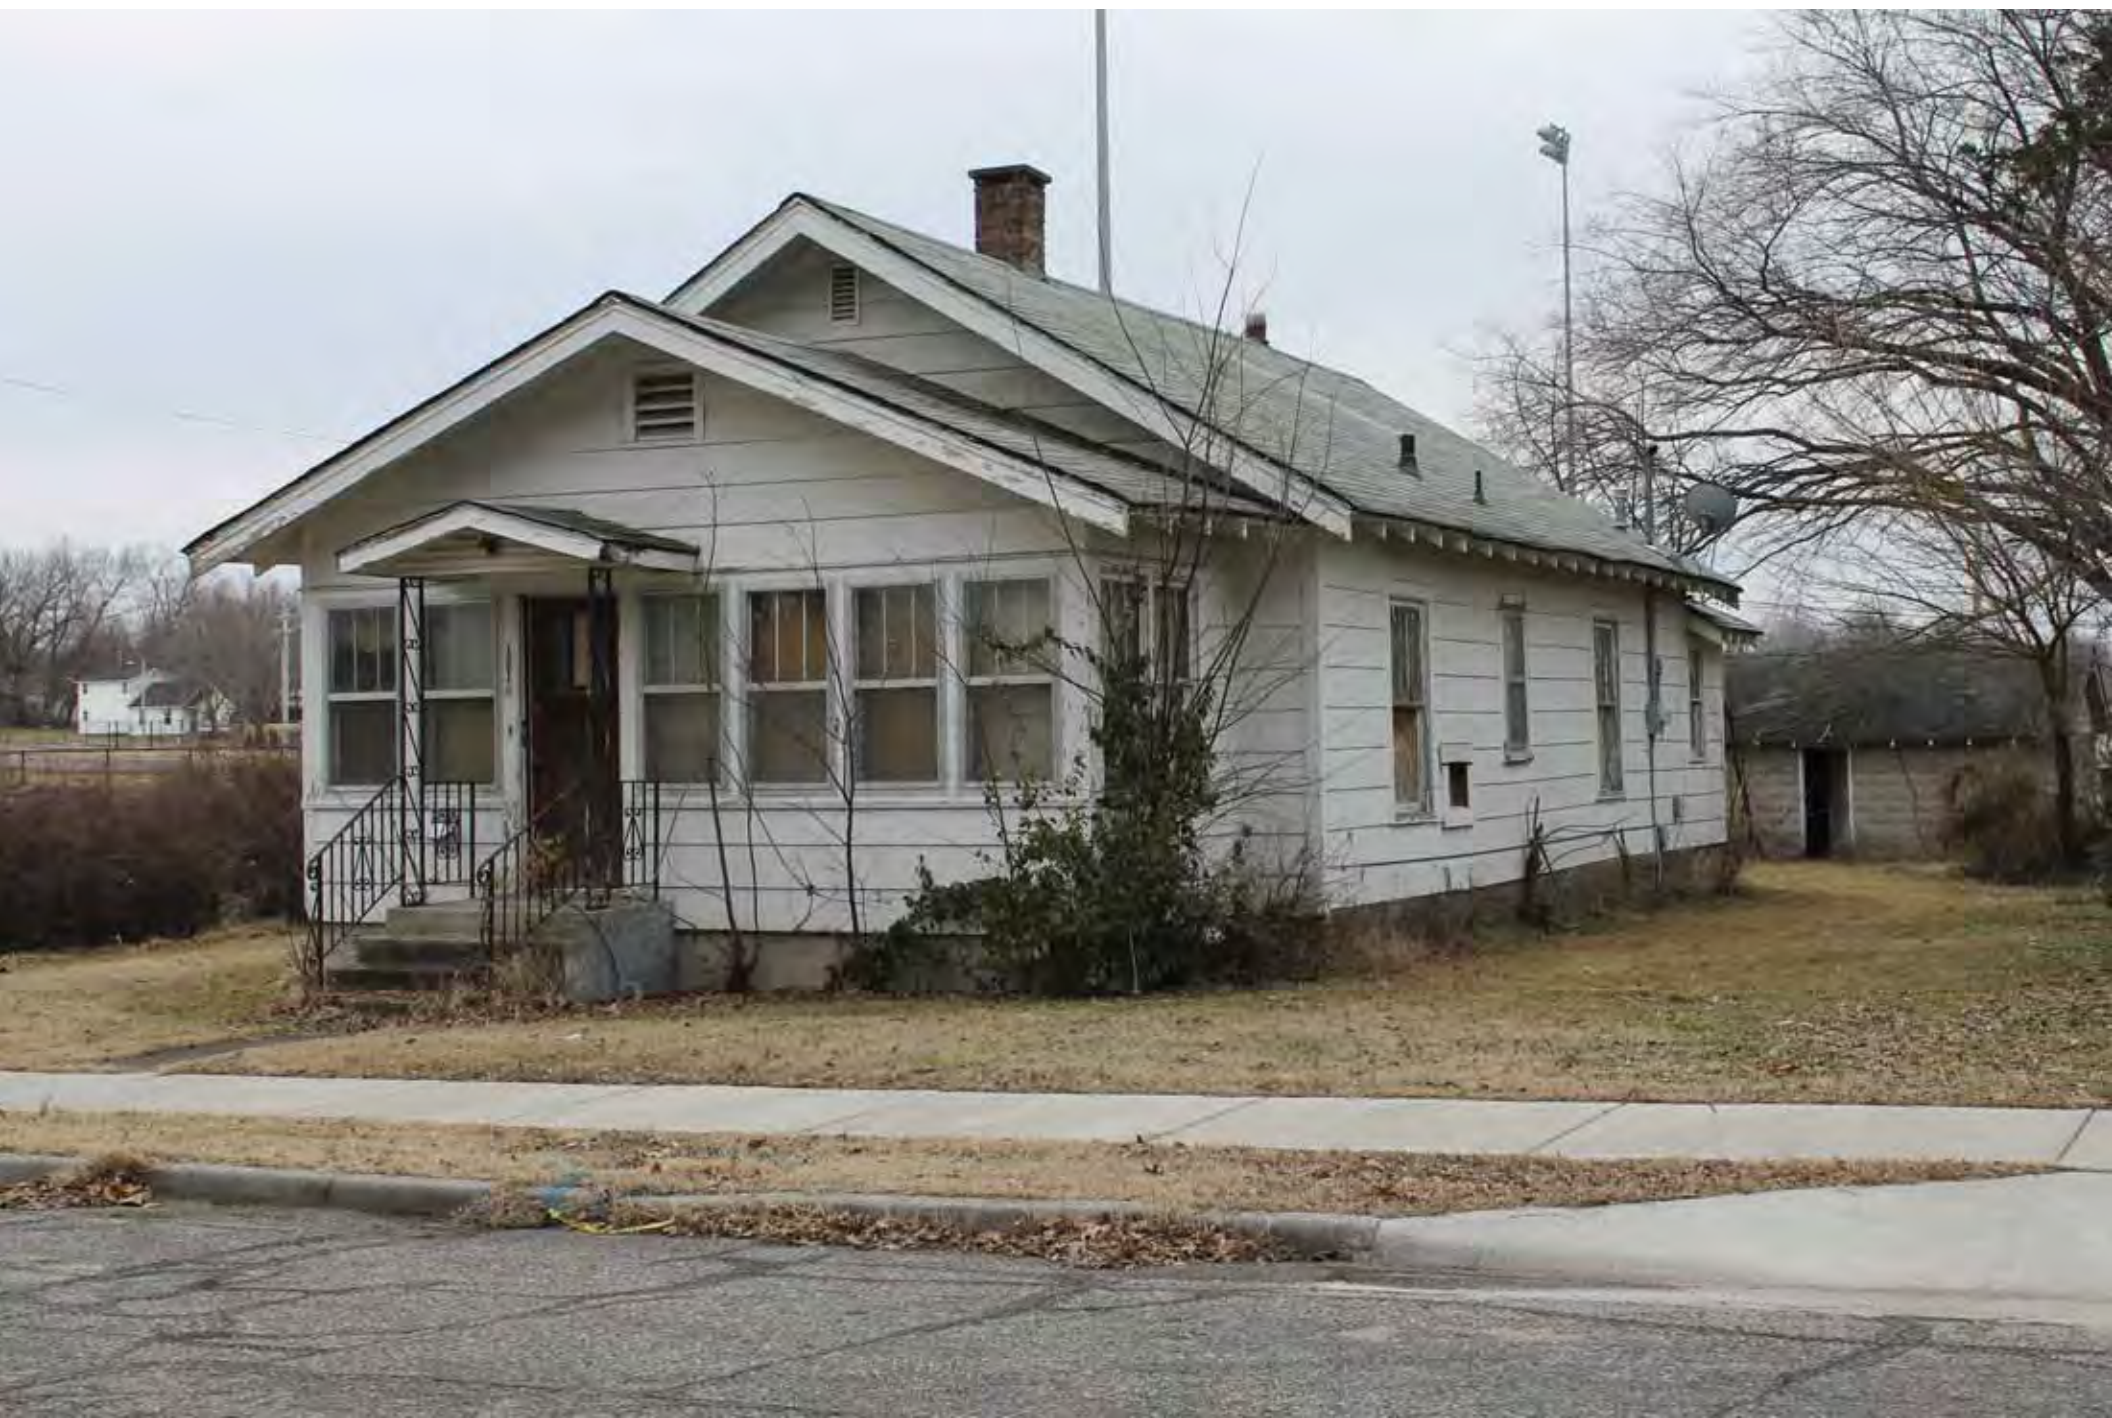
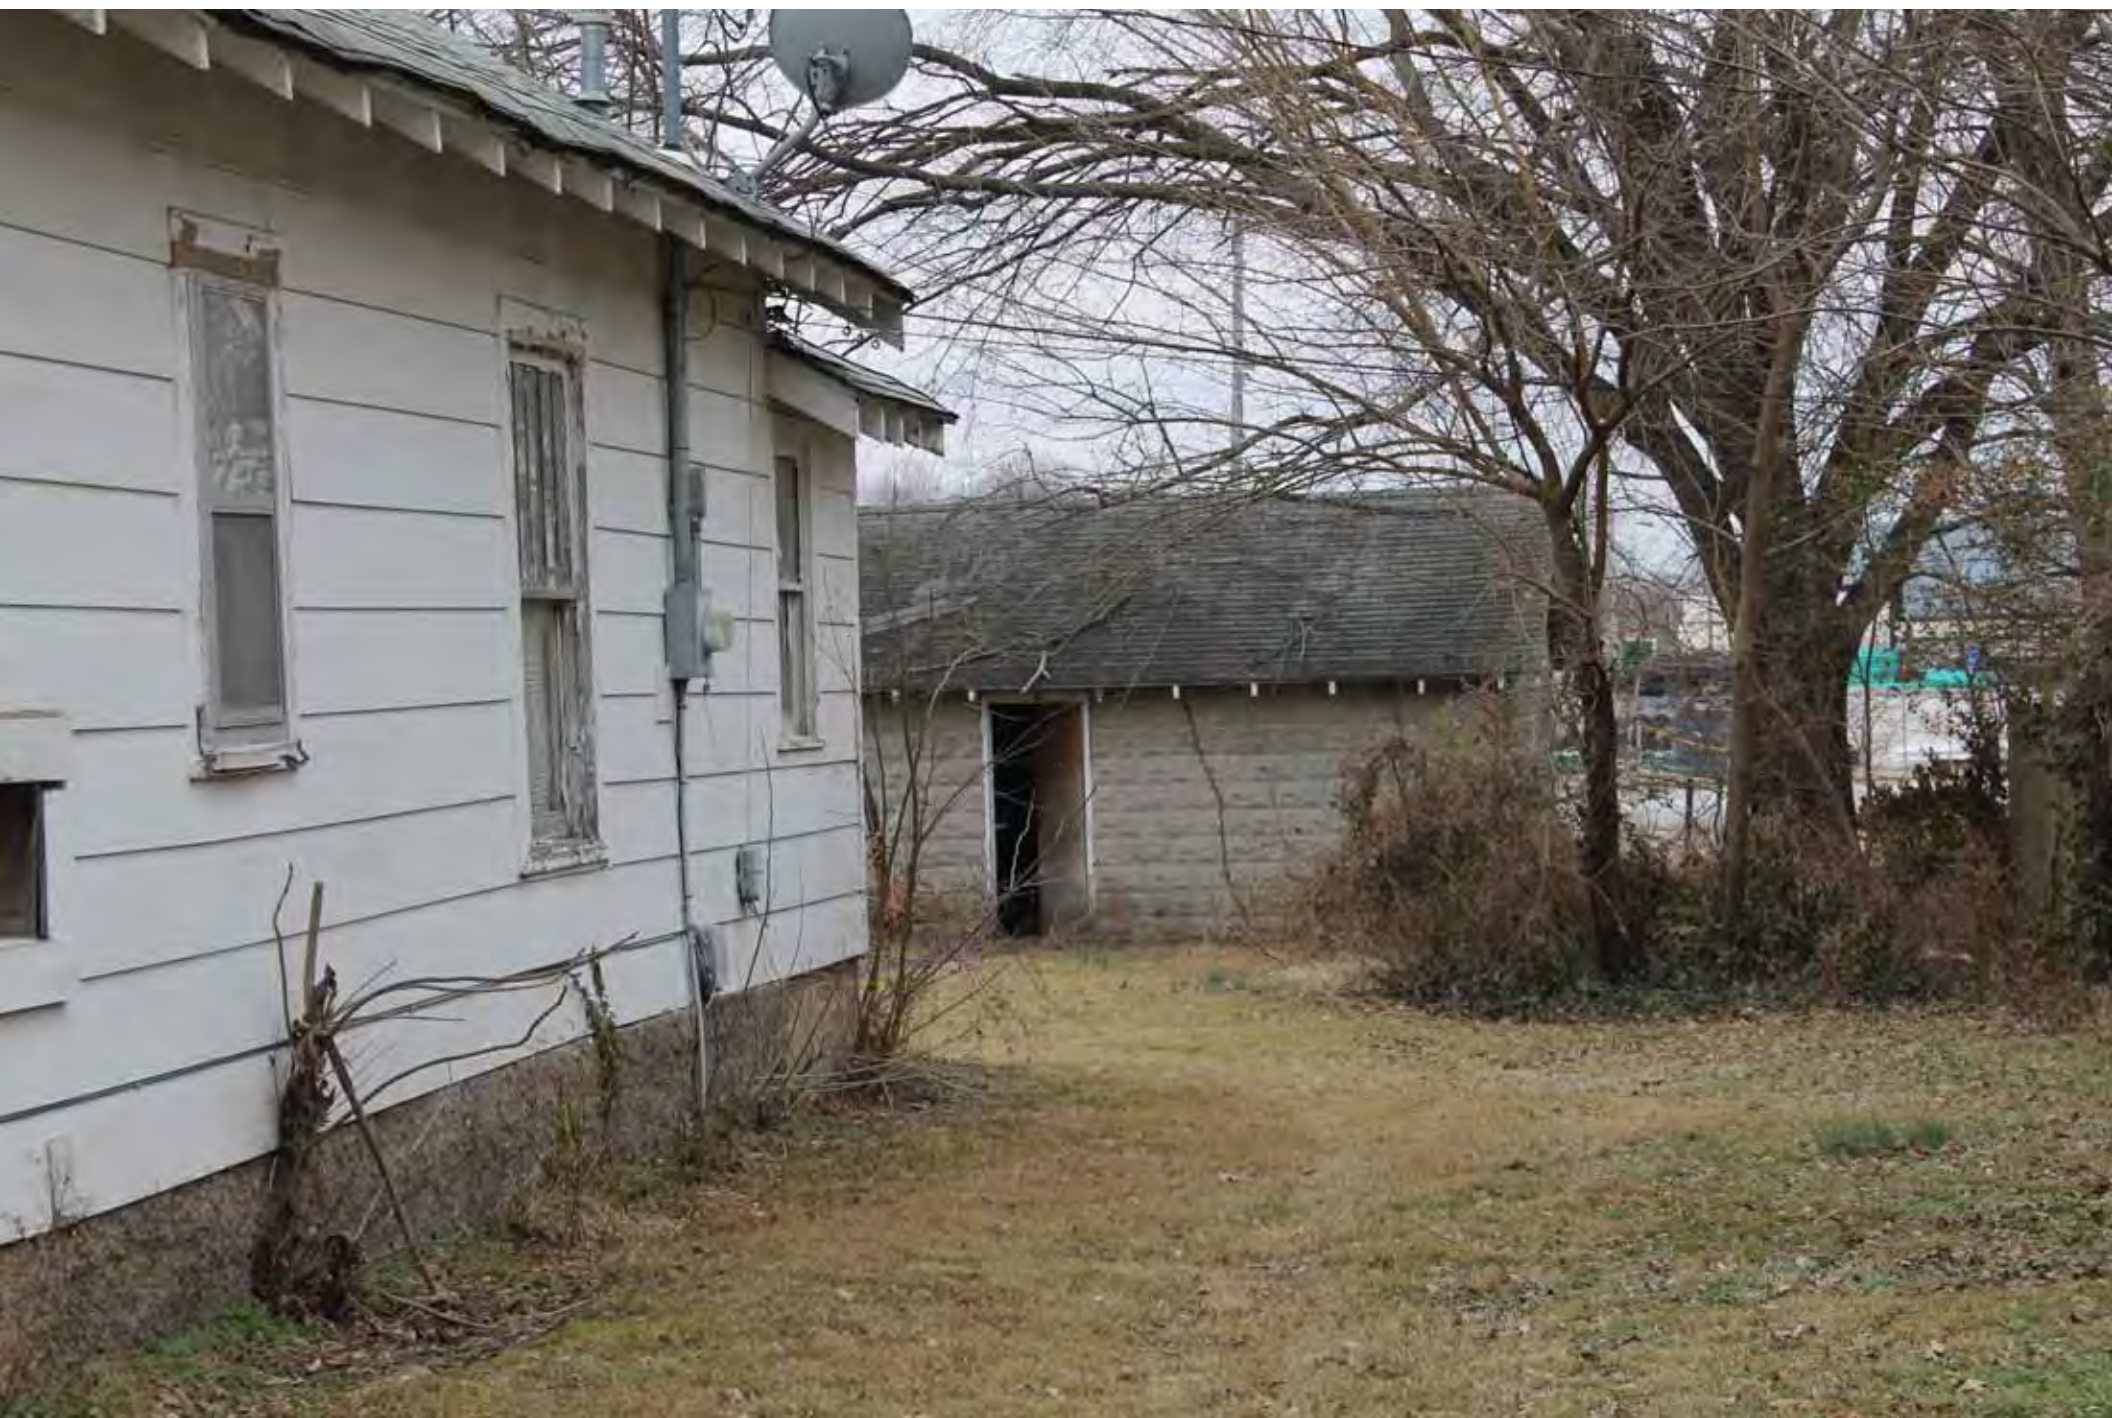
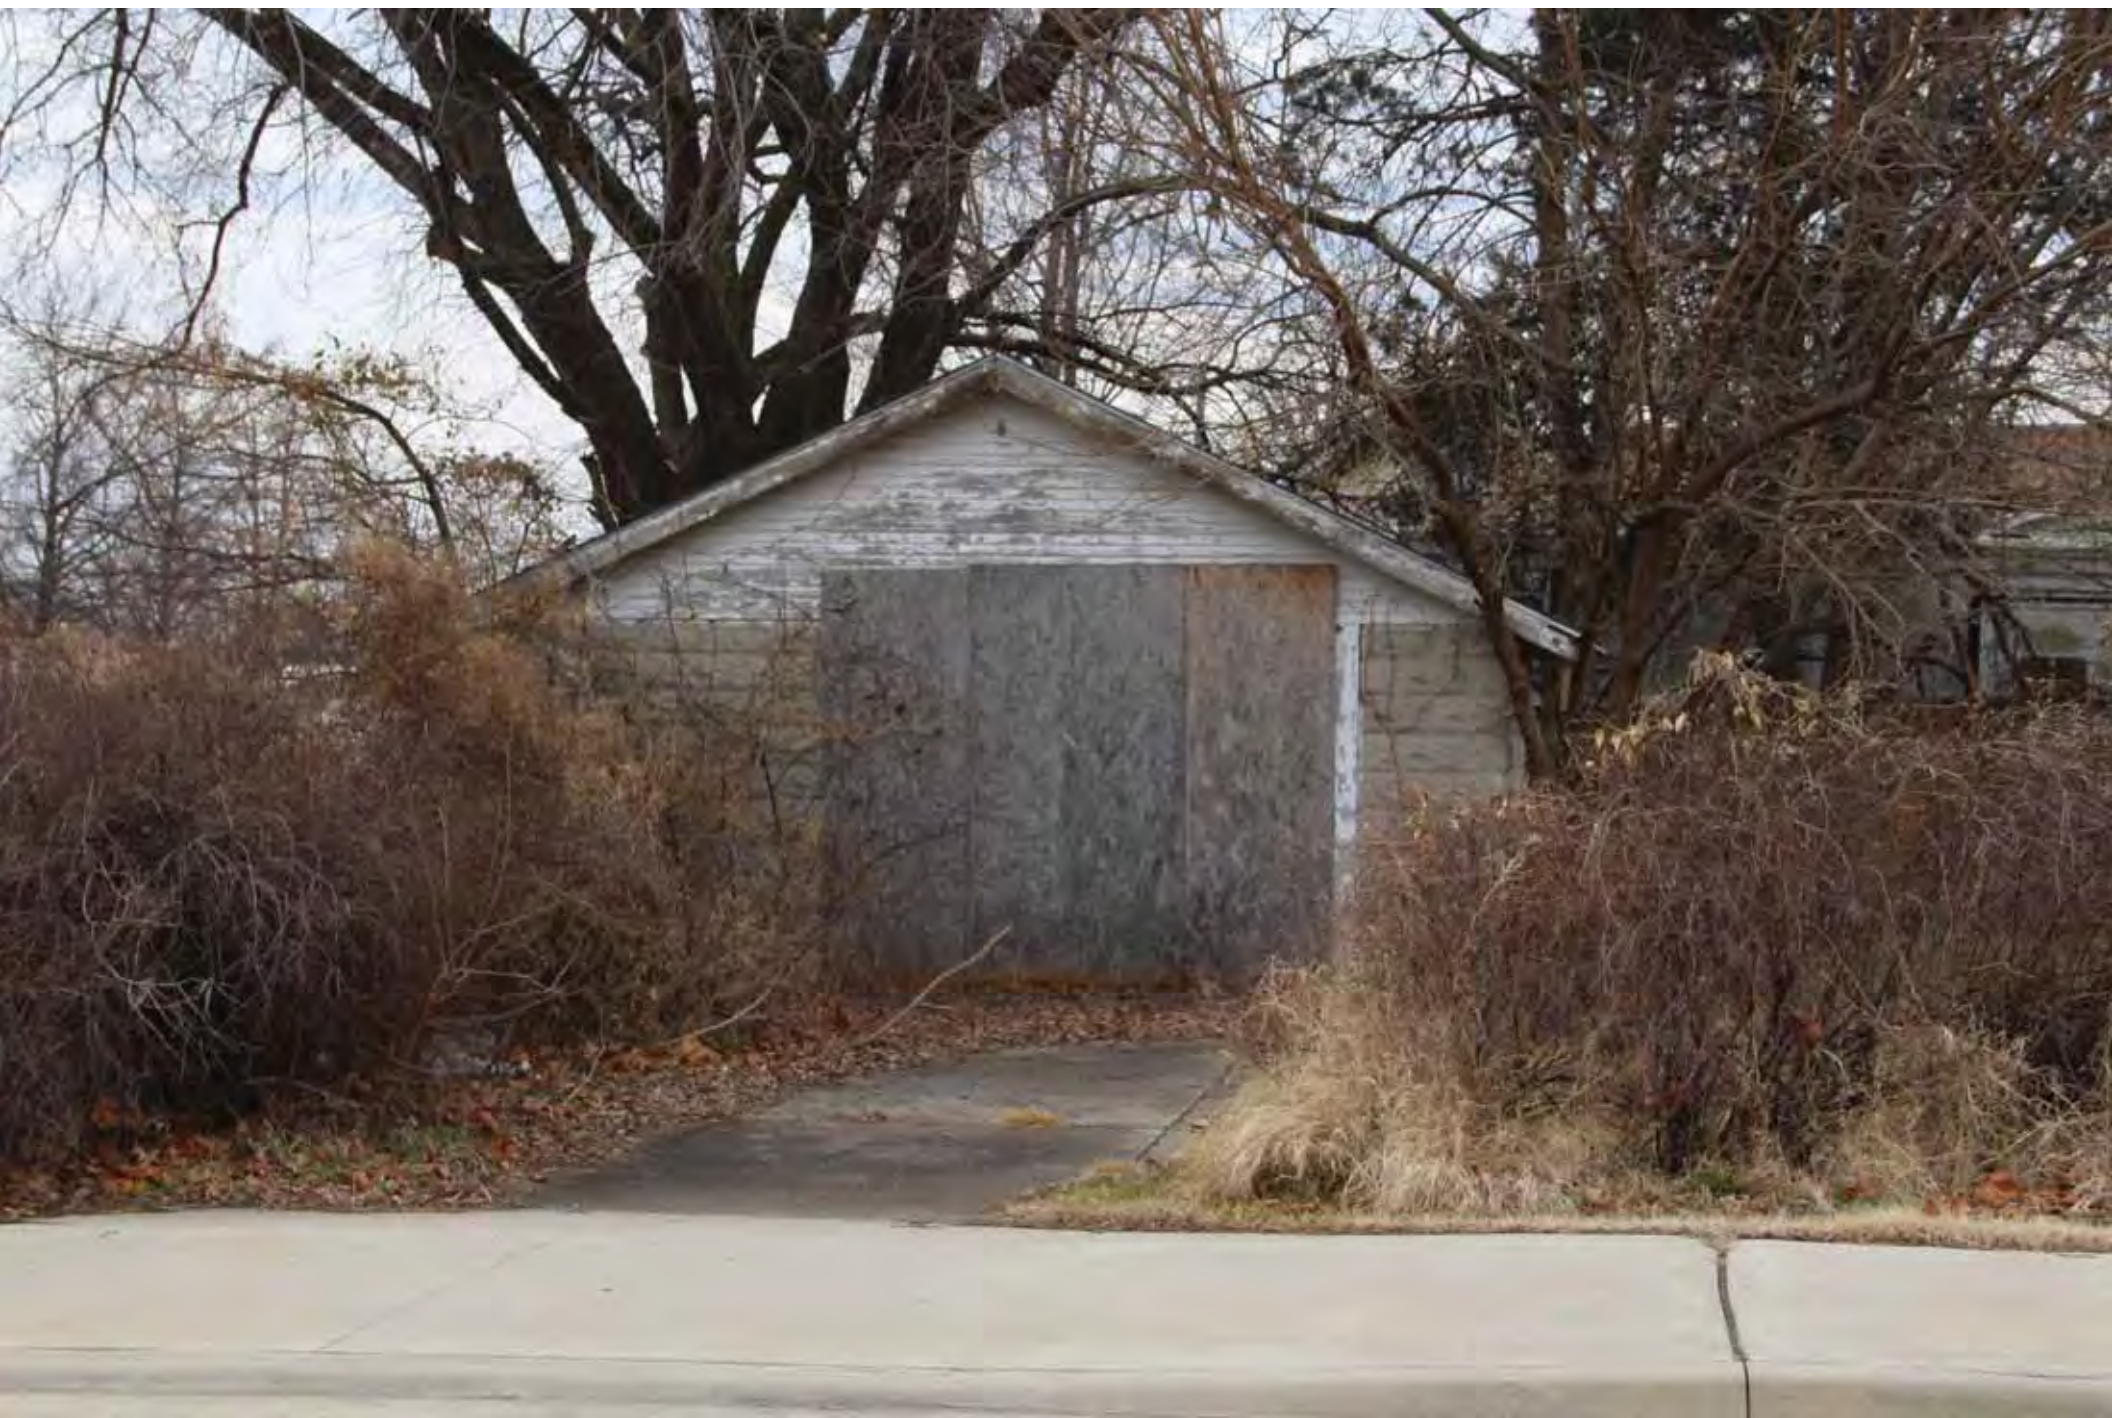
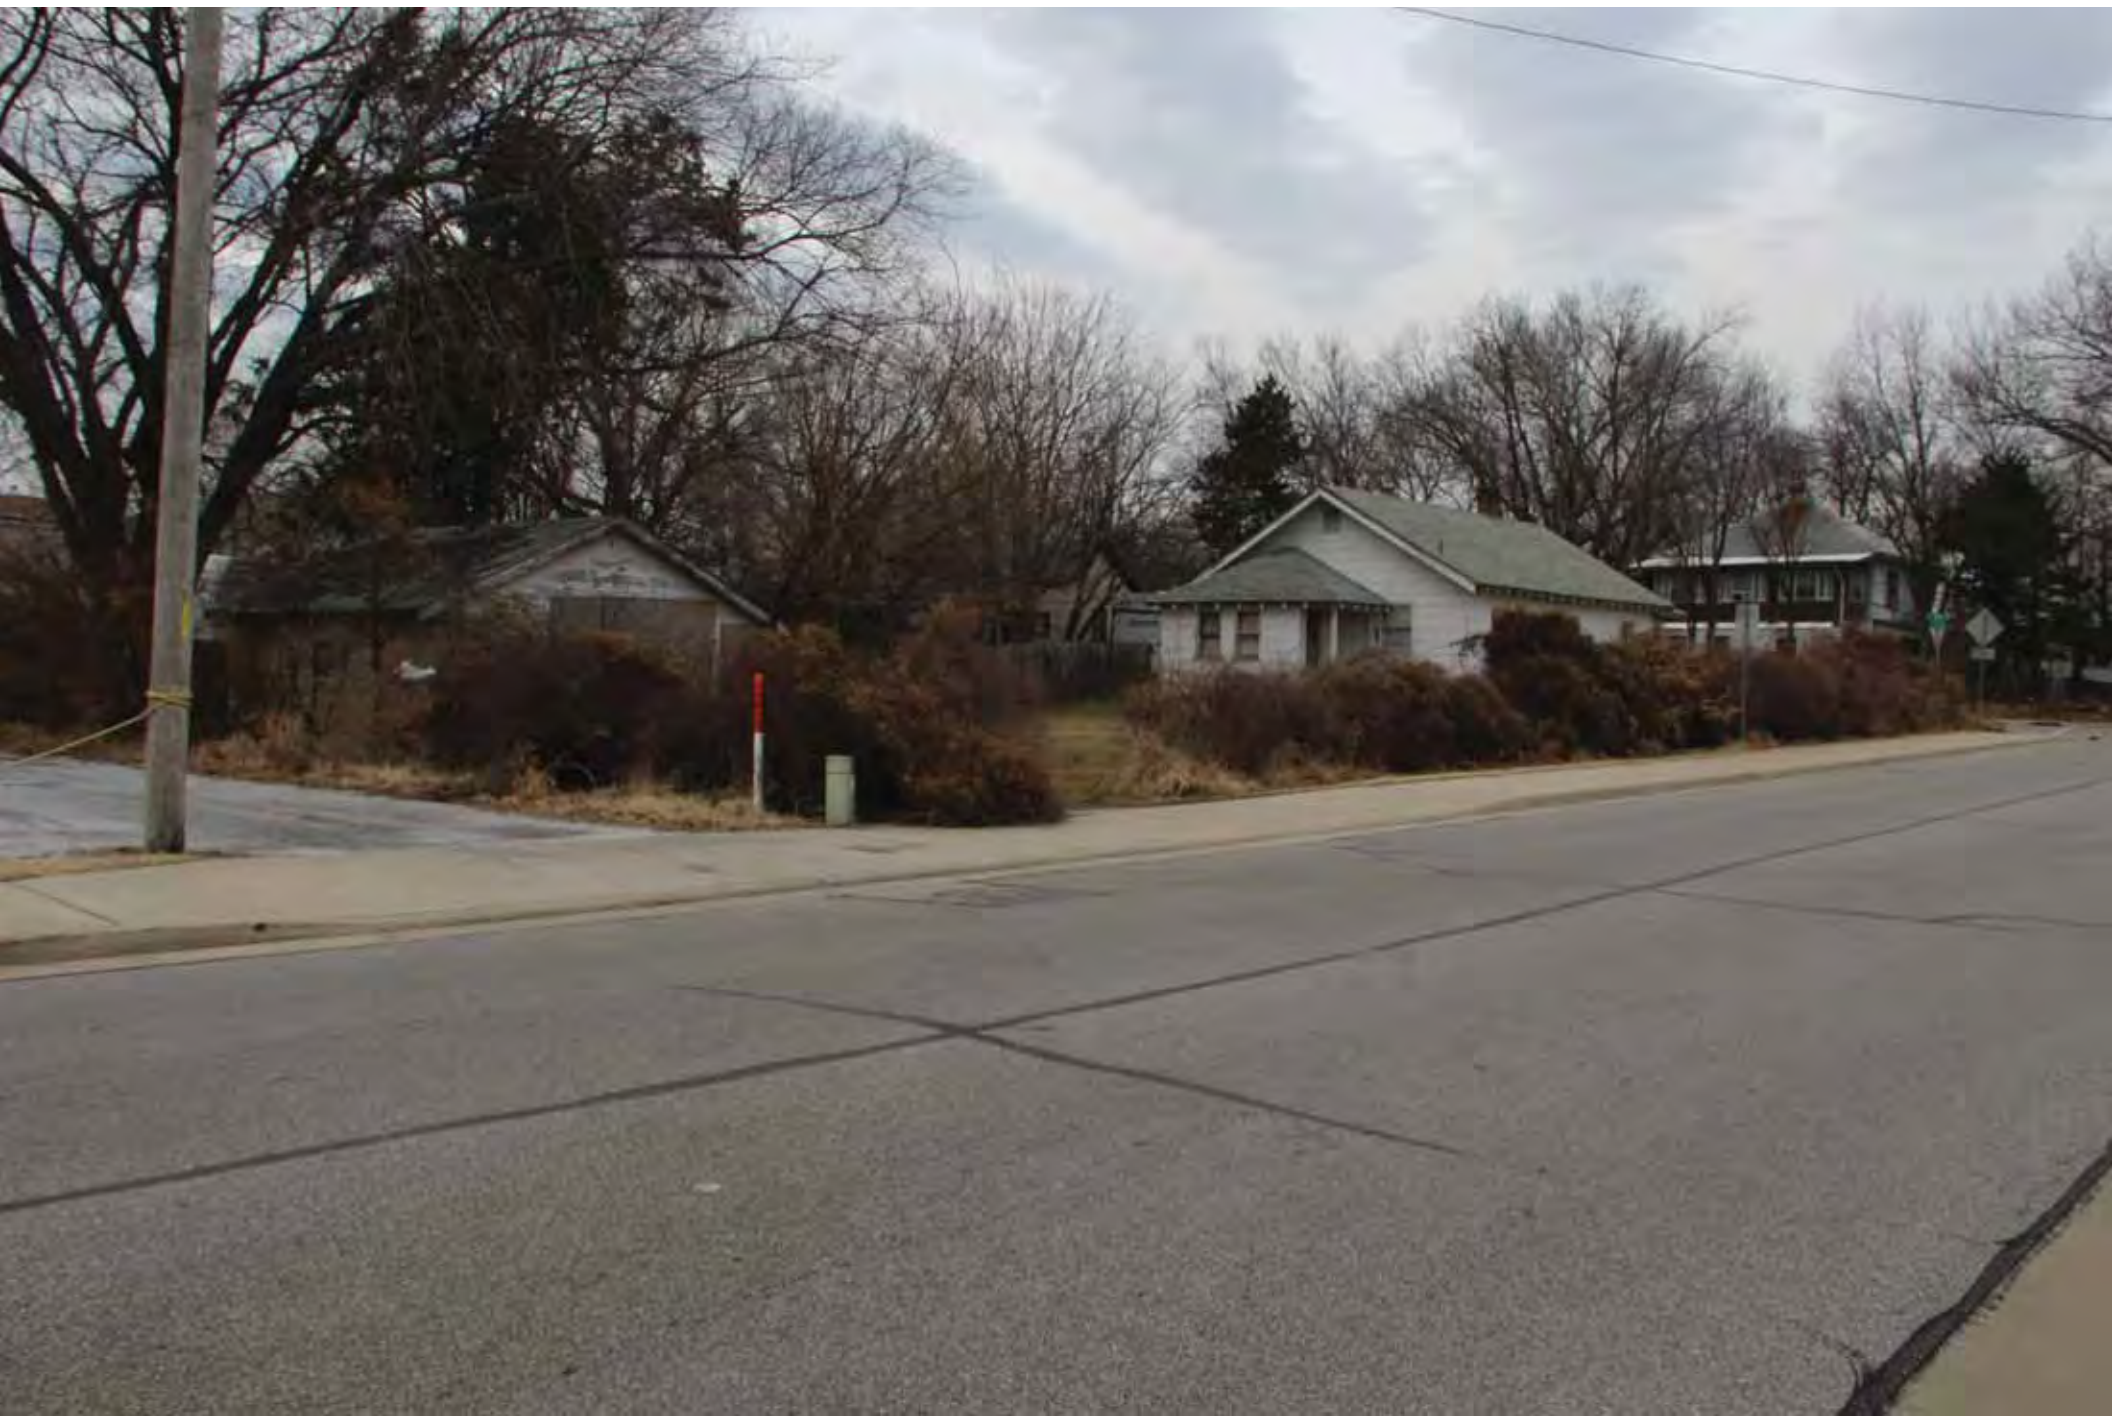
This dwelling is a common property type that does not exhibit significant architectural detailing (Criterion C). The dwelling is not associated with any individual (Criterion B) or historical event(s) (Criterion A) of notable significance. The property is not within an area recommended as a historic district. For these reasons, the dwelling is not individually eligible for the National Register of Historic Places.

The property at 1216 E. 2nd Street features a gable-front plan Bungalow with an asphalt shingled roof, exposed eave rafters, exterior wide wood siding and a concrete foundation. At the roofline ridge is a central original brick chimney. The primary (north) elevation holds an enclosed full gabled porch. A central concrete stoop and steps with wrought iron railings and a gabled portico leads to a central Craftsman style door on the porch's north elevation. The door is off-center, flanked by original three-over-one windows spanning and wrapping the porch walls. The porch and north elevation gable fields hold louvered vents. Side elevations hold one-over-one and four-over-one windows. The rear (south) elevation features a small enclosed porch wing with a hipped roof and exposed rafter tails.
