MISSOURI DEPARTMENT OF NATURAL RESOURCES
STATE HISTORIC PRESERVATION OFFICE, P.O. Box 176, Jefferson City, MO 65102
ARCHITECTURAL/HISTORIC INVENTORY FORM

1. Survey No. JP-AS-007-001		2. Survey name: East Town (Original Joplin) Historic Survey Phase 2	
3. County: JASPER		4. Address (Street No.) 618	Street (name) E. 2 nd Street
5. City: Joplin	Vicinity: <input type="checkbox"/>	6. Geographical Reference:	7. Township/Range/Section: T: R: S:
8. Historic name (if known):		9. Present/other name (if known):	
10. Ownership: <input checked="" type="checkbox"/> Private <input type="checkbox"/> Public		11a. Historic use (if known): Domestic: Single Dwelling	11b. Current use: Domestic: Single Dwelling

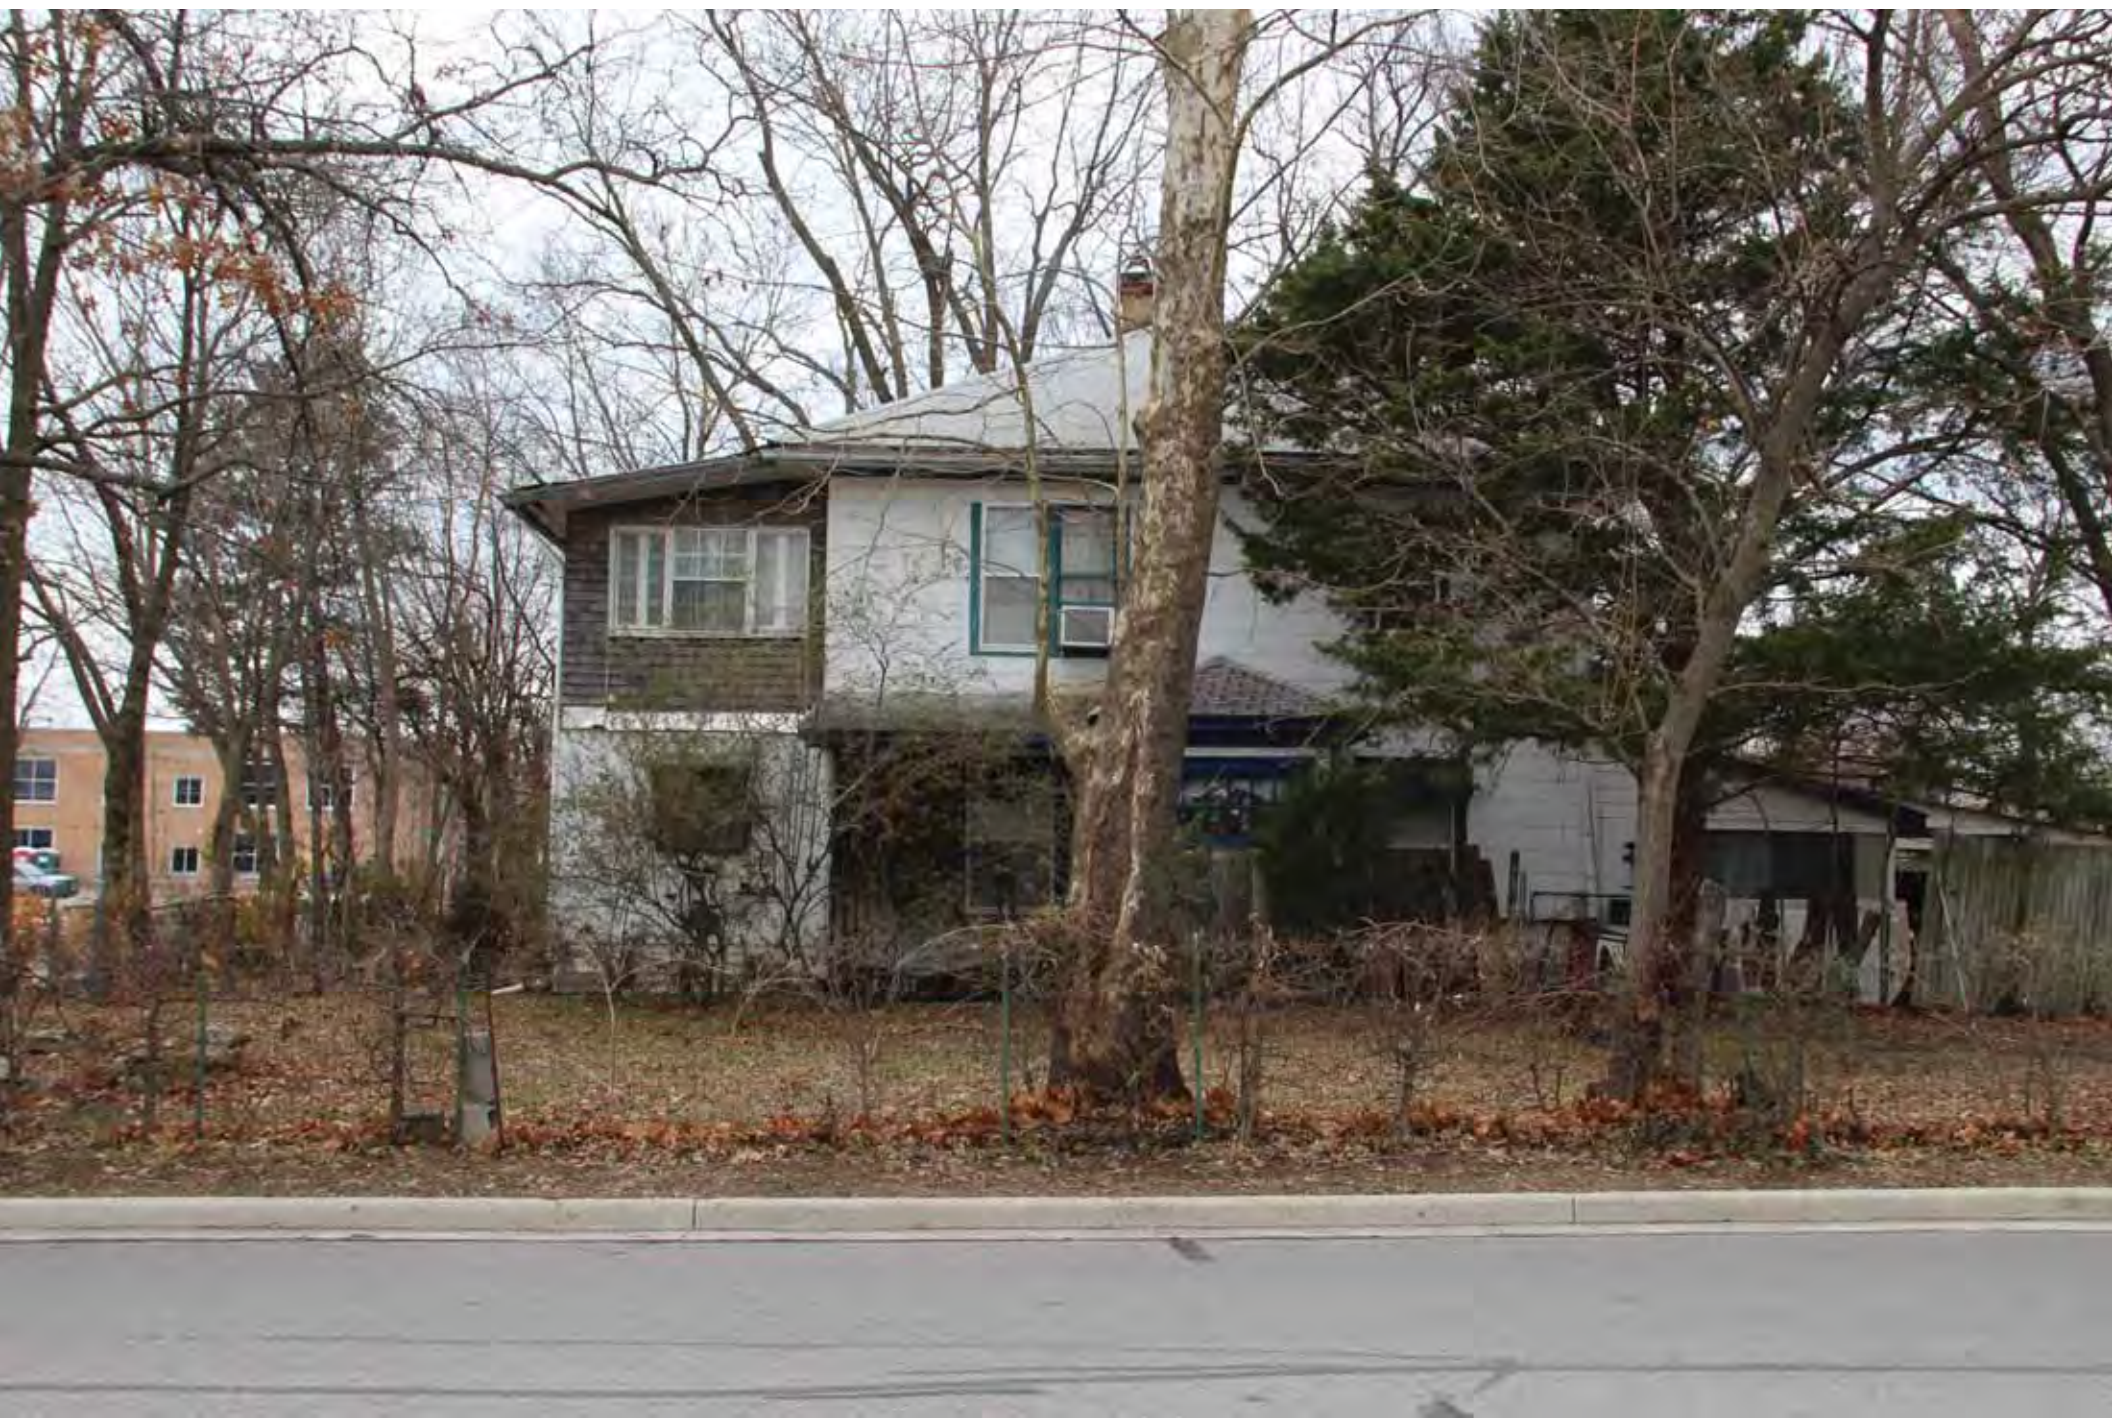
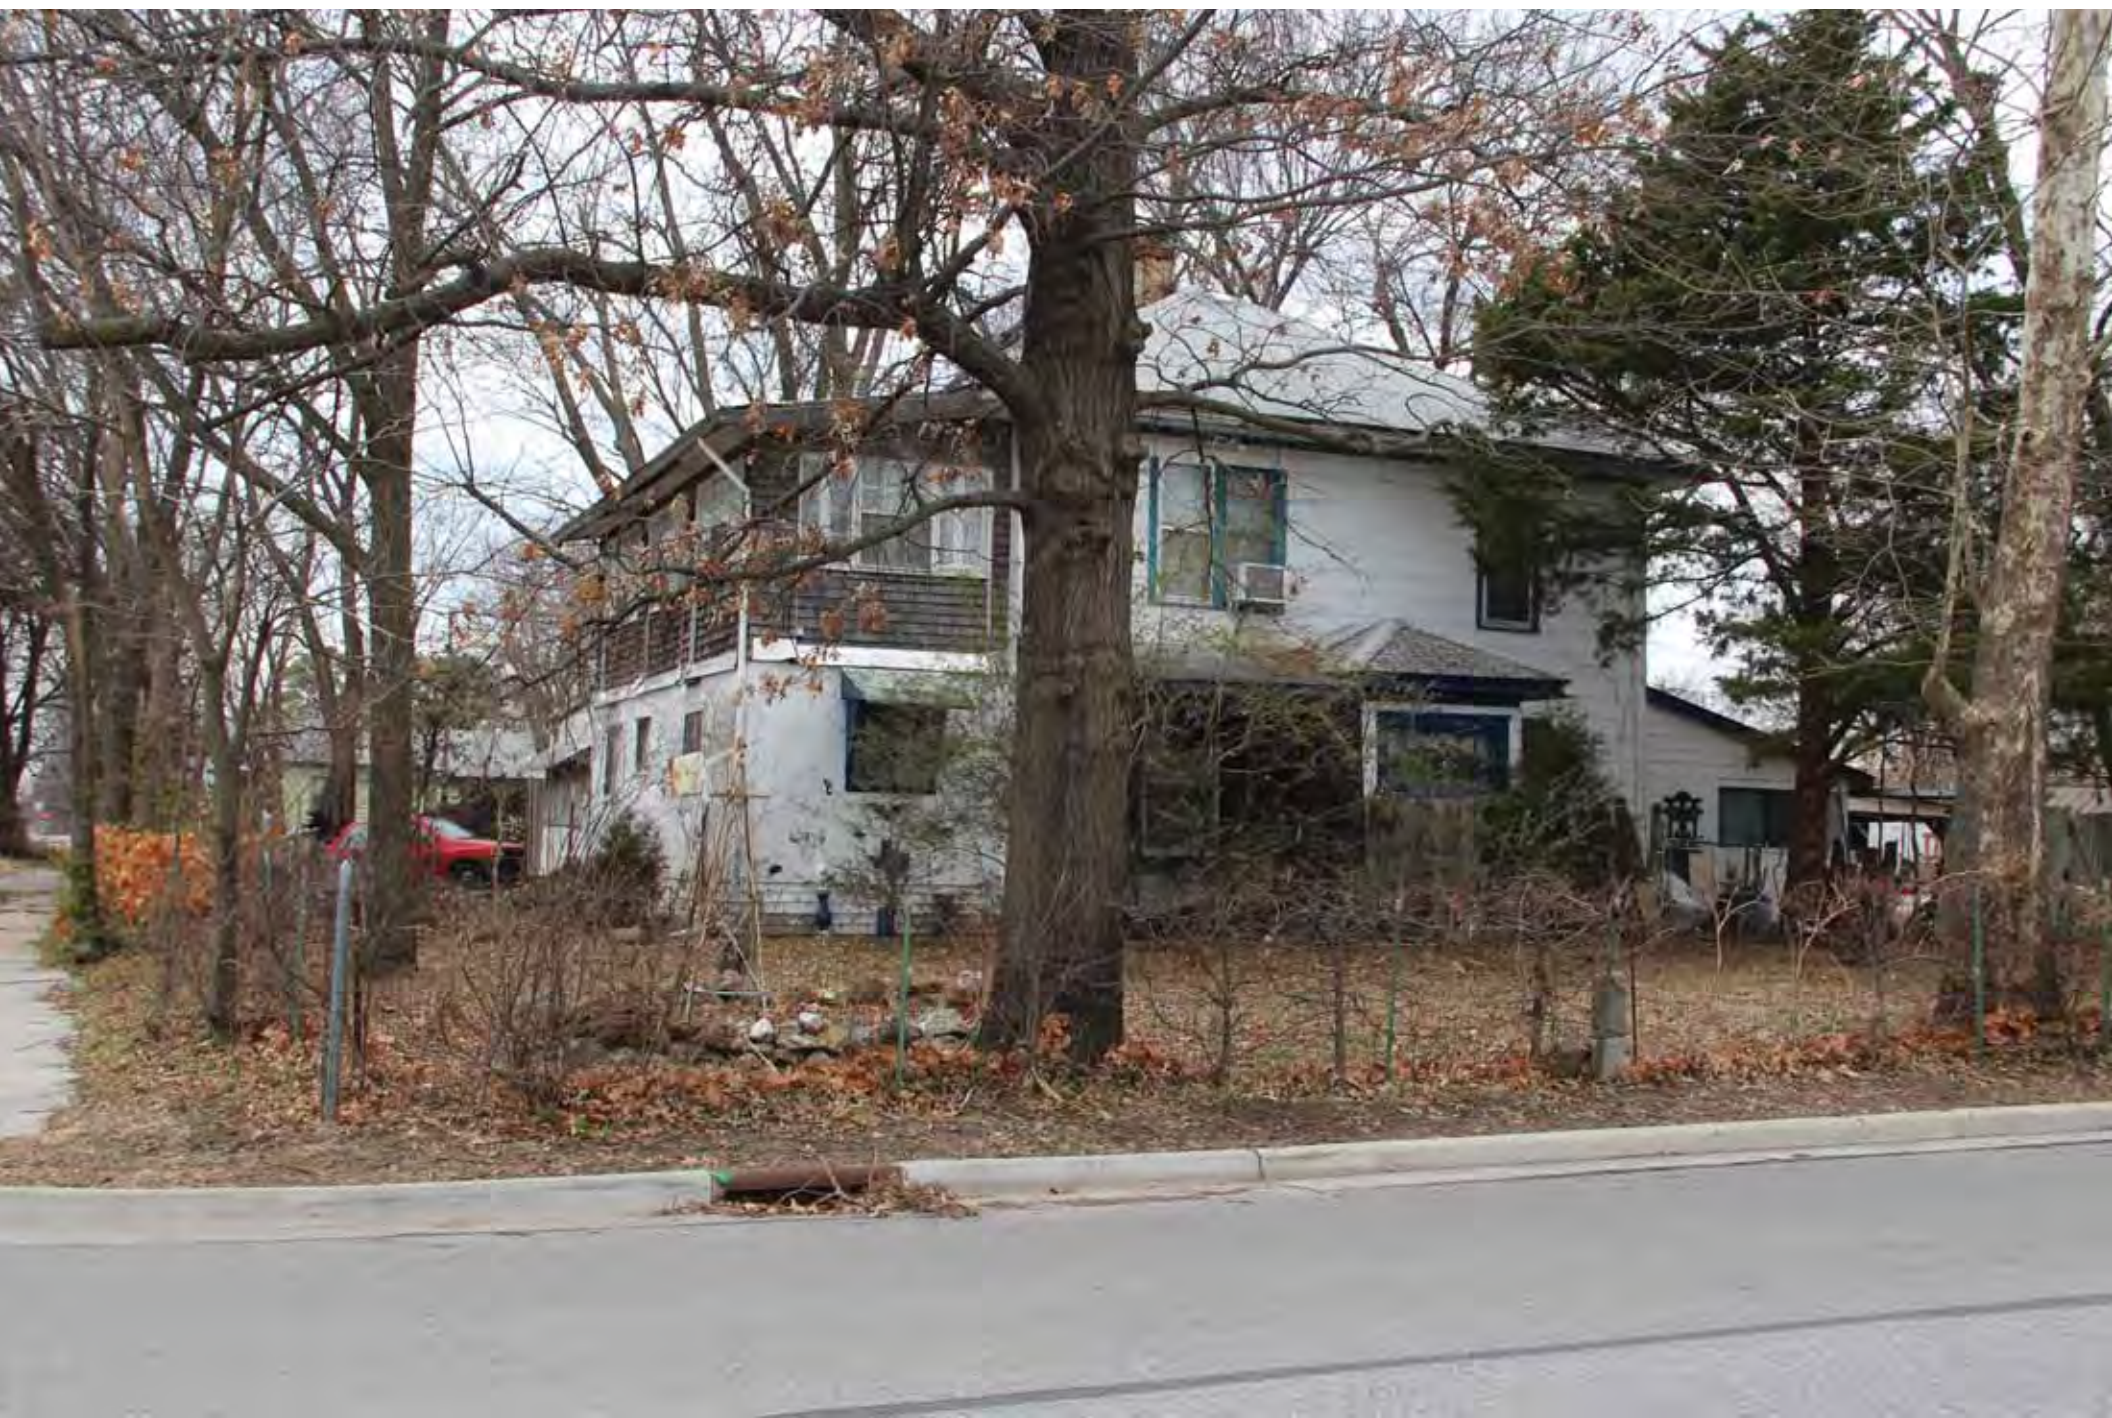
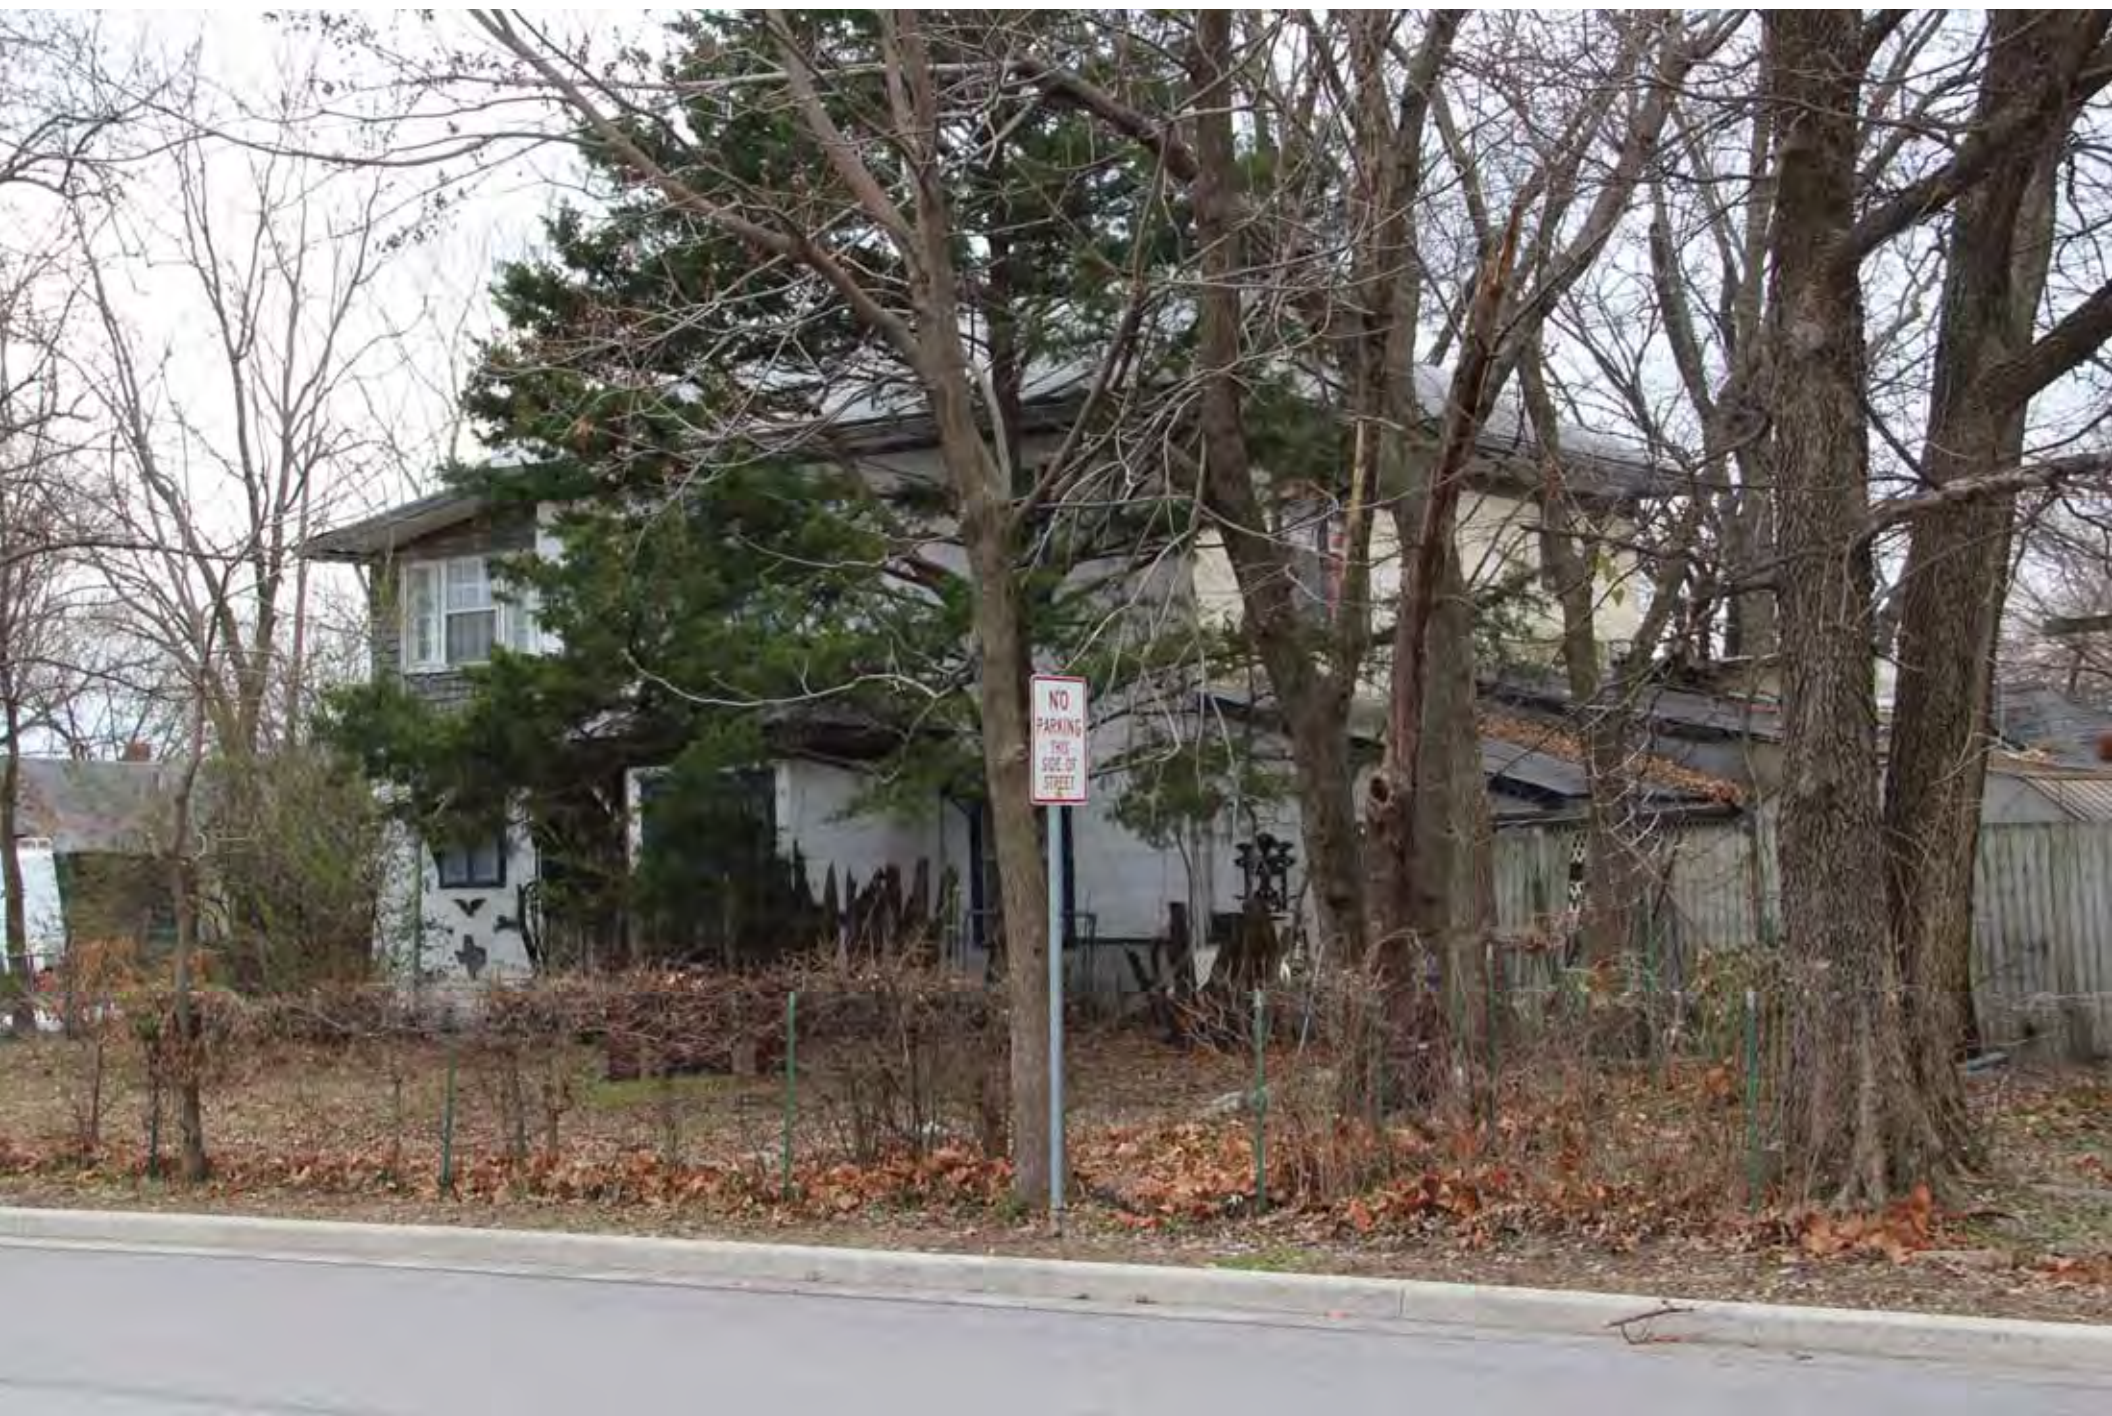
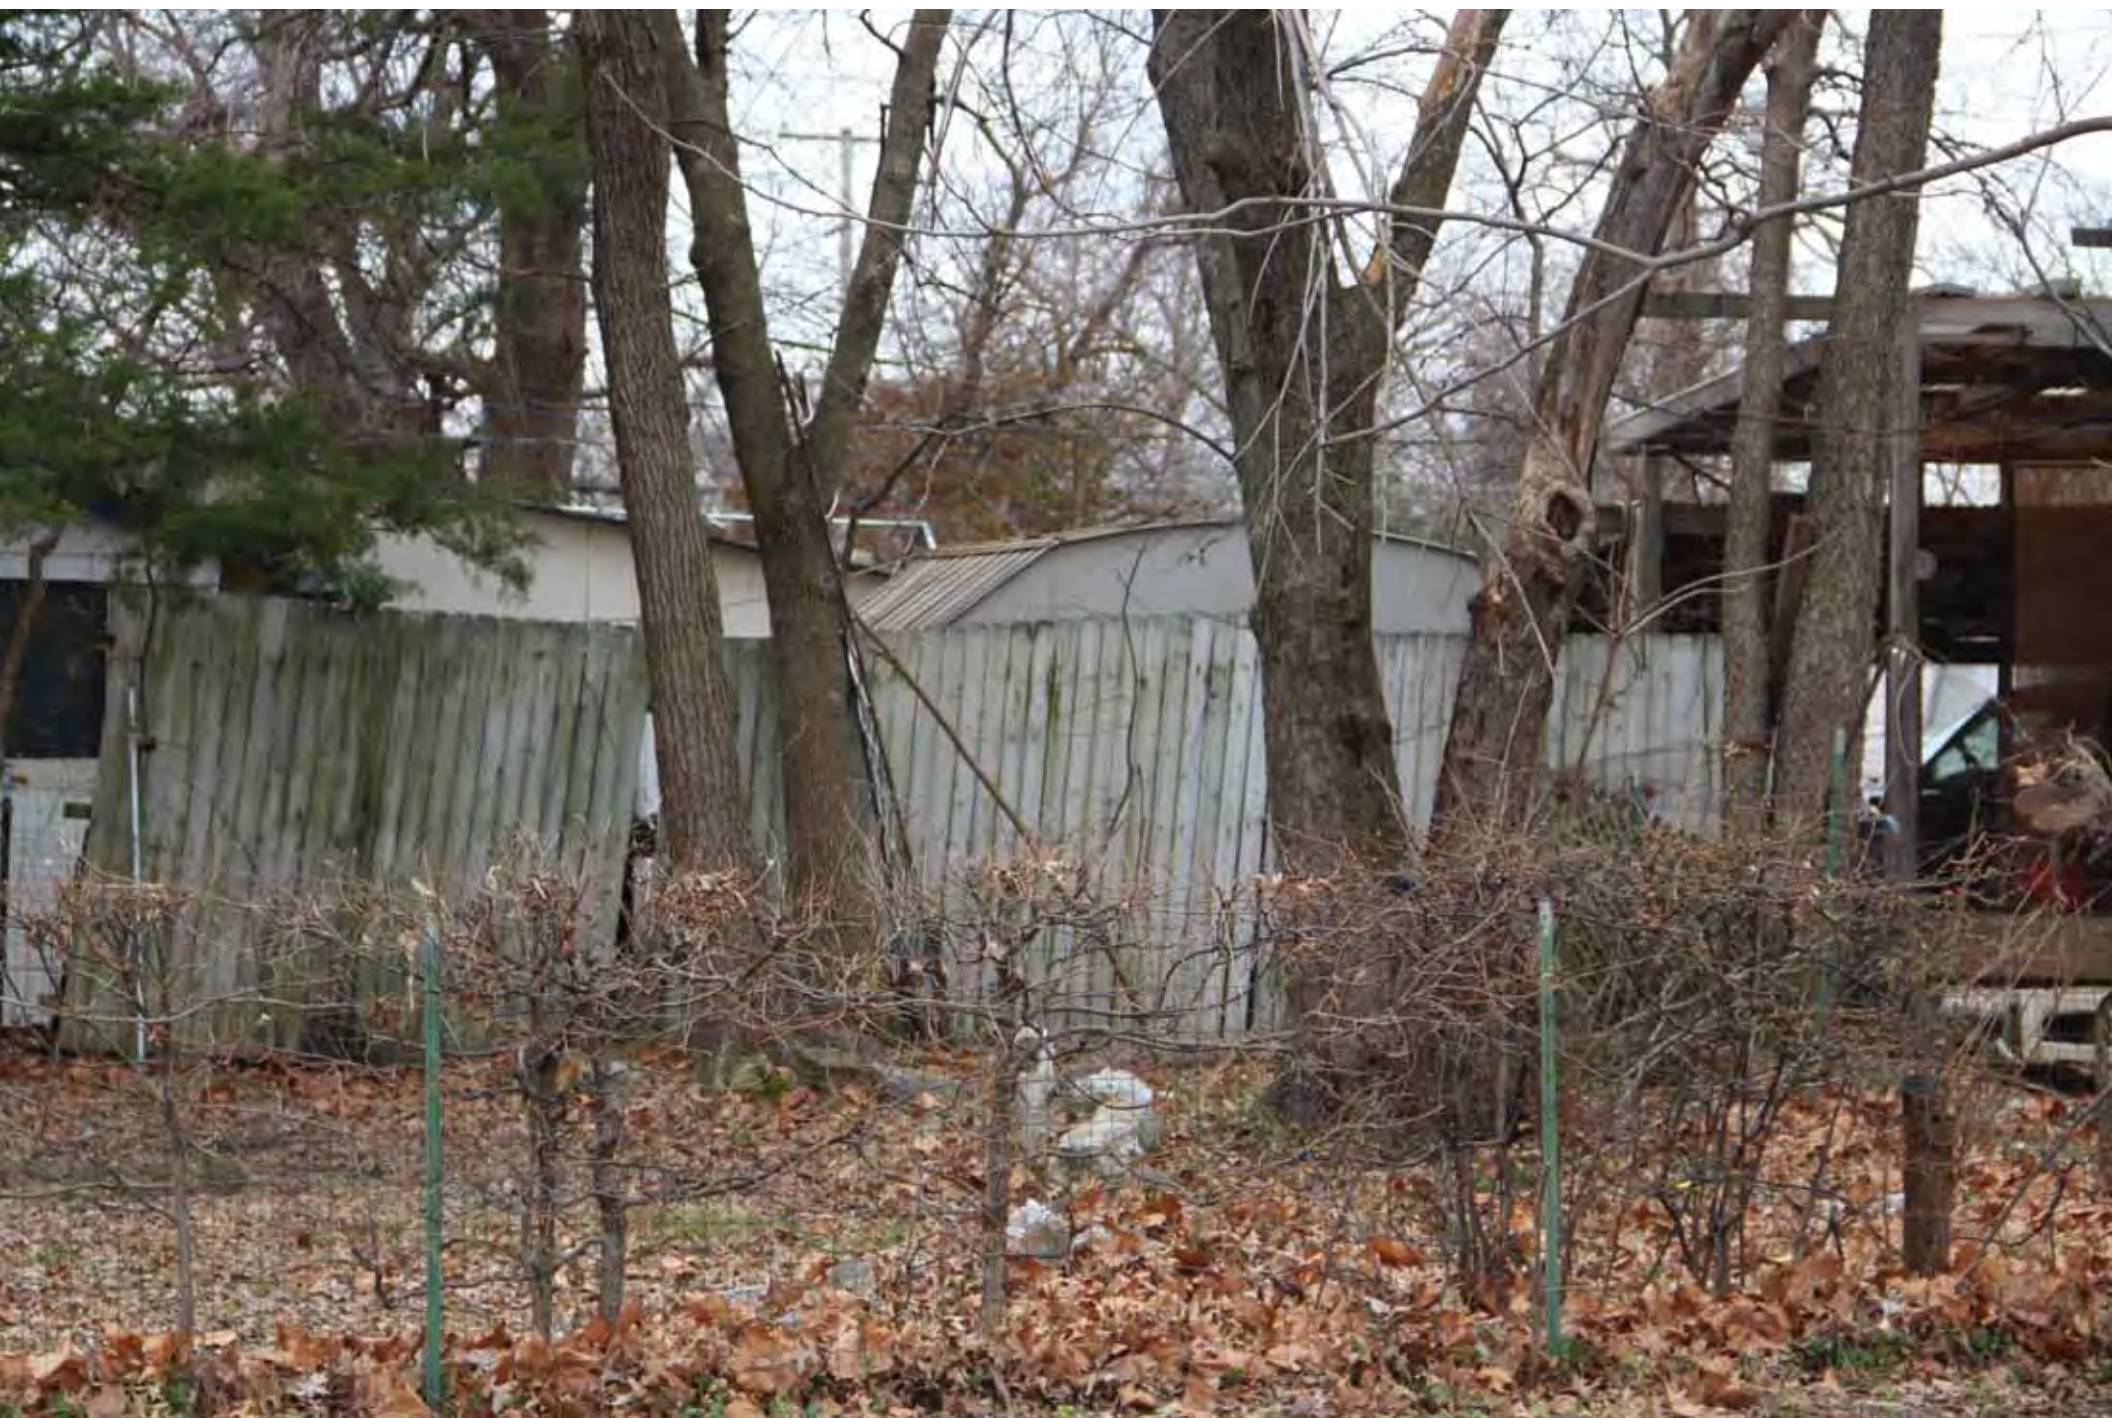
This dwelling has been modified with the addition of exterior asbestos siding and replacement of some original window lights. For this reason, the property does not retain integrity in relation to its architectural (Criterion C) significance. Research did not associate the dwelling with any individual (Criterion B) or historical event(s) (Criterion A) of notable significance. The property is not within an area recommended as a historic district. For these reasons, the dwelling is not individually eligible for the National Register of Historic Places.

The property at 1217 E. 2nd Street features an altered two-story American Foursquare dwelling with an asphalt shingled hipped roof and exterior wood shingle (original), stucco (original) and asbestos (c. 1955) siding. The primary (east) elevation faces S. High Avenue and is largely obscured by foliage. The elevation has an off-center small hipped single-story partially enclosed porch with an original multi-light window on the east wall. The entry is within the porch enclosure on the east wall. The porch is flanked by one-over-one windows. The south end of the dwelling is composed of a two-story shed wing. The east elevation of this wing supports a six-over-six window flanked by multi-light casement windows (second story) and paired one-over-one windows below an awning (first story). The upper shed wing is clad with shake siding; the lower elevation is clad with stucco. Shake siding obscures the foundation. The north elevation has three single-story shed wings.

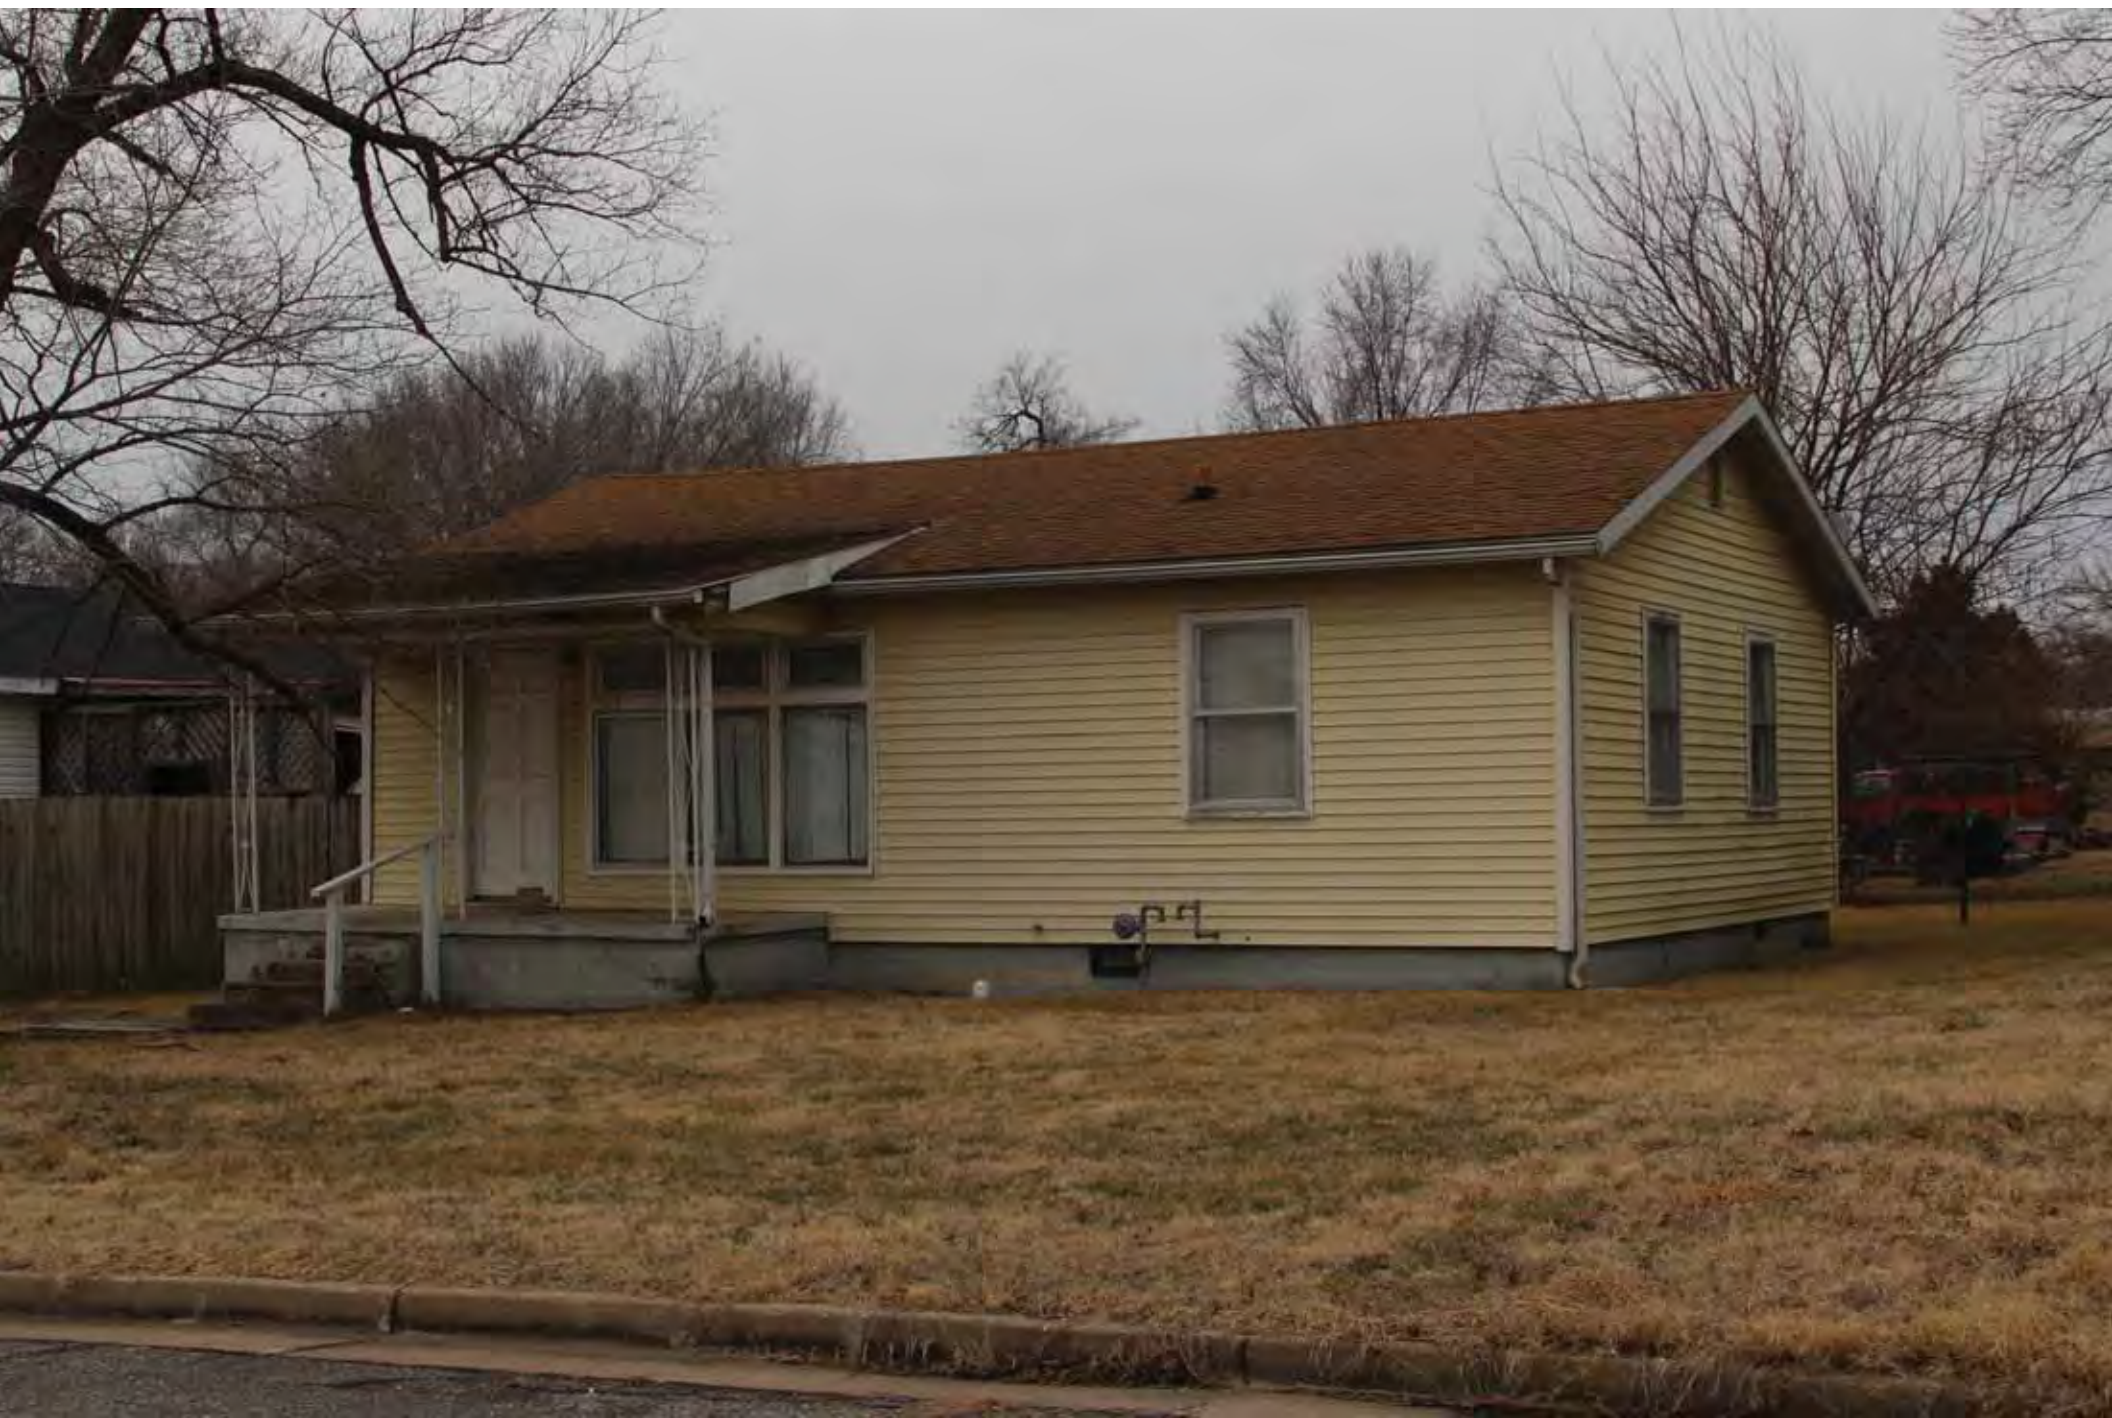
The property at 1403 E. 2nd Street features a single-story Ranch-influenced dwelling with an asphalt shingled end gable plan roof, exterior vinyl siding and a concrete foundation. The primary (south) elevation supports an off-center shed porch supported by wrought iron columns on a concrete base. Within the porch bay is an entry with a solid paneled replacement door. The entry is offset by a large six-light fixed sash replacement window. Offsetting this bay on the east is a one-over-one window. Side (east/west) elevations hold one-over-one windows – two on each elevation. Gable fields support louvered vents.
