MISSOURI DEPARTMENT OF NATURAL RESOURCES
STATE HISTORIC PRESERVATION OFFICE, P.O. Box 176, Jefferson City, MO 65102
ARCHITECTURAL/HISTORIC INVENTORY FORM

1. Survey No. JP-AS-007-001		2. Survey name: East Town (Original Joplin) Historic Survey Phase 2	
3. County: JASPER		4. Address (Street No.) 618	Street (name) E. 2 nd Street
5. City: Joplin	Vicinity: <input type="checkbox"/>	6. Geographical Reference:	7. Township/Range/Section: T: R: S:
8. Historic name (if known):		9. Present/other name (if known):	
10. Ownership: <input checked="" type="checkbox"/> Private <input type="checkbox"/> Public		11a. Historic use (if known): Domestic: Single Dwelling	11b. Current use: Domestic: Single Dwelling

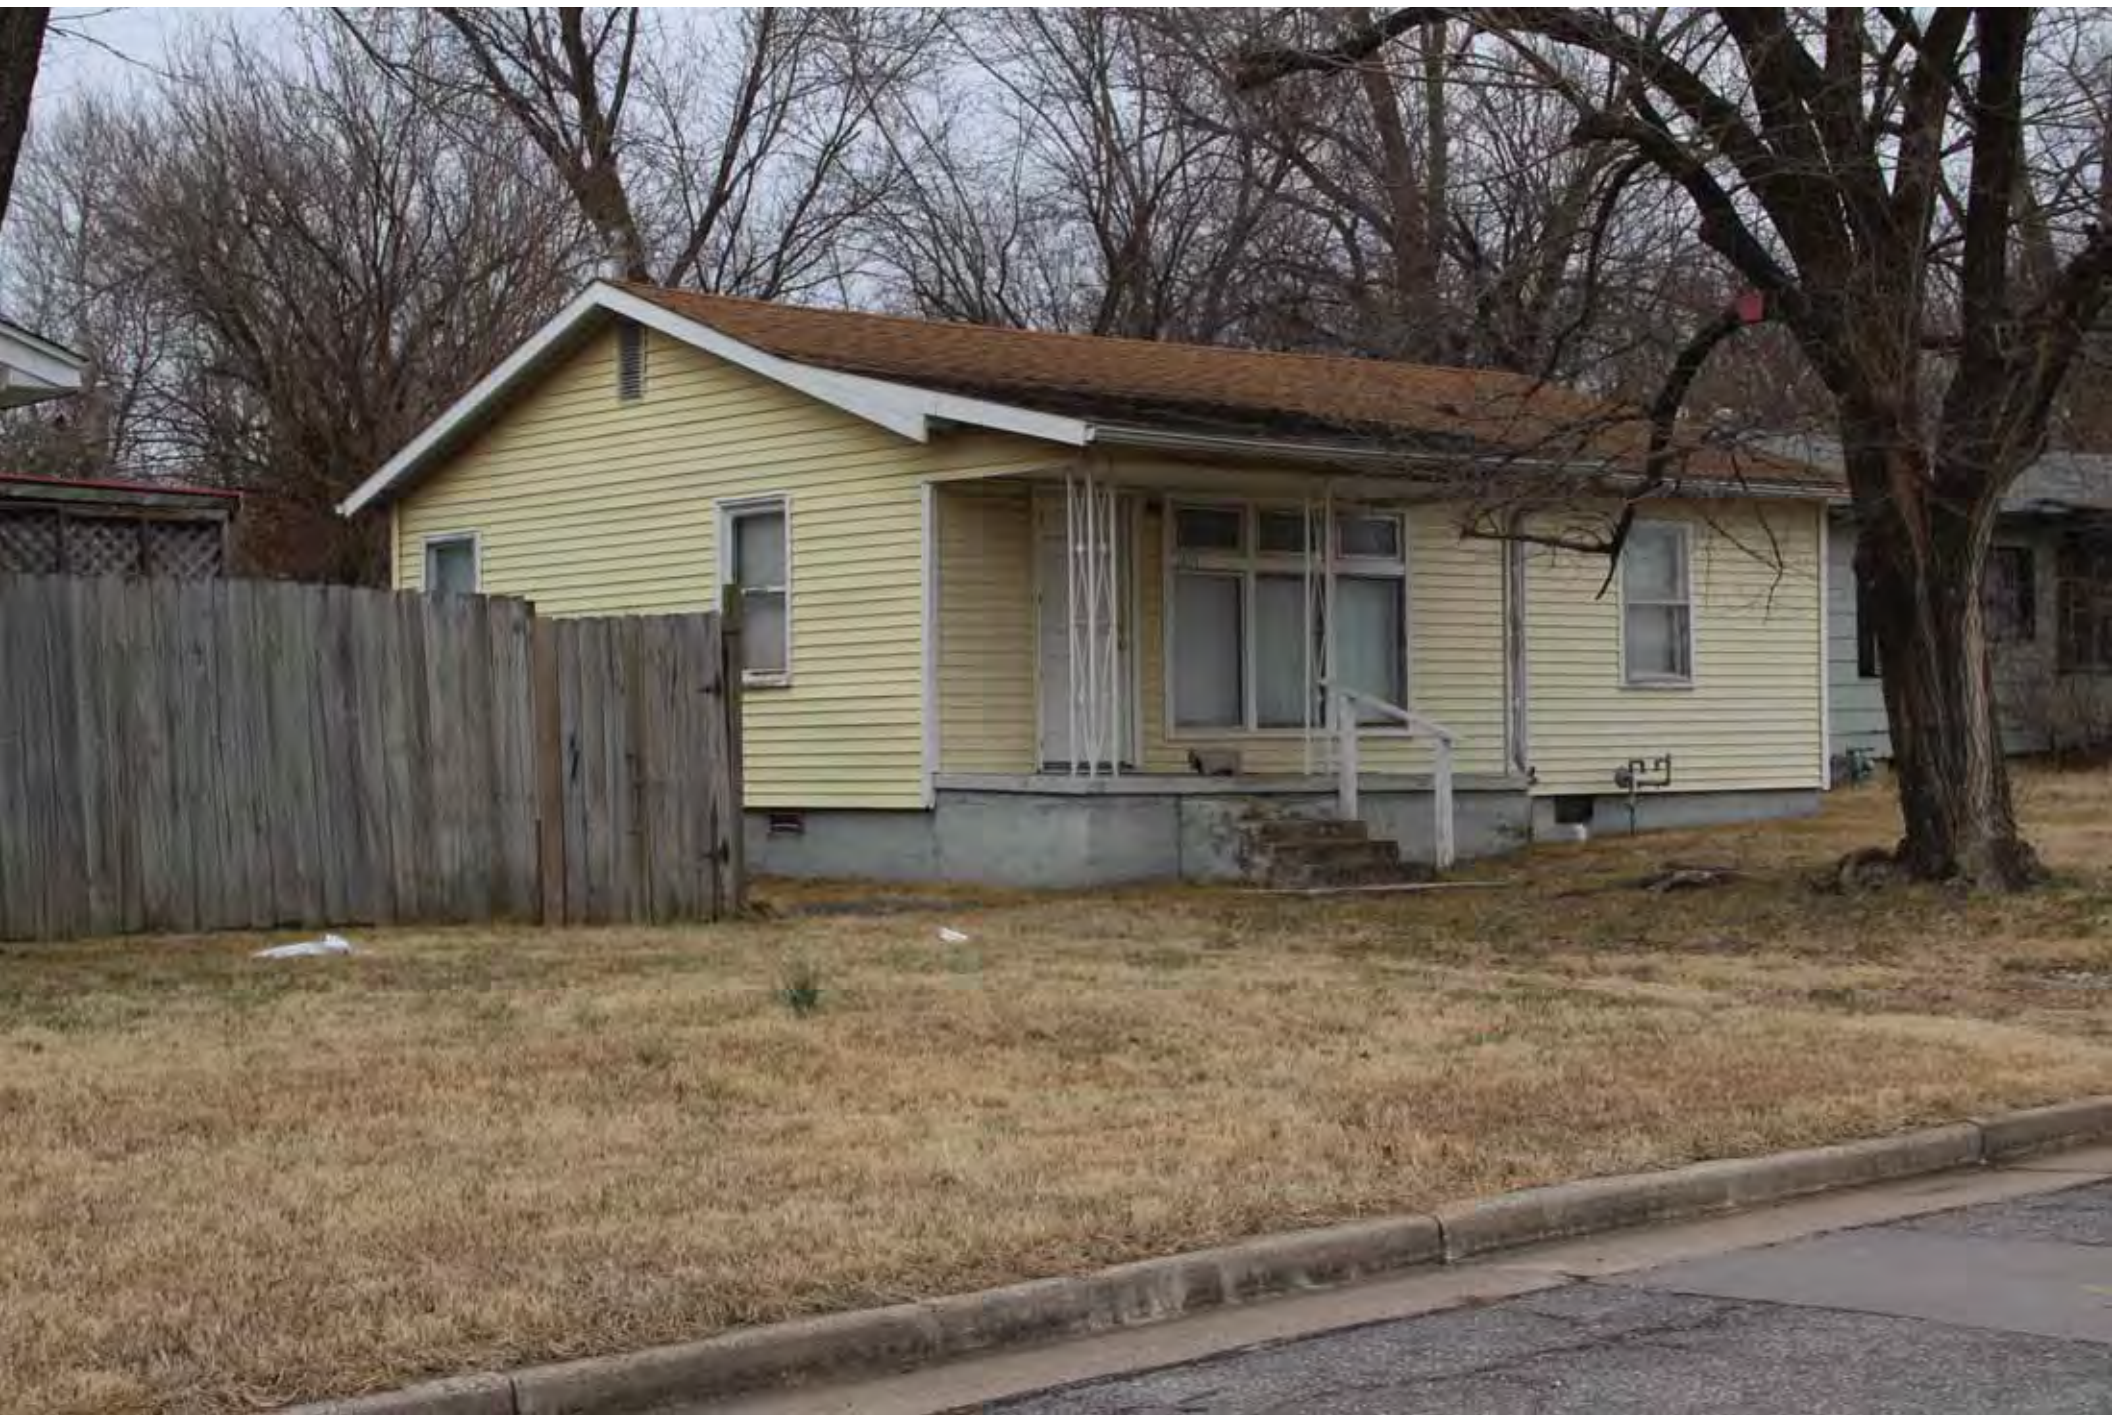
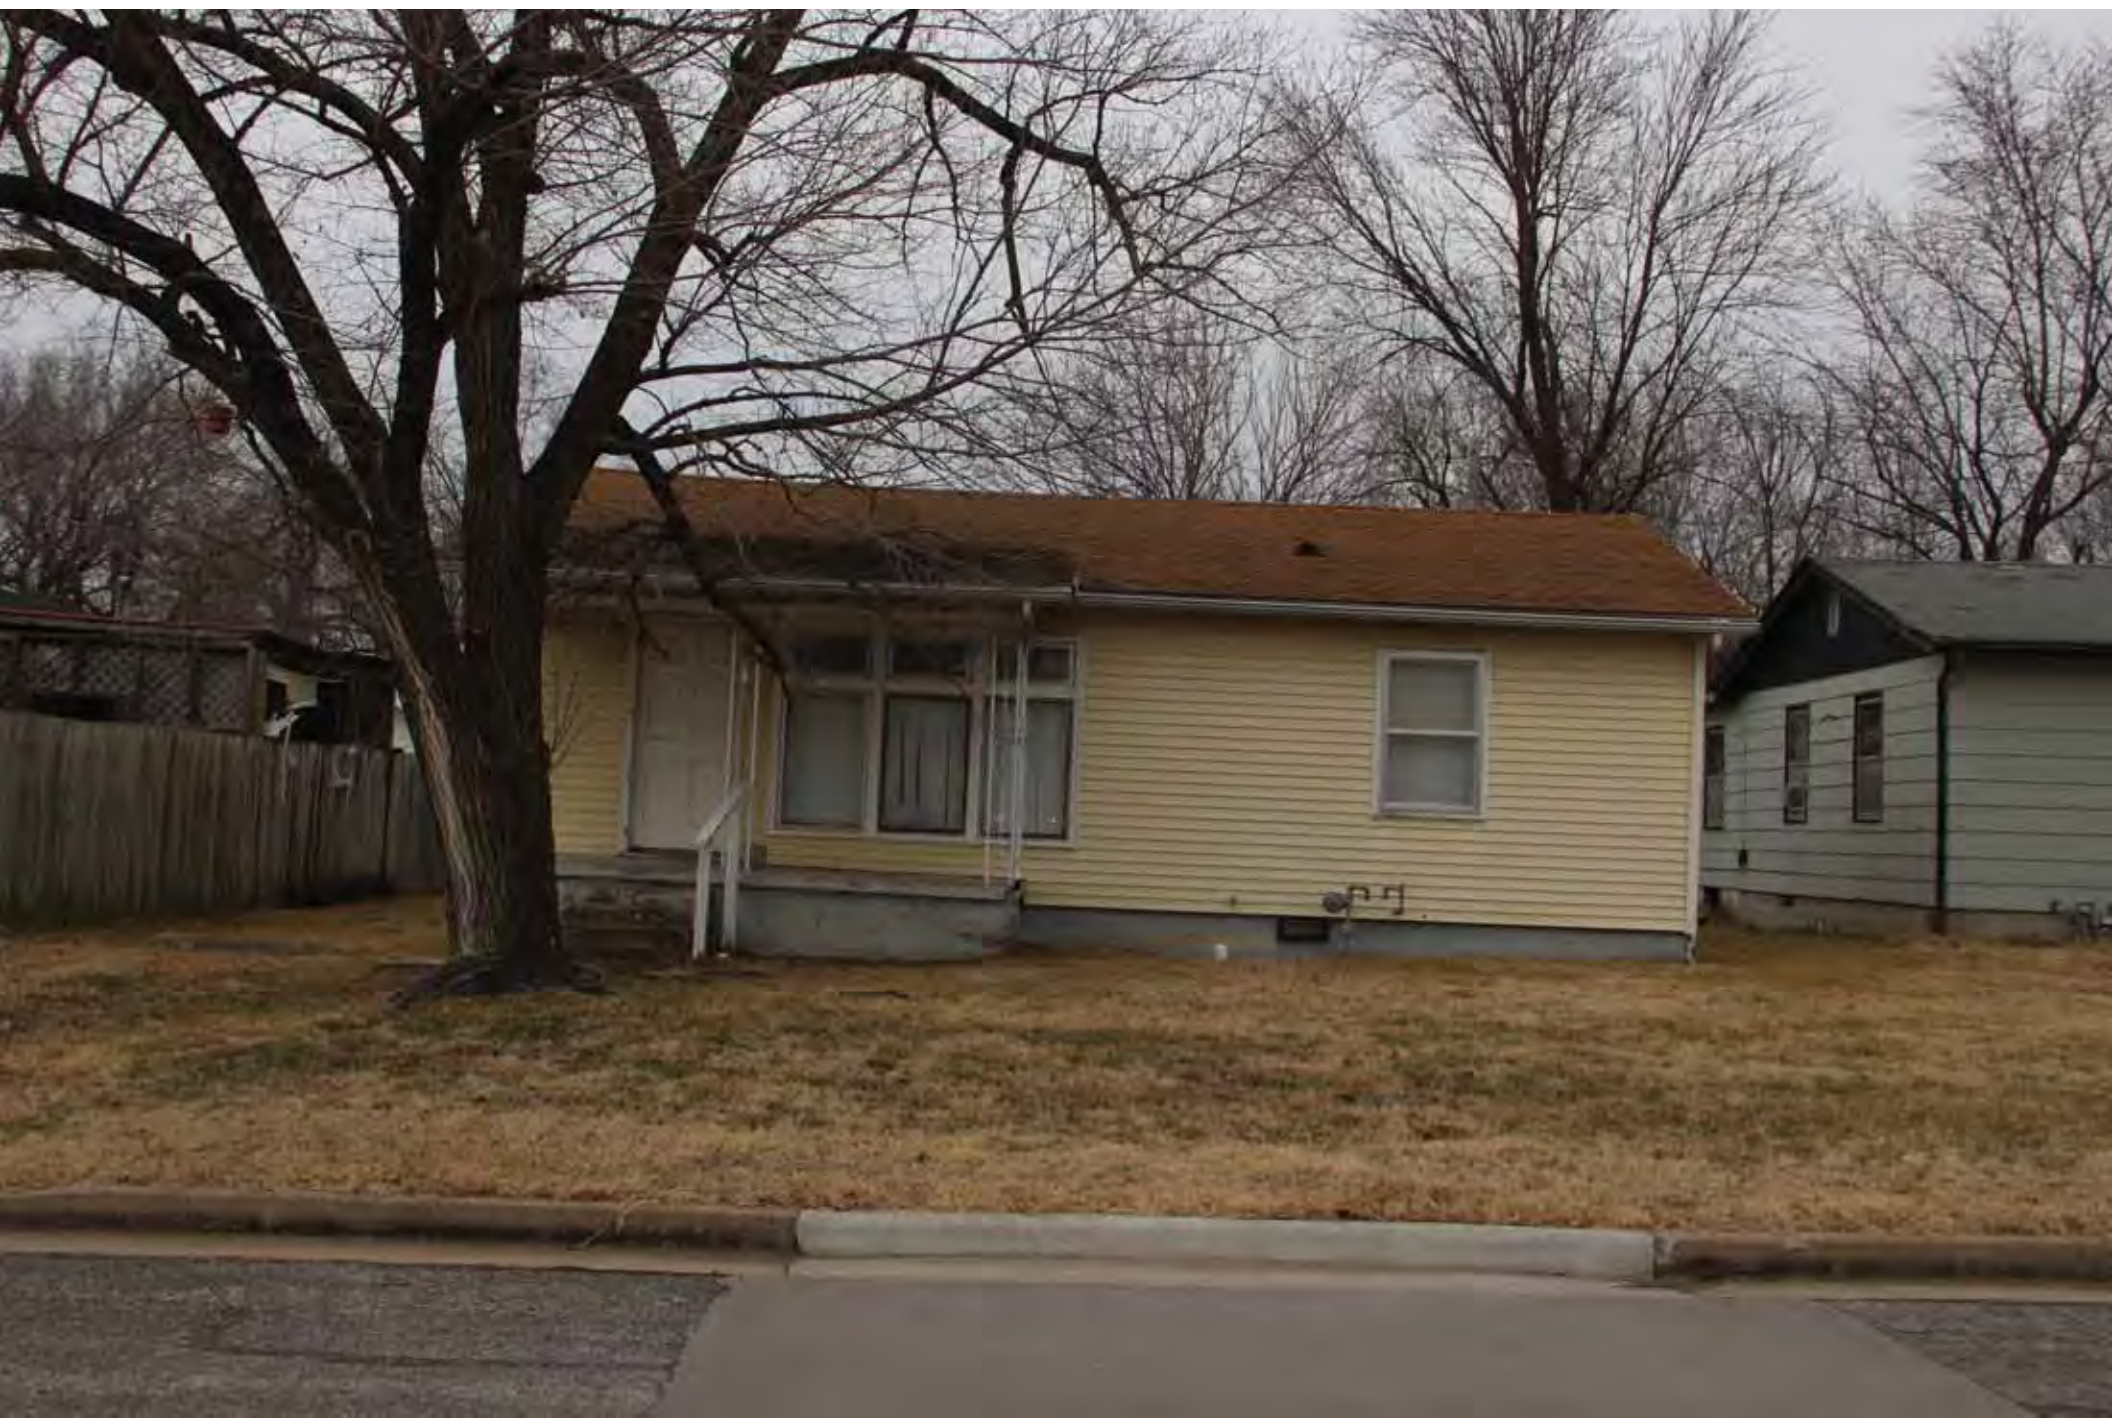
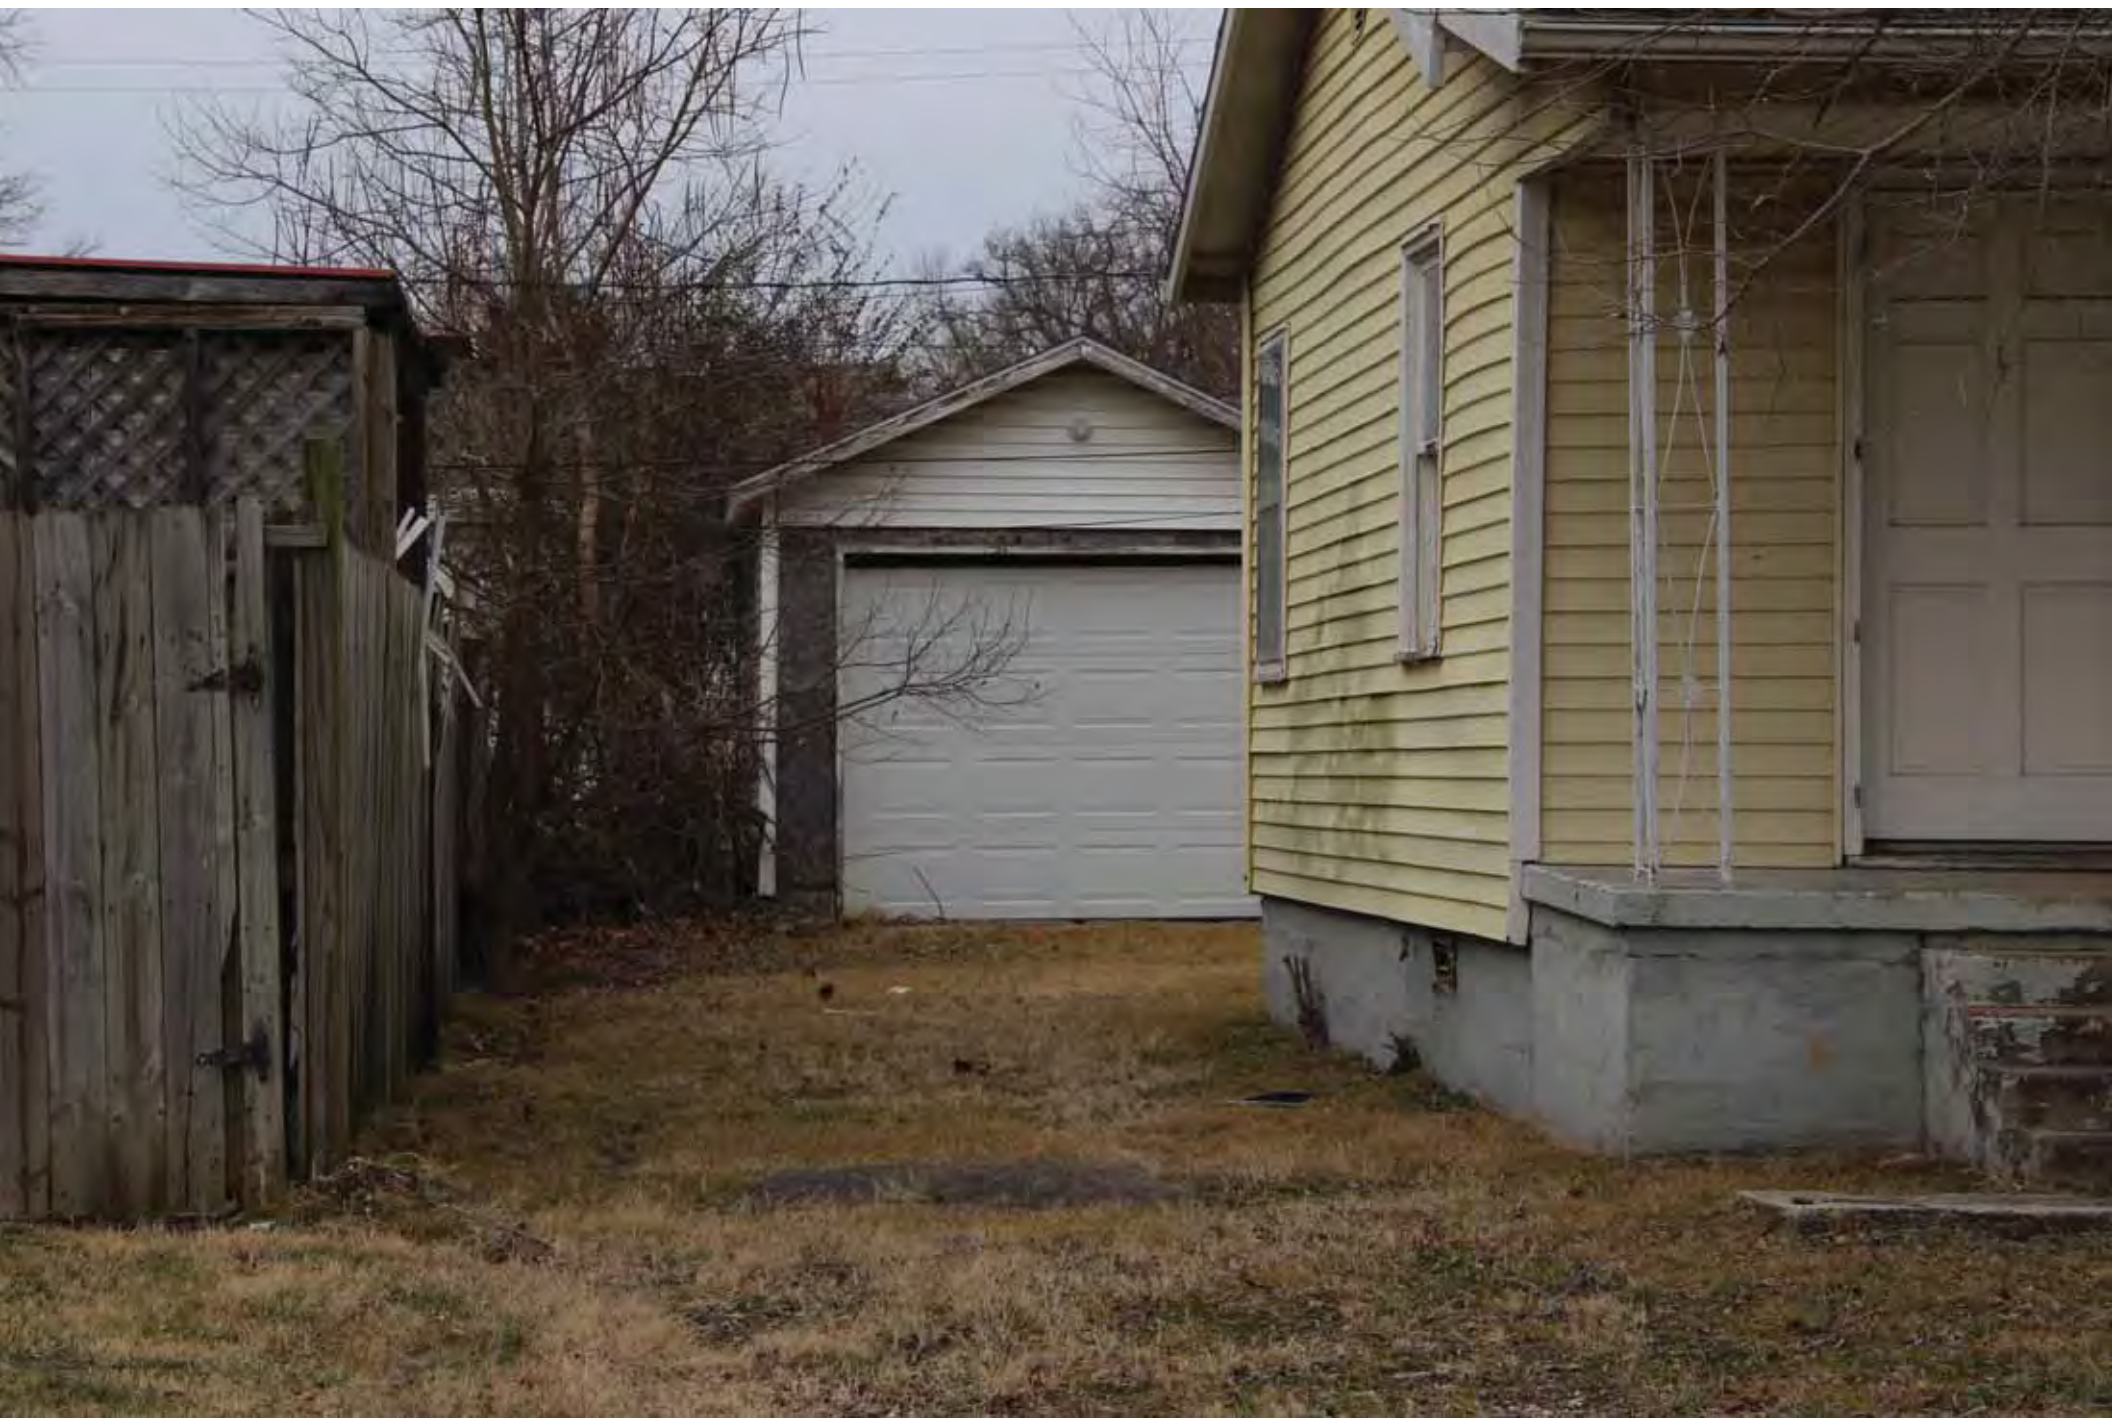
This dwelling is a common property type that has been altered with the addition of vinyl siding and replacement of façade windows – for this reason, the property does not retain its architectural integrity (Criterion C). The dwelling is not associated with any individual (Criterion B) or historical event(s) (Criterion A) of notable significance. The property is not within an area recommended as a historic district. For these reasons, the dwelling is not individually eligible for the National Register of Historic Places.

The property at 1403 E. 2nd Street features a single-story Ranch-influenced dwelling with an asphalt shingled end gable plan roof, exterior vinyl siding and a concrete foundation. The primary (south) elevation supports an off-center shed porch supported by wrought iron columns on a concrete base. Within the porch bay is an entry with a solid paneled replacement door. The entry is offset by a large six-light fixed sash replacement window. Offsetting this bay on the east is a one-over-one window. Side (east/west) elevations hold one-over-one windows – two on each elevation. Gable fields support louvered vents.

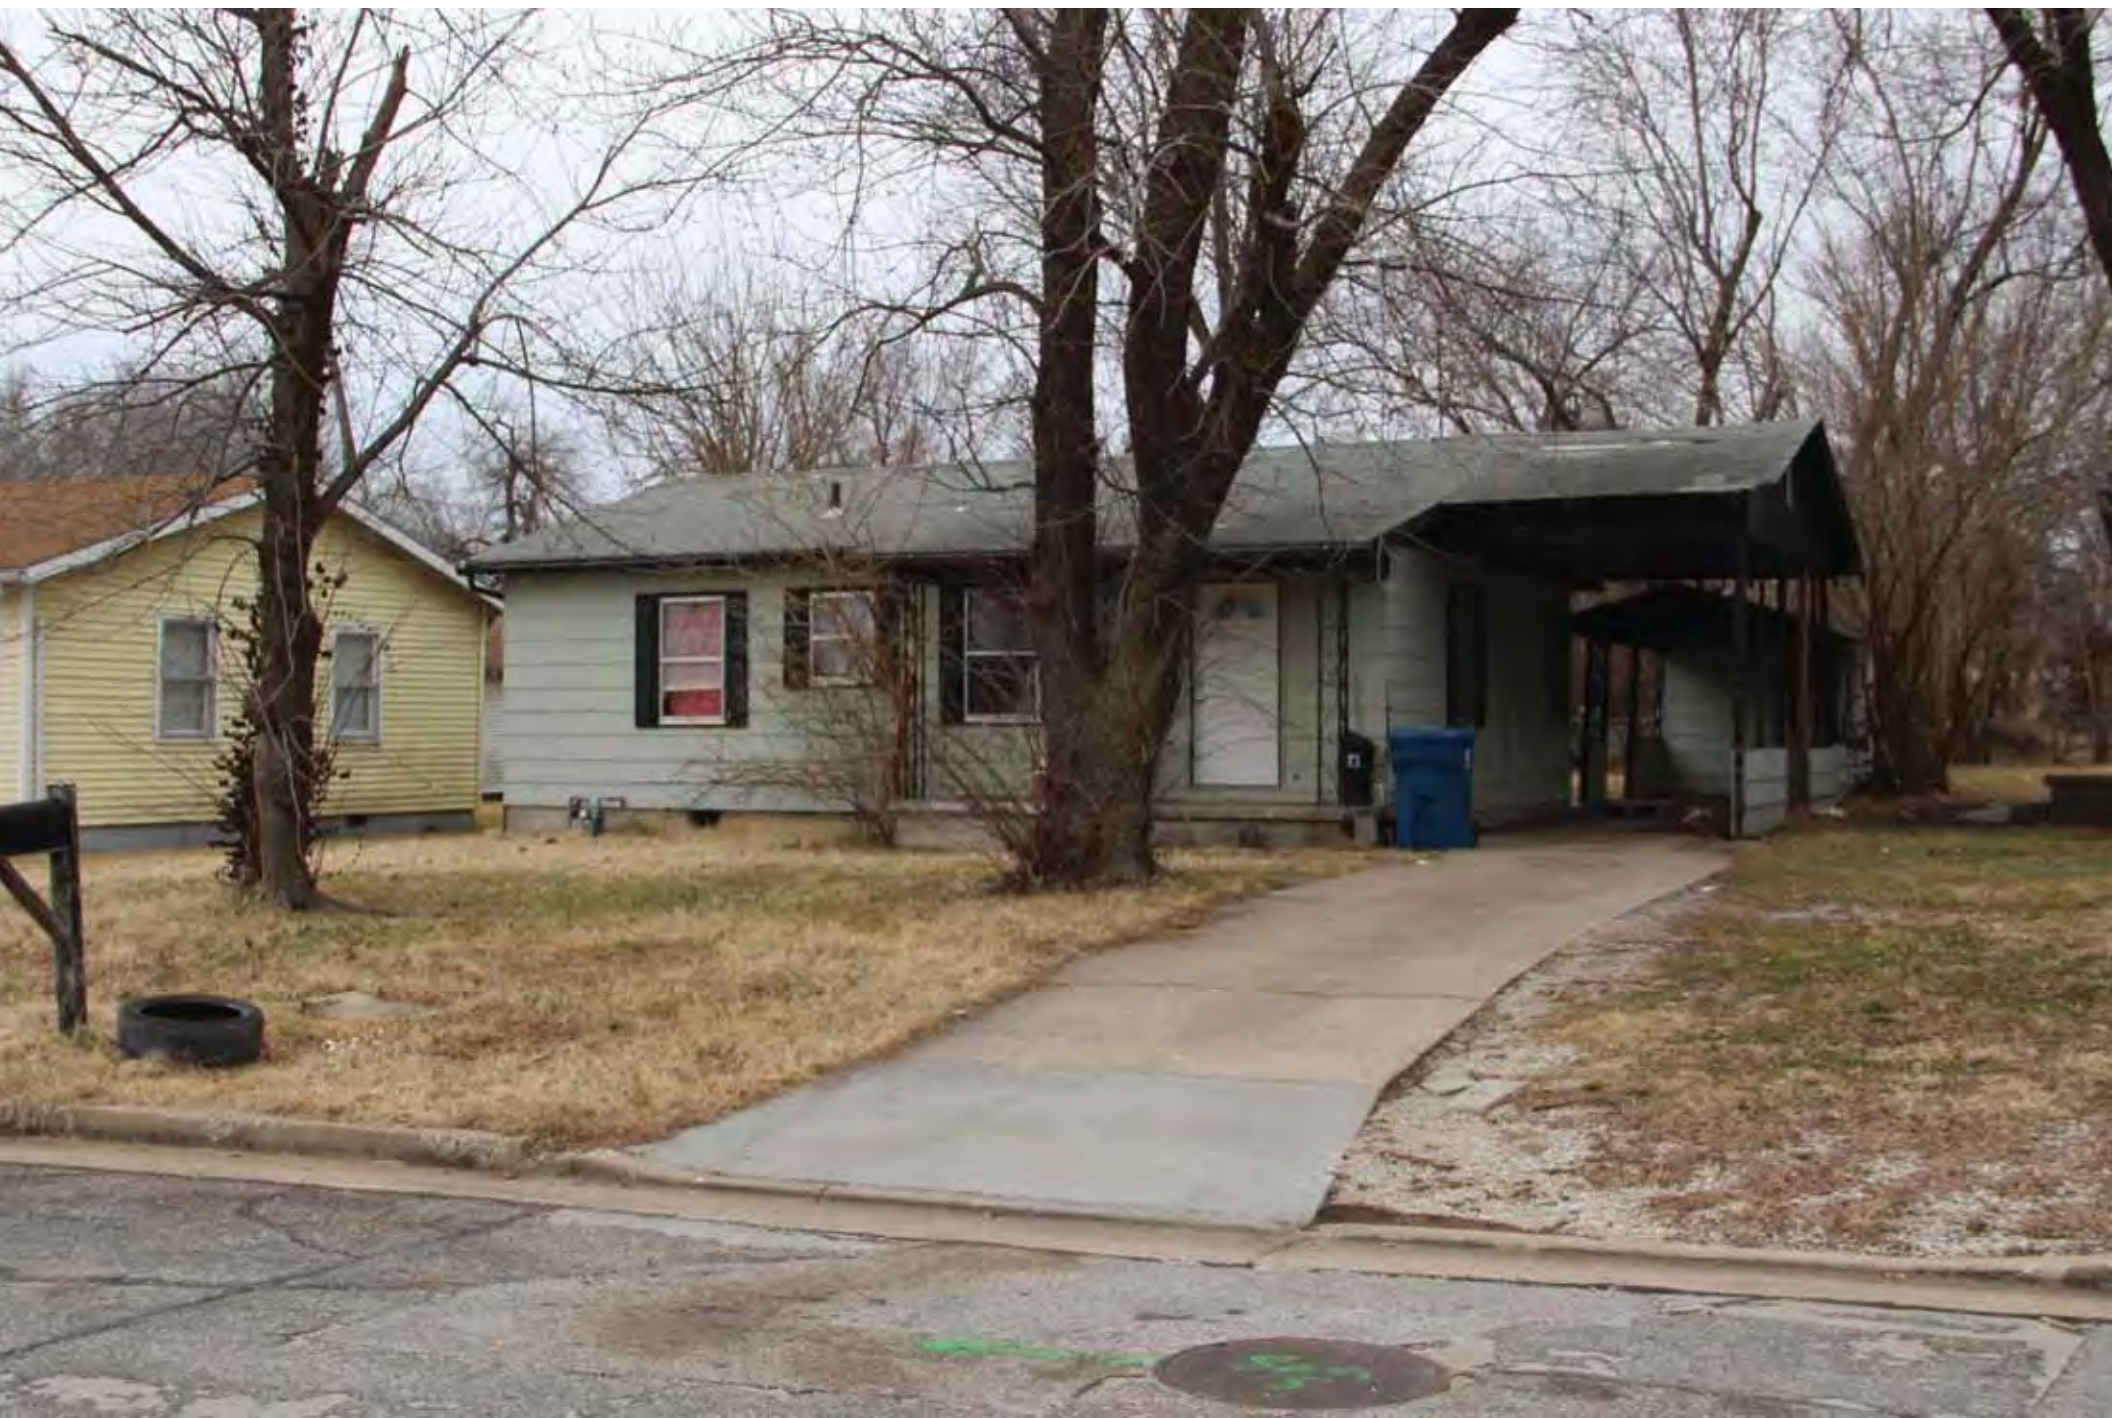
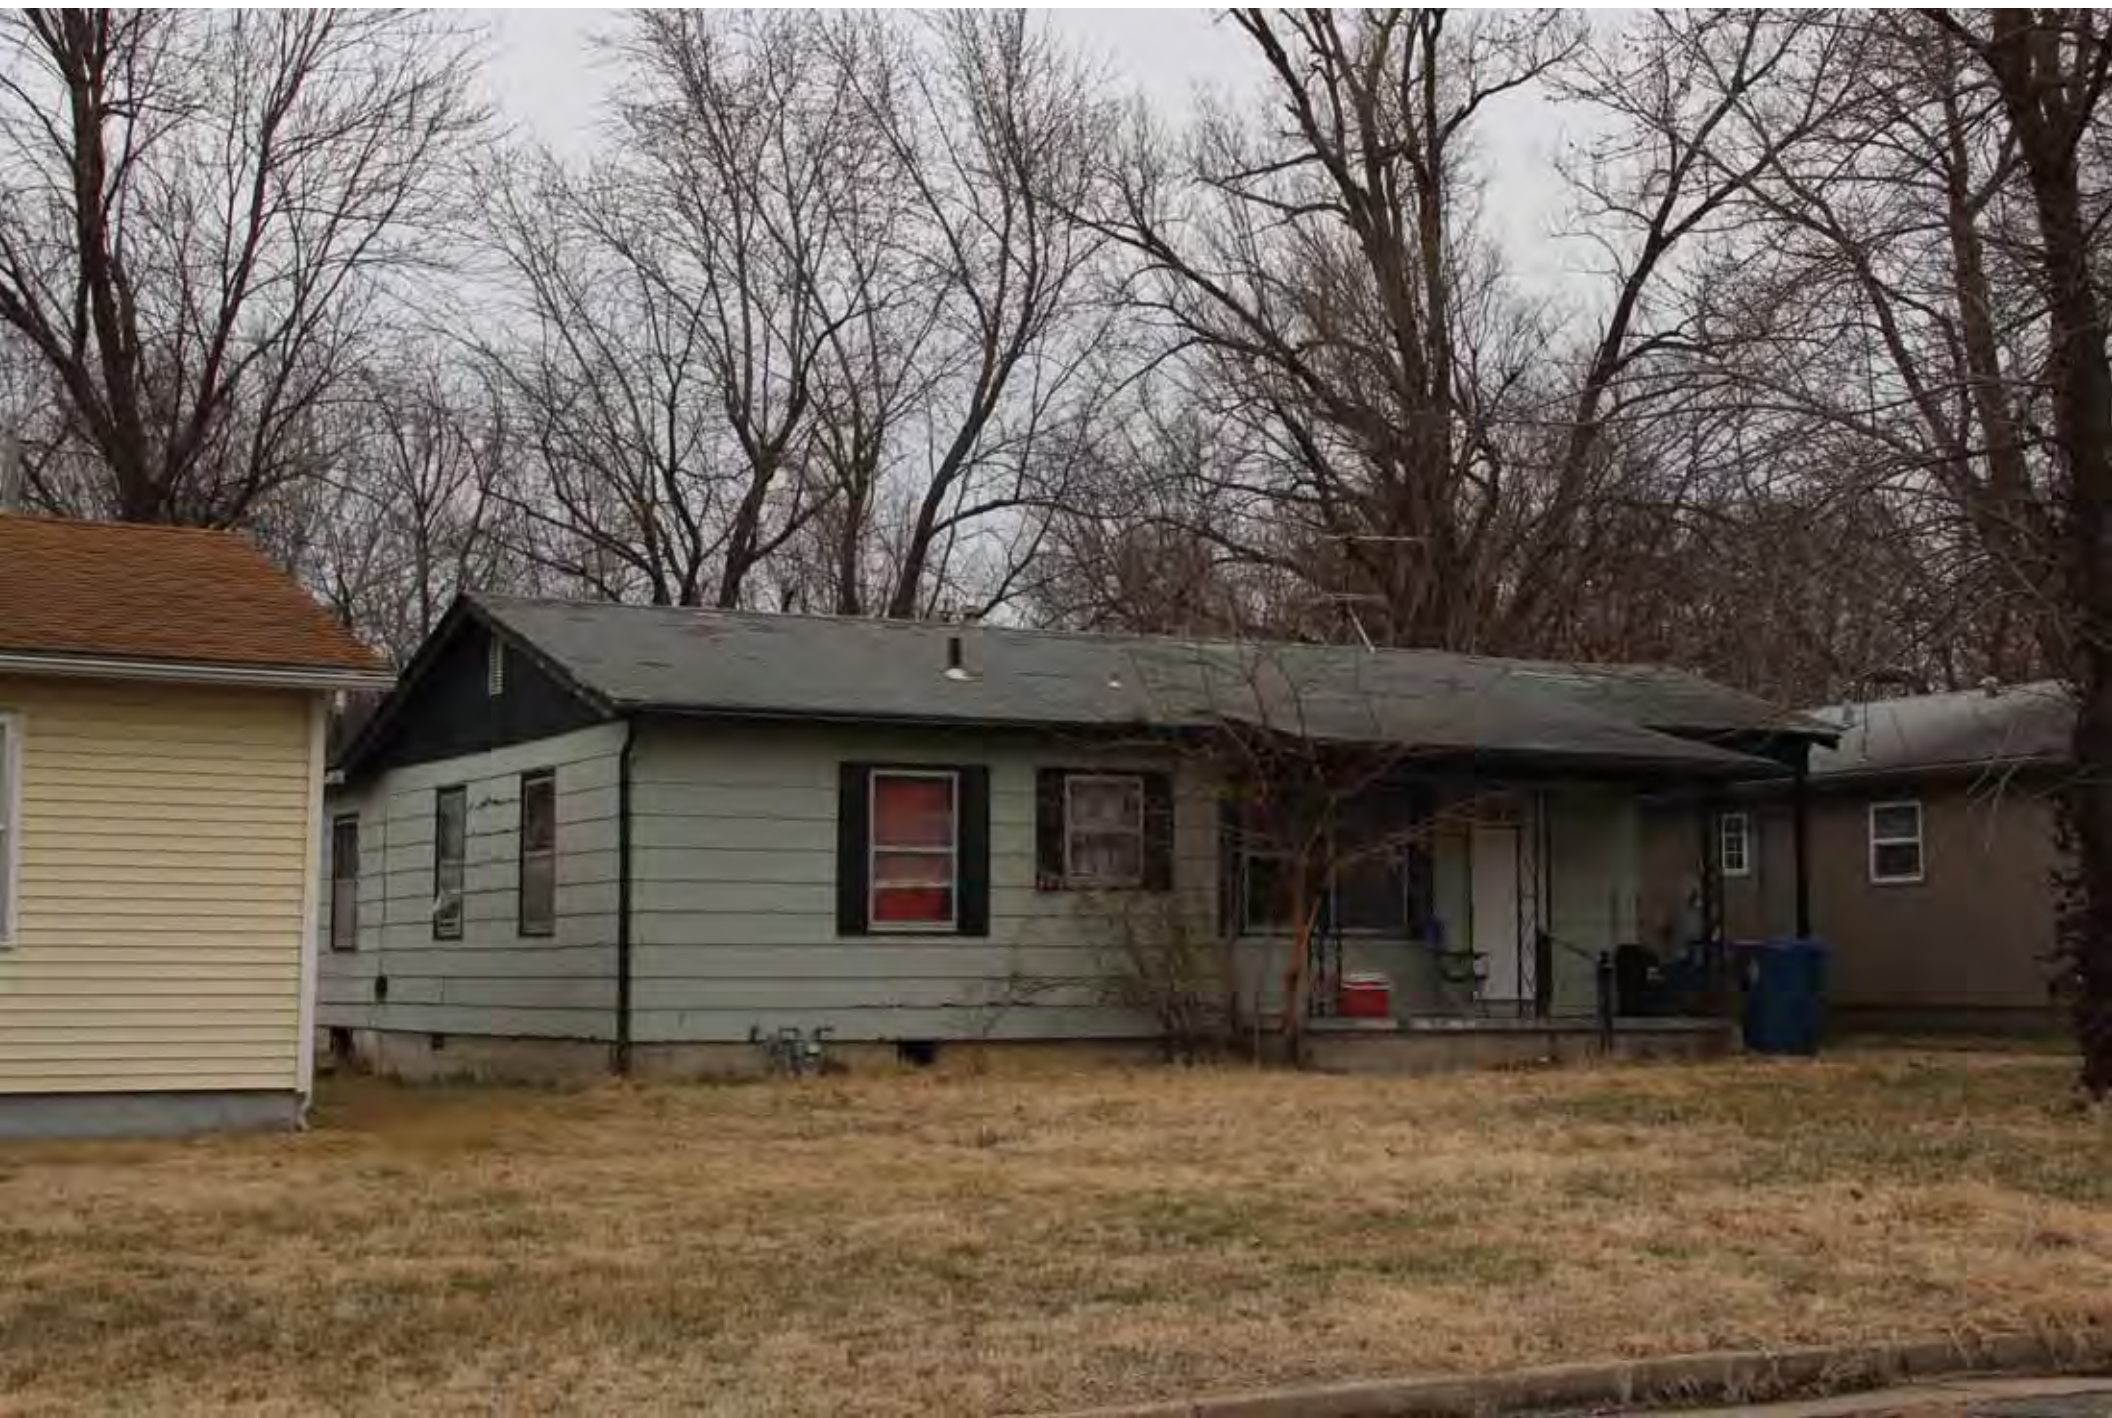
The property at 1405 E. 2nd Street features a single-story Ranch style dwelling with an asphalt-shingled gabled roof, exterior wide board siding and a concrete foundation. The primary (south) elevation supports an off-center shed porch supported by wrought iron columns. The porch has a concrete base. Within the porch bay is a c. 2015 paneled door with an upper fanlight. Paired one-over-one windows offset the entry. The remaining façade (west end) supports two one-over-one windows. The east elevation holds three windows. The west elevation roofline extends to create a gabled carport supported by wood columns. The dwelling's west elevation supports two windows.

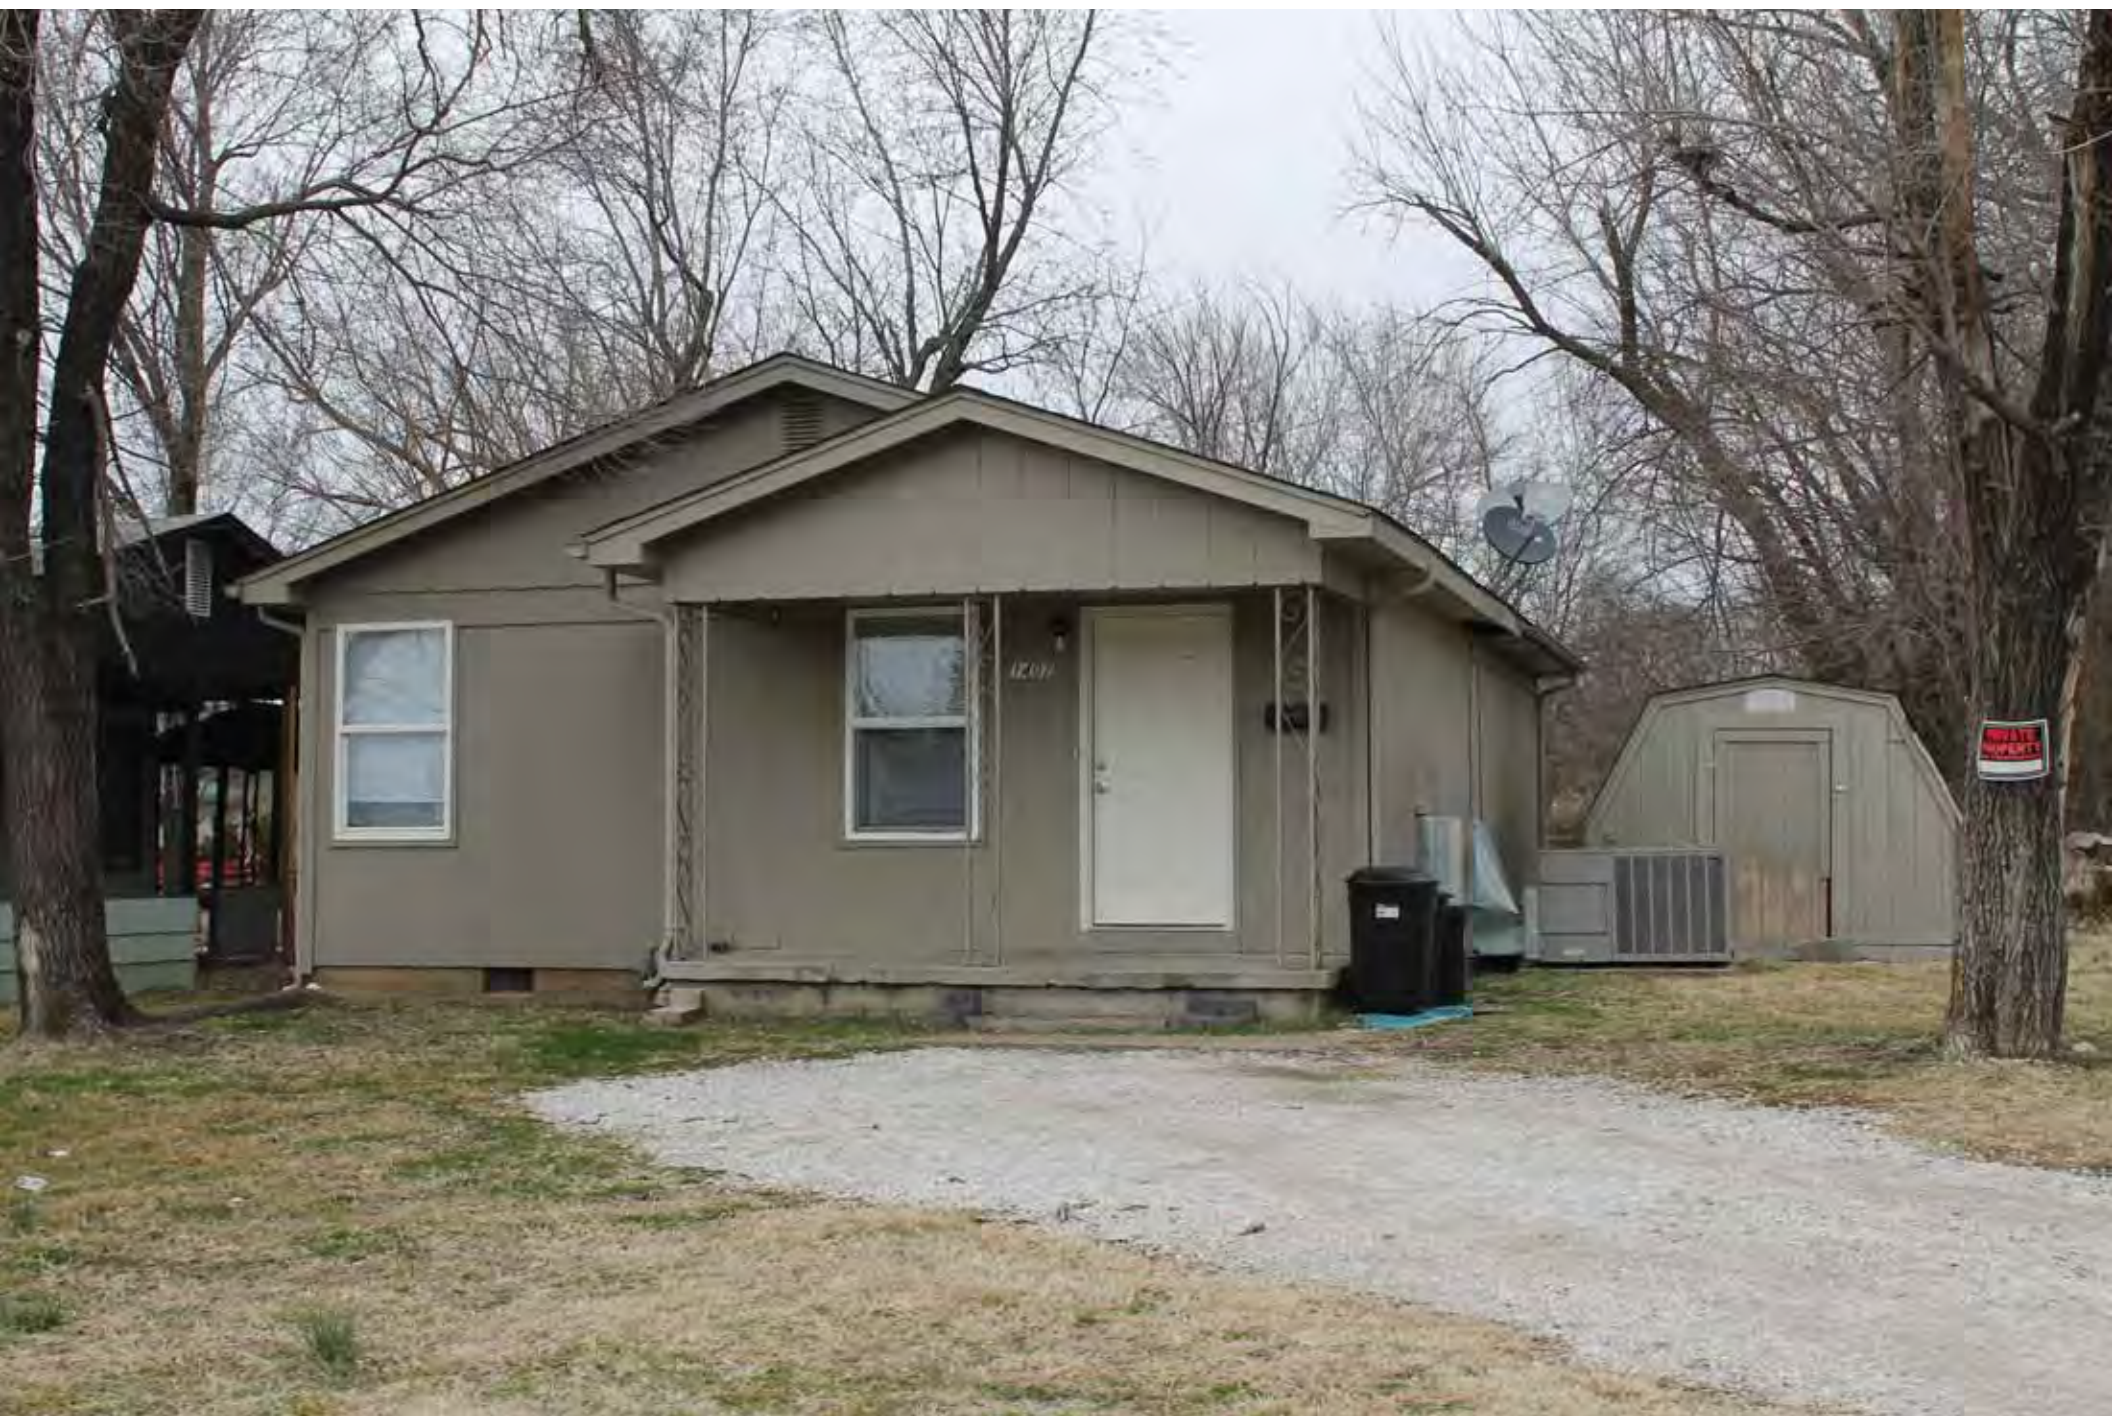
The property at 1407 E. 2nd Street features a single-story gable-front plan dwelling with an asphalt-shingled roof, exterior vertical board replacement siding and a concrete foundation. The primary (south) elevation supports an off-center gabled porch supported by wrought iron columns on a concrete base. Within the porch bay is a c. 2015 paneled door offset by a one-over-one replacement window. A second window is situated at the west end of the façade. The gable field of the porch has scalloped edge siding (vertical board). Within the upper gable field of the north elevation (which also supports scalloped edge siding) is a louvered vent. The west elevation has a secondary entry and a concrete stoop. There are two windows on the west elevation. The east elevation has no fenestration.
