MISSOURI DEPARTMENT OF NATURAL RESOURCES
STATE HISTORIC PRESERVATION OFFICE, P.O. Box 176, Jefferson City, MO 65102
ARCHITECTURAL/HISTORIC INVENTORY FORM

1. Survey No. JP-AS-007-001		2. Survey name: East Town (Original Joplin) Historic Survey Phase 2	
3. County: JASPER		4. Address (Street No.) 618	Street (name) E. 2 nd Street
5. City: Joplin	Vicinity: <input type="checkbox"/>	6. Geographical Reference:	7. Township/Range/Section: T: R: S:
8. Historic name (if known):		9. Present/other name (if known):	
10. Ownership: <input checked="" type="checkbox"/> Private <input type="checkbox"/> Public		11a. Historic use (if known): Domestic: Single Dwelling	11b. Current use: Domestic: Single Dwelling

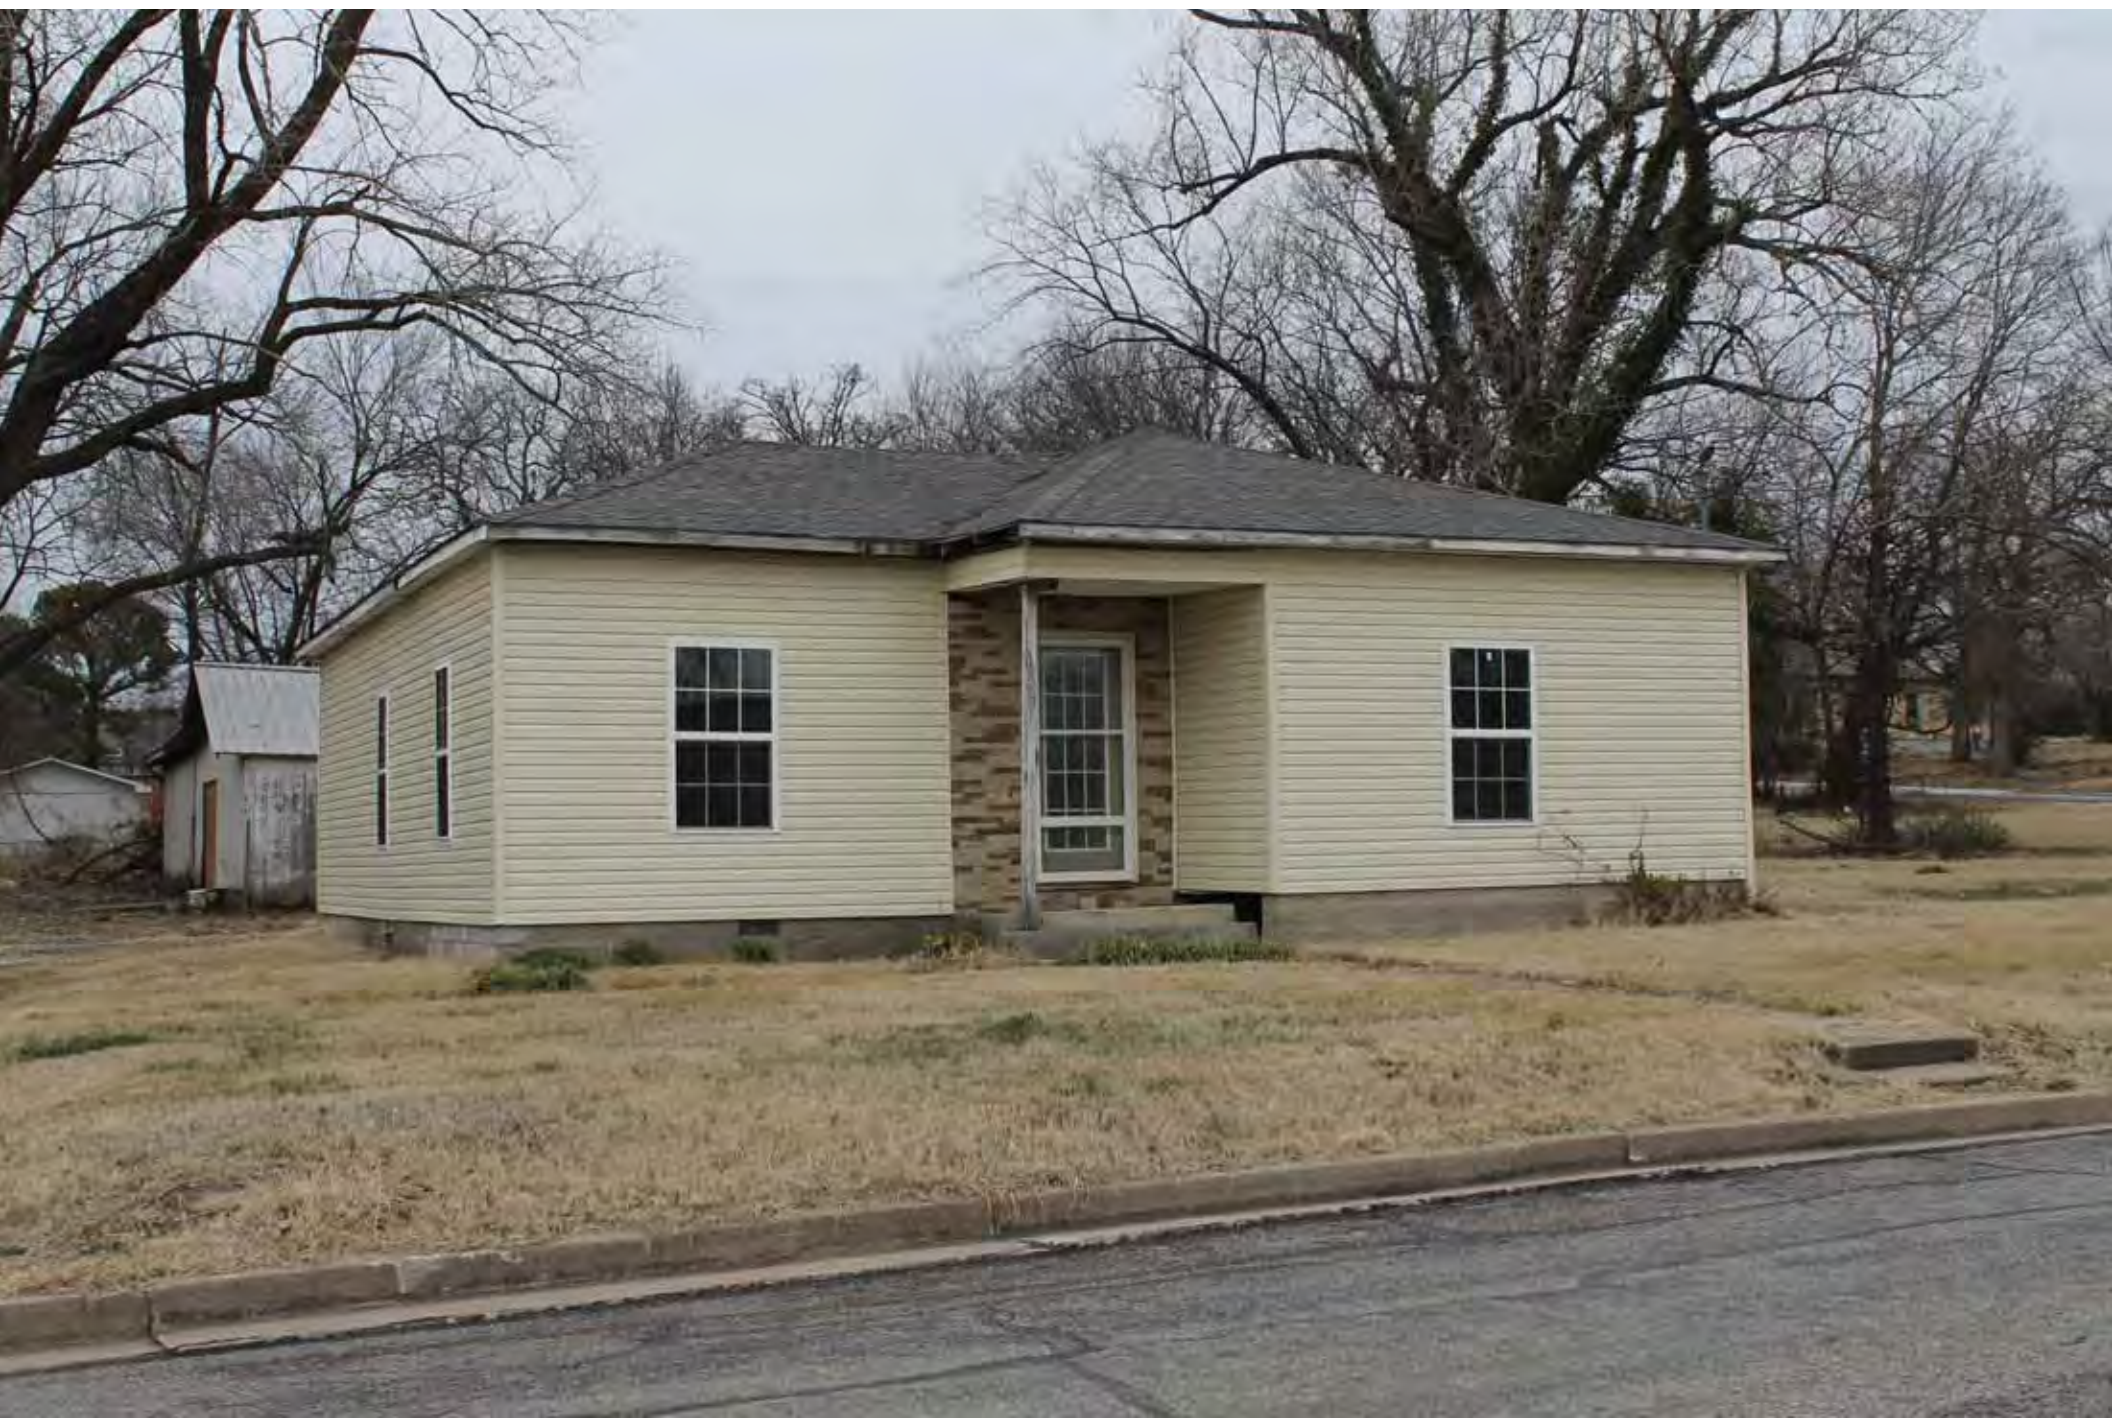
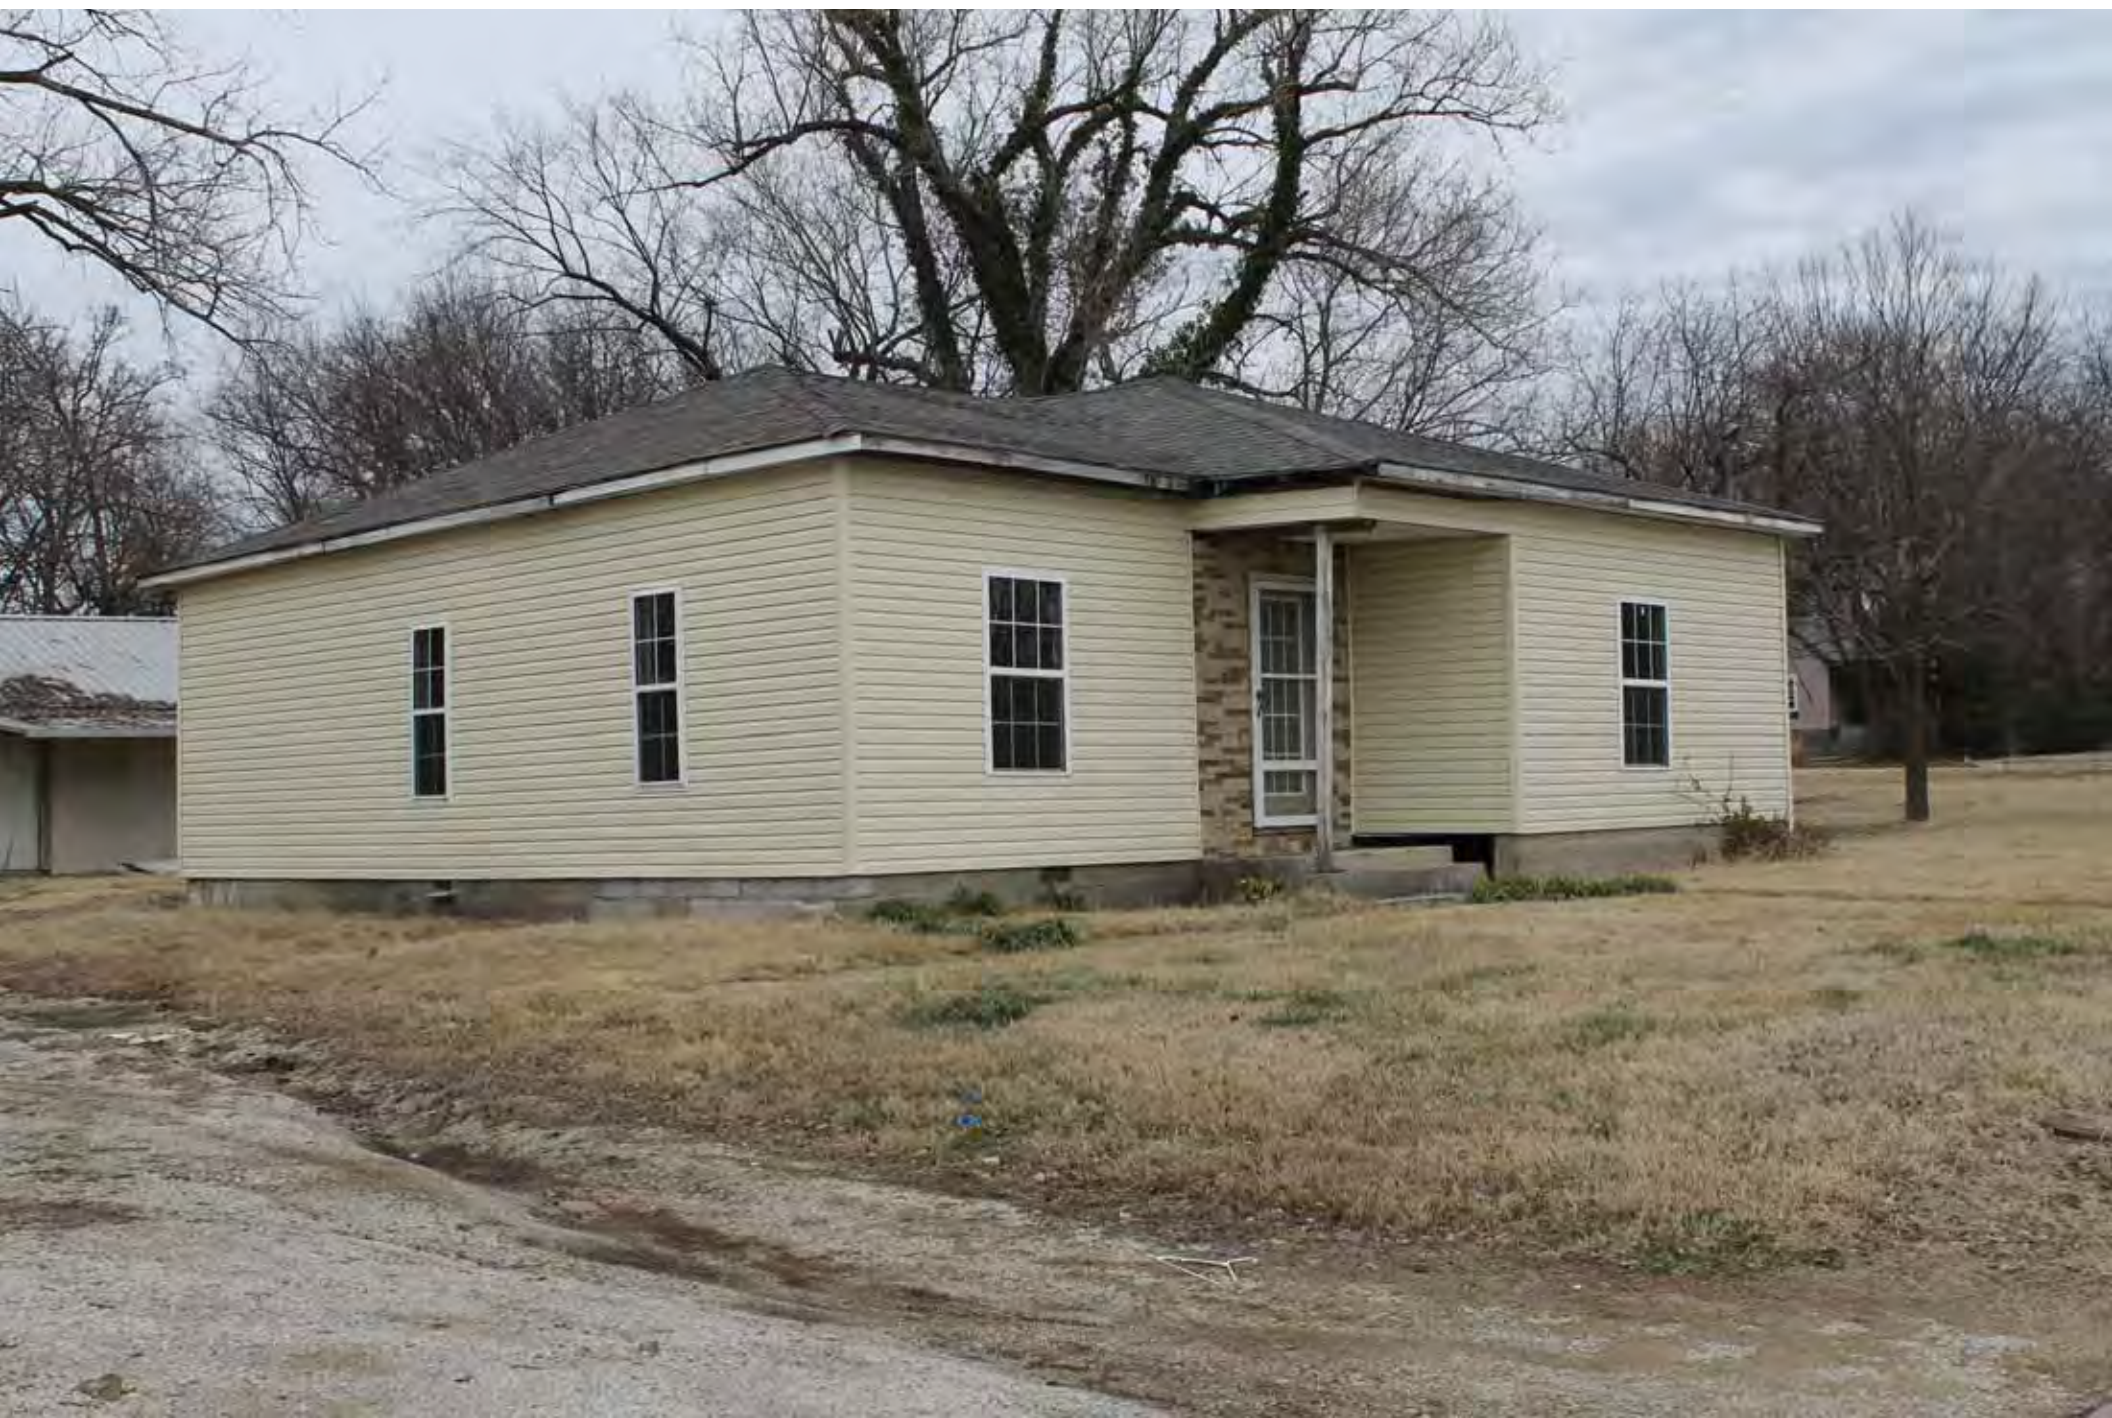
The property at 1409 E. 2nd Street features a single-story dwelling altered c. 2019. The house has an asphalt-shingled hipped roof, exterior vinyl siding, and six-over-six and four-over-four replacement windows. The dwelling has a projecting wing at the east end, which creates a porch with a hipped integral roof. The small porch has a concrete stoop and the roof is supported by a single wood column. Within the porch bay is a multi-light c. 2019 door. Windows (6/6) on the south elevation flank the porch. Side elevations have four-over-four windows.

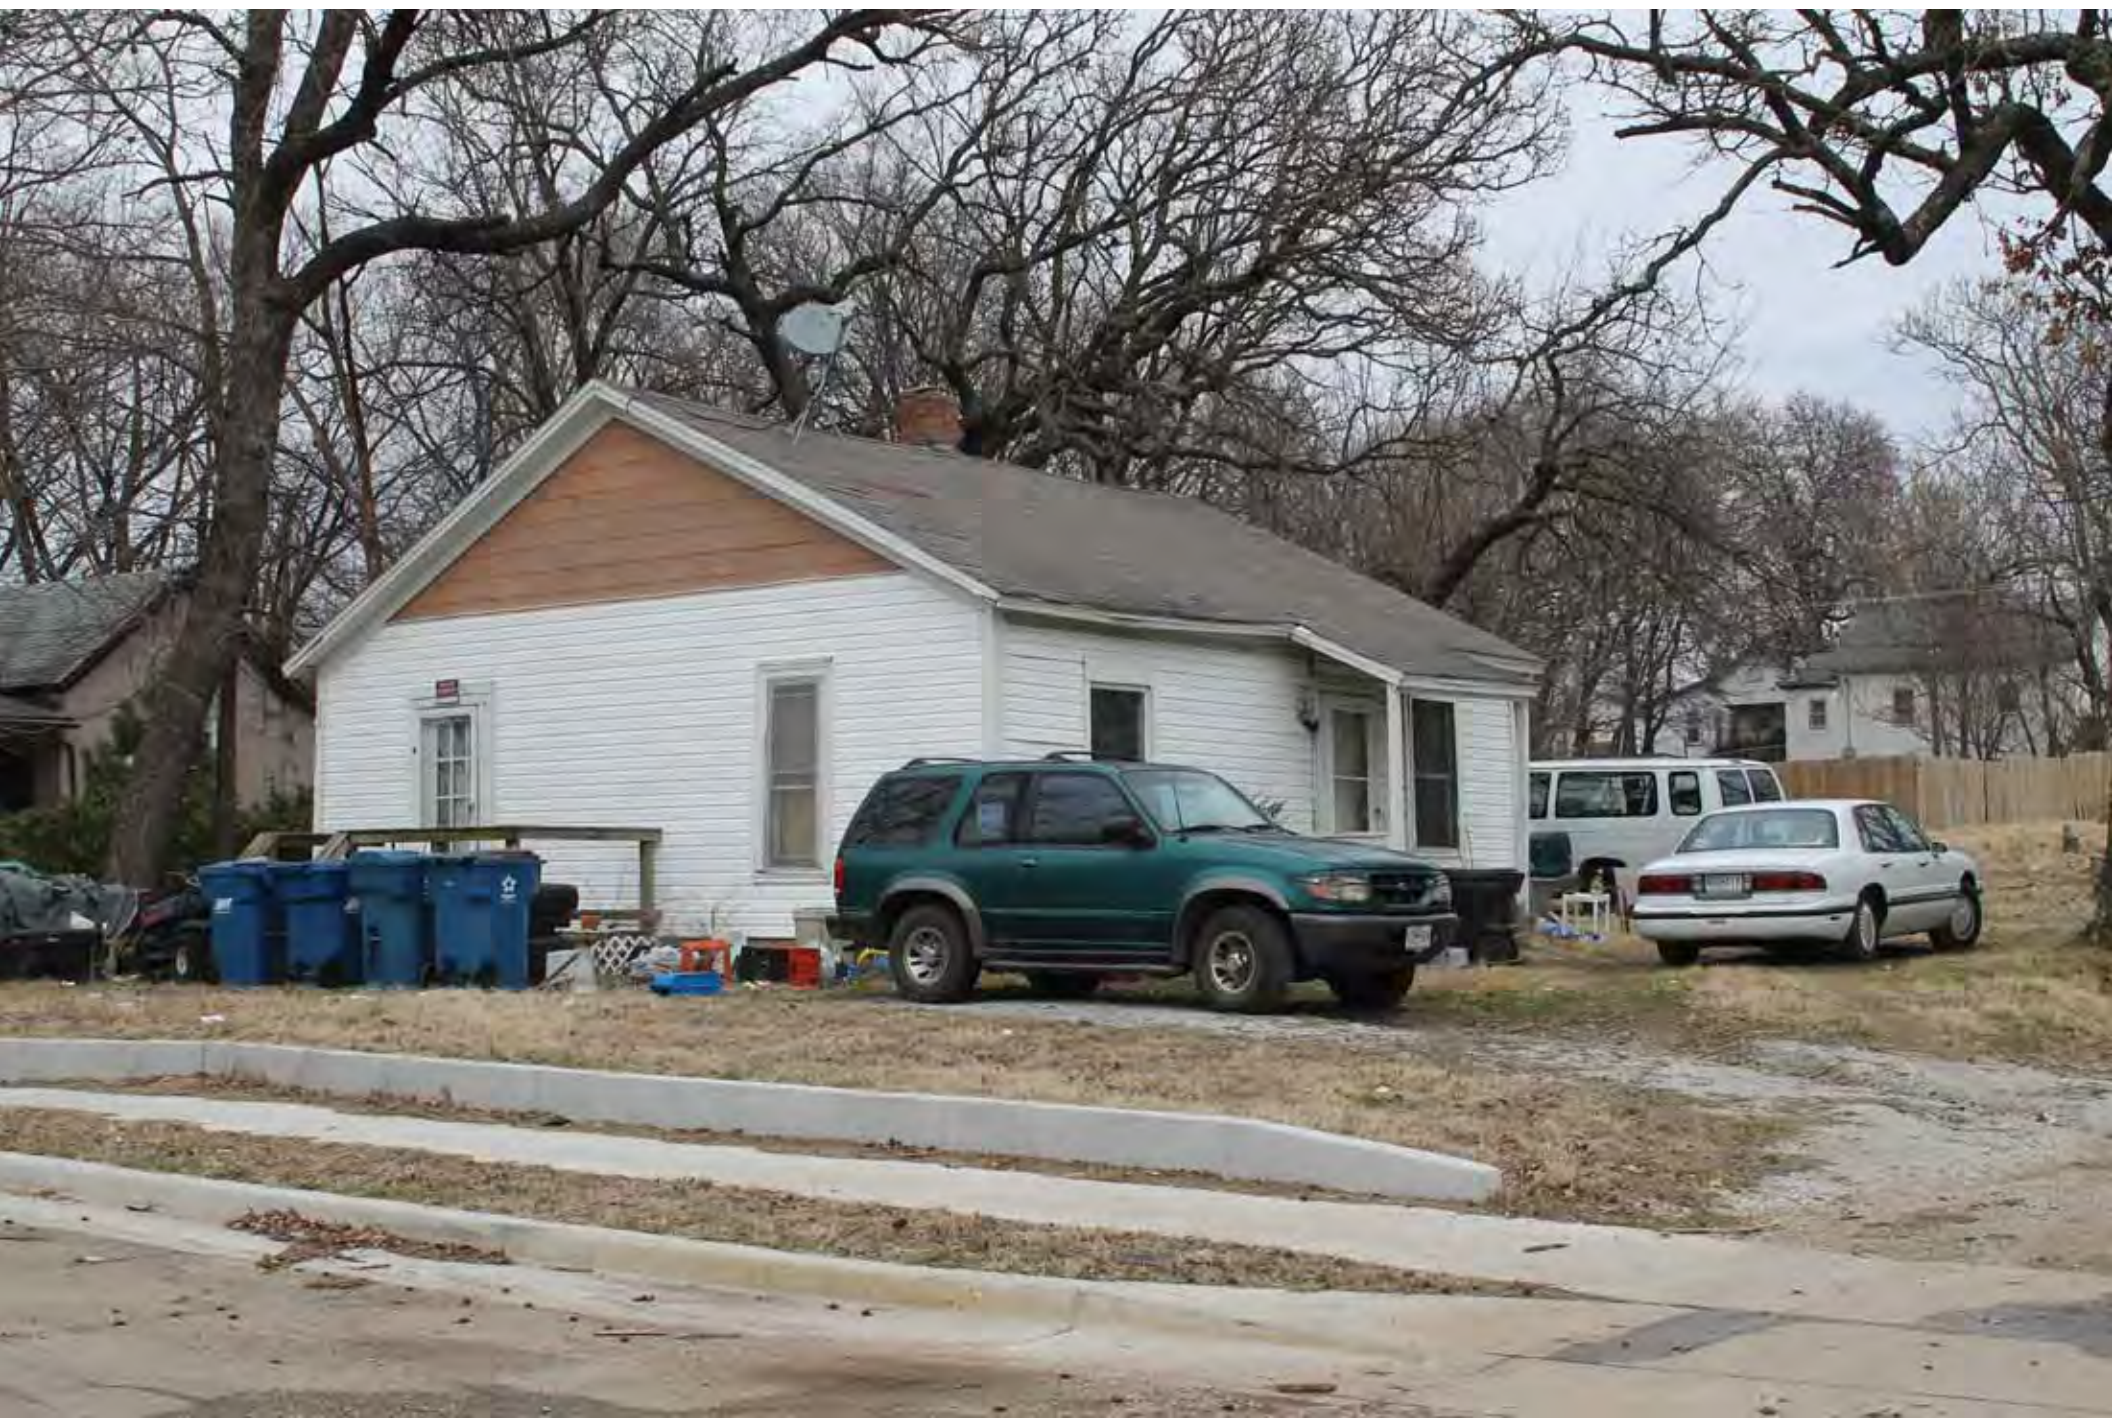
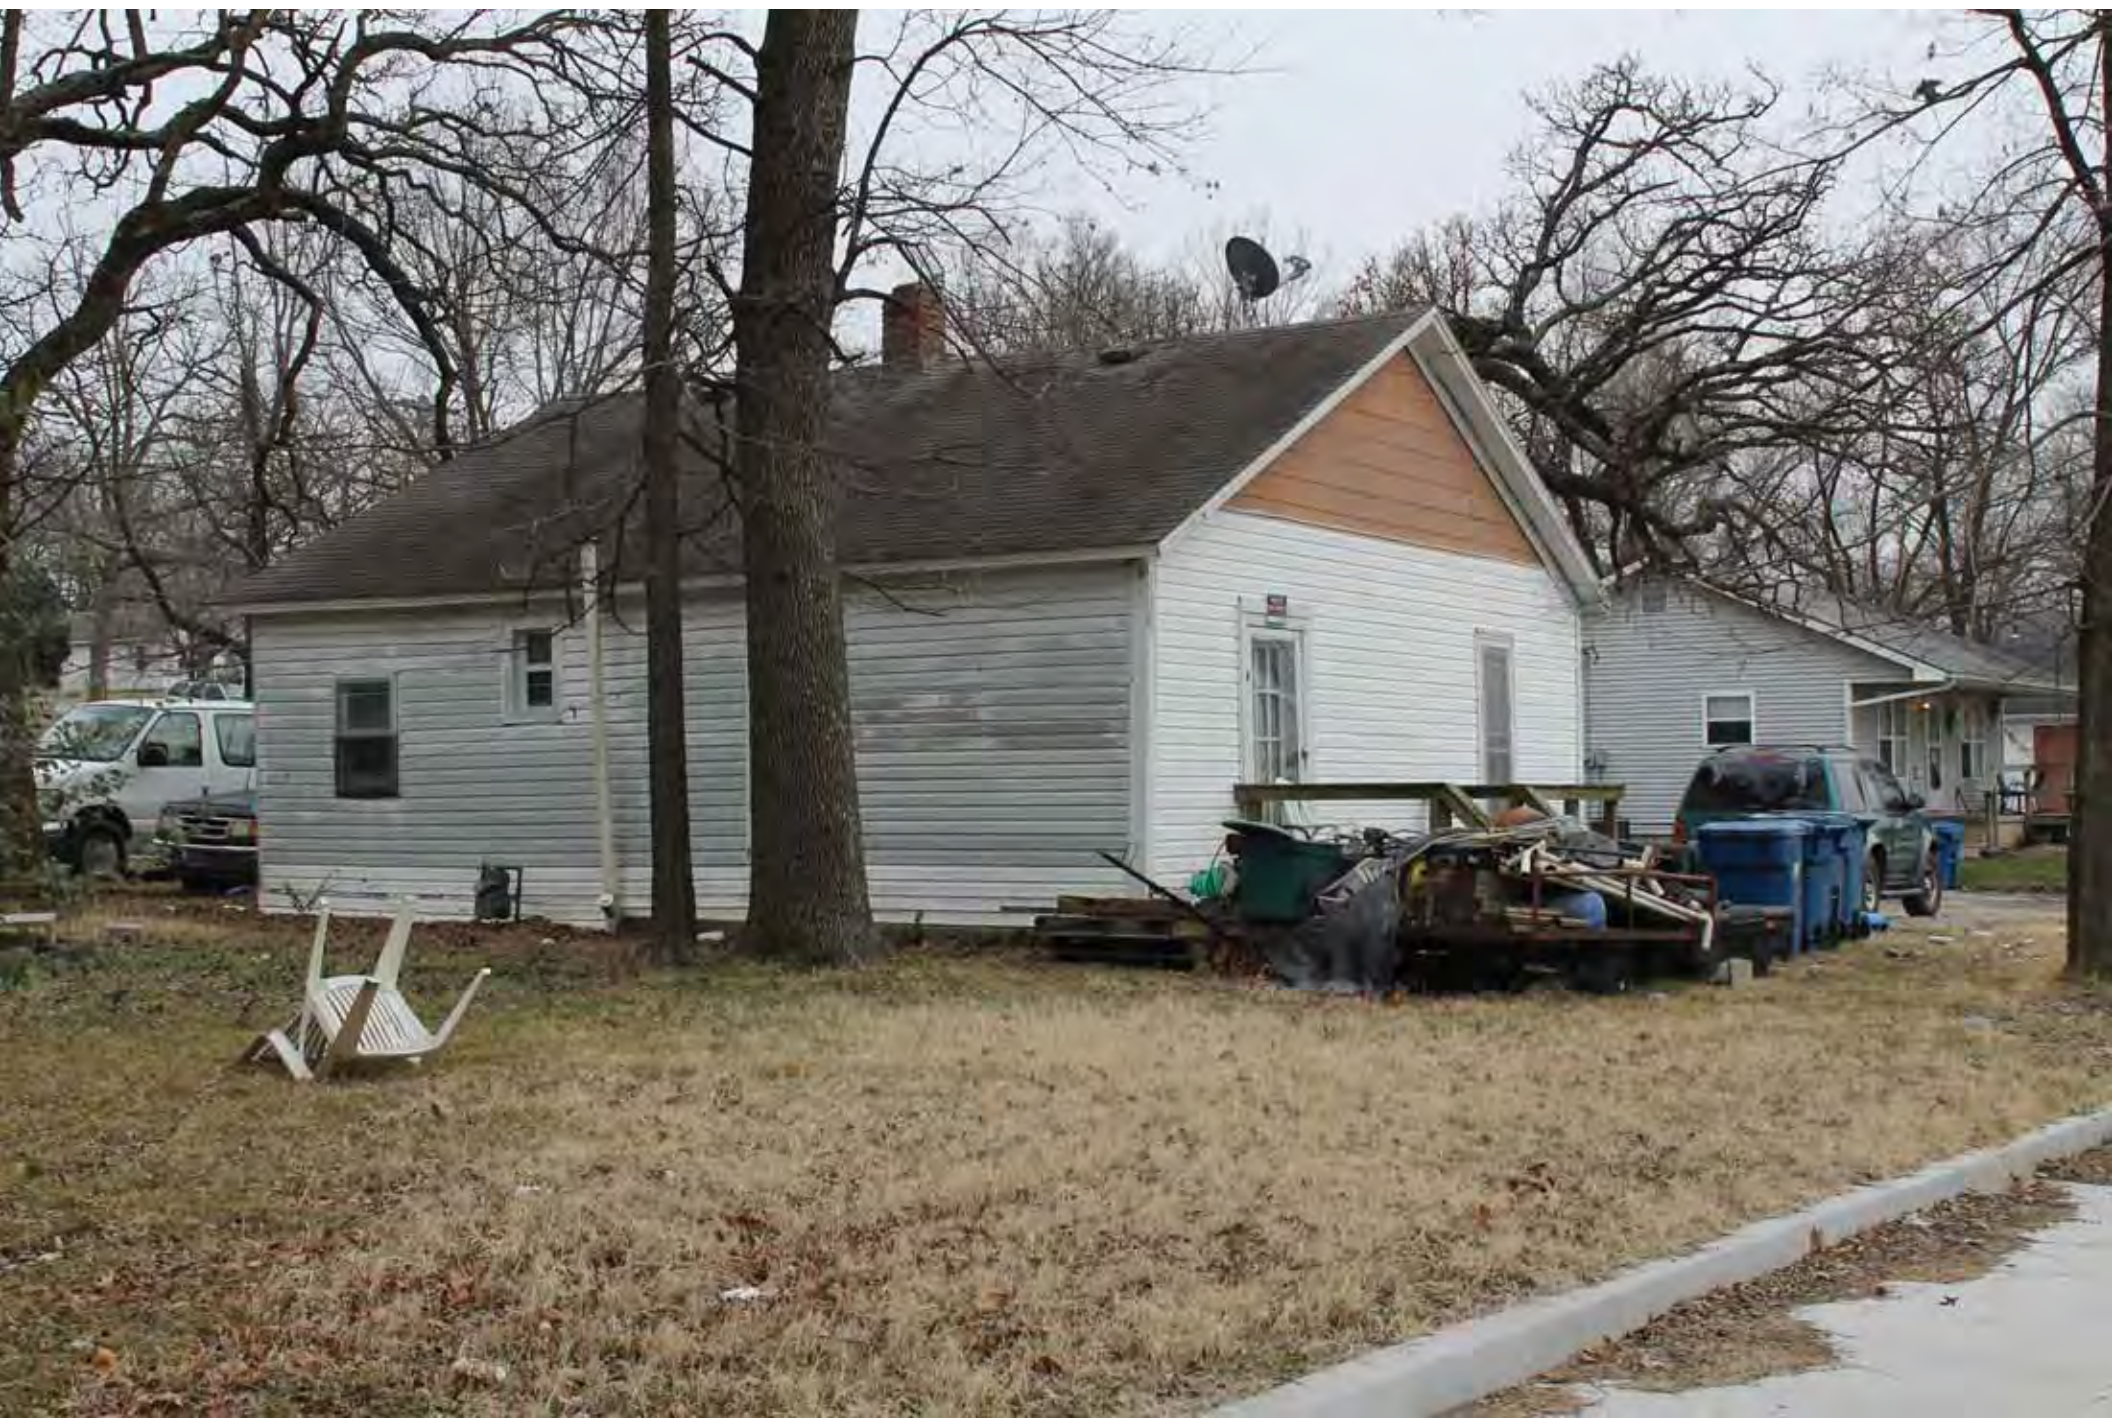
The property at 1501 E. 2nd Street features a single-story dwelling altered c. 2019. The house has an asphalt-shingled gable roof with an interior brick chimney at the ridge. The dwelling is clad with vinyl siding and has a concrete foundation. The primary (south) elevation holds an off-center shed portico supported by two wood columns. Within the portico bay is a solid c. 2019 paneled door. The entry is flanked by replacement one-over-one windows. The west elevation holds a c. 2019 multi-light door and an original one-over-one window. The rear (north) elevation has two small windows near the east end.
