MISSOURI DEPARTMENT OF NATURAL RESOURCES
STATE HISTORIC PRESERVATION OFFICE, P.O. Box 176, Jefferson City, MO 65102
ARCHITECTURAL/HISTORIC INVENTORY FORM

1. Survey No. JP-AS-007-001		2. Survey name: East Town (Original Joplin) Historic Survey Phase 2	
3. County: JASPER		4. Address (Street No.) 618	Street (name) E. 2 nd Street
5. City: Joplin	Vicinity: <input type="checkbox"/>	6. Geographical Reference:	7. Township/Range/Section: T: R: S:
8. Historic name (if known):		9. Present/other name (if known):	
10. Ownership: <input checked="" type="checkbox"/> Private <input type="checkbox"/> Public		11a. Historic use (if known): Domestic: Single Dwelling	11b. Current use: Domestic: Single Dwelling

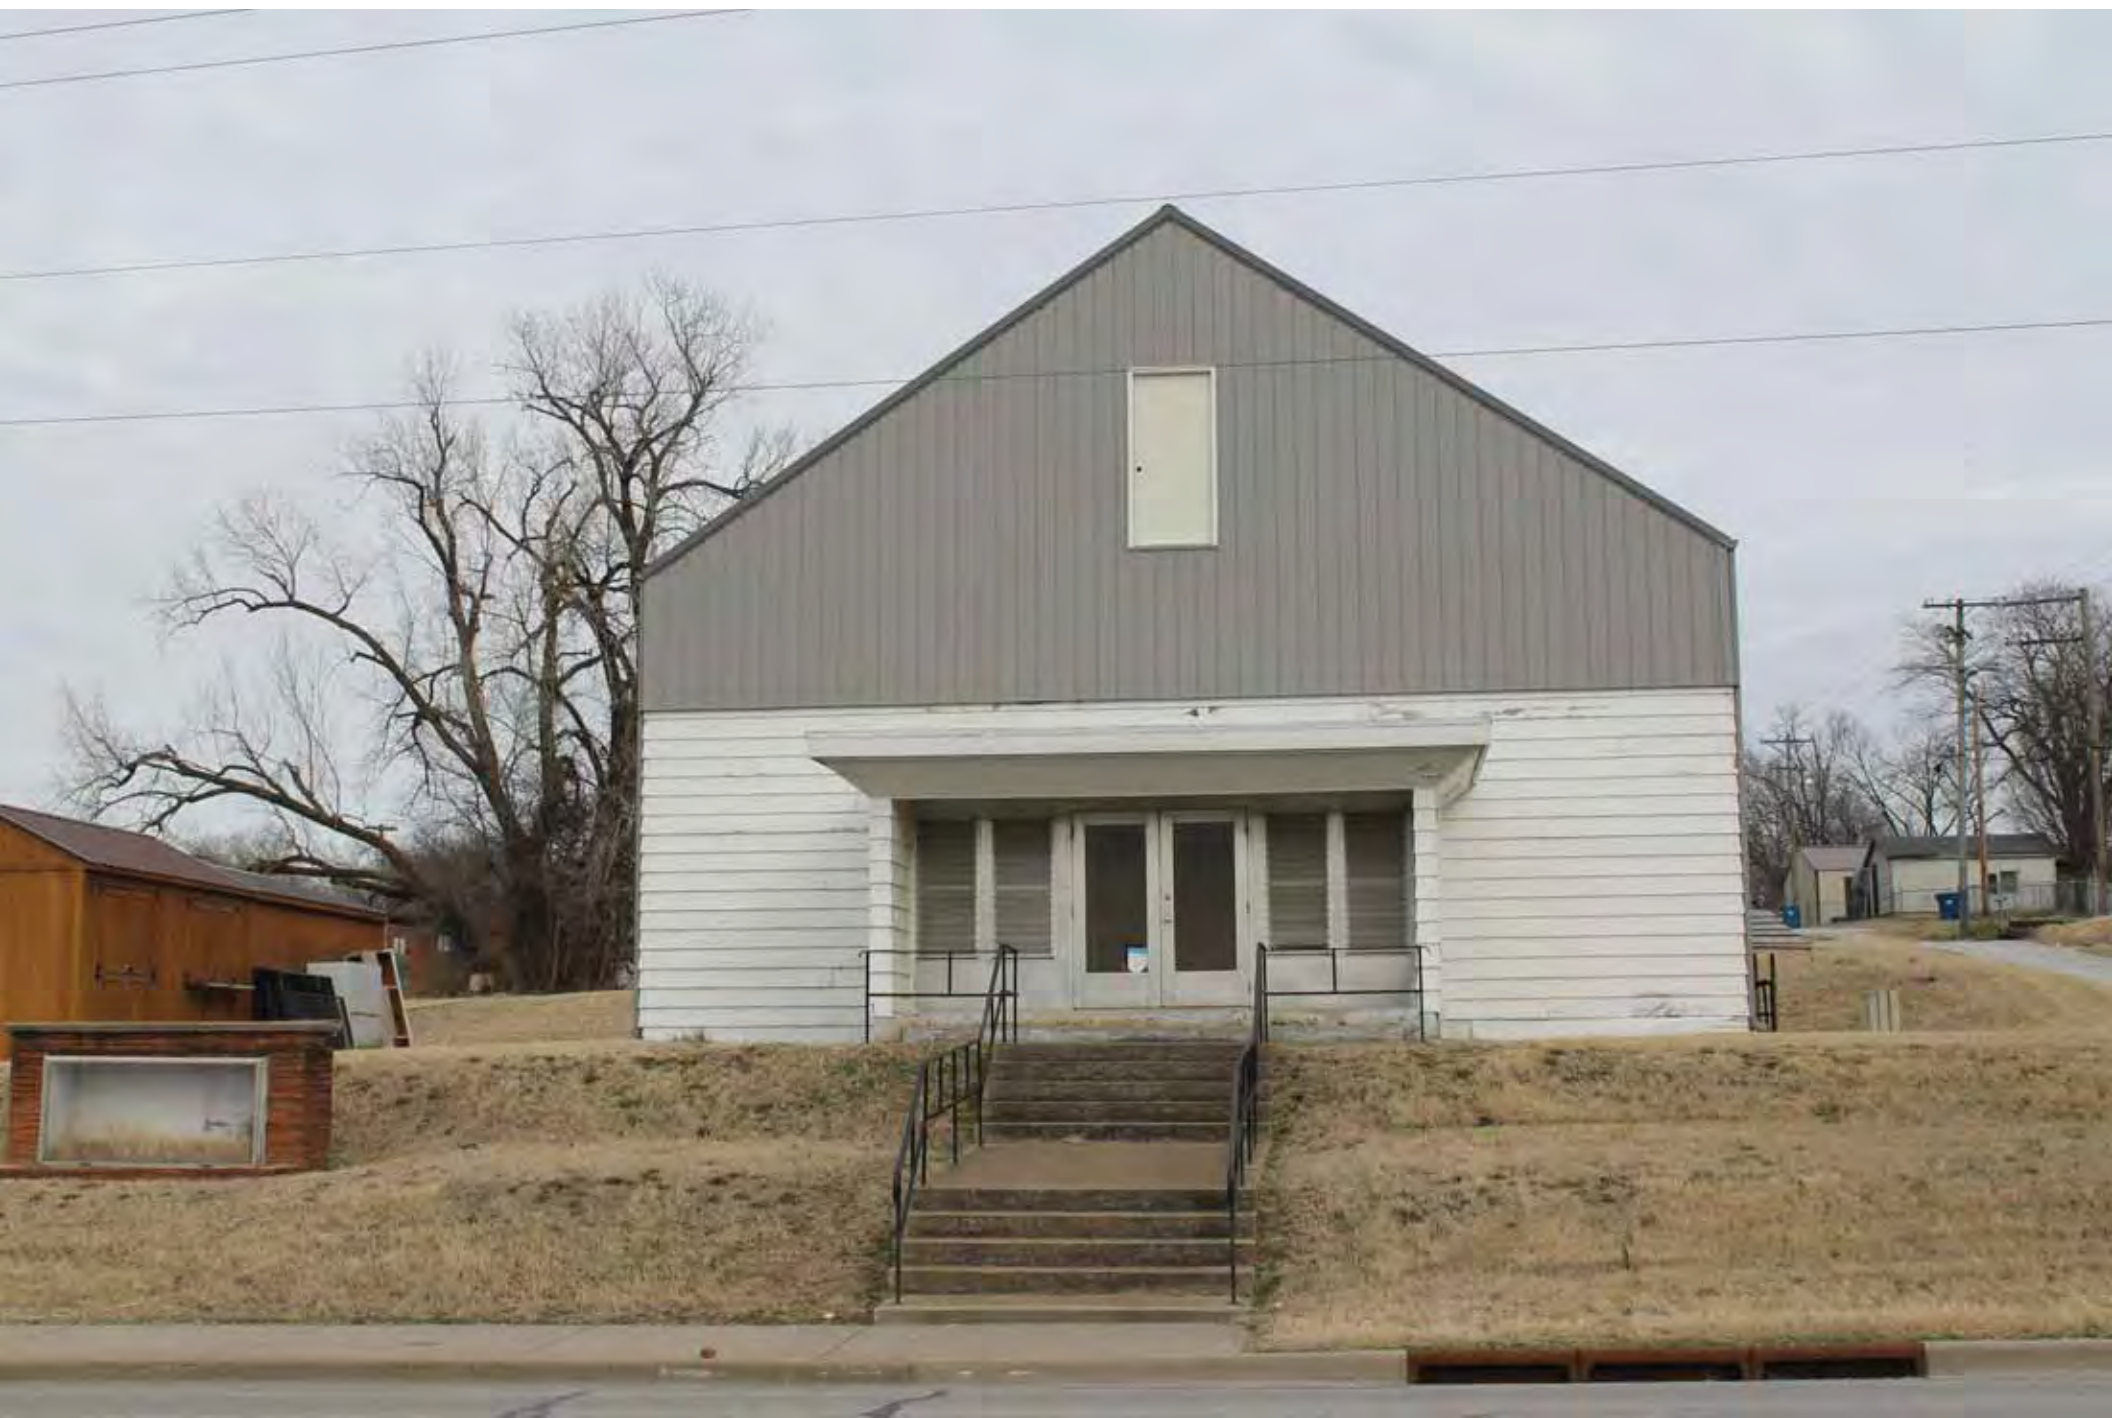
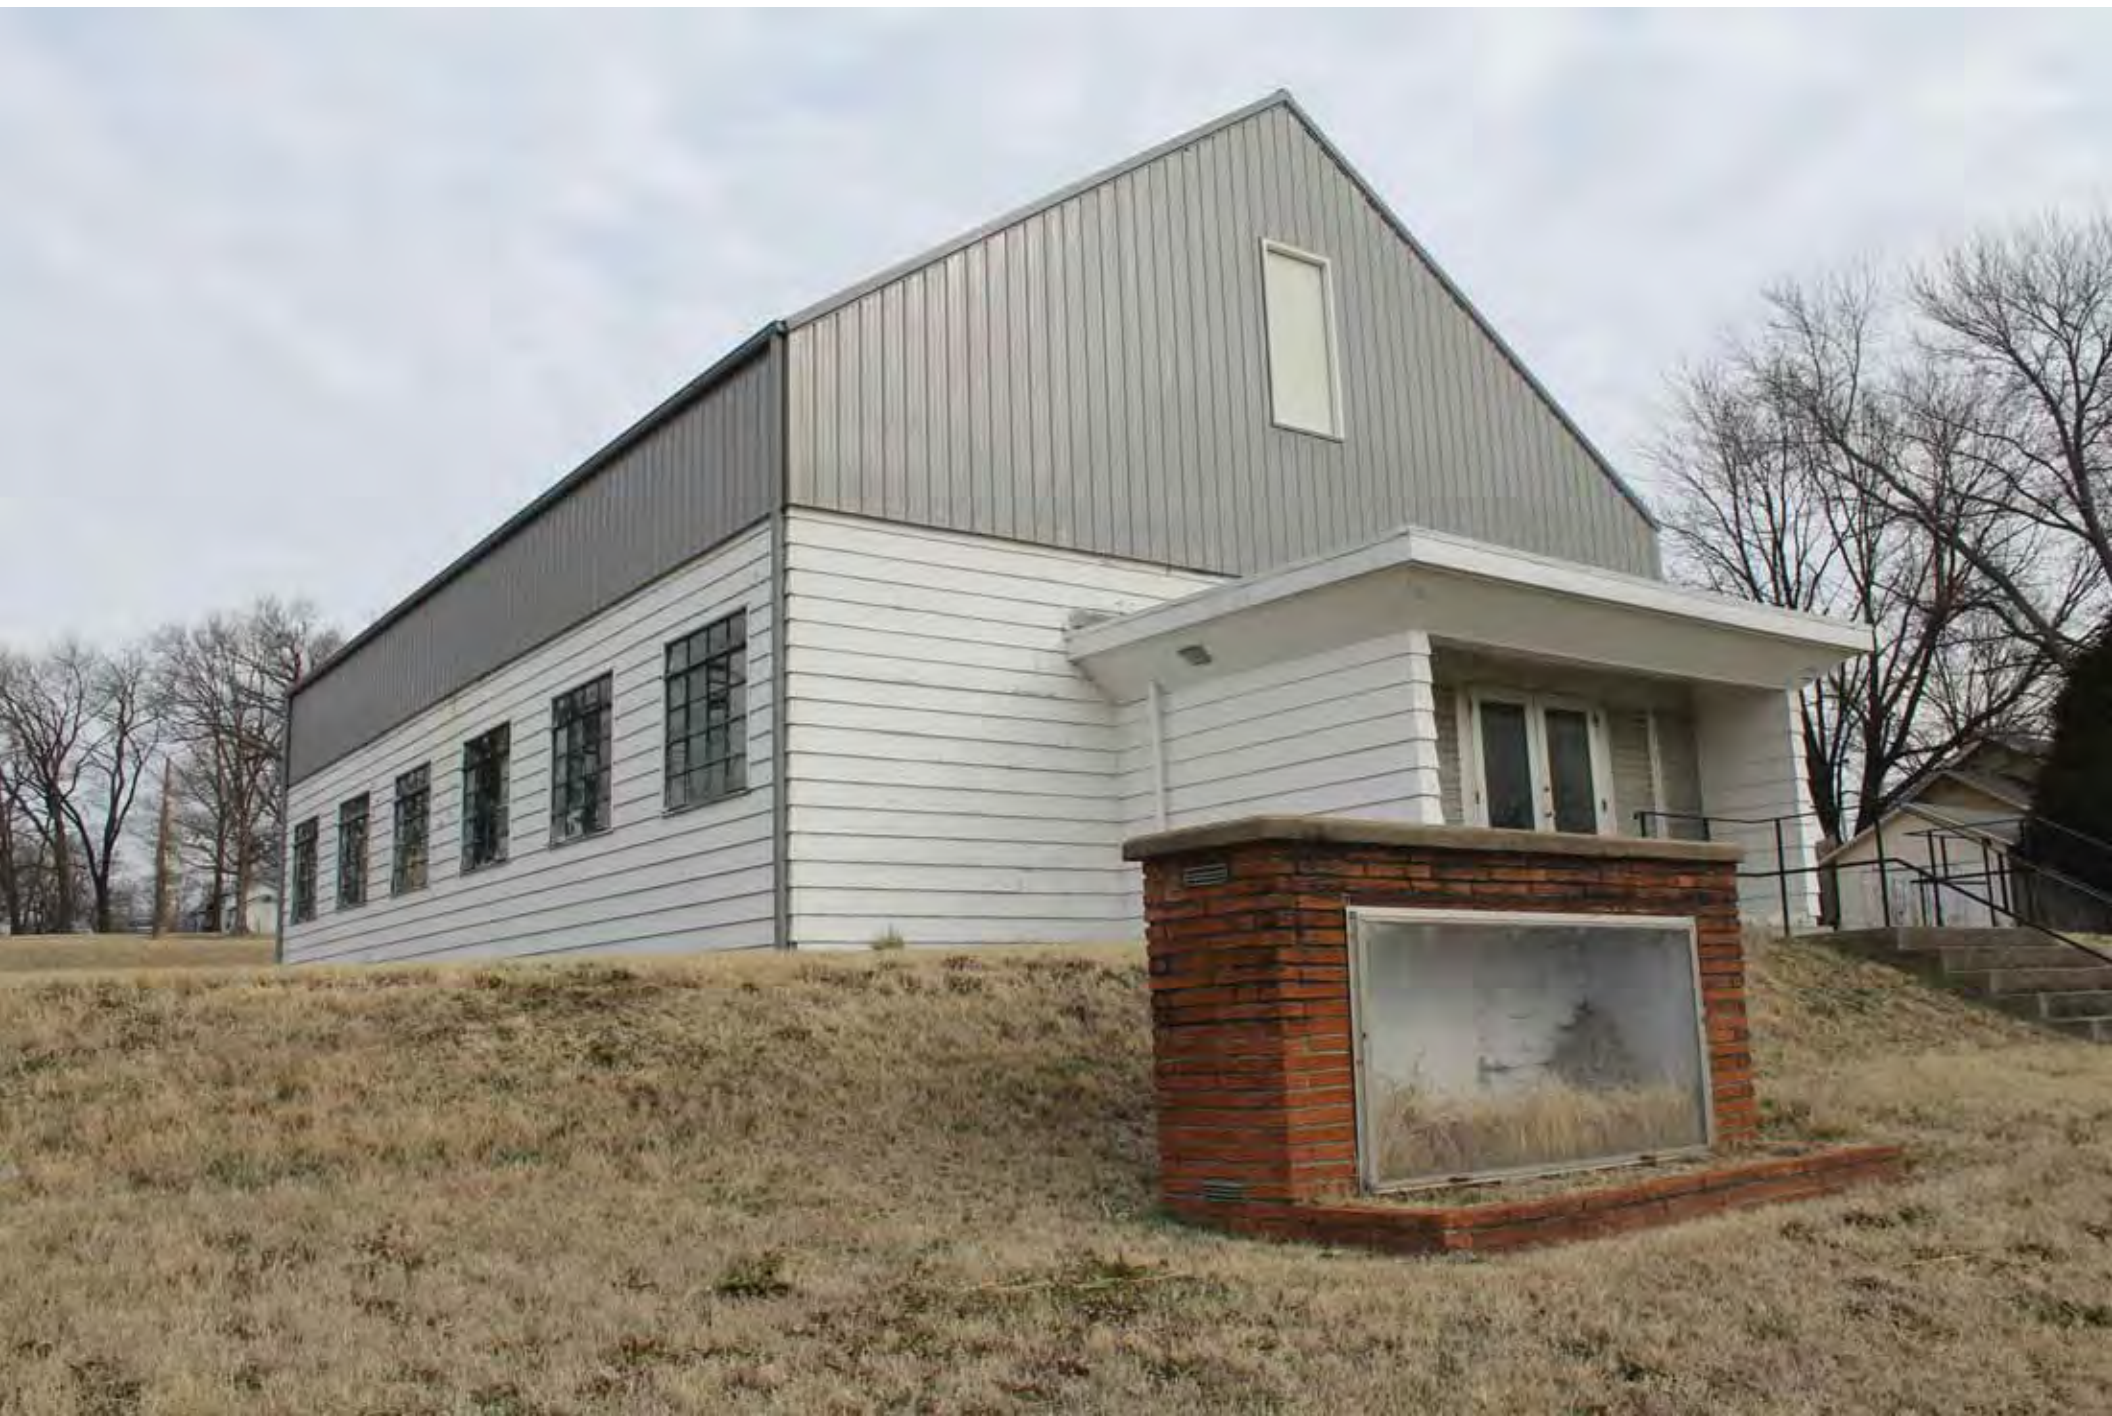
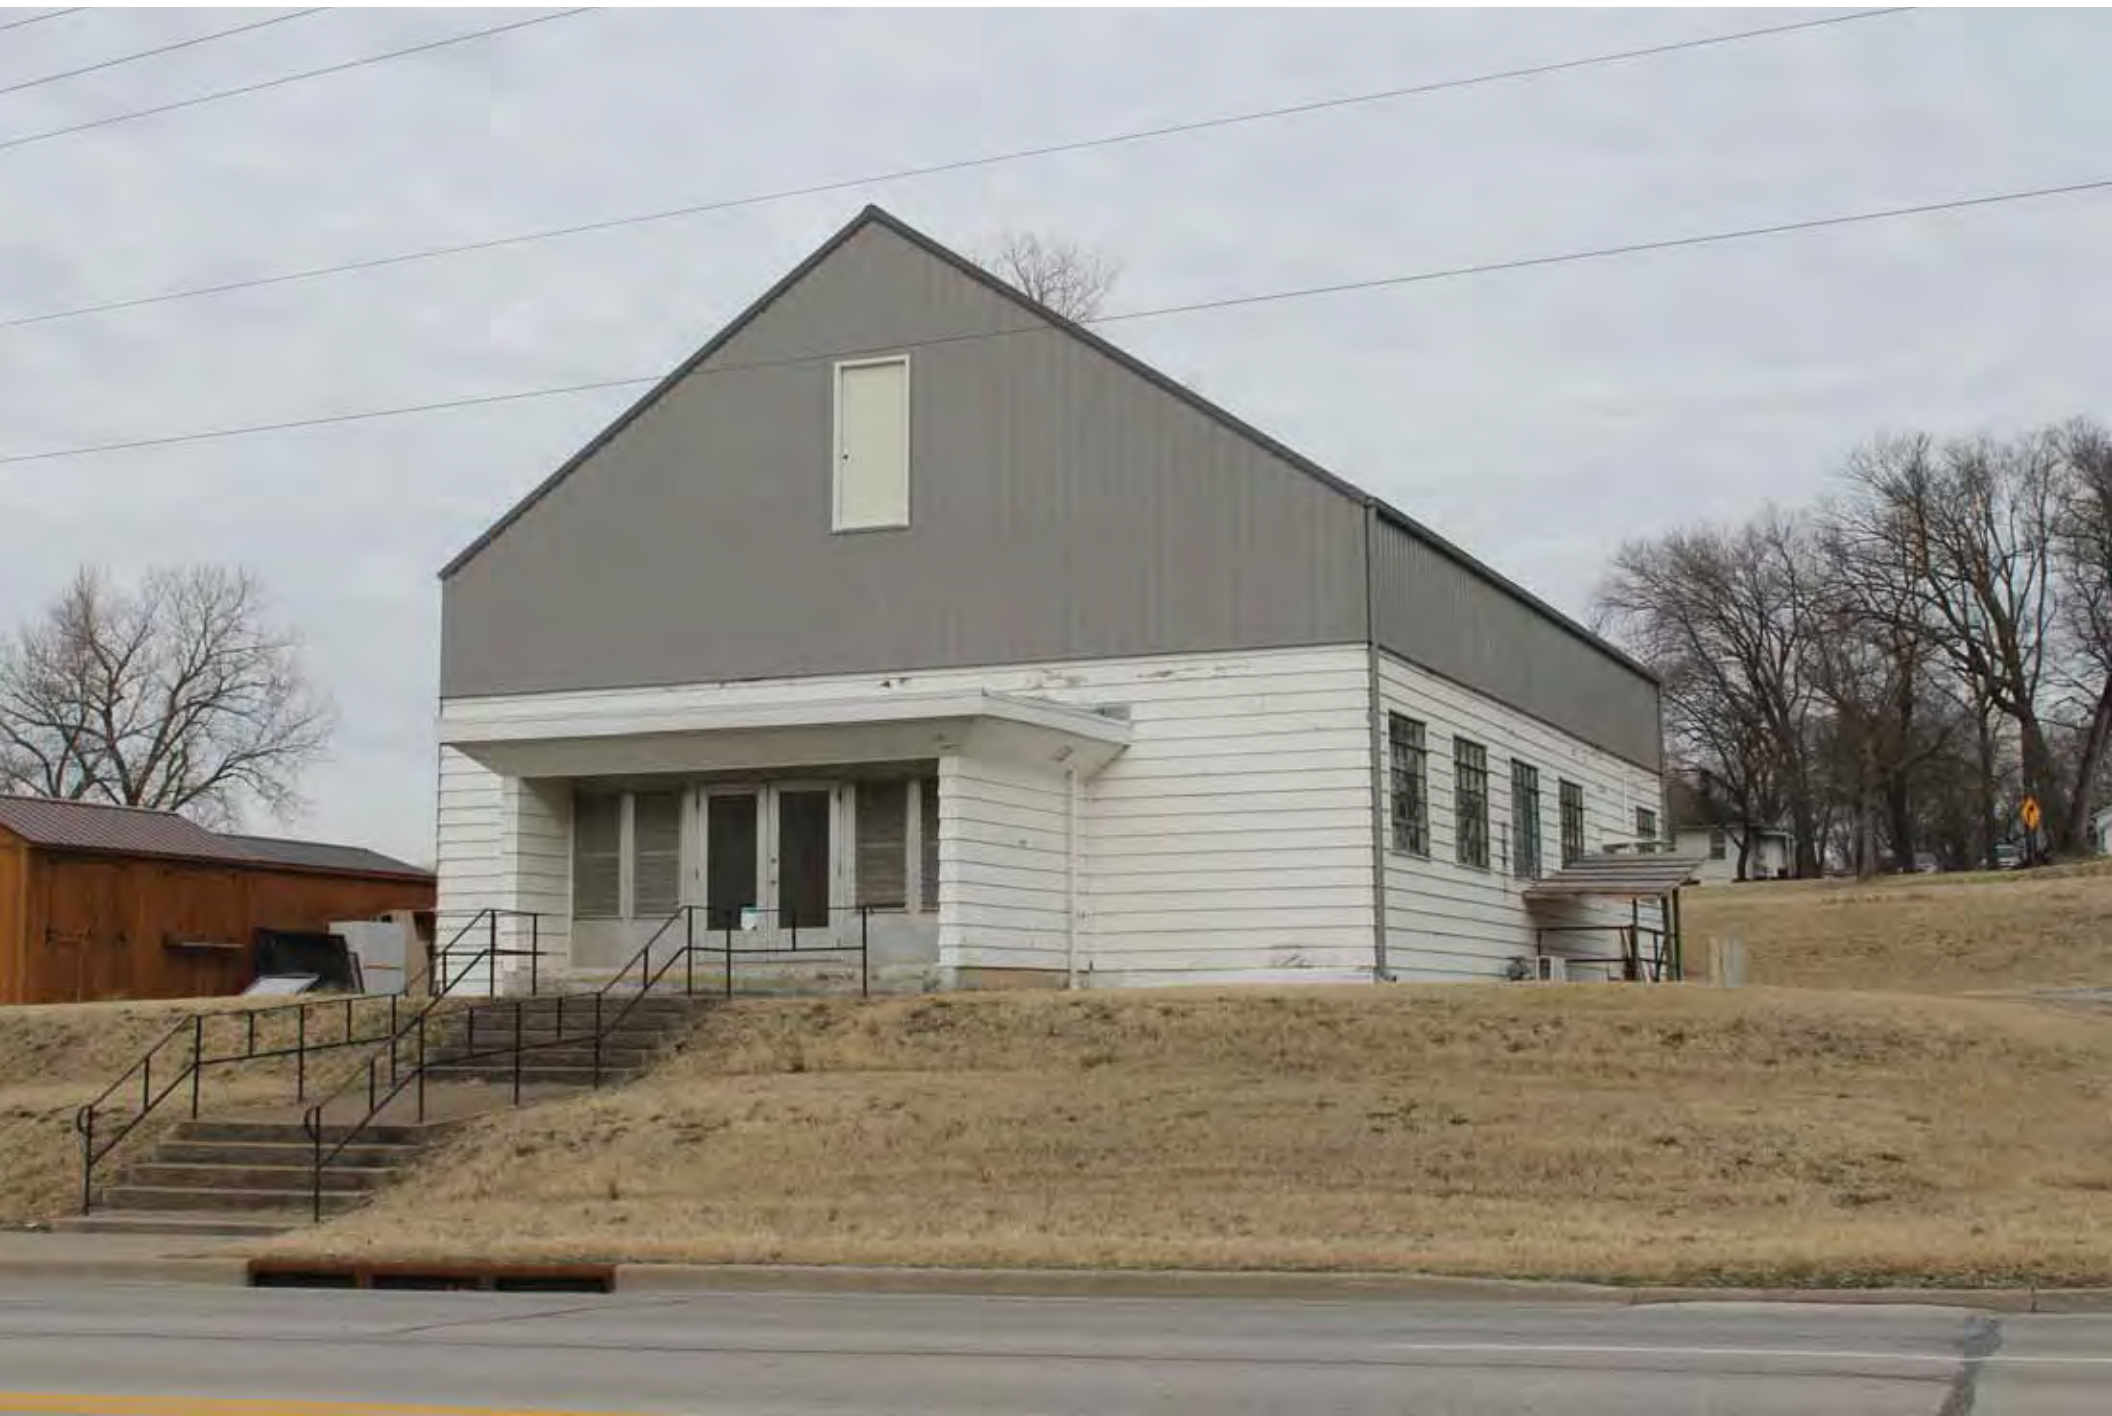
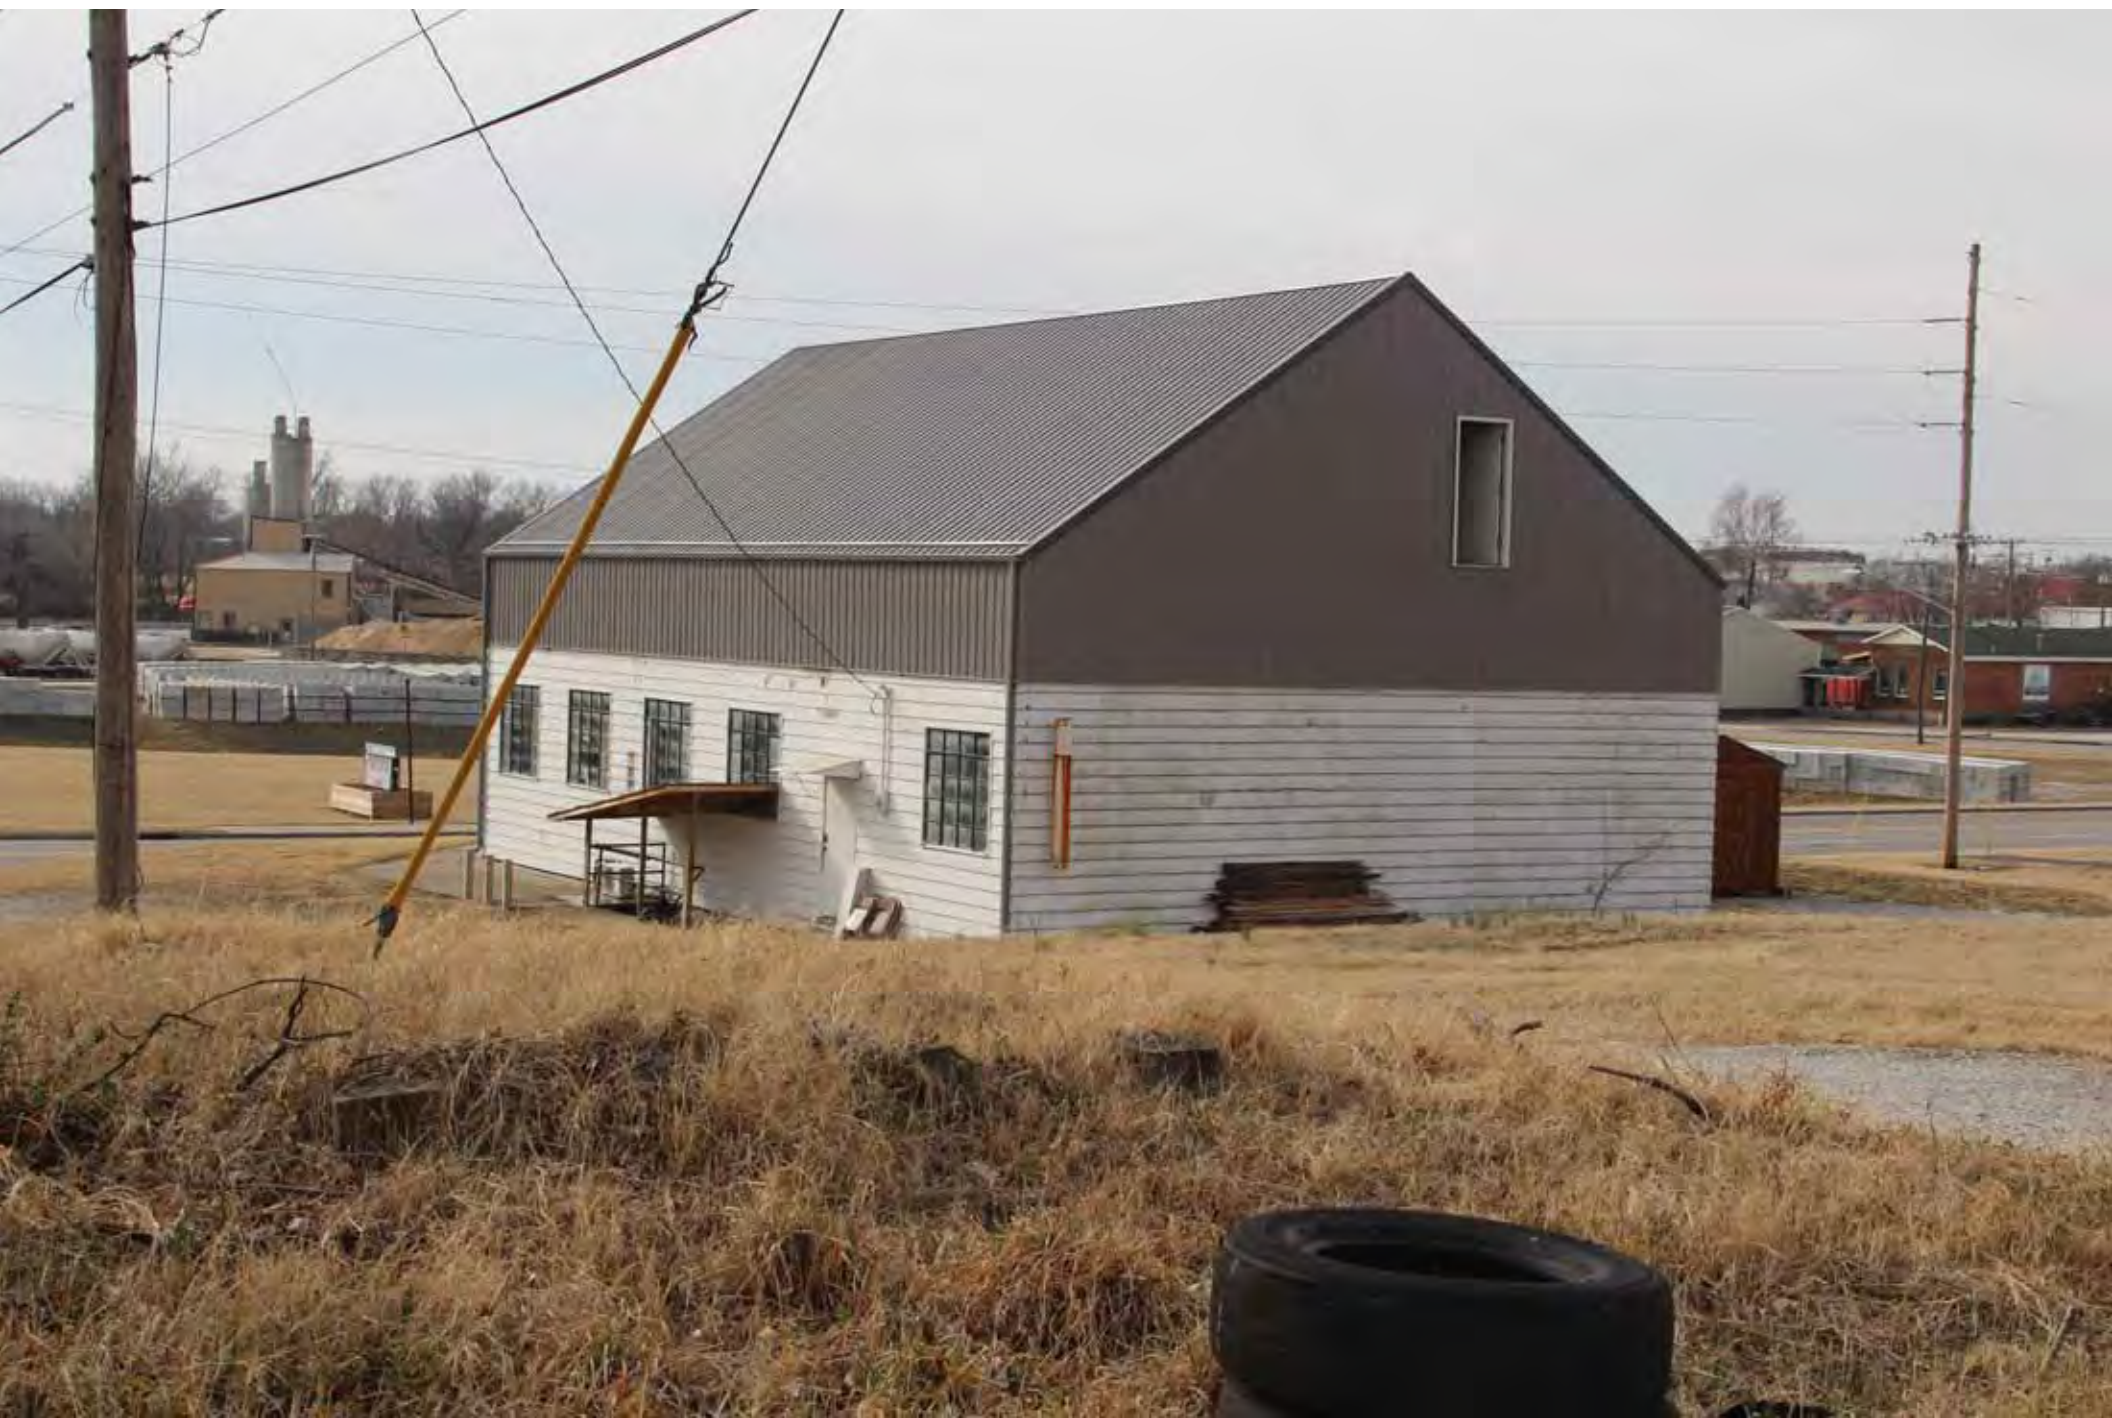
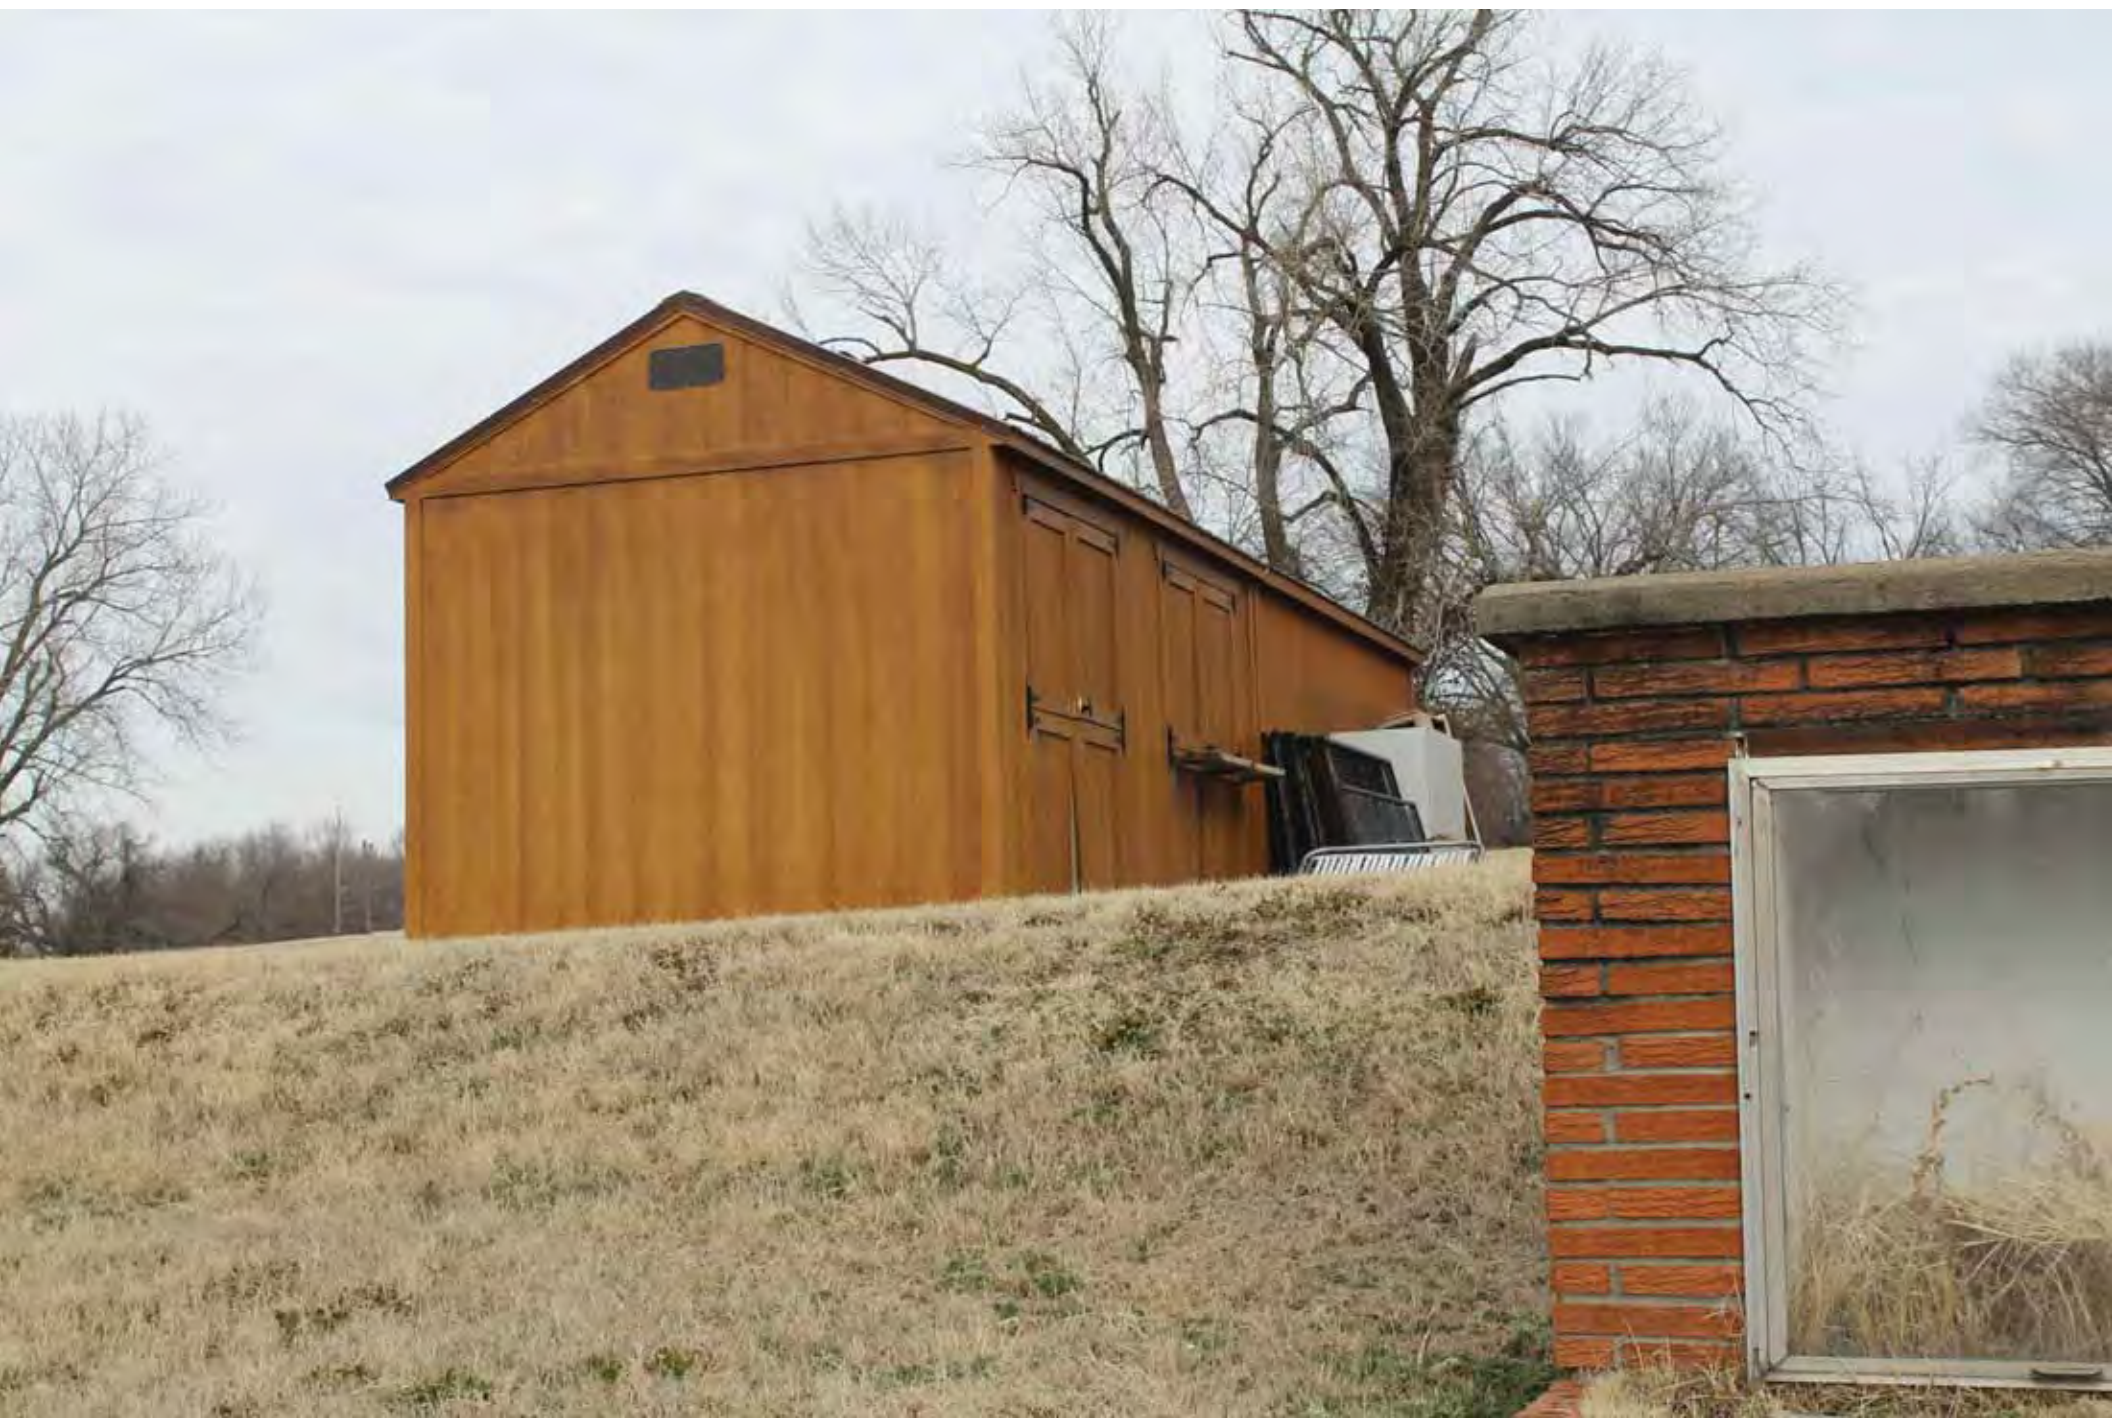
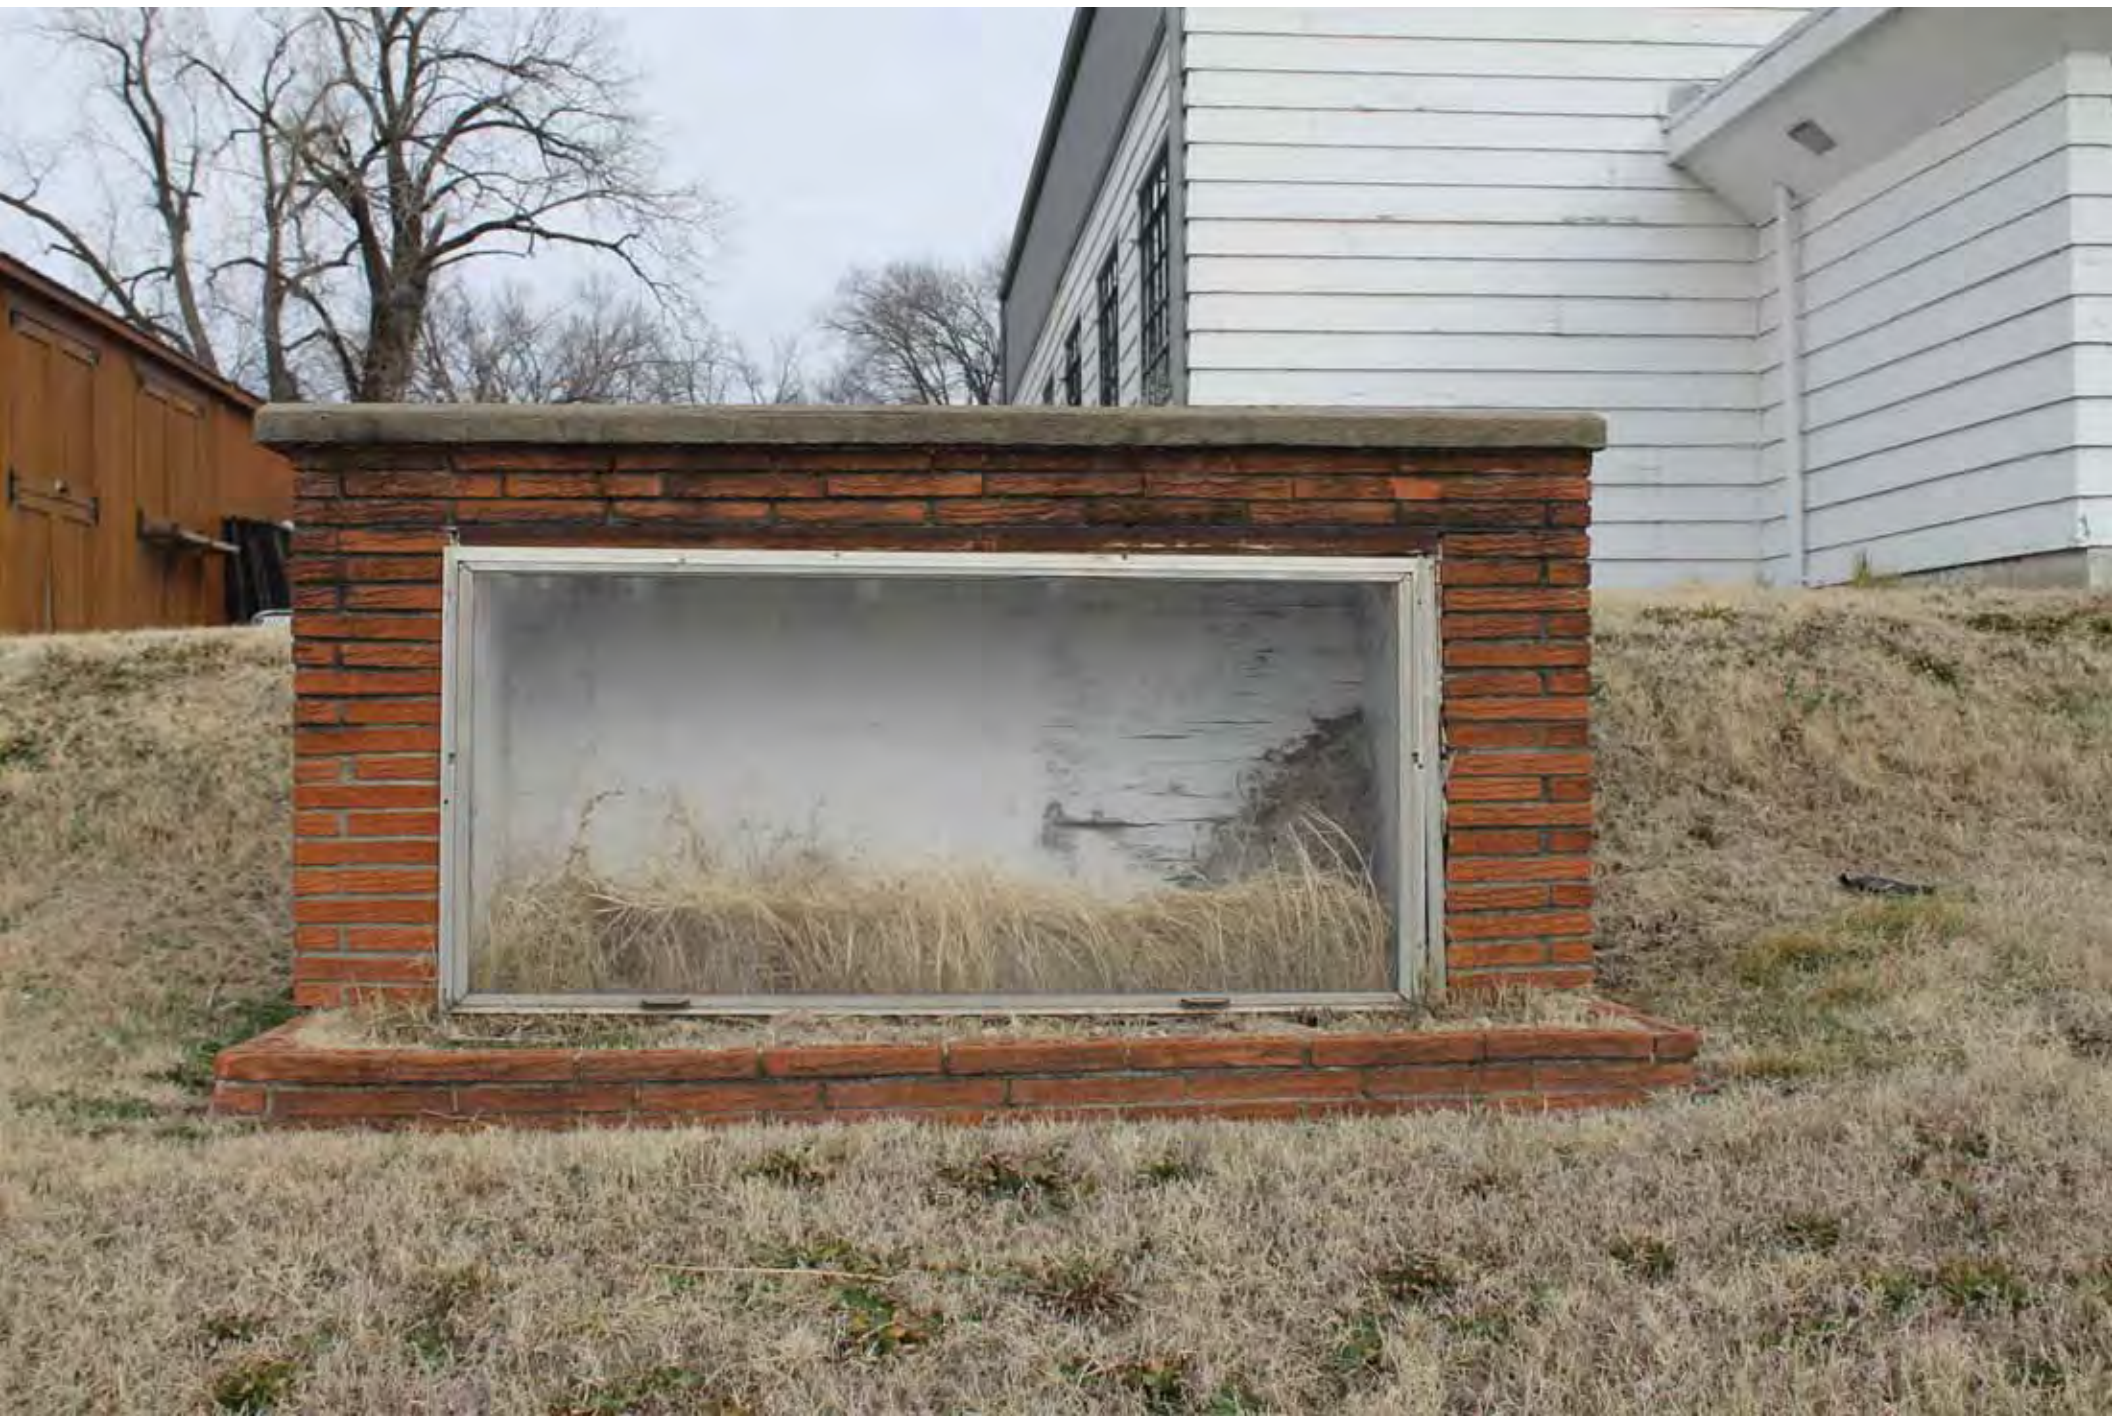
The property at 700 E. 4th Street is a former commercial or warehouse building, which originally had a flat roof. It is frame with wood siding and rectangular in form and plan. In 2018 a large front facing medium-pitched gable roof was added to the building. The building construction has been to convert the structure to a church, although it does not appear to be occupied at this time.

Along the front elevation of the building, facing E. 4th Street is the front entrance, which is approached by concrete steps. The front entrance is symmetrical, with central glass double doors sheltered beneath a flat roof entrance extension with frame sides and a metal overhanging cornice. On the east and west elevations are five original metal casement windows, which each have 20 panes of glass. There is a side entrance to the building on the east elevation. The rear or north elevation is a blind wall, with only vertical wood siding. At the gable addition level is a single door, which is not accessible from the exterior.
