MISSOURI DEPARTMENT OF NATURAL RESOURCES
STATE HISTORIC PRESERVATION OFFICE, P.O. Box 176, Jefferson City, MO 65102
ARCHITECTURAL/HISTORIC INVENTORY FORM

1. Survey No. JP-AS-007-001		2. Survey name: East Town (Original Joplin) Historic Survey Phase 2	
3. County: JASPER		4. Address (Street No.) 618	Street (name) E. 2 nd Street
5. City: Joplin	Vicinity: <input type="checkbox"/>	6. Geographical Reference:	7. Township/Range/Section: T: R: S:
8. Historic name (if known):		9. Present/other name (if known):	
10. Ownership: <input checked="" type="checkbox"/> Private <input type="checkbox"/> Public		11a. Historic use (if known): Domestic: Single Dwelling	11b. Current use: Domestic: Single Dwelling

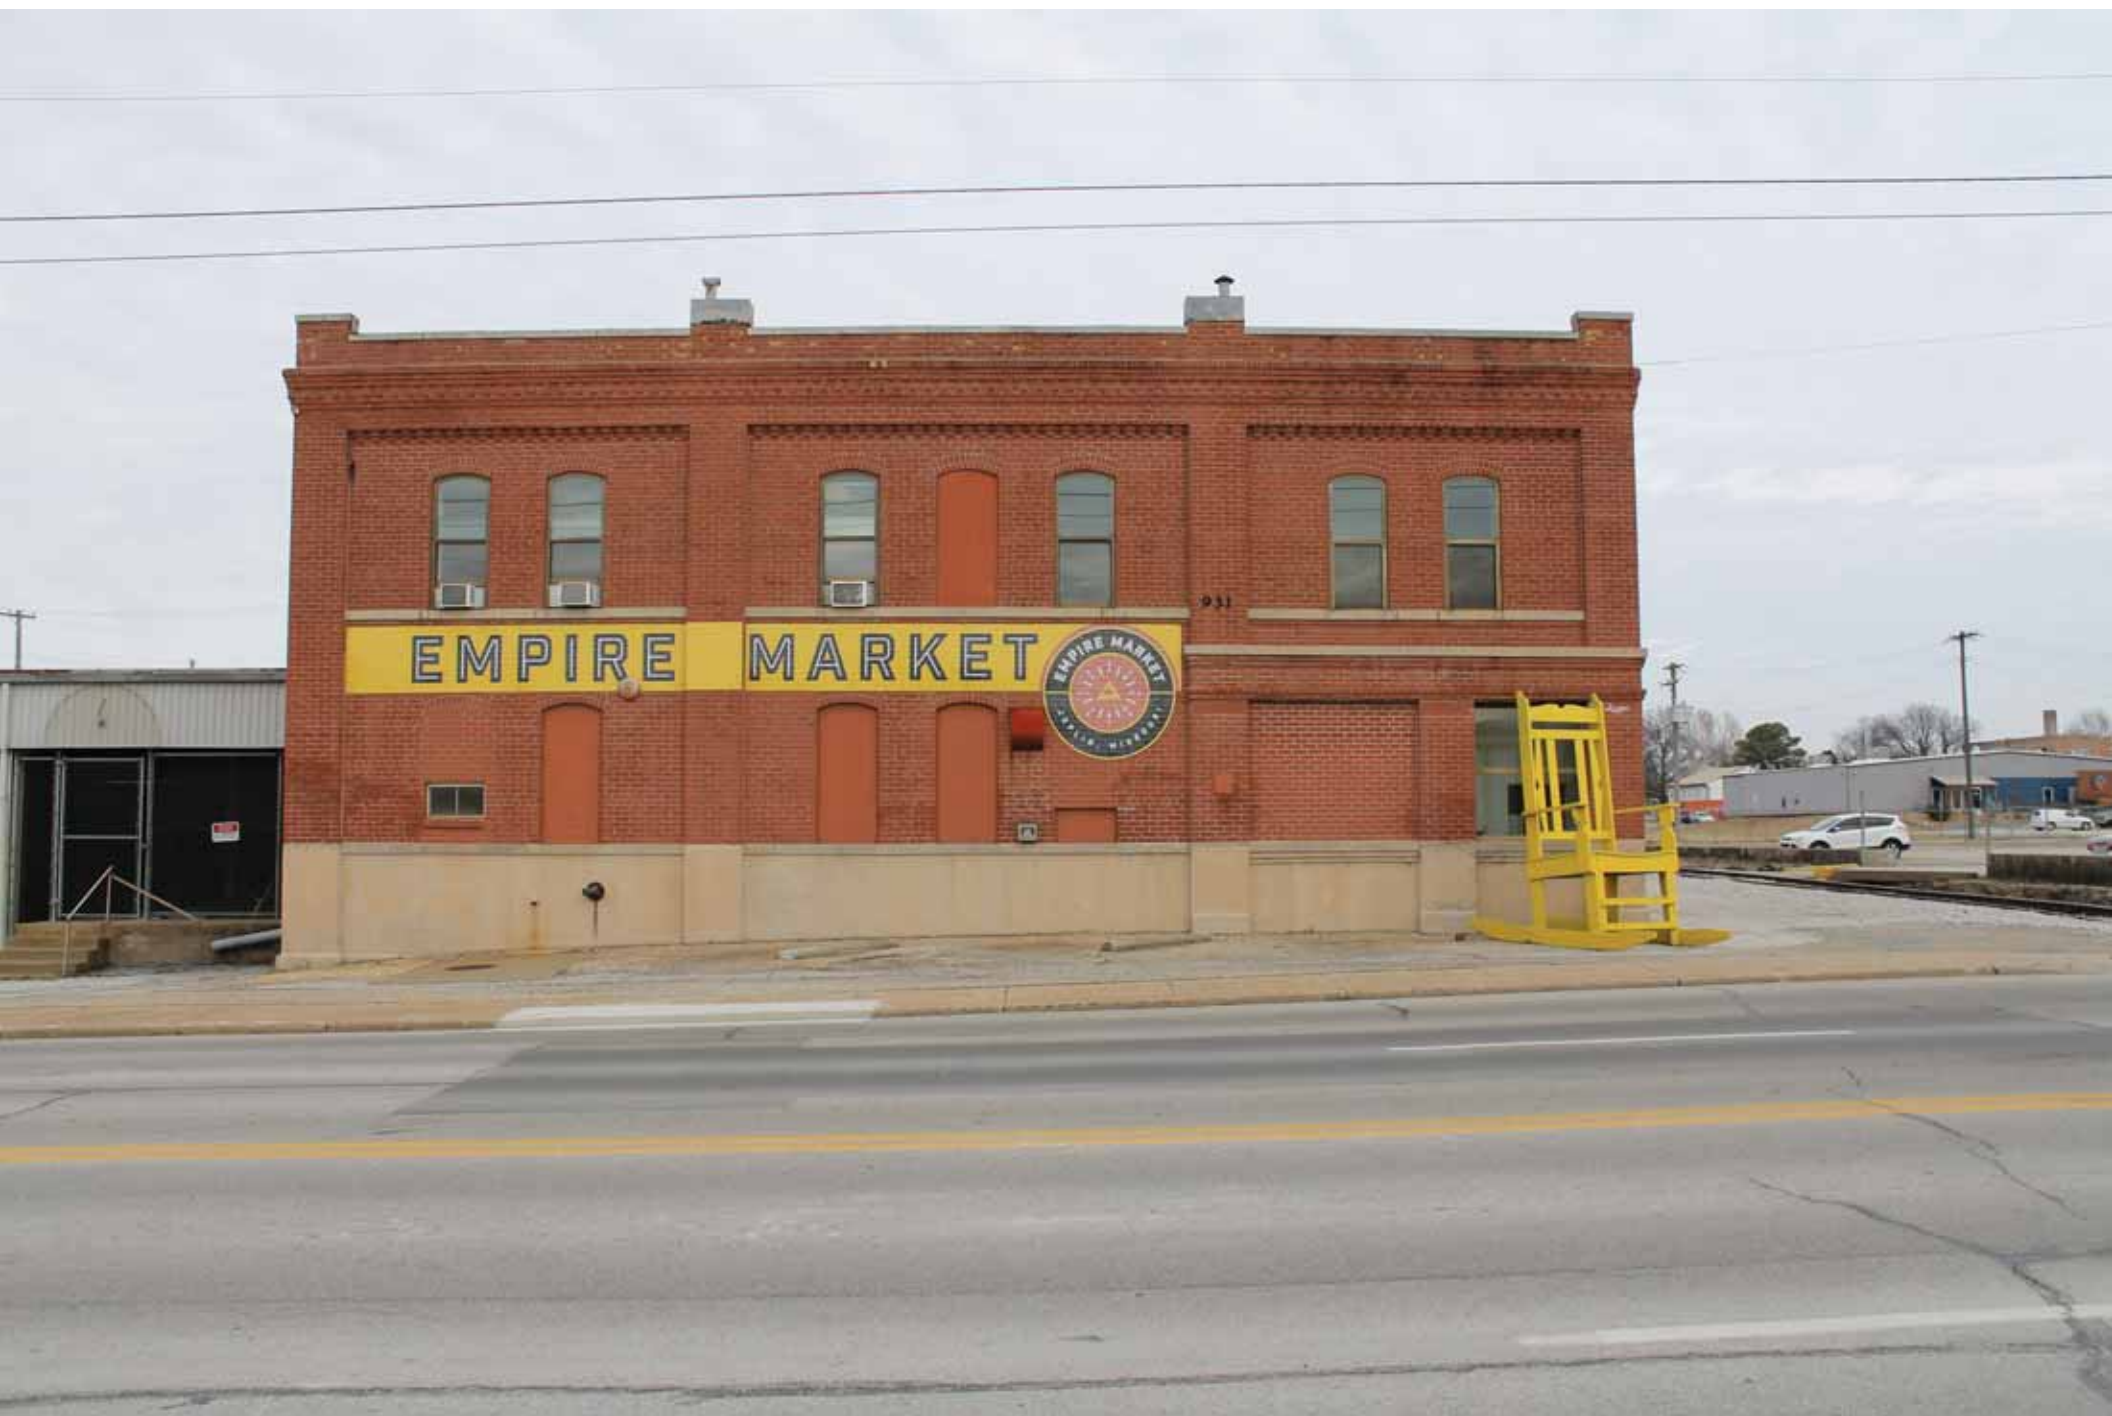
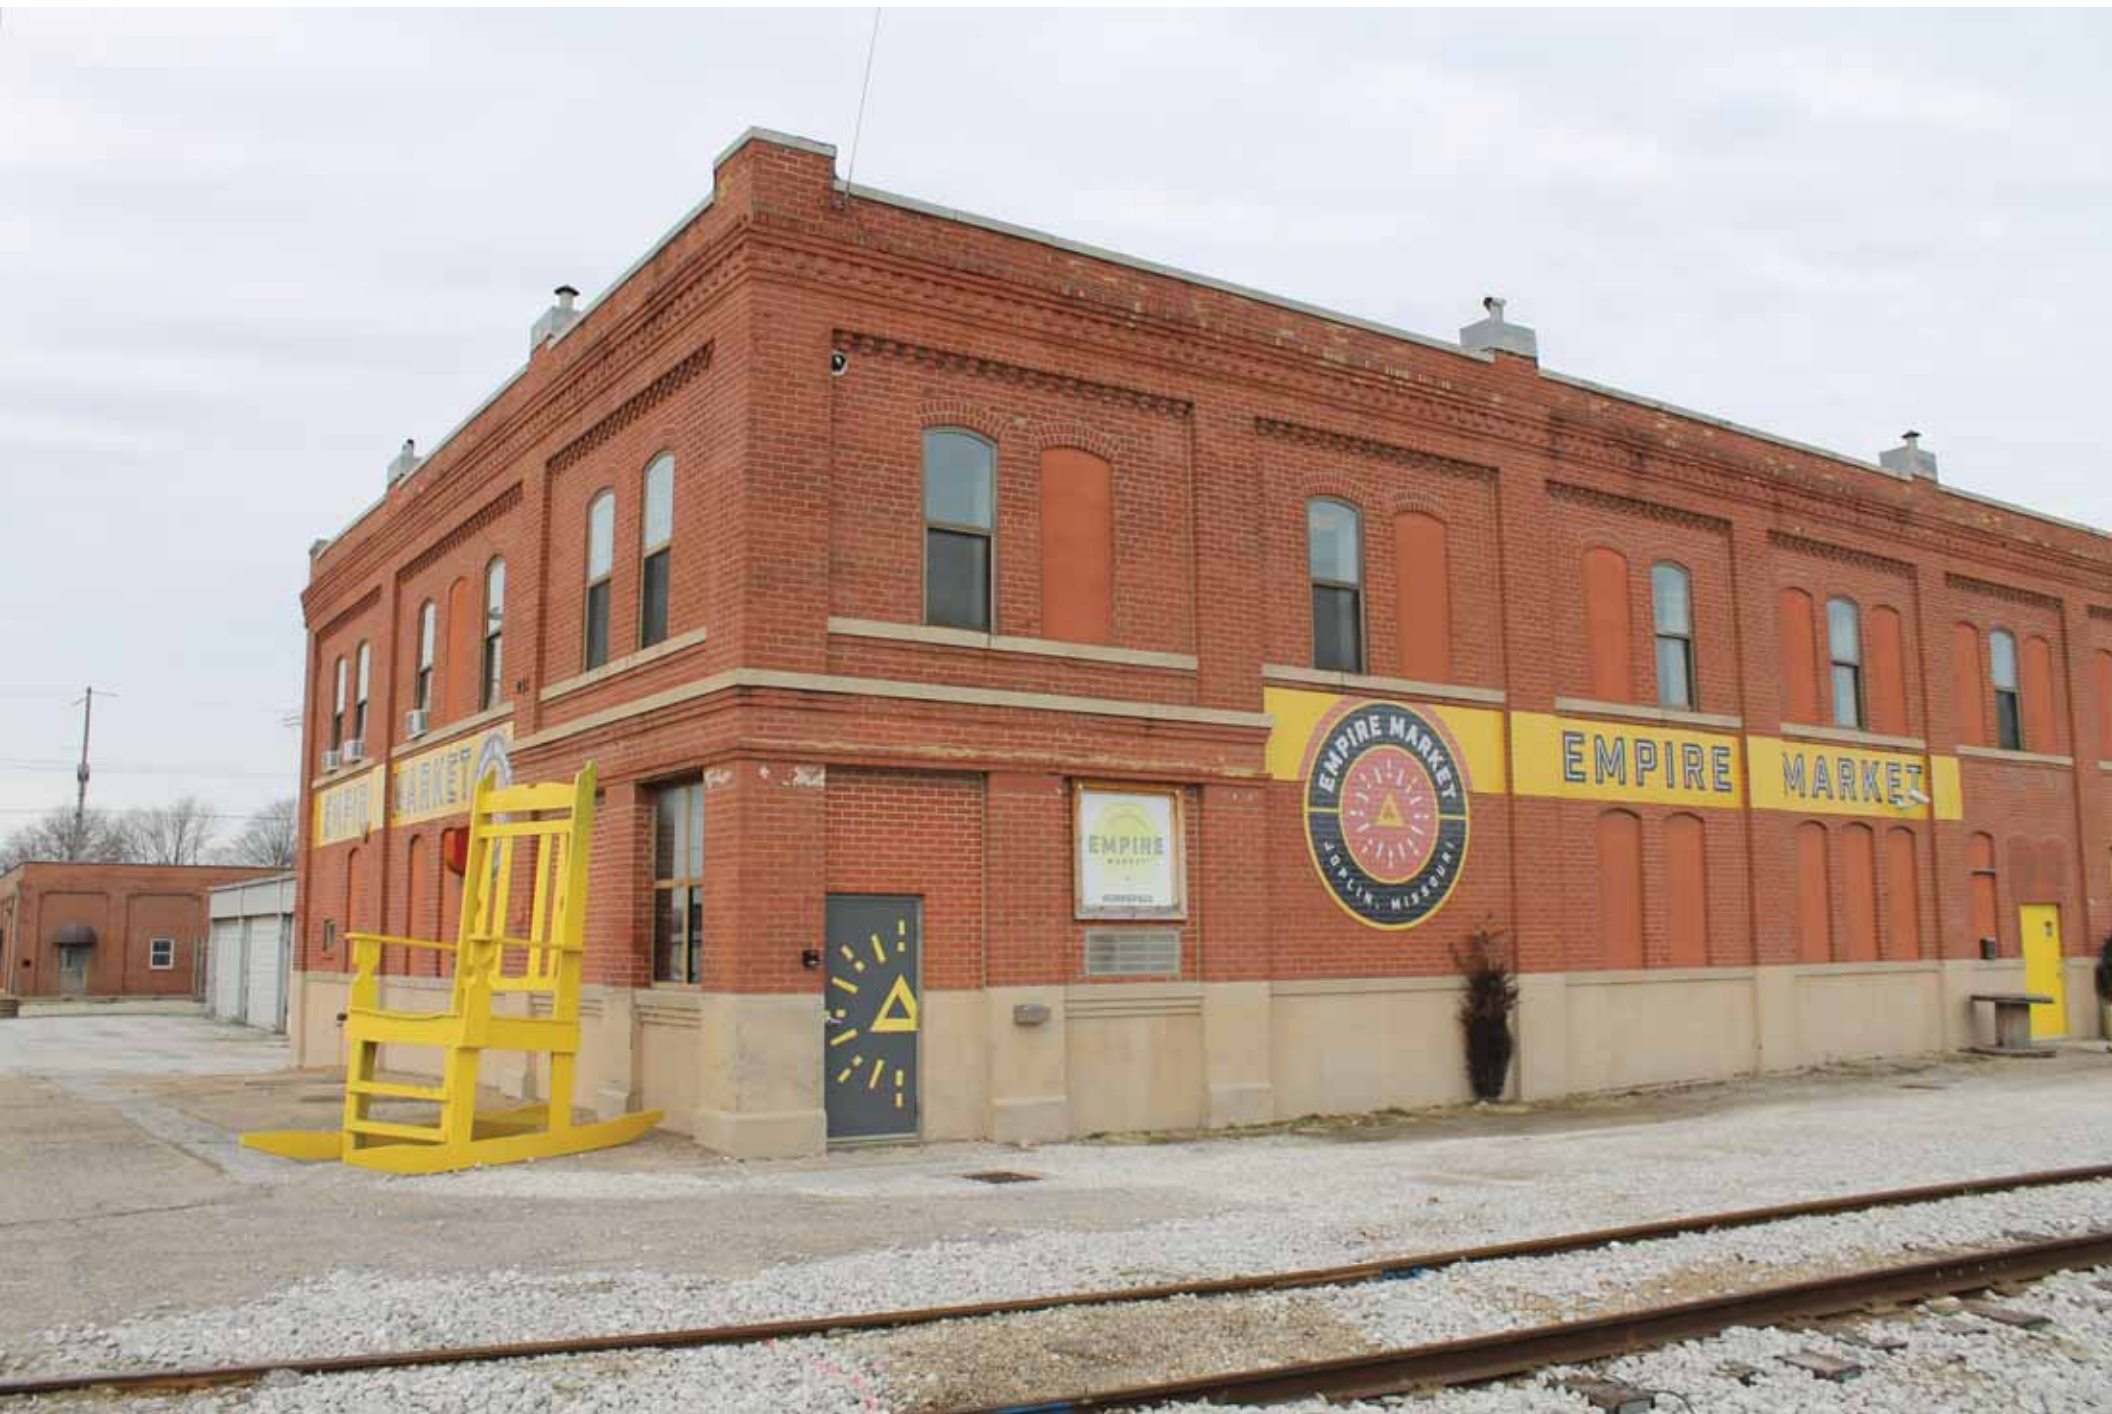
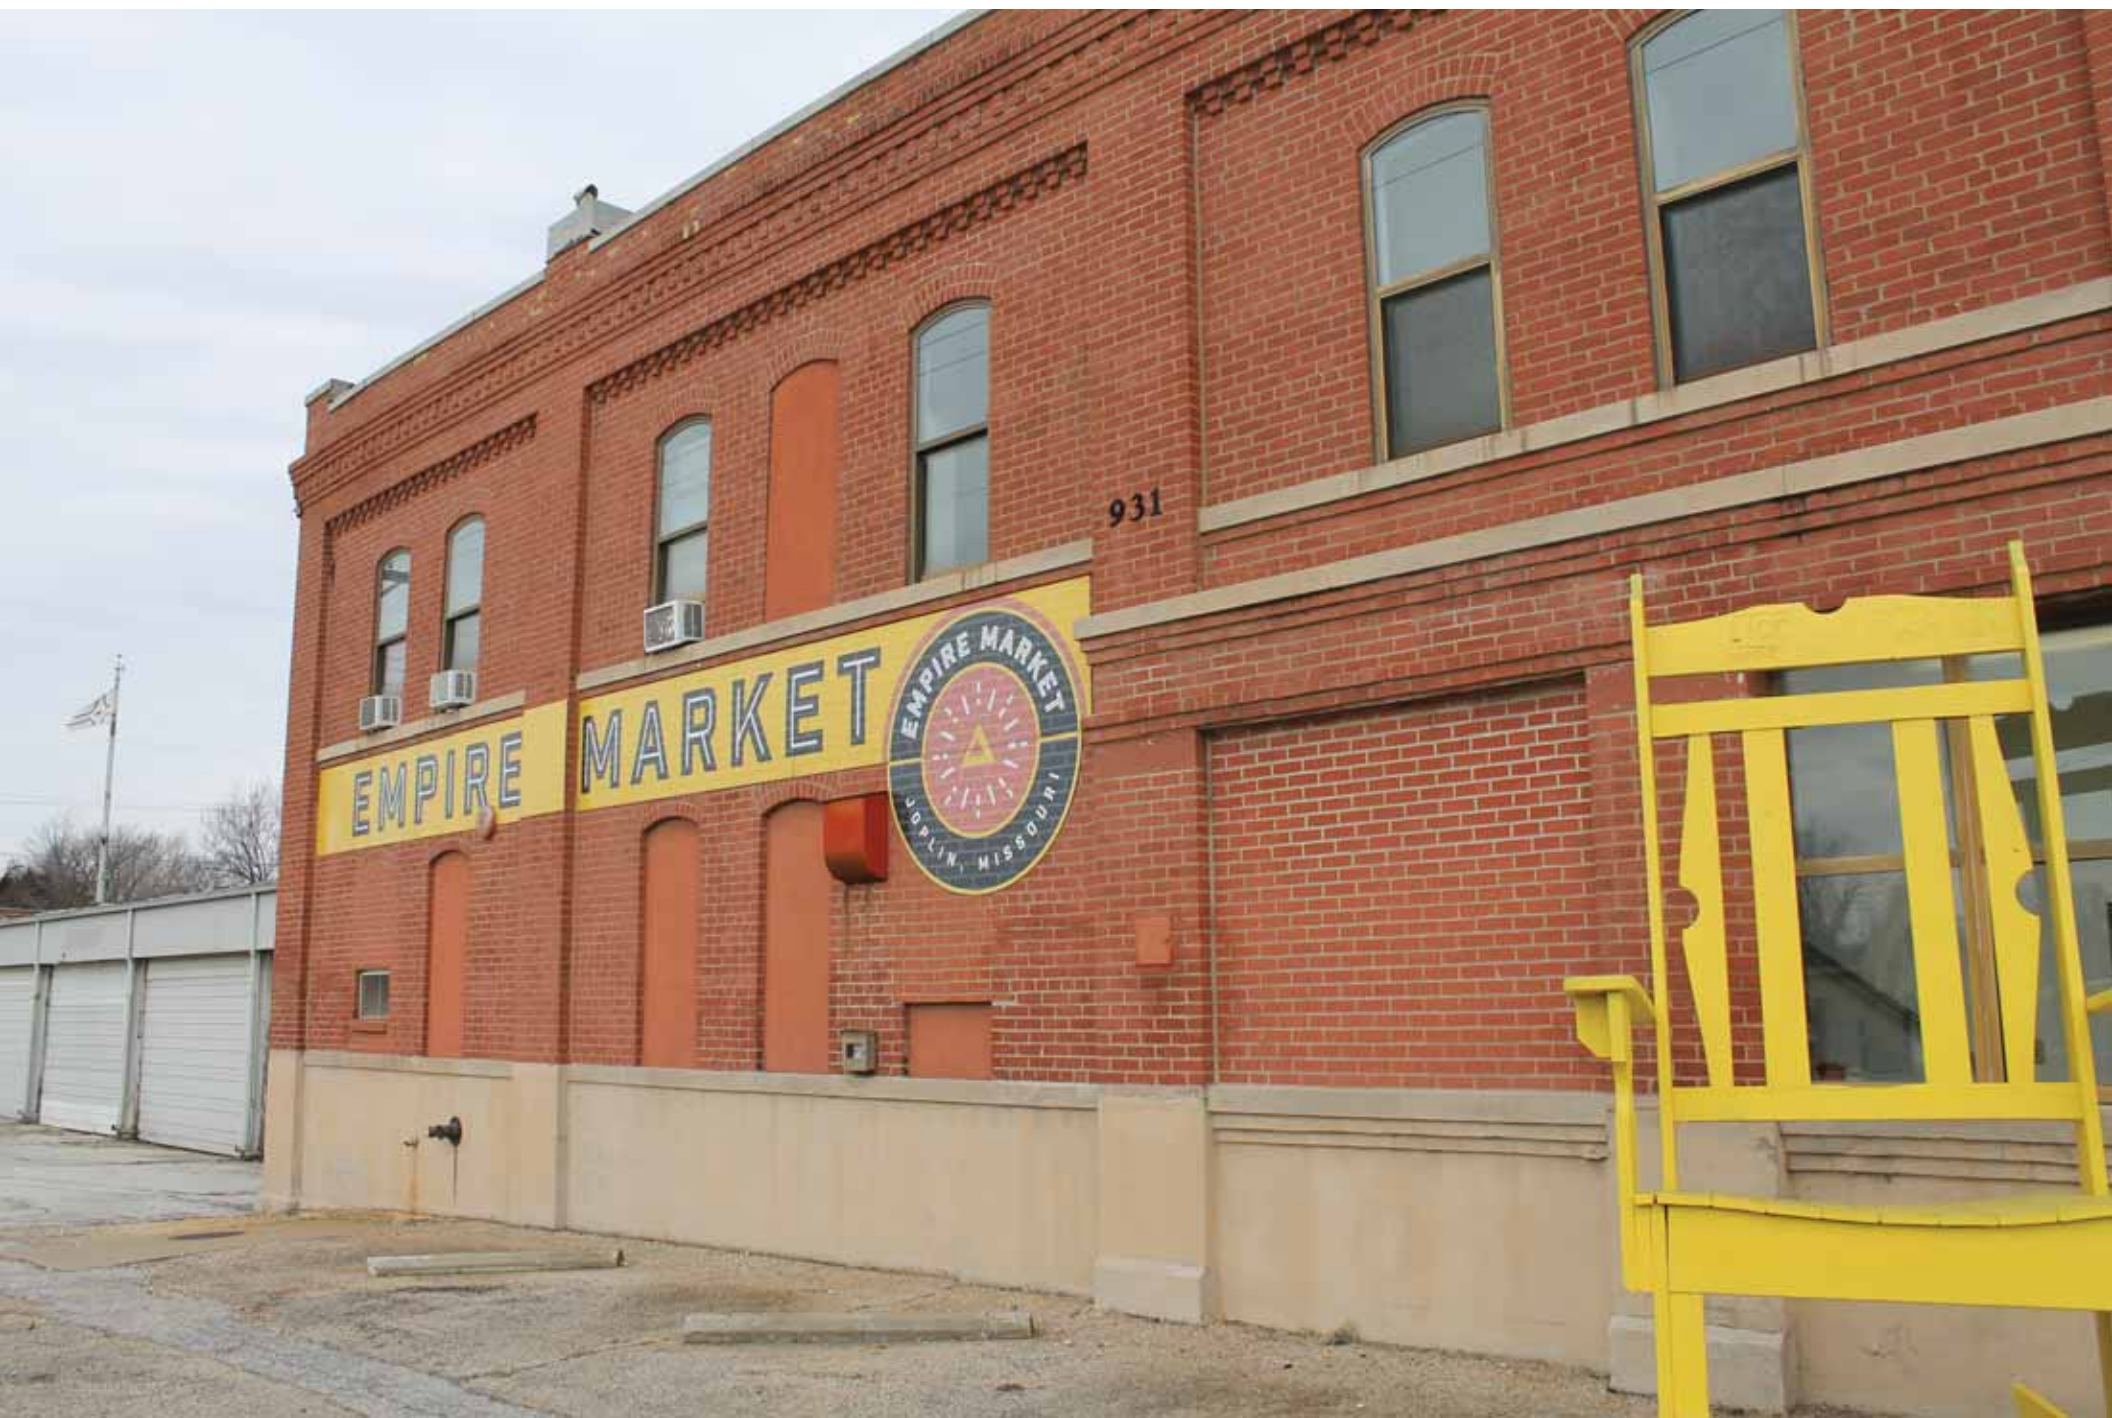
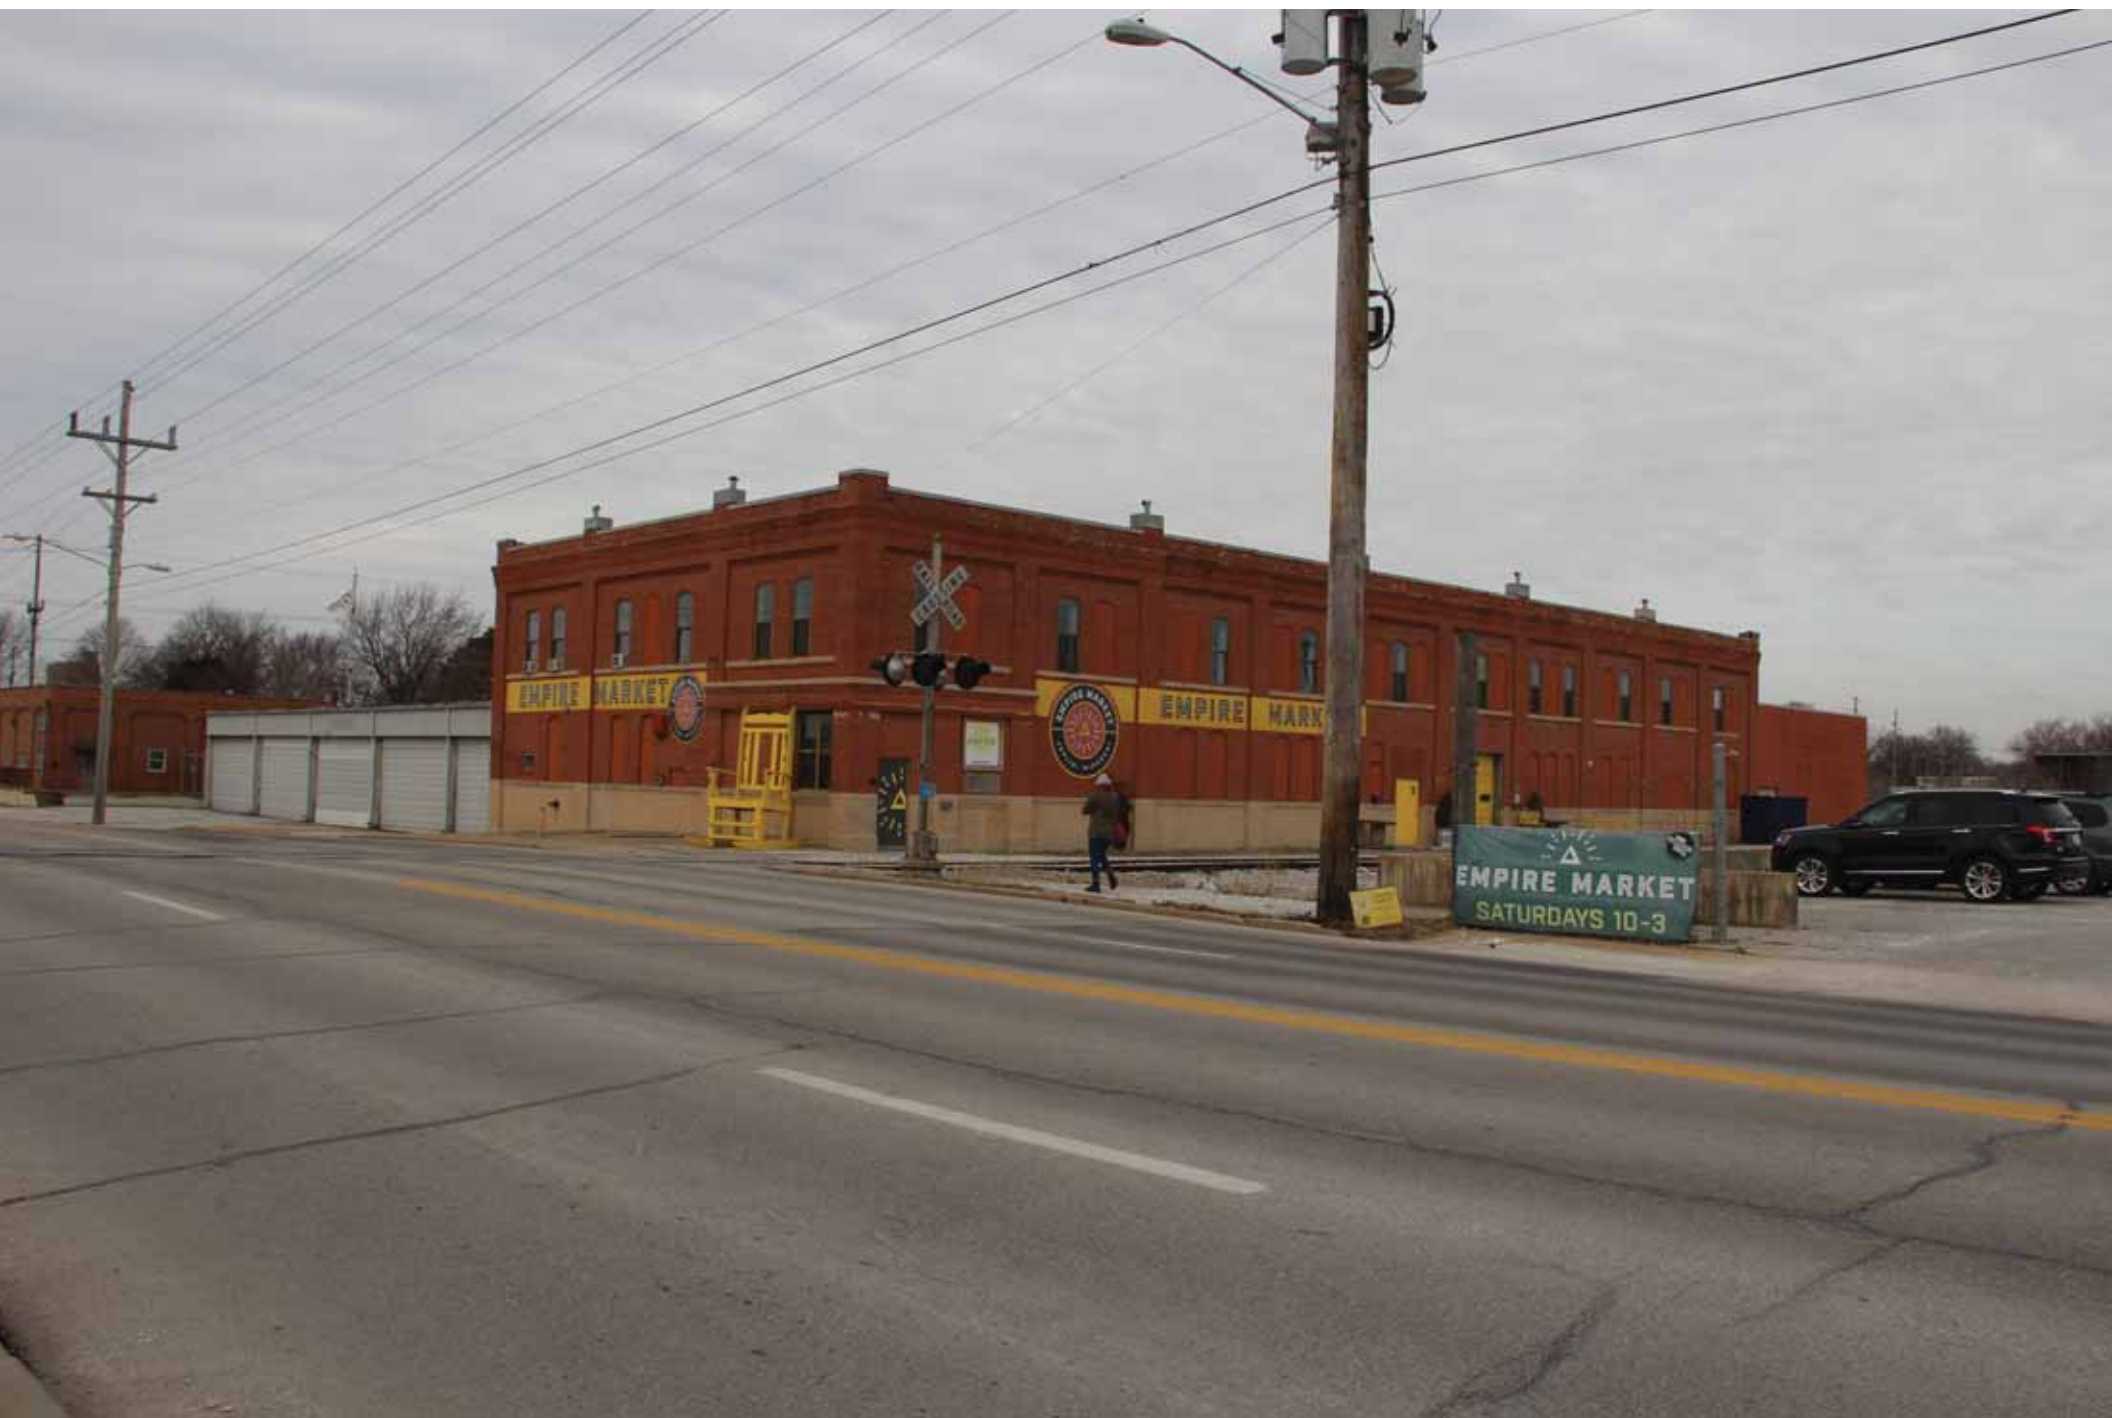
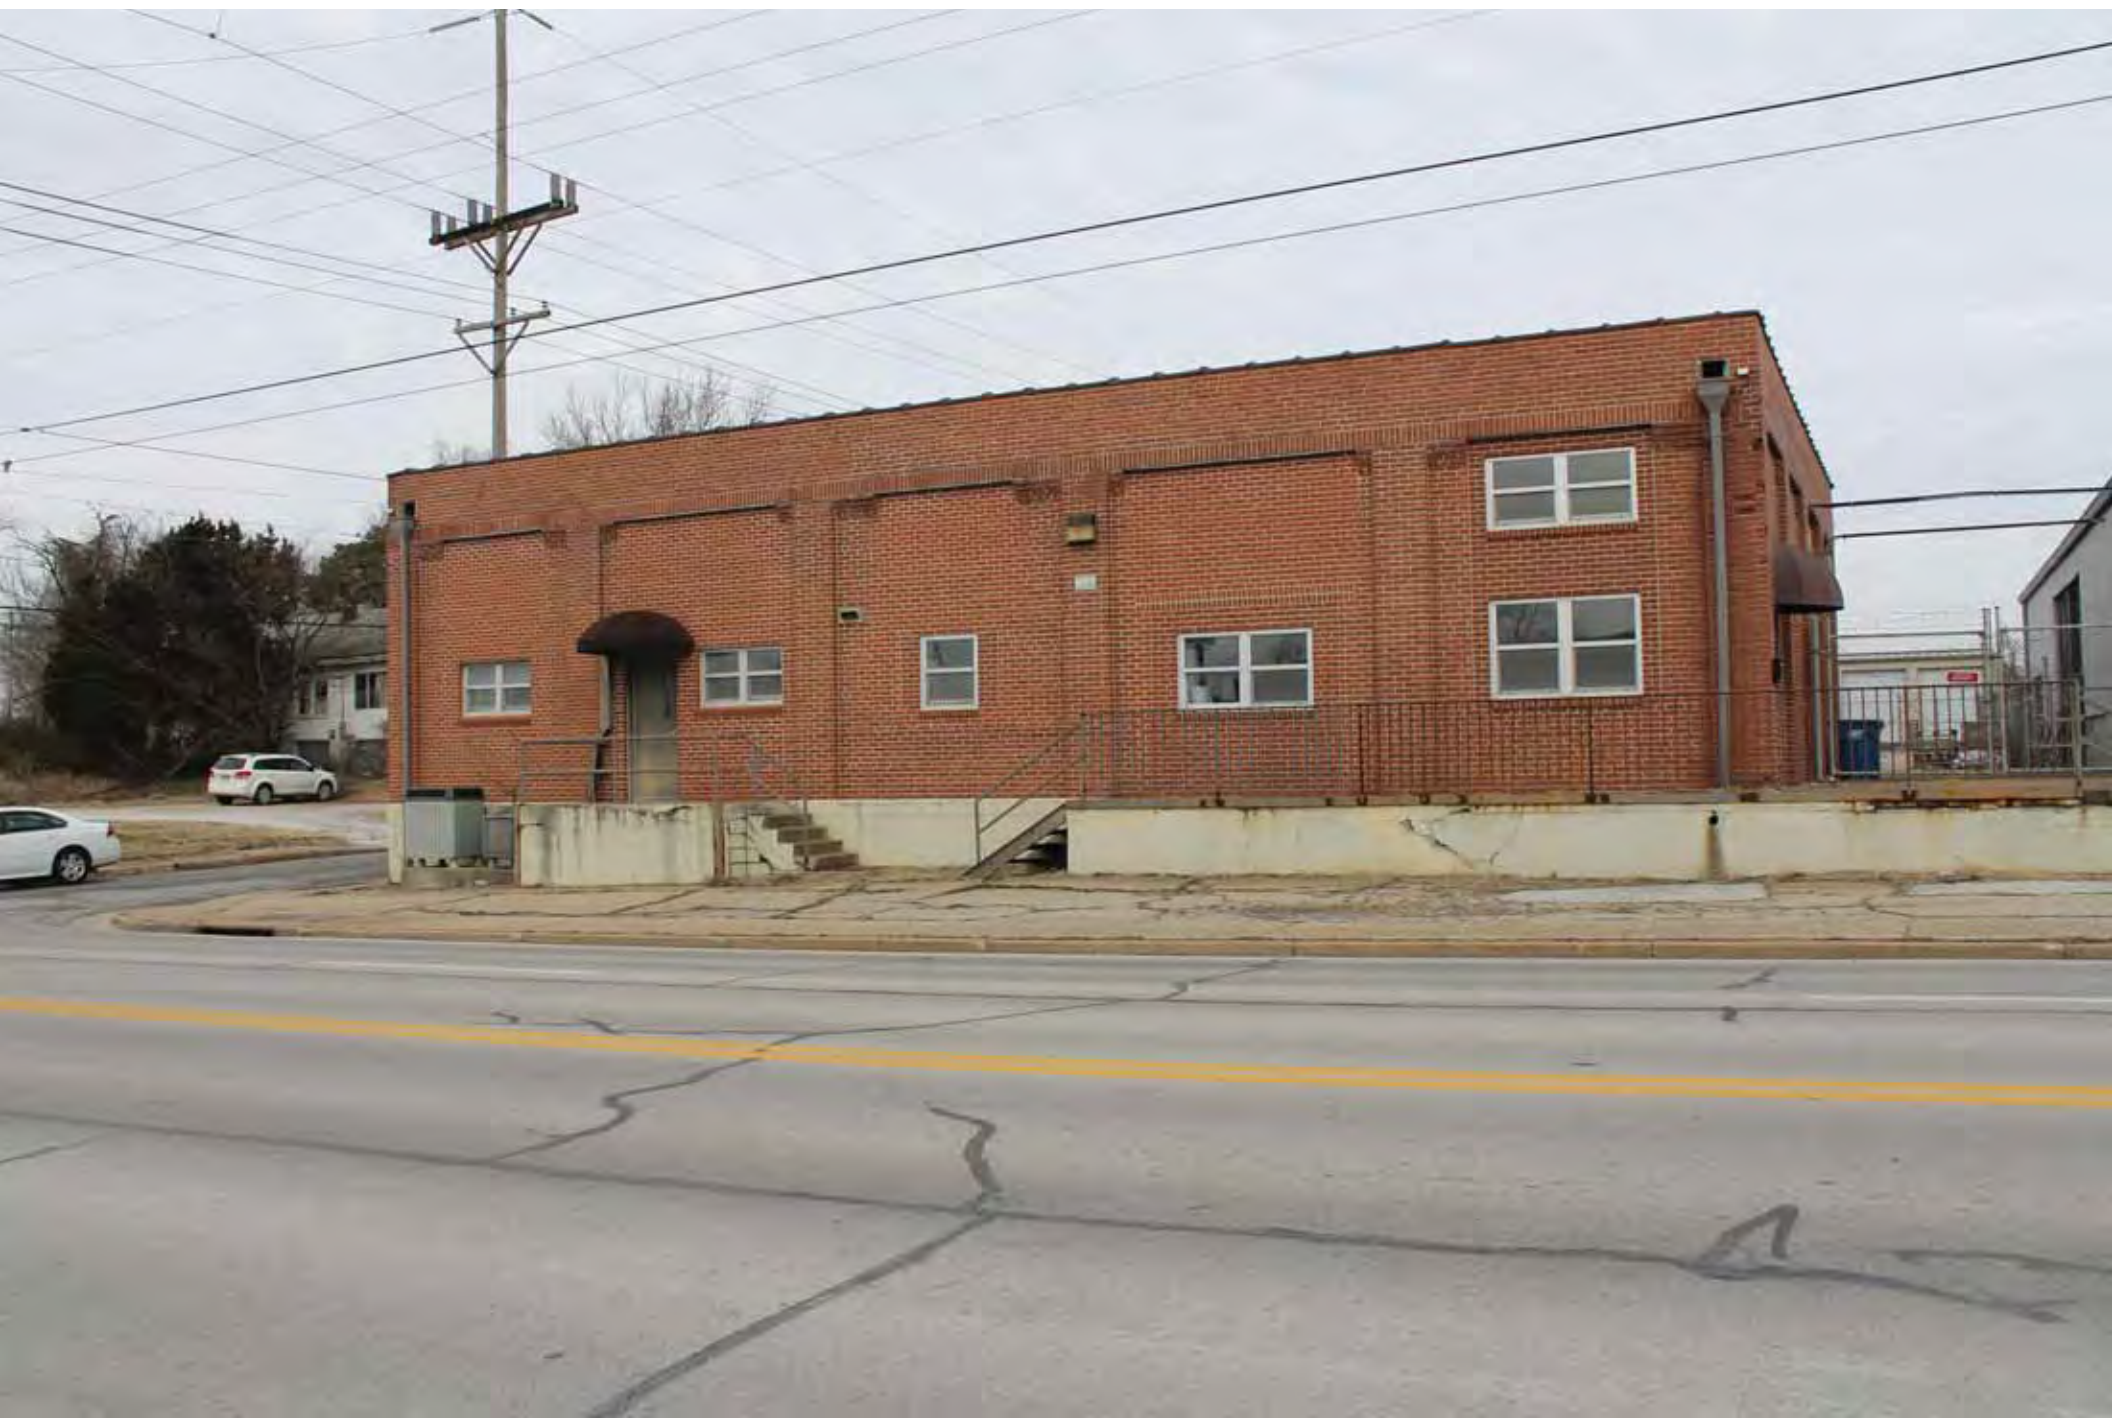
The main historic building at 931 E. 4th Street is a two-story brick warehouse built c. 1918 for the Empire District Electric Company. It has a flat roof with terra cotta coping. The main or south elevation faces E. 4th Street and is three bays wide. Brick pilasters divide each bay, with brick corbelling at the top of each bay, and brick corbelling at the cornice. The center bay is the widest, with three single windows at the first and second floors. A stone stringcourse runs along the sills of the windows at both floors. At the first floor these three original window openings have been filled in. At the second floor the middle window has been filled in, the other two have one-over-one windows in the original window openings. At the first bay of the front elevation are two window openings at each floor. On the first floor both windows have been filled in, and on the second floor there are one-over-one windows in the original openings. The third, or eastern most bay, has no windows on the first floor, but a recessed entrance at the southeast corner of the building. Above at the second floor are two one-over-one windows.

The side of the building is ten bays wide, with brick pilasters dividing each bay, identical to the design of the other elevations of the building. The eastern elevation is most visible from the street and the surface parking lot to the east of the railroad tracks. In the middle of this eastern elevation is a modern metal garage door and the main entrance door. The original window openings along the first floor have been bricked in. At the second floor each of the ten bays has two single window openings. Consistently each bay has one window that has been filled in, and one one-over-one window in the original opening. The western elevation is of identical design, although the one story metal outbuilding is attached to this elevation and details are not as visible from the street. At the rear of the building, at the north elevation is a one-story brick addition. It is not clear when this addition was built, but it has a flat roof and a concrete foundation.
