MISSOURI DEPARTMENT OF NATURAL RESOURCES
STATE HISTORIC PRESERVATION OFFICE, P.O. Box 176, Jefferson City, MO 65102
ARCHITECTURAL/HISTORIC INVENTORY FORM

1. Survey No. JP-AS-007-001		2. Survey name: East Town (Original Joplin) Historic Survey Phase 2	
3. County: JASPER		4. Address (Street No.) 618	Street (name) E. 2 nd Street
5. City: Joplin	Vicinity: <input type="checkbox"/>	6. Geographical Reference:	7. Township/Range/Section: T: R: S:
8. Historic name (if known):		9. Present/other name (if known):	
10. Ownership: <input checked="" type="checkbox"/> Private <input type="checkbox"/> Public		11a. Historic use (if known): Domestic: Single Dwelling	11b. Current use: Domestic: Single Dwelling

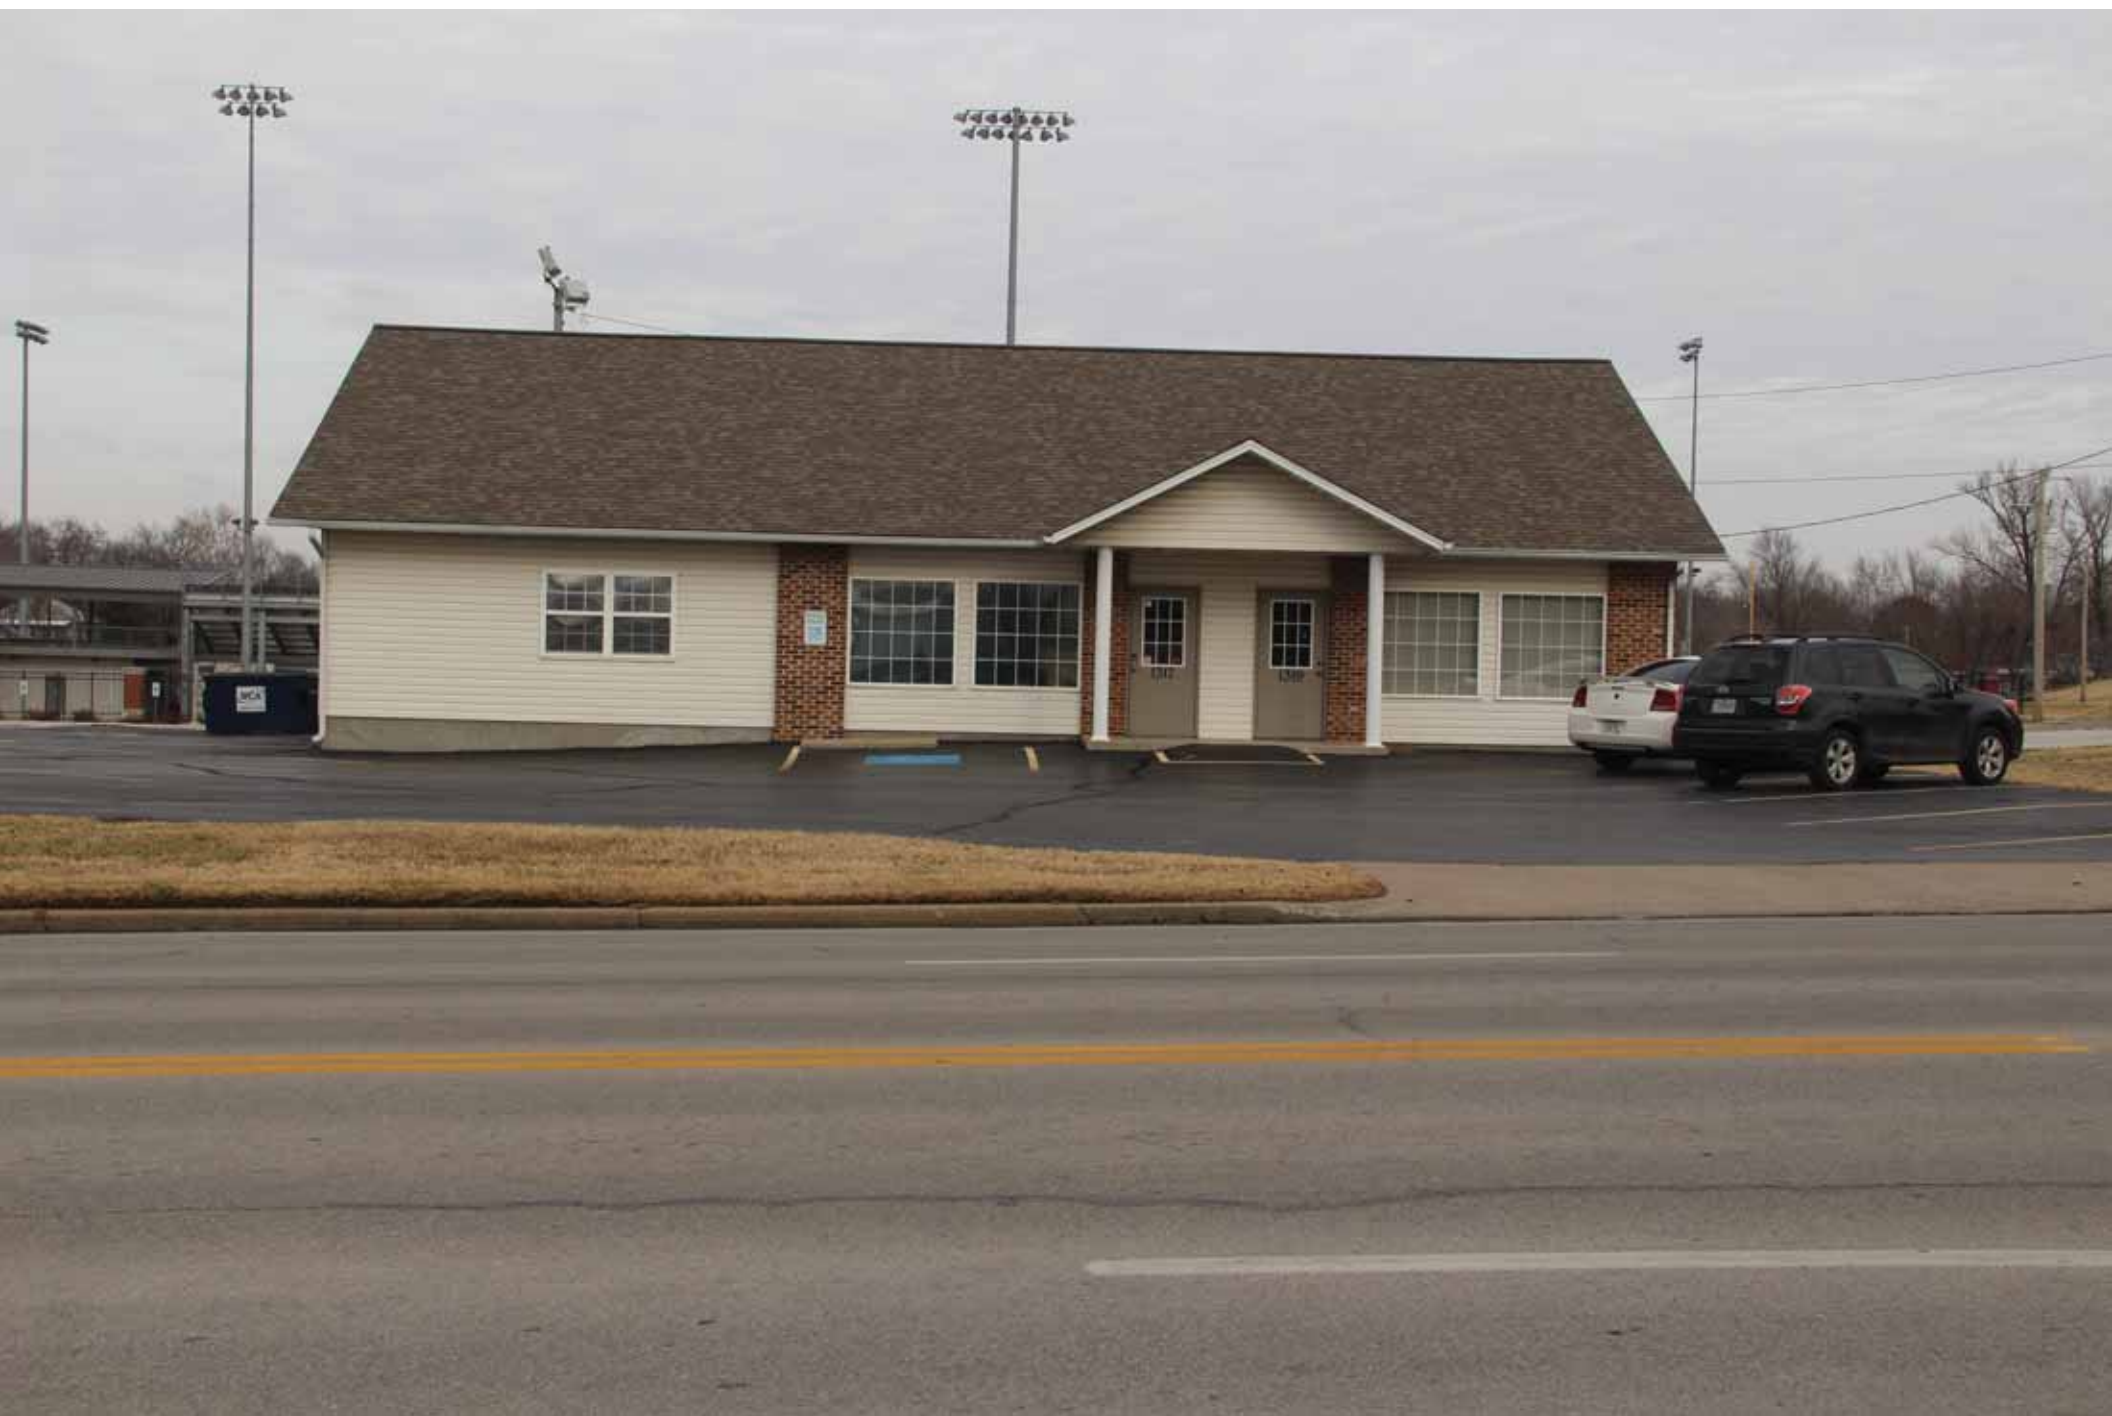
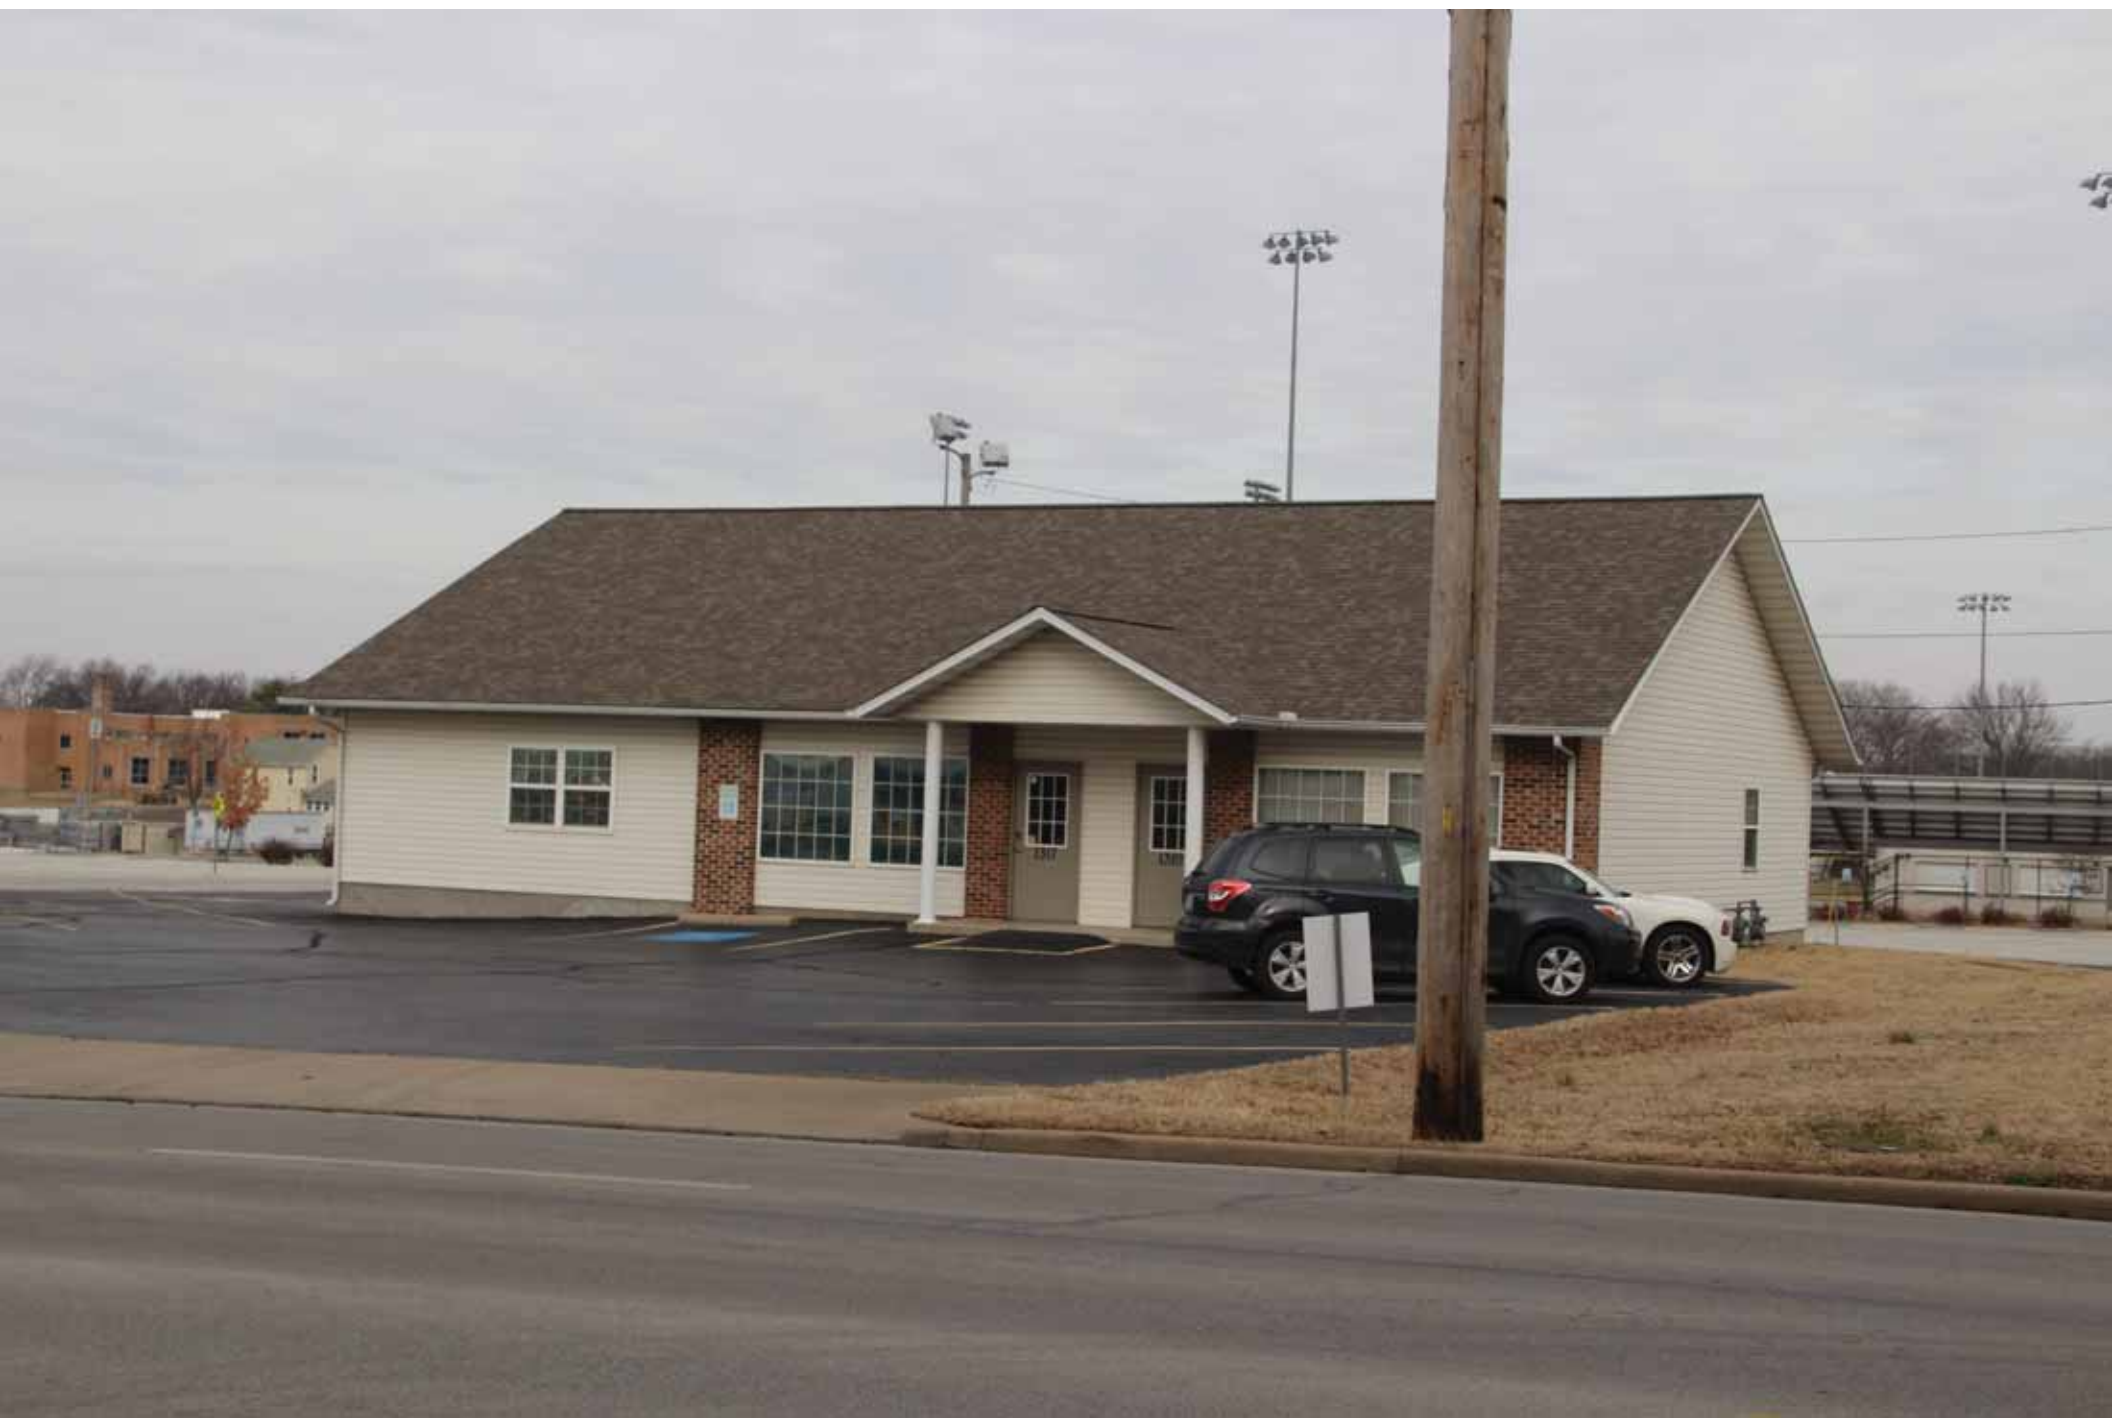
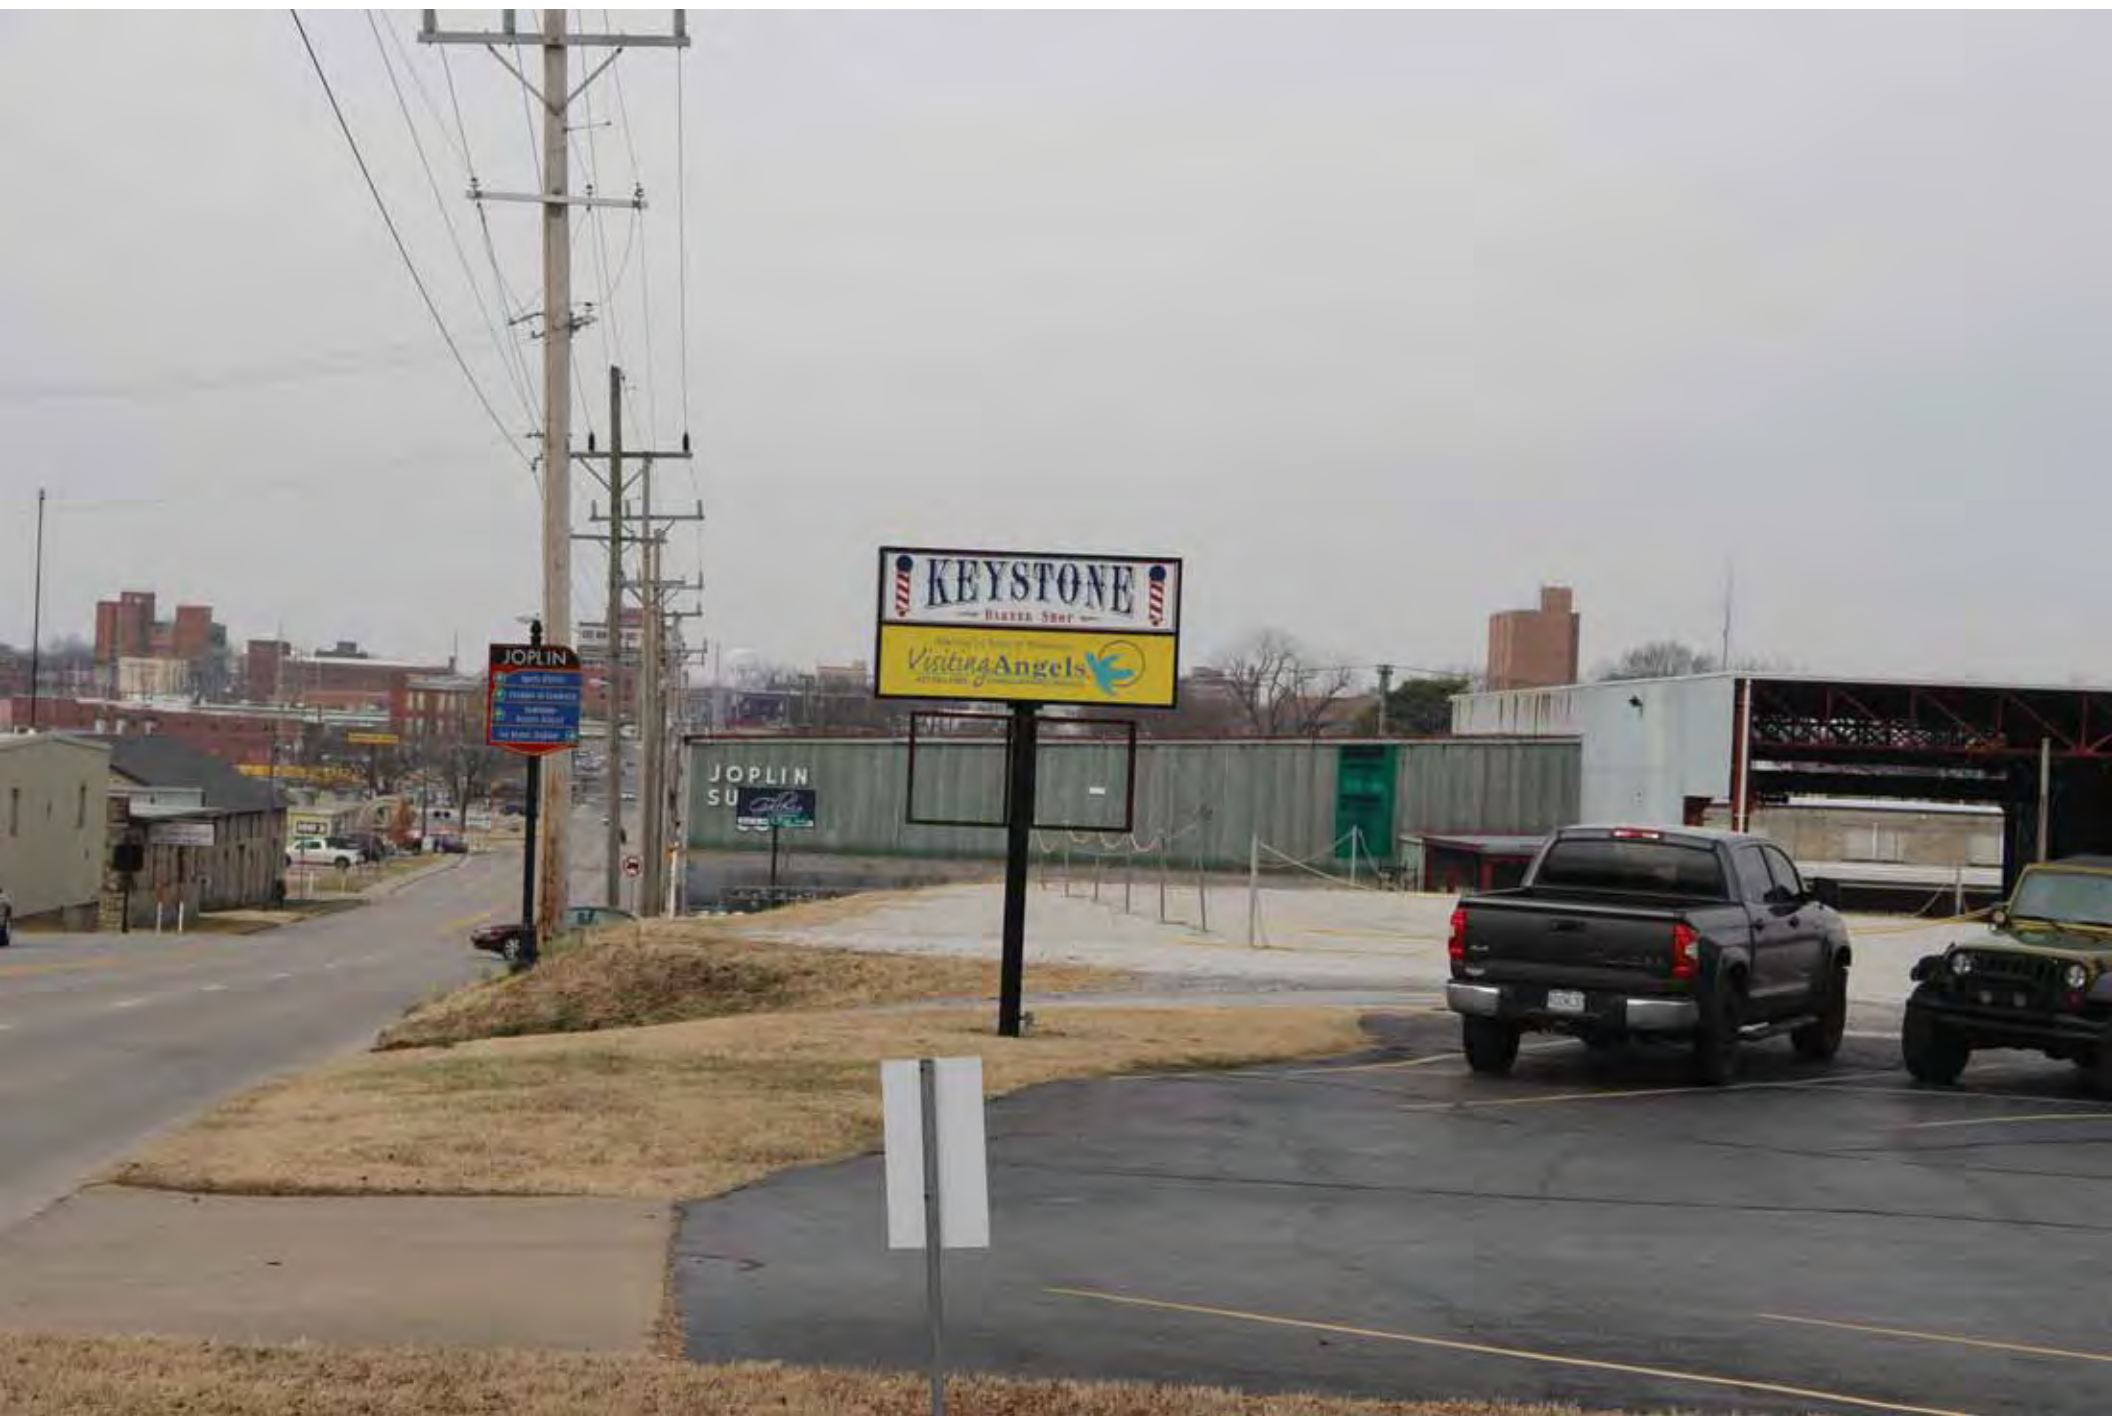
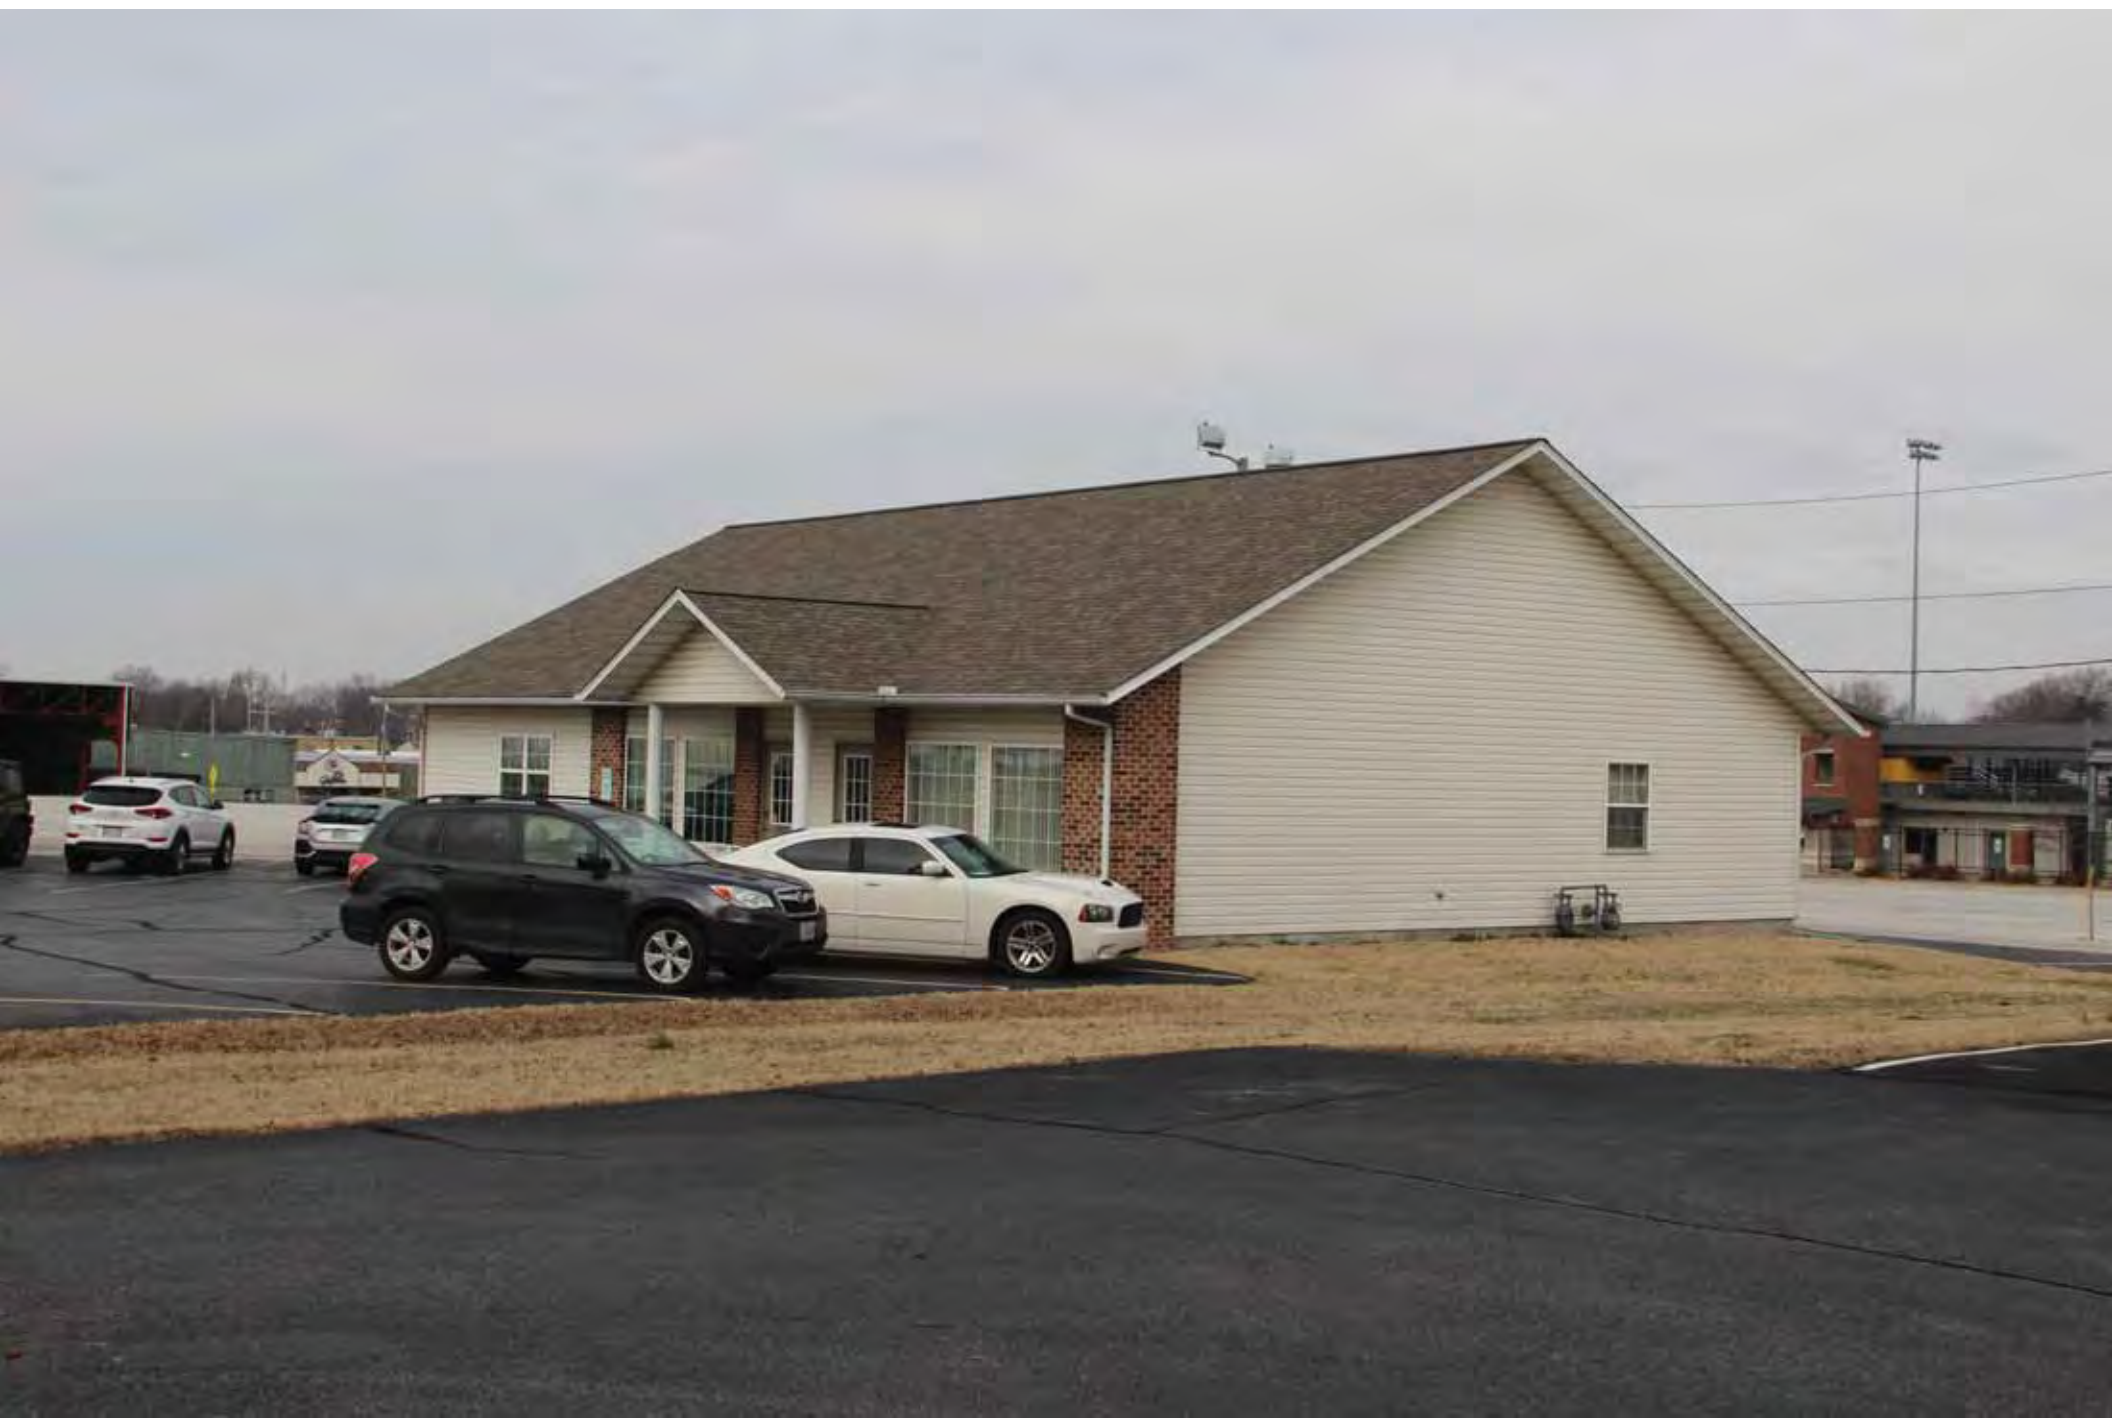
The building associated with this parcel is a single-story rectangular commercial property. The building has an asphalt shingled gable roof, exterior vinyl siding (with bands of brick veneer separating the primary elevation bays) and a poured concrete foundation. Eaves are enclosed with vinyl. The primary (south) elevation facing E. 4th Street has a slightly off-center portico supported by two round columns. Within this bay are two doors, each with nine upper lights. Flanking the entry bay are large paired multi-light fixed sash windows. Smaller paired six-over-six windows are situated at the west end of the façade. The east elevation has a single six-over-six window. The west elevation has a solid entry bay offset by two six-over-six windows south of the door.

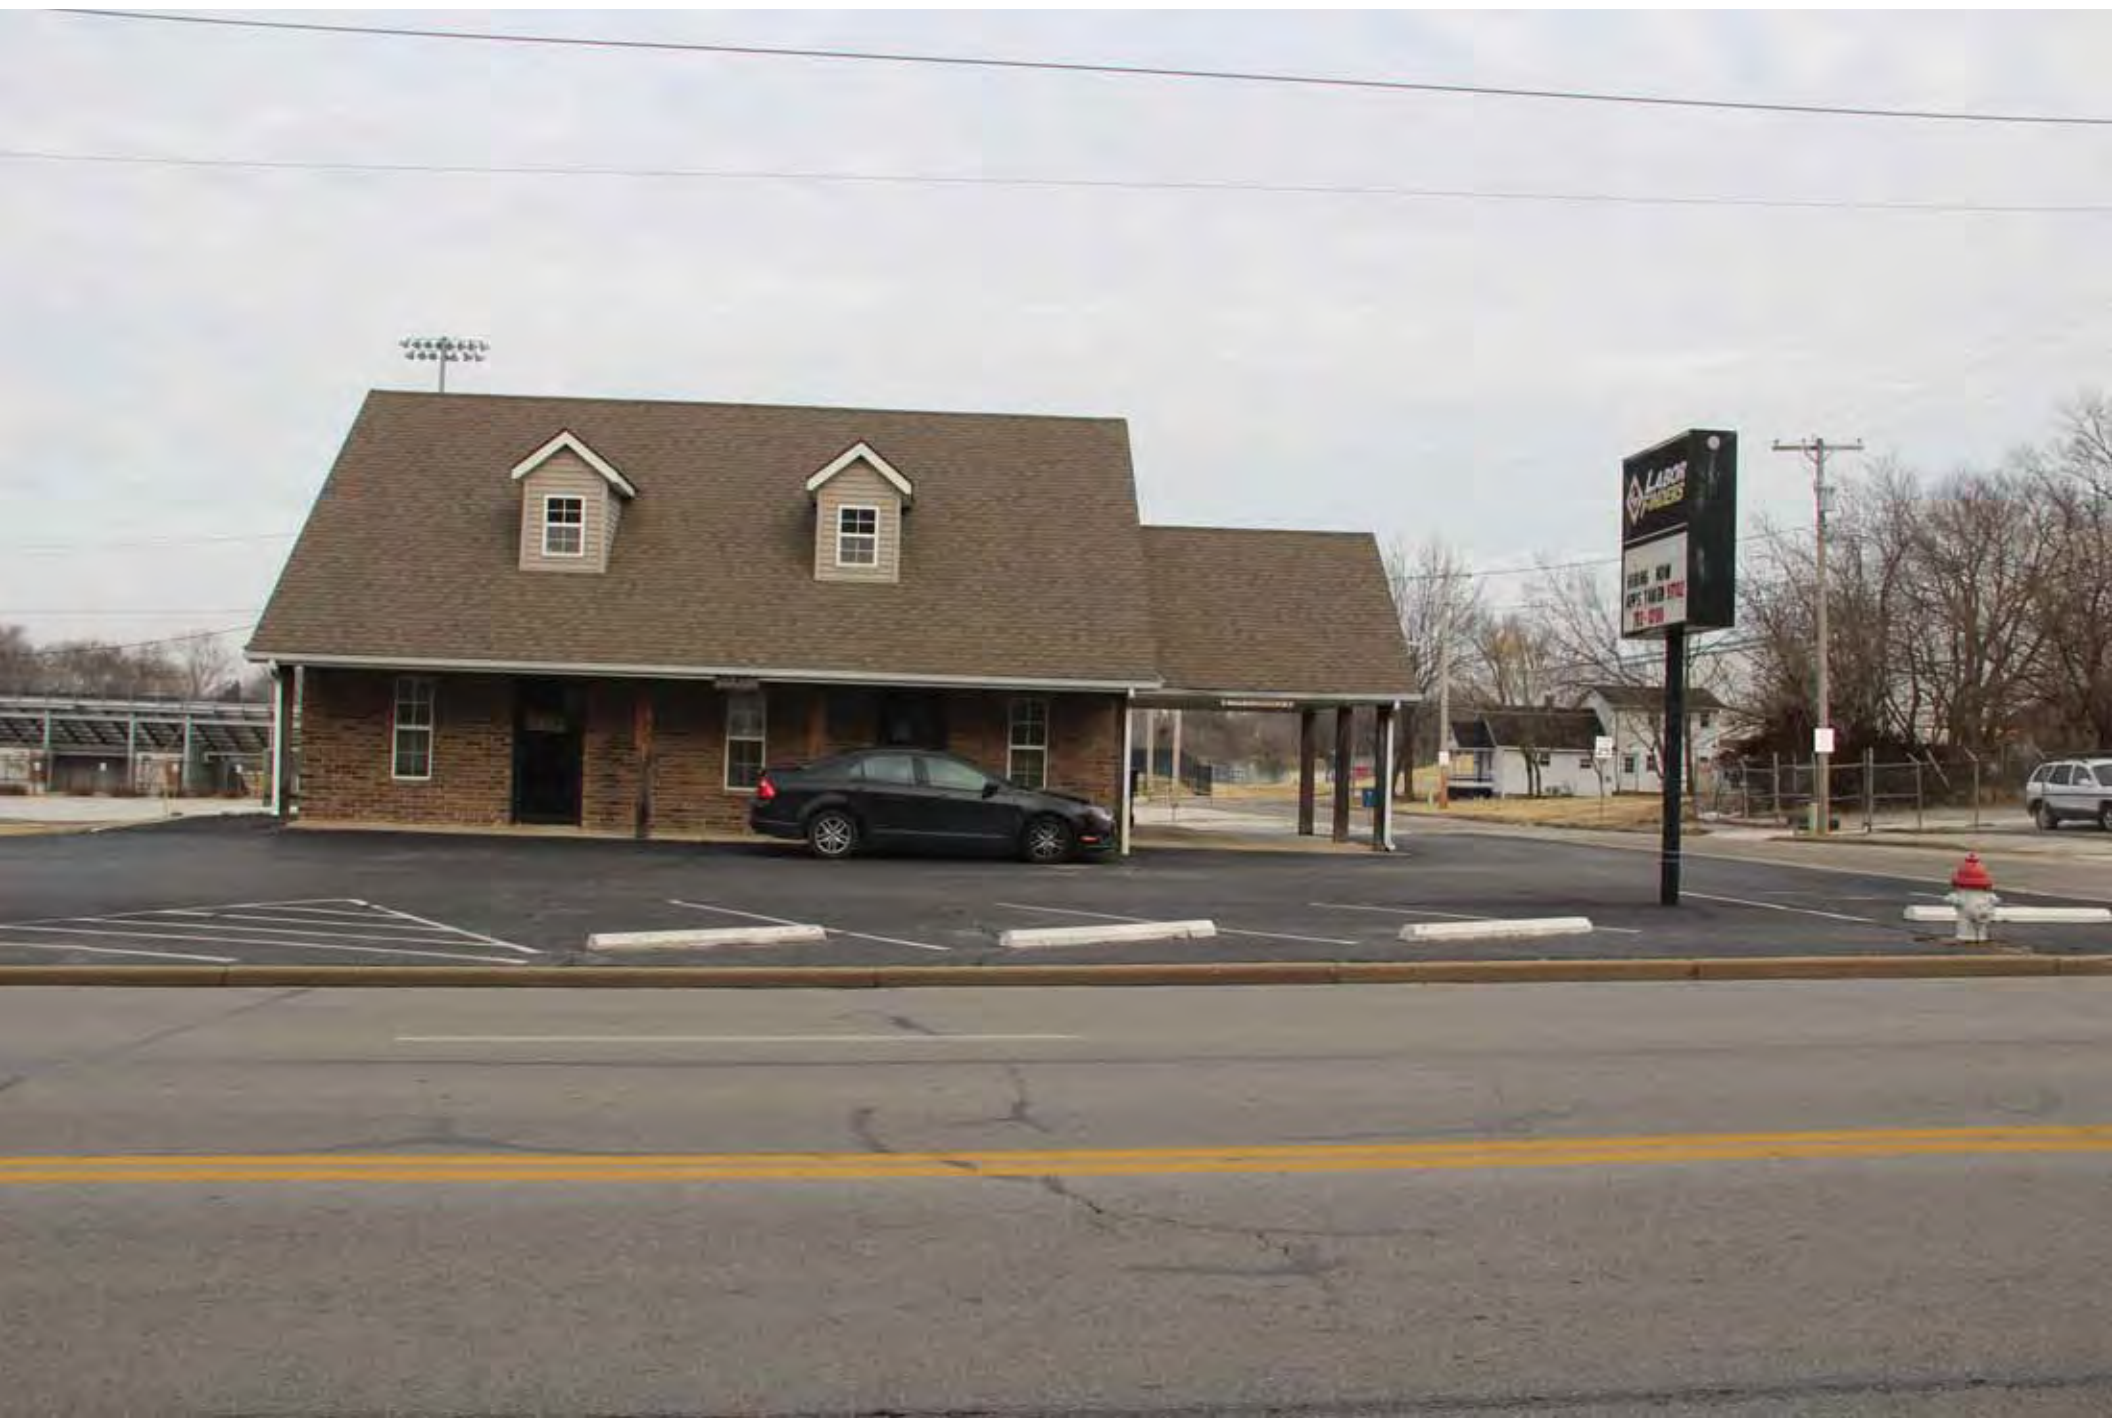
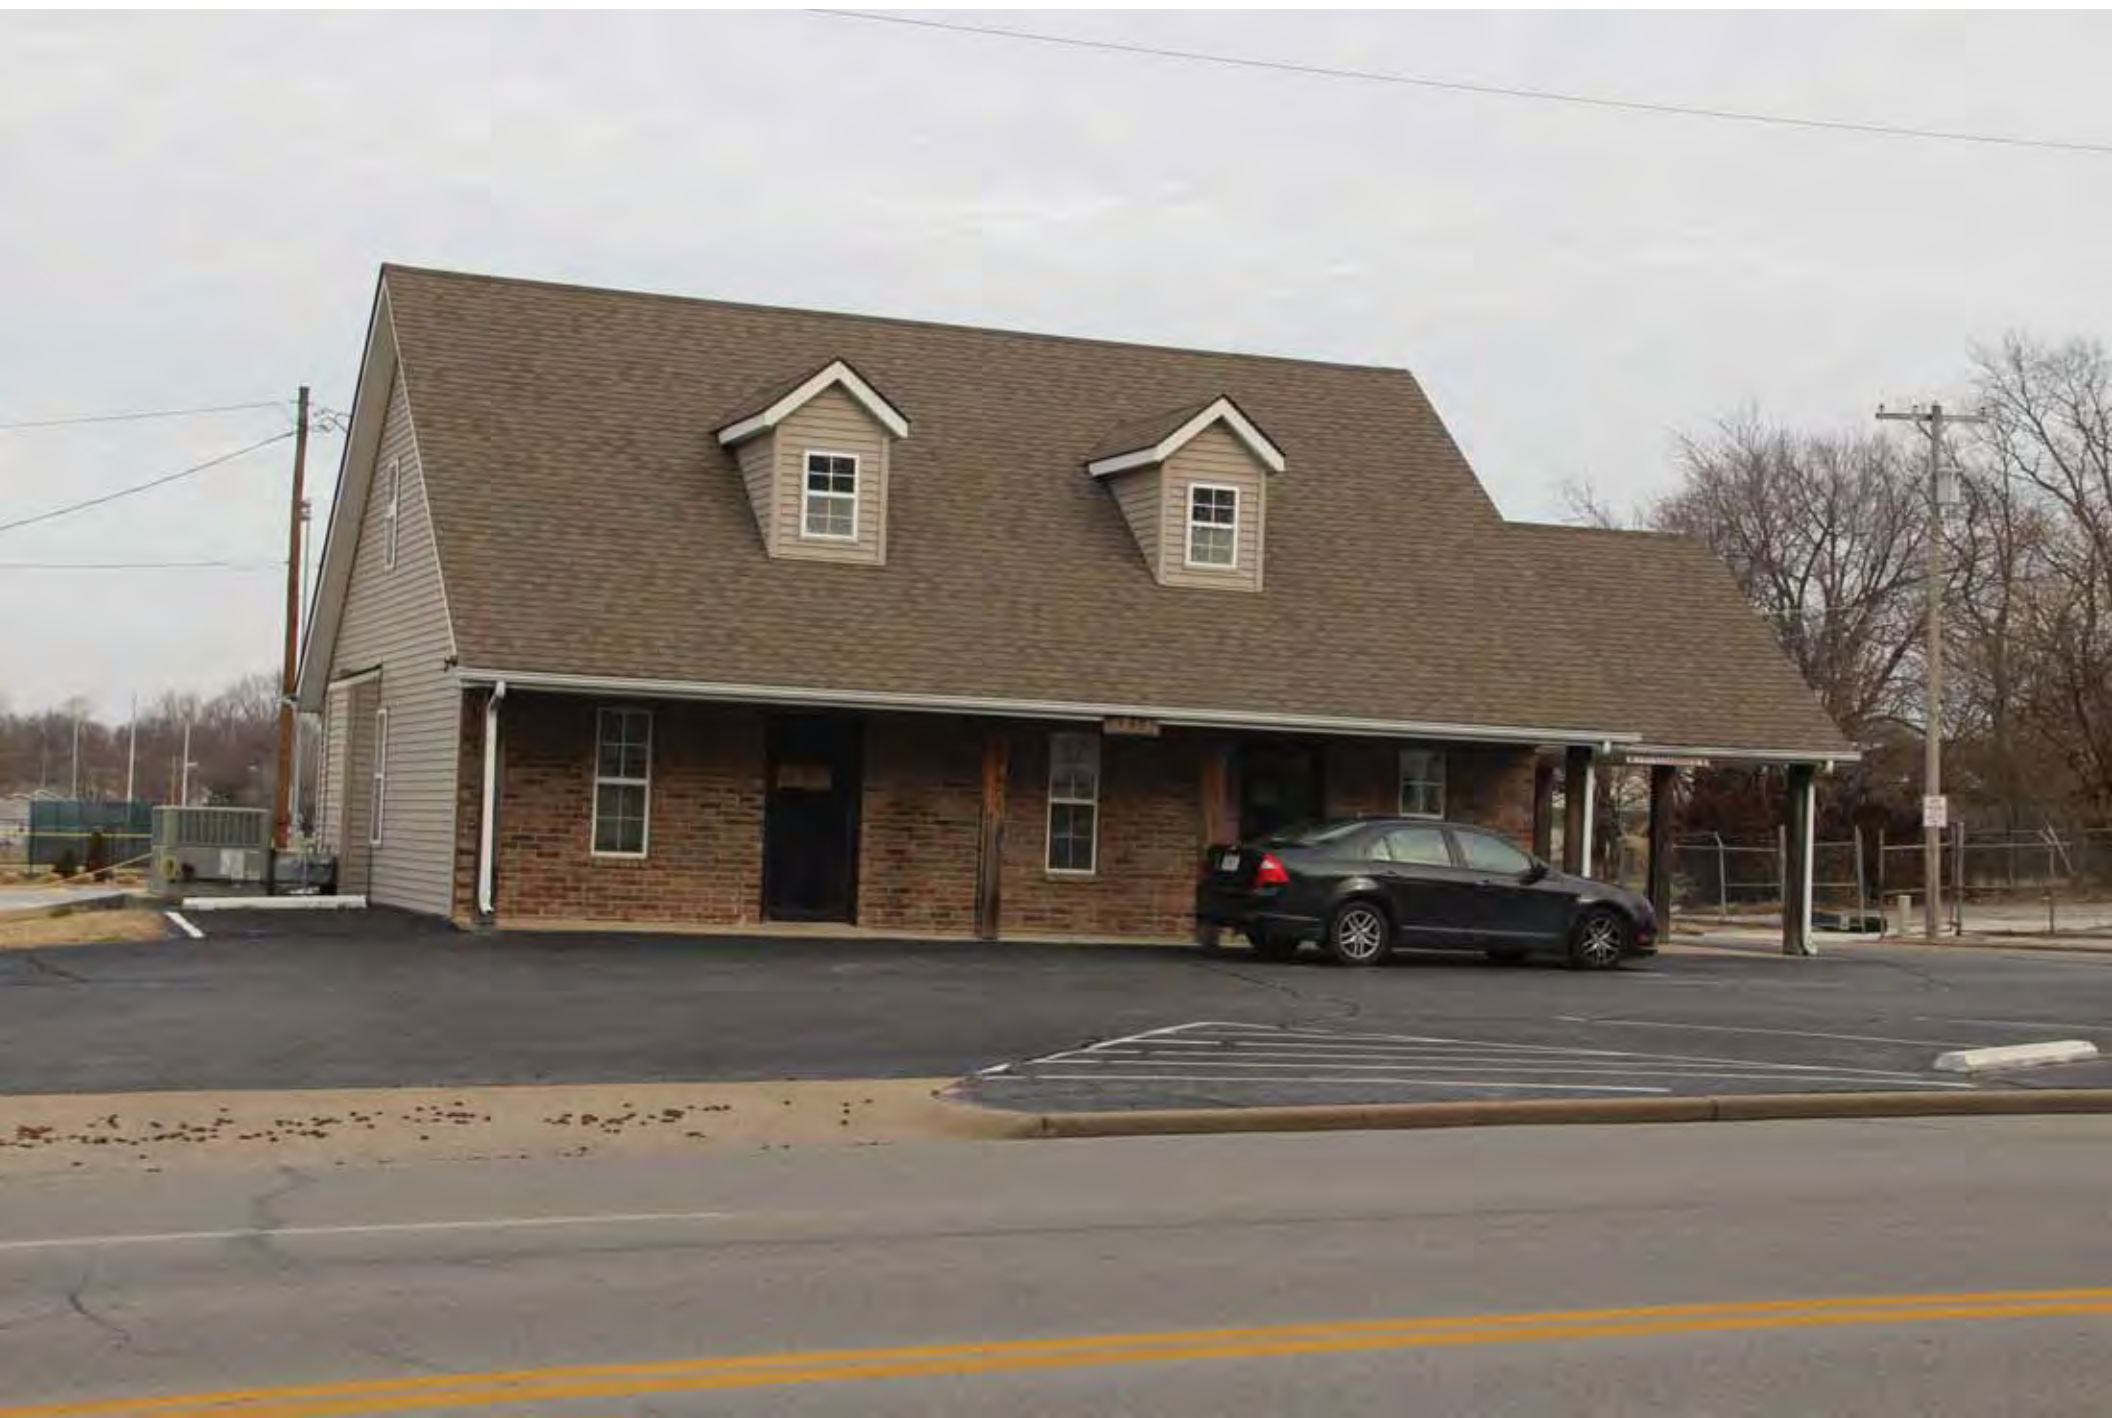
The building associated with this parcel is a 1.5-story rectangular plan commercial property. The building has an asphalt shingled gable roof, exterior brick veneer (façade) and vinyl siding (side and rear elevations). The building rests on a concrete slab foundation. Eaves are enclosed with vinyl. The primary (south) elevation facing E. 4th Street has a full-width porch supported by four wood posts. Within the porch bay are two single entry bays, each of which holds a single-light commercial style door. Doors are offset by individual windows of four-over-four design. There are three windows on the façade at the center and east/west ends of the elevation. Above the porch, the roof supports two gabled dormers. Dormers each hold a single four-over-four window. Dormer walls are clad with vinyl. The west (side) elevation has a small projecting shed bay. The elevation has one lower and one upper window – each window is four-over-four. The east elevation faces S. Comingo Avenue. This elevation has a gabled drive-through attached canopy supported by three wood columns. The gable field of the canopy holds a louvered octagonal vent. The building's east wall facing the drive-through area holds a single sliding two-light window. The area below the canopy is covered with concrete.
