MISSOURI DEPARTMENT OF NATURAL RESOURCES
STATE HISTORIC PRESERVATION OFFICE, P.O. Box 176, Jefferson City, MO 65102
ARCHITECTURAL/HISTORIC INVENTORY FORM

1. Survey No. JP-AS-007-001		2. Survey name: East Town (Original Joplin) Historic Survey Phase 2	
3. County: JASPER		4. Address (Street No.) 618	Street (name) E. 2 nd Street
5. City: Joplin	Vicinity: <input type="checkbox"/>	6. Geographical Reference:	7. Township/Range/Section: T: R: S:
8. Historic name (if known):		9. Present/other name (if known):	
10. Ownership: <input checked="" type="checkbox"/> Private <input type="checkbox"/> Public		11a. Historic use (if known): Domestic: Single Dwelling	11b. Current use: Domestic: Single Dwelling

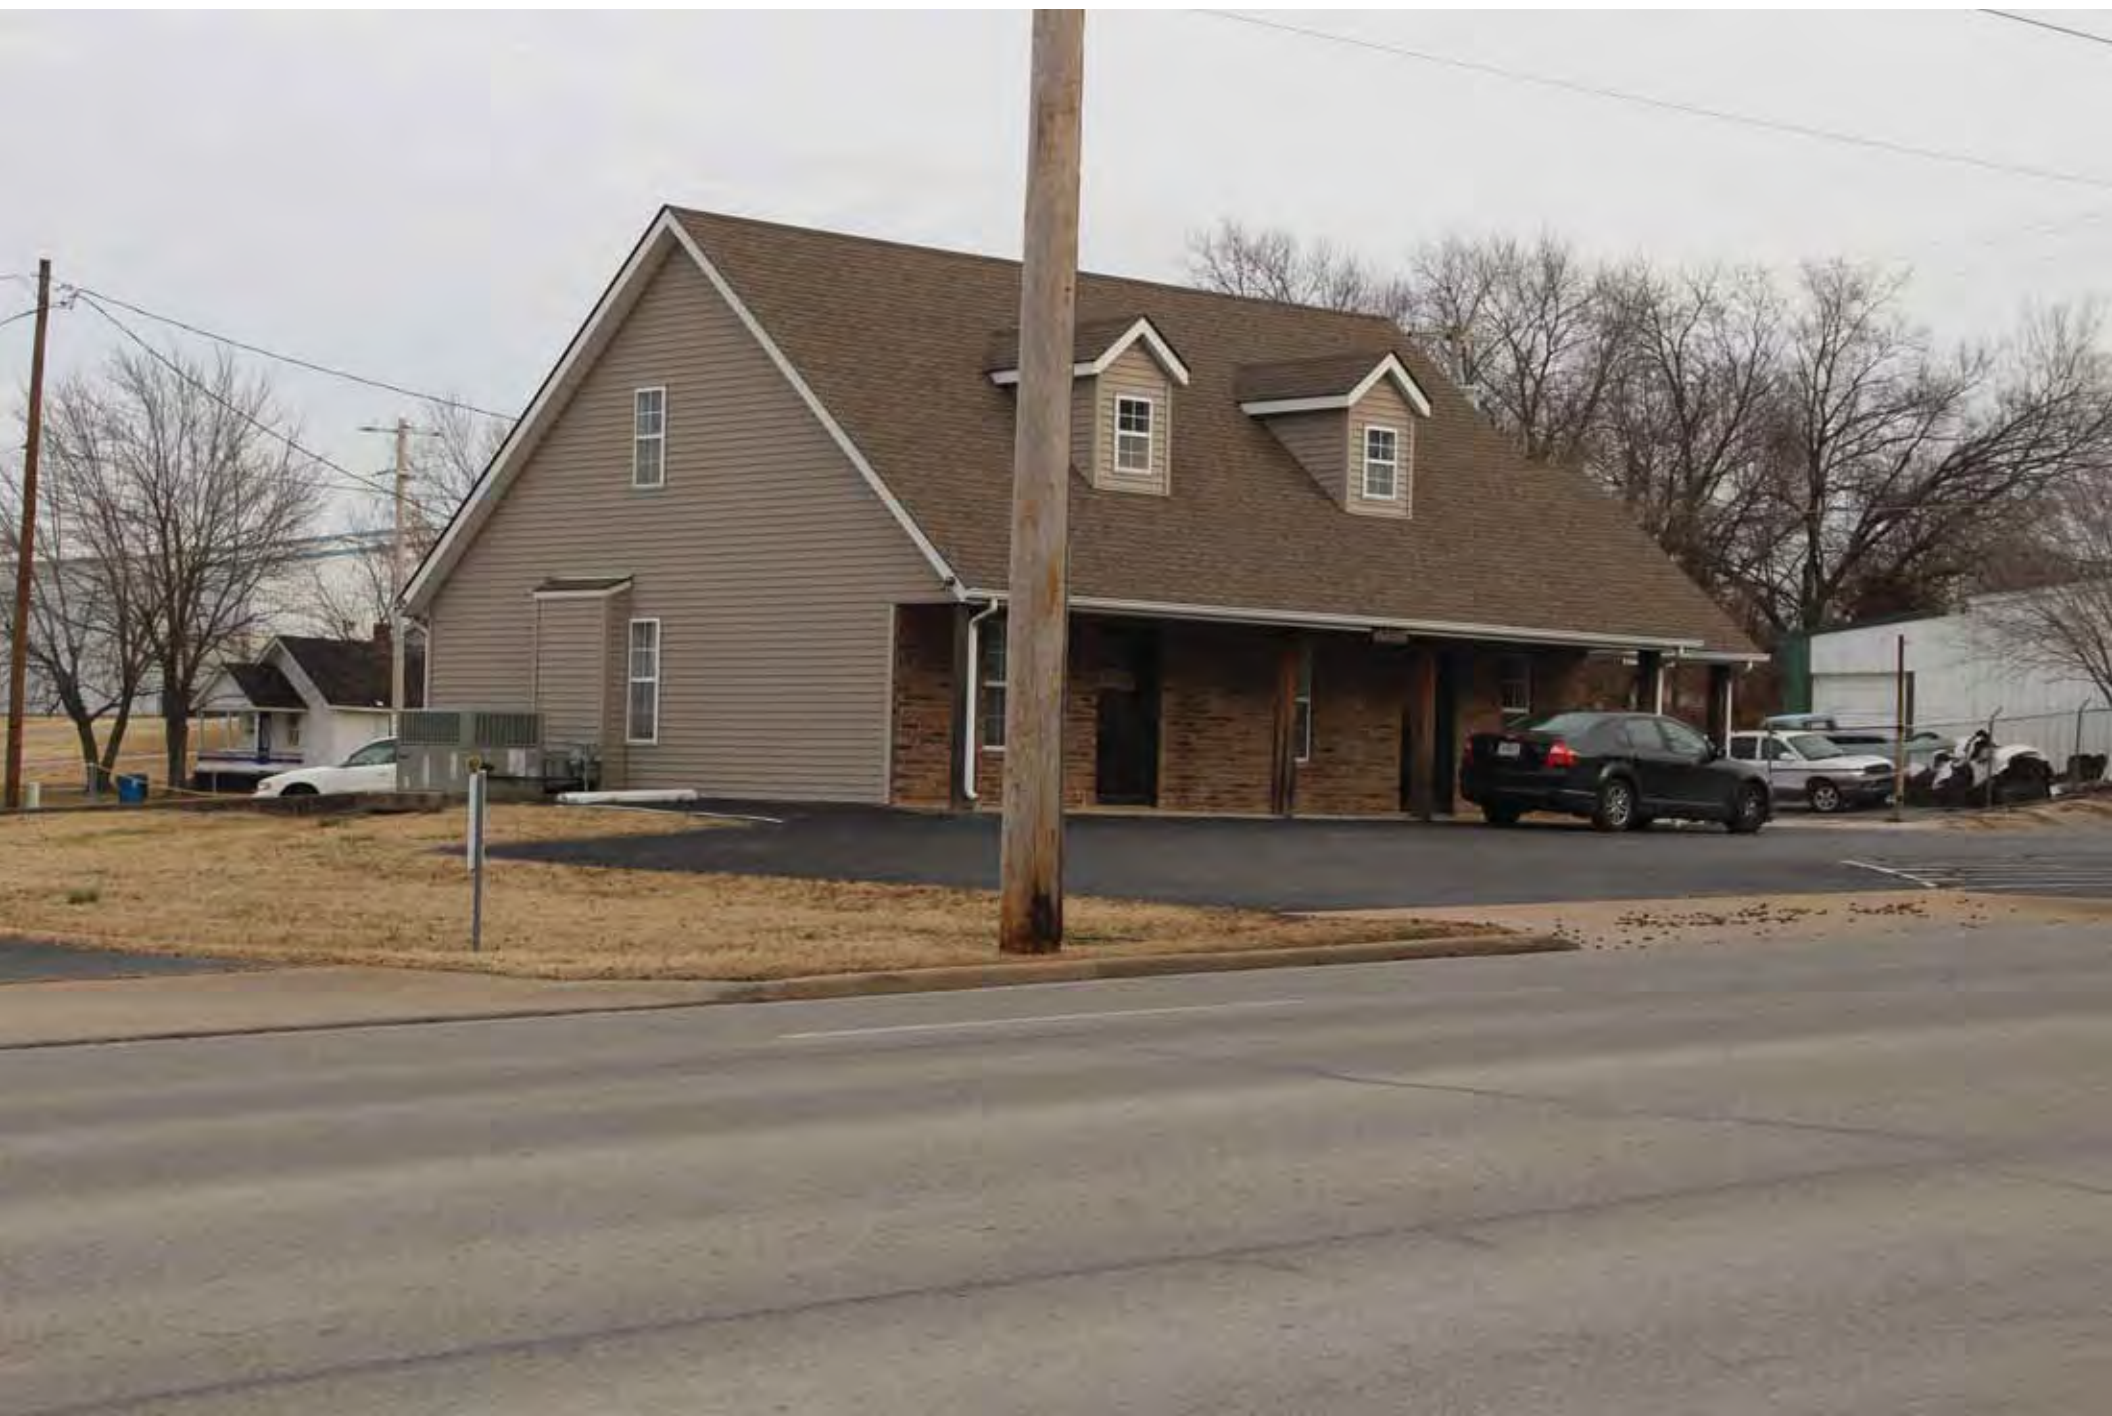
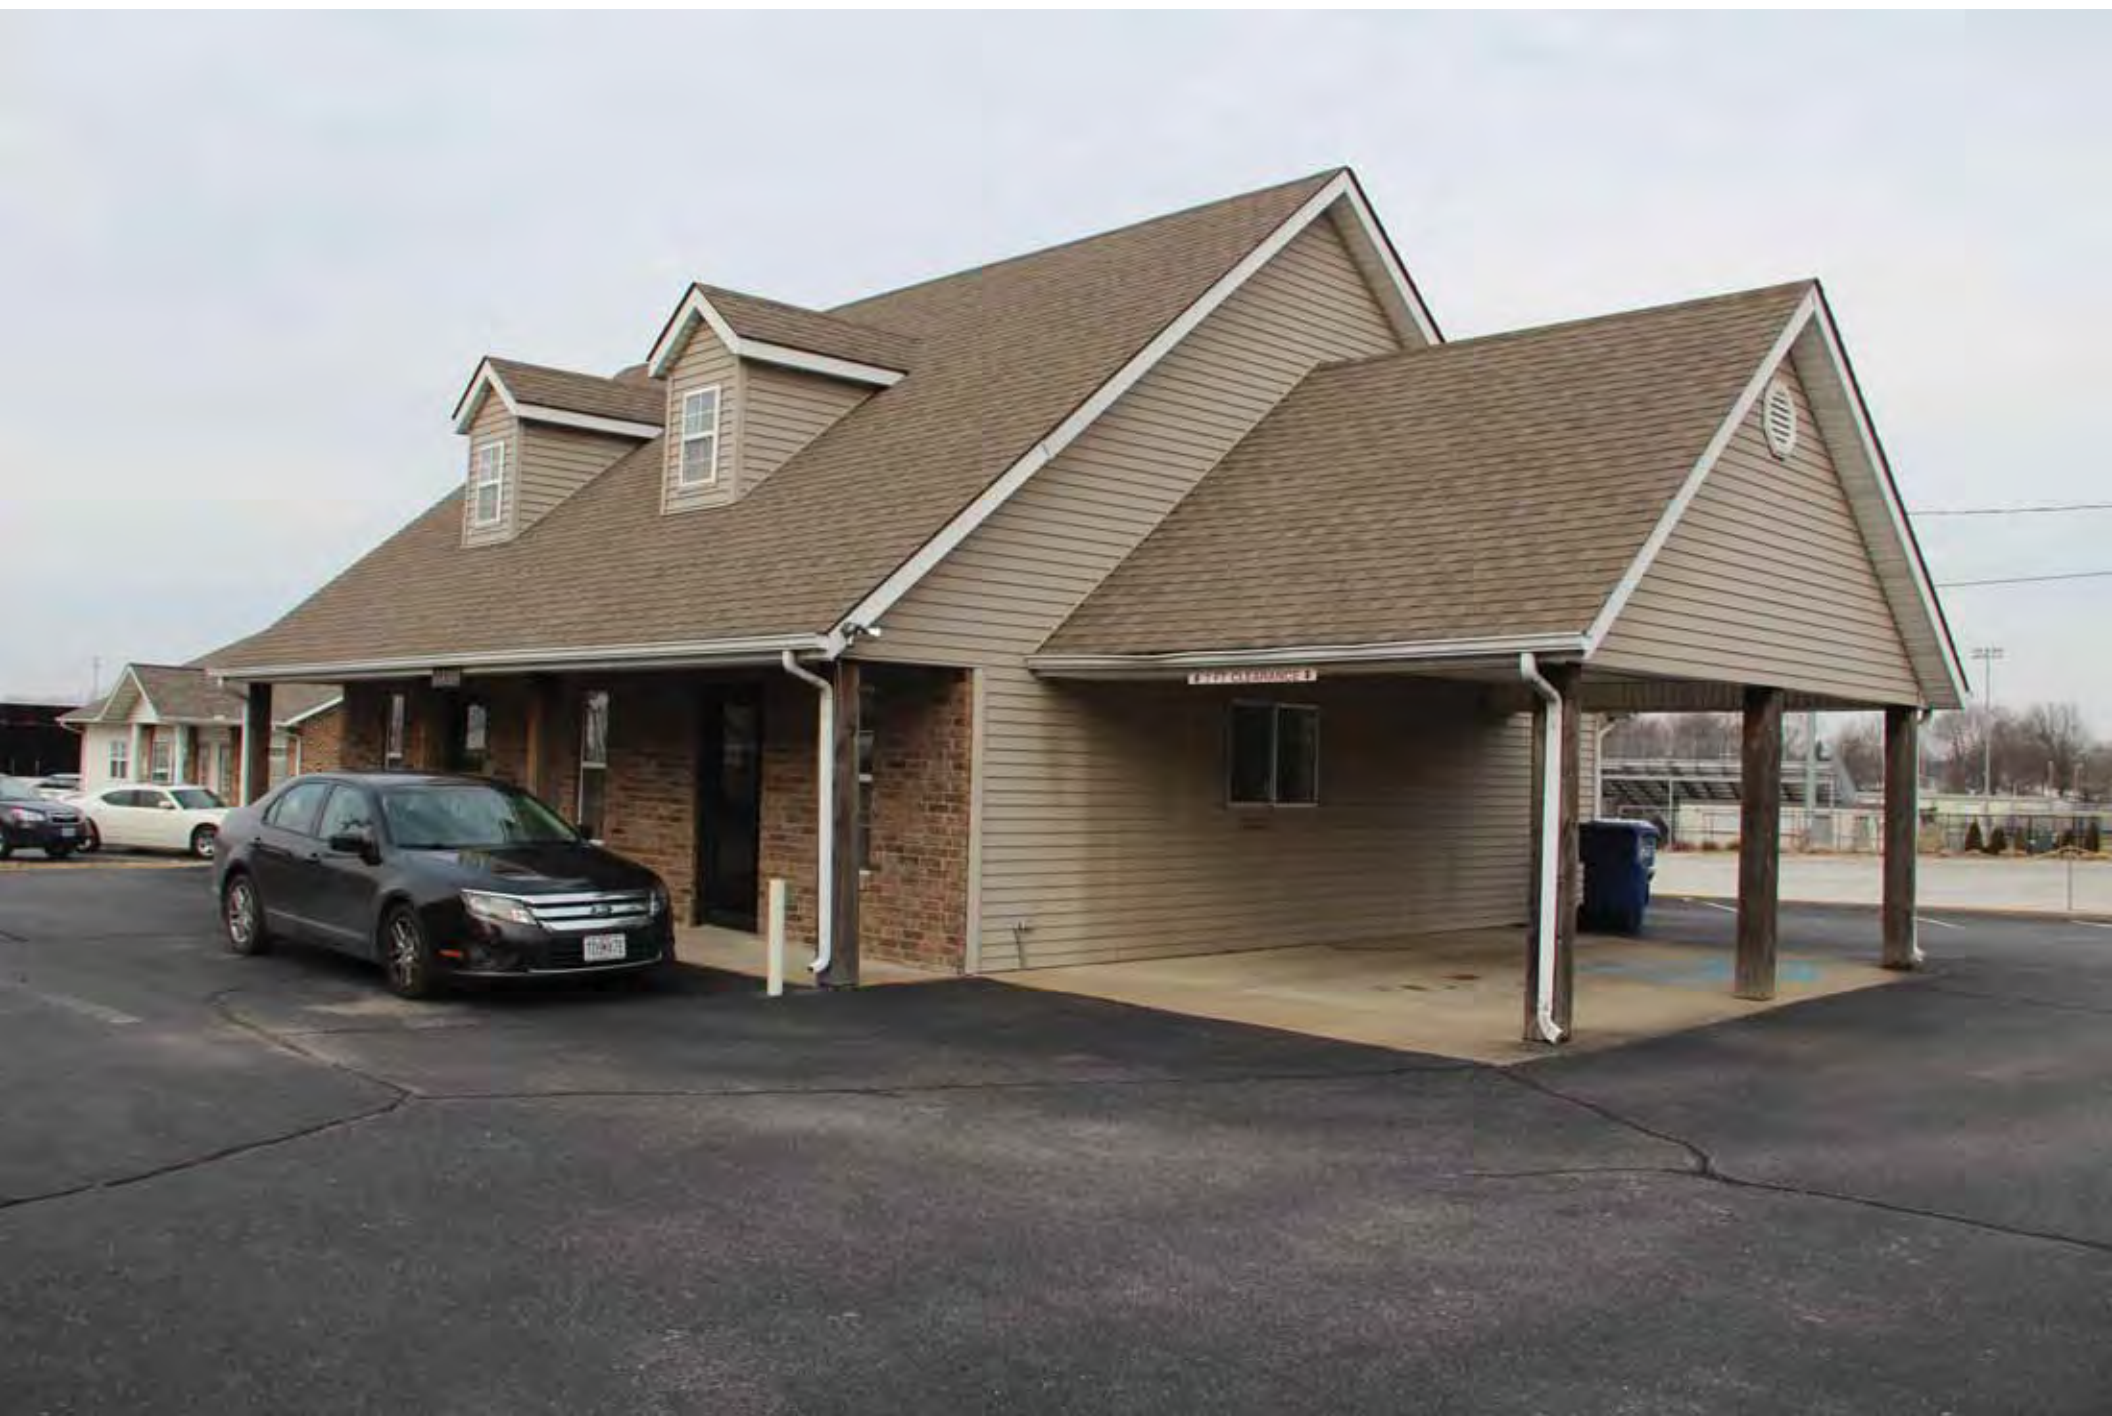
The building associated with this parcel is a 1.5-story rectangular plan commercial property. The building has an asphalt shingled gable roof, exterior brick veneer (façade) and vinyl siding (side and rear elevations). The building rests on a concrete slab foundation. Eaves are enclosed with vinyl. The primary (south) elevation facing E. 4th Street has a full-width porch supported by four wood posts. Within the porch bay are two single entry bays, each of which holds a single-light commercial style door. Doors are offset by individual windows of four-over-four design. There are three windows on the façade at the center and east/west ends of the elevation. Above the porch, the roof supports two gabled dormers. Dormers each hold a single four-over-four window. Dormer walls are clad with vinyl. The west (side) elevation has a small projecting shed bay. The elevation has one lower and one upper window – each window is four-over-four. The east elevation faces S. Comingo Avenue. This elevation has a gabled drive-through attached canopy supported by three wood columns. The gable field of the canopy holds a louvered octagonal vent. The building's east wall facing the drive-through area holds a single sliding two-light window. The area below the canopy is covered with concrete.

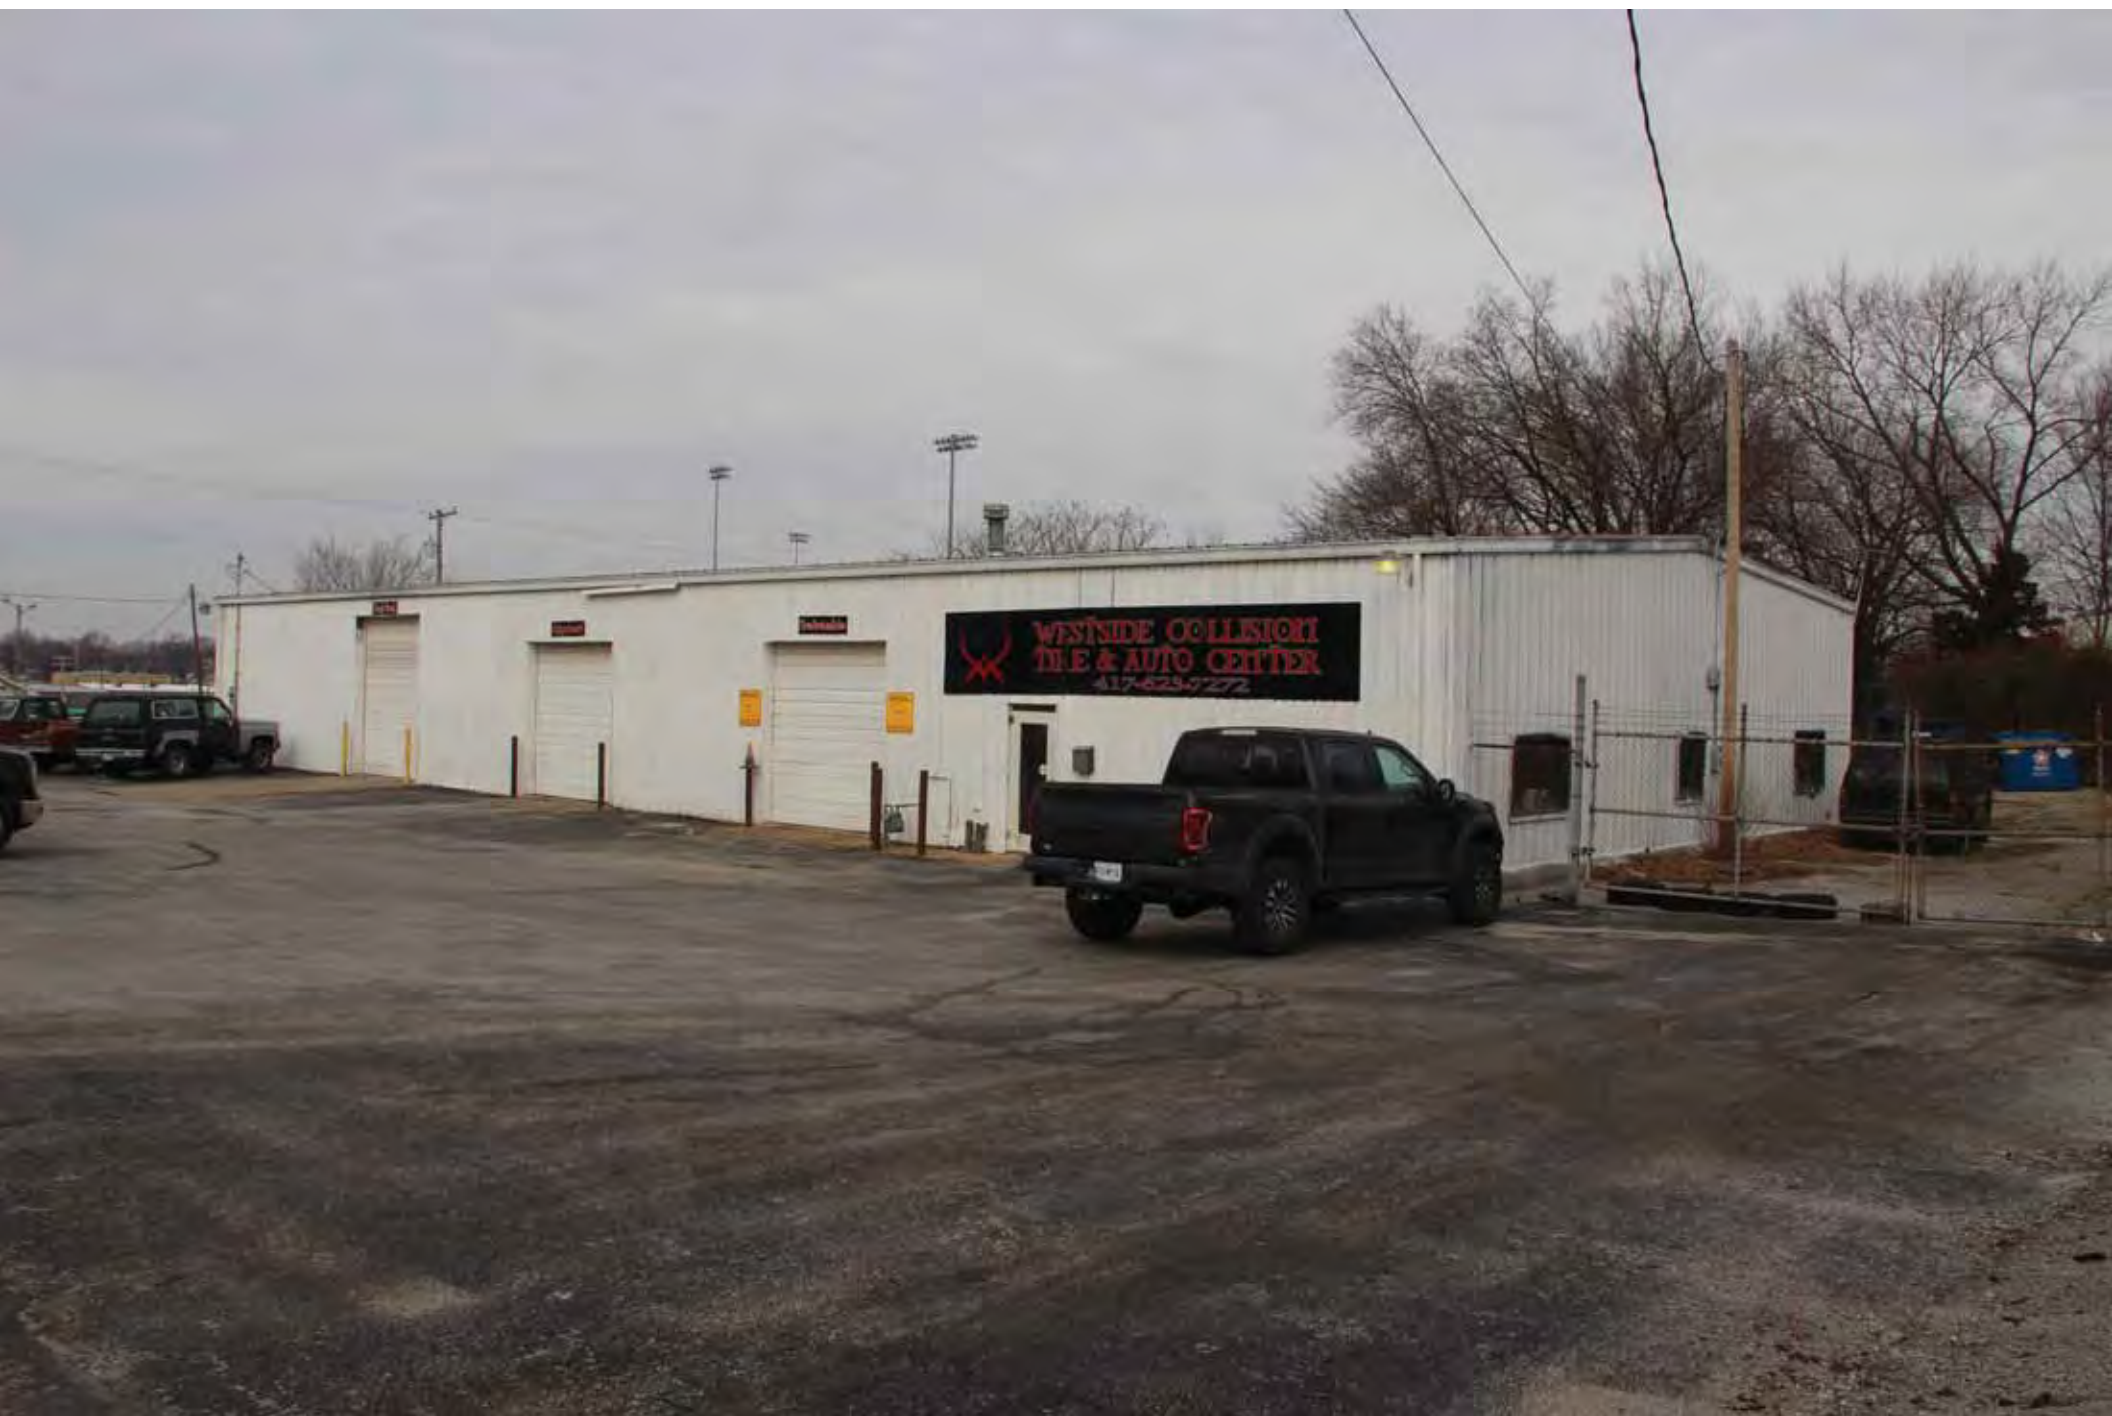
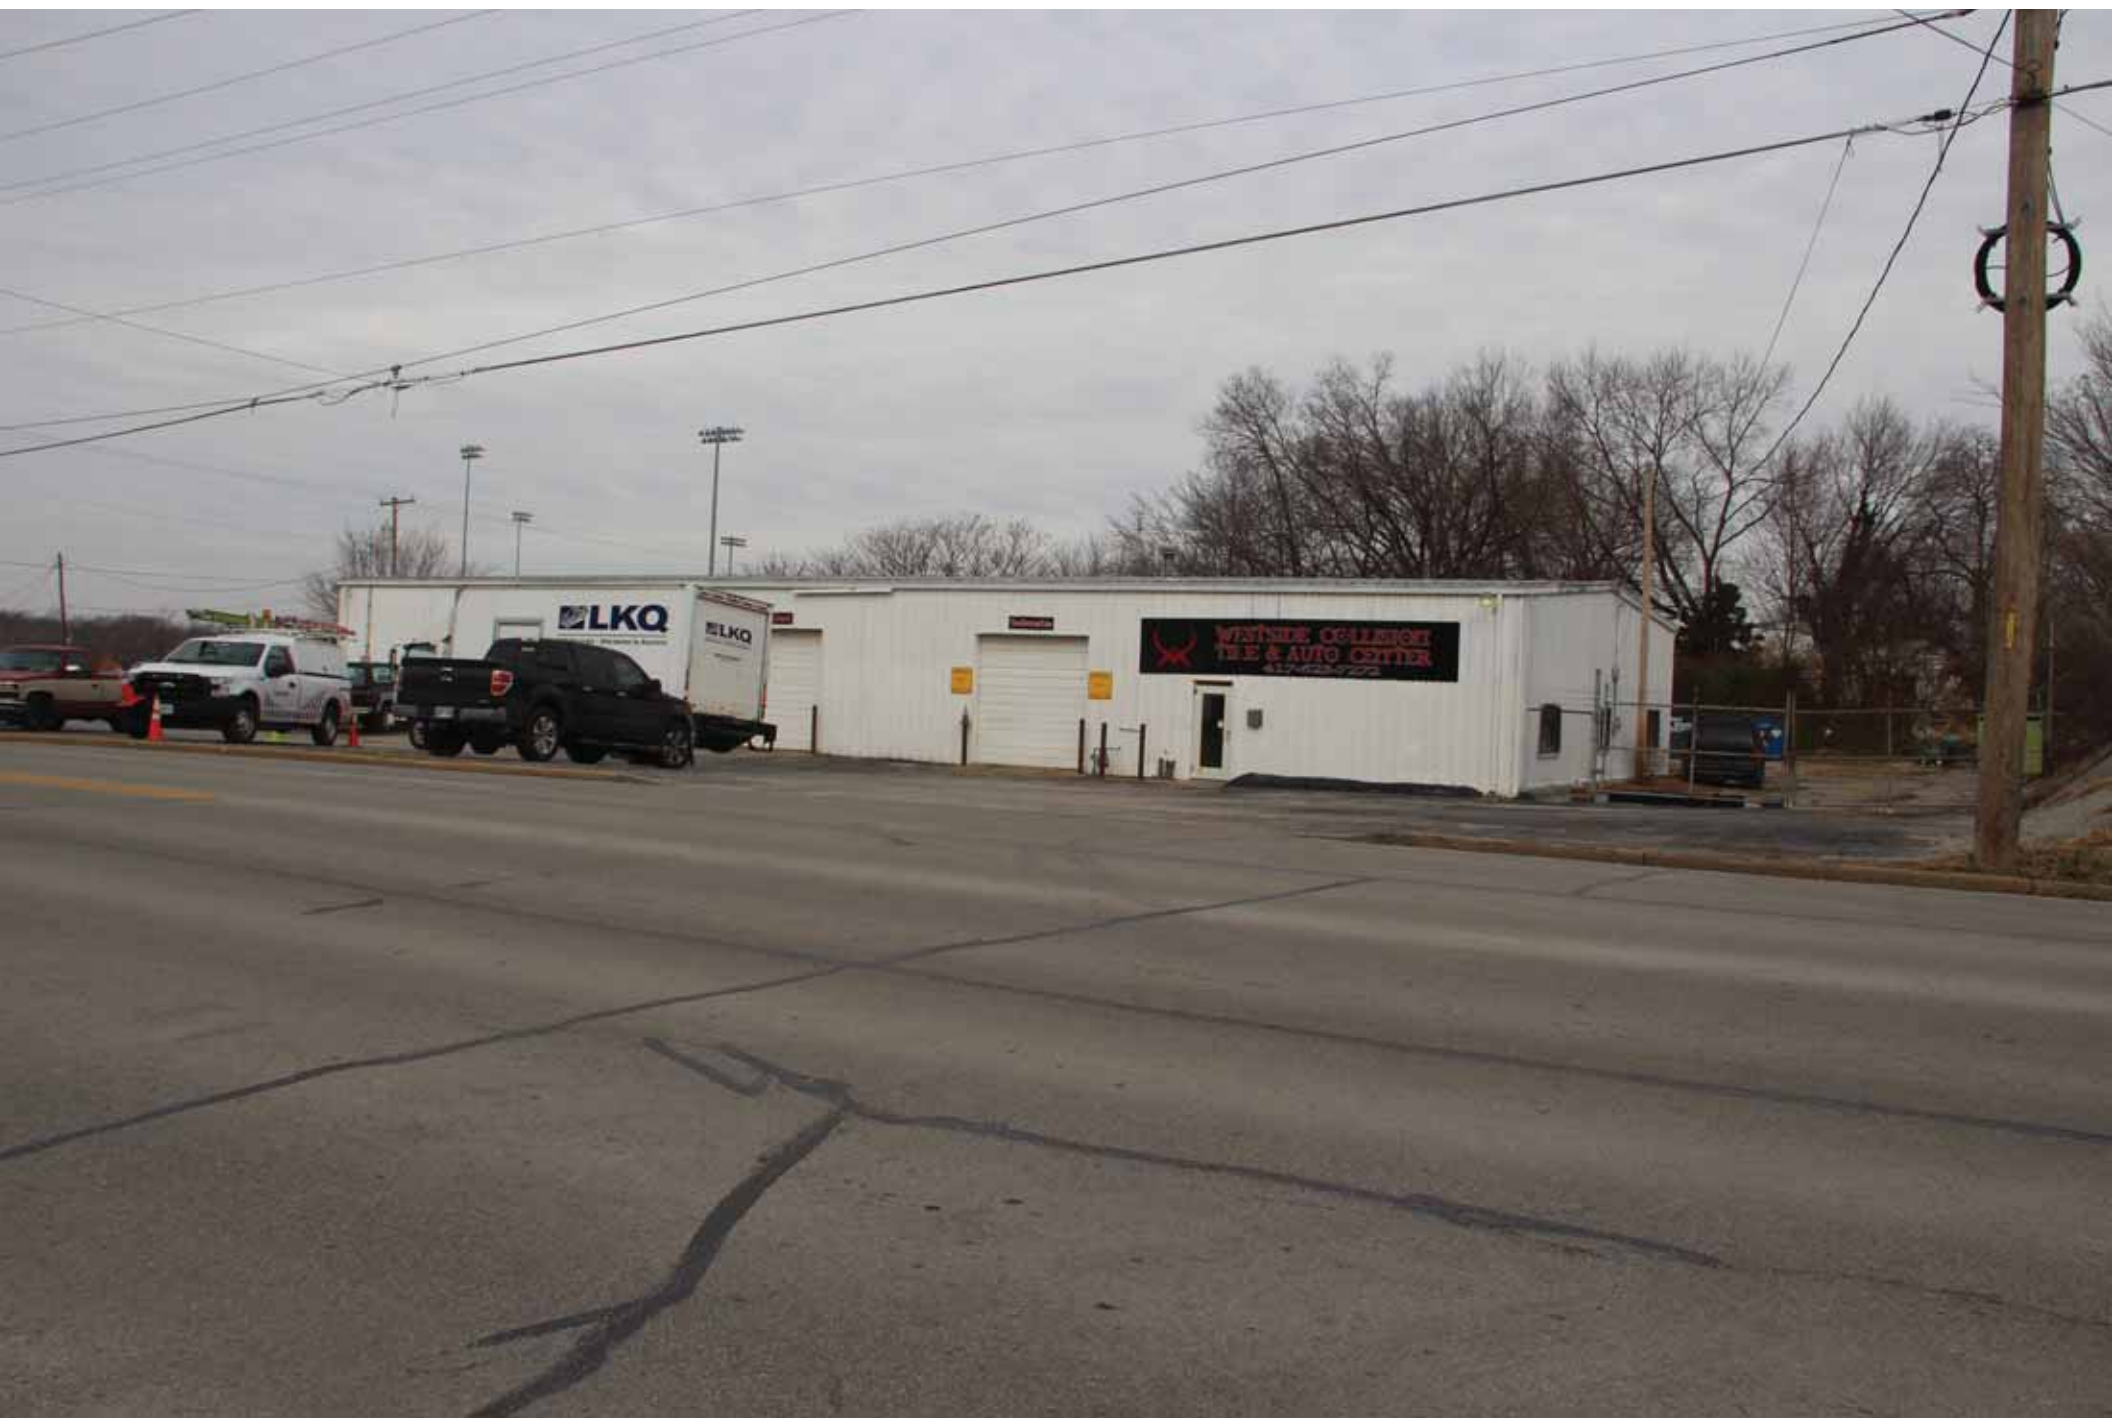
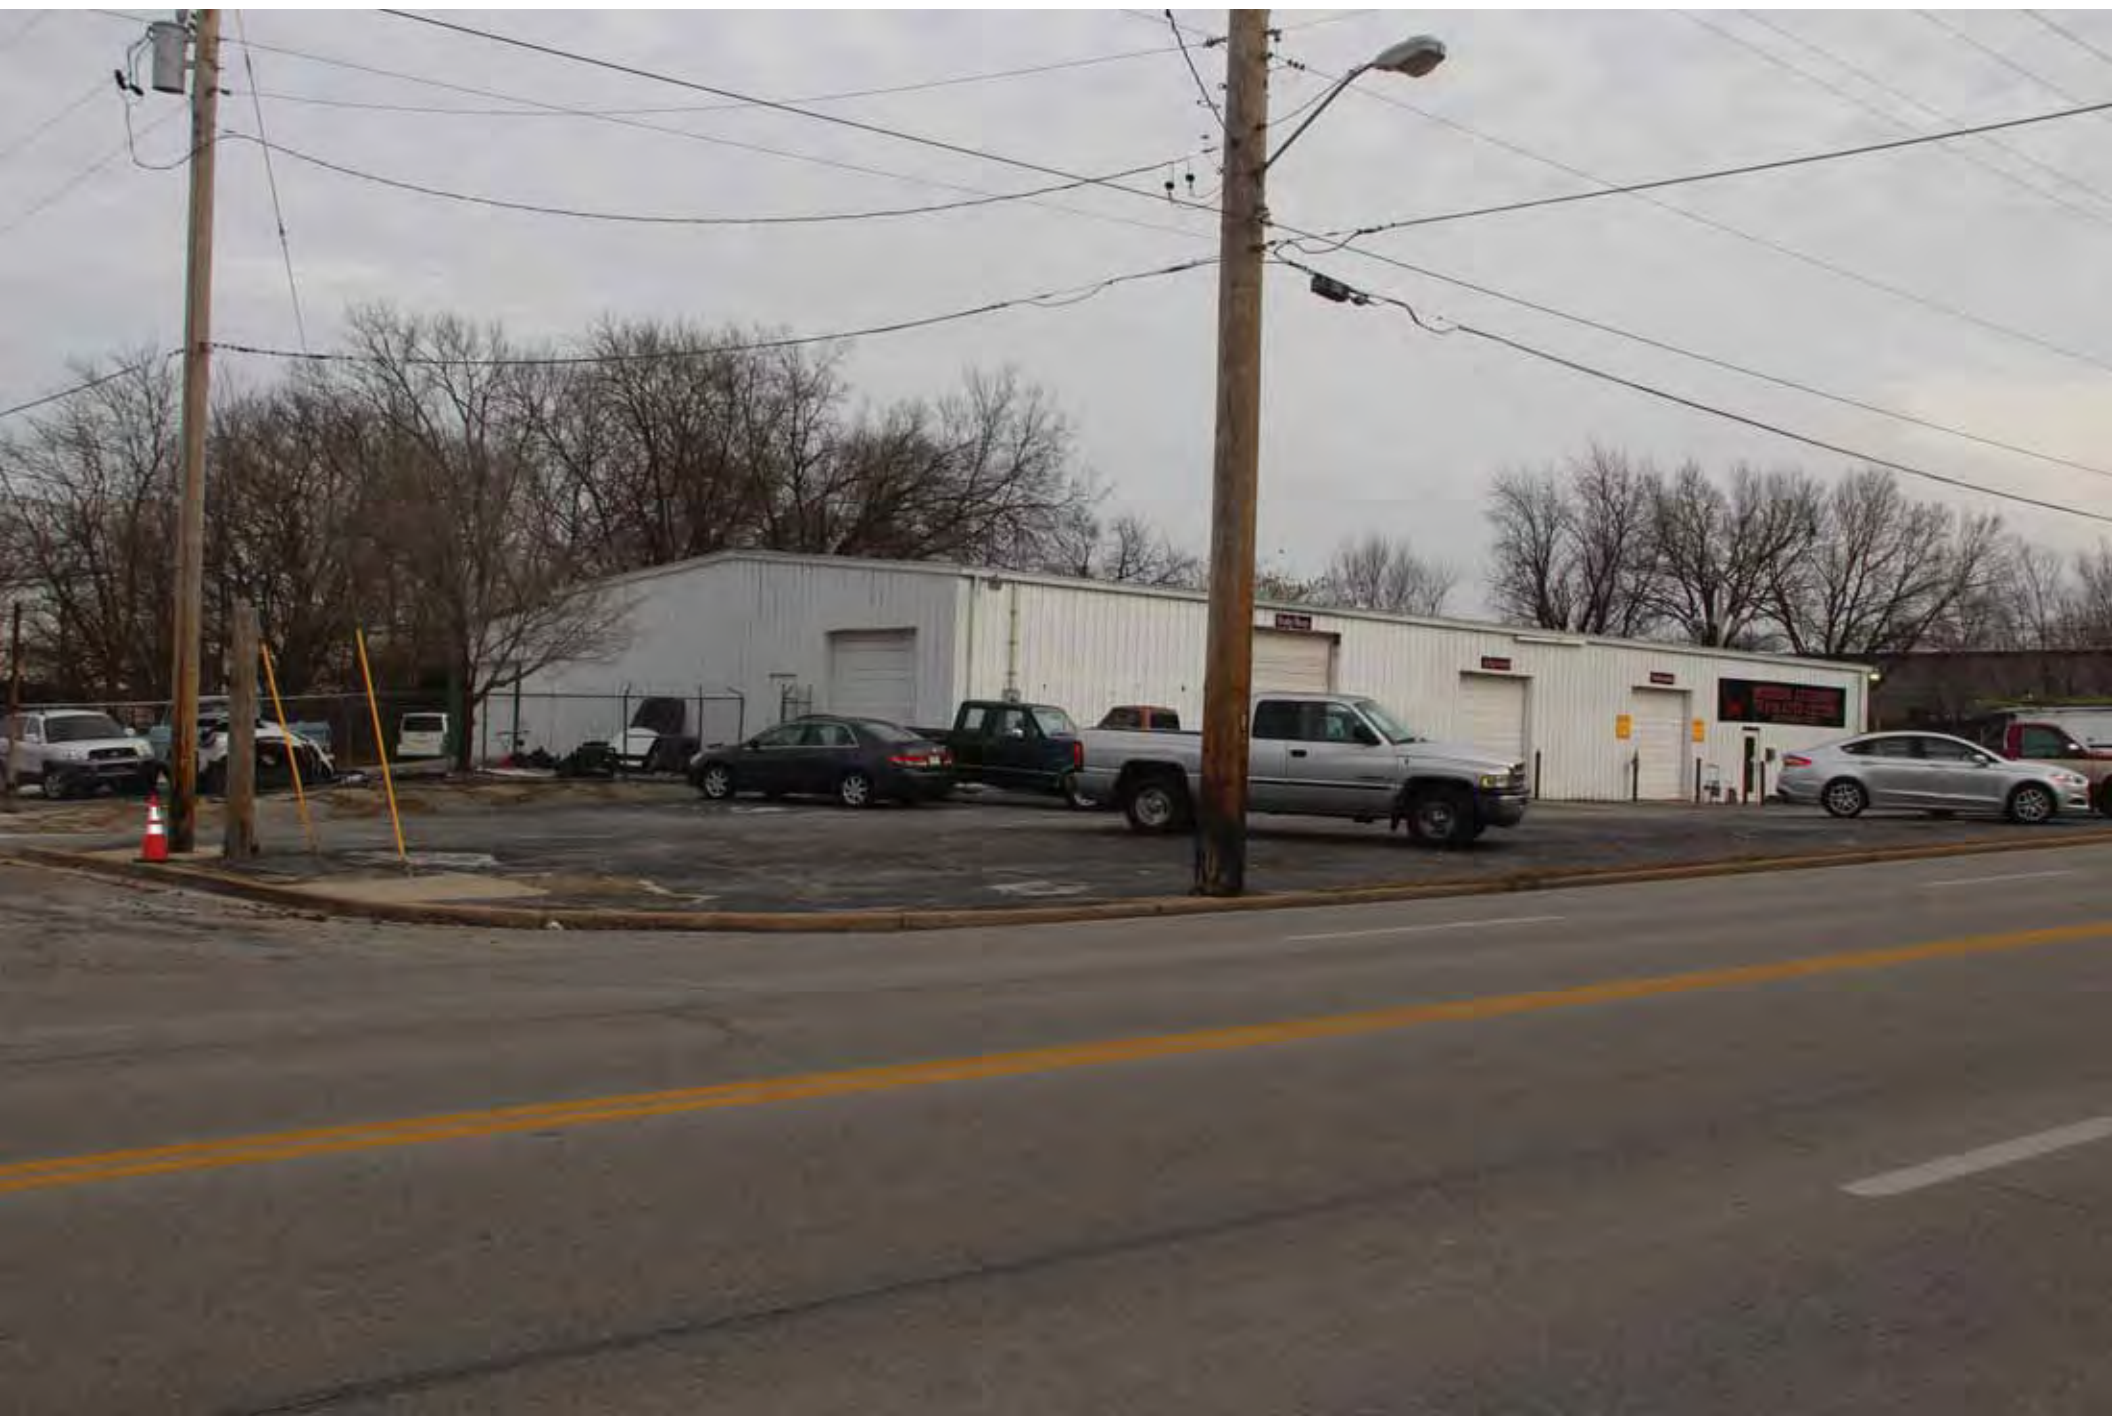
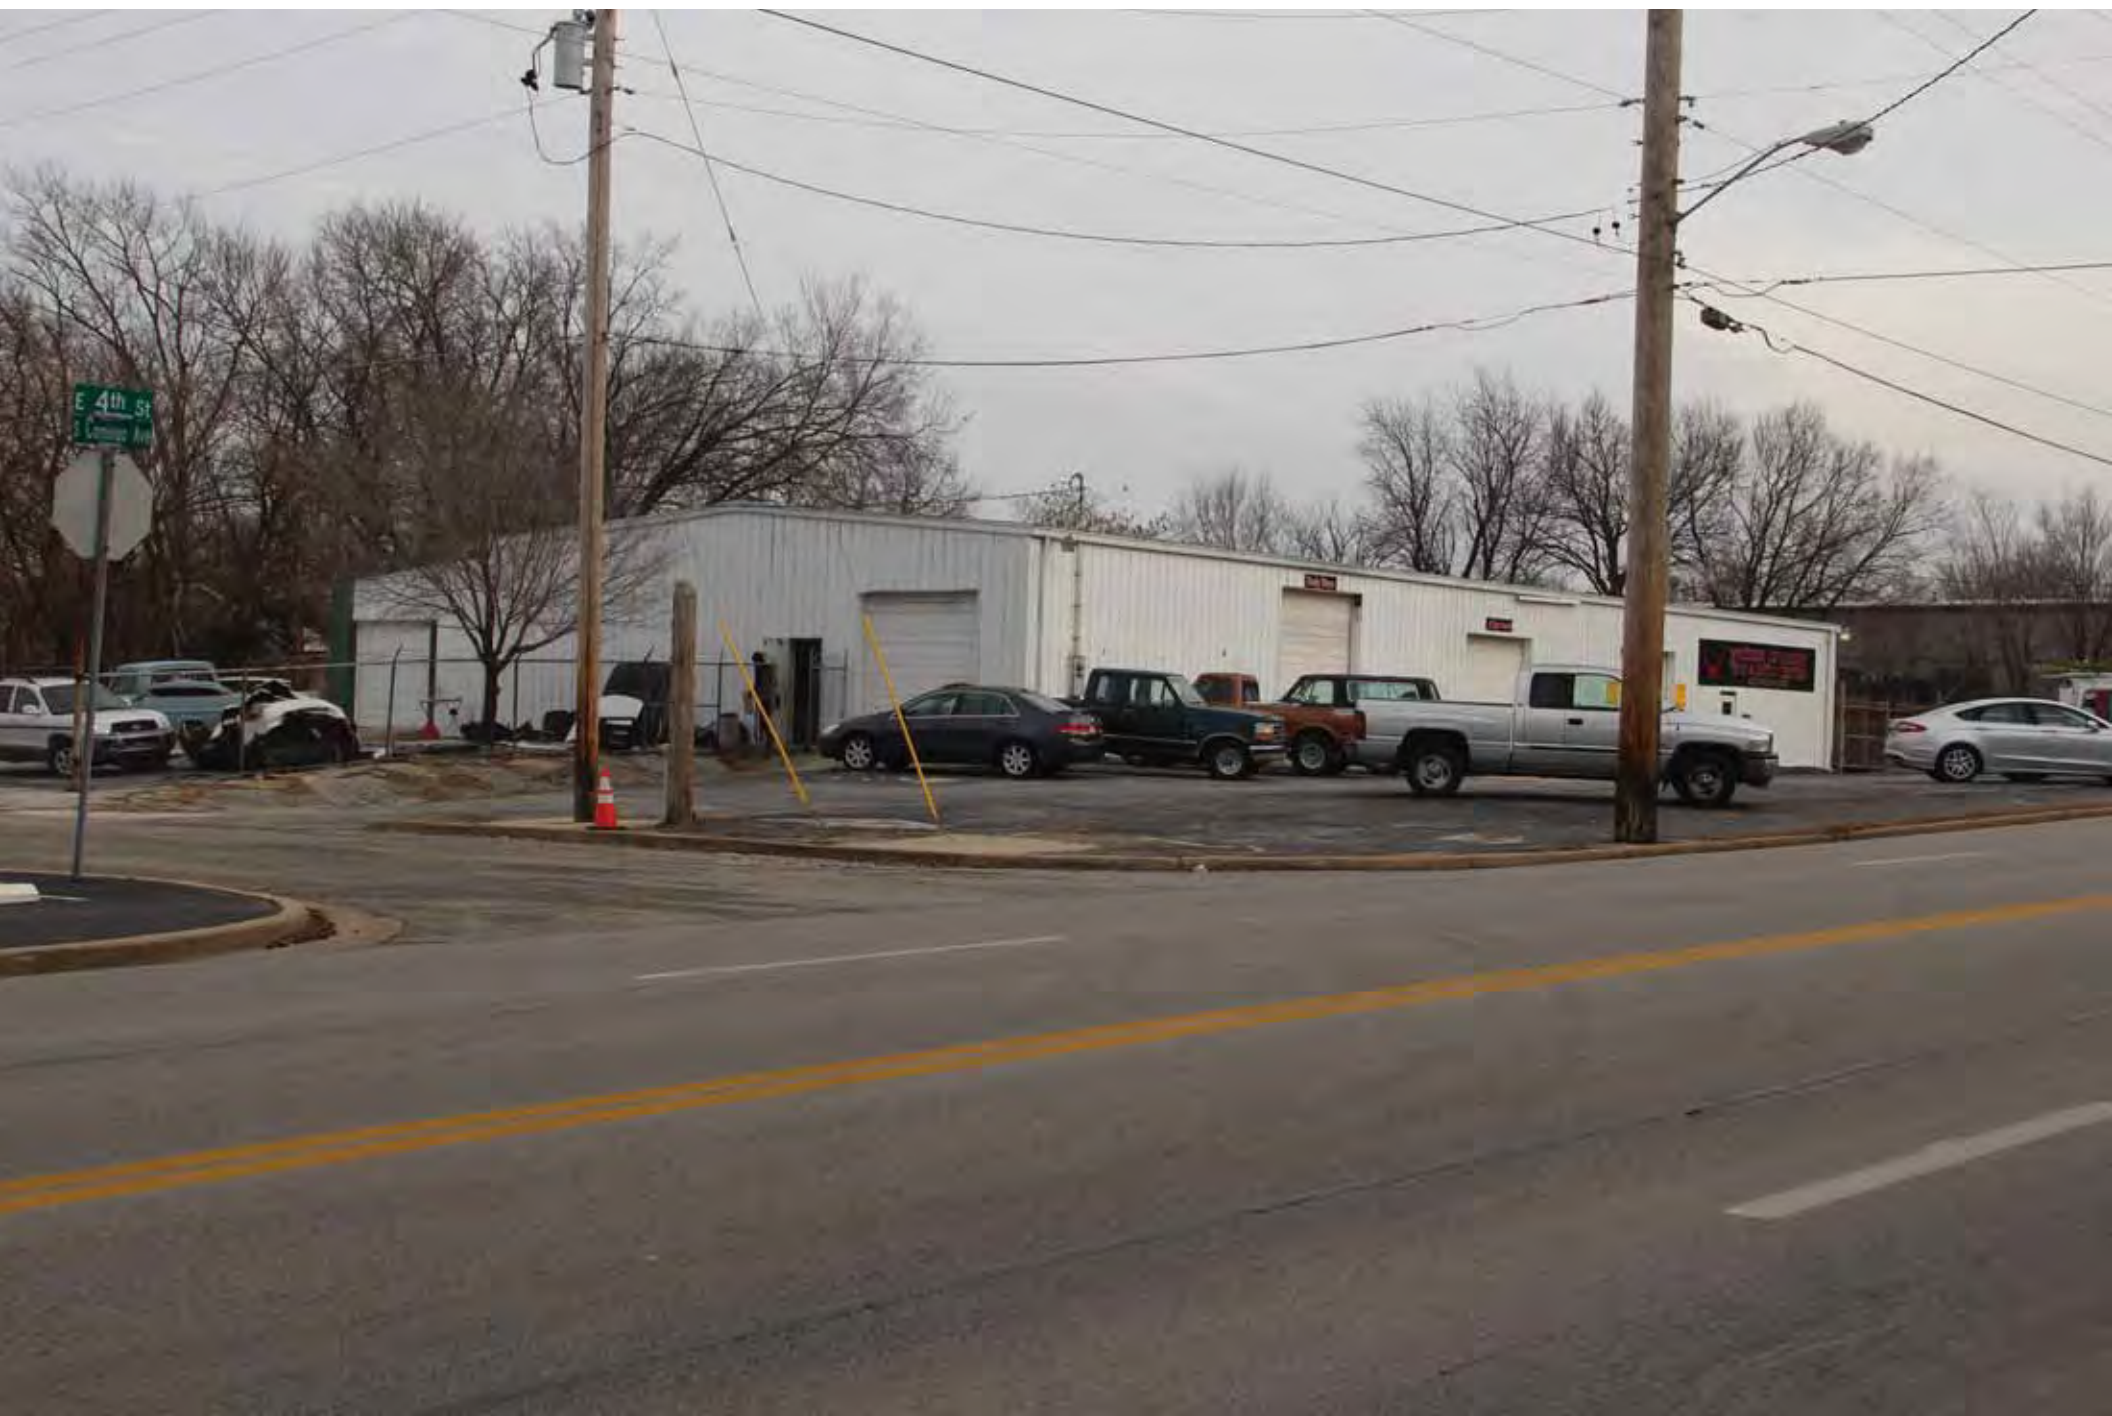
The building associated with this parcel is a 1.0-story rectangular plan prefabricated metal warehouse. The building has a metal low gabled roof, exterior metal walls and a slab concrete foundation. The primary (south) elevation facing E. 4th Street has three overhead track doors covering garage bays and a single pedestrian door. The overhead track doors do not appear original (c. 1990). The pedestrian single-light door appears to have been replaced (c. 2010) and is located at the east end of the elevation. A vinyl sign is attached to the building above the door bearing the name of the current tenant. Smaller vinyl signs above garage bays indicate what each bay is utilized for in relation to the business. The west elevation has two garage bays with c. 1990 overhead track doors and a solid pedestrian door. The east elevation features three single-light commercial windows.
