MISSOURI DEPARTMENT OF NATURAL RESOURCES
STATE HISTORIC PRESERVATION OFFICE, P.O. Box 176, Jefferson City, MO 65102
ARCHITECTURAL/HISTORIC INVENTORY FORM

1. Survey No. JP-AS-007-001		2. Survey name: East Town (Original Joplin) Historic Survey Phase 2	
3. County: JASPER		4. Address (Street No.) 618	Street (name) E. 2 nd Street
5. City: Joplin	Vicinity: <input type="checkbox"/>	6. Geographical Reference:	7. Township/Range/Section: T: R: S:
8. Historic name (if known):		9. Present/other name (if known):	
10. Ownership: <input checked="" type="checkbox"/> Private <input type="checkbox"/> Public		11a. Historic use (if known): Domestic: Single Dwelling	11b. Current use: Domestic: Single Dwelling

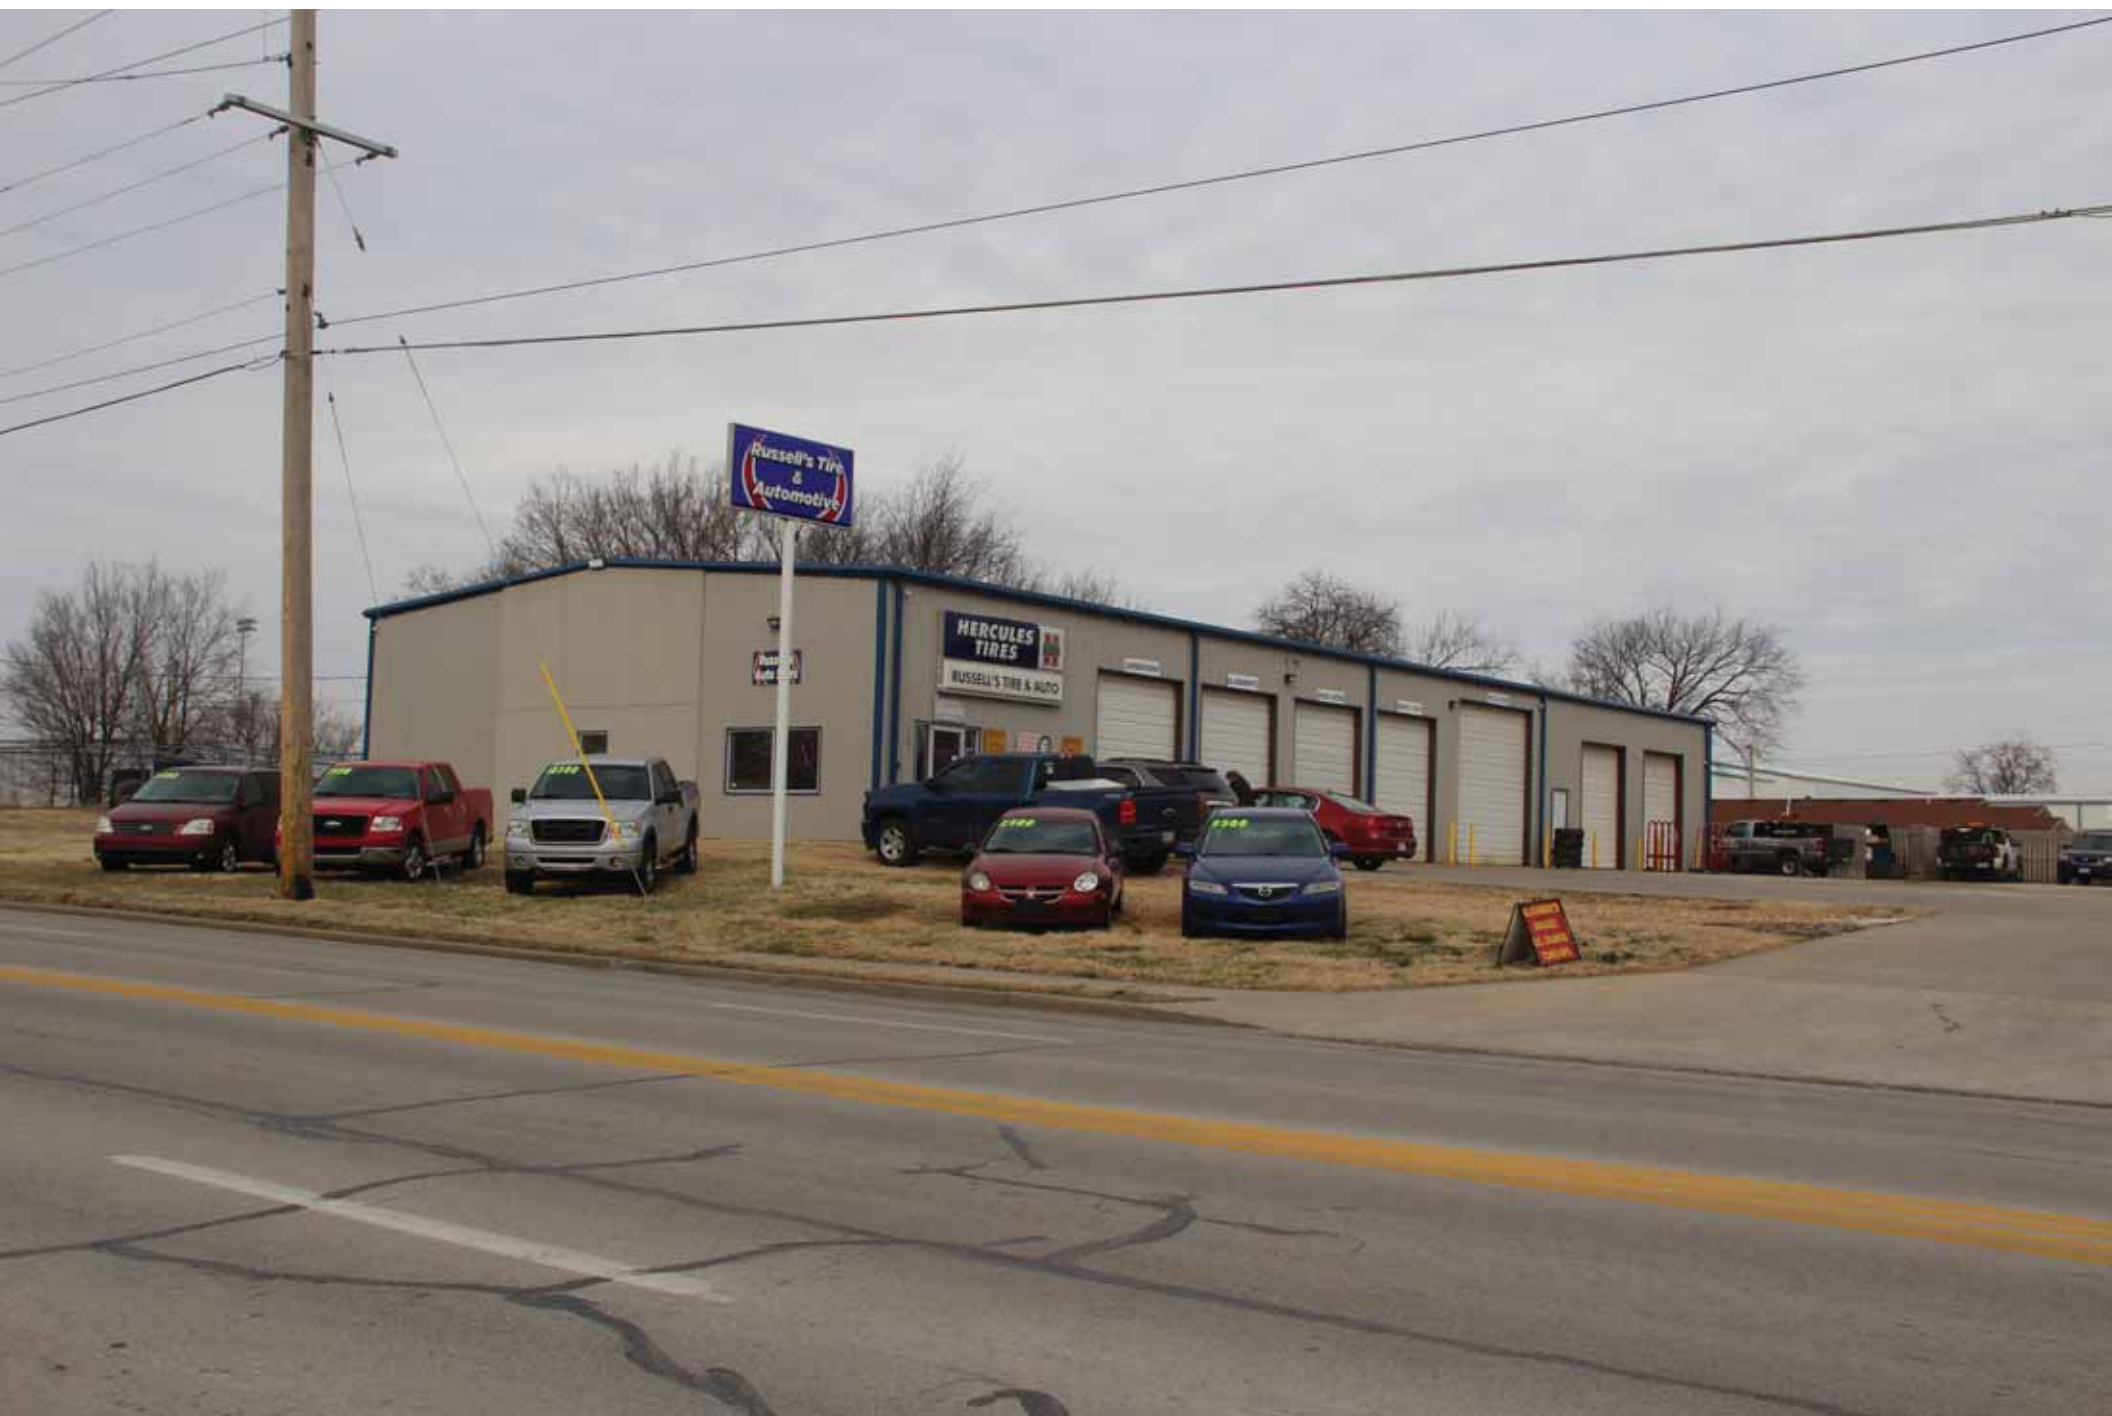
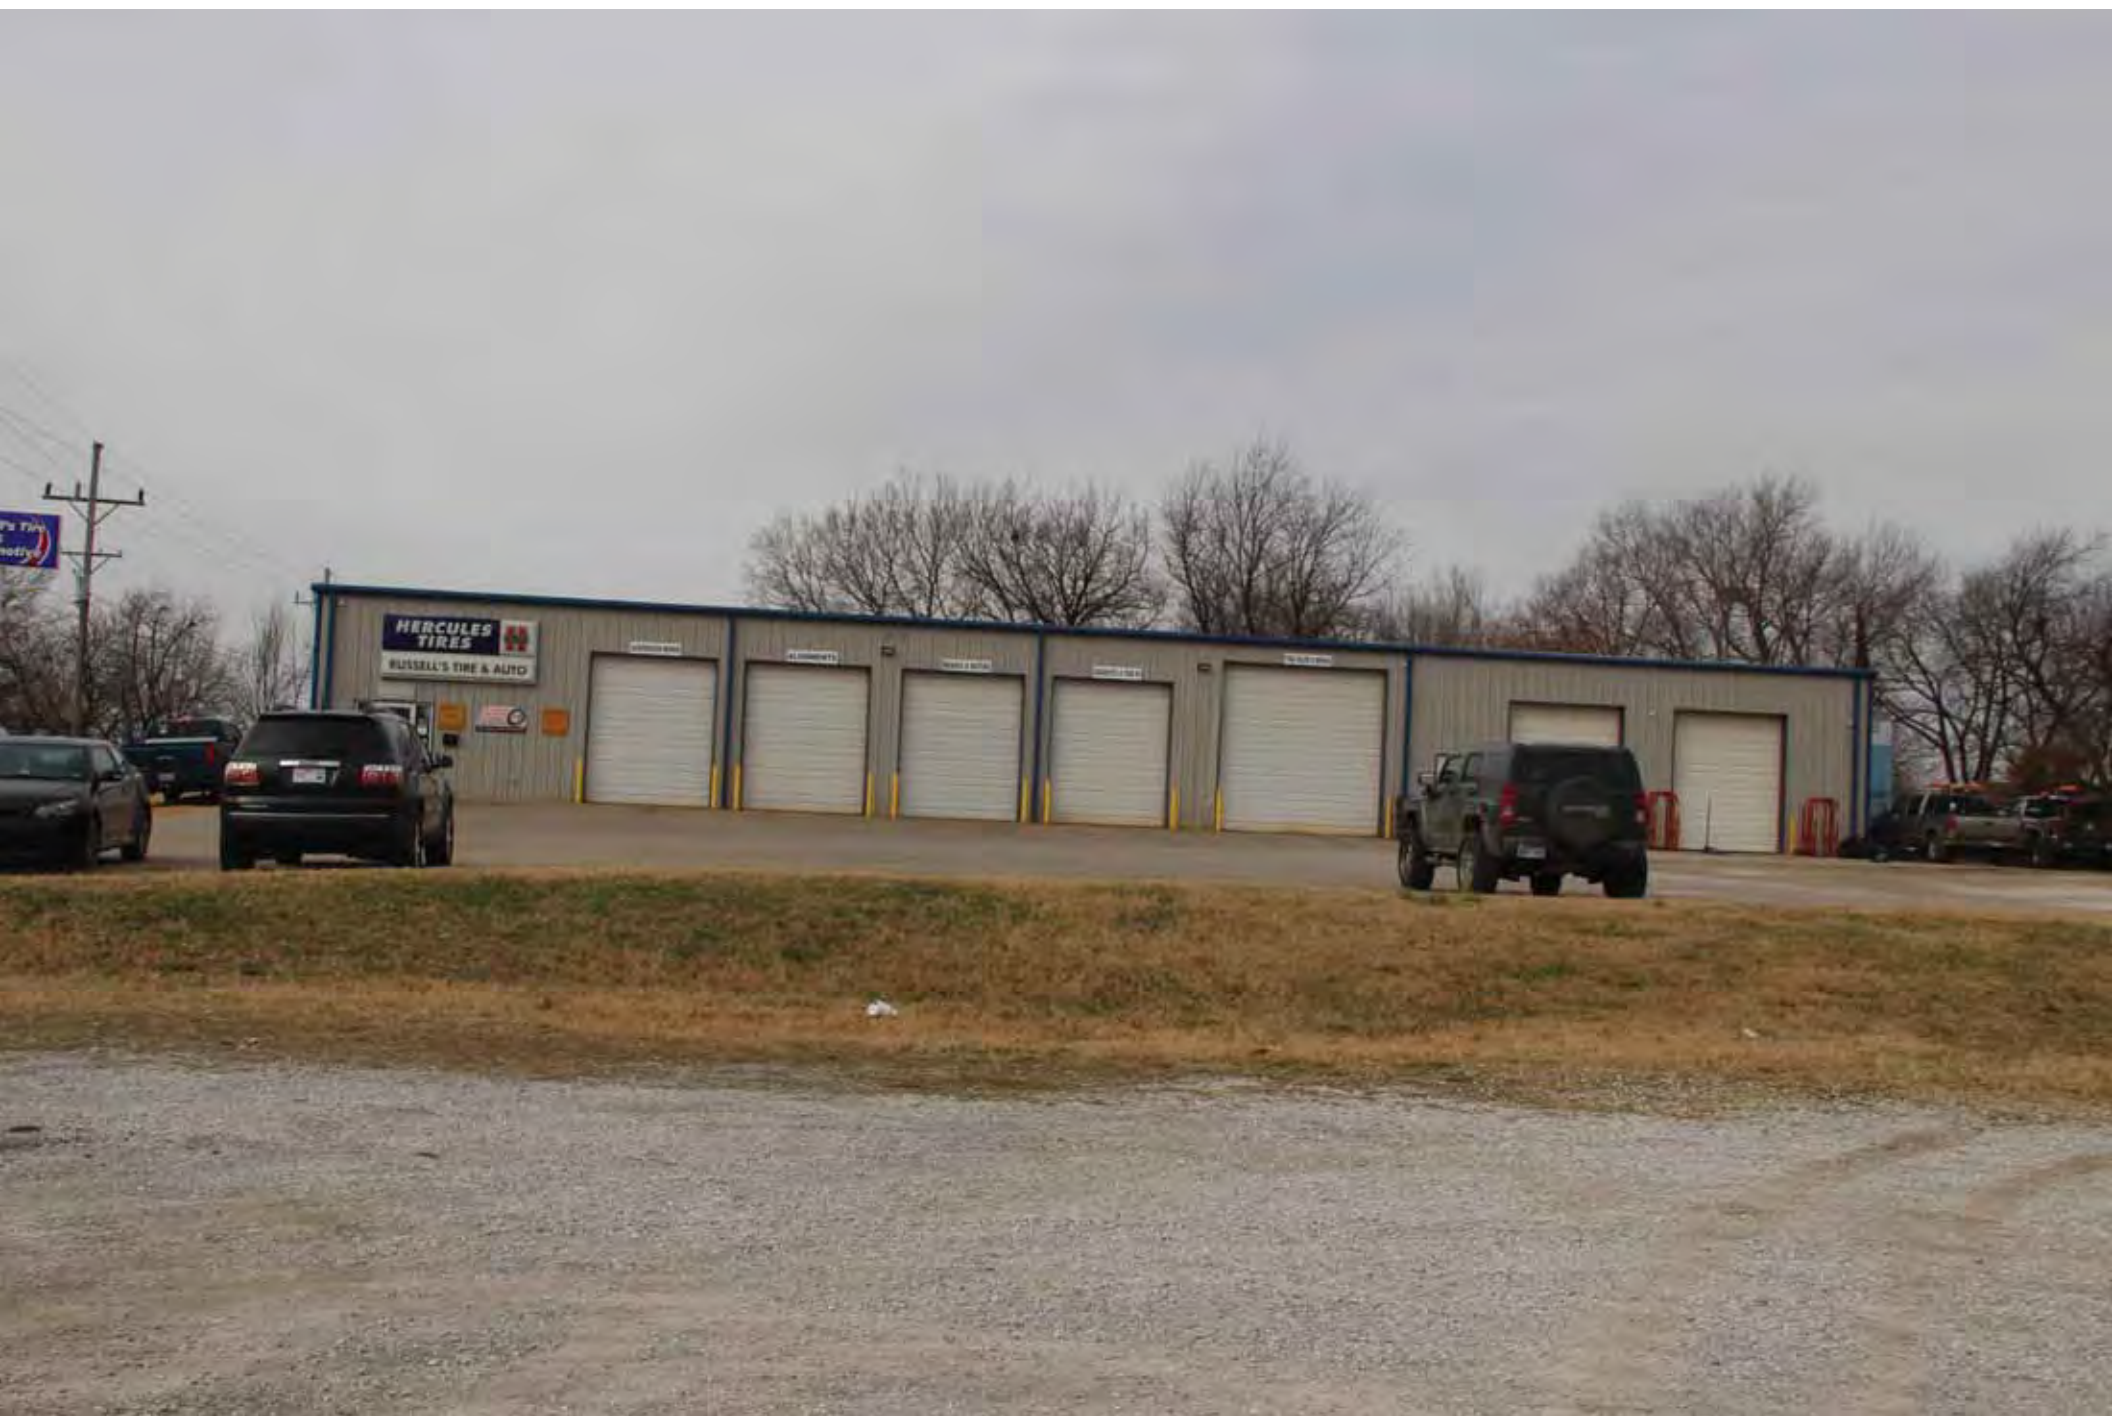
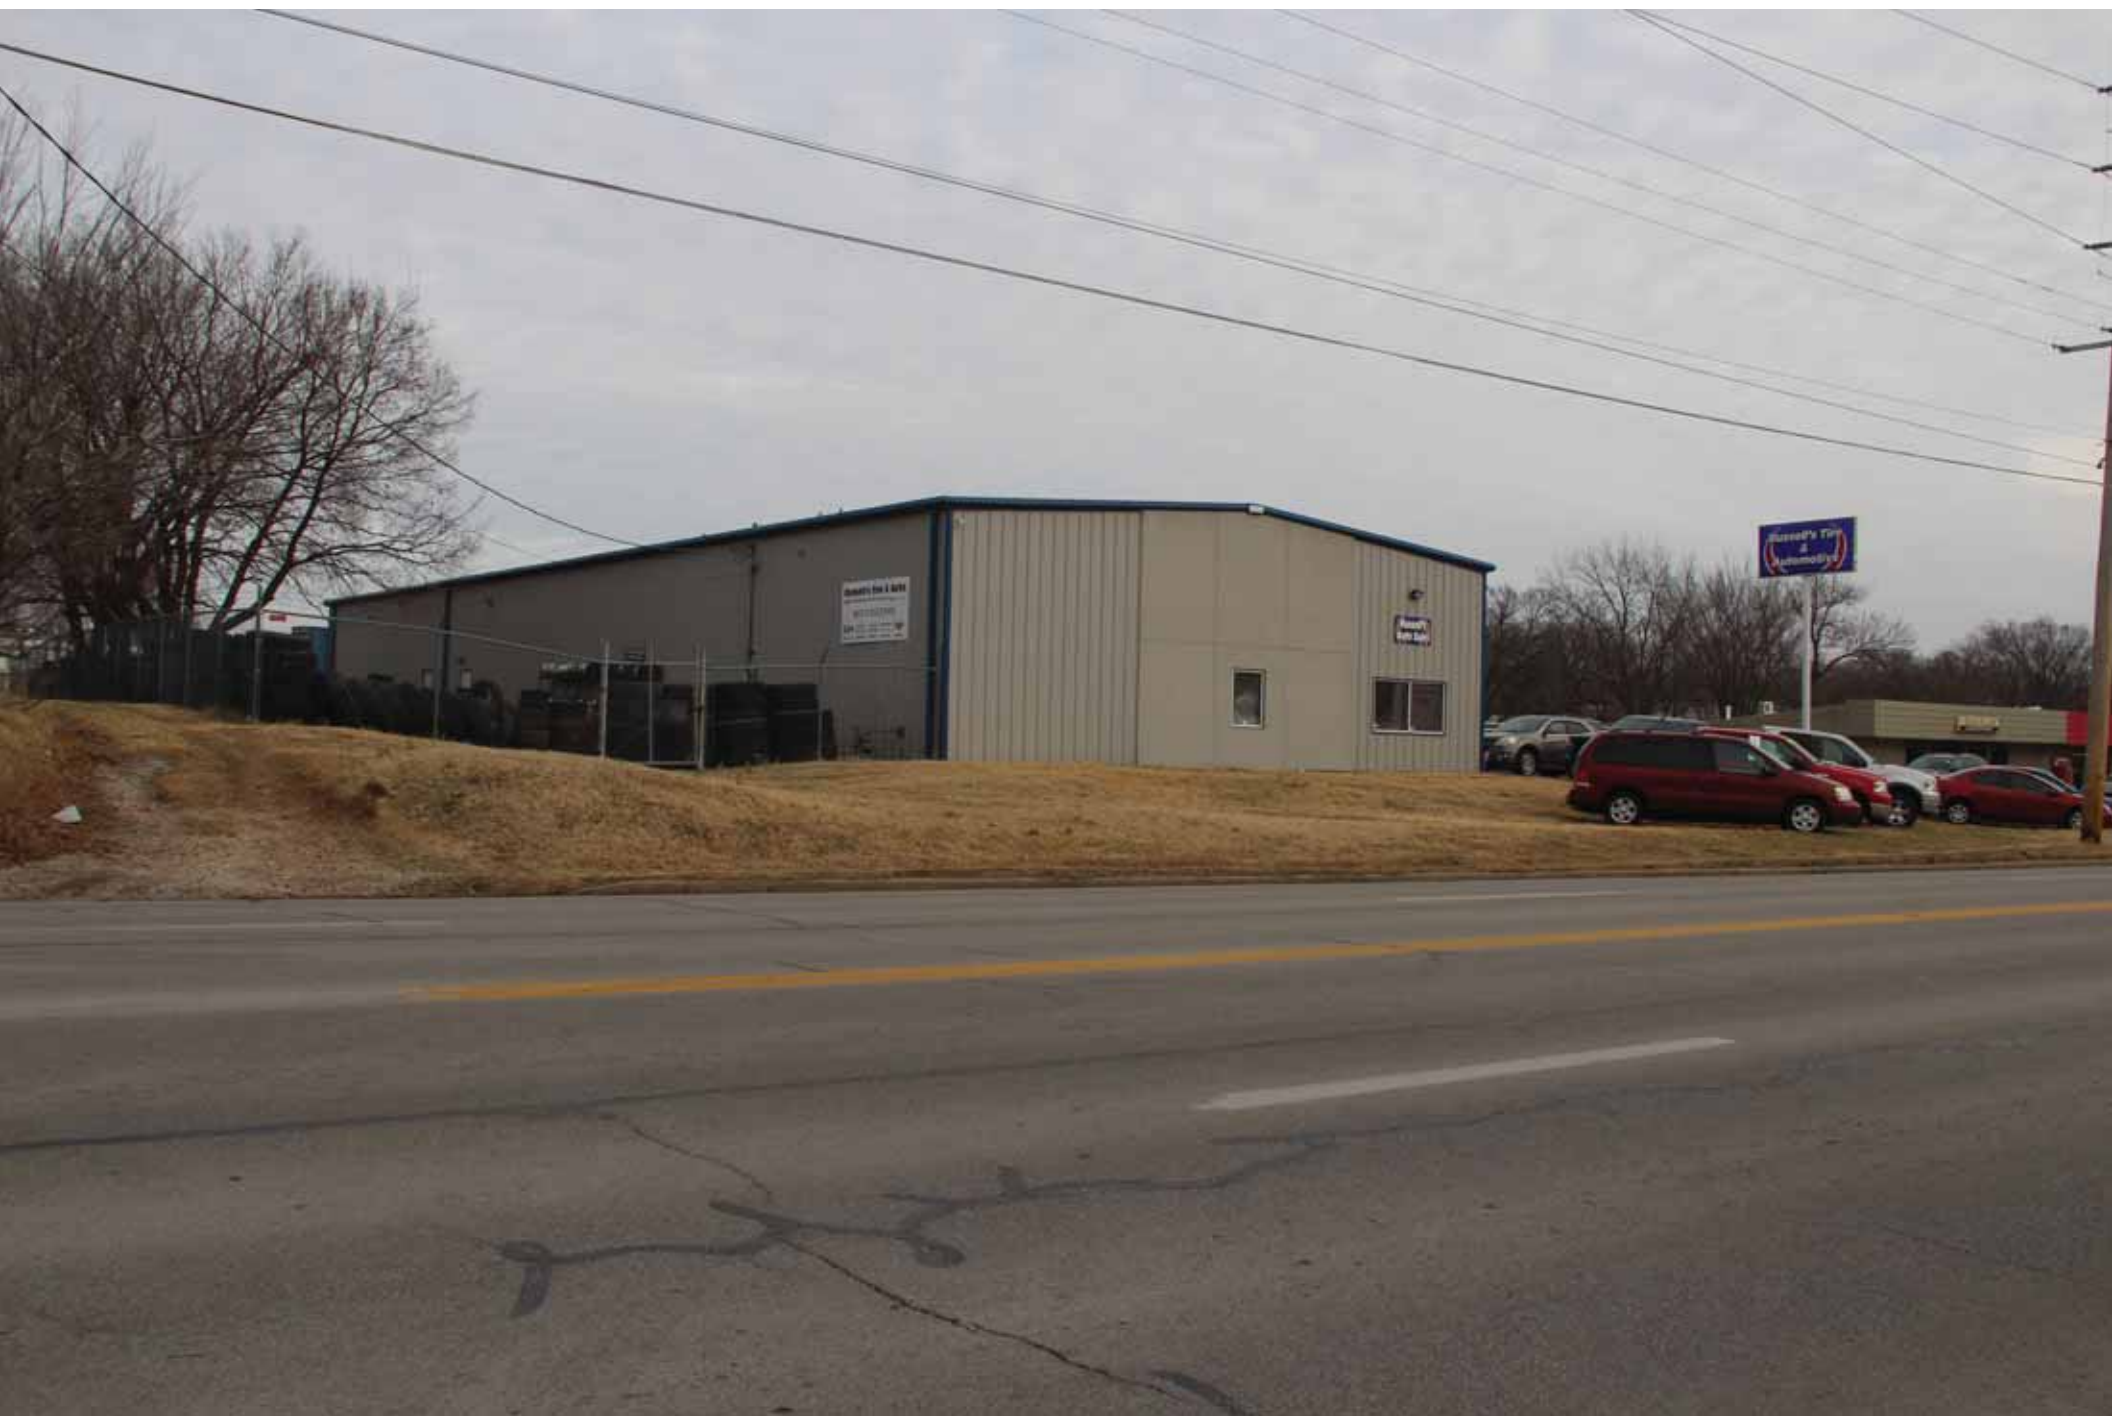
The building associated with this parcel is a 1.0-story rectangular plan prefabricated metal warehouse. The building faces east and has a metal low gabled roof, exterior metal walls and a slab concrete foundation. The south elevation facing E. 4th Street has two windows of single and two-light fixed design. The primary (east) elevation has seven garage bays with overhead track doors. The main commercial entrance is situated at the south end of this elevation. The entry bay holds a glass and aluminum commercial door with single-light sidelights. A plastic sign bearing the name of the business is attached to the building above the entrance. Another pedestrian entrance (service access) is situated near the north end of the elevation. This entry bay is filled with a solid metal door. Some of the garage bays have small metal signs affixed above them, identifying the type of service performed within each bay. Secondary signs with the business name are attached to the south (side) and rear (west) elevations. The rear (west) elevation has two entrances, each filled with a solid metal door.
