MISSOURI DEPARTMENT OF NATURAL RESOURCES
STATE HISTORIC PRESERVATION OFFICE, P.O. Box 176, Jefferson City, MO 65102
ARCHITECTURAL/HISTORIC INVENTORY FORM

1. Survey No. JP-AS-007-001		2. Survey name: East Town (Original Joplin) Historic Survey Phase 2	
3. County: JASPER		4. Address (Street No.) 618	Street (name) E. 2 nd Street
5. City: Joplin	Vicinity: <input type="checkbox"/>	6. Geographical Reference:	7. Township/Range/Section: T: R: S:
8. Historic name (if known):		9. Present/other name (if known):	
10. Ownership: <input checked="" type="checkbox"/> Private <input type="checkbox"/> Public		11a. Historic use (if known): Domestic: Single Dwelling	11b. Current use: Domestic: Single Dwelling

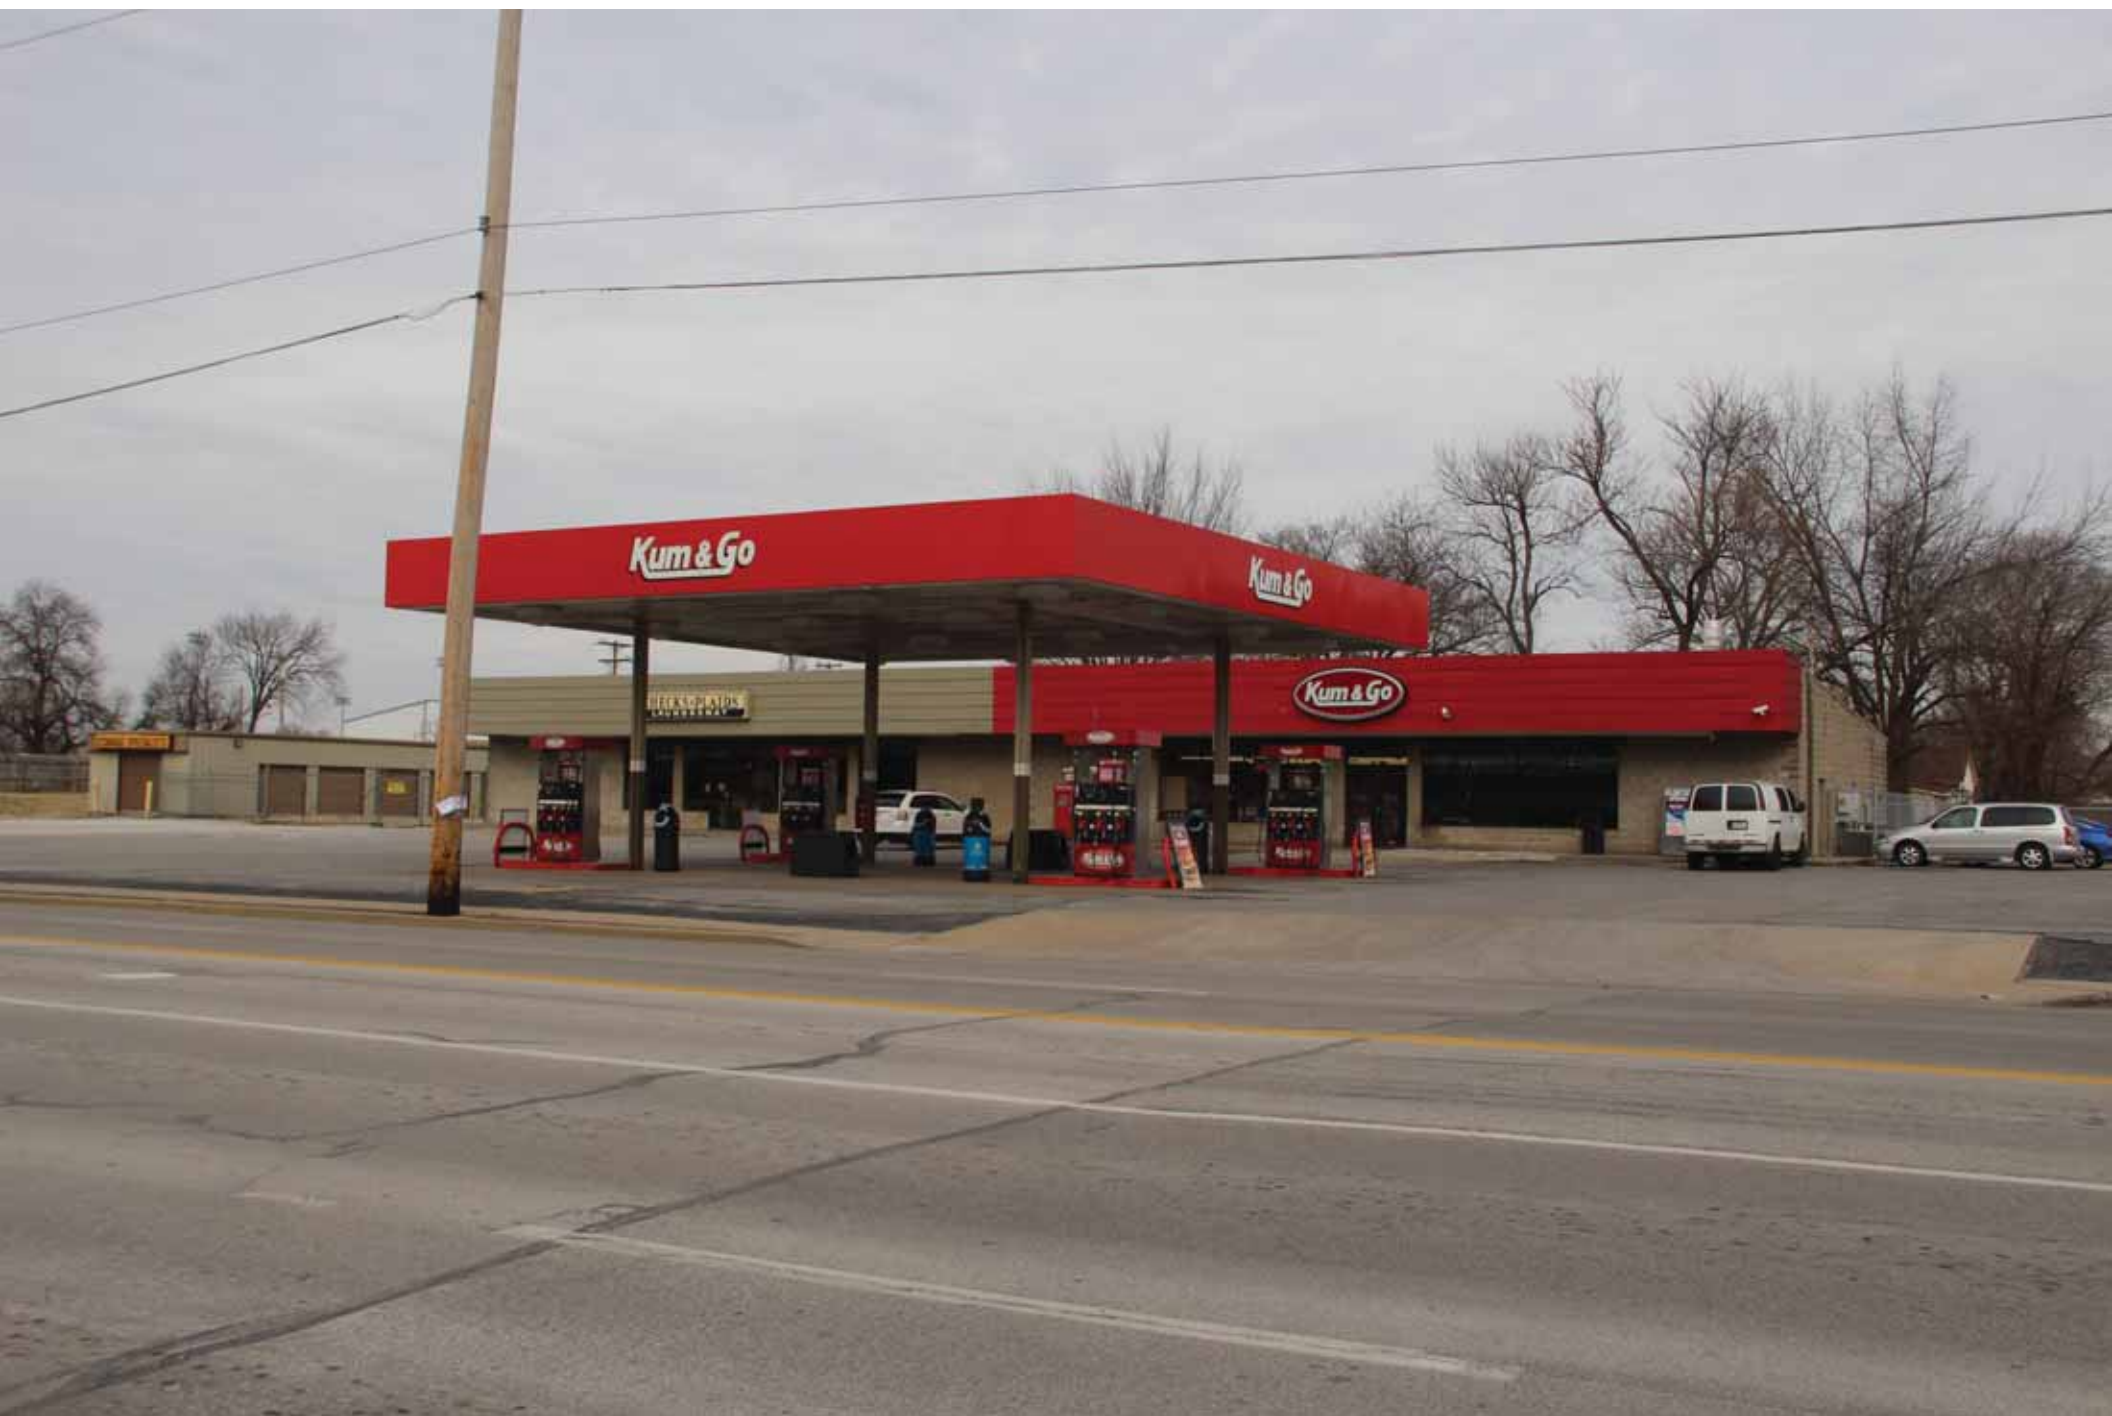
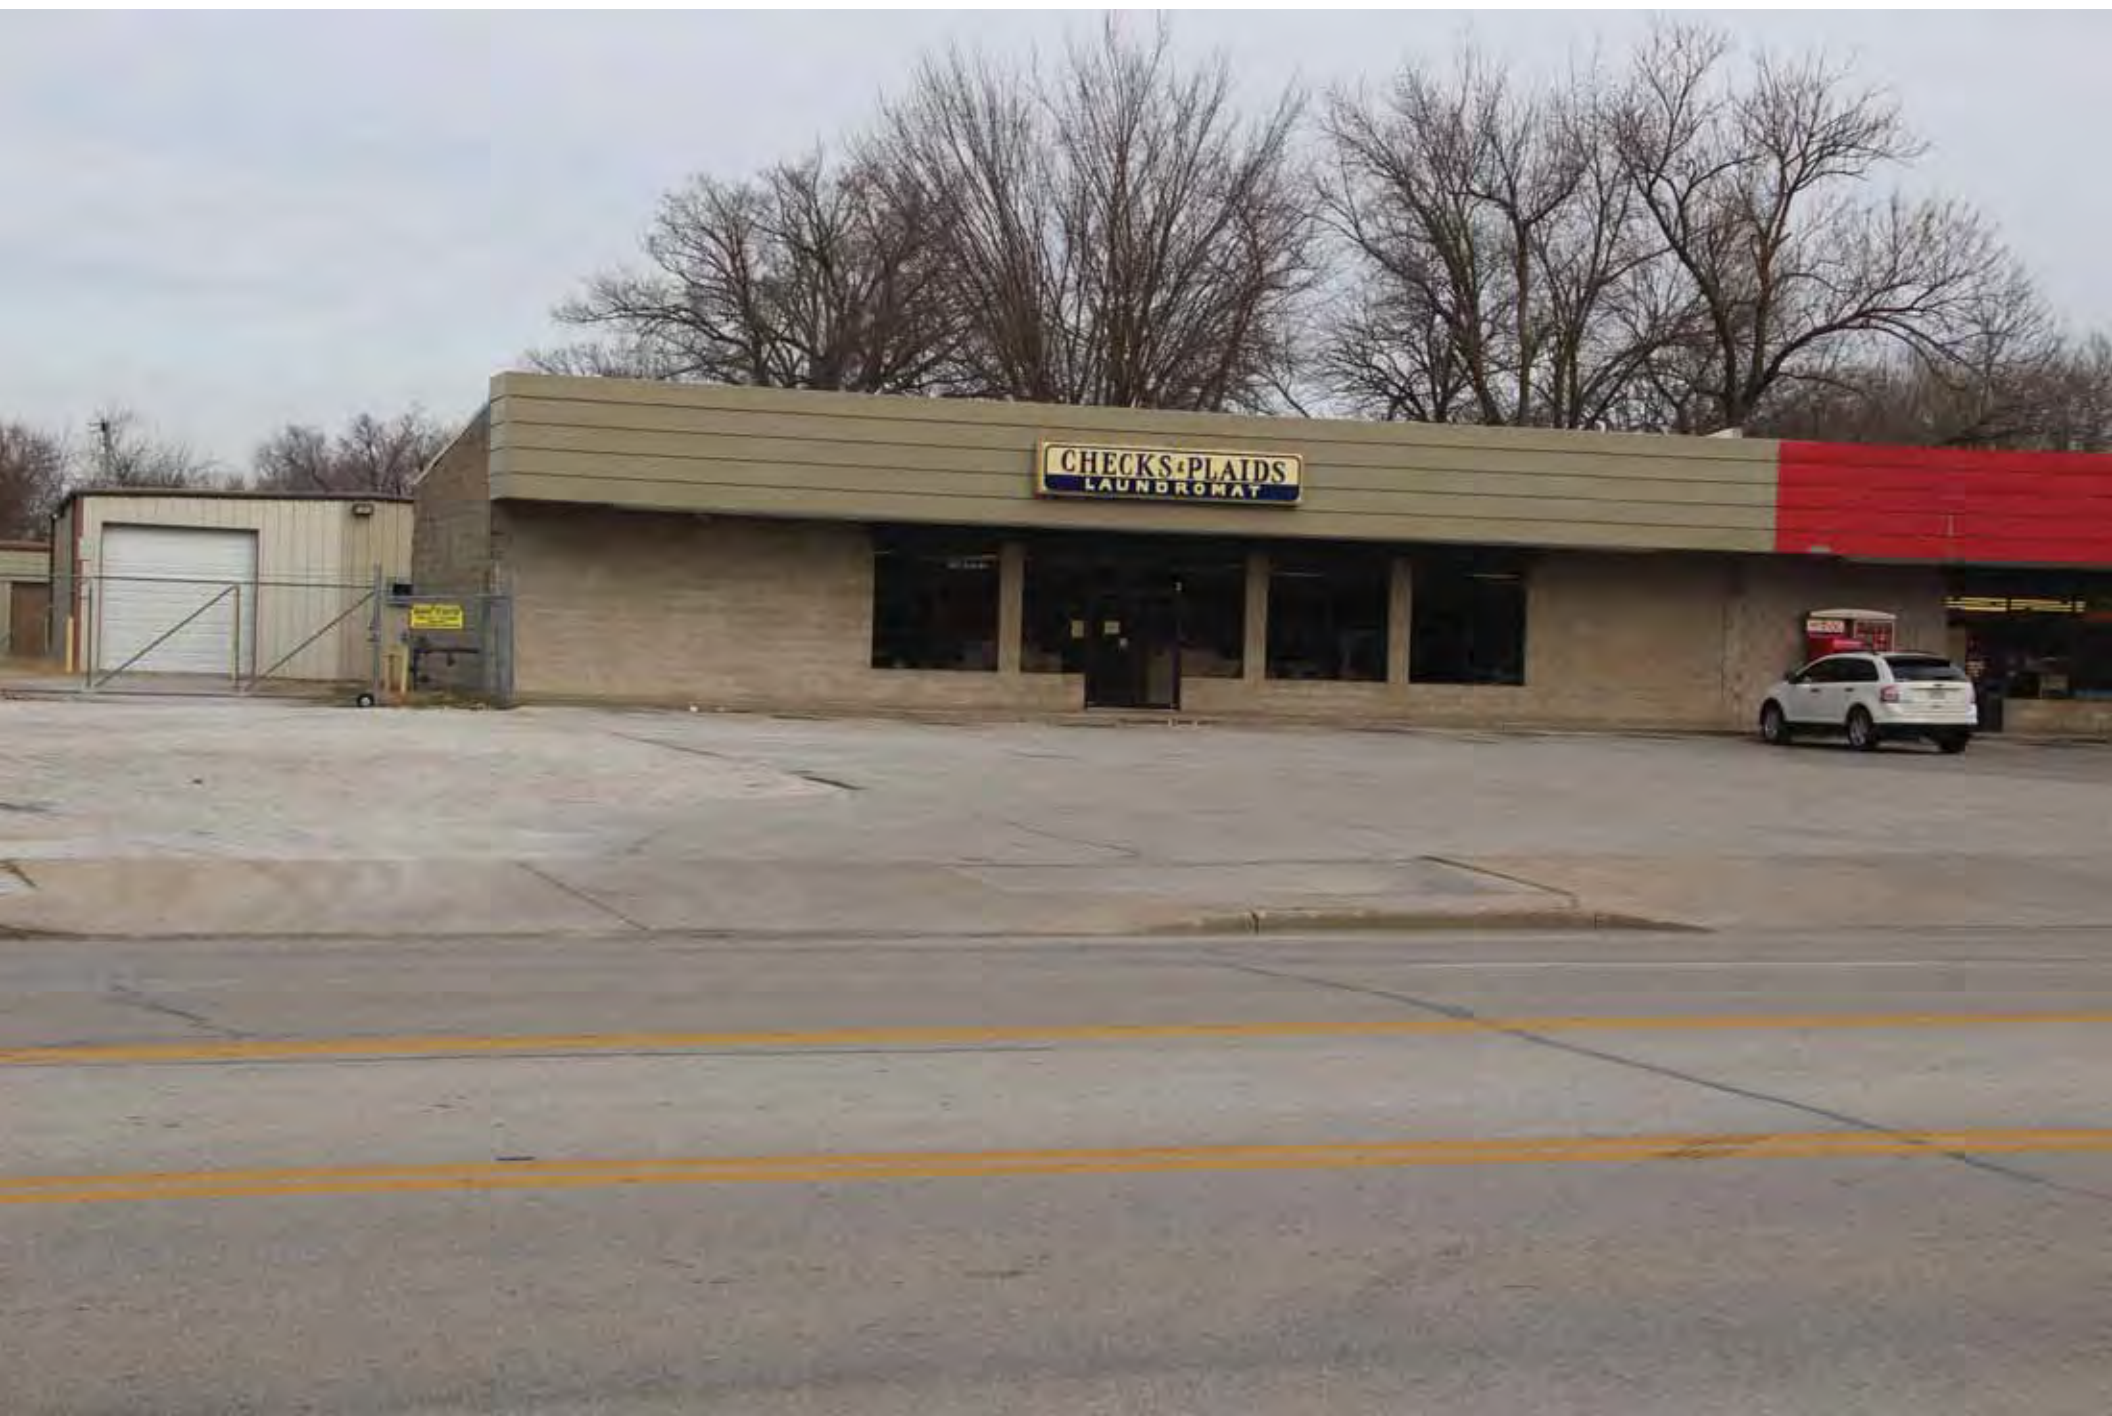
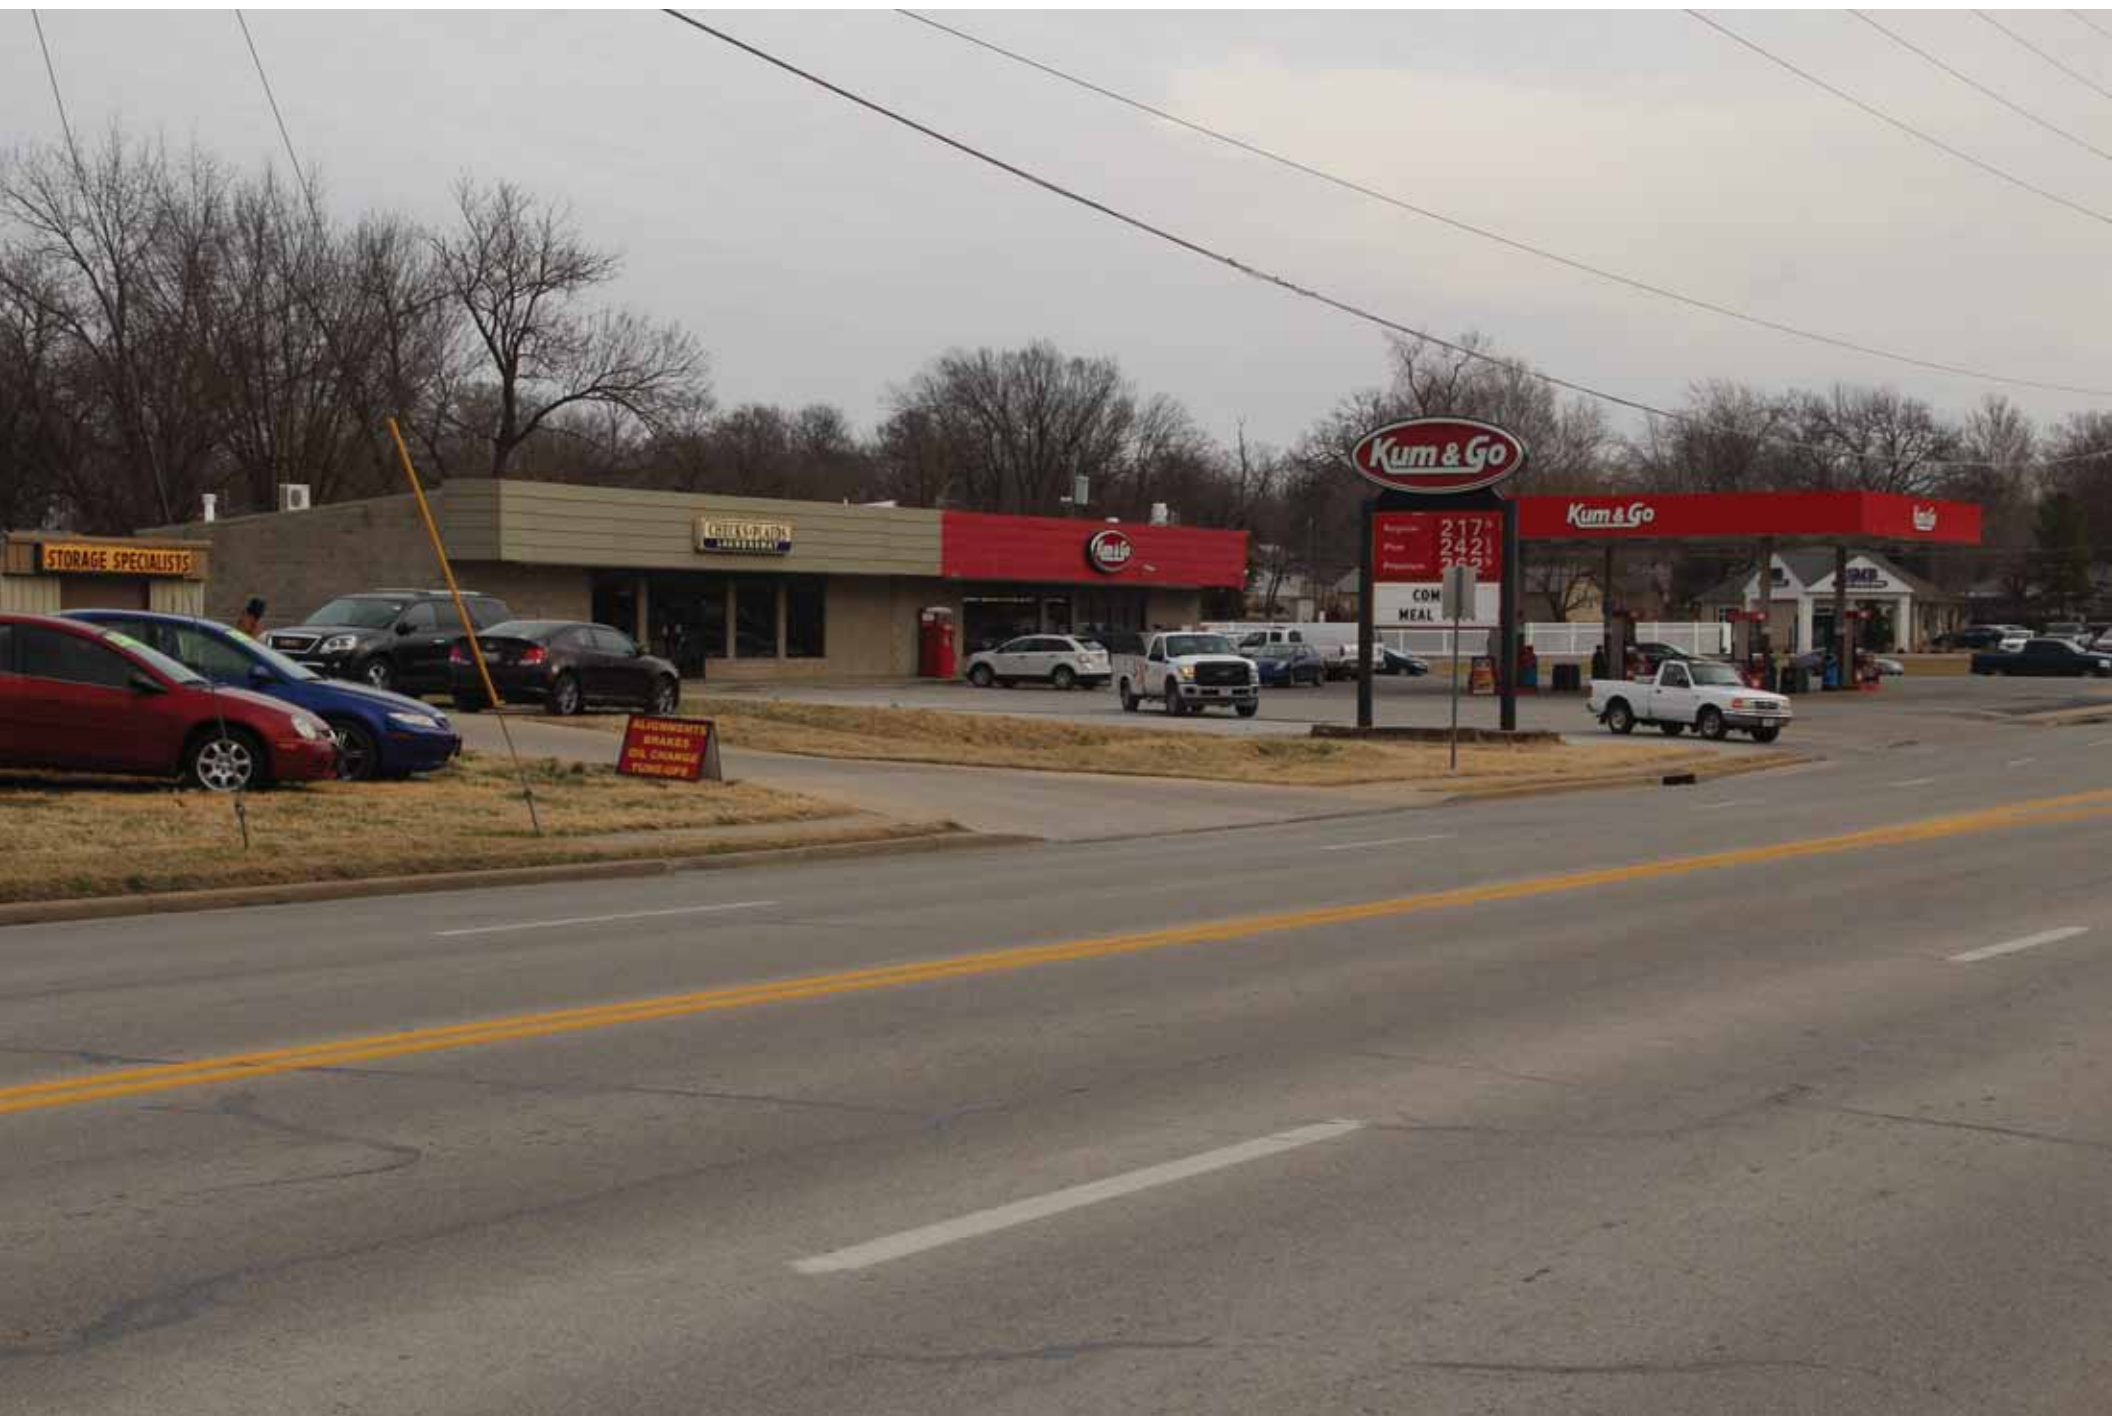
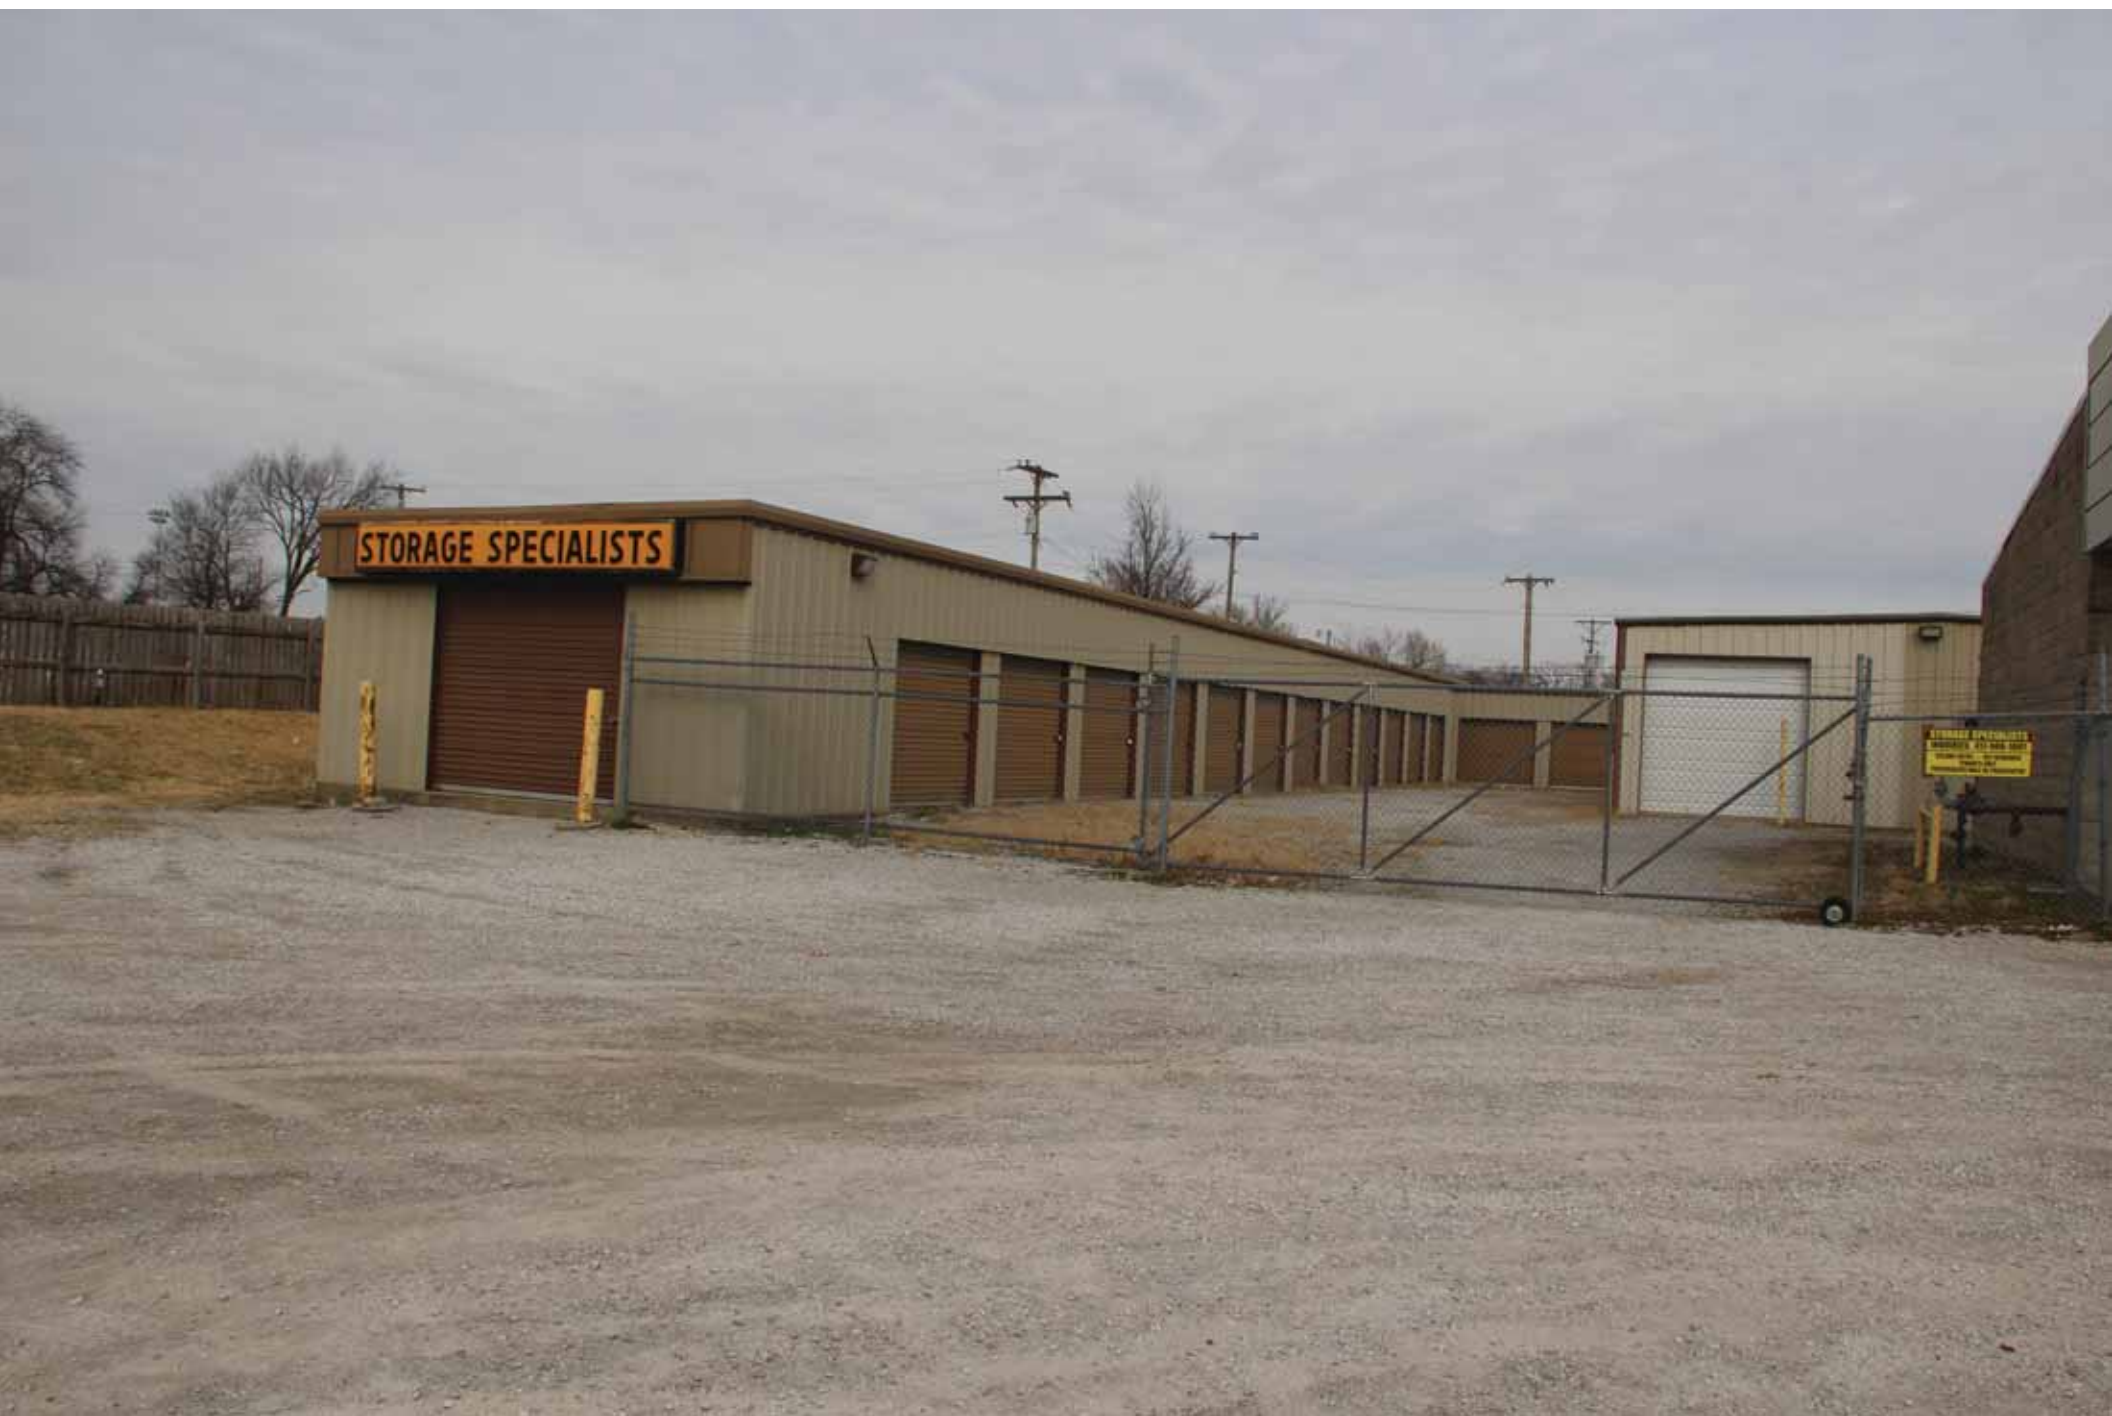
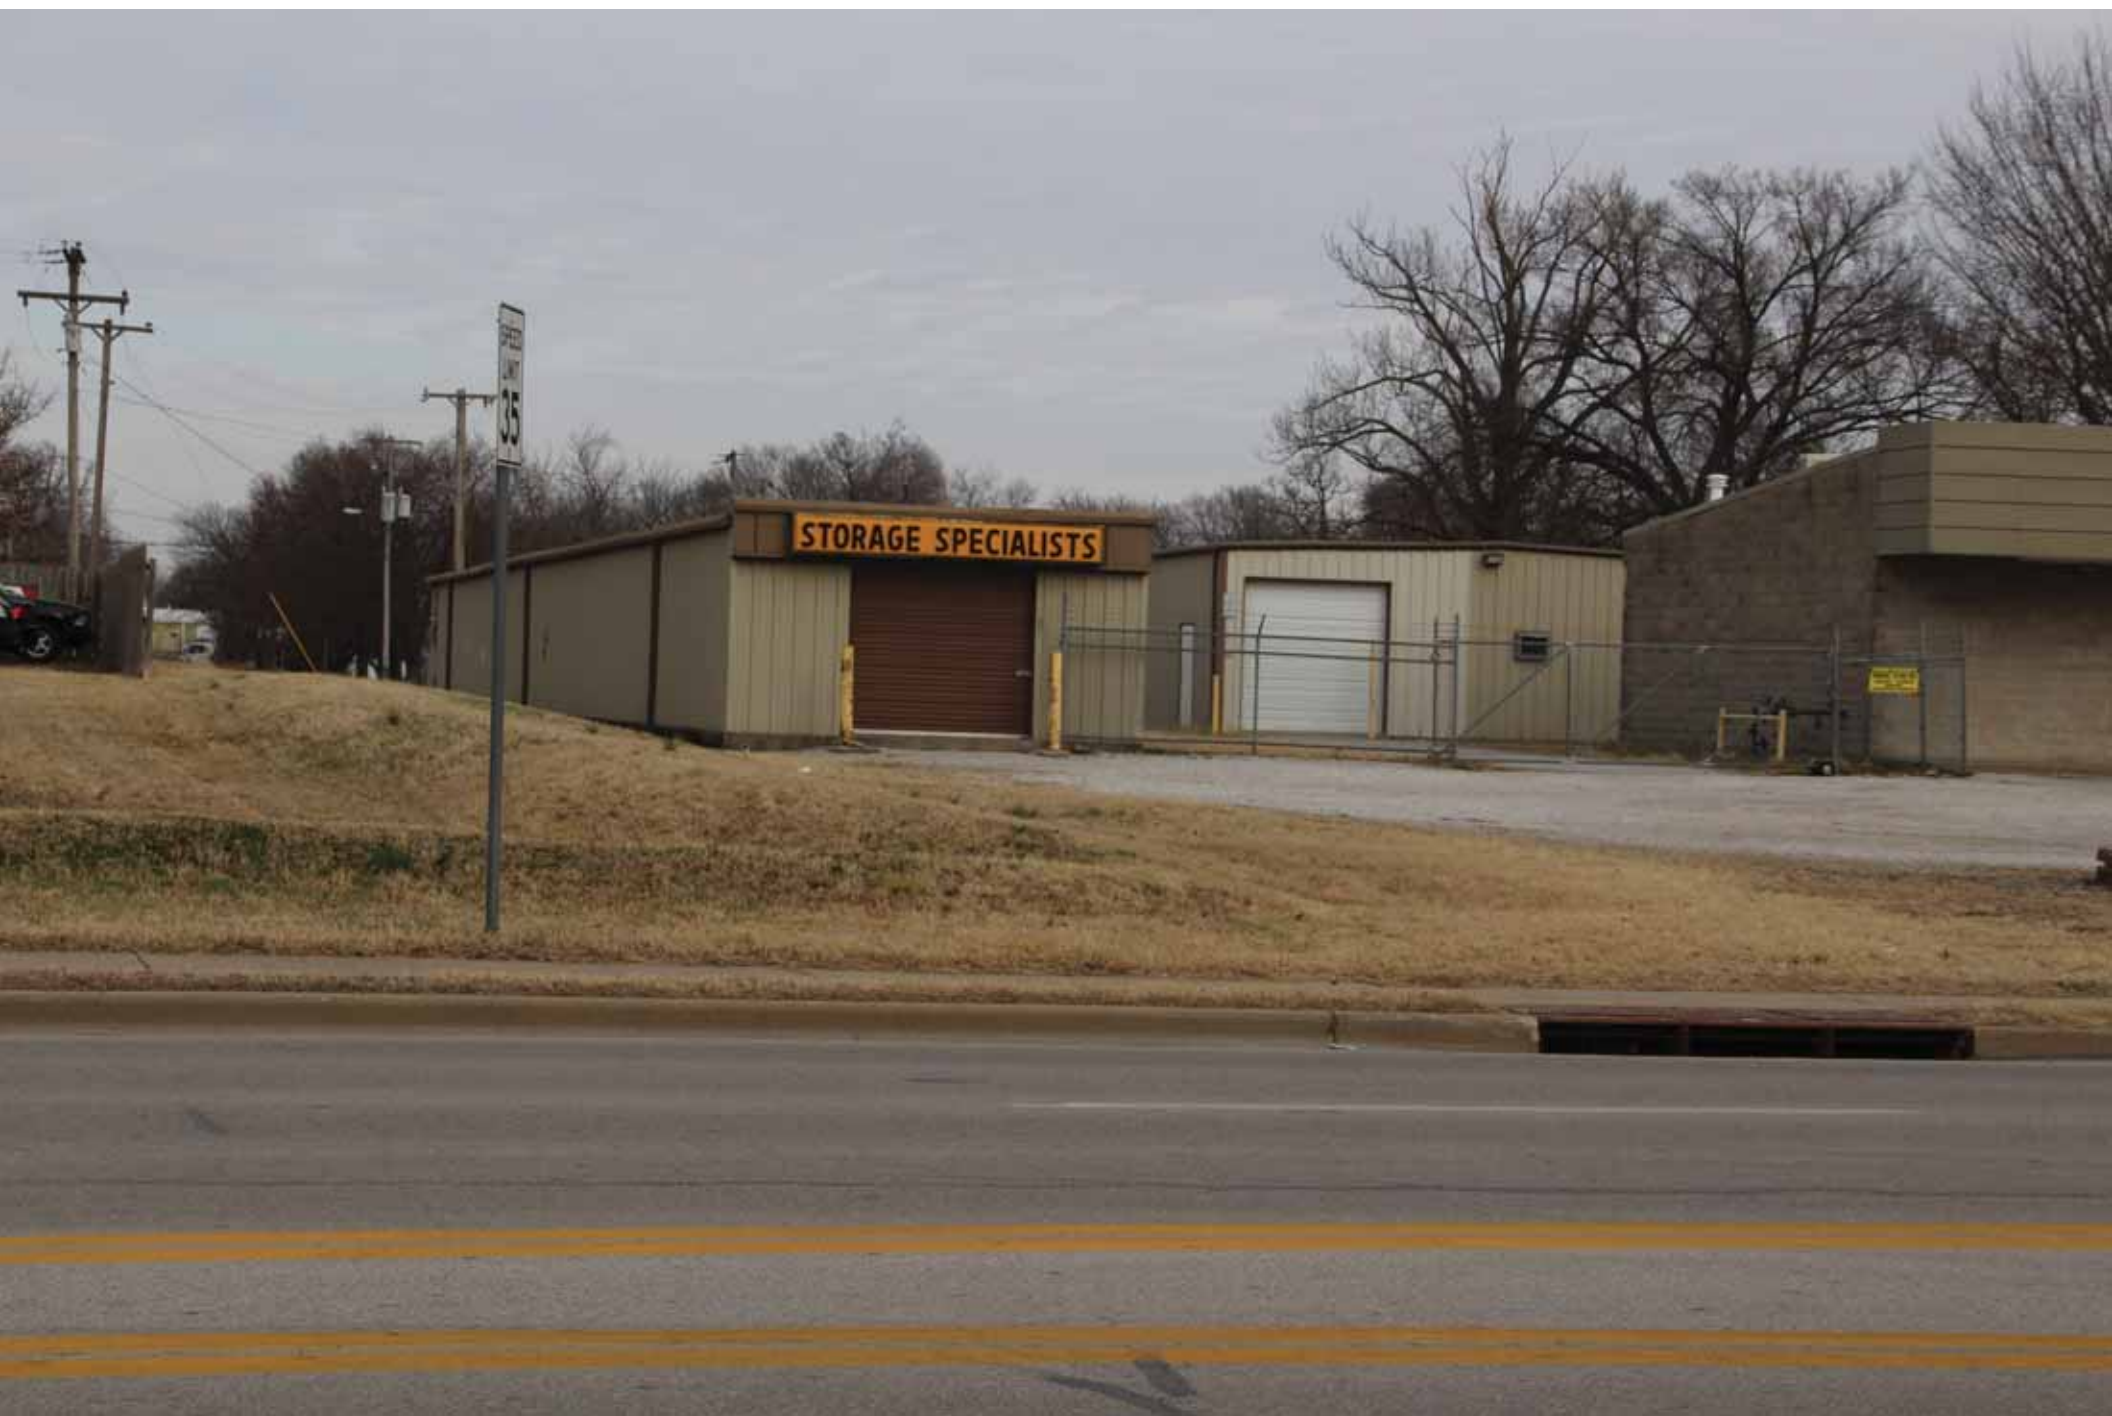
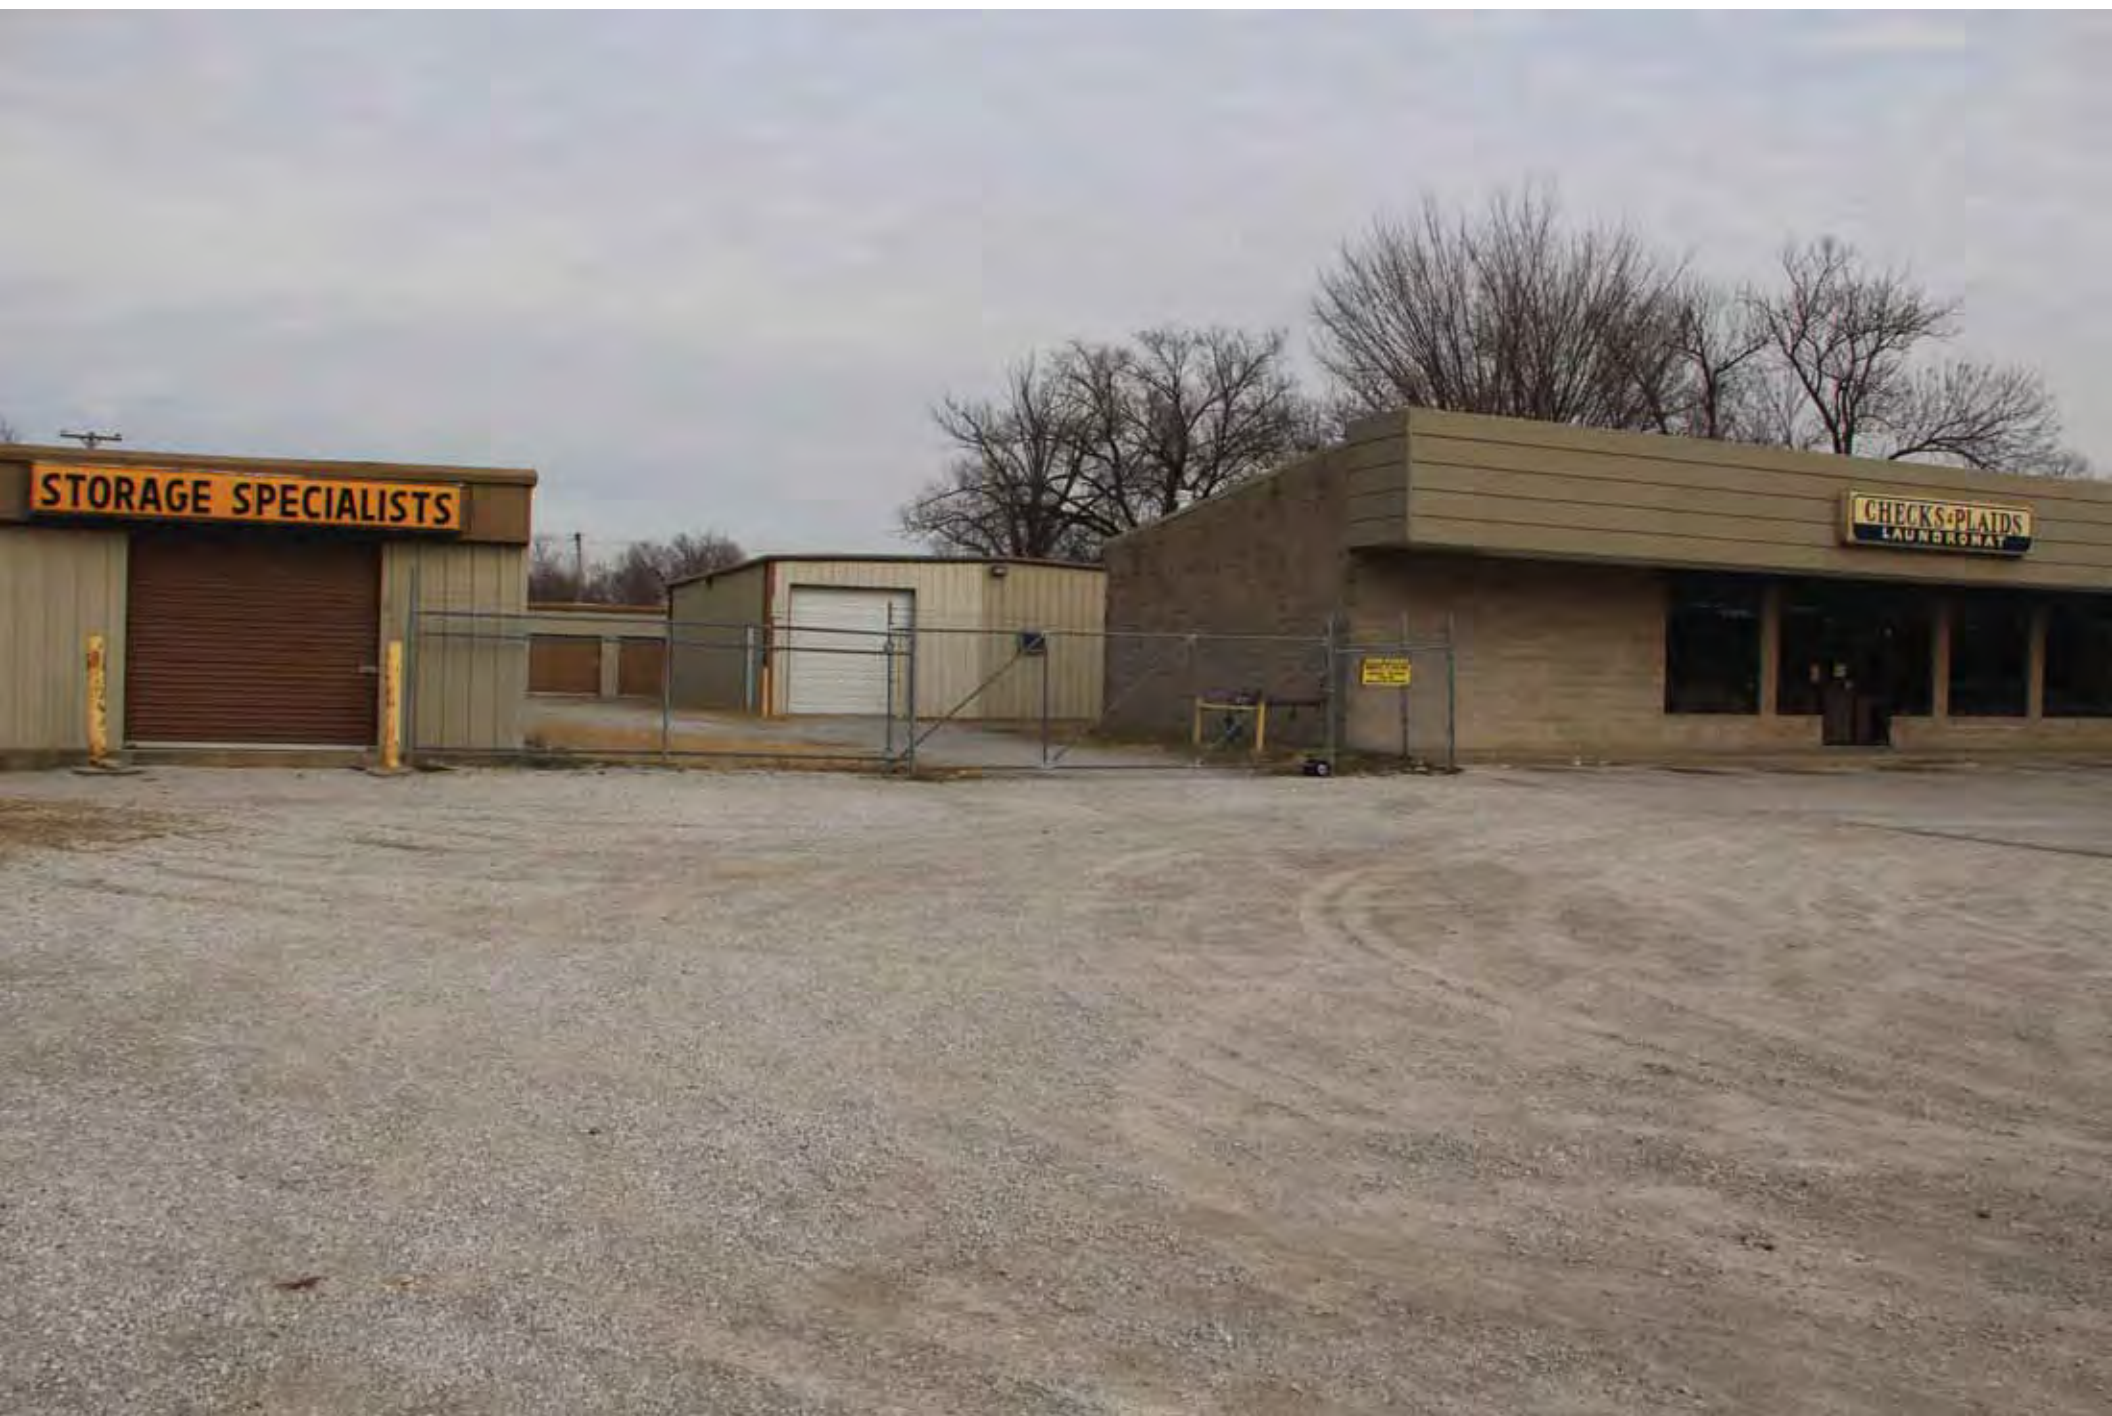
The warehouse buildings (2) have flat gabled metal roofs, exterior metal walls and slab concrete foundations. The south elevation of the U-shaped building has a bay filled with an overhead track door (west end of the “U”). A business sign is attached to the building above the bay. The east elevation of the west leg of the “U” wing holds twelve garage bays with overhead track doors. The south elevation of the center “U” wing holds eight bays (only three are visible from E. 4th Street). These bays are filled with overhead track doors. The east leg of the U-shaped warehouse is not visible but per building records, appears to attach to the rear (north) elevation of the concrete block store/laundromat building described below.

The concrete block building at the east end of the property holds two businesses as noted. The business occupying the west end of the building is a laundromat. The façade (south elevation) of this business has four bays – the entry bay is slightly off center and holds paired glass and metal doors. Flanking the entry bay are commercial style single-light windows with metal framing – one is west of the doors and two are east of the doors. Above the entry/windows is a sign affixed to the upper wall bearing the name of the business. The west wall has no fenestration. The façade of the adjoined business on the right (a convenience store) has three bays. The center entry bay holds two glass and metal commercial style doors. Flanking the entry are fixed sash large commercial style windows. The name of the business is affixed to the façade above the doors. The concrete block building's east elevation (facing St. Louis Avenue) holds a pedestrian entry with a solid metal door.
