MISSOURI DEPARTMENT OF NATURAL RESOURCES
STATE HISTORIC PRESERVATION OFFICE, P.O. Box 176, Jefferson City, MO 65102
ARCHITECTURAL/HISTORIC INVENTORY FORM

1. Survey No. JP-AS-007-001		2. Survey name: East Town (Original Joplin) Historic Survey Phase 2	
3. County: JASPER		4. Address (Street No.) 618	Street (name) E. 2 nd Street
5. City: Joplin	Vicinity: <input type="checkbox"/>	6. Geographical Reference:	7. Township/Range/Section: T: R: S:
8. Historic name (if known):		9. Present/other name (if known):	
10. Ownership: <input checked="" type="checkbox"/> Private <input type="checkbox"/> Public		11a. Historic use (if known): Domestic: Single Dwelling	11b. Current use: Domestic: Single Dwelling

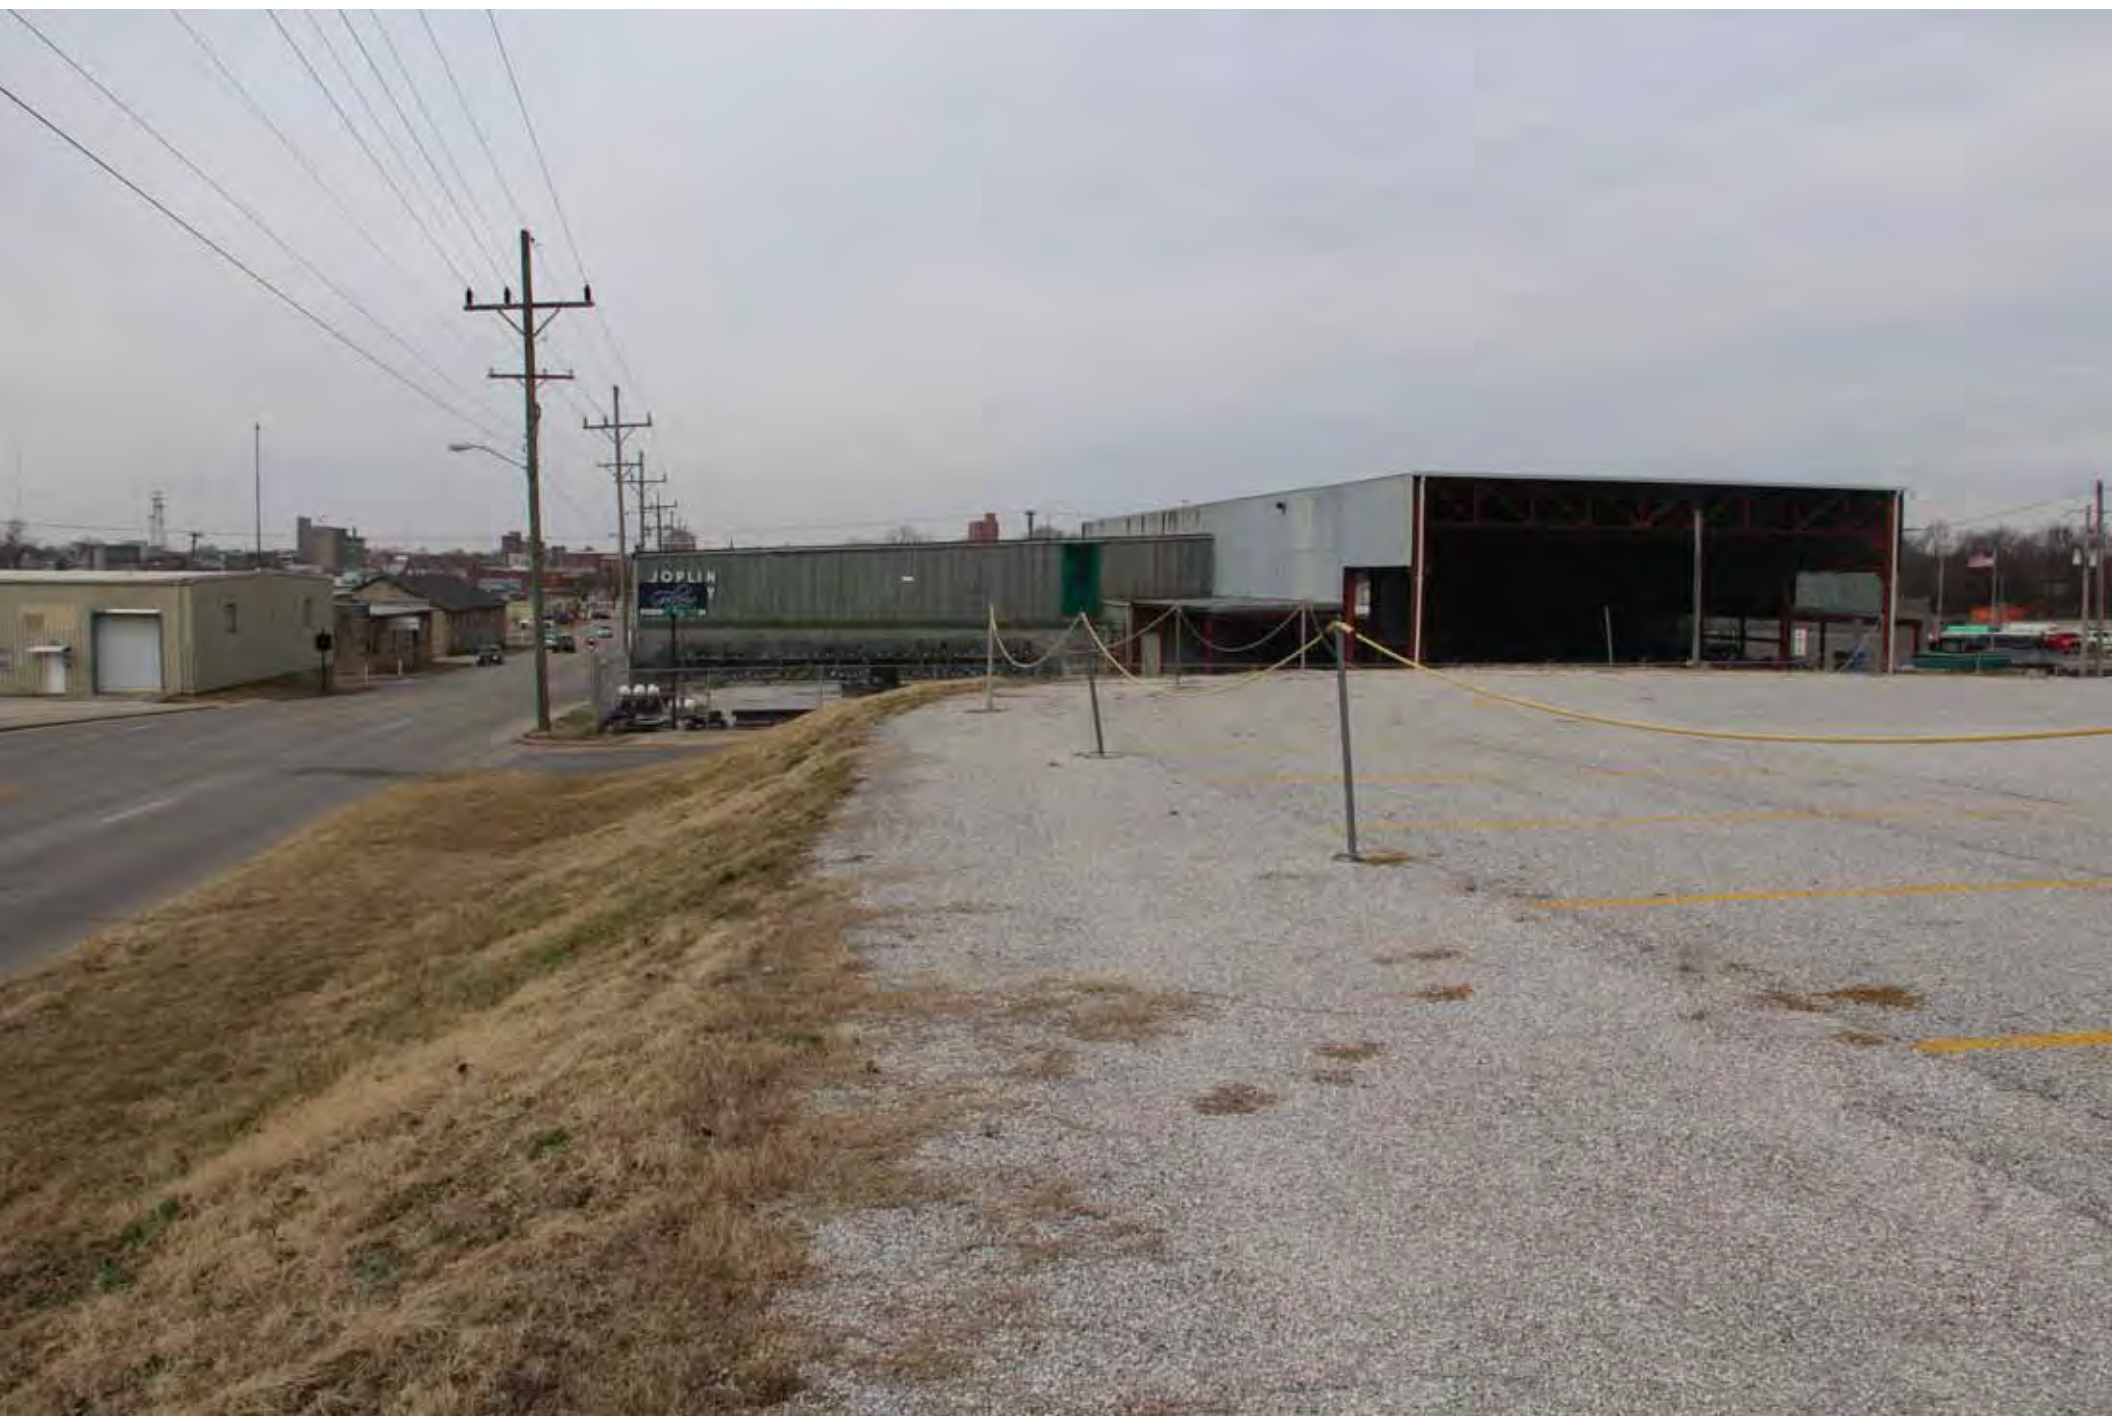
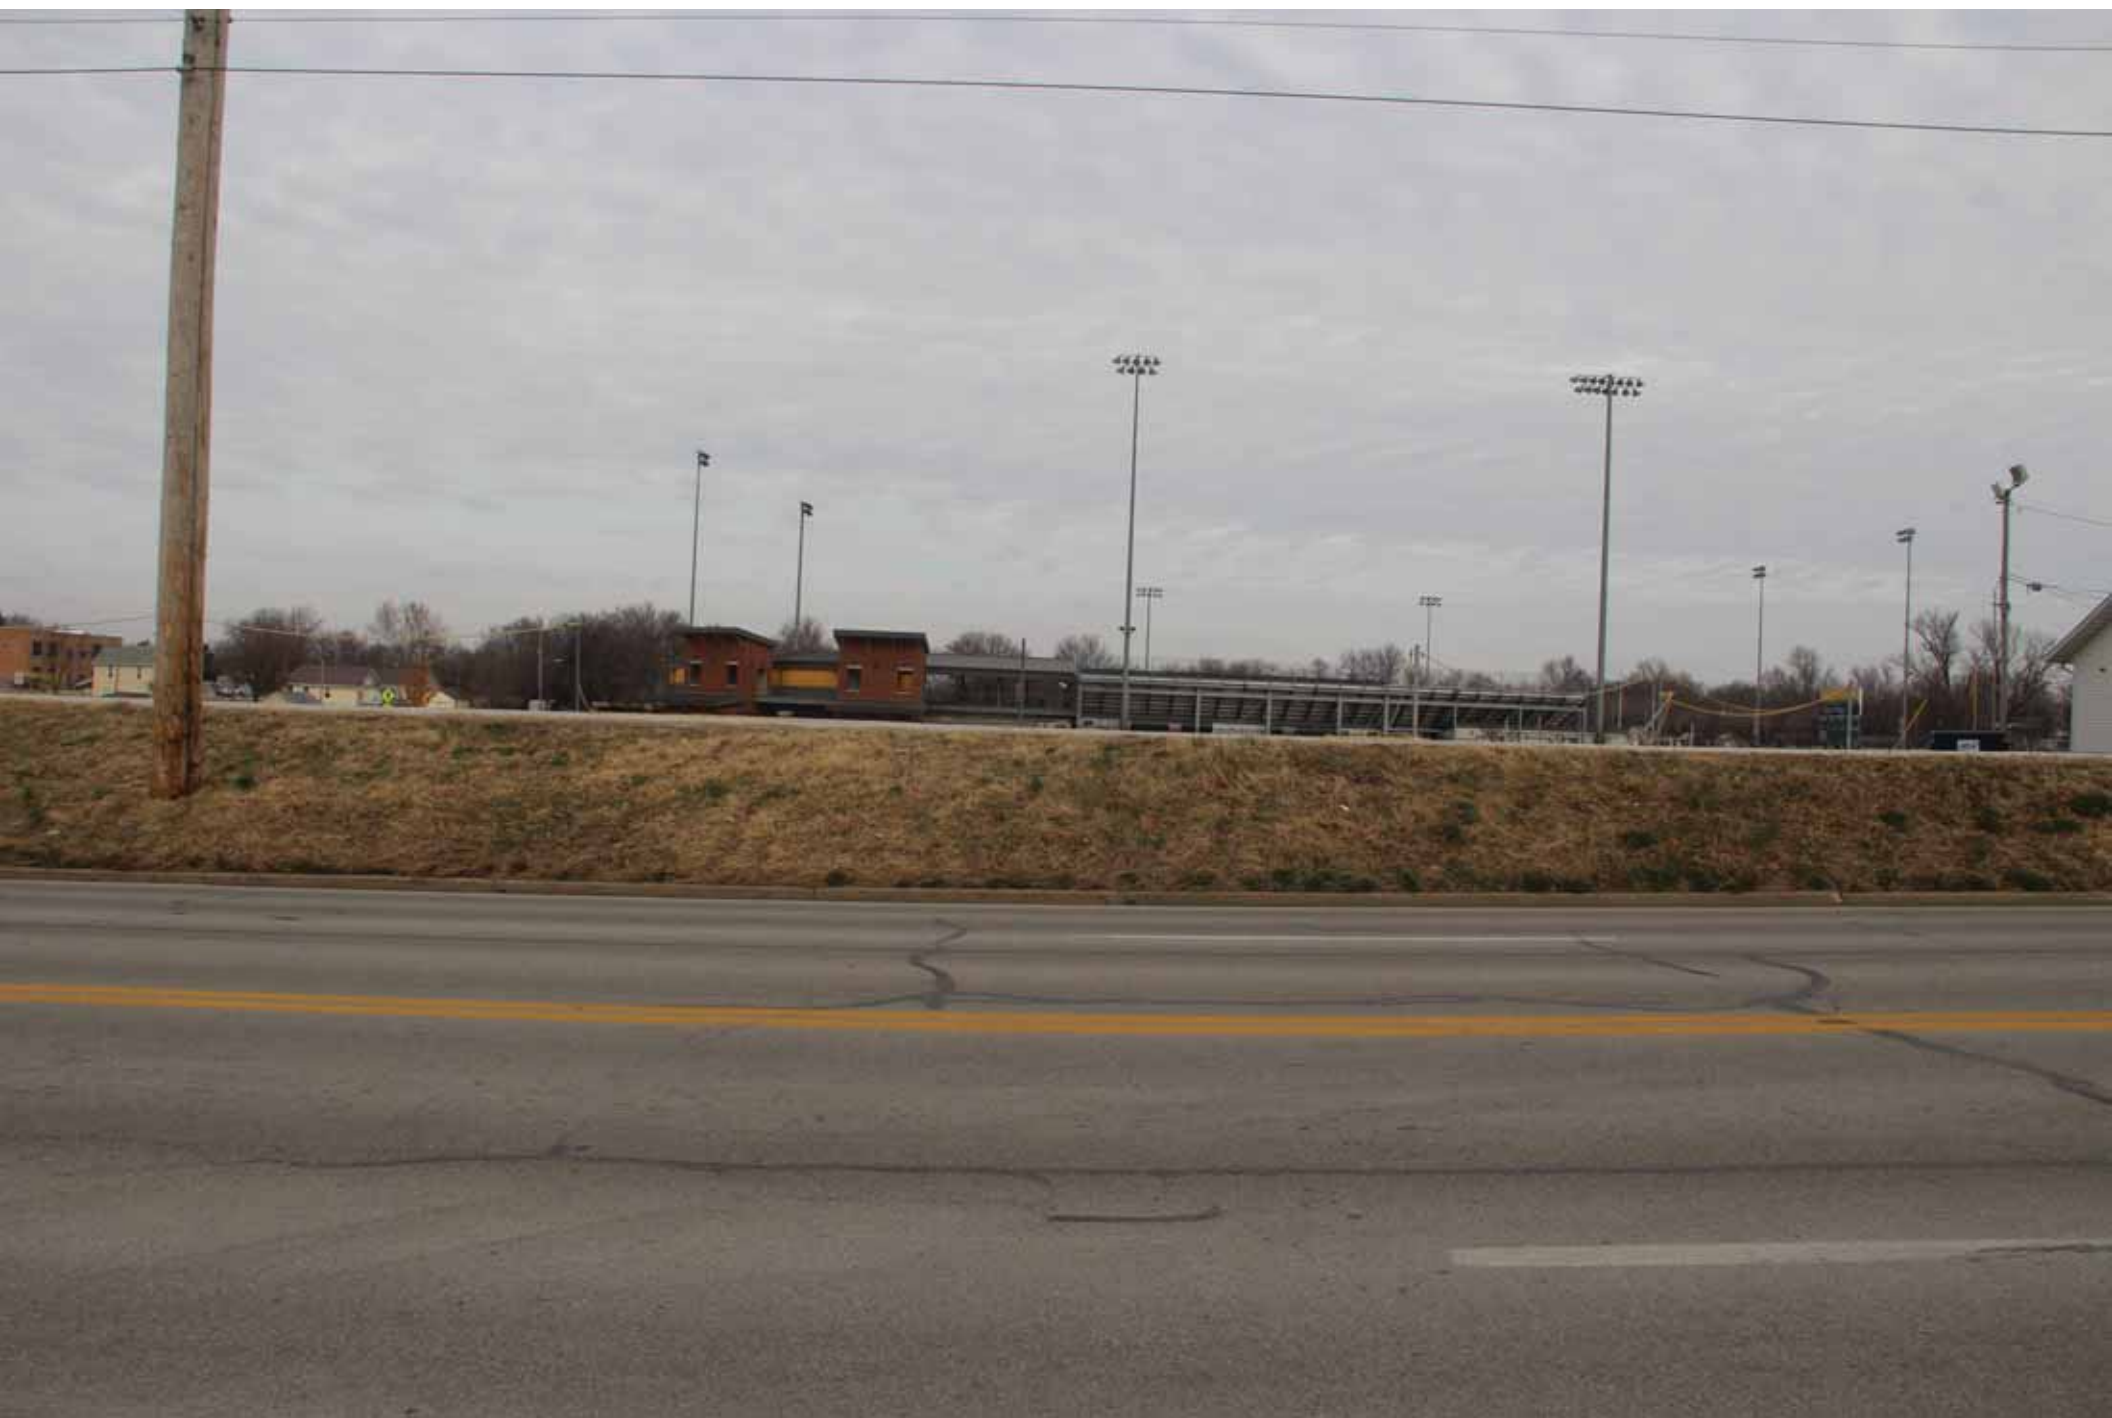
The property at the northeast corner of E. 4th Street and S. High Avenue is a gravel covered lot used for parking, as described above.

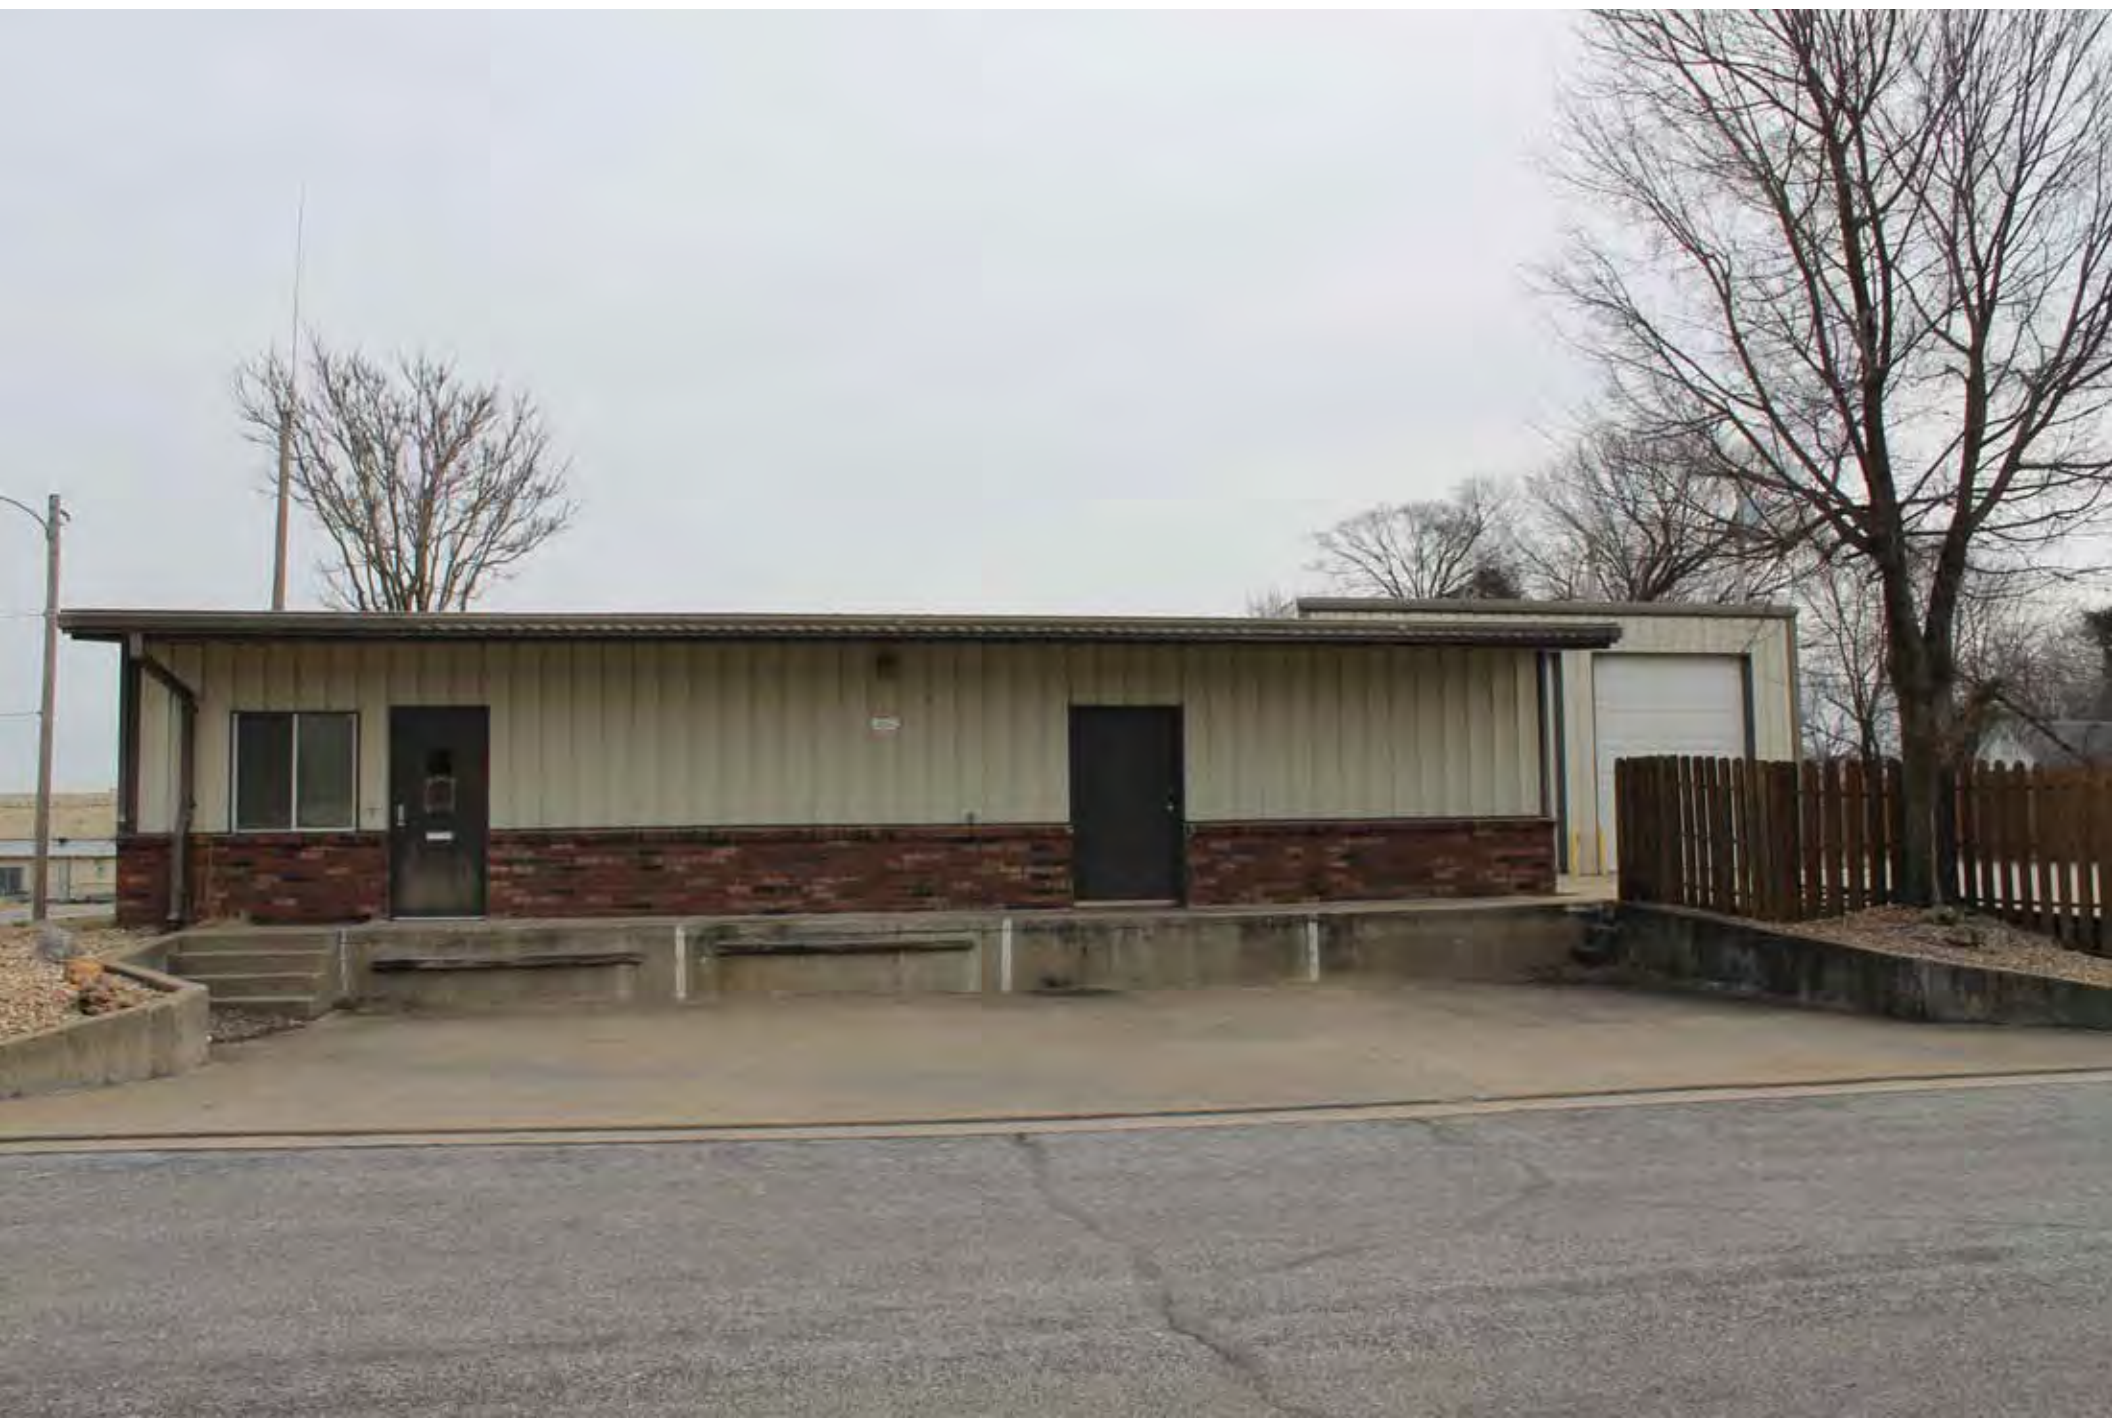
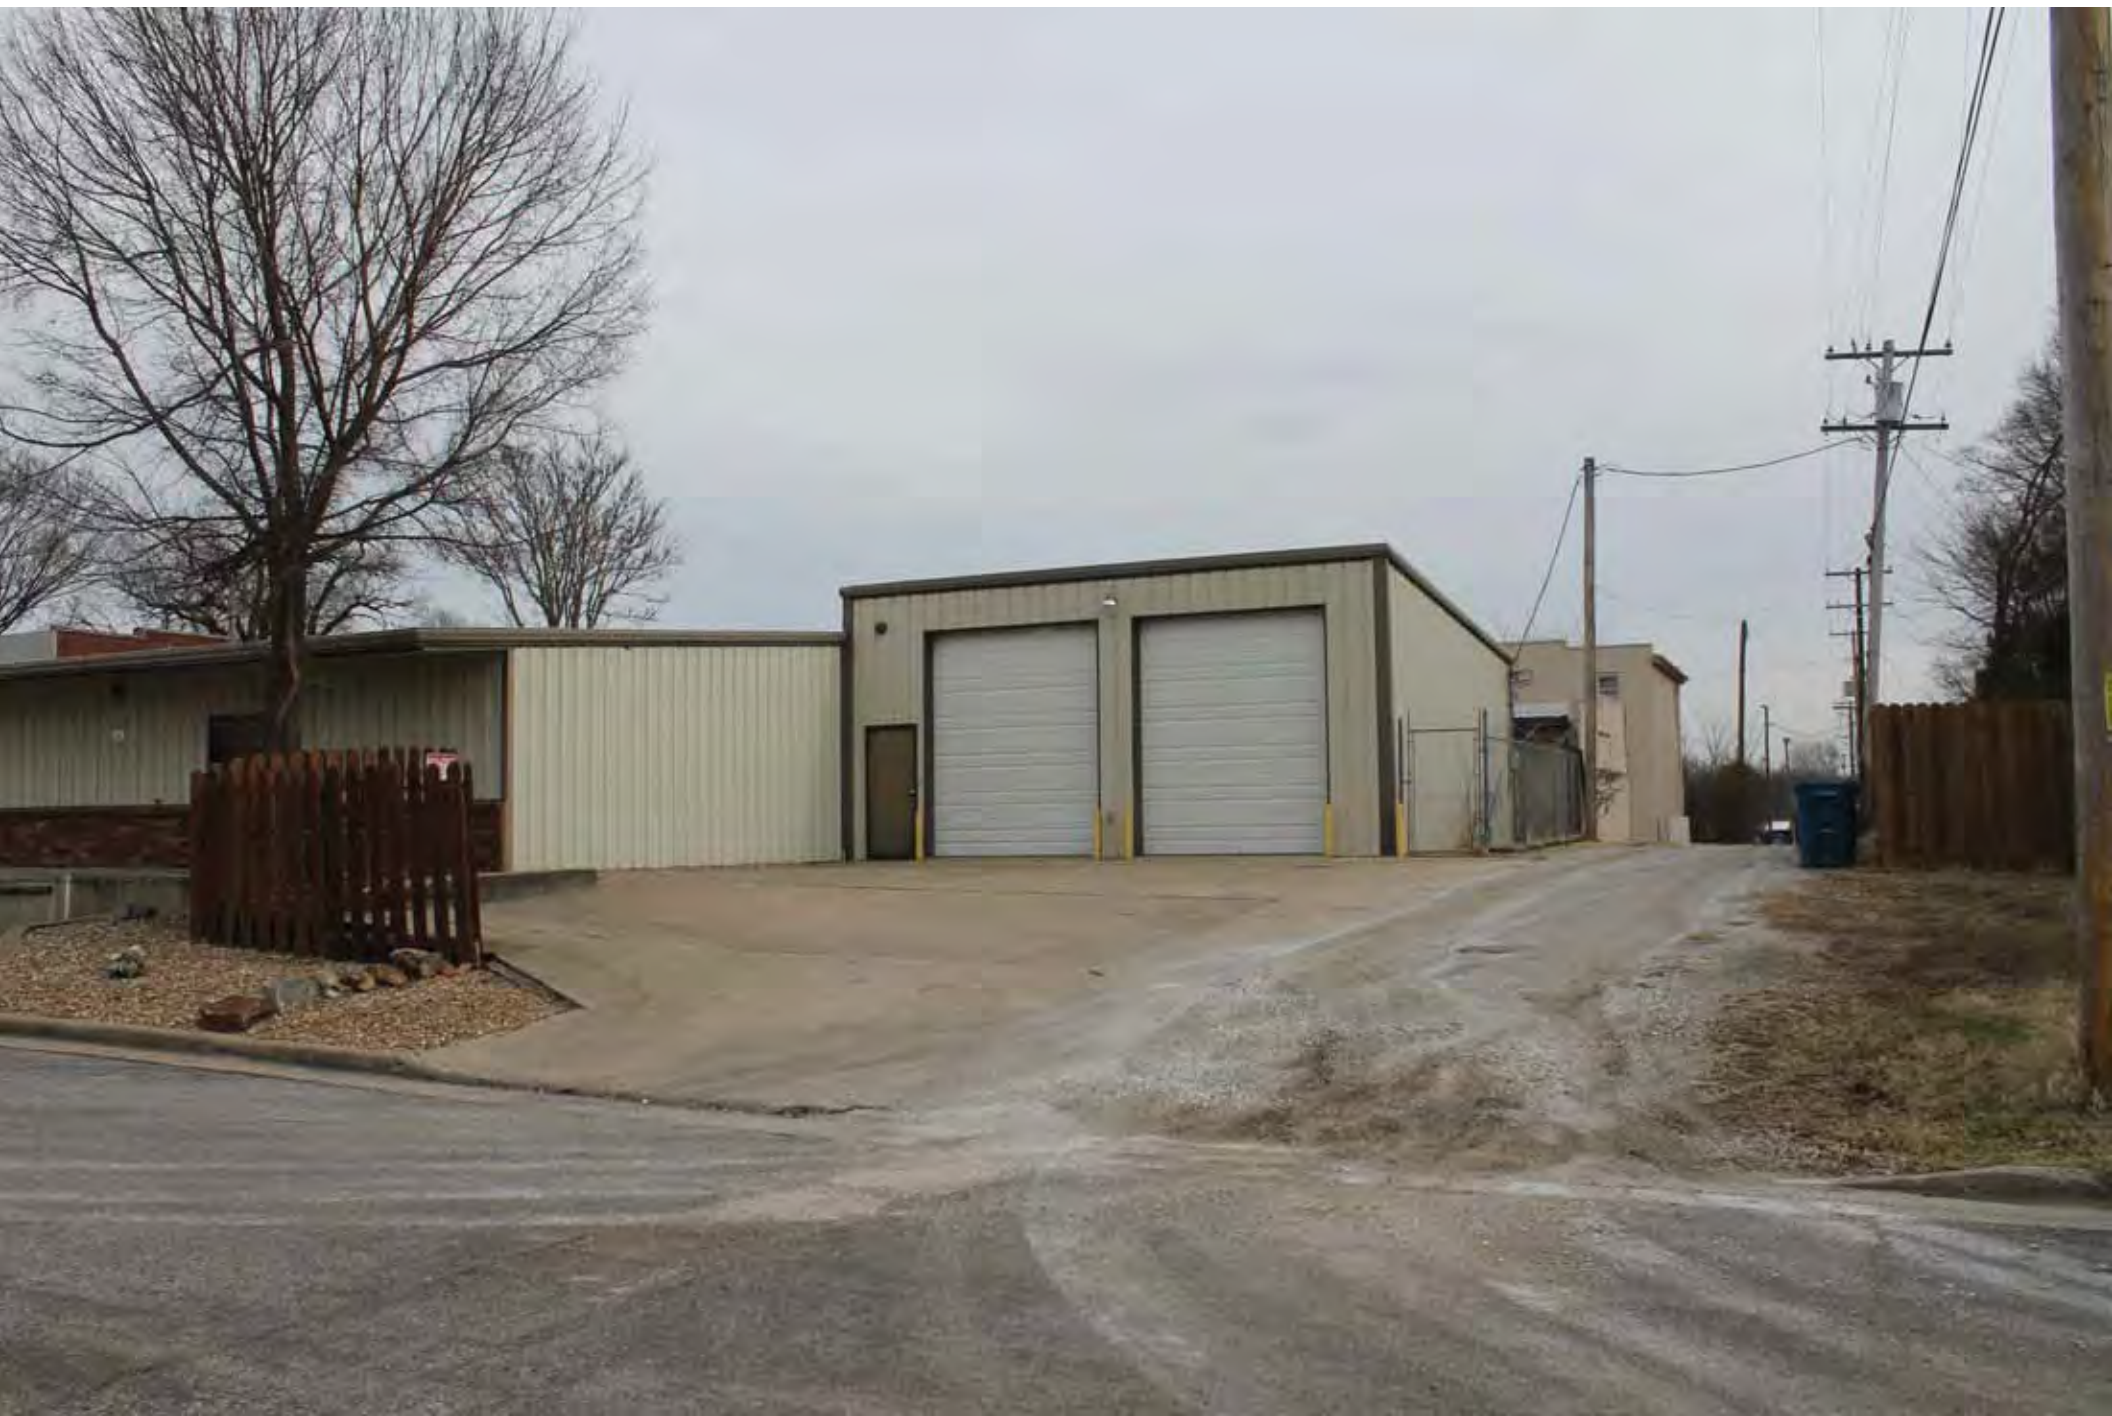
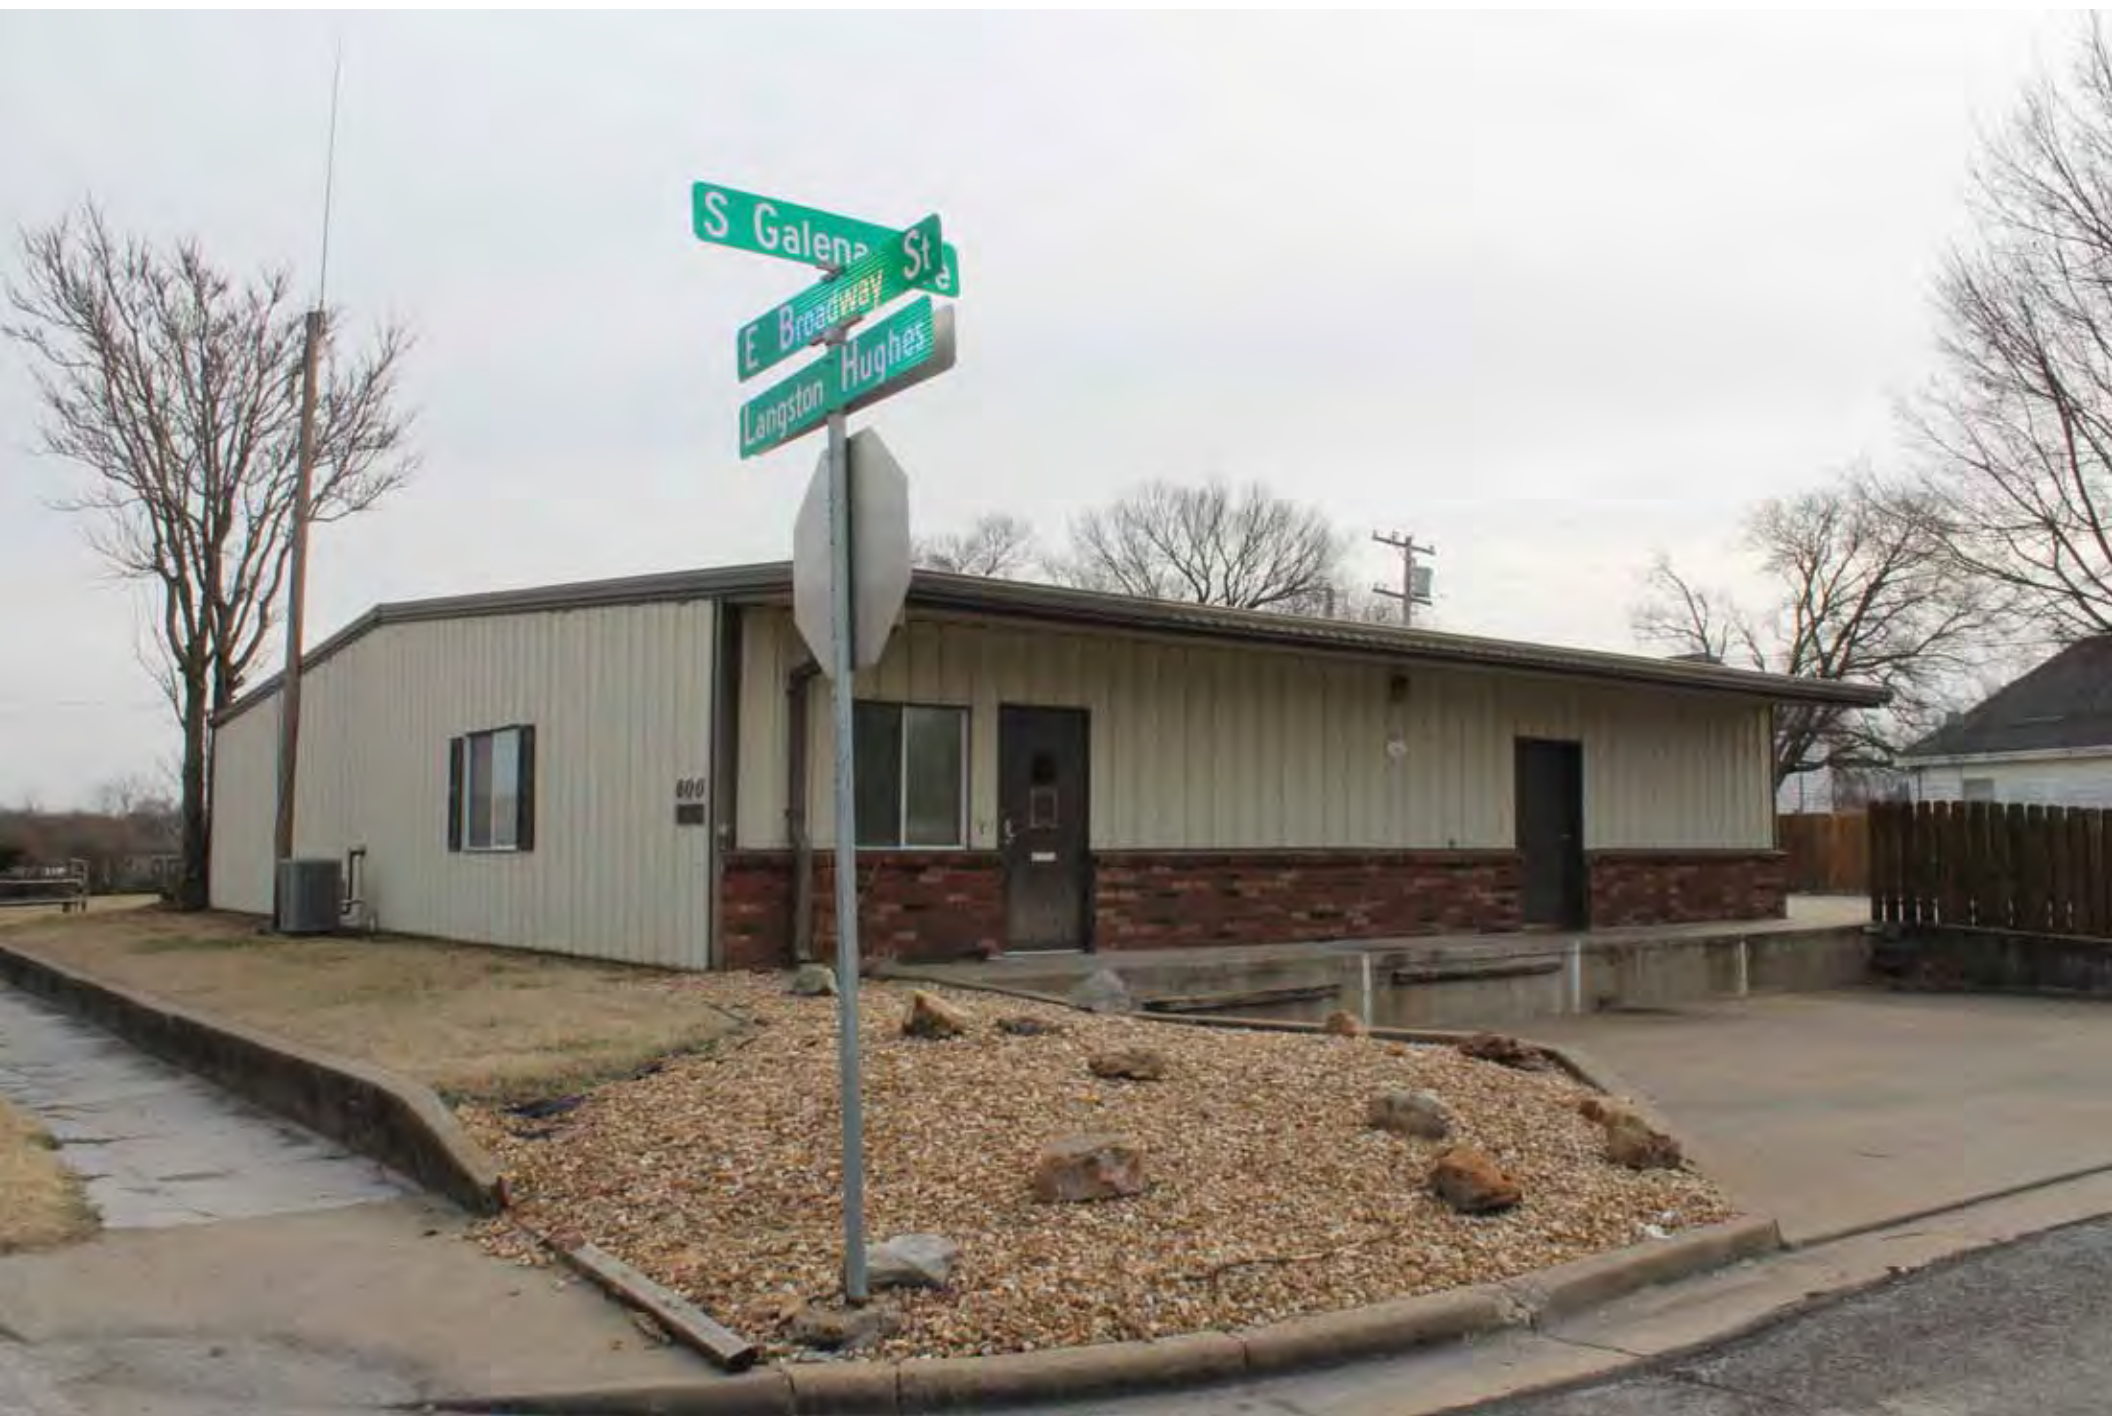
The building associated with this parcel is a prefabricated metal warehouse. The building faces east with the entrance and garage bays along S. Galena Avenue. The main portion of the building is one-story with a low-pitched metal roof. On S. Galena Avenue is a concrete lot that leads to this east elevation. There is a concrete loading dock along the east side of the building. The east elevation also has the main entrance, with two metal doors and a single casement window. Below the window this elevation is covered in a brick veneer. The north elevation of the building, along E. Broadway Street, has a single casement window. Attached at the southeast rear portion of this building is a separate section of the building that houses the garage bays on its east elevation. It has a metal shed roof two large garage bays with metal track doors. There is a single metal entrance door to the north of the garage bays.
