MISSOURI DEPARTMENT OF NATURAL RESOURCES
STATE HISTORIC PRESERVATION OFFICE, P.O. Box 176, Jefferson City, MO 65102
ARCHITECTURAL/HISTORIC INVENTORY FORM

1. Survey No. JP-AS-007-001		2. Survey name: East Town (Original Joplin) Historic Survey Phase 2	
3. County: JASPER		4. Address (Street No.) 618	Street (name) E. 2 nd Street
5. City: Joplin	Vicinity: <input type="checkbox"/>	6. Geographical Reference:	7. Township/Range/Section: T: R: S:
8. Historic name (if known):		9. Present/other name (if known):	
10. Ownership: <input checked="" type="checkbox"/> Private <input type="checkbox"/> Public		11a. Historic use (if known): Domestic: Single Dwelling	11b. Current use: Domestic: Single Dwelling

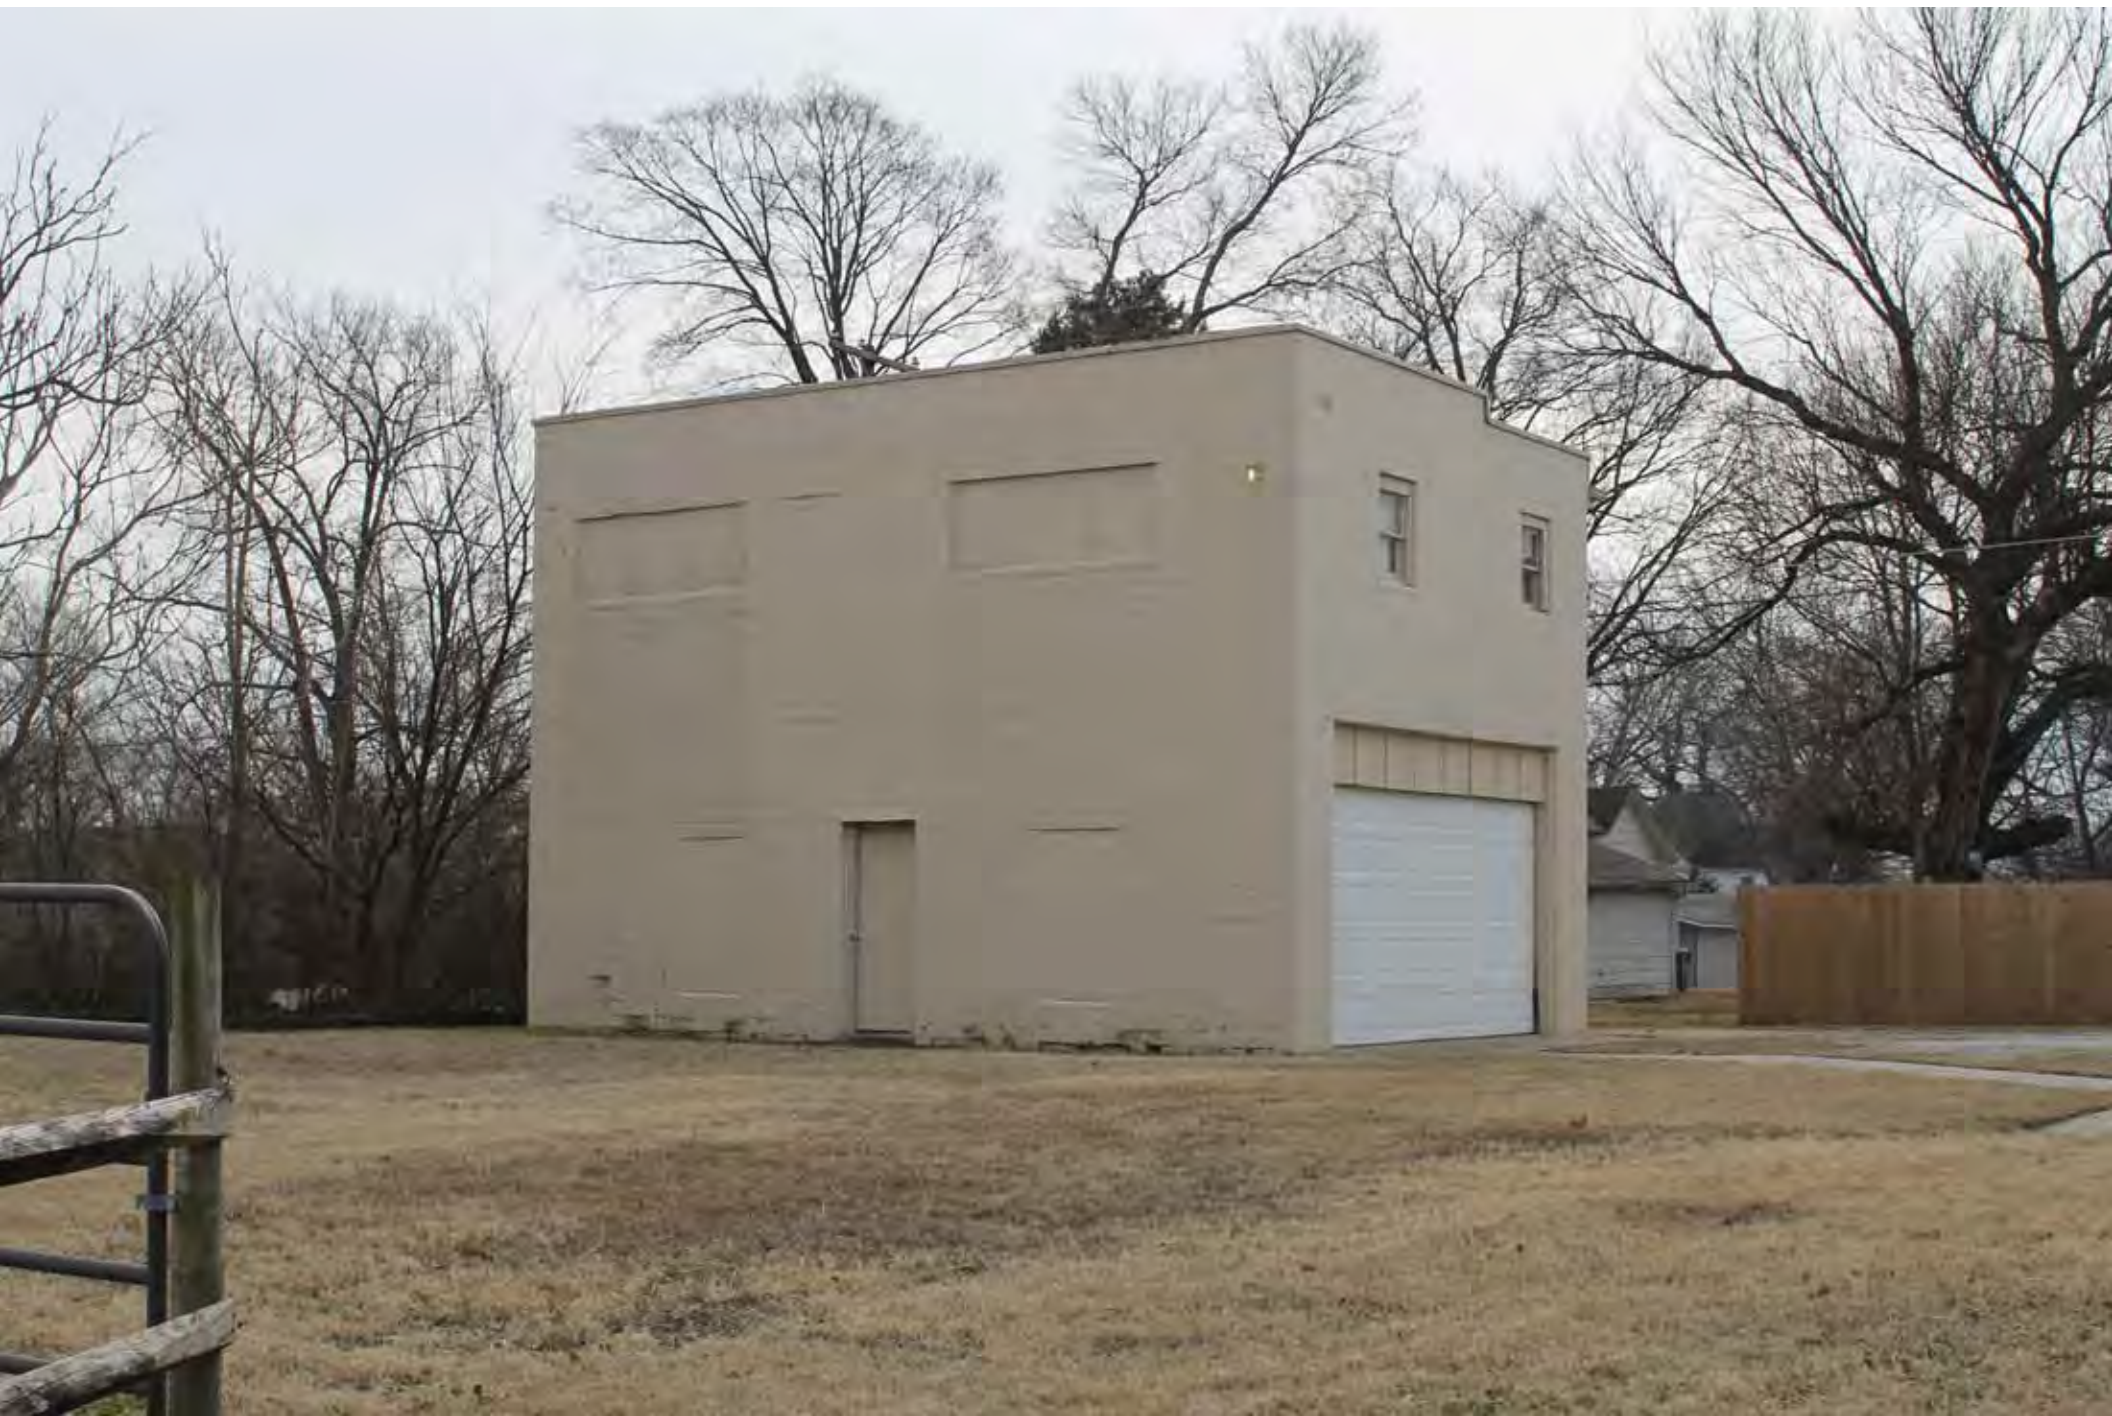
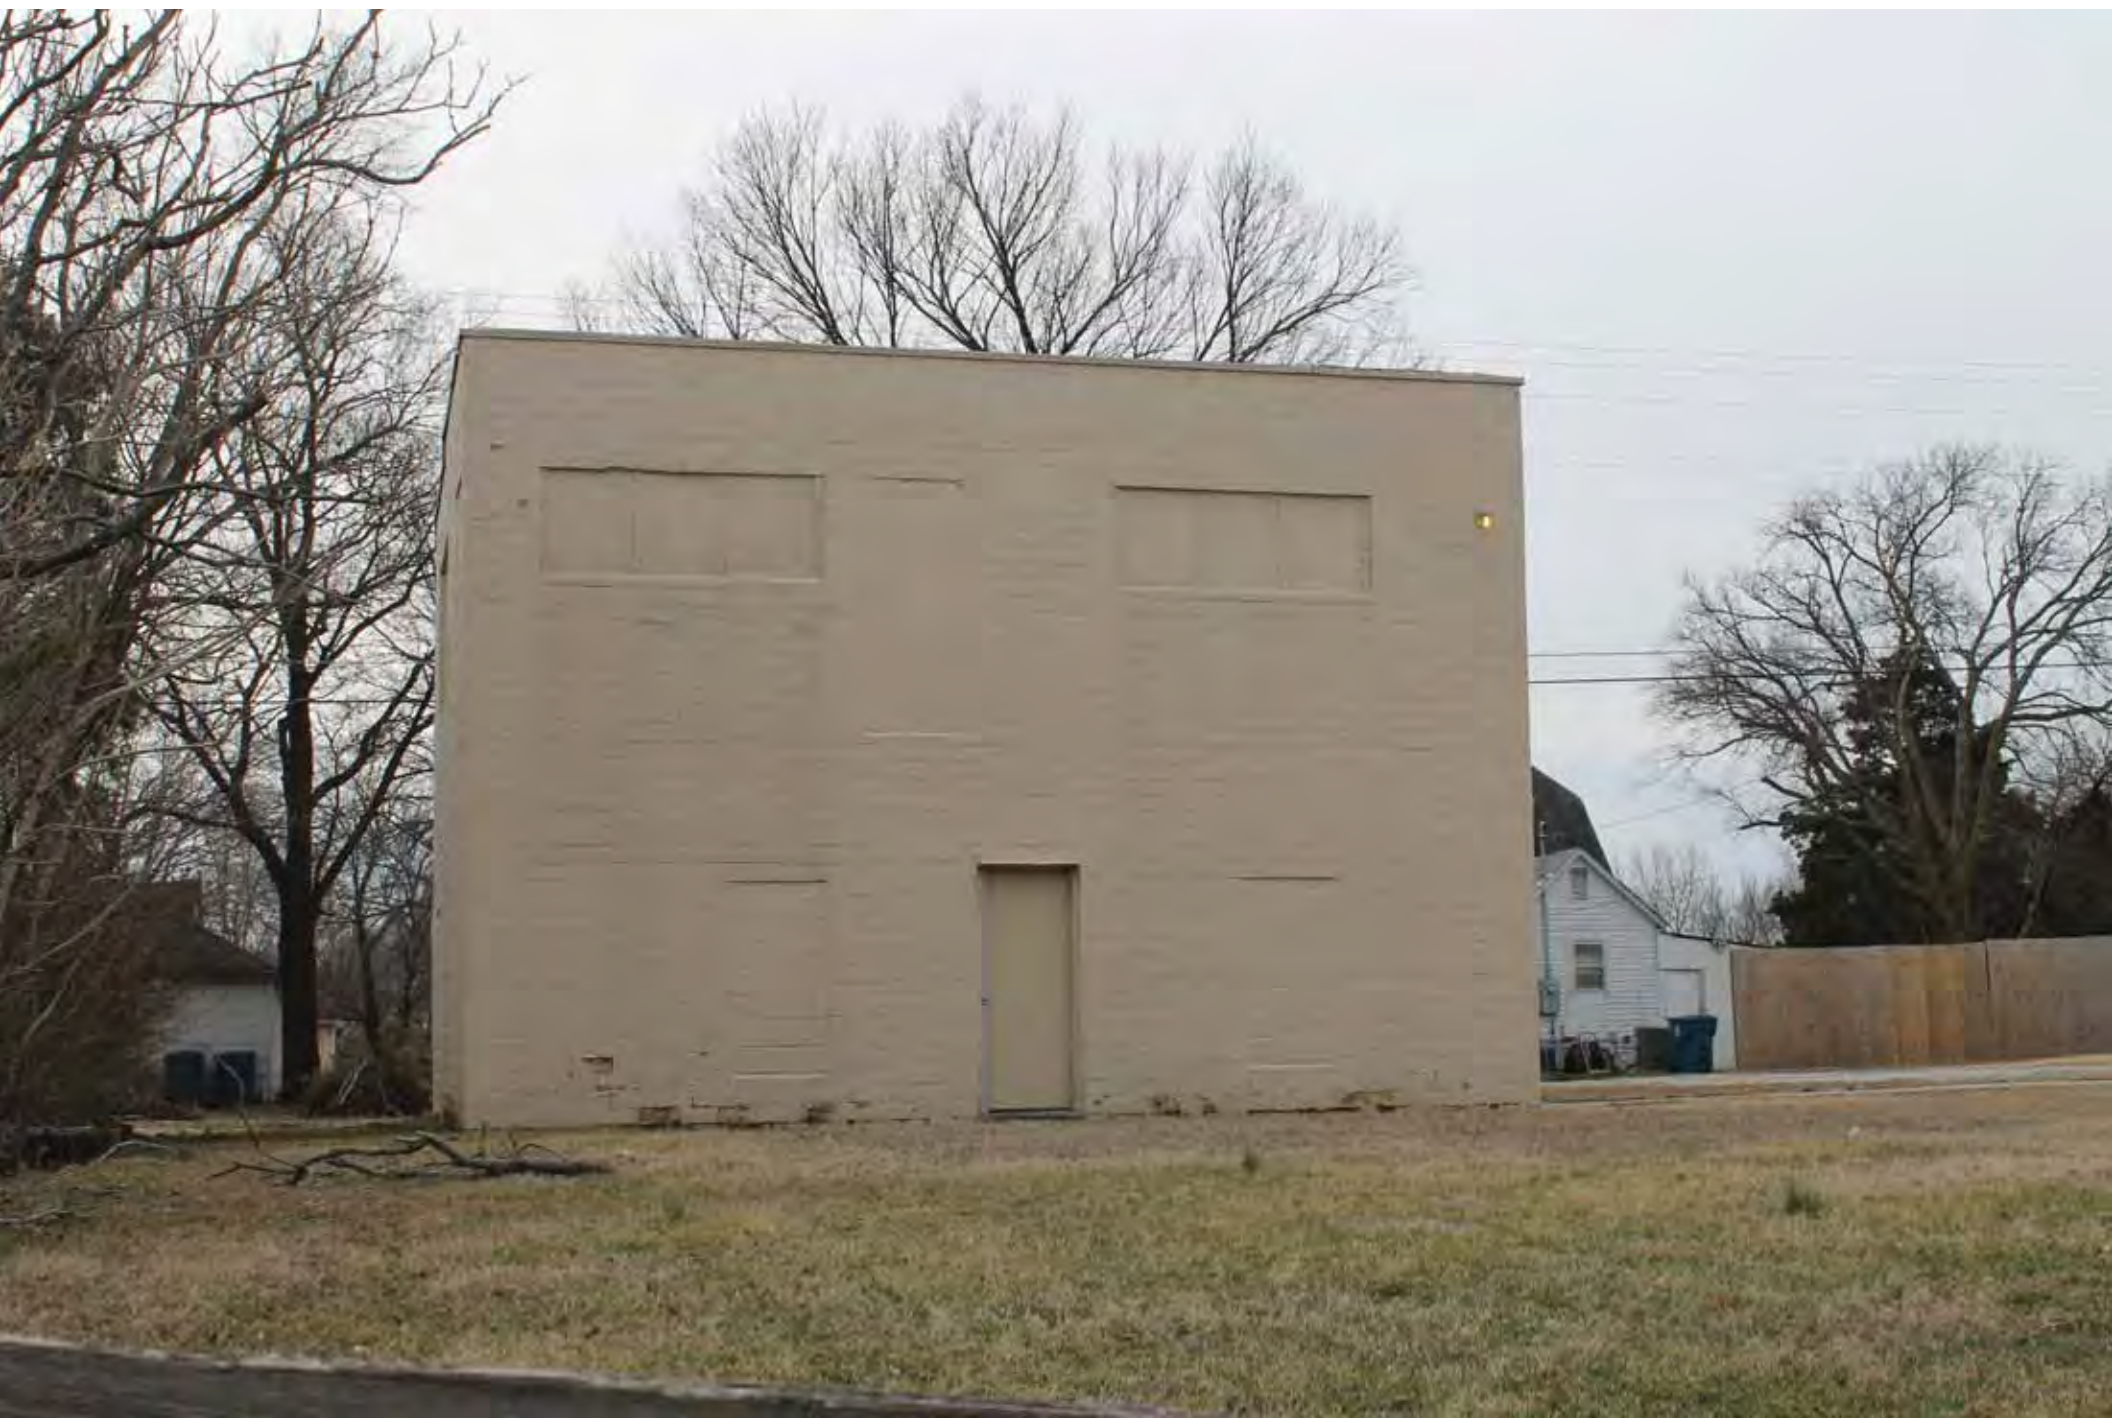
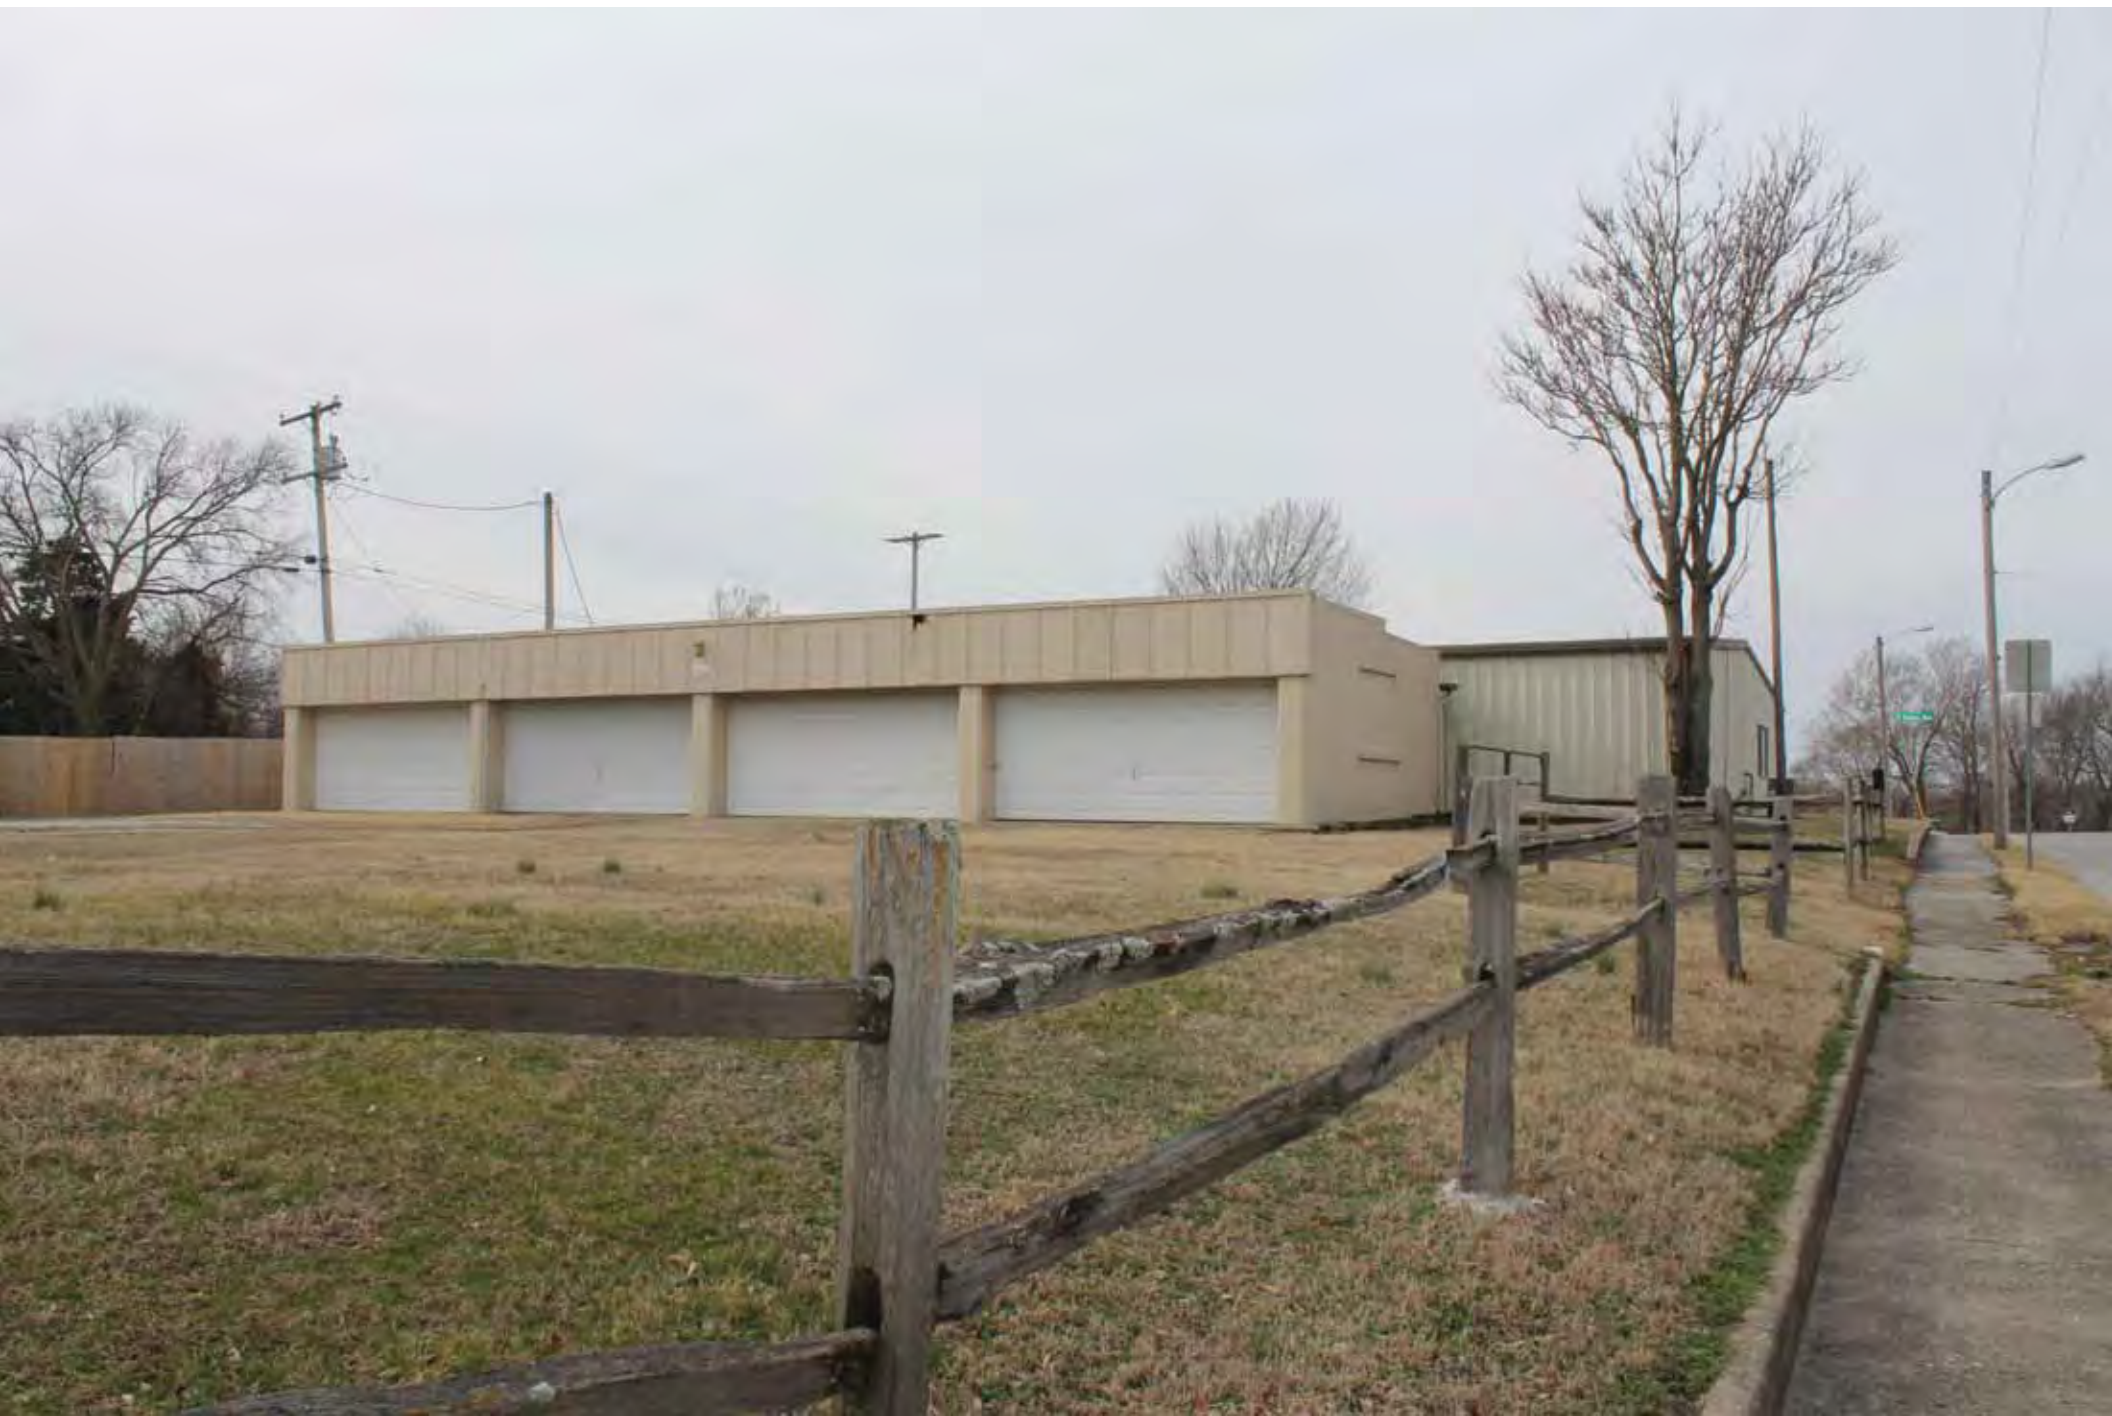
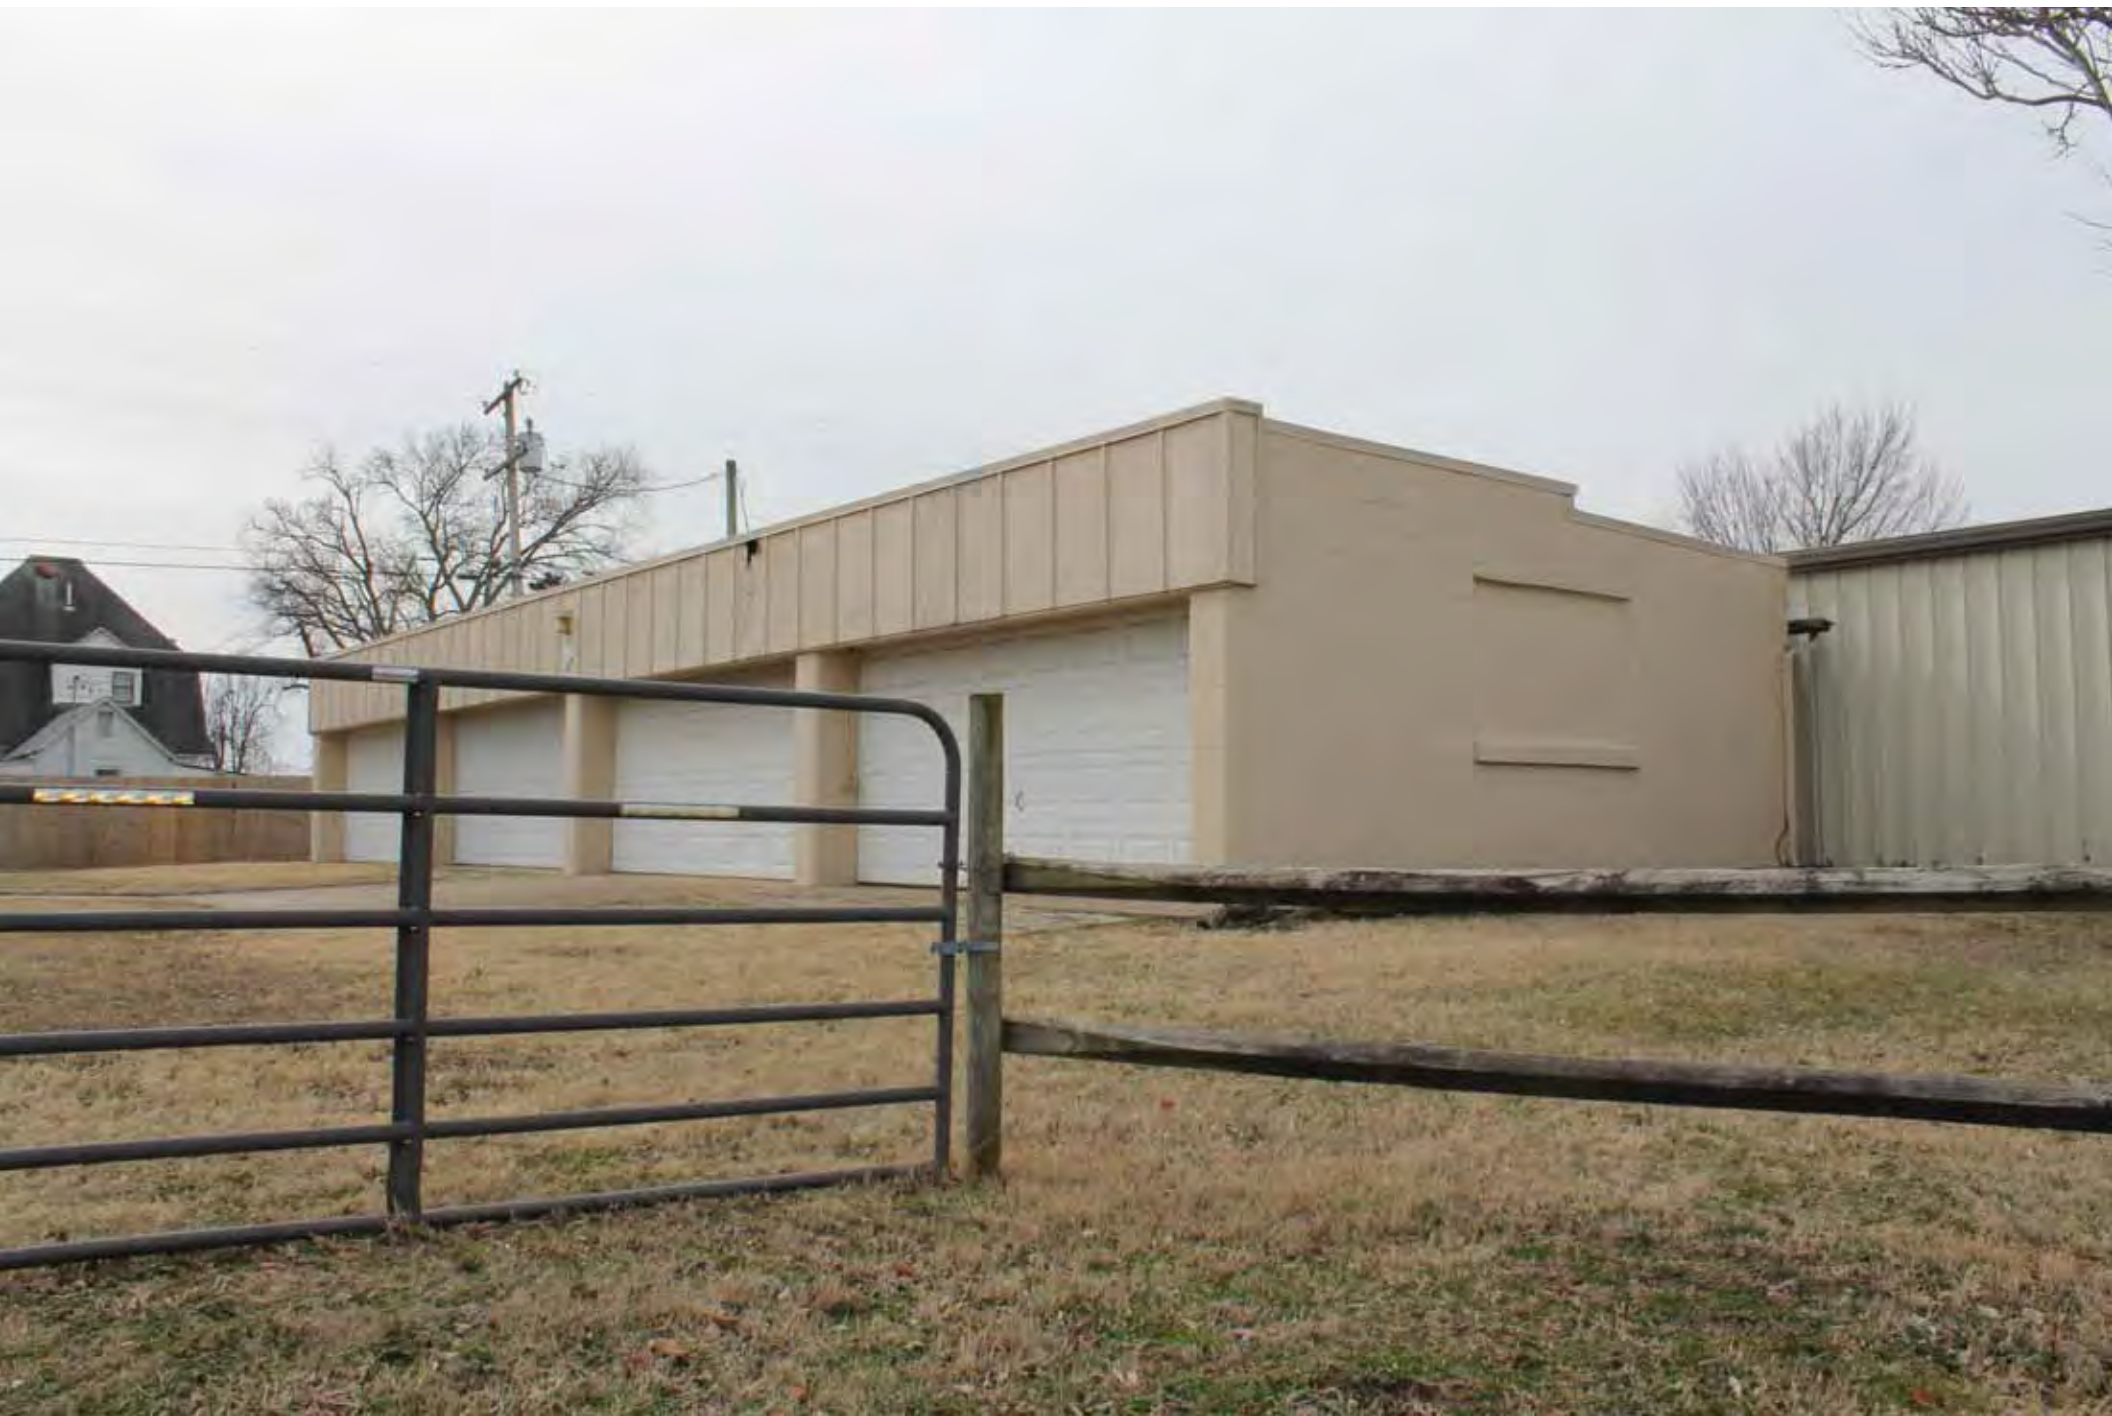
The oldest building on this parcel is a two-story brick commercial/warehouse building. It has a flat roof with a single step in the parapet. The exterior brick has been painted. On the front or north elevation the front door and four window openings have boarded up and painted. On the east elevation is a modern metal track garage door on the first floor. Above it at the second floor are two small one-over-one windows.

On the west side of the parcel is a one-story brick garage building with a flat roof. Along the west elevation are four large garage bays with metal track garage doors. Both buildings have been painted.

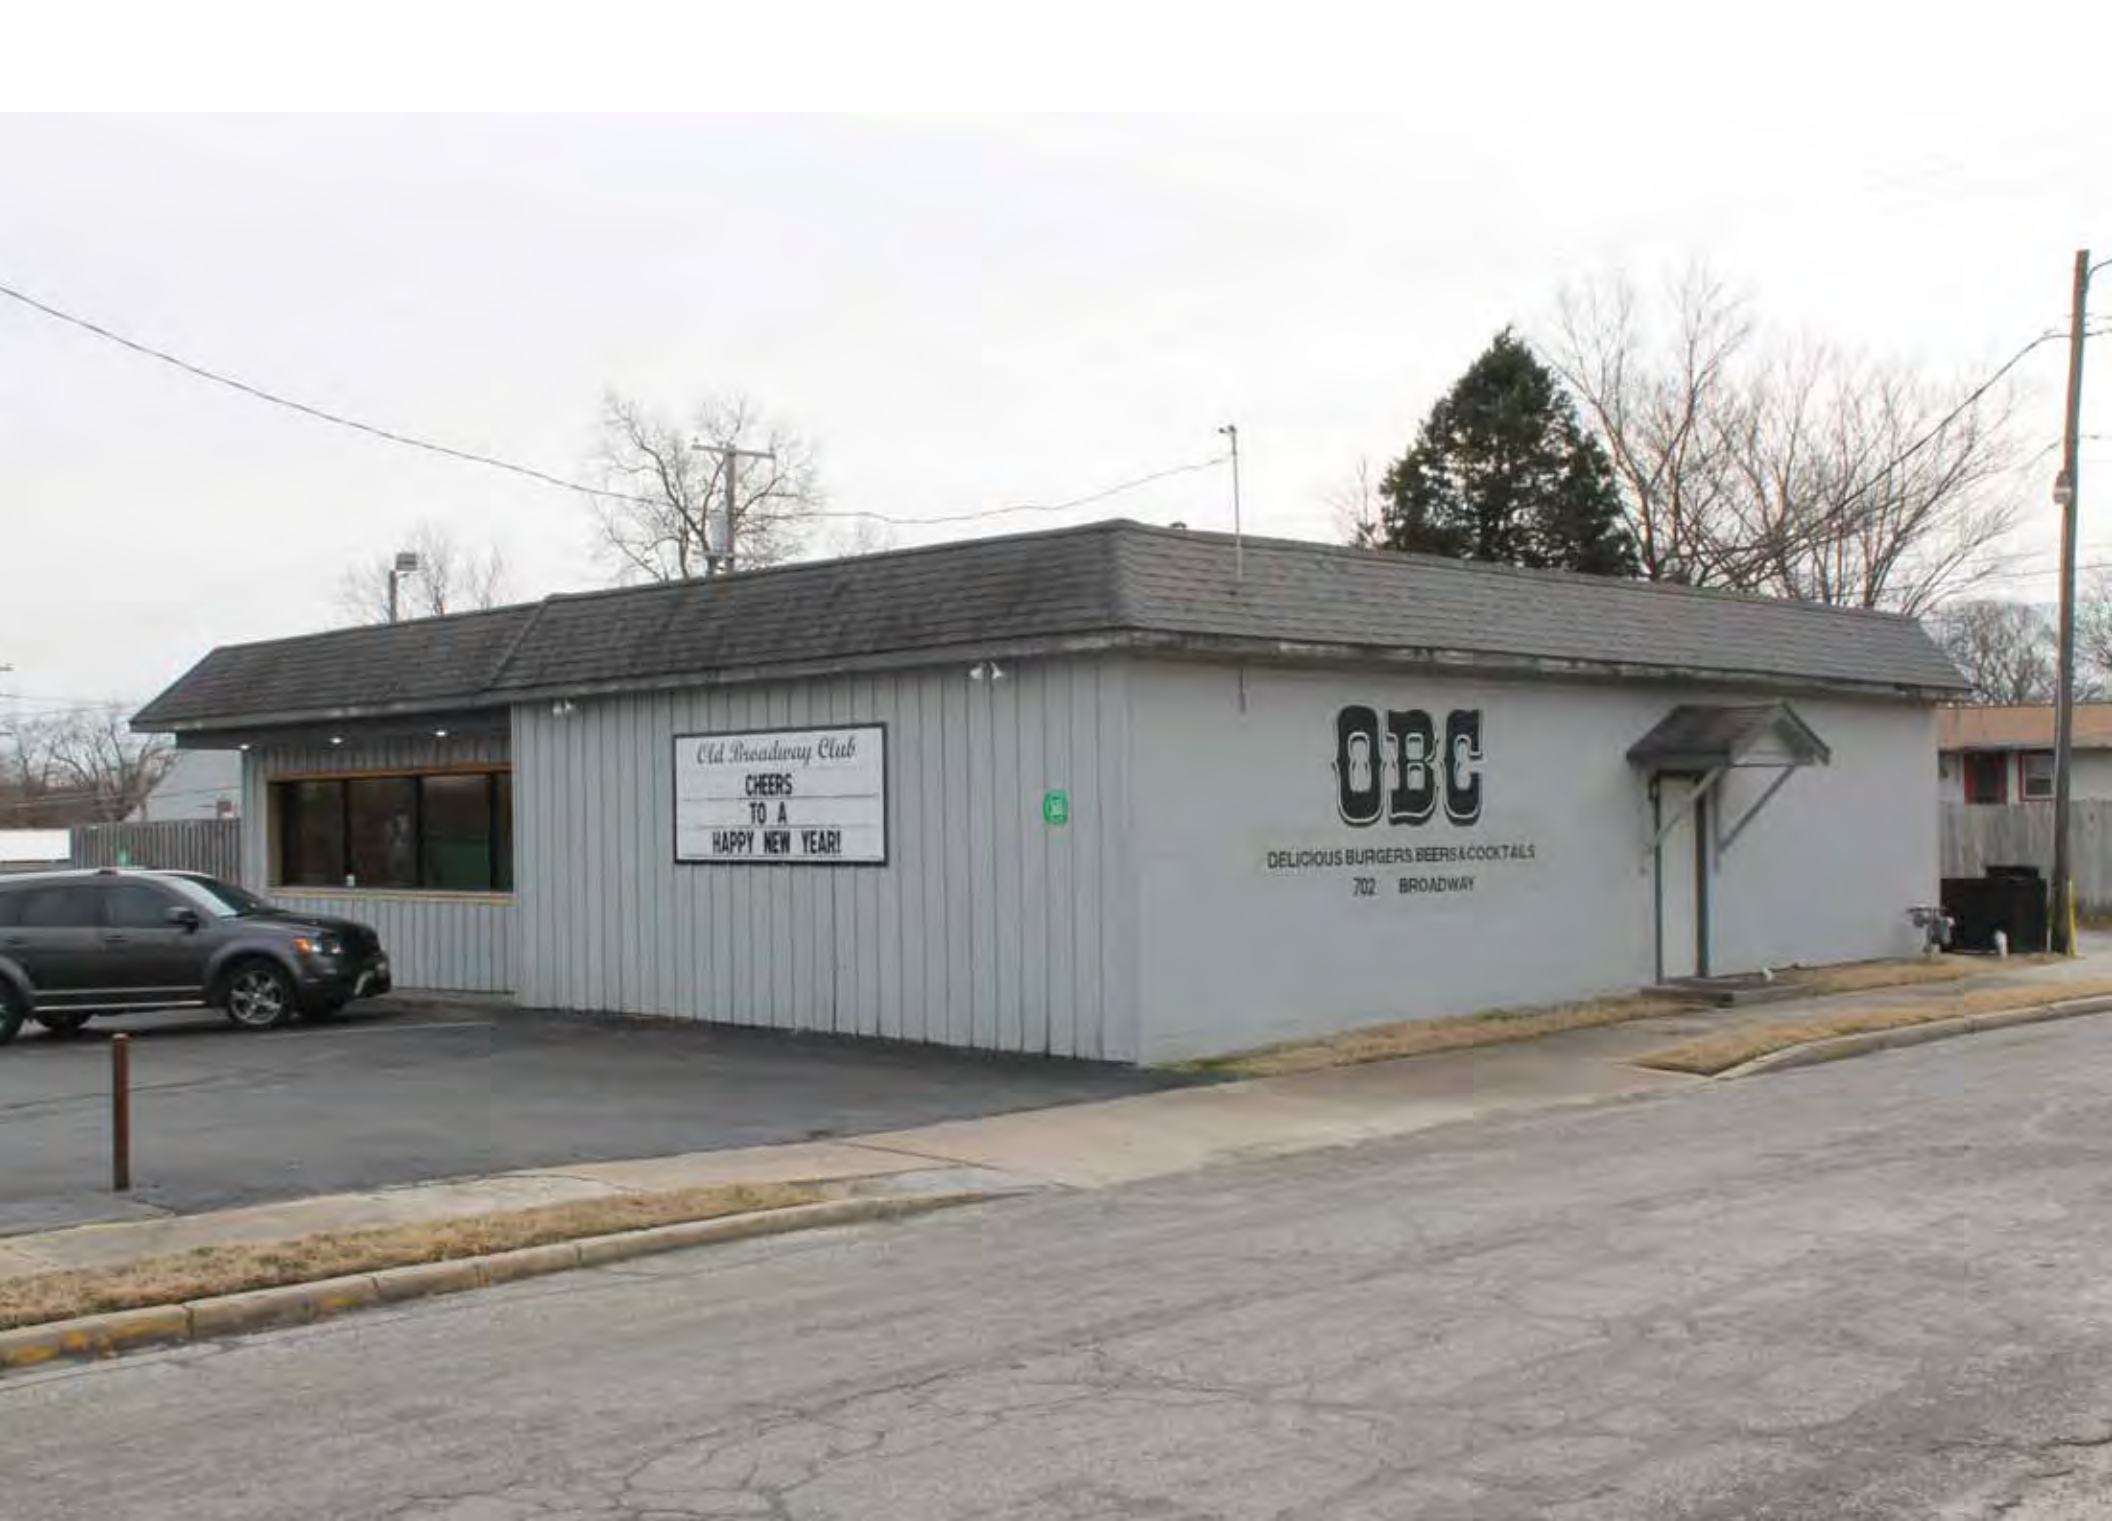
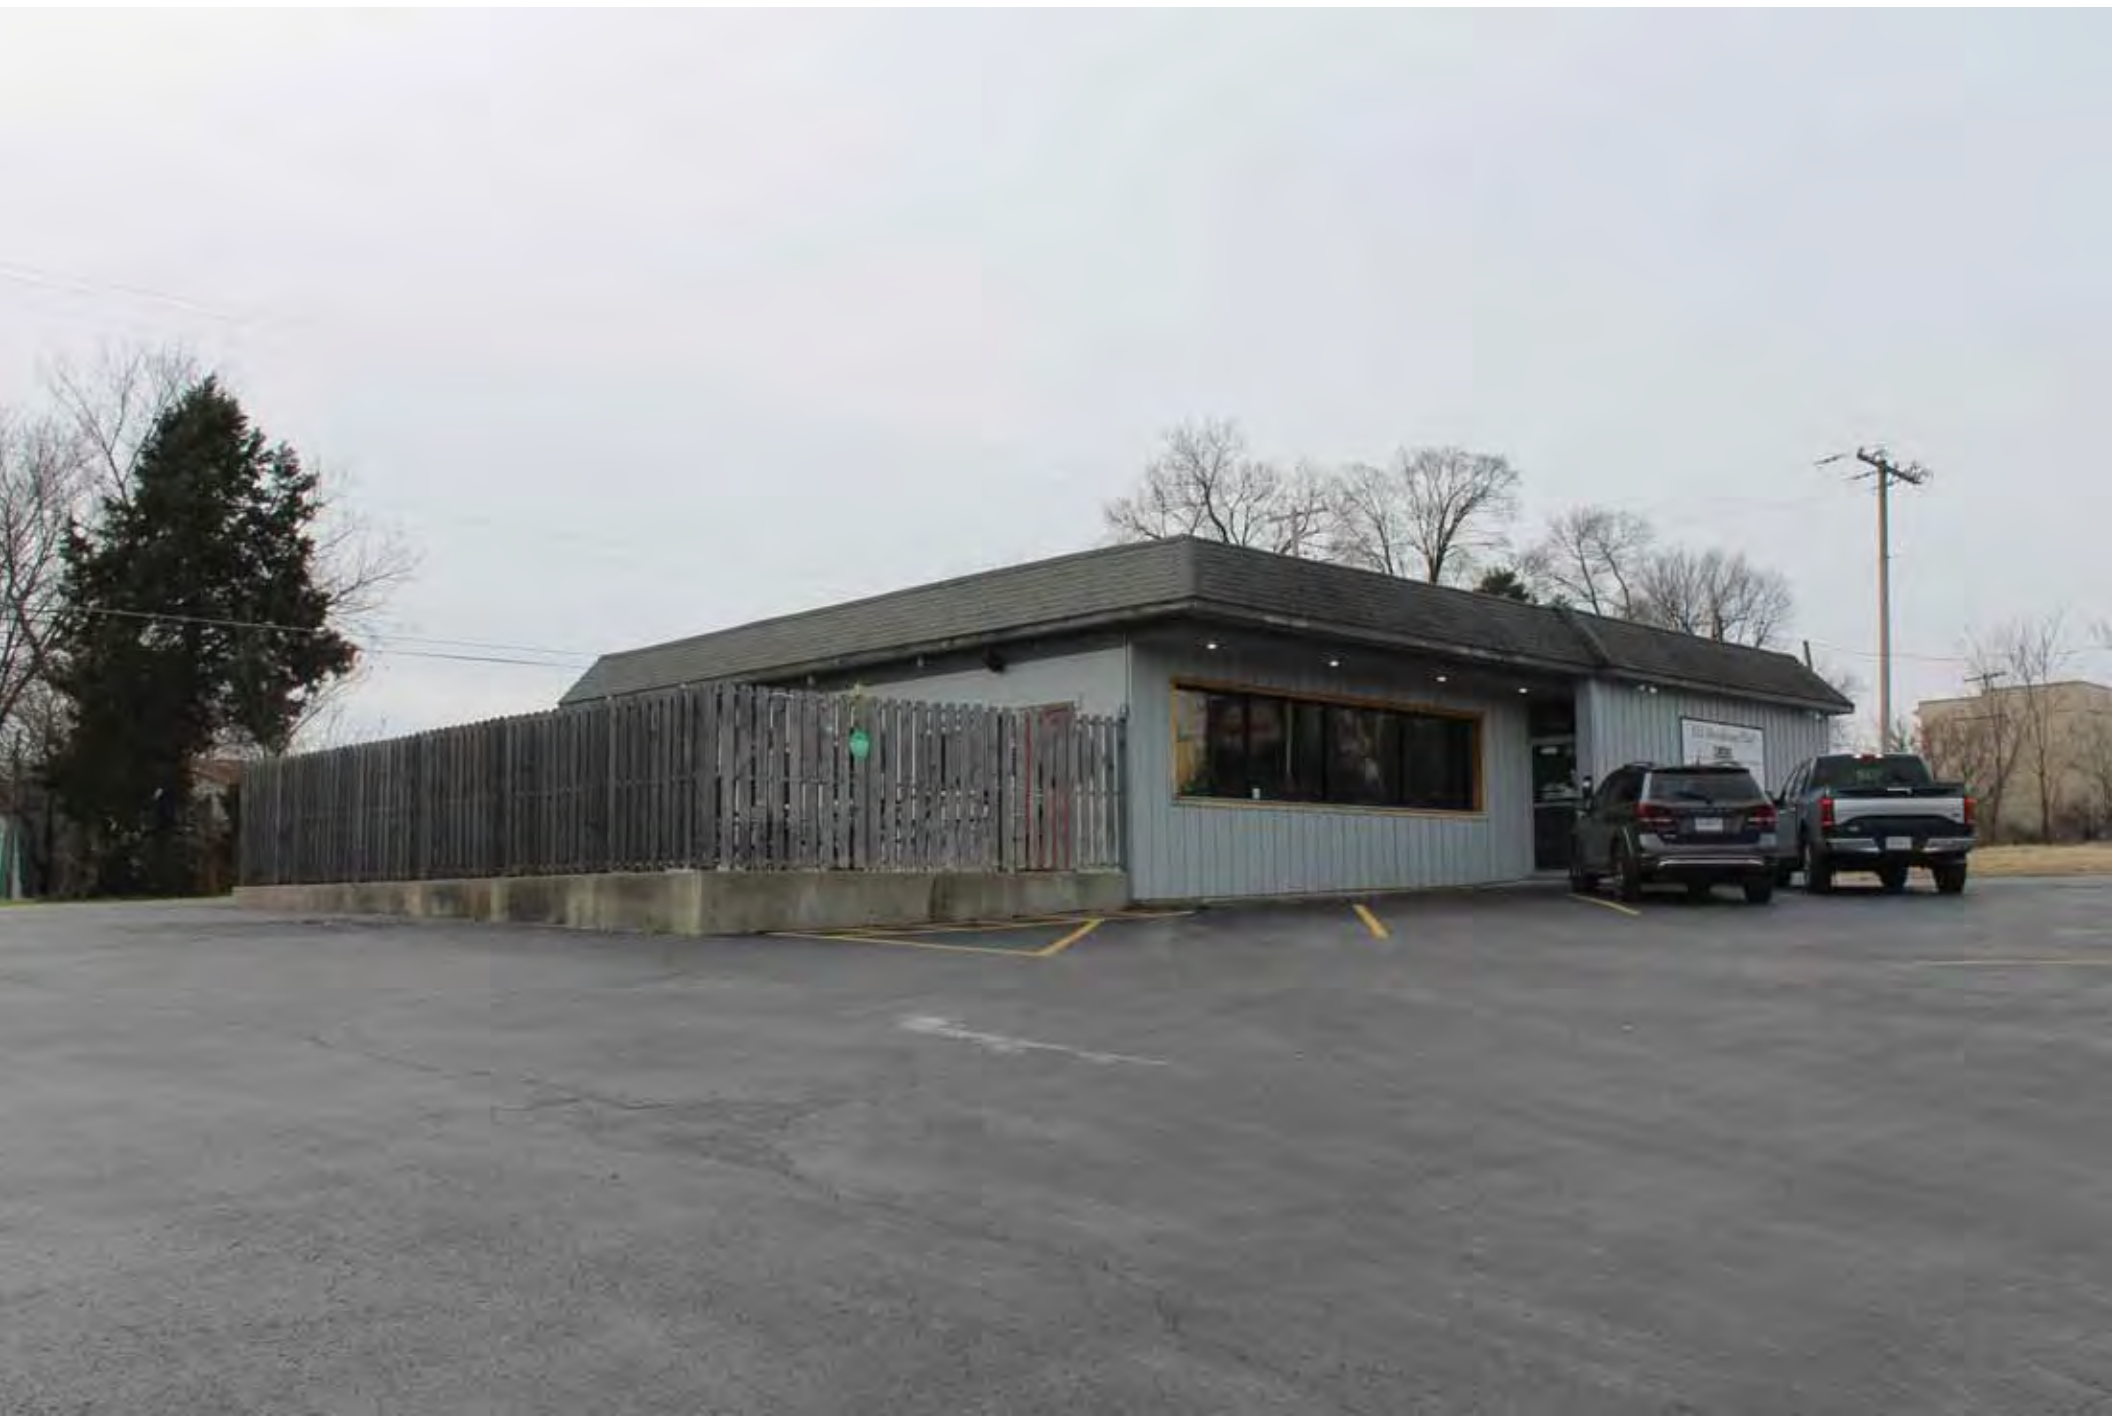
The building on this parcel is a one-story brick restaurant. According to Jasper County records it was built in 1965 as a tavern. It has a flat roof with an asphalt mansard. The brick has been painted and painted wood paneling has been added to the front elevation, along E. Broadway Street. There is a restaurant sign hanging on the wood paneling. To the left or east of the sign there is a large rectangular fixed window on the front elevation.
