MISSOURI DEPARTMENT OF NATURAL RESOURCES
STATE HISTORIC PRESERVATION OFFICE, P.O. Box 176, Jefferson City, MO 65102
ARCHITECTURAL/HISTORIC INVENTORY FORM

1. Survey No. JP-AS-007-001		2. Survey name: East Town (Original Joplin) Historic Survey Phase 2	
3. County: JASPER		4. Address (Street No.) 618	Street (name) E. 2 nd Street
5. City: Joplin	Vicinity: <input type="checkbox"/>	6. Geographical Reference:	7. Township/Range/Section: T: R: S:
8. Historic name (if known):		9. Present/other name (if known):	
10. Ownership: <input checked="" type="checkbox"/> Private <input type="checkbox"/> Public		11a. Historic use (if known): Domestic: Single Dwelling	11b. Current use: Domestic: Single Dwelling

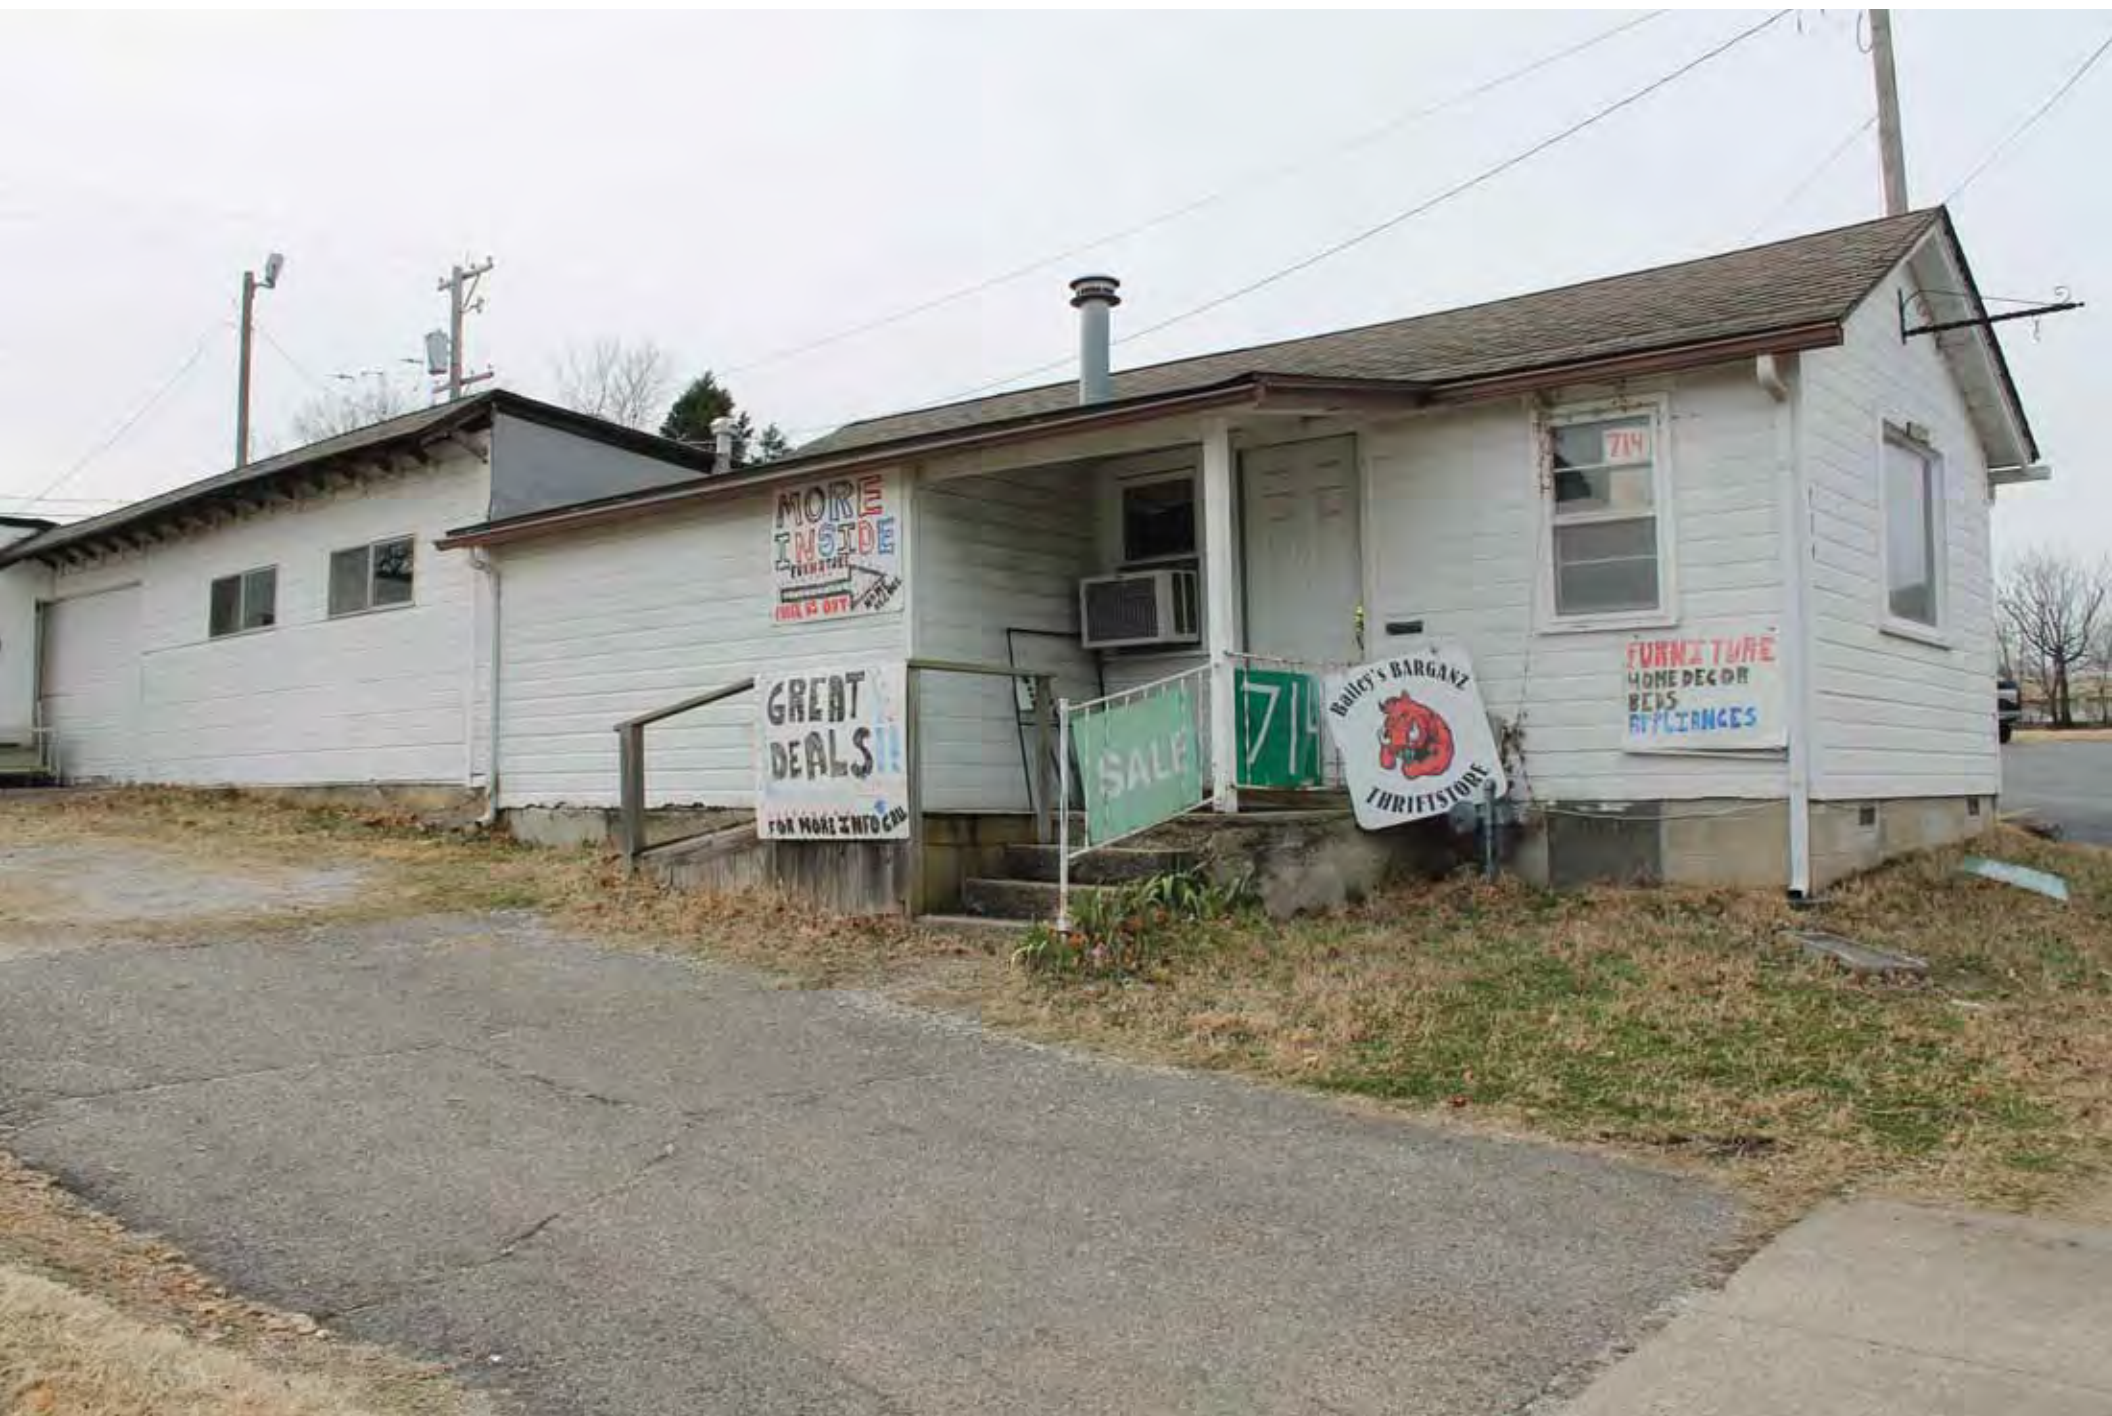
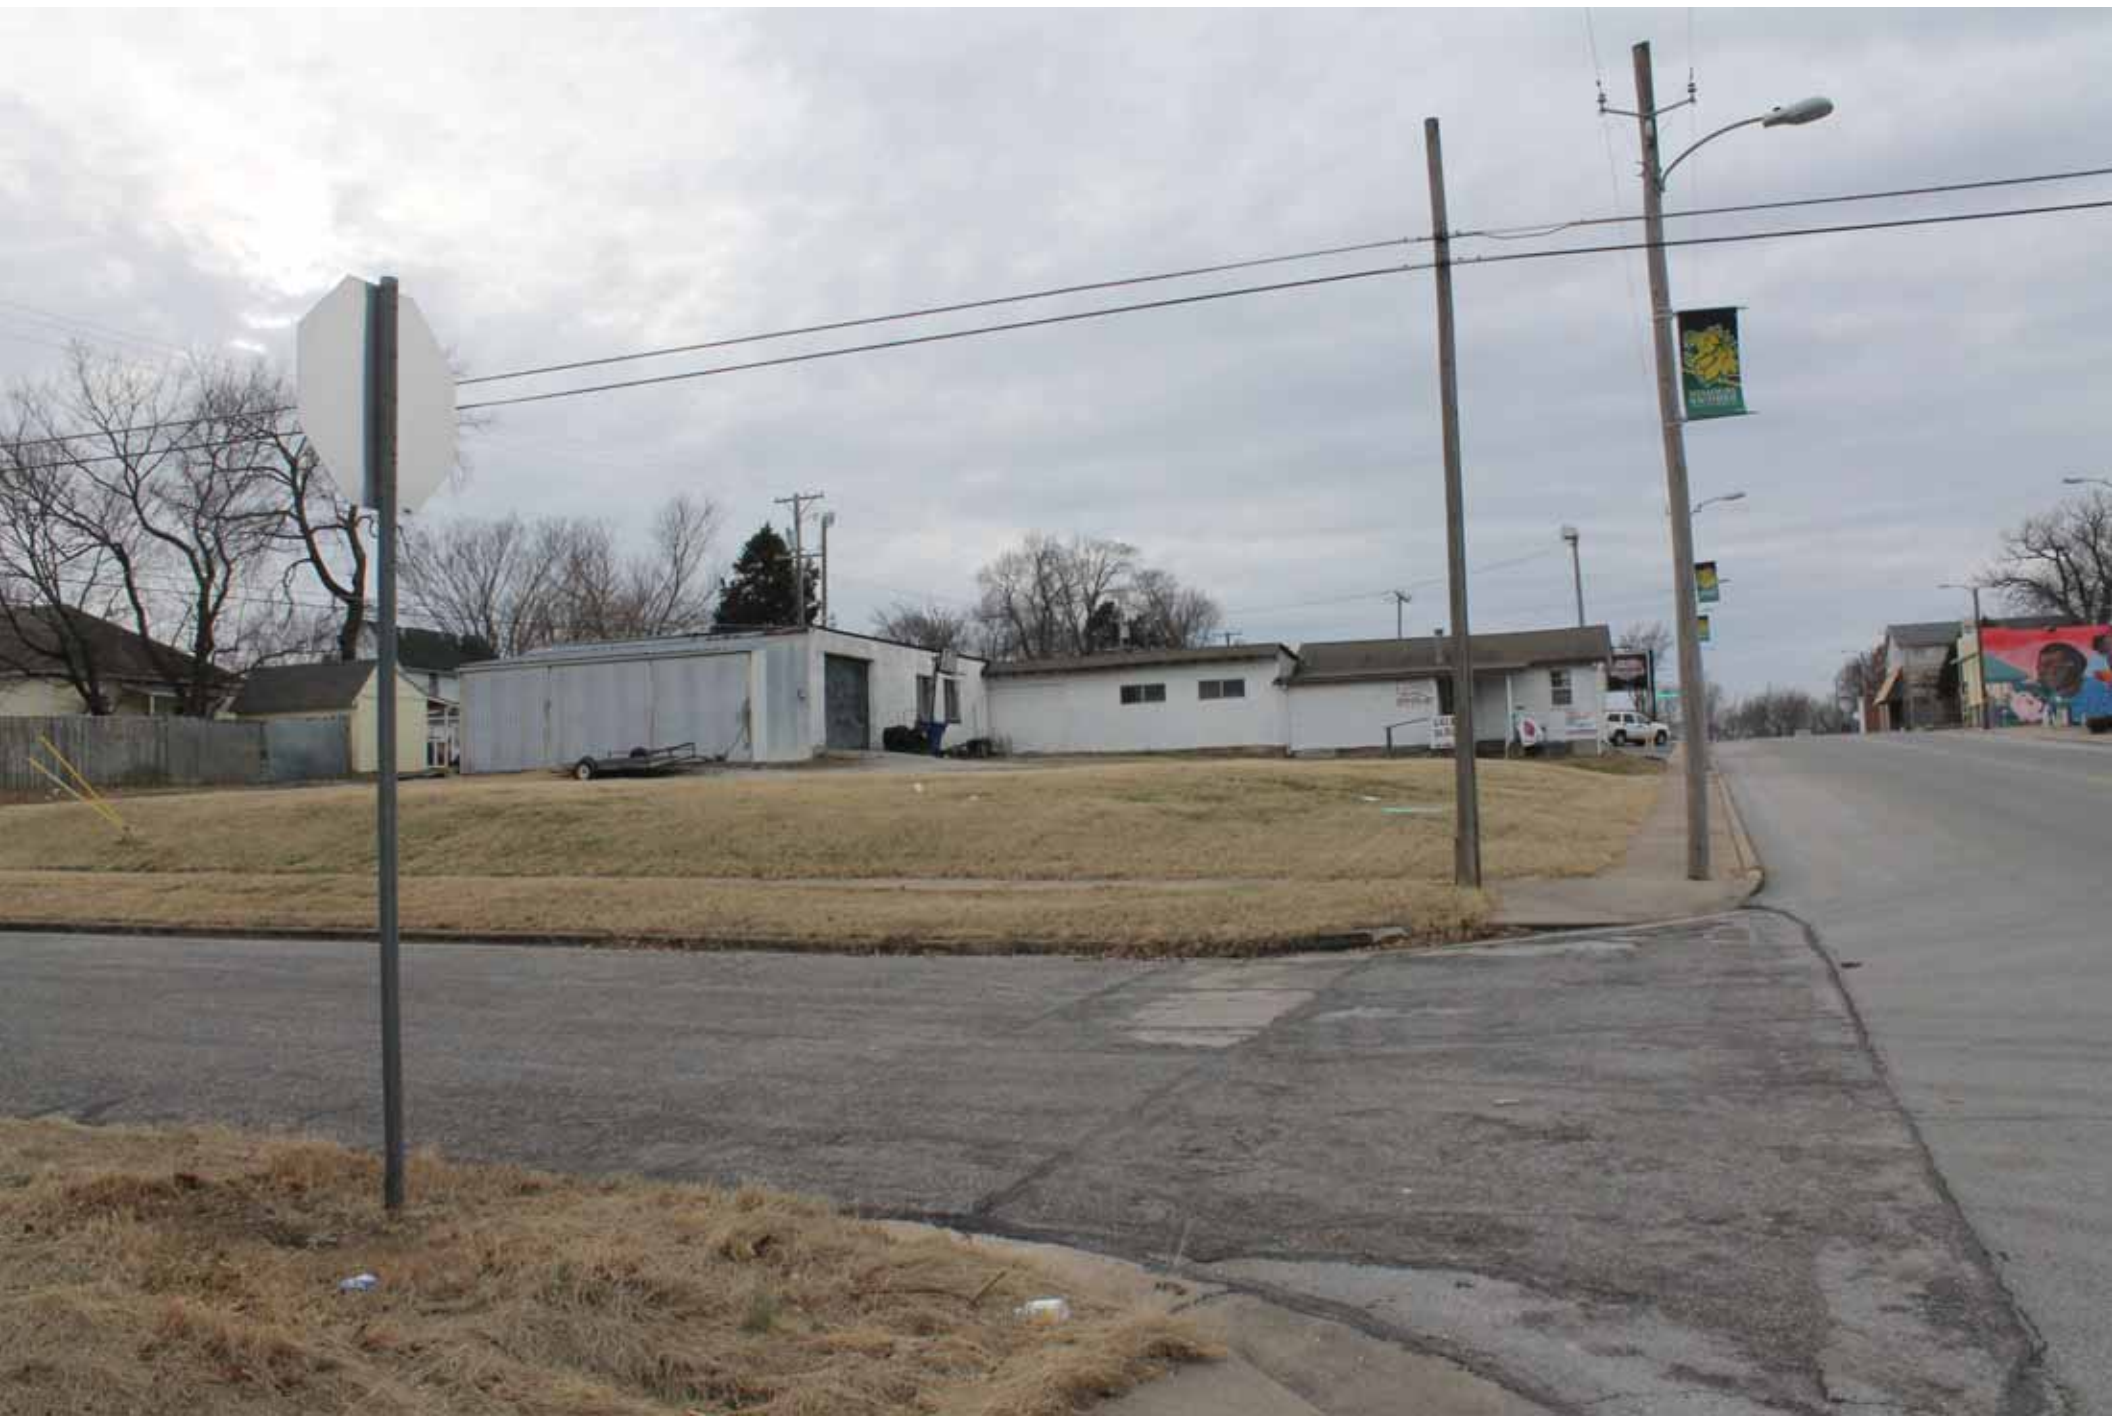
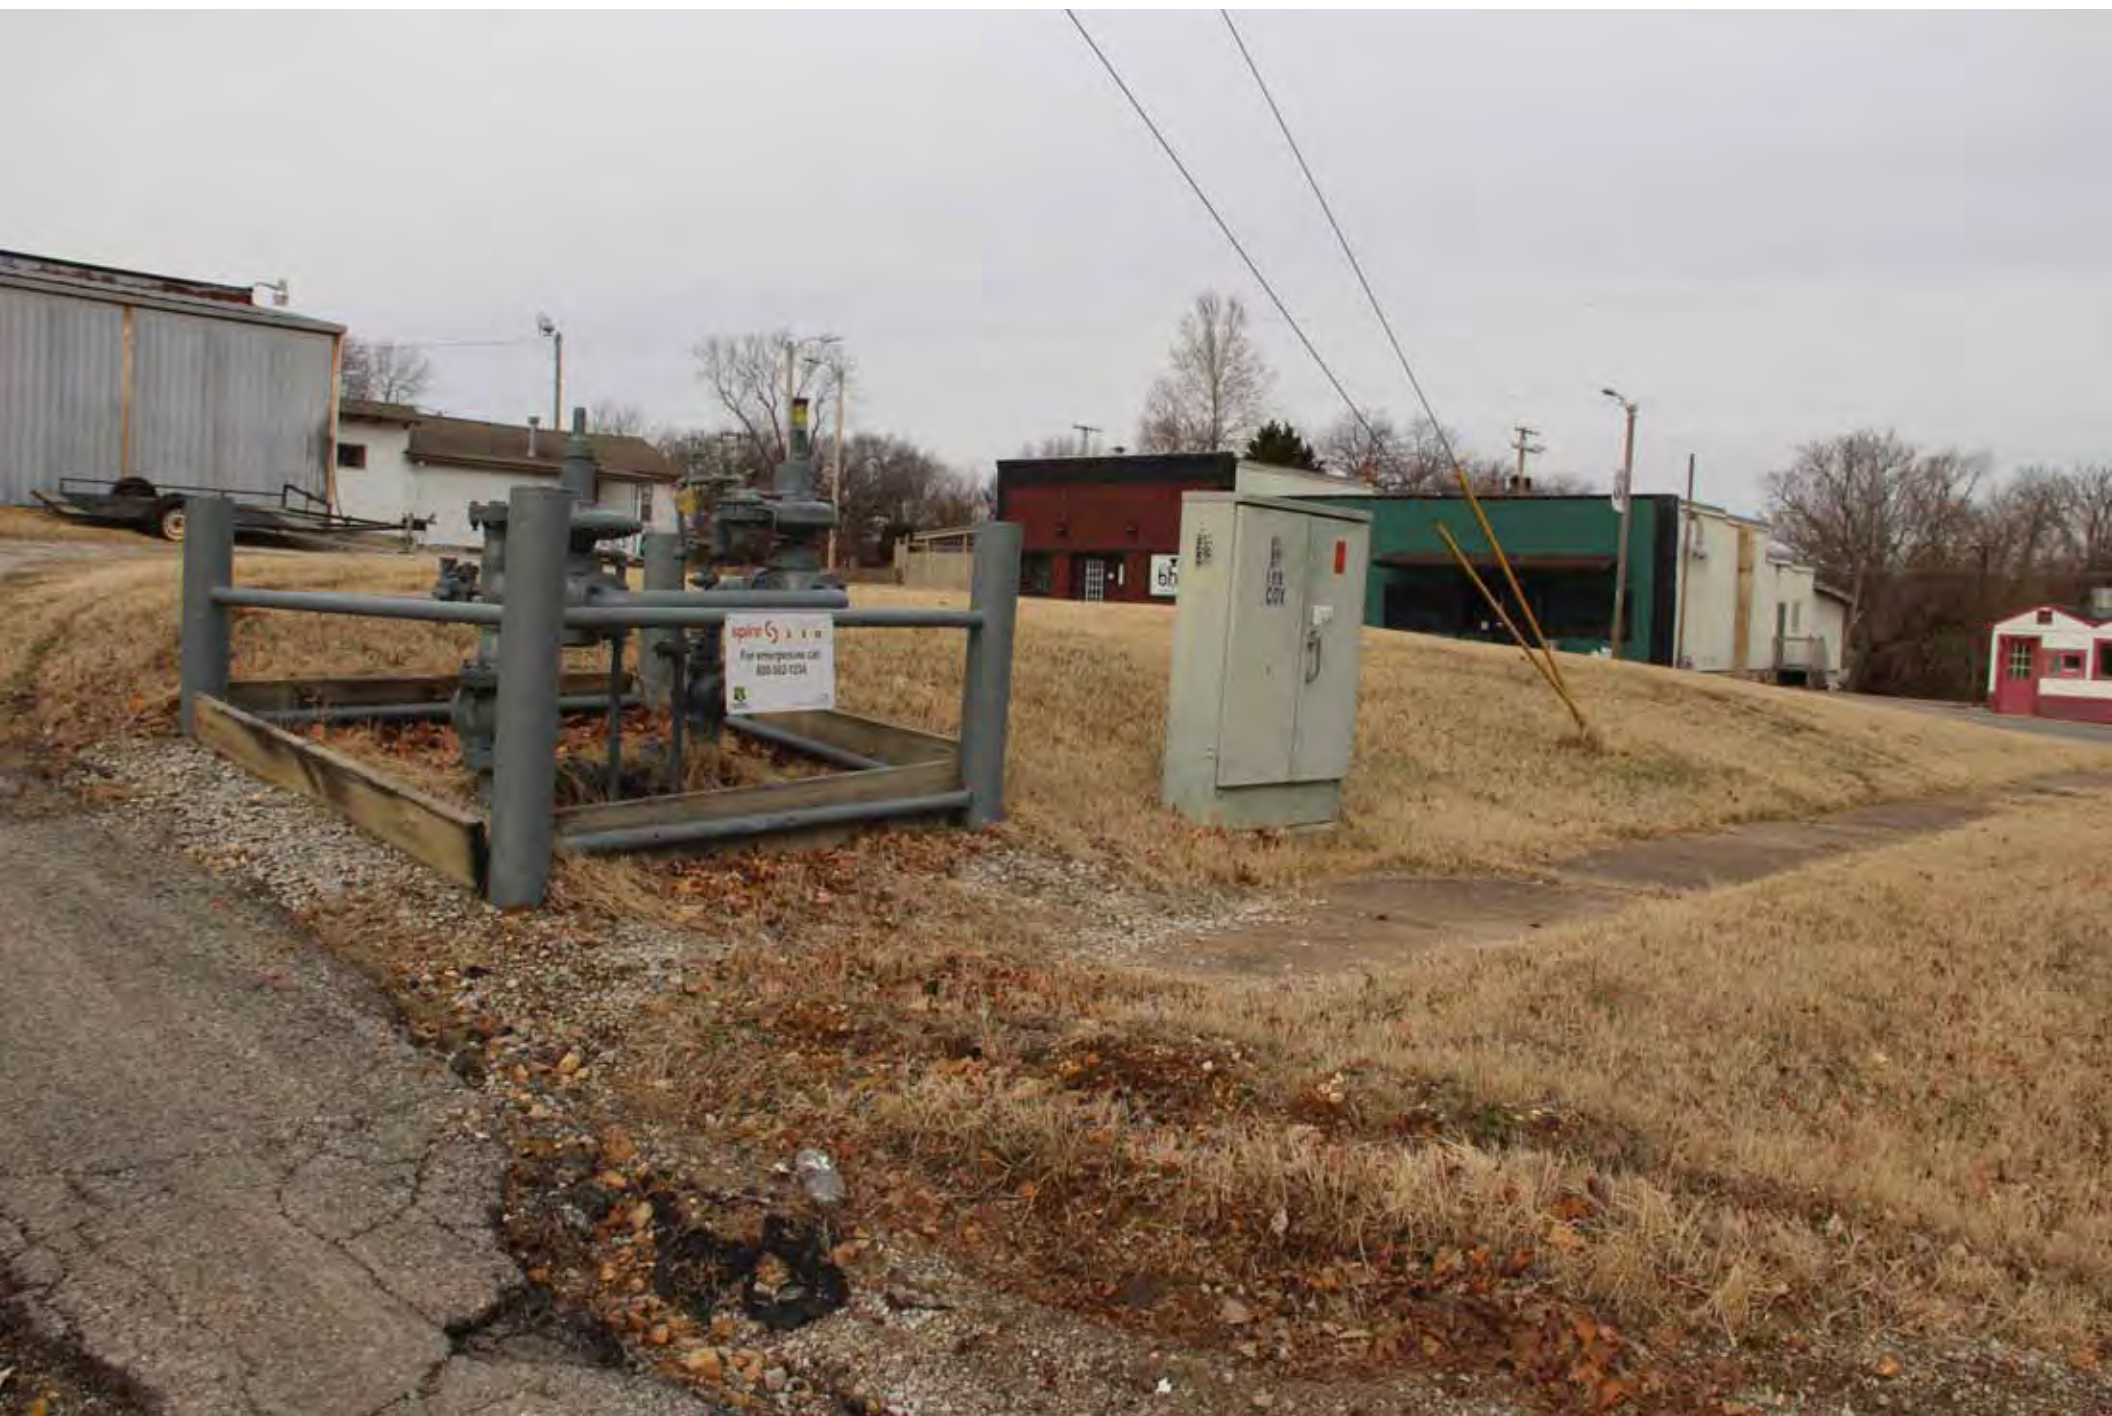
The portion of the building closest to the street is a one-story gable roofed former office. Its front elevation faces east. Its side elevation, along E. Broadway, has one large fixed window. On the east elevation is a small lean to addition and a small wooden porch with a concrete foundation. This porch shelters the entrance door, which is a metal replacement door. To the right of the door is a single one-over-one replacement window. The building is frame and has a concrete foundation.

Connecting the office and the garage is a one-story frame addition with a shed roof and exposed rafters. On its east elevation it has one garage bay and two fixed casement windows.
