MISSOURI DEPARTMENT OF NATURAL RESOURCES
STATE HISTORIC PRESERVATION OFFICE, P.O. Box 176, Jefferson City, MO 65102
ARCHITECTURAL/HISTORIC INVENTORY FORM

1. Survey No. JP-AS-007-001		2. Survey name: East Town (Original Joplin) Historic Survey Phase 2	
3. County: JASPER		4. Address (Street No.) 618	Street (name) E. 2 nd Street
5. City: Joplin	Vicinity: <input type="checkbox"/>	6. Geographical Reference:	7. Township/Range/Section: T: R: S:
8. Historic name (if known):		9. Present/other name (if known):	
10. Ownership: <input checked="" type="checkbox"/> Private <input type="checkbox"/> Public		11a. Historic use (if known): Domestic: Single Dwelling	11b. Current use: Domestic: Single Dwelling

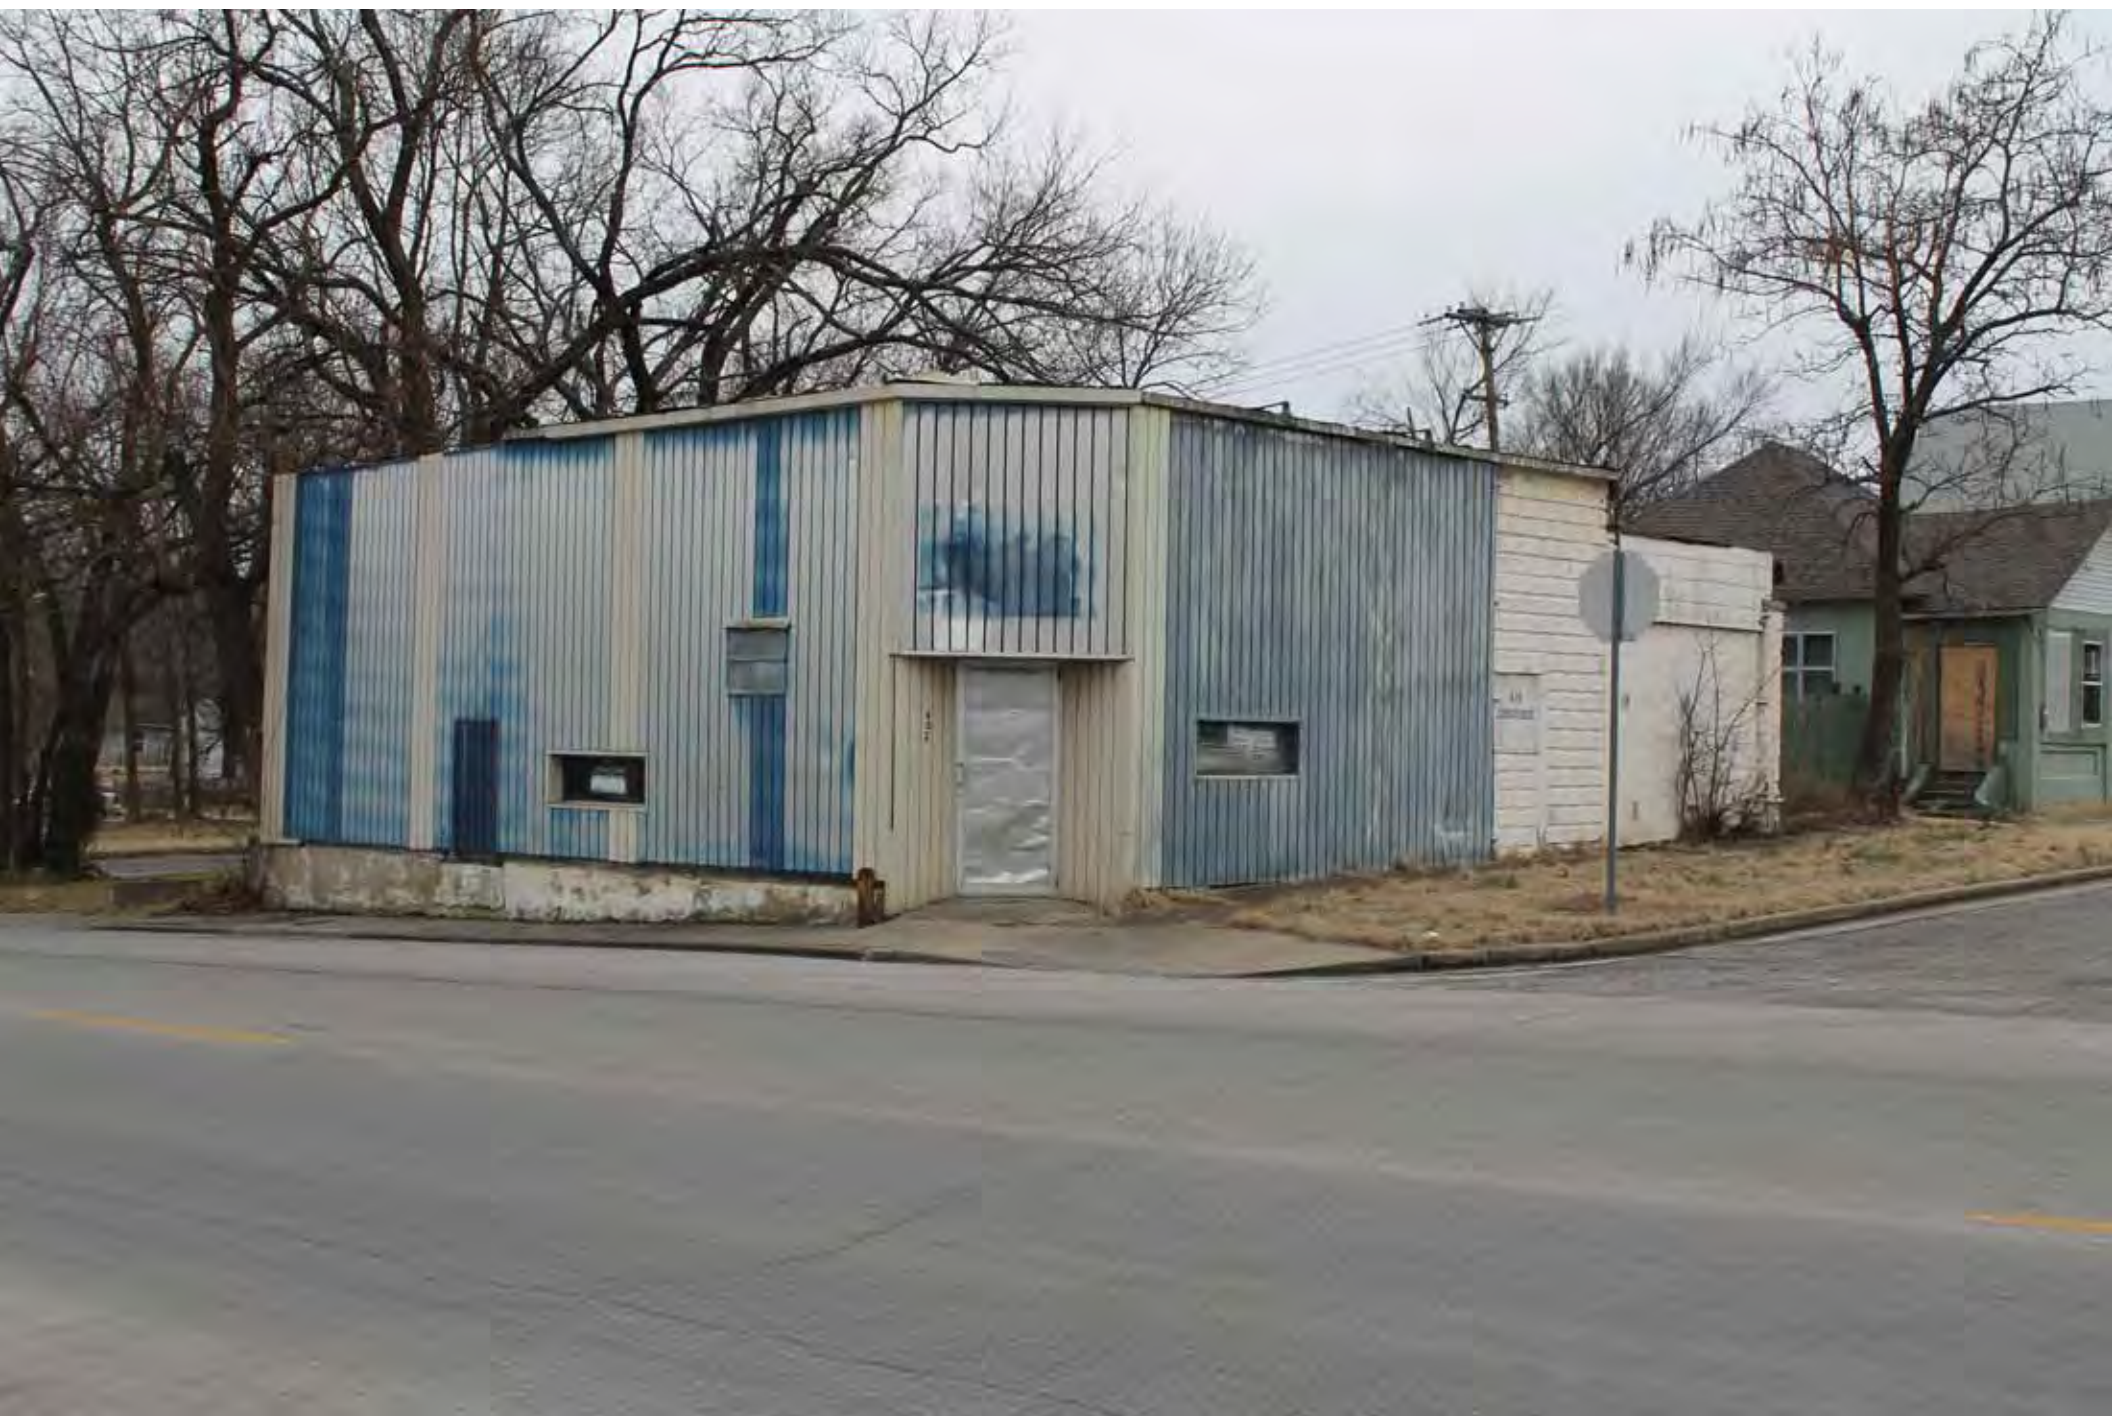
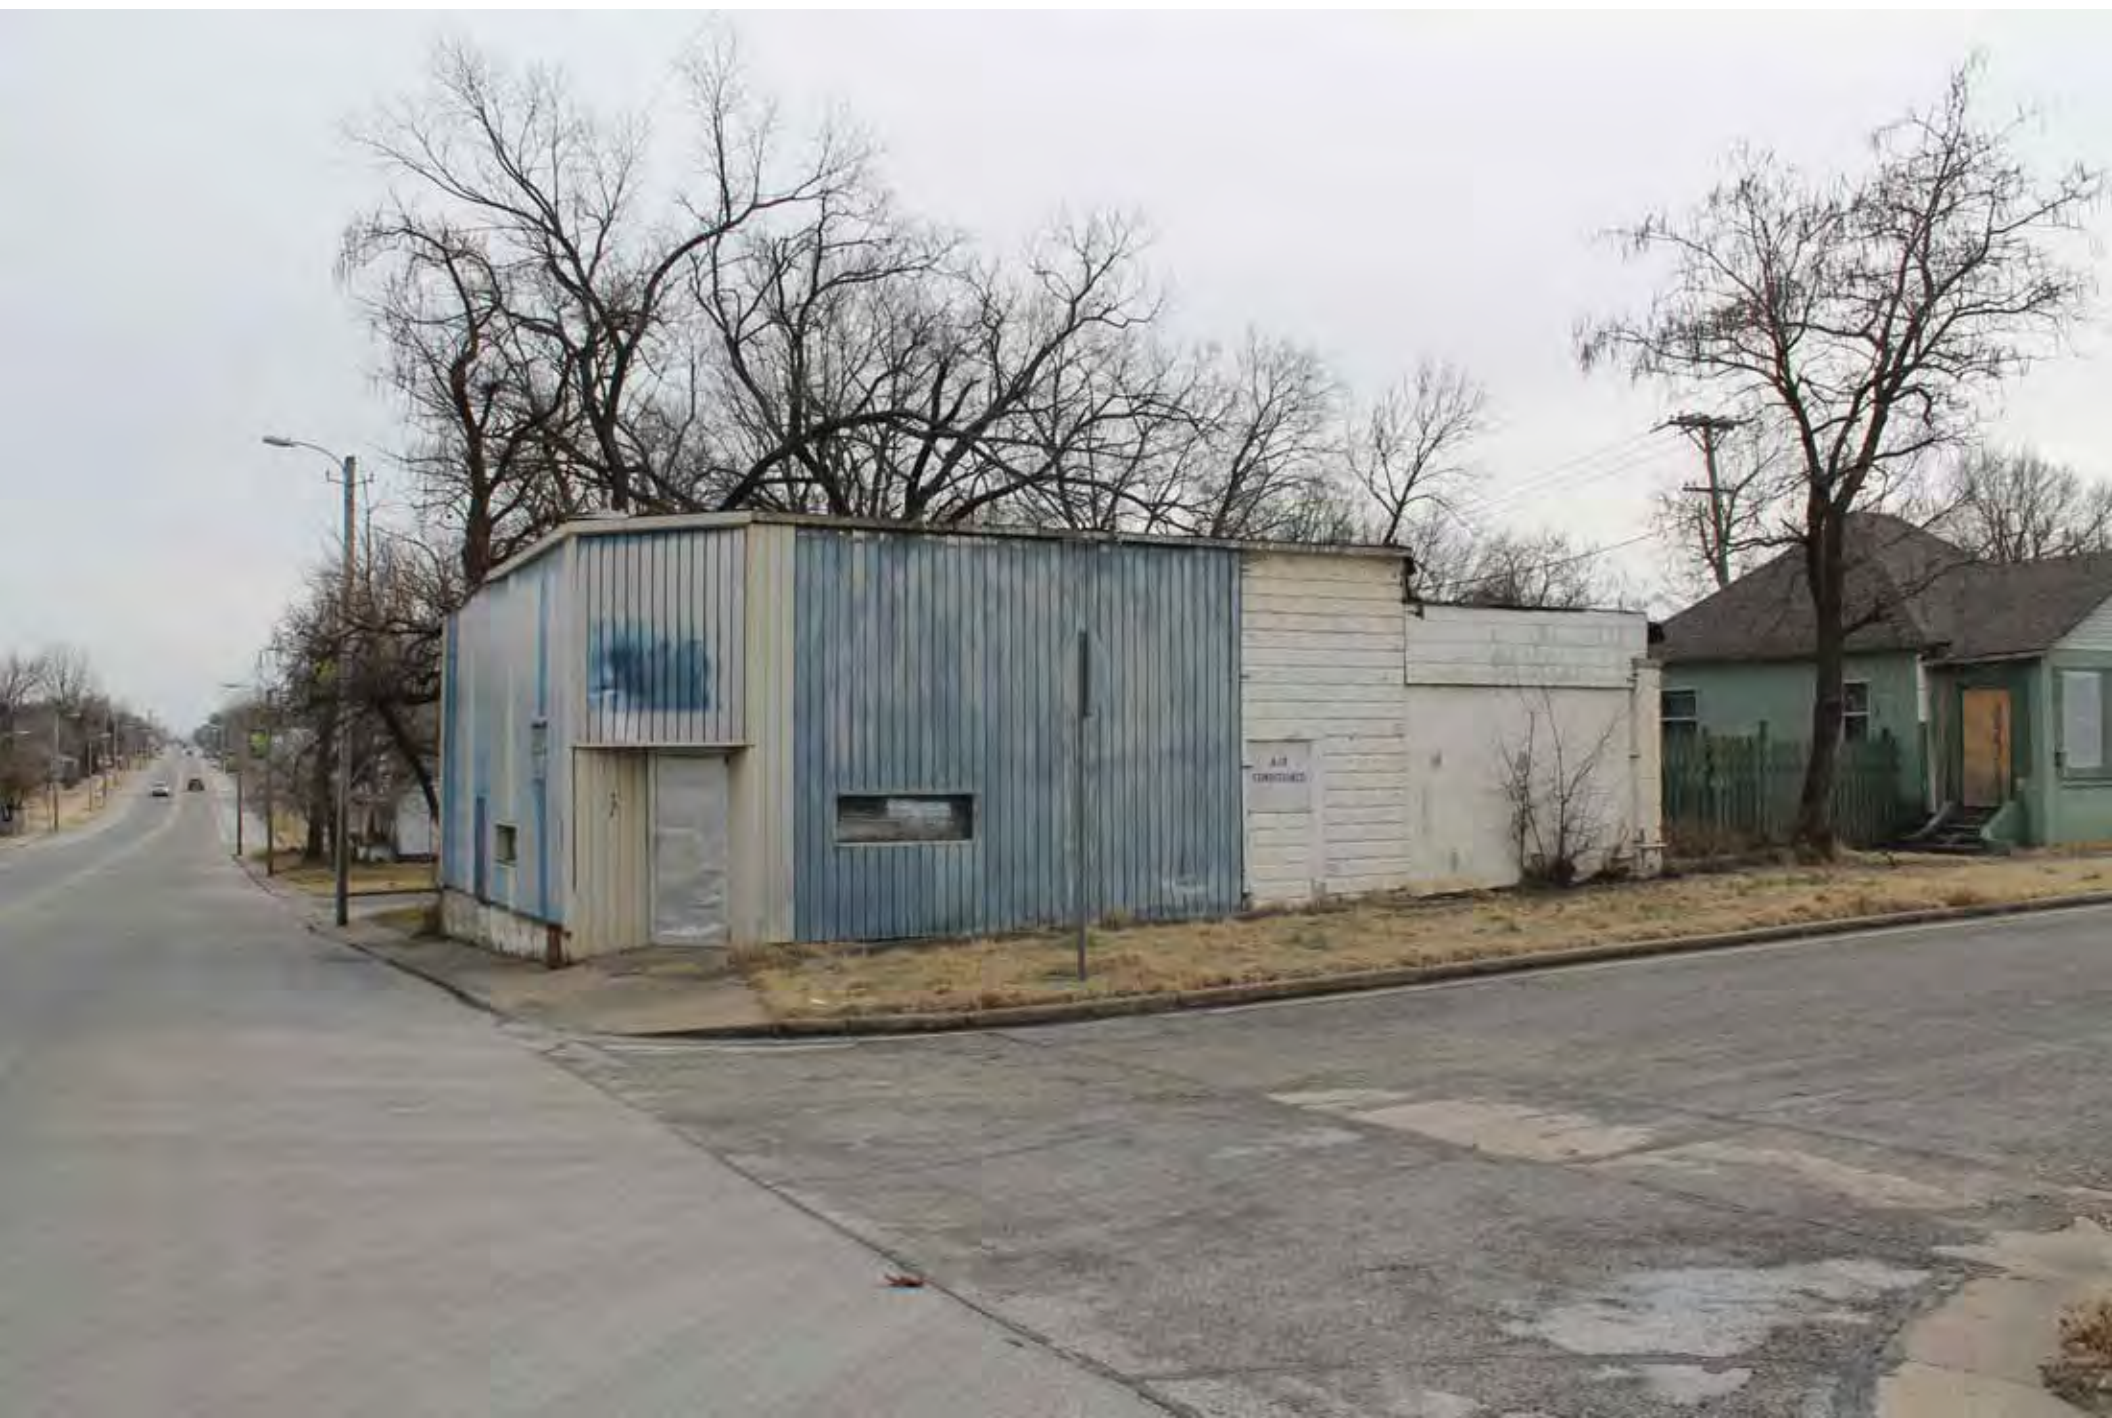
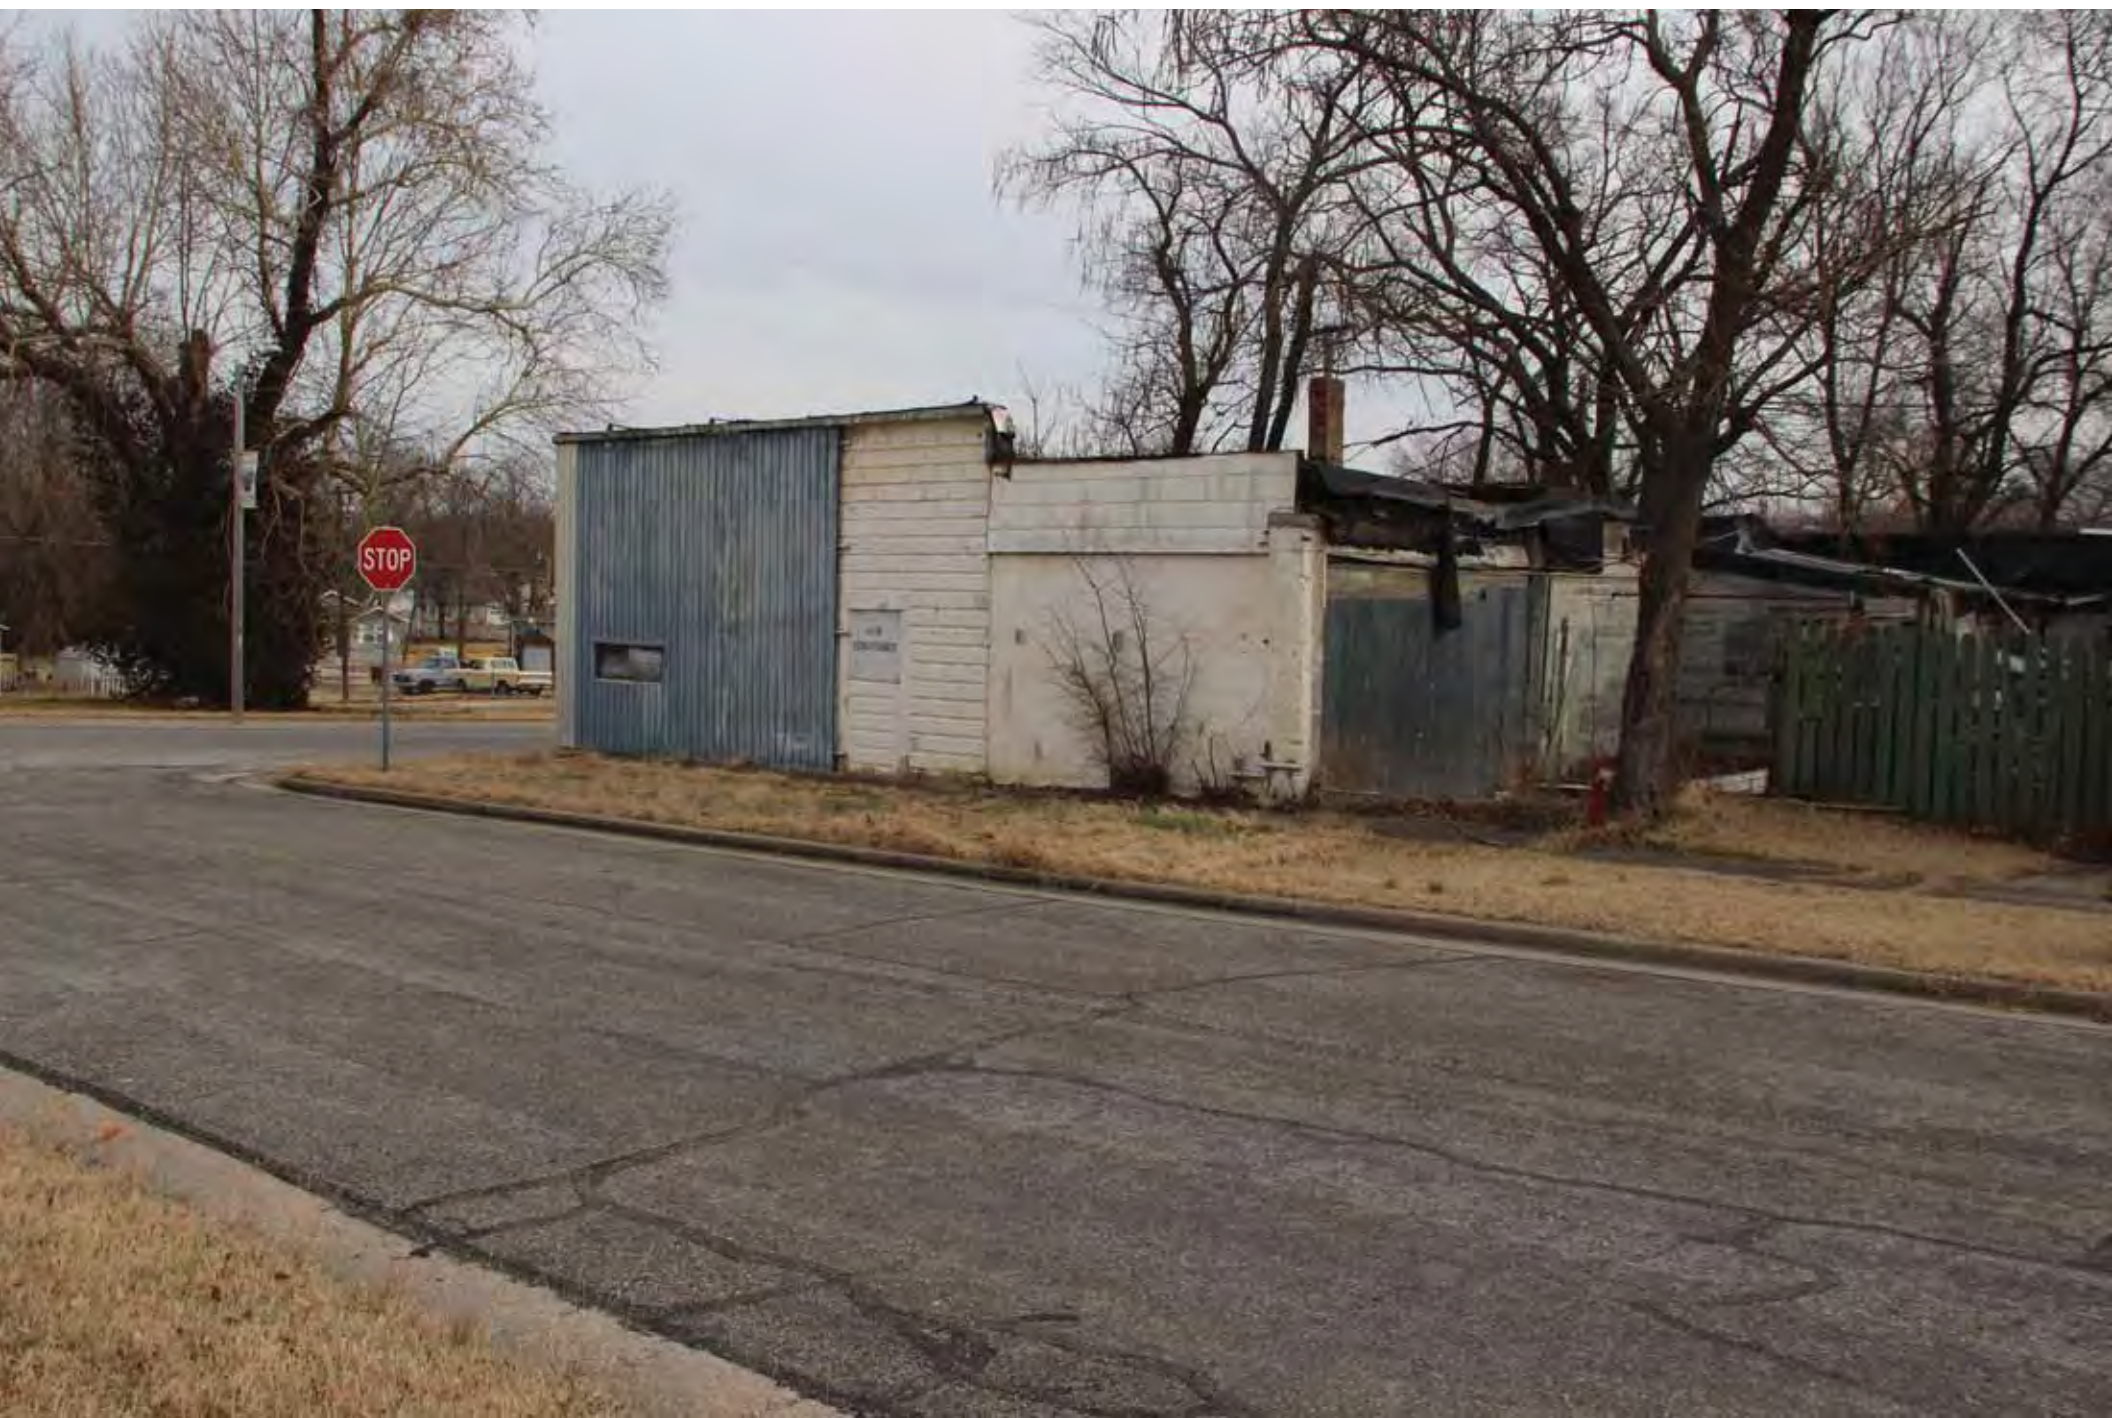
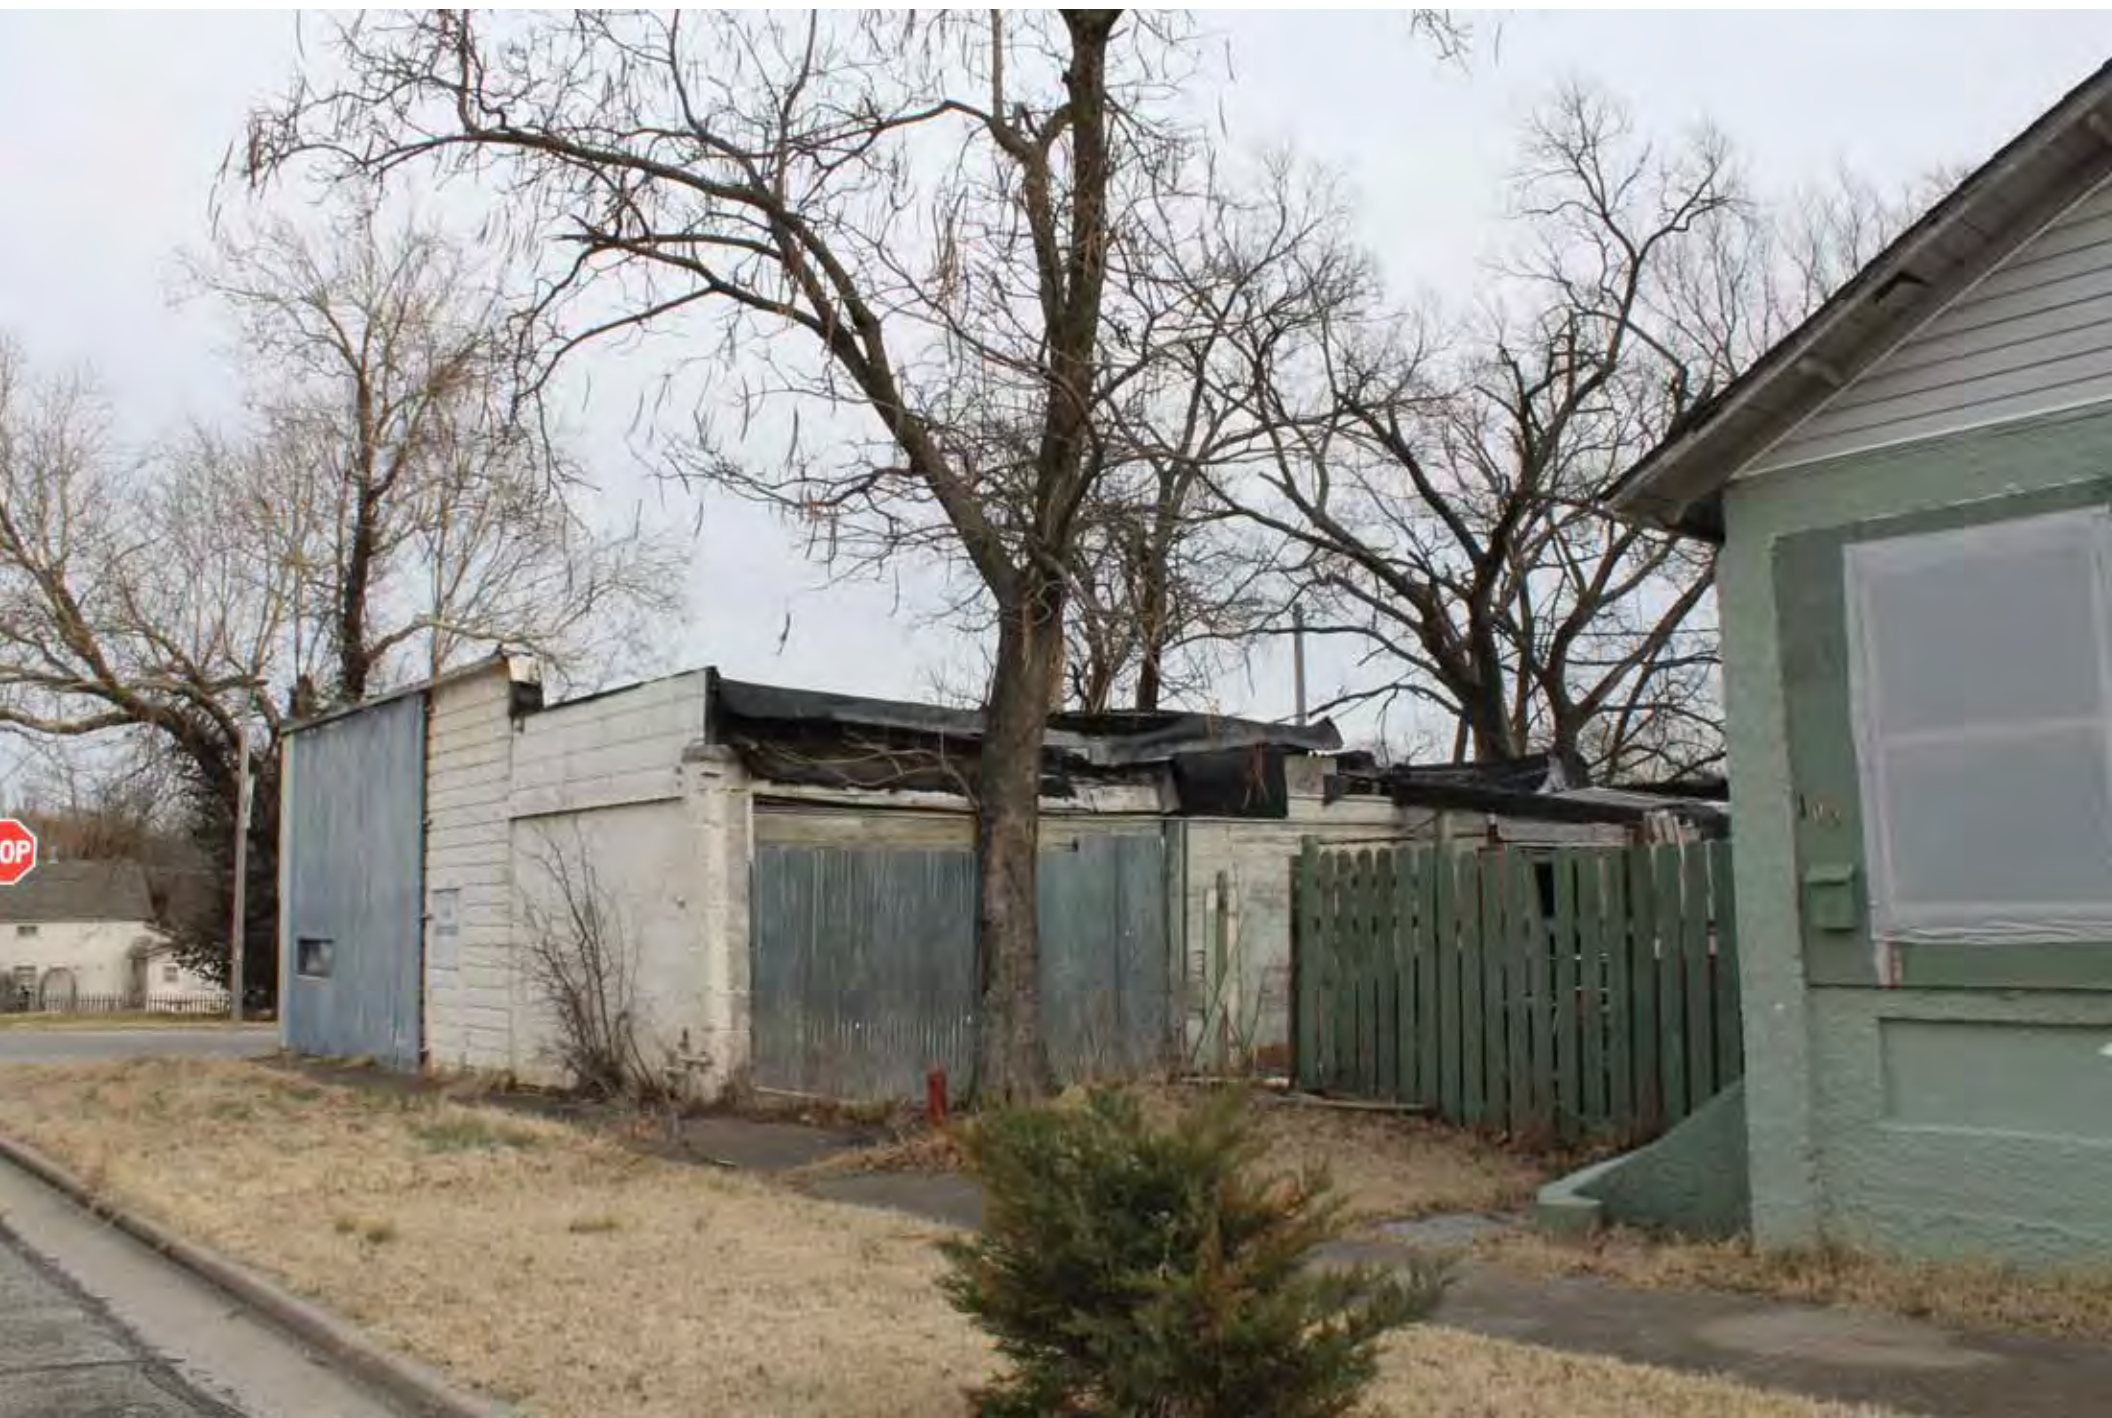
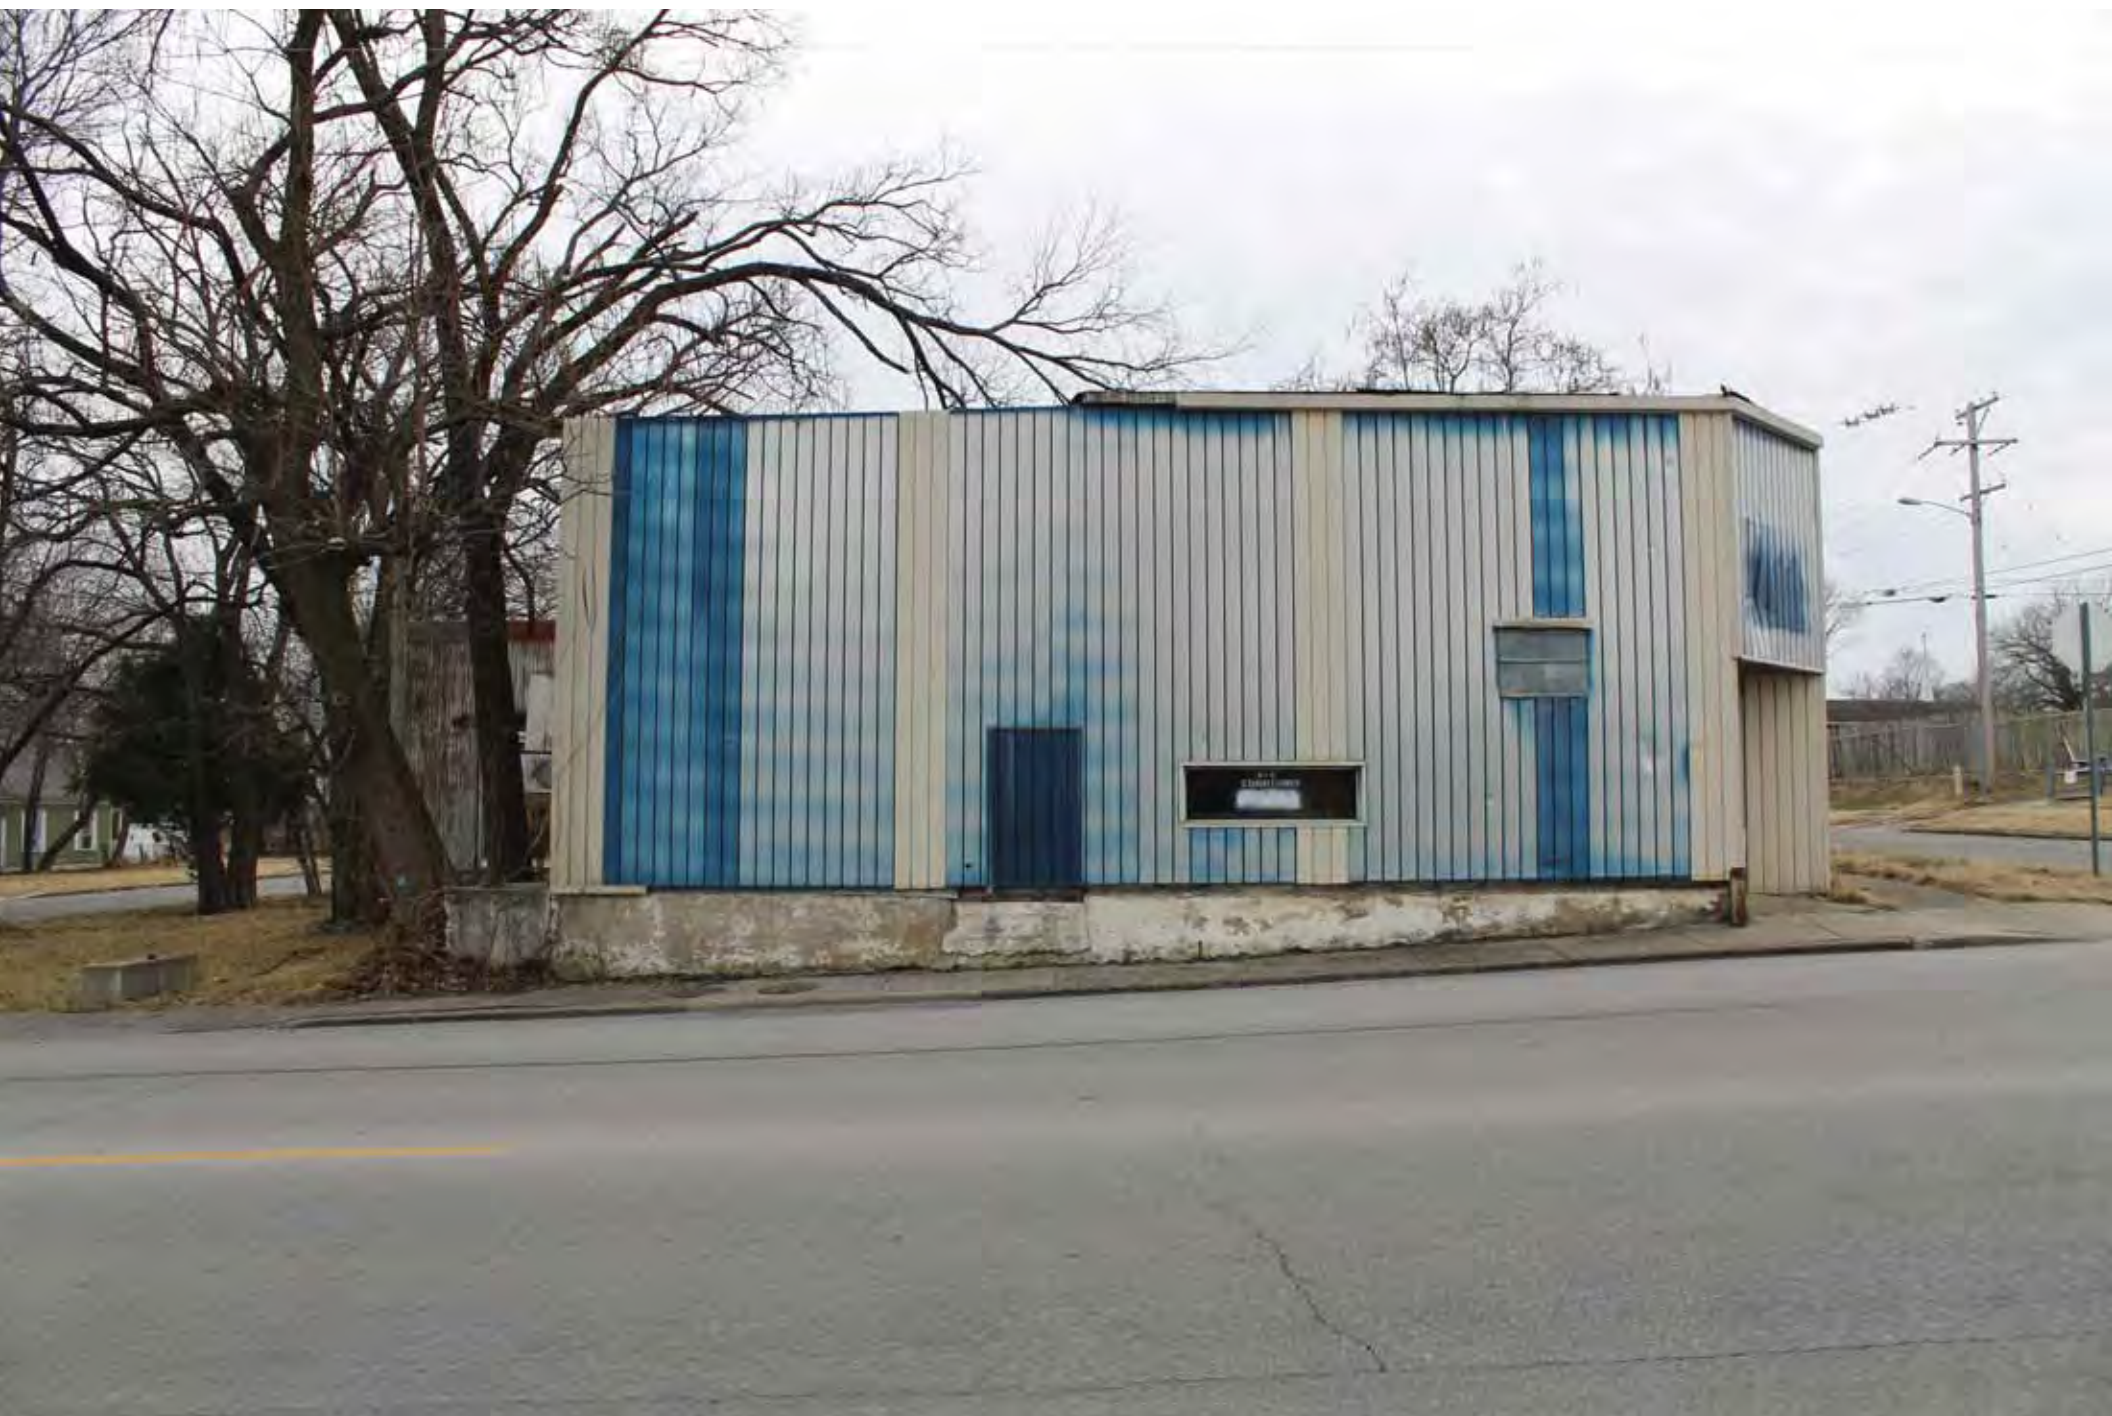
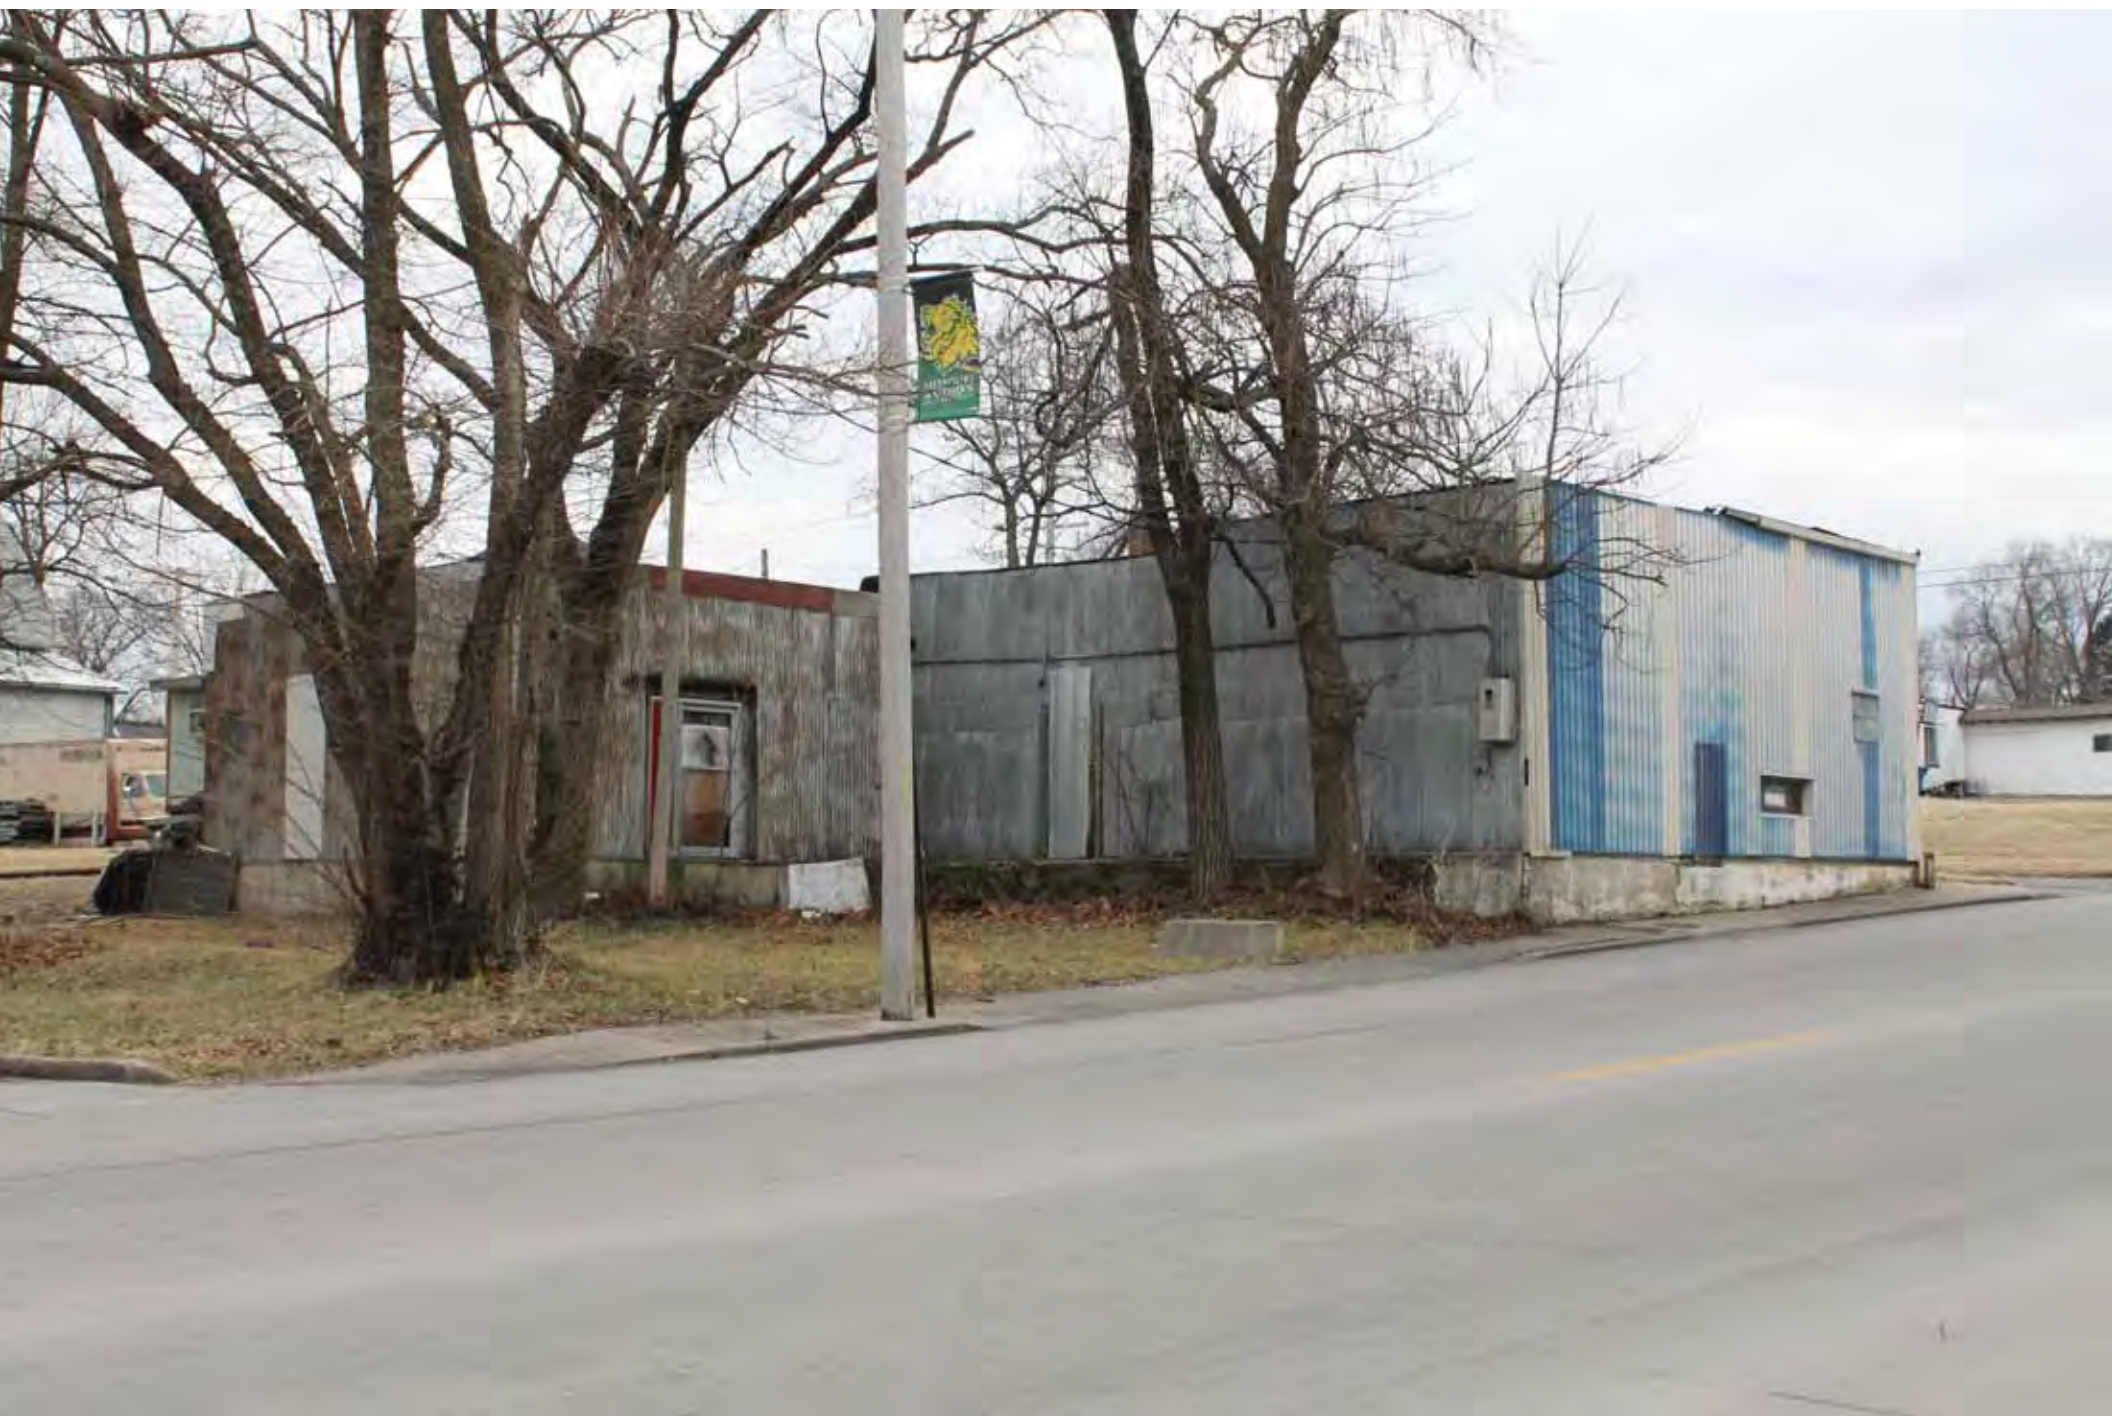
This one-story commercial building has several additions on the rear of the building. The main elevation sits on E. Broadway Street, with a corner entrance at S. Cox Avenue. This front and side elevation is covered in metal siding, which at some point was painted. At the rear of the building is a one-story concrete block garage, which appears to have been added at a later date. The garage has a flat roof and has been painted. There is one garage door bay facing S. Cox Avenue. On the east side of the building is a square one-story addition that has a concrete foundation and is covered in corrugated metal.
