MISSOURI DEPARTMENT OF NATURAL RESOURCES
STATE HISTORIC PRESERVATION OFFICE, P.O. Box 176, Jefferson City, MO 65102
ARCHITECTURAL/HISTORIC INVENTORY FORM

1. Survey No. JP-AS-007-001		2. Survey name: East Town (Original Joplin) Historic Survey Phase 2	
3. County: JASPER		4. Address (Street No.) 618	Street (name) E. 2 nd Street
5. City: Joplin	Vicinity: <input type="checkbox"/>	6. Geographical Reference:	7. Township/Range/Section: T: R: S:
8. Historic name (if known):		9. Present/other name (if known):	
10. Ownership: <input checked="" type="checkbox"/> Private <input type="checkbox"/> Public		11a. Historic use (if known): Domestic: Single Dwelling	11b. Current use: Domestic: Single Dwelling

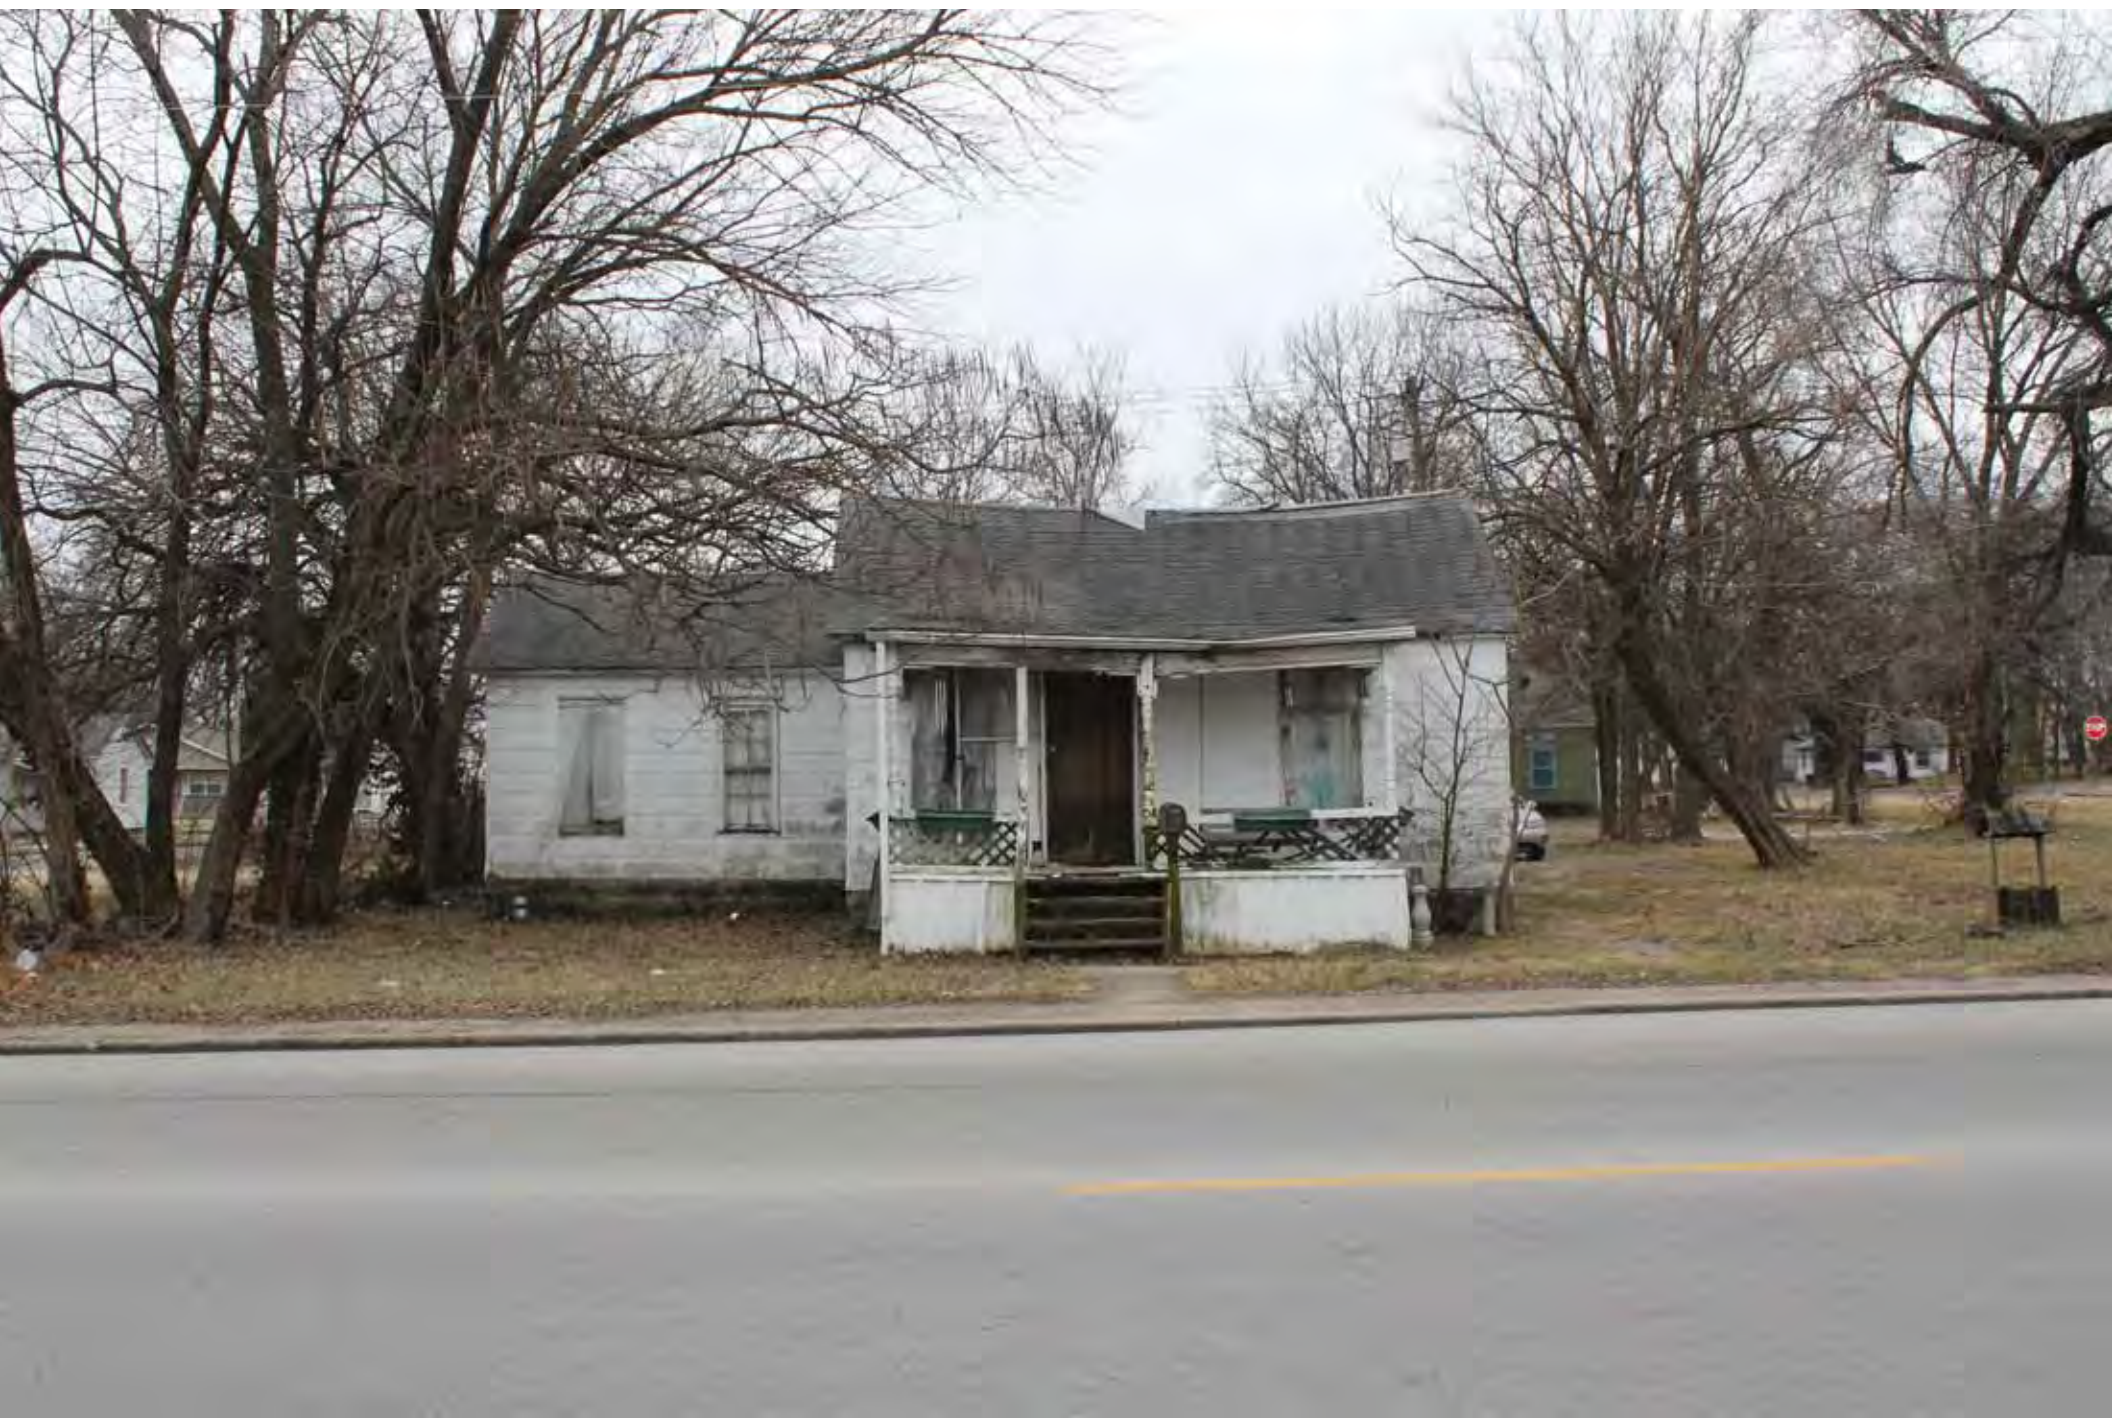
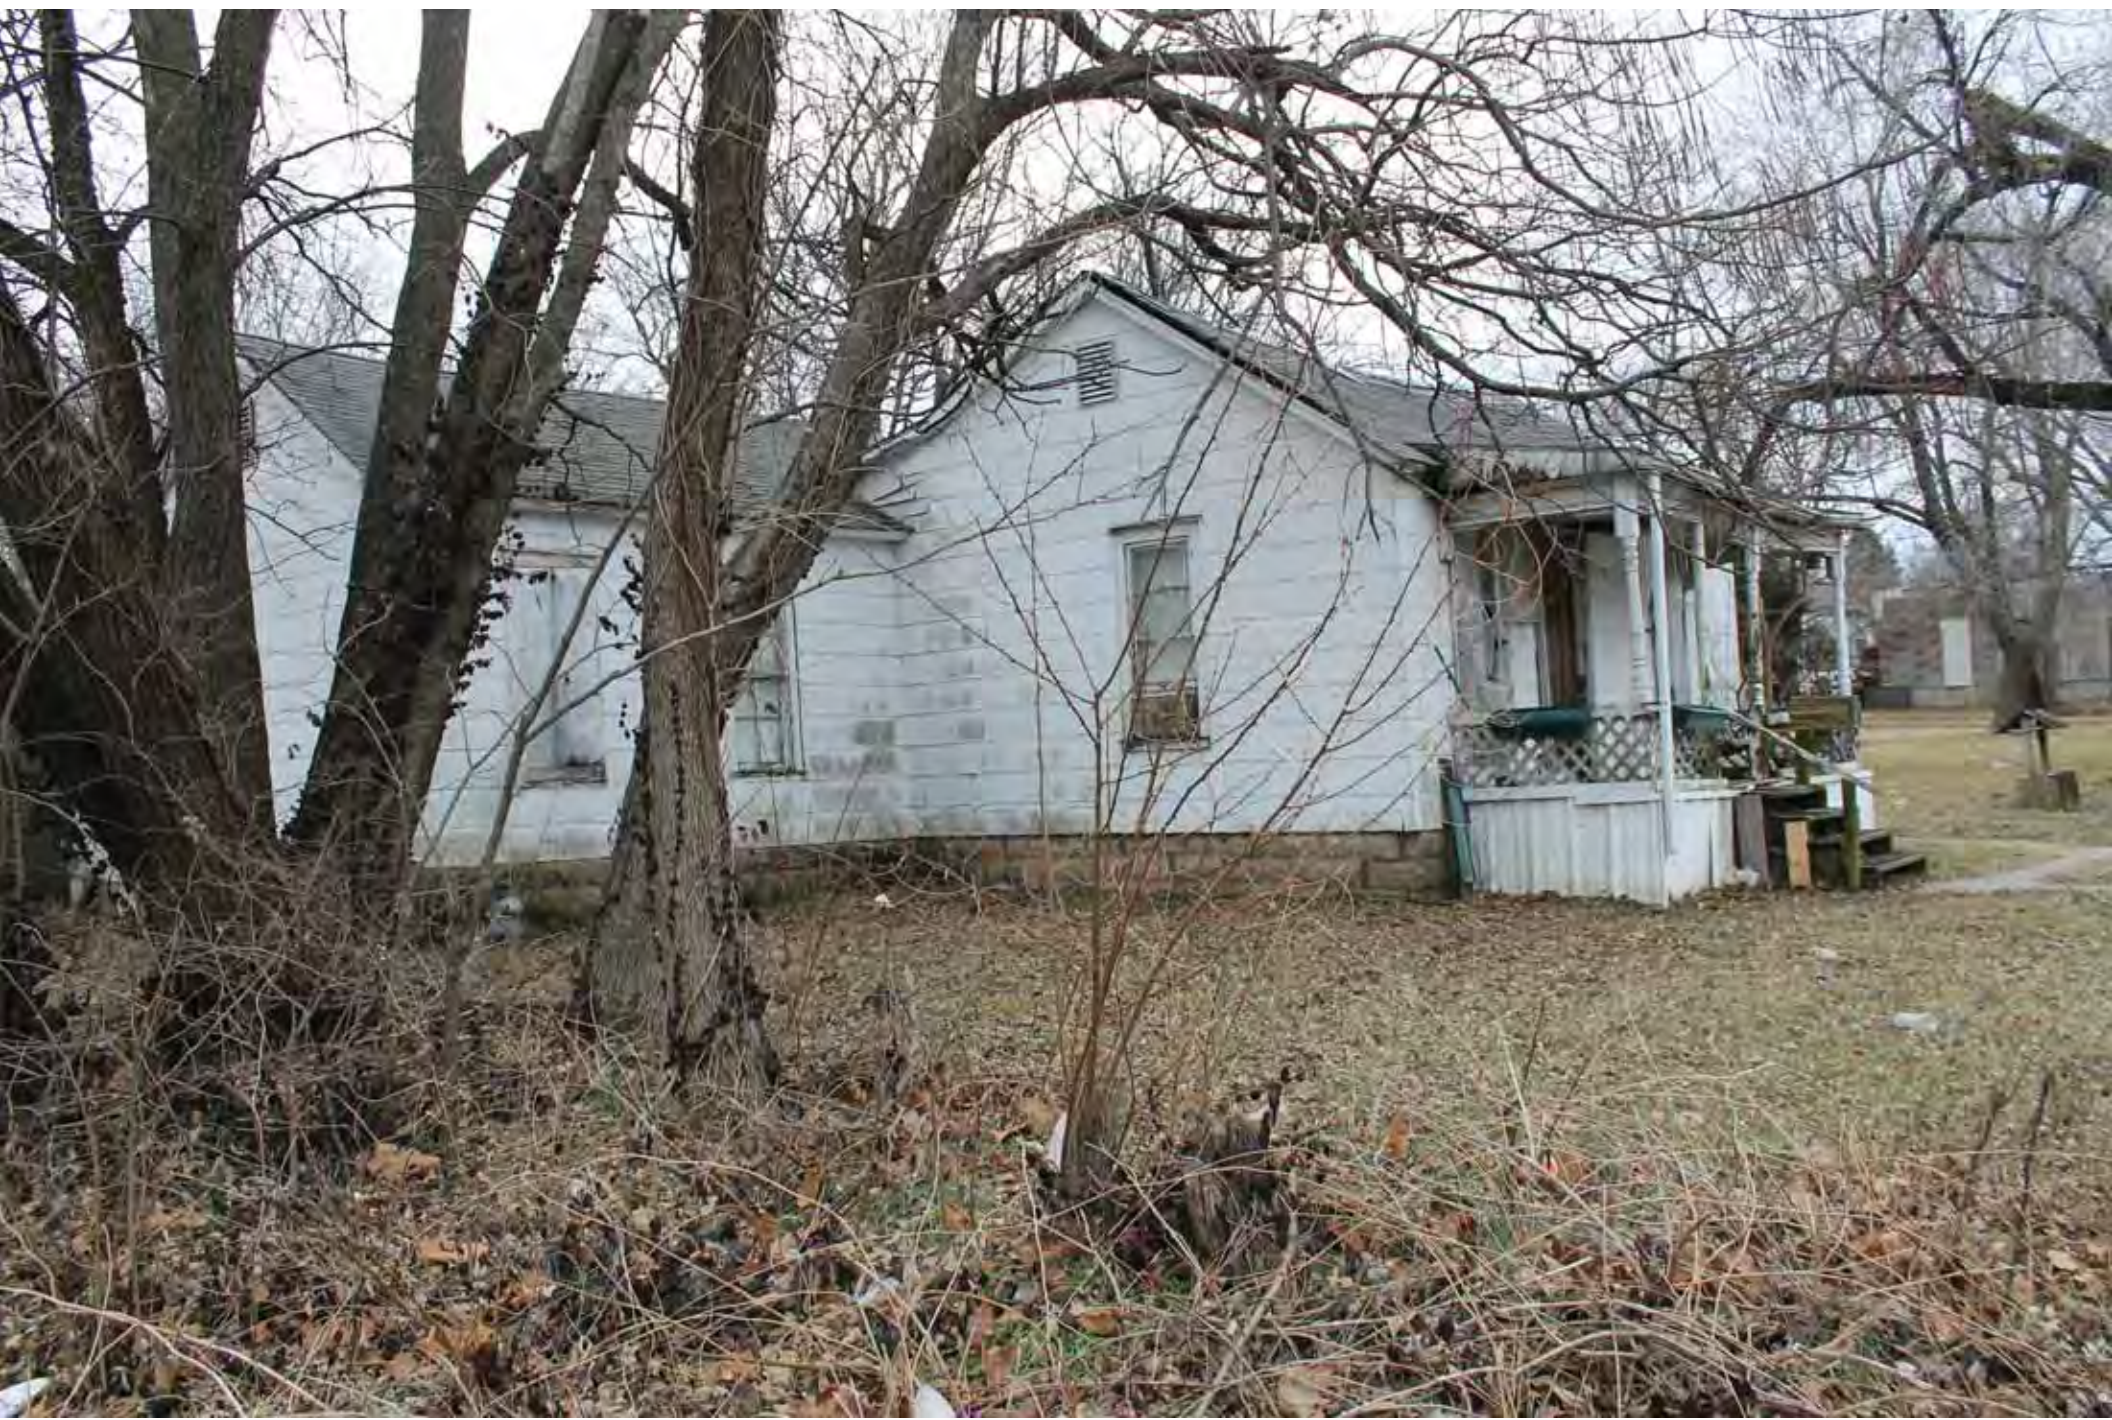
The property at 801 E. Broadway Street is a one-story frame house, with a side-gabled roof covered in asphalt siding. It has a central wooden door sheltered by a wooden front porch with a flat roof. The porch extends the front elevation and shelters the central door and two single wood windows, which flank the door on either side. On the east side of the house is a one-story older addition, which also has a side-gabled roof. This addition has two single wood windows on the front elevation.

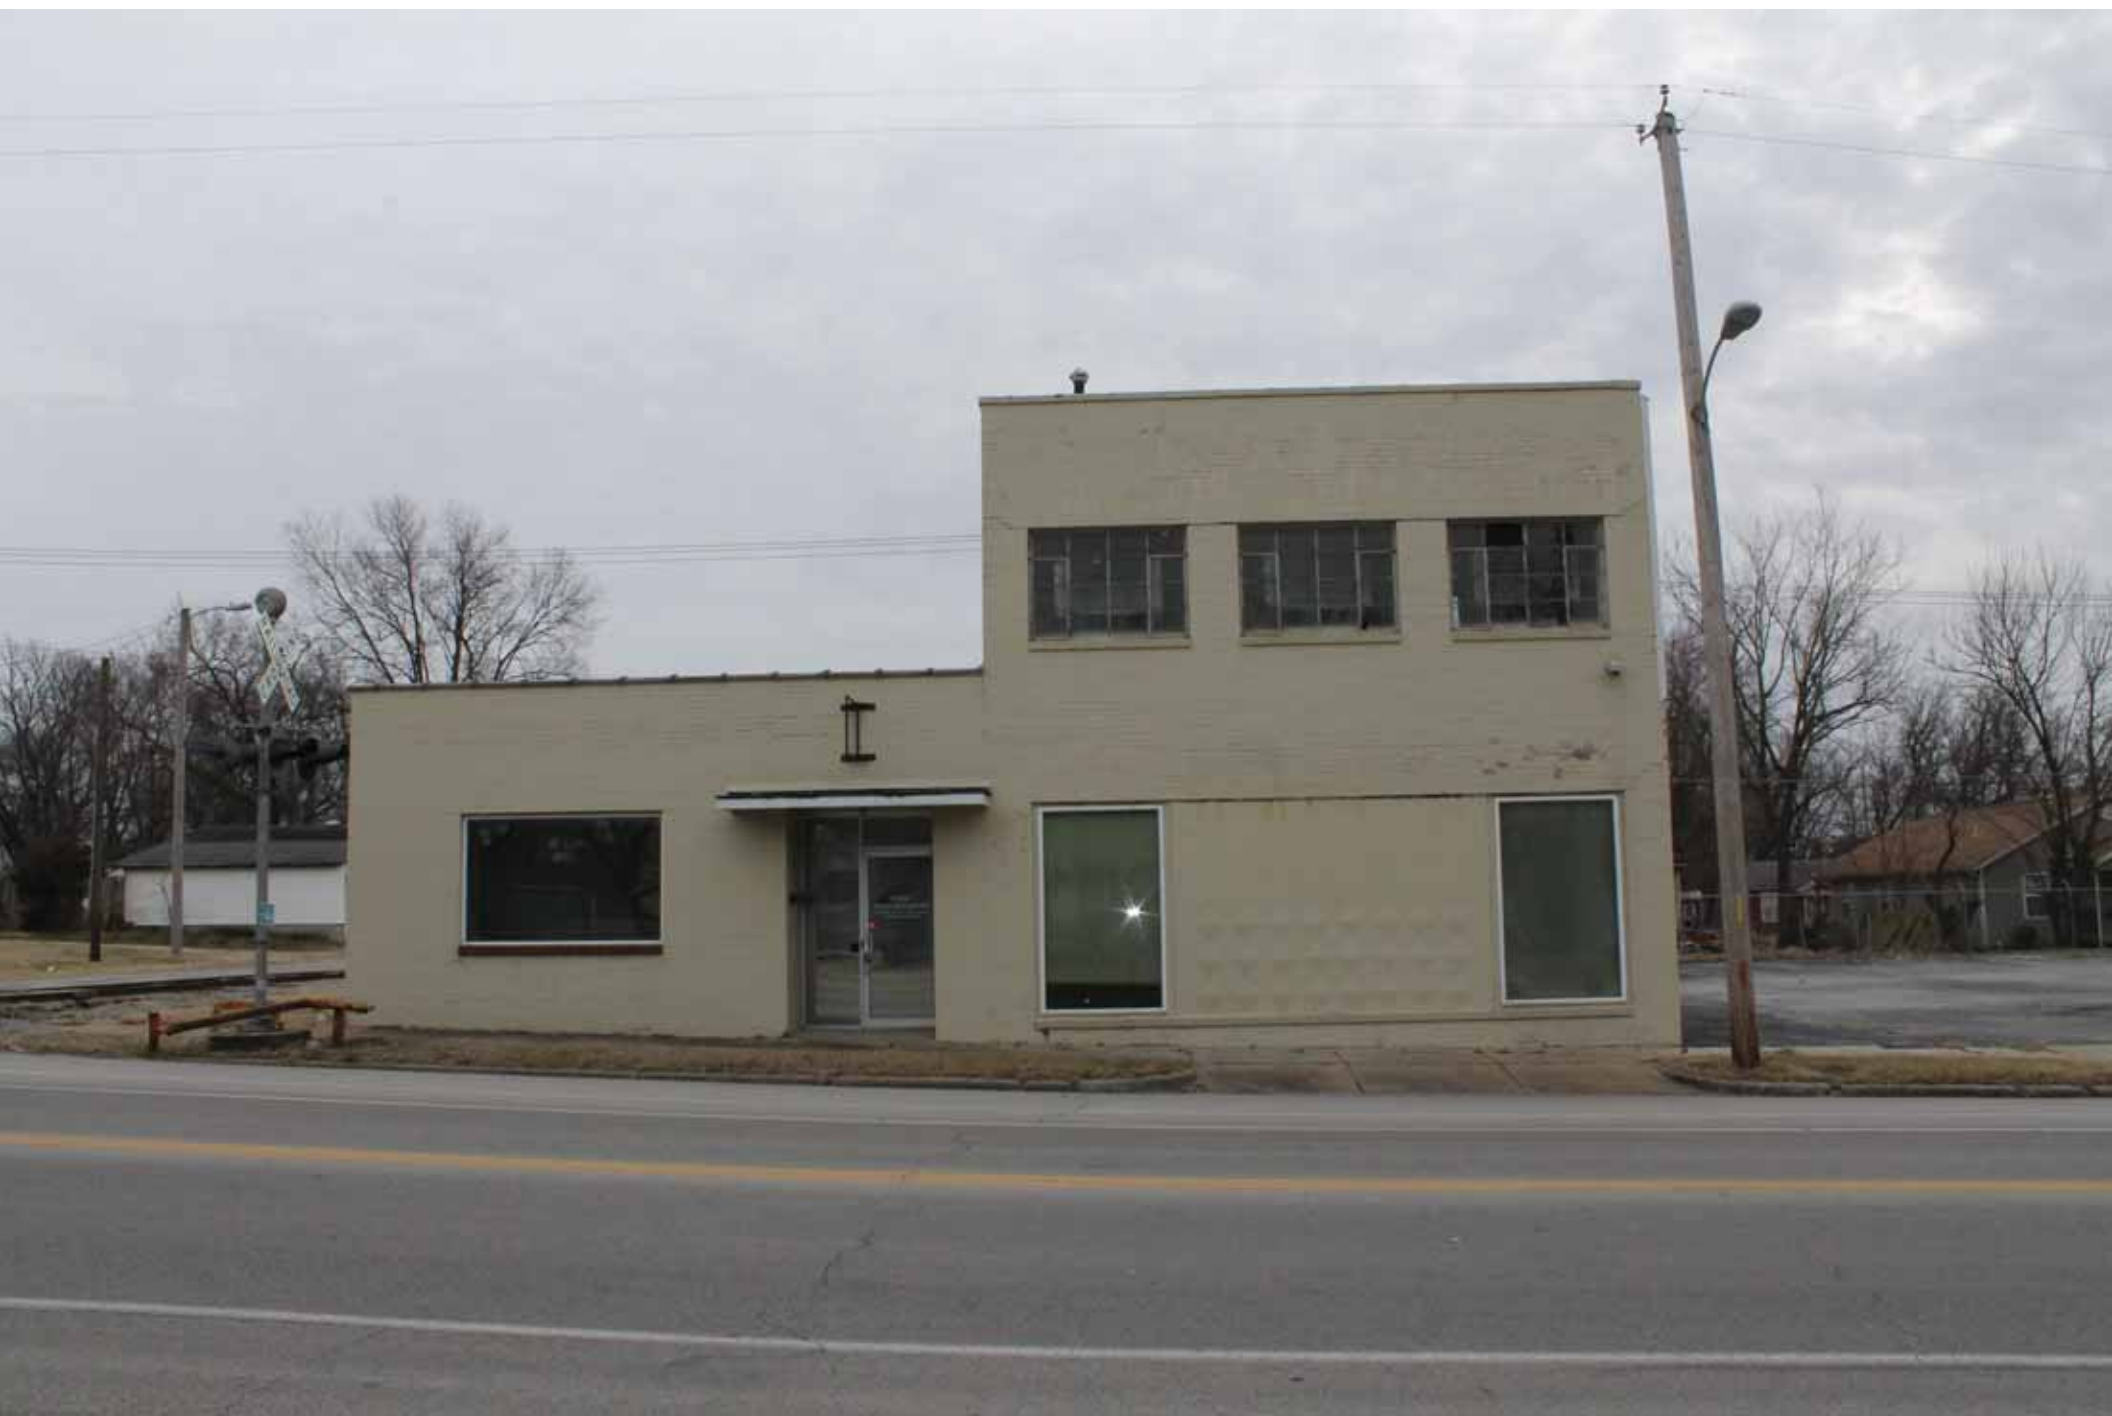
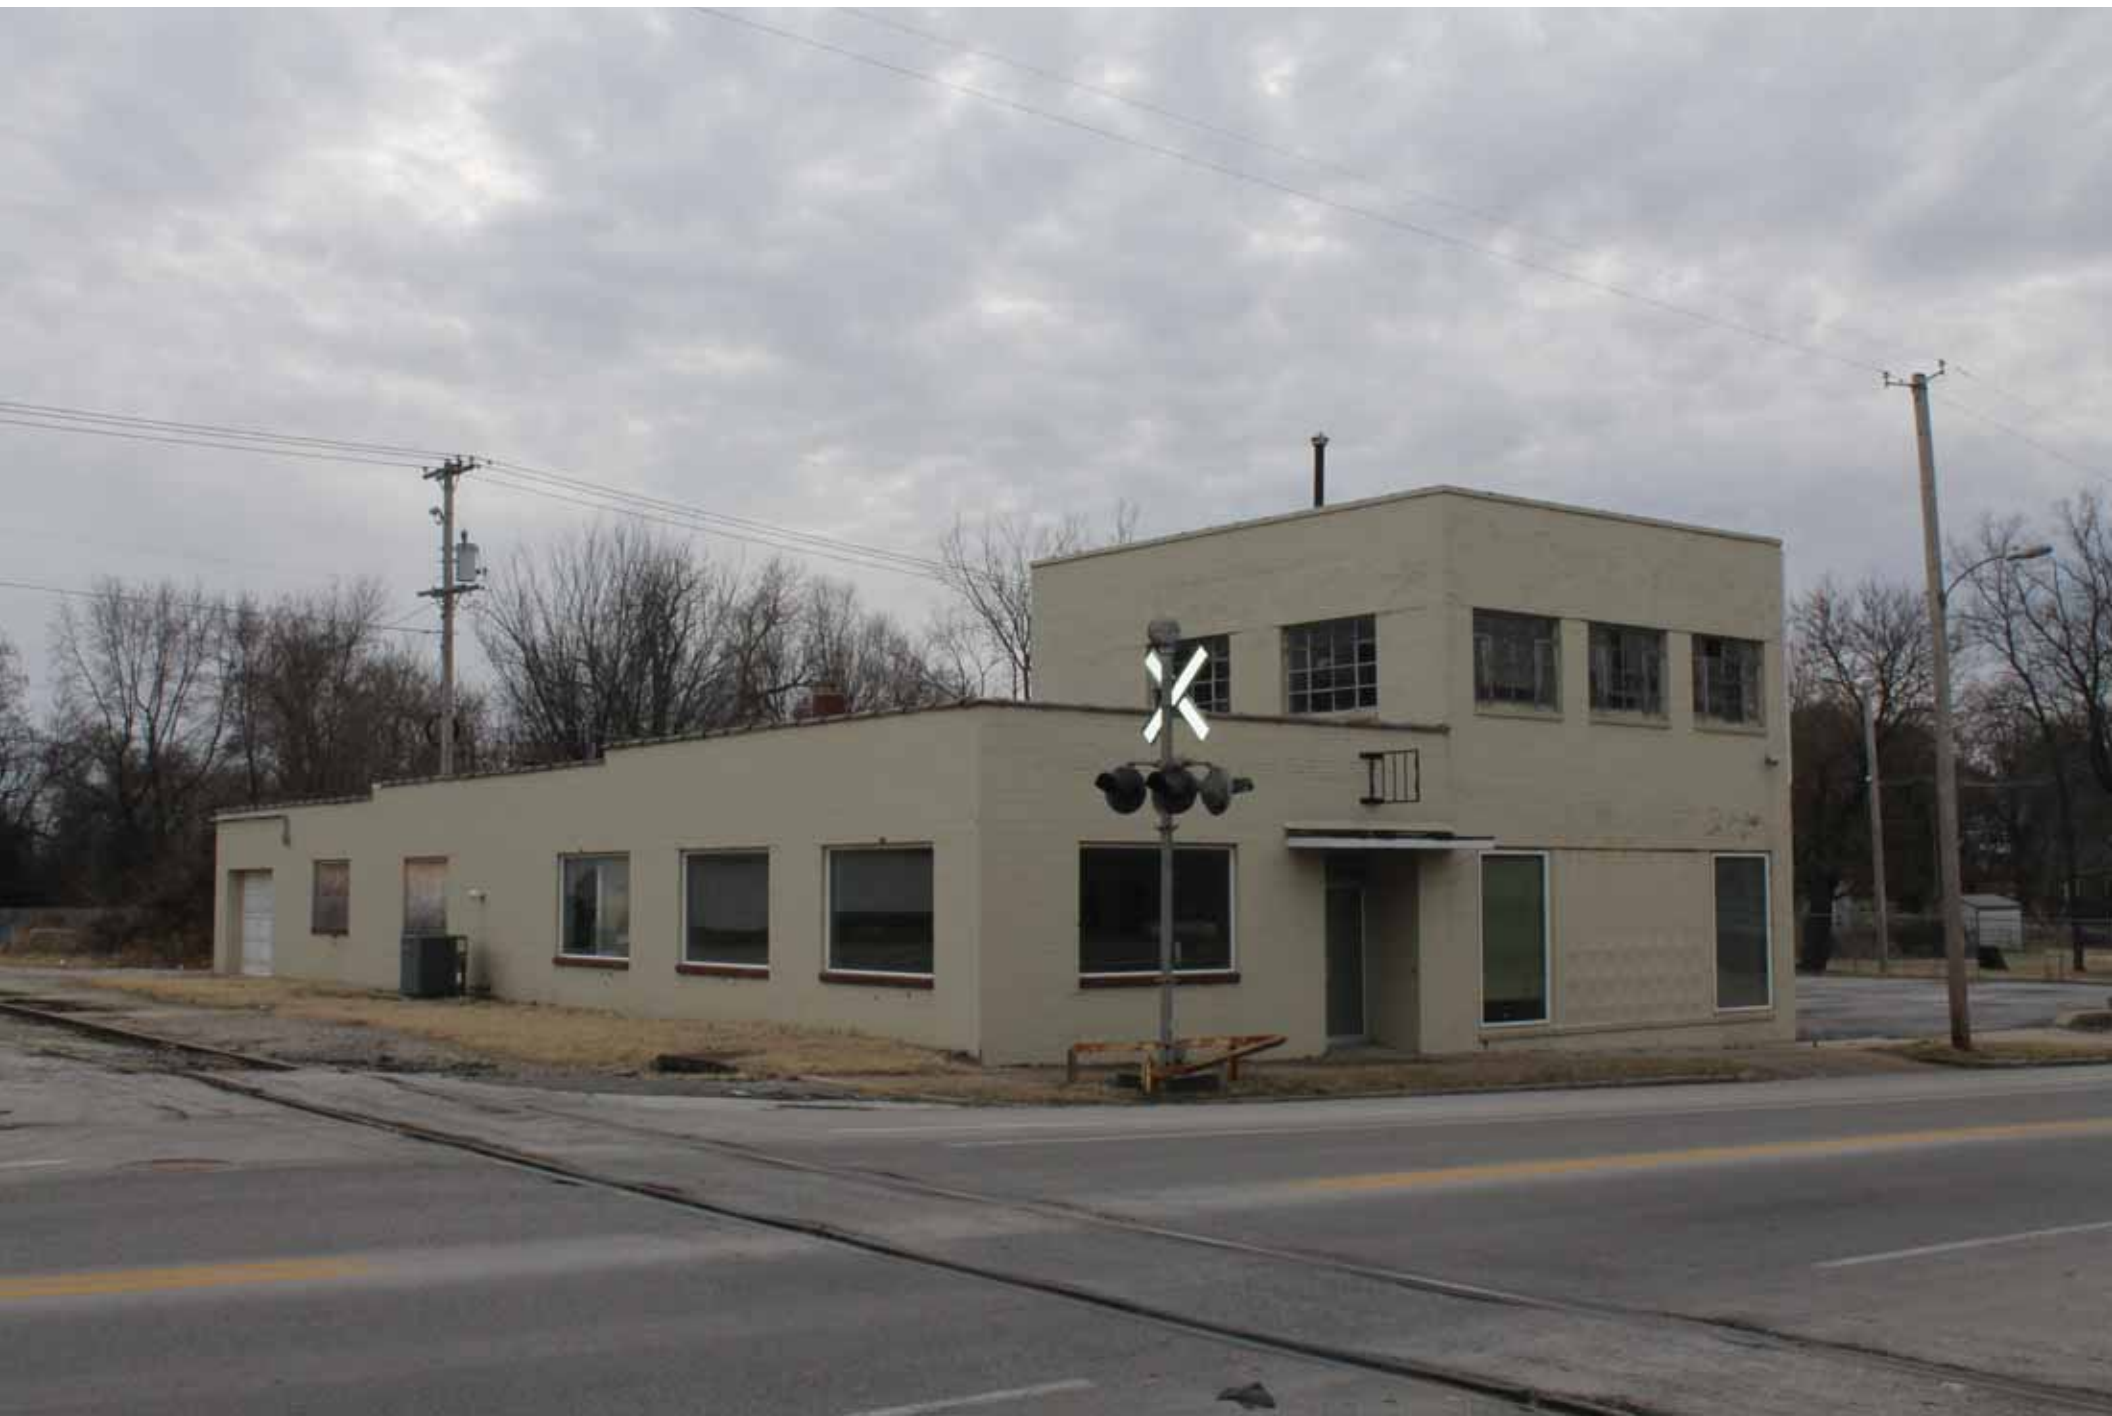
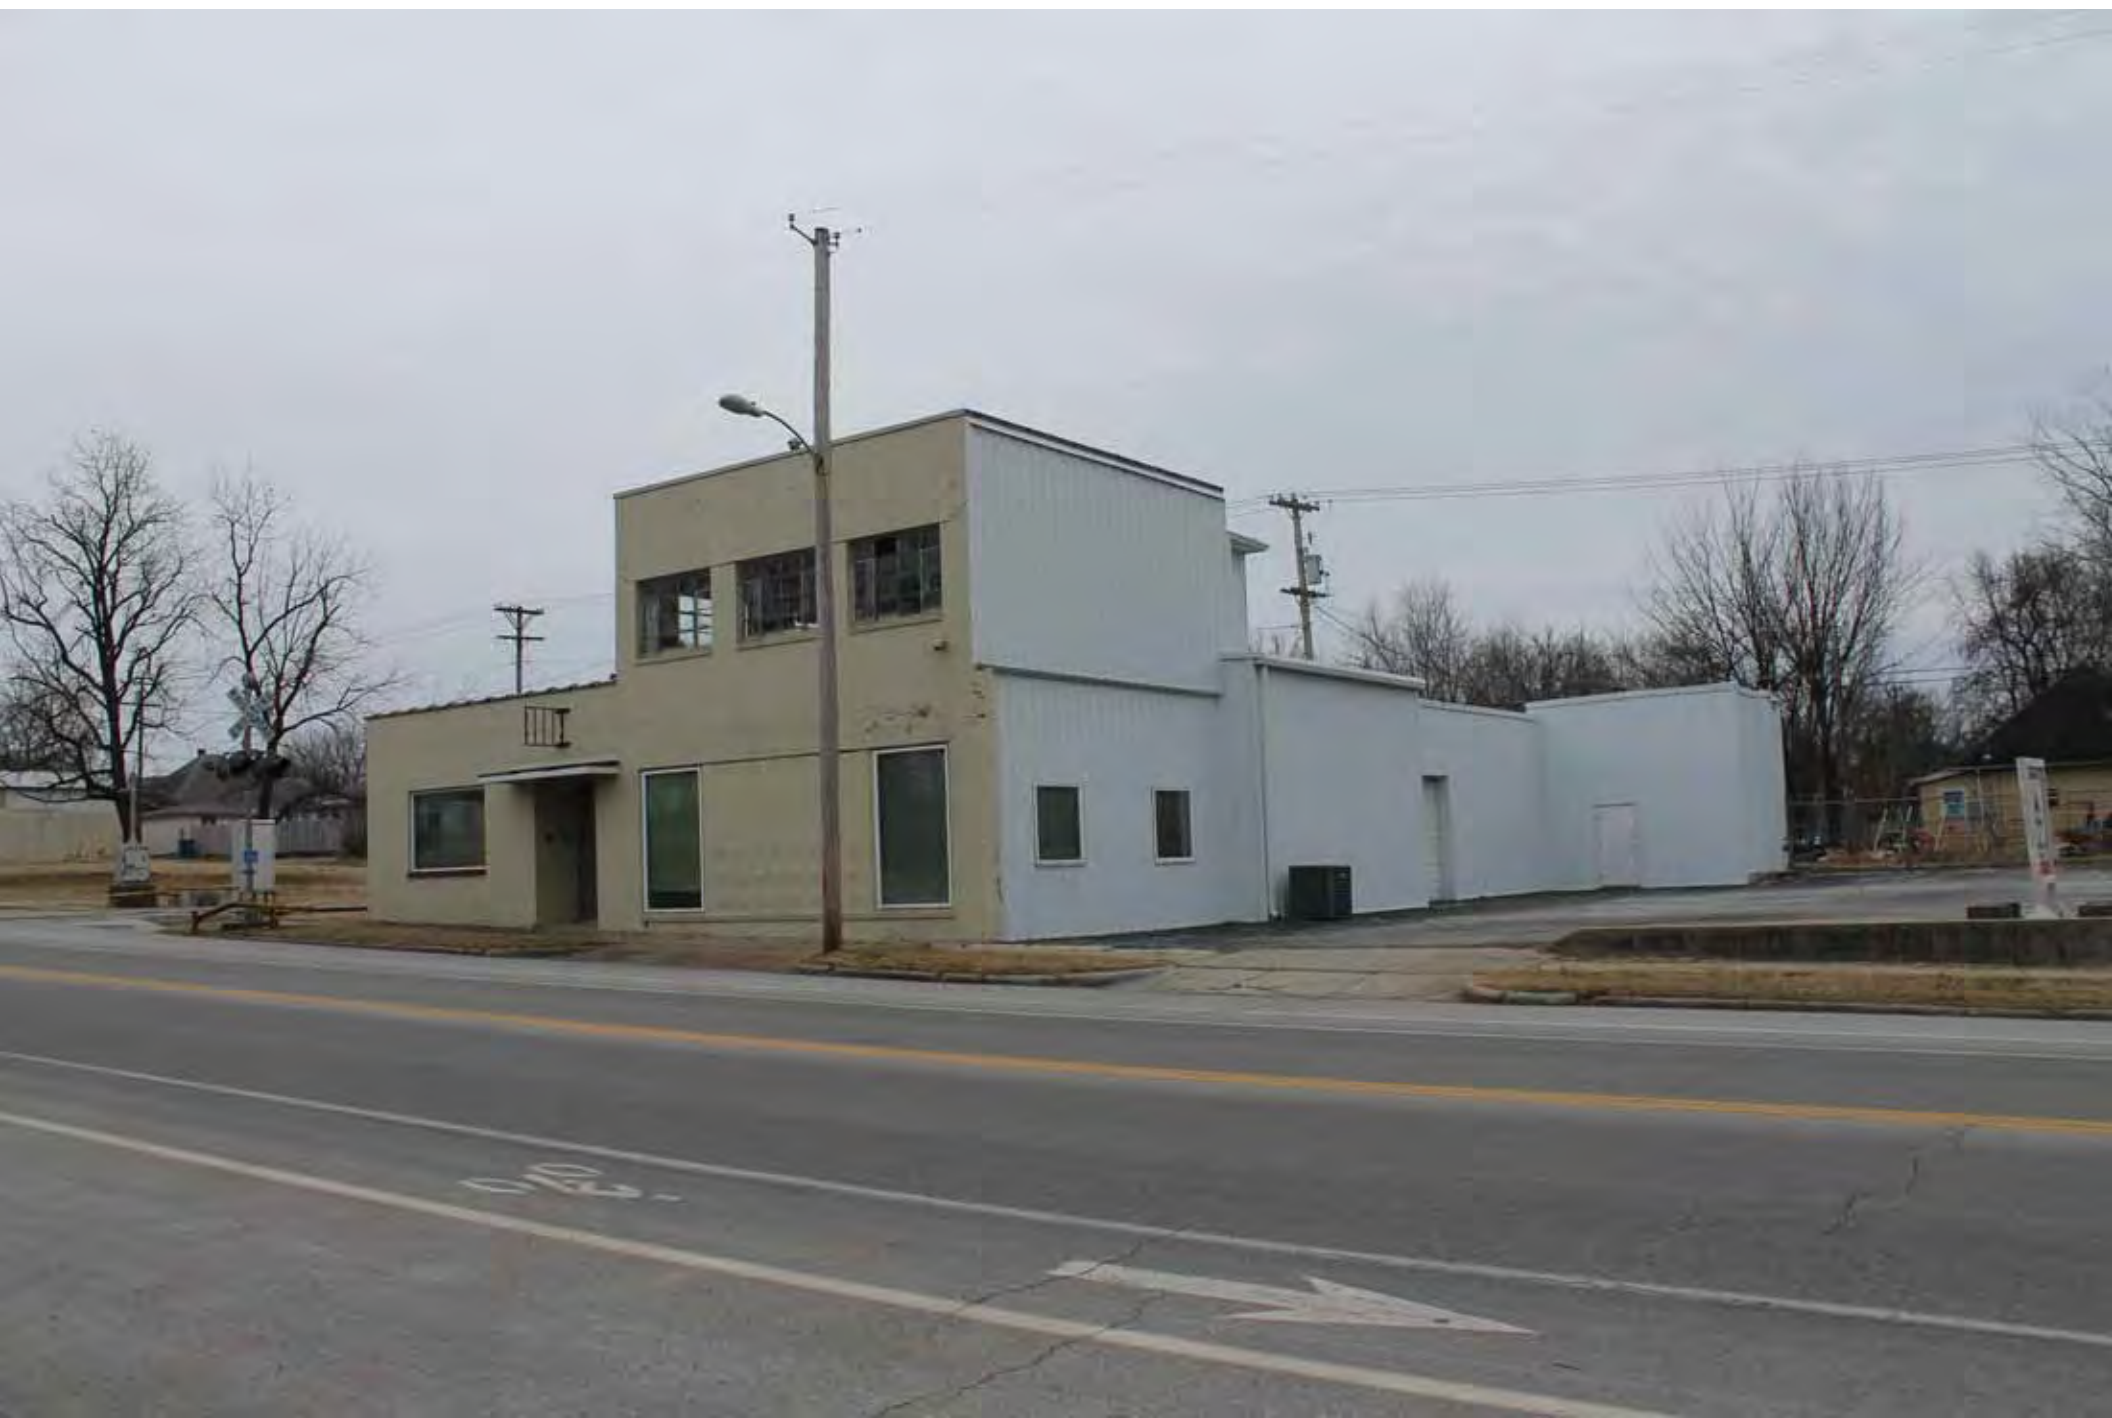
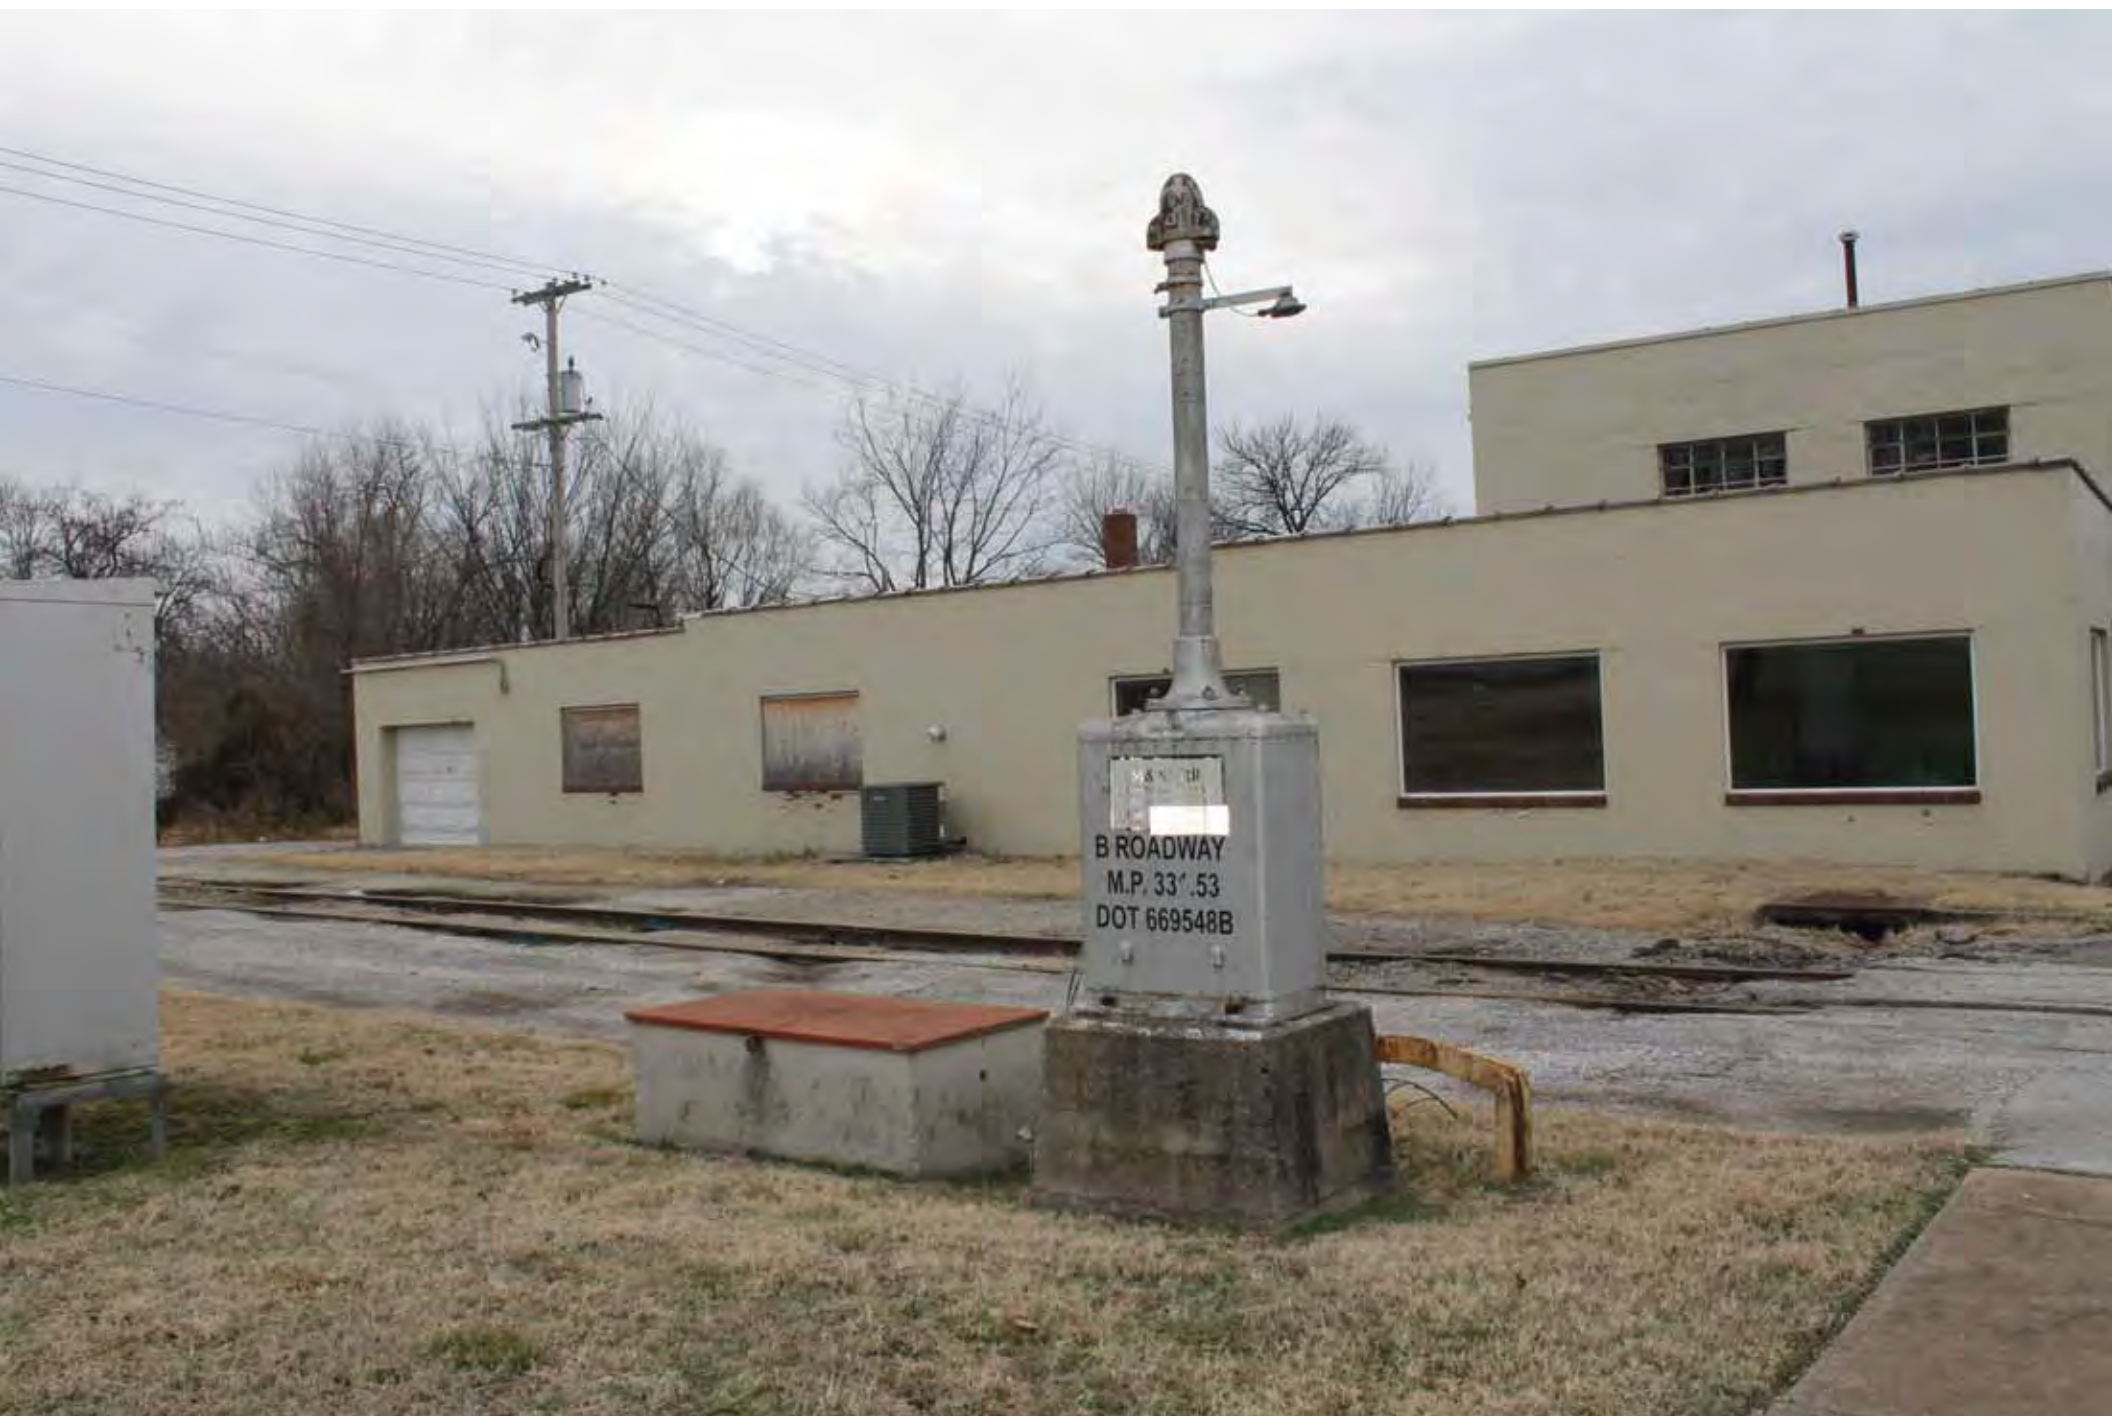
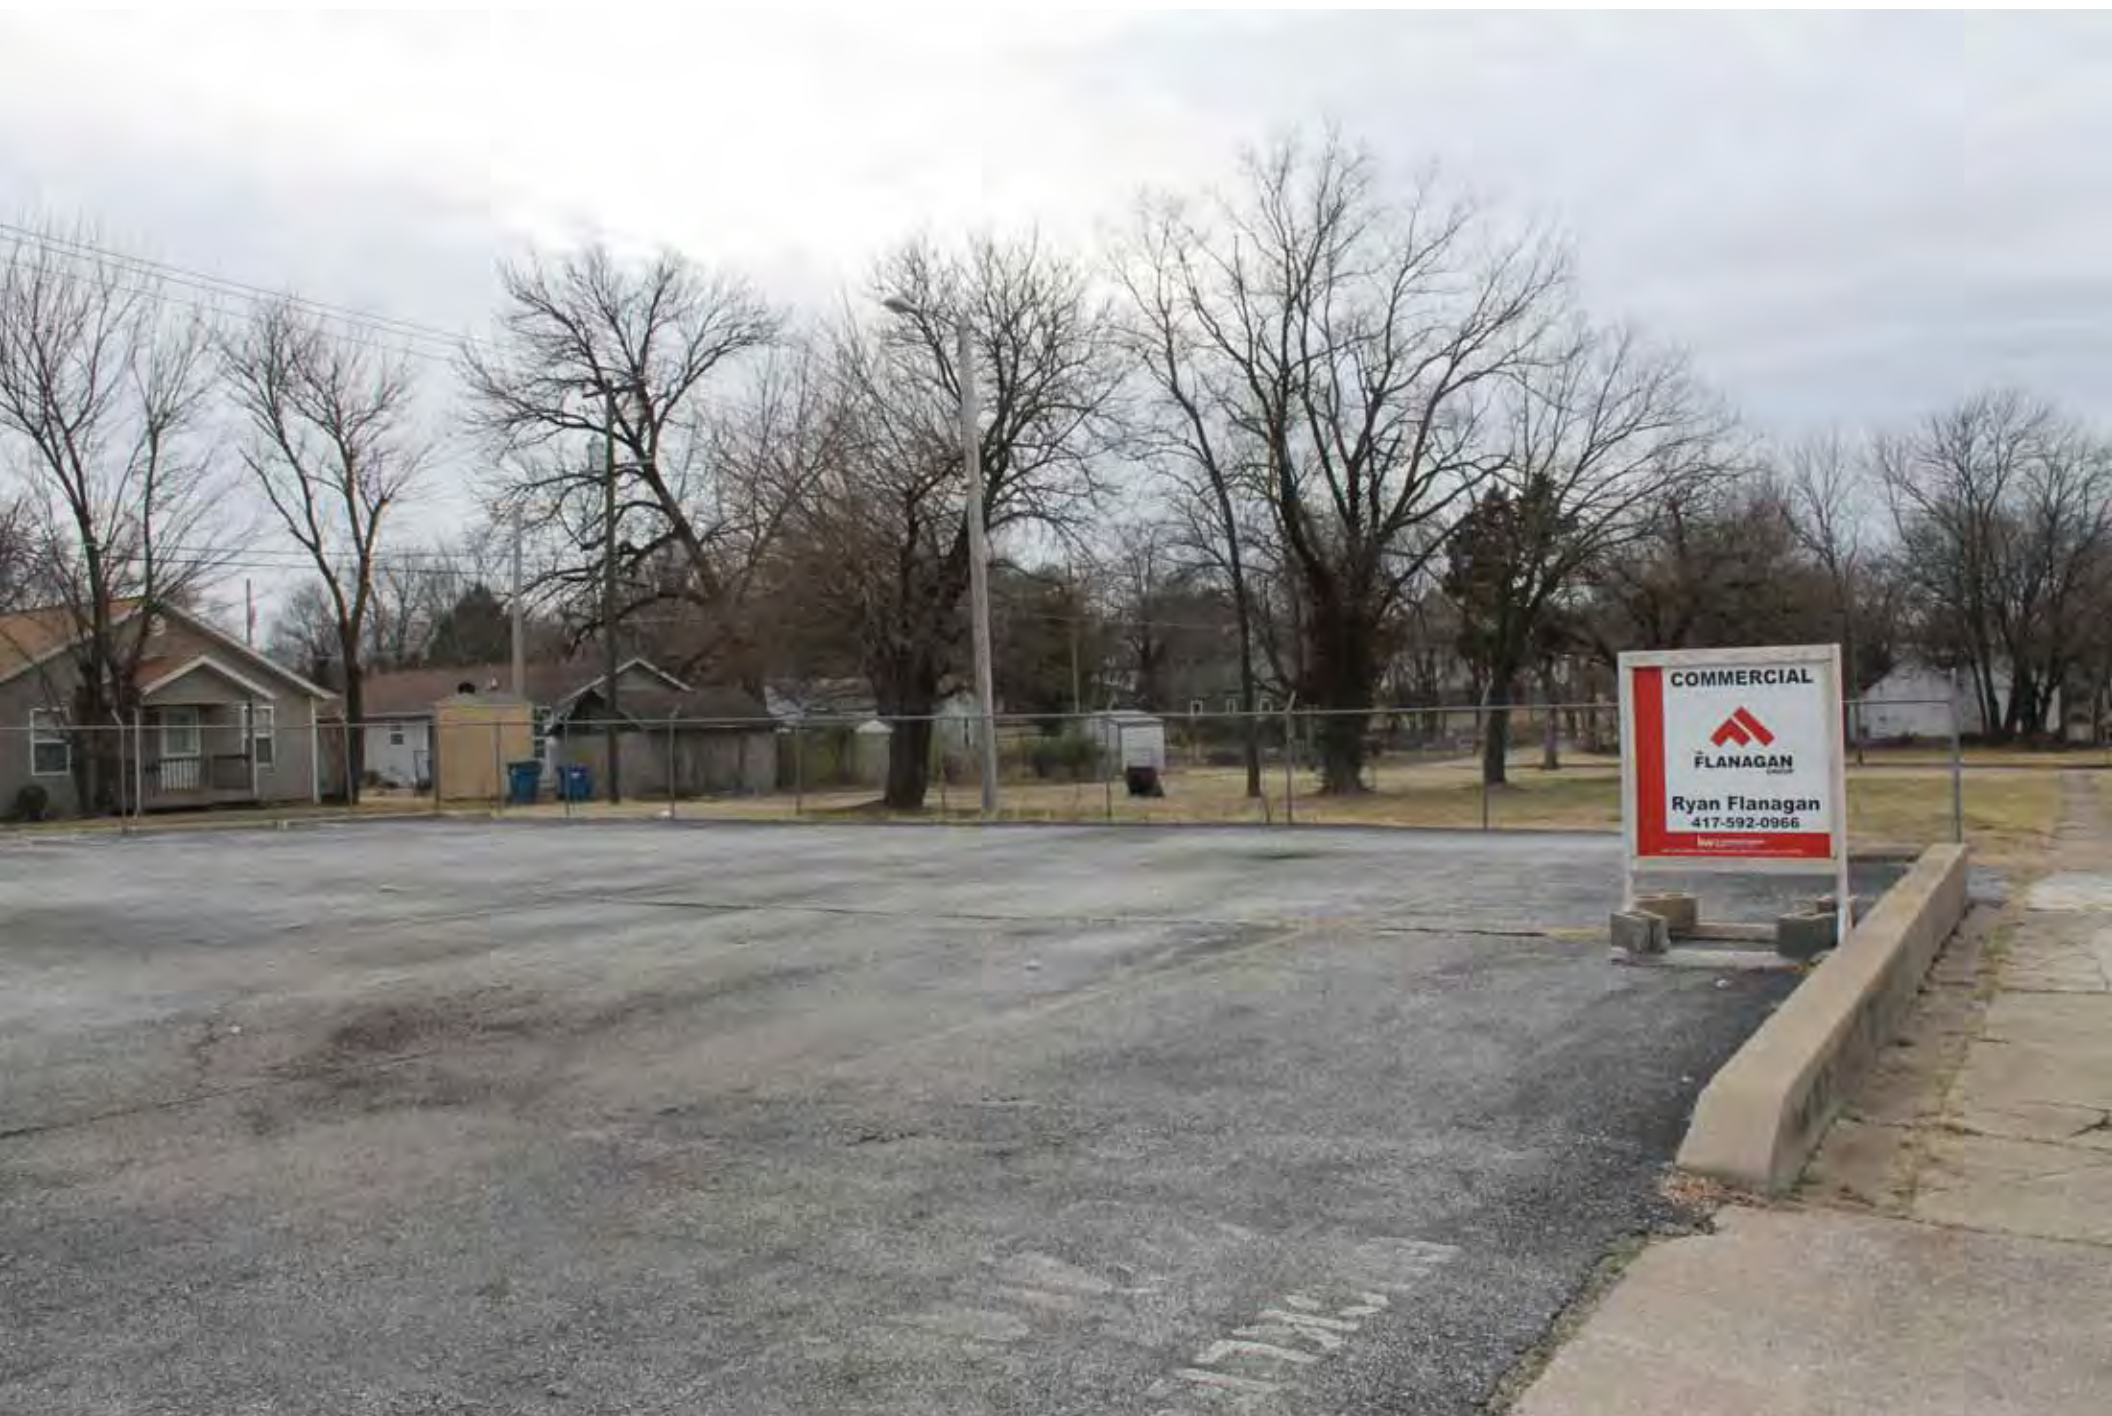
The buildings do not have enough integrity to be individually listed on the National Register of Historic Places due to window replacement (façade) and side (west) elevation synthetic siding. The property is not within an area recommended as a potential historic district.

This building is a two-story brick commercial/warehouse building. It has a flat roof with terra cotta along the parapet. The exterior brick has been painted. On the east side of the building is a one-story brick portion, likely a later addition. It also has a flat roof with terra cotta along the parapet. On the front elevation of this one-story portion is a modern glass entrance door with sidelight, beneath an art deco style awning. To the east of the front door is a large rectangular fixed window. The first floor front elevation of the two-story section of the building has been blocked in, with two replacement windows. This area has been painted yellow to match the rest of the building. On the second floor are three historic metal casement windows. There is a series of one-story additions on the back of the building. The west elevation of this addition has a single garage door opening facing the parking lot. The east elevation, facing the tracks, has a series of rectangular fixed replacement windows. At the rear of this elevation is one garage bay, with a metal garage door.
