MISSOURI DEPARTMENT OF NATURAL RESOURCES
STATE HISTORIC PRESERVATION OFFICE, P.O. Box 176, Jefferson City, MO 65102
ARCHITECTURAL/HISTORIC INVENTORY FORM

1. Survey No. JP-AS-007-001		2. Survey name: East Town (Original Joplin) Historic Survey Phase 2	
3. County: JASPER		4. Address (Street No.) 618	Street (name) E. 2 nd Street
5. City: Joplin	Vicinity: <input type="checkbox"/>	6. Geographical Reference:	7. Township/Range/Section: T: R: S:
8. Historic name (if known):		9. Present/other name (if known):	
10. Ownership: <input checked="" type="checkbox"/> Private <input type="checkbox"/> Public		11a. Historic use (if known): Domestic: Single Dwelling	11b. Current use: Domestic: Single Dwelling

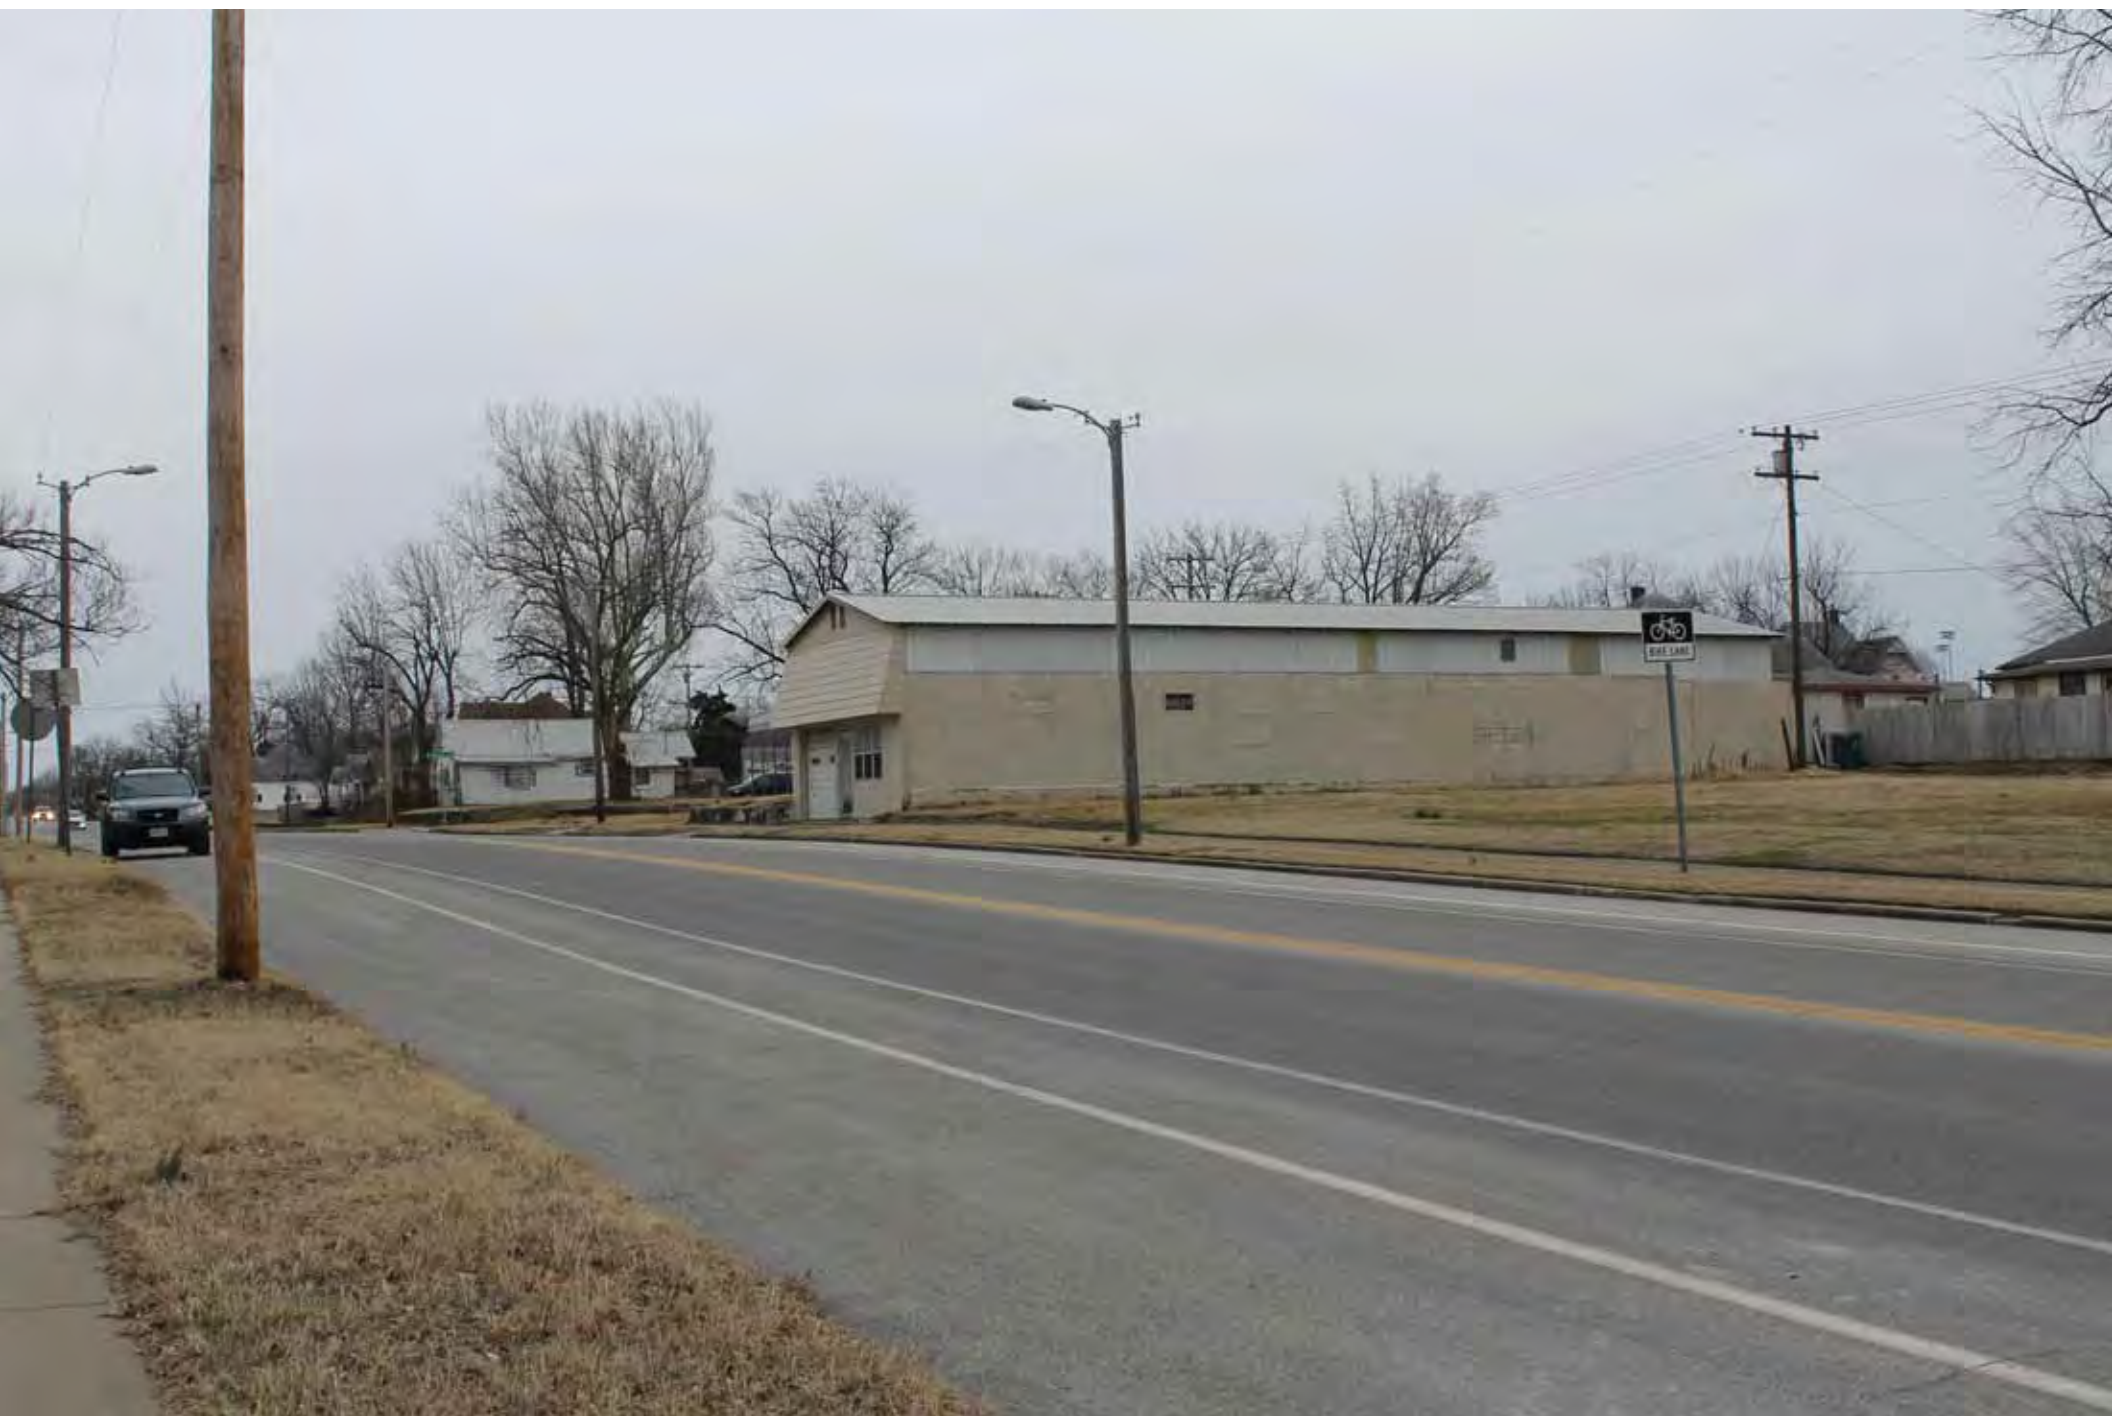
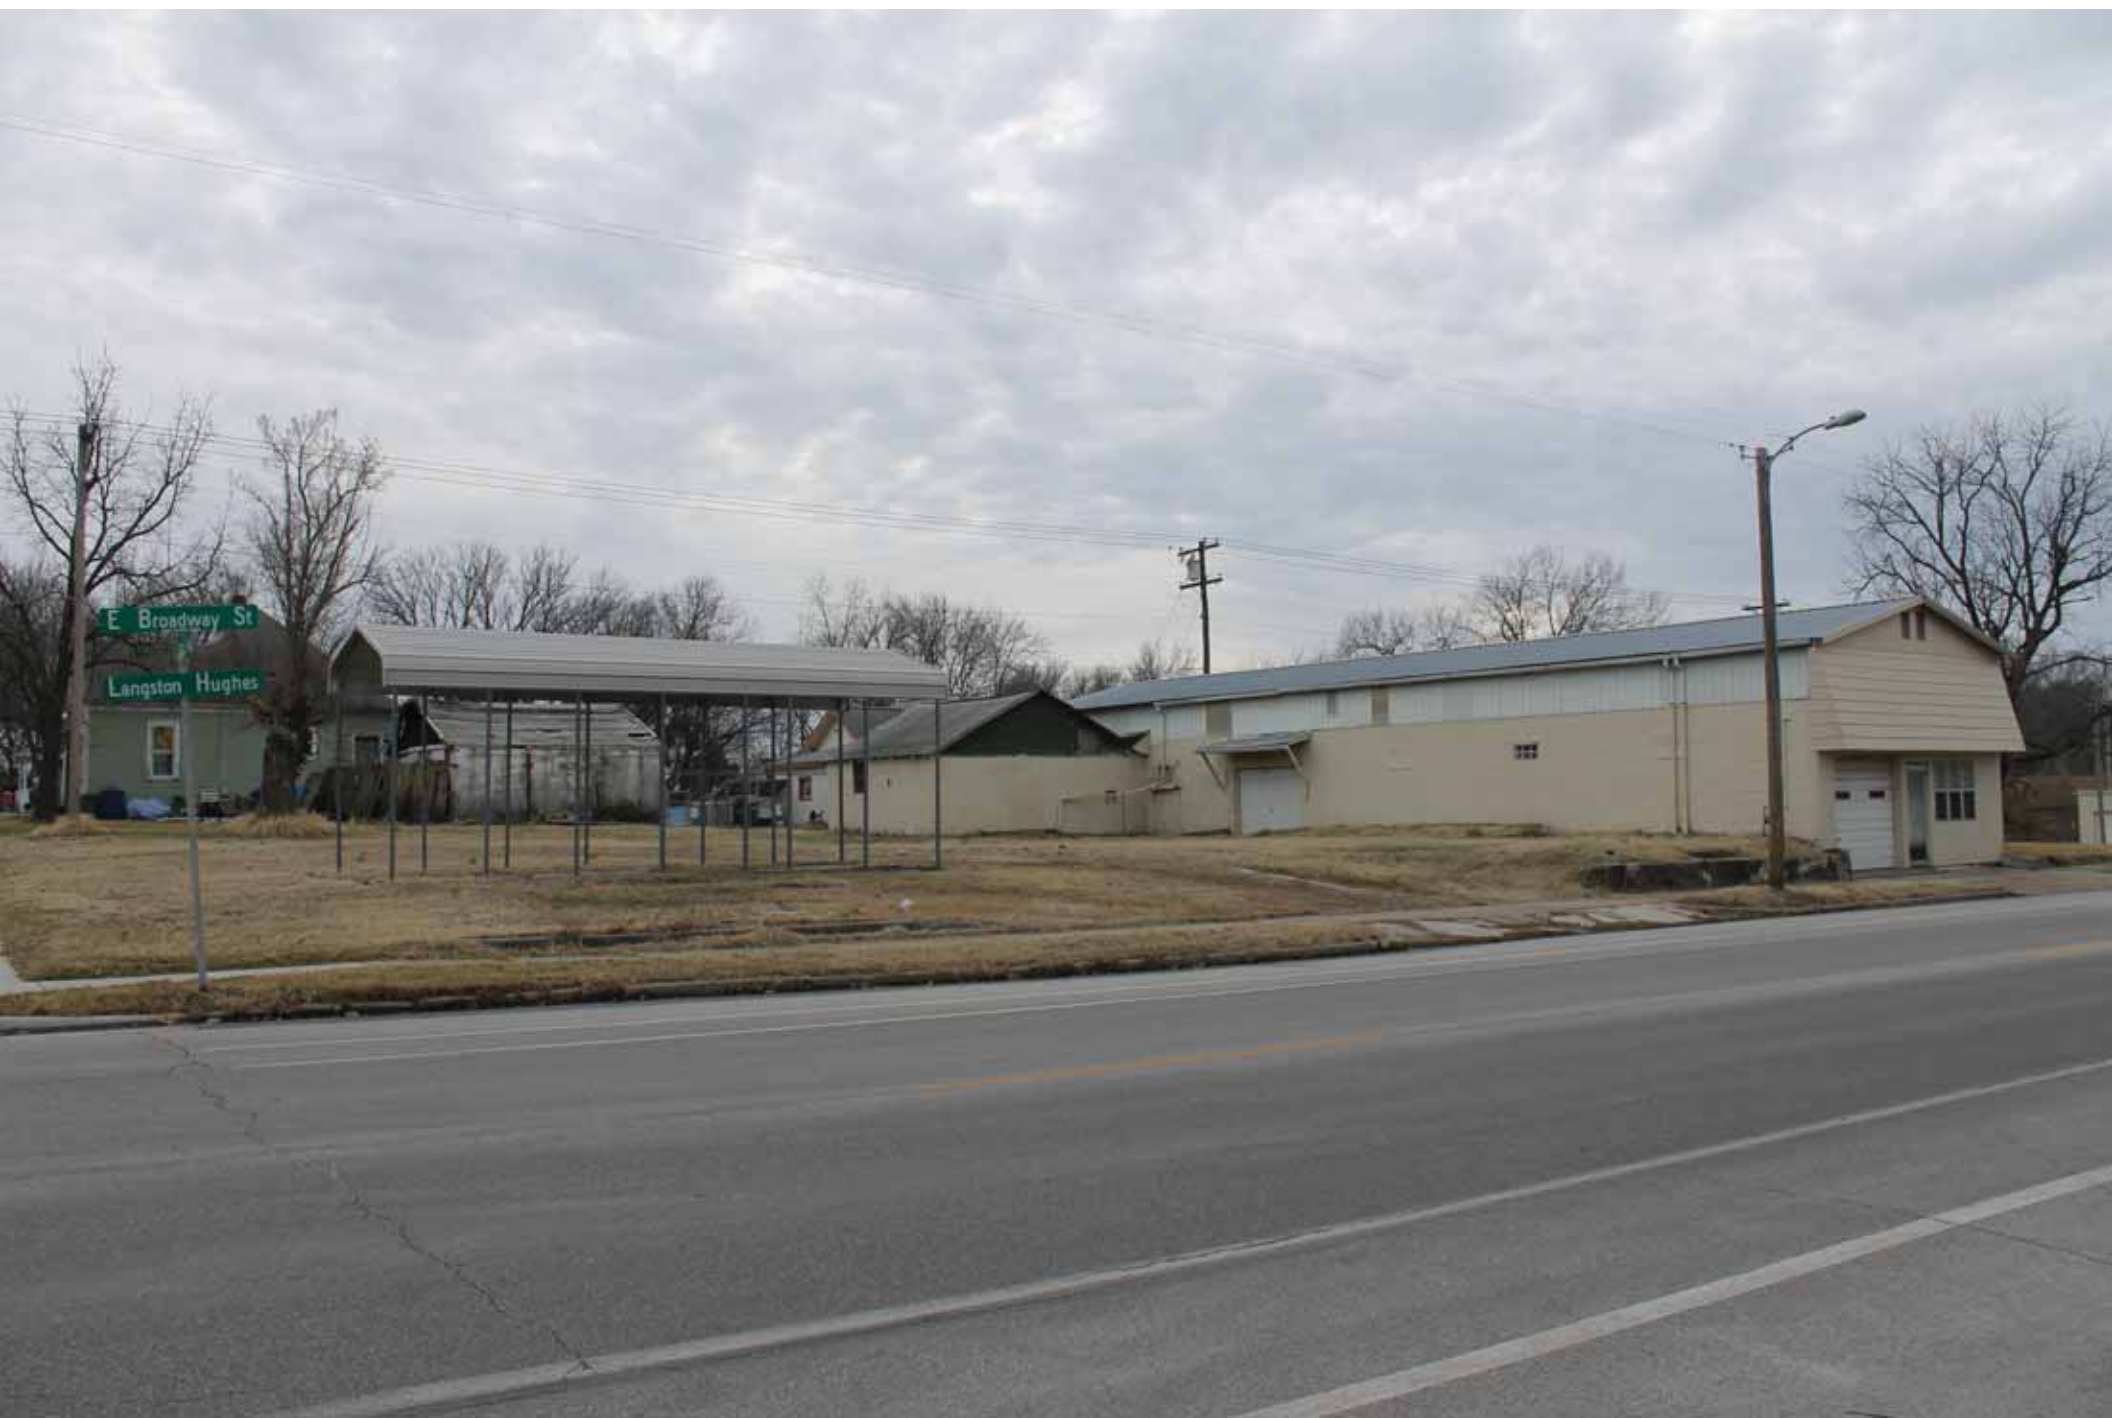
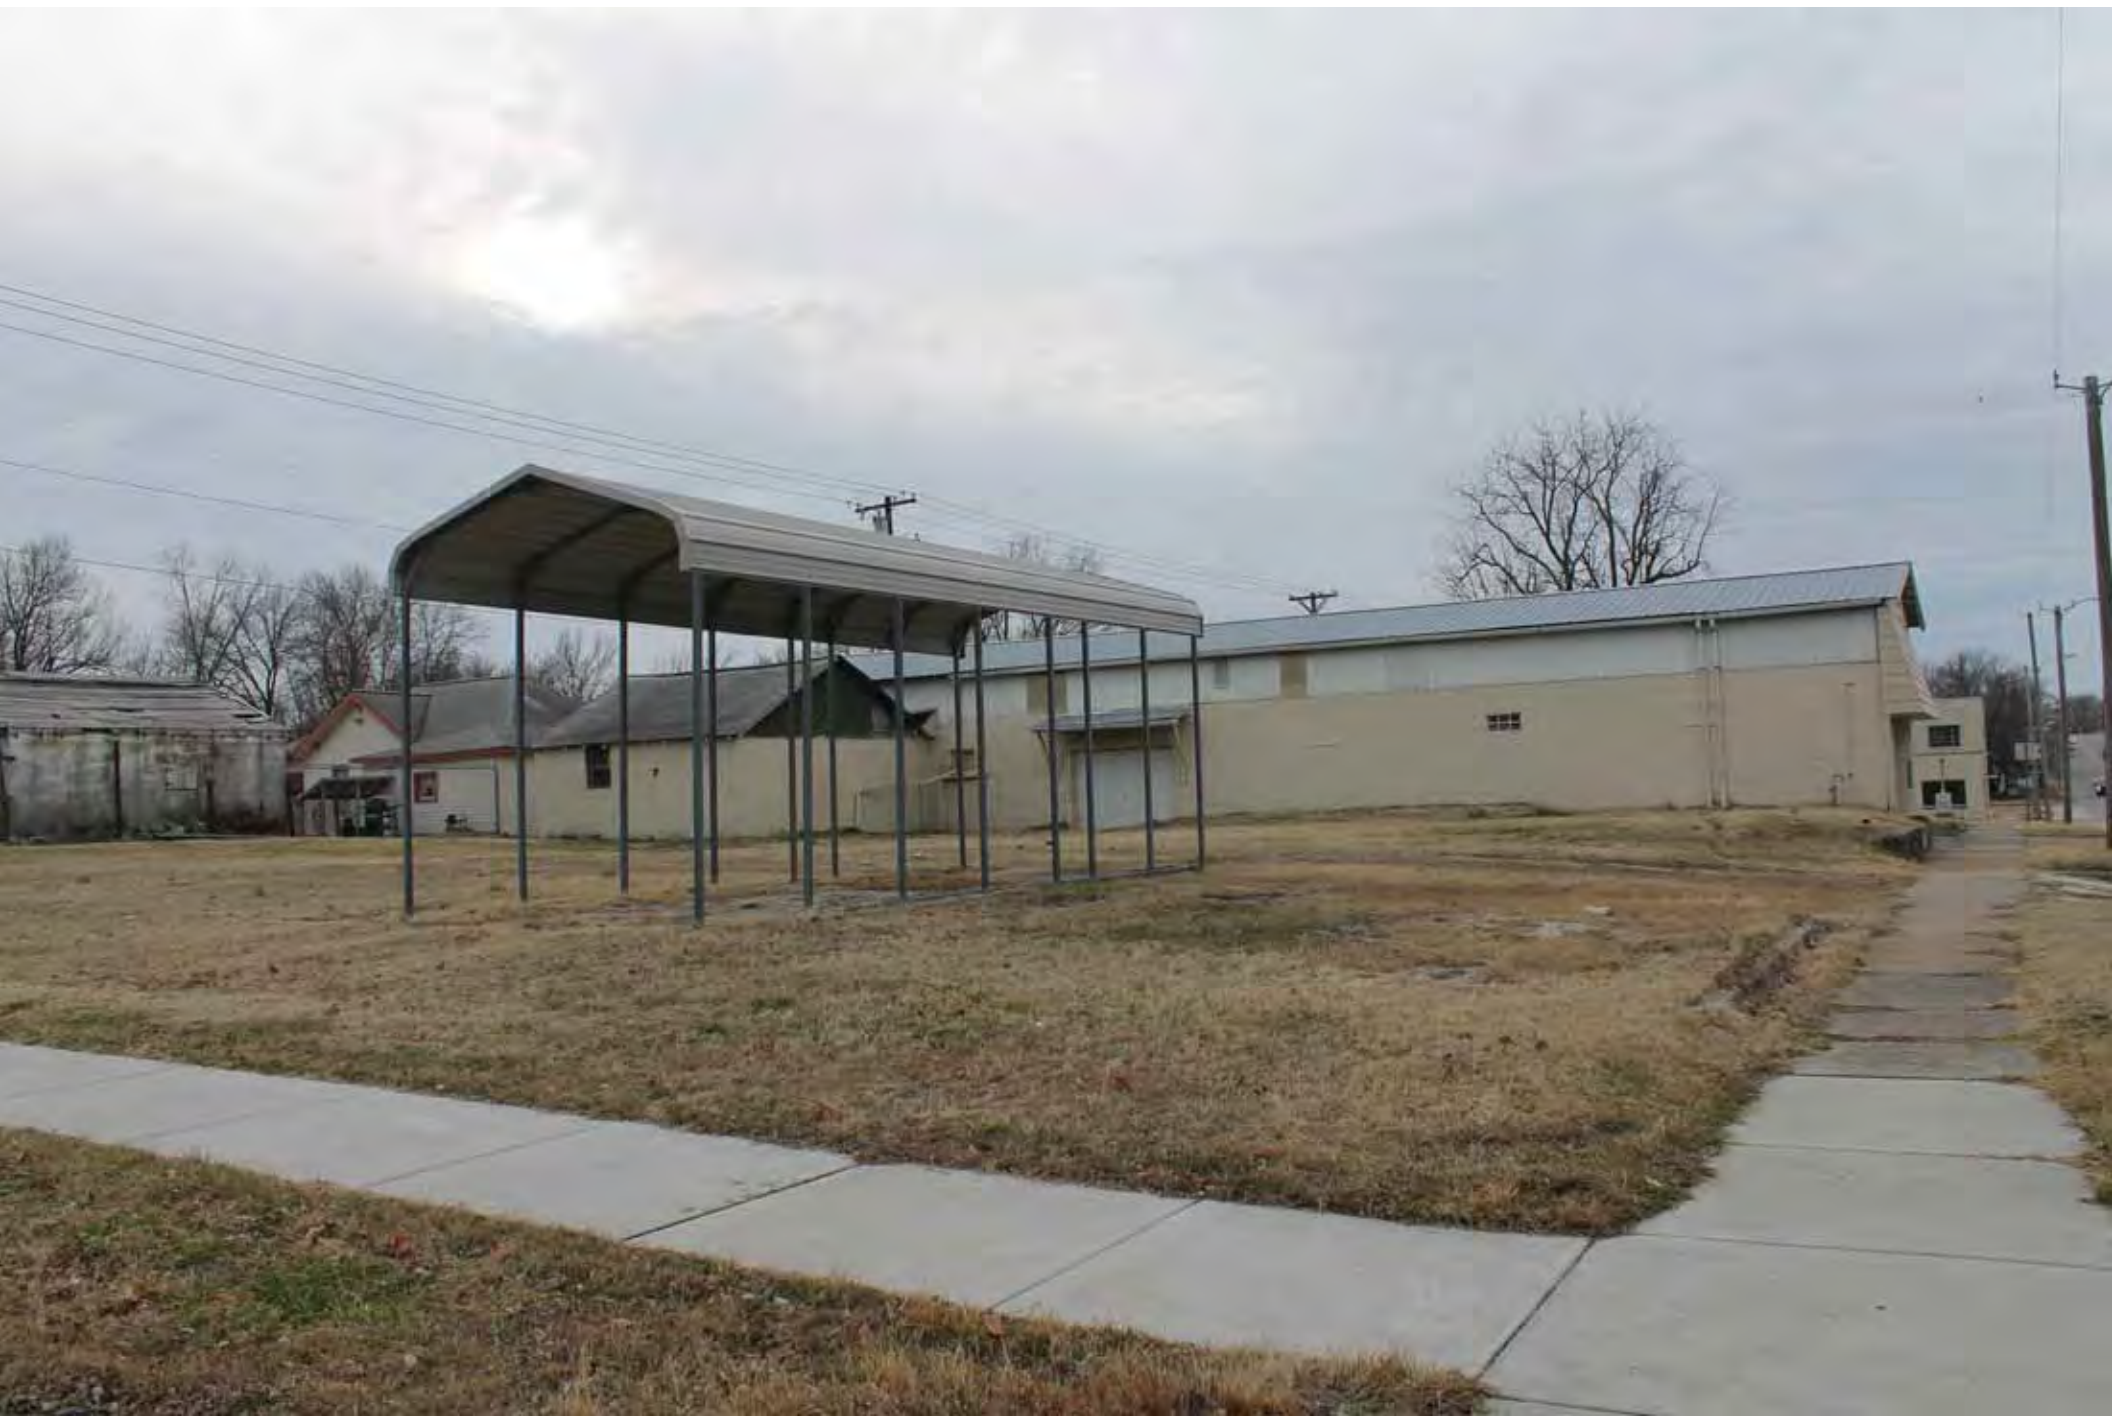
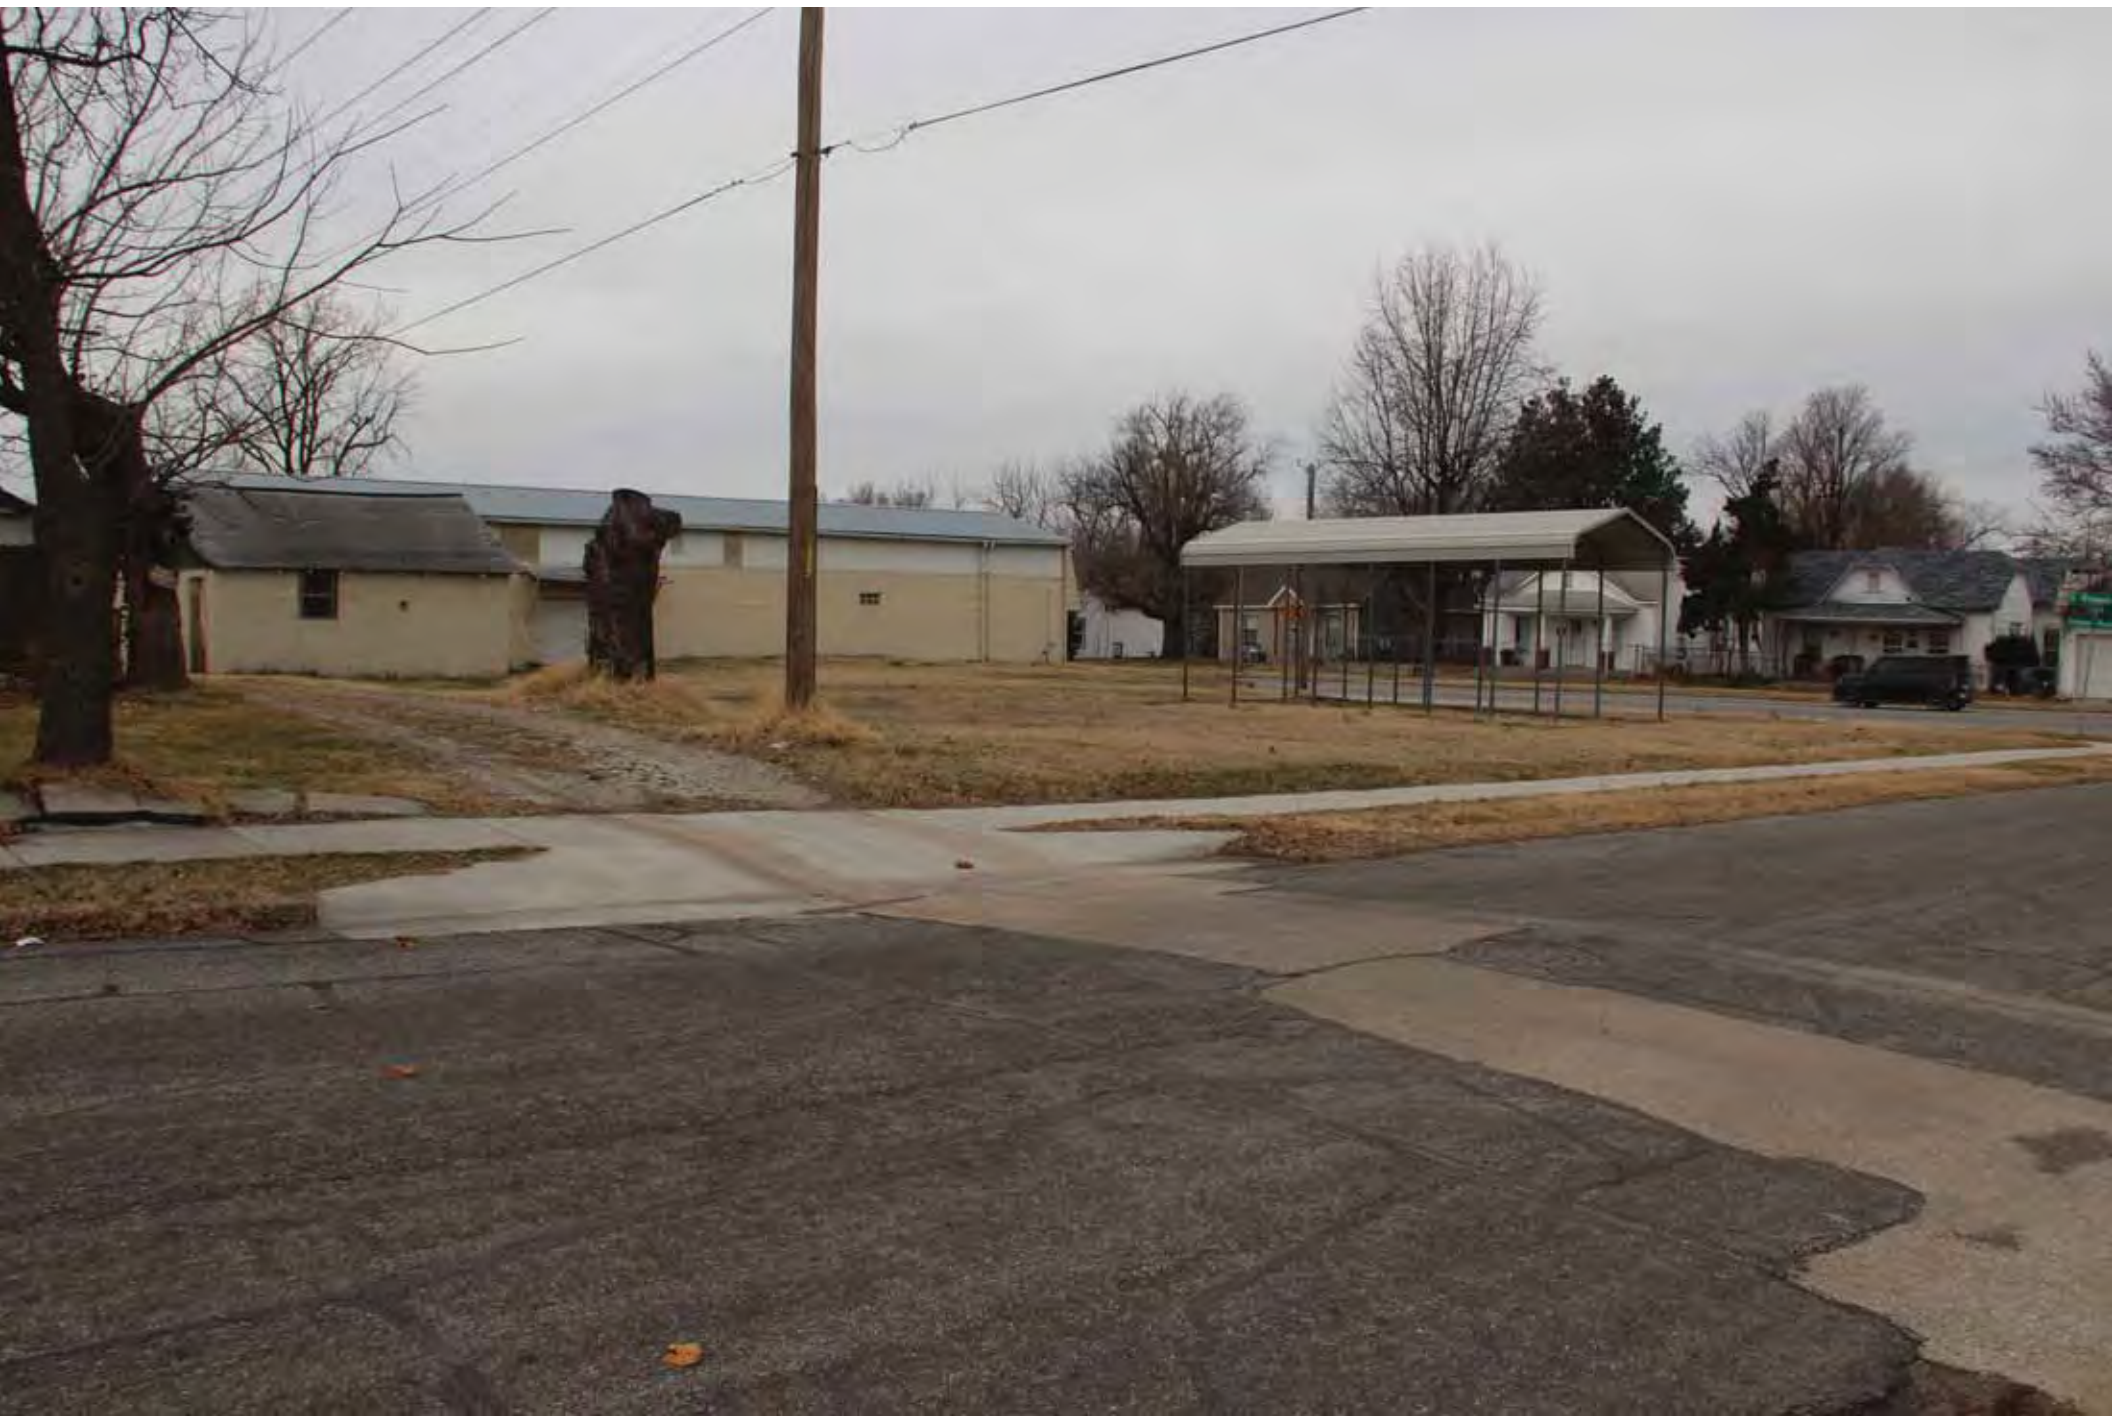
This building is a one-story concrete block commercial/warehouse building. It has a front-facing gable roof along E. Broadway Street. The entire building has been painted. On the front elevation is an asphalt shingle mansard roof or awning added. The front elevation has a garage door, an entrance door, and a band of three small windows. The east elevation is a blank wall, with one garage door at the rear of the building. There is a large square addition on the southeast rear of the building. It has a gable roof with exposed rafters.

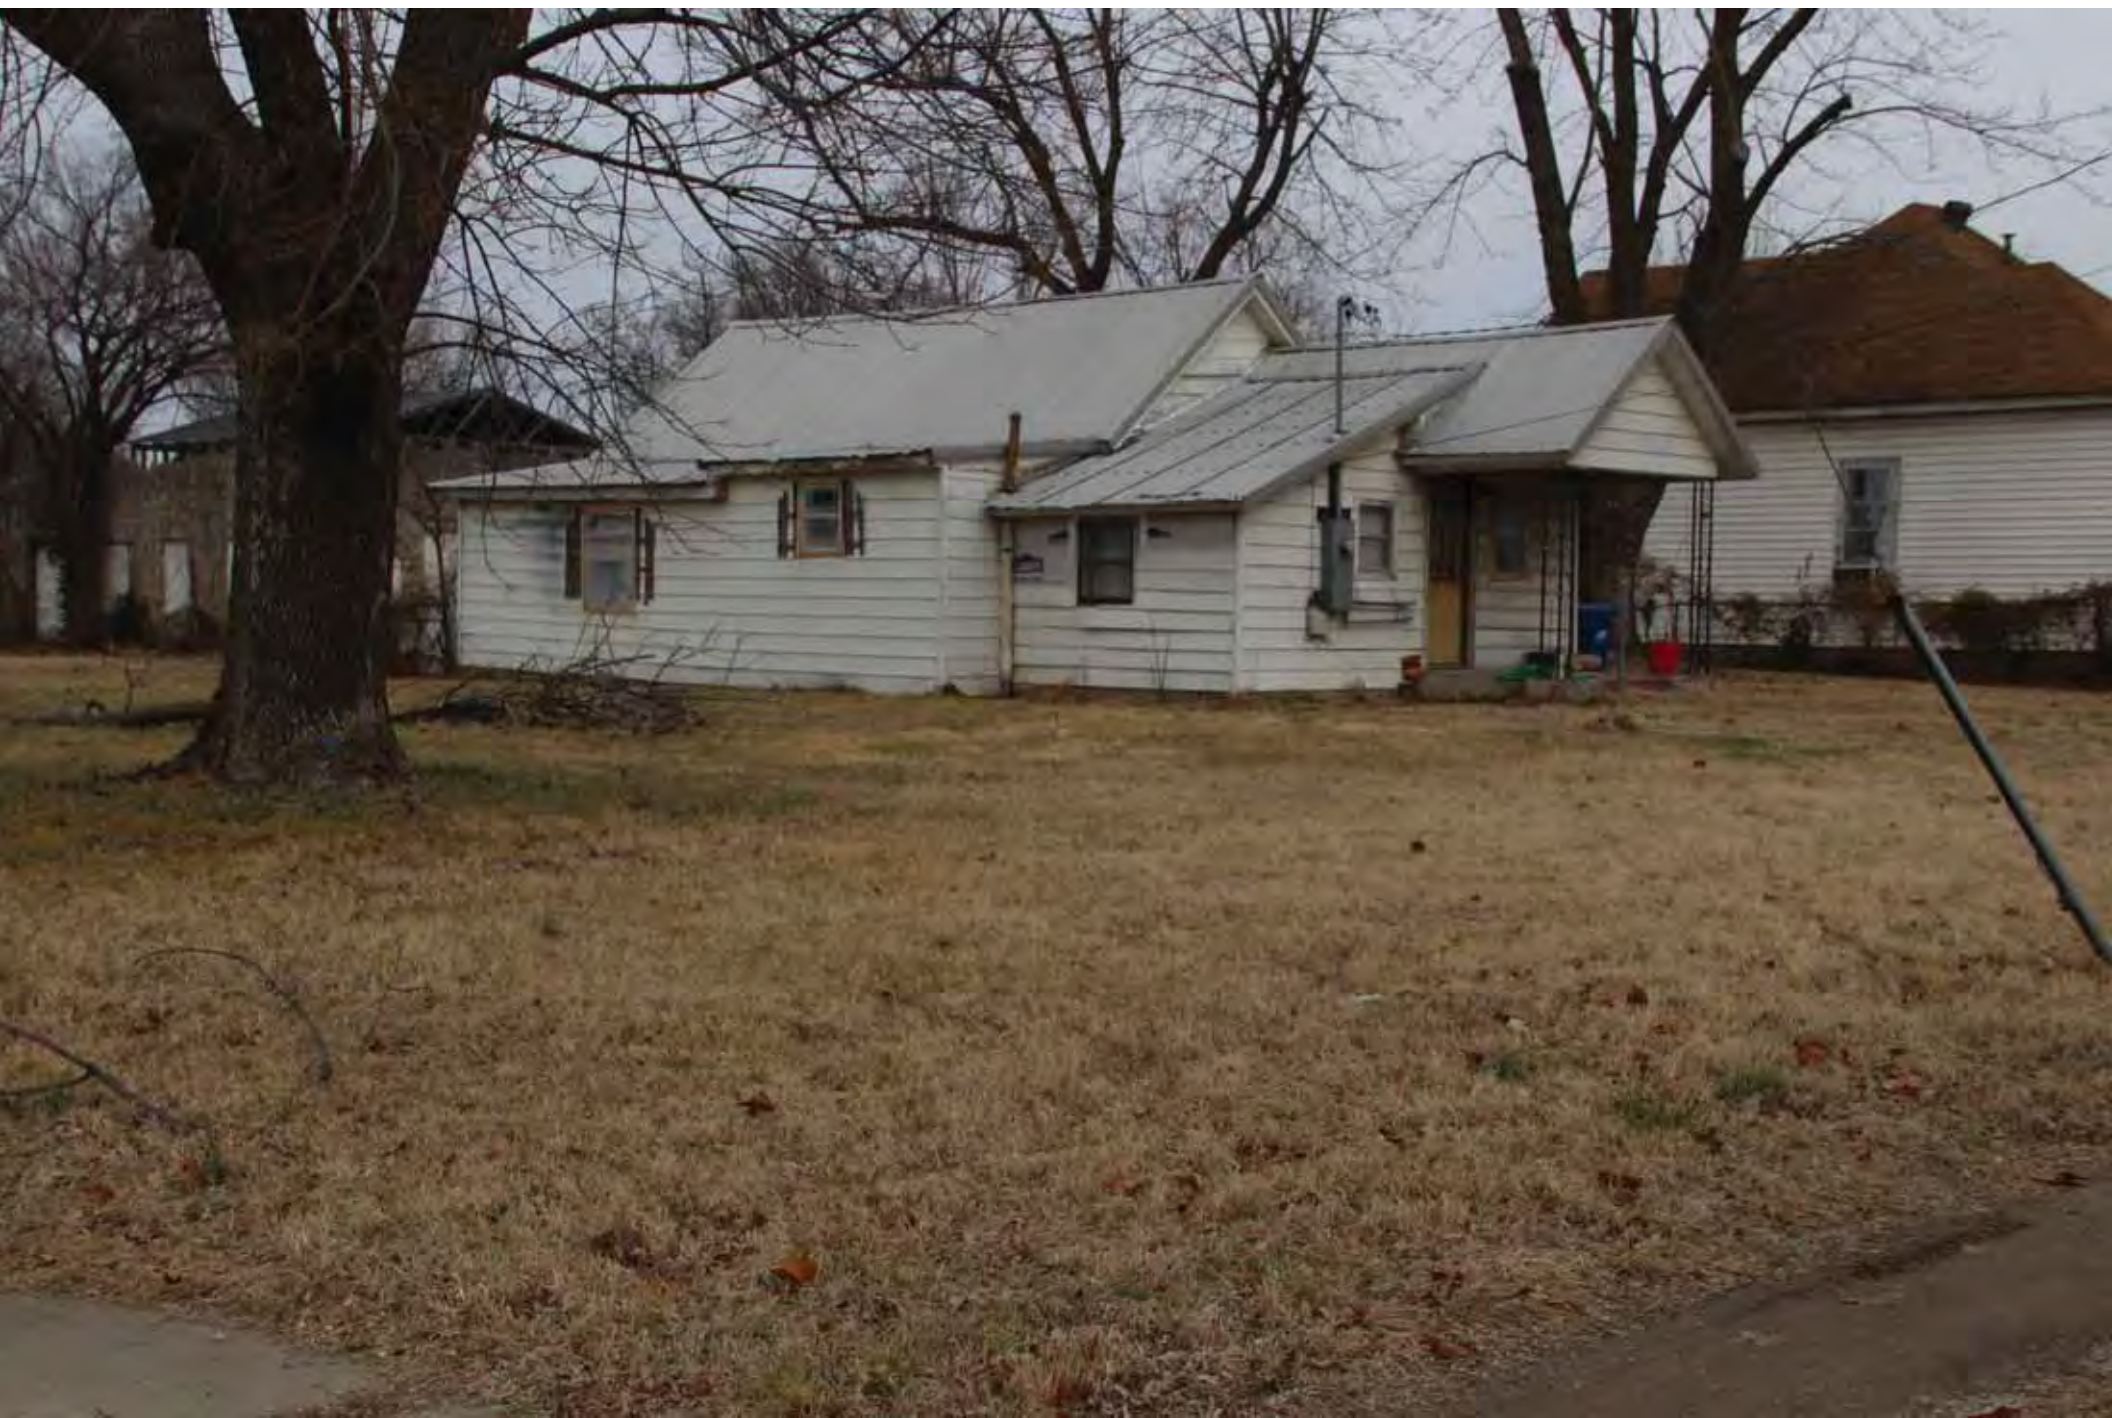
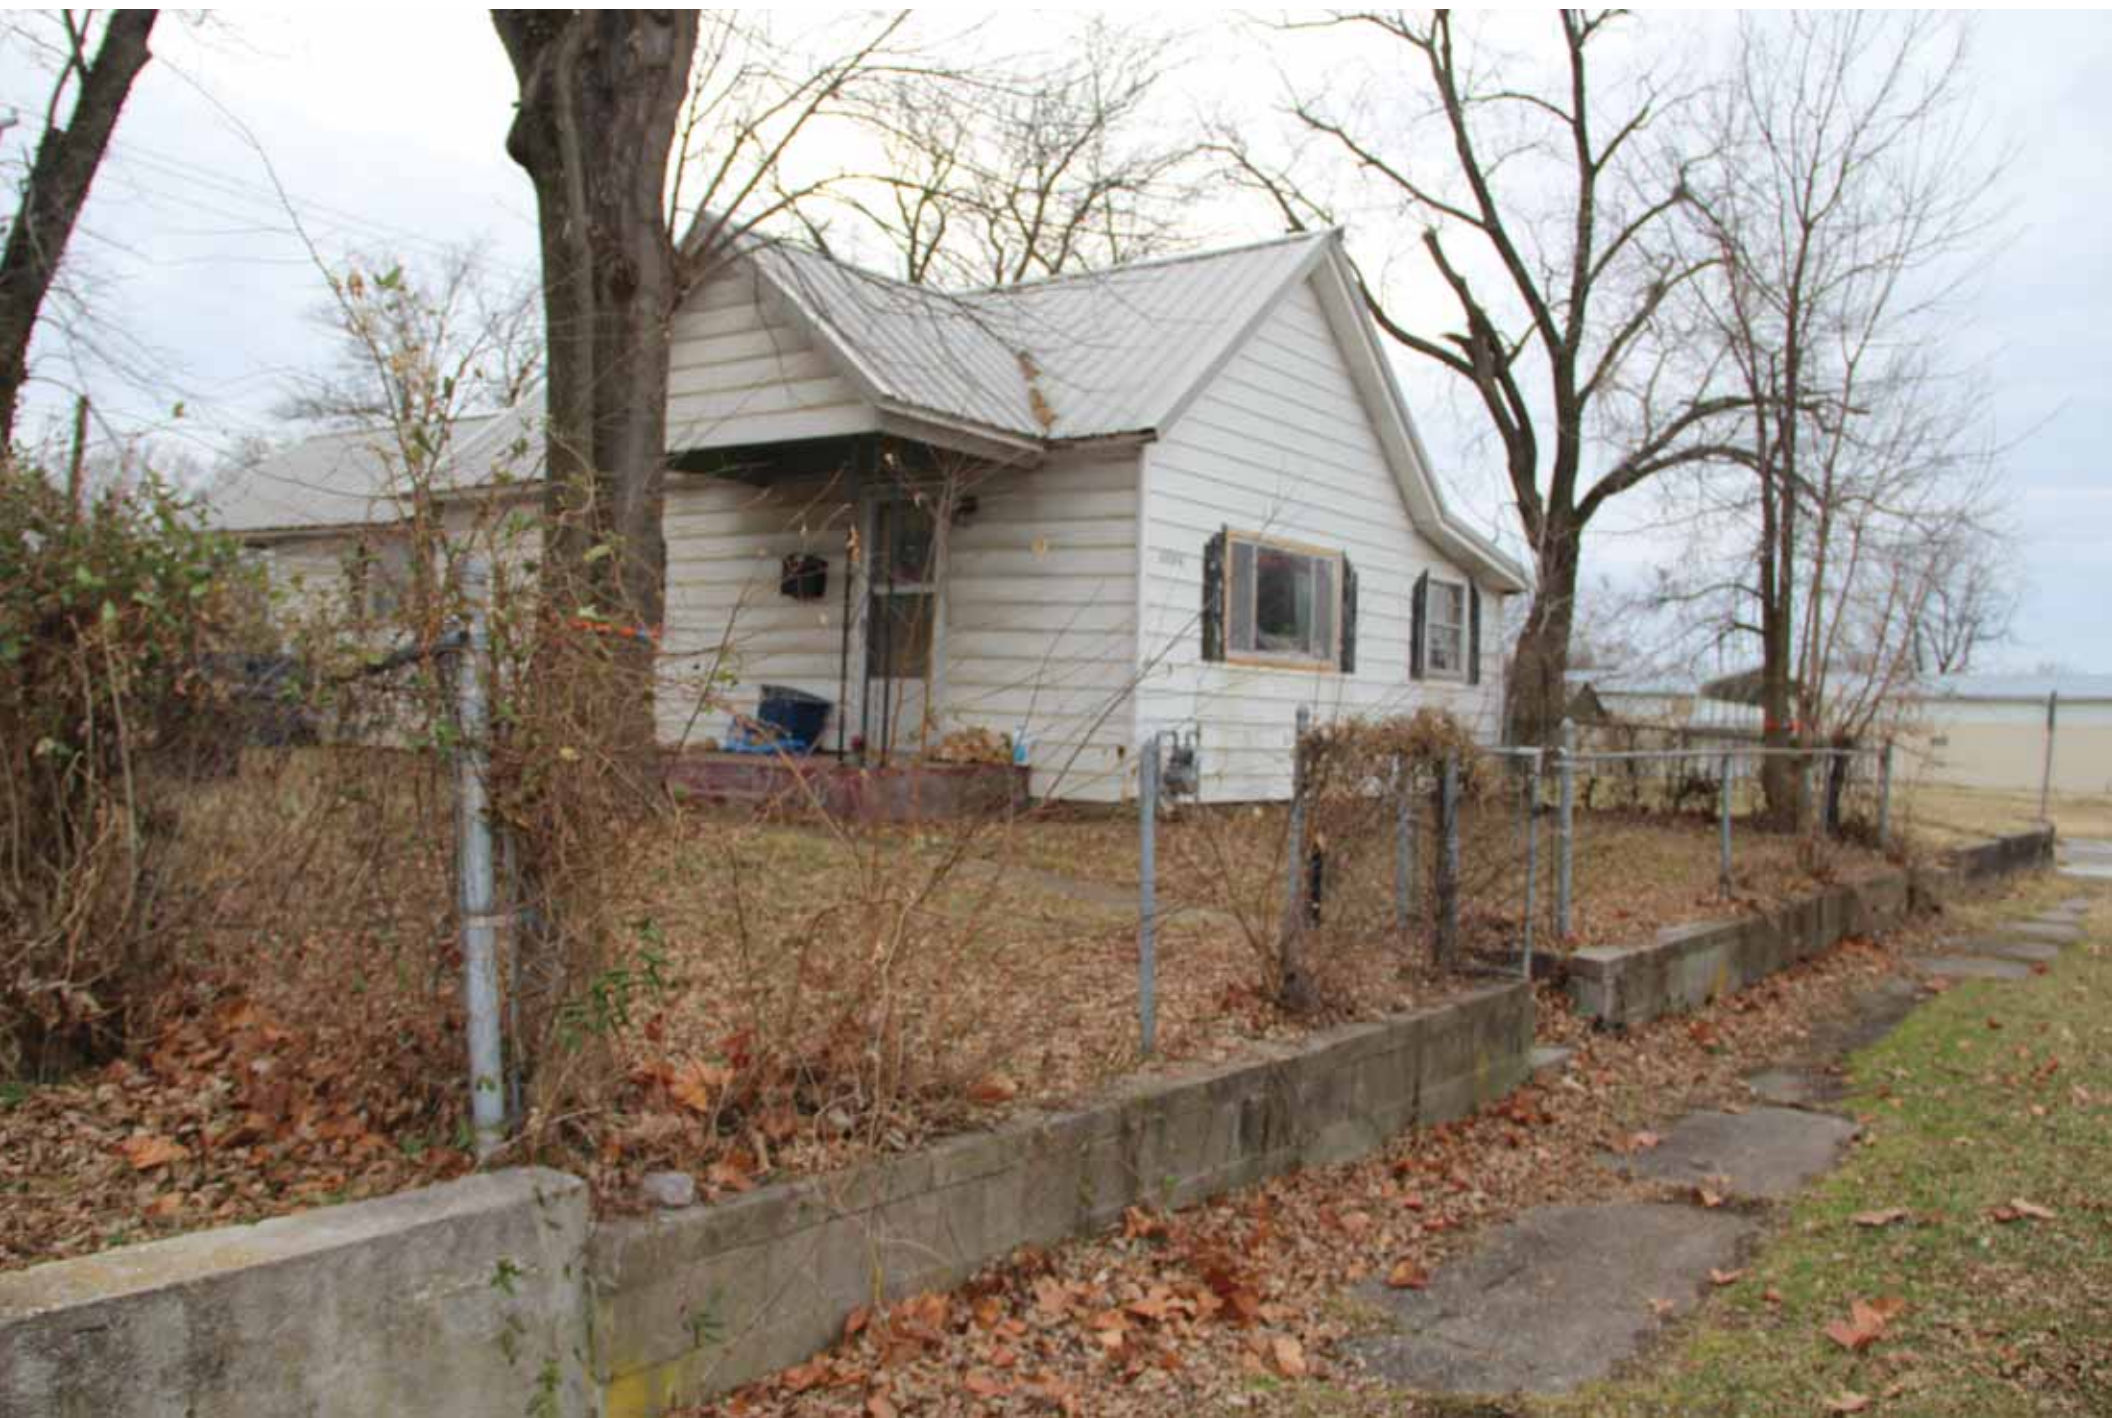
1106 E. Broadway features a single-story end-gable plan dwelling. The house has a corrugated metal clad roof, exterior vinyl siding and a concrete foundation. The primary (north) elevation facing E. Broadway holds an off-center gabled portico supported by wrought iron columns. The columns rest on a concrete stoop leading to the primary entry bay, which holds a metal storm door. Offsetting the entry and porch on the east are two one-over-one windows (north elevation). The west elevation holds a tri-part window and a two-over-two horizontal sash window. Windows have faux shutters. The rear (south) elevation facing the alley has a gable-front plan portico supported by wrought iron columns resting on a low concrete stoop. The south elevation has a multi-light contemporary door within the porch area flanked by small one-over-one windows.

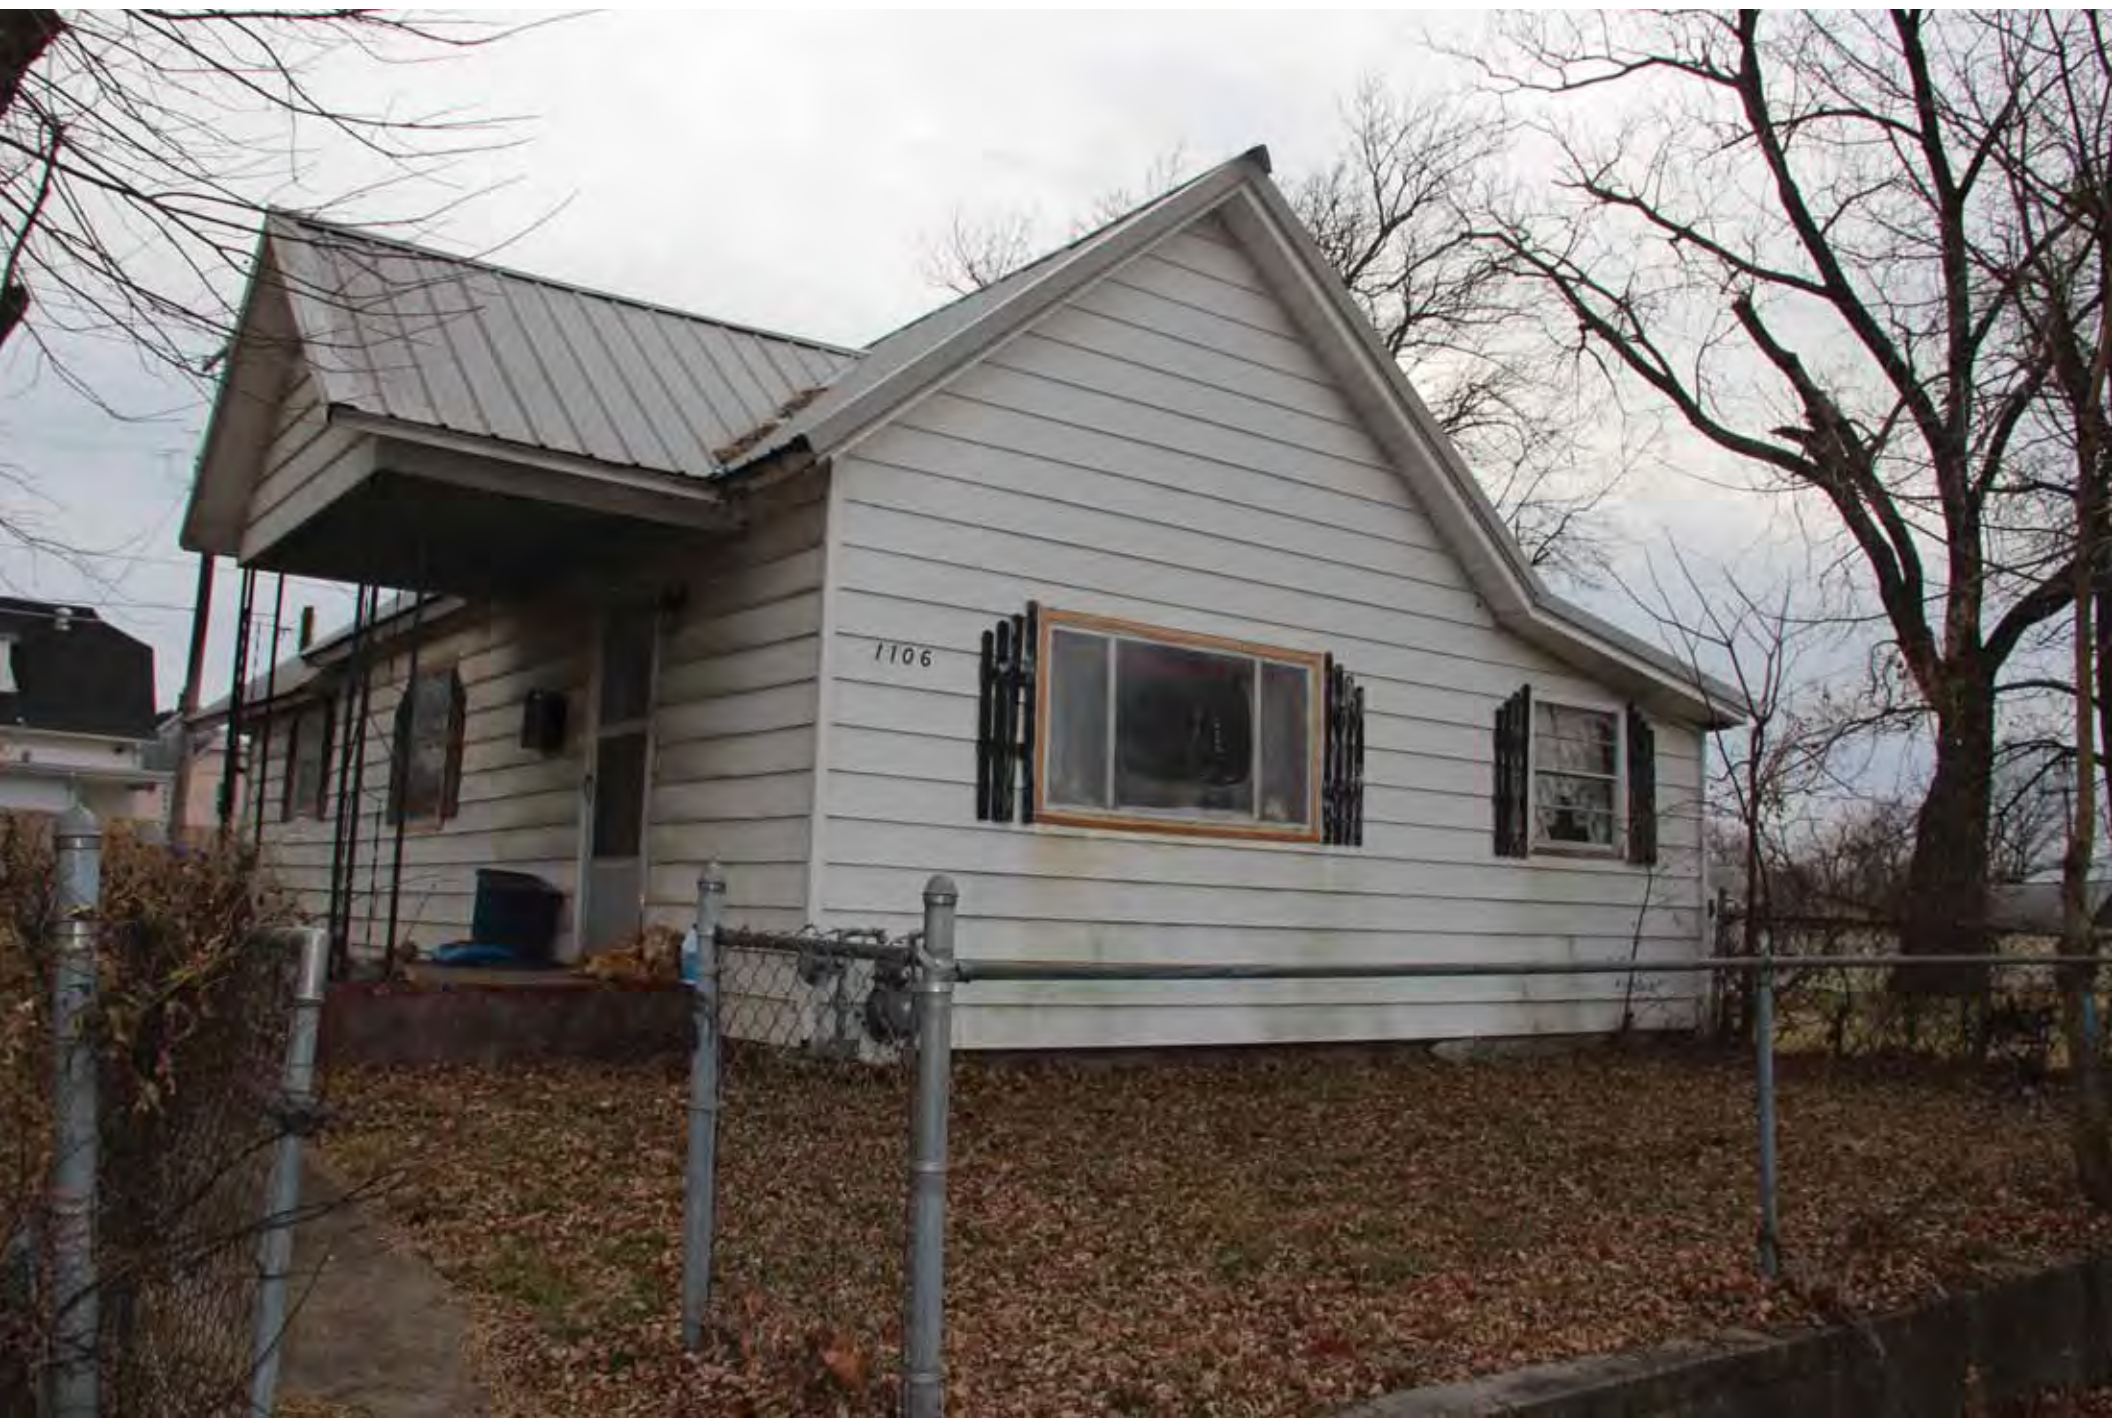
This dwelling has been altered through the addition of c. 1990 exterior siding (vinyl) and replacement of original windows. Due to the lack of exterior original siding, the dwelling does not retain integrity that would render it individually eligible for the National Register of Historic Places. The dwelling is not situated in an area recommended as a historic district.
