MISSOURI DEPARTMENT OF NATURAL RESOURCES
STATE HISTORIC PRESERVATION OFFICE, P.O. Box 176, Jefferson City, MO 65102
ARCHITECTURAL/HISTORIC INVENTORY FORM

1. Survey No. JP-AS-007-001		2. Survey name: East Town (Original Joplin) Historic Survey Phase 2	
3. County: JASPER		4. Address (Street No.) 618	Street (name) E. 2 nd Street
5. City: Joplin	Vicinity: <input type="checkbox"/>	6. Geographical Reference:	7. Township/Range/Section: T: R: S:
8. Historic name (if known):		9. Present/other name (if known):	
10. Ownership: <input checked="" type="checkbox"/> Private <input type="checkbox"/> Public		11a. Historic use (if known): Domestic: Single Dwelling	11b. Current use: Domestic: Single Dwelling

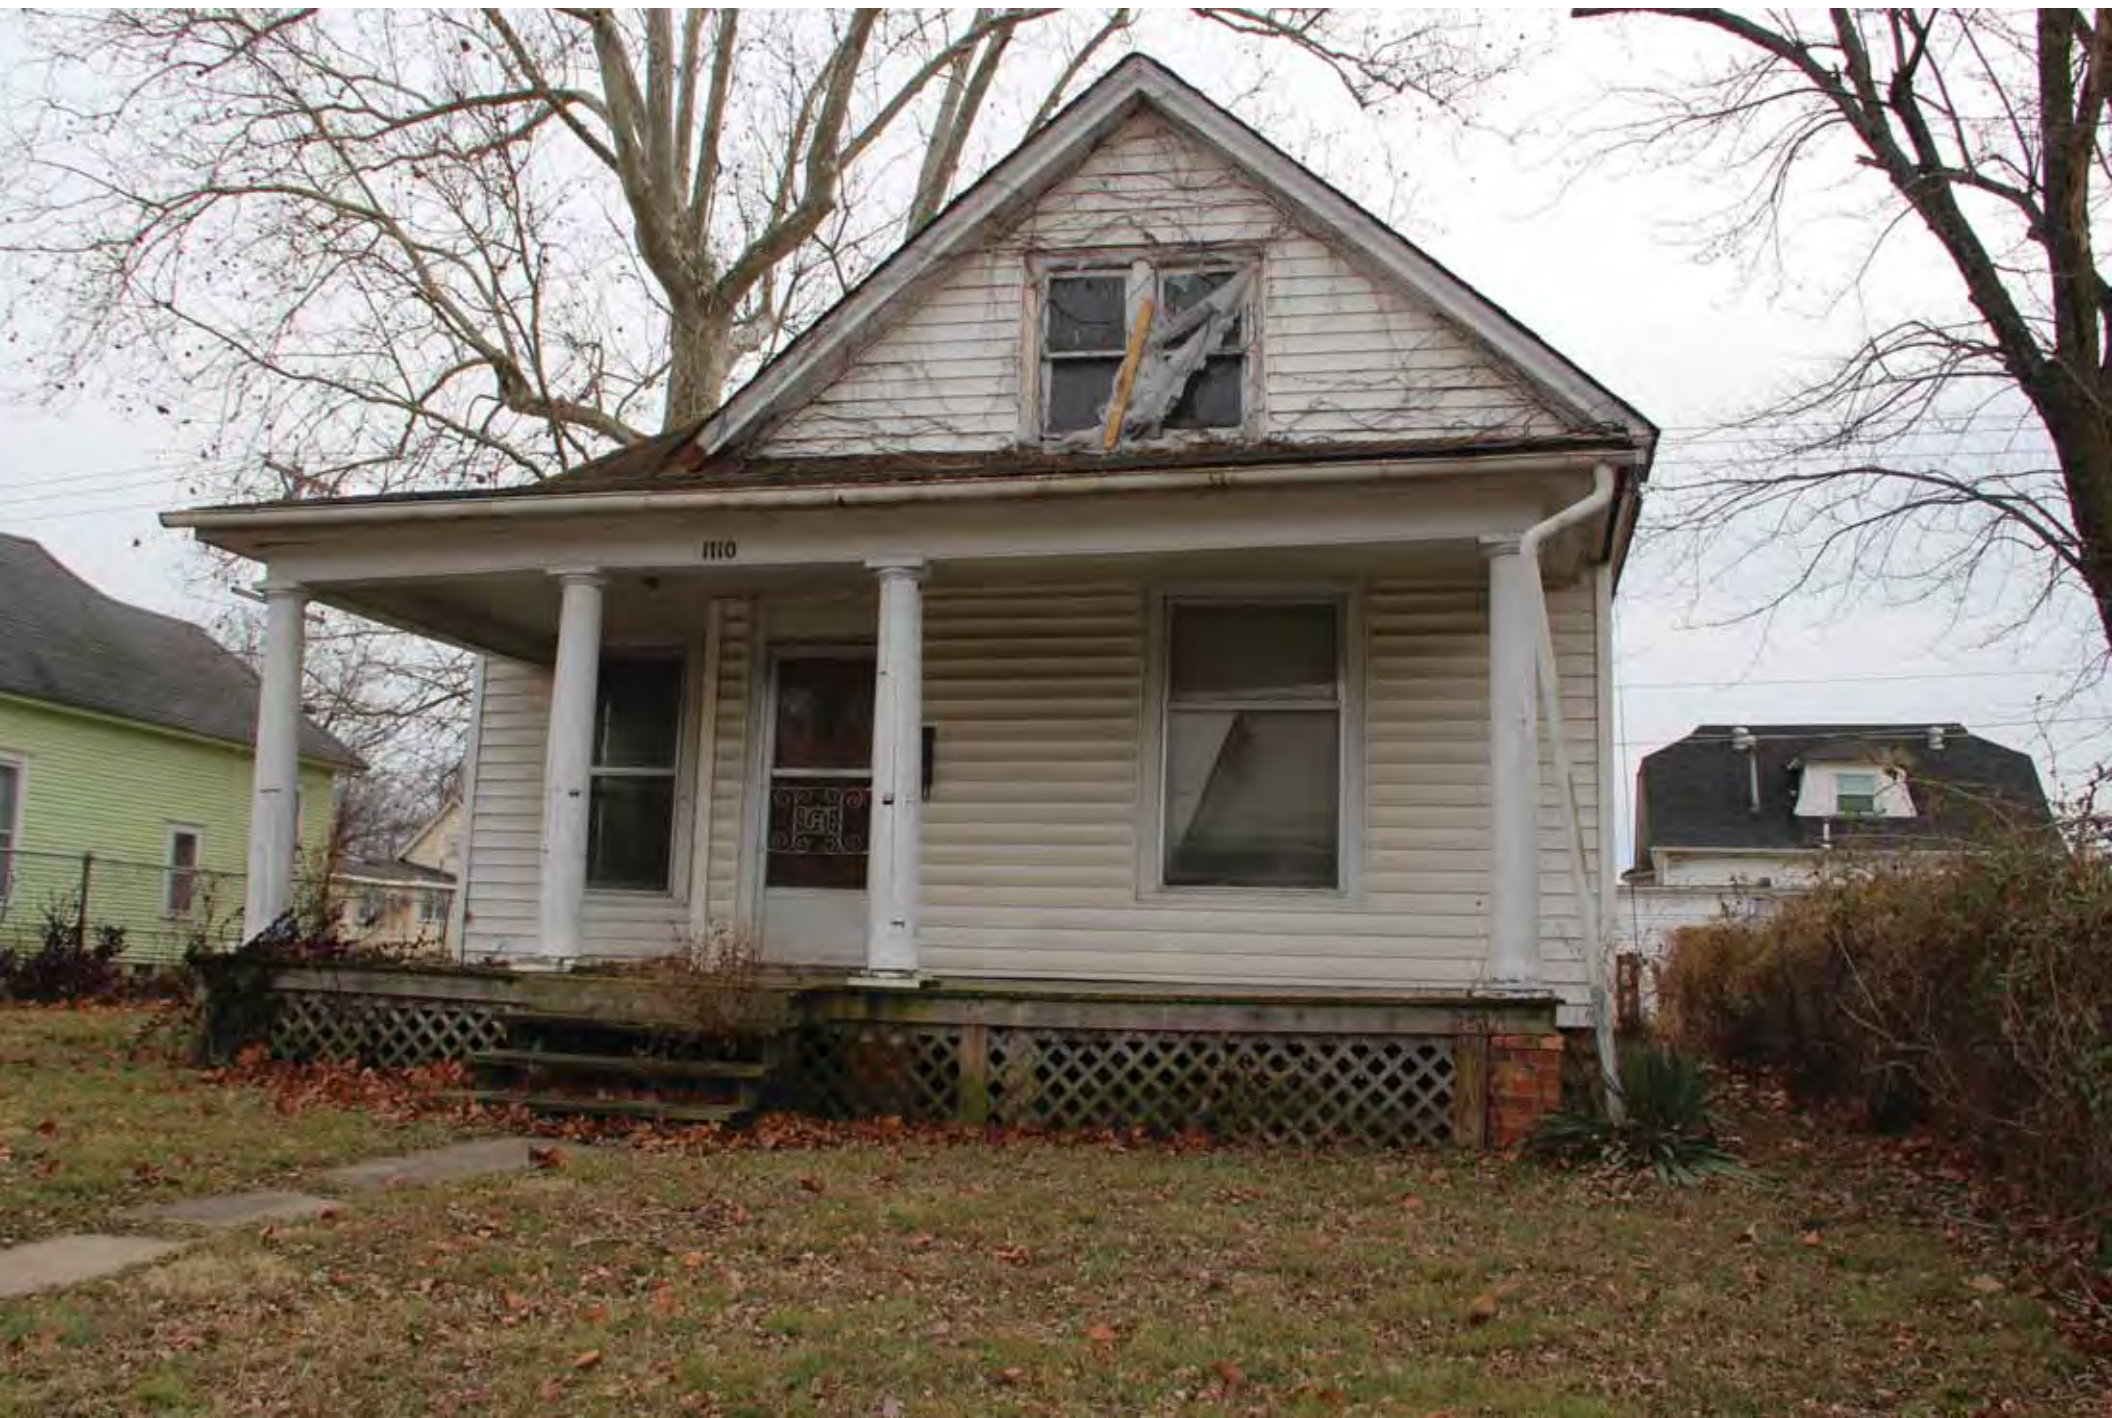
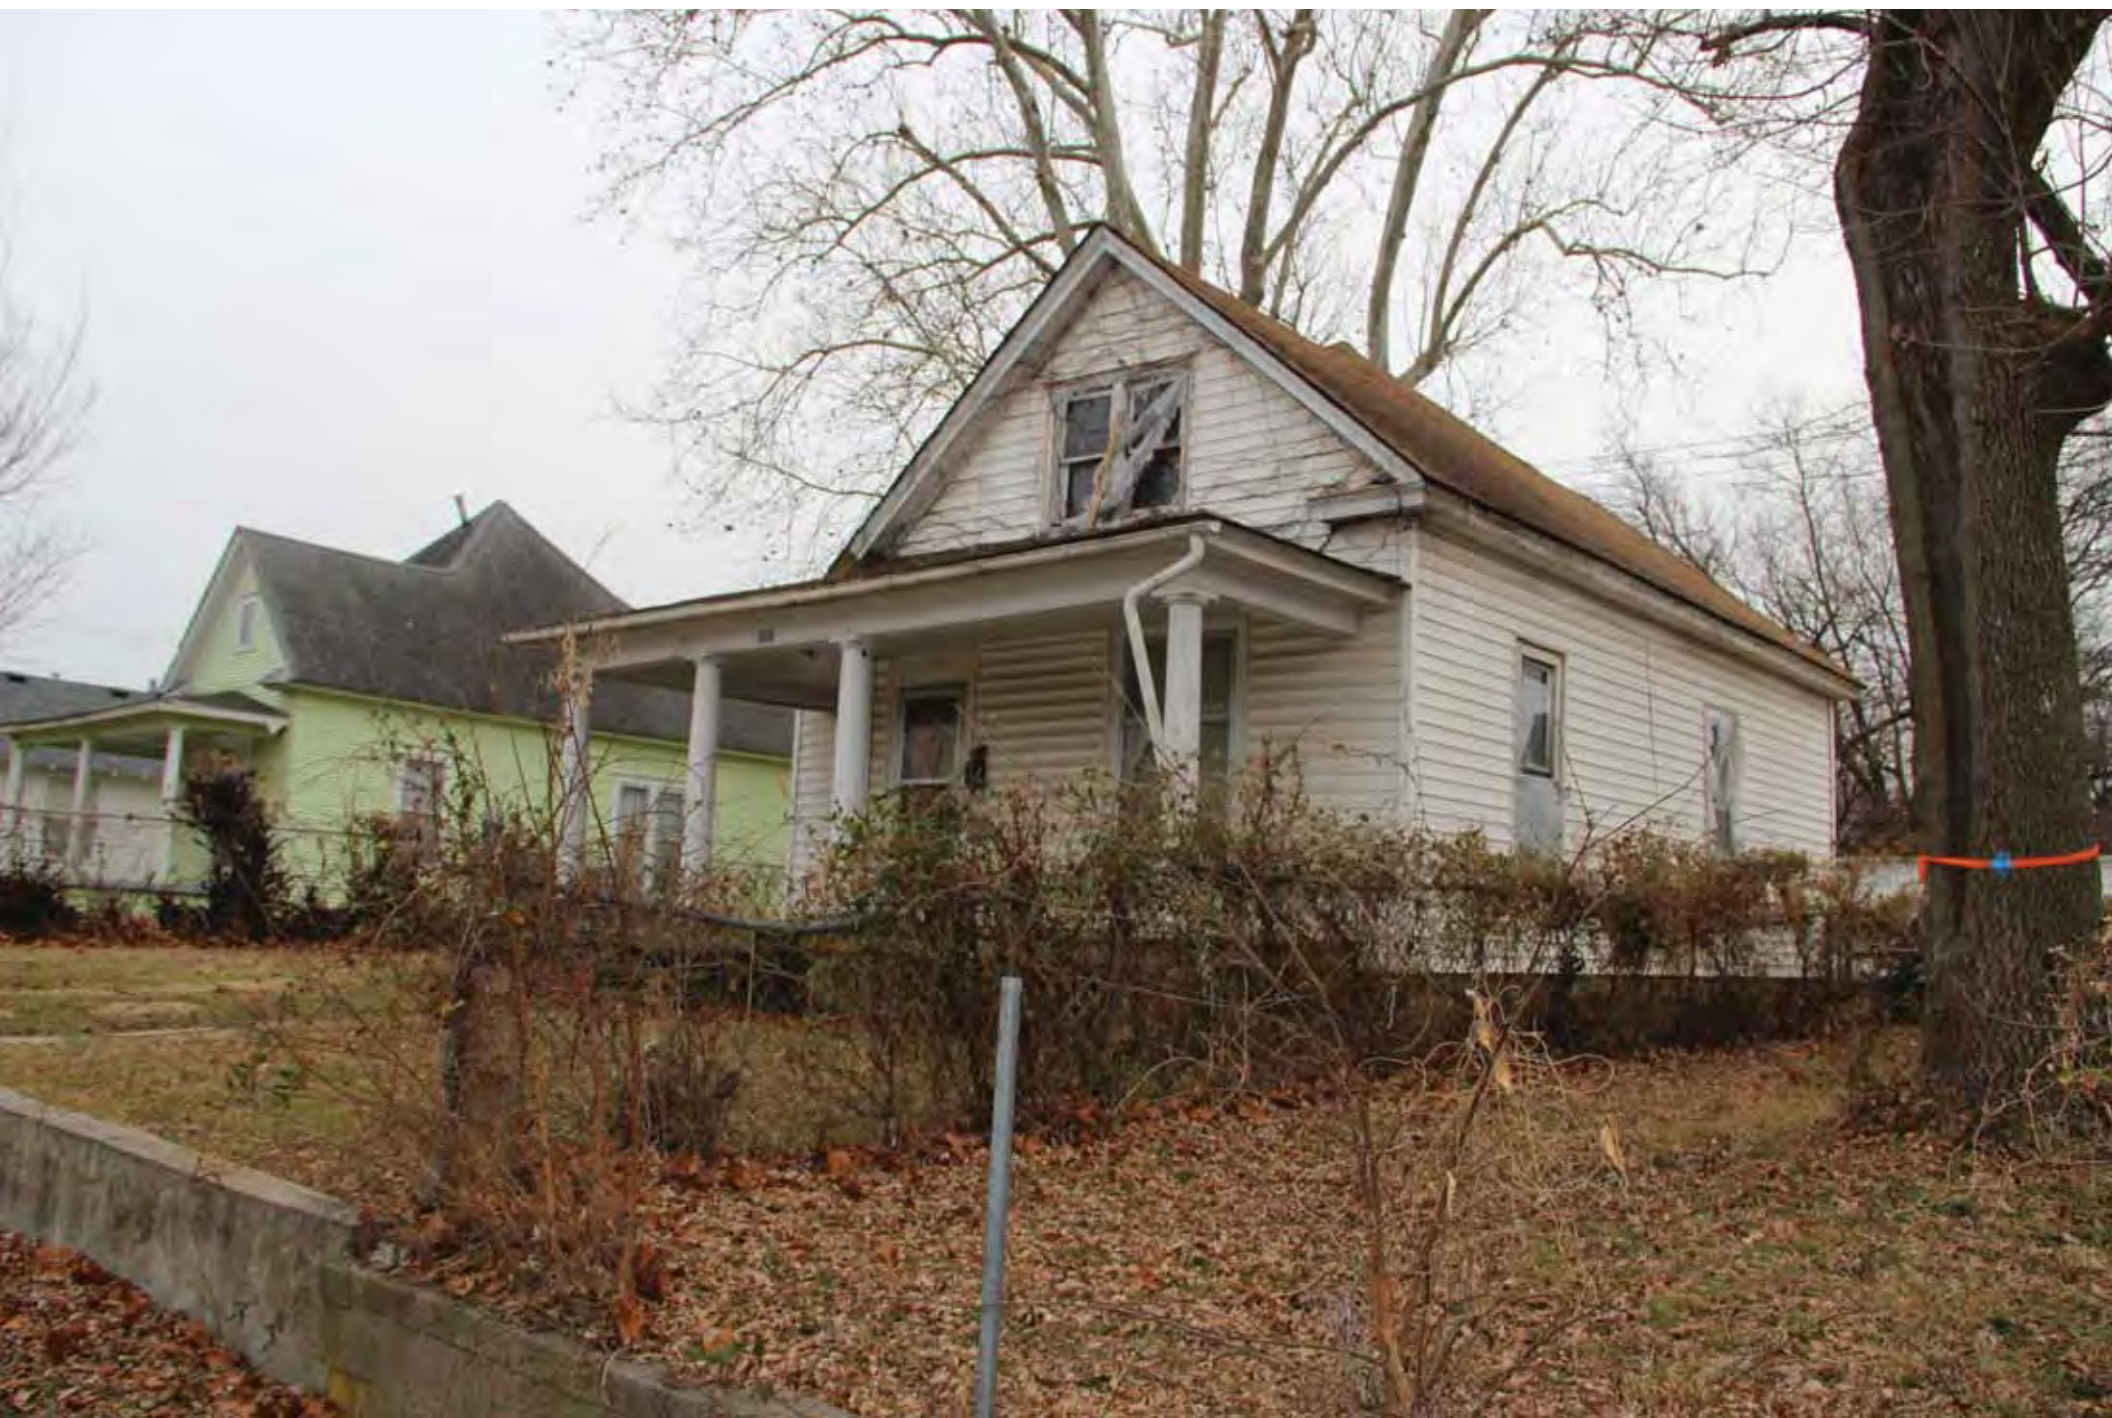
The property at 1110 E. Broadway is a 1.5-story National style dwelling constructed in 1910. The dwelling has a steeply pitched pyramidal roof clad with asphalt shingles and exterior vinyl siding. A projecting front-gabled wing is situated on the primary (north) elevation. The elevation holds a single-story hipped porch supported by original Tuscan columns resting on a wood porch platform. The porch has a brick pier foundation with frame lattice obscuring the open area below the porch floor. The remaining foundation of the house is limestone with concrete infill. The primary (north) elevation features an off-center entry filled with a diamond light wood door (c. 1960). The entry bay appears to have transom infill above the door. Windows appear original and are one-over-one. The upper gable field above the porch holds paired windows. Windows flanking the porch entry are likewise one-over-one but are of different sizes – both appear original. The projecting gabled front wing creates a set-back wall on the east end of the porch.

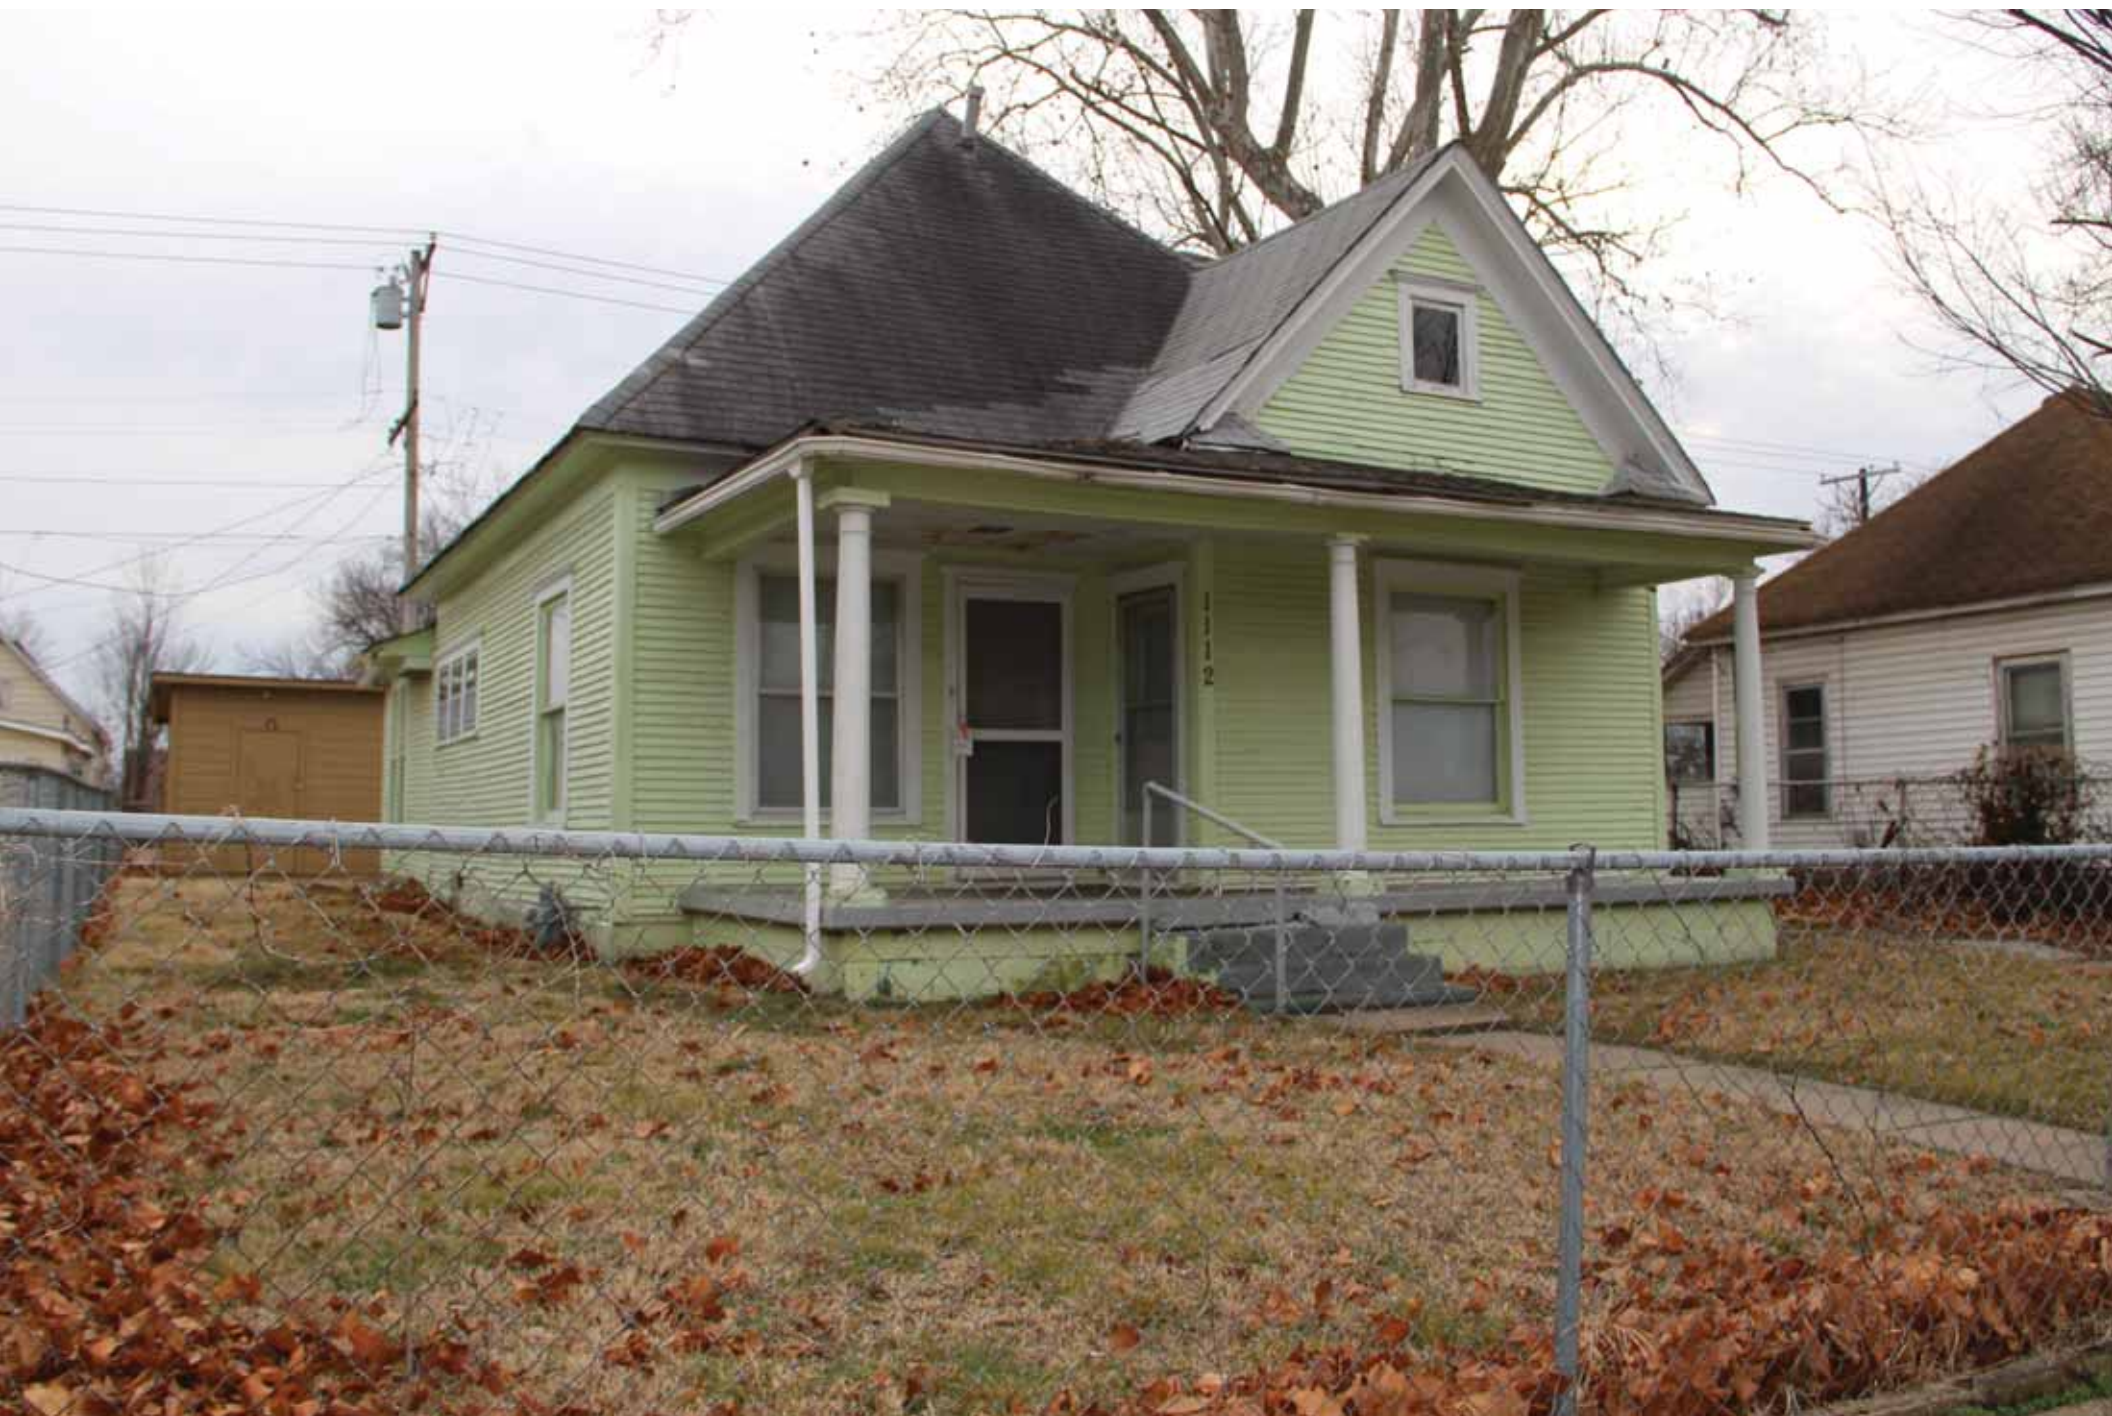
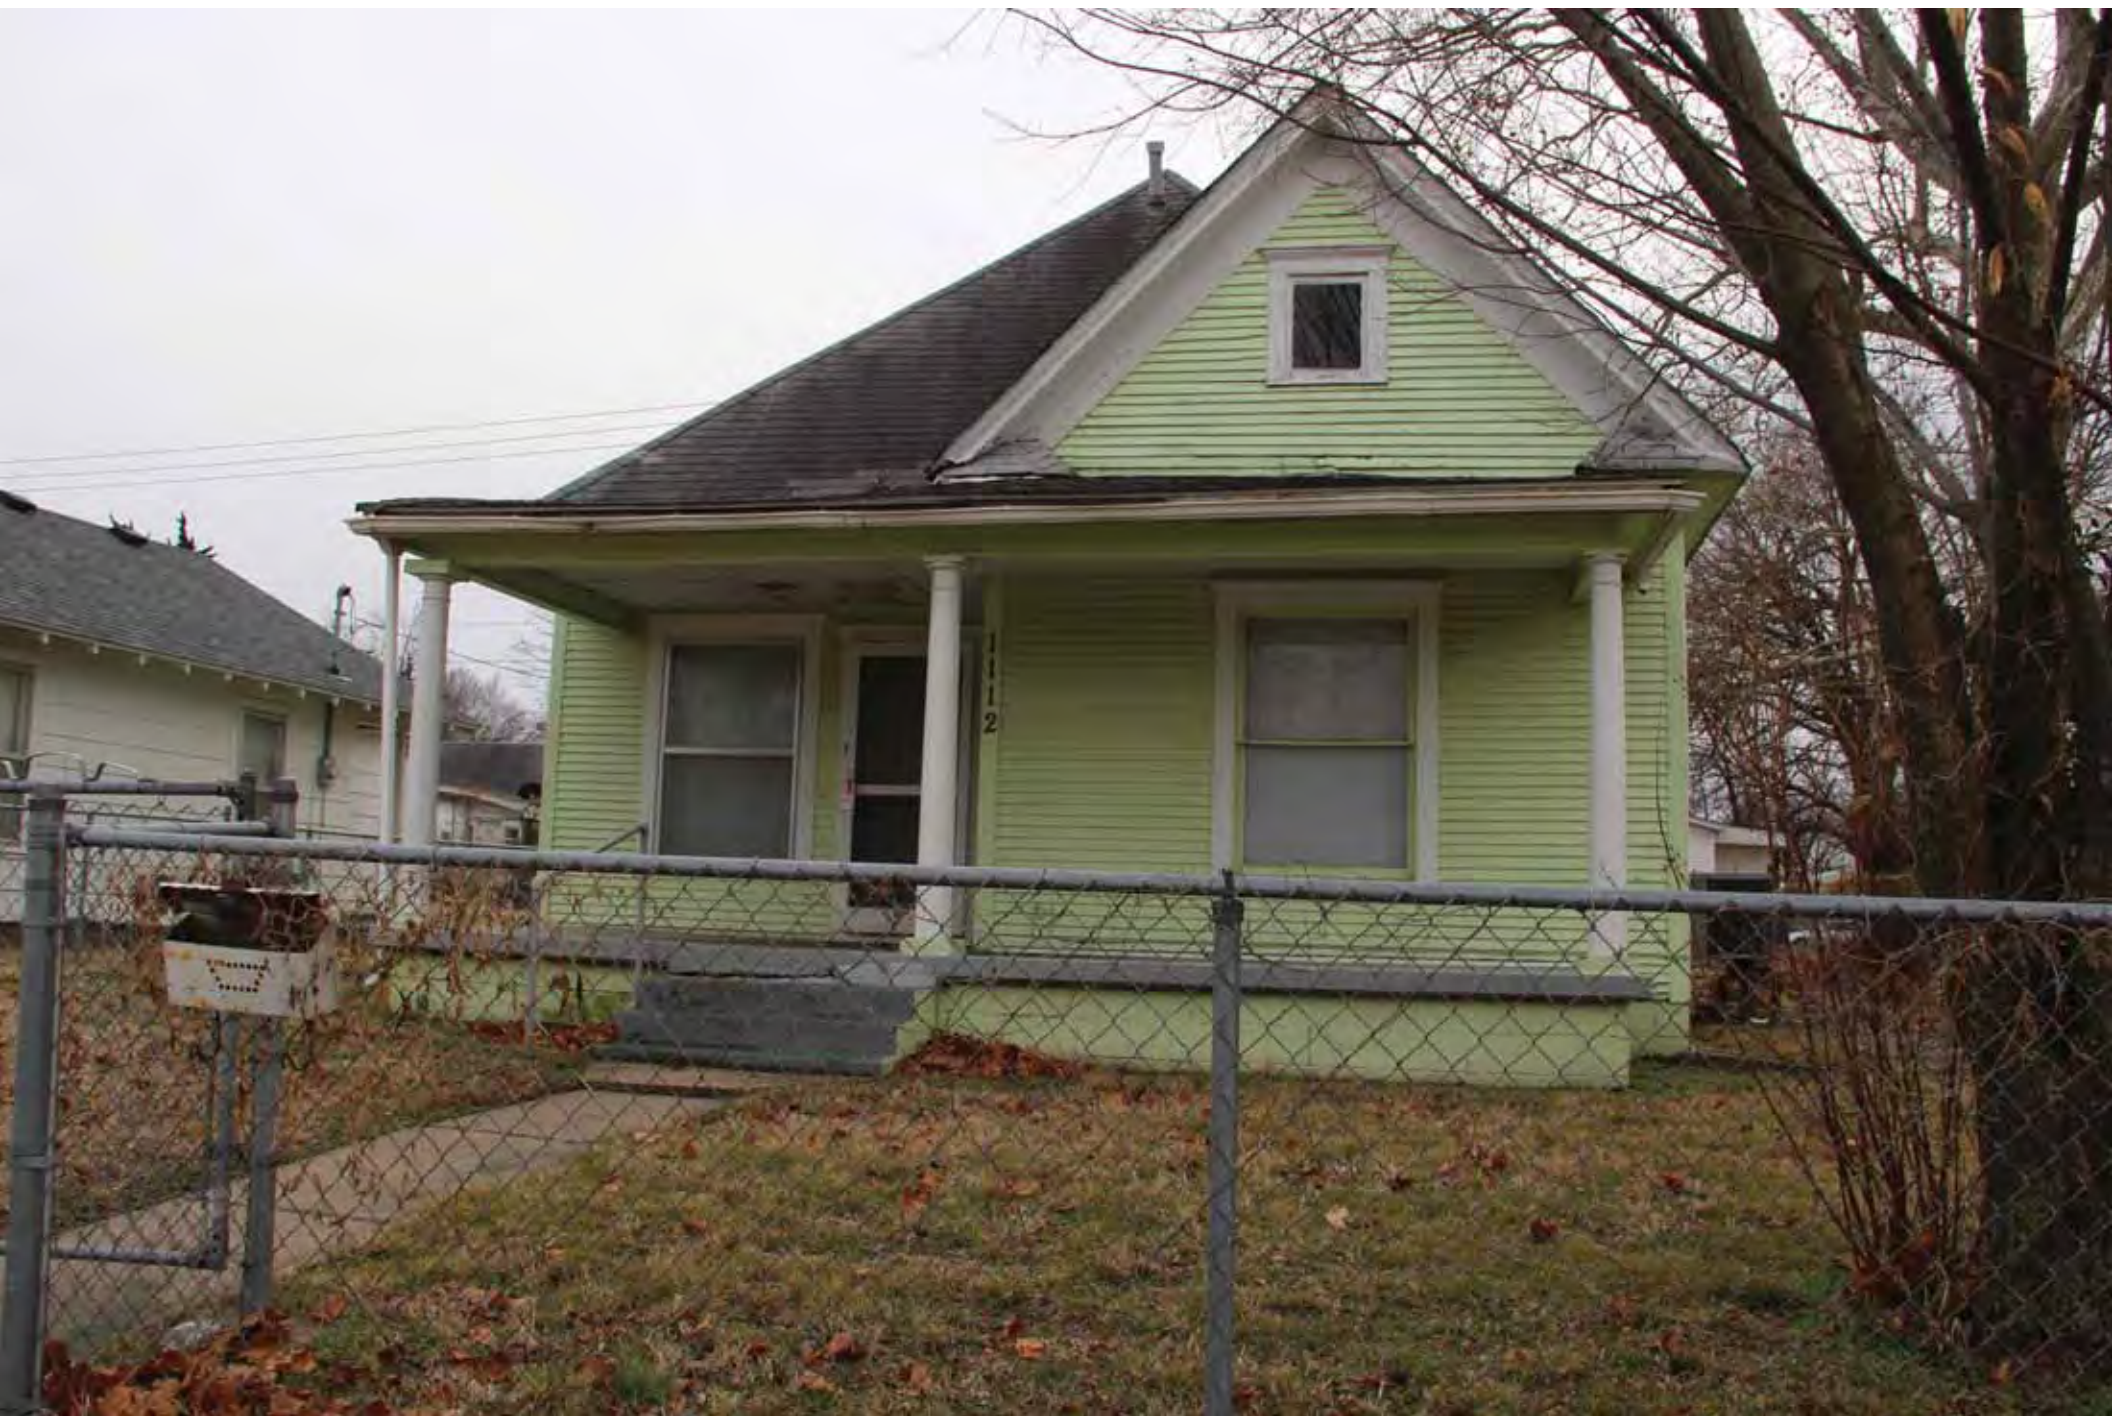
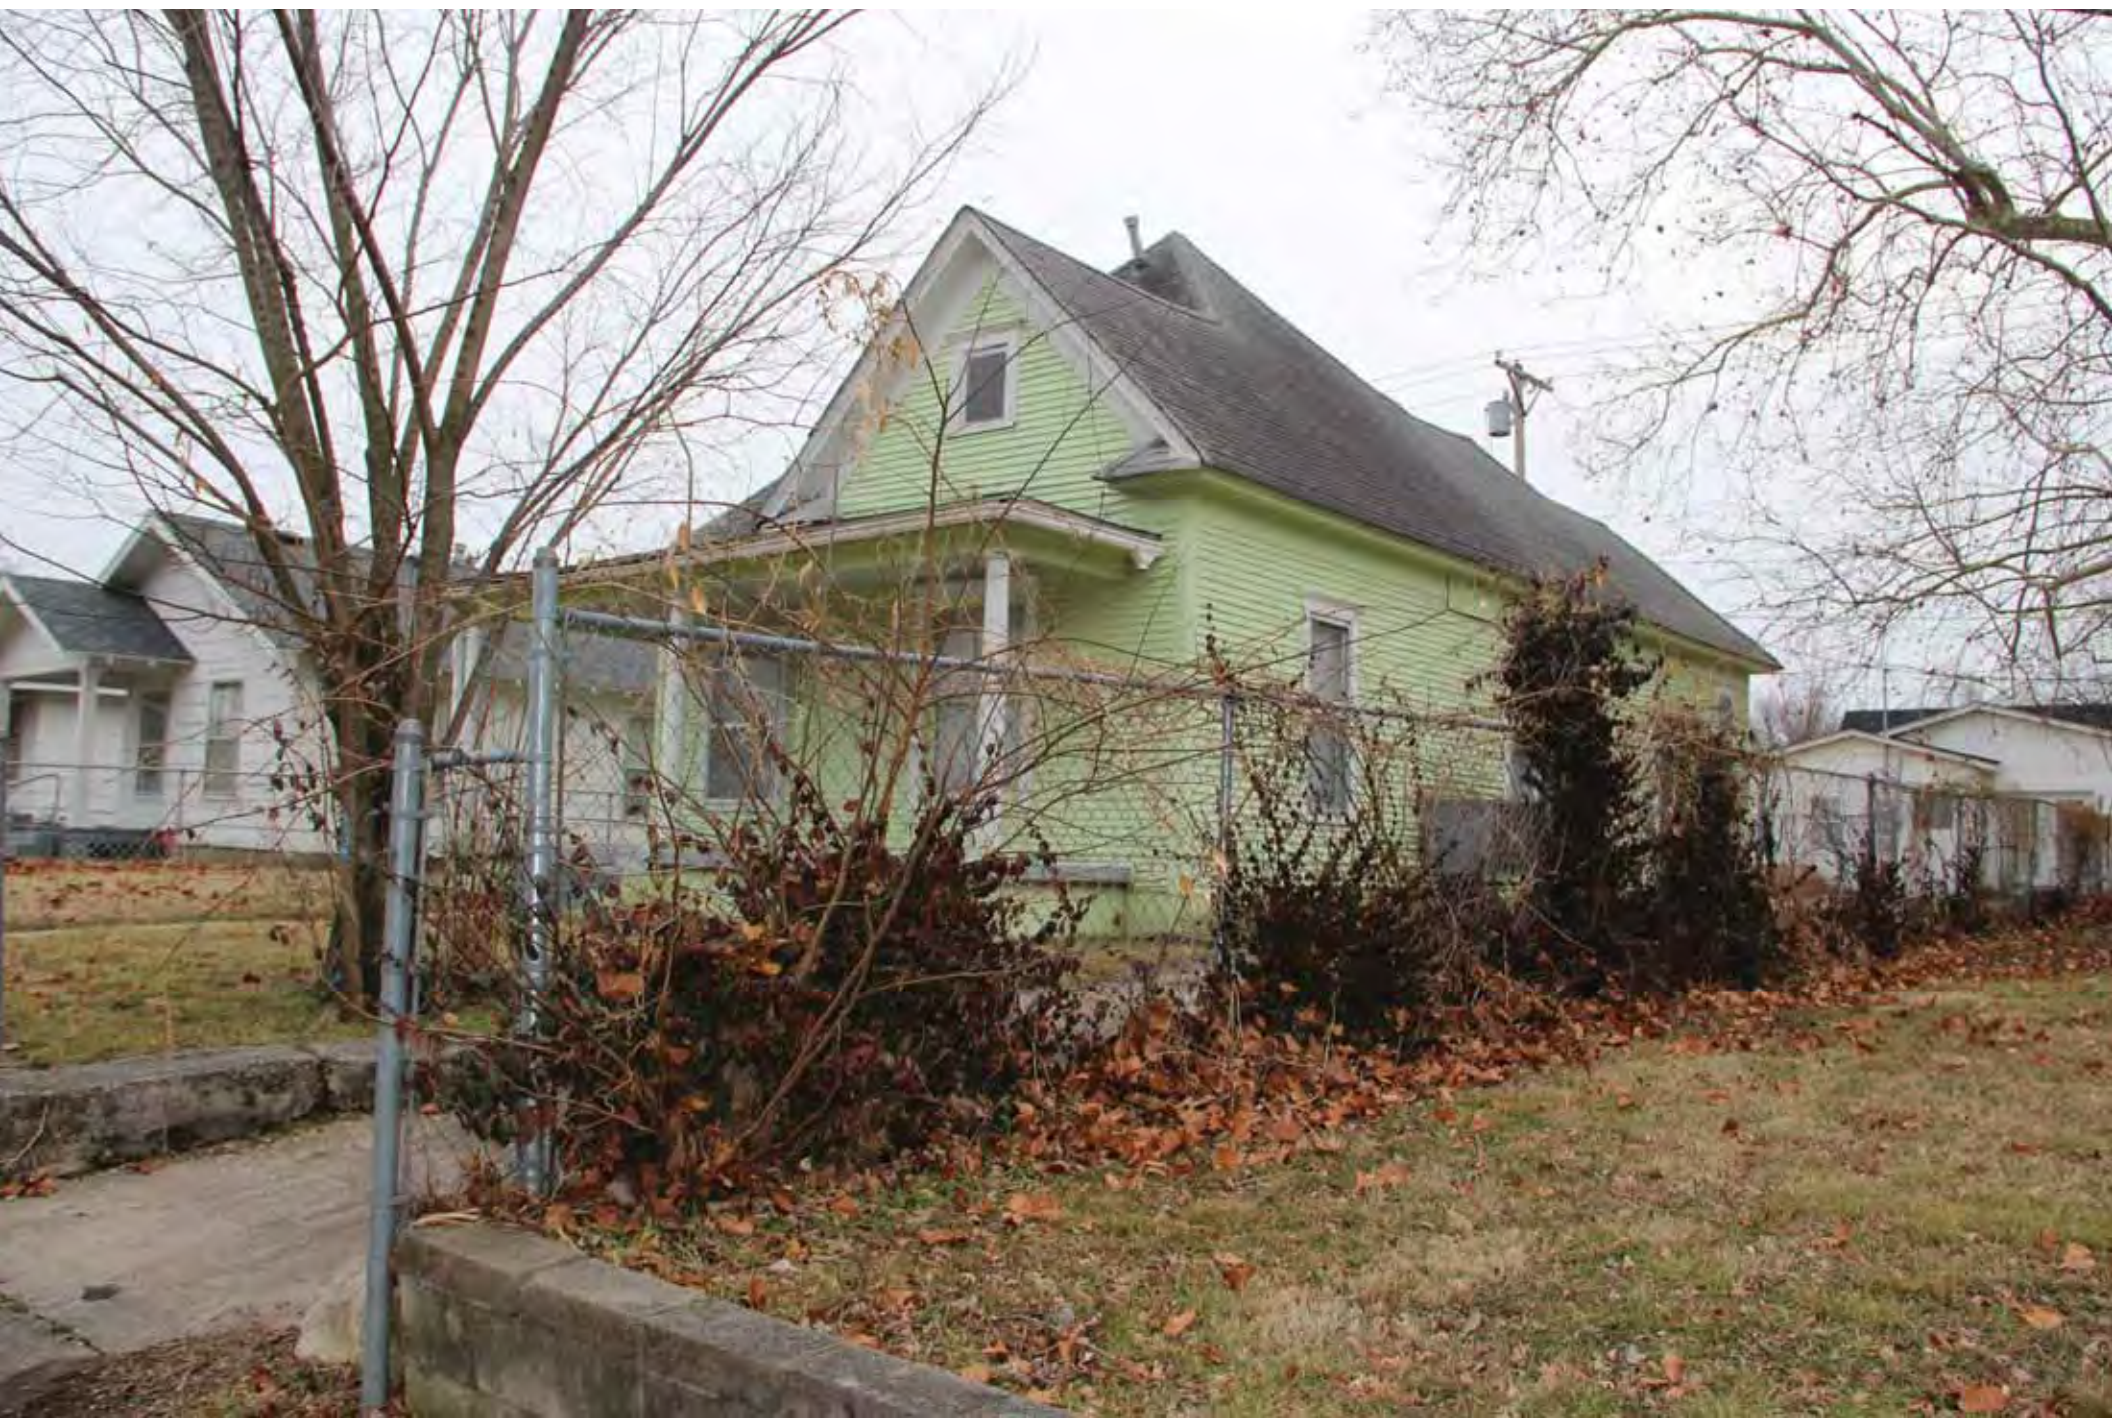
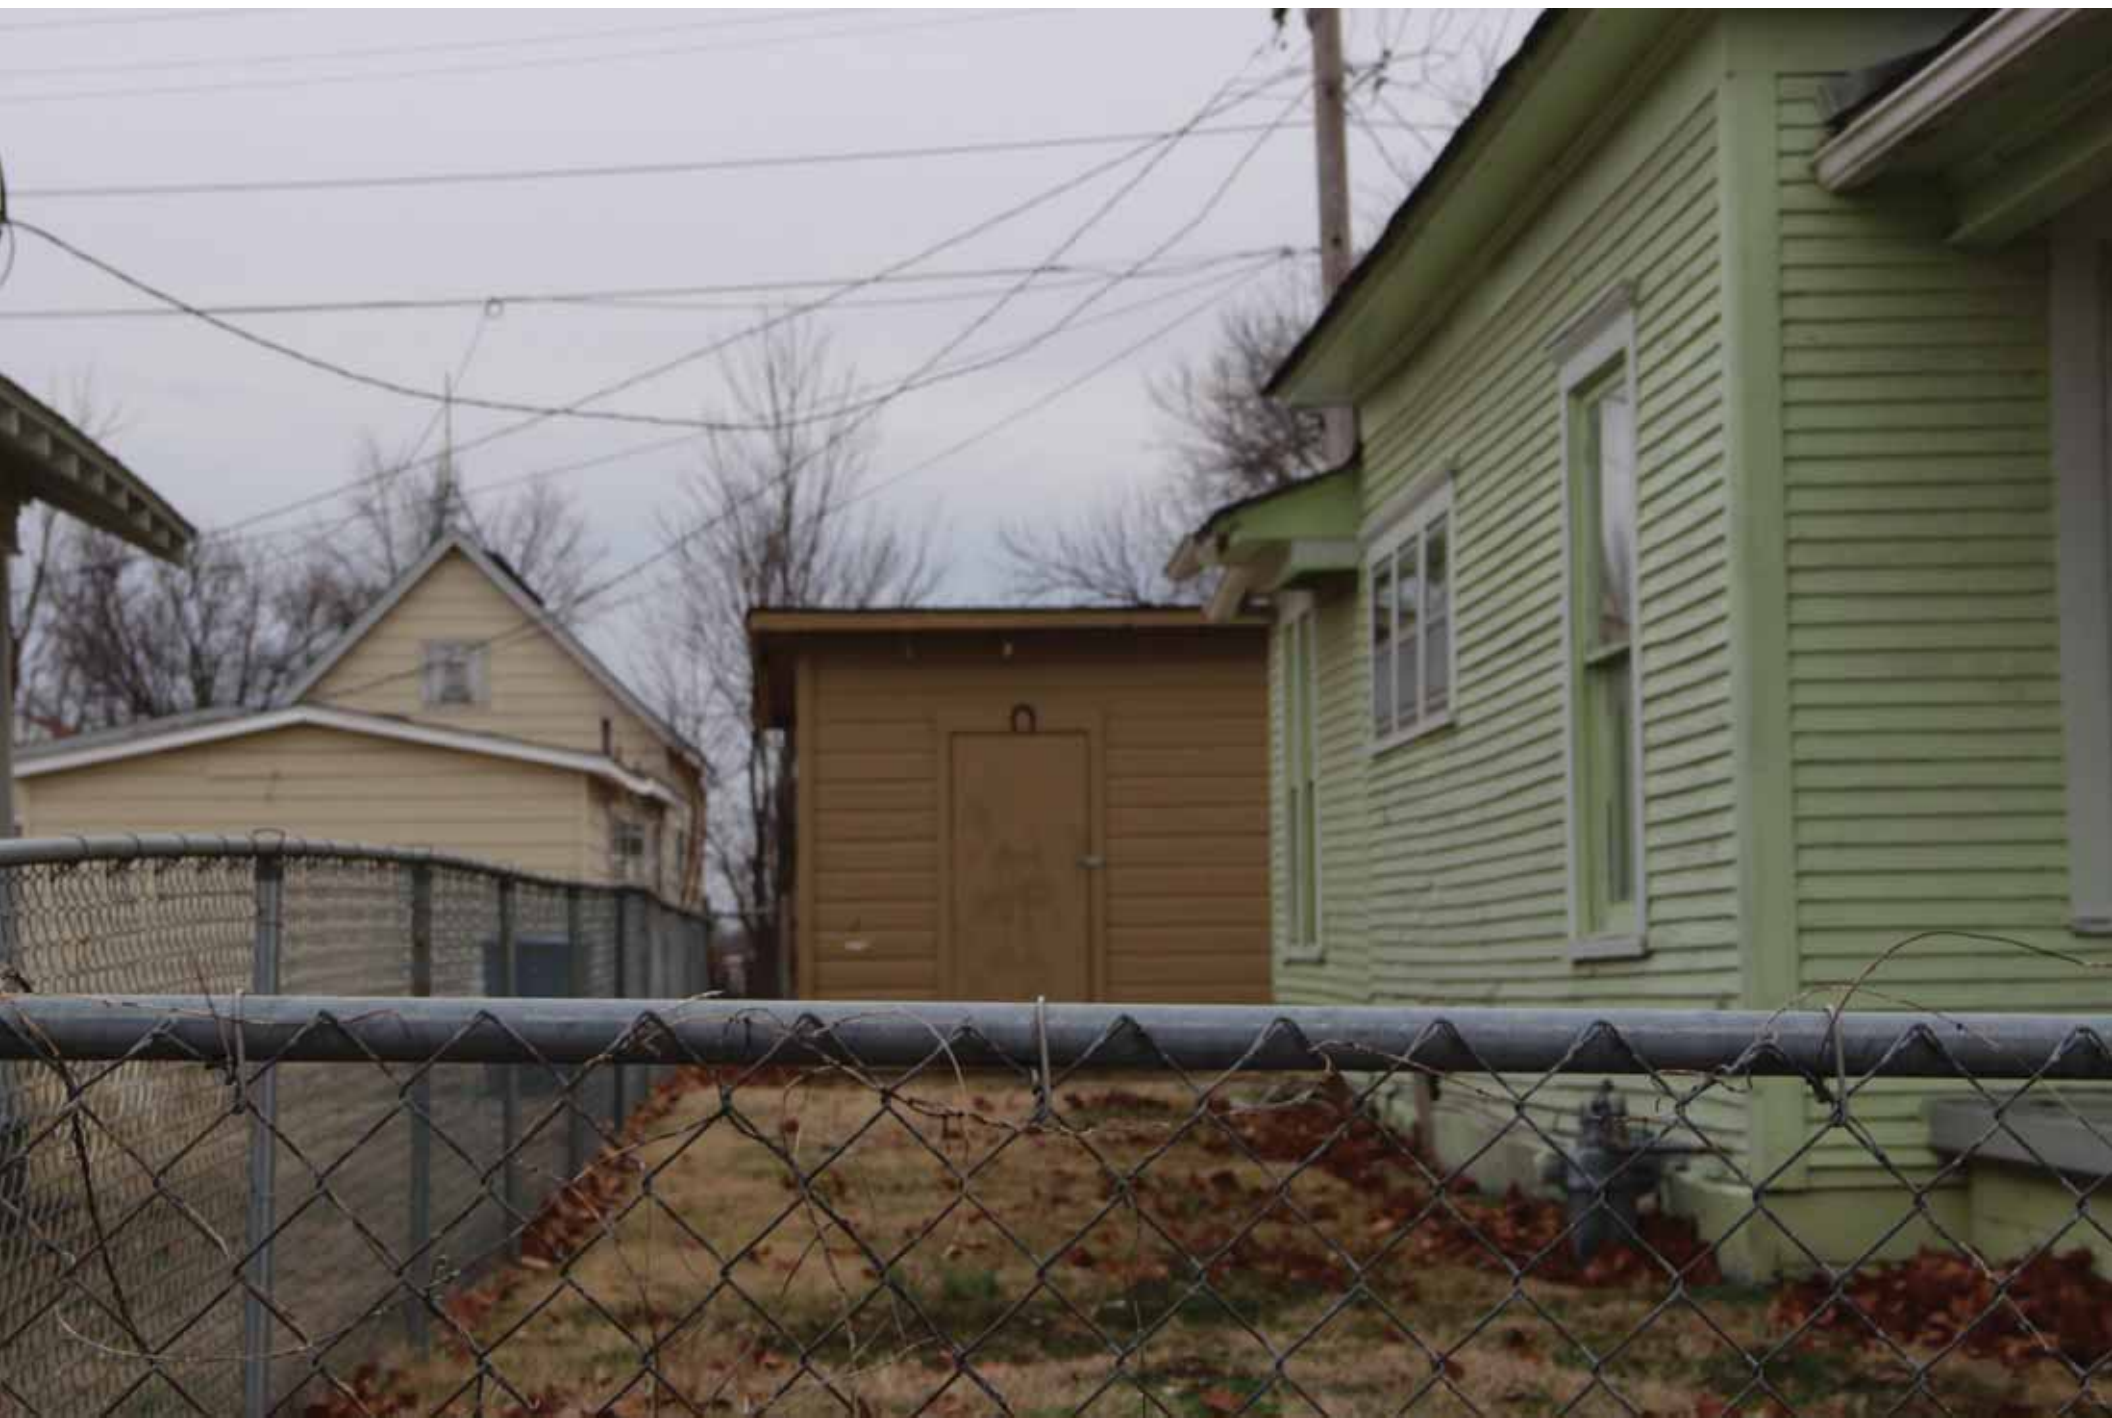
The property at 1112 E. Broadway is a 1.5-story National style dwelling constructed in 1910. The dwelling has a steeply pitched pyramidal roof clad with asphalt shingles and exterior weatherboard siding. A projecting front-gabled wing is situated on the primary (north) elevation at the west end of the façade. The south (primary) elevation supports a single-story hipped porch supported by original Tuscan columns. The floor of the porch is concrete and the foundation is concrete block. The primary (north) elevation features two entrances – one faces north and the other (situated on the front gabled west wing) faces east. Windows appear original and are one-over-one. The upper gable field above the projecting wing holds a single sash window. The east elevation has a band of small windows (three) near the rear (south) end of the house. The window band is flanked by a single 1/1 window (north end) and paired windows (south end). The east elevation has three double-hung windows.
