MISSOURI DEPARTMENT OF NATURAL RESOURCES
STATE HISTORIC PRESERVATION OFFICE, P.O. Box 176, Jefferson City, MO 65102
ARCHITECTURAL/HISTORIC INVENTORY FORM

1. Survey No. JP-AS-007-001		2. Survey name: East Town (Original Joplin) Historic Survey Phase 2	
3. County: JASPER		4. Address (Street No.) 618	Street (name) E. 2 nd Street
5. City: Joplin	Vicinity: <input type="checkbox"/>	6. Geographical Reference:	7. Township/Range/Section: T: R: S:
8. Historic name (if known):		9. Present/other name (if known):	
10. Ownership: <input checked="" type="checkbox"/> Private <input type="checkbox"/> Public		11a. Historic use (if known): Domestic: Single Dwelling	11b. Current use: Domestic: Single Dwelling

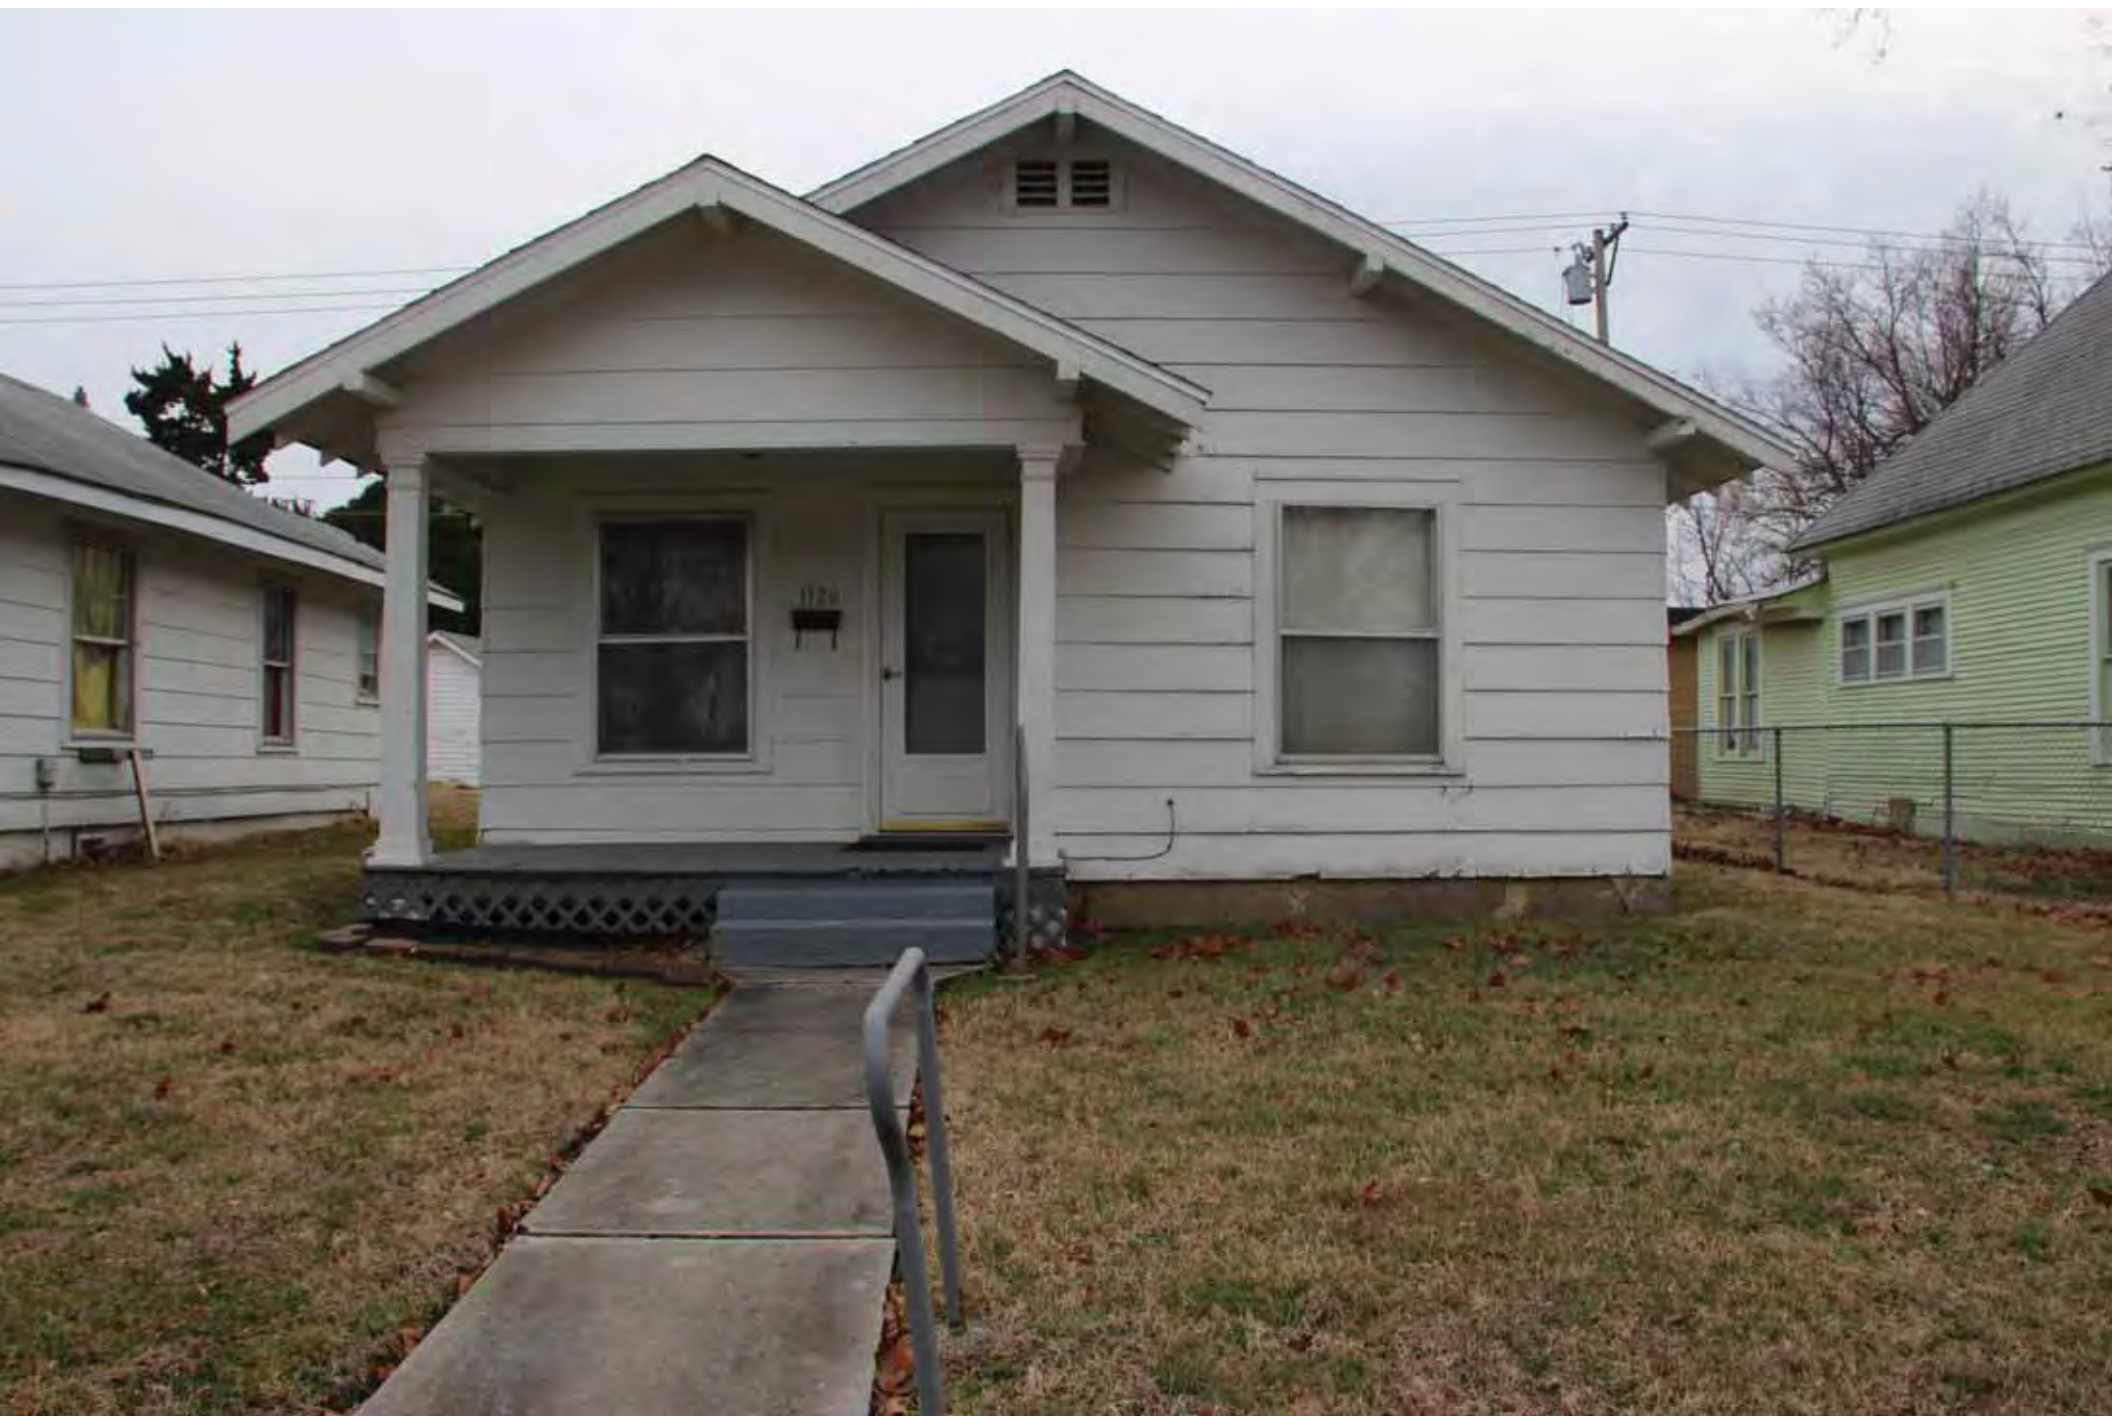
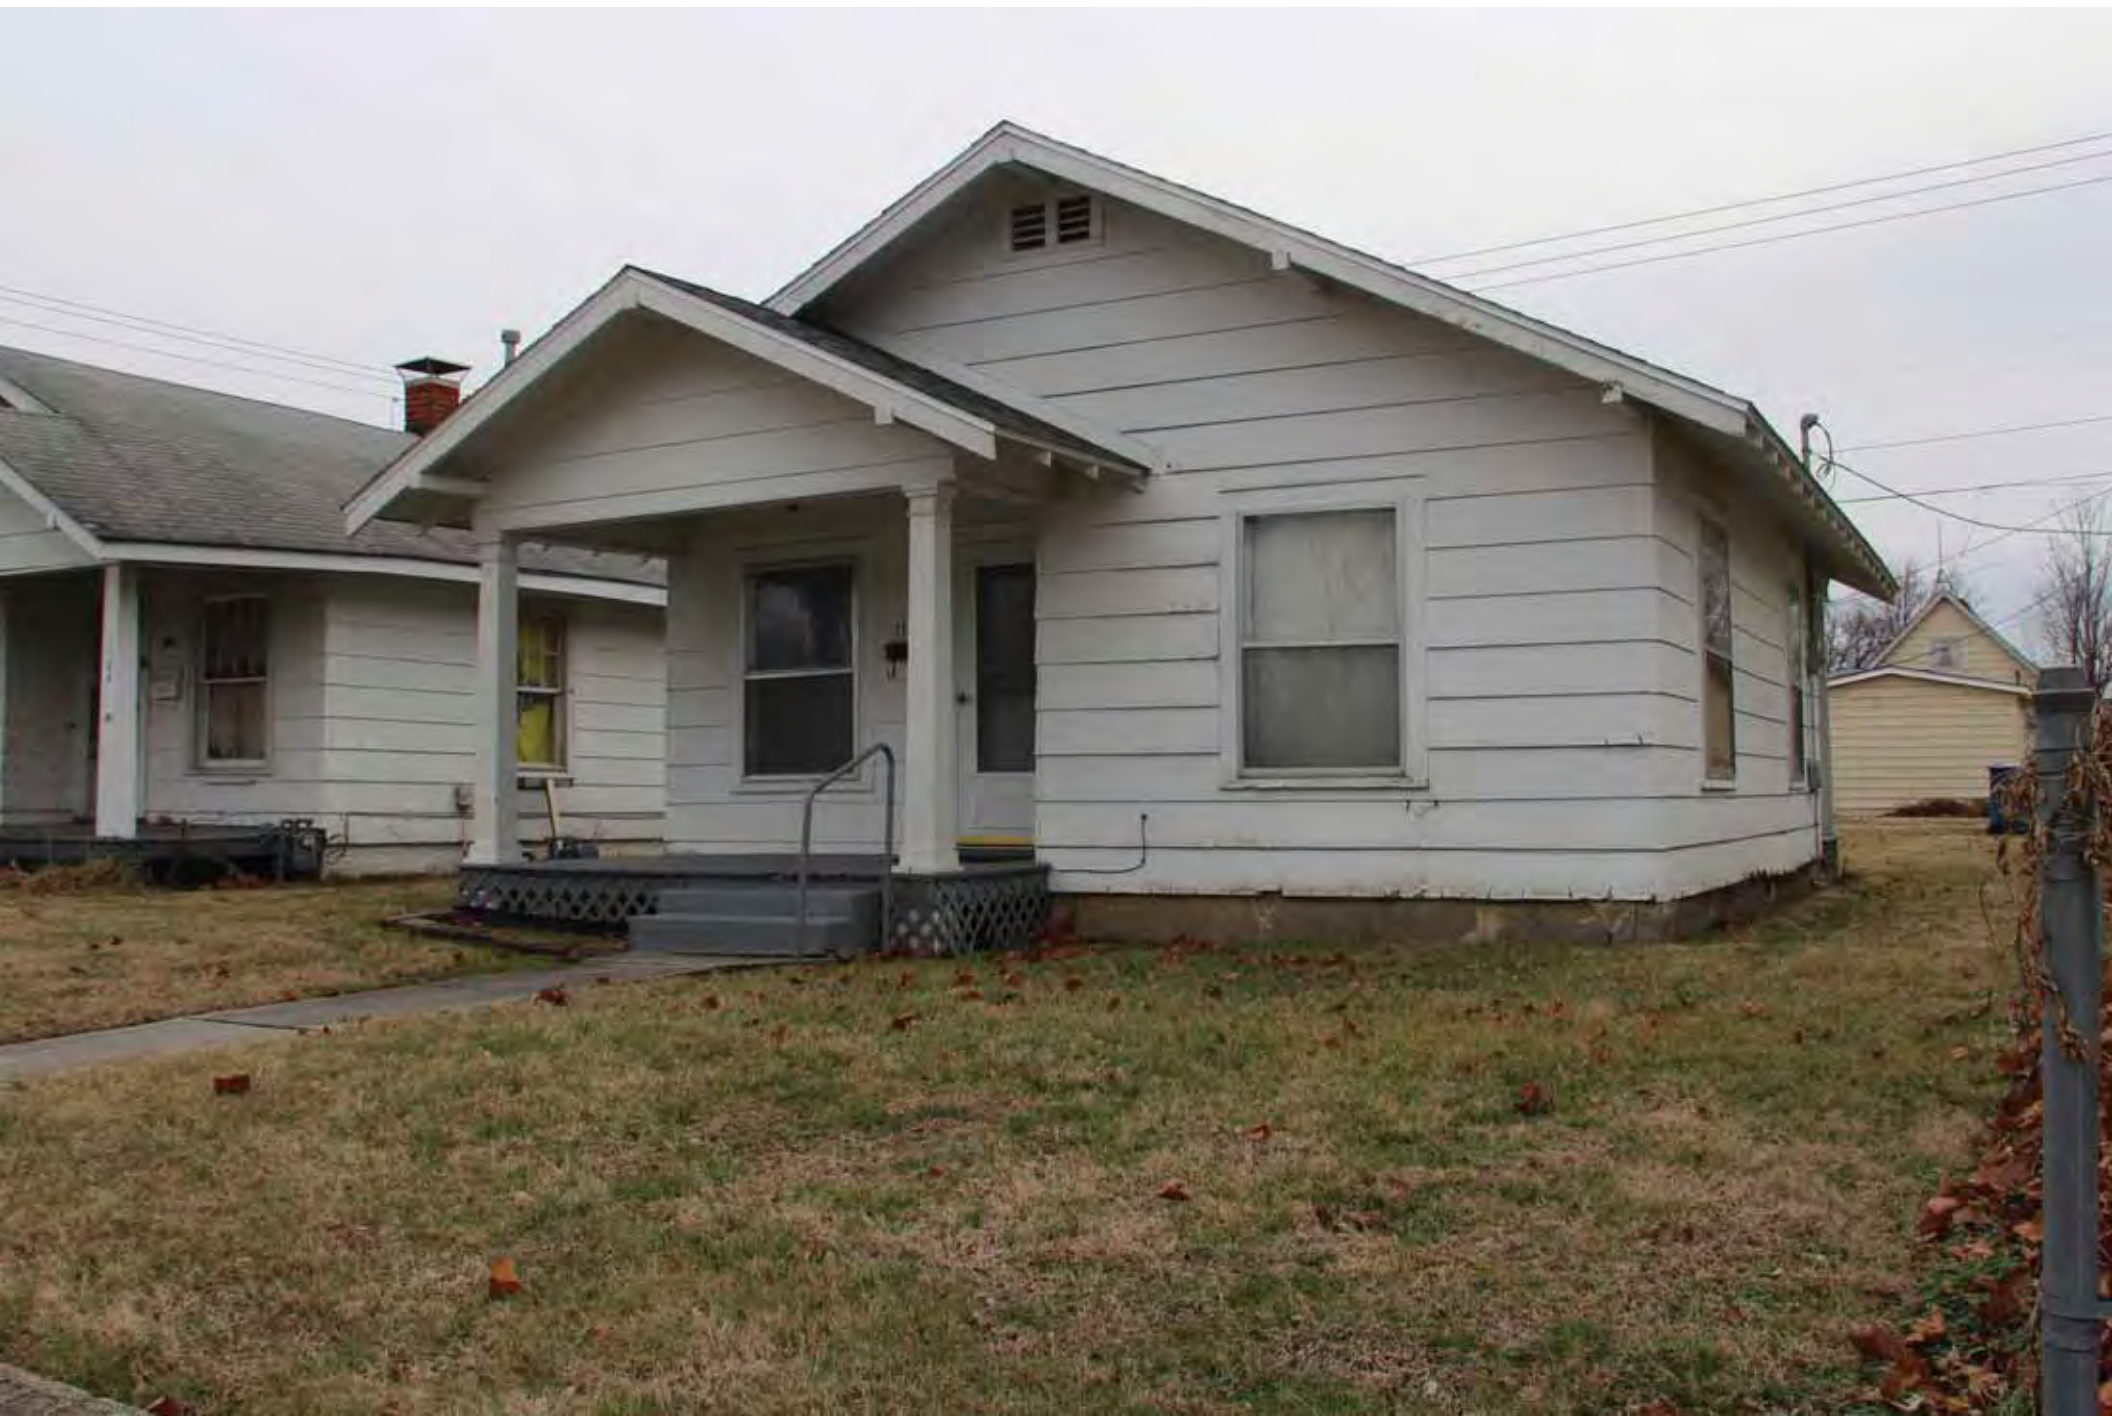
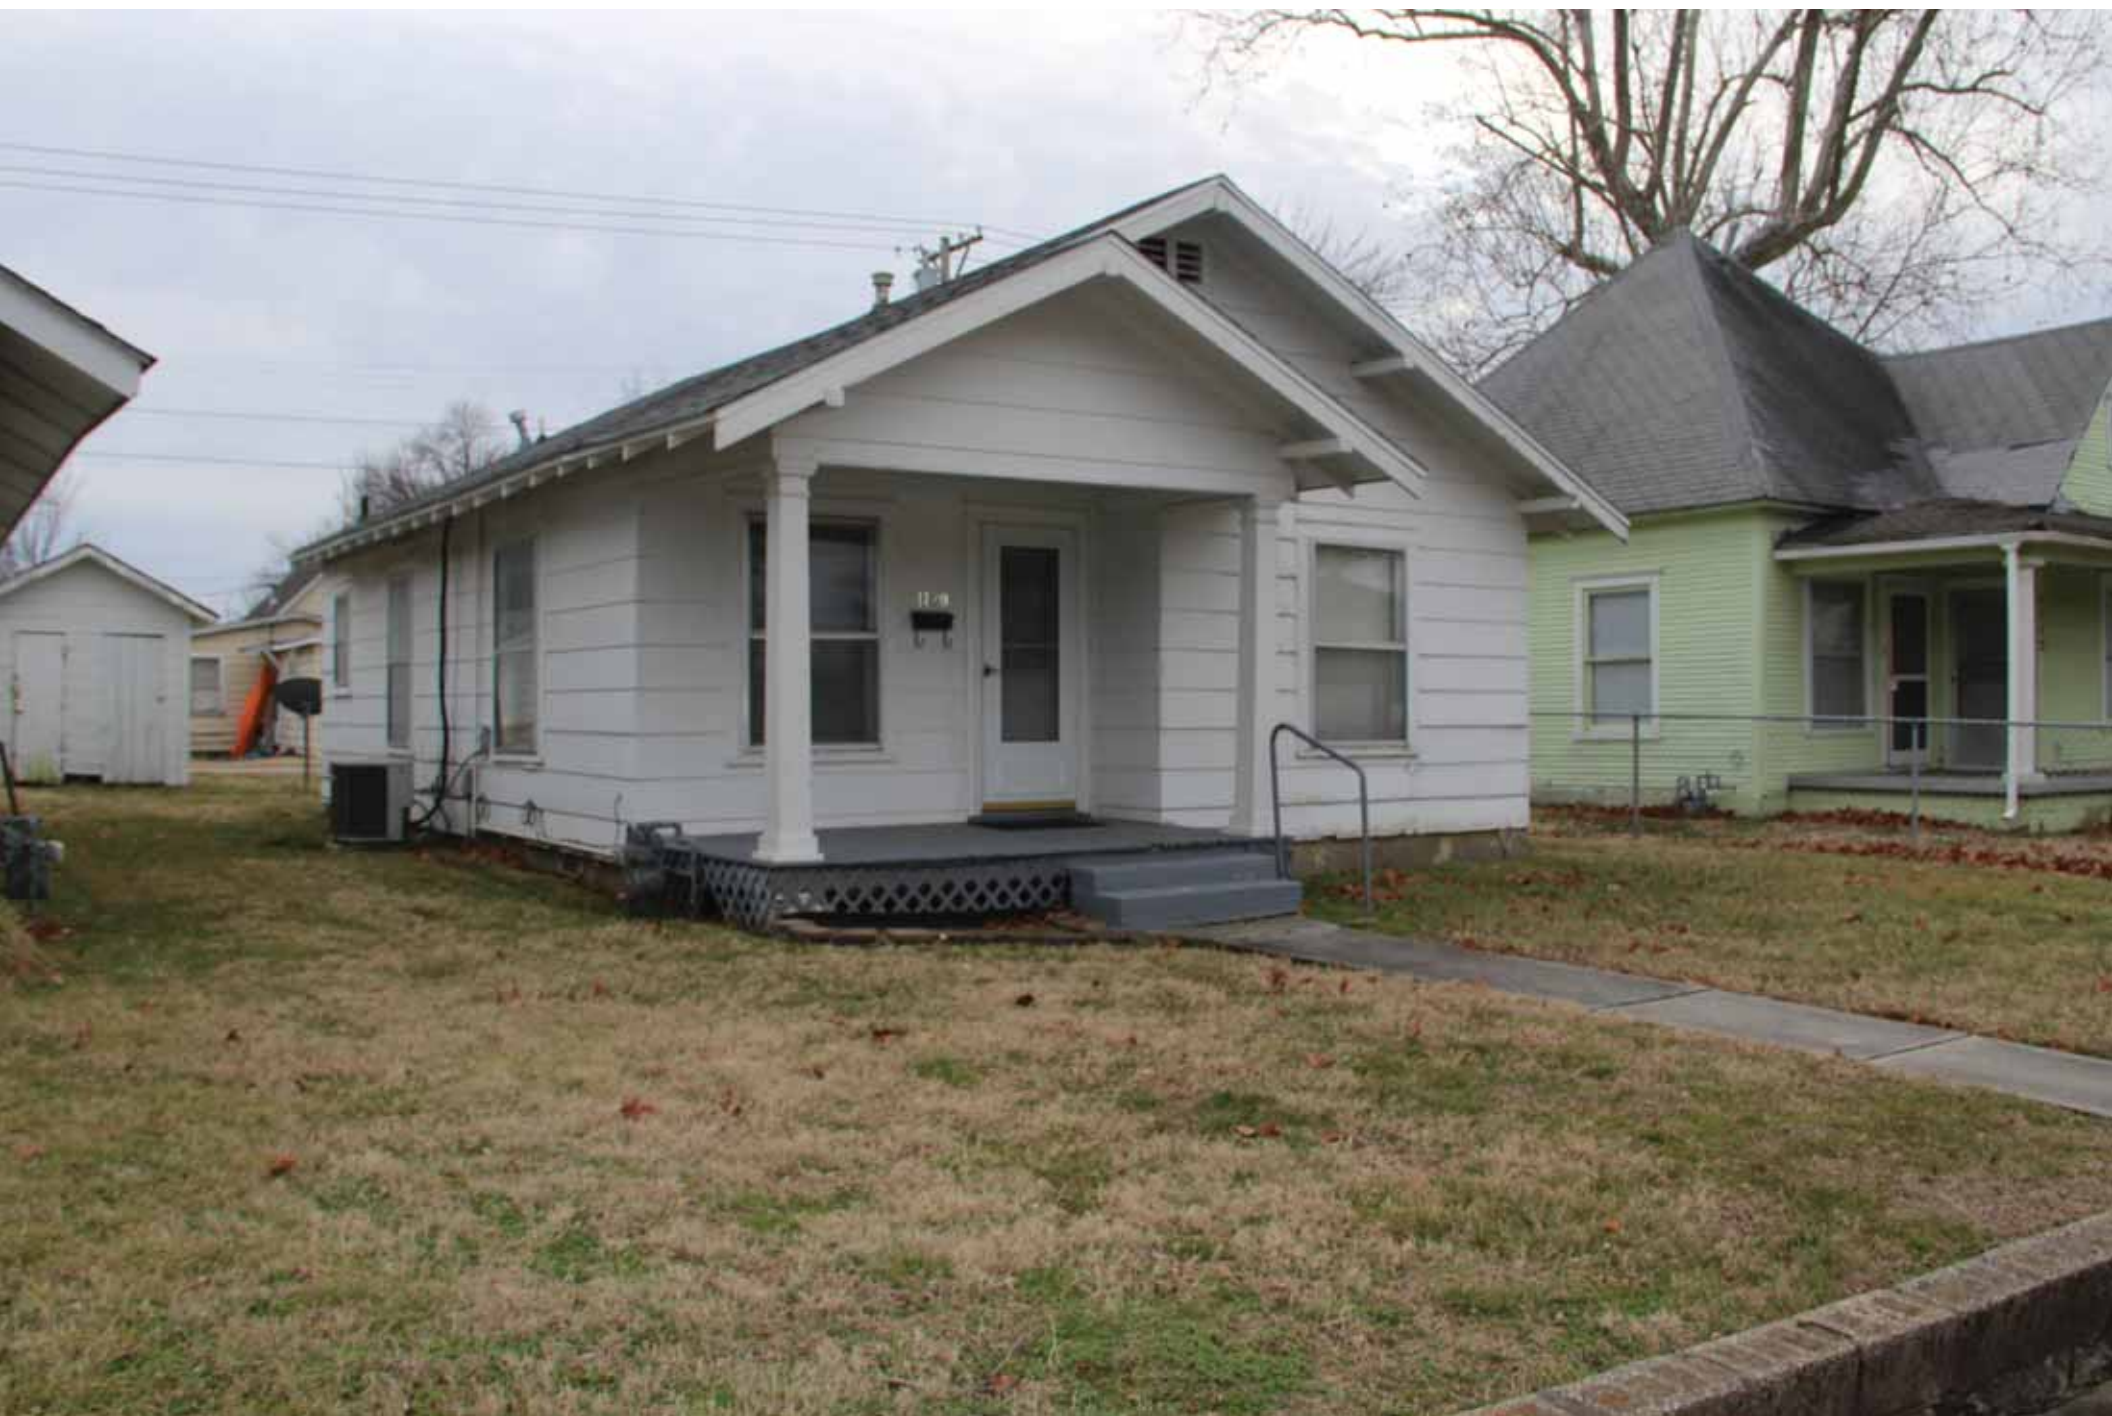
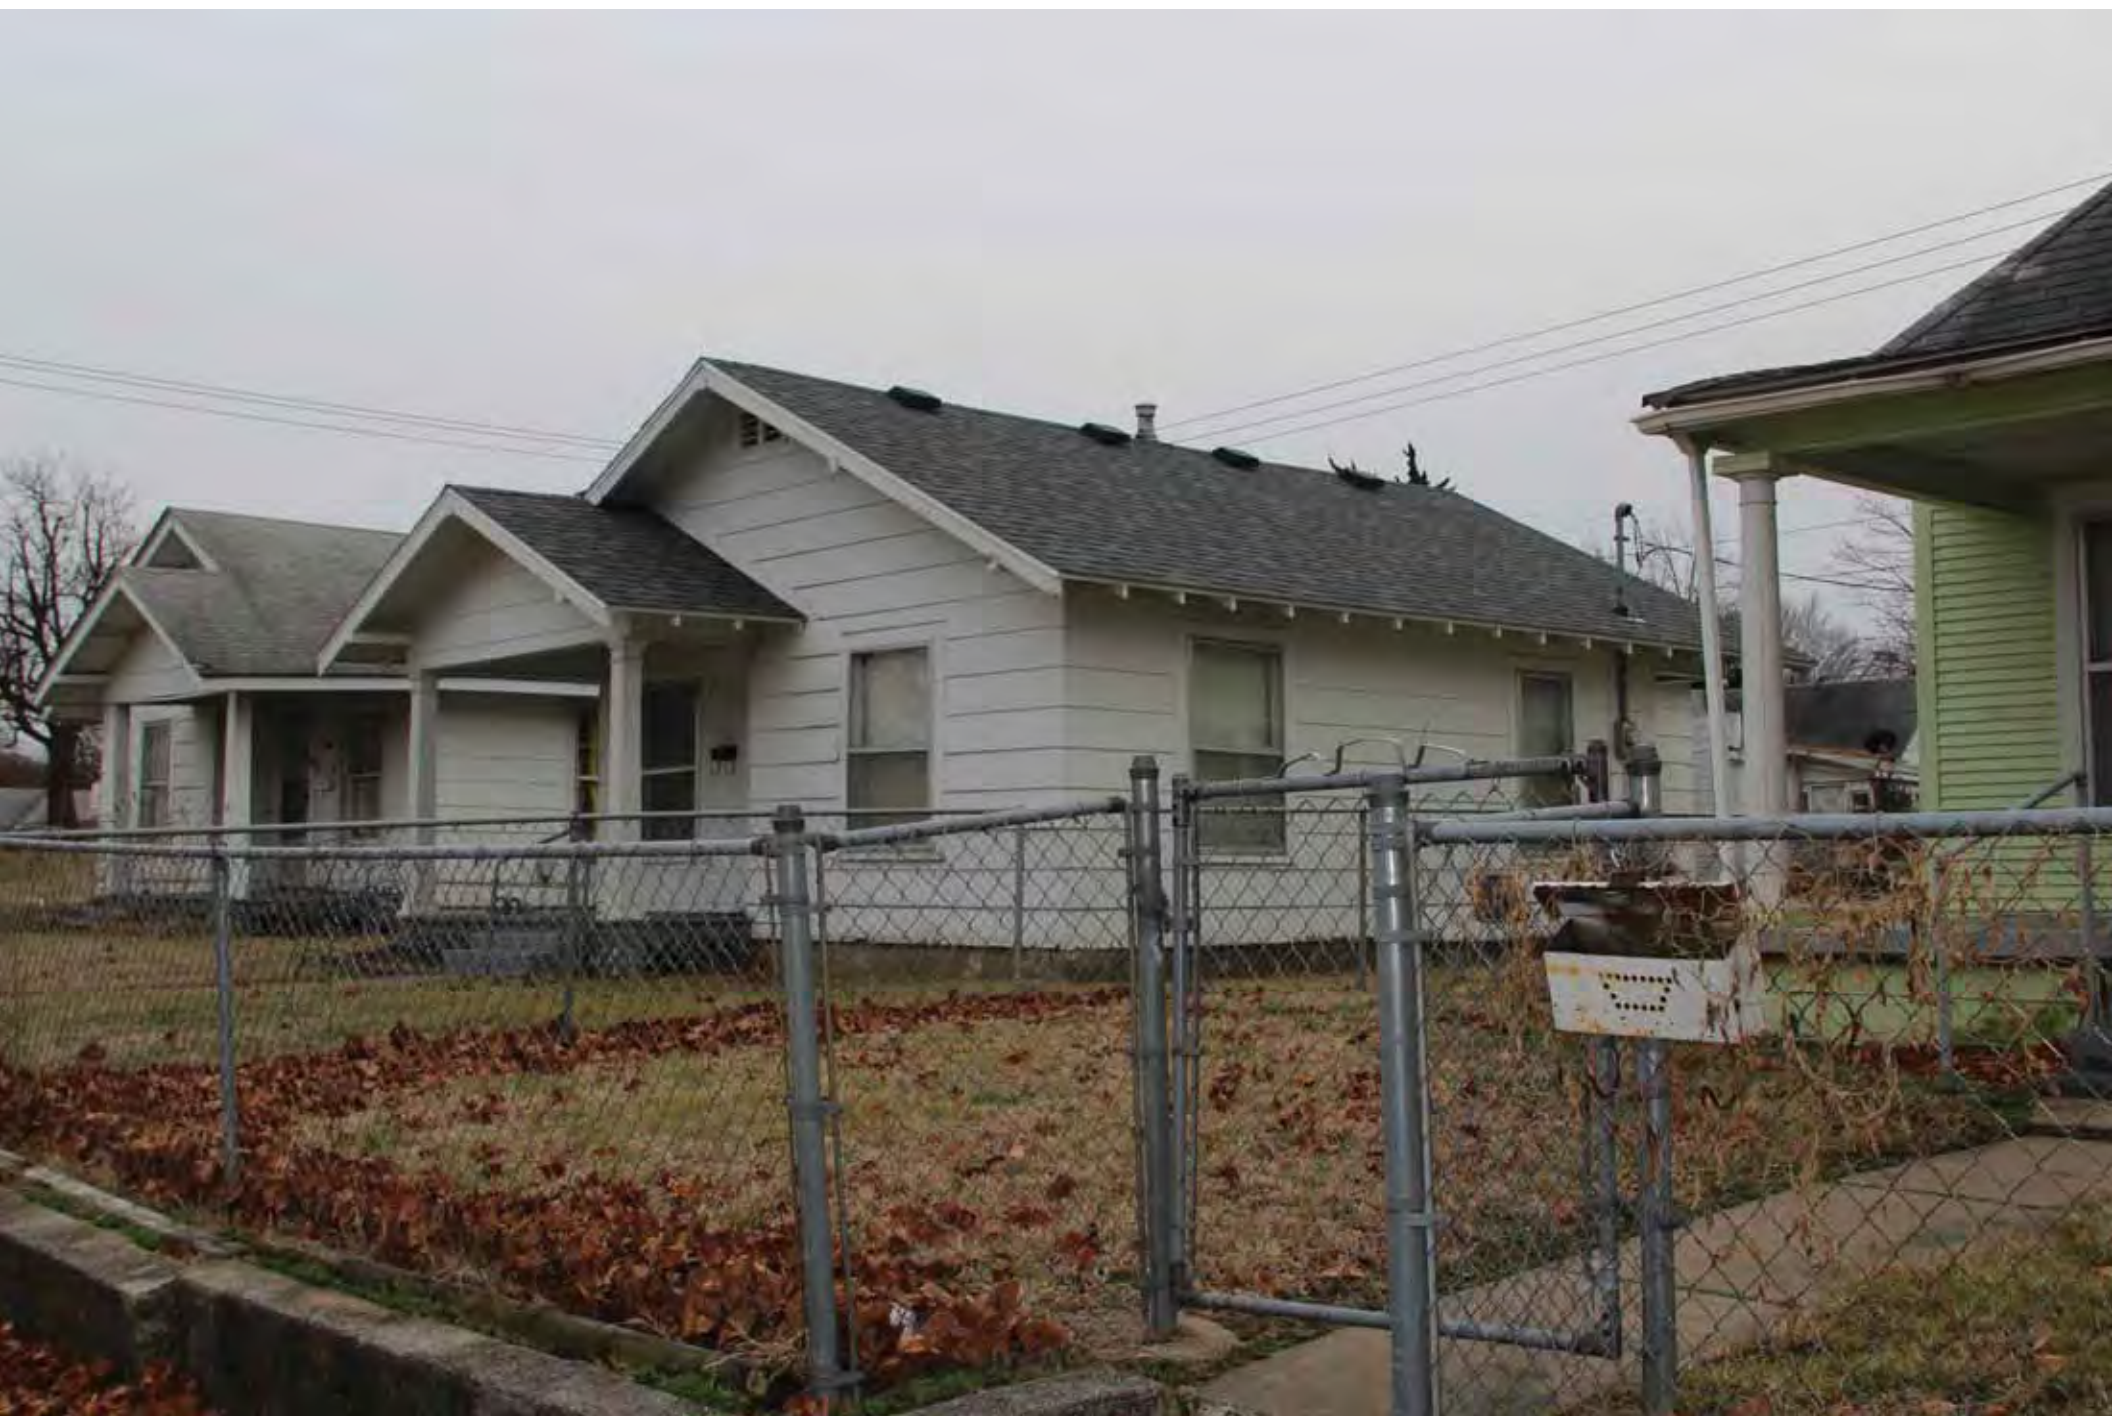
The property at 1120 E. Broadway is a single-story gable-front plan Bungalow with an asphalt shingled roof, exterior wide board siding and a concrete foundation. The primary (north) elevation supports an off-center gabled porch supported by two original wood columns. The porch has a pier foundation covered by lattice. Within the porch bay is an original single-light paneled door covered by a contemporary single-light storm door. Flanking the door are single one-over-one windows. The front façade wall extends slightly north at the west end of the porch. The porch roof and open eaves feature exposed rafter tails. In the front gable is an original louvered vent. Side (east and west) elevations support single one-over-one windows.

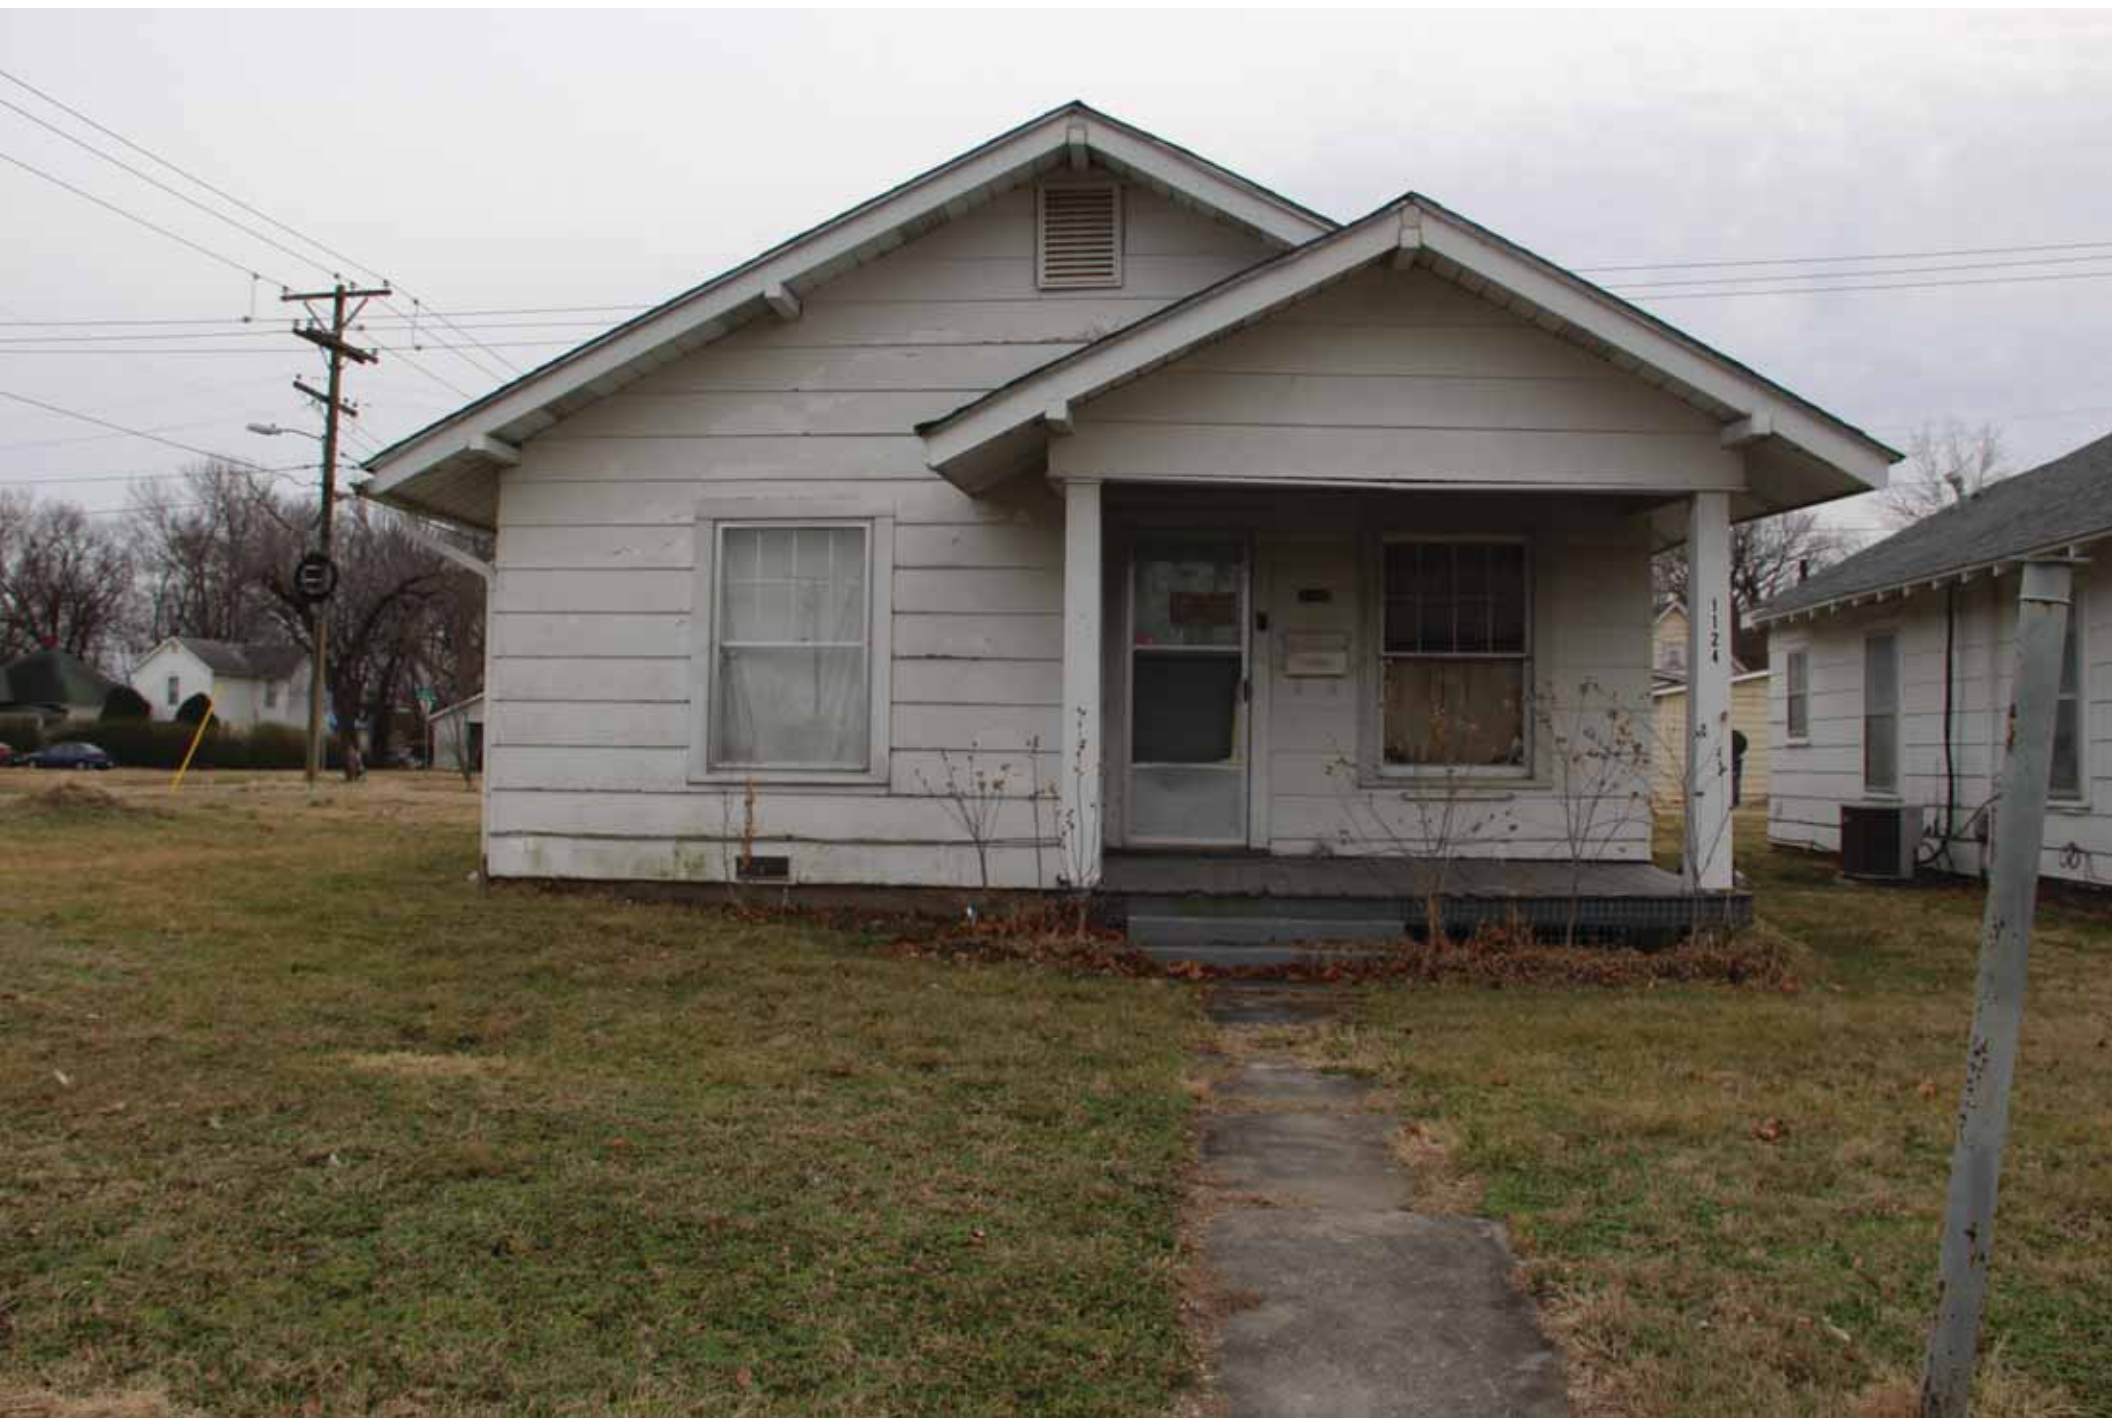
The property at 1124 E. Broadway is a single-story gable-front plan Bungalow with an asphalt shingled roof, exterior wide board siding and a concrete foundation. The primary (north) elevation supports an off-center gabled porch supported by two flared wood columns. The porch has a wood pier foundation. The remaining foundation is concrete rubble. Within the porch bay is a replacement (c. 1960) door with an upper single light. Flanking the door are single six-over-one windows. Some windows on side elevations have missing lights. The front façade wall extends slightly north at the east end of the porch. The porch roof and open eaves feature exposed rafter beams. In the front gable is a louvered vent.
